# Geomorphic and Habitat Assessments of Trout Streams in the Lower Minnesota River Watershed District

August 2019

Prepared For: The Lower Minnesota River Watershed District

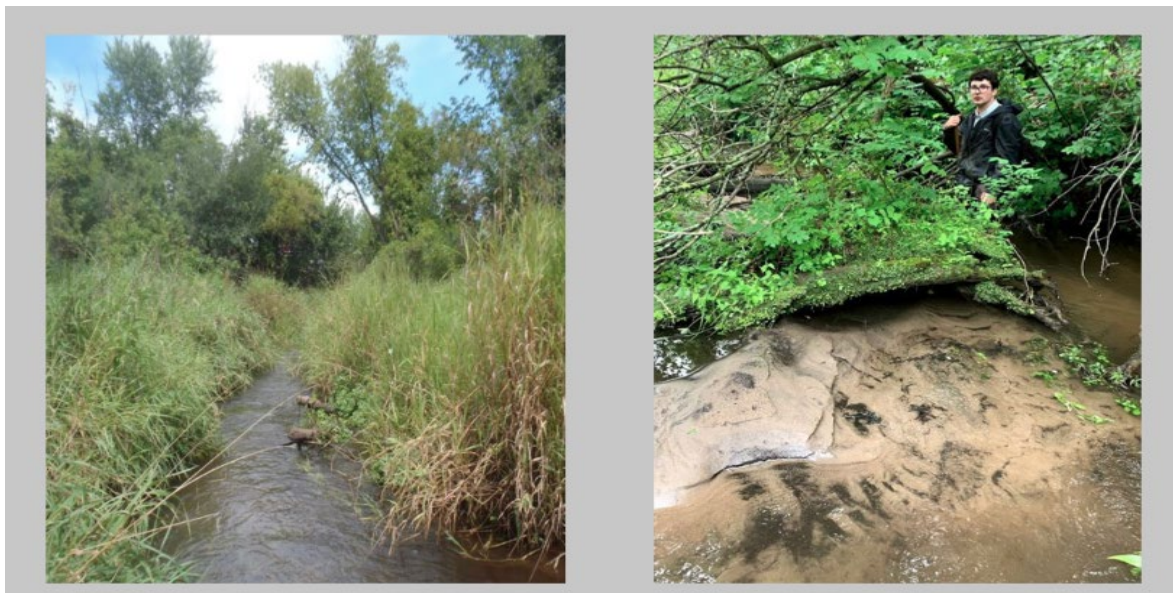
In 2014, Brenda DeZiel, Research Scientist at the University of Minnesota, visited Eagle Creek and completed a habitat assessment. At that point, she rated channel stability as high and depth variability as excellent. She came back in 2019 to show the team how to properly perform a habitat assessment, and observed that there had been major differences in the stream since 2014. More areas of aggradation are apparent today throughout Eagle Creek, but channel stability and depth variability mostly maintained their 2014 scores ([see figure A.2 in Appendix A](#)).

Figure A.2. Eagle Creek in 2014 on left and picture of increased aggradation in 2019 on right. Brenda DeZiel (2014). Kirsten Haus (June 2019).

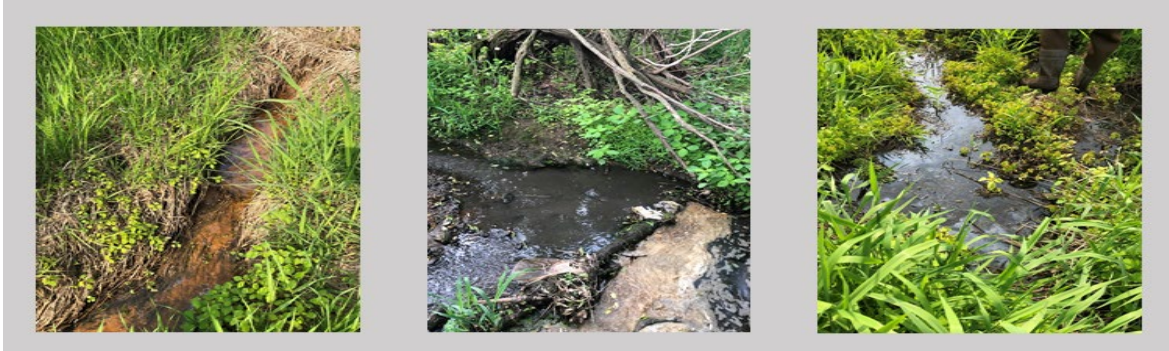
The western reach of Assumption Creek consists of survey sites 7-12, begins at the headwaters, and runs about halfway through the branch of the stream west of Flying Cloud Drive (see Figure 5). At the headwaters, the stream is only about a foot wide and covered heavily with vegetation. It was easily found during reconnaissance due to the minimal vegetation in early June. In late June, the stream was almost unrecognizable and very difficult to locate as the headwaters had mostly dried up. The headwaters and stream is supported by baseflow. The land use is wetland and prairie, but as the stream moved west, the right bank land use changed to urban/industrial. This reach had an average of an extensive riparian width (>150 feet) and varied much in its riparian flow refuge. Survey sites 7, 8, and 9 had narrow or no riparian flow refuge (0%-20%) while survey sites 10 and 11 had moderate to widely accessible flood plains (50%-100%). This is due to the stream becoming less incised as it moves west. This part of the stream had natural to minor bank erosion issues. While the stream is located in mostly grasslands/prairie/wetland with no major trees for shade, the stream is well-shaded (50%-75%) throughout the reach due to overhanging vegetation. This reach has an average of extensive (>50%) cover/concealment amount. The types of cover include undercut banks, overhanging vegetation, woody debris, root mats, instream vegetation, shallows, and backwaters/side channels. The types of instream vegetation include emergent cattail and reed canary grass. The amount of pools and riffles also almost completely disappears, and the stream becomes a long run. The velocity types of the stream include slow, intermittent, and none. The water level was incredibly shallow throughout. The depth is uniform throughout, making variability poor (<8 inches). The stream begins with almost no degree of stream meandering. This whole part of the western reach has fair channel development, with a pool/riffle/run sequence present, but the thalweg is not distinct throughout. The western reach had an average habitat score of 33.33. The pebble count showed 69% silt/clay/muck, 17% sands, and 14% types of gravel. The pools included majority sand and the riffles and runs consisted of fine gravel and sand. As the stream moved west (points 9, 10, and 11), the substrate was almost completely fine sand, silt, and muck ([see figure D.1 in Appendix D](#)).

Figure D.1. Muck and silt present at Assumption Creek Western reach. Erica Bock (July 2019).

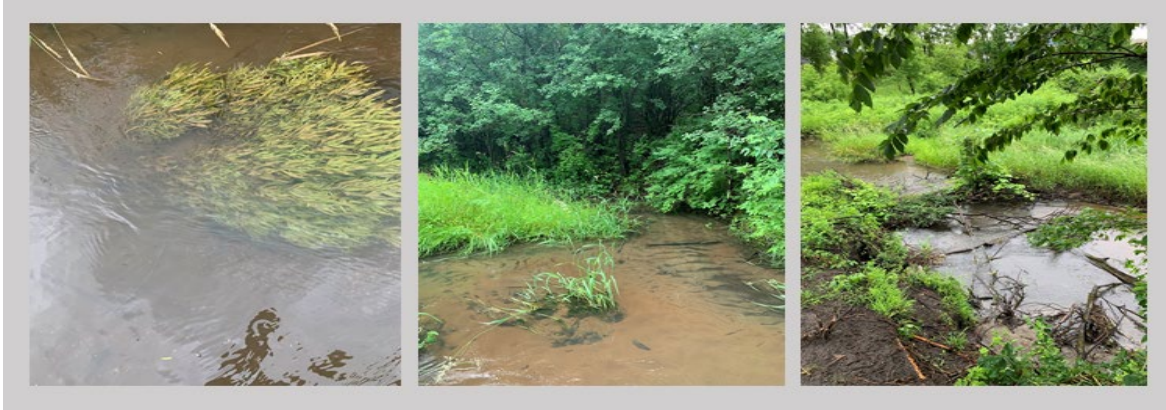
Figure E.1. Instream vegetation and overhanging vegetation. Erica Bock (June 2019).

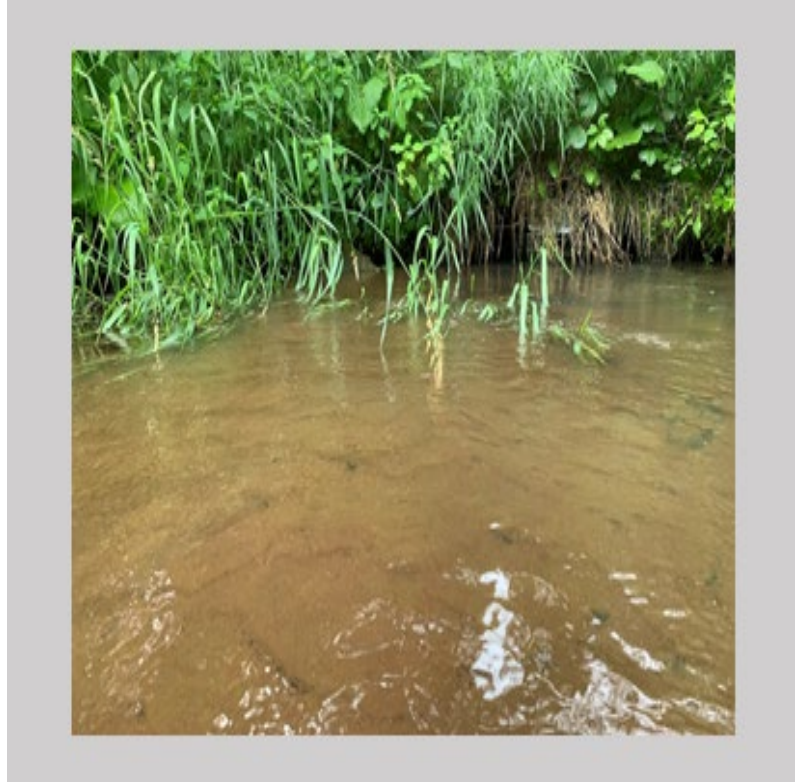
Figure E.2. Undercutting on the bank. Erica (June 2019).

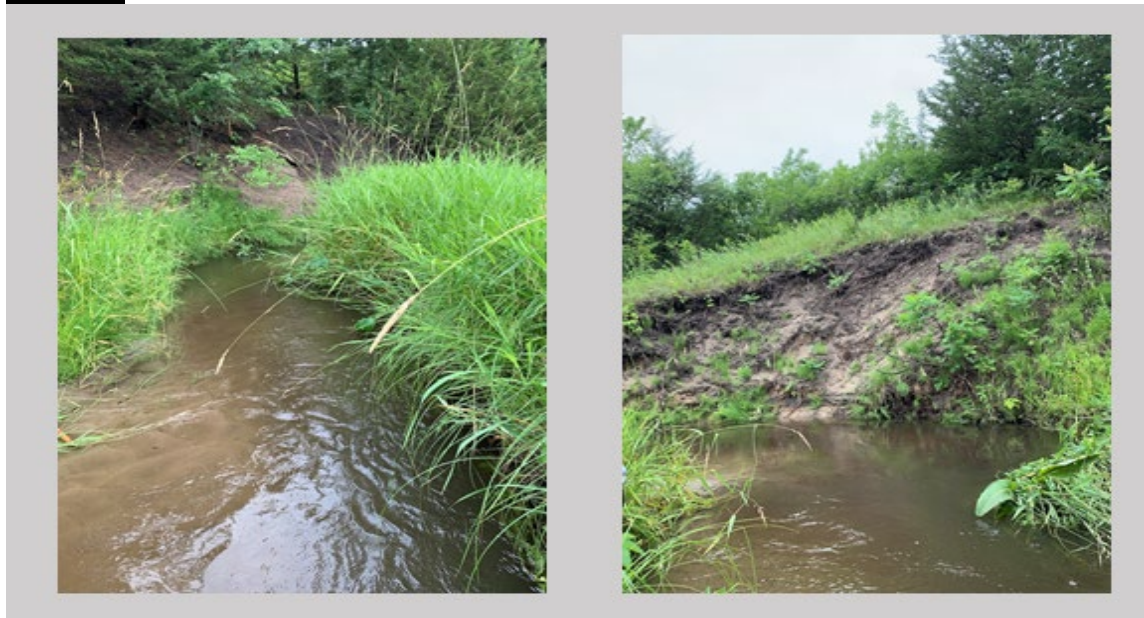
Figure E.5. Bank erosion and scouring at Point 18 on Eagle Creek East Branch. Kirsten Haus (June 2019).

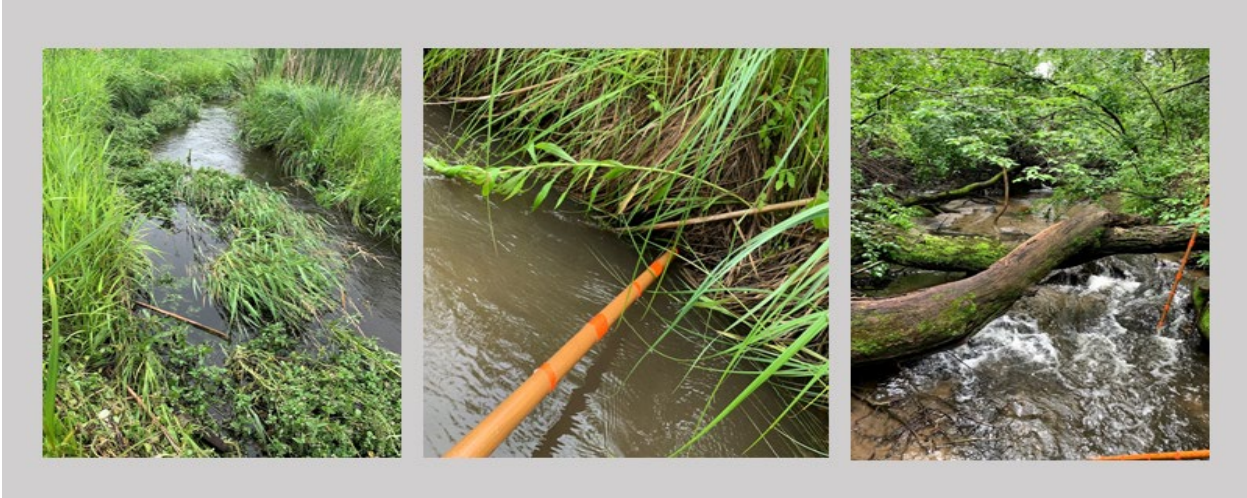
Figure E.6. Concealment in Eagle East Branch. Erica Bock (July 2019).

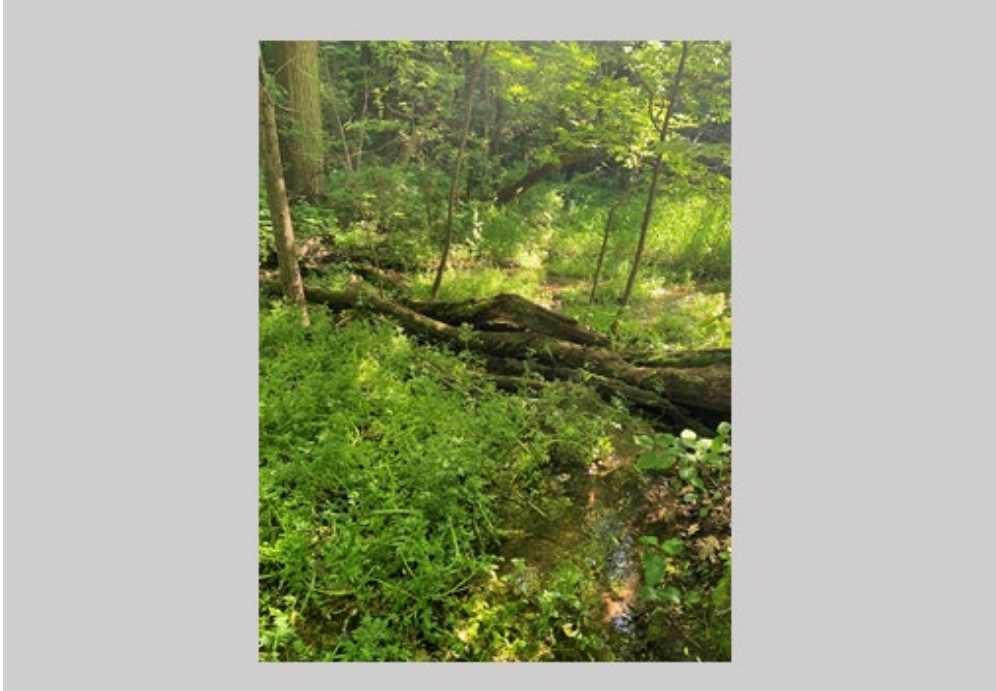
Figure F.3. Excessive Instream vegetation. Erica Bock (July 2019).

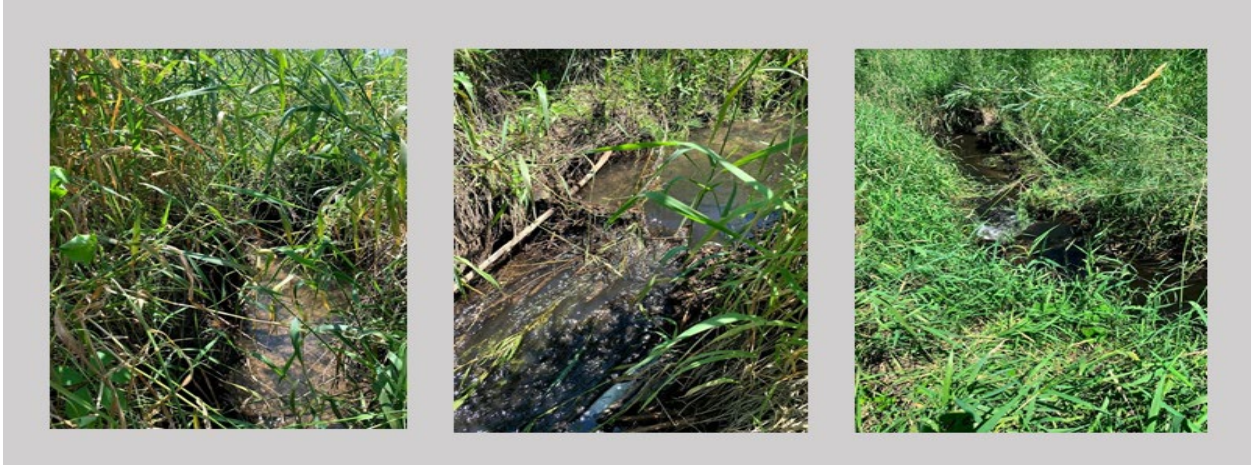
Figure G.1. Vegetation on Kennaley. Sam Wheeler (July 2019).

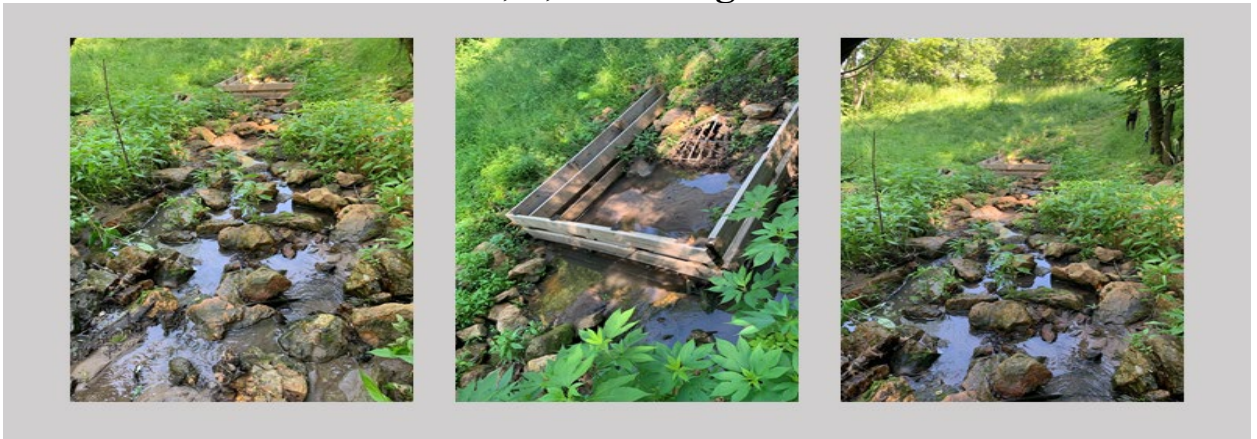
Figure H.1. Construction on the stream. Kirsten Haus (July 2019).

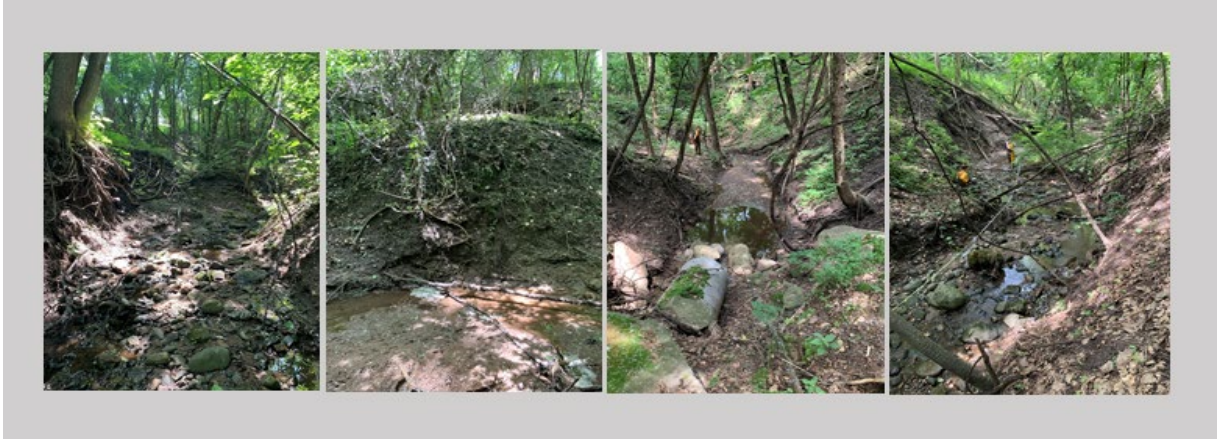
Figure H.2. Erosion. Erica Bock (July 2019).

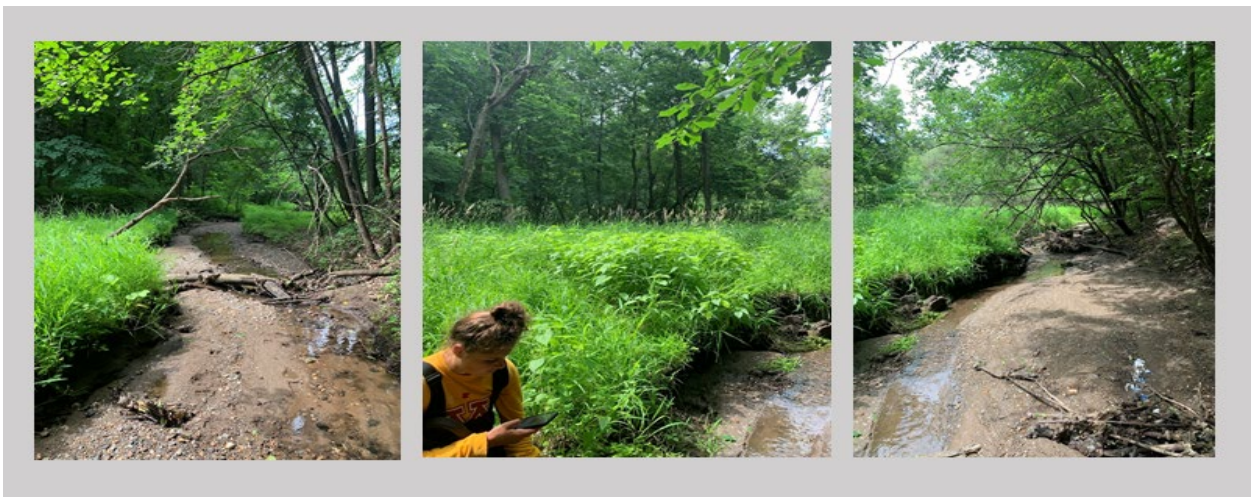
Figure H.3. Land change. Erica Bock (July 2019).
