Erosion Stabilization Study

Study Area 3 Final Report

Prepared for the
City of Eden Prairie

Prepared by
SRF CONSULTING GROUP, INC.
SRF No. 0076205

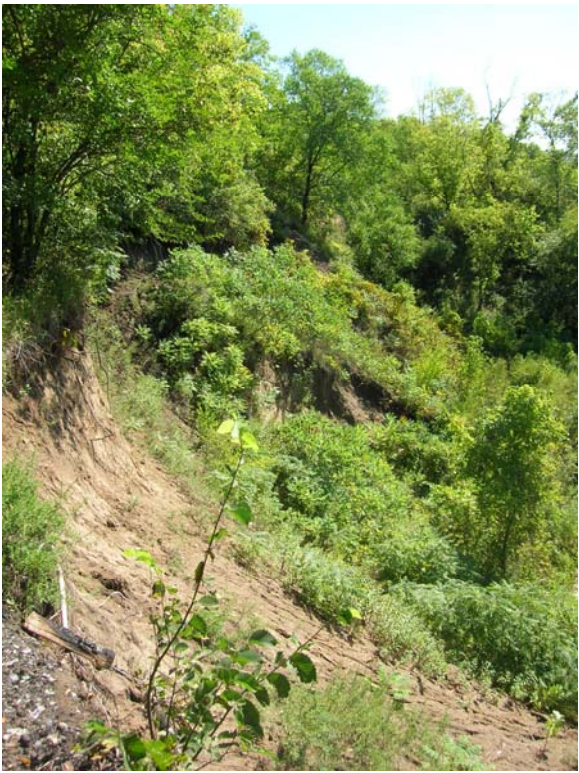
Analysis of the survey information and cross sections reveals that the most severely eroded area is limited to approximately 100 feet of roadway collapse where a bare, nearly vertical face is exposed. Figure 2a shows the most severe area of erosion. Below the vertical face, the slope gradually decreases to a more gentle grade before reaching water's edge (Figure 2b). Upstream and downstream from this area, the vertical face gradually transitions to approximately 1v:2h slope that is somewhat vegetated (Figure 2c). In addition, the survey data clearly delineates a 150-foot long cut in the river bank just below the most severe bluff landslide area.

As noted earlier, a series of springs emerge from the bluff between five and ten feet (vertical) above the water surface (as measured on May 16, 2008). Several cross sections within the most severely eroded area (station 11+25 through station 12+00 in Appendix B) show that sloughing above this elevation is somewhat more evident than in other sections.

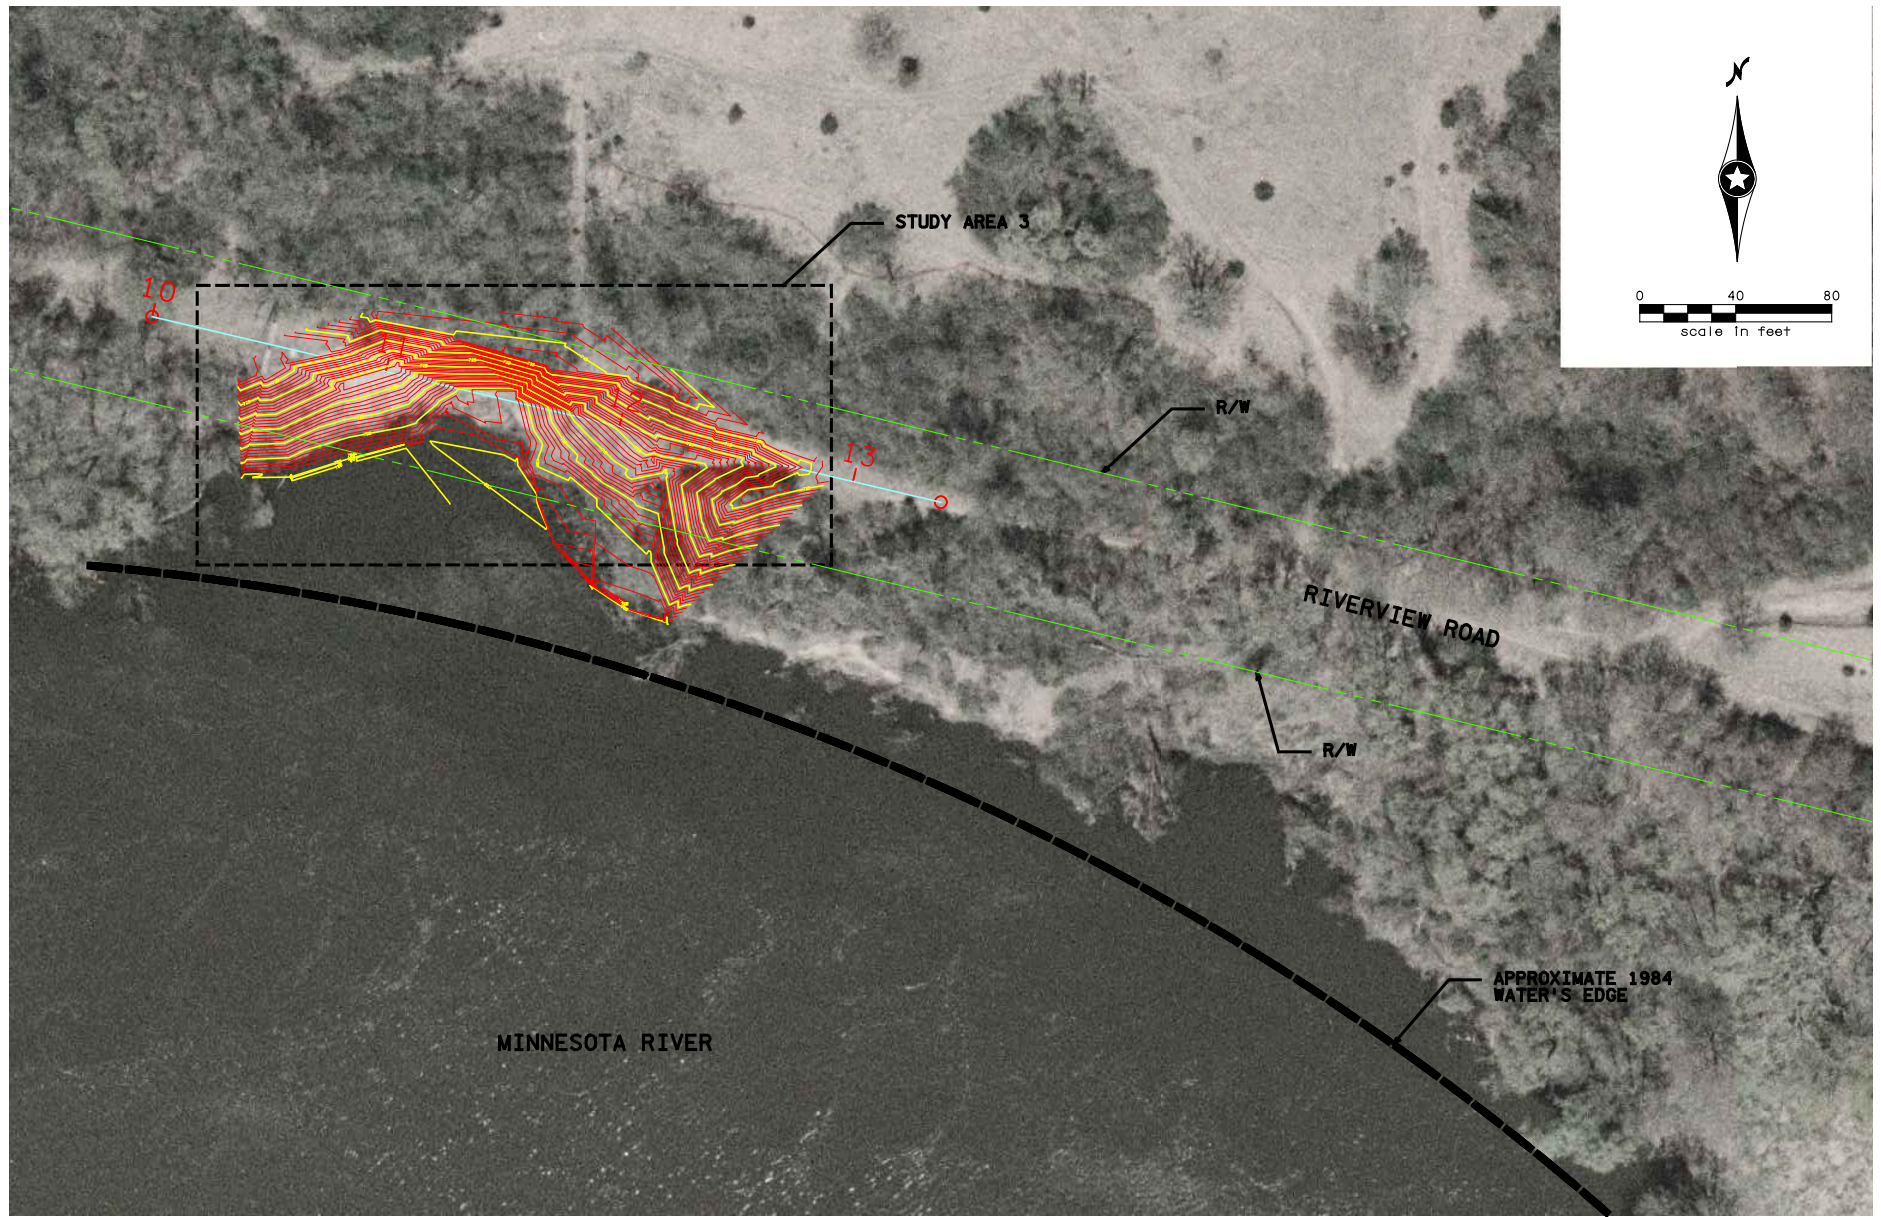
Study Area 3 Existing Conditions

Since a localized cut in the river bank has formed and mass wasting has occurred over the years, it is important to consider where the toe of the stabilized embankment should be located. Ensuring a smooth curve through which the river travels is of greatest importance. Yet the final riverbank position would not necessarily have to be at its original location. Figure 3 shows where the 1984 water's edge may have been prior to the bluff failure. Before 1984, the roadway had not been compromised and the river bend was still somewhat smooth. After 1984, landslides accelerated and by 1991 the roadway had been compromised. It is reasonable, then, to assume that water's edge prior to 1984 represents a smooth, somewhat stable transition through the river bend. In order to accomplish this, the existing toe would need to be placed approximately 100 feet from the centerline of Riverview Road, thus pushing the toe out into the river over 50 feet. Unfortunately, a significant amount of imported soil and great expense would be necessary to backfill and return the 200 foot area that is most severely eroded to the 1984 condition. Filling the cut area to a lesser extent and armoring it – thereby providing a reasonable transition as the river bends through 100 degrees – is, however, quite possible. This would reduce or eliminate vortex currents that may have contributed to the original failure. Placing the proposed toe approximately 50 feet from the center of Riverview Road and armoring with riprap would provide a reasonably smooth and stable transition while limiting excessive importation of backfill.
