Technical Memorandum

To: Linda Loomis, Administrator
Lower Minnesota River Watershed District

Re: Area 3 Slope Stability Project Update

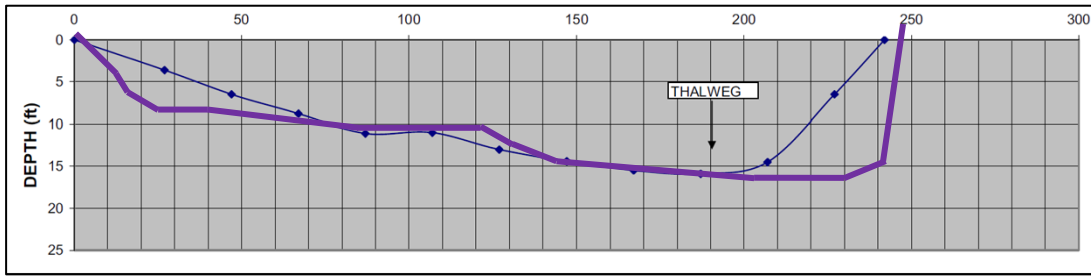
Cross-Section 1

Cross sections 1–2 are upstream of Area 3 and show evidence of scouring and continuing erosion since 2009; the channel has deepened, and the right bank significantly eroded. Cross section 3 is also upstream of Area 3 but shows some deposition evidence in the channel. Still, the overall shape and extent of the cross section appear to be only minorly changed.

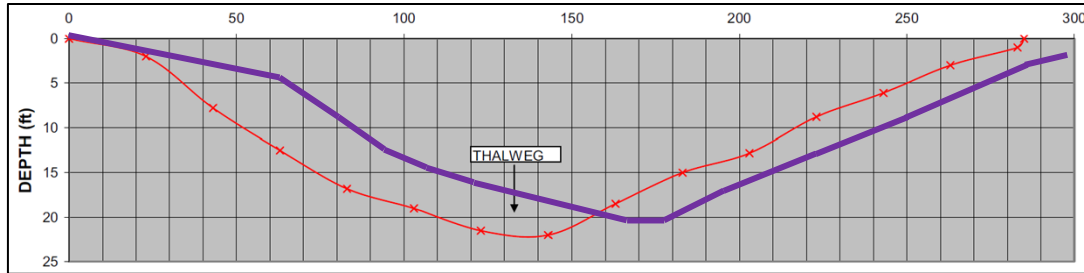
Cross-Section 4

Cross sections 4 through 6 are within the Area 3 project area and all show evidence of channel movement and scour. Cross section 5 clearly shows the channel has moved toward the left bank—closer to the Area 3 embankment—and has deepened since 2009. This movement is consistent with the 2009 Wenck assumptions and historical aerial photo analysis, which showed the river has been migrating north at an average of 2 feet per year between 1937 and 2008.

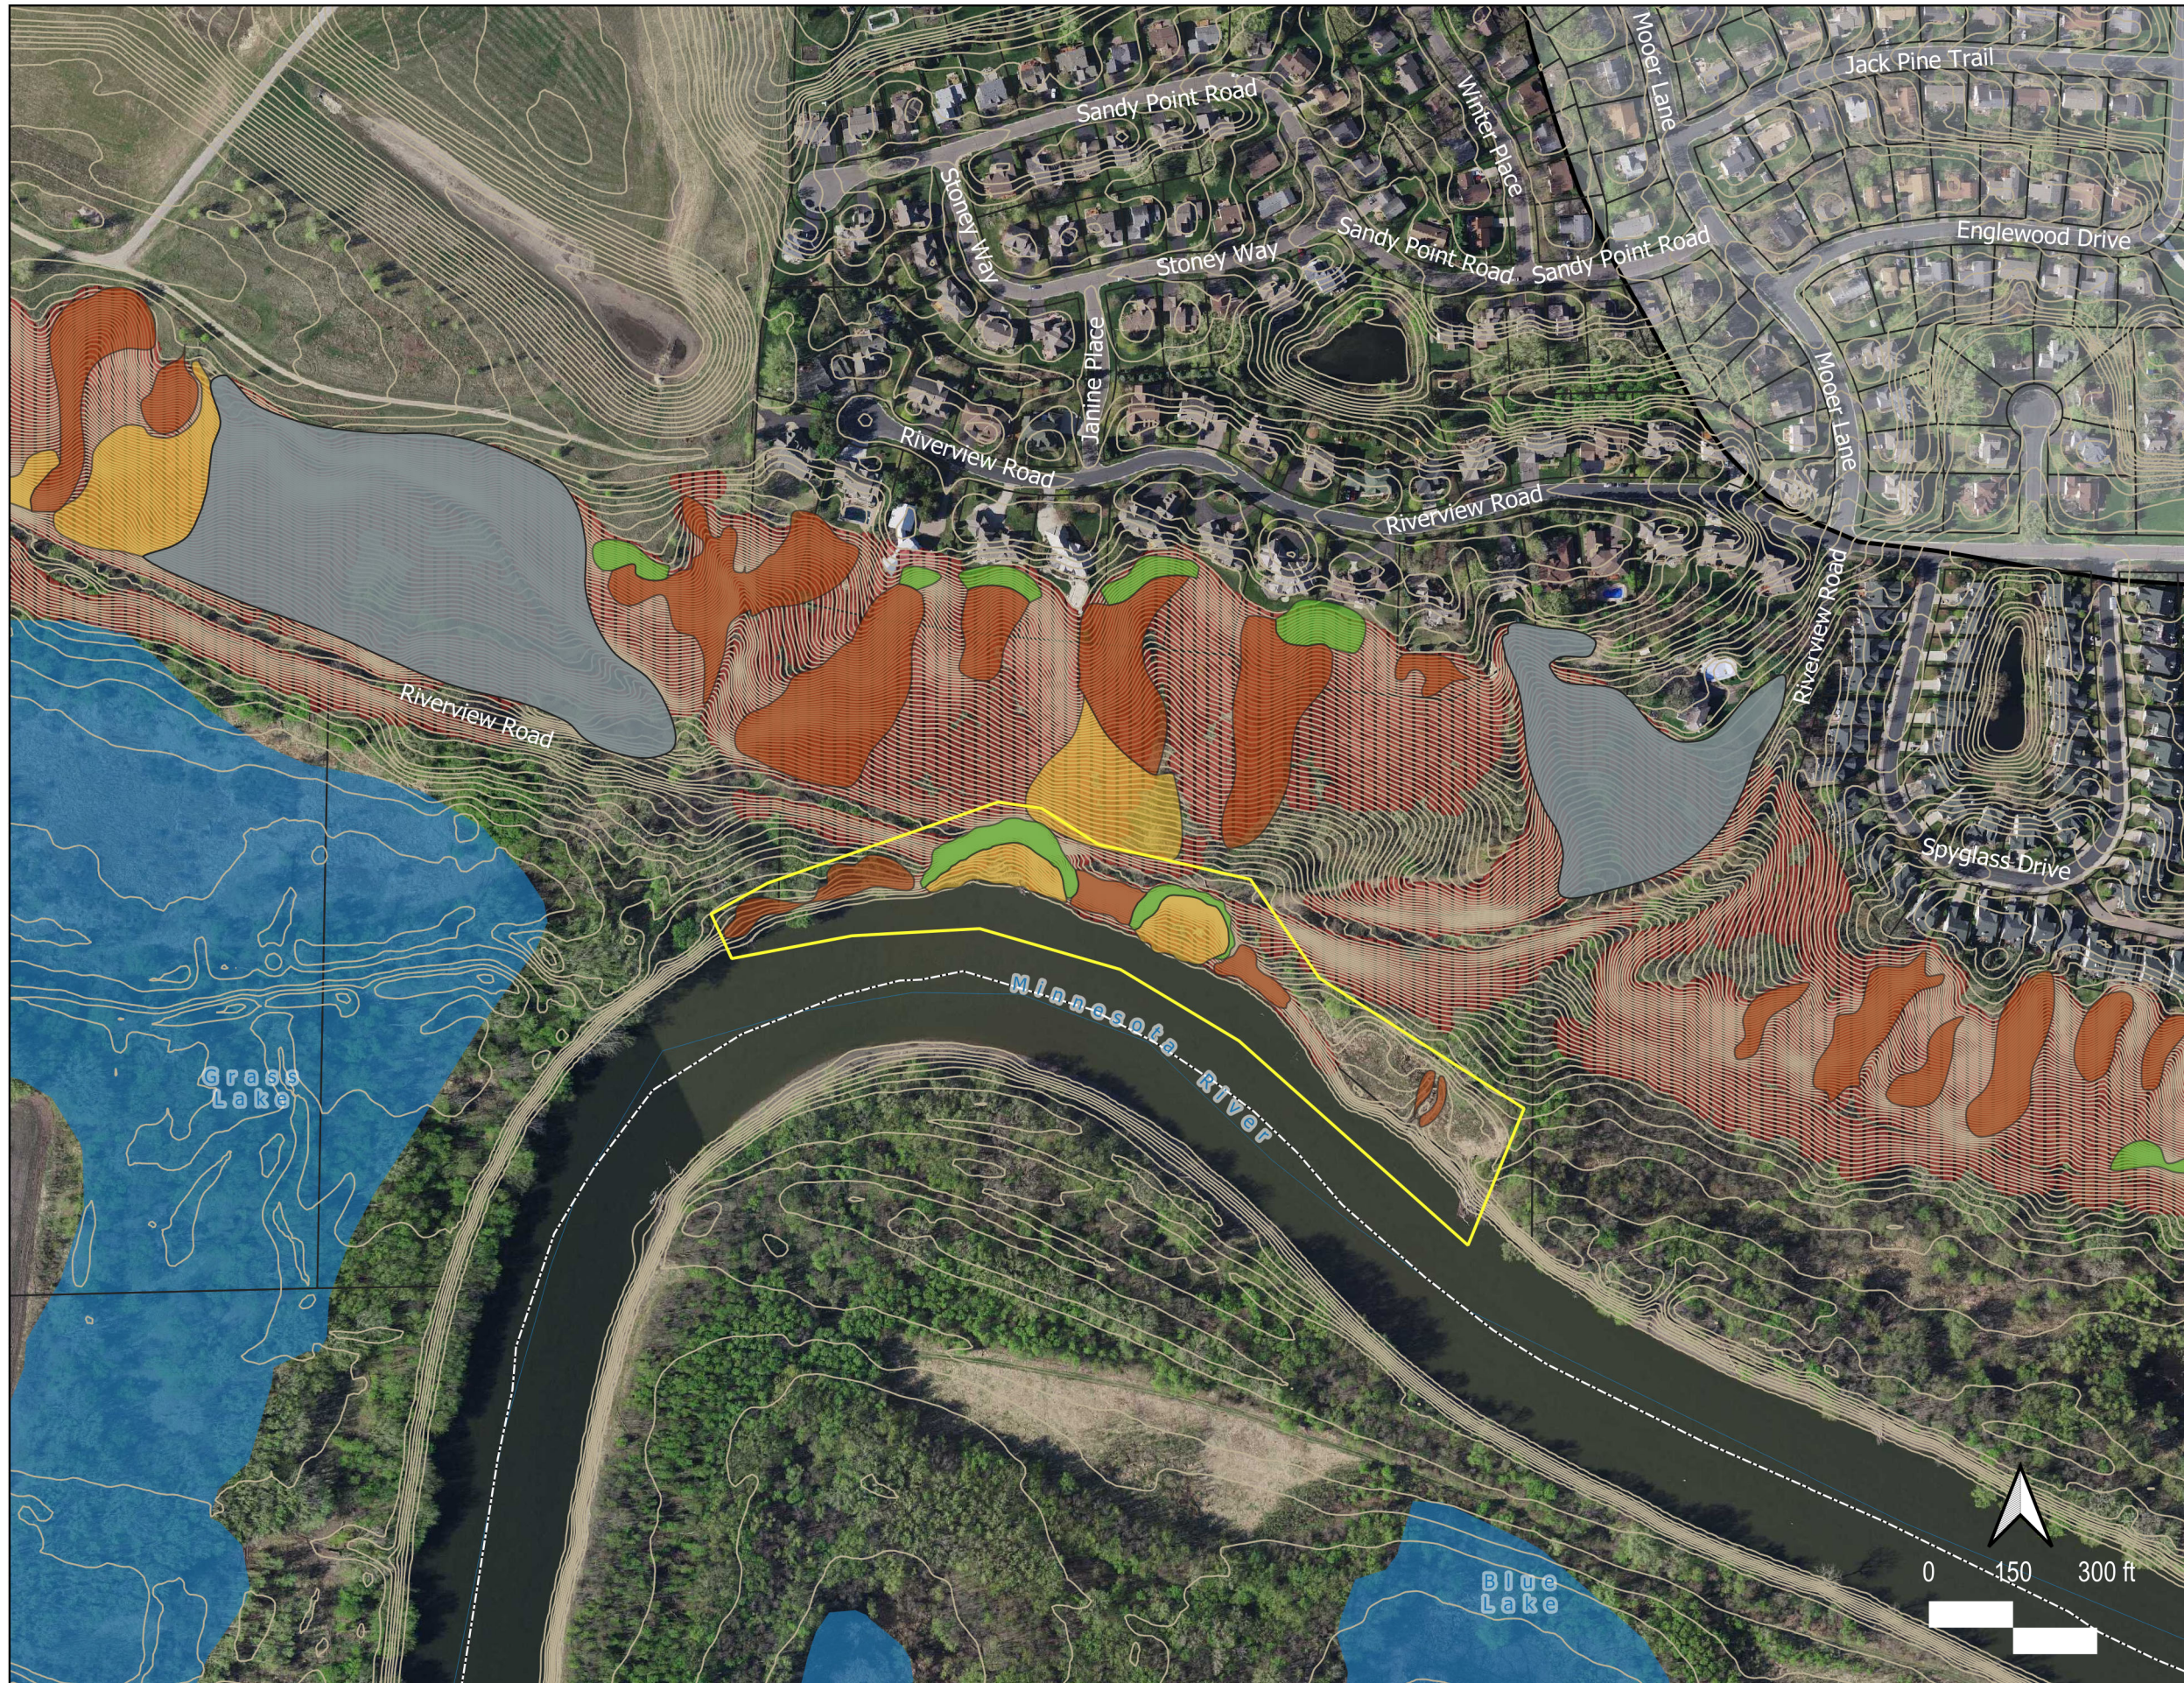
**Figure 3:
Area 3 Historic
Landslides**

Hennepin County provided locations of historic landslides derived from an analysis of LiDAR topography. The Area 3 embankment has been subject to several historical landslides, which have deposited material along the slope's left toe and within the

Minnesota River (**Figure 3**). The inventory lends additional credibility for the continued slope movement monitoring of the embankment.

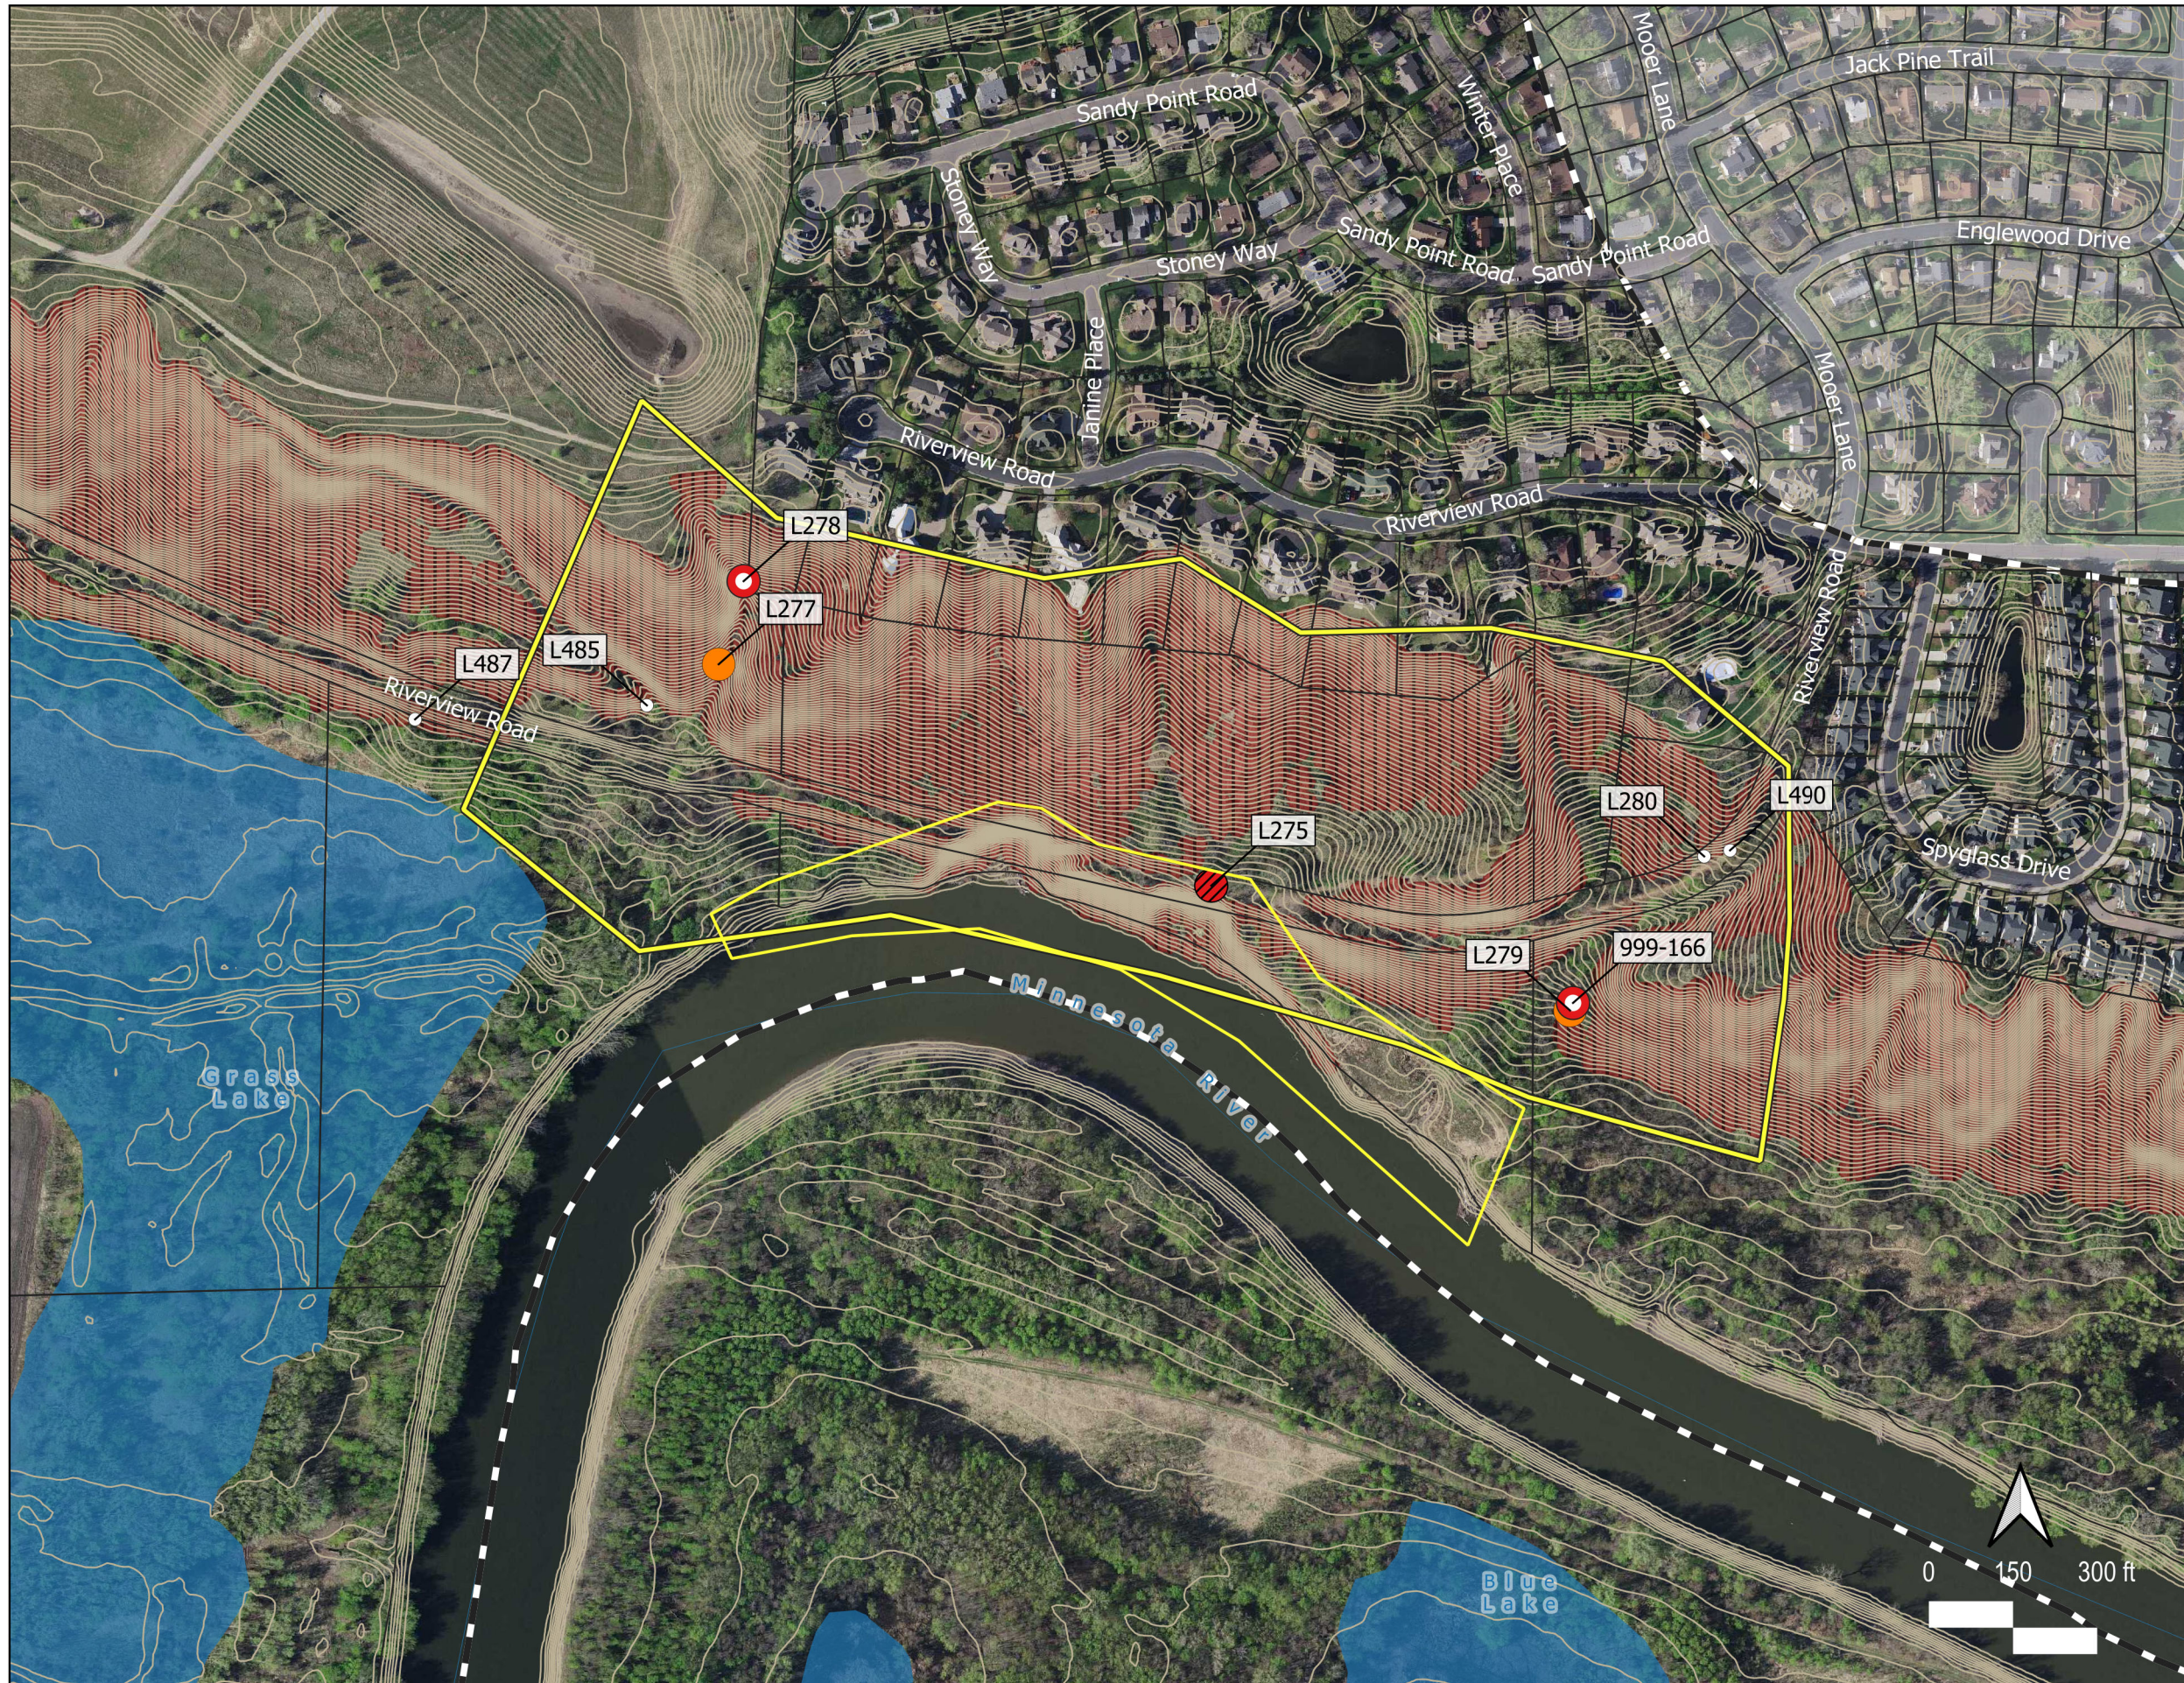
**Figure 4:
Area 3 2020 Gully
Inventory Sites**

Several sites were surveyed over the summer and are shown in **Figure 4**. The area was identified as High-Priority Region (HPR) 14 in the *2020 Gully Inventory* due to the cluster of high-priority gullies found. This area contains several gullies rated as having high erosion potential, meaning they may be actively eroding and transporting sediment downstream. Most of the sites surveyed in HPR 14 noted evidence of slope movement, including curved or leaning trees and hillside slumps.

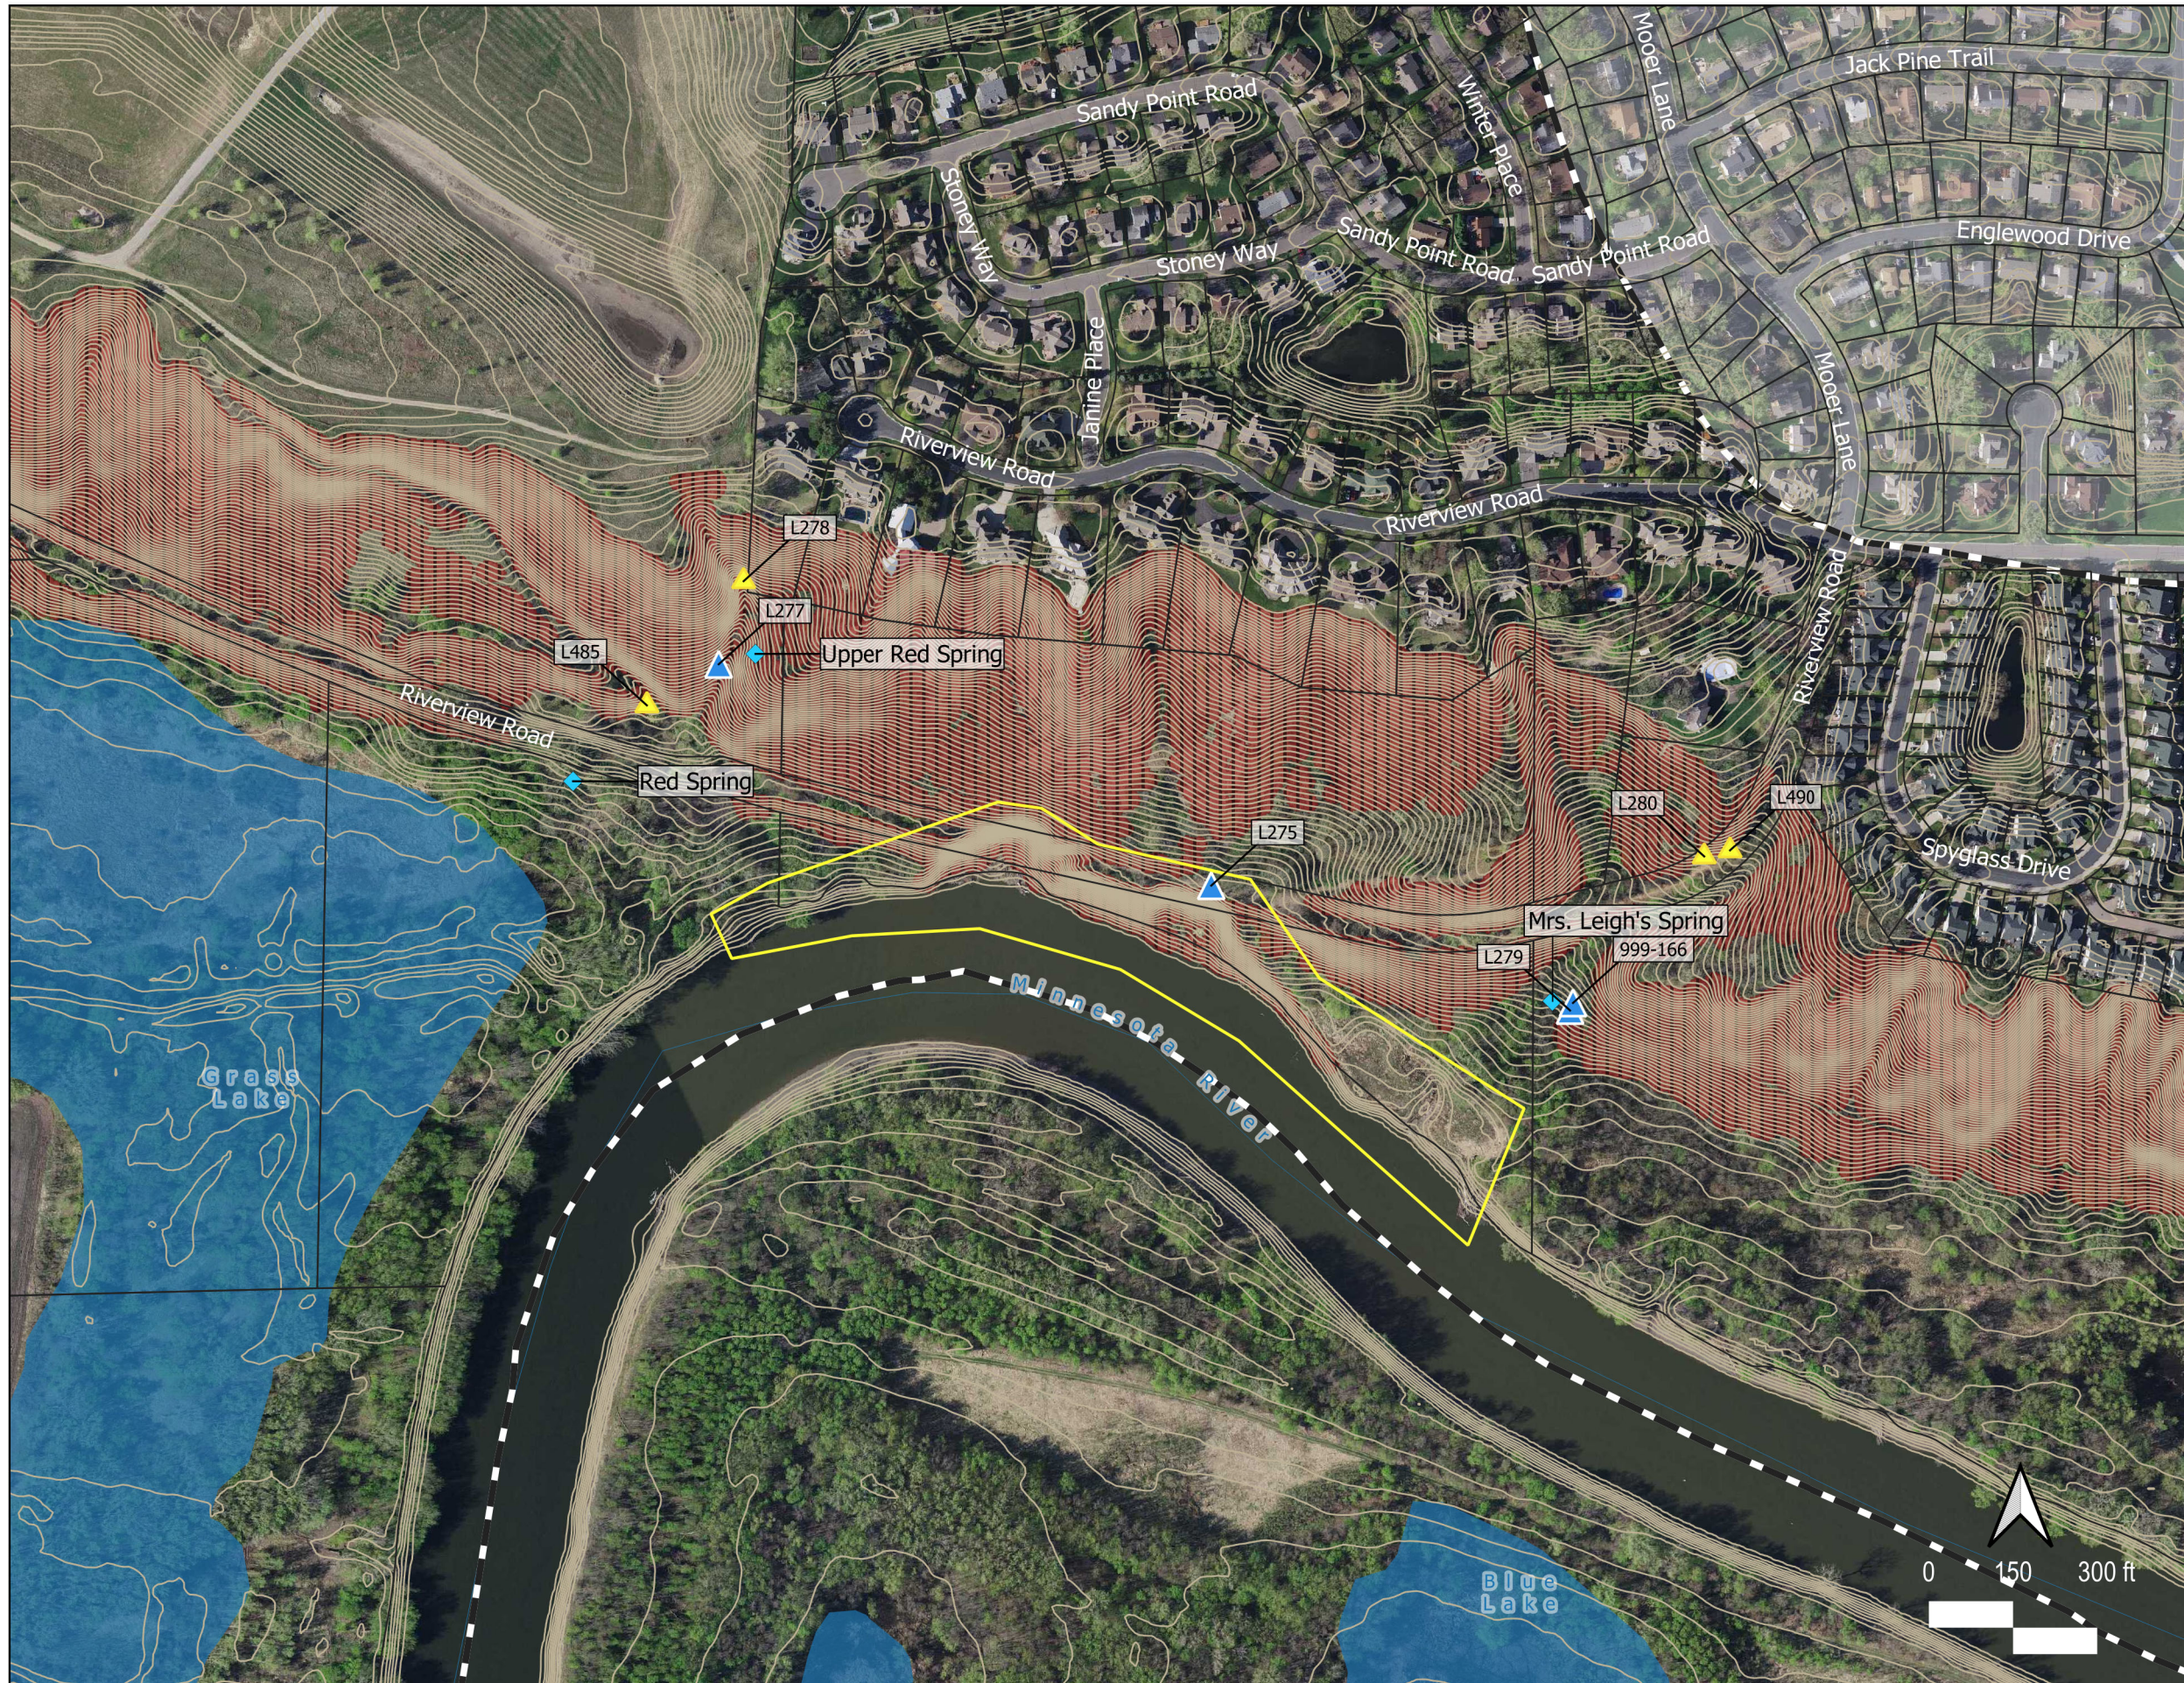
**Figure 5:
Area 3 Groundwater
Observations**

Many of the sites surveyed also noted seeps or groundwater and listed it as a potential cause for erosion and gully development (see individual datasheets attached). These sites correlate well with the MnDNR *Springs Inventory* (**Figure 5**) and provide additional confirmation that groundwater baseflow will need to be considered as part of any future stabilization designs.

The MnDNR has been crowdsourcing, collecting new data, and digitizing historic spring data through the Minnesota Spring Inventory Recording Application. The inventory contains both potential and verified springs. In Area 3, there are three springs shown: the Upper Red Spring, the Red Spring to the west, and an unnamed spring (once known as “Mrs. Leigh’s Spring”) to the east (**Figure 5**).

1. The bend in the Minnesota River at this location has been and will continue to direct flows at the Area 3 slope and erode the embankment's toe.
2. Groundwater is a concern in this area. The baseflow from these seeps and springs may continue to cause gully development and erosion, further destabilizing the slope. Future slope stabilization designs will need to include a groundwater management system to prevent the stabilized slope from becoming saturated by groundwater.

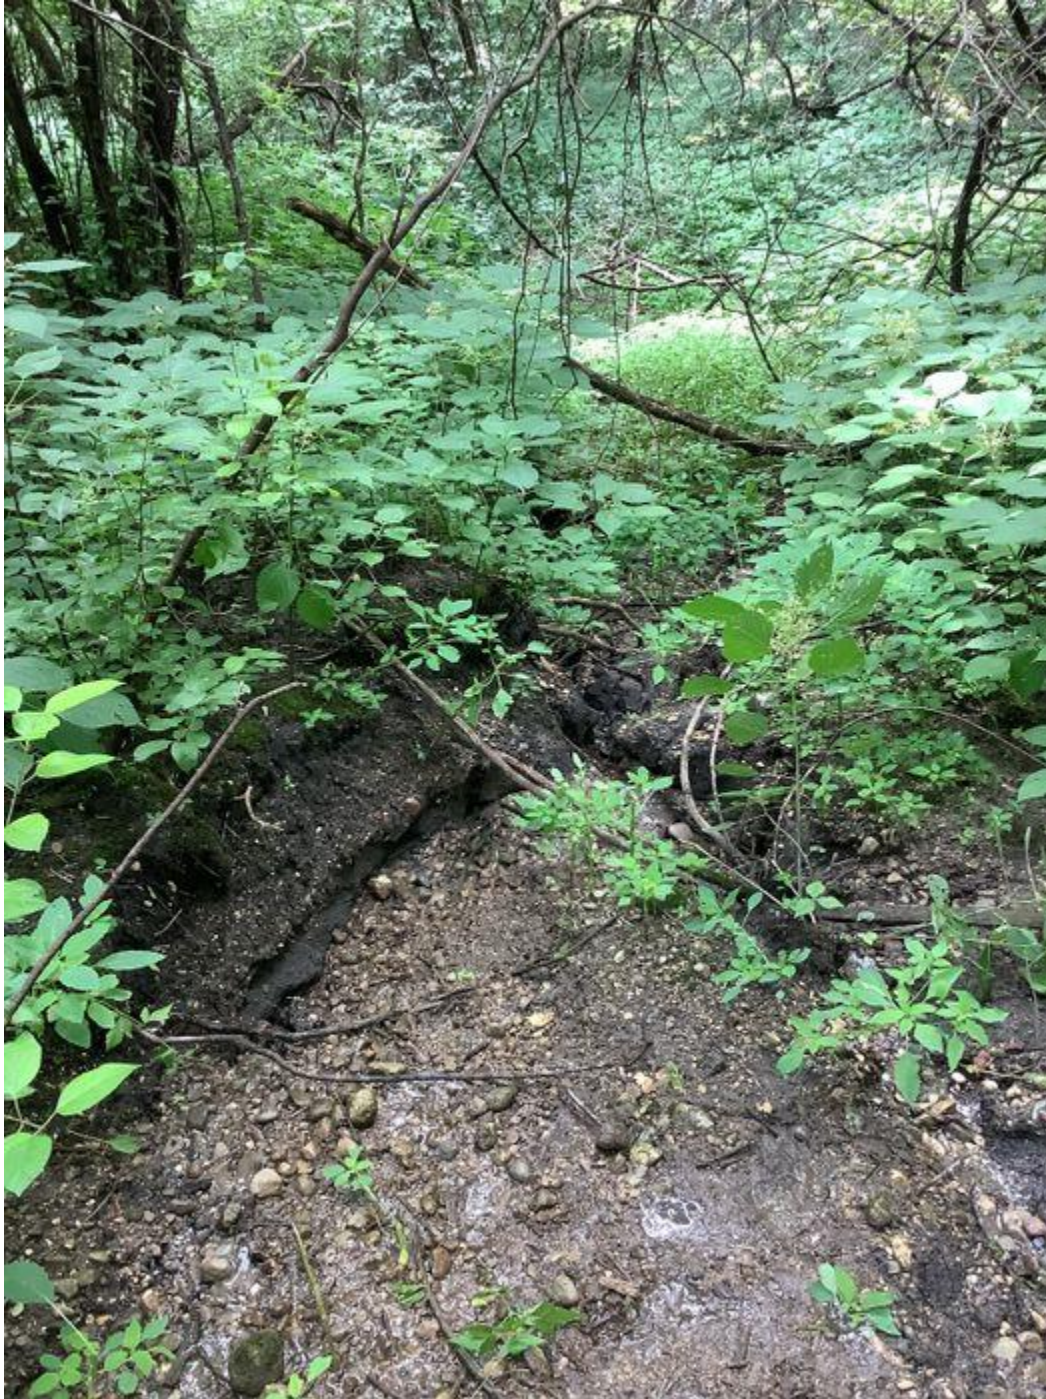
Looking d/s from groundwater seep at headcut and channel incision

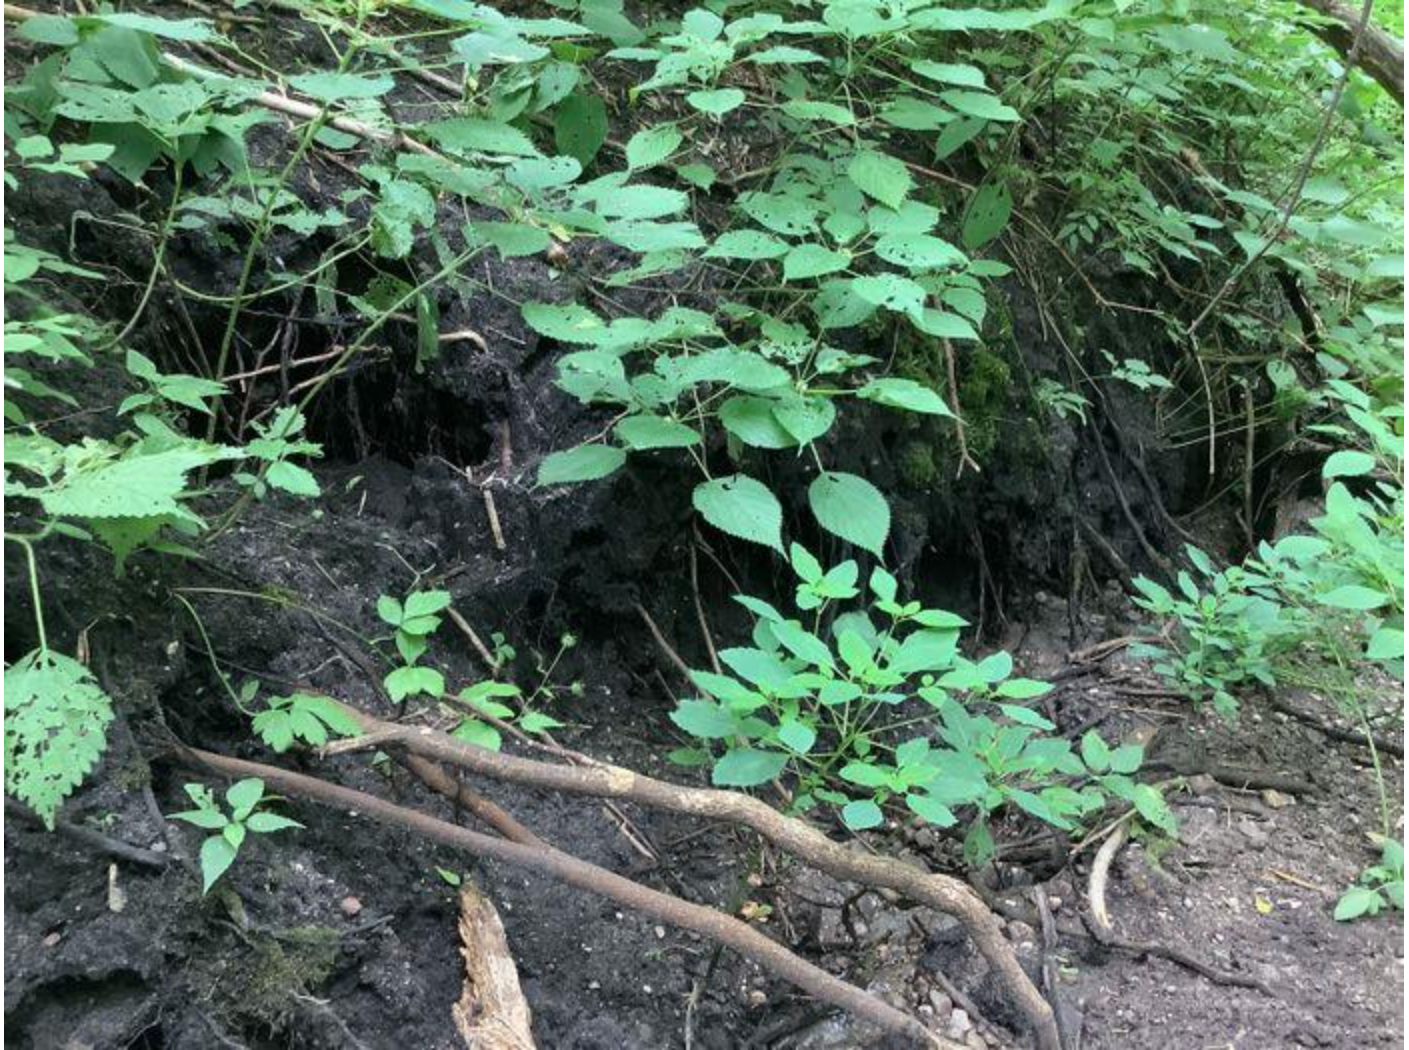
Looking d/s from right bank at a slump and severely overhanging left banks

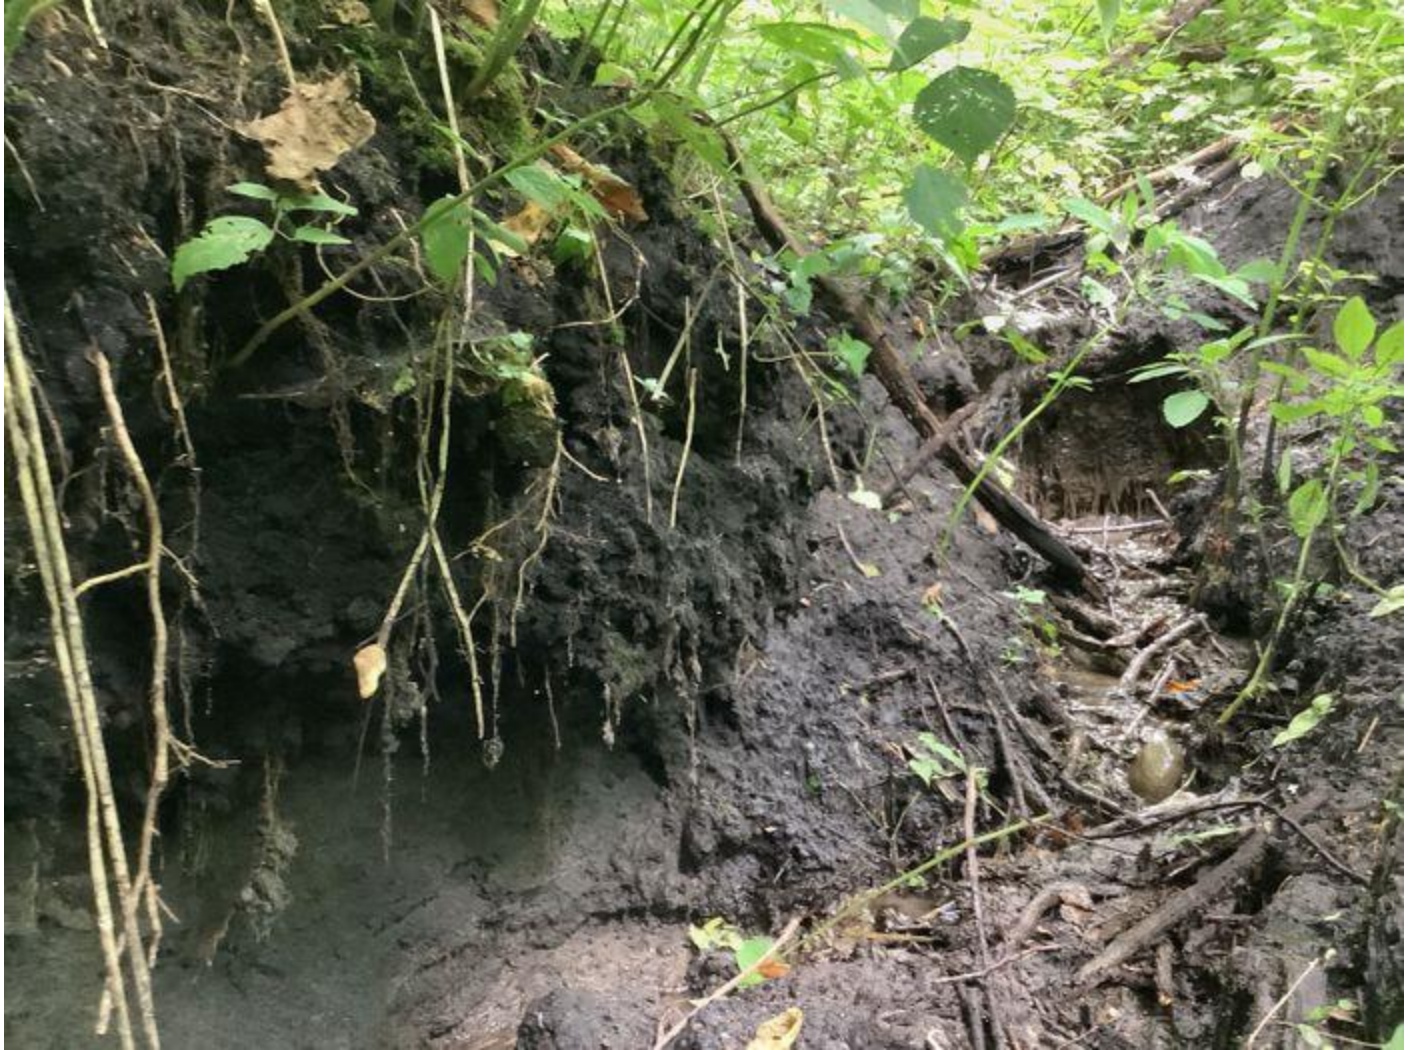
Looking u/s at overhanging right banks (d/s from initial slumping)

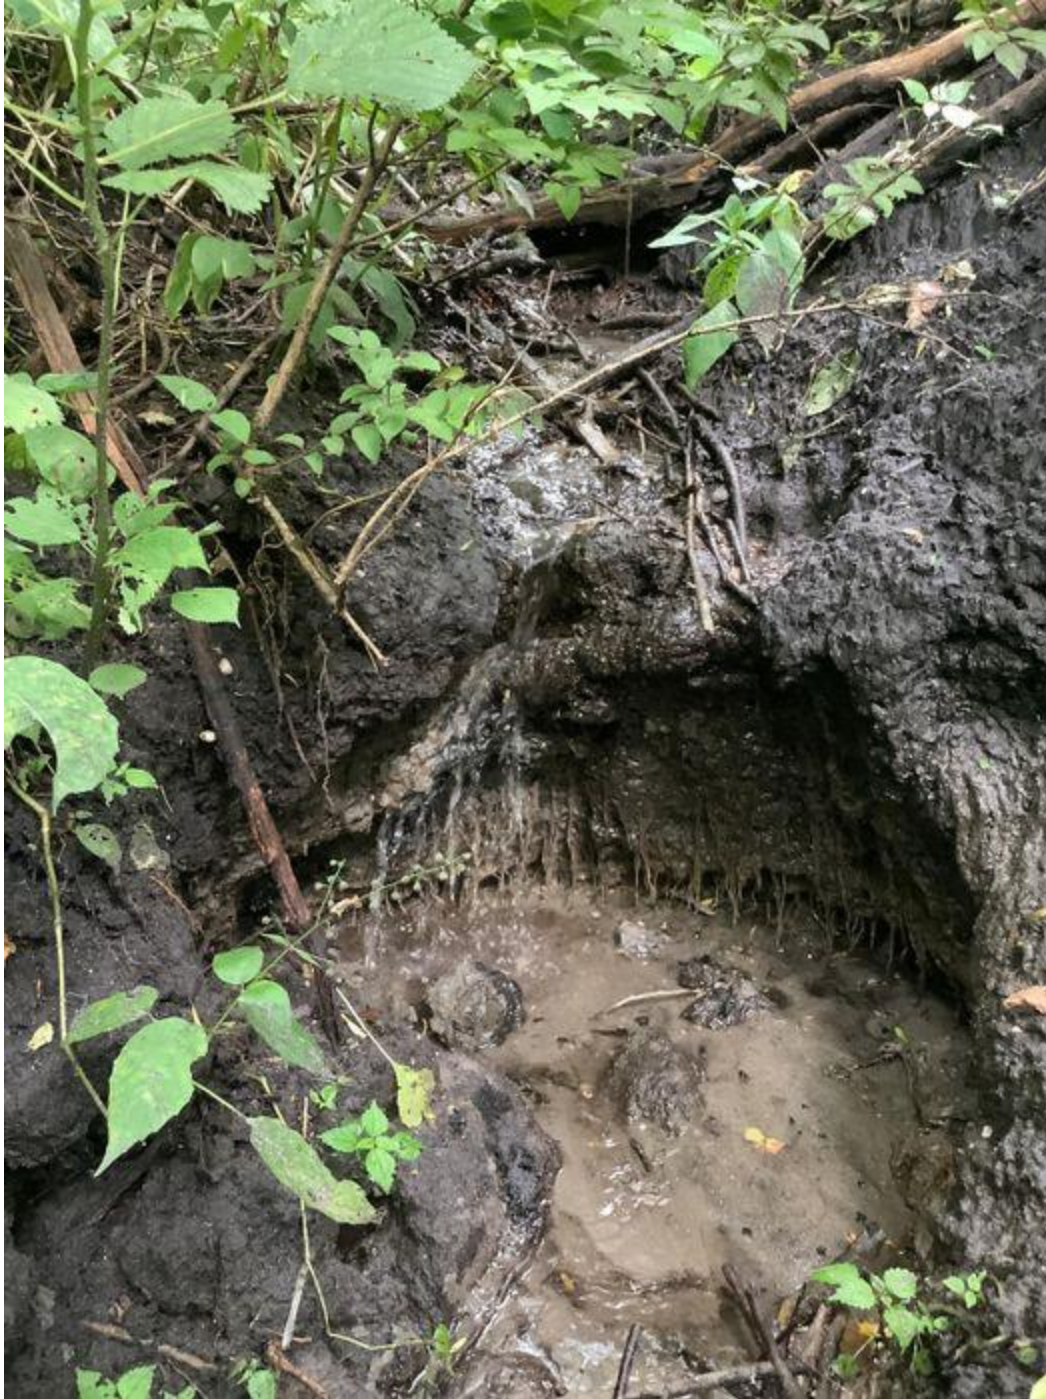
Looking u/s from large knickpoint (d/s from initial slumping)

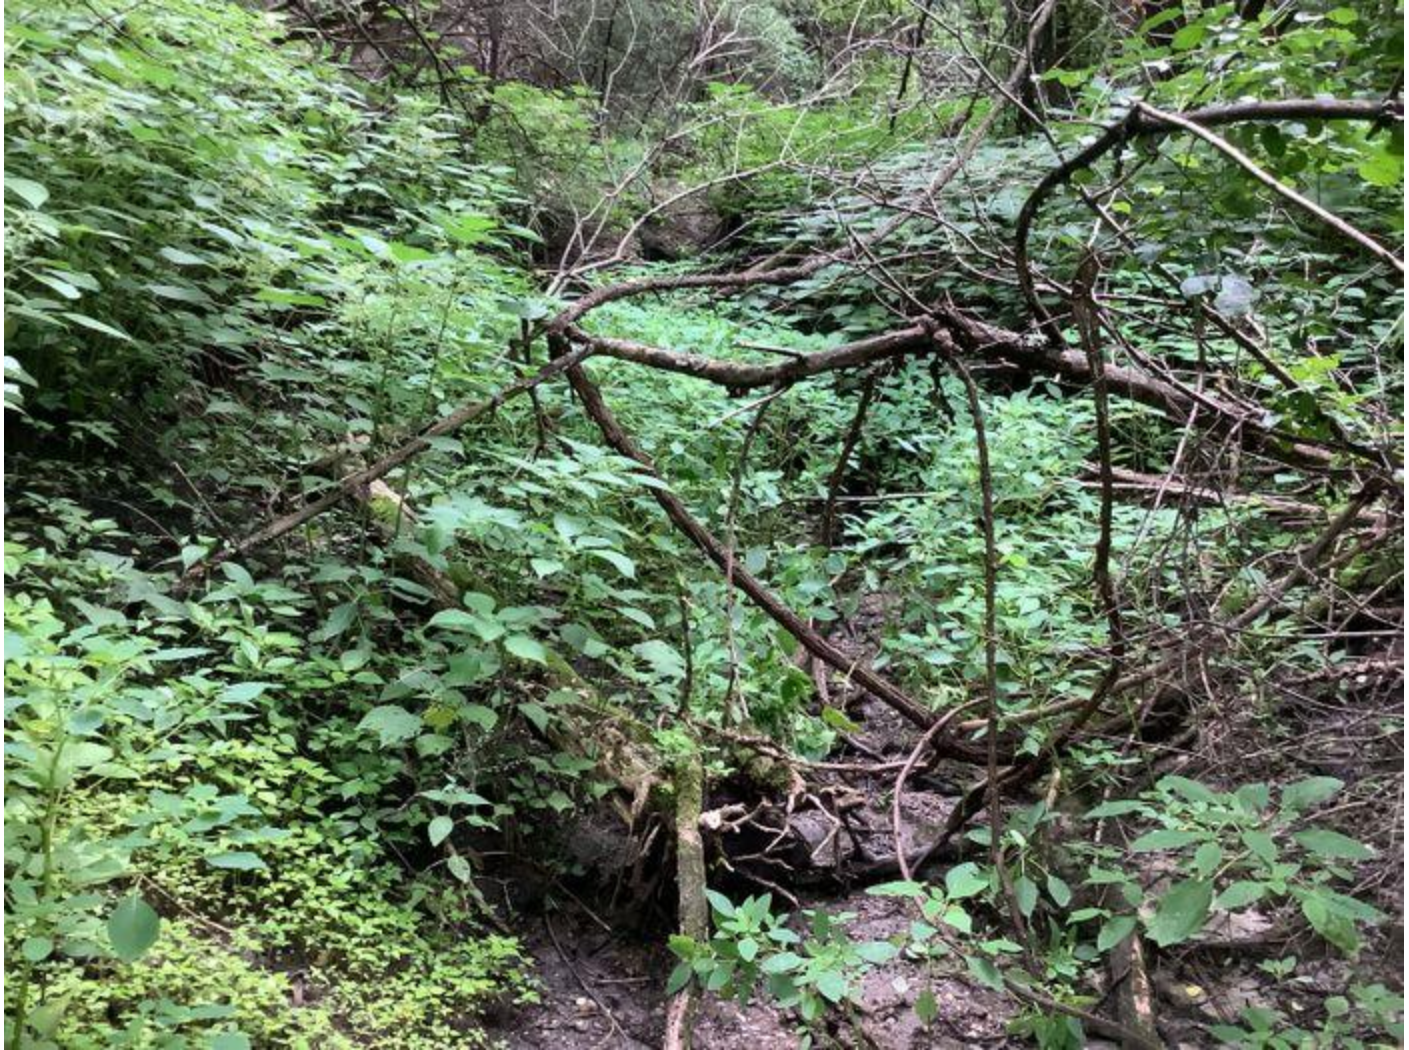
Looking u/s from widened section of gully at heavier vegetation. Gully returns to severe erosion shortly d/s (at knickpoint in picture above)

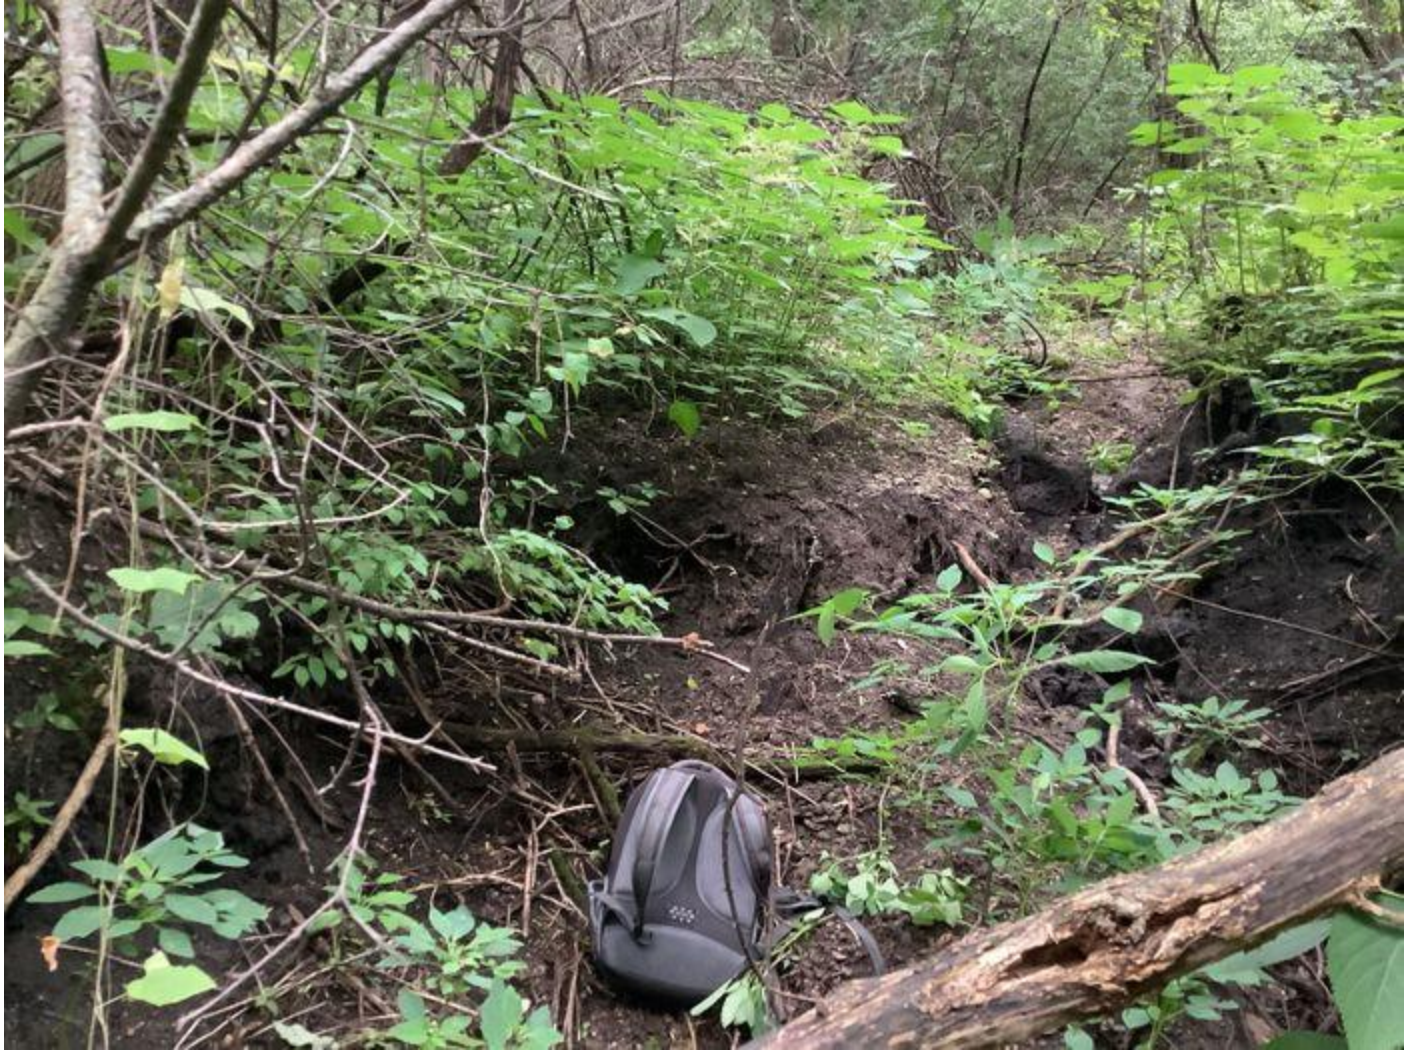
Looking u/s from gully bottom near headcut at slumping along the right bank and a backpack for scale. Headcut visible with groundwater seep above in the background

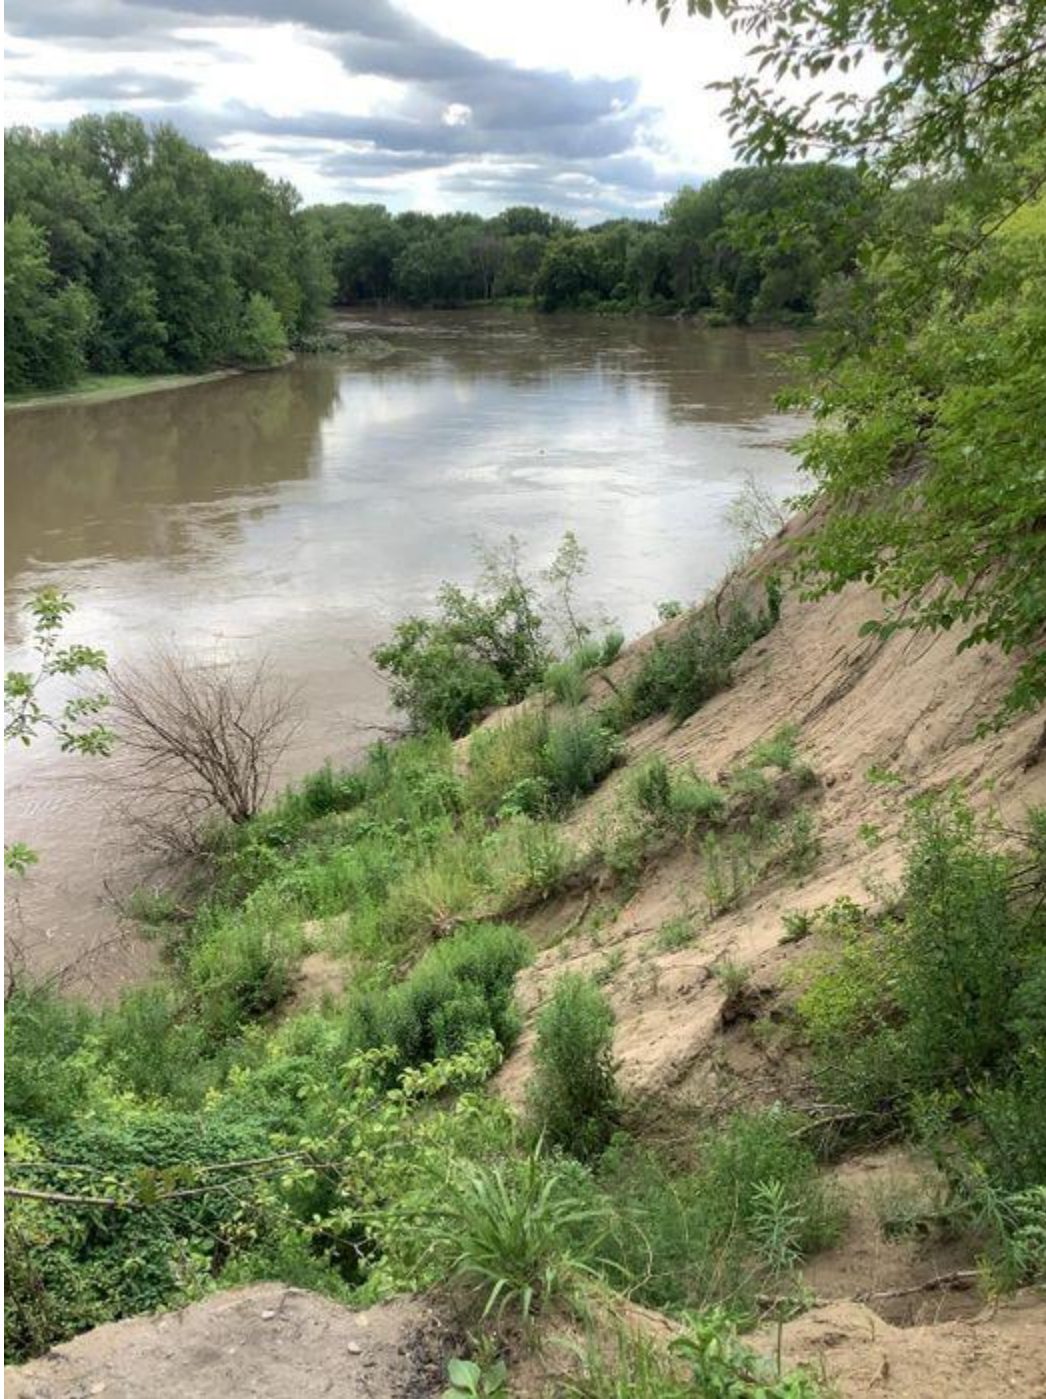
Looking from the left bank of the slump to the right bank
