Technical Memorandum

To: Linda Loomis, Administrator
Lower Minnesota River Watershed District

Re: Area 3 Slope Stability Project Update

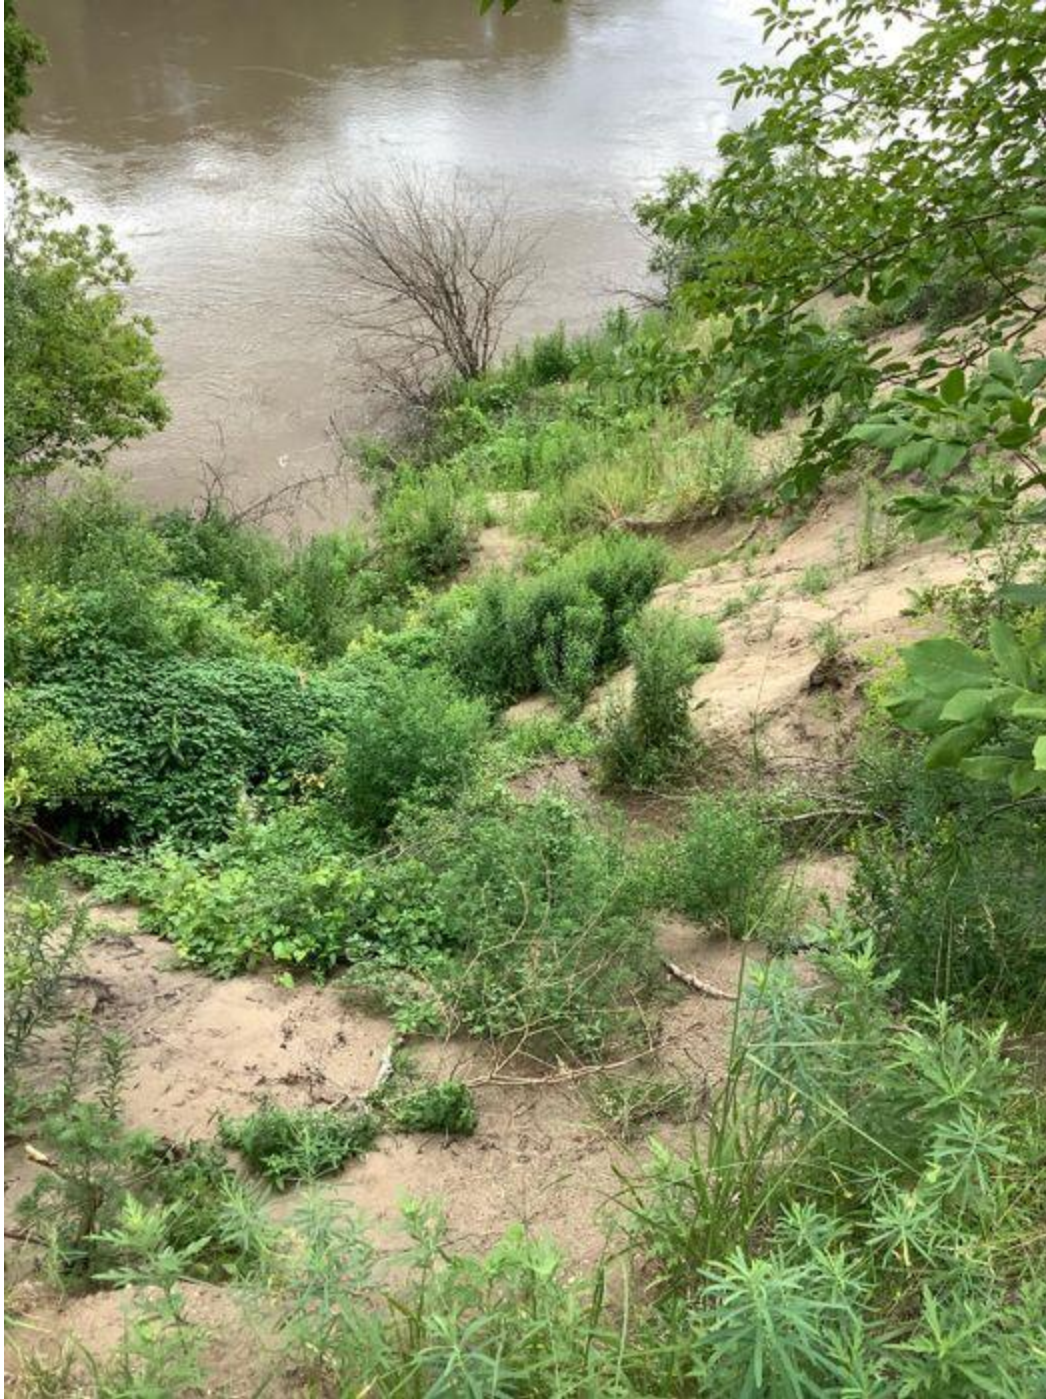
Looking d/s from left bank viewpoint area at sandy banks and a seep in the middle of the picture

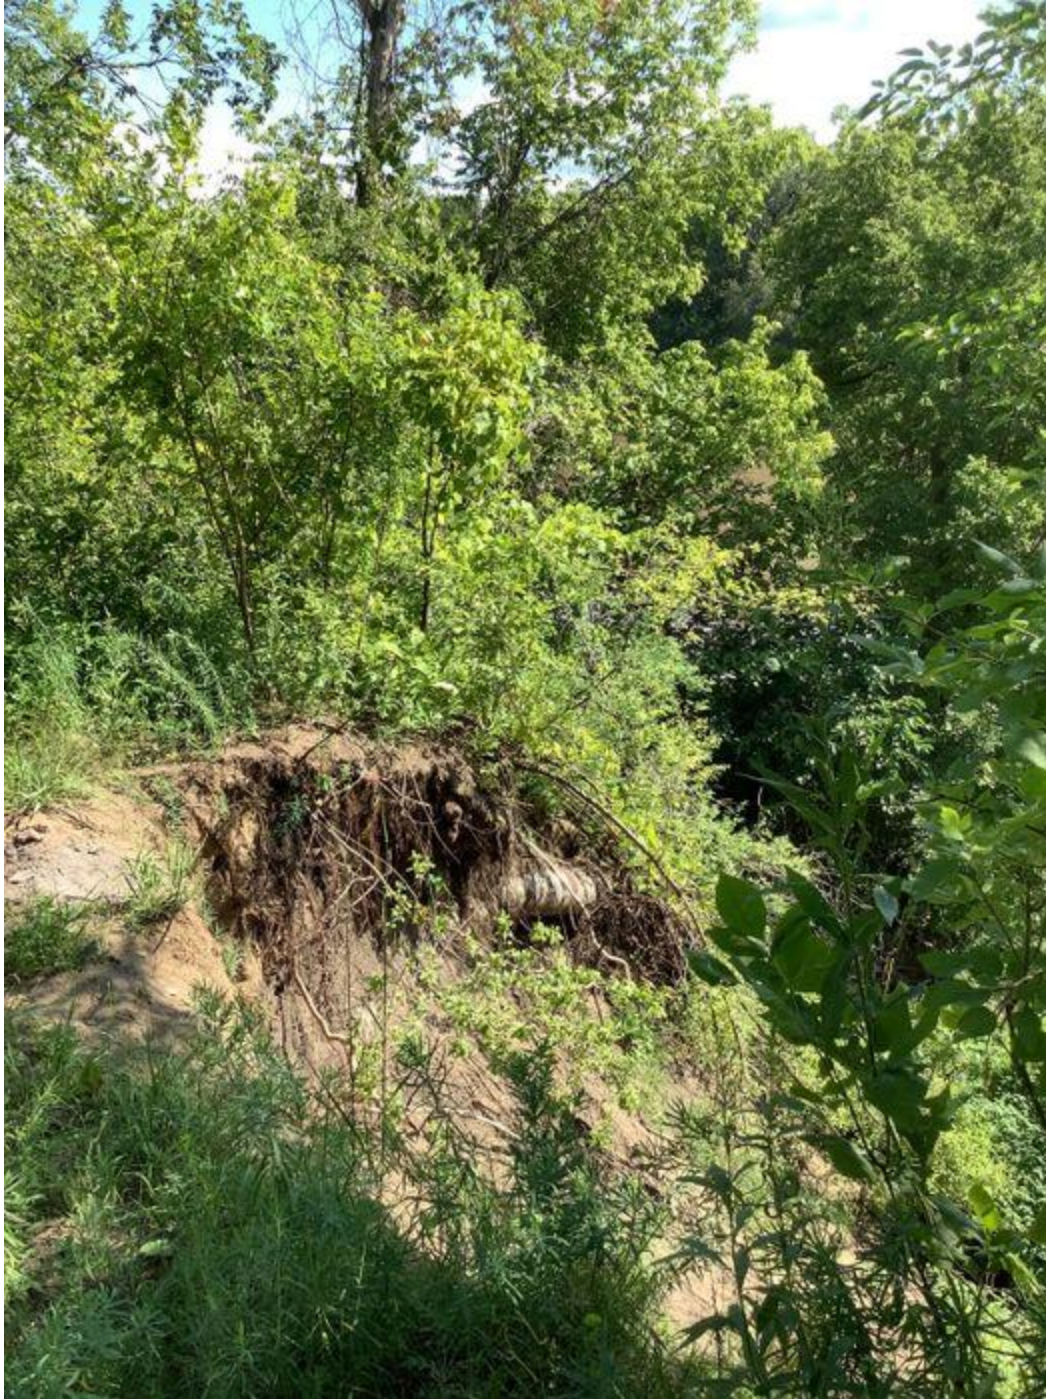
Pipe found along the left bank, but unable to assess due to steep slopes

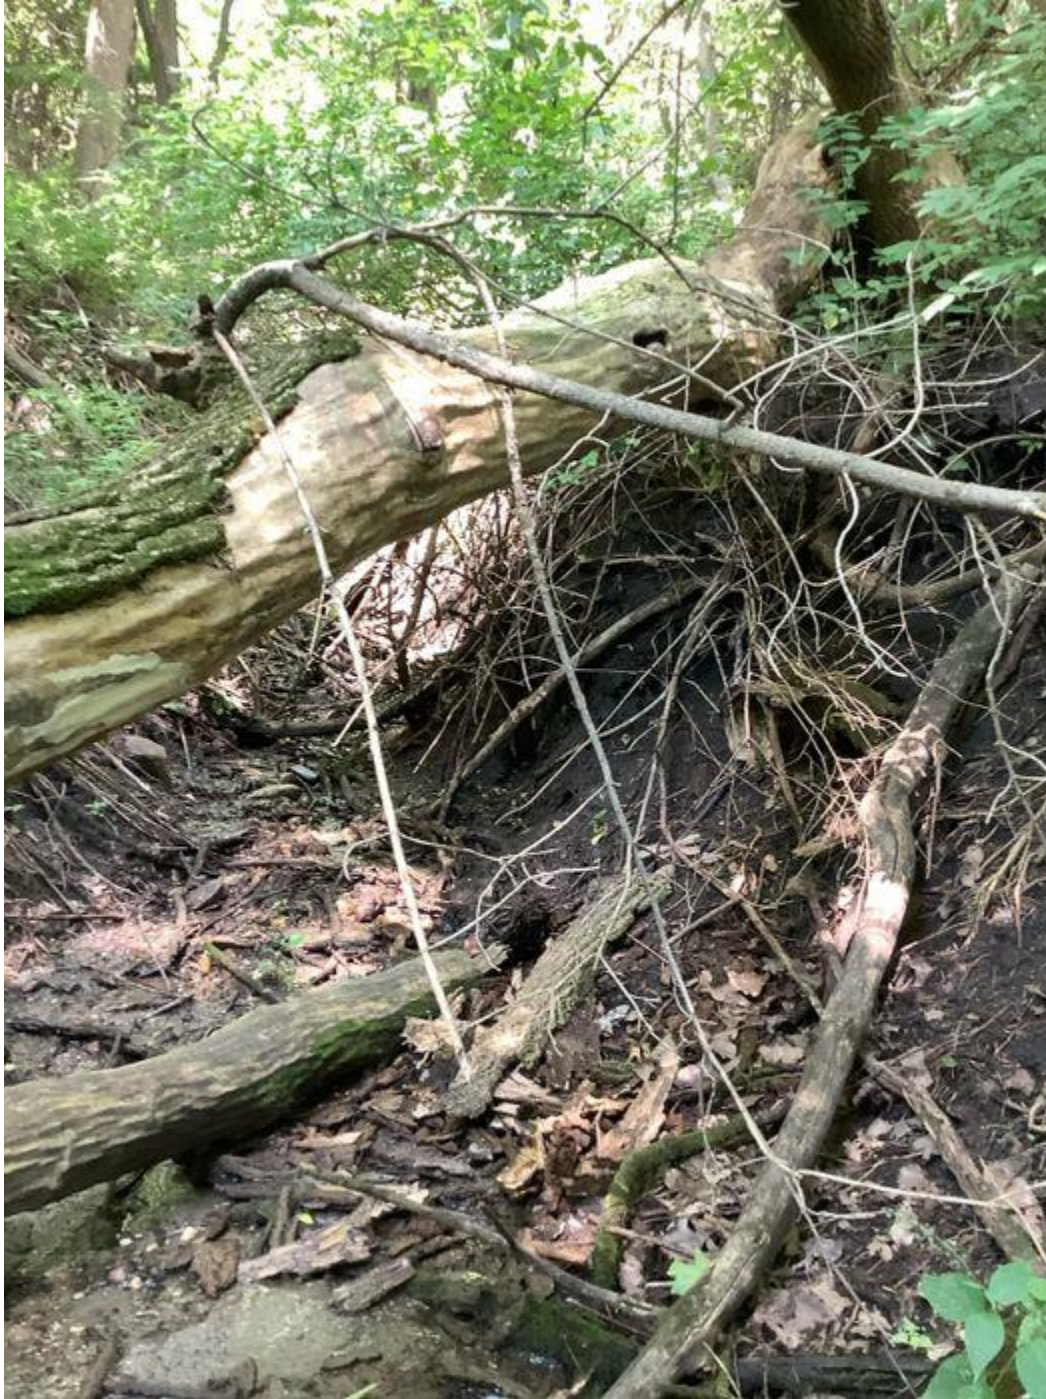
Upstream view of slumping along left bank and channel incision. View from gully bottom near toe.

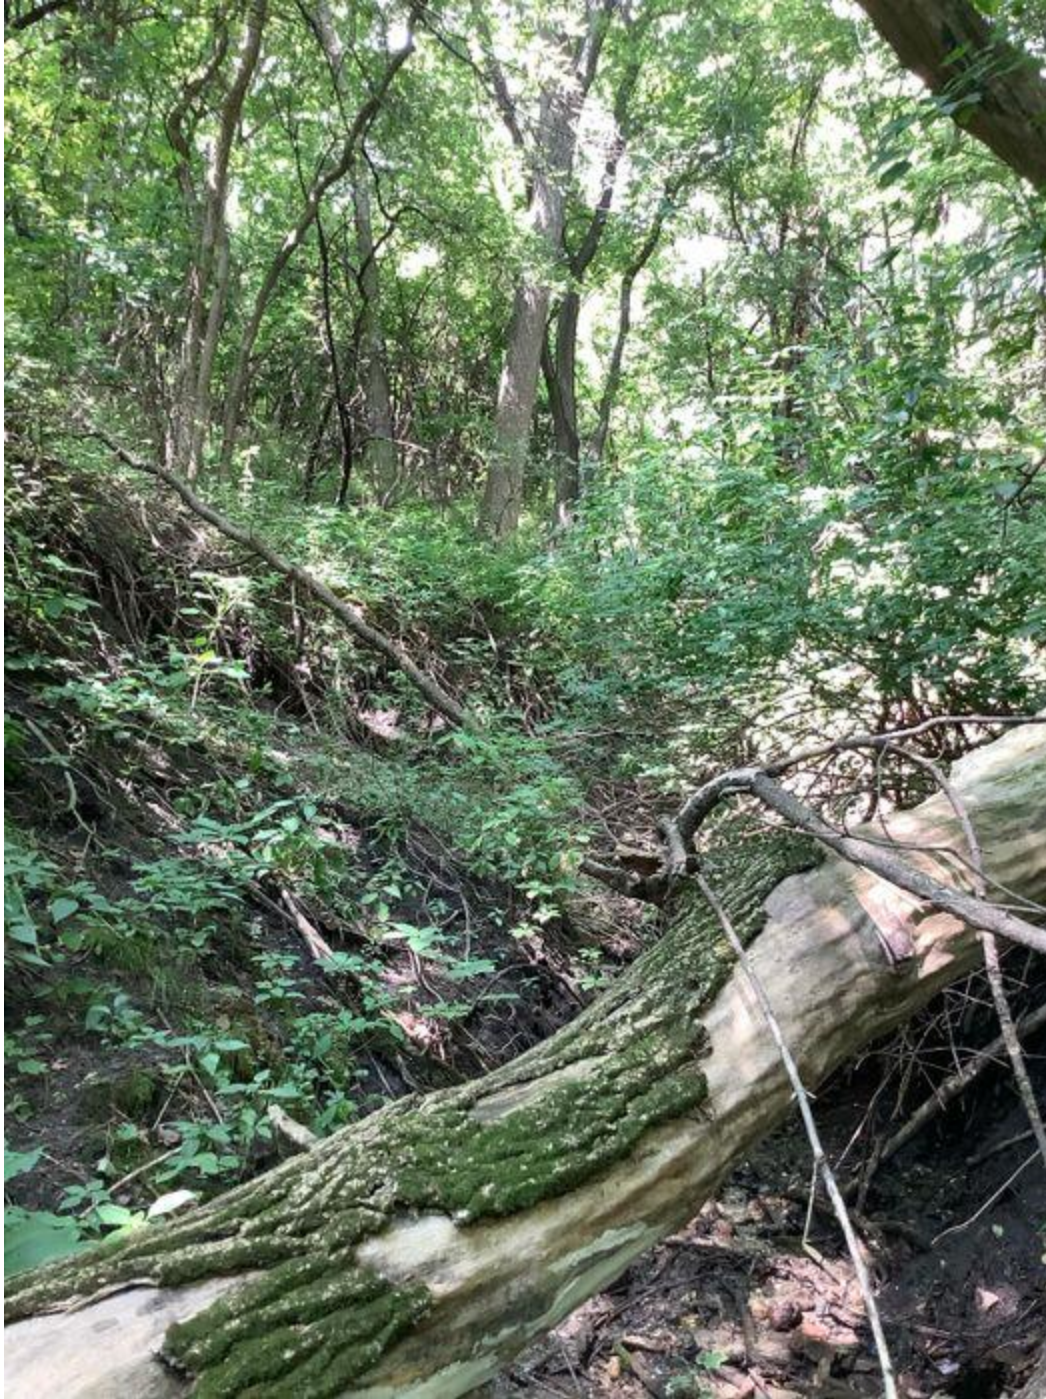
Upstream view from gully bottom near toe looking at partial vegetation and overhanging right banks.

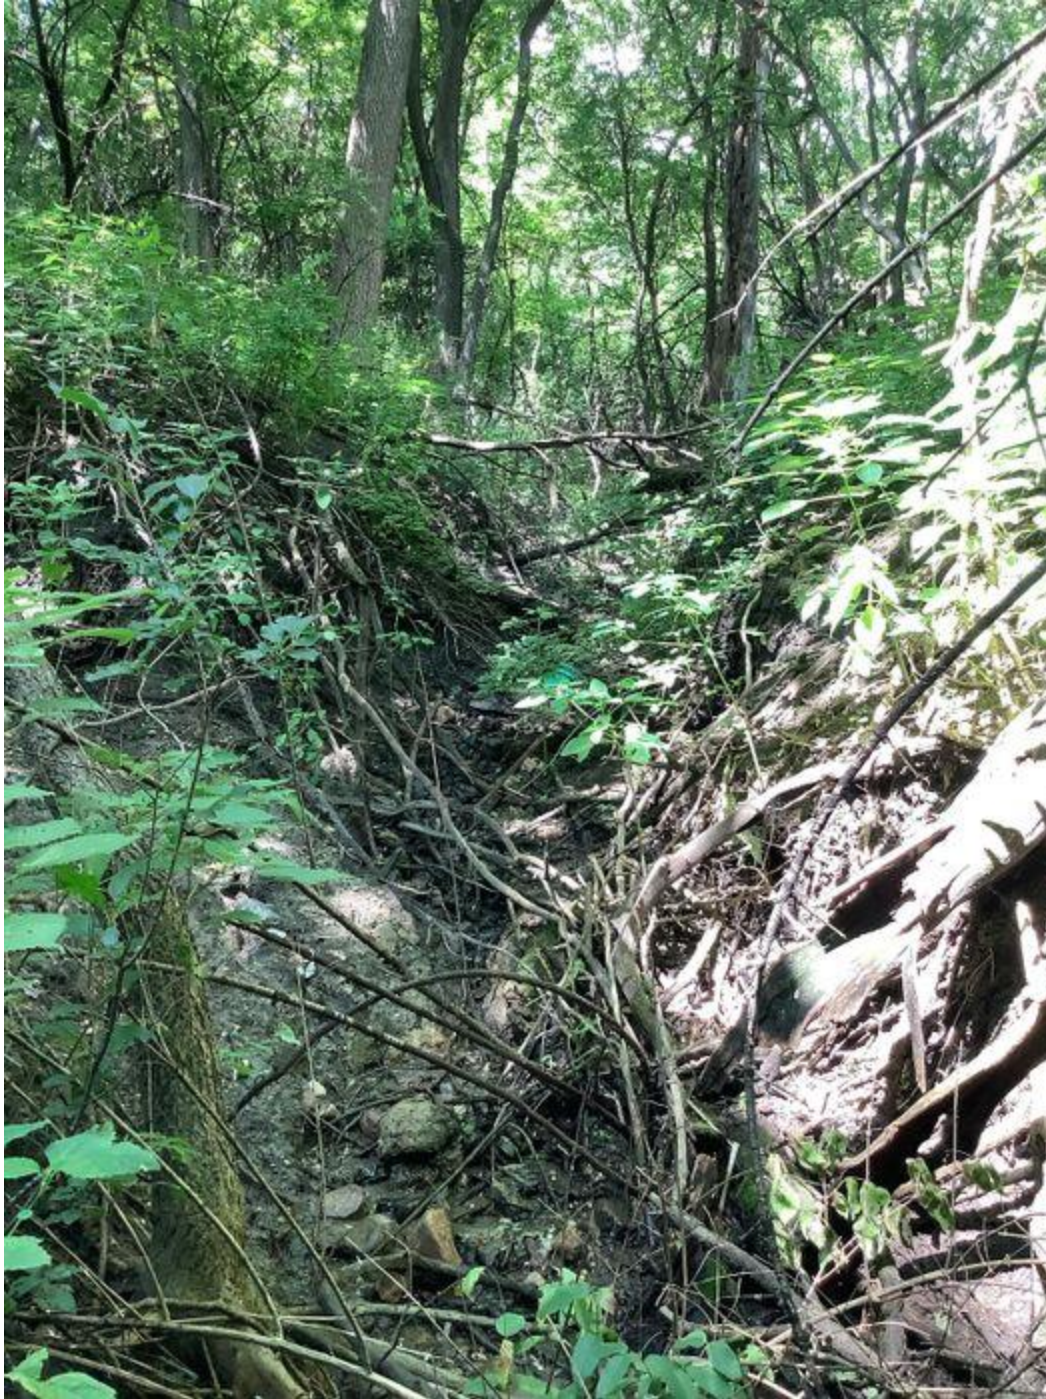
Upstream view from gully bottom looking at channel view and tree debris with incision visible.

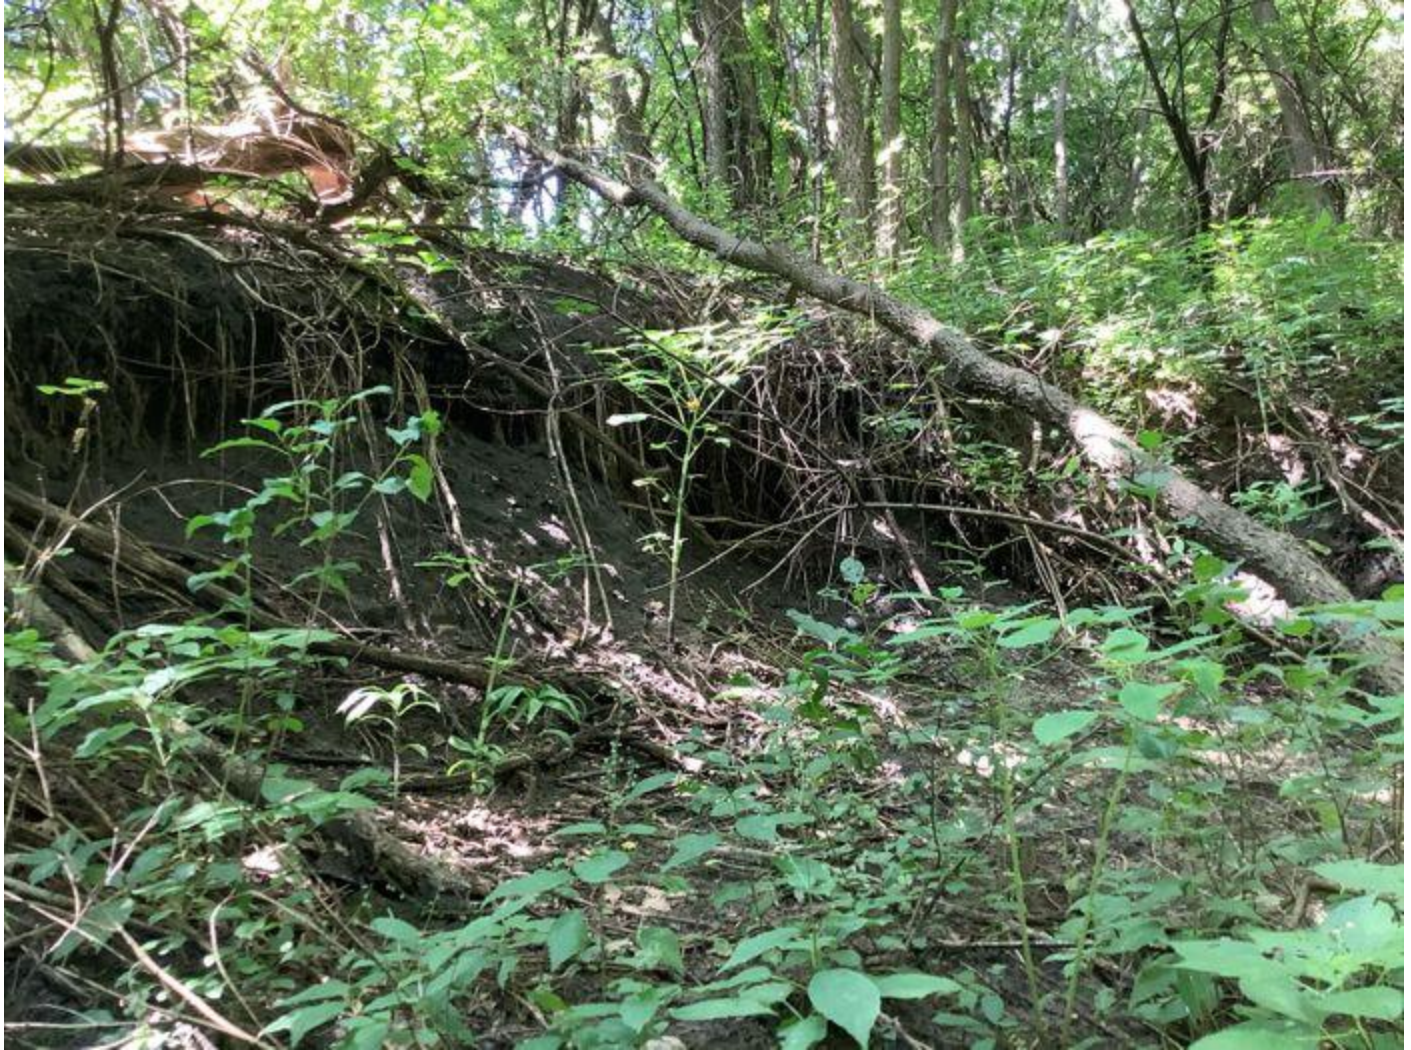
Upstream view from gully bottom looking at overhanging right banks above slump.

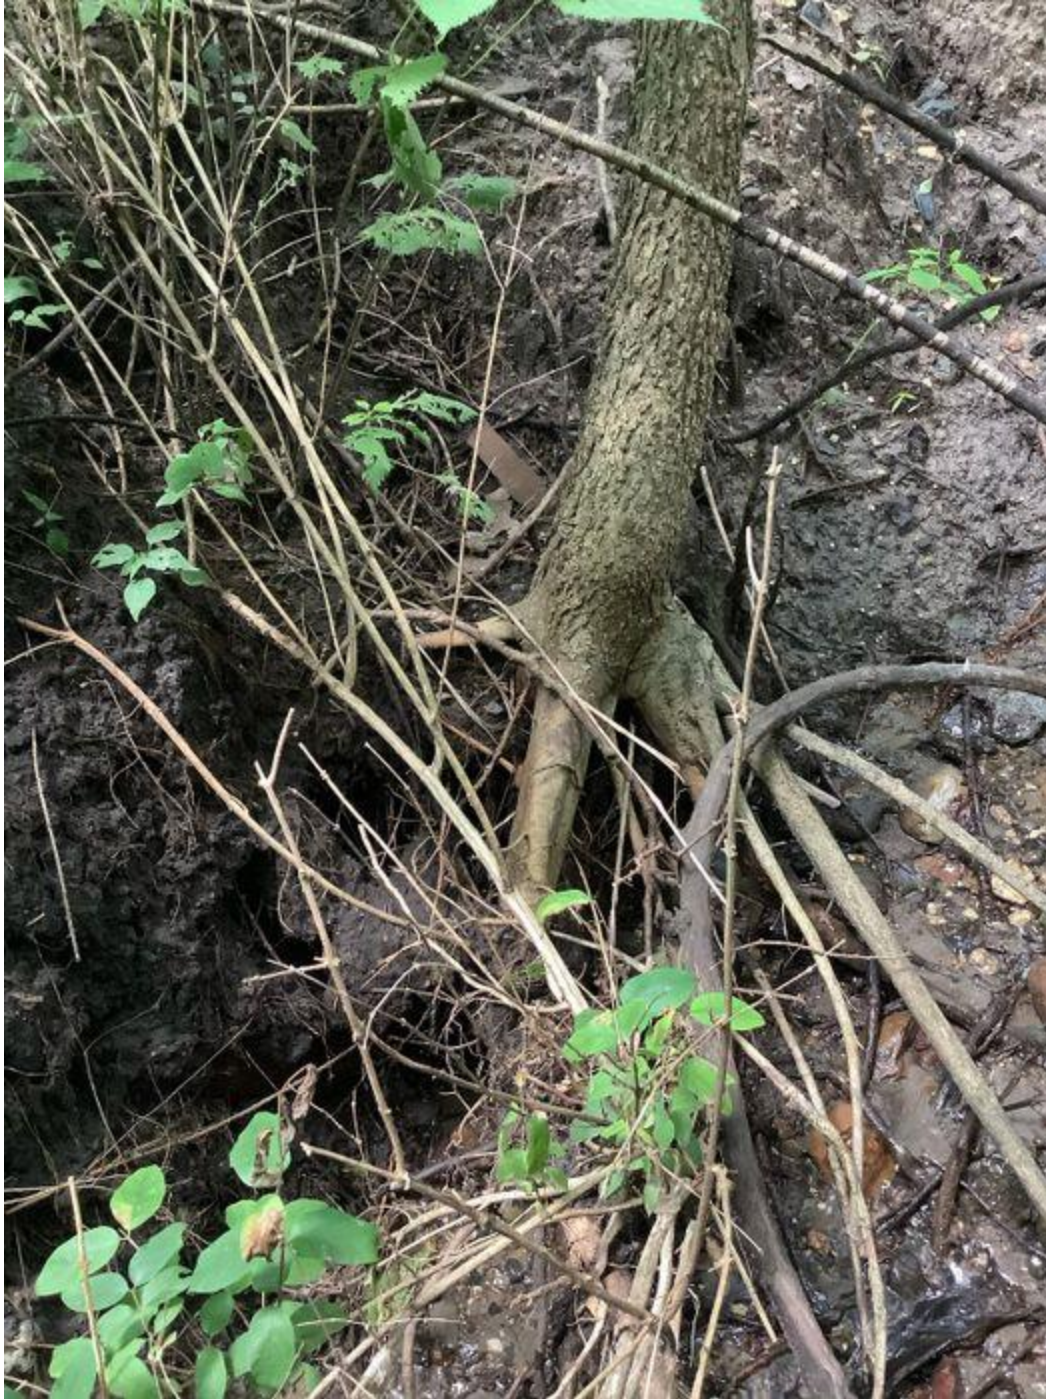
Close up of a tree that recently slumped into gully bottom along right bank. Upstream view from gully bottom.

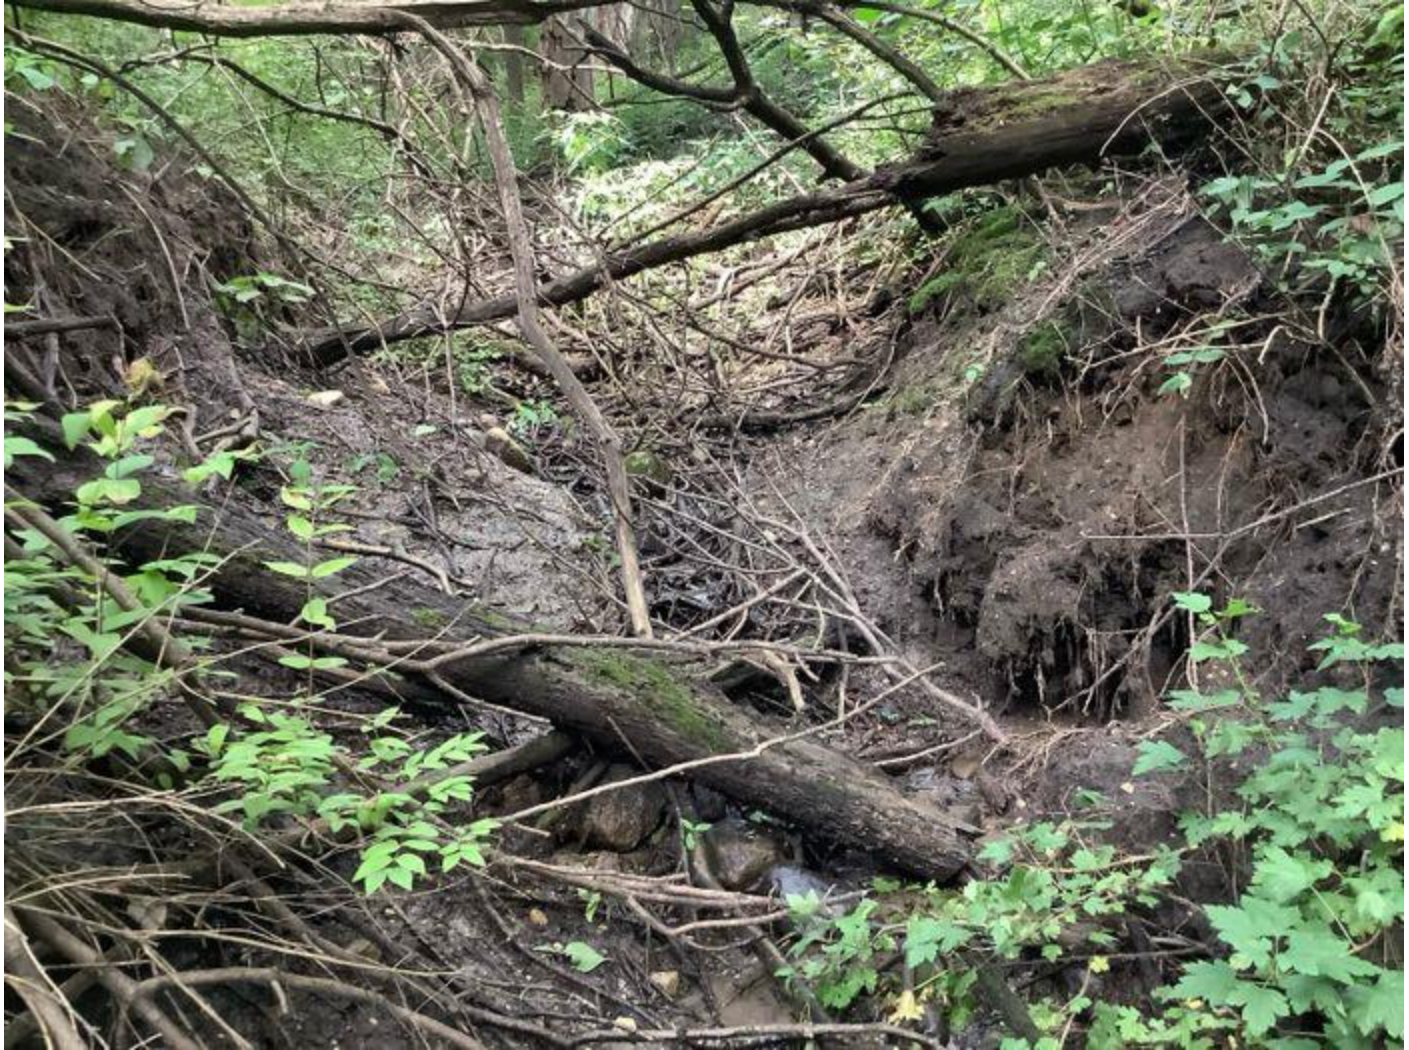
Upstream view looking at channel view with slumping and bare soil along left bank. View from gully bottom.

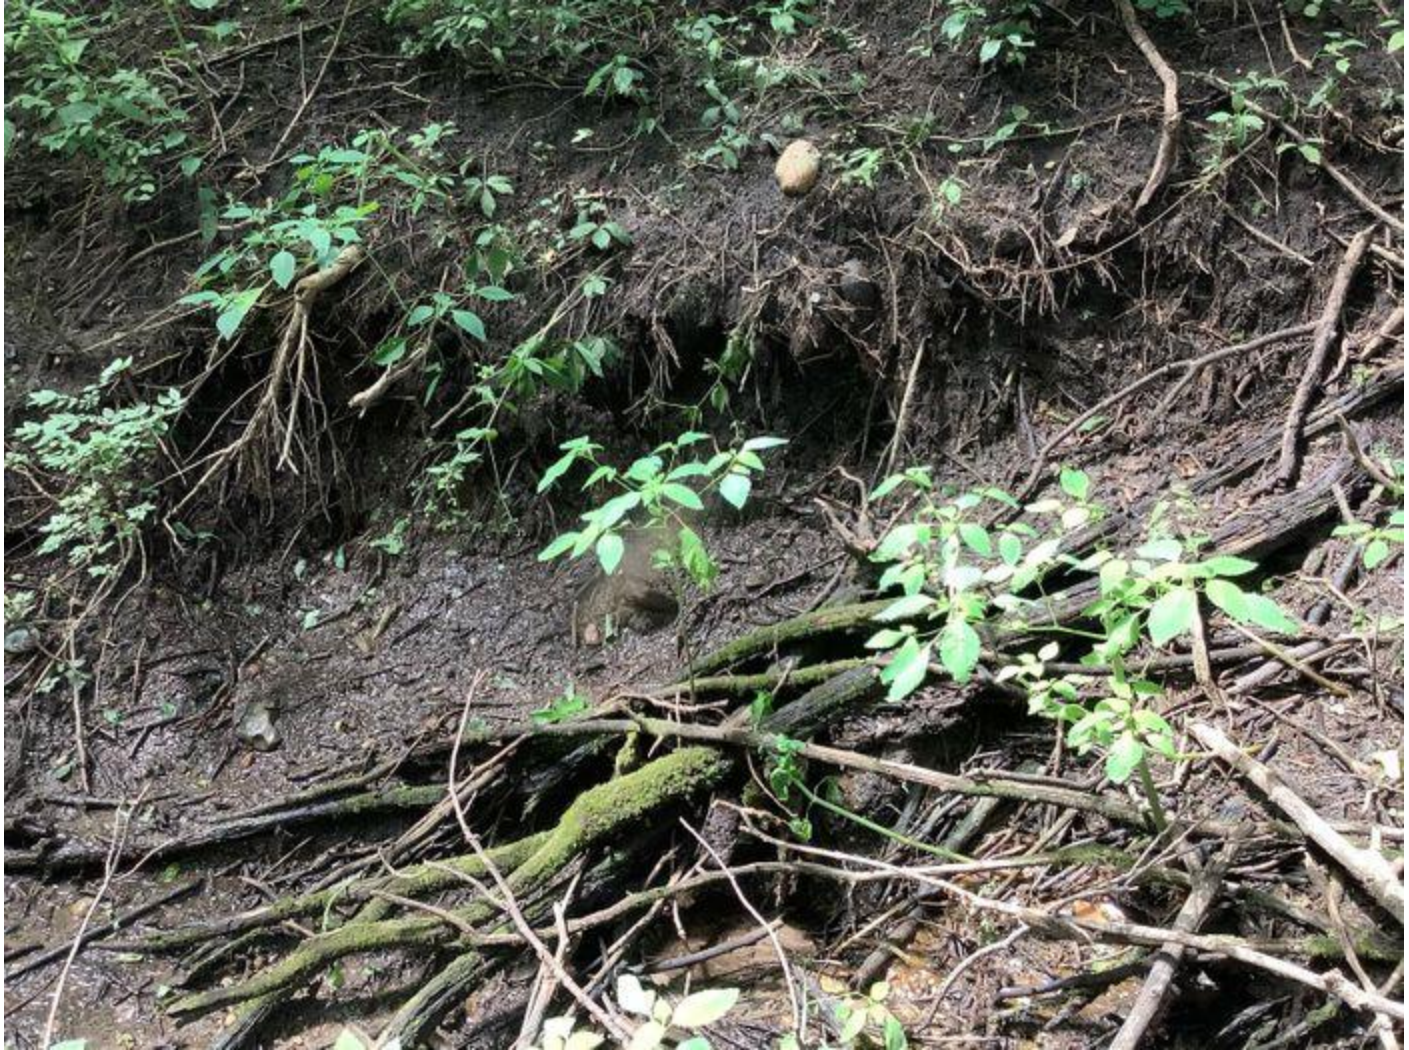
Side stream view from left bank looking at slumping and bare soil along right bank near headcut.

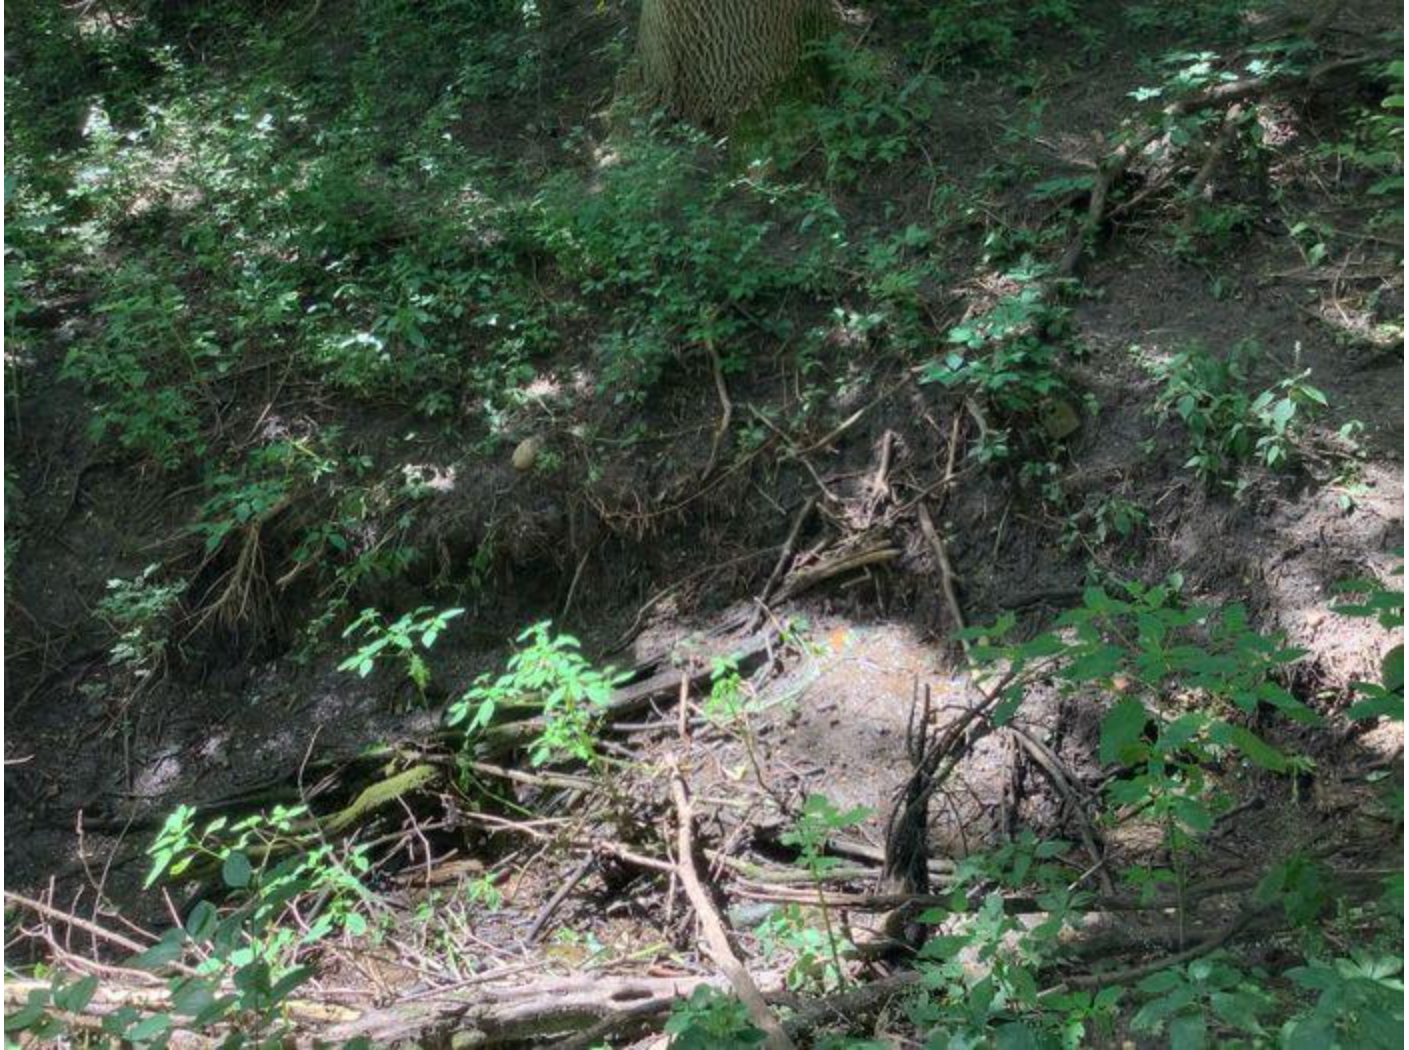
Side stream view from left bank at headcut looking at where seepage begins.

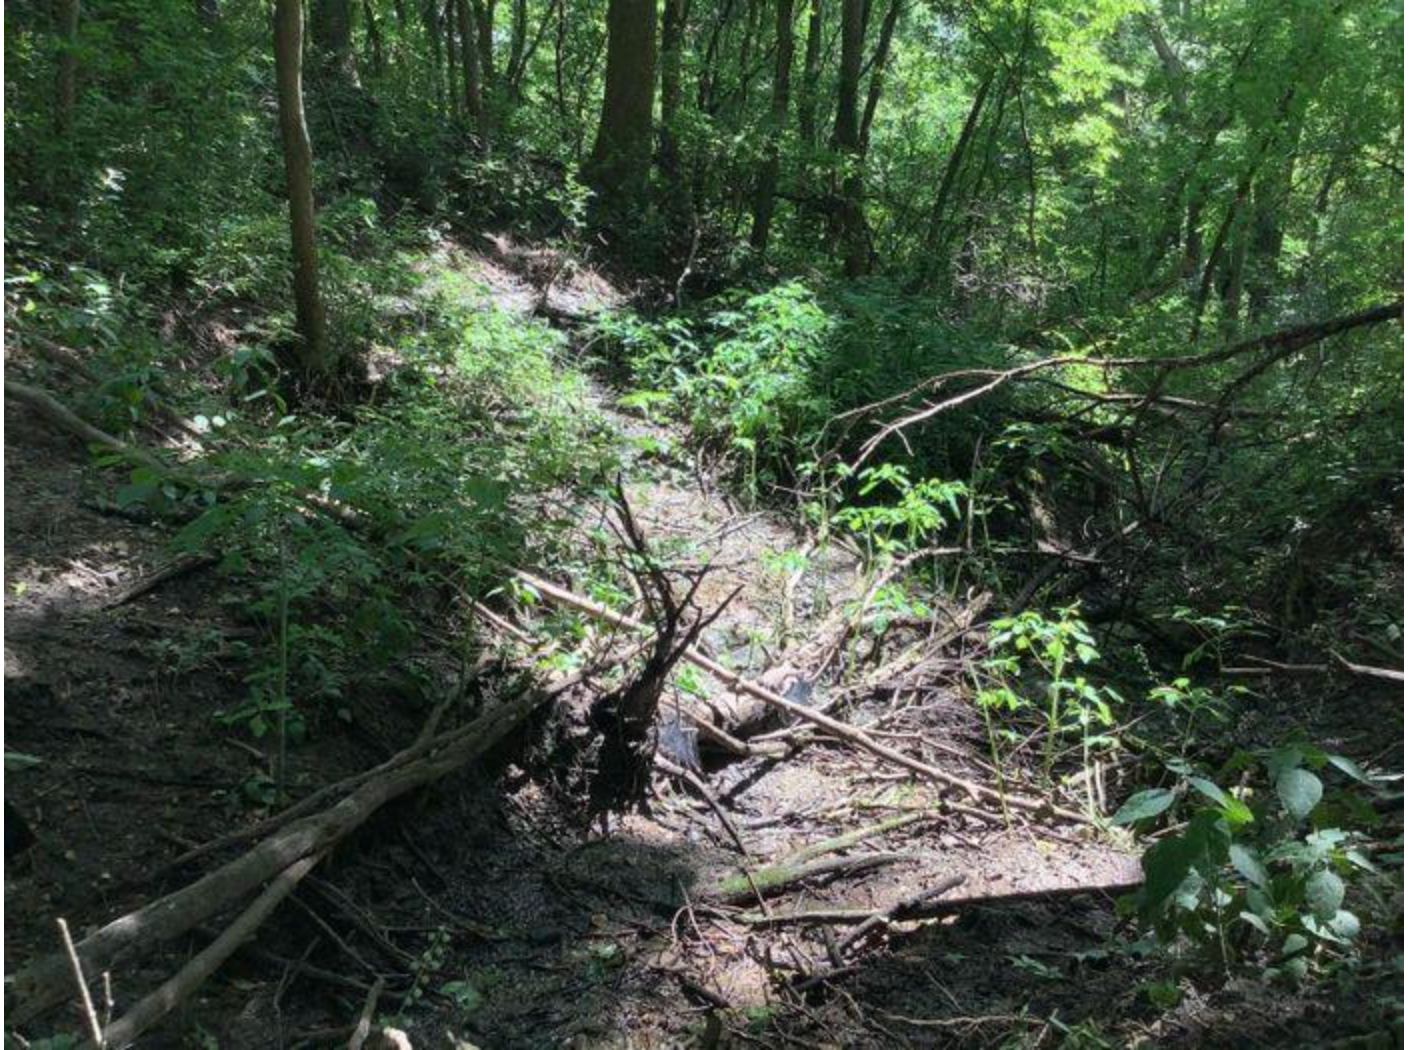
Downstream view from right bank of headcut looking at large slump along left bank.

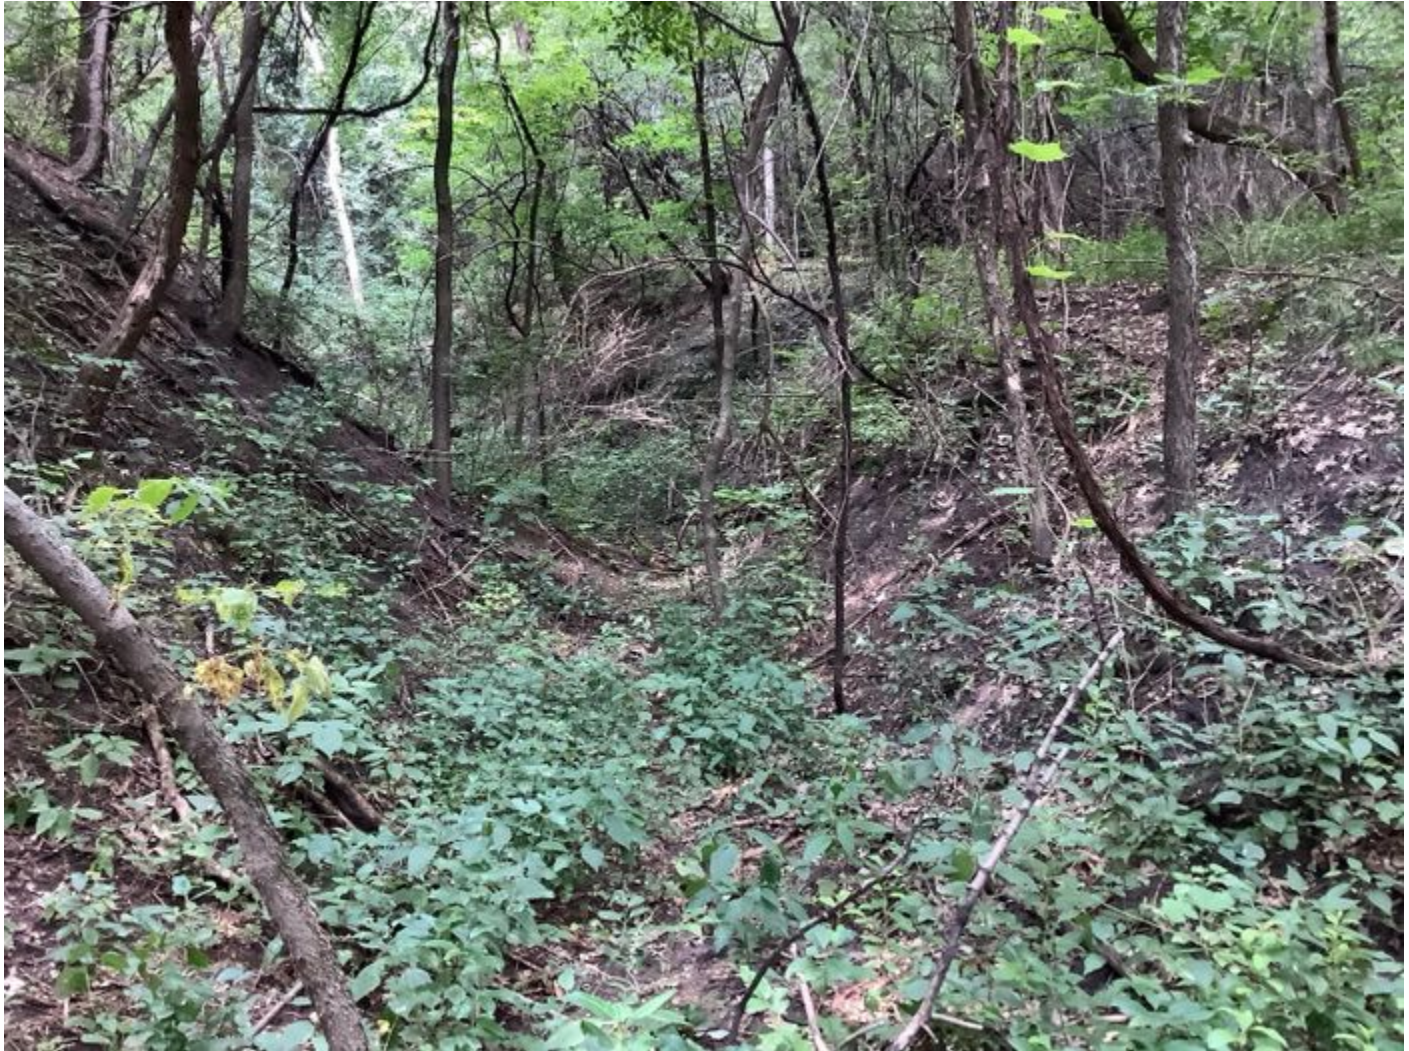
Looking u/s at gully channel from toe. Leaning tree on right bank and bare soil exhibited

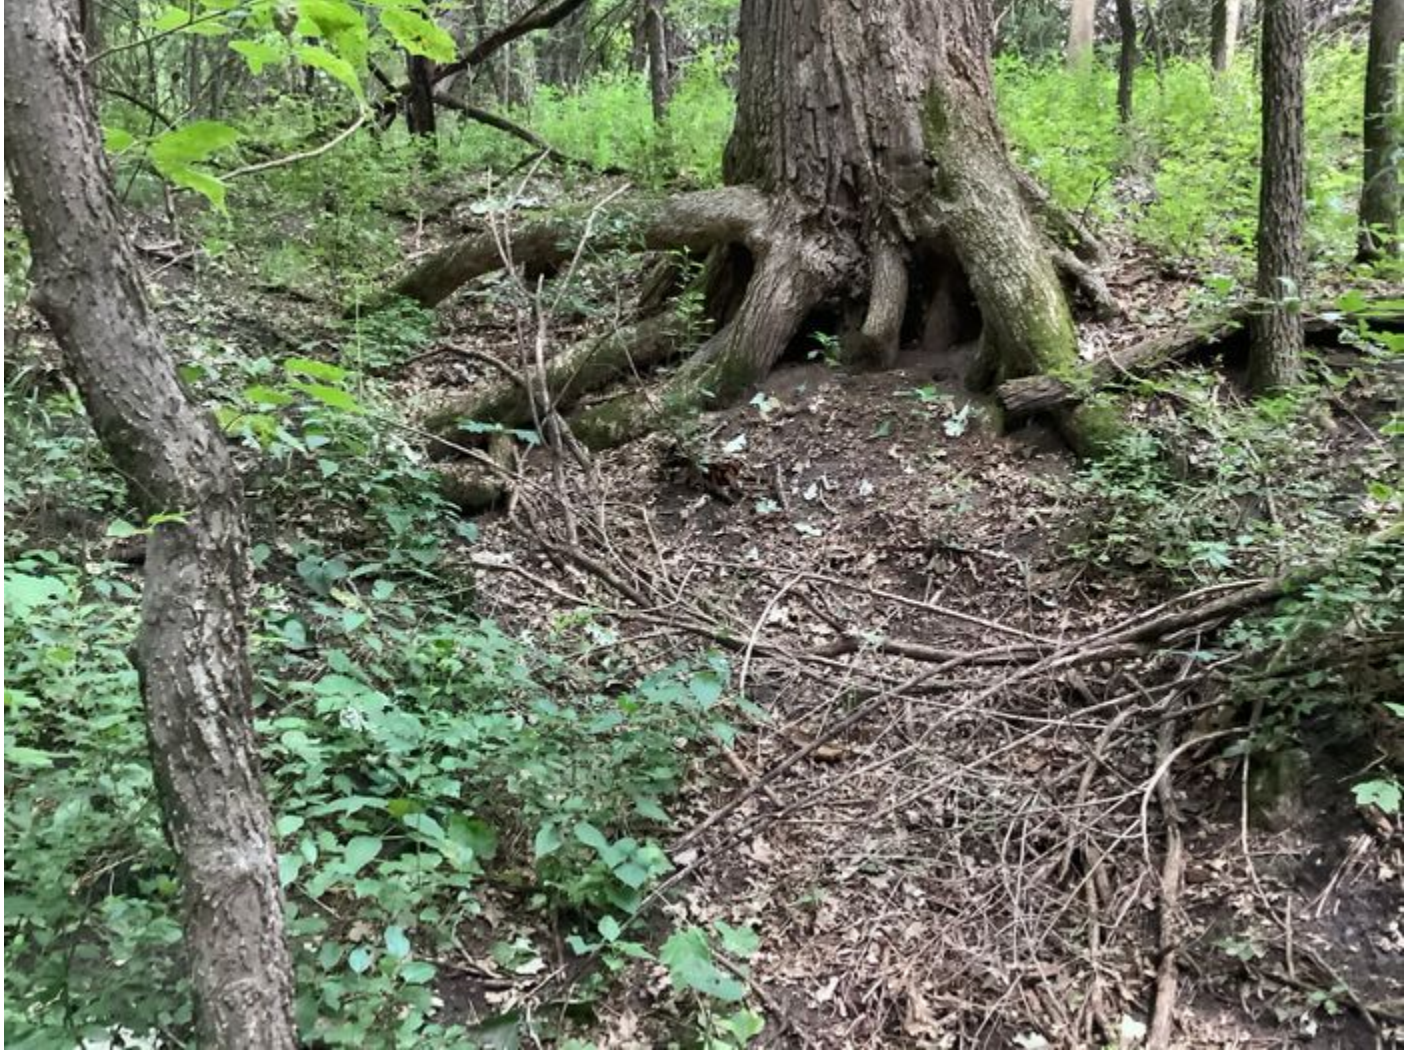
Looking u/s from gully toe towards left bank at exposed tree roots and bare soil

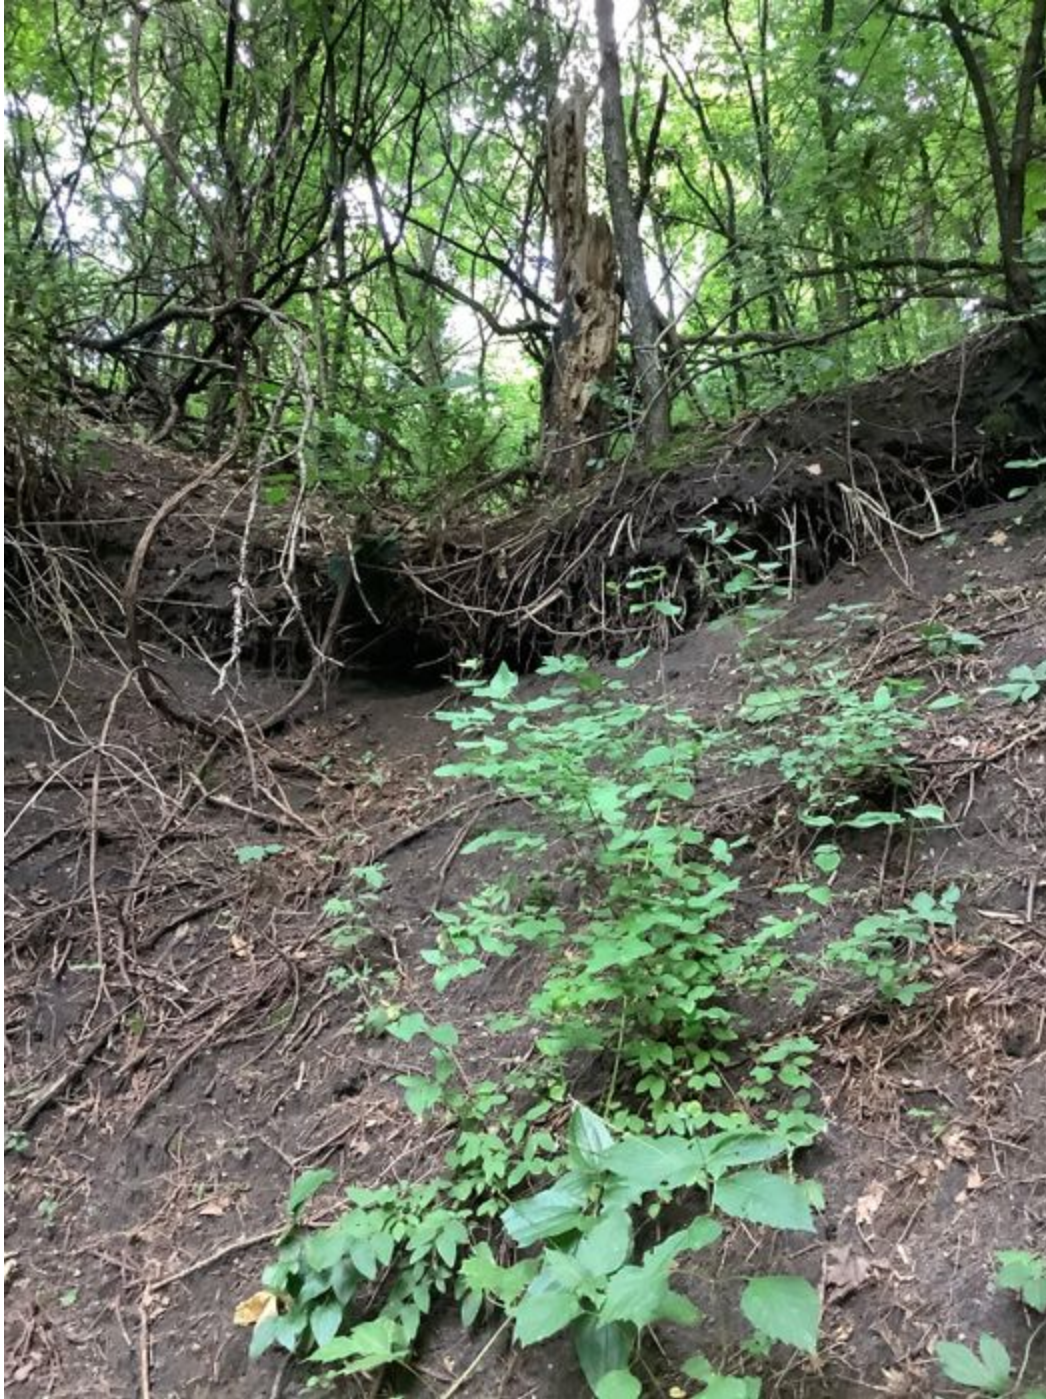
Looking u/s from gully bottom towards headcut at overhanging banks

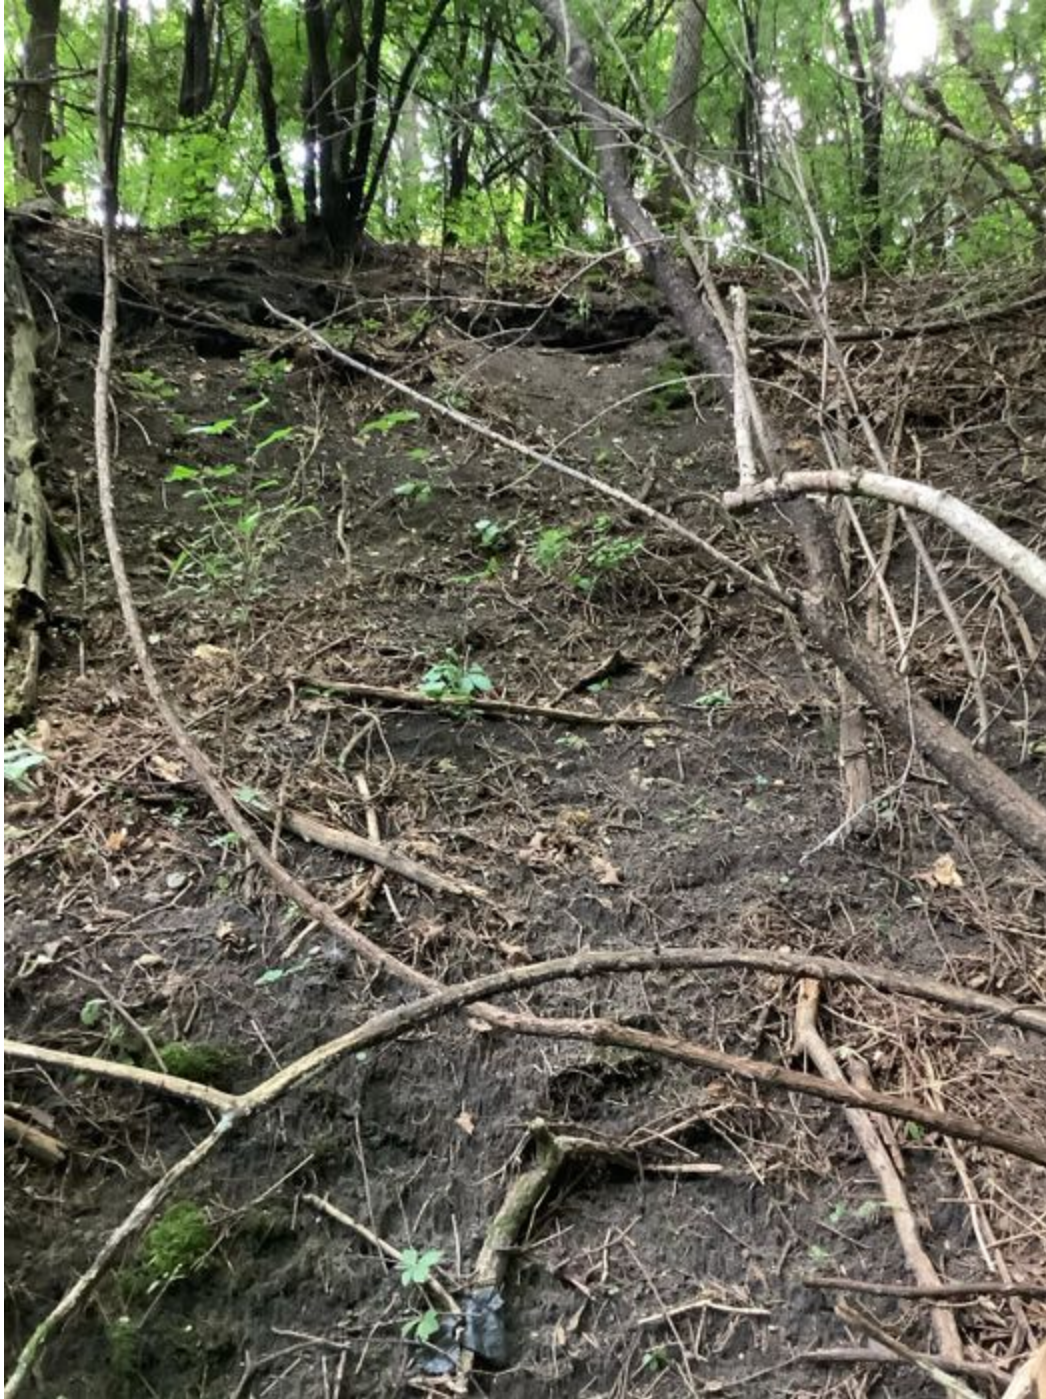
Looking u/s from gully bottom towards the headcut at the steep slopes and bare soil along the right bank
