Technical Memorandum

To: Linda Loomis, Administrator
Lower Minnesota River Watershed District

Re: Area 3 Slope Stability Project Update

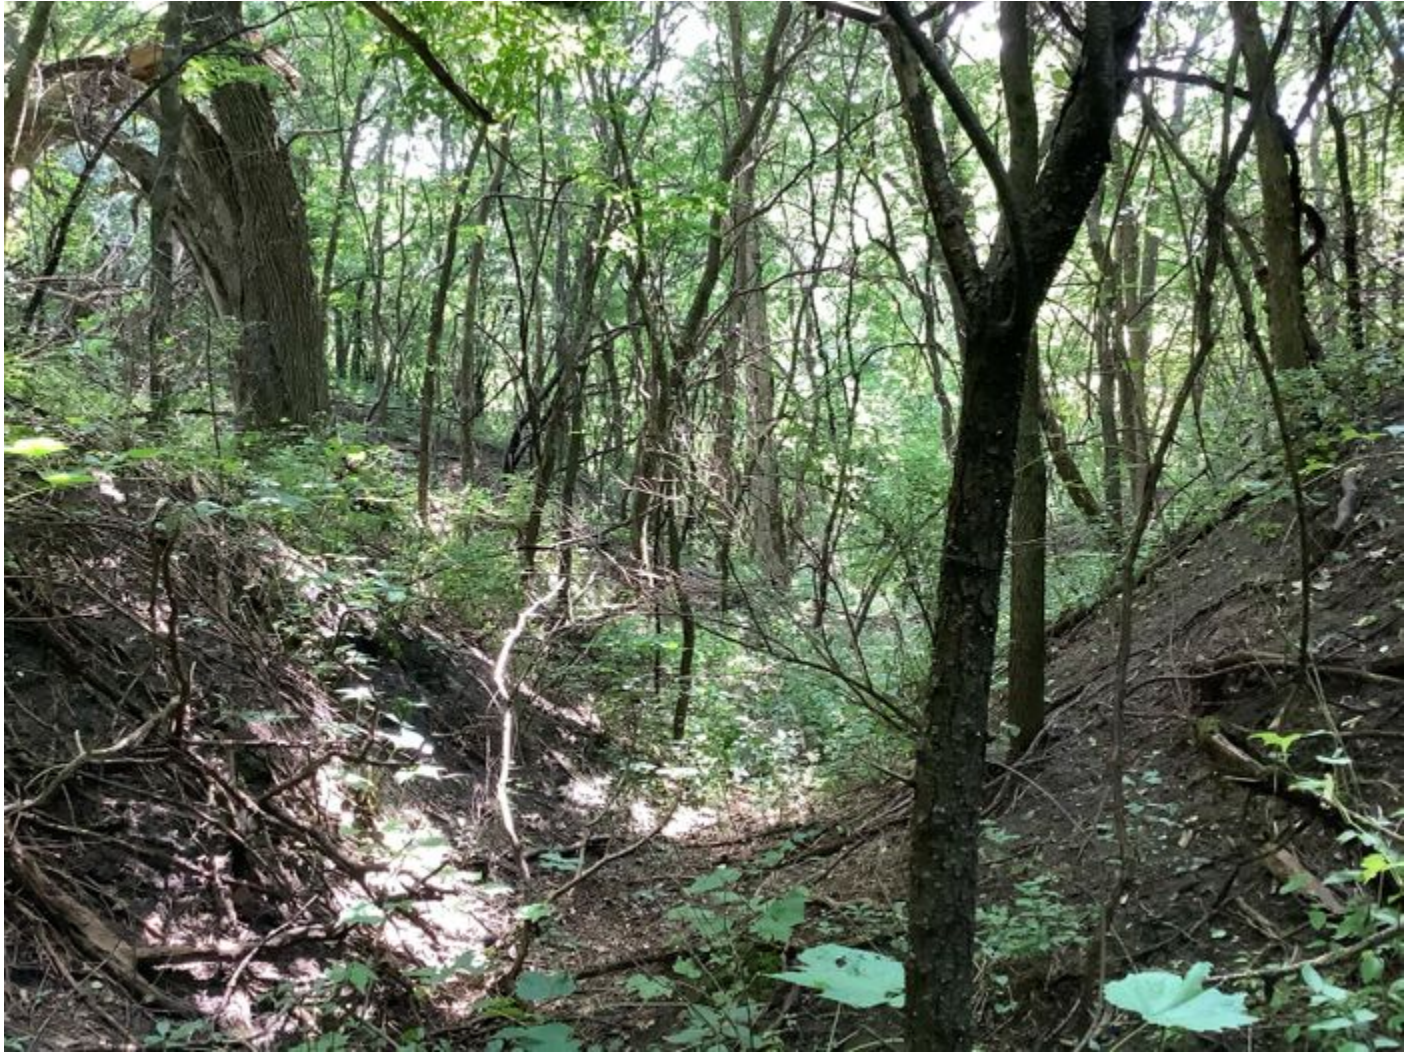
Looking d/s from gully bottom and bare soil and steep banks

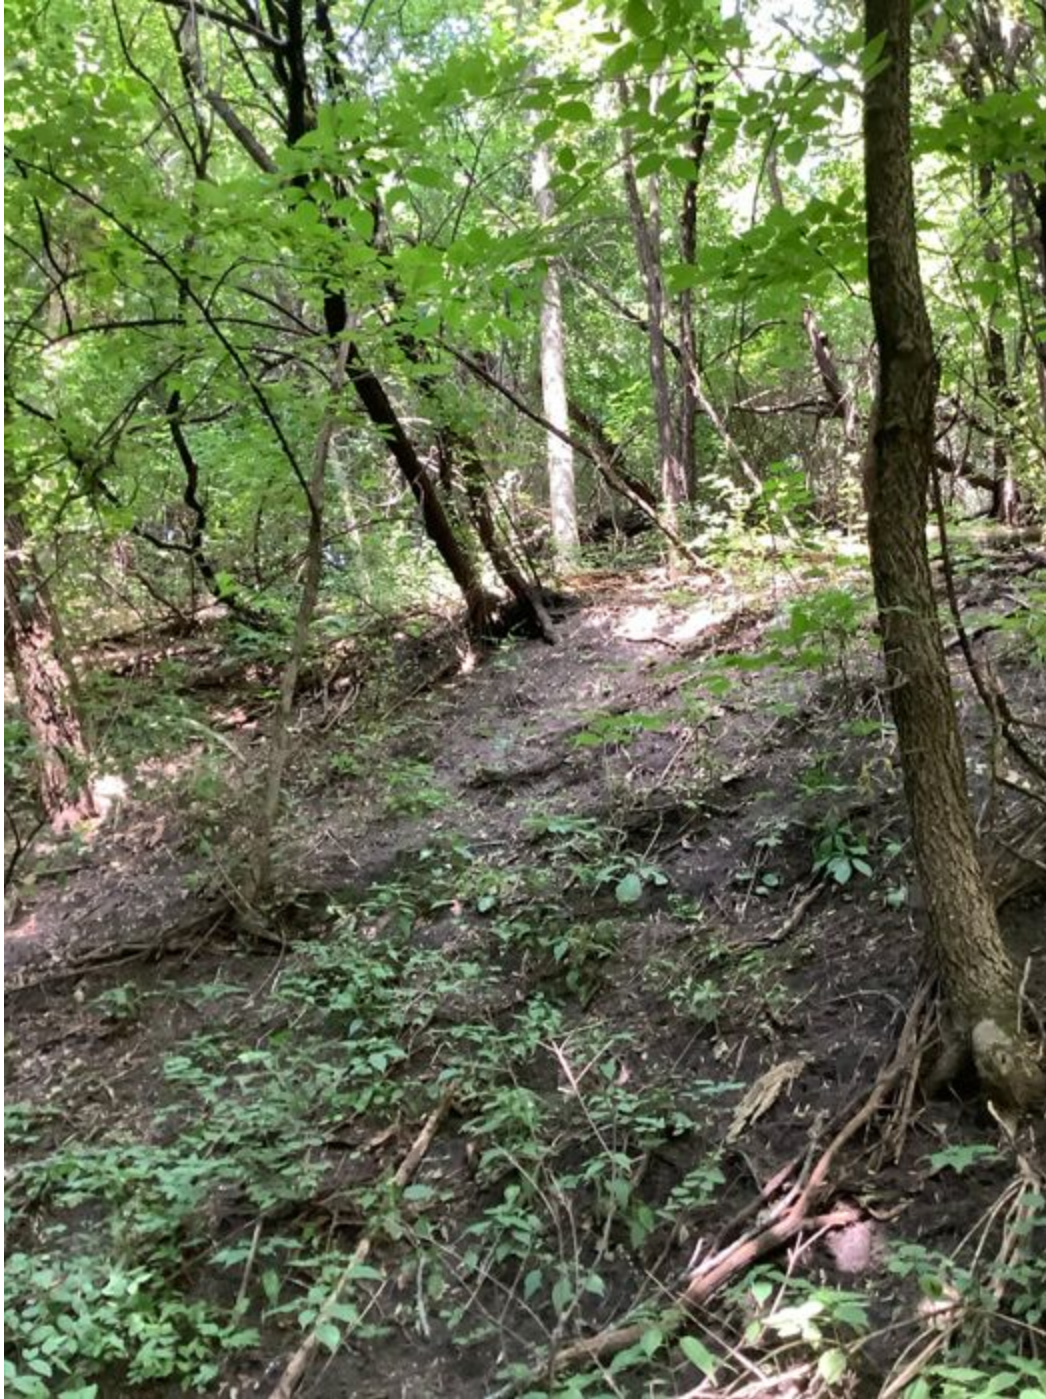
Looking d/s from gully bottom at bare soil and leaning tree along the right bank

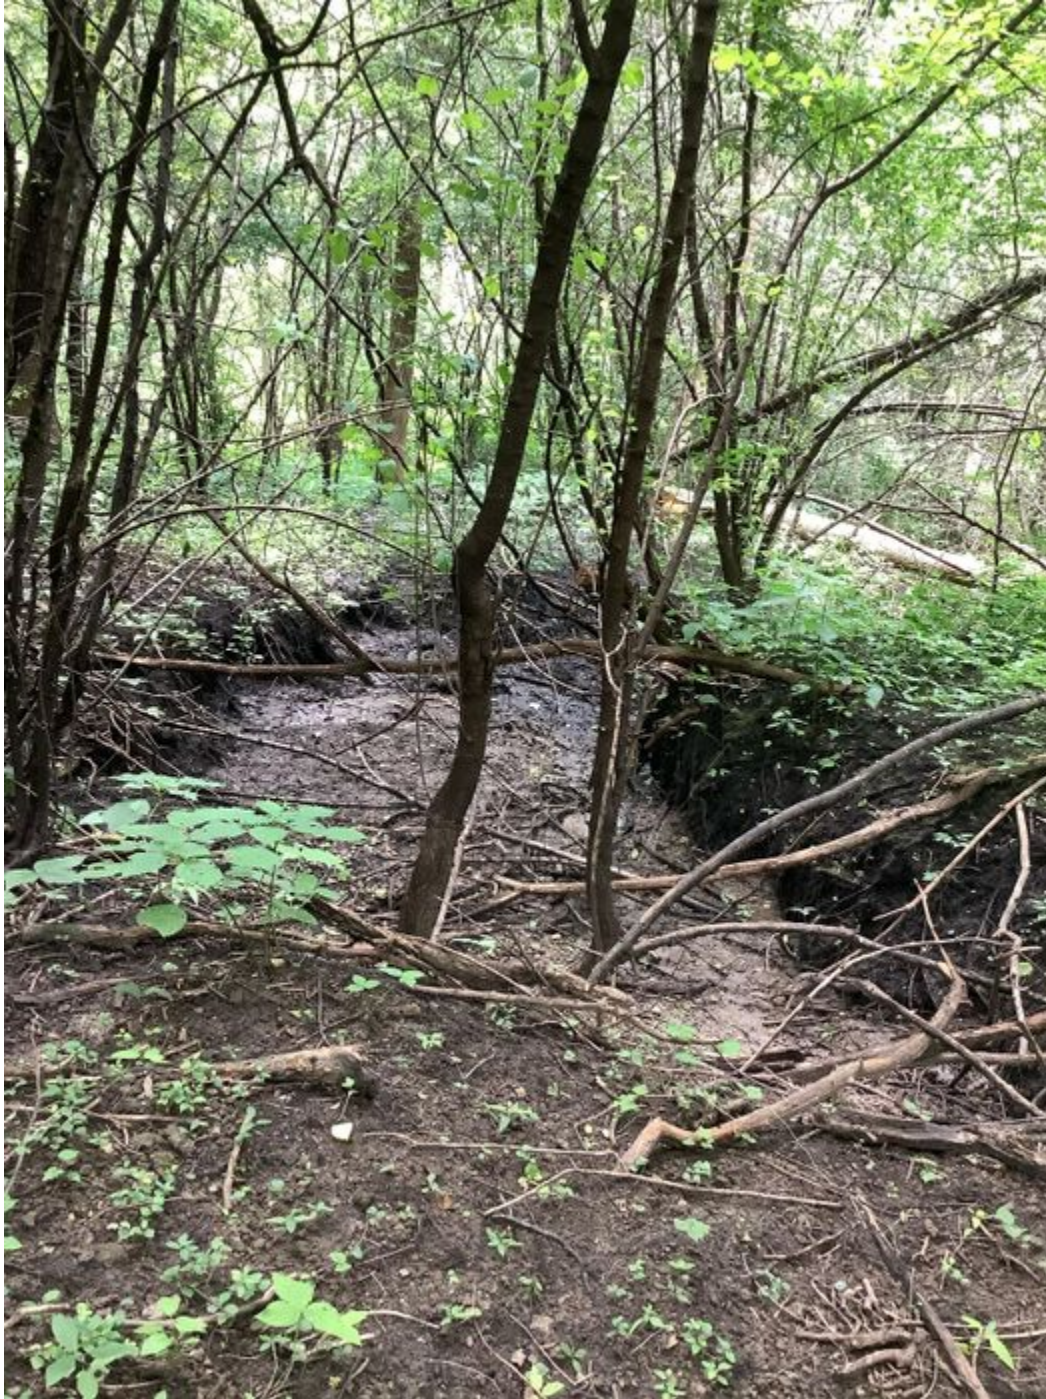
Downstream view from mid gully looking at overhang and slumping along both banks and a knick point close to the right bank.

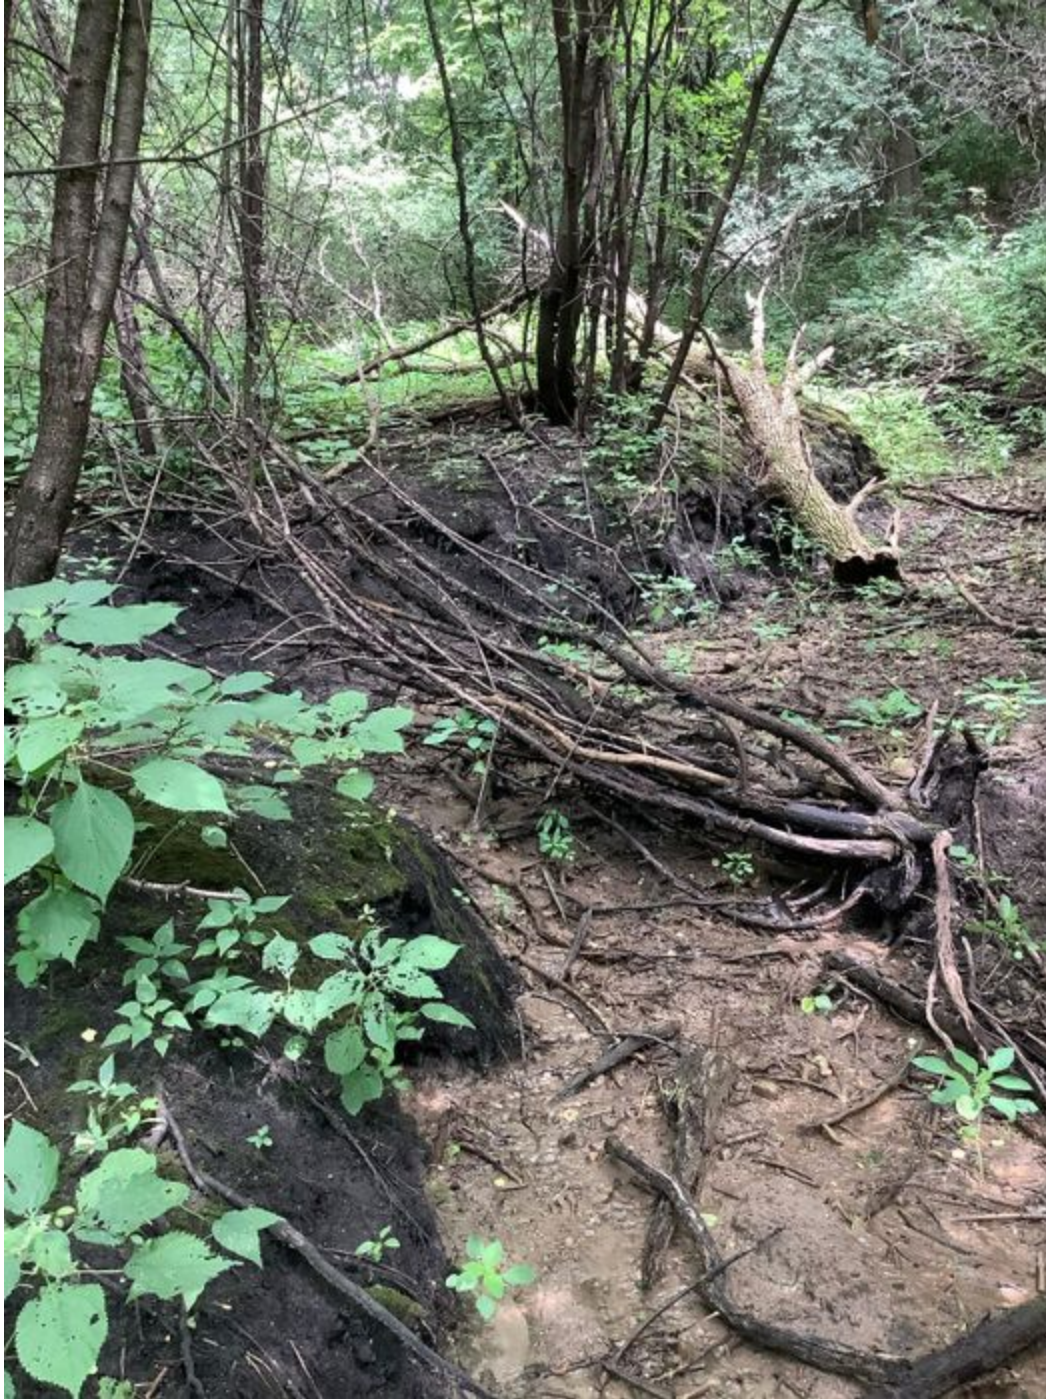
Upstream view of widened section of the gully with slumping along the right bank. View from mid gully bottom.

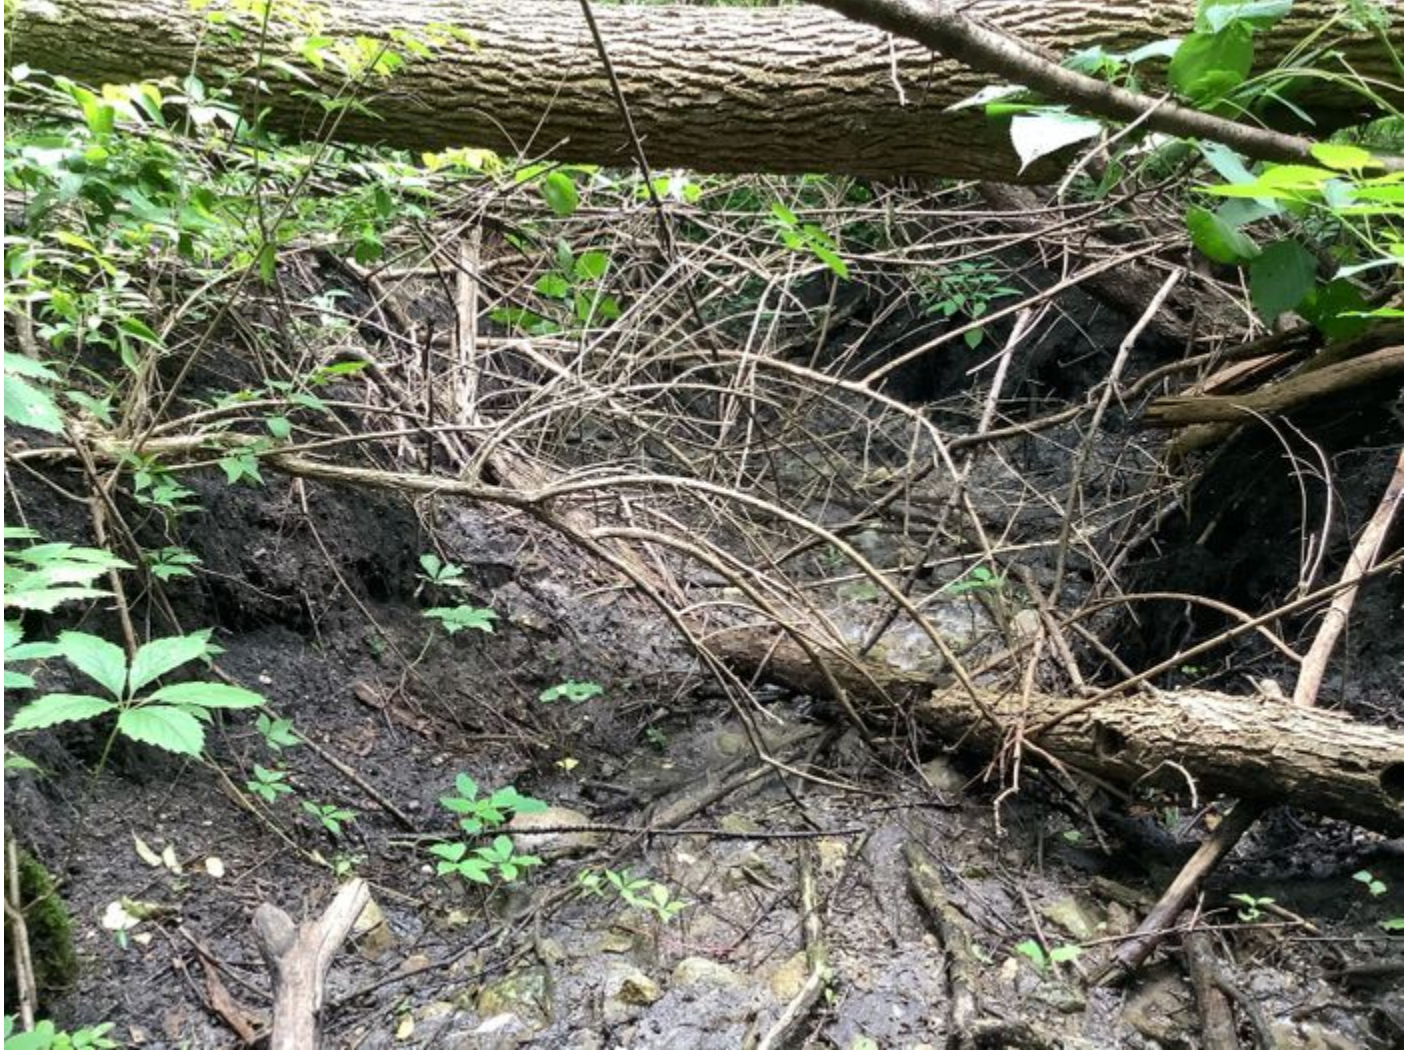
Downstream view from gully bottom looking at incision and tree debris

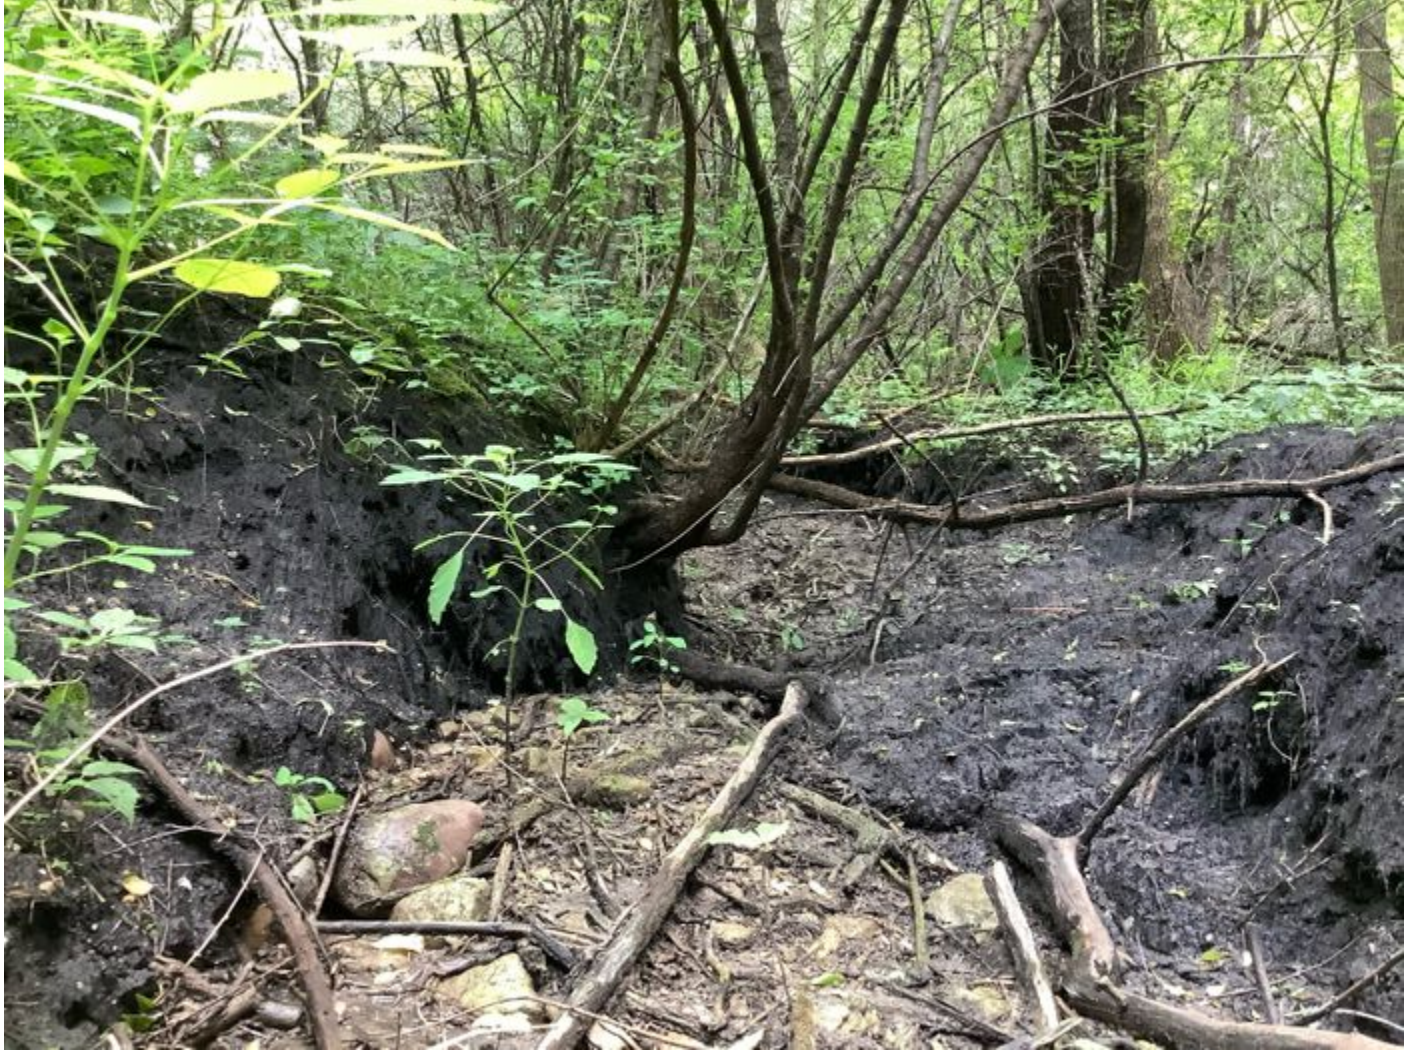
Upstream view from gully bottom looking at overhanging banks on both sides and leaning tree on right bank.

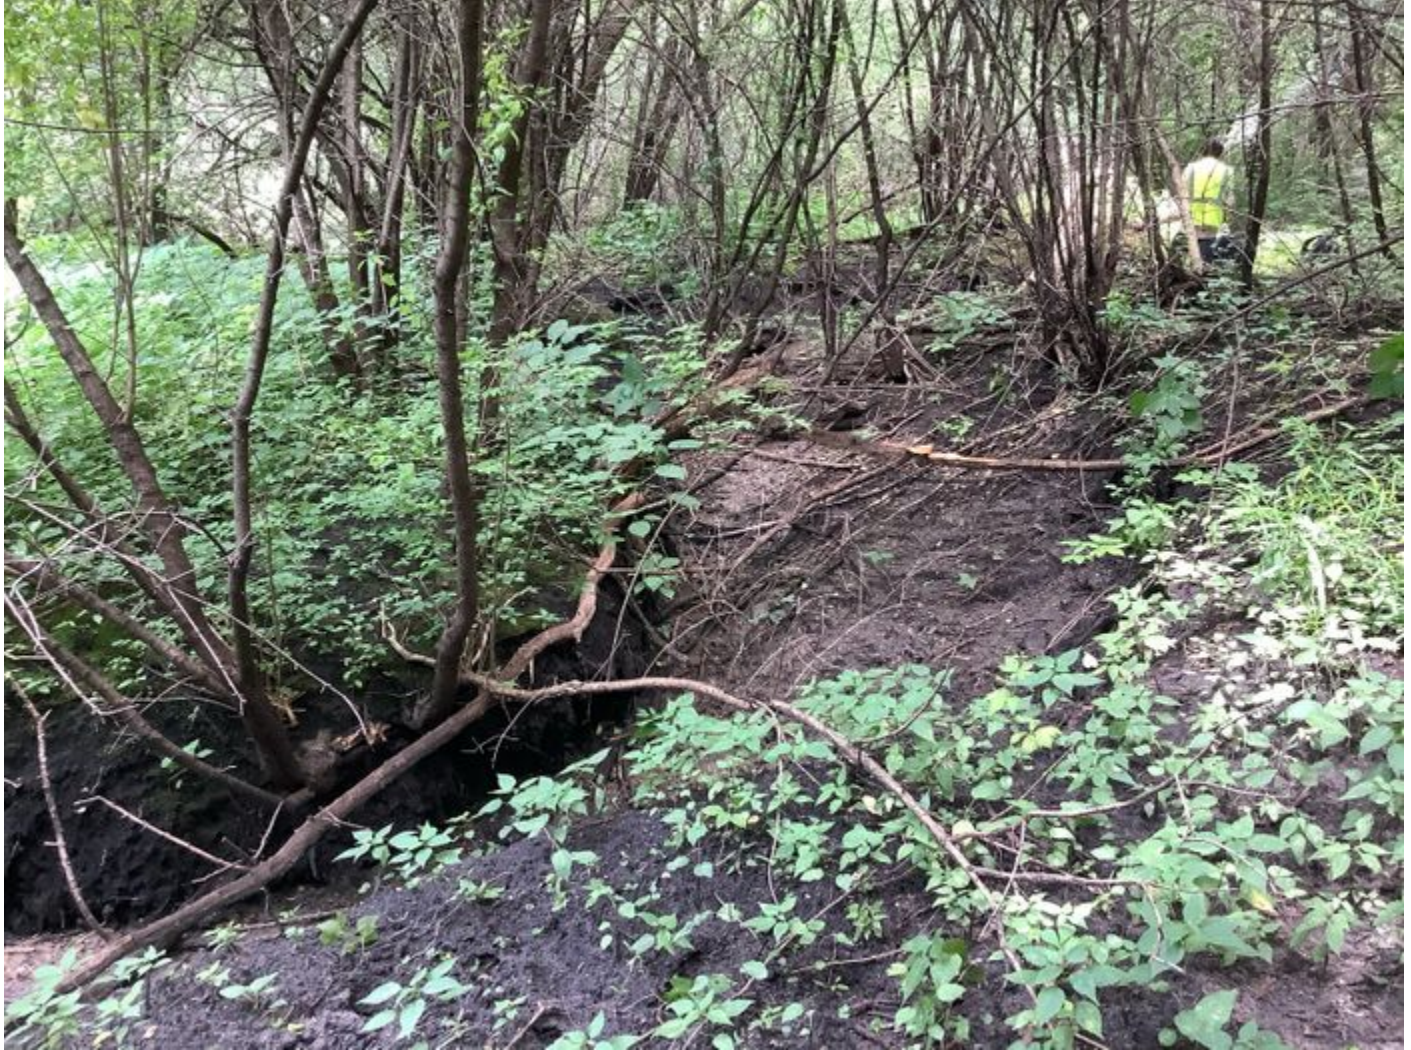
Upstream view from left bank looking at deep incision along right bank with person for scale.

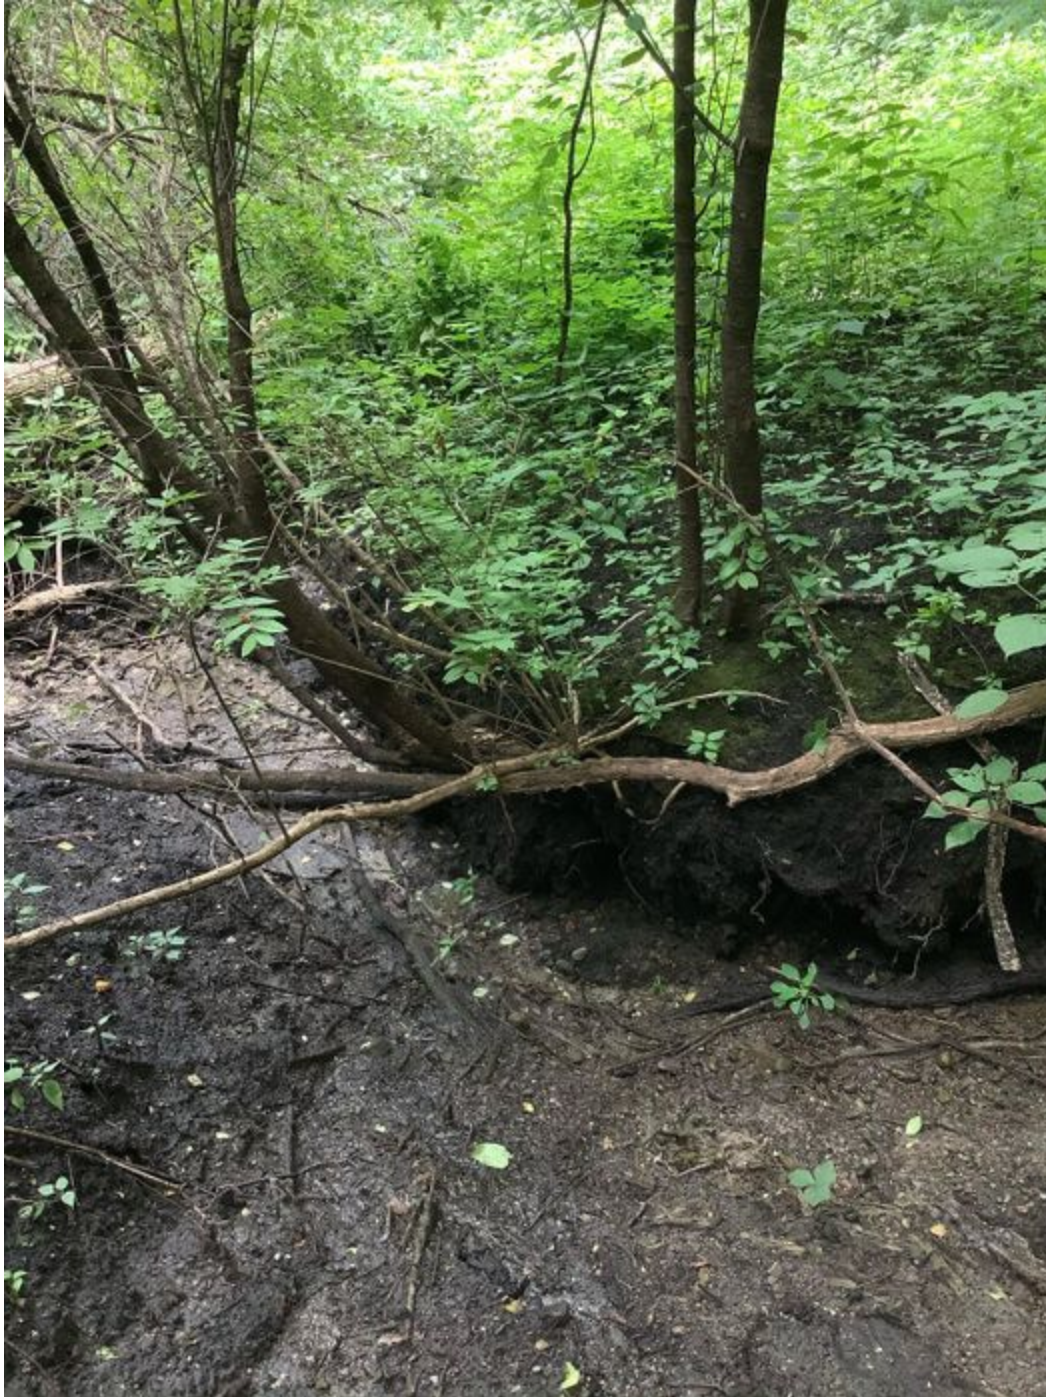
Side stream view from left bank looking at section of overhang on right bank.

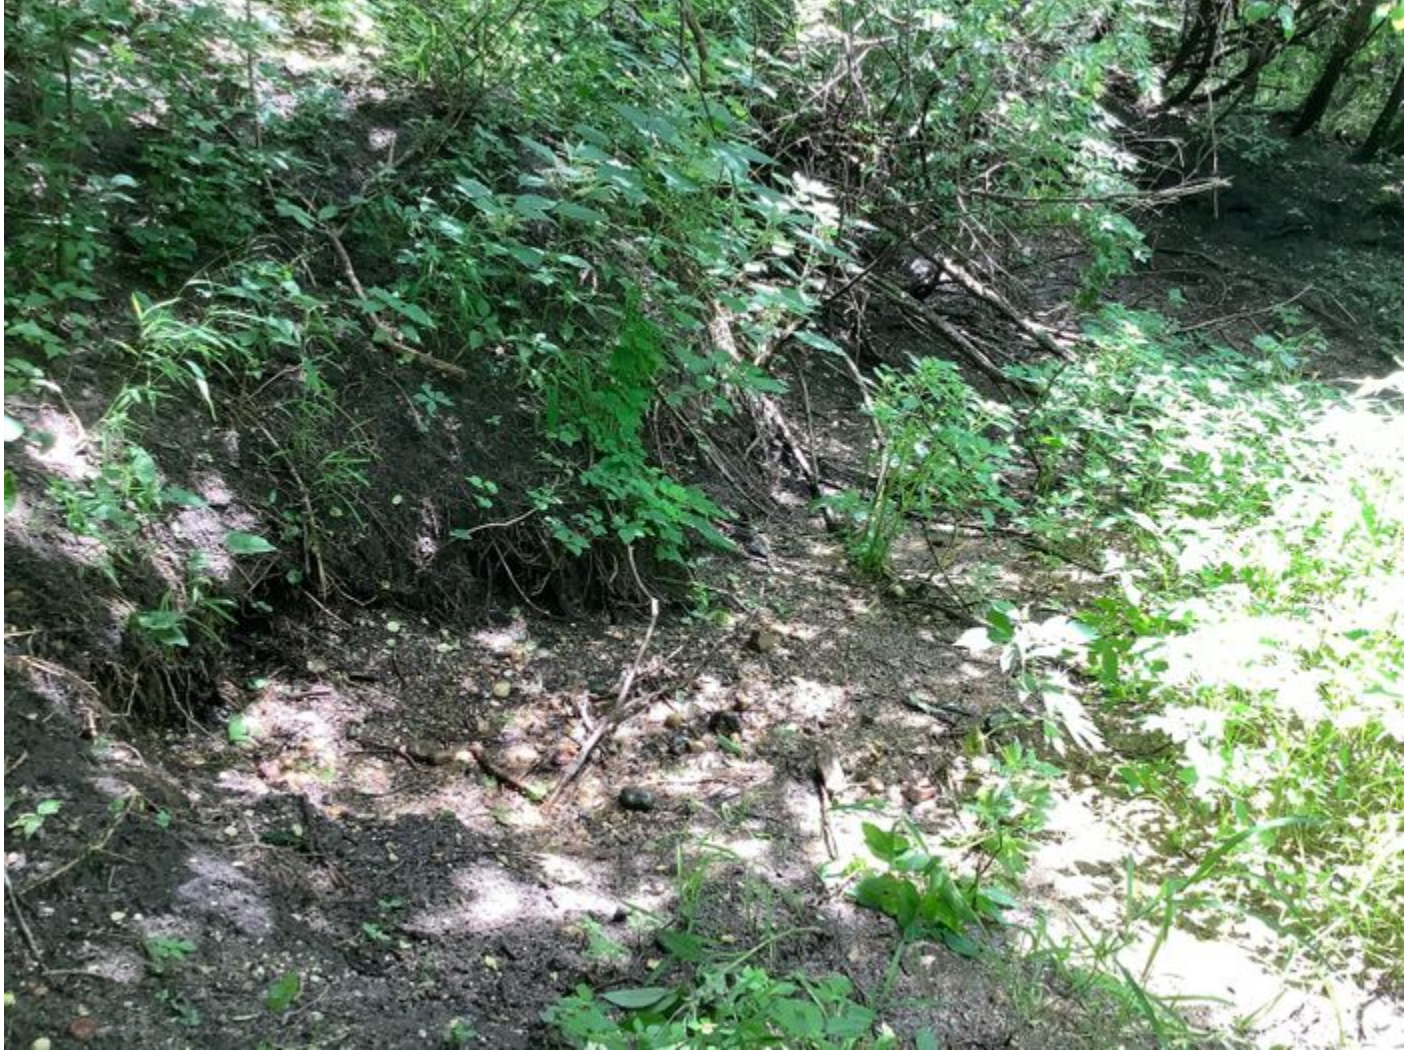
Downstream view from right bank look at headcut, slumping along left bank.

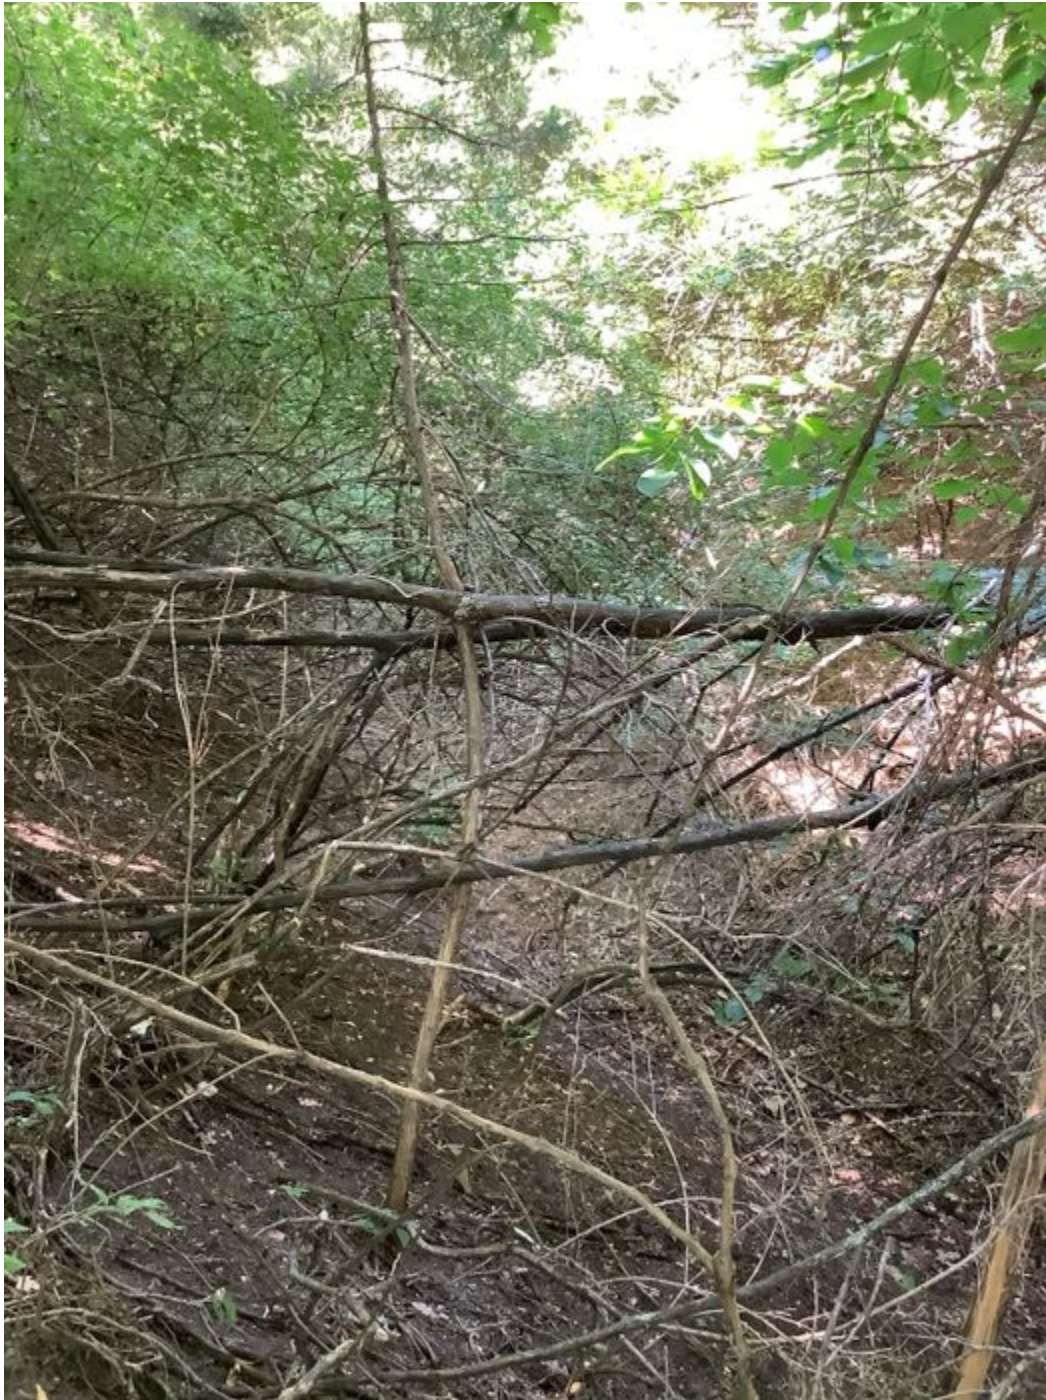
Upstream view from right bank looking at gully channel and fallen tree debris and bare soil along the banks.

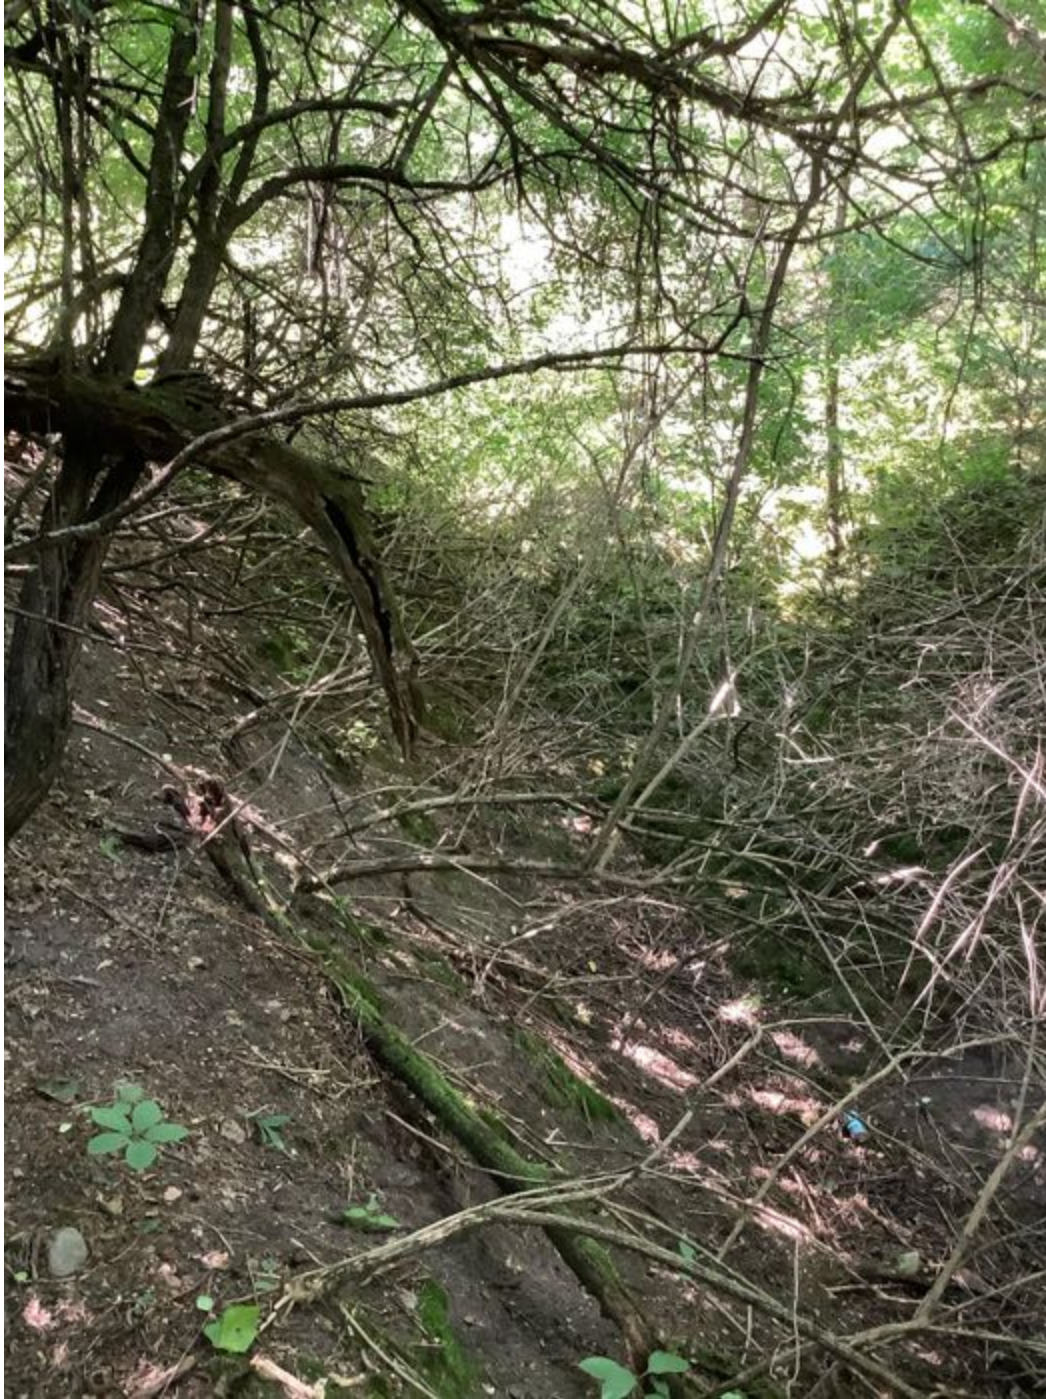
Upstream view from right bank looking at gully channel and fallen tree debris and bare soil along the banks.

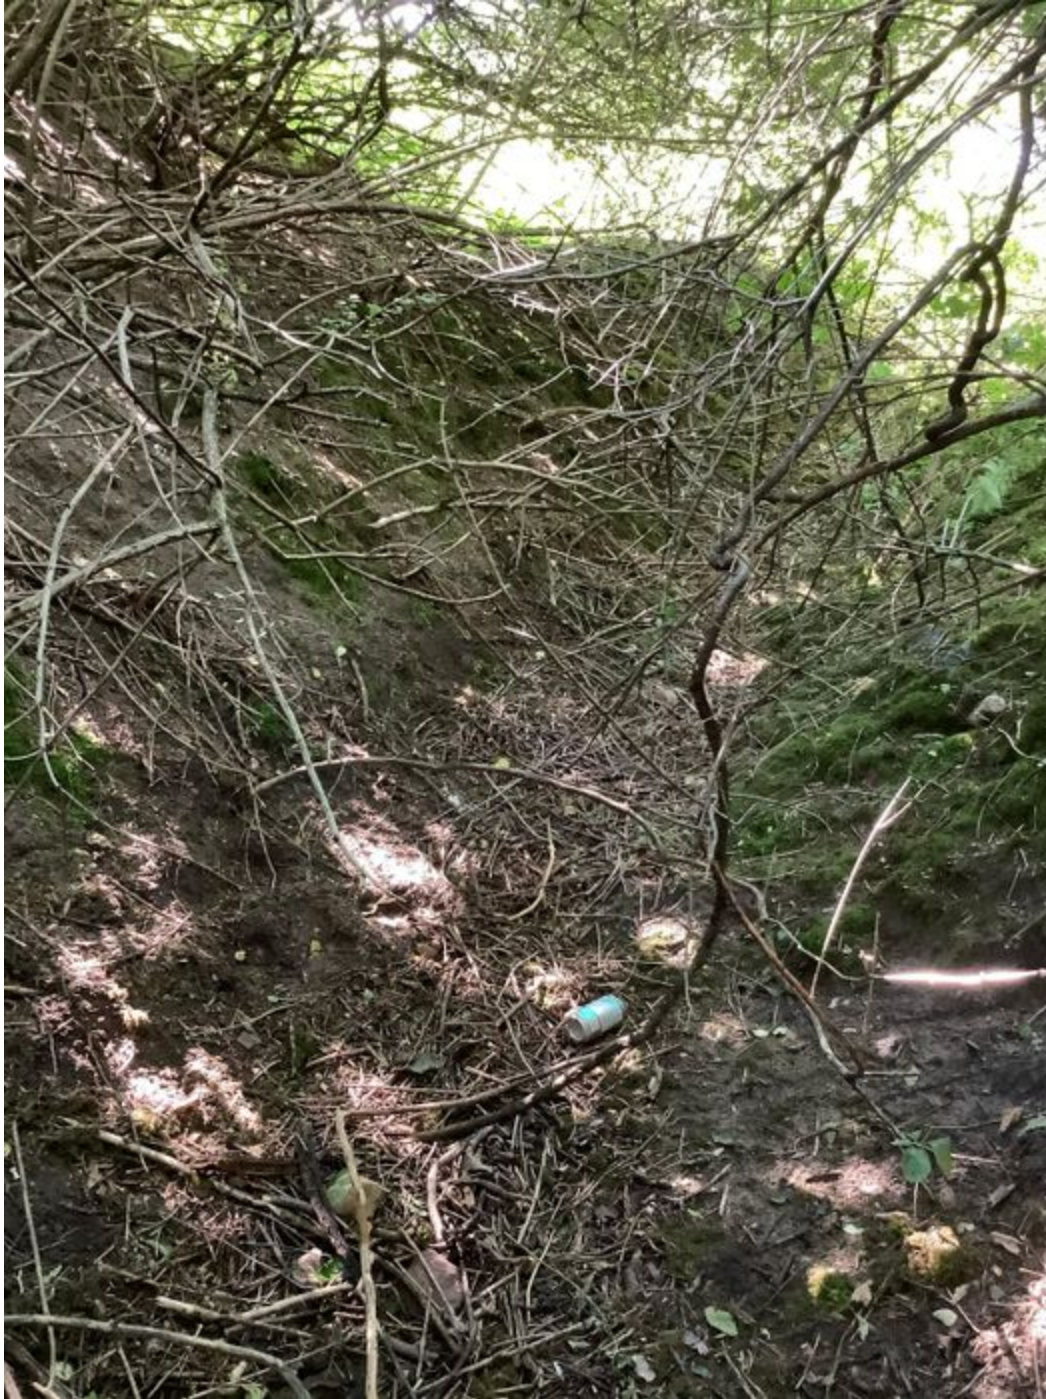
Upstream view from gully bottom looking towards headcut. View of bare soil, channel incision, and abundance of dead trees.

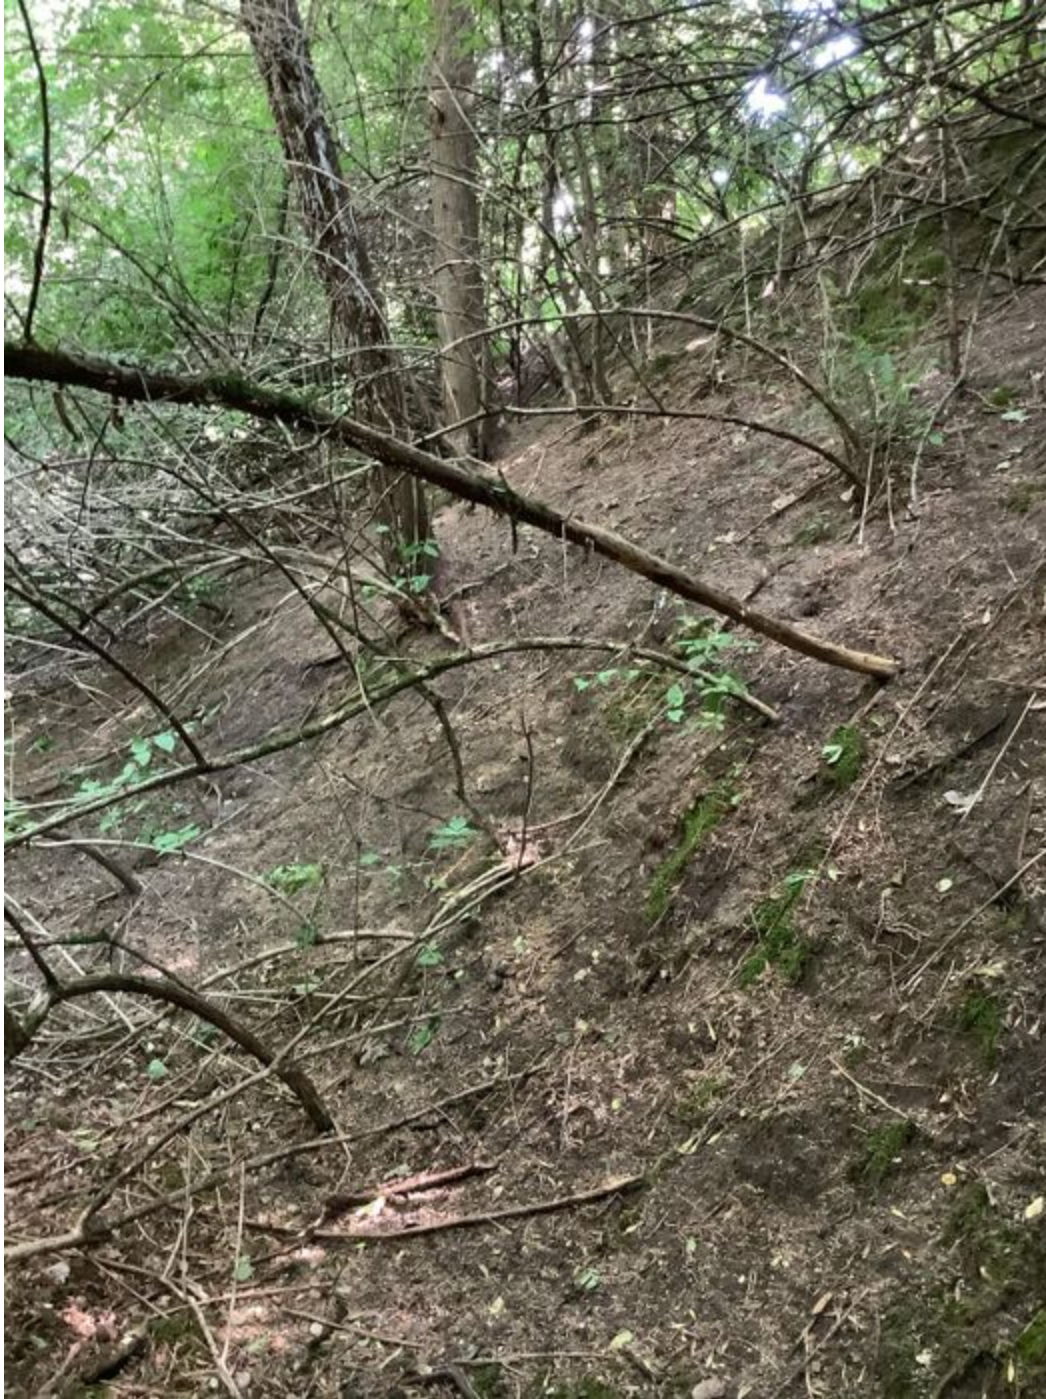
Upstream view from gully bottom looking at bare soil along right bank of channel.

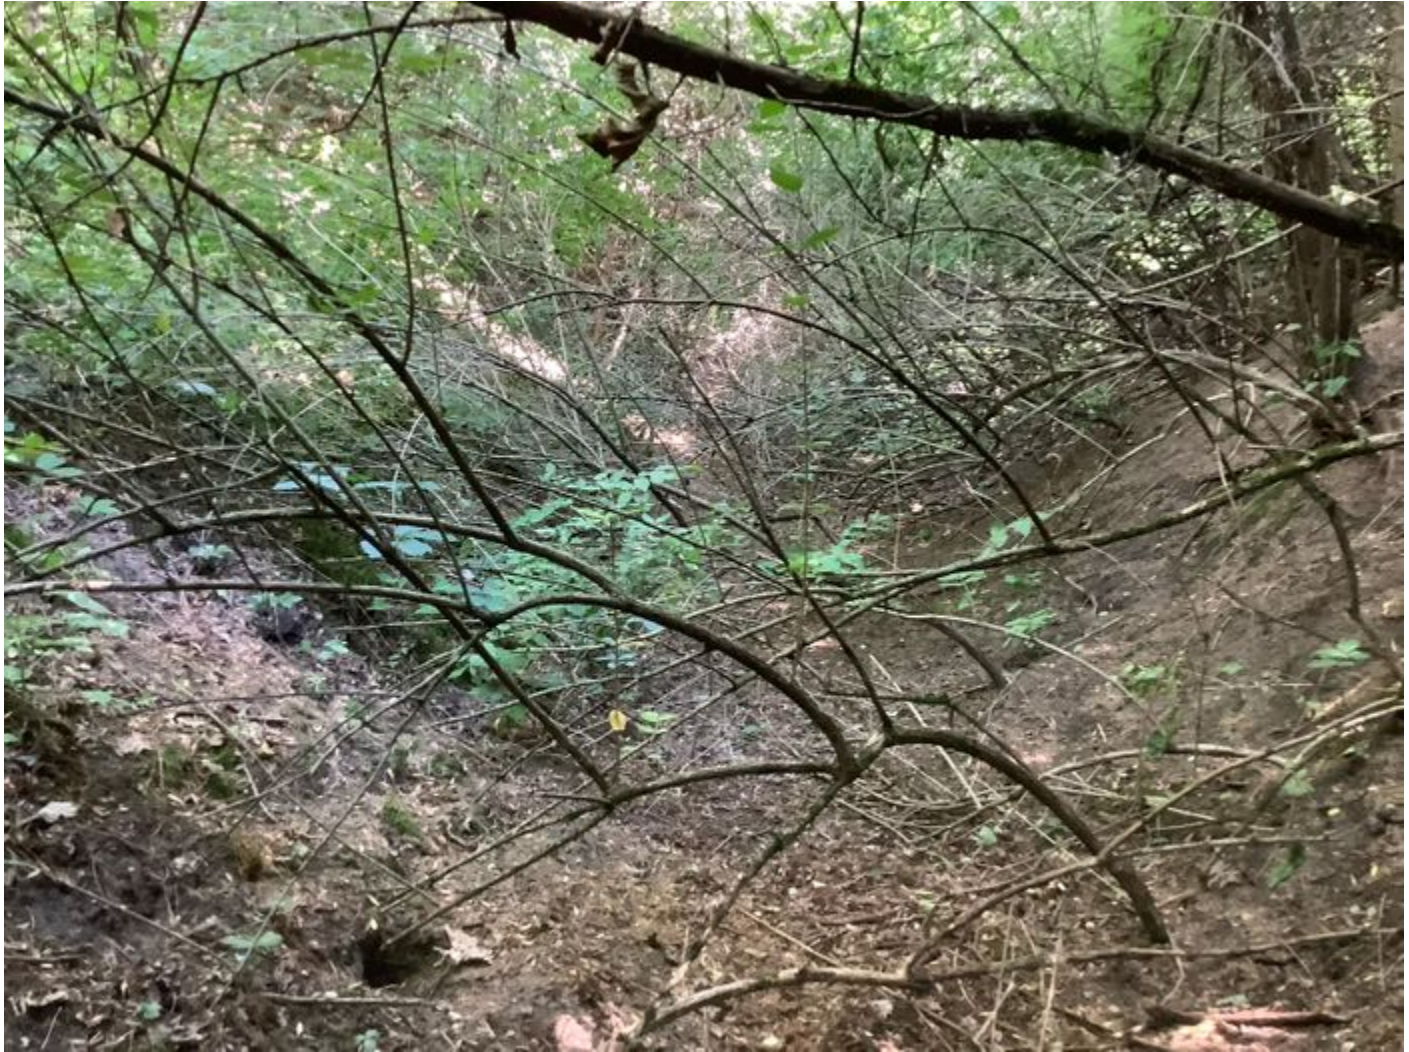
Downstream view from gully channel looking at bare soil along the banks and the V-shape of the channel.

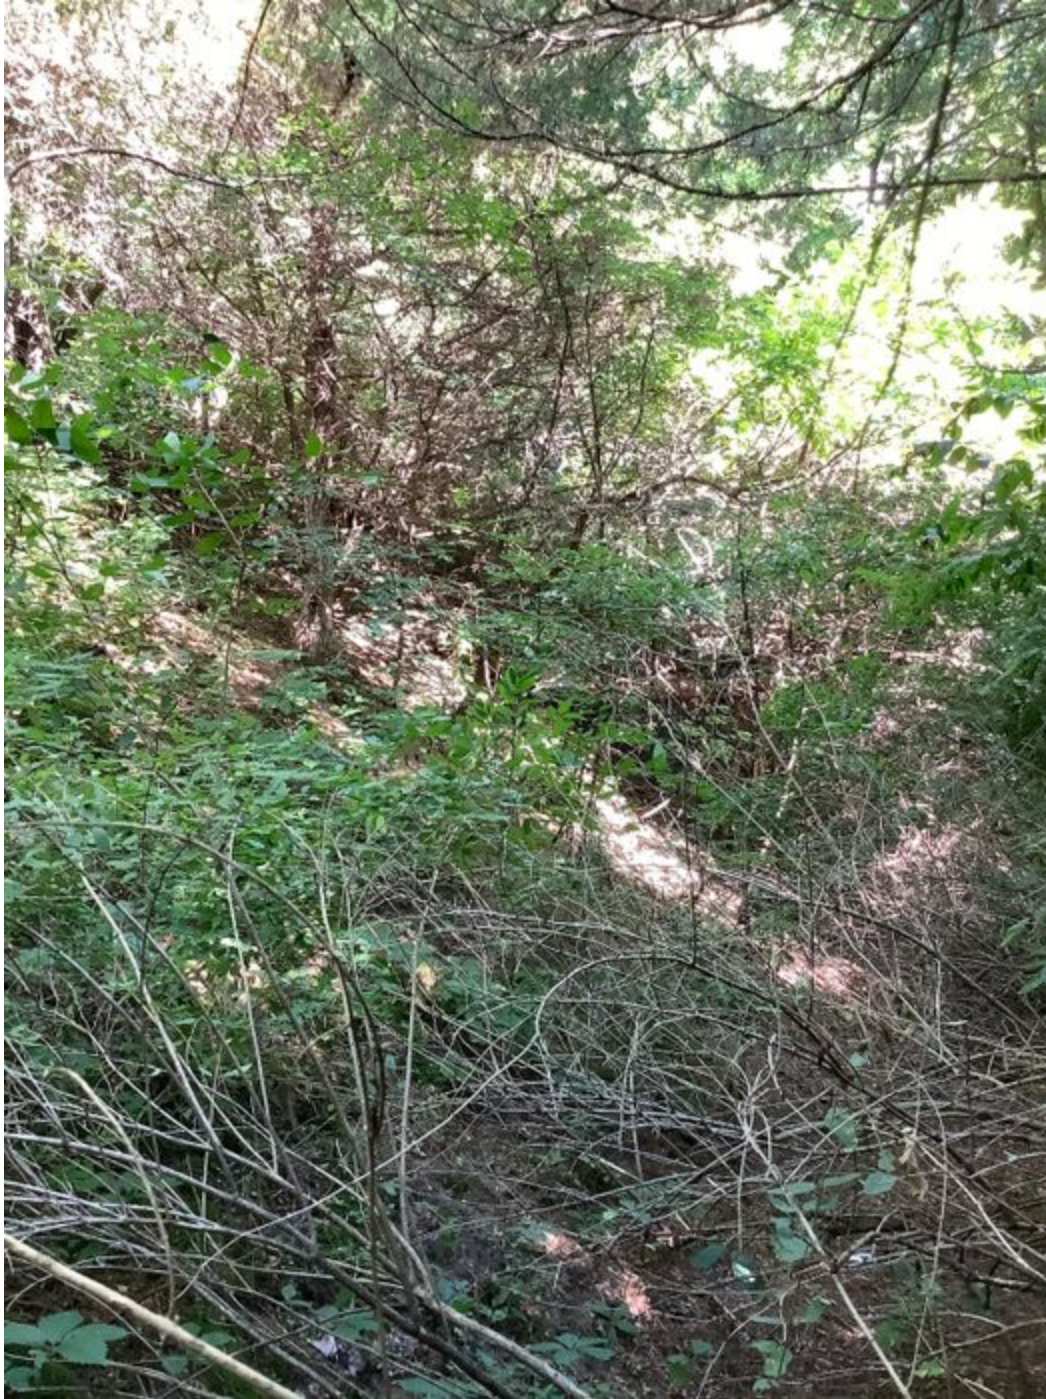
Downstream view of left bank of channel which is mostly obstructed by trees. View of partial vegetation on left bank and steep bank slope. View from gully bottom.
