Technical Memorandum

To: Linda Loomis, Administrator
Lower Minnesota River Watershed District

Re: Area 3 Slope Stability Project Update

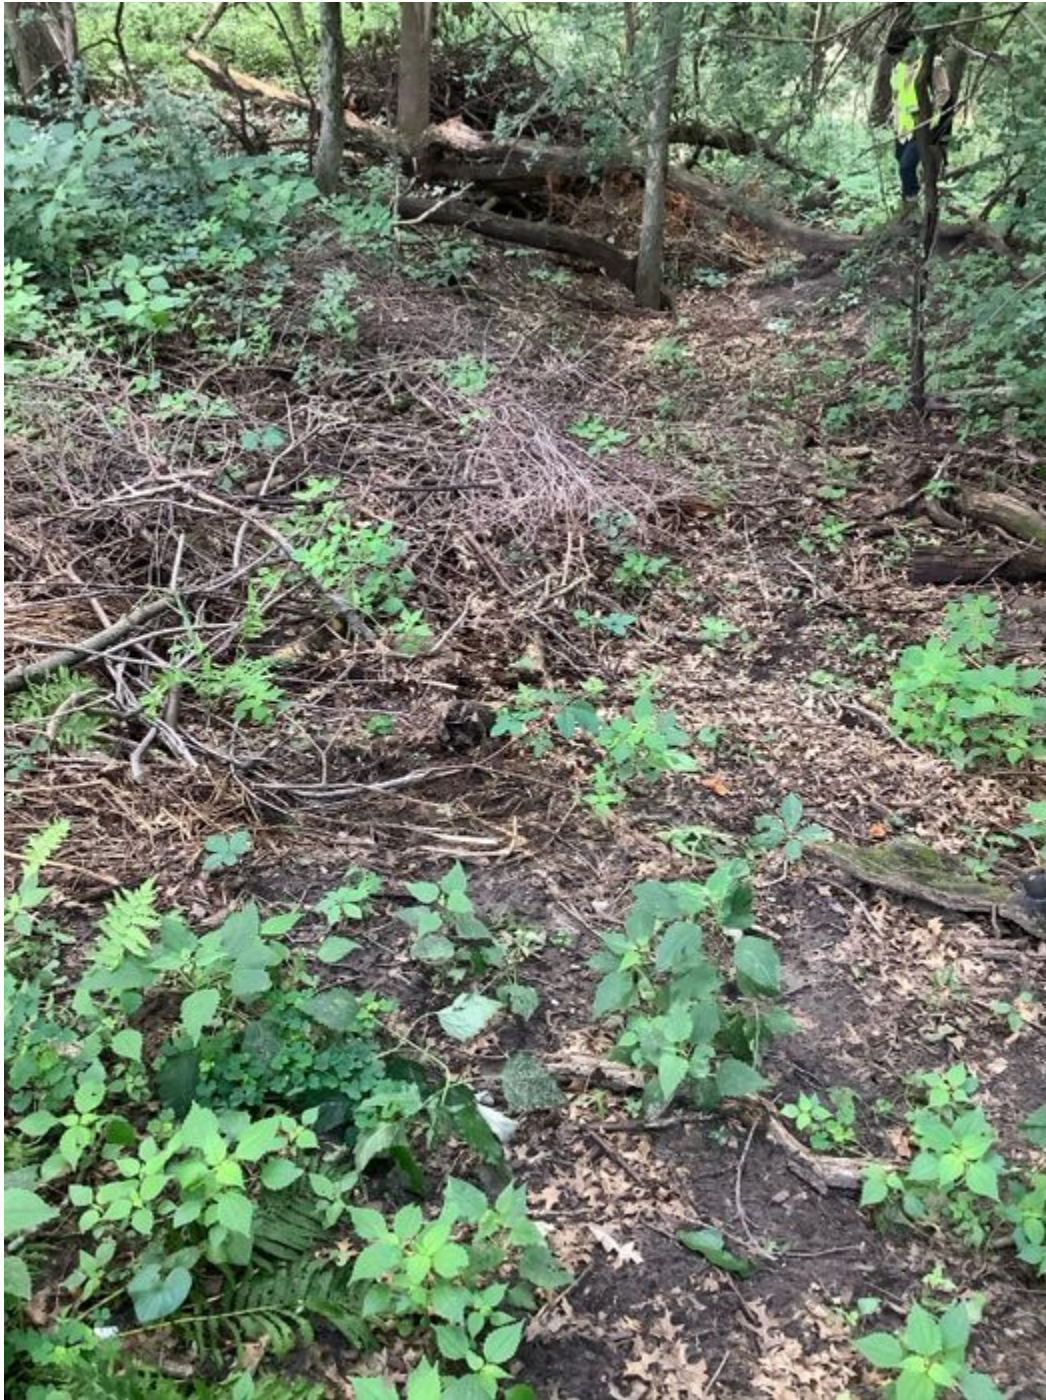
Downstream view from headcut looking at bare soil around headcut area but no signs of active slumping and tree debris piled in headcut channel.

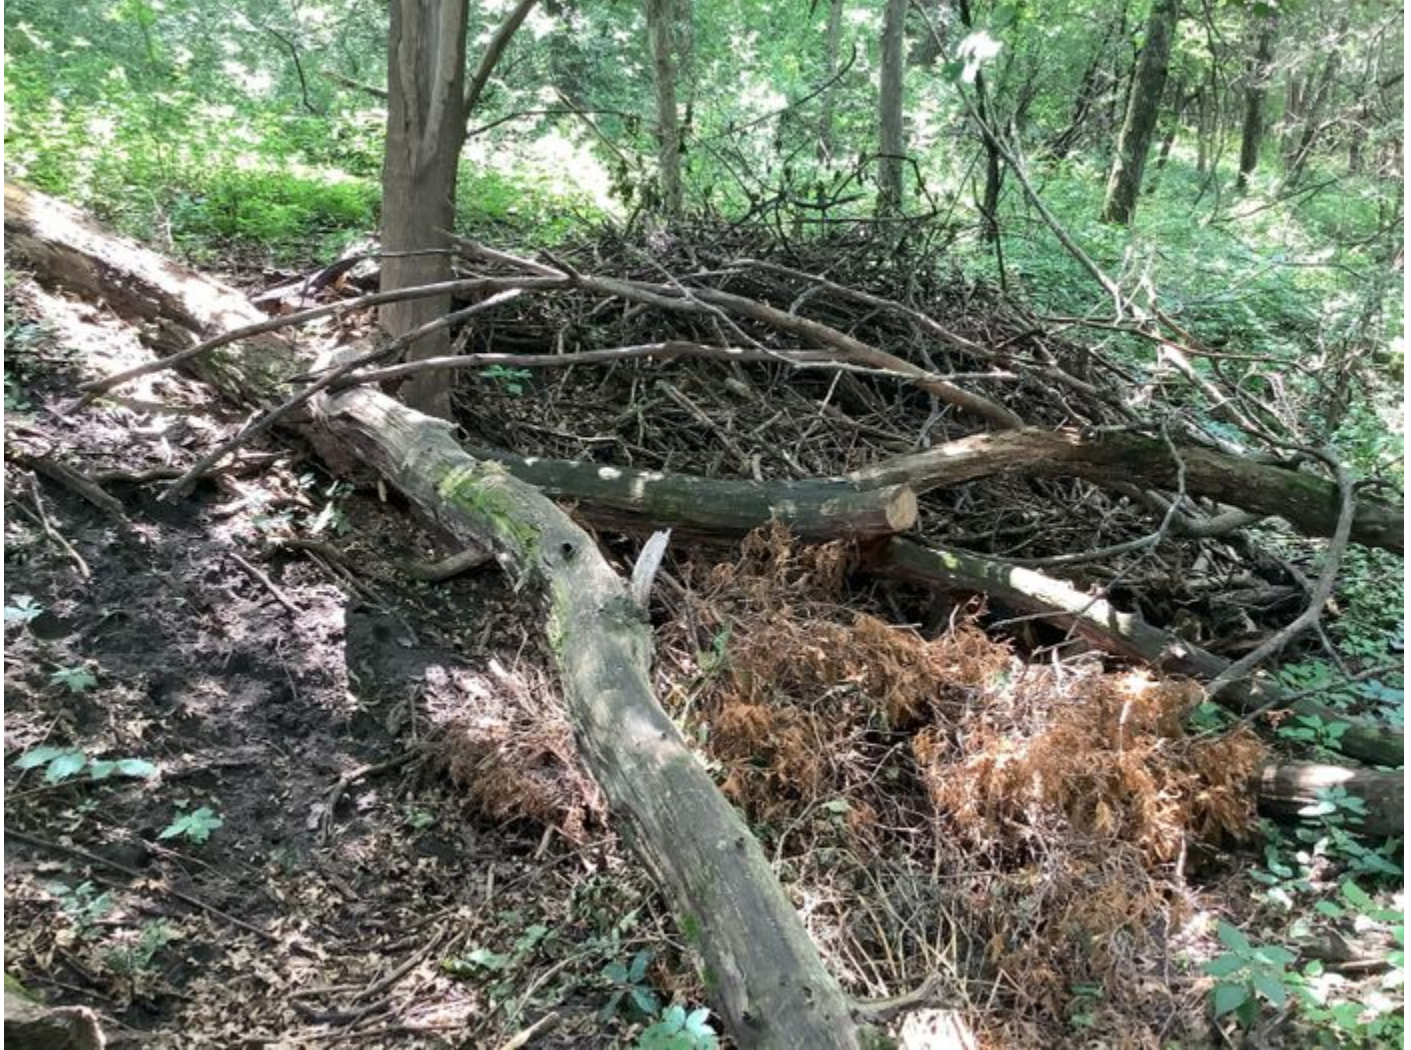
Downstream view from right bank looking at bare soil and tree debris near headcut.

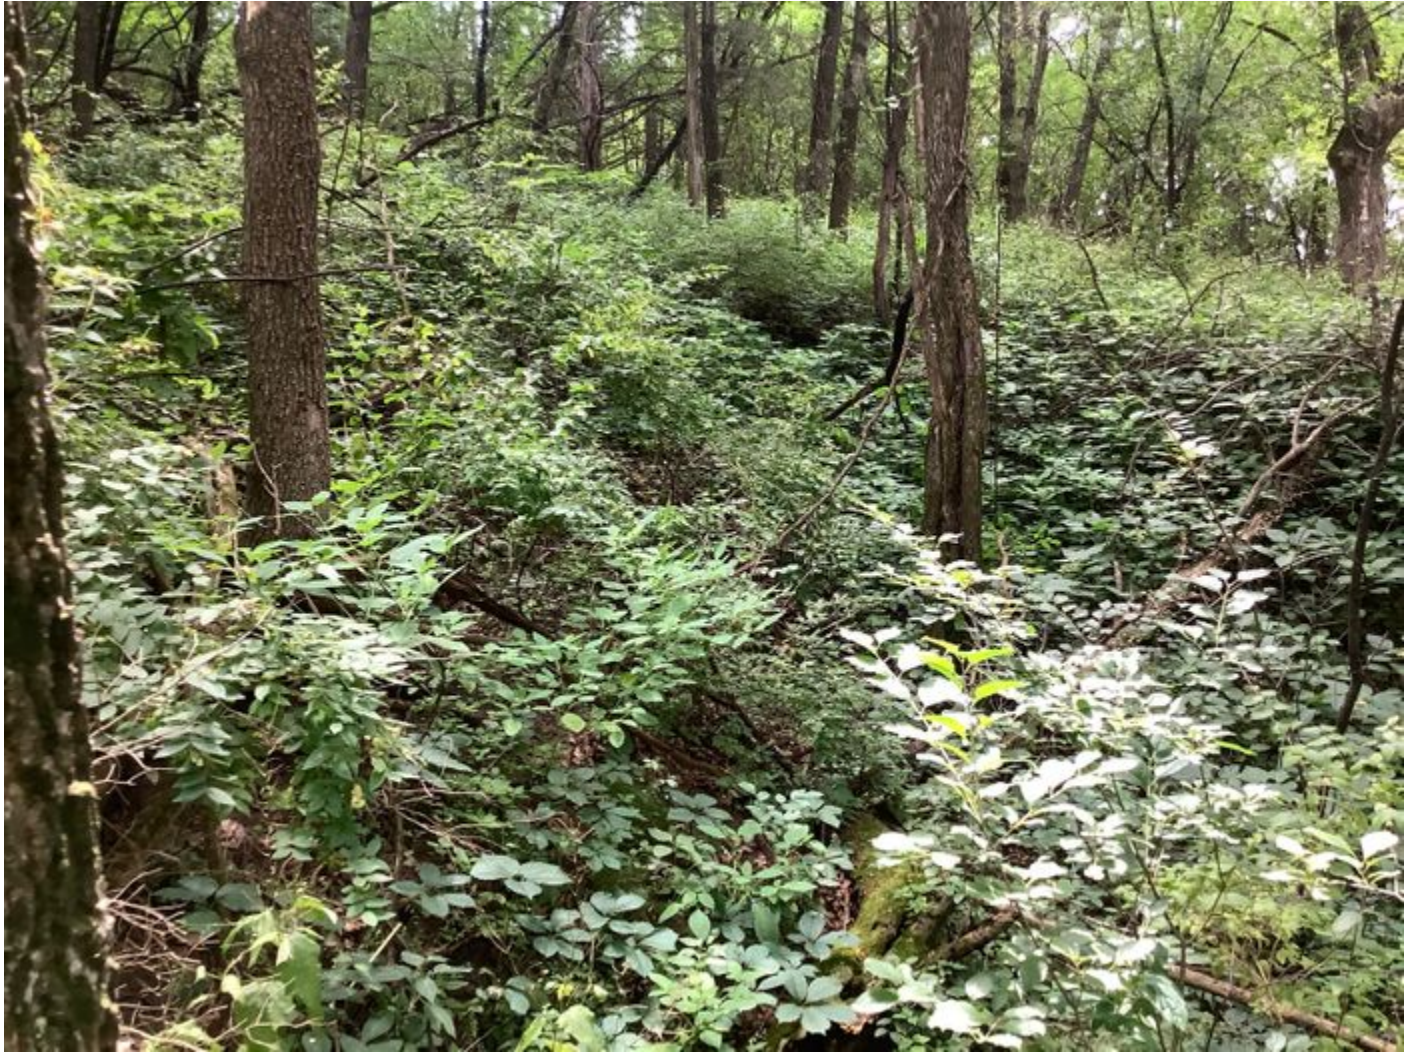
Downstream view from gully channel looking at historic slump on left bank that has revegetated.

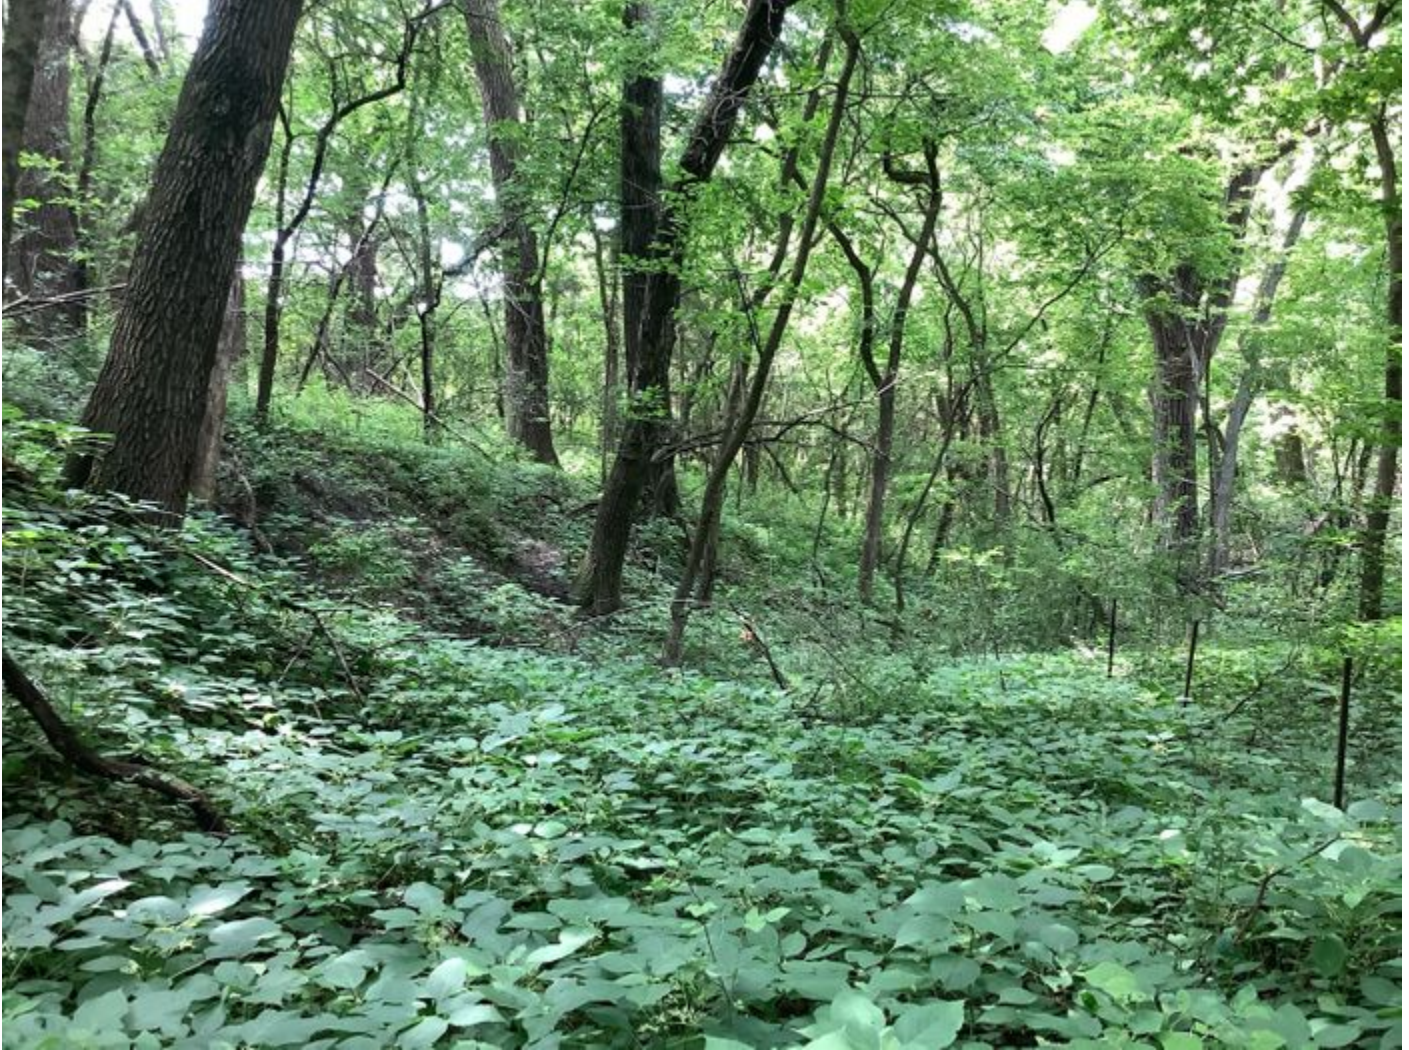
Downstream view from gully bottom looking at channel widening, leaning trees along left bank, and heavy vegetation.

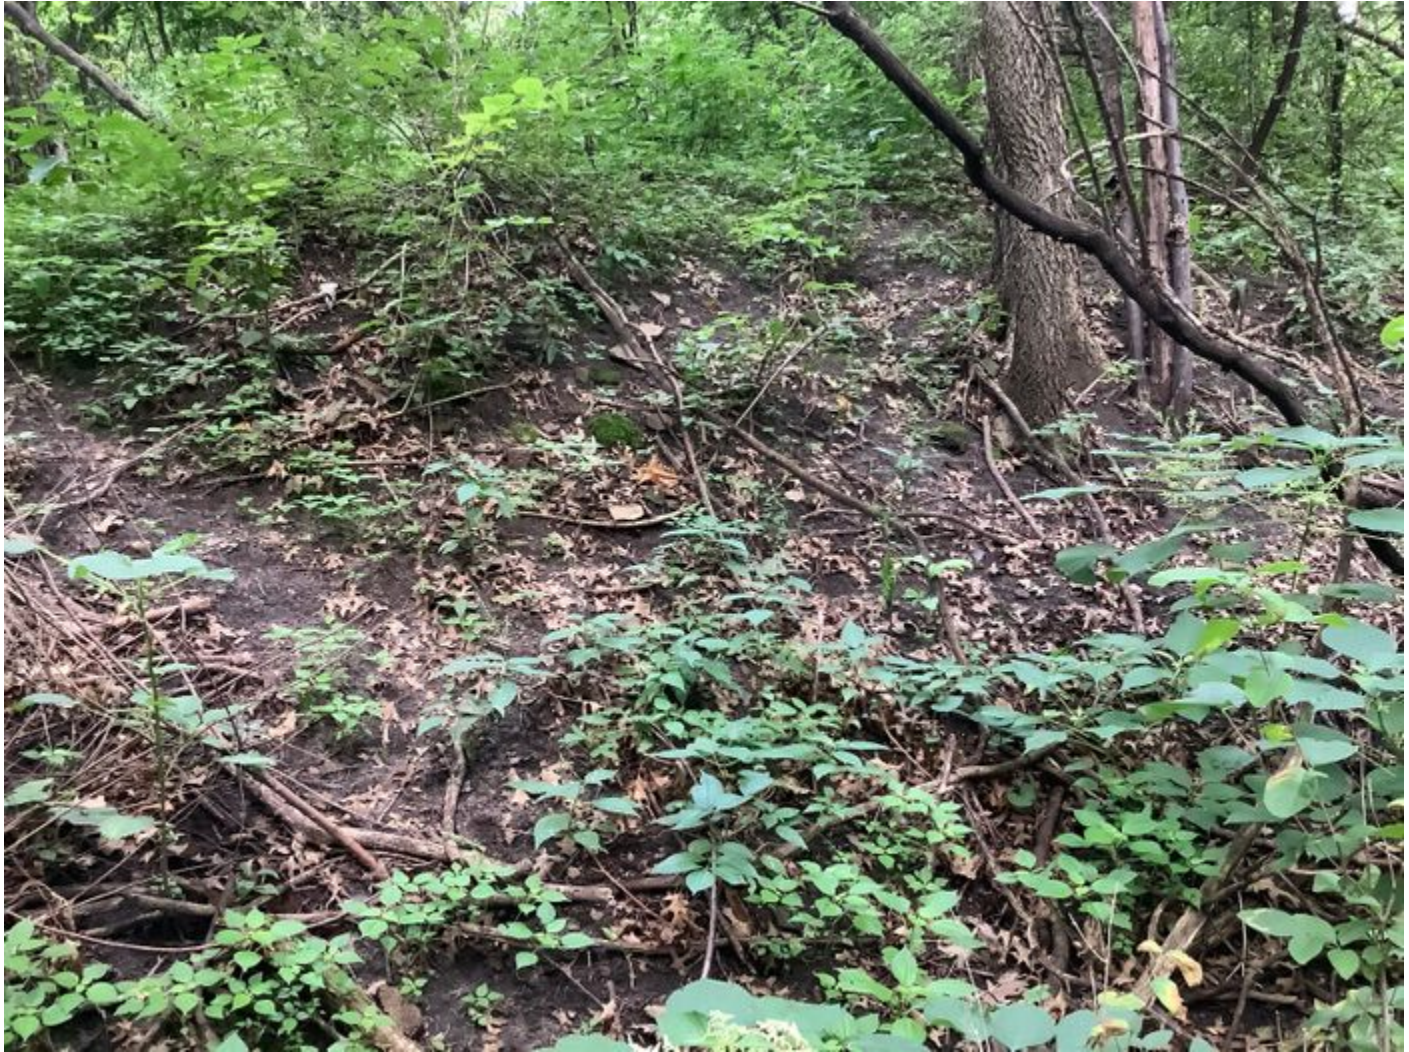
Side stream view of patch of bare soil and pistol butted tree along right bank. View from left bank looking right.
