4.0 FIELD DATA COLLECTION

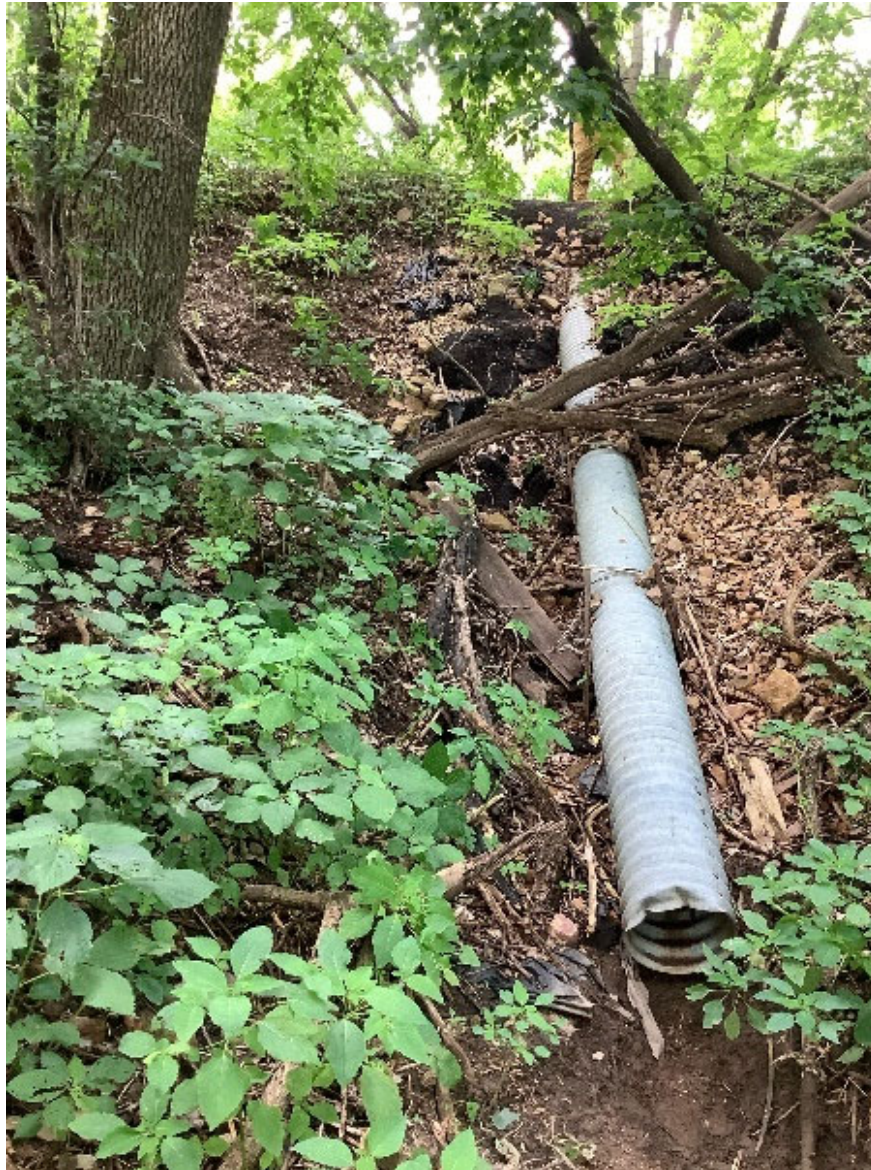
- **In need of immediate repair (Figure 7):**
 - Severely hanging pipes
 - Causing direct destabilization in the downstream gully
 - Presence of severe rust, corrosion, or broken outlet features
 - Buried in sediment

Figure 7. Example of a pipe outfall marked as needing immediate repair.

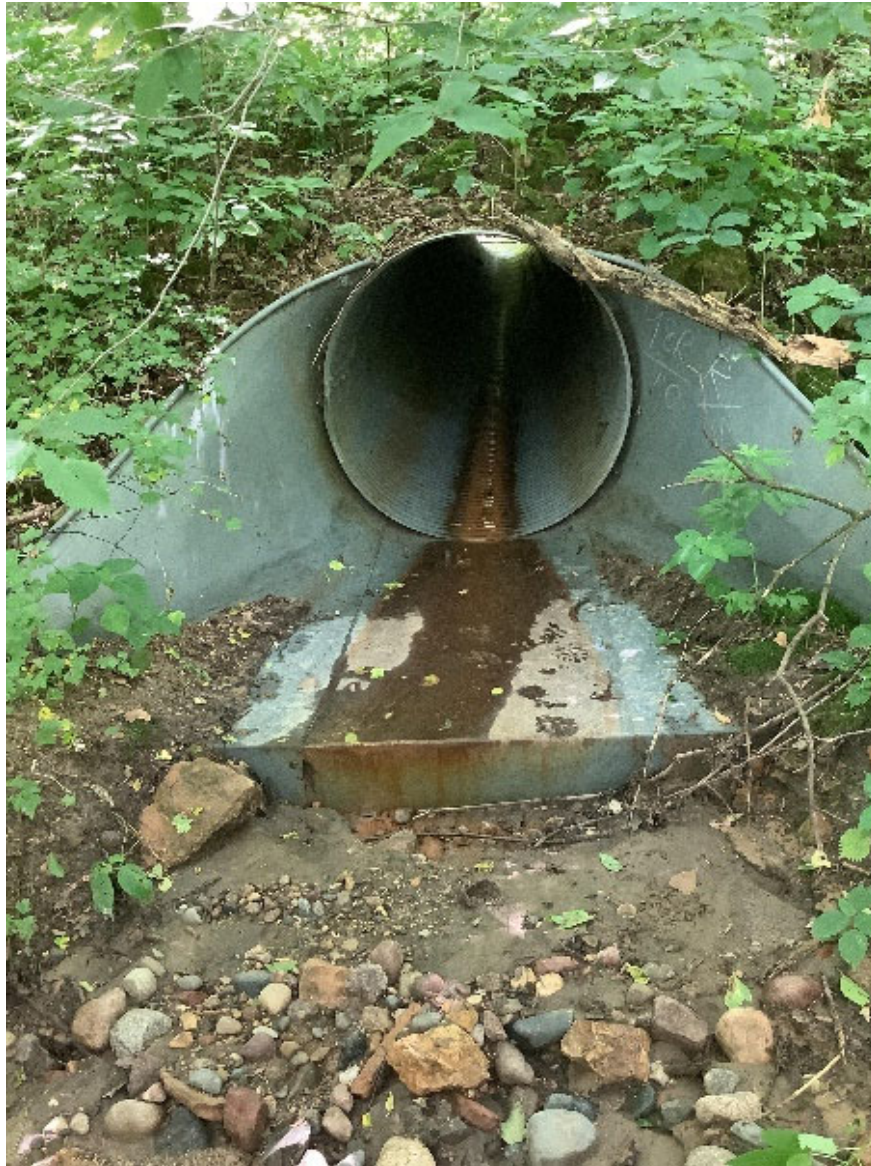
Maybe in need of repair (Figure 8):

- Possible hanging or minor erosion present at outfall and discharging into downstream gully; current state did not make it possible to determine if immediate attention was required
- Exhibited some signs of destabilization, but did not appear to need immediate attention

Figure 8. Example of a pipe outfall marked as “maybe” needing repairs.

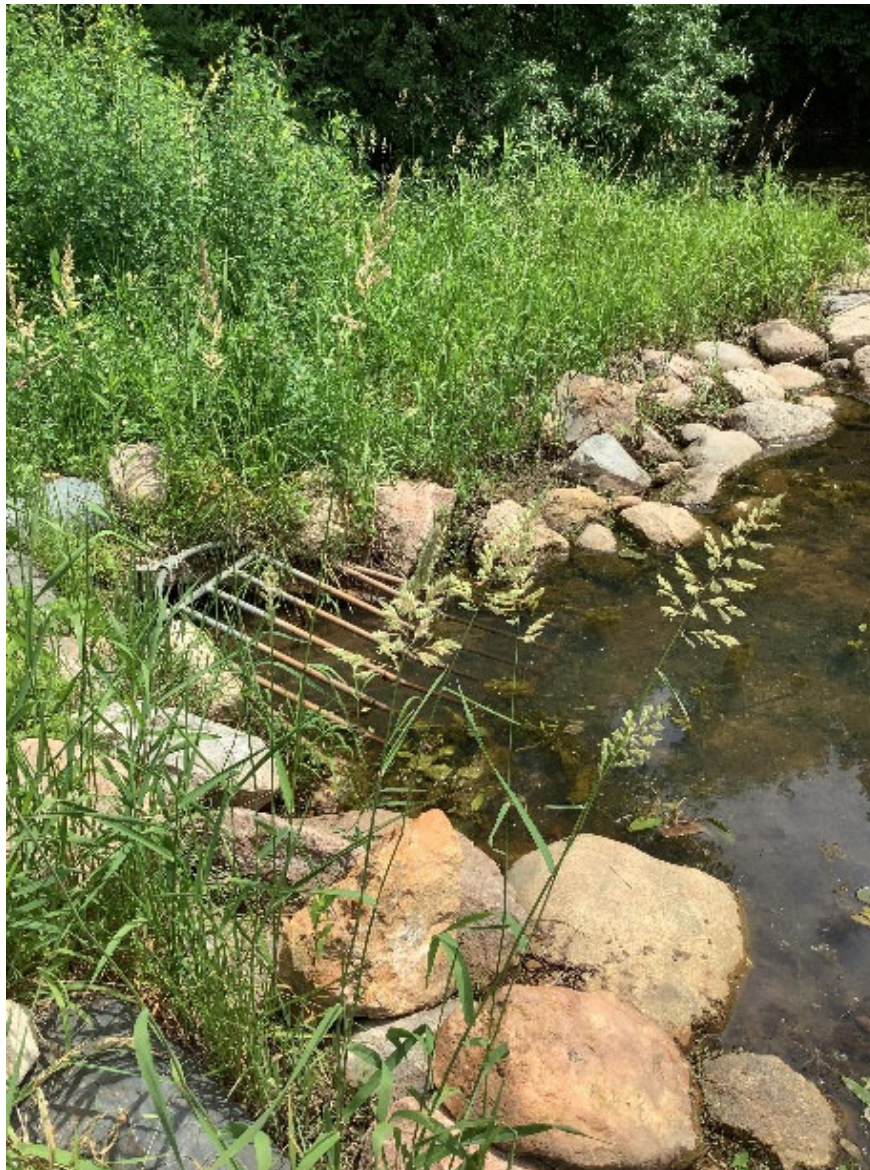
Stable or not in need of repair (Figure 9):

- Showed no signs of significant erosion or aggradation at the outfall.
- Structure appeared to be stable and intact.

Figure 9. Example of a pipe rated as being stable and not in need of immediate repairs.
