3.0 2008 INVENTORY ASSESSMENT AND DATA REVIEW

3.1 2008 Gully Inventory Background

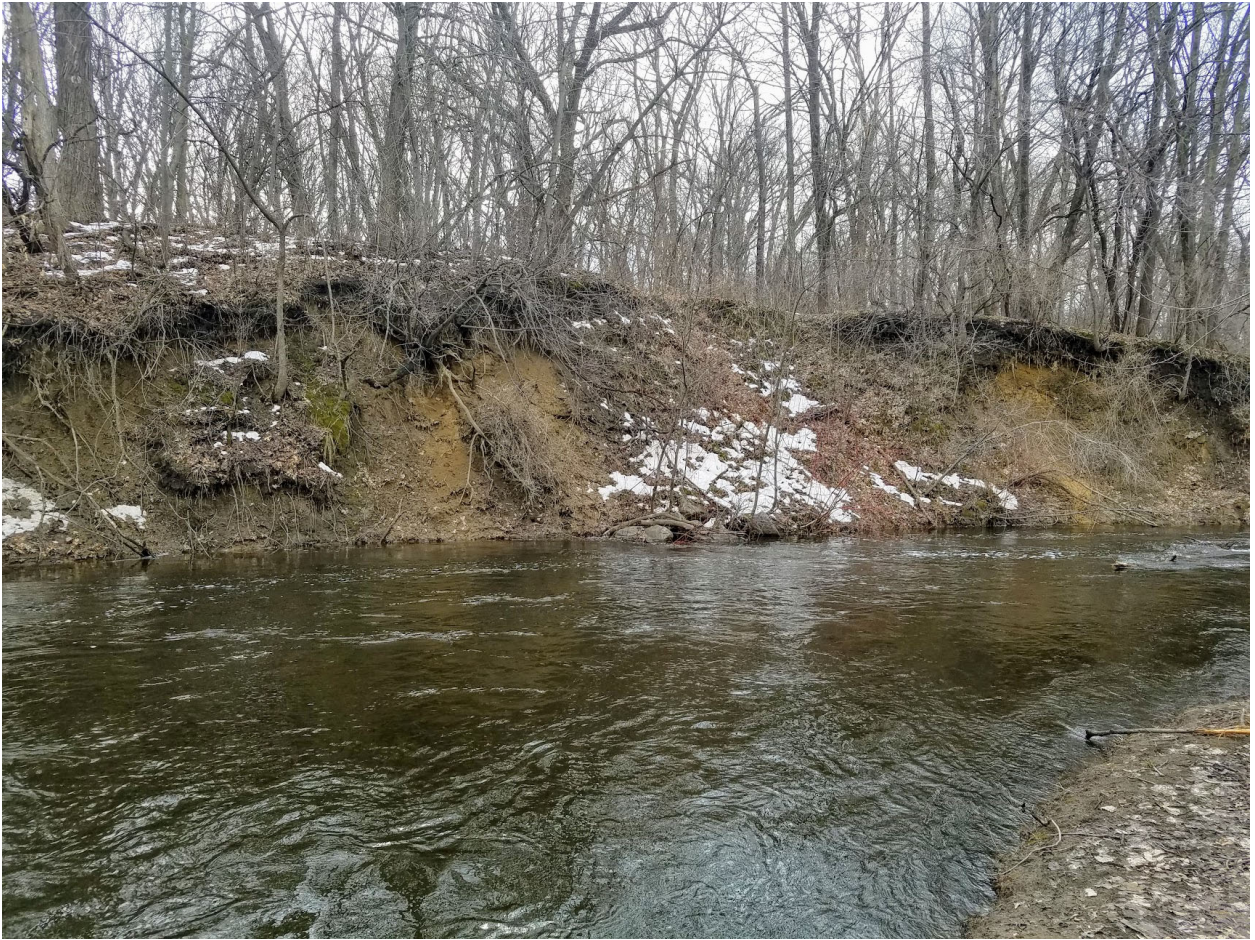
- **High erosion potential (Figure 3):**
 - Gully shape: V-shaped channel cross-section (King 1977)
 - Active erosion: Sloughing banks or recent slumps; active slides or movement of soils; incision or down-cutting of the channel

- Bank characteristics: Tall banks, typically greater than 10 feet; steep or vertical banks; no connection to a larger floodplain for big storm events (King 1977)

- Vegetation characteristics: Vegetative overhand or exposed tree roots; lack of vegetation on slopes or gully bottom; invasive species such as buckthorn

- Trees: Trees with a severe lean or trees that have fallen into the gully channel; leaning trees, especially those with bent or curved trunks ("pistol-butted") which indicate active ground movement/potential slope failure

- Cattle or livestock impacts: Game trails, stabilized river crossings
 - Evidence of past stabilization: Failed or poor condition riprap, gunnite or concrete slope protection, gabions, etc.

Figure 3. Example of a high erosion potential site along Rice Creek in Fridley, MN in 2019.

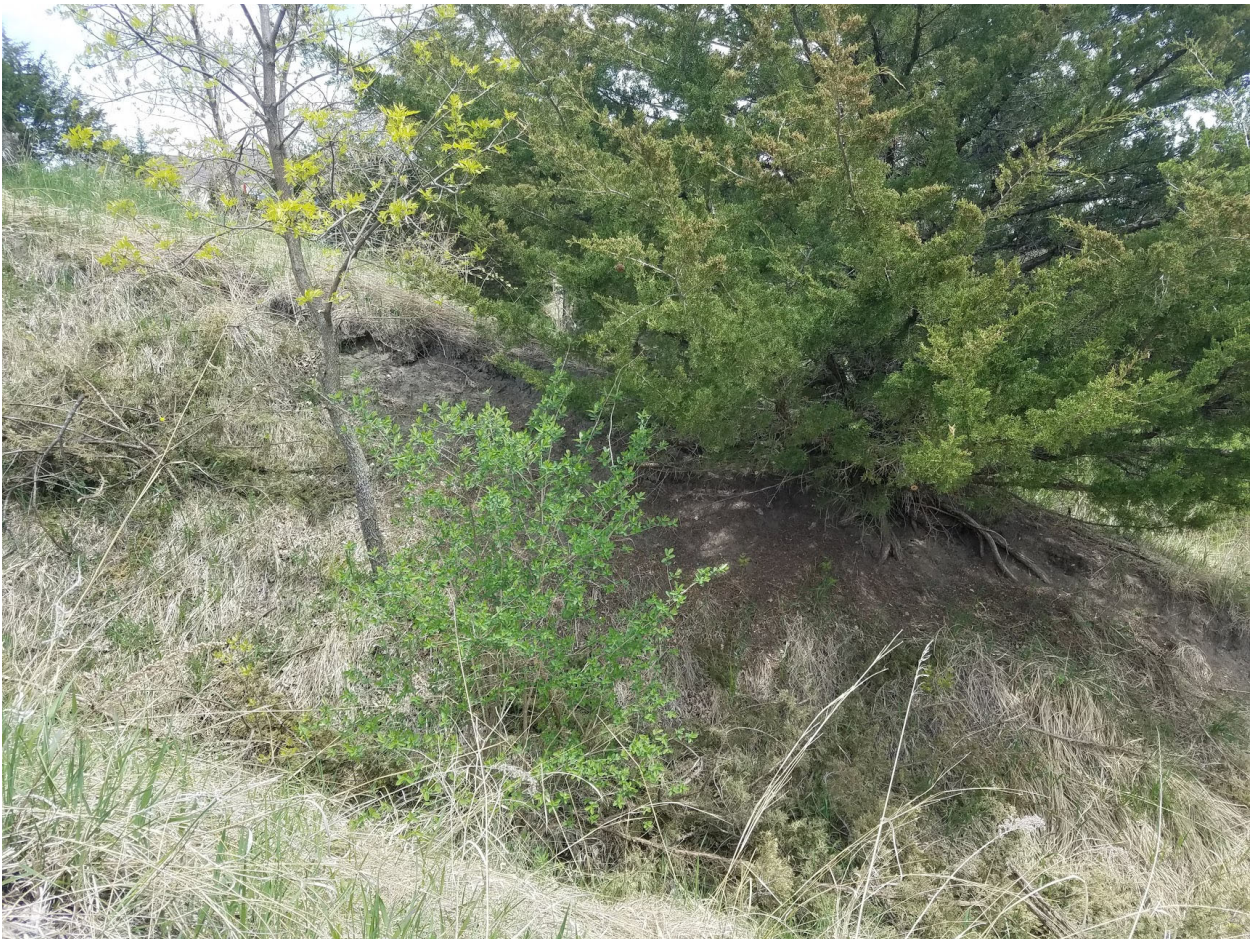
Moderate erosion potential (Figure 4):

- Gully shape: U- or V-shaped gully cross-section
- Active erosion: Minor signs of sloughing banks, no recent slumps, minor channel incision
- Bank characteristics: Medium bank height between 3 and 10 ft; steeply sloping banks
- Vegetation characteristics: Some vegetative overhang or exposed tree roots; bank slopes predominantly bare of vegetation; invasive species such as buckthorn
- Trees: Leaning trees or trees with bent or curved trunks (“pistol-butted”)
- Cattle or livestock impacts: None
- Evidence of past stabilization: Stable or good condition riprap, gunnite or concrete slope protection, gabions, etc.

Figure 4. Example of a moderate erosion potential site in Eden Prairie, MN in 2020.

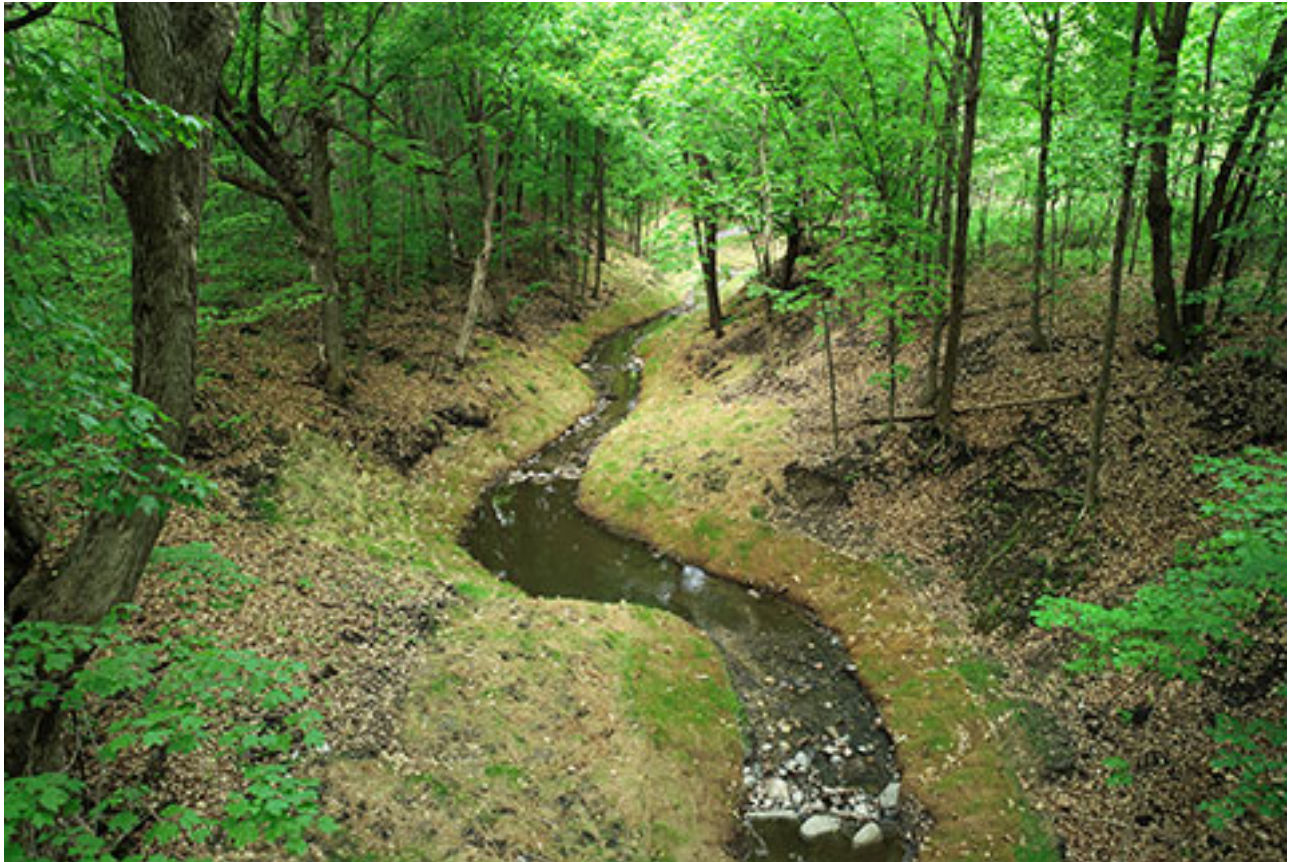
Low erosion potential (Figure 5):

- Gully shape: Trapezoid or U-shaped gully cross-section
- Active erosion: Little to no signs of active erosion
- Bank characteristics: Short banks, typically less than 3 ft high; gradually sloping side slopes; often connected to a floodplain for large flow events
- Vegetation characteristics: Little to no vegetative overhang or exposed tree roots; bank slopes predominantly vegetated
- Trees: Straight to slightly leaning, straight trunks which indicate active ground movement
- Cattle or livestock impacts: None
- Evidence of past stabilization: Stable or good condition riprap, gunnite or concrete slope protection, gabions, and other signs

Figure 5. Example of a low erosion potential site in Medina, MN in 2020 (Outdoor News 2020).
