5.0 CITY OF BLOOMINGTON

5.4 Bloomington Gully Progression

5.5 Bloomington High-Priority Sites

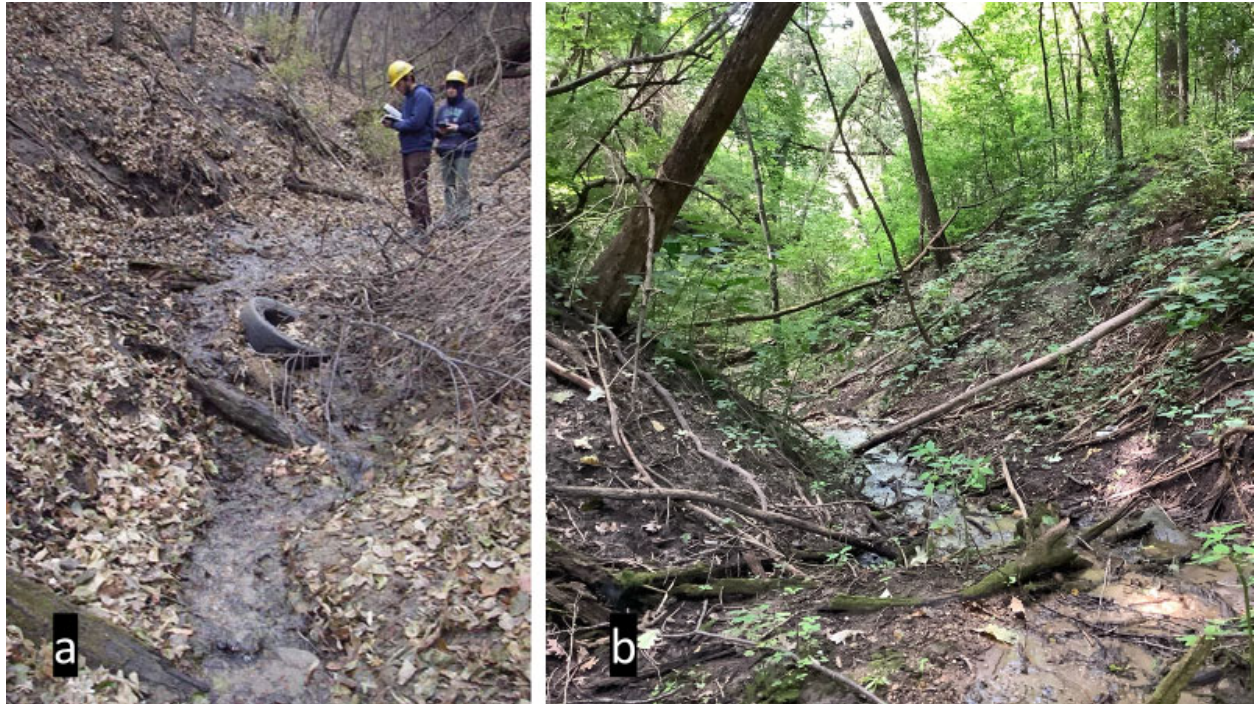
HPR 15 is made up of two sites: L216 and L219 (**Figure 15**). The gully system started with groundwater upwelling beginning at L216 that steadily grew to become a stream channel with a low amount of fast-moving water. Further downstream in the channel, a significant knickpoint with a depth over 4 feet formed the head cut of L219. The subsequent erosion along L219 was far more severe than the erosion noted at site L216. Despite the difference in severity, the gullies within the system shared similar problem indicators. Both sites showed evidence of slumping, loss of bank vegetation, and overhanging banks. Although some vegetation was present—especially along the banks of L216—it did not look heavy enough to stabilize the area. The wide bottom width at Site L216 narrowed downstream from the knickpoint, and L219 was characterized as having a V-shaped channel. In addition to the problem indicators at L216, L219 exhibited degradation, incision, and pistol-butted trees.

The cause of the gully system appears to have been groundwater upwelling. Channel incision and slope were found to have contributed to erosion past the knickpoint in L219.

Figure 16. Comparison of erosion within the L216 stream channel in 2008 (a) and 2020 (b).

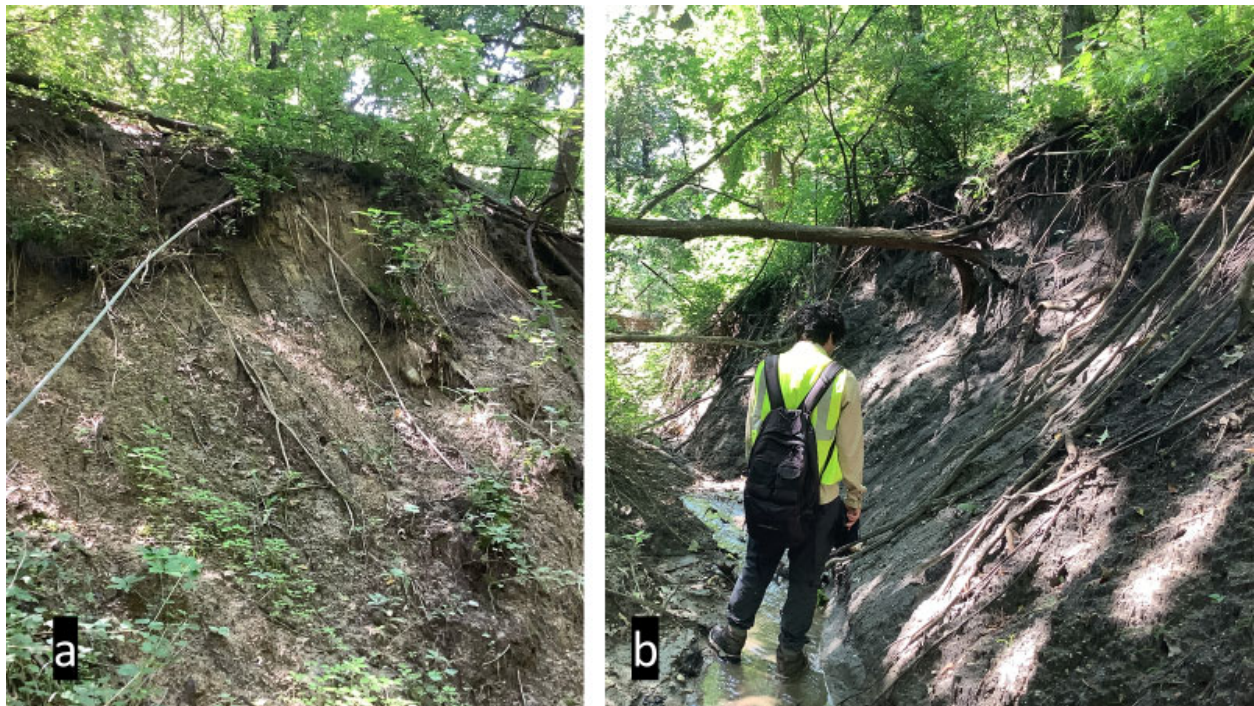
In the 2008 Inventory, no waypoint or pictures existed along the section of the channel recorded as L219. Because this site was not noted in the 2008 Inventory, it is unknown how quickly the gully has progressed to reach its current state. **Figure 17** illustrates the state of this gully observed during the field survey. **Figure 17a** shows overhanging roots along the top perimeter of the left bank, with bare sandy soil below. **Figure 17b** shows a tree falling into the V-shaped channel with undercut right banks.

Figure 17. Photos from the 2020 field survey to L219. Person for scale in 'b' emphasizes depth of incision.

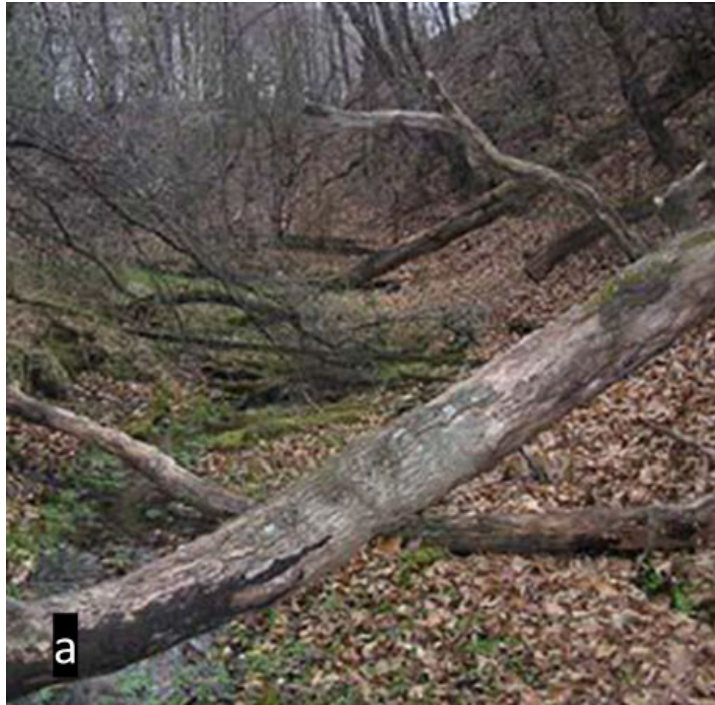
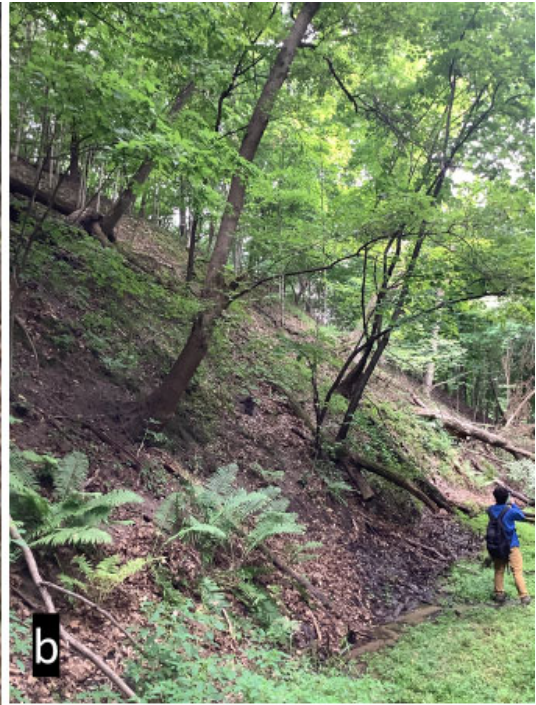
This site consisted of a U-shaped channel with both a wide top and bottom width. The channel was generally flat and consisted of sand. Bare soil was noted along the banks and some vegetation was noted within the center of the channel. The gully was rated with high erosion potential because once the groundwater seeps emerged and formed the channel, it undercut banks along the bottom perimeter of the channel and almost completely vertical banks slopes were observed. The trees were leaning at an angle that threatened the stability of the gully. One major section containing an eroding slump was also noted during the field survey.

A comment from the 2008 Inventory stated that the area “overall looked good.” The corresponding picture, as illustrated in [Figure 18a](#), highlighted some steep bank slopes but did not note any clear erosion. This led to the site’s being benchmarked as having low erosion potential. However, as [Figure 18b](#) illustrates, there is incision along the channel and a significant number of leaning and fallen trees that indicate soil movement. The erosion progression since 2008 was hard to judge solely from the 2008 picture.

Figure 18. Photo 'a' is from 2008, depicting the L32 channel and right bank. Photo 'b' illustrates erosion along the left bank of the channel in 2020.

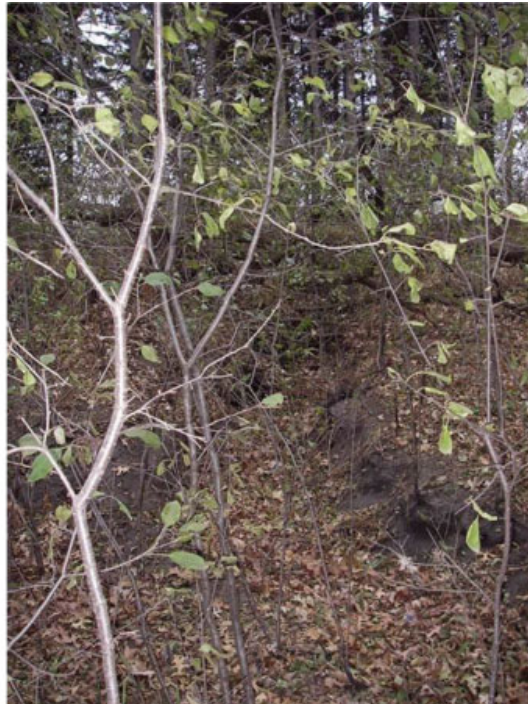
Gully L232 was benchmarked with moderate erosion potential based on the picture, where some loss of bank vegetation and incision is visible, as well as the accompanying description “gully bank erosion,” which noted active erosion. Although it was difficult to tell from the 2008 Inventory, it looked as though the gully had continued to widen and destabilize the soil, causing some trees to fall into the channel. The gully in its current state appears to have progressed from moderate to high erosion potential. **Figure 20** illustrates the photo taken during the 2008 Inventory and **Figure 21** illustrates the current head cut (a) and the main gully channel (b).

Figure 20. Photo of Gully L232 in 2008.

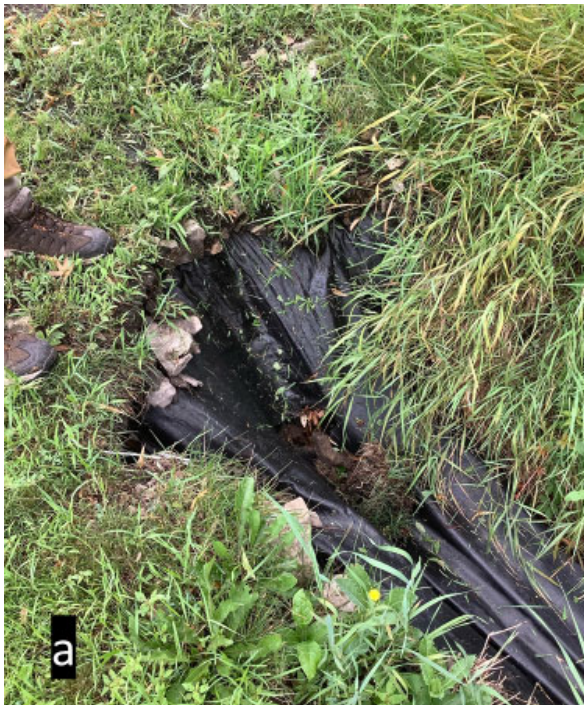
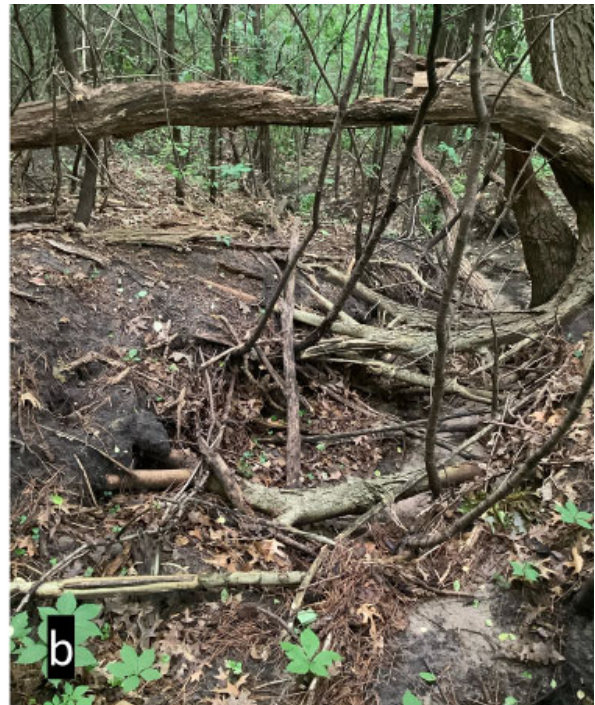
Figure 21. Photos of Gully L232 in 2020. In photo 'a' the head cut recedes into grass near a parking lot and is covered by geotextile fabric. In photo 'b' the gully channel widens further downstream.

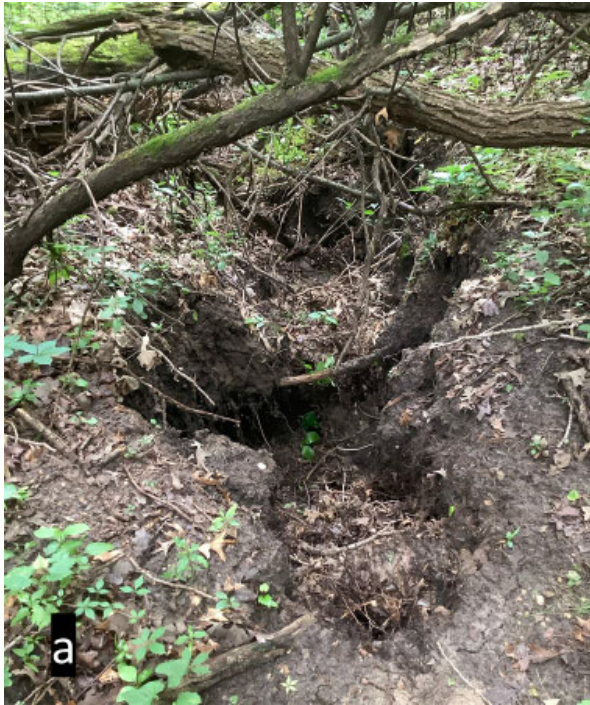
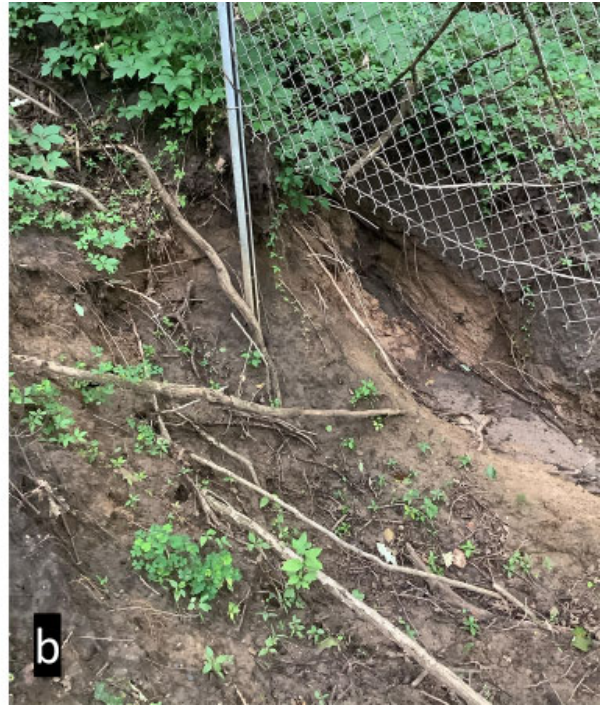
Gully L232 turned into a moderate gully downstream until a large knickpoint formed the head cut of Gully 999-117. At that point, the severity of the gully dramatically increased. Gully 999-117 shared many of the same problem characteristics as Site L232, such as incision, leaning trees, overhanging banks, and bare soil. However, L232 was shallow, while Gully 999-117 was deeper and had a narrower V-shape. Small knickpoints apparent throughout the channel also caused the field team to mark degradation as a problem indicator. Additionally, the trees along the channel of 999-117 were more severely undercut than those along L232. The cause of the deep incision in this gully is unknown. However, as pictured in **Figure 22**, the substrate type switched from sand to clay for one portion of 999-117, with completely bare banks.

Gully 999-117 was not noted in the 2008 Inventory; its erosion progression is therefore unknown. **Figure 22** illustrates the severely eroded conditions at the head cut (a) and along the left bank (b) seen during the field visit.

Figure 22. Severe erosion at Gully 999-117. Photo 'a' was taken looking downstream at the head cut. Photo 'b' was taken looking downstream at an incised section of the gully.

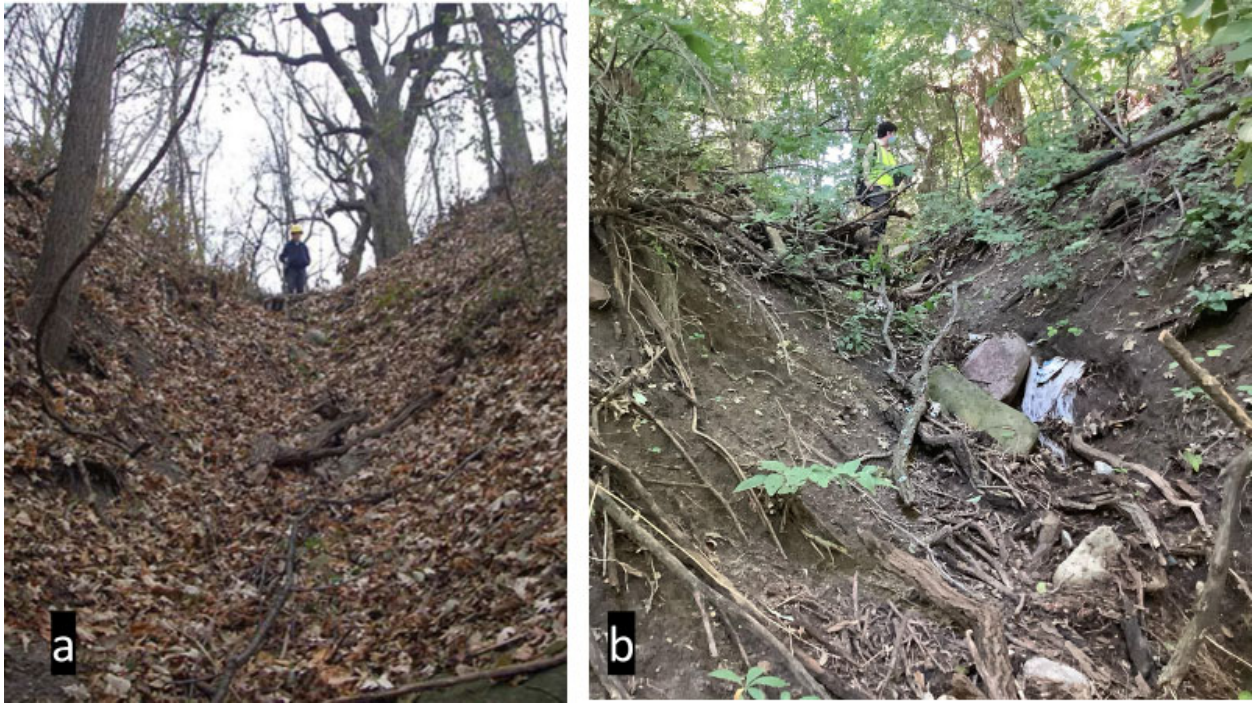
Gully L453 was directly behind a residential backyard. The homeowner seemed interested in possible restoration. Gully L453 exemplified one of the most extreme cases of gullies along steep slopes in Bloomington. The gully itself began at a head cut in the backyard and became heavily incised. About mid-gully, the channel slope turned into a 45-degree angle for at least 30 horizontal feet. Along this section, an incised V-shape channel consisting of bare banks, as well as degradation within the channel, was present. The general gully material was sand; fallen tree debris, along with buckthorn, was seen throughout the channel.

No groundwater was observed; any cause other than steep slopes is unknown. Problem indicators included degradation, incision, leaning trees, and a loss of bank vegetation.

L453 was benchmarked as having high erosion potential. Photos from the 2008 Inventory matched descriptions that noted a “pronounced gully” with “significant erosion.” **Figure 24** compares the 2008 Inventory with the 2020 condition.

Figure 24. Comparison of gully L453 in 2008 (a) and 2020 (b). Both photos were taken looking upstream at the steep gully channel.

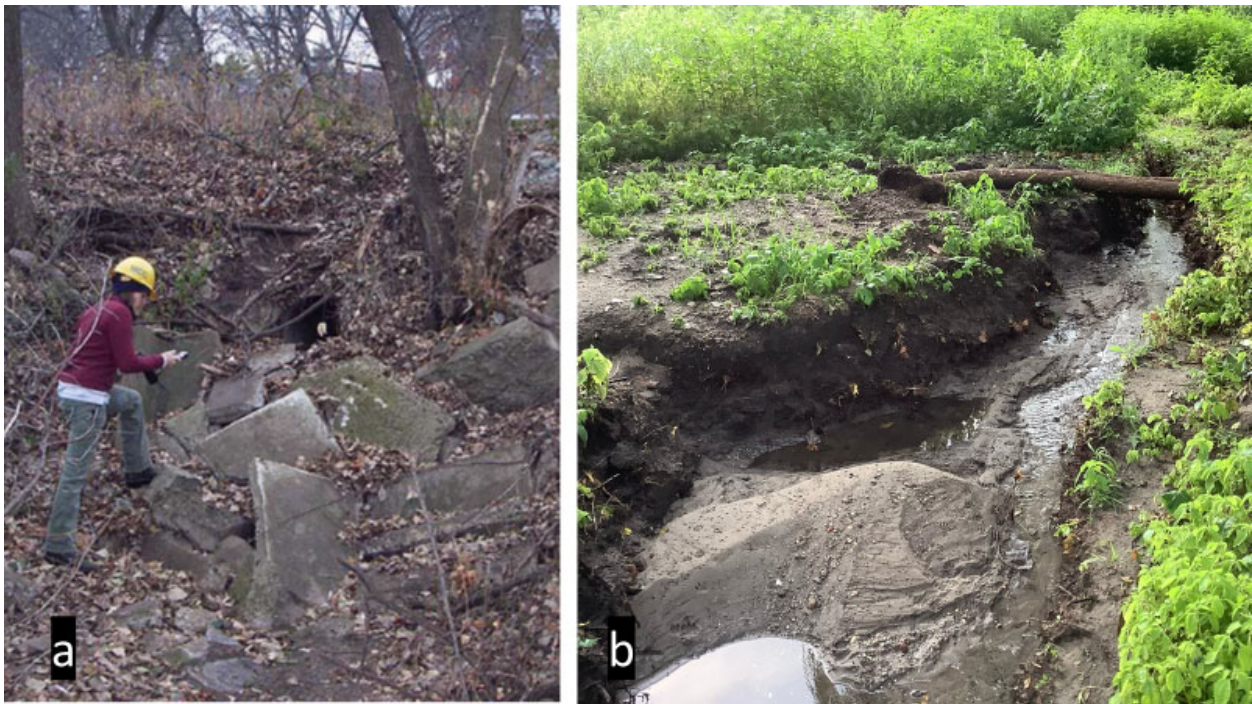
The last gully in HPR 17, Gully L233, was a shallow, incised, U-shaped channel forming downstream of a pipe outfall. Bare soil was noted along the gully bottom and banks, and there was a moderate level of slow-moving water in the gully at the time of the field visit. Sand was the main substrate within the gully.

The storm pipe outfall causing the gully drained below Palmer Road. The pipe appeared to be stable and vegetated and was surrounded by riprap. However, downstream from the pipe and riprap, the new incised channel was collected as a new Gully 999-192. Problem indicators in the gully included degradation, aggradation, incision, slumping, and overhanging banks. Active erosion at the head cut was also noted.

The 2008 Inventory noted that a storm pipe was observed with the comment, “Storm sewer drain pipe outlet.” However, there was no mention of an incised channel beneath the pipe. The erosion potential was initially noted as low, because neither the picture nor the comments mentioned any erosion. Gully L233 looks to have formed in the time since the 2008 Inventory. **Figure 25** compares the pipe outfall from the 2008 Inventory with the incised channel currently at the site.

Figure 25. Comparison of Gully L233 from 2008 (left) to 2020 (right). The 2008 photo depicts the pipe outfall filled with riprap, and the 2020 photo shows the incised channel formed below the pipe outlet.

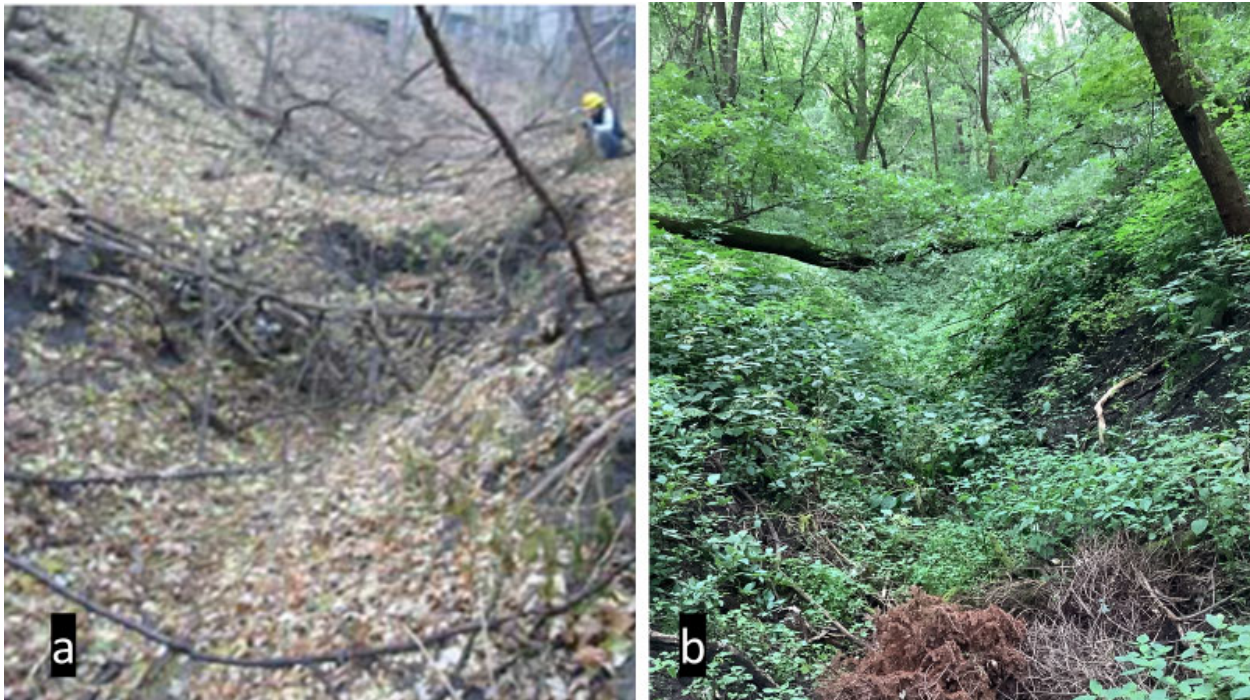
An actively eroding head cut, as well as steep bank slopes that led into an incised channel, were noted. Mass wasting seemed to be occurring as the slopes weakened and the channel continued to down-cut. Because of these problem indicators, the site was noted with a high erosion potential. Both slope and channel incision were noted as the apparent causes.

The high erosion potential designation for the site was consistent with the benchmarked 2008 Inventory. Site L47 was benchmarked with a high erosion potential ranking due to the incision evident in the photo and a description of a “deep-cut gully about 60 yards in length.” **Figure 26** illustrates the continued degradation in the channel since the 2008 Inventory. Although vegetation covers the banks, leaning trees and an incised V-shape channel are visible in the 2020 picture (b).

Figure 26. Comparison of Site L47 between 2008 (a) and 2020 (b). Photo ‘b’ was taken looking downstream from the head cut.

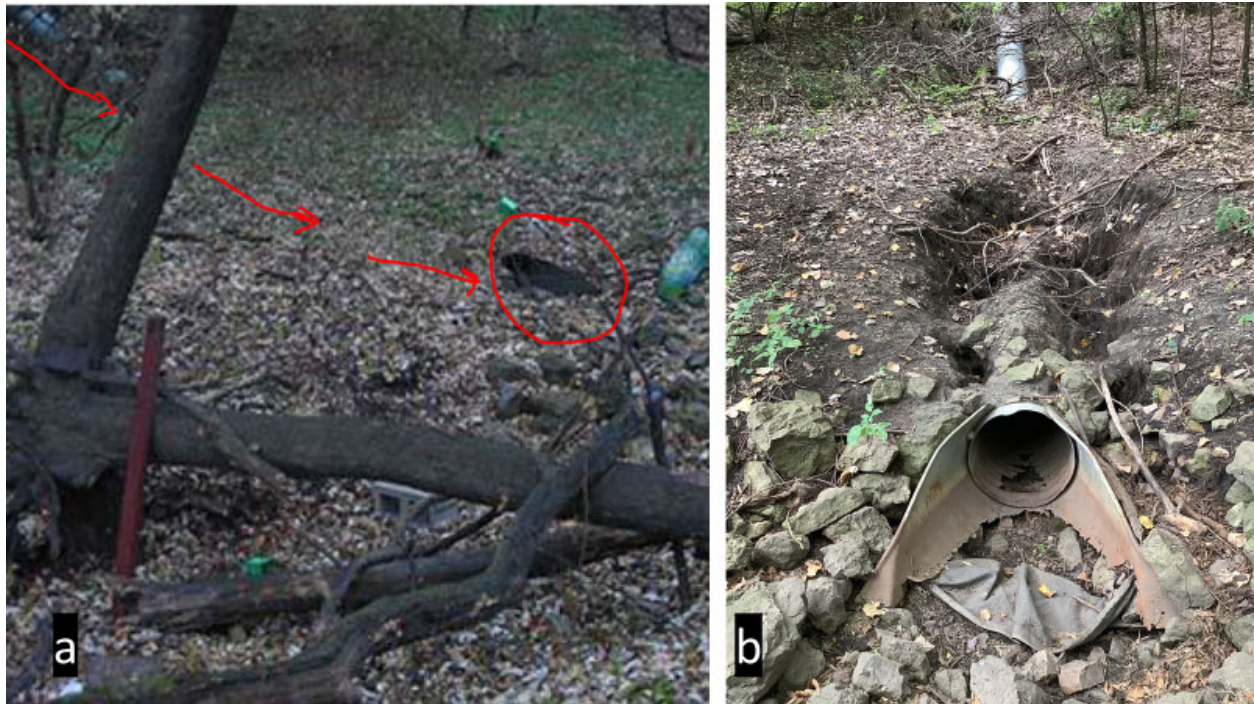
The L364 site was benchmarked as having low erosion potential because the 2008 Inventory only noted the stormwater pipe outlet and no signs of erosion other than a shallow channel visible in the photo. Although unclear from the 2008 photo, all the headward erosion along the pipe appears to have occurred since the 2008 Inventory. **Figure 27** offers a comparison in erosion around the pipe outfall between 2008 (a) and 2020 (b).

Figure 27. A comparison of the pipe outfall and gully head cut between 2008 (a) and 2020 (b).

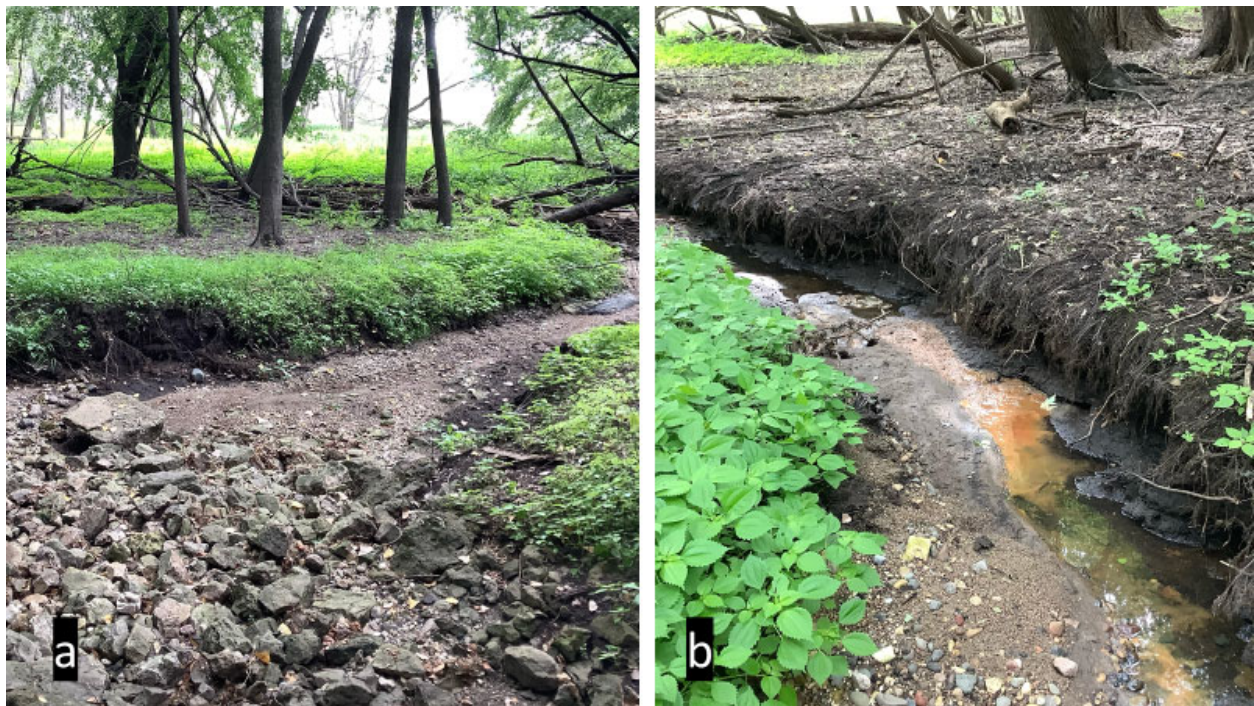
Downstream from the pipe outfall, the main gully channel was also actively eroding. Although the gully was shallow and had a wide bottom width, future erosion appeared imminent due to the incised banks and overhanging vegetation. **Figure 28** illustrates erosion within the channel.

Figure 28. Photo 'a' is looking downstream from the head cut toward riprap and a widened gully channel. Photo 'b' is looking downstream toward the toe of the gully at overhanging banks.

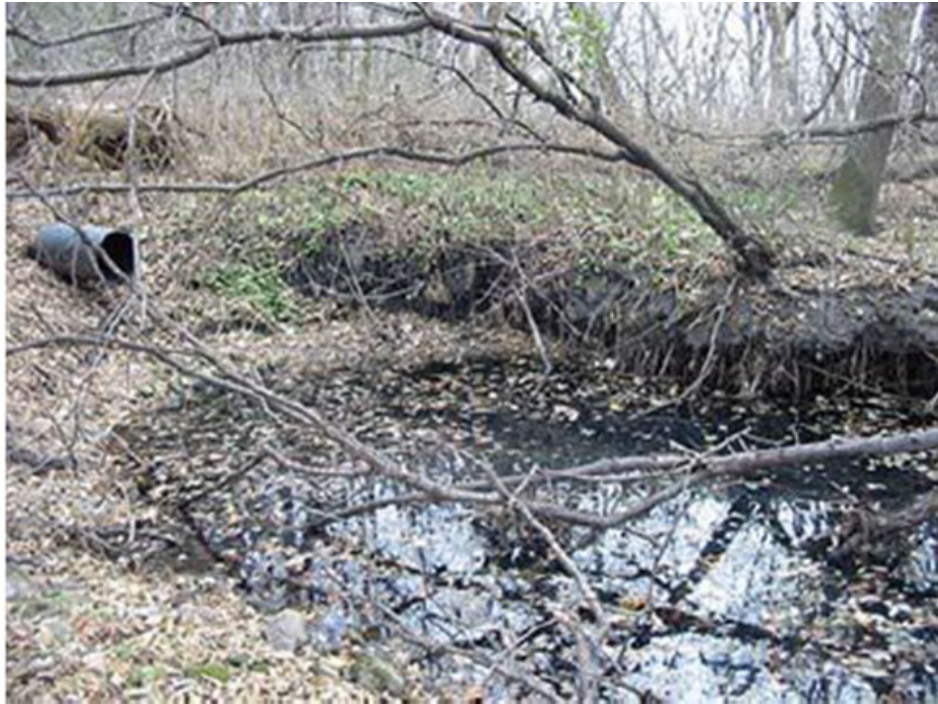
Gully L381 was benchmarked as having high erosion potential based on a photo depicting overhanging banks and description of a pipe outfall with some bank erosion. The length of the channel was not noted in the 2008 Inventory; it is therefore difficult to determine the progression of erosion for the entire channel. However, overhanging banks and exposed soil around the immediate discharge area remained consistent from 2008 to 2020. **Figure 29** and **Figure 30** illustrate the erosion around the pipe outfall and gully since the 2008 Inventory was completed.

Figure 29. Photo from the 2008 Gully Inventory illustrating the pipe outfall and scour.

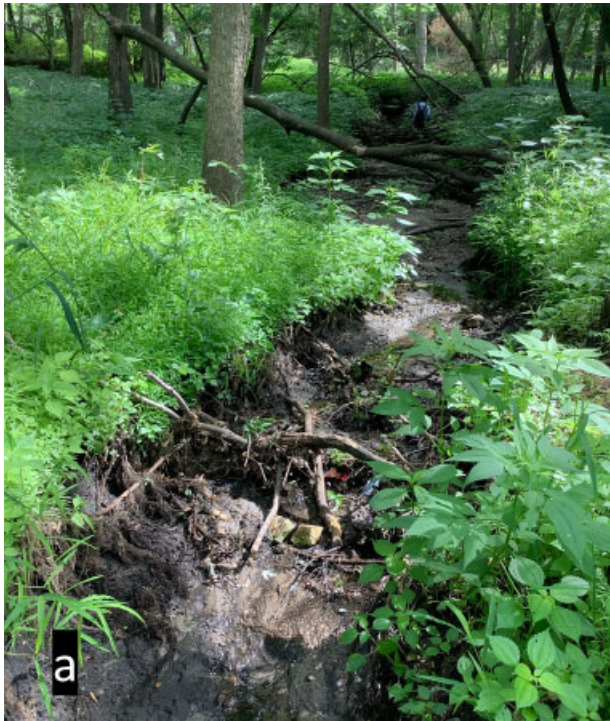
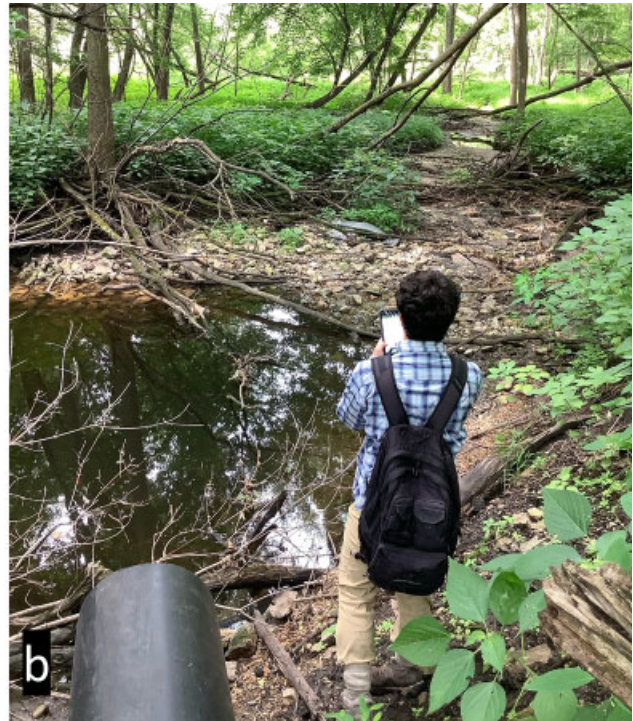
Gully L381 is located west of Mound Springs Park. This gully discharges into the wetlands surrounding Mound Springs Park. Gully L381 exists because of an unstable drainage feature. The hanging pipe outfall emptied into a pond-like area that was filled with water at the time of the site visit. A gully channel continued downstream from the pond. Riprap near the head cut did not seem to be stabilizing the area.

Figure 30. Photos from 2020 Inventory. Photo 'a' is looking upstream at the gully channel. Photo 'b' is looking downstream at the pipe outfall and pond.

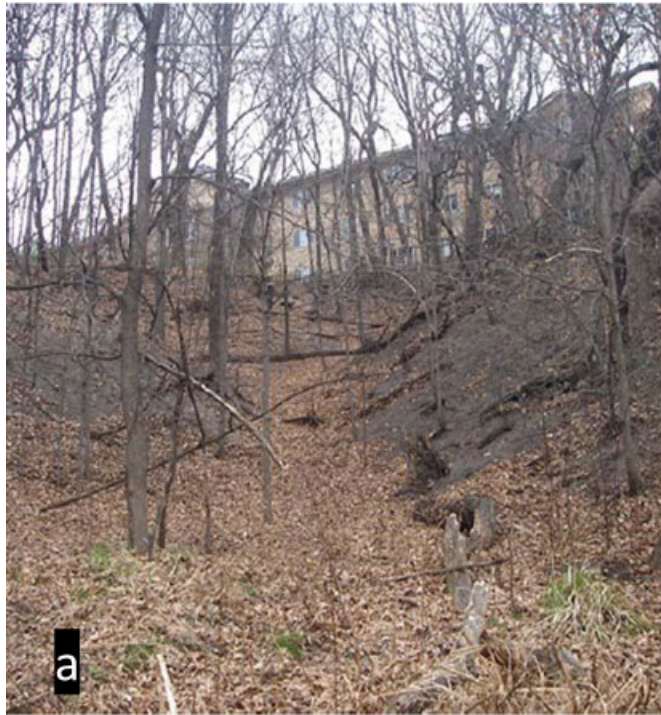
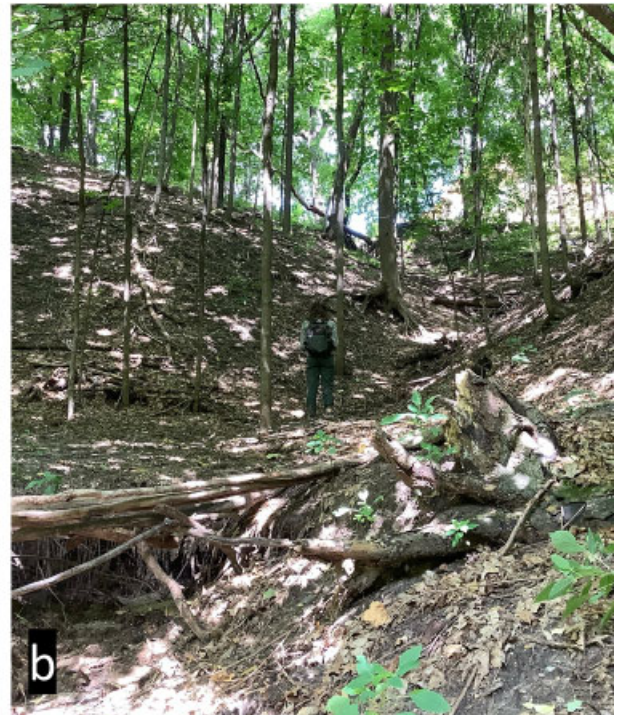
Gully 999-151 and Gully L255 exhibited very similar characteristics. Both gullies had a medium depth with a narrow bottom width. Additionally, both gullies formed because of an unstable pipe outfall with a small diameter. Gully 999-151 was significantly shorter than Gully L255, which was located directly behind the Meadow Woods Assisted Living facility. L255 was more severe than Gully 999-151 and there were multiple knickpoints in the channel contributing to degradation. Near the head cut, slumps were visible and overhanging trees were at risk of falling in. In addition to the pipe outfall, a groundwater seep occurred close to the toe of L255. A steep hillslope exacerbated the erosion at Site L255.

Figure 32. Comparison of site L255 between 2008 (a) and 2020 (b).

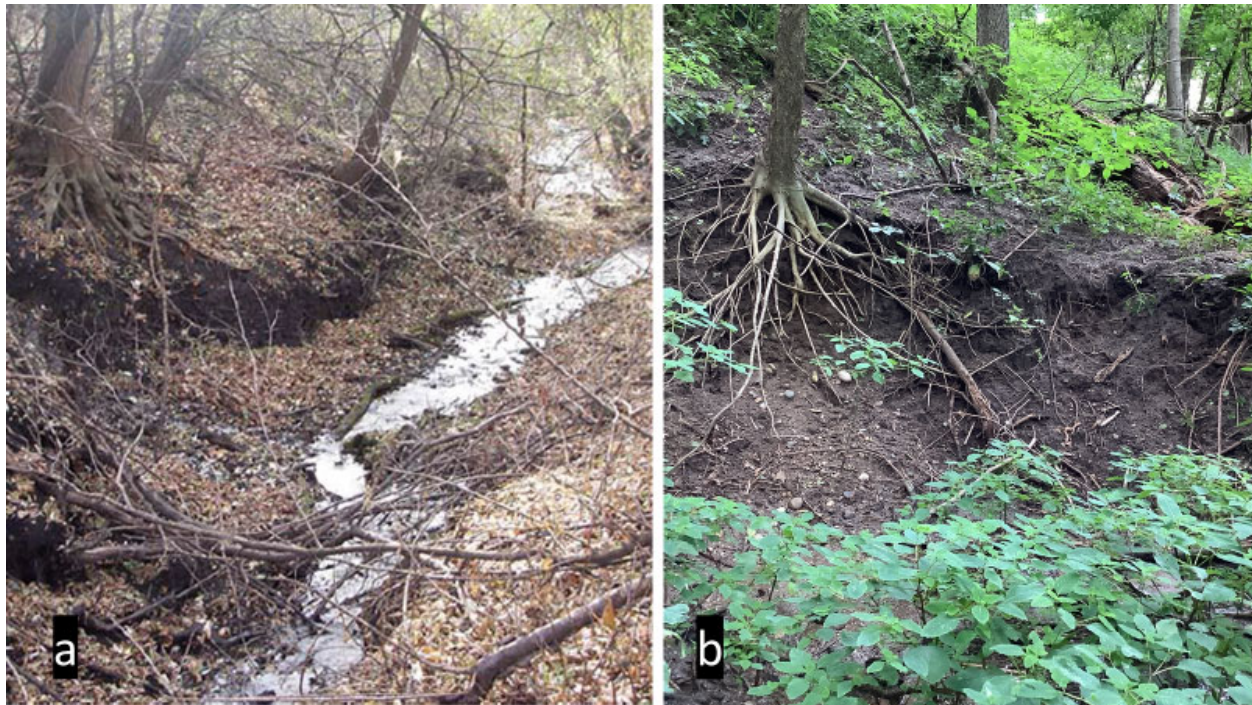
Gully L260, located close to the Old Cedar Ave. Bridge, is a deep gully with a medium bottom width. The head cut of the gully was a wide arc where groundwater seeps contributed to slumping and headward erosion. The general gully material consisted of sand, while the channel was armored. A moderate amount of fast-moving water was present within the gully channel at the time of the visit.

The apparent causes for L260 were an unstable hanging metal pipe, as well as multiple groundwater seeps around the head cut area. Problem indicators included overhanging banks, leaning trees, slumping, incision, and a loss of bank vegetation. Tree debris were present in the channel and many trees had exposed roots and appeared close to falling in.

The 2008 Inventory included a picture highlighting bare, incised banks within the gully and noted “severe erosion throughout gully.” This caused the site to be benchmarked as having a high erosion potential. Although the channel was more vegetated than shown in the photo of the 2008 Inventory, slumping along the banks and an actively eroding head cut were still visible. **Figure 33** illustrates the difference between the 2008 and the 2020 conditions.

Figure 33. Photo a: Channel incision and bare soil along the banks of L260 in 2008. Photo b: Left bank of Gully Channel L260 in 2020.

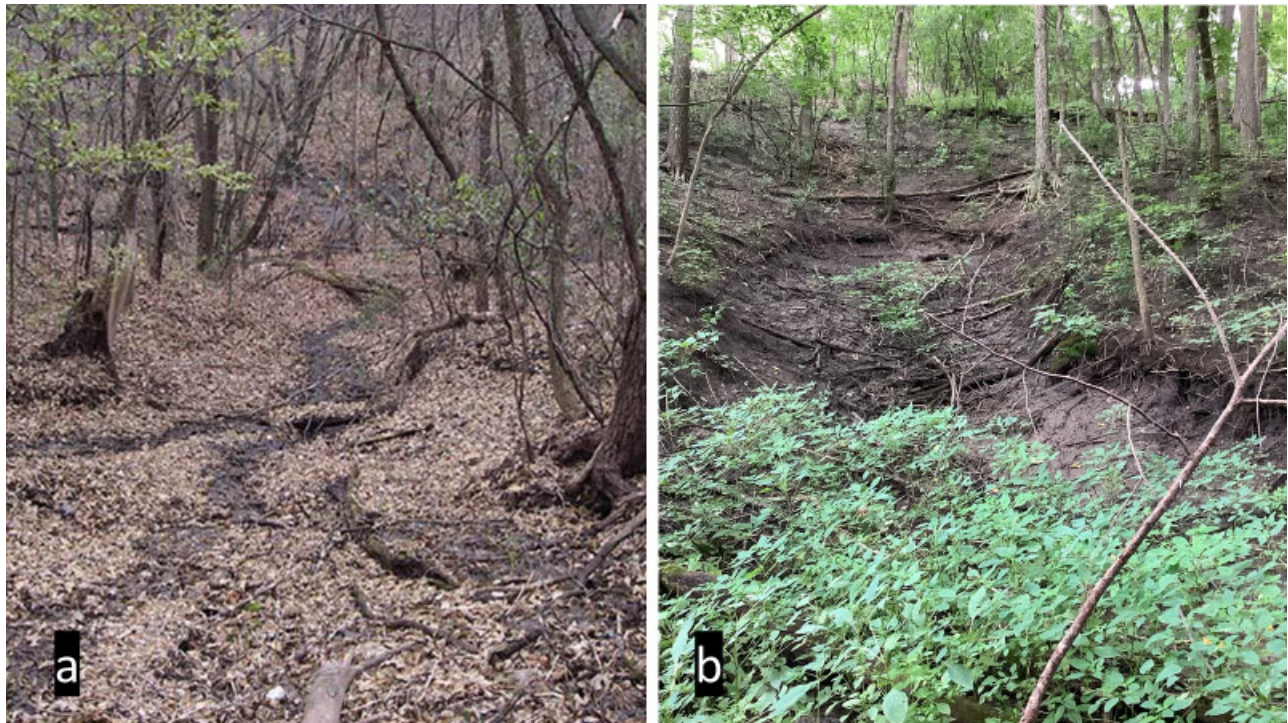
Gully L266 was located within a channel parallel to Minnesota State Highway 77. A moderate amount of fast-moving water was observed within the gully at the time of the visit. L266 had a medium depth and wide bottom width, and it consisted of a flat U-shaped channel with bare soil along the bottom and banks. A moderate amount of buckthorn was also observed.

Groundwater seeps are presumed as the primary cause for this gully. Problem indicators including aggradation, degradation, a loss of bank vegetation, incision, overhanging banks, slumping, and leaning trees led to the high erosion potential ranking at this site. Aggradation was found in the form of mid-channel sandbars. Additionally, tributary streams with less severe erosions were noted.

The 2008 Inventory contained comments that this gully had moderate erosion and a spring. The image showed a shallow channel with little evident erosion (**Figure 34a**). The gully appears to have progressed from moderate to high erosion potential since the 2008 Inventory, as evidenced by visible incision and channel widening when comparing the site photos in **Figure 34**.

Figure 34. Comparison of Site L266 between 2008 (a) and 2020 (b). Channel widening and unstable banks are evident in photo 'b'.

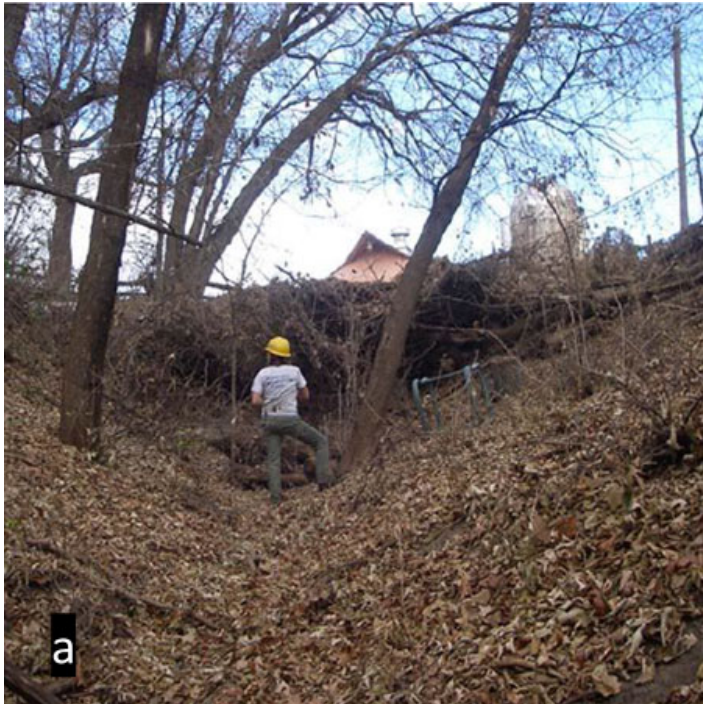
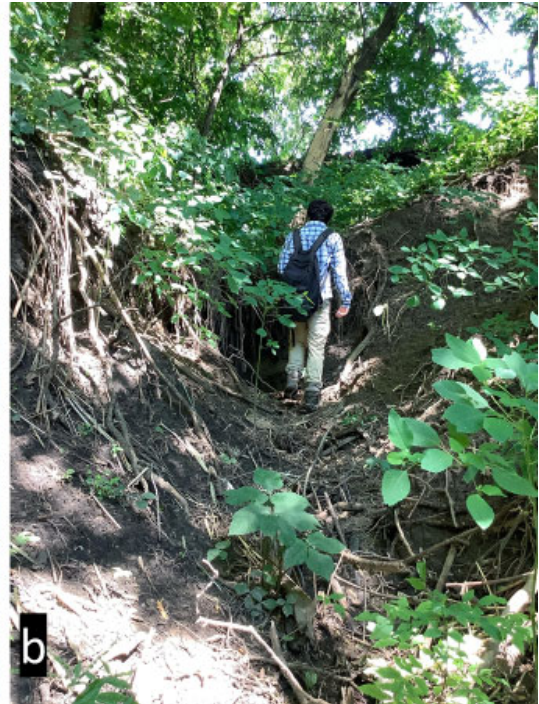
Although groundwater upwelling occurred along the banks of Ike's Creek, no seeps were observed within the gully channel formed by L270 and L269. The specific causes of the severe erosion, outside of slope and channel incision, were unknown.

In the 2008 Inventory, "extreme erosion" was noted at Site L269, and a head cut with overhanging banks was evident in the L270 site picture (**Figure 36a**). Both L269 and L270 were benchmarked with high erosion potential. The erosion potential appears to have remained consistent between the past and current assessment. No stabilization measures were noted, and compared to the 2008 Inventory photos, both gullies appeared to have deepened. **Figure 36** illustrates a narrower V-shape and larger perimeter of overhanging banks at the head cut of L270 in 2020 than in 2008.

Figure 36. Difference in Site L270 between 2008 (a) and 2020 (b).

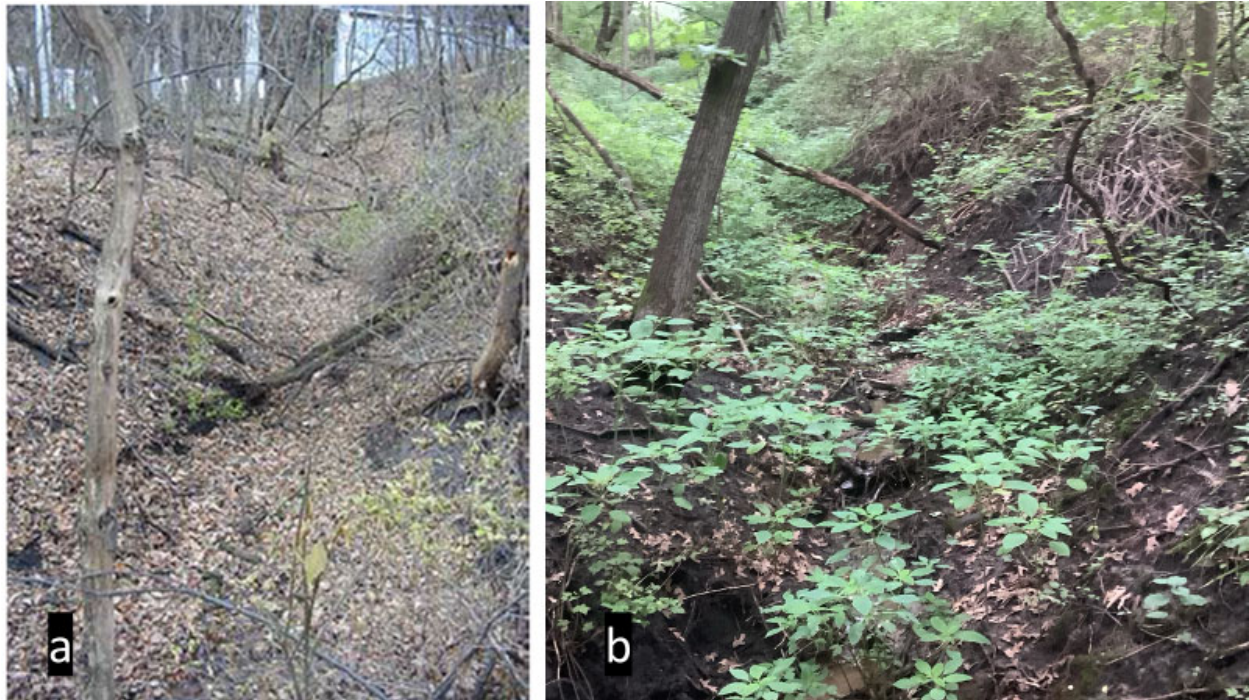
Gully L105 is located behind a commercial building along East Old Shakopee Road and drains toward Long Meadow Lake. Gully L105 was a deep trapezoid-shaped gully with a medium bottom width. The channel slope was steep and had bare soil along the gully bottom and partial vegetation along the gully banks. A moderate amount of fast-moving water was observed in the channel.

Figure 37. Comparison of Gully L105 between 2008 (a) and 2020 (b).

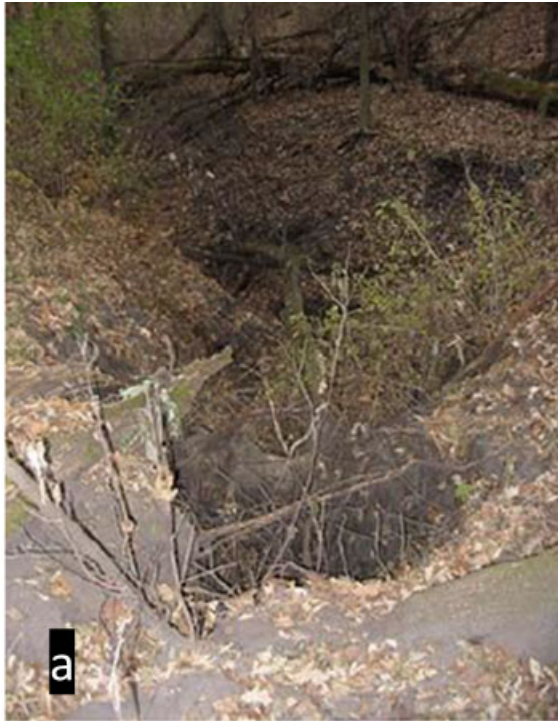
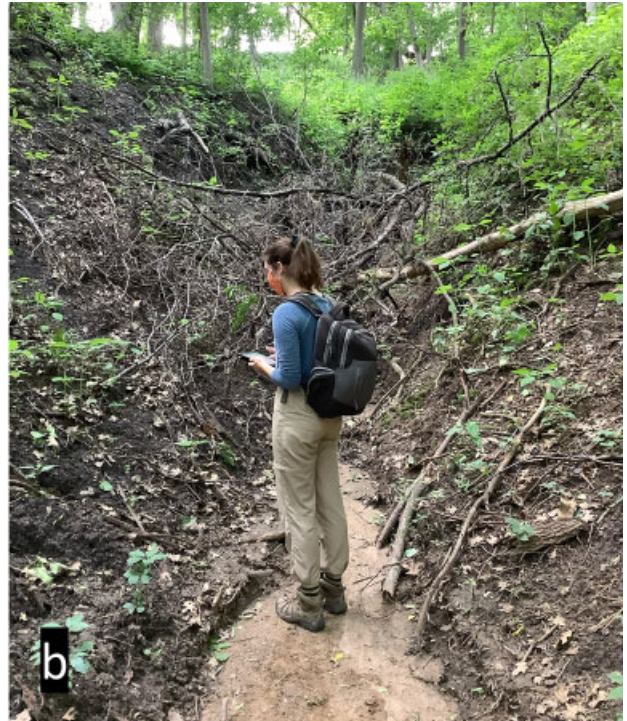
Figure 39. A comparison of Site L394 between 2008 (a) and 2020 (b).
