7.0 CITY OF CHANHASSEN

7.3 Findings

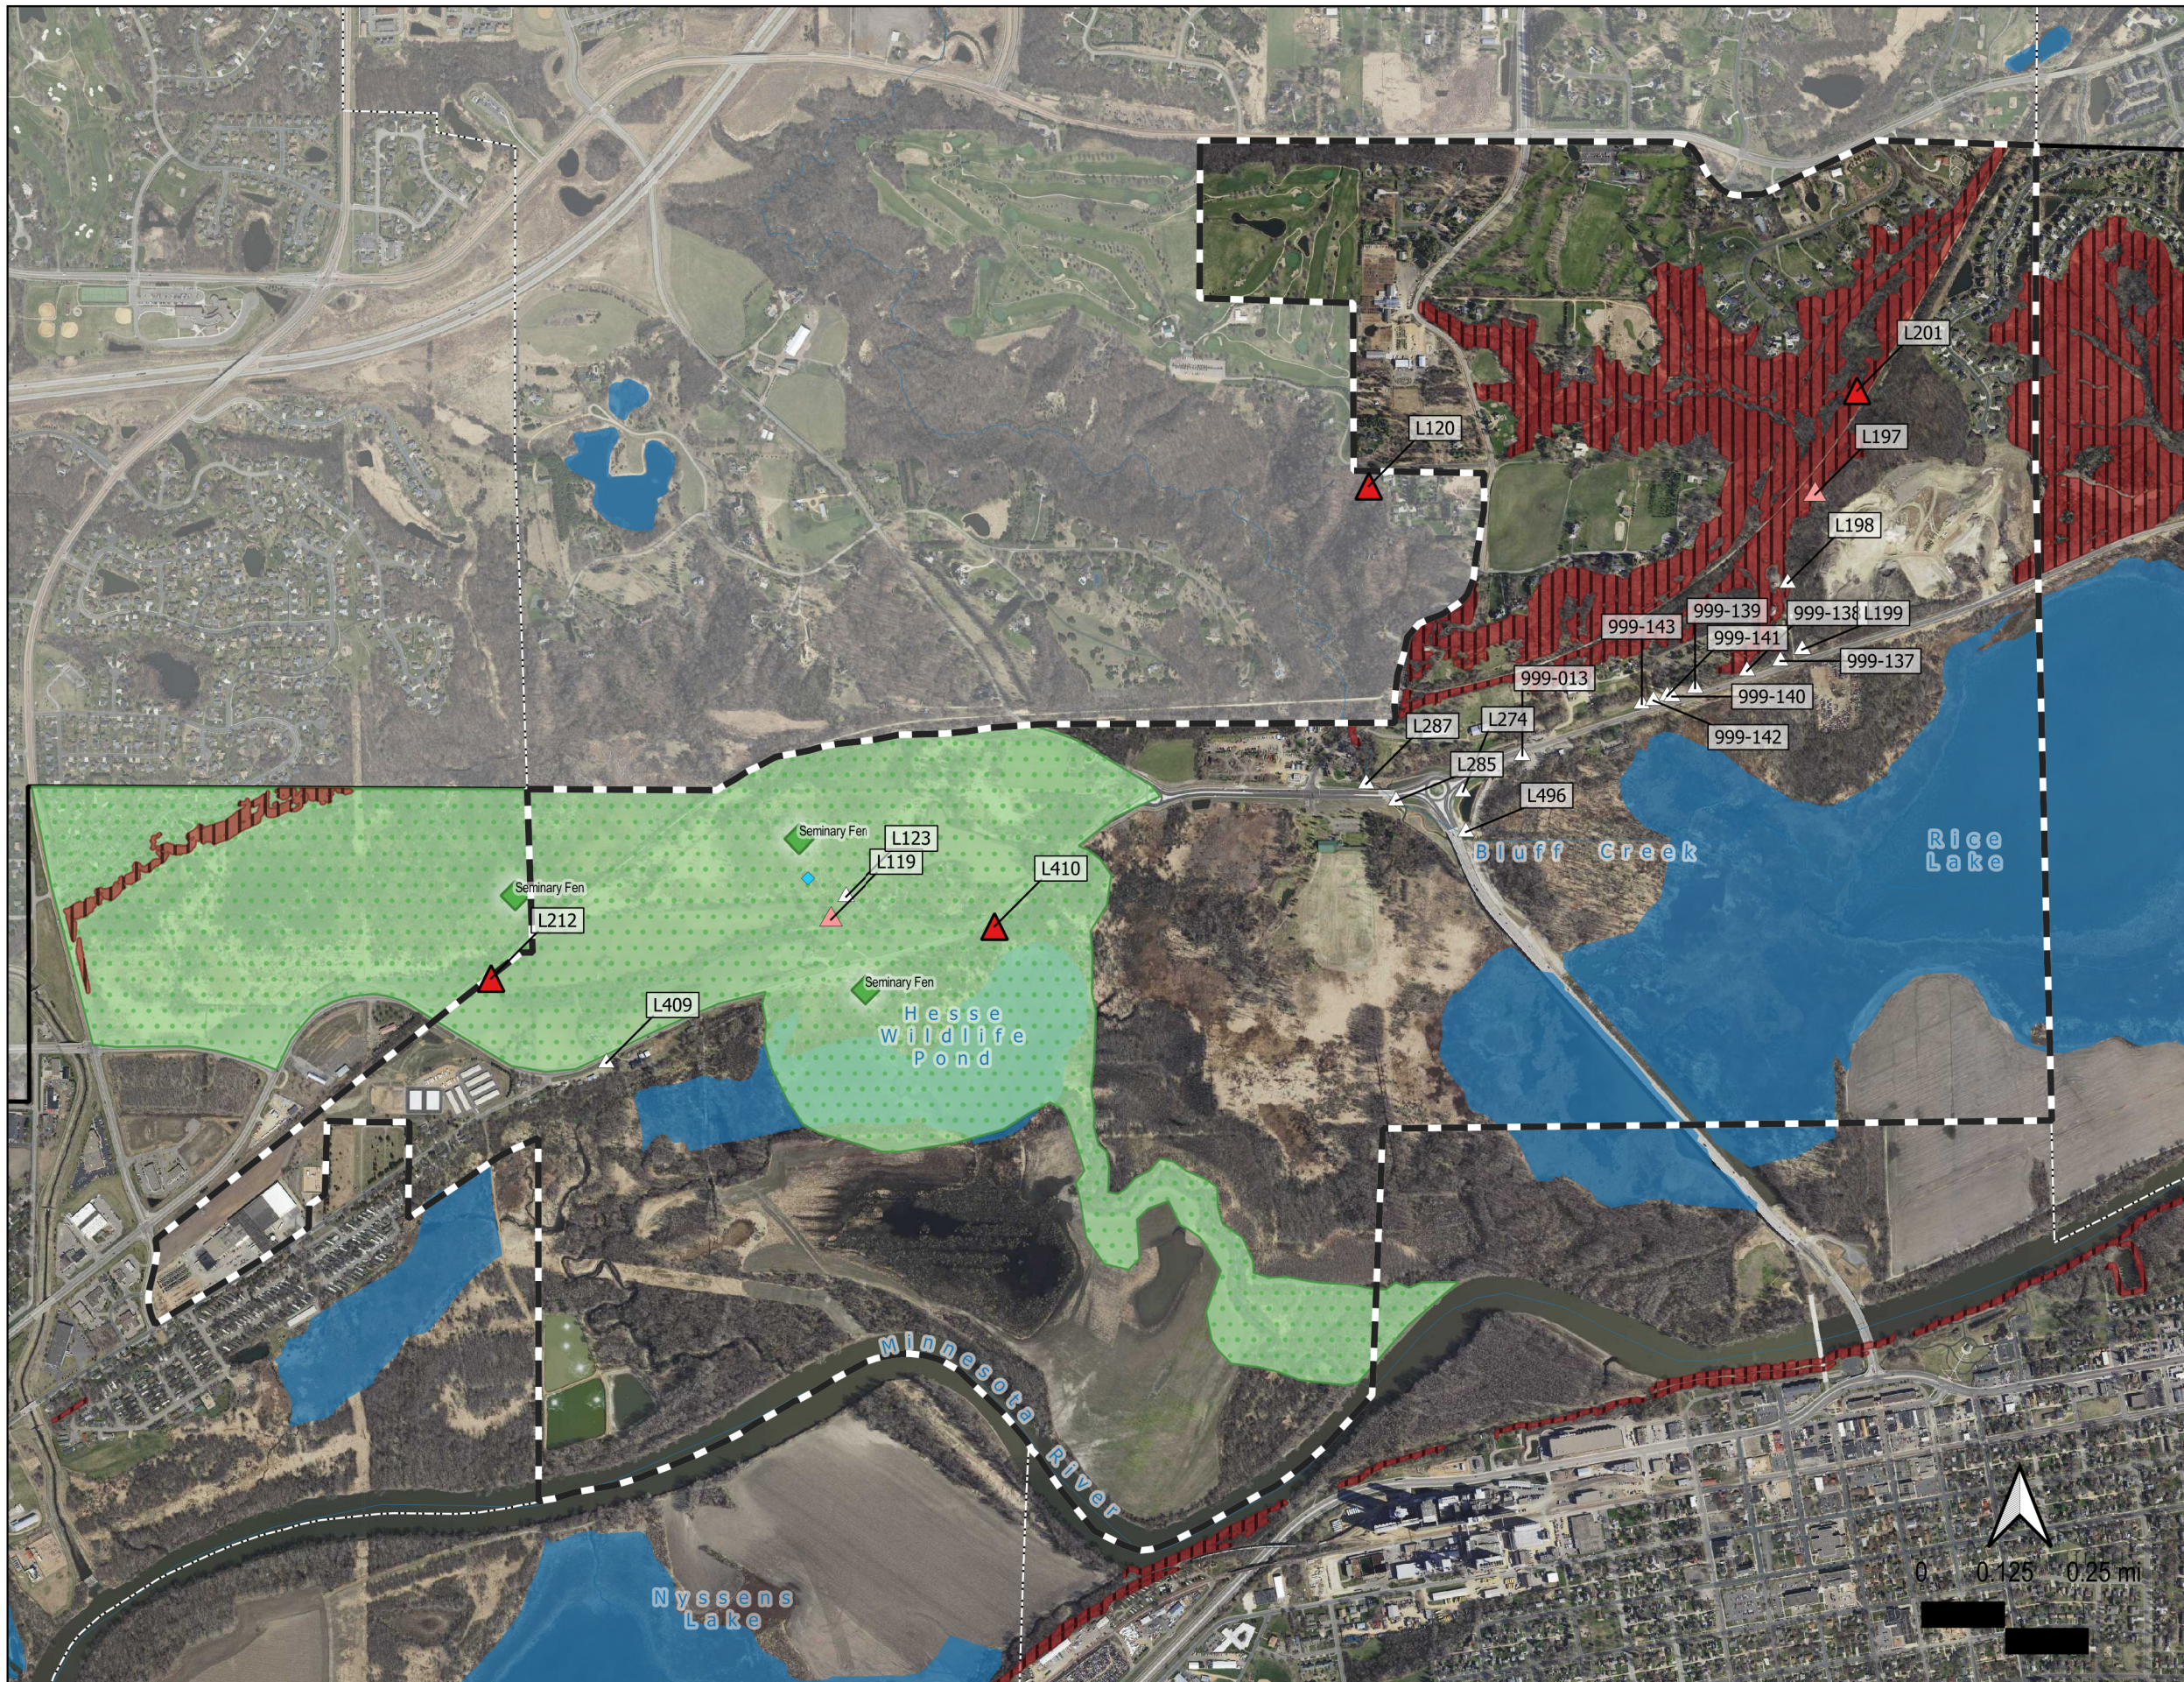
**Figure 70:
Chanhasen 2020
Pipe Outfall
Conditions**

The team noted current and recently finished road construction along Flying Cloud Drive. As a result, they recorded a large number of new pipe outfalls draining underneath and around the highway. Many of these pipe outfalls looked stable and drained into retention ponds. The team noted that two pipe outfalls will require maintenance soon (**Figure 70**).

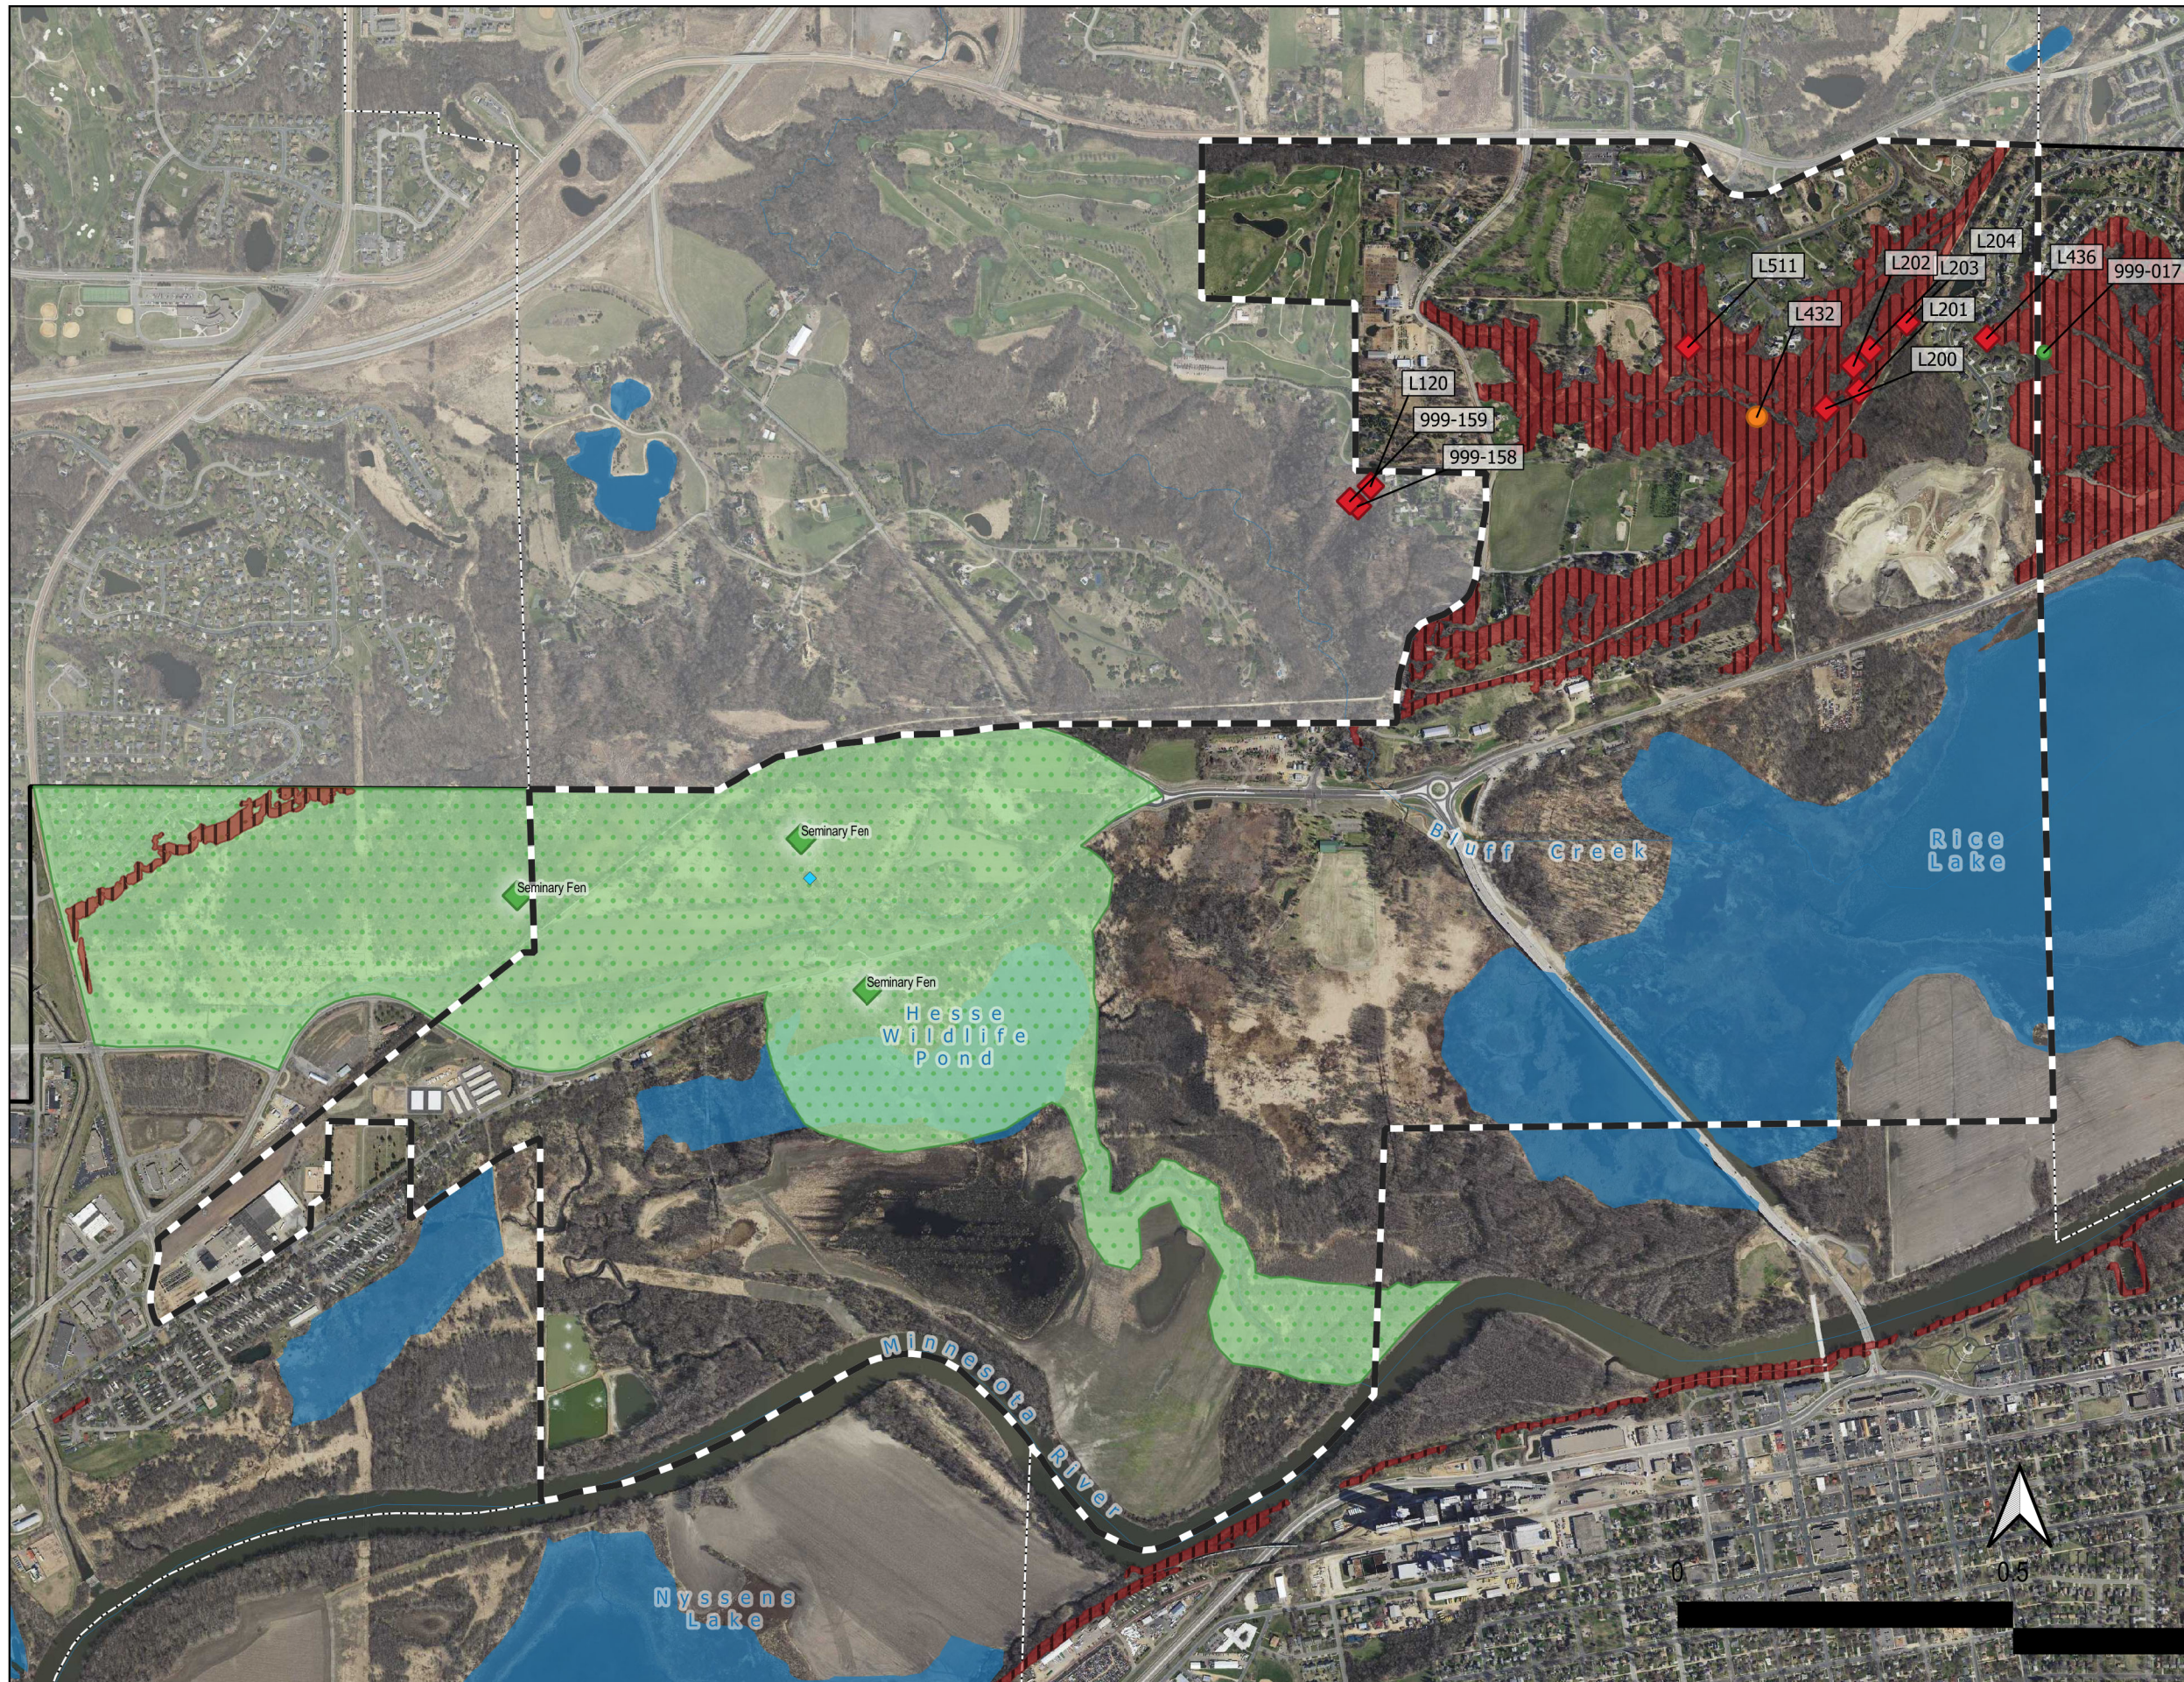
**Figure 71:
Chanhasen 2020
Gully Conditions**

Chanhassen shared similar land characteristics with cities along the western area of the watershed district. Steep slopes, as well as an upwelling of groundwater seeps and streams, seemed to cause most of the gullies, and in some sites unstable drainage features exacerbated the erosion. Most of the gullies surveyed in Chanhassen were rated as having high erosion potential. Within Chanhassen, the field team assessed gullies in three main areas. Unnamed groundwater-fed streams between Trails End Road and Deerbrook Drive accounted for many of the most severe gully sites in Chanhassen. In the Chanhassen portion of the Richard T. Anderson Conservation Area, the field team found two gullies with high erosion potential receding right up to the edge of residential property. Finally, gullies with high erosion potential were found along the slopes of Bluff Creek Park (**Figure 71**).

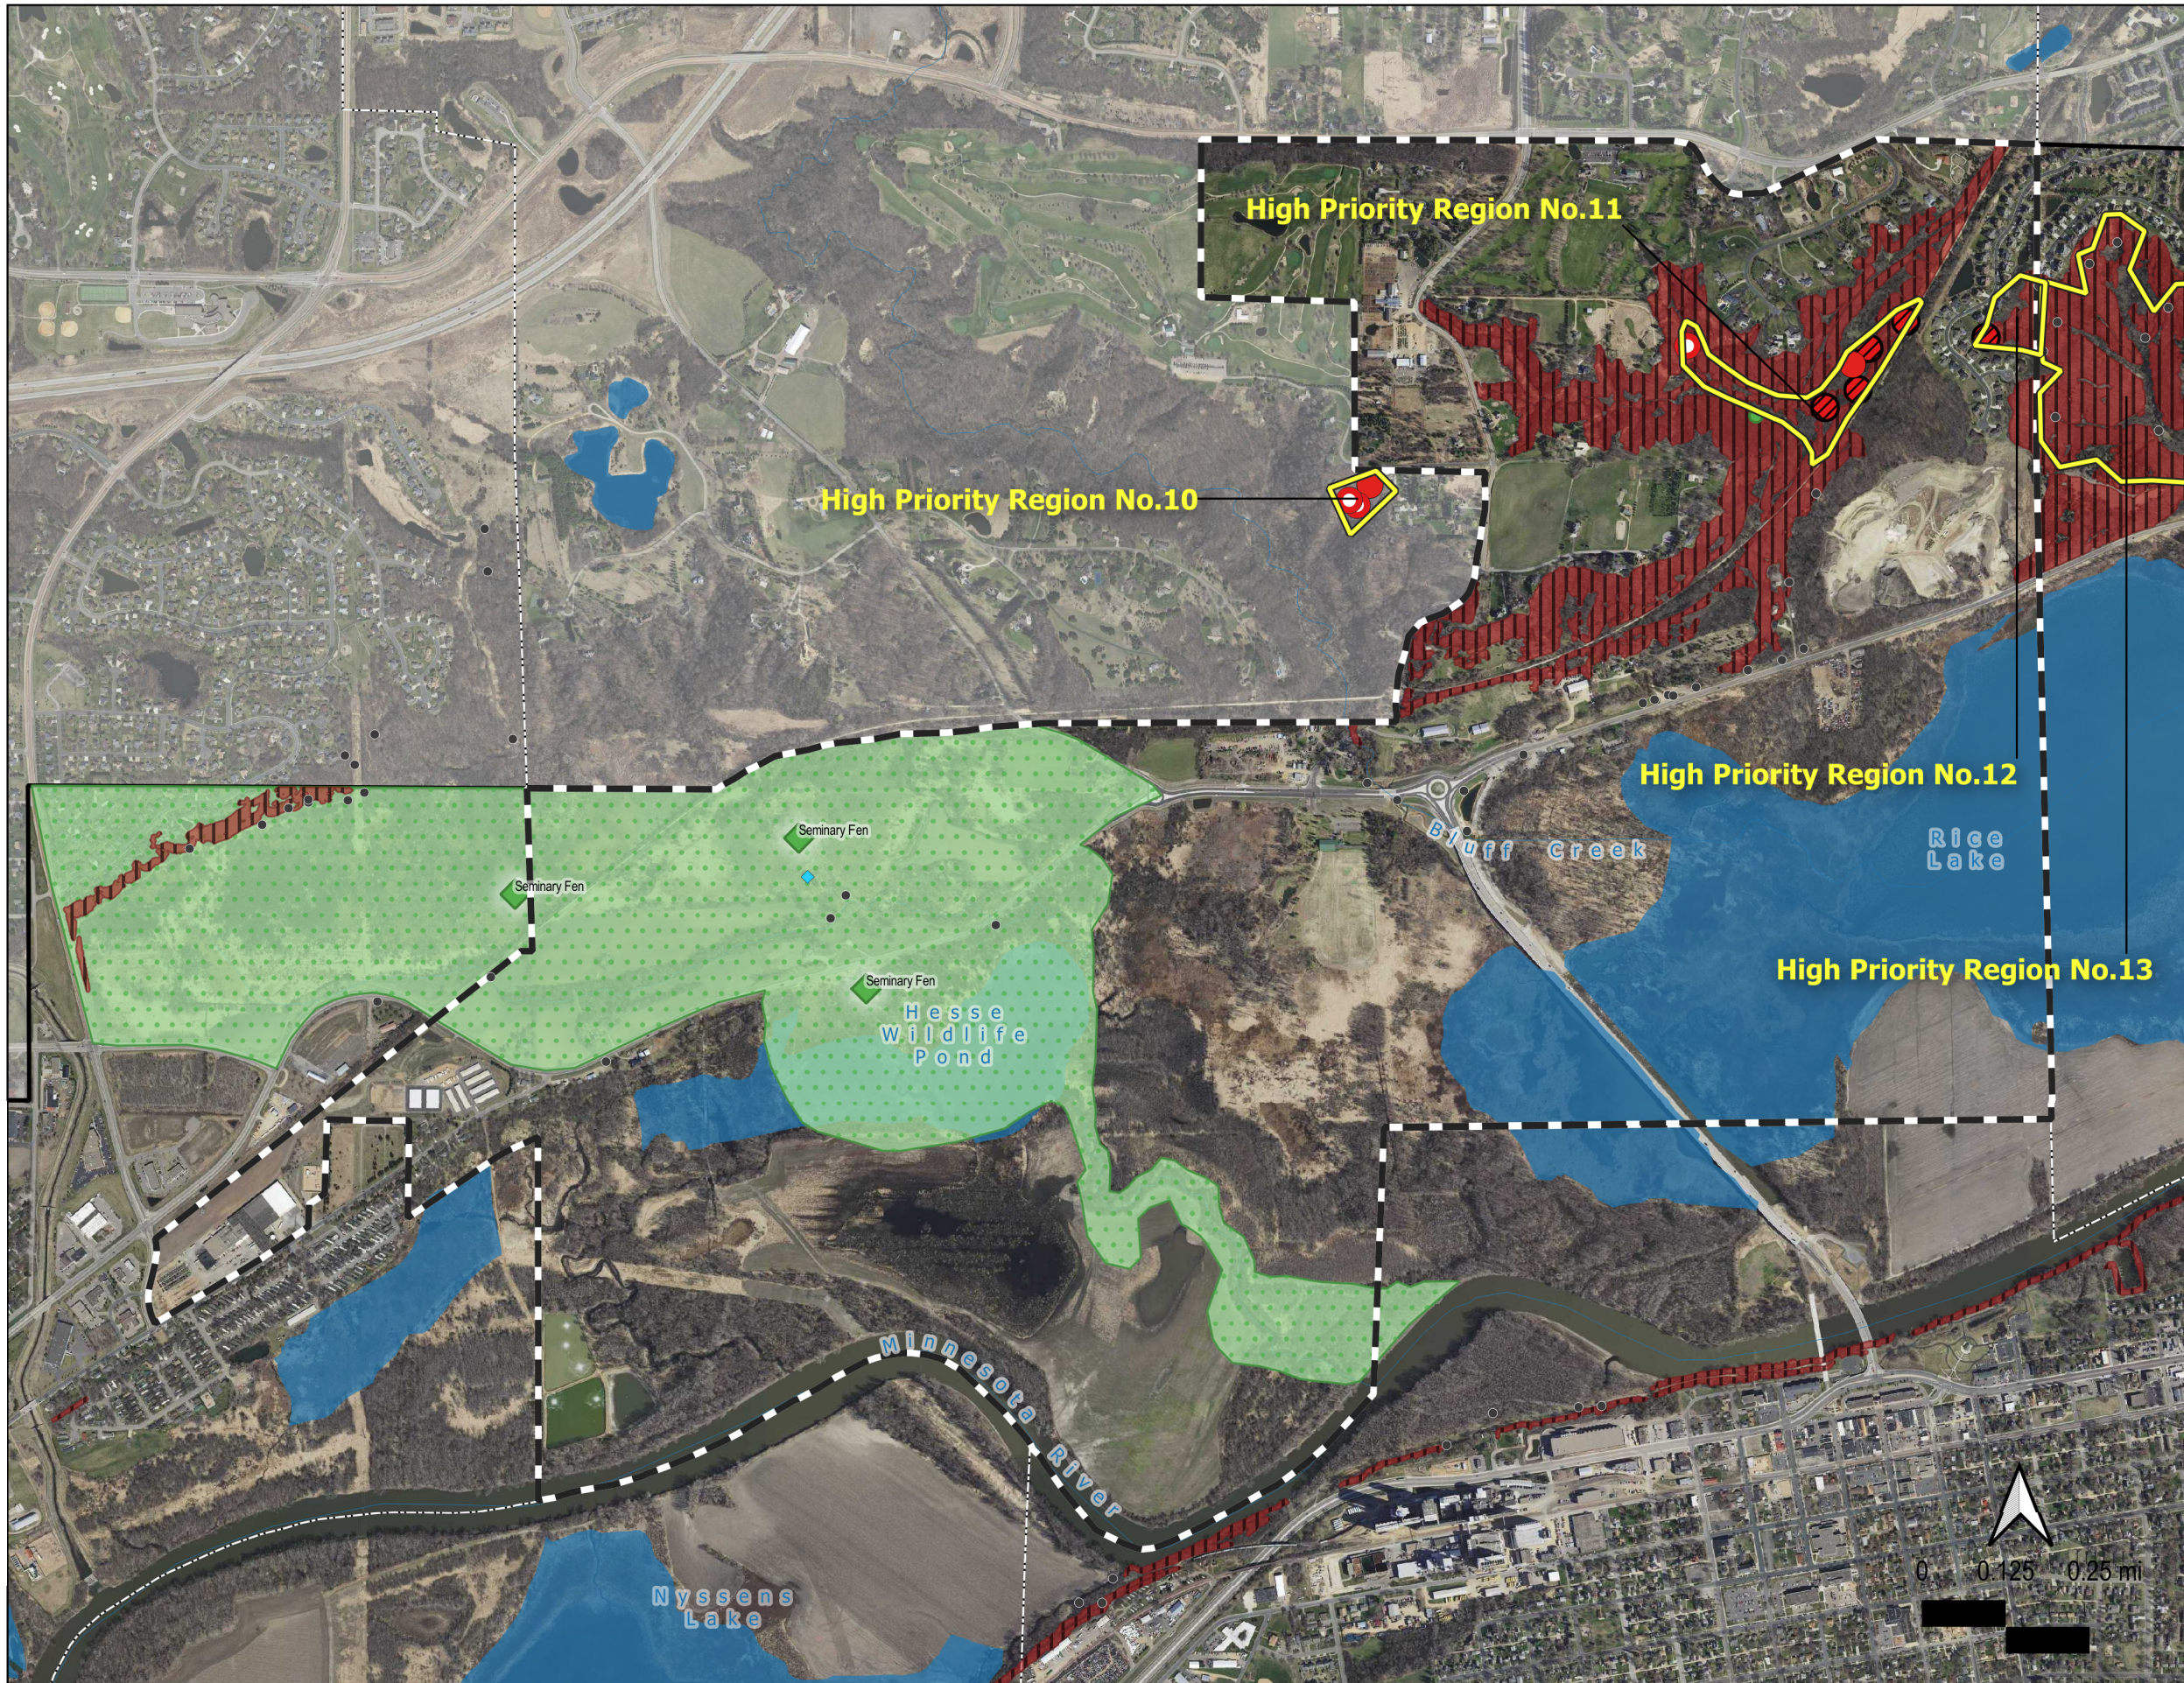
**Figure 72:
Chanhassen Erosion
Progression and HPRs**

To better assess the erosion progression of an individual site, the change in erosion potential is mapped in **Figure 72**. Priority was placed on sites that increased in severity, going from low to high or moderate erosion potential. In the City of Chanhassen, two sites increased from low to high erosion potential, and three were newly identified as having high erosion potential. Again, the more appropriate ranking of the

The details of the individual erosion progression are shown on **Figure 72**. Most of the gullies within the City of Chanhassen were located near the Eden Prairie border, and all were rated as having high erosion potential due to the severity of the erosion present at these locations. **Figure 72** details the total erosion progression in Chanhassen.

Only one gully, L432, was found to have decreased in erosion potential from 2008, from high to moderate potential. In the 2008 Inventory a long section of bare, exposed soil along a stream bank. In 2020, the field team noted that the patch of bare soil seemed to be cutting down deeper into the hillslope. However, the length and depth of the gully did not warrant a high erosion potential rating. The gully does not look to have stabilized; but based on the picture provided, the erosion seemed to be contained to a smaller area than in 2008.

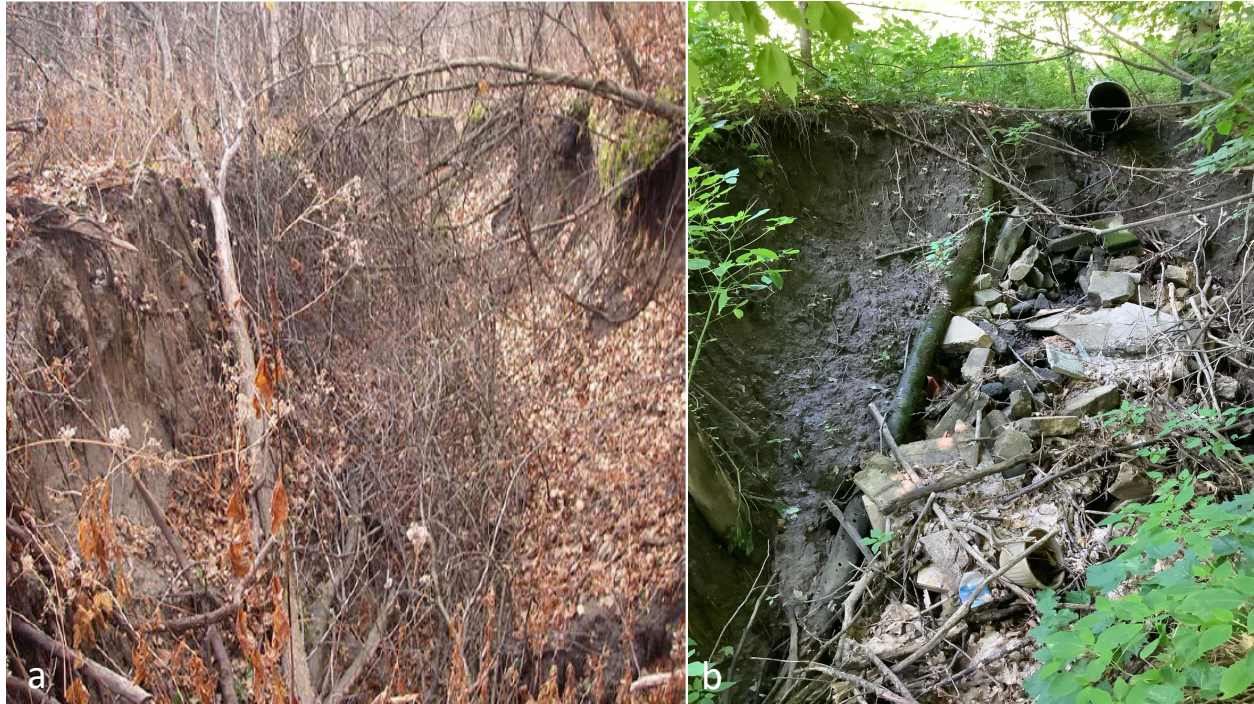
In 2008, this gully system was recorded as “severe erosion in two parallel gullies,” and the photo from the 2008 report shows evidence of overhanging banks and bare soil (**Figure 74a**). The description of the gully system in the 2008 report is consistent with the significant erosion found by the 2020 field team.

When visited in the field, all three gullies in the region exhibited signs of overhanging banks, channel incision, and unstable V-shaped banks consisting of bare soil. Since the 2008 report, no stabilization seems to have occurred in the region. **Figure 74b** provides a view looking upstream at erosion and slumping along the banks at the head cut, where pipe outfall 999-157 discharged into Gully L120.

At the time of the site visit, the field team noted a low amount of standing water in pipe outfall 999-157, and the unstable drainage feature caused severe downstream erosion in Gully L120. Although L120 flattened before the knickpoint that formed the head cut of Gully 999-158, water draining into L120 likely also caused the destabilization of Gully 999-158. Parallel to the two-gully system, the field team did not find a conclusive cause for Gully 999-159. However, an area of groundwater seepage was noted upstream from the head cut; although no water was noted in the gully channel at the time of the field visit, the seepage may have contributed to the destabilization of the soil.

Figure 74. Comparison of gully sites between 2008 (a) and 2020 (b). The 2008 picture shows an unspecified angle of the gully. The 2020 picture shows an upstream view toward the head cut and unstable pipe outlet.

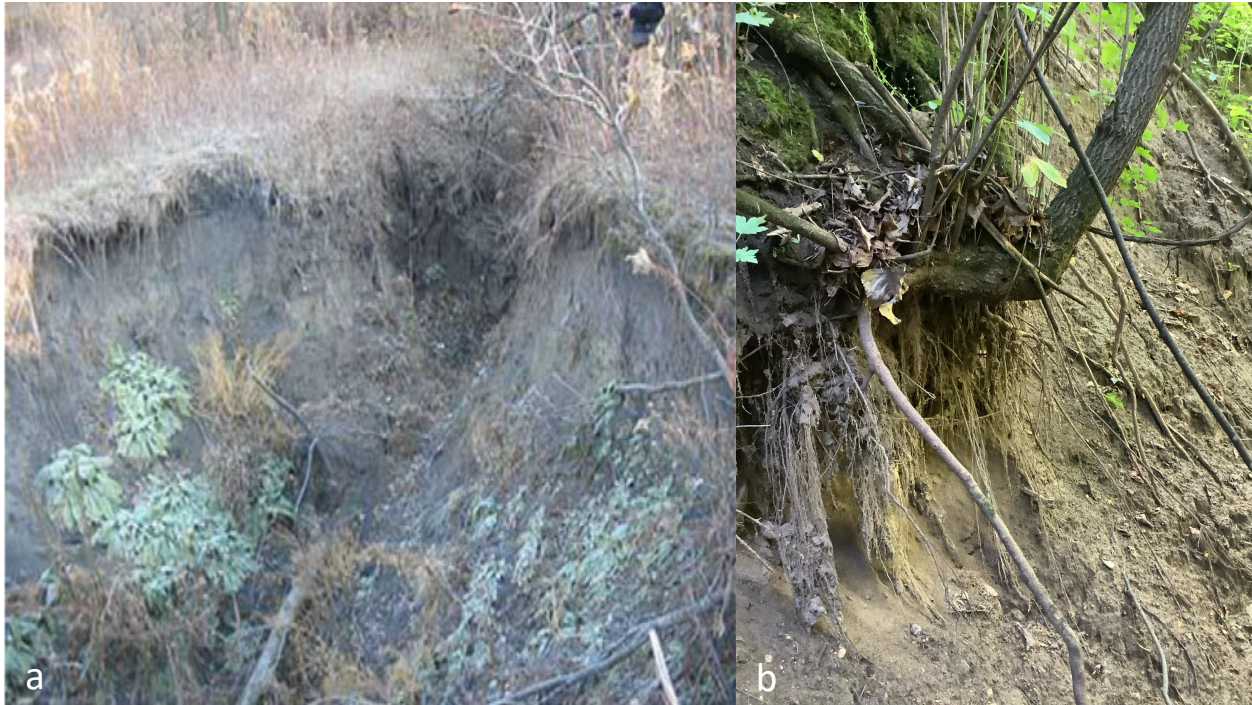
In 2008, four of the sites in the HPR were rated as having high erosion potential, and one site was noted as having low erosion potential. Gully L511 was a new location visited by the team; no previous benchmarking data was therefore available. **Figure 76** (below) depicts Site L203, which was noted as having “extreme erosion” in the 2008 report. A similarly incised channel with bare sandy banks was found during the 2020 inventory, although a clear view was blocked by tree debris and vegetation.

Figure 76. Similar characteristics and active erosion around Gully L203 in 2008 (a) and 2020 (b). Deep incision not seen at time of the visit, possibly blocked by vegetation.

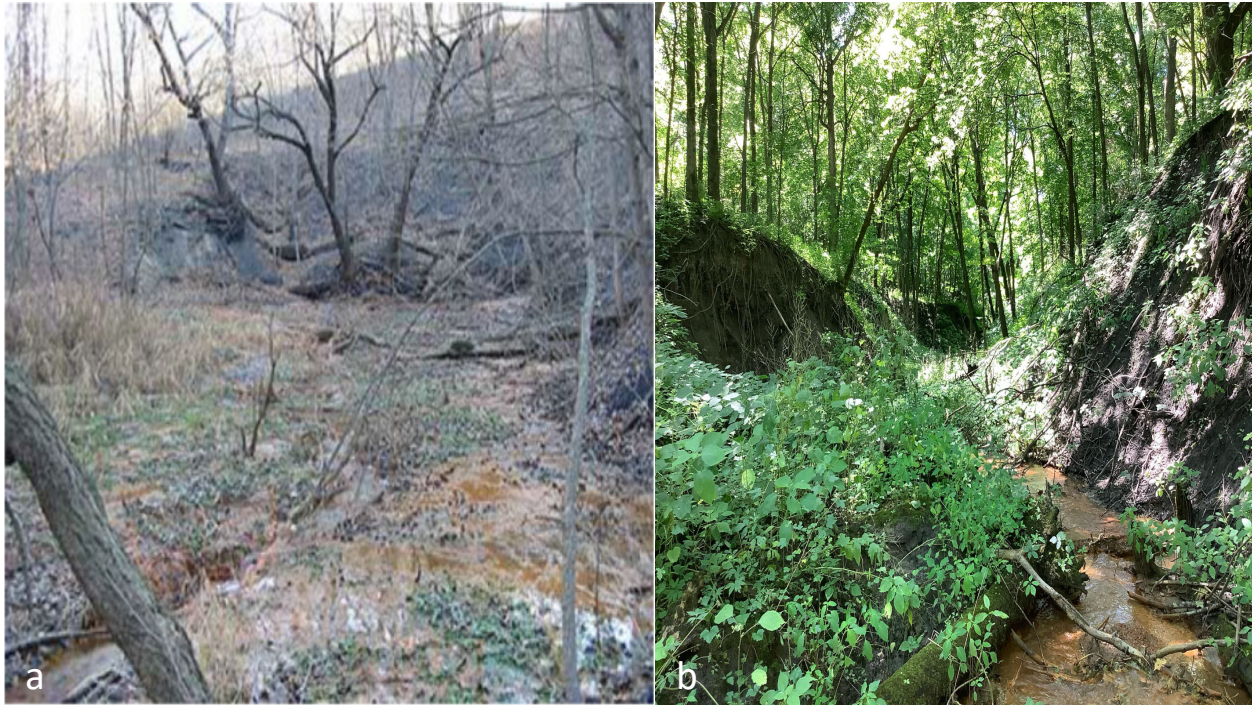
Based on the benchmark assessment, Gully L202 progressed from low to high erosion potential. In the 2008 Inventory, the previous field team only noted the spring and a sulfur smell. Based on the minimal erosion in the pictures, it was considered to have low erosion potential during the benchmark analysis. In 2020 the field team noted the same region of groundwater seeps, but severe slumping and downstream erosion nearby led to a high erosion potential rating. Based on the limited pictures of the 2008 report, the stream reach around L200 appears to have heavily eroded along the banks ([Figure 77](#)). The same slumping, bare banks, and overhanging roots continued at Site L200, which was noted in both 2008 and 2020 as having high erosion potential.

Figure 77. Progression of low erosion potential to high erosion potential at Site L202. Photo 'a': 2008, looking upstream; Photo 'b': 2020, looking downstream.

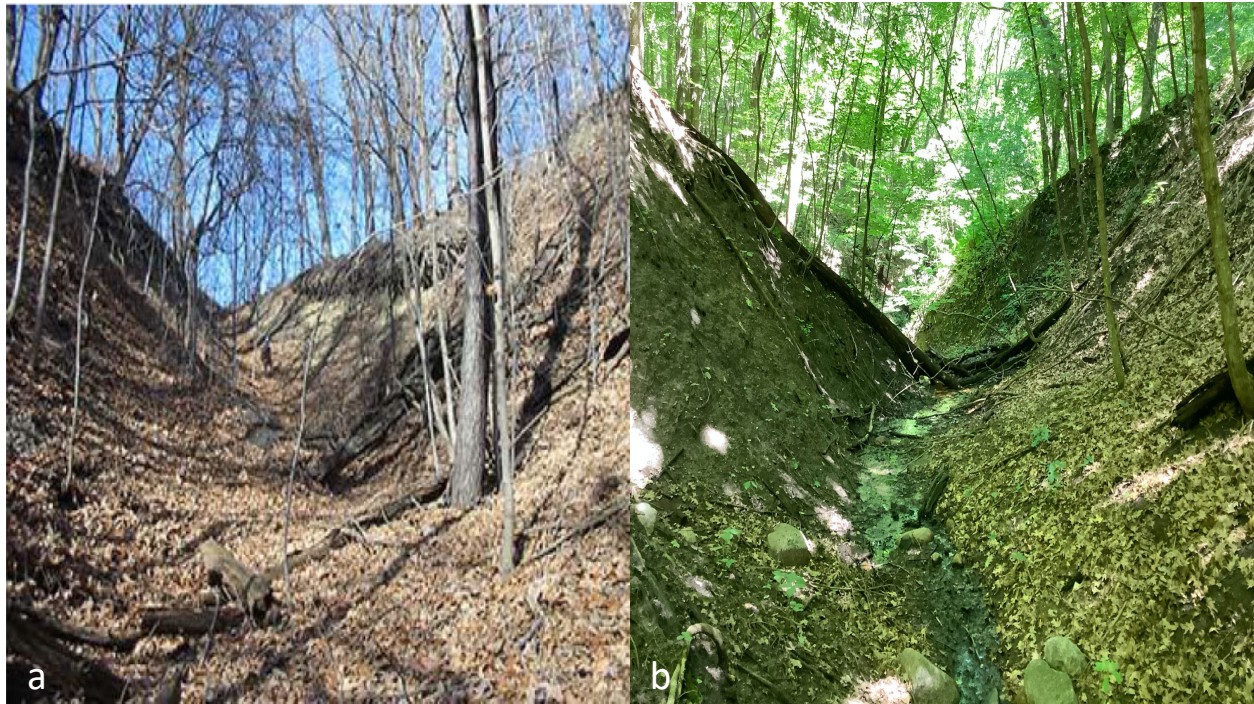
Both gullies in this region are branches that connect at a confluence point to a stream at Site 999-165, which lies in HPR 13. The two gullies each consisted of a V-shaped channel with bare soil along the gully bottoms and little to no vegetation along the banks. Sand made up the general material of the gullies. Gully L436 shifted to a U-shaped channel near the head cut, and fallen tree debris was thrown in to stabilize the area. The groundwater seep also extended farther back into Gully L436 than in Gully L465.

Slope and channel incision were apparent causes for both gullies. A dense canopy was a possible cause for L435, while groundwater contributed to erosion in L436. Problem indicators in both gullies included degradation, loss of bank vegetation, incision, slumping, overhanging banks, and leaning trees. The field team noted that large sections of soil appeared to have recently slumped off along the banks of L436. The previous report noted the proximity of Site L435 to a new development, and a nearby house was visible from the head cut. Gully L435 backed right onto residential property, and at the time of the visit, a tree in the channel seemed to have been recently uprooted. Without intervention, severe erosion is likely to continue along both branches.

Figure 79. Comparison of Gully L436 in 2008 (a) and 2020 (b).

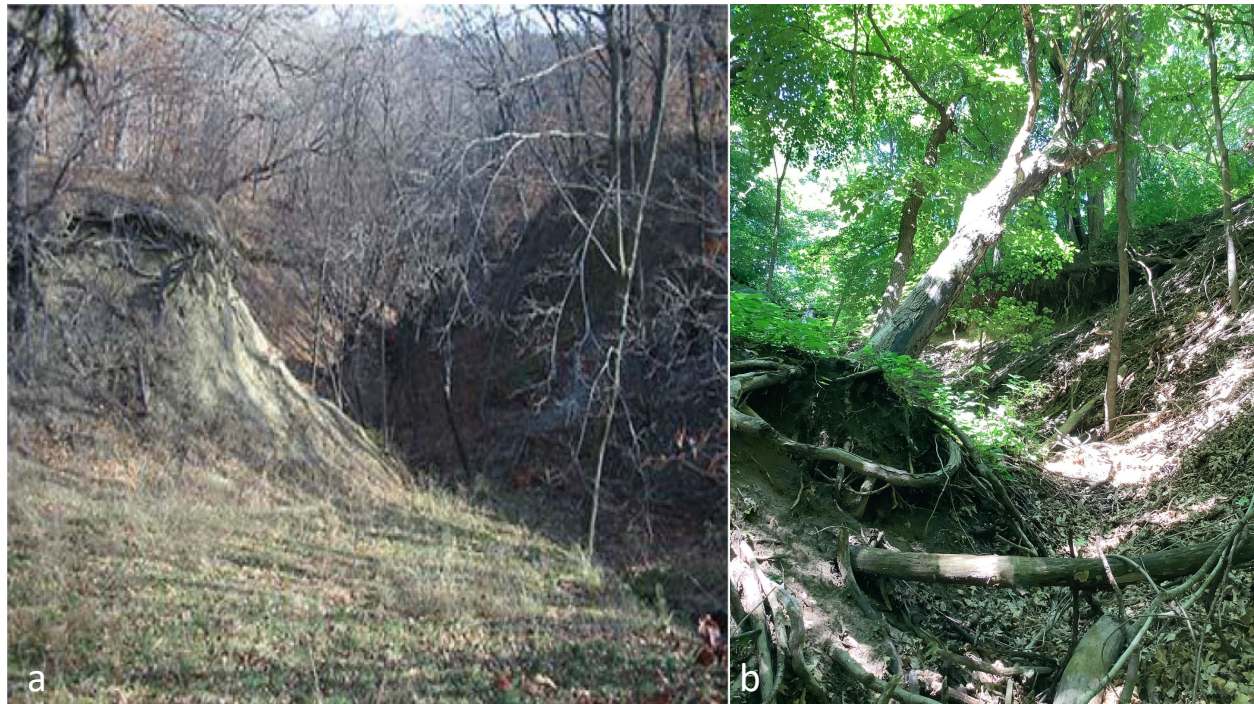
Figure 80. Comparison of Gully L435 in 2008 (a) and 2020 (b)
