8.0 CITY OF CHASKA

8.4 Chaska Gully Progression

8.5 Chaska High-Priority Sites and Regions

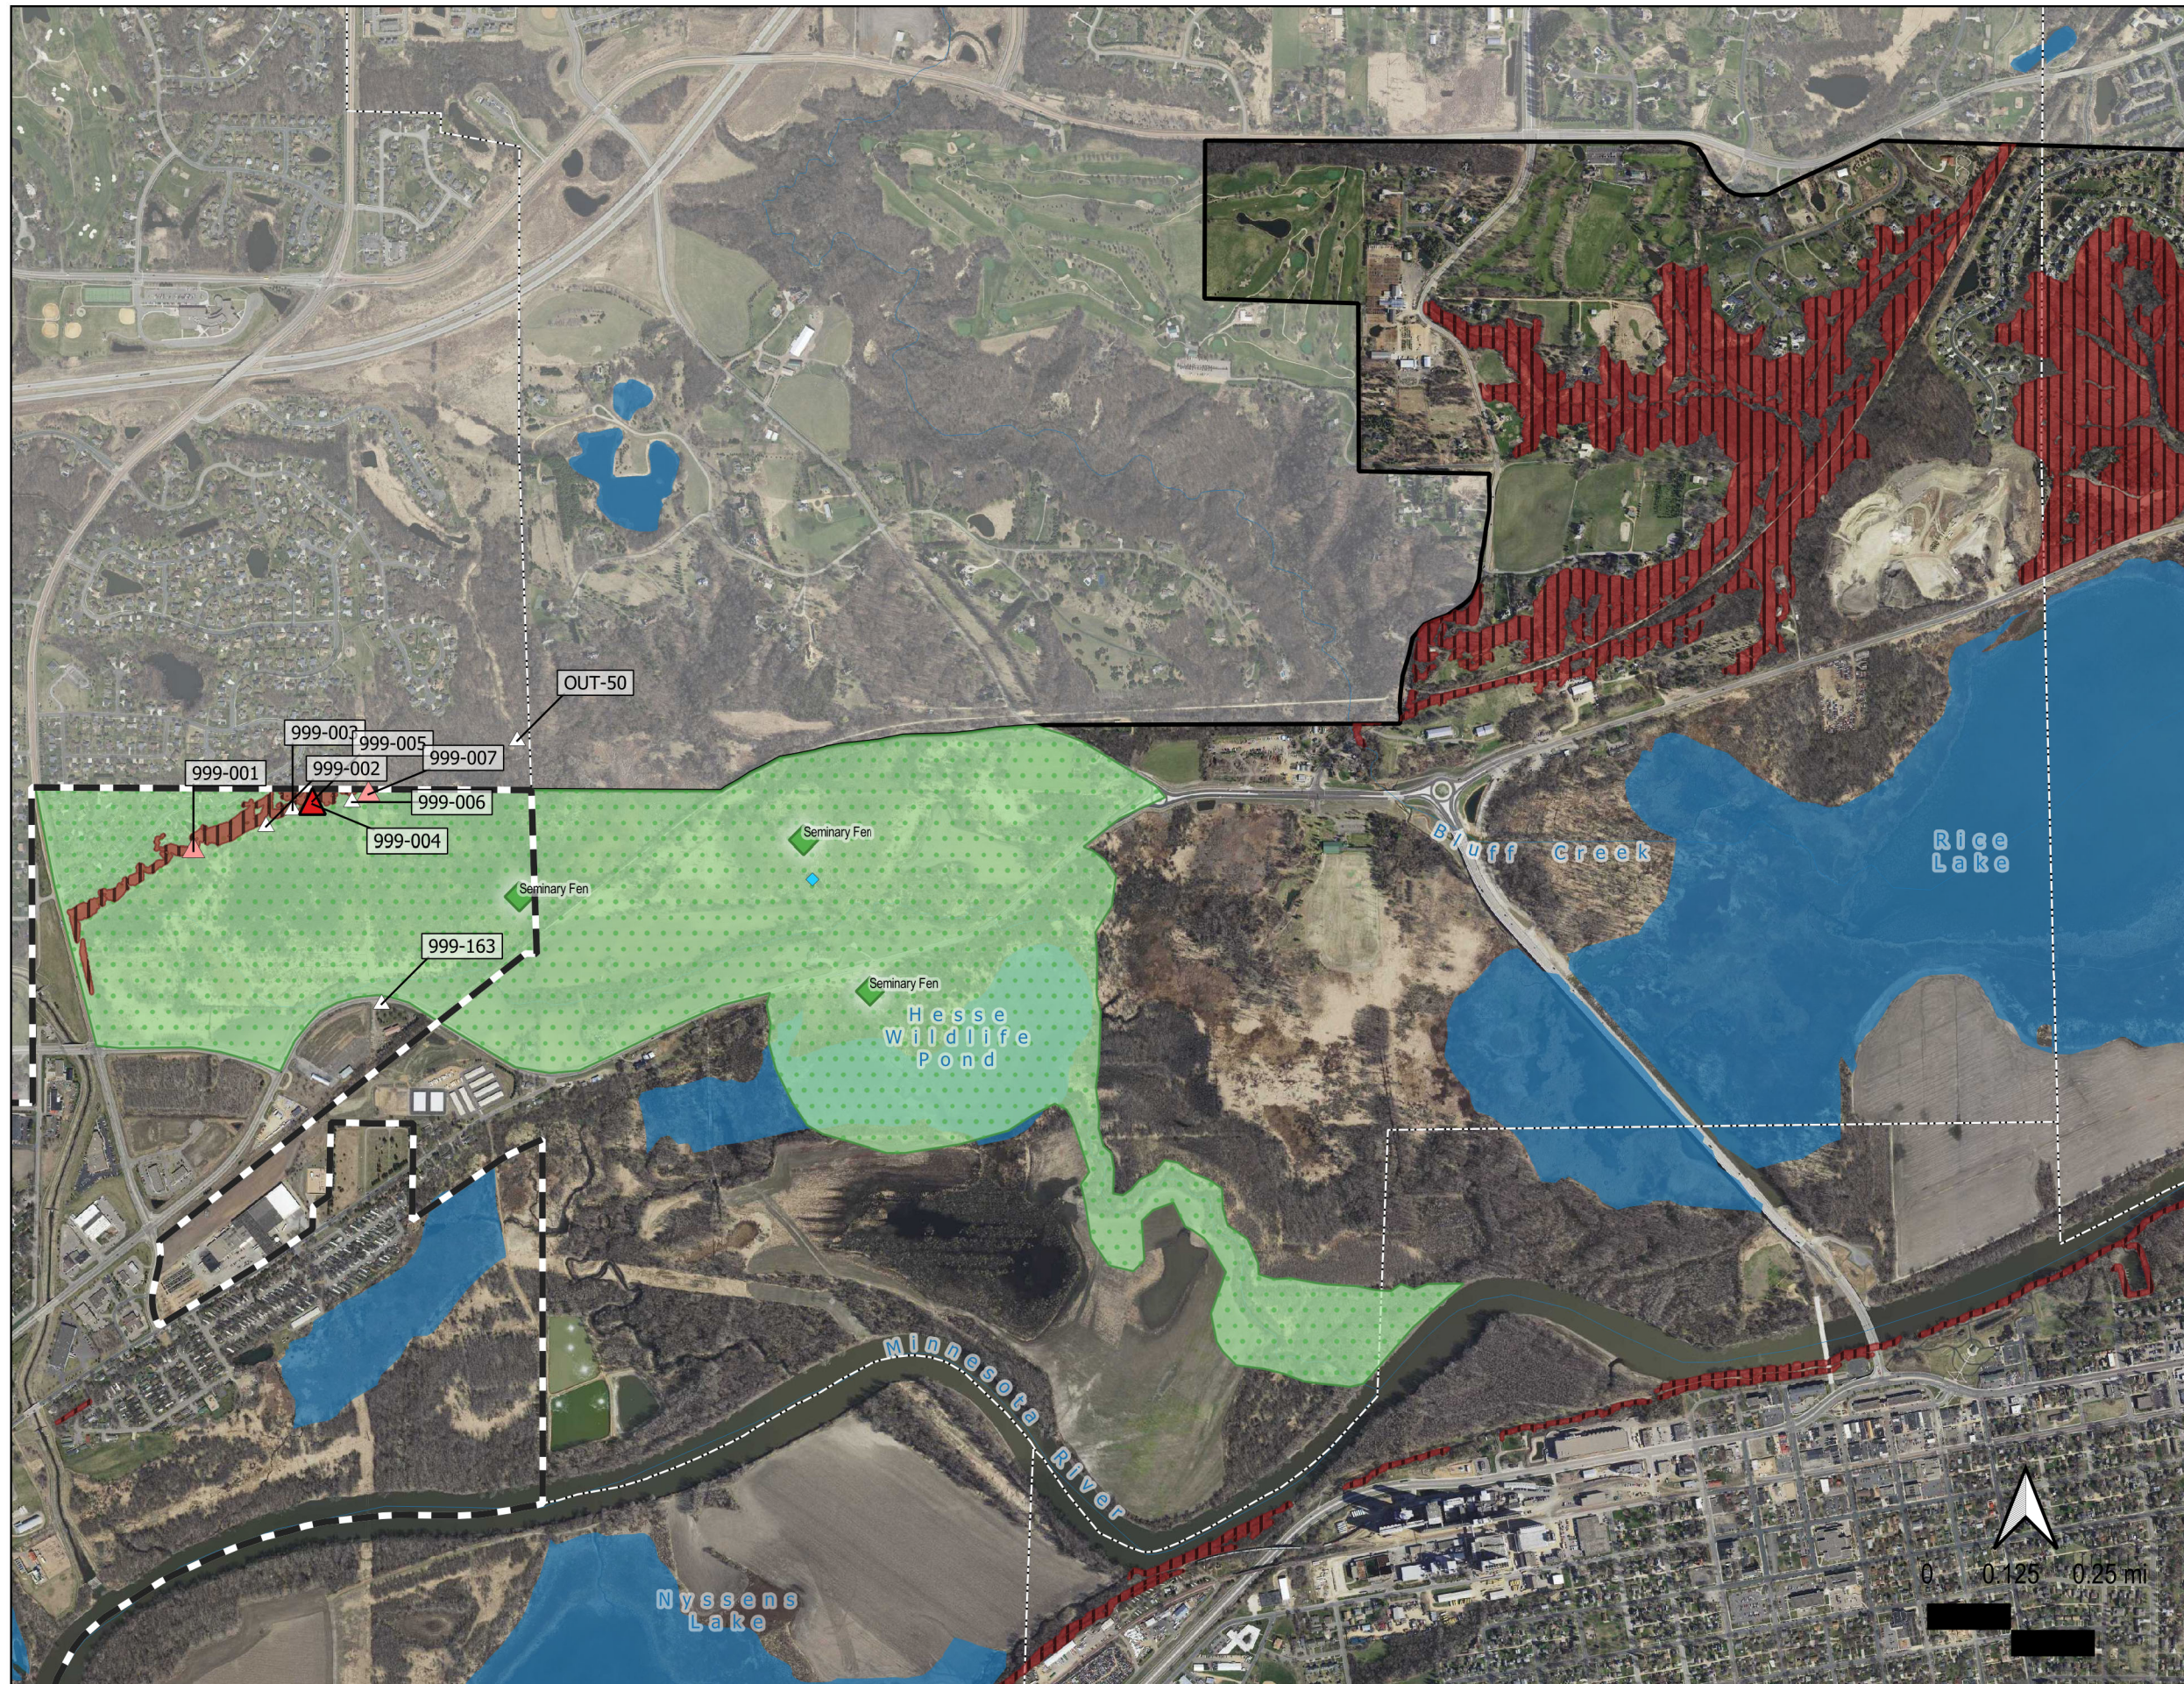
**Figure 83:
Chaska 2020 Pipe
Outfall Conditions**

In Chaska, water in the area came from groundwater which flowed through small tributaries of the Minnesota River. Groundwater seeps were noted, especially near Seminary Fen. East Creek, which flows through downtown Chaska, contained most of the pipe outfalls. Pipe outfalls ranged from subsurface drainage pipes to large, aproned concrete and metal pipes. The field team also noted five additional pipe outfalls along the trail south of Falls Curve Road, near Seminary Fen. The team noted that four of the pipe outfalls will require maintenance soon (**Figure 83**).

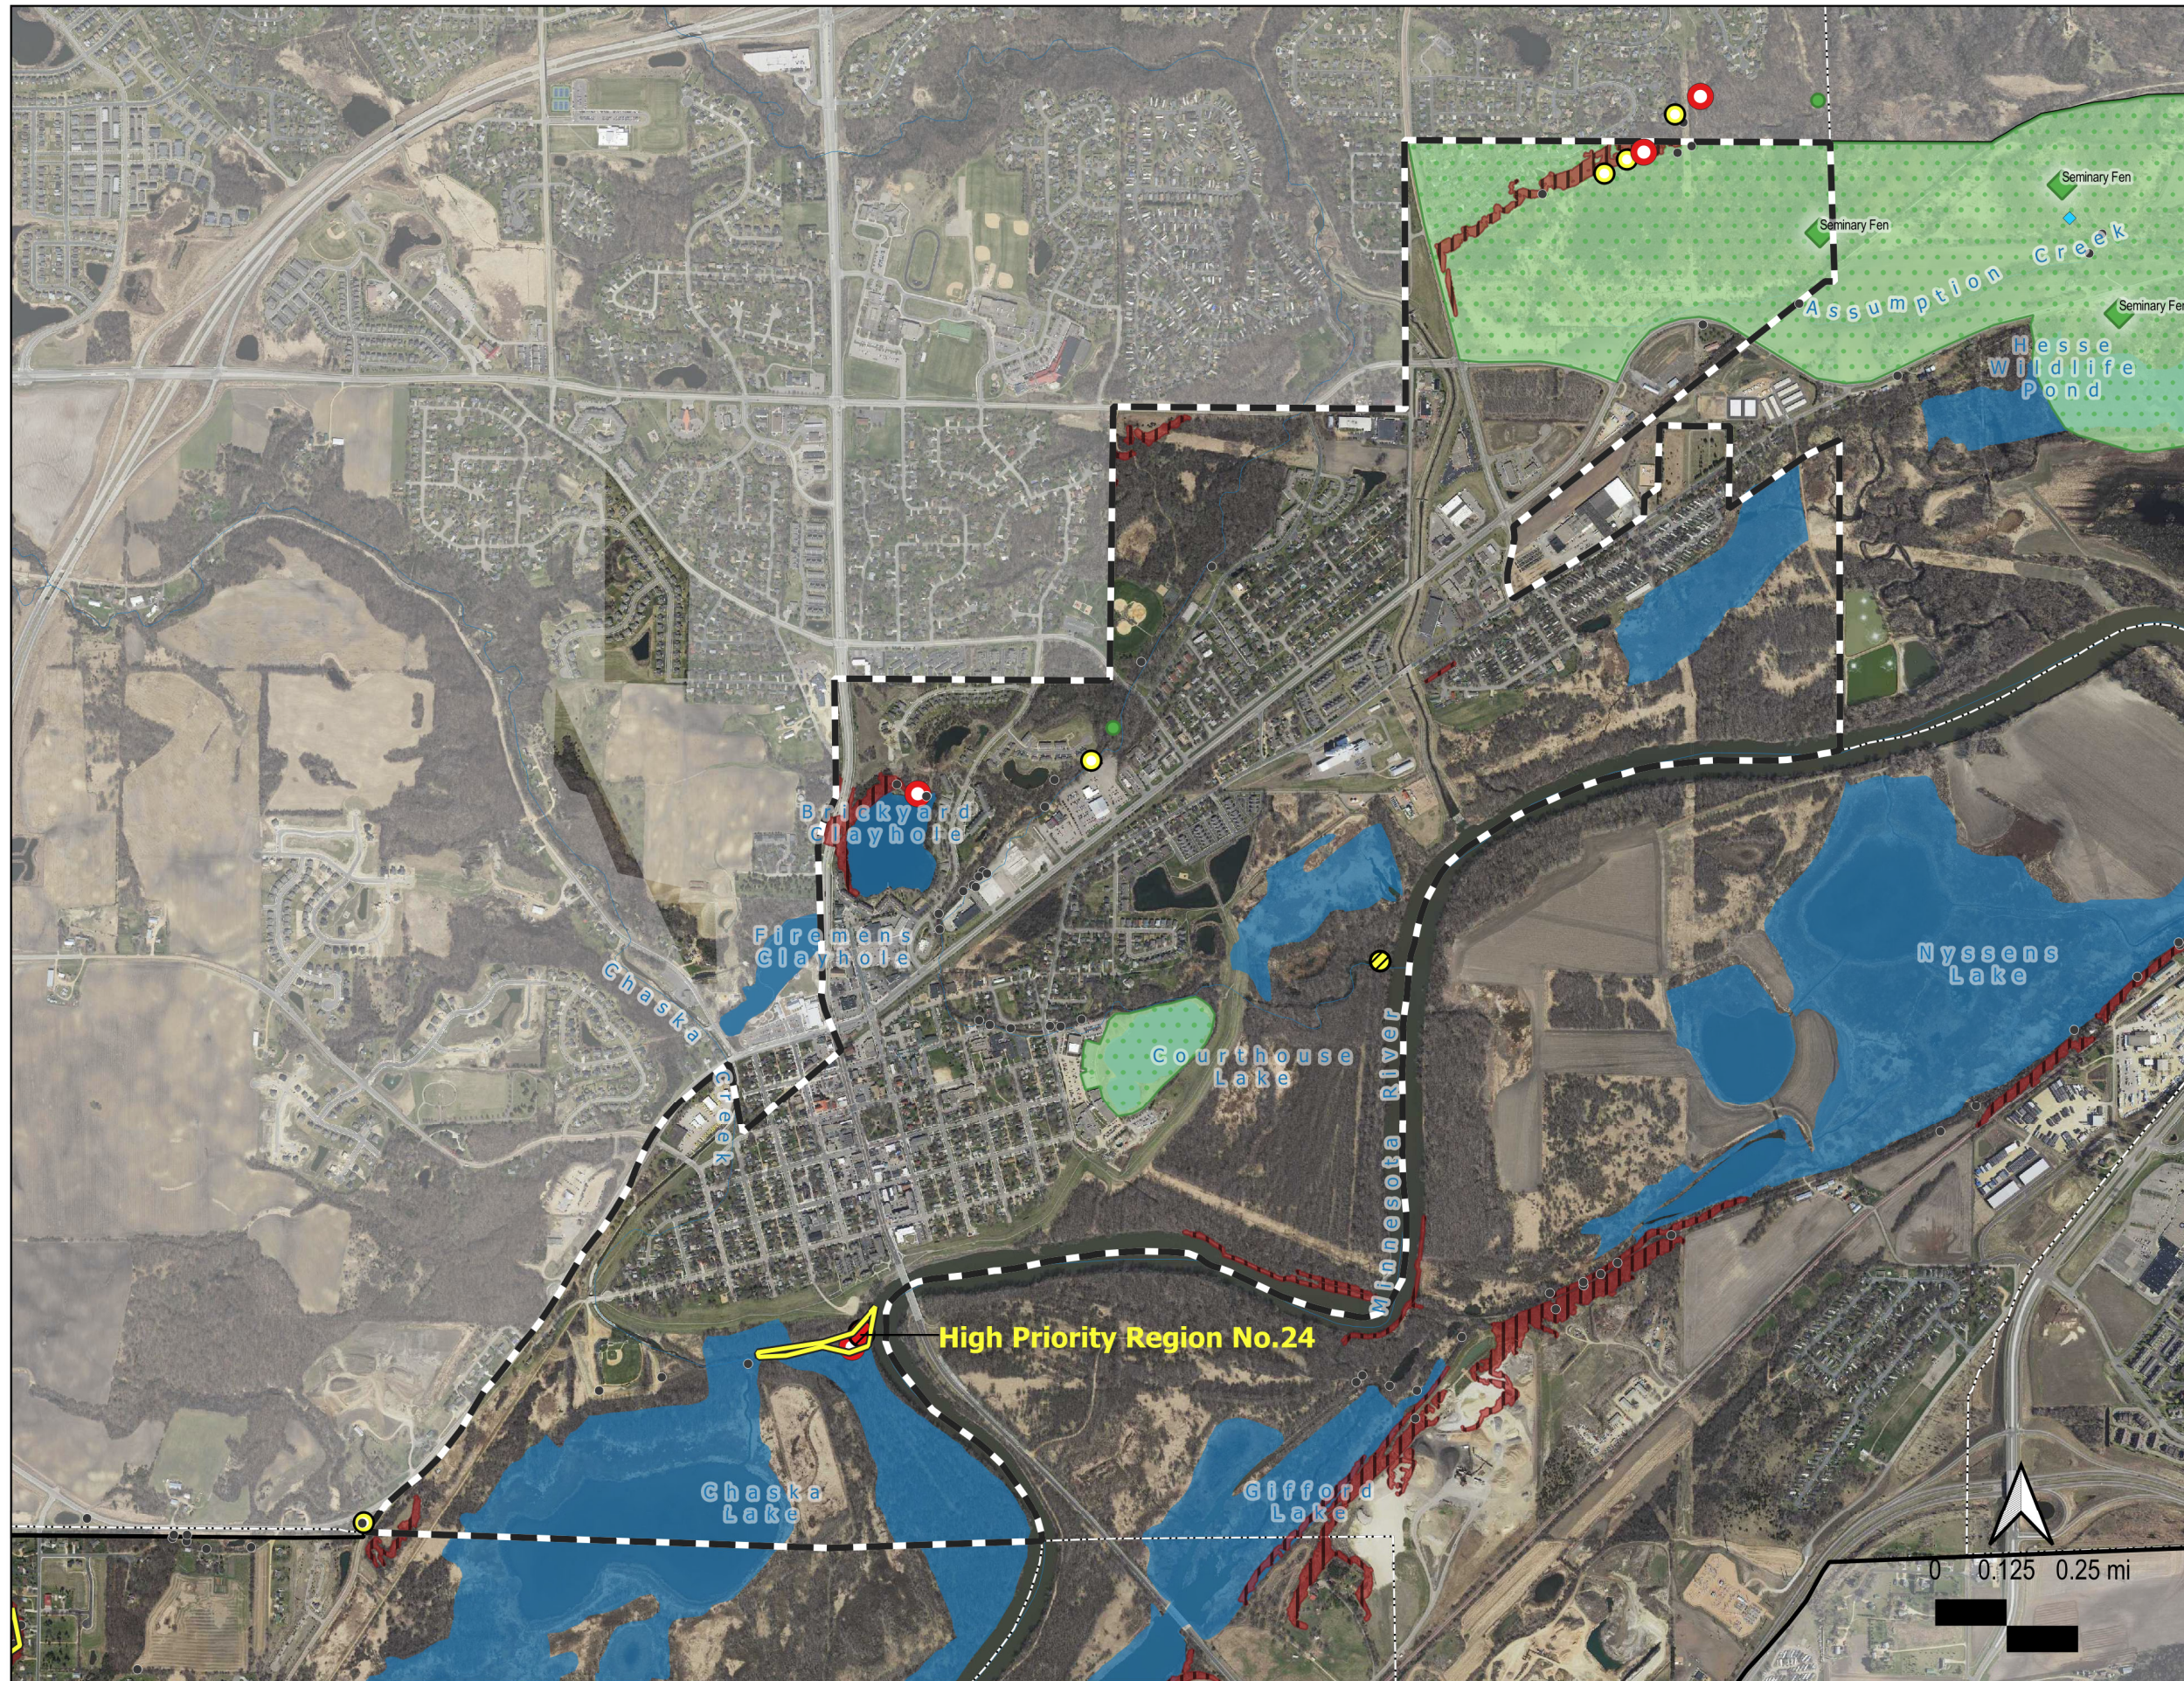
**Figure 85:
Chaska Erosion
Progression and HPRs**

To better assess the erosion progression of an individual site, changes in erosion potential are mapped in **Figure 85**. Two previously benchmarked sites experienced a reduction in erosion potential. Priority was placed on sites that remained high or on newly identified sites that were found to have high erosion potential. The sites rated as less severe in 2020 than in 2008 can be linked to the limited information provided from the 2008 Inventory for benchmarking conditions. The more appropriate ranking of the sites in the 2020 study may be attributed in part to improved data collection rather than any significant progressive change in conditions.

In the City of Chaska, two stand-alone High-Priority Sites and one High-Priority Region were identified (**Figure 85**). The two stand-alone sites that are not along Chaska Creek were found to be inside of the Steep Slopes Overlay District. No seeps were noted at any of the high-priority sites or regions, but the Minnesota Spring Inventory provides evidence of springs in area surrounding 999-005. The high-priority site and regions are described below:

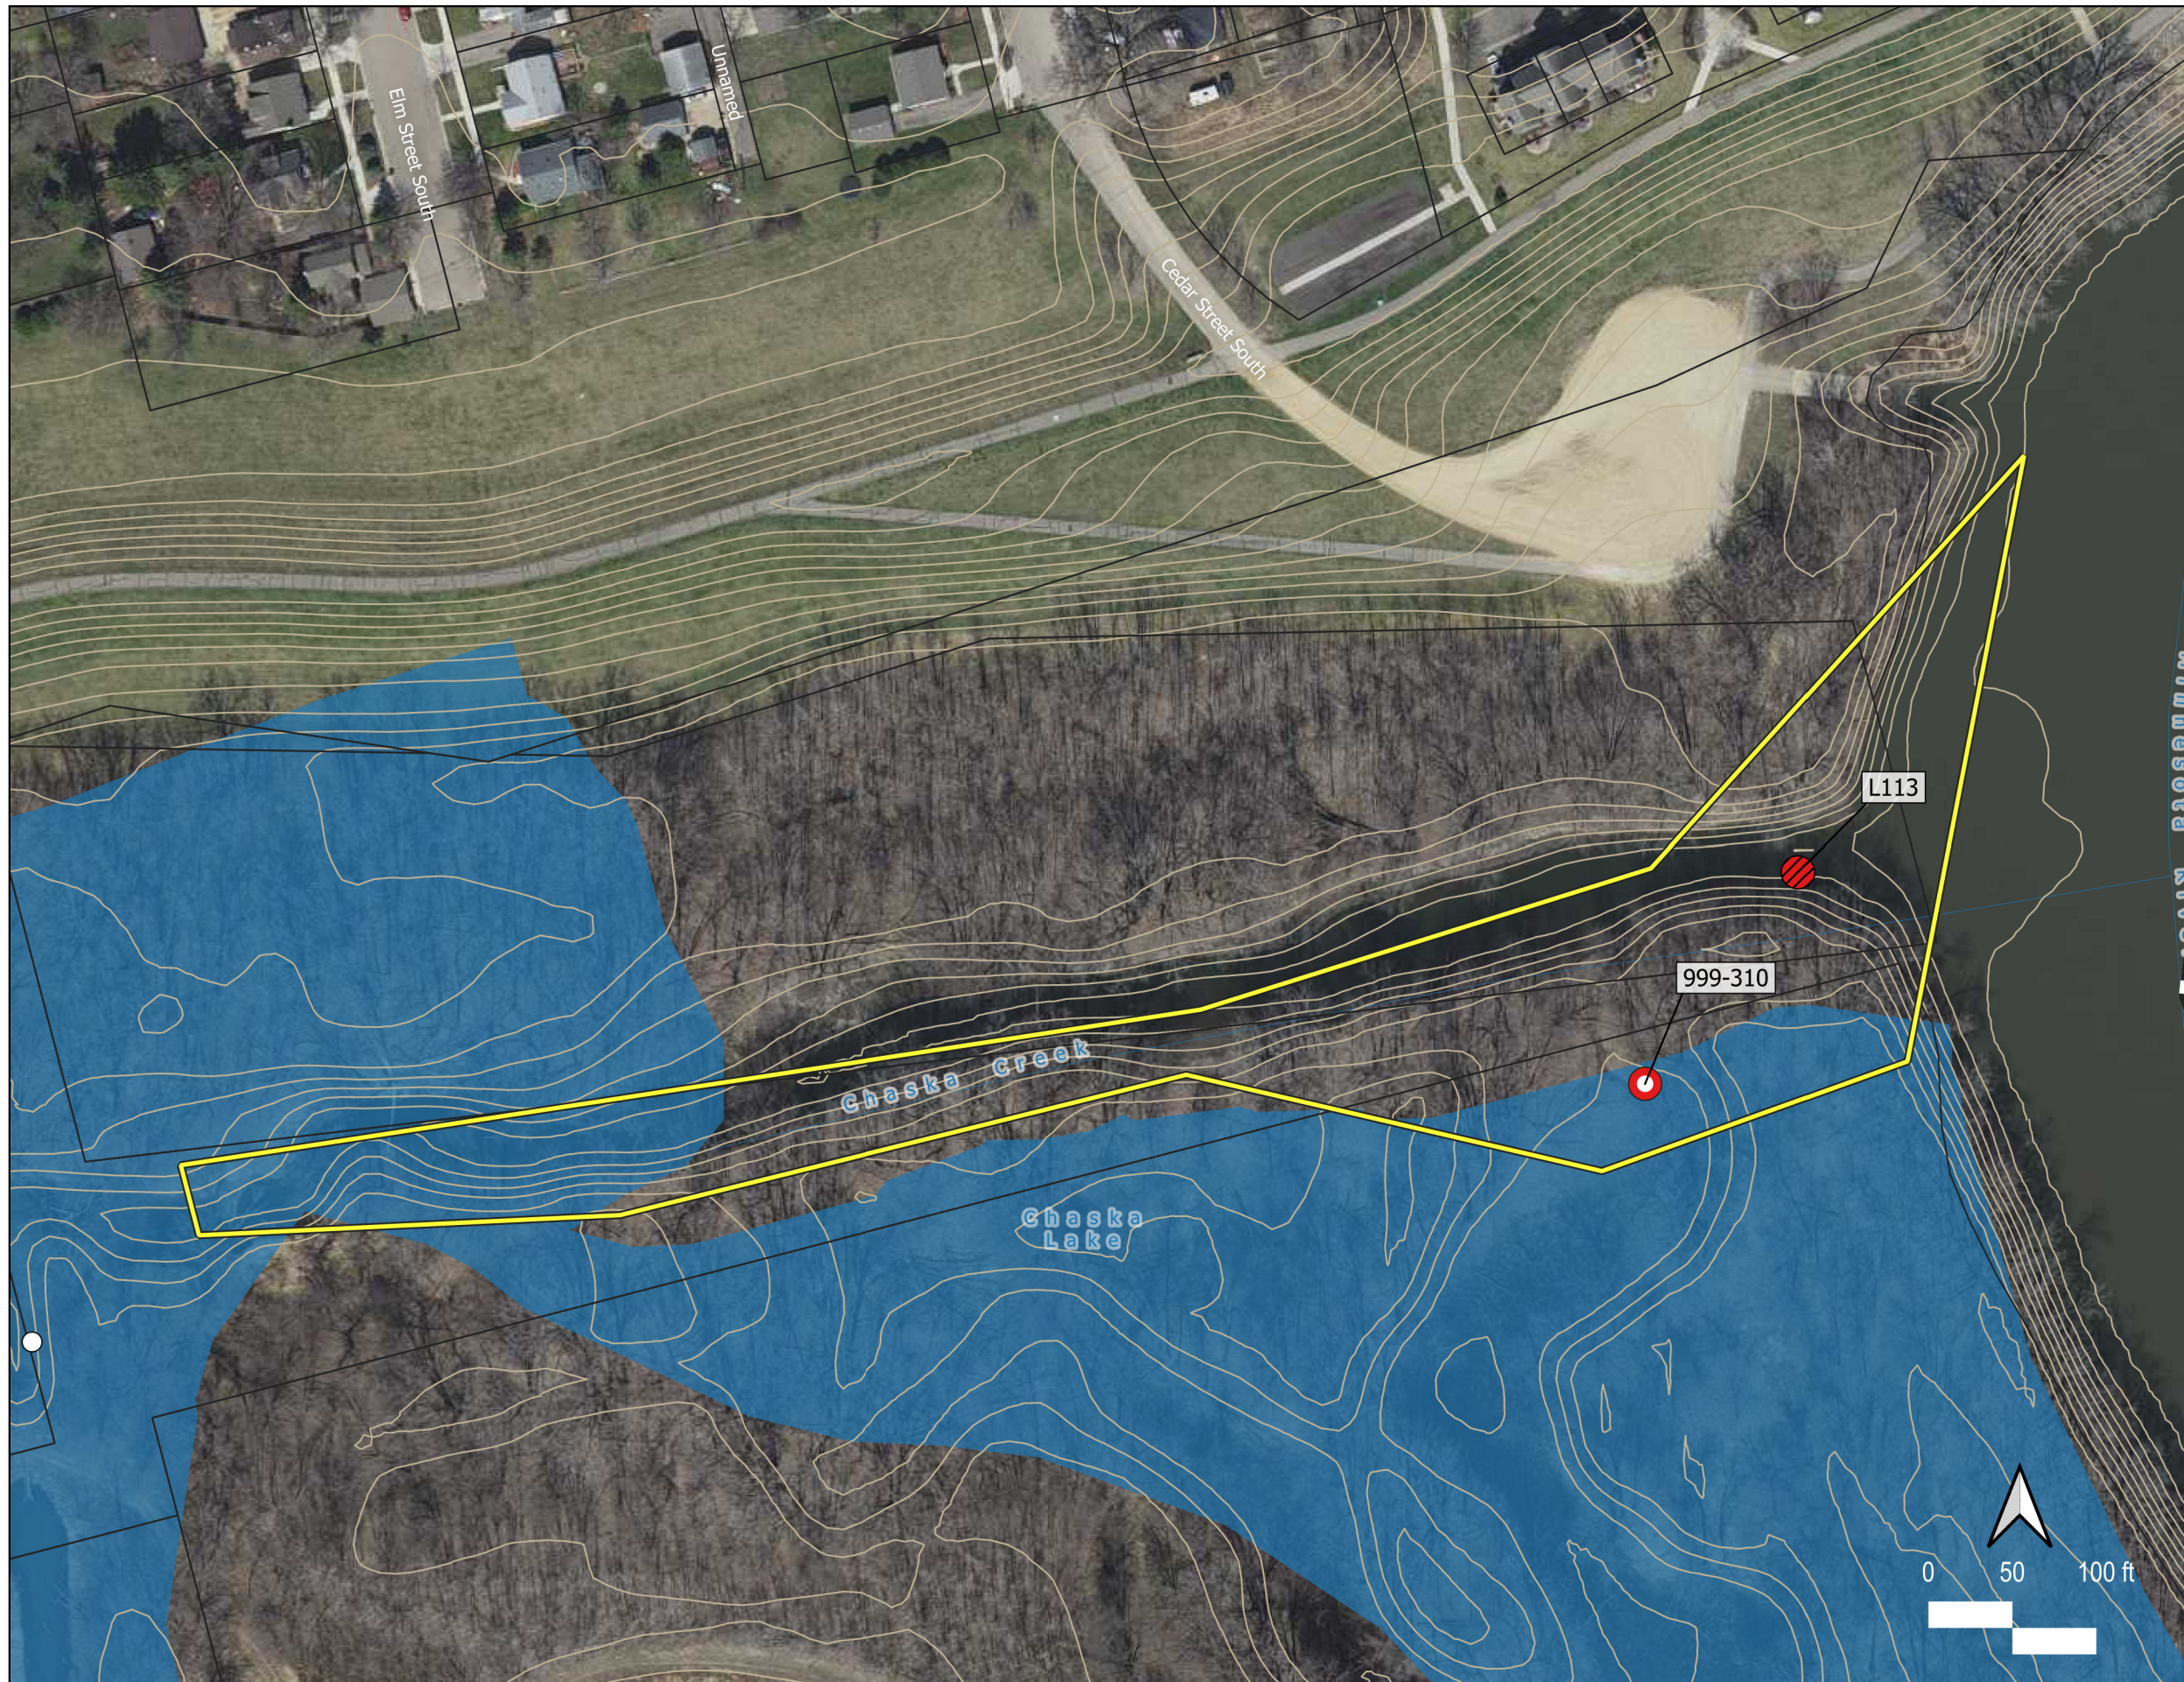
**Figure 86:
Chaska High-Priority
Region No. 24**

From our review of the field data collected, Chaska contained only one HPR at the delta of the Chaska Creek with the Minnesota River (**Figure 86**). The HPR contained Points L113 and L509, one in the channel of Chaska Creek and the other an offshoot finger gully that drains into the creek. Both gullies had a medium depth, but varied in width, length, slopes, and shape. Gully L509 was a narrow, medium length and sized gully with a steep channel gradient. Gully L113 was a long, medium-sized, wide gully with a flat channel gradient. Water was present in both channels, representing a consistent source of erosive power for the region. Commonly, the gullies in the region have bare banks and channel bottoms. L509 was observed to have fine-grained cohesive sediment as its predominant material and a trapezoidal channel shape. L113 was observed to have sand as its predominant material and a U-shaped channel. Water was present at the time of the visit for both sites. A low level of fast-moving water was seen at L509, and a full amount of fast-moving water was observed at L113. No seeps were observed in this region at the time of the visit.

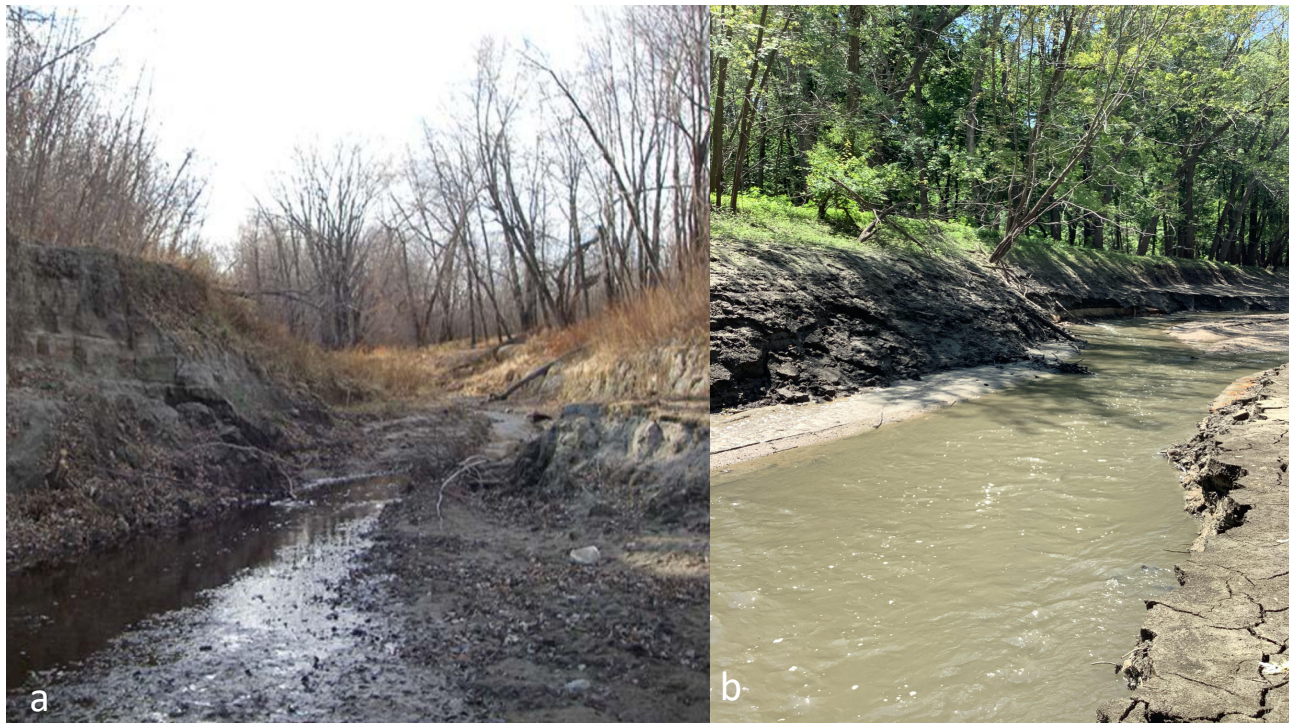
Common problem indicators in the region were incision and slumping. Site L509 also exhibited degradation, leaning trees, and undercut banks at the time of the visit. The apparent cause for the region was found to be channel incision. It was also noted at L509 that other apparent causes for its formation included slope and lack of any vegetation. It was determined in the field that the stream channel at point L113 would continue to erode severely if left unchecked.

In 2008, the survey documented L113 as severe incision and erosion of the banks of Chaska Creek and noted the sediment delta at its confluence with the Minnesota River. The benchmarking study completed in 2020 ranked it as having high erosion potential based on the visual evidence provided from the 2008 inventory. In 2020, the field team also observed severe channel incision and erosion and confirmed the presence of the sediment delta at L113. The team concurred with the high erosion potential ranking.

Figure 87 shows a side-by-side comparison of conditions observed in both studies. **Figure 87a** shows the upstream view of L113's channel taken in 2008, highlighting the severe incision and erosion along its valley wall. **Figure 87b** shows an upstream view of the channel taken in 2020, highlighting similar severe incision and erosion along the valley wall as was observed in 2008. Gully L509 was not documented in the 2008 inventory, and therefore, a prior benchmarking condition could not be assigned to it.

Figure 87. Photo 'a' is an upstream view of L113's channel taken in 2008; Photo b is an upstream view of L113's channel taken in 2020

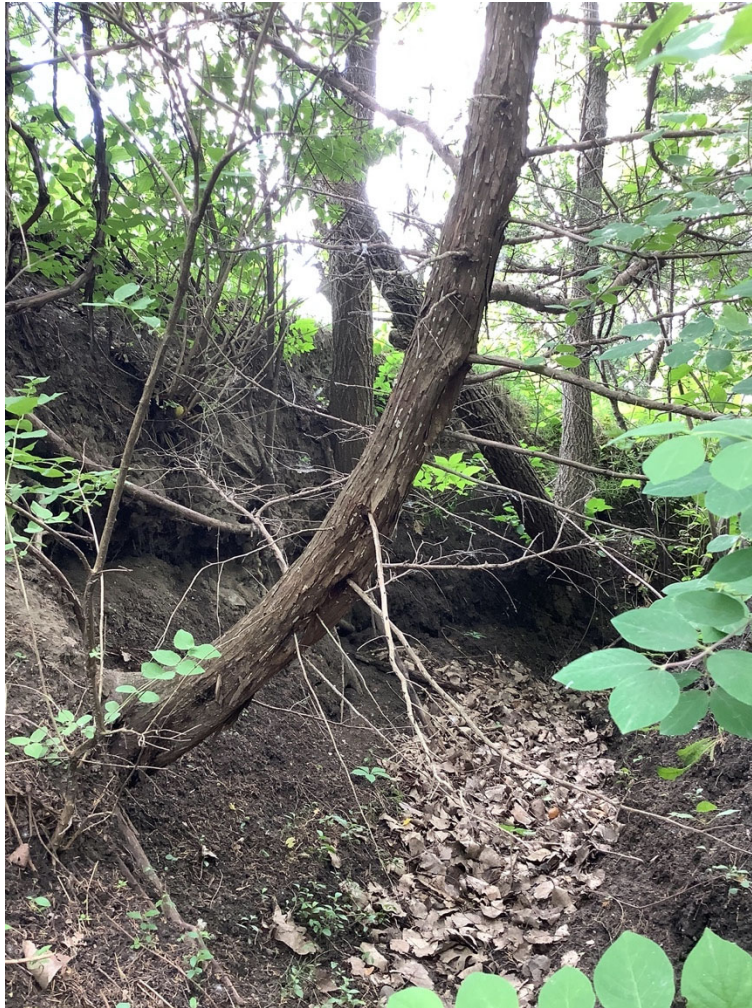
Gully 999-035 is a newly identified gully found during the 2020 study. It is a stand-alone gully site located on the north side of Clay Hole Lake. It is a medium-sized, narrow gully that had no water present in the channel at the time of the visit. Additionally, no seeps were noted at the time of the visit. 999-035 was observed to have a flat channel gradient, with a V-shaped channel. The gully was found to have a bare channel bottom with some vegetation noted along its banks. Sand was the predominant gully material at this site.

The problem indicators seen at 999-035 when visited include loss of bank vegetation, incision, slumping, undercut banks, and leaning trees. **Figure 88** shows a downstream view of 999-035's channel, depicting the incision, leaning trees, and undercut banks observed in the field during the 2020 study. No apparent causes were clearly delineated at this site, and dense buckthorn canopy was the suggested culprit. This site was not evaluated in the 2008 Inventory; therefore, no benchmarking conditions can be attributed to it for erosion progression or comparison.

Figure 88. Downstream view of 999-035's channel taken in 2020.

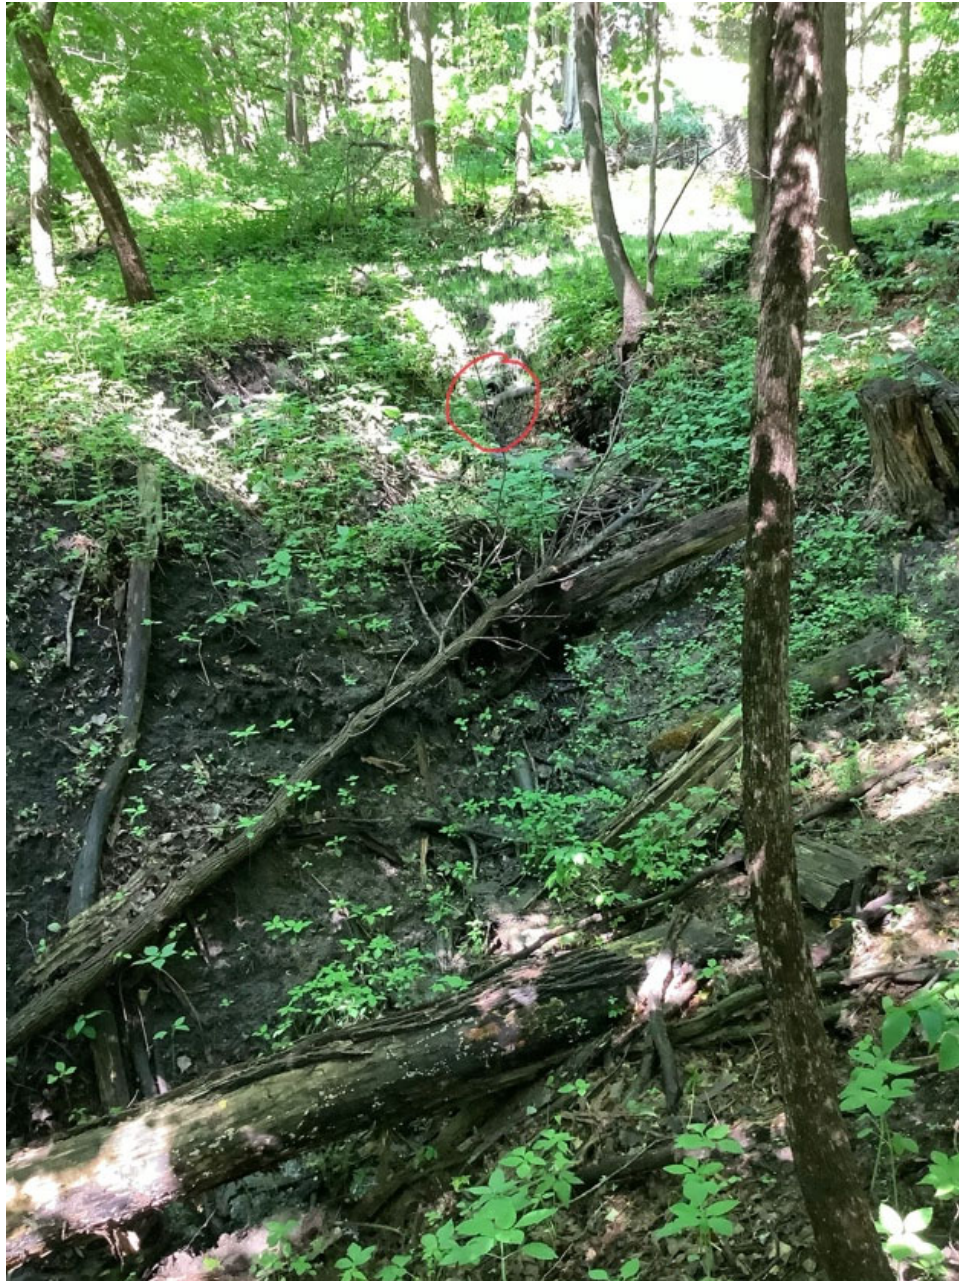
Gully Site 999-005 is a newly identified gully located on the valley wall overlooking the north side of Seminary Fen. It was found in the field to be a short, medium-sized gully with a steep channel gradient. A low amount of fast-moving water was present at the time of the visit to the gully, with a high-intensity rainfall occurring in the previous 24 hours. No seeps were noted at the time of the visit.

The problem indicators observed at 999-005 were incision, degradation, and loss of bank vegetation. The apparent cause of the gully was determined to be an existing residential drainage pipe causing severe downstream erosion. **Figure 89** shows the residential drainage pipe and its discharge area forming the head cut of the gully. As this is a newly identified site, this gully was not evaluated in 2008; therefore, no benchmarked condition can be assigned to it.

Figure 89. Upstream view of Gully 999-005's channel taken in 2020, residential drain pipe is circled in red.
