10.0 JACKSON TOWNSHIP

10.4 Jackson Township Gully Progression

10.5 Jackson Township High-Priority Sites

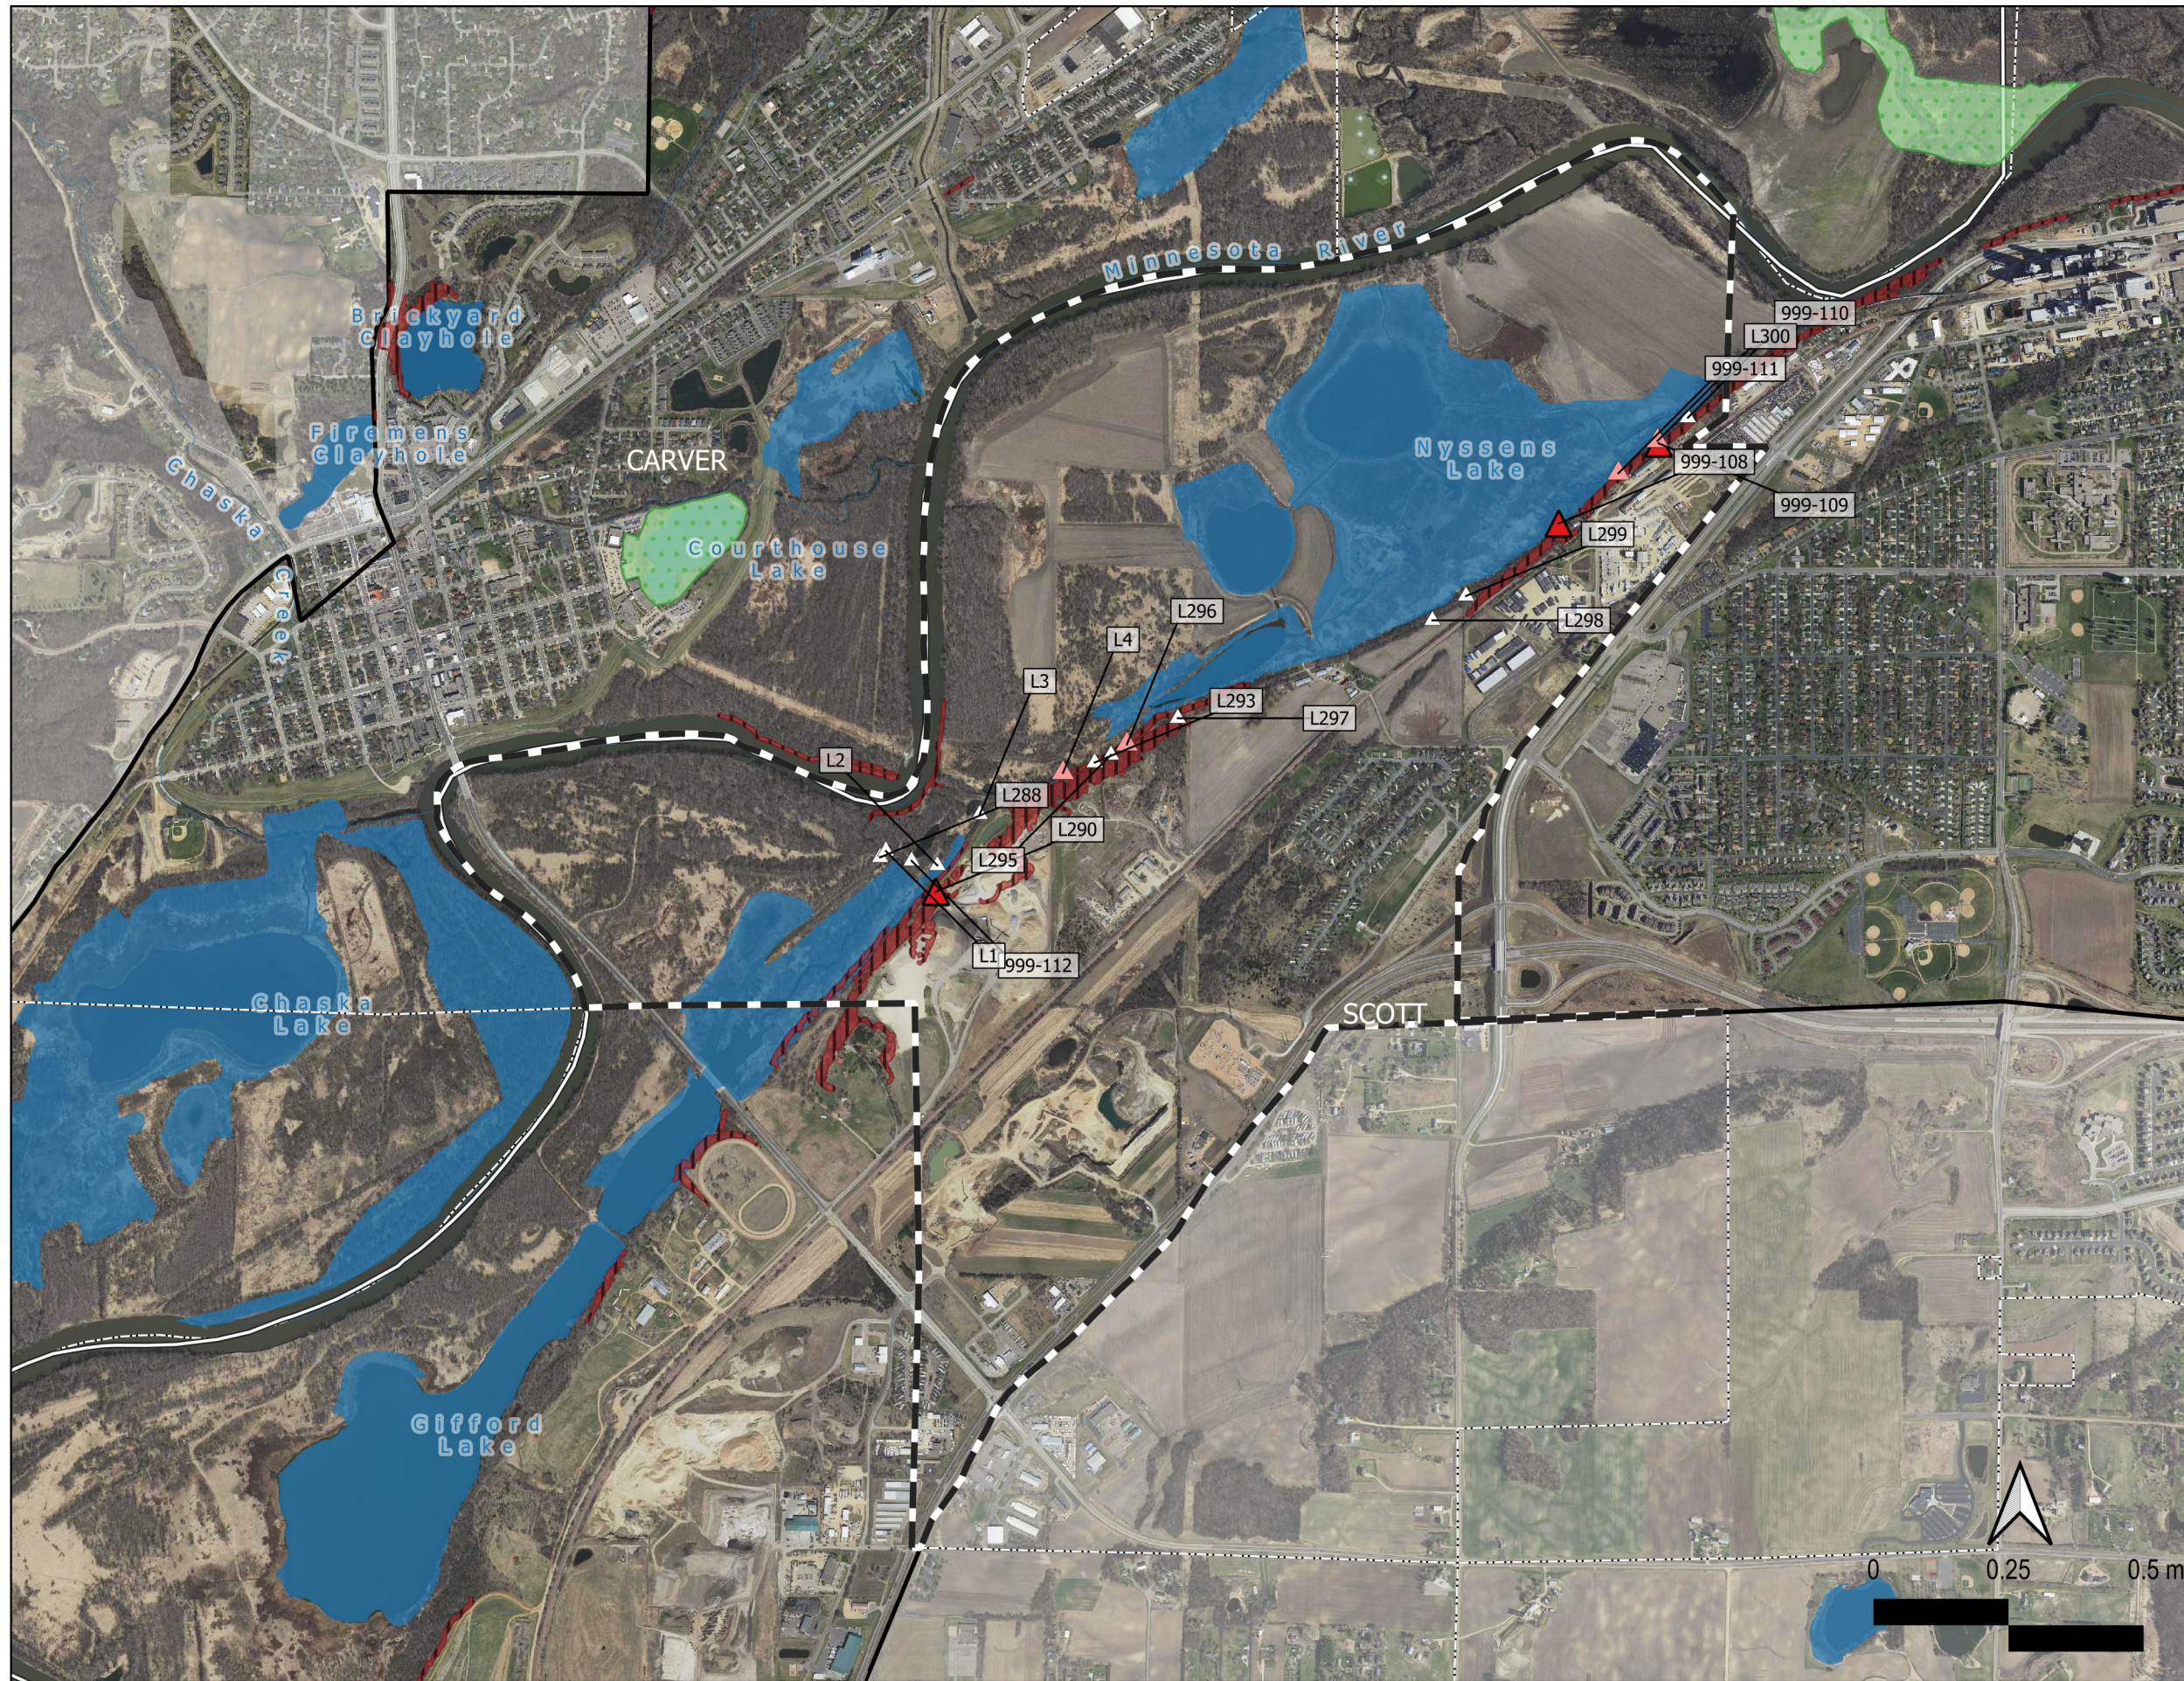
**Figure 108:
Jackson Twp. 2020
Pipe Outfall
Conditions**

Overall gully evolution from 2008 to 2020 appears to have remained relatively steady, with most sites not having progressed in severity since 2008. The benchmarking analysis did over-estimate the number of gullies when compared with the 2020 survey, shown in **Table 10-1**. During field surveys, many sites were discovered not to be true gullies but rather pipe outfalls in poor condition (**Figure 108**).

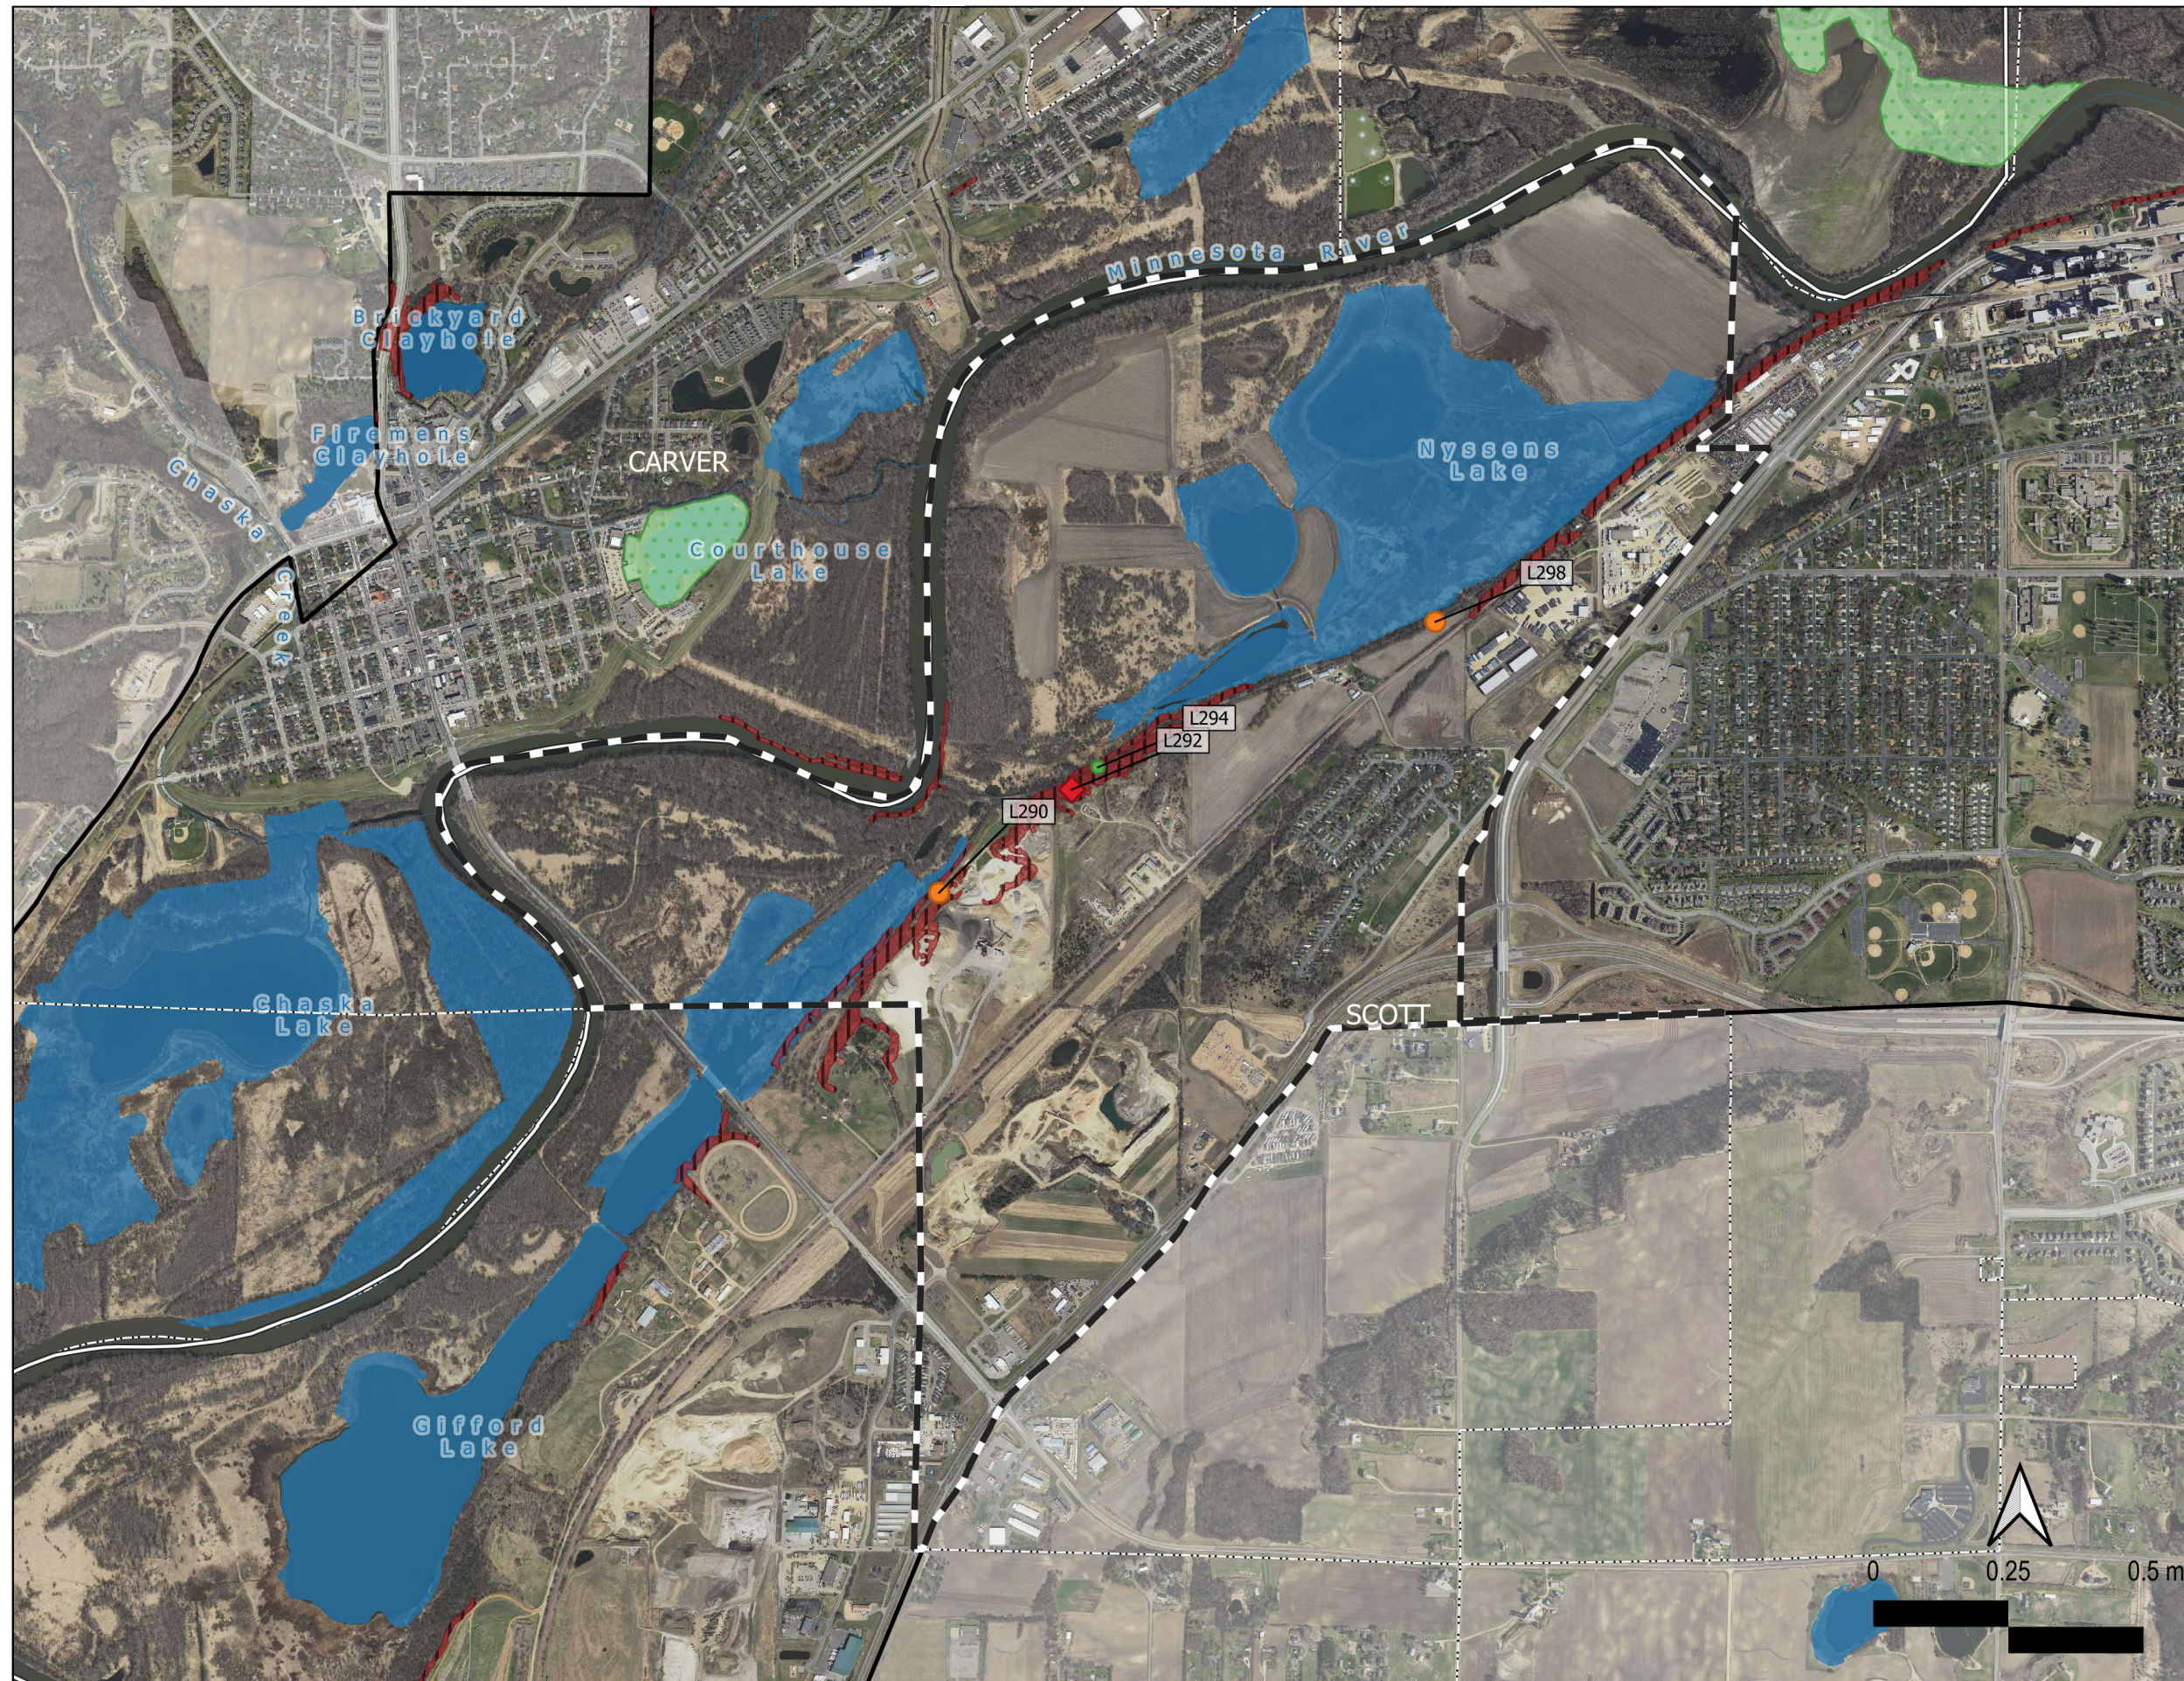
**Figure 109:
Jackson Twp. 2020
Gully Conditions**

One gully moved from the high erosion potential category to the moderate erosion potential category; another moved from moderate to low. Gully L290 was characterized in the 2008 Inventory as a pipe outfall causing significant erosion in its downstream scour, creating a channel. Due to the limited information available, it was rated as a high erosion potential site during the desktop analysis. During the field survey it was determined that the site has not eroded significantly since the previous survey, and was accordingly recategorized as having moderate erosion potential. However, the pipe outfall required attention (**Figure 108**). Gully L294 was observed in during the 2008 Inventory as having moderate erosion potential. During the field survey, the site was determined to have a low erosion potential because of the heavy vegetation observed to be providing stability throughout the channel (**Figure 109**).

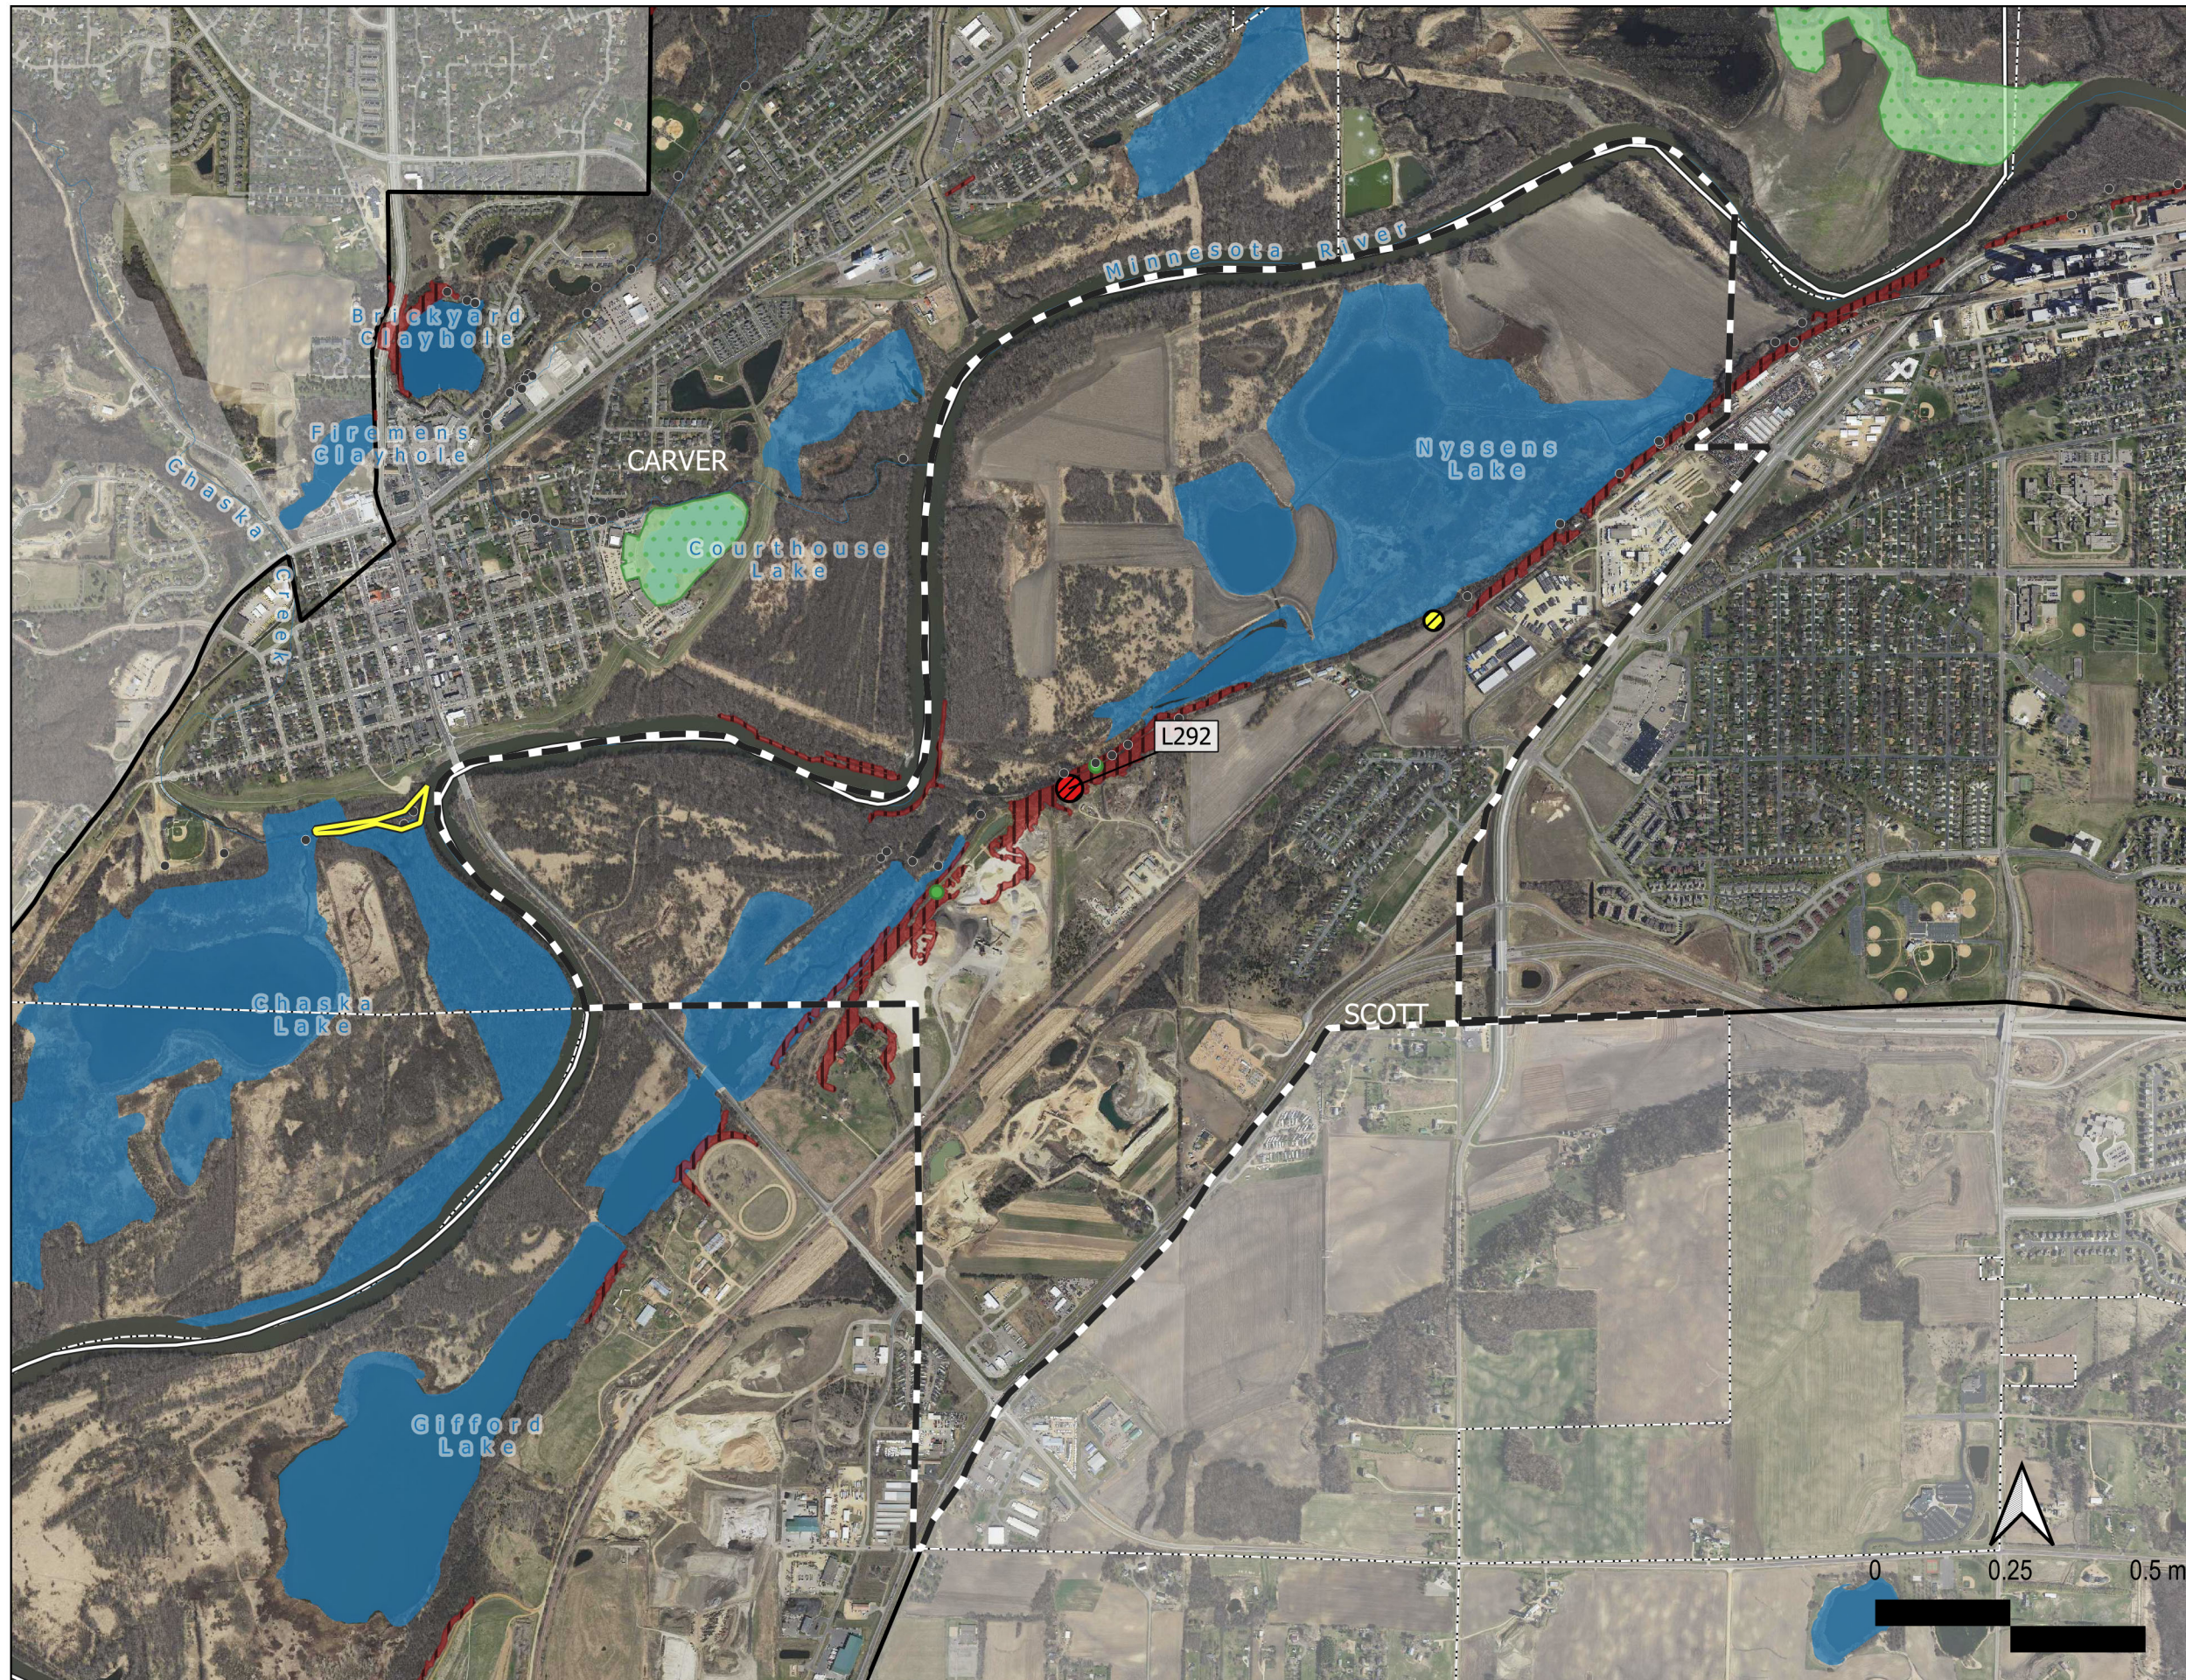
**Figure 110:
Jackson Twp. Erosion
Progression and HPRs**

Jackson Township was found to only have one high-priority site, and in turn, no region groupings were created for the City (**Figure 110**). The high-priority site's characteristics and rationale for its ranking is described in the section below.

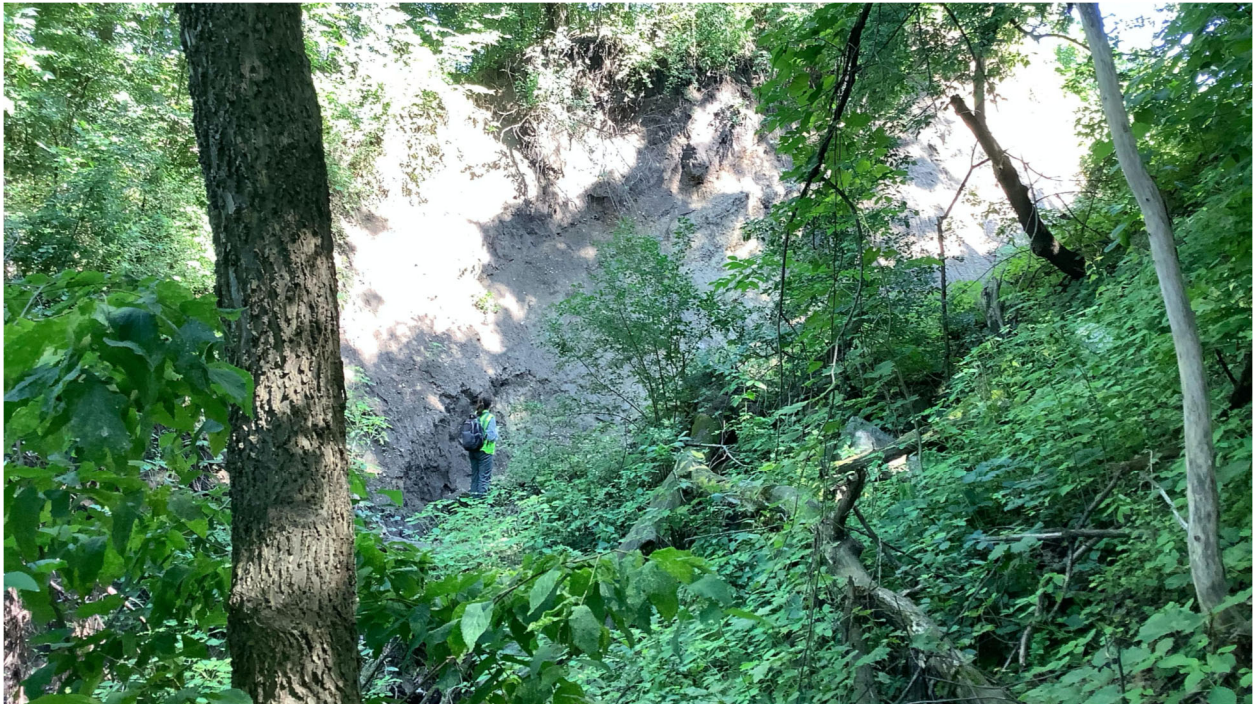
Gully L292 was found to be a deep, steep, and long gully; the gully channel was incised throughout its length. The right bank had bare soil, while the left bank had some vegetation. A quarry for Barton Sand & Gravel Co. was located right behind the head cut of the gully. The problem indicators observed at the time of the visit included slumping, overhanging/undercut banks, loss of bank vegetation, incision, and leaning trees. Additionally, a medium amount of buckthorn was noted, which may have contributed to the observed loss of bank vegetation. A large severe slump was seen on the right bank of the gully with overhanging banks along the top edge. **Figure 111** is an image taken in 2020 showing the scale of the slump along the gully channel and the magnitude of erosion and incision, further providing rationale for the site's high-priority ranking. An additional slump was observed downstream of L292 with overhanging banks. The apparent causes for the gully were not distinct and conclusive, but the field team hypothesized that slope and channel incision would be the likely culprits.

Figure 111. Side stream view of the large slump on Gully L292's right bank, with person for scale.

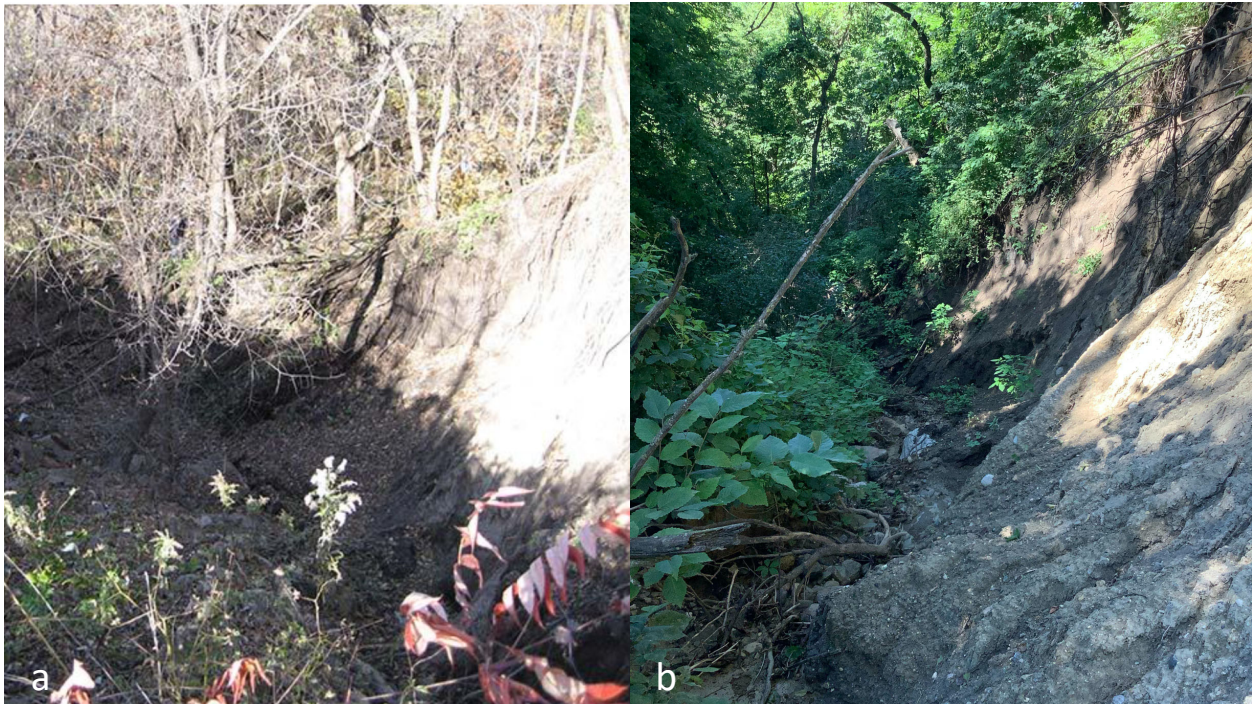
The gully was noted in the 2008 Inventory to have lots of litter, major erosion, large boulders, and natural springs. The field survey confirmed a substantial amount of erosion, resulting in a high erosion potential. No groundwater seeps or water in the channel were observed during the field survey. The Minnesota Spring Inventory confirmed that there is no evidence of groundwater upwelling in the region around L292. **Figure 112** is a side by side comparison of the 2008 and 2020 conditions observed. Both images show the incised, steep banks. **Figure 112b** depicts the recent slumping seen in the channel in 2020, showing that this gully is actively eroding.

Figure 112. Photo 'a' shows the downstream channel conditions at Gully L292 in 2008; Photo 'b' shows the downstream channel conditions in 2020.
