13.0 CITY OF MENDOTA HEIGHTS

13.3 Findings

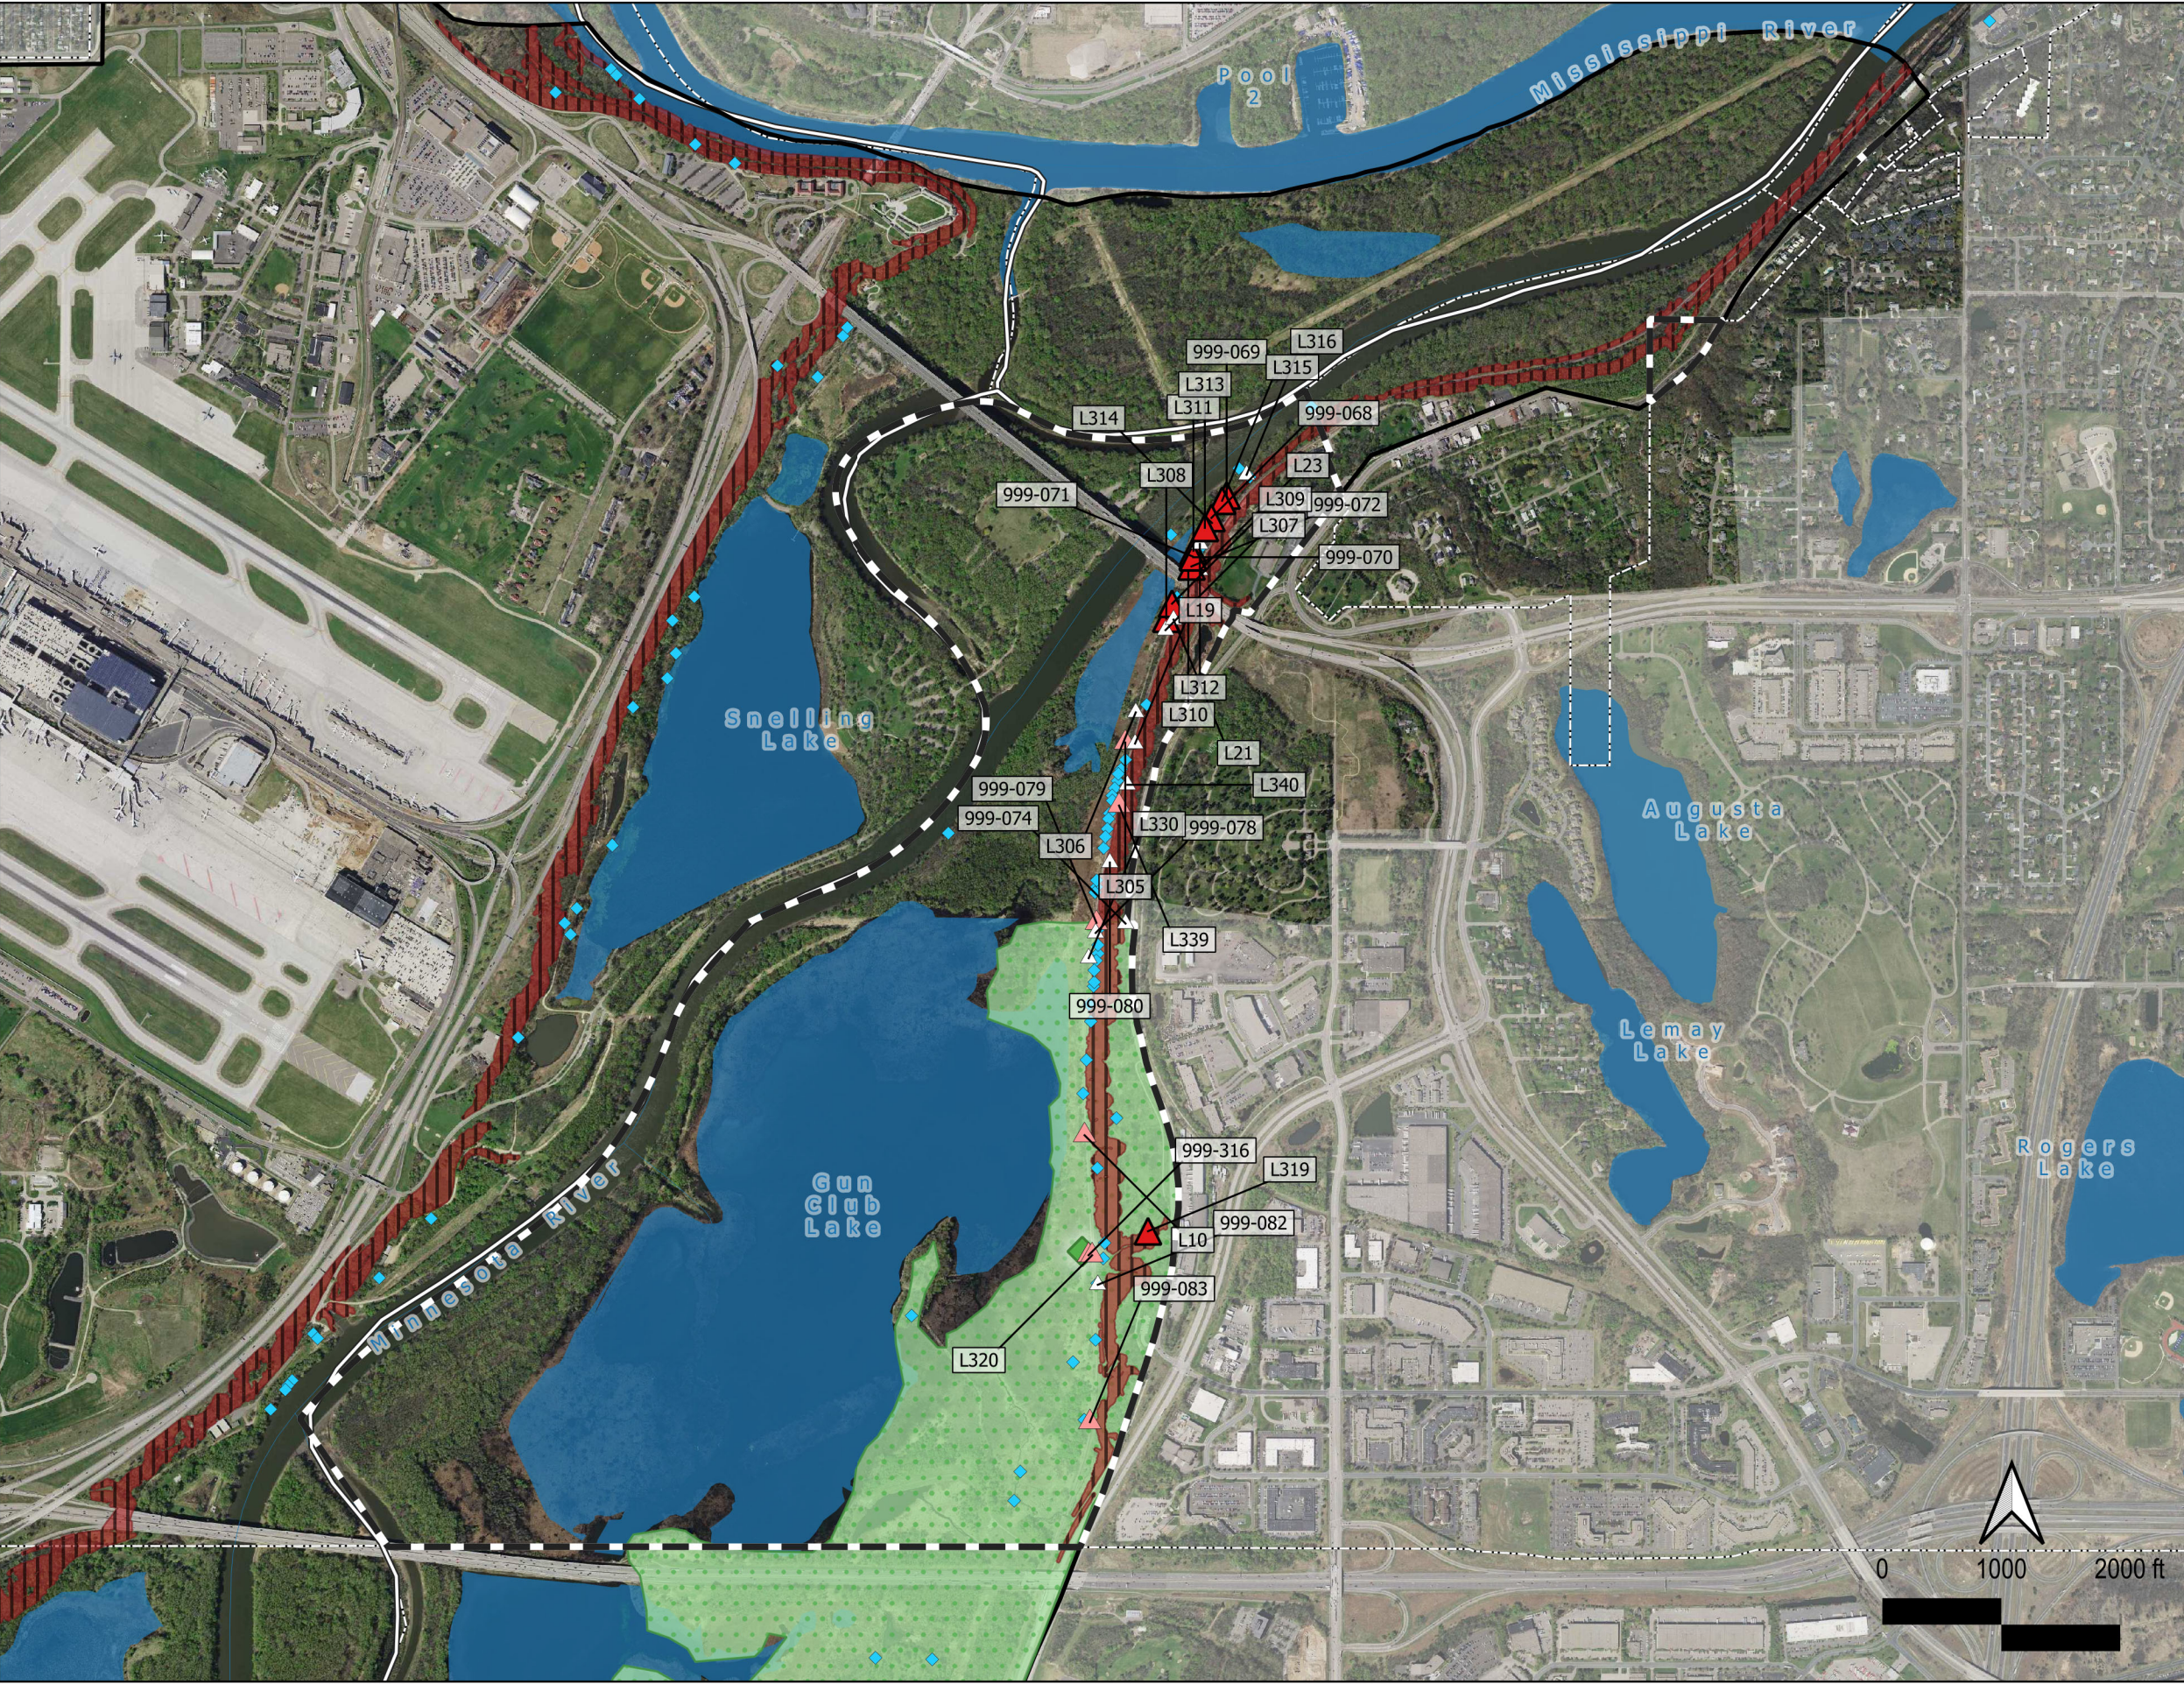
**Figure 122:
Mendota Heights
2020 Pipe Outfall
Conditions**

the field team identified and evaluated 31 pipe outfalls located along the railroad track (**Figure 122**). Seven sites could not be reached due to vegetation, but may be good candidates for either drone inspection or for a reinspection in the early spring or late fall after the loss of foliage.

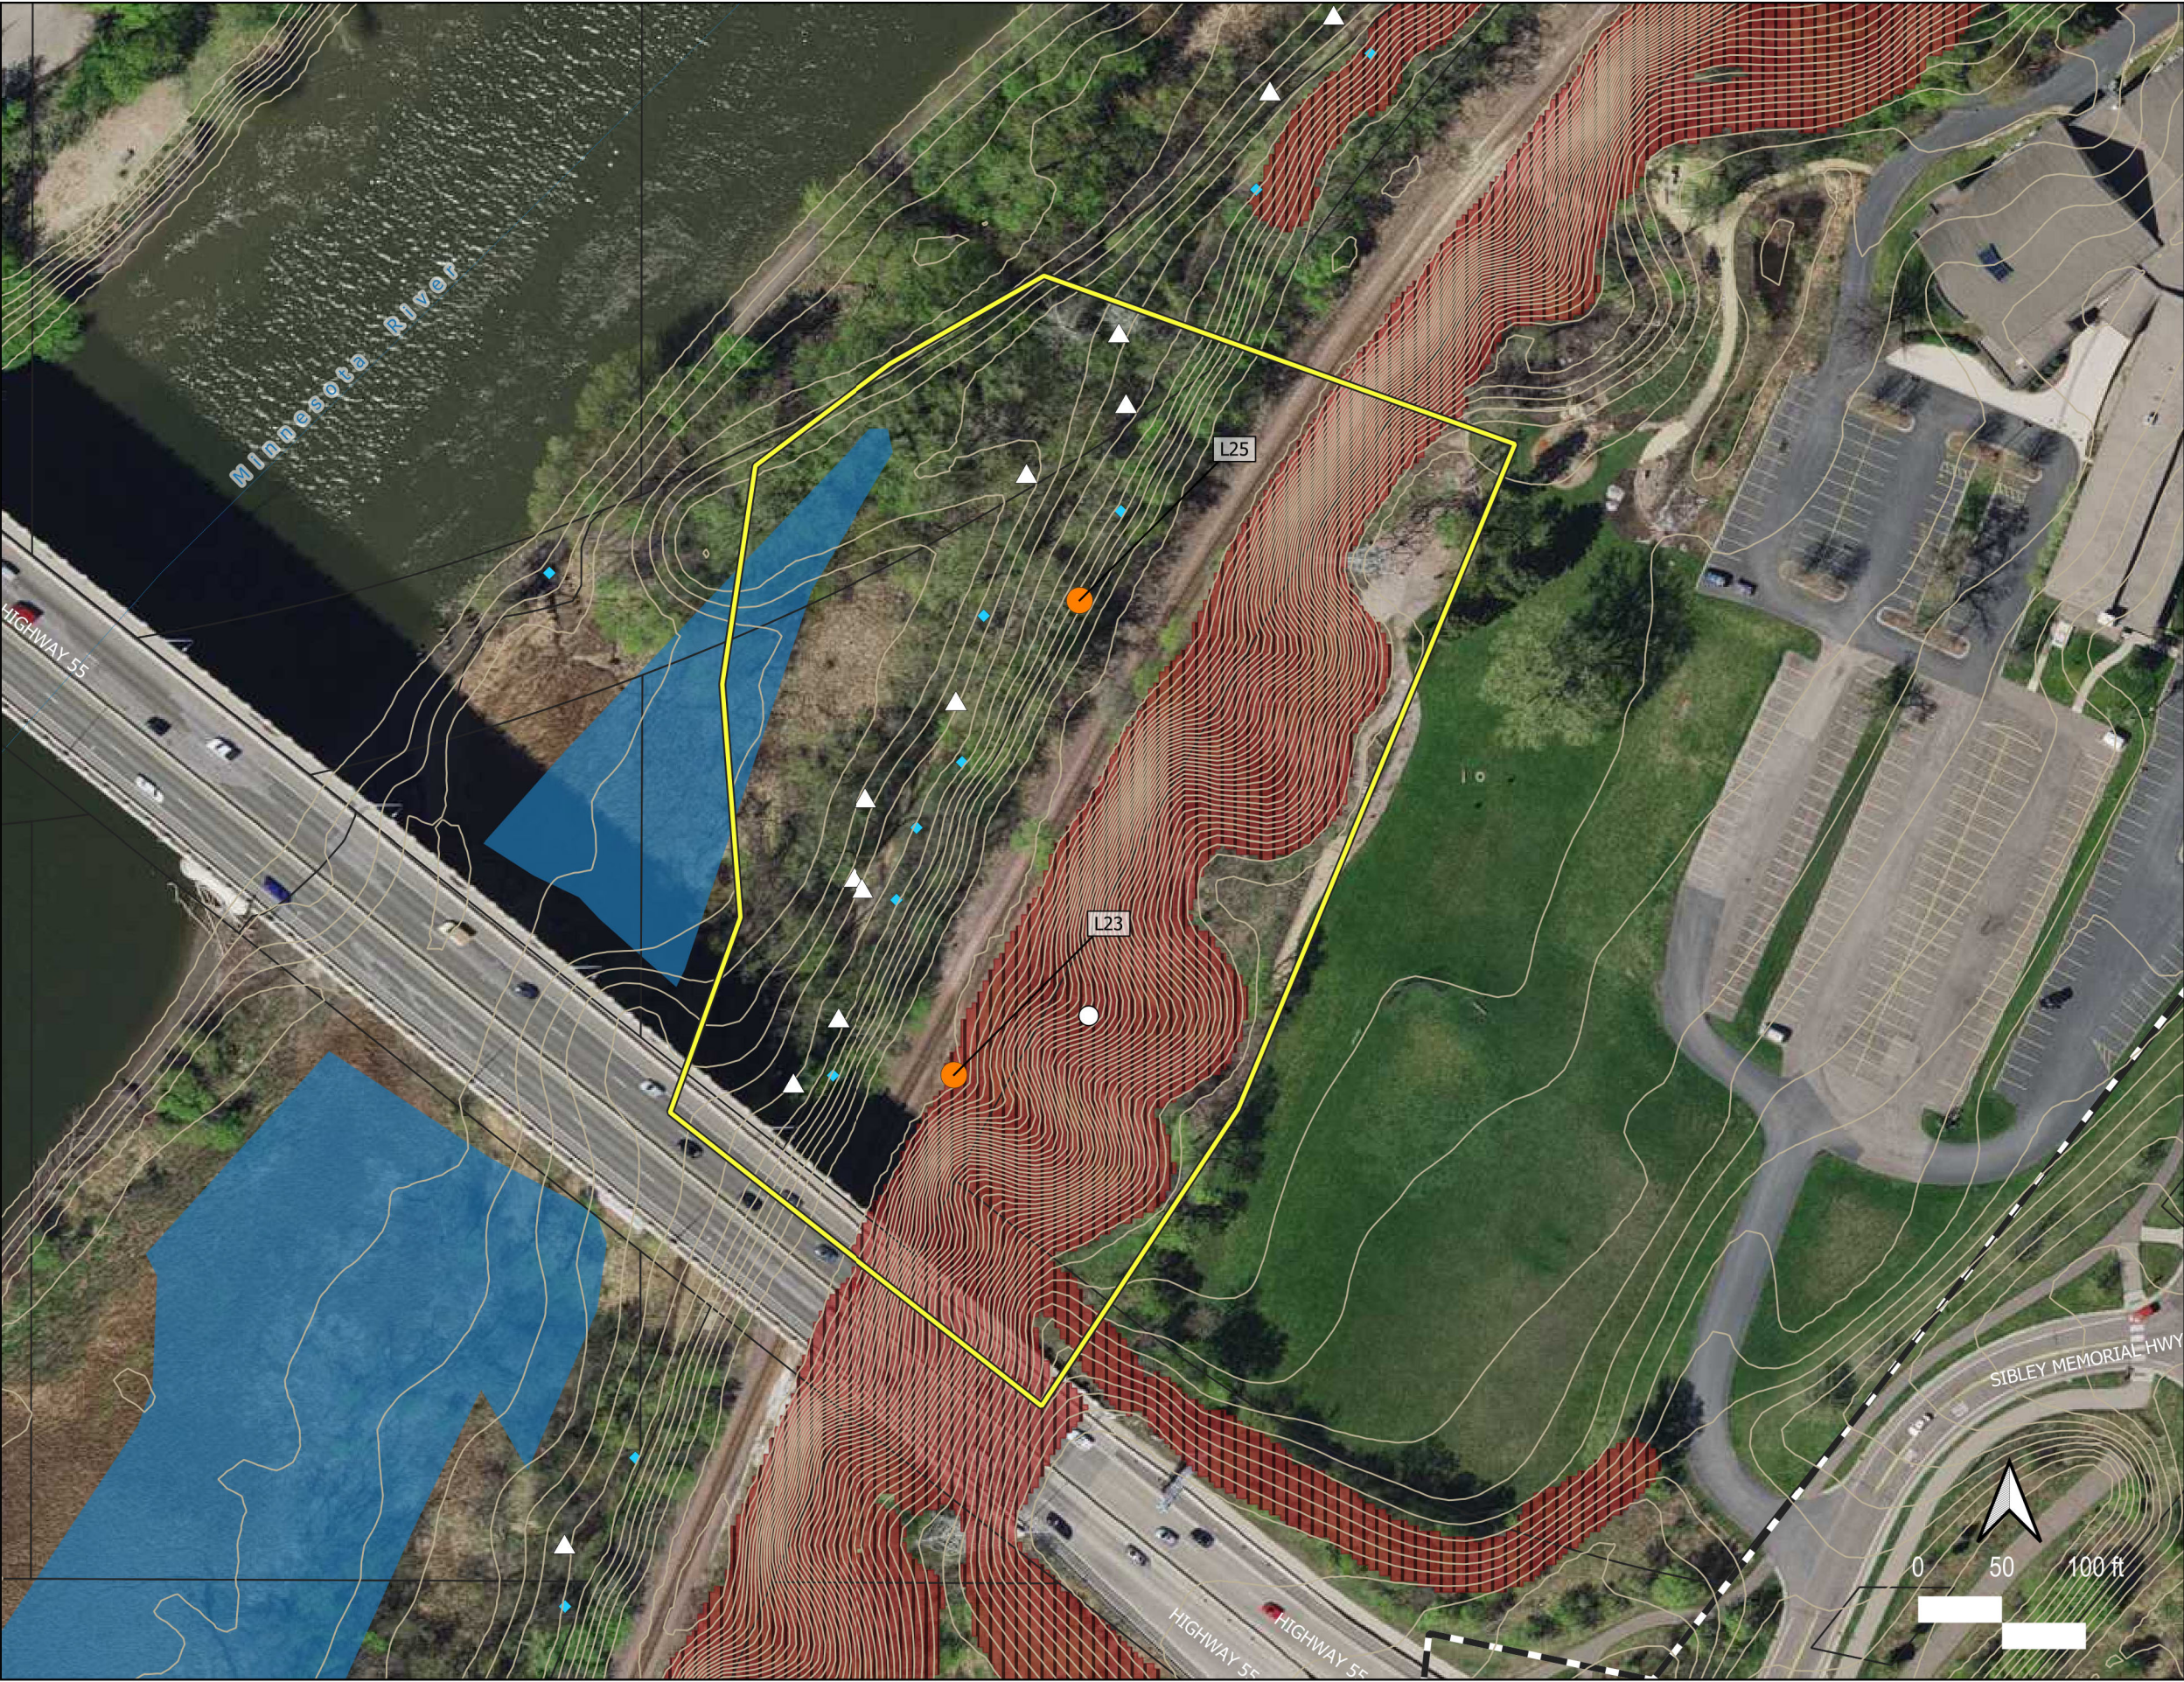
**Figure 125:
Mendota Heights
High Priority Region
No. 21**

HPR 21 consists of Gullies L25 and L23 ([Figure 125](#)). Both gullies have progressed from moderate to high erosion potential between 2008 to 2020. The gullies in the region are deep and have a range from narrow to medium-sized channel width. Bare soil around the channels is common to the region, and the soil material was observed to be sandy due to the underlying St. Peter sandstone. Rockfall debris was seen throughout the region, with fractured pieces of bedrock acting as natural armoring for the channels. Throughout the region, eroding bedrock was observed as an apparent cause for gully formation along with high-gradient channel slopes. Leaning trees were commonly observed within HPR 21, pointing to active slope movement. Gully L25 was found to exhibit signs of channel incision and bank slumping. Gully L23 showed signs of degradation near the toe, where it entered a pipe outfall that ultimately drains into the Minnesota River.

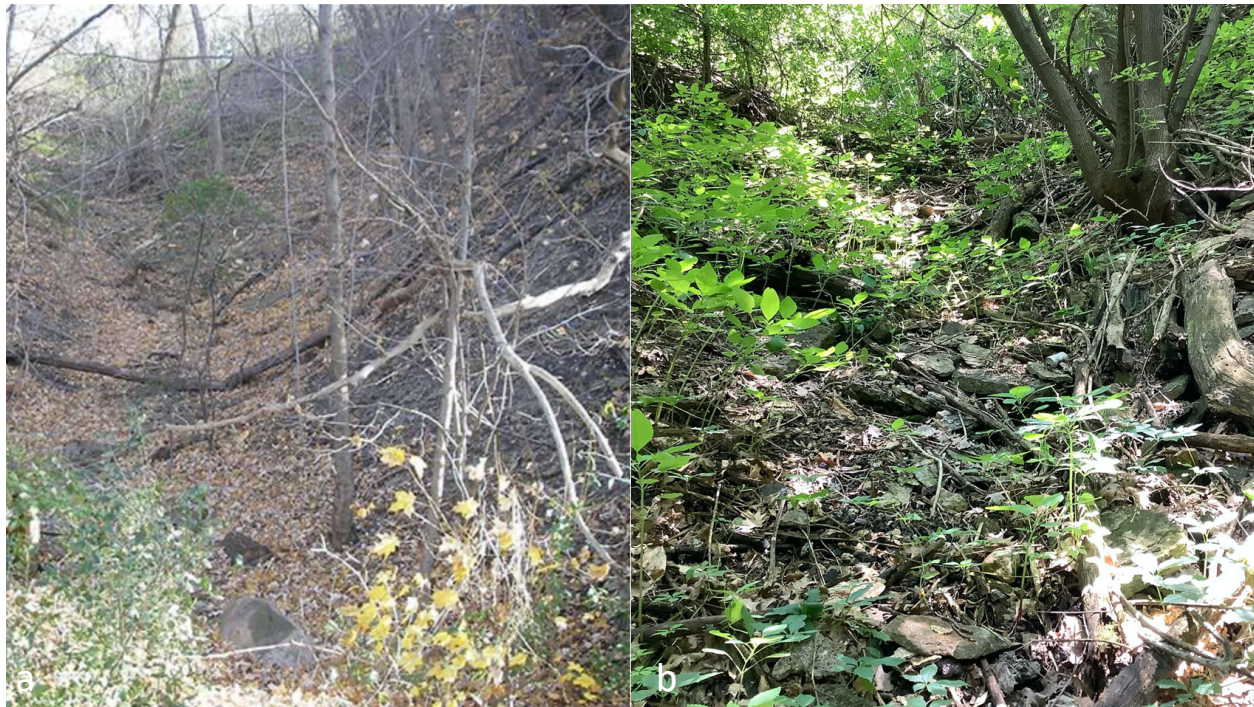
In 2008, Gully L23 was described as “moderate-major erosion” and it was classified as moderate erosion during the desktop analysis. In 2020, the field team observed the gully to have a high erosion potential, finding that the gully has progressed to a worsened state since the previous evaluation. Increased incision, reduced vegetation, and a significant amount of rockfall and fallen tree debris were seen during evaluation in 2020 ([Figure 126](#)).

Figure 126. Upstream view of Gully L23; 3a is an upstream view of Gully L23's channel taken in 2008, 3b is an upstream view of Gully L23's channel taken in 2020.

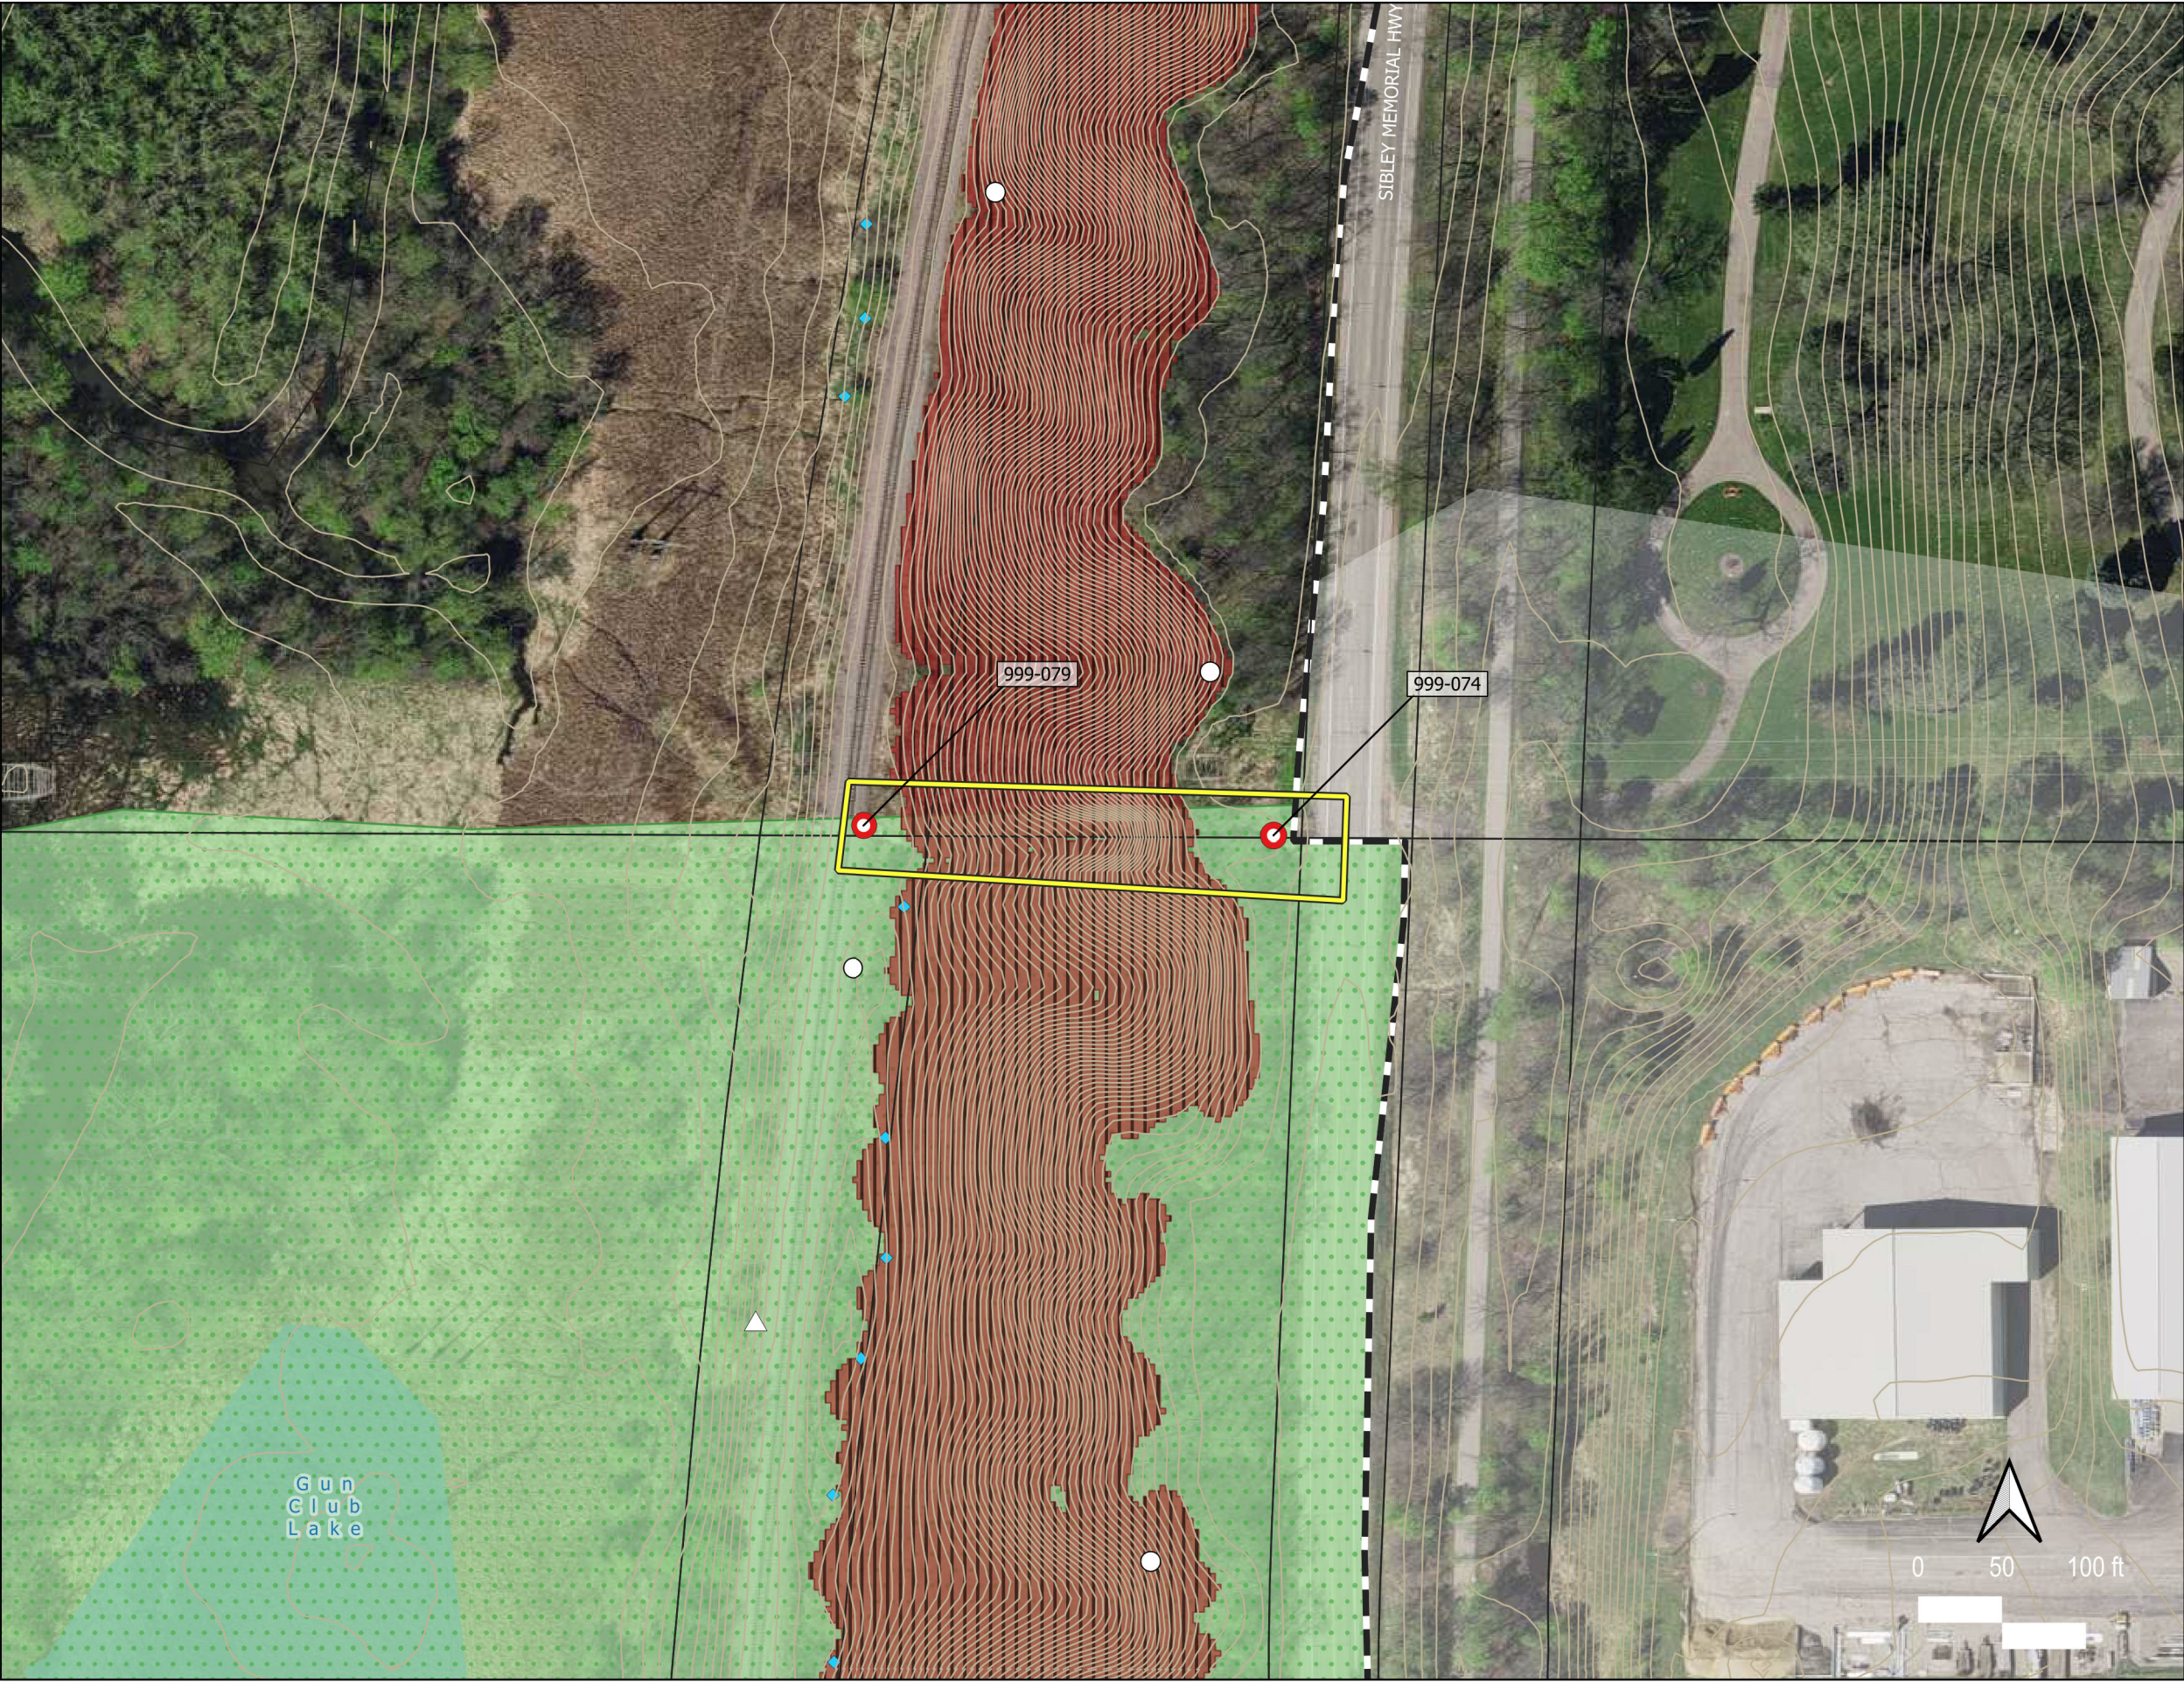
**Figure 127:
Mendota Heights
High Priority Region
No. 22**

HPR 22 consists of one gully composed of two sites, L17 and 999-047 (**Figure 127**). A culvert under Sibley Memorial Highway forms Gully L17, which discharges west into the gully, toward the Minnesota River over the top of the bluffs. At the bottom of the hillslope, the stormwater runoff has carved a scour hole and created the channel of Gully 999-047, which ultimately drains into Gun Club Lake Fen. Due to the proximity to Gun Club Lake Fen and location within the HVRA, this site was elevated to a regional high-priority ranking. **Figure 128b** shows the top of the knickpoint at the end of L17, **Figure 128c** depicts the end of the knickpoint forming the downstream channel of 999-047. In general, the gully system was found to have bare banks with an armored channel bottom due to rockfall debris. Both reaches of the channel were U-shaped and the gully material was found to be St. Peter sandstone. Differential weathering rates of the bedrock and overlying soil create incised and overhanging banks. **Figure 128b** shows an example of the differential weathering rates typical of this gully system; characterized by the overhanging, juttied out soil on top of receding sandstone outcrops below. Slumping was observed throughout the system, and leaning trees point to active slope movement. The steep knickpoint at the end of L17 causes degradation in the downstream channel of the system. The apparent causes for gully formation in HPR 22 were channel slope, incision, unstable drainage features, and eroding bedrock.

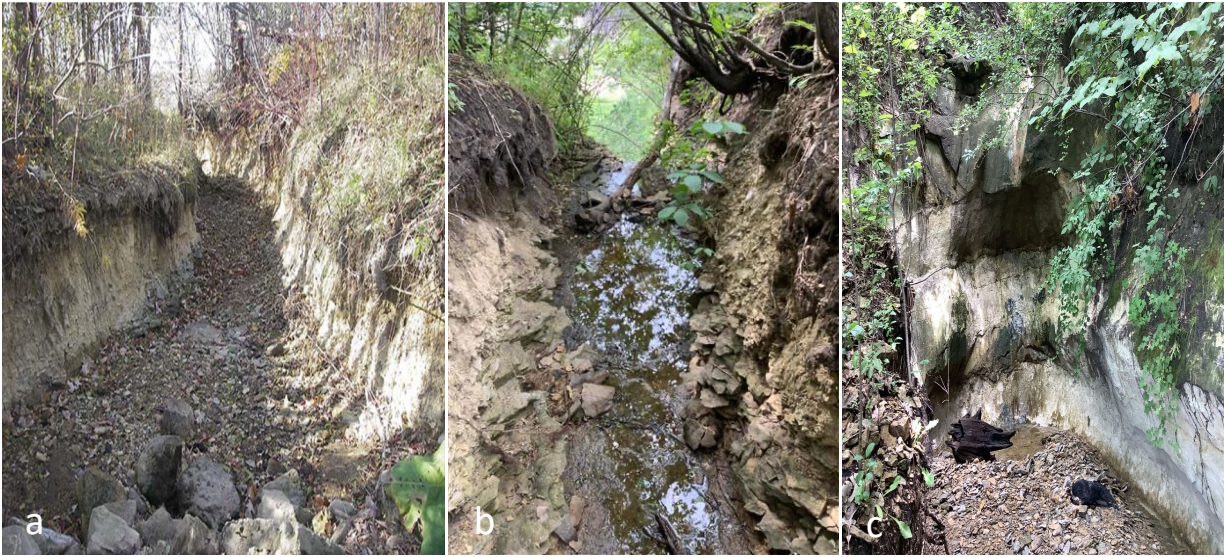
In 2008, the Gully L17 was noted to have “erosion due to a culvert creating a 3–4-foot-deep channel,” as depicted in **Figure 128a**. During the 2020 desktop analysis, the team determined it was a high erosion potential site. The 2020 field observations are consistent with the previous findings and the site has remained a high erosion potential. Gully 999-047 was not evaluated in the 2008 survey, and with no previous benchmark its erosion progression is thus unknown.

Figure 128. Left to right: a. Gully L17 upstream view in 2008; b. Gully L17 downstream view in 2020; c. Upstream view of end of knickpoint and start of Gully 999-047 in 2020.

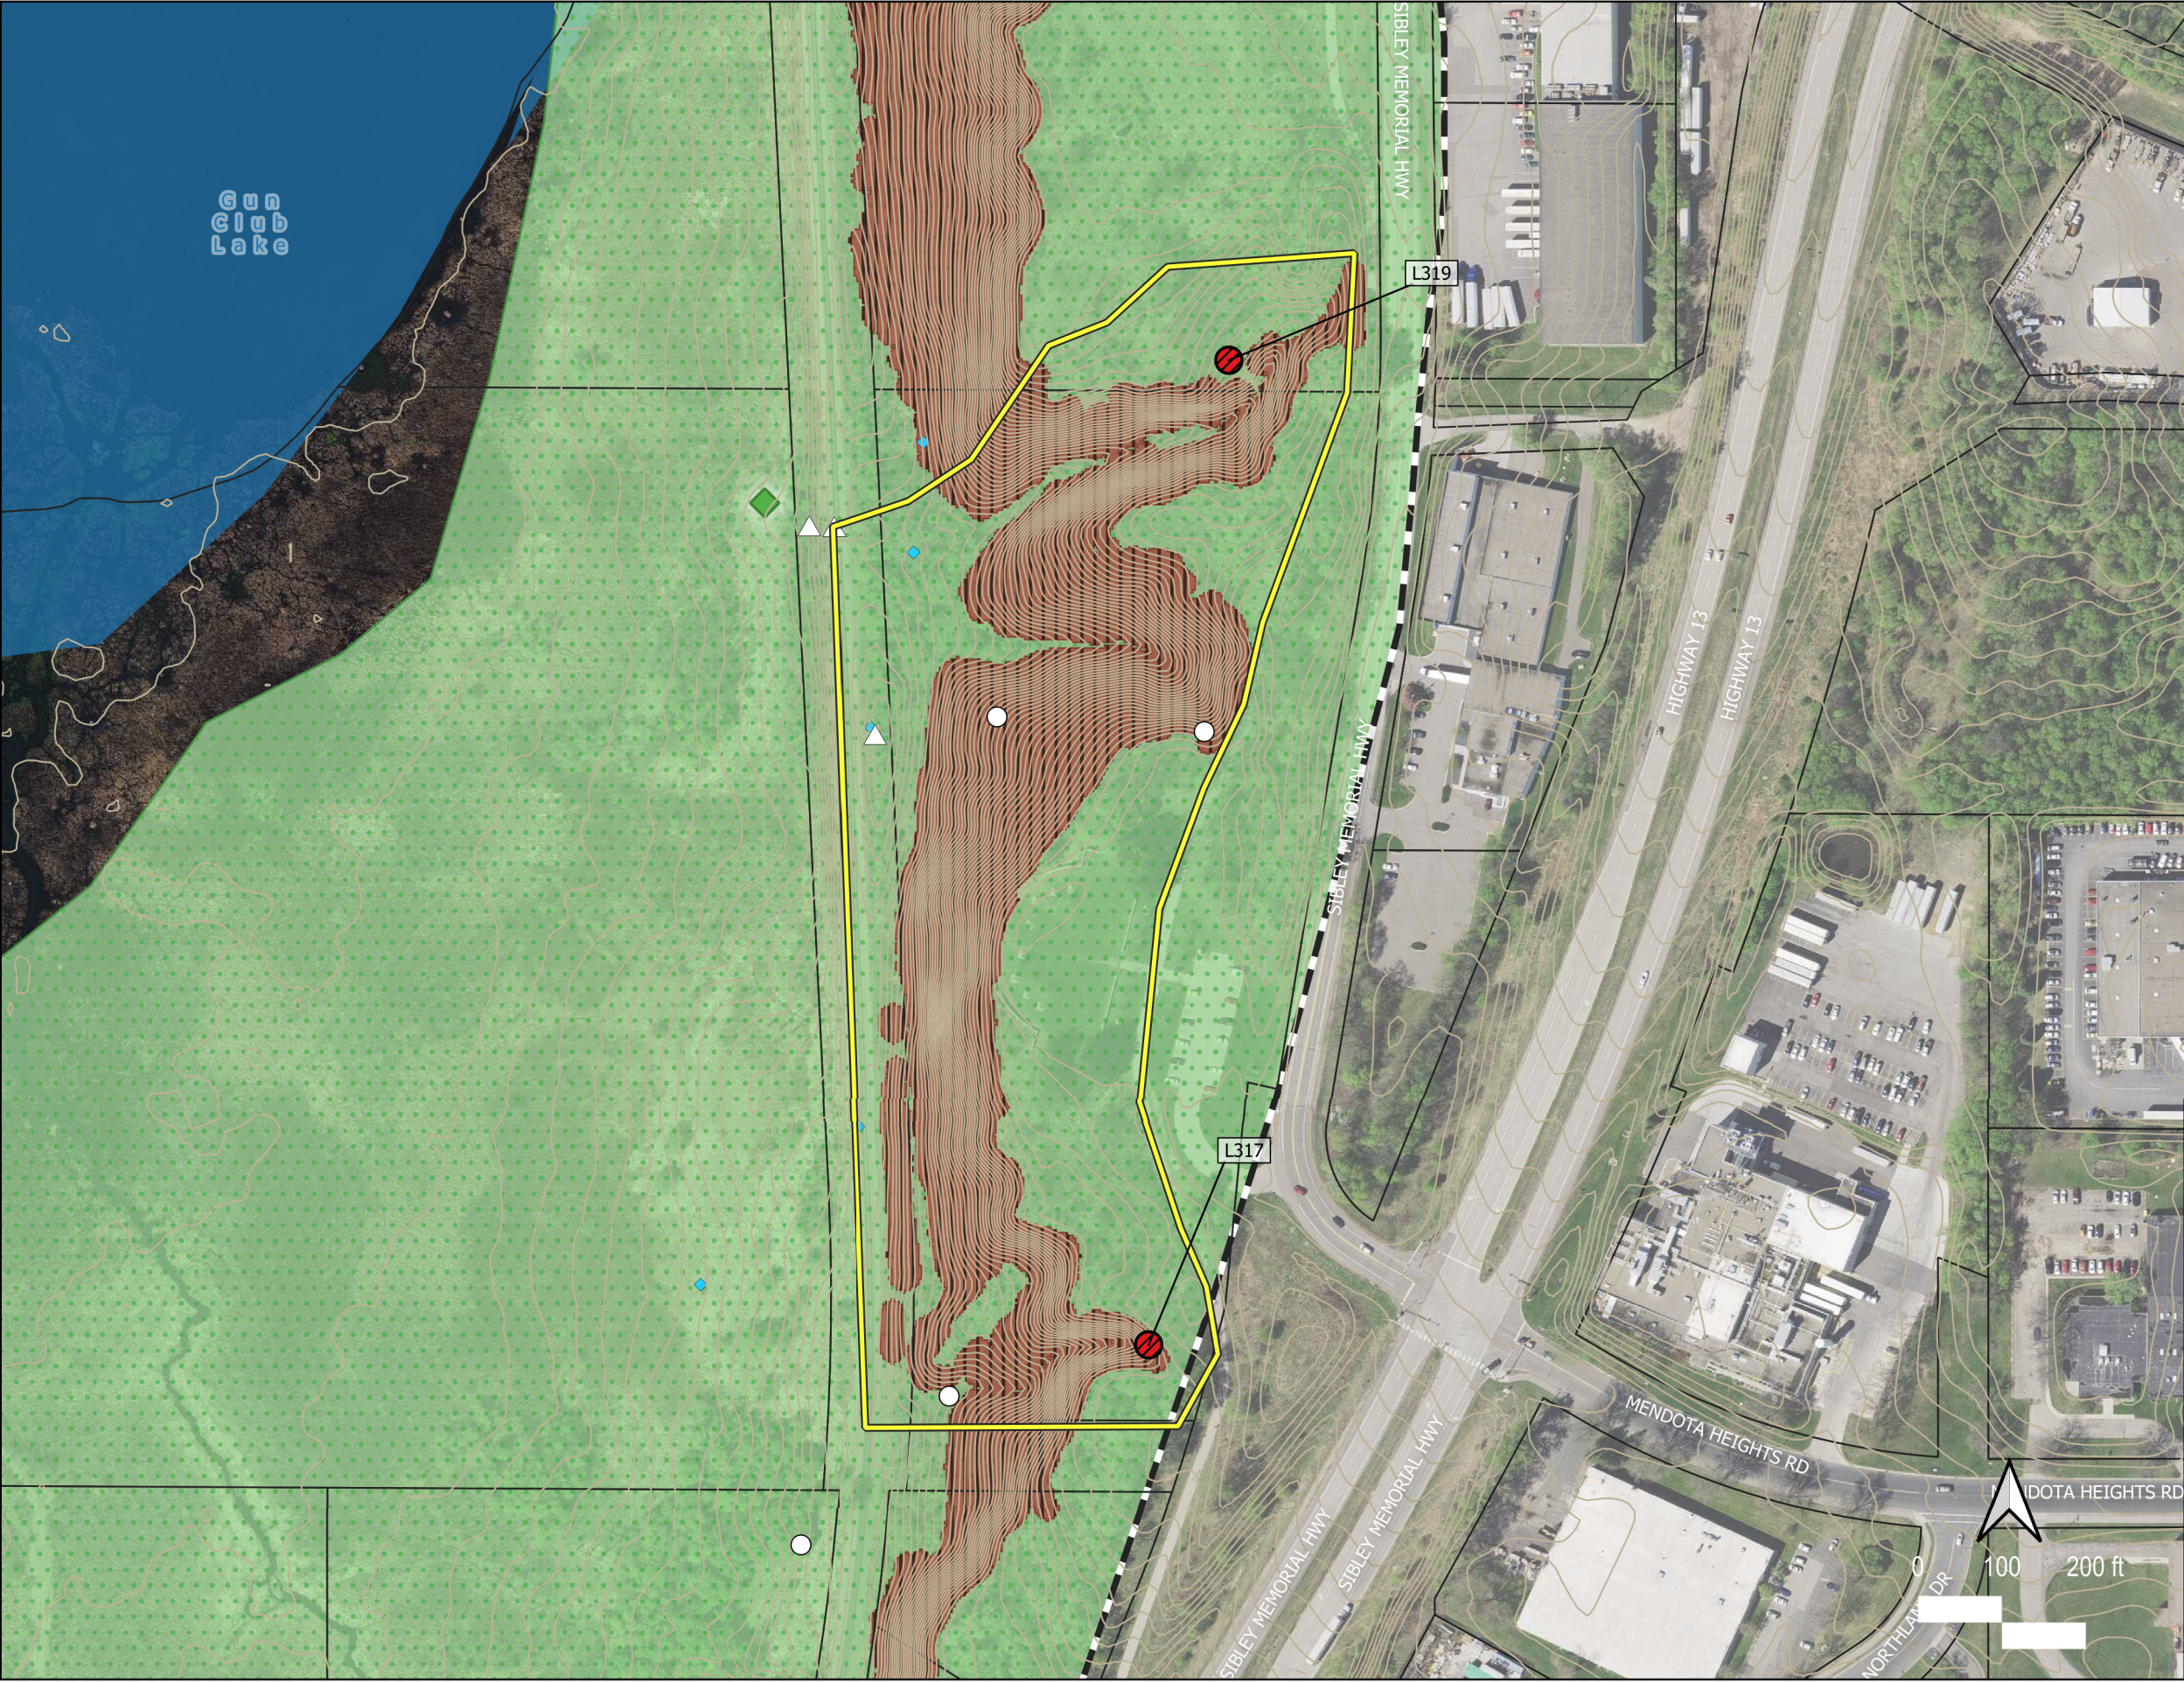
**Figure 129:
Mendota Heights
High Priority Region
No. 23**

HPR 23 consists of Gullies L317 and L319 (**Figure 129**). Both gullies discharge into Gun Club Lake Fen and threaten that high-value resource, further providing rationale for the region's grouping and high-priority ranking. Due to the variable characteristics of the gullies in the region, each gully is described individually.

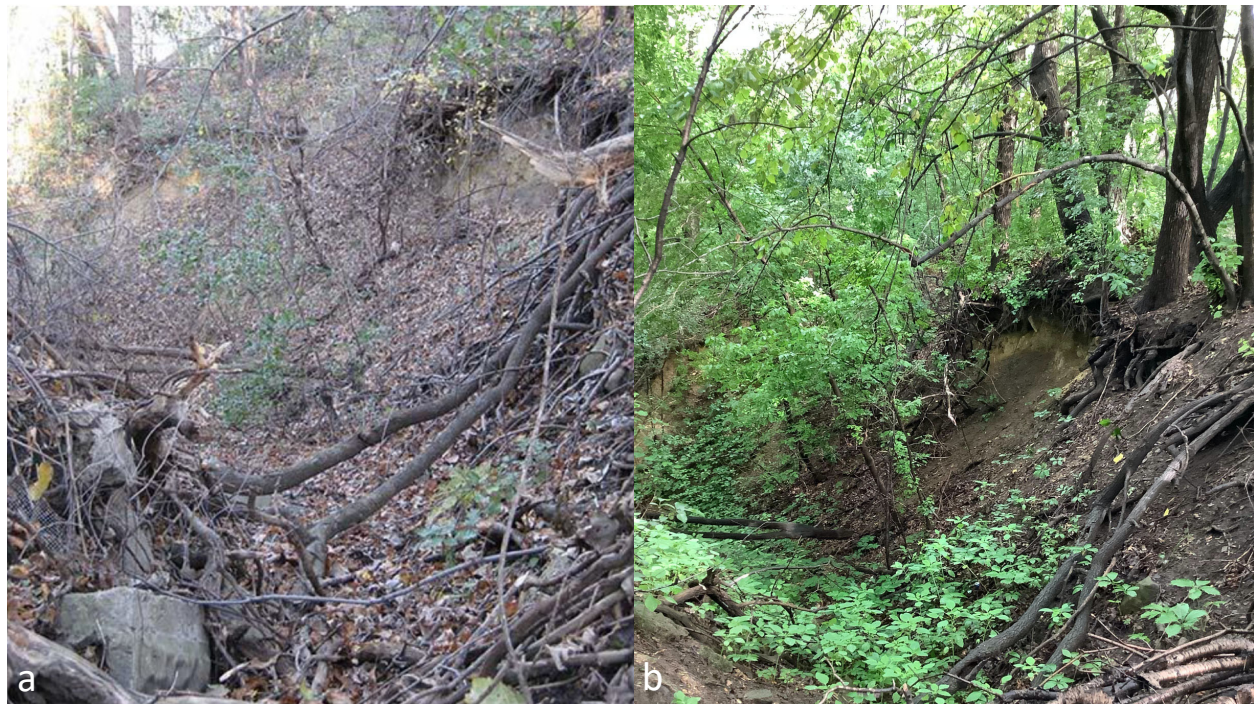
Gully L317 was a long, deep gully whose channel showed signs of slumping, undercut banks, and leaning trees. Rockfall debris was observed in the channel, and the steep gully slope was listed as one of the apparent causes of its formation. A large amount of buckthorn was found around the gully channel, with dense canopy listed as the other apparent cause.

L317 was evaluated in 2008 and described as having major erosion; it was rated during the 2020 desktop analysis as having a high erosion potential. The field team confirmed this rating in 2020, finding the site to have high erosion potential. **Figure 130** shows a side-by-side comparison of the downstream channel from 2008 and 2020. Both images show overhanging and incised banks, with exposed roots, slumping, and steep bank slopes evident, further providing reasoning for the high erosion potential ranking attributed to it.

Figure 130. Photo 'a' is an upstream view of Gully 317's channel taken in 2008, Photo 'b' is a downstream view of Gully 317's channel taken in 2020.

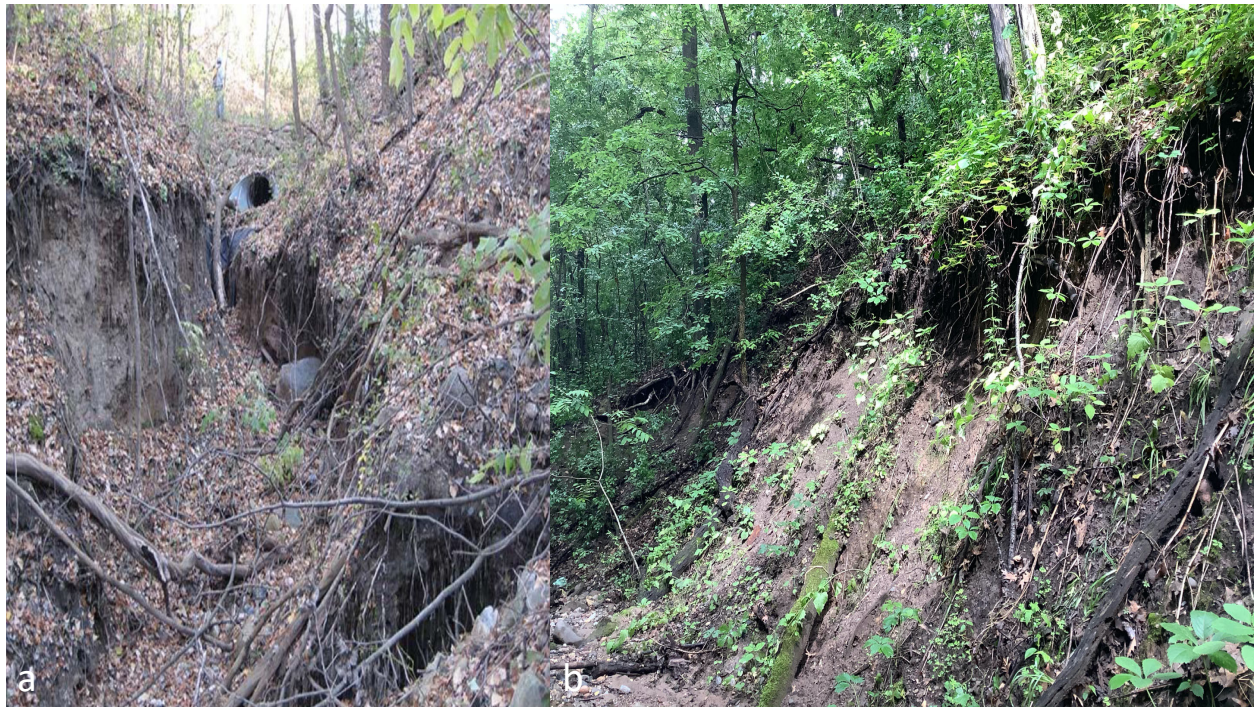
Gully L319 is a long, medium-sized gully with a variable depth formed from an existing outfall pipe with severe downstream erosion that creates a downstream channel. The gully had exhibited evidence of slumping, incision, and degradation, undercutting the channel banks leading to slope instability exemplified by leaning trees. In 2008, it was described as having major erosion with large cuts into the ground stemming from a culvert. During the 2020 desktop analysis, it was benchmarked as a high erosion potential site. In 2020, the team confirmed these findings, documenting a down-cut channel exhibiting major erosion downstream of a pipe outfall and ranking it as a high erosion potential site. **Figure 131** is a side-by-side comparison of upstream views of L319's channel taken in 2008 and 2020. Both images depict incised stream channels and severely overhanging banks. Photo 'b' shows the increased channel incision observed at the time of the visit during the 2020 study, representing the evolution of the gully since 2008.

Figure 131. Photo 'a' shows the upstream view of Gully L319's channel taken back in 2008; Photo 'b' shows the upstream view of Gully L319's channel taken in 2020.
