Technical Memorandum

Re: Area 3 Site Visit Meeting Summary

Re: Eden Prairie Area 3 and the Minnesota River—Meeting summary and recommendations

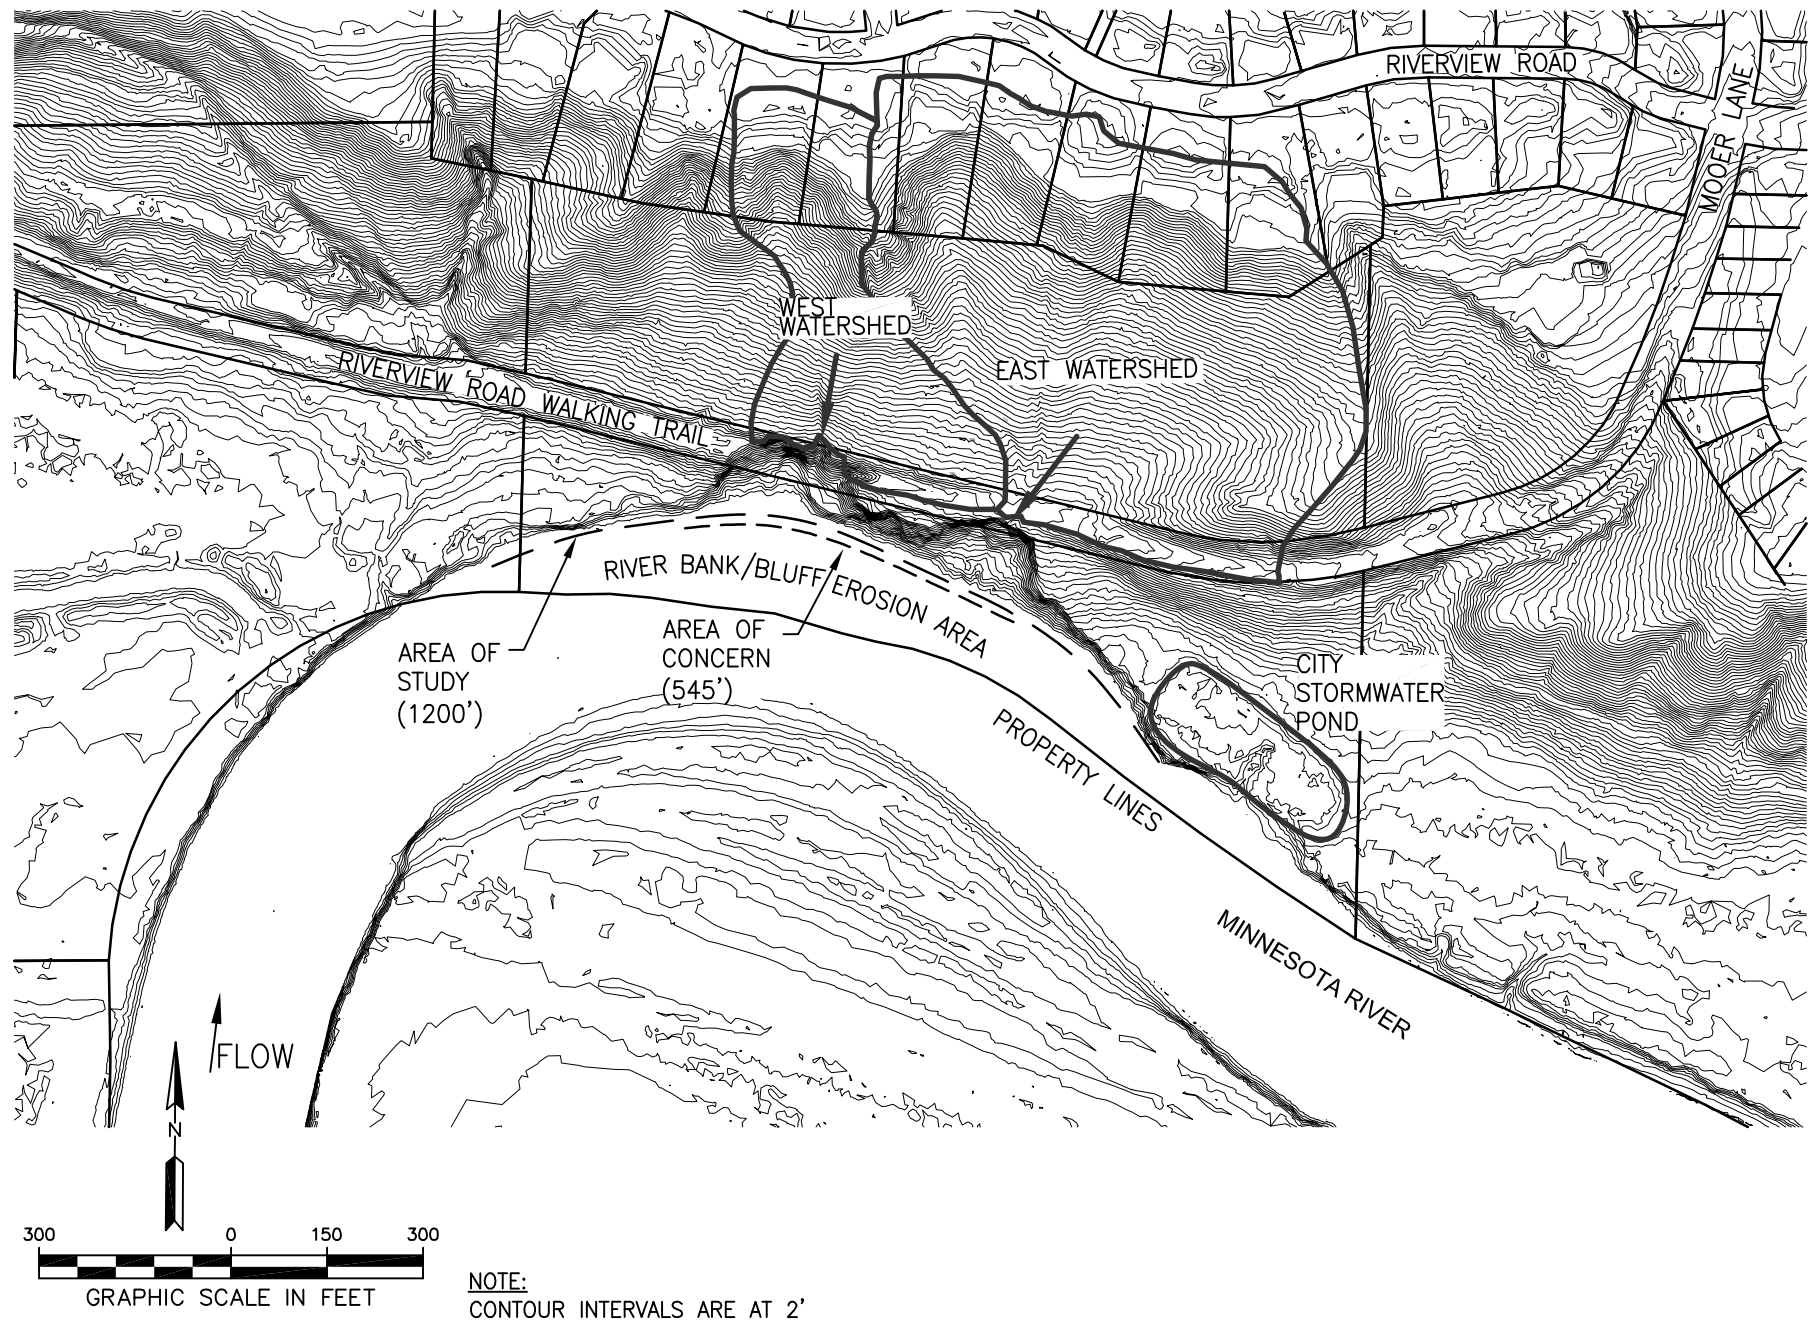
Existing Conditions

In 2010, the team of Wenck Associates, Inc. and Stanley Consultants, Inc. were retained to expand on the information produced by SRF. The Wenck team focused on the slope interface with the river (see enclosed existing conditions map). Additional data were collected, and the team completed hydrology, hydraulics slope stability and geotechnical analyses. The Wenck team’s conclusions were similar to SRF’s. They highlight that the meander is a natural process that has been accelerated by changes in hydrology and climate variability and increased erosion due to stormwater runoff concentrated on the surface and seepage flows (Wenck, 2010). The Wenck team concluded that if left as is, without stabilization, erosion will continue as the meander moves downstream. That said, they did note that the slope stability analyses showed the bluff had an acceptable safety factor for the residences and properties.

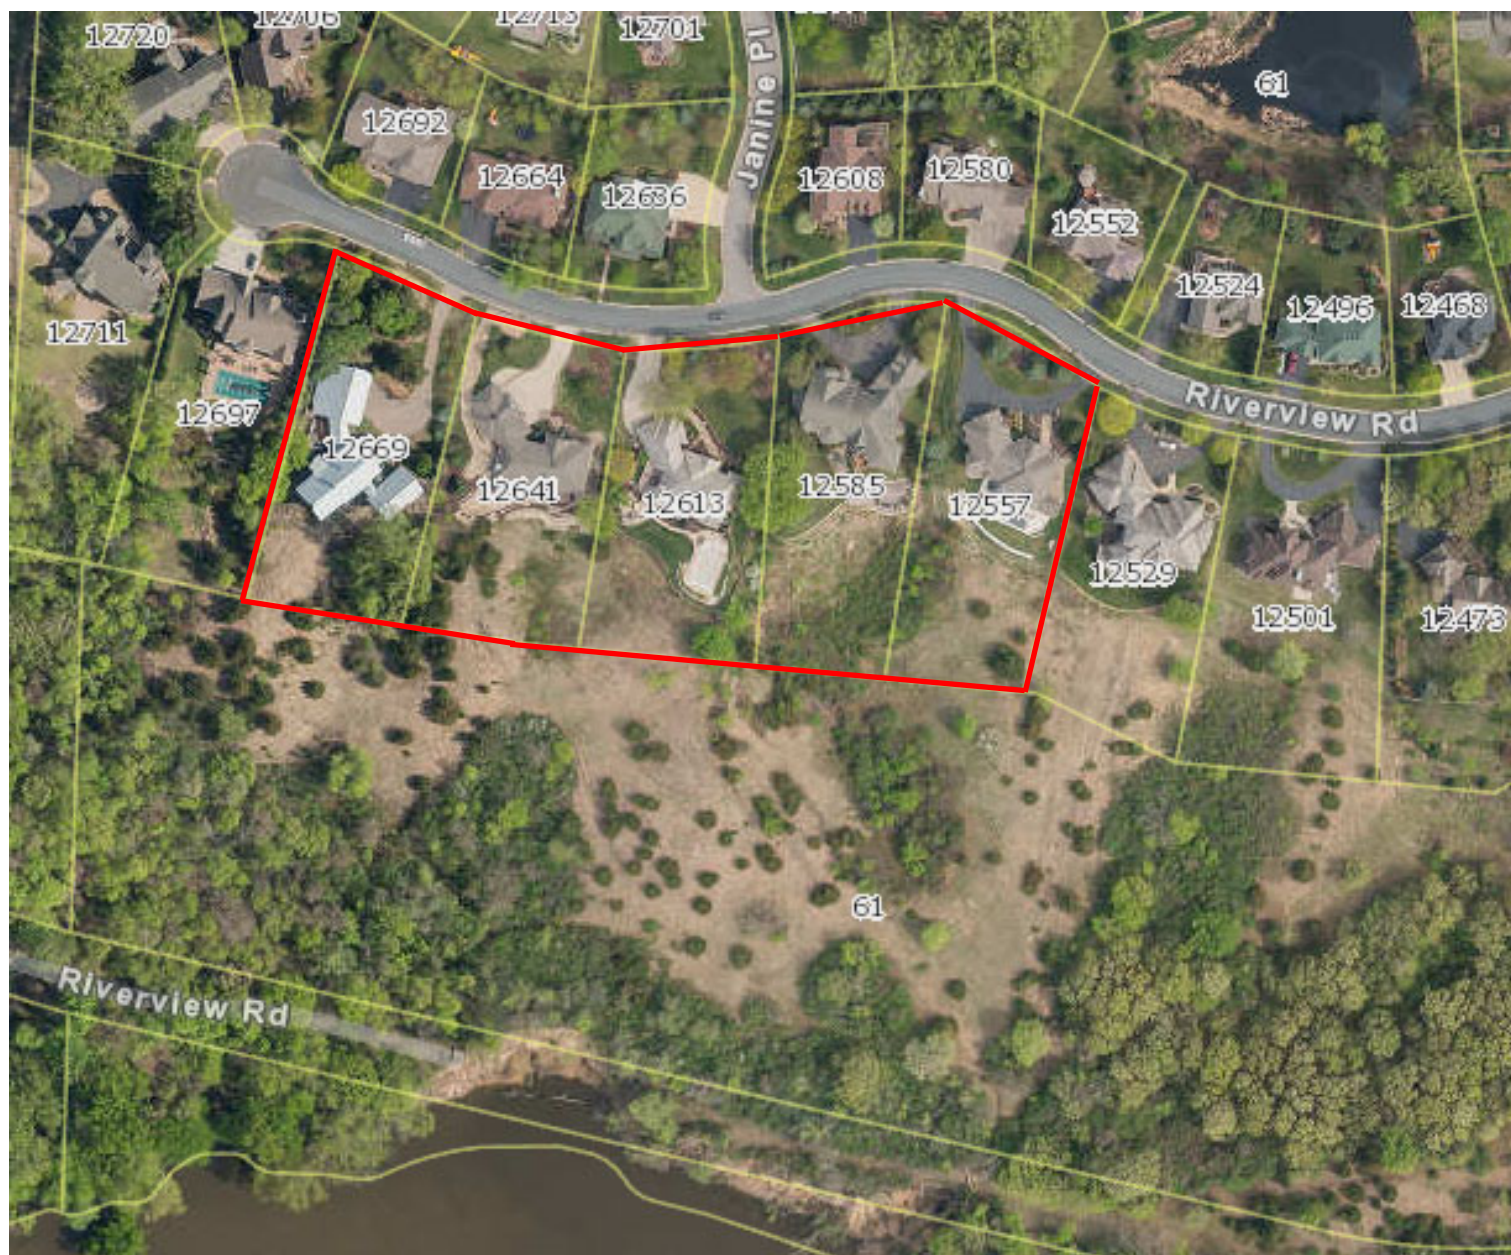
12585 Riverview Rd

The owner of 12613 Riverview Road was outside and allowed access to the bluff on her property. She has lived there since 2003 and said that the rate of erosion on the bluff near the property has accelerated in recent years. She said that she reached out to LMRWD, the City, and the US Army Corps of Engineers (USACE) several times to discuss the neighborhood concerns, especially the need to install retaining walls to protect their residences. The backyards of 12557, 12585, 12613, 12641, and 12669 Riverview Road all were observed to have relatively new retaining walls located near the residences (see attached landowners map and photos).

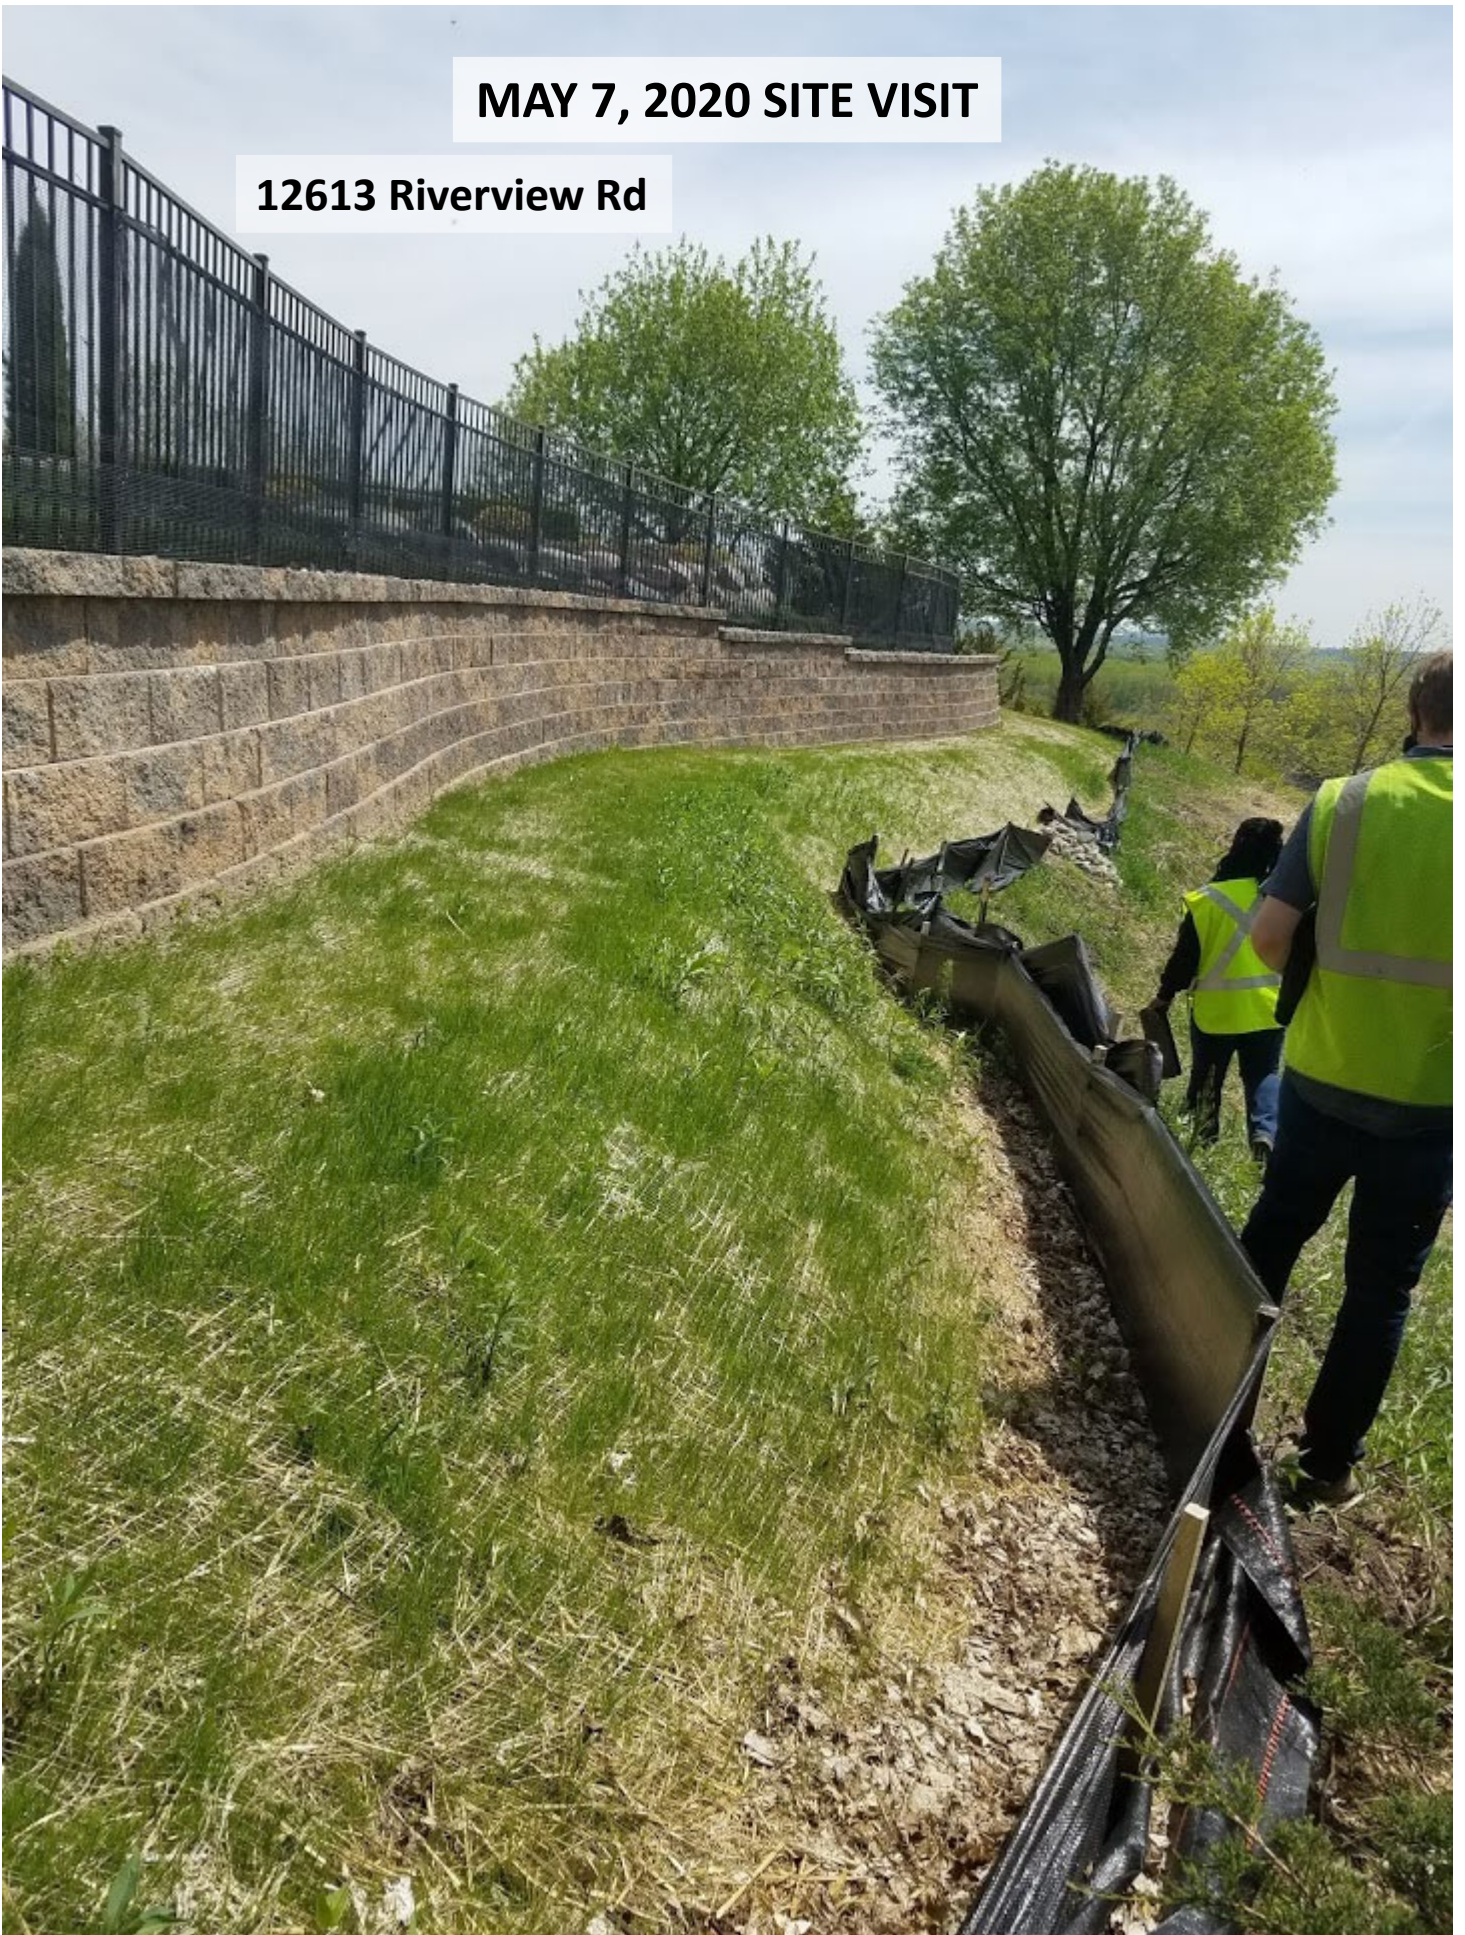
The homeowner confirmed that the soils around her property were extremely sandy, as evidenced by active bank erosion in nearby gullies. The gullies contained numerous

brush clippings and vegetation, placed in the gully at the advice of USACE staff several years ago.

**Active gully erosion
at 12613 Riverview
Rd and homeowner
preventative
measures**

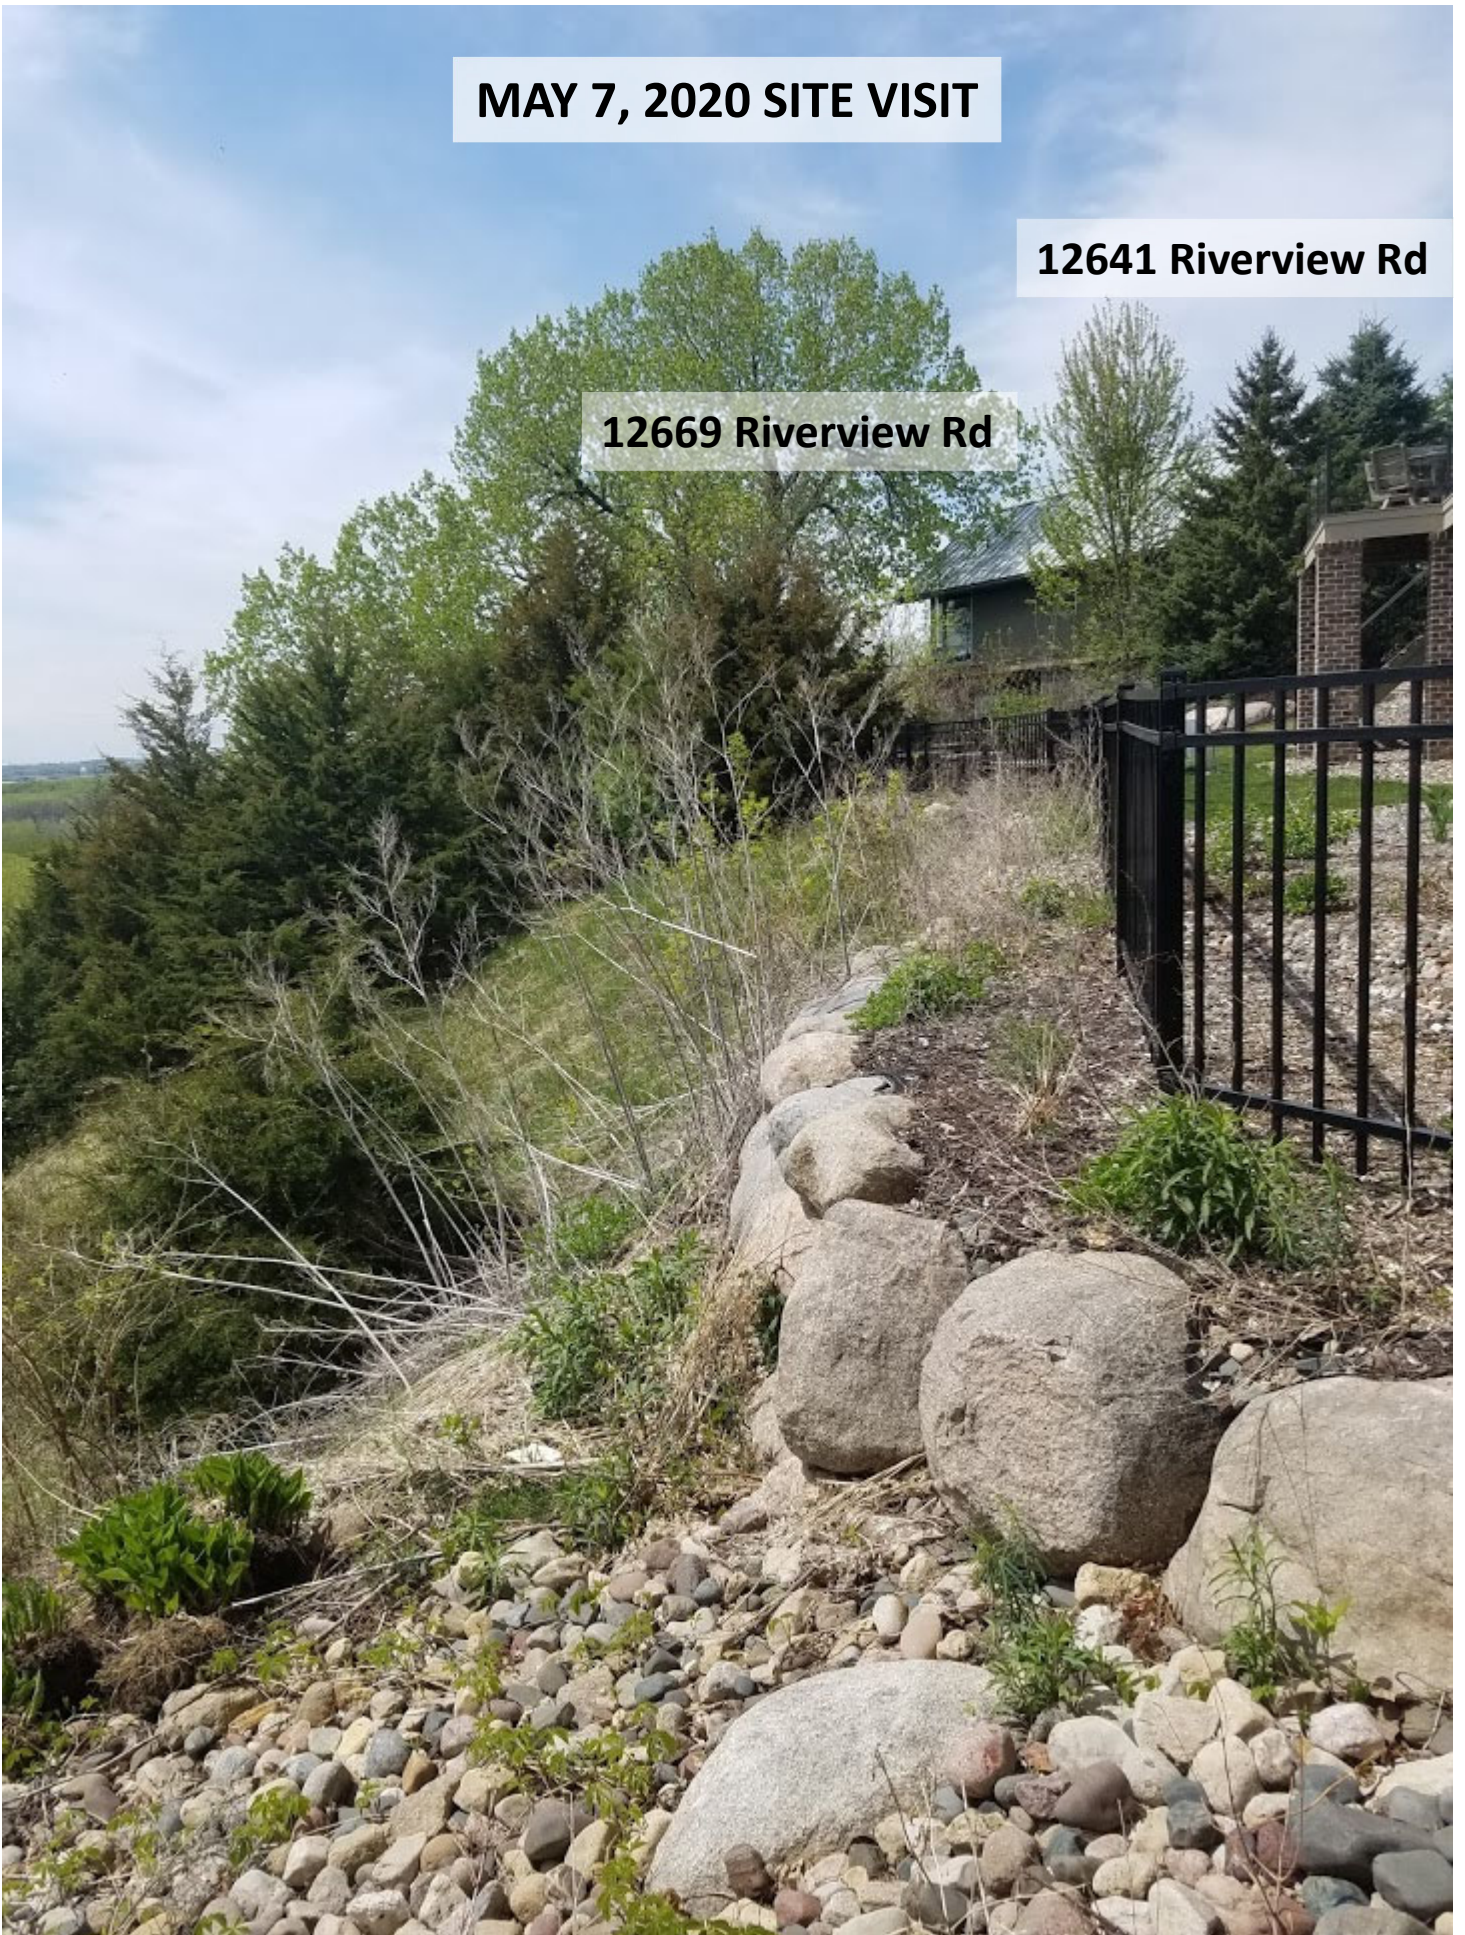
12641 Riverview Rd

The inclinometers could not be found during the visit, but no signs of active landslides or mass wasting processes were observed in the field. The active erosion seemed to be contained to the existing gullies and runoff from private property.
