## LMRWD Stability Study

B14-03590 (formerly SP-09-04727)  
LMRWD Stability Analysis  
Eden Prairie, Minnesota

## Technical Memorandum

**To:** Della Nyondi Schall Young – Young Environmental Consulting Group, LLC  
**From:** Garrett Bayrd, Jacob Sharpe – Barr Engineering Co.  
**Subject:** Monitoring Event – Fall 2020  
**Date:** November 2<sup>nd</sup>, 2020  
**Project:** LMRWD Eden Prairie Slope Monitoring

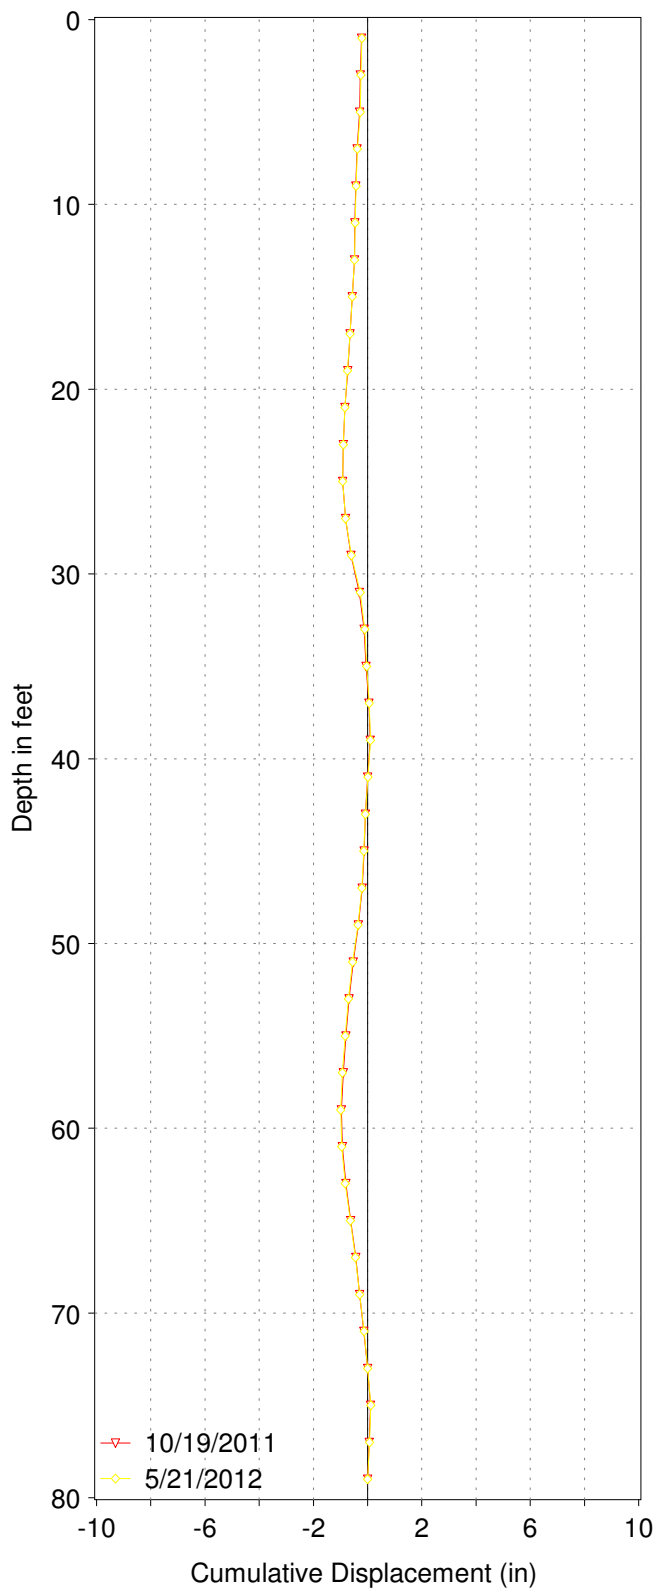
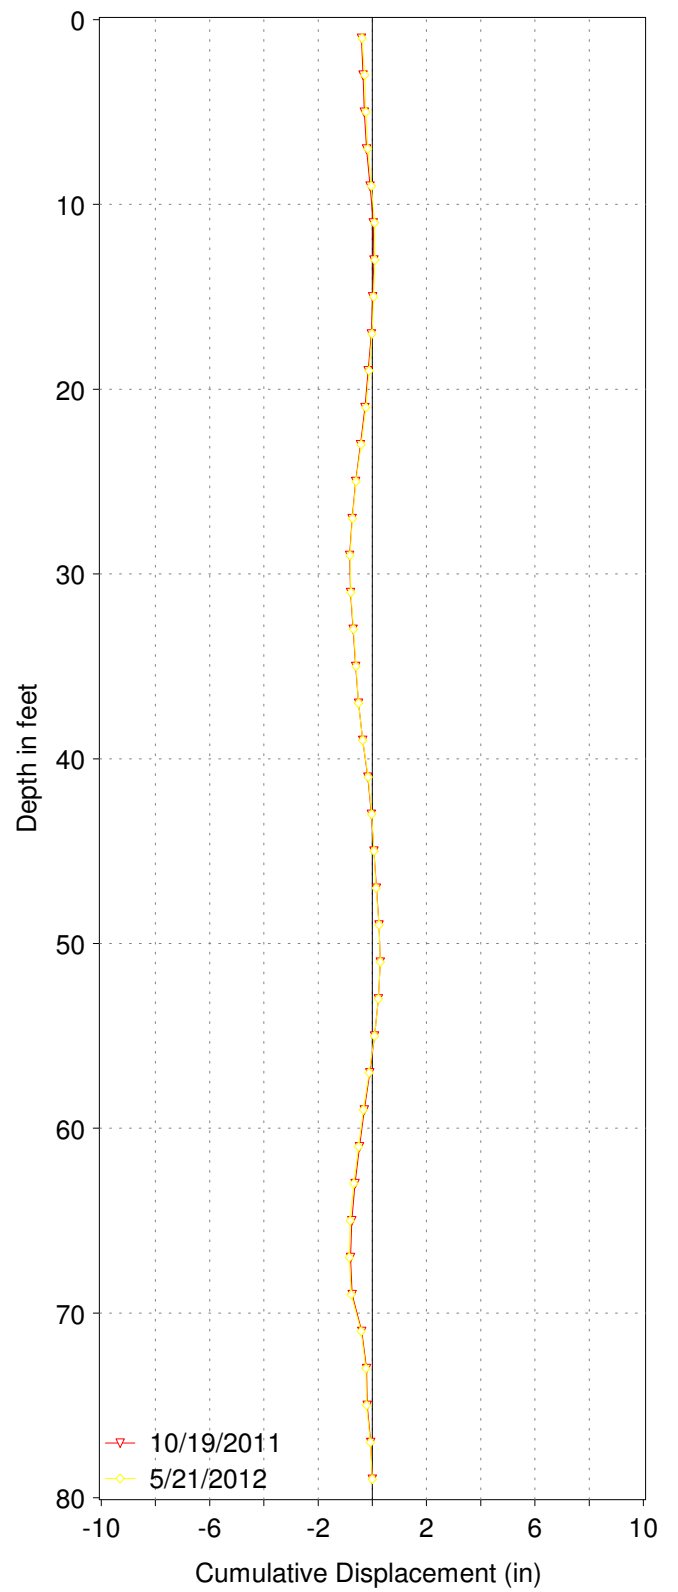
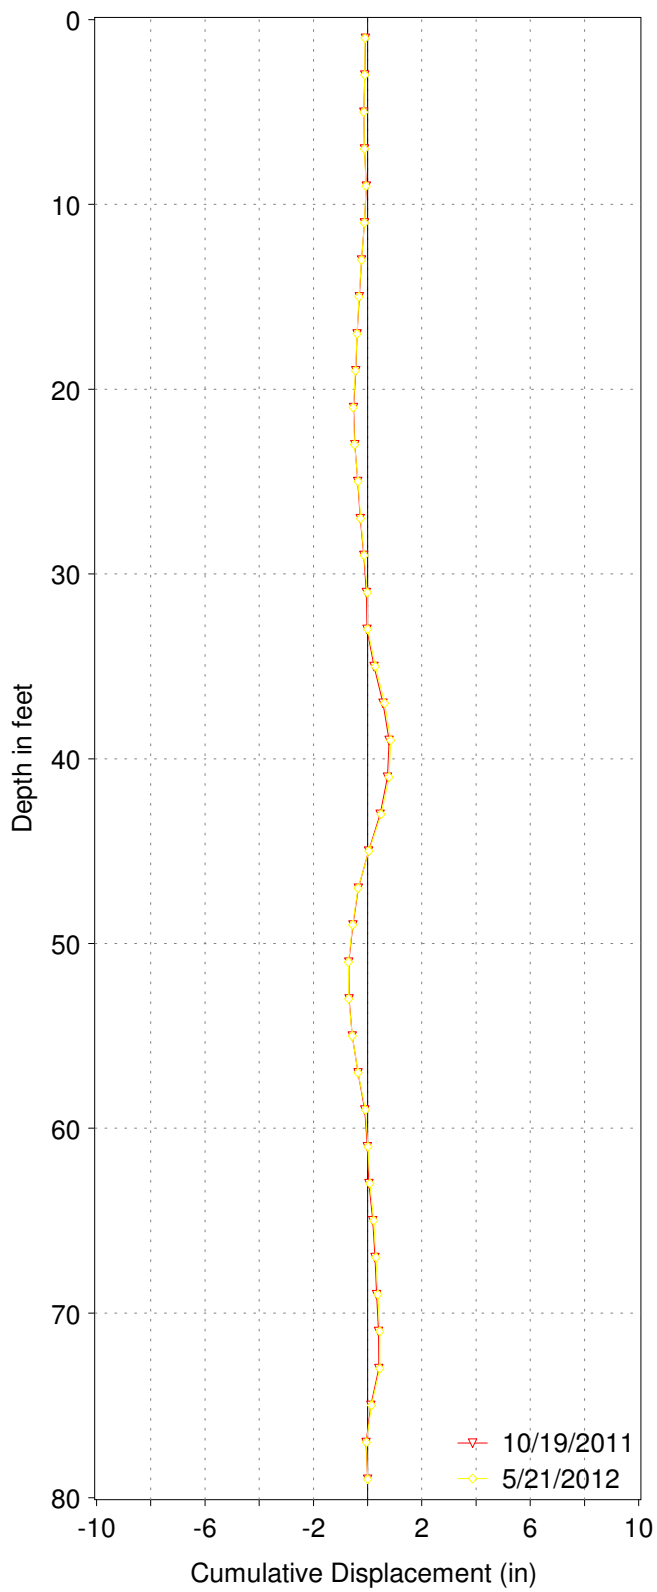
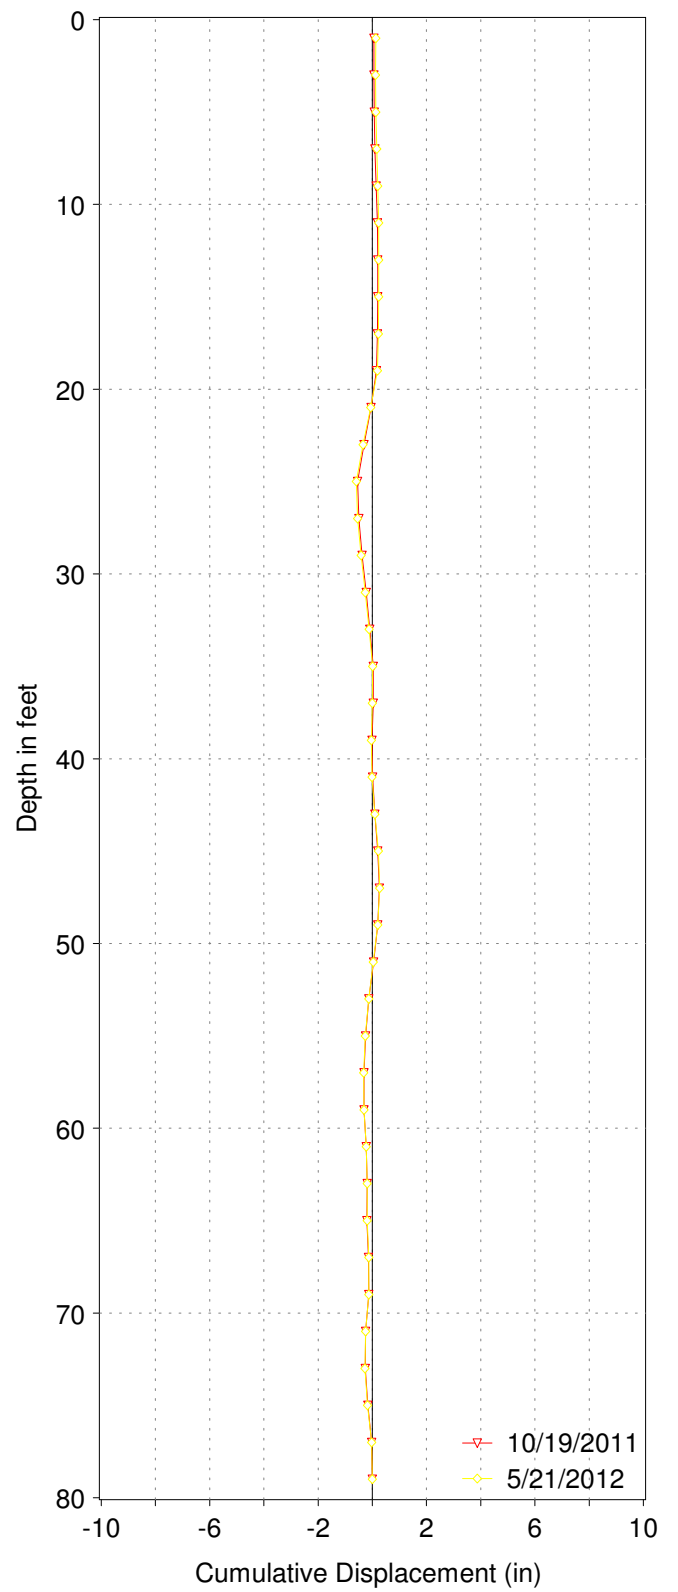
Good news. No movement since last fall.

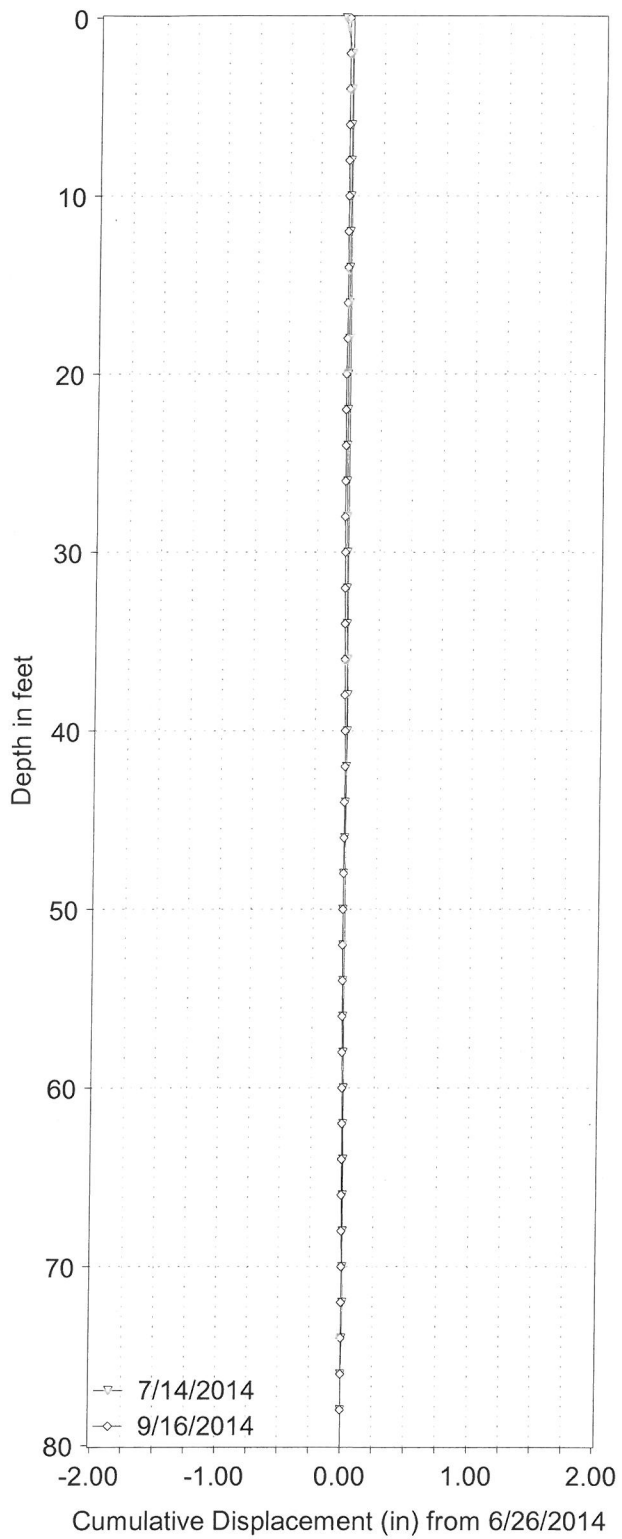
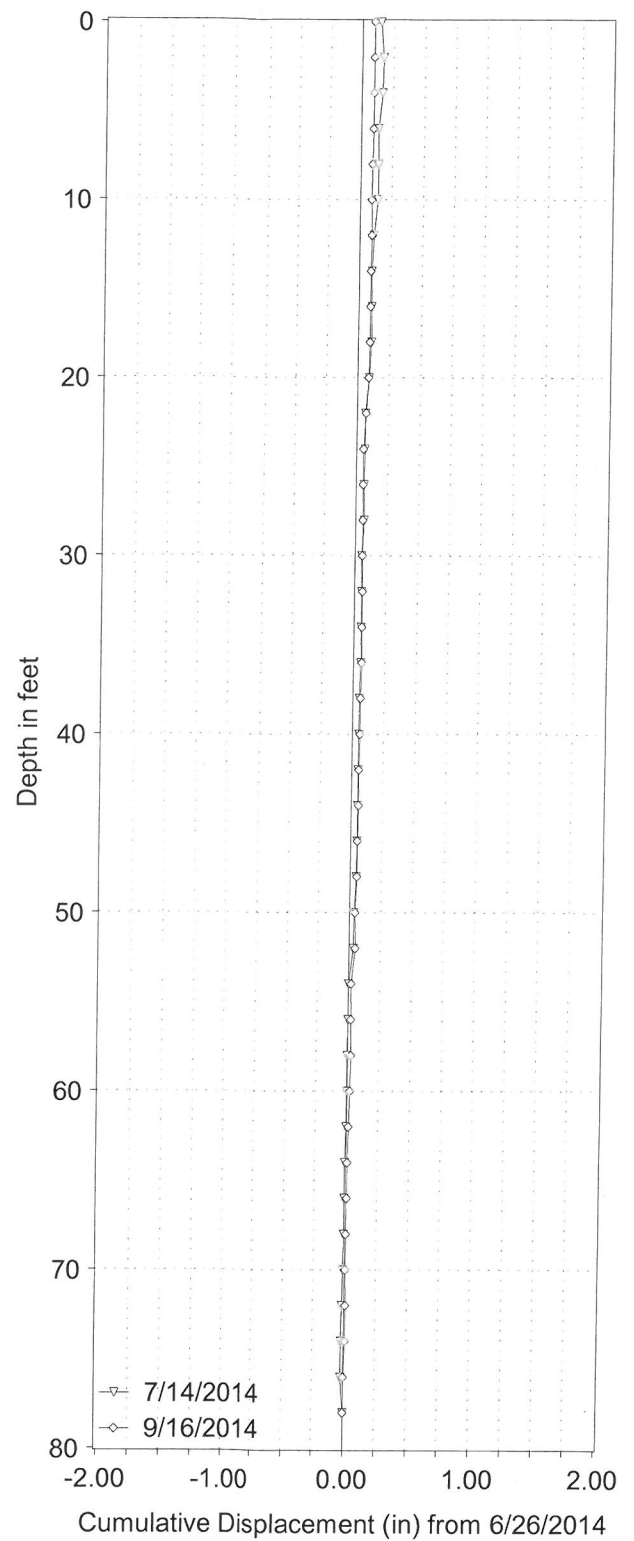
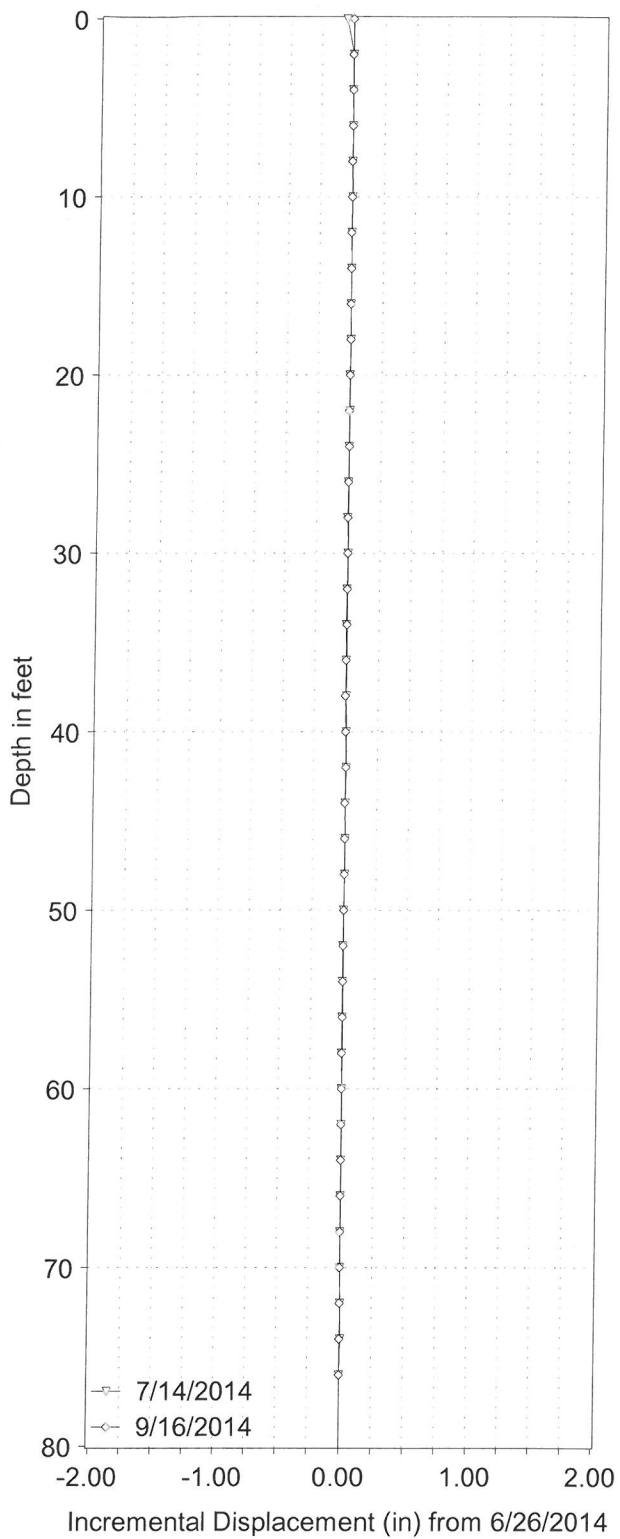
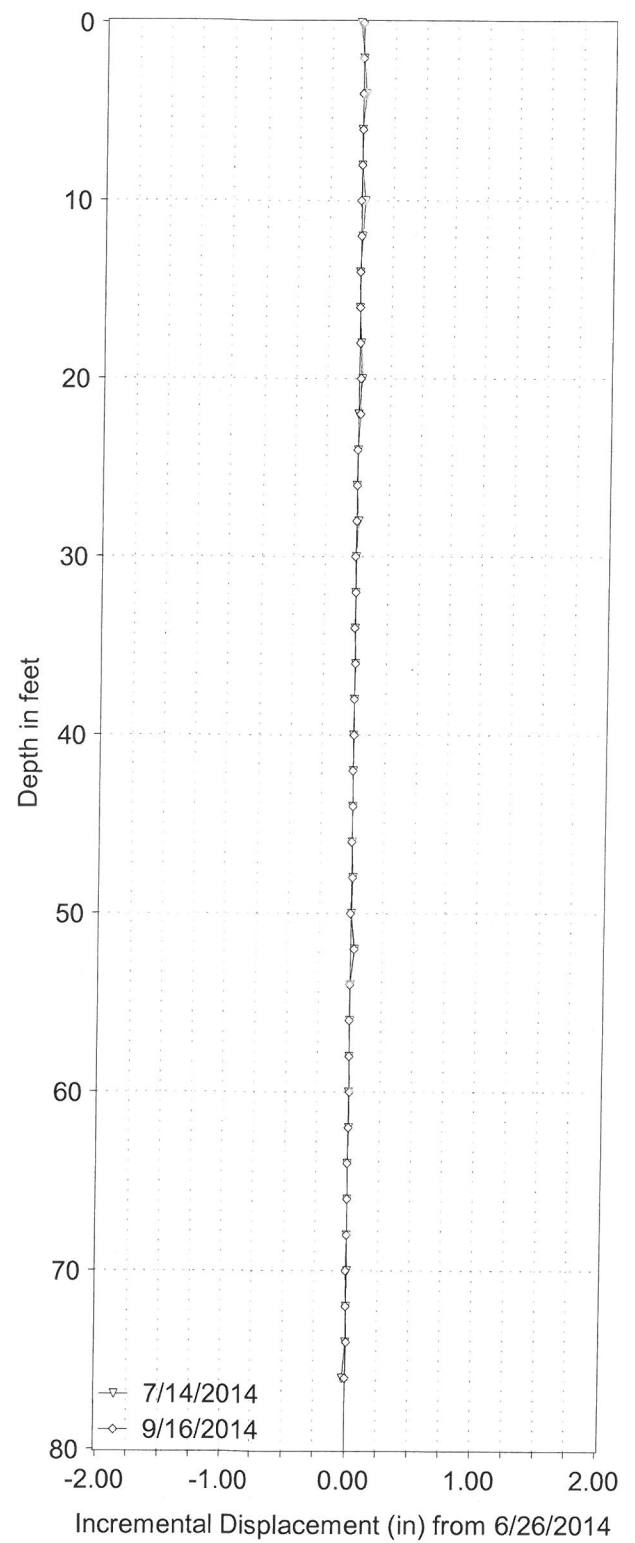
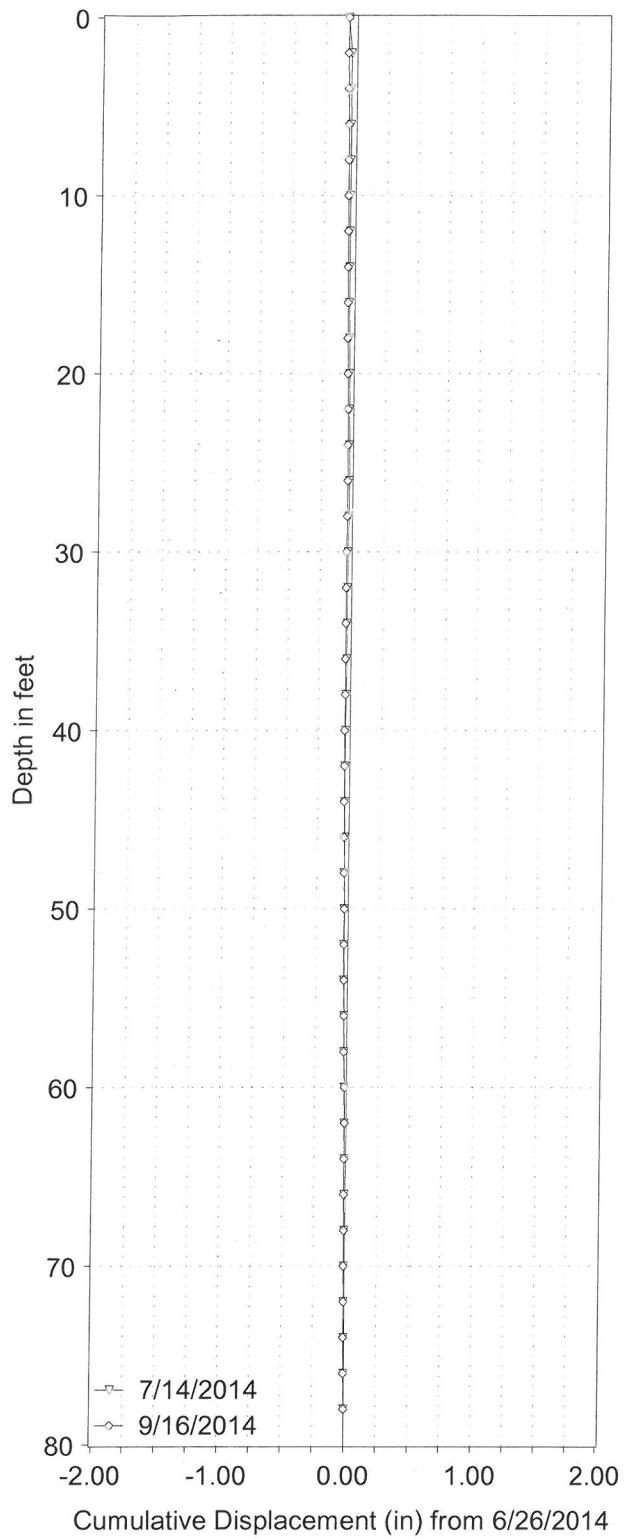
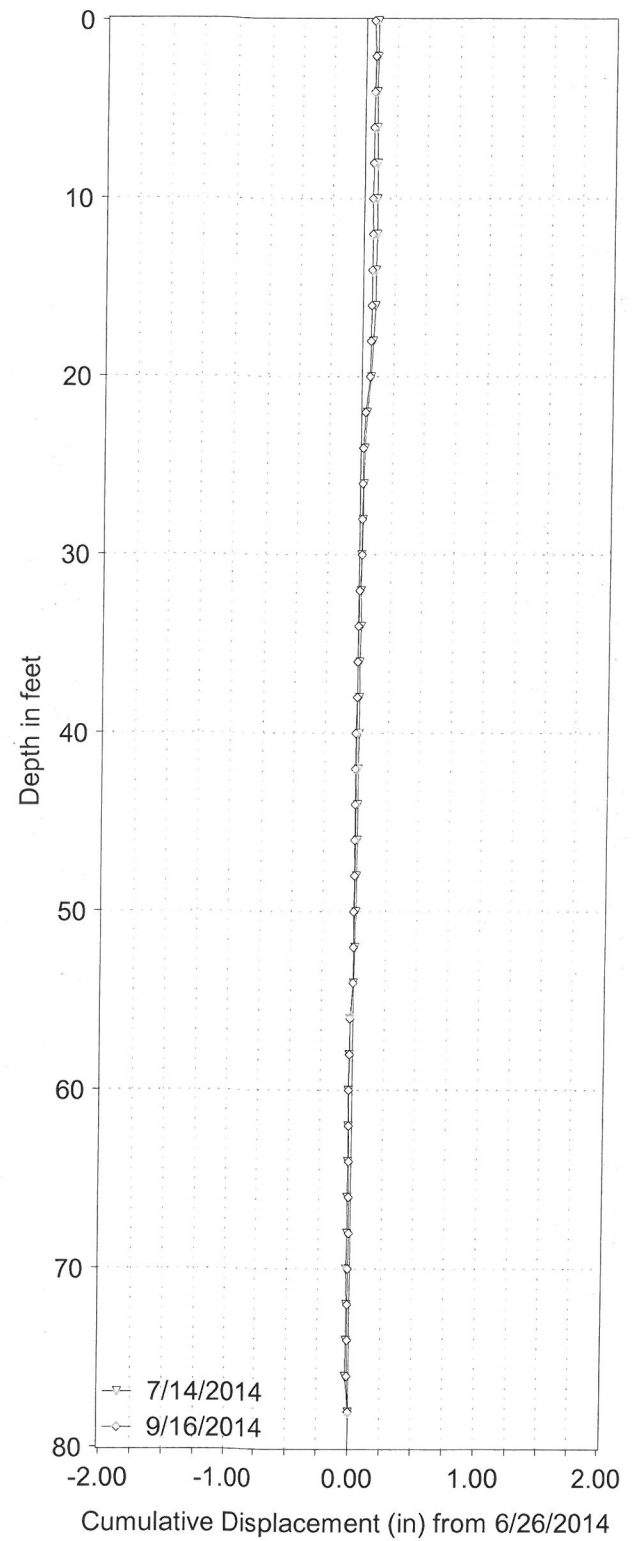
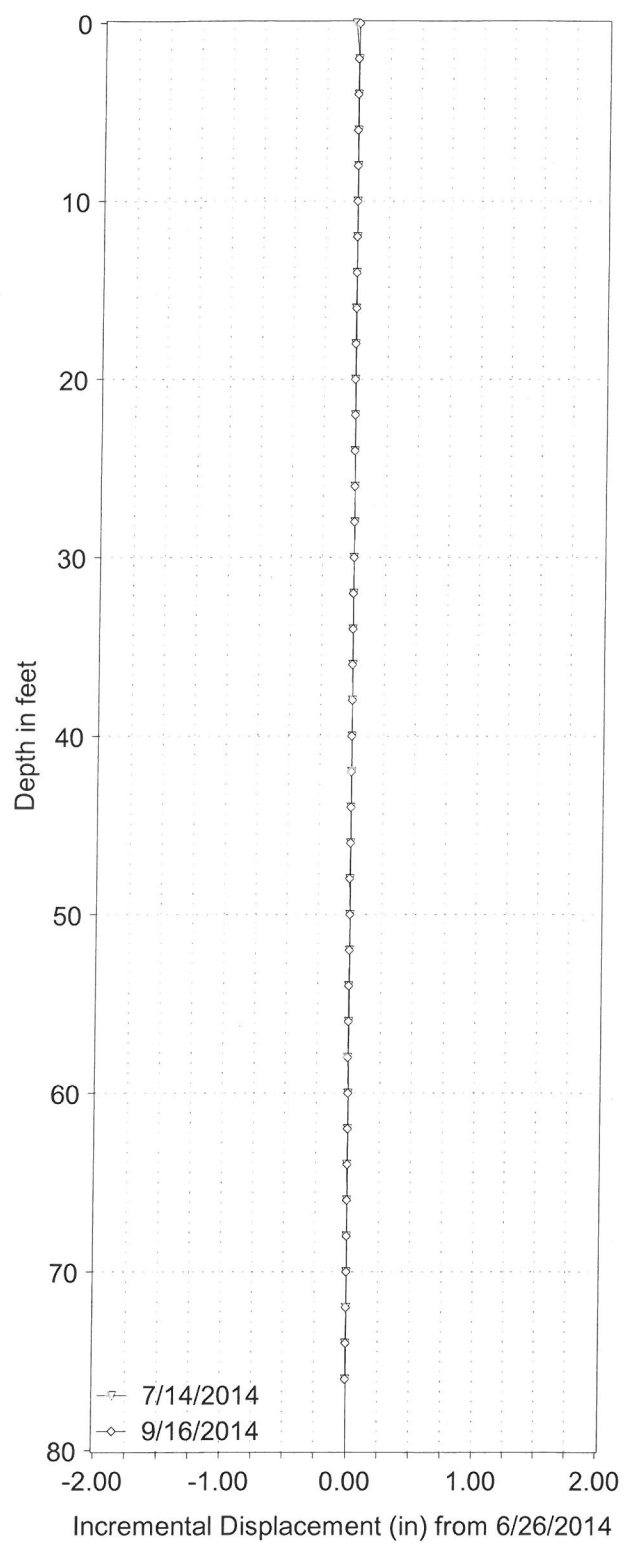
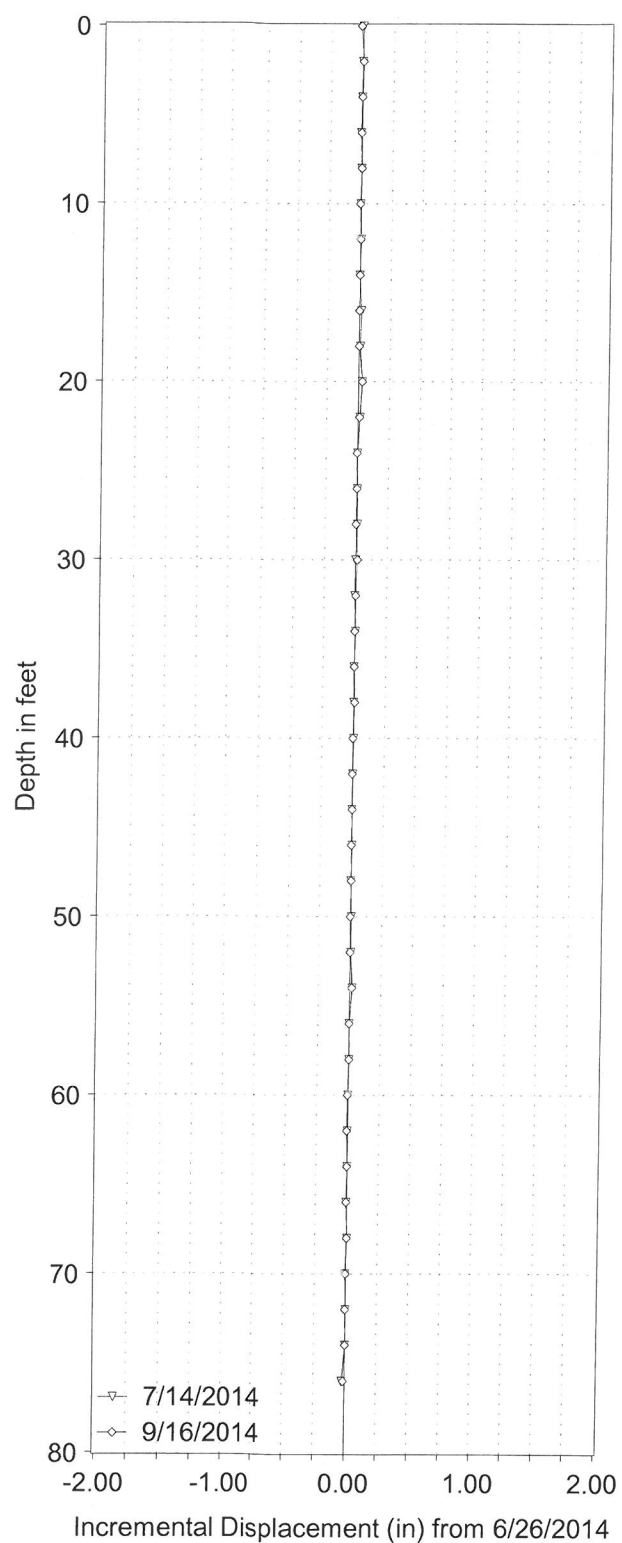
We did get Braun out to the site again to read those inclinometers on September 16<sup>th</sup>. The attached show the comparison with the July 14<sup>th</sup> readings earlier this summer. The displacement graphs show some variation in the casing profiles post July 2014, but that variation is minor, and per Braun, within the limits of instrument and operator variability. In addition, Braun indicated that the direction of the differentials was opposite those which would suggest failure-related movement. So their conclusion was that the area being monitored is currently stable. Braun also indicated that no evidence of movement was observed on the ground surface during the reading events.

In summary, neither Braun nor Stanley see any indication of the slope moving in the vicinity of the inclinometers and homes. It is unfortunate that we lost the ability to utilize the earlier (pre 2014) readings due to equipment problems, but we now have a good baseline as we move forward. We still need to be aware that while movement has not occurred in the vicinity of the homes or inclinometers, the base of the bluff continues to erode and slough, and unless measures are taken to stabilize, may eventually encroach upon our instrumentation.

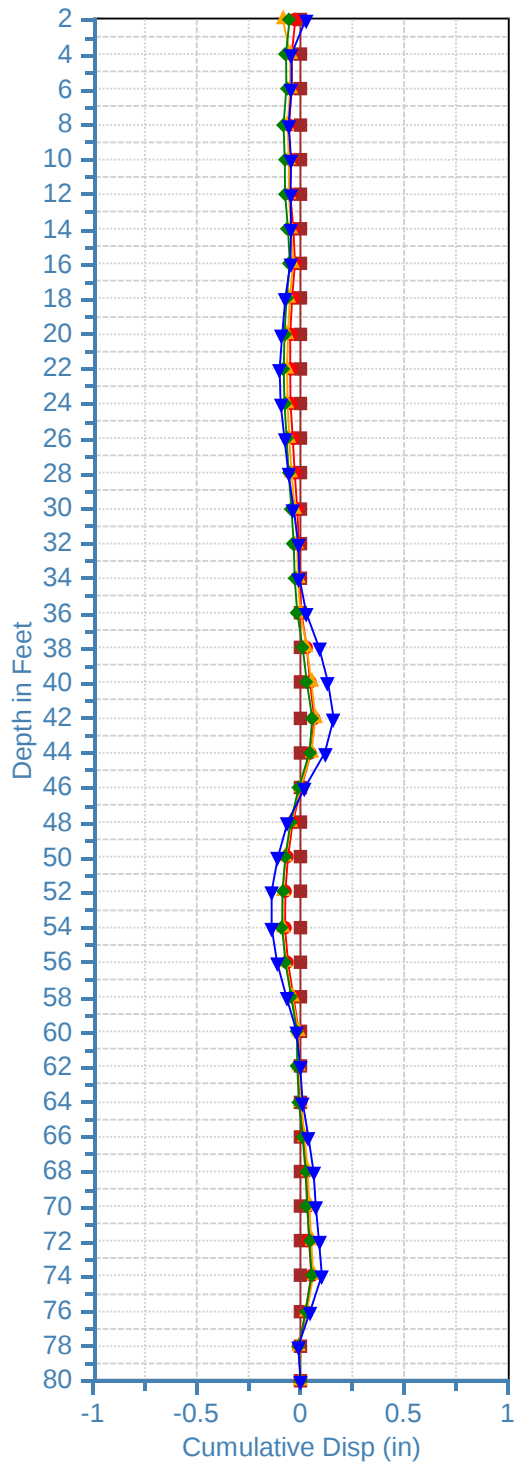
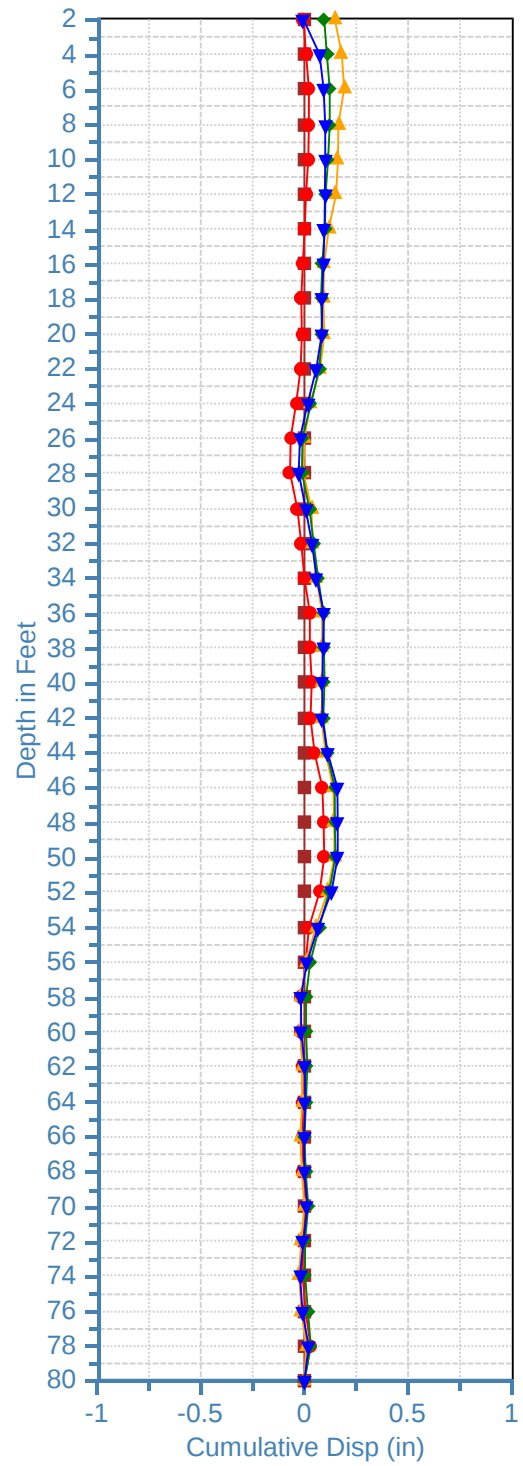
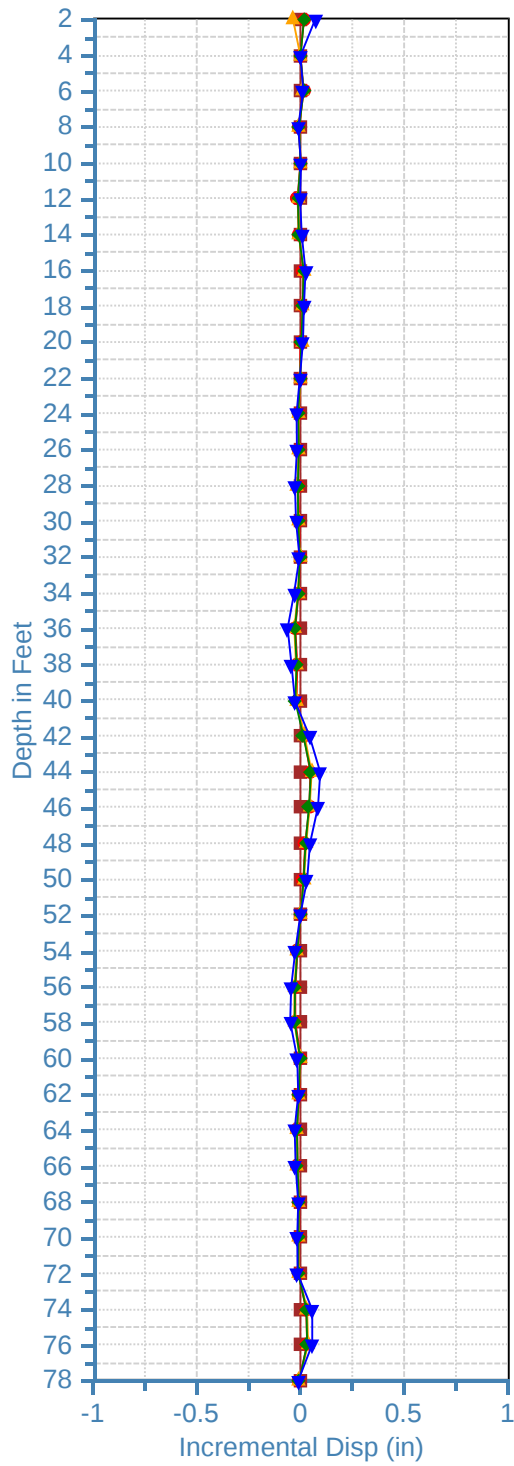
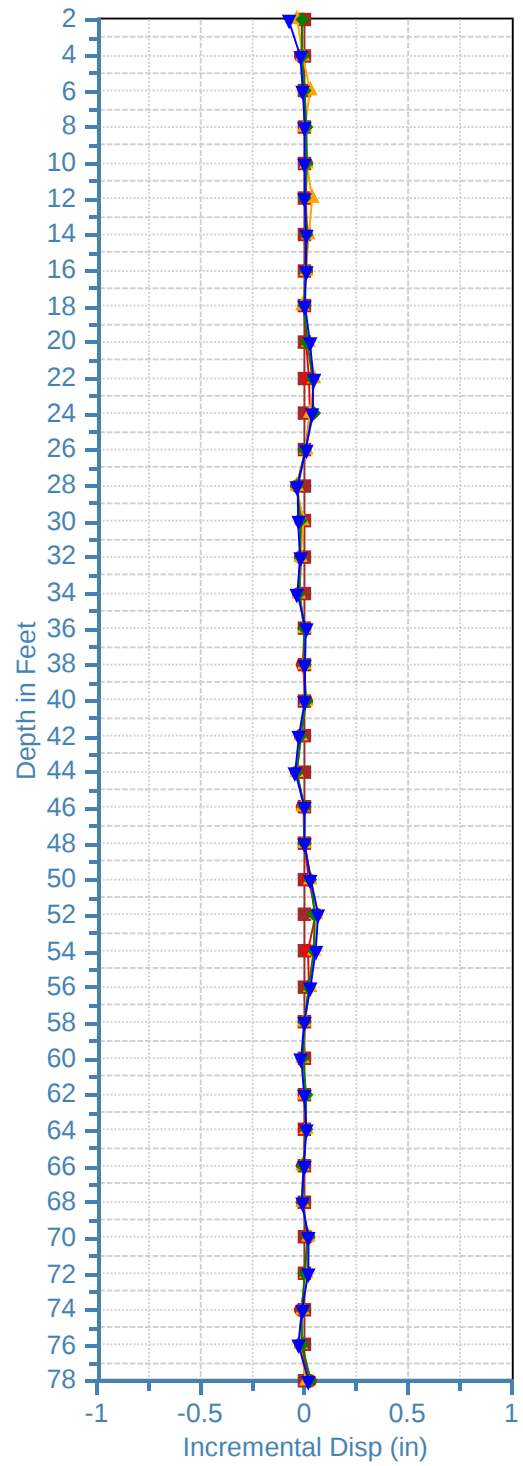
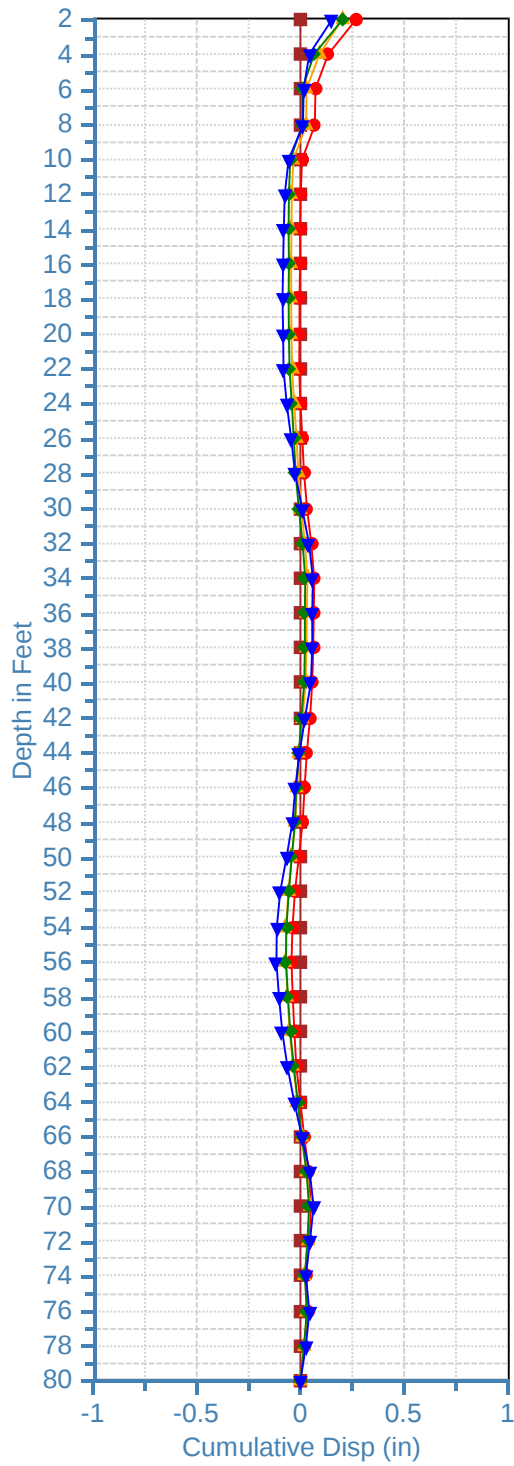
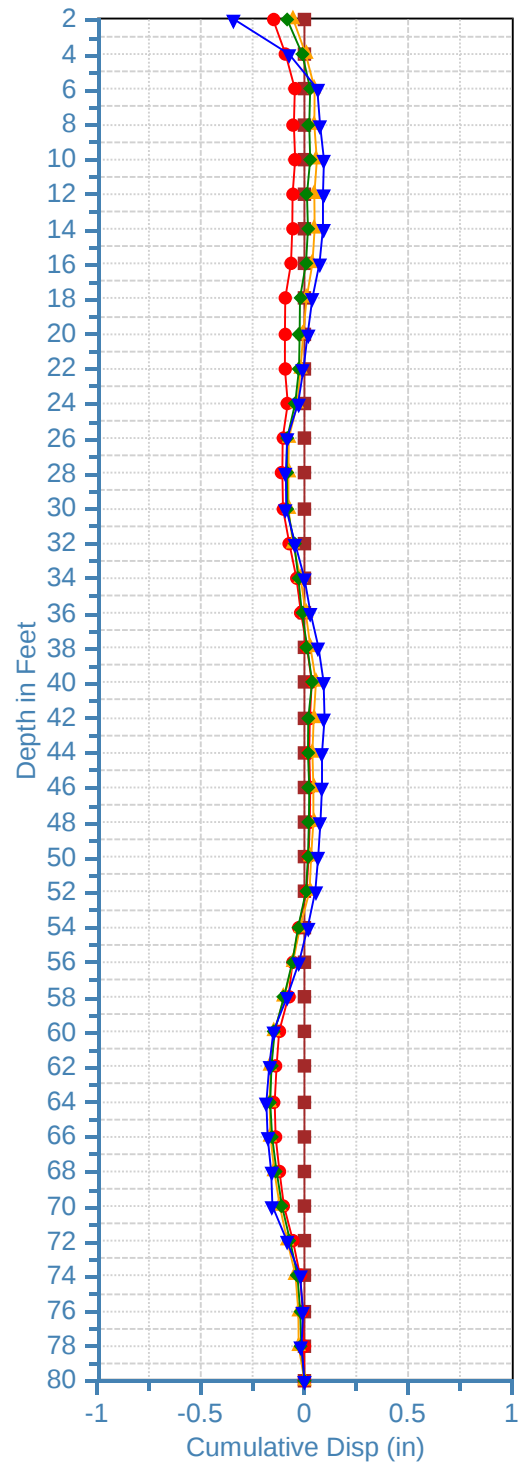
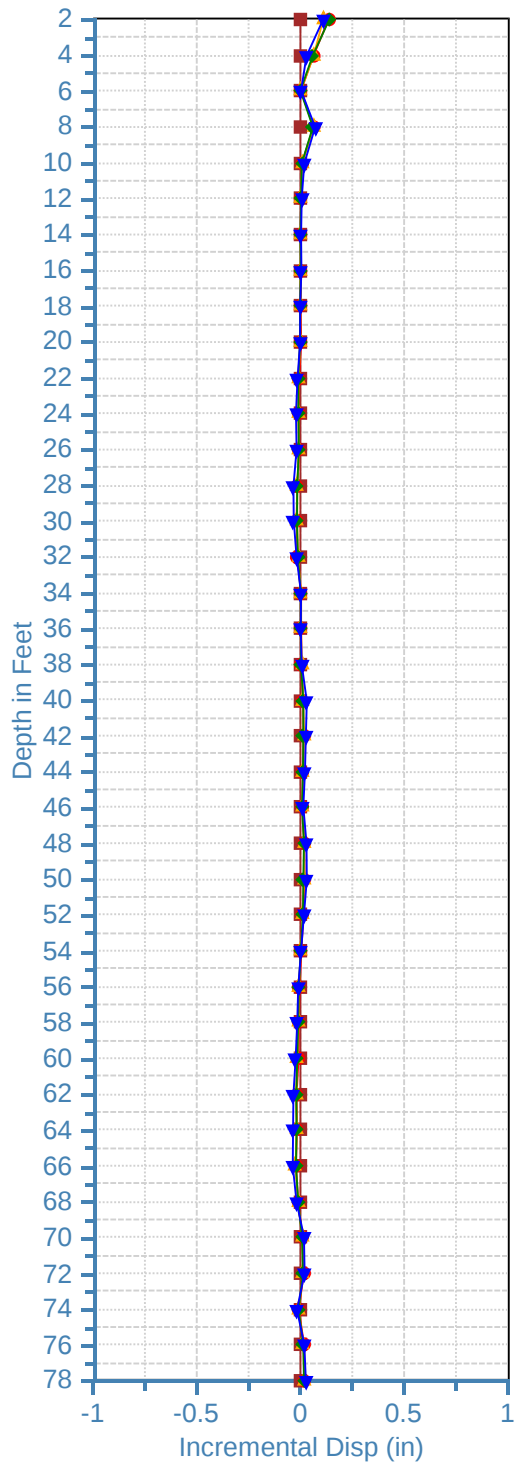
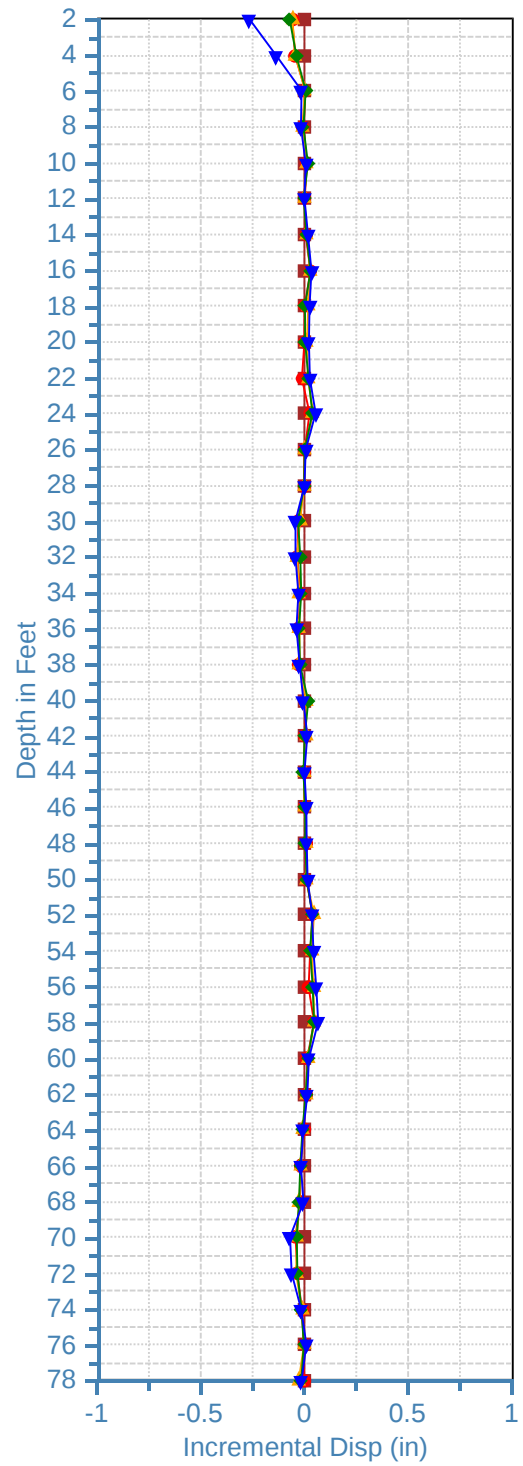
The most recent readings are attached. Potentially some slight change (.1 inches or less) at depth, but I feel within the accuracy of the instrument. Nothing that alarms me. I suggest we take another set of readings next spring, or after a high water event.

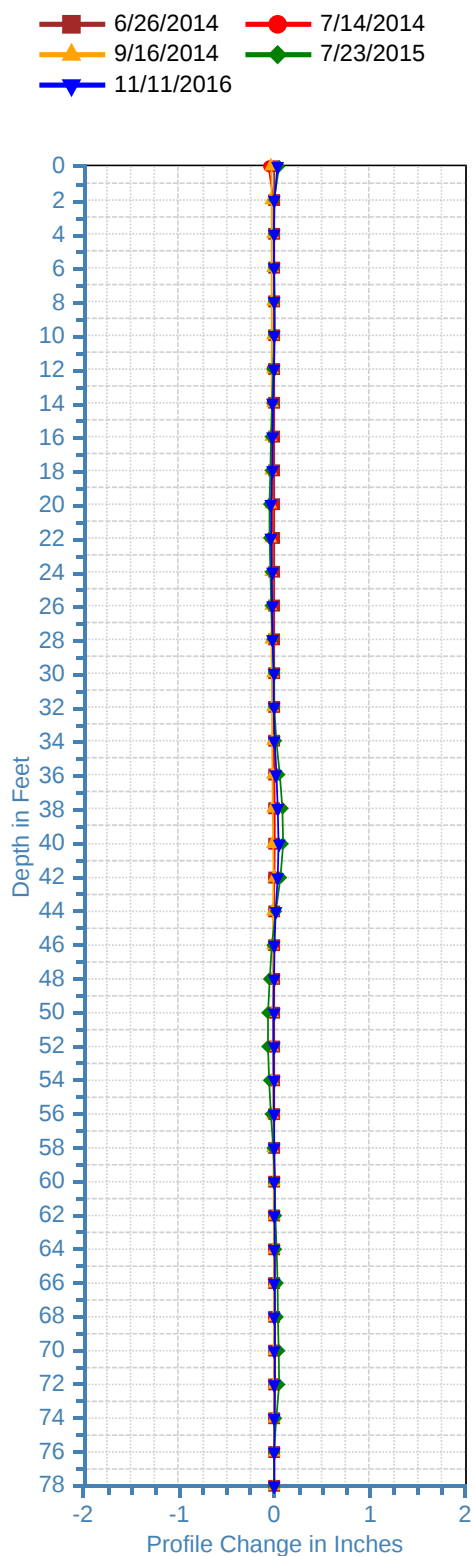
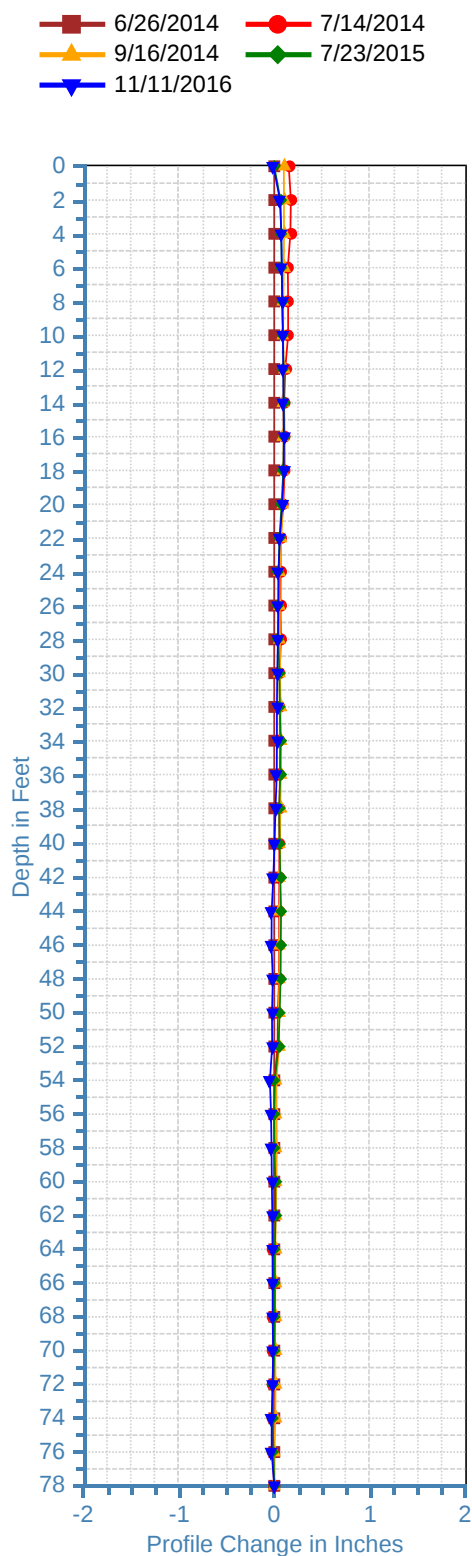
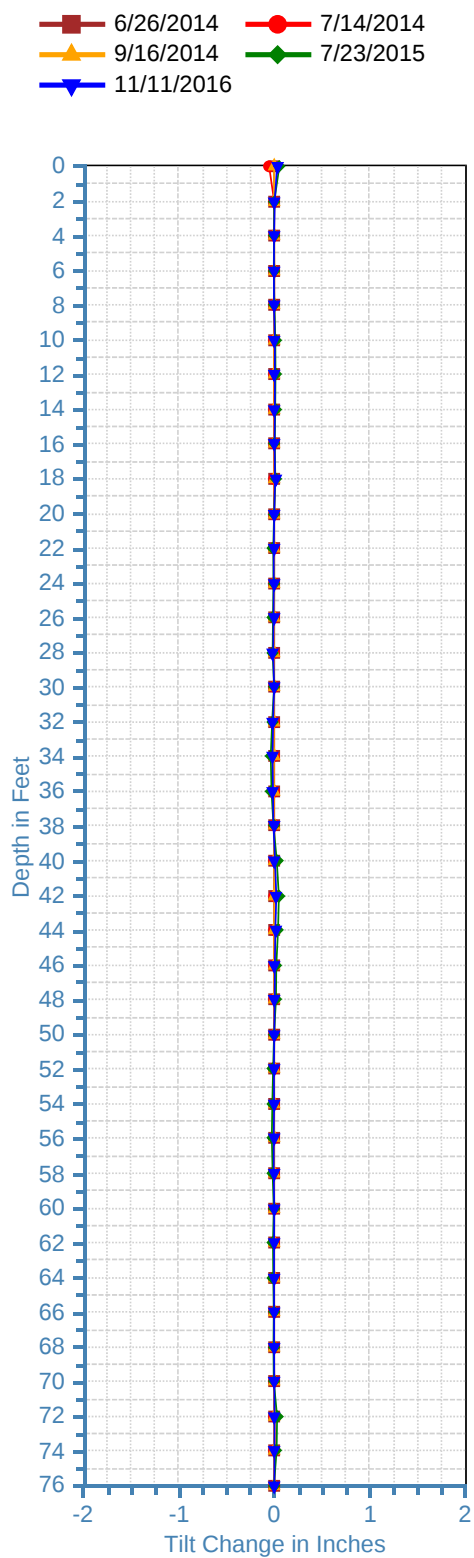
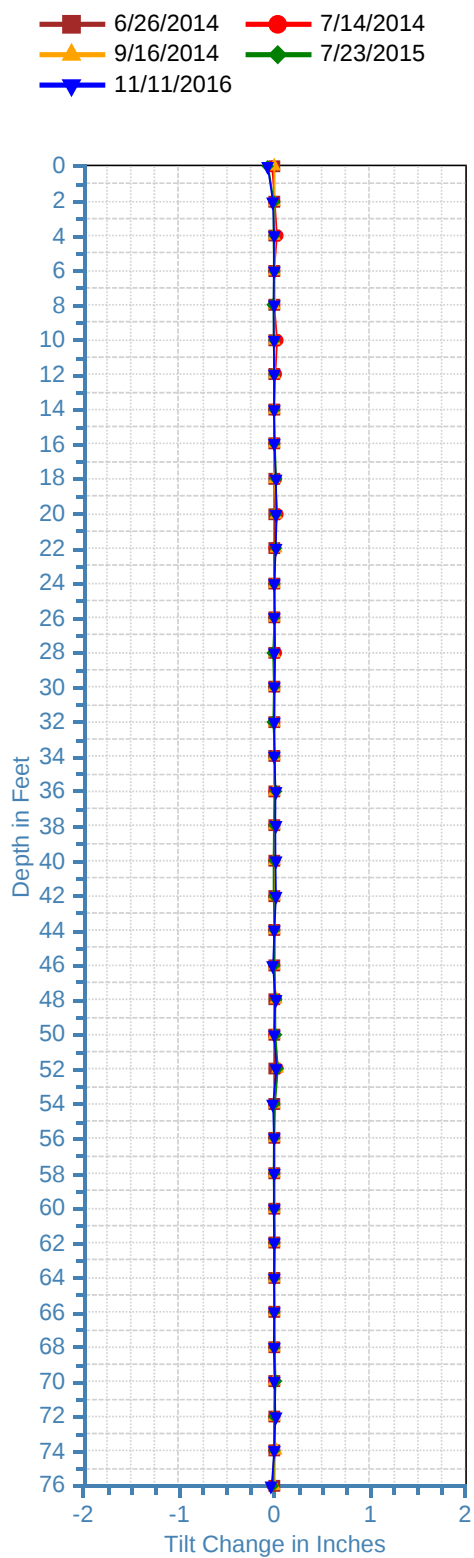
Attached are the inclinometer readings that we took last Friday. Little if any movement was recorded for ST-3.

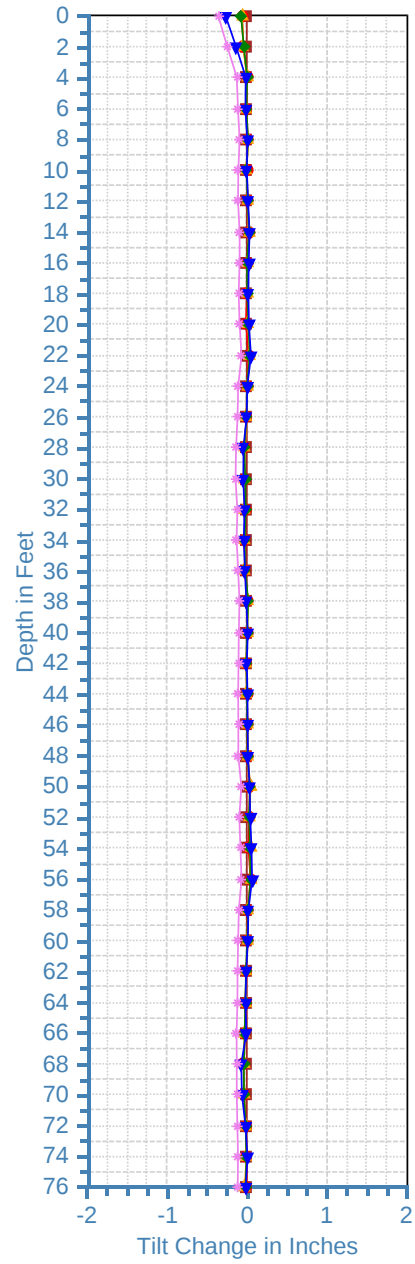
ST-4, E-W

However one of the readings for ST-4 appears to be off. We suspect the reason is that the bottom of ST-4 has some sediment in it. It appears that the cap and top showed signs of deer chewing on it (see attached image). When we made some adjustments to the bottom reading, the movement was more in line with the other readings, showing a 0.5 inch or less movement since the beginning of the recordings.

It is our opinion that the inclinometers are showing no appreciable movement. However we can go back out again this year to get a new set of readings at ST-4. Also during that time, we can slip over sections of capped PVC pipe to protect both inclinometers.
