## LMRWD Stability Study

B14-03590 (formerly SP-09-04727)  
LMRWD Stability Analysis  
Eden Prairie, Minnesota

## Technical Memorandum

**To:** Della Nyondi Schall Young – Young Environmental Consulting Group, LLC  
**From:** Garrett Bayrd, Jacob Sharpe – Barr Engineering Co.  
**Subject:** Monitoring Event – Fall 2020  
**Date:** November 2<sup>nd</sup>, 2020  
**Project:** LMRWD Eden Prairie Slope Monitoring

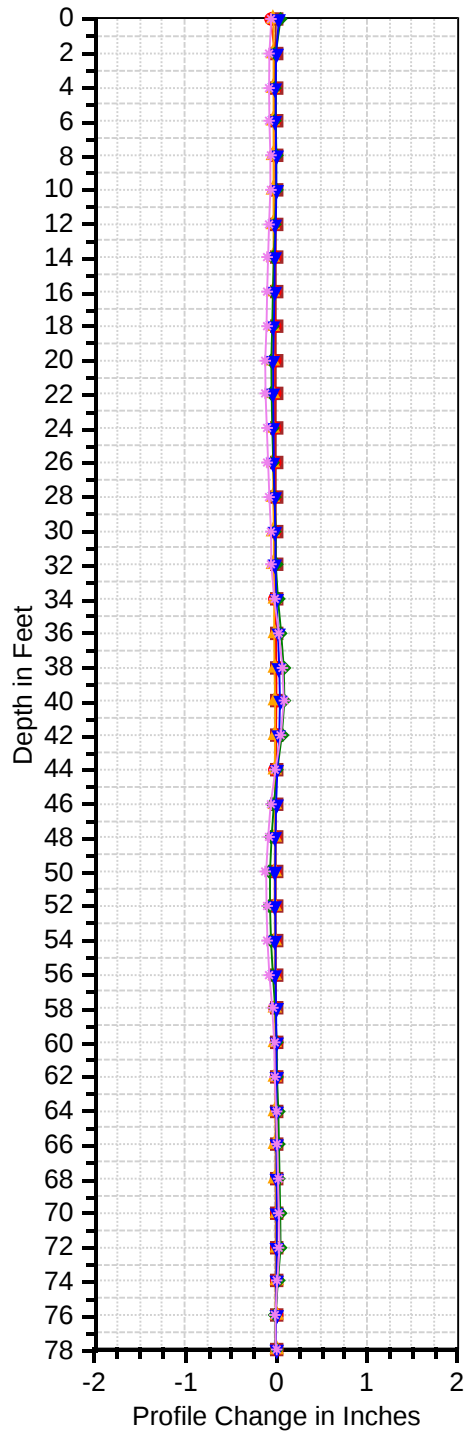
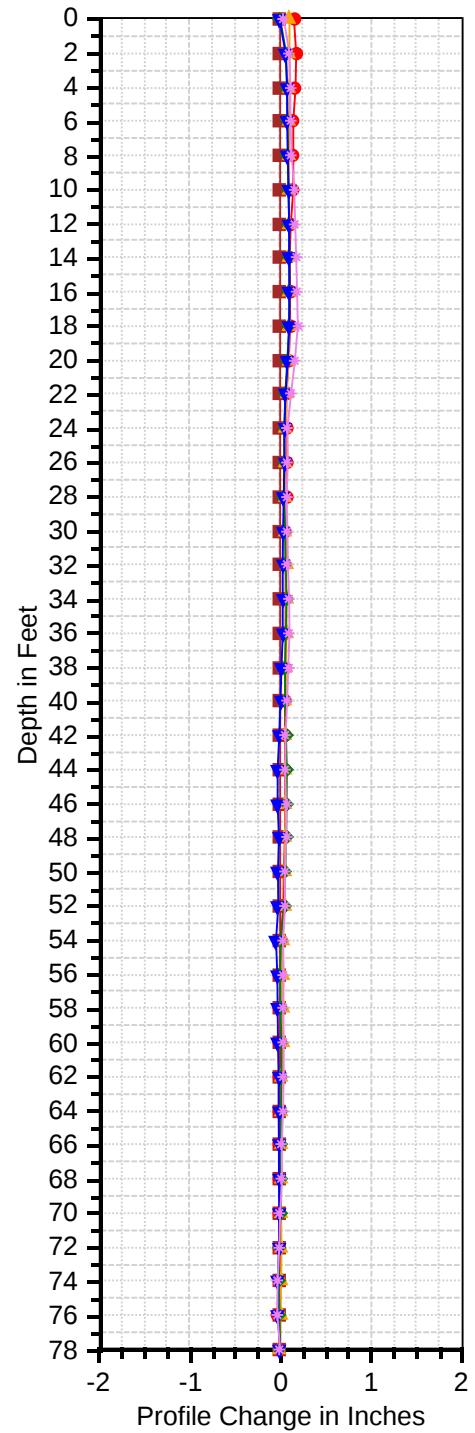
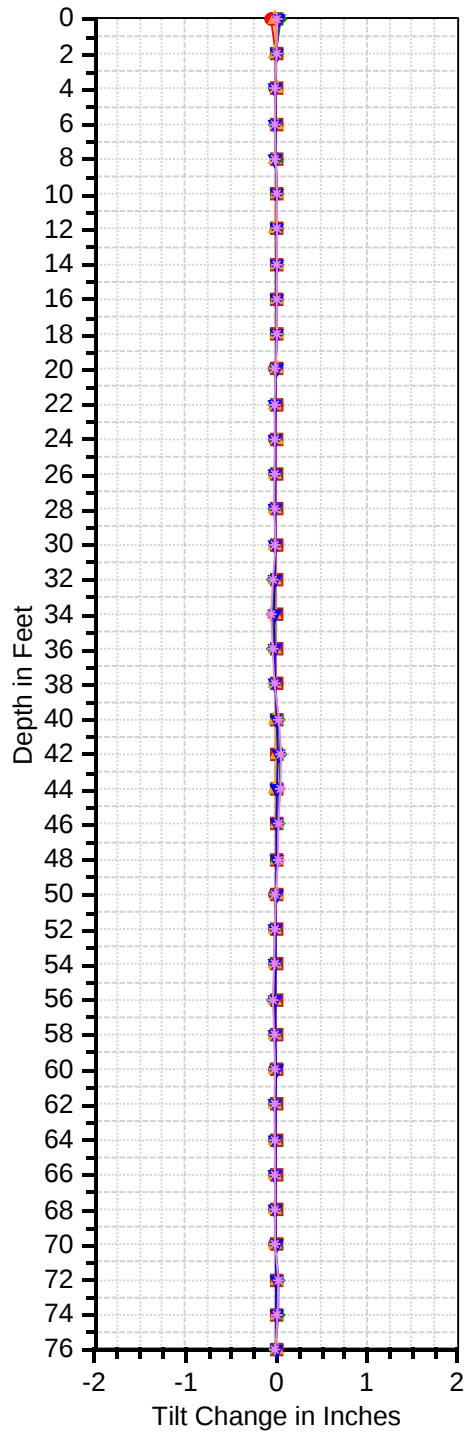
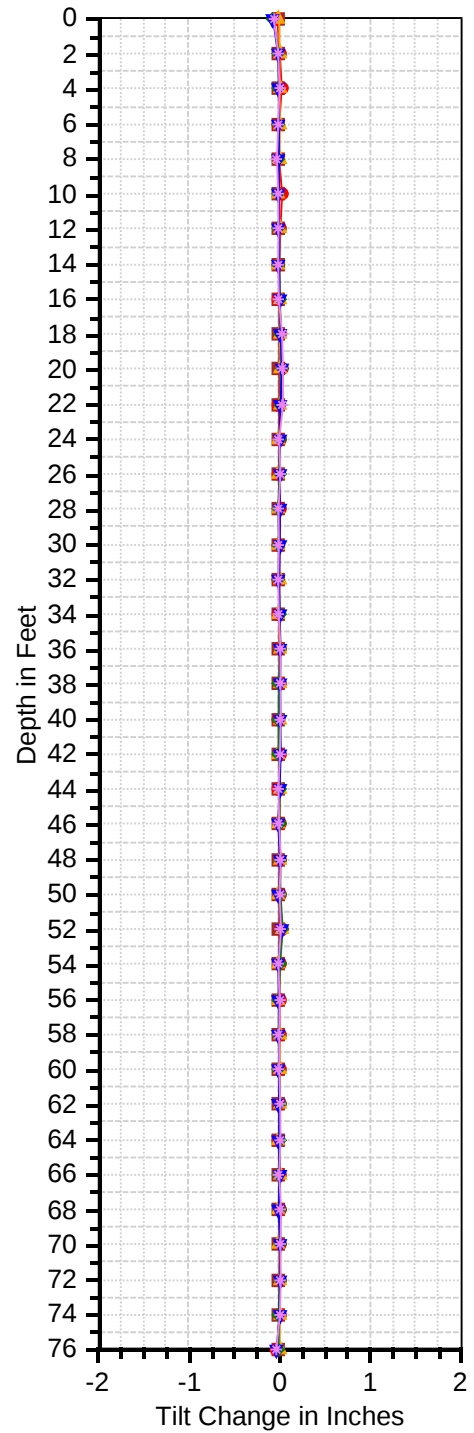
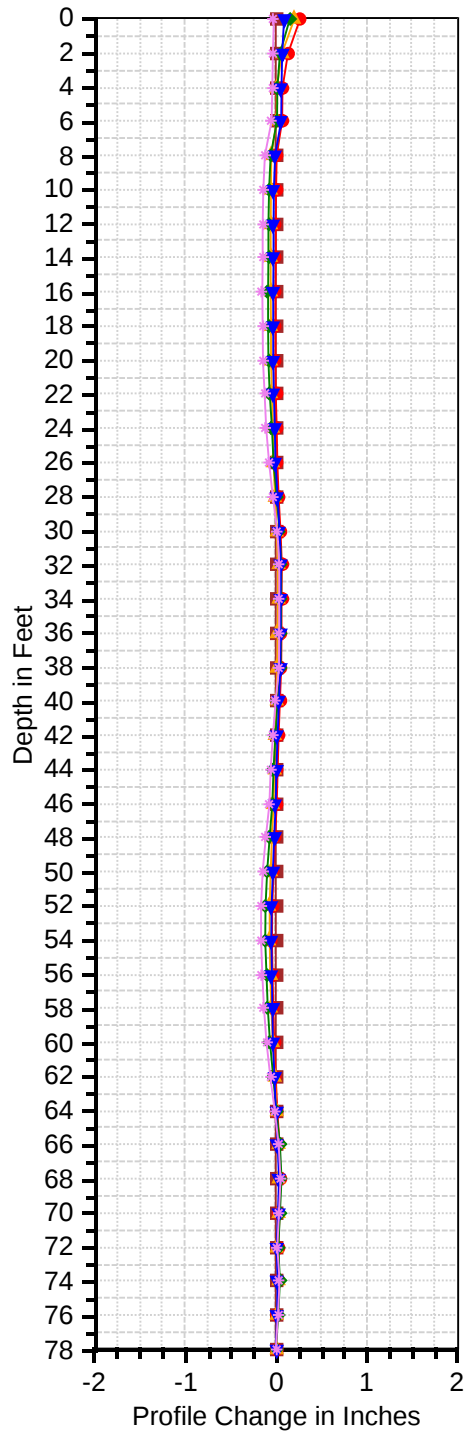
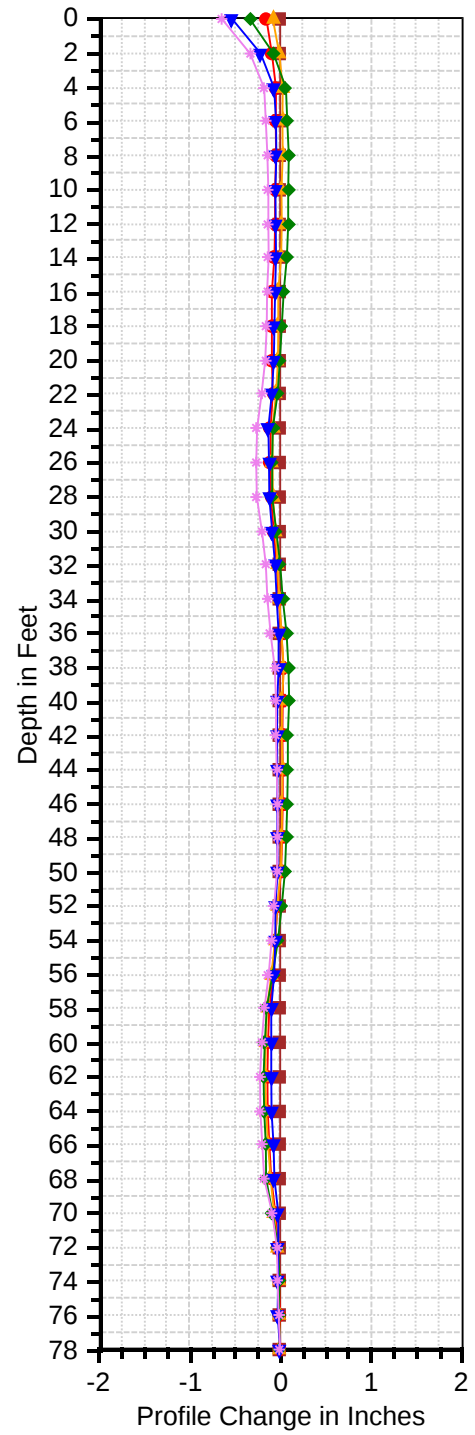
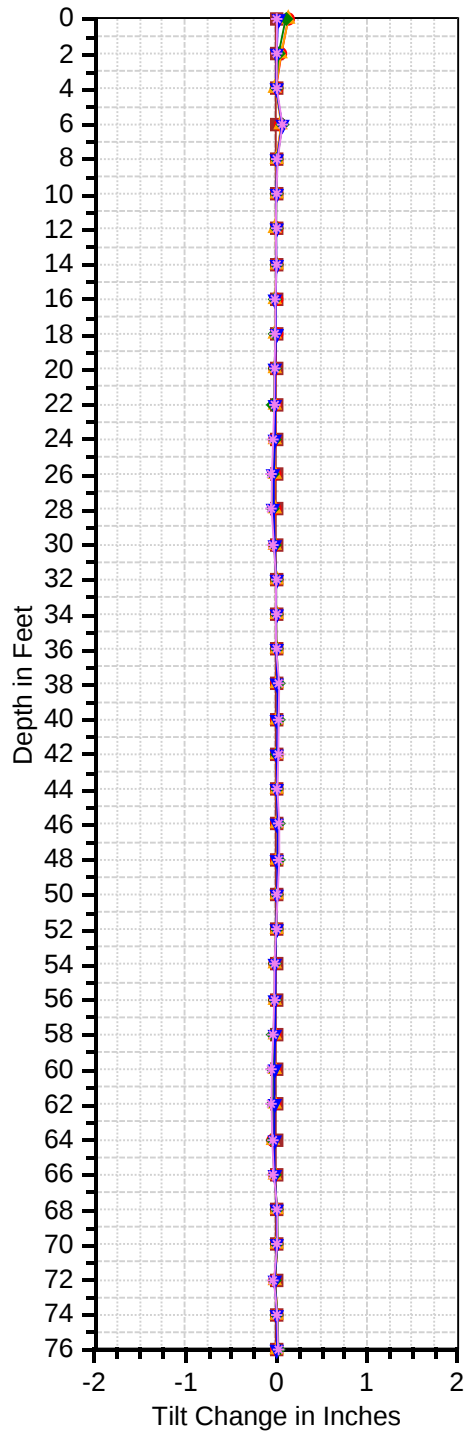
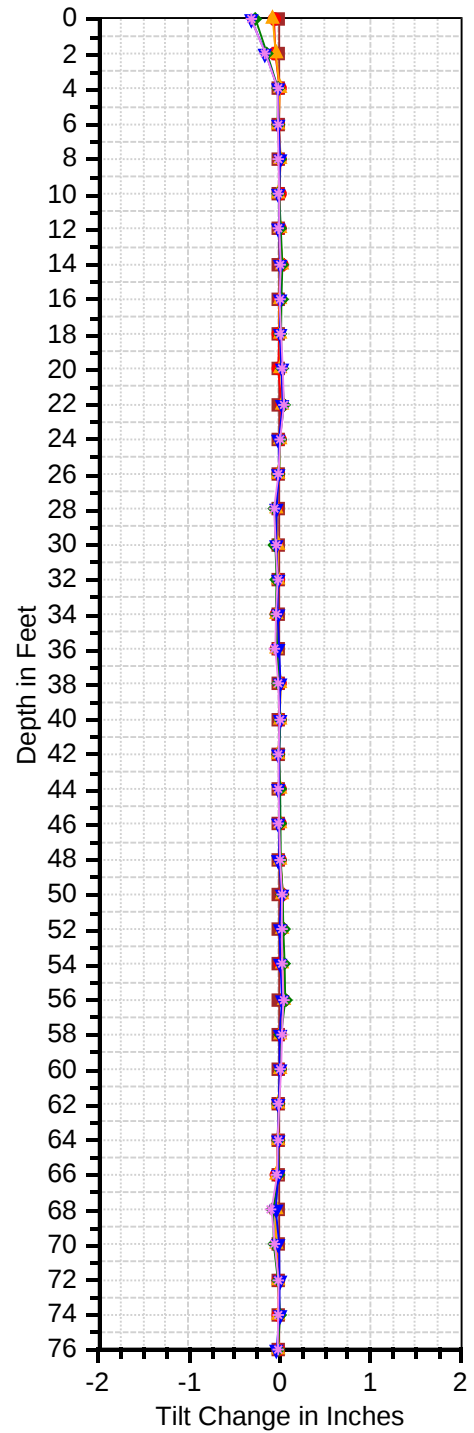
Attached are the inclinometer readings that we took this fall. Little if any movement was recorded for ST-3 or ST-4.

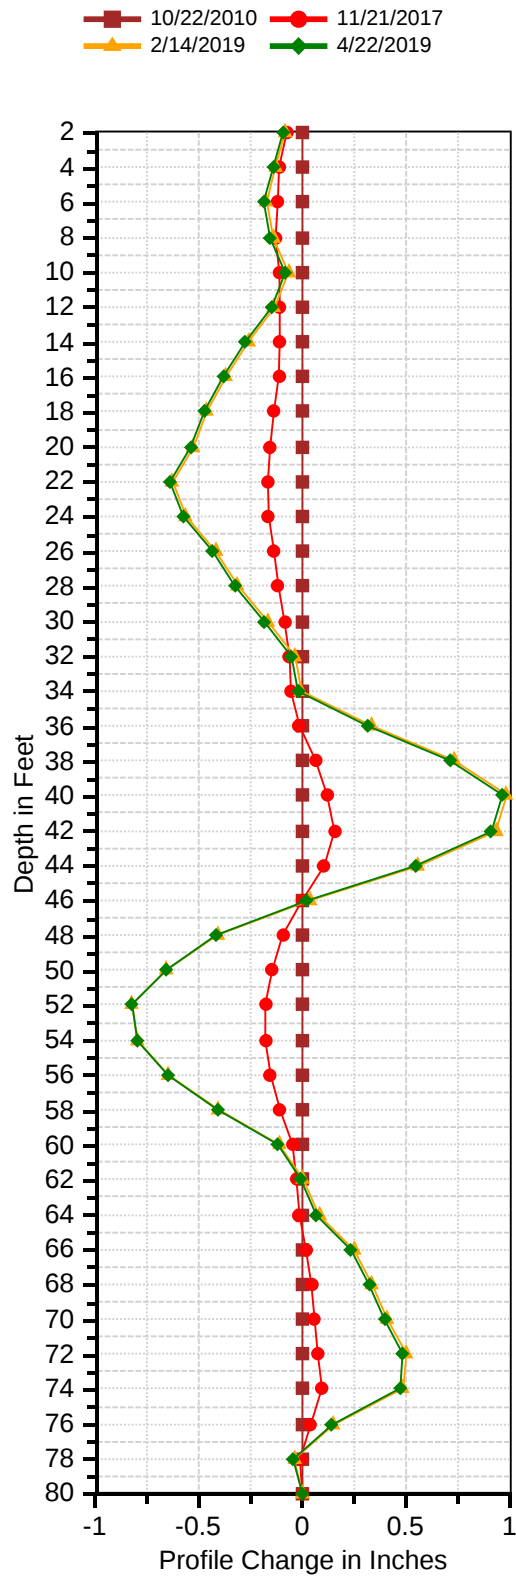
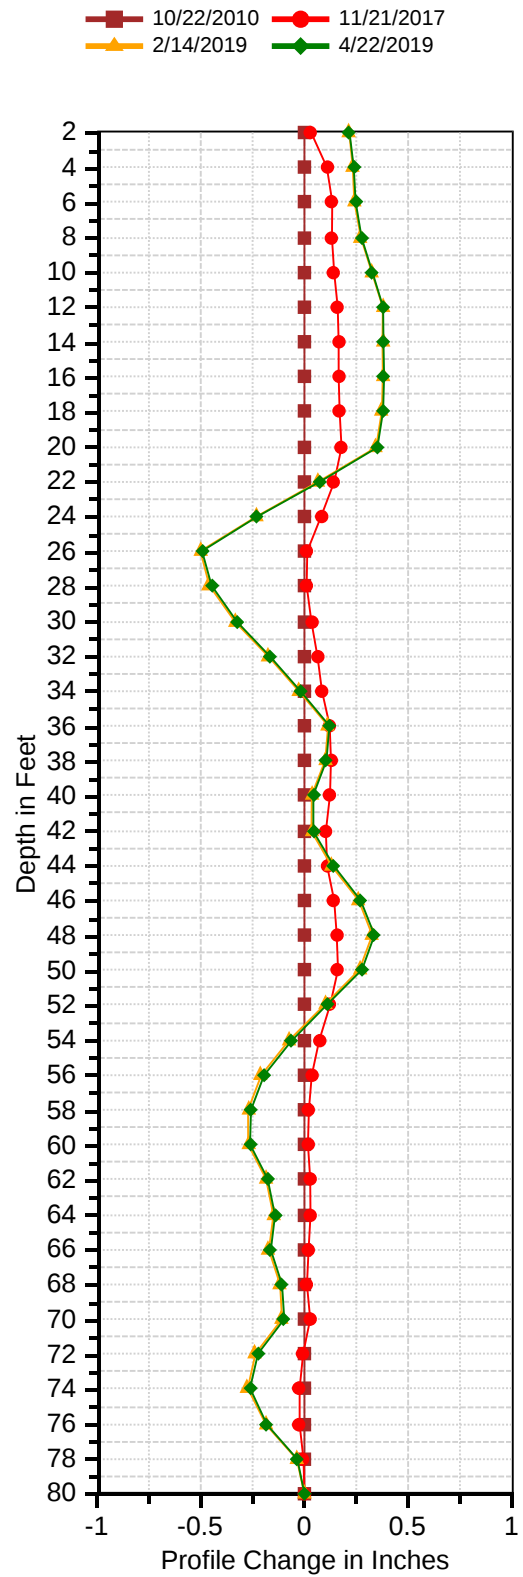
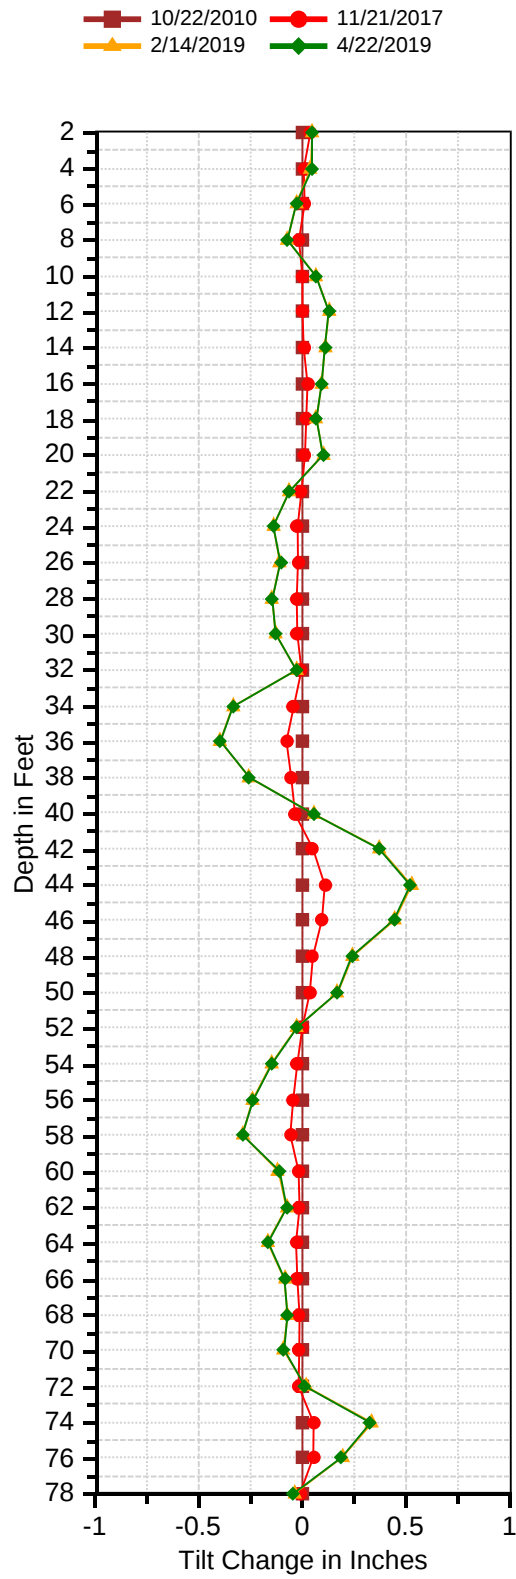
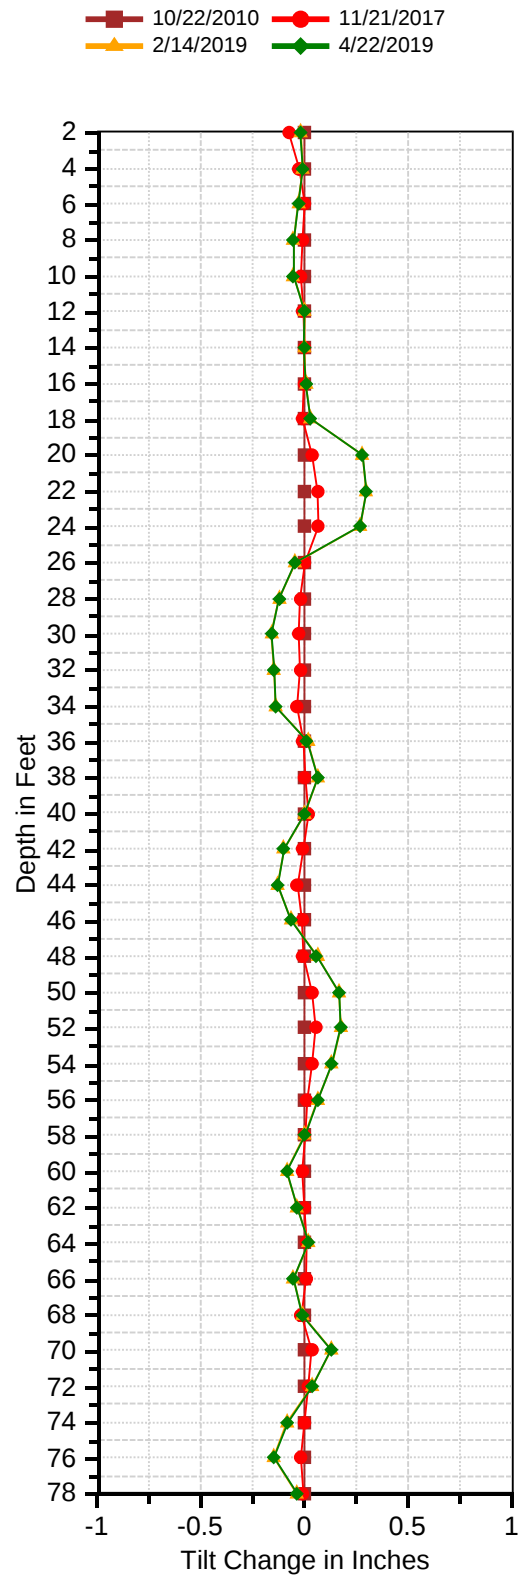
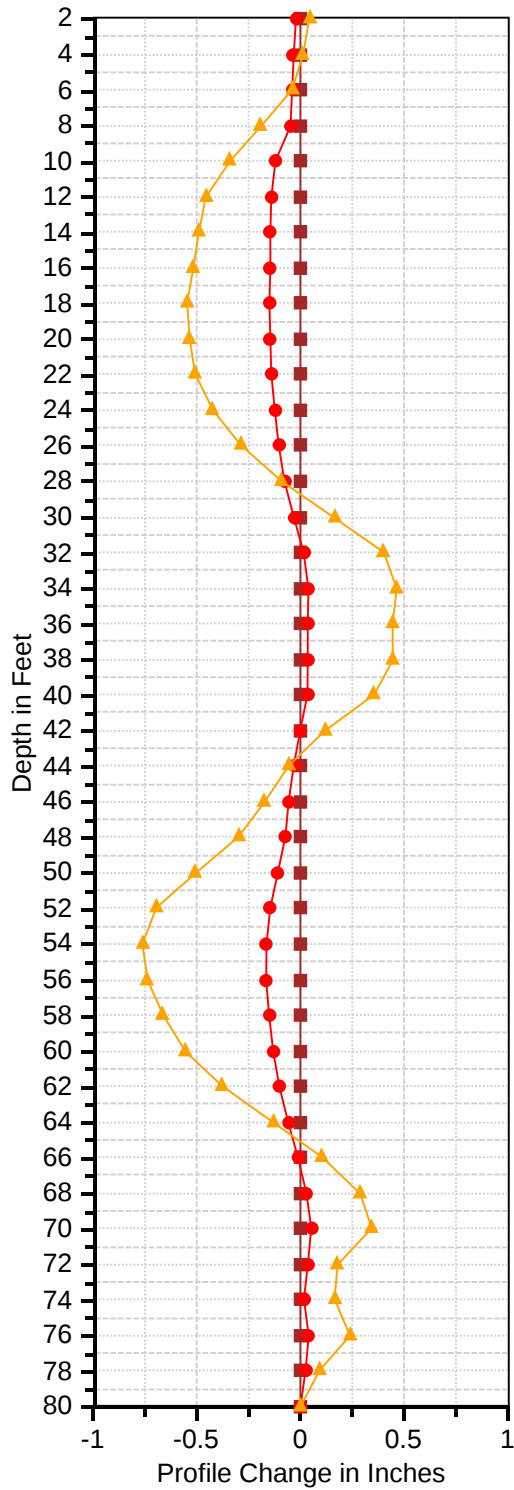
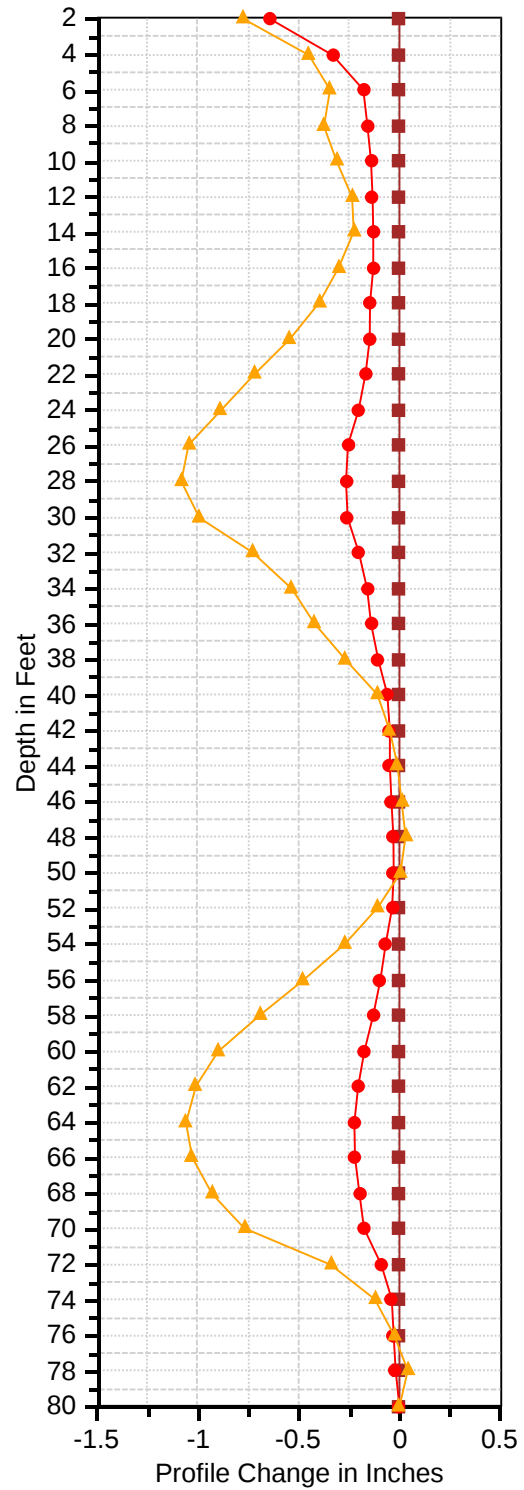
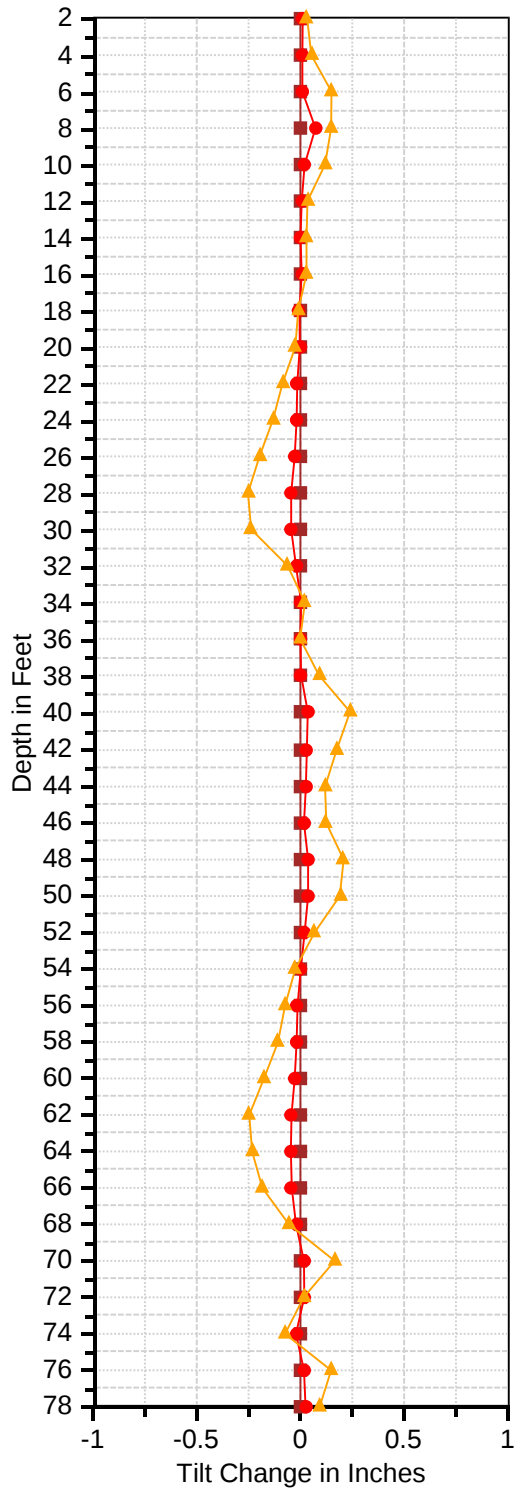
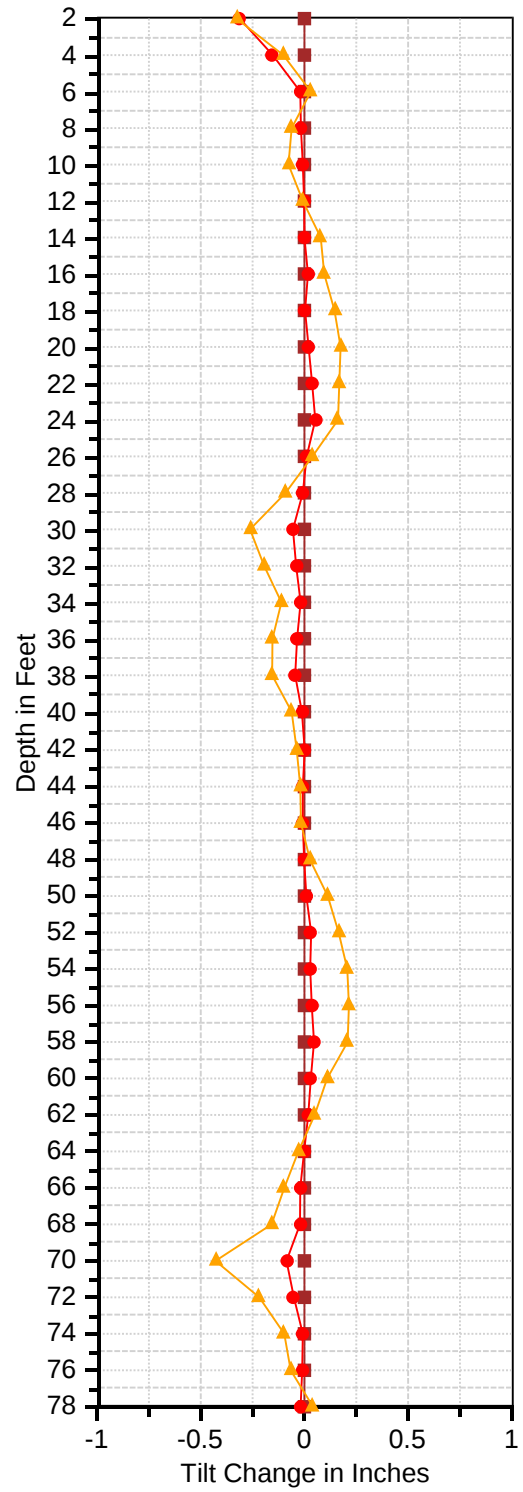
Attached are the most recent plots. We are starting to see more movement in both inclinometers. As I wrote to you earlier there was ice in ST-4 inclinometer for the reading on February 14. However, as you can see, the readings for ST-3 on February 14 and April 22 are essentially identical. I recommend that we take another set of readings soon, say within the next couple of weeks to see if the movement has calmed down.

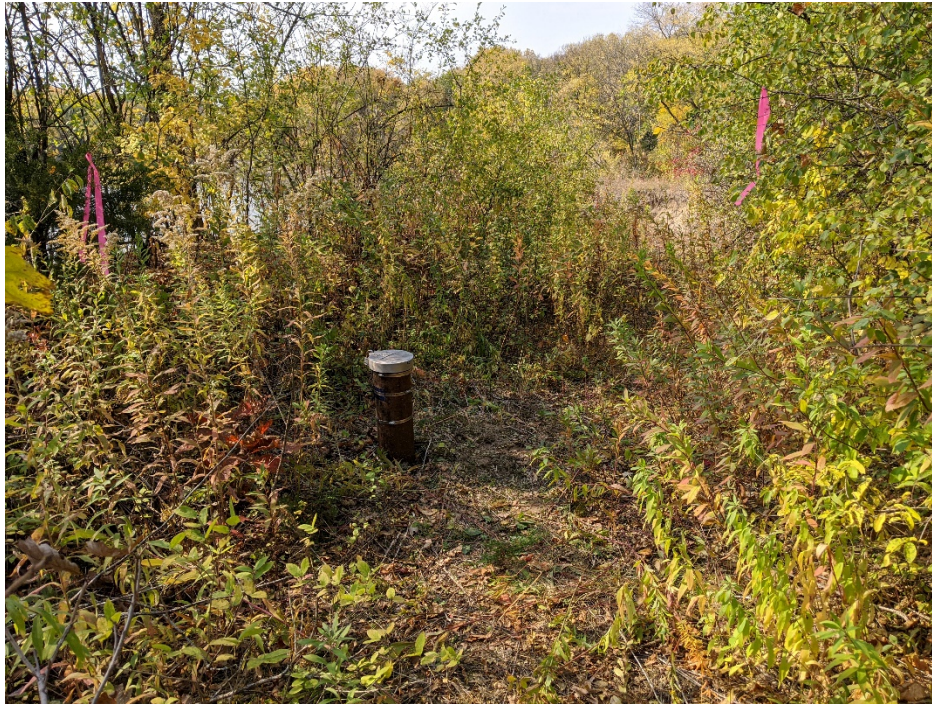
**Photo 2: Well SB-6**

Barr staff located boring SB-6 during the October 9<sup>th</sup>, 2020 site visit. A well was installed by others during the initial drilling of boring SB-6 in November 2009. The well was still extant and accessible. The well is registered with the Minnesota Department of Health as unique well No. 772801.

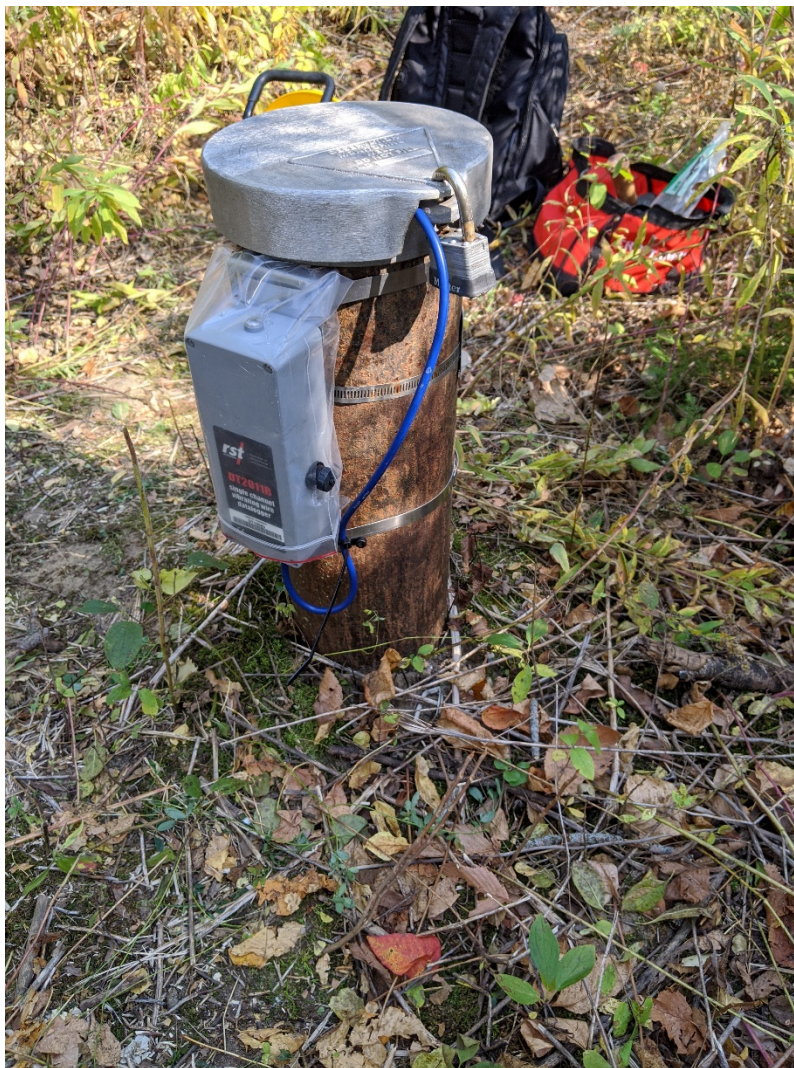
Barr staff took manual readings of the groundwater, which was present 40.0 feet below ground surface during the site visit. Staff installed a vibrating wire piezometer in the well at a depth of 76.9 feet below ground surface. The vibrating wire piezometer was connected to a local datalogger which will record the groundwater level every 12 hours. The calibration sheet for the vibrating wire piezometer is included in this memo as Attachment 2. Barr staff took a manual water level reading and downloaded the data from the datalogger during a subsequent site visit on Thursday, October 29<sup>th</sup>. The water level data is included in this memo as Attachment 3. As the plot shows, the water level in this well varied only a few feet over the 3 weeks of monitoring. During subsequent site visits Barr staff will continue to download data from this datalogger and update these plots.

**Photo 3: Well SB-6 with vibrating wire piezometer cable (blue) and datalogger (grey) attached**

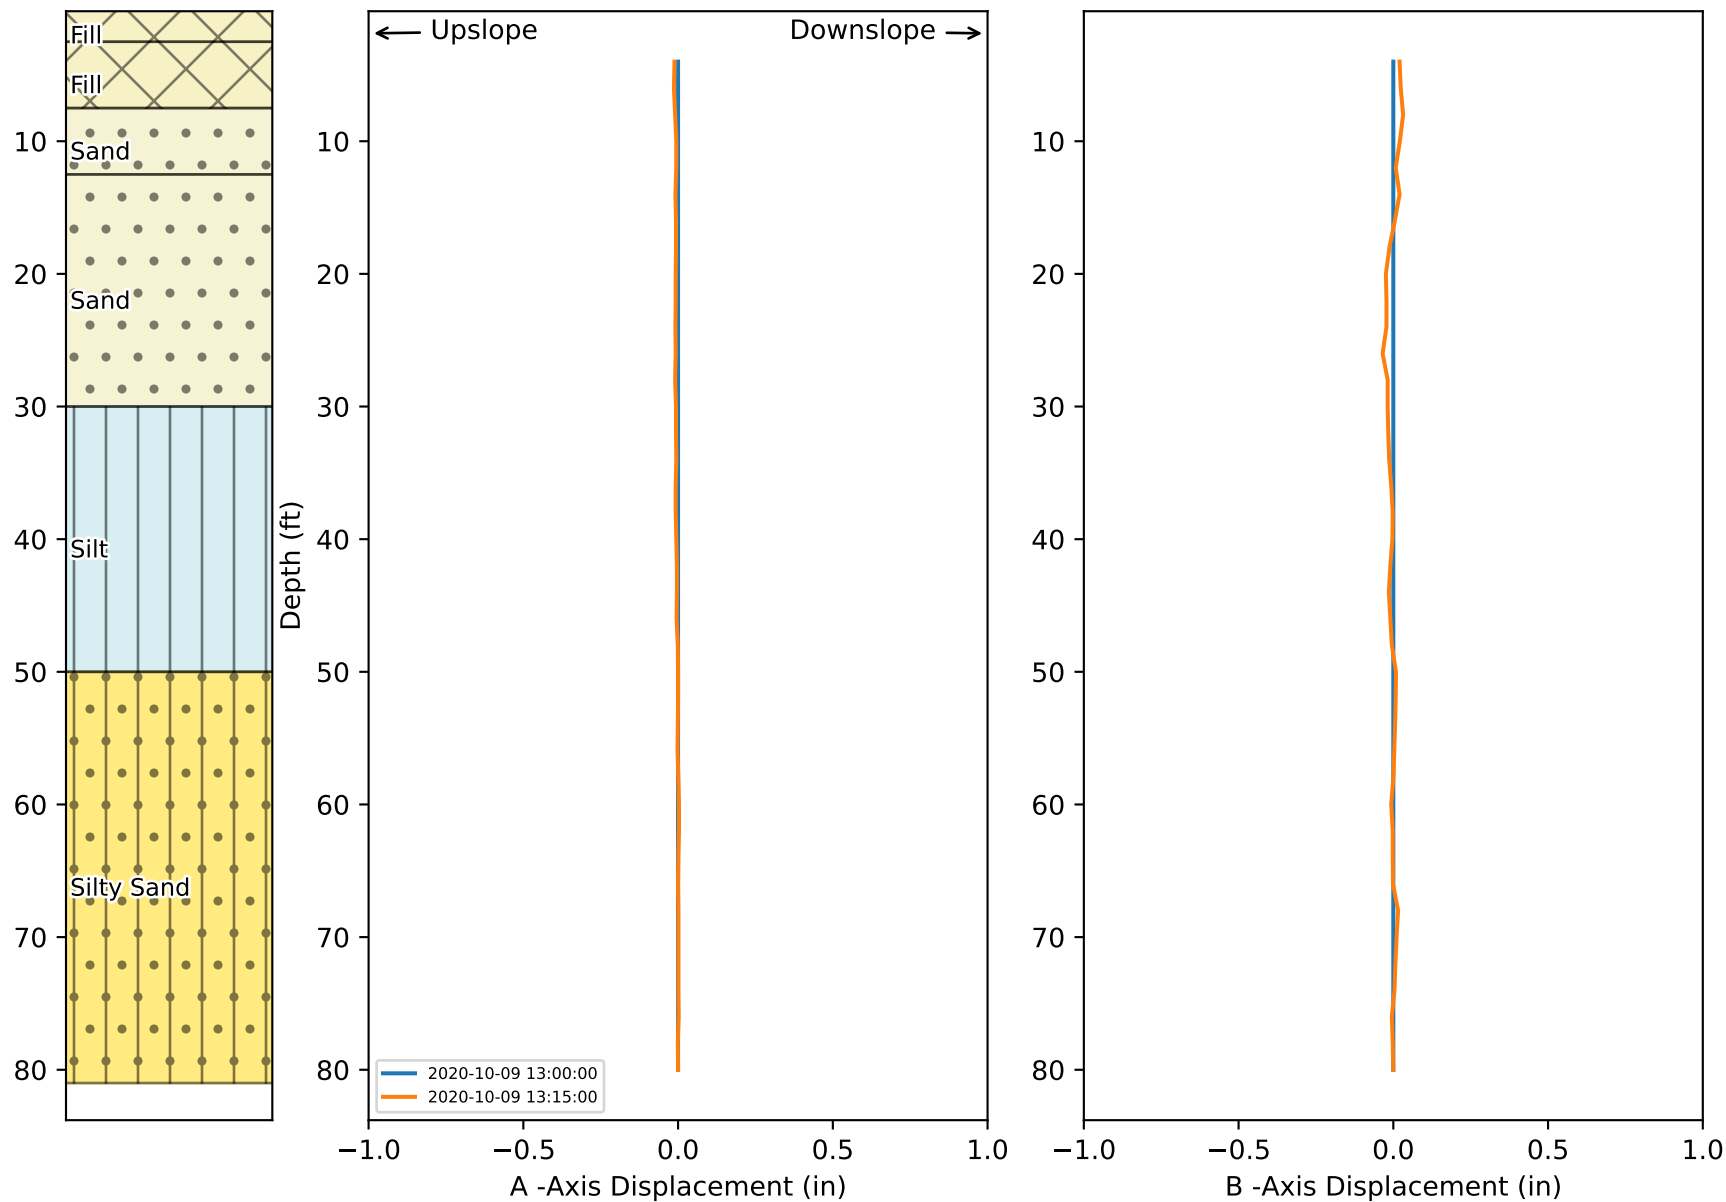
LMRWD Area 3 Slope Stability  
Eden Prairie, Minnesota  
SBINC-3 Inclinometer Data

October 2020  
Profile-Change Plots

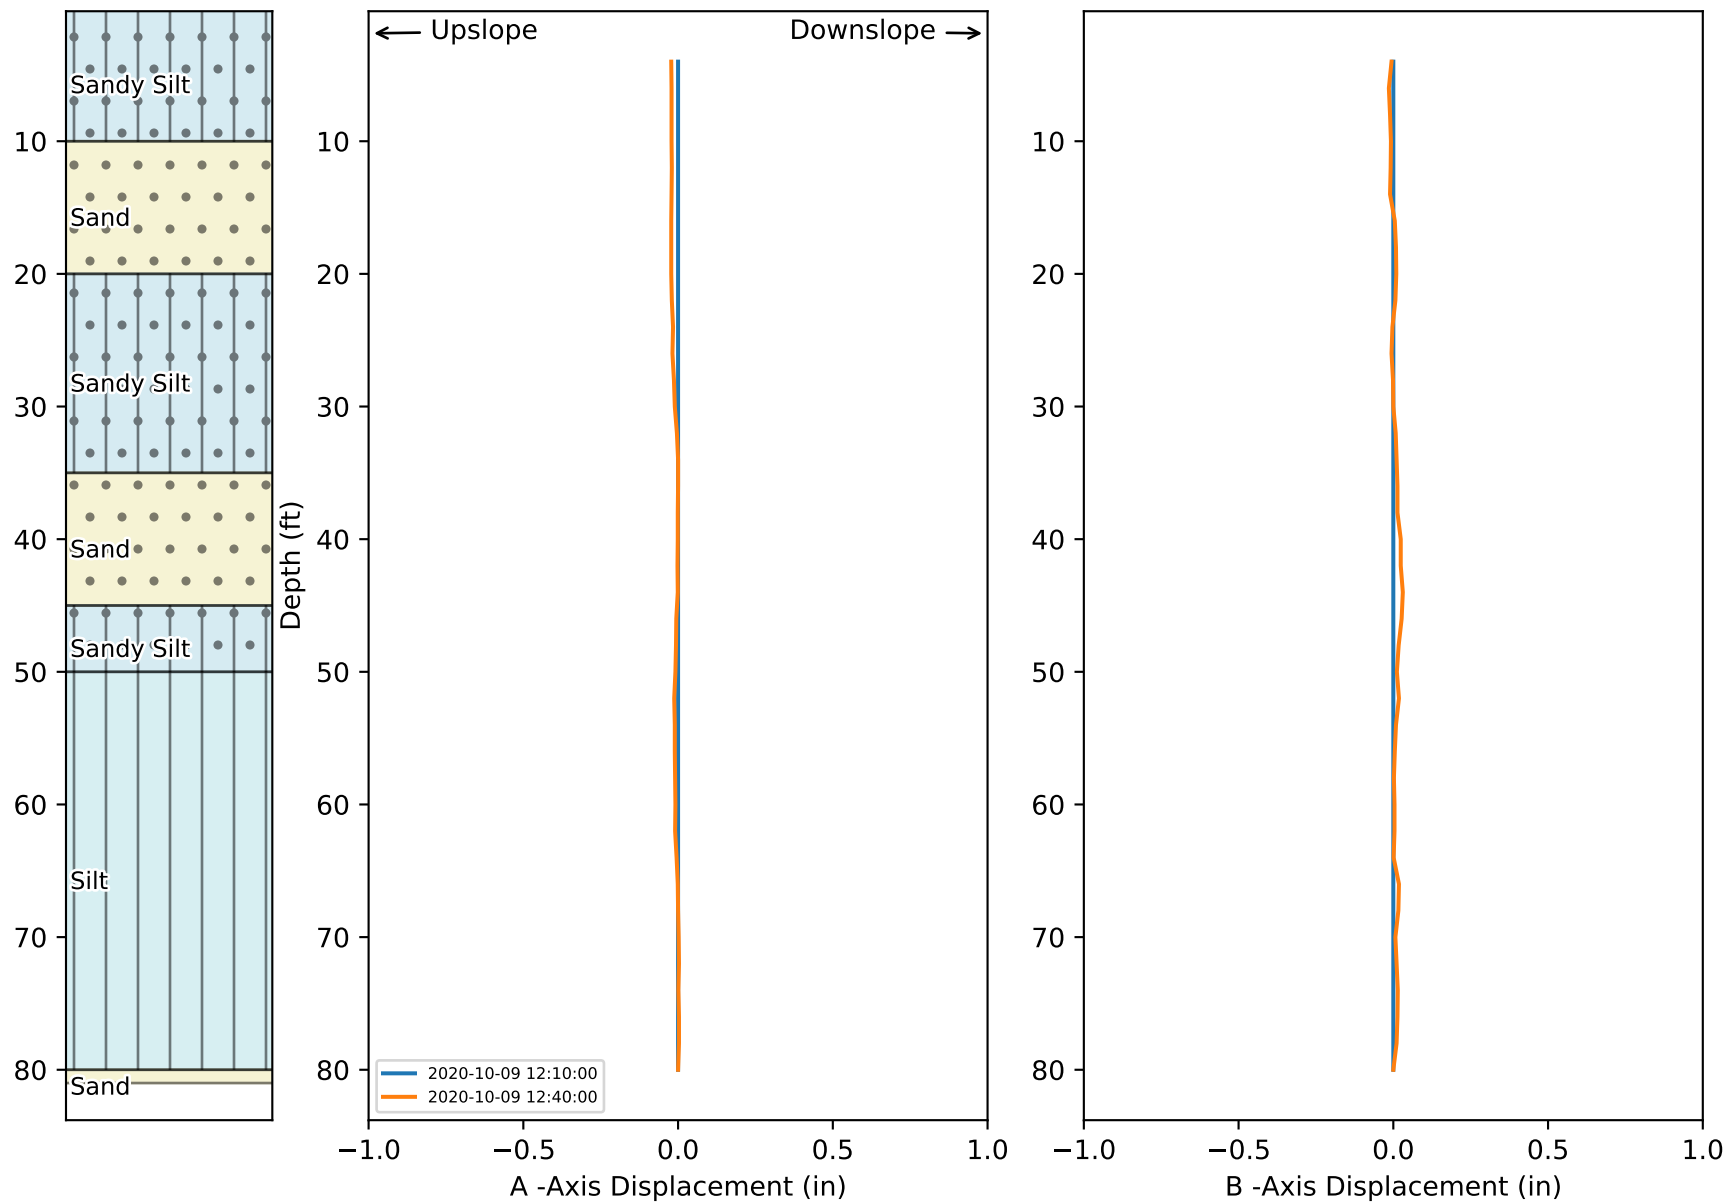
LMRWD Area 3 Slope Stability  
Eden Prairie, Minnesota  
SBINC-4 Inclinometer Data

October 2020  
Profile-Change Plots

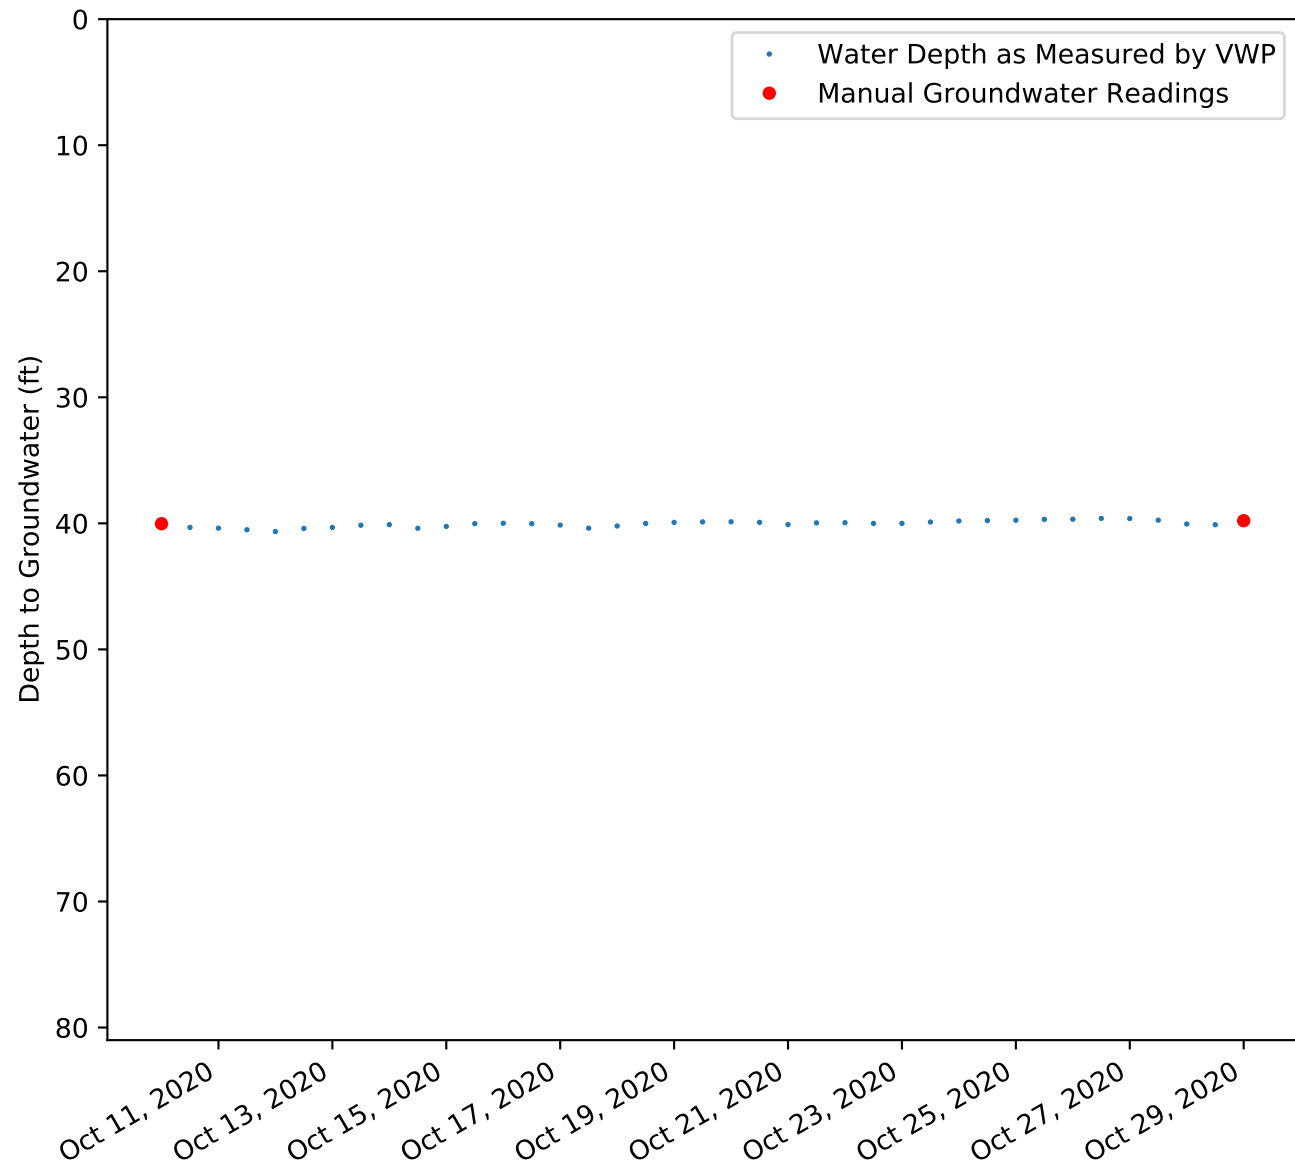
### **Water Depth in Boring SB-6**

LMRWD Area 3 Slope Stability  
Eden Prairie, Minnesota  
SB-6 Well Data
