# Technical Memorandum

**Date:** October 16, 2020

**Re:** Area 3 Slope Stability Project Update

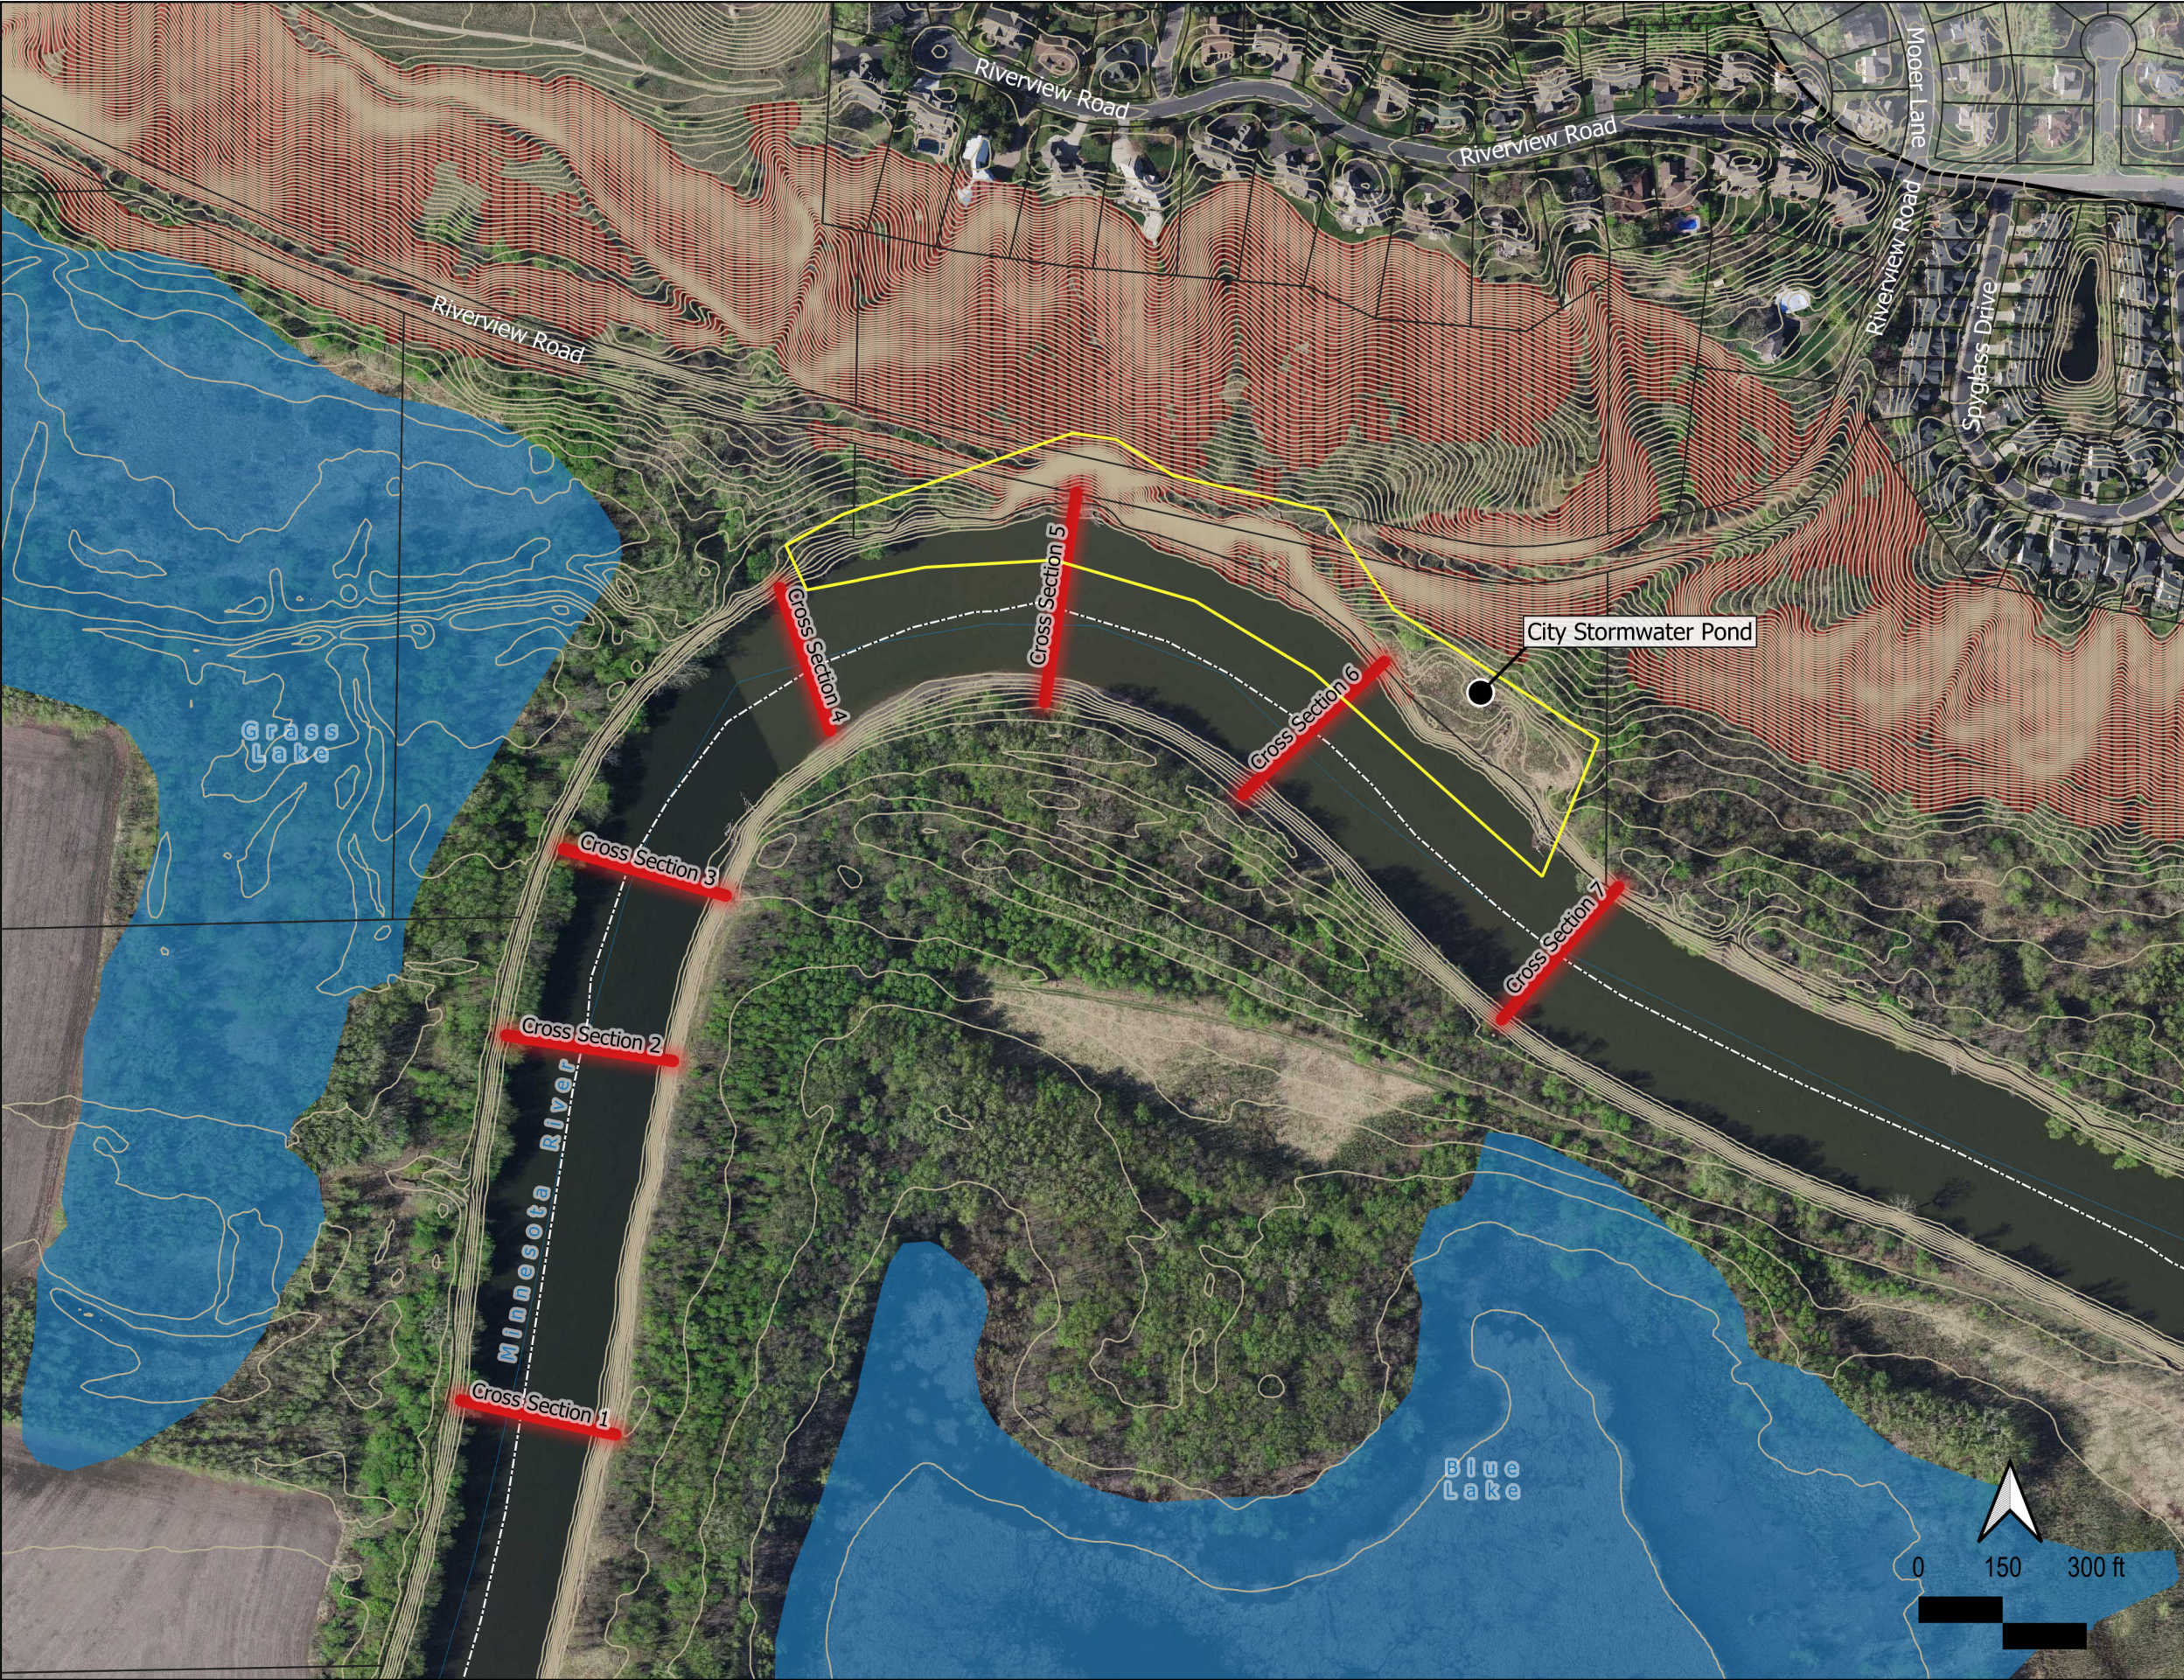
**Figure 1:  
River Cross-Sections**

Barr conducted a bathymetric survey of the six cross sections surveyed in 2009 on September 3, 2020 (**Figure 1**). The cross-sectional data was compared to the 2009 data by aligning the horizontal stations and elevations at the survey (**Figure 2**).

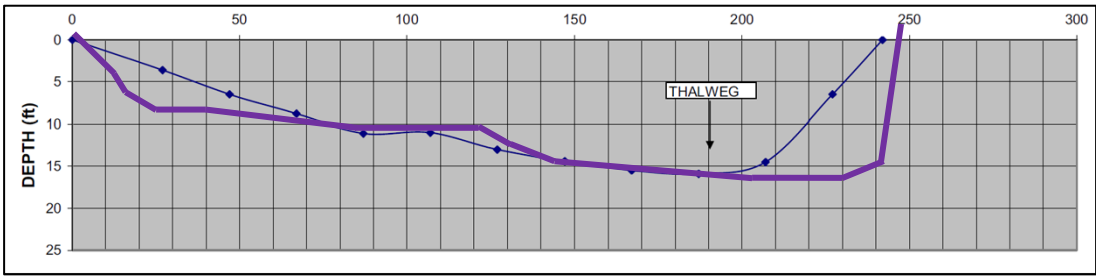
Cross-Section 1

Cross sections 1–2 are upstream of Area 3 and show evidence of scouring and continuing erosion since 2009; the channel has deepened, and the right bank significantly eroded. Cross section 3 is also upstream of Area 3 but shows some deposition evidence in the channel. Still, the overall shape and extent of the cross section appear to be only minorly changed.

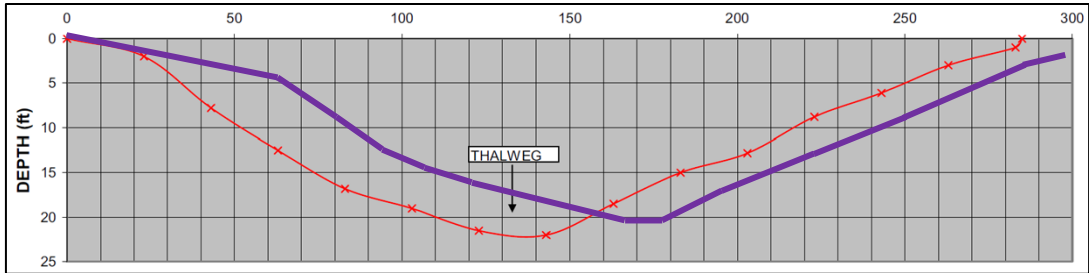
Cross-Section 4

Cross sections 4 through 6 are within the Area 3 project area and all show evidence of channel movement and scour. Cross section 5 clearly shows the channel has moved toward the left bank—closer to the Area 3 embankment—and has deepened since 2009. This movement is consistent with the 2009 Wenck assumptions and historical aerial photo analysis, which showed the river has been migrating north at an average of 2 feet per year between 1937 and 2008.

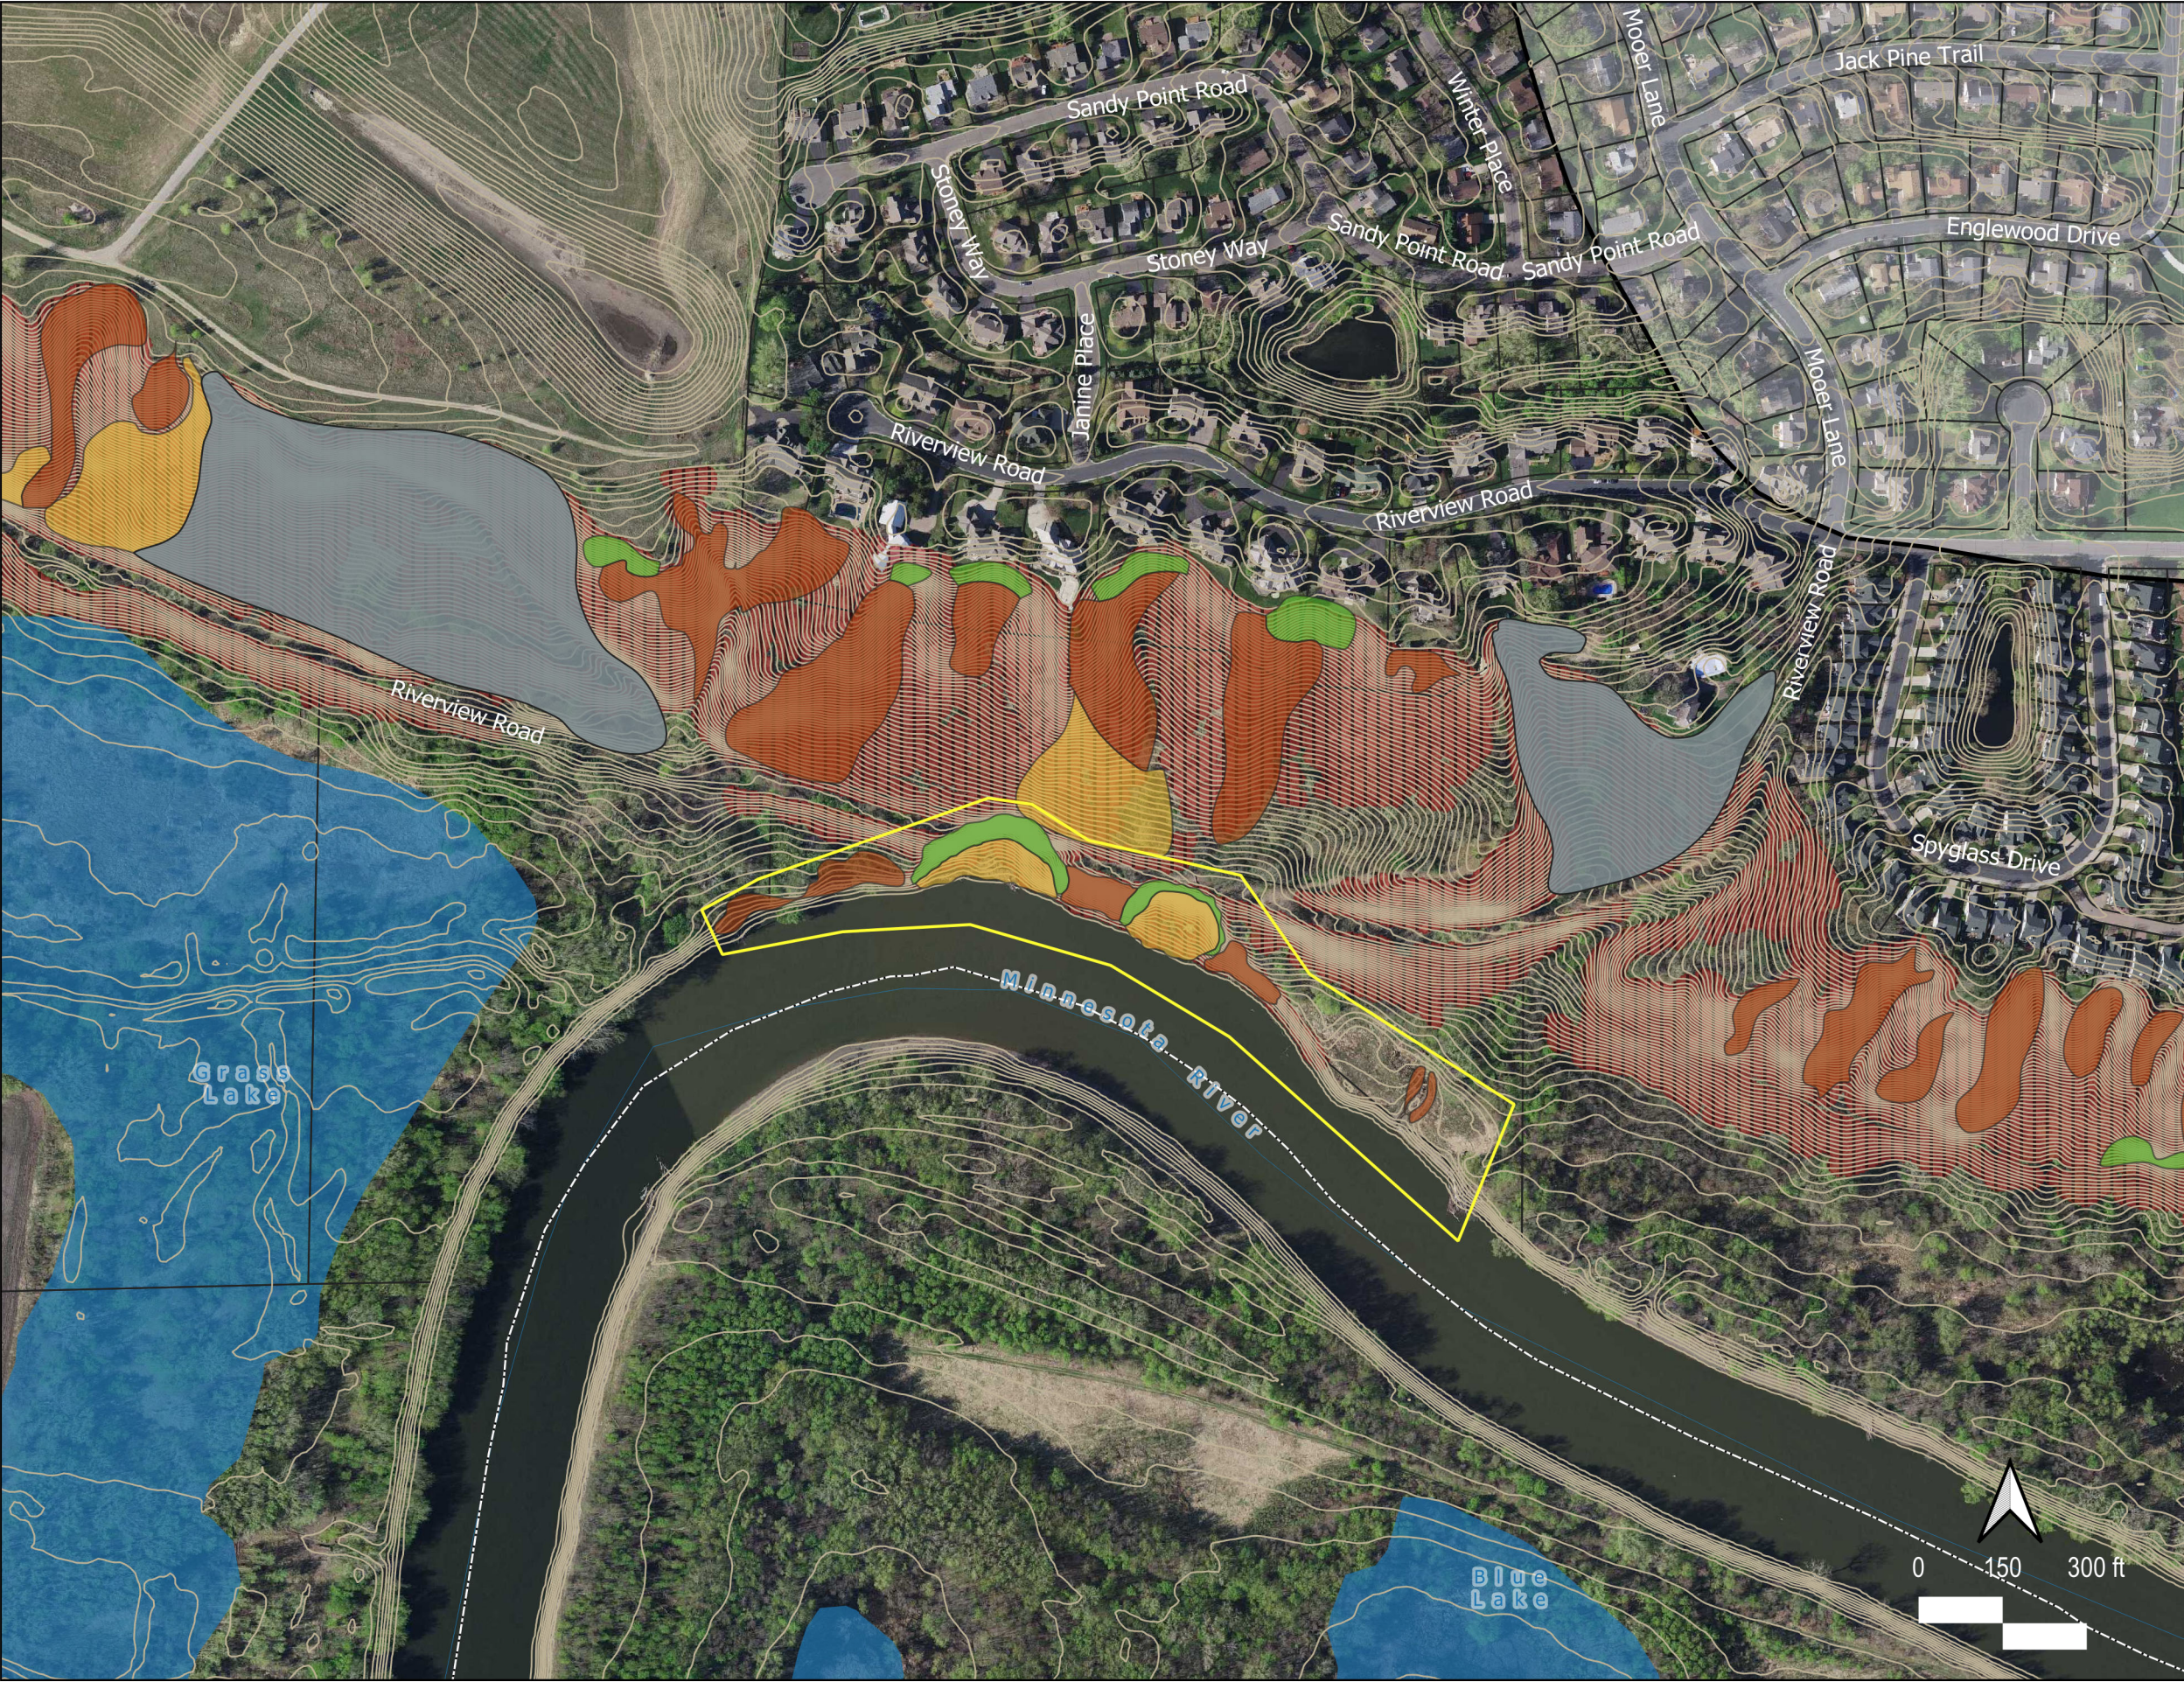
**Figure 3:  
Area 3 Historic  
Landslides**

Hennepin County provided locations of historic landslides derived from an analysis of LiDAR topography. The Area 3 embankment has been subject to several historical landslides, which have deposited material along the slope's left toe and within the

Minnesota River (**Figure 3**). The inventory lends additional credibility for the continued slope movement monitoring of the embankment.

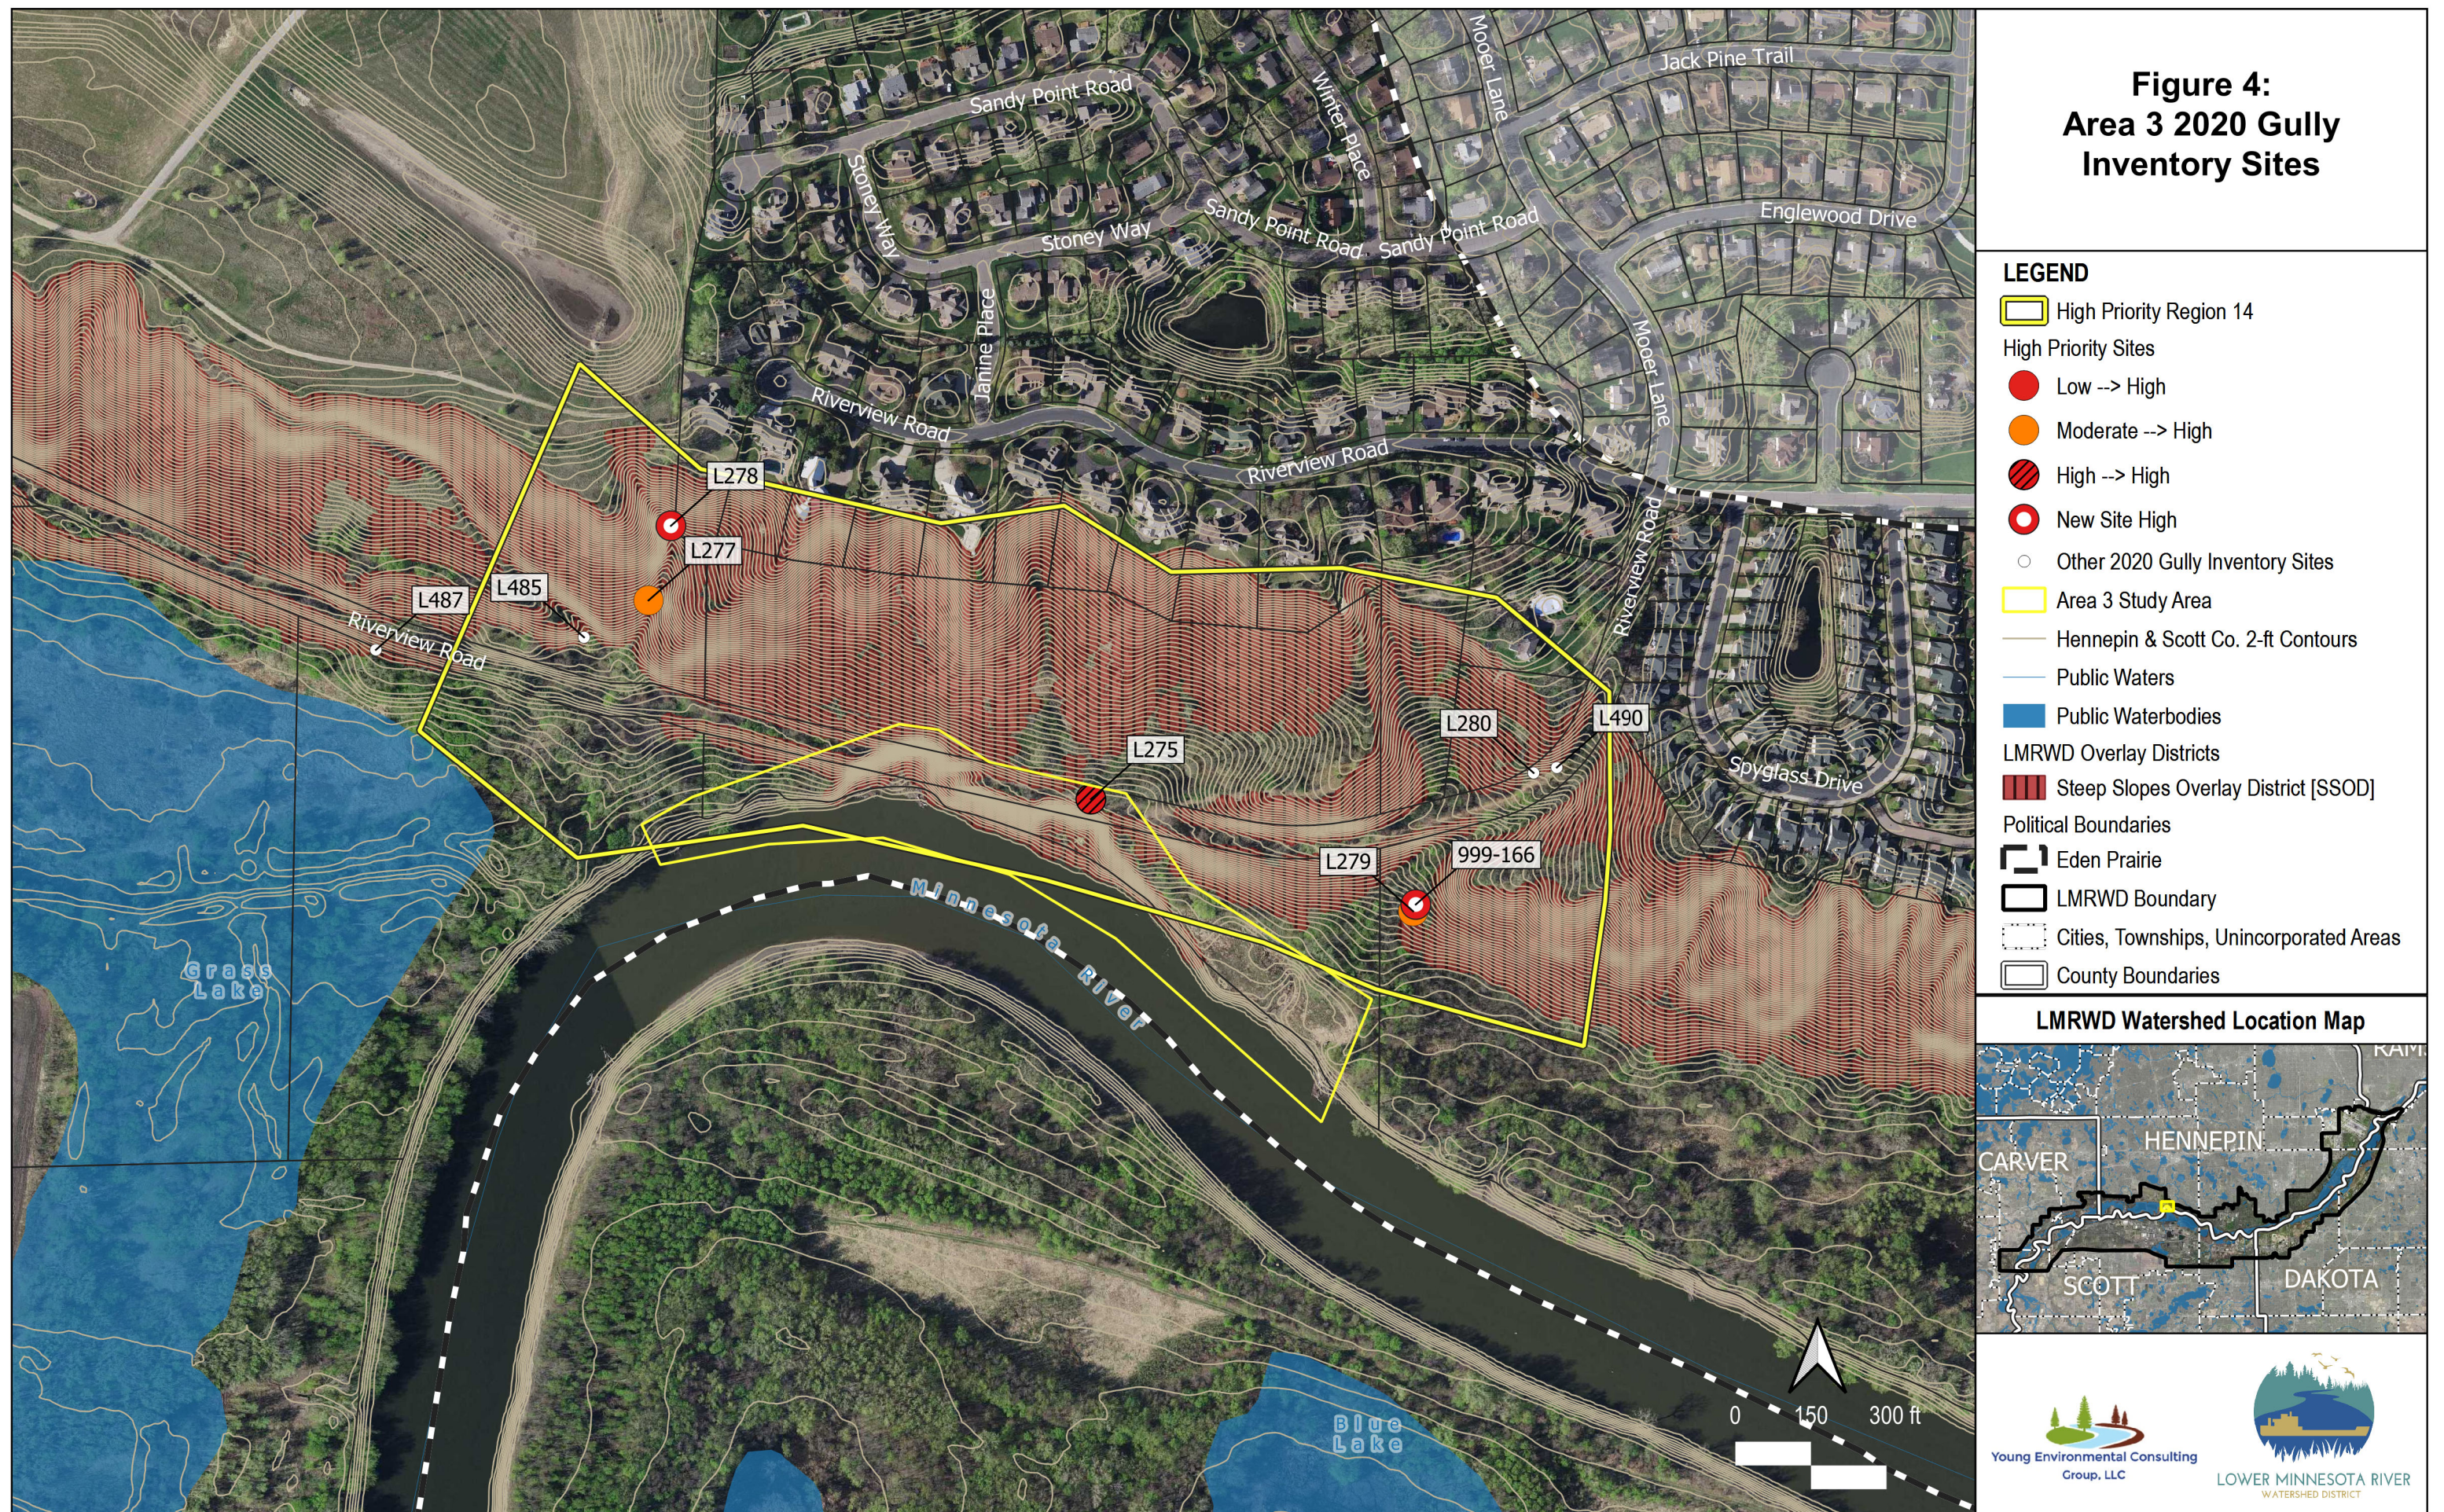
**Figure 4:  
Area 3 2020 Gully  
Inventory Sites**

Several sites were surveyed over the summer and are shown in **Figure 4**. The area was identified as High-Priority Region (HPR) 14 in the *2020 Gully Inventory* due to the cluster of high-priority gullies found. This area contains several gullies rated as having high erosion potential, meaning they may be actively eroding and transporting sediment downstream. Most of the sites surveyed in HPR 14 noted evidence of slope movement, including curved or leaning trees and hillside slumps.

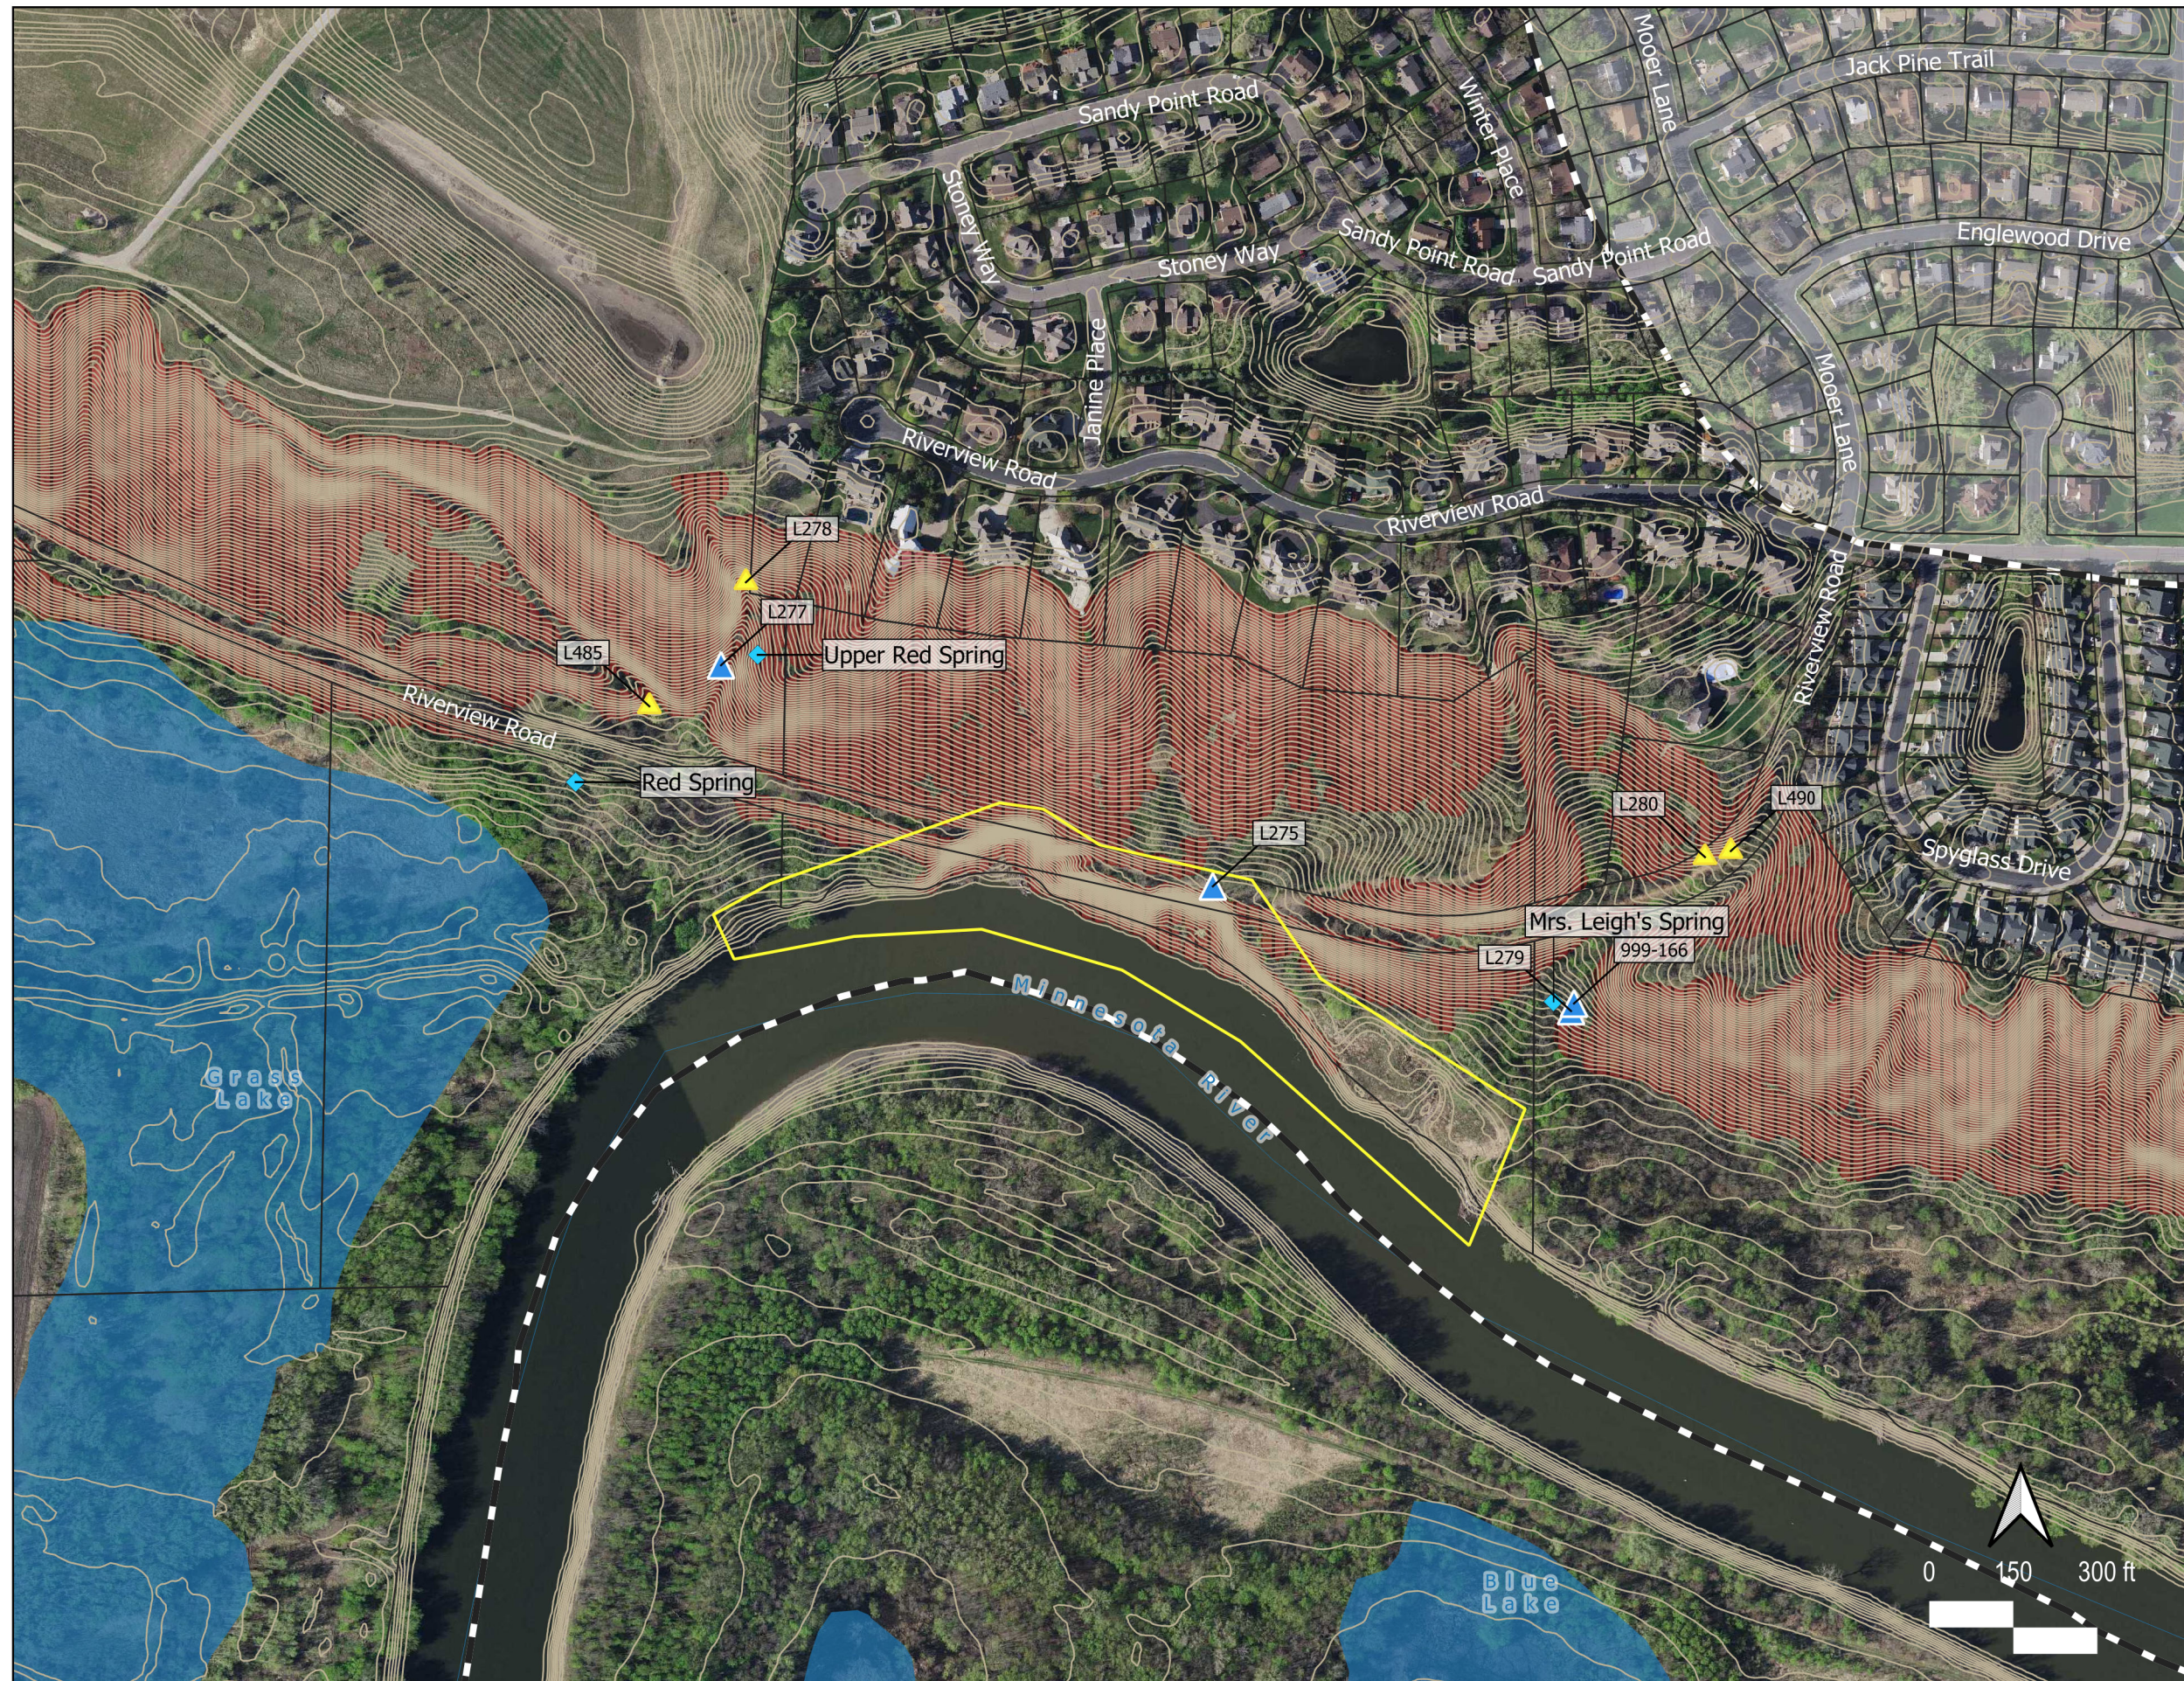
**Figure 5:  
Area 3 Groundwater  
Observations**

Many of the sites surveyed also noted seeps or groundwater and listed it as a potential cause for erosion and gully development (see individual datasheets attached). These sites correlate well with the MnDNR *Springs Inventory* (**Figure 5**) and provide additional confirmation that groundwater baseflow will need to be considered as part of any future stabilization designs.

The MnDNR has been crowdsourcing, collecting new data, and digitizing historic spring data through the Minnesota Spring Inventory Recording Application. The inventory contains both potential and verified springs. In Area 3, there are three springs shown: the Upper Red Spring, the Red Spring to the west, and an unnamed spring (once known as “Mrs. Leigh’s Spring”) to the east (**Figure 5**).

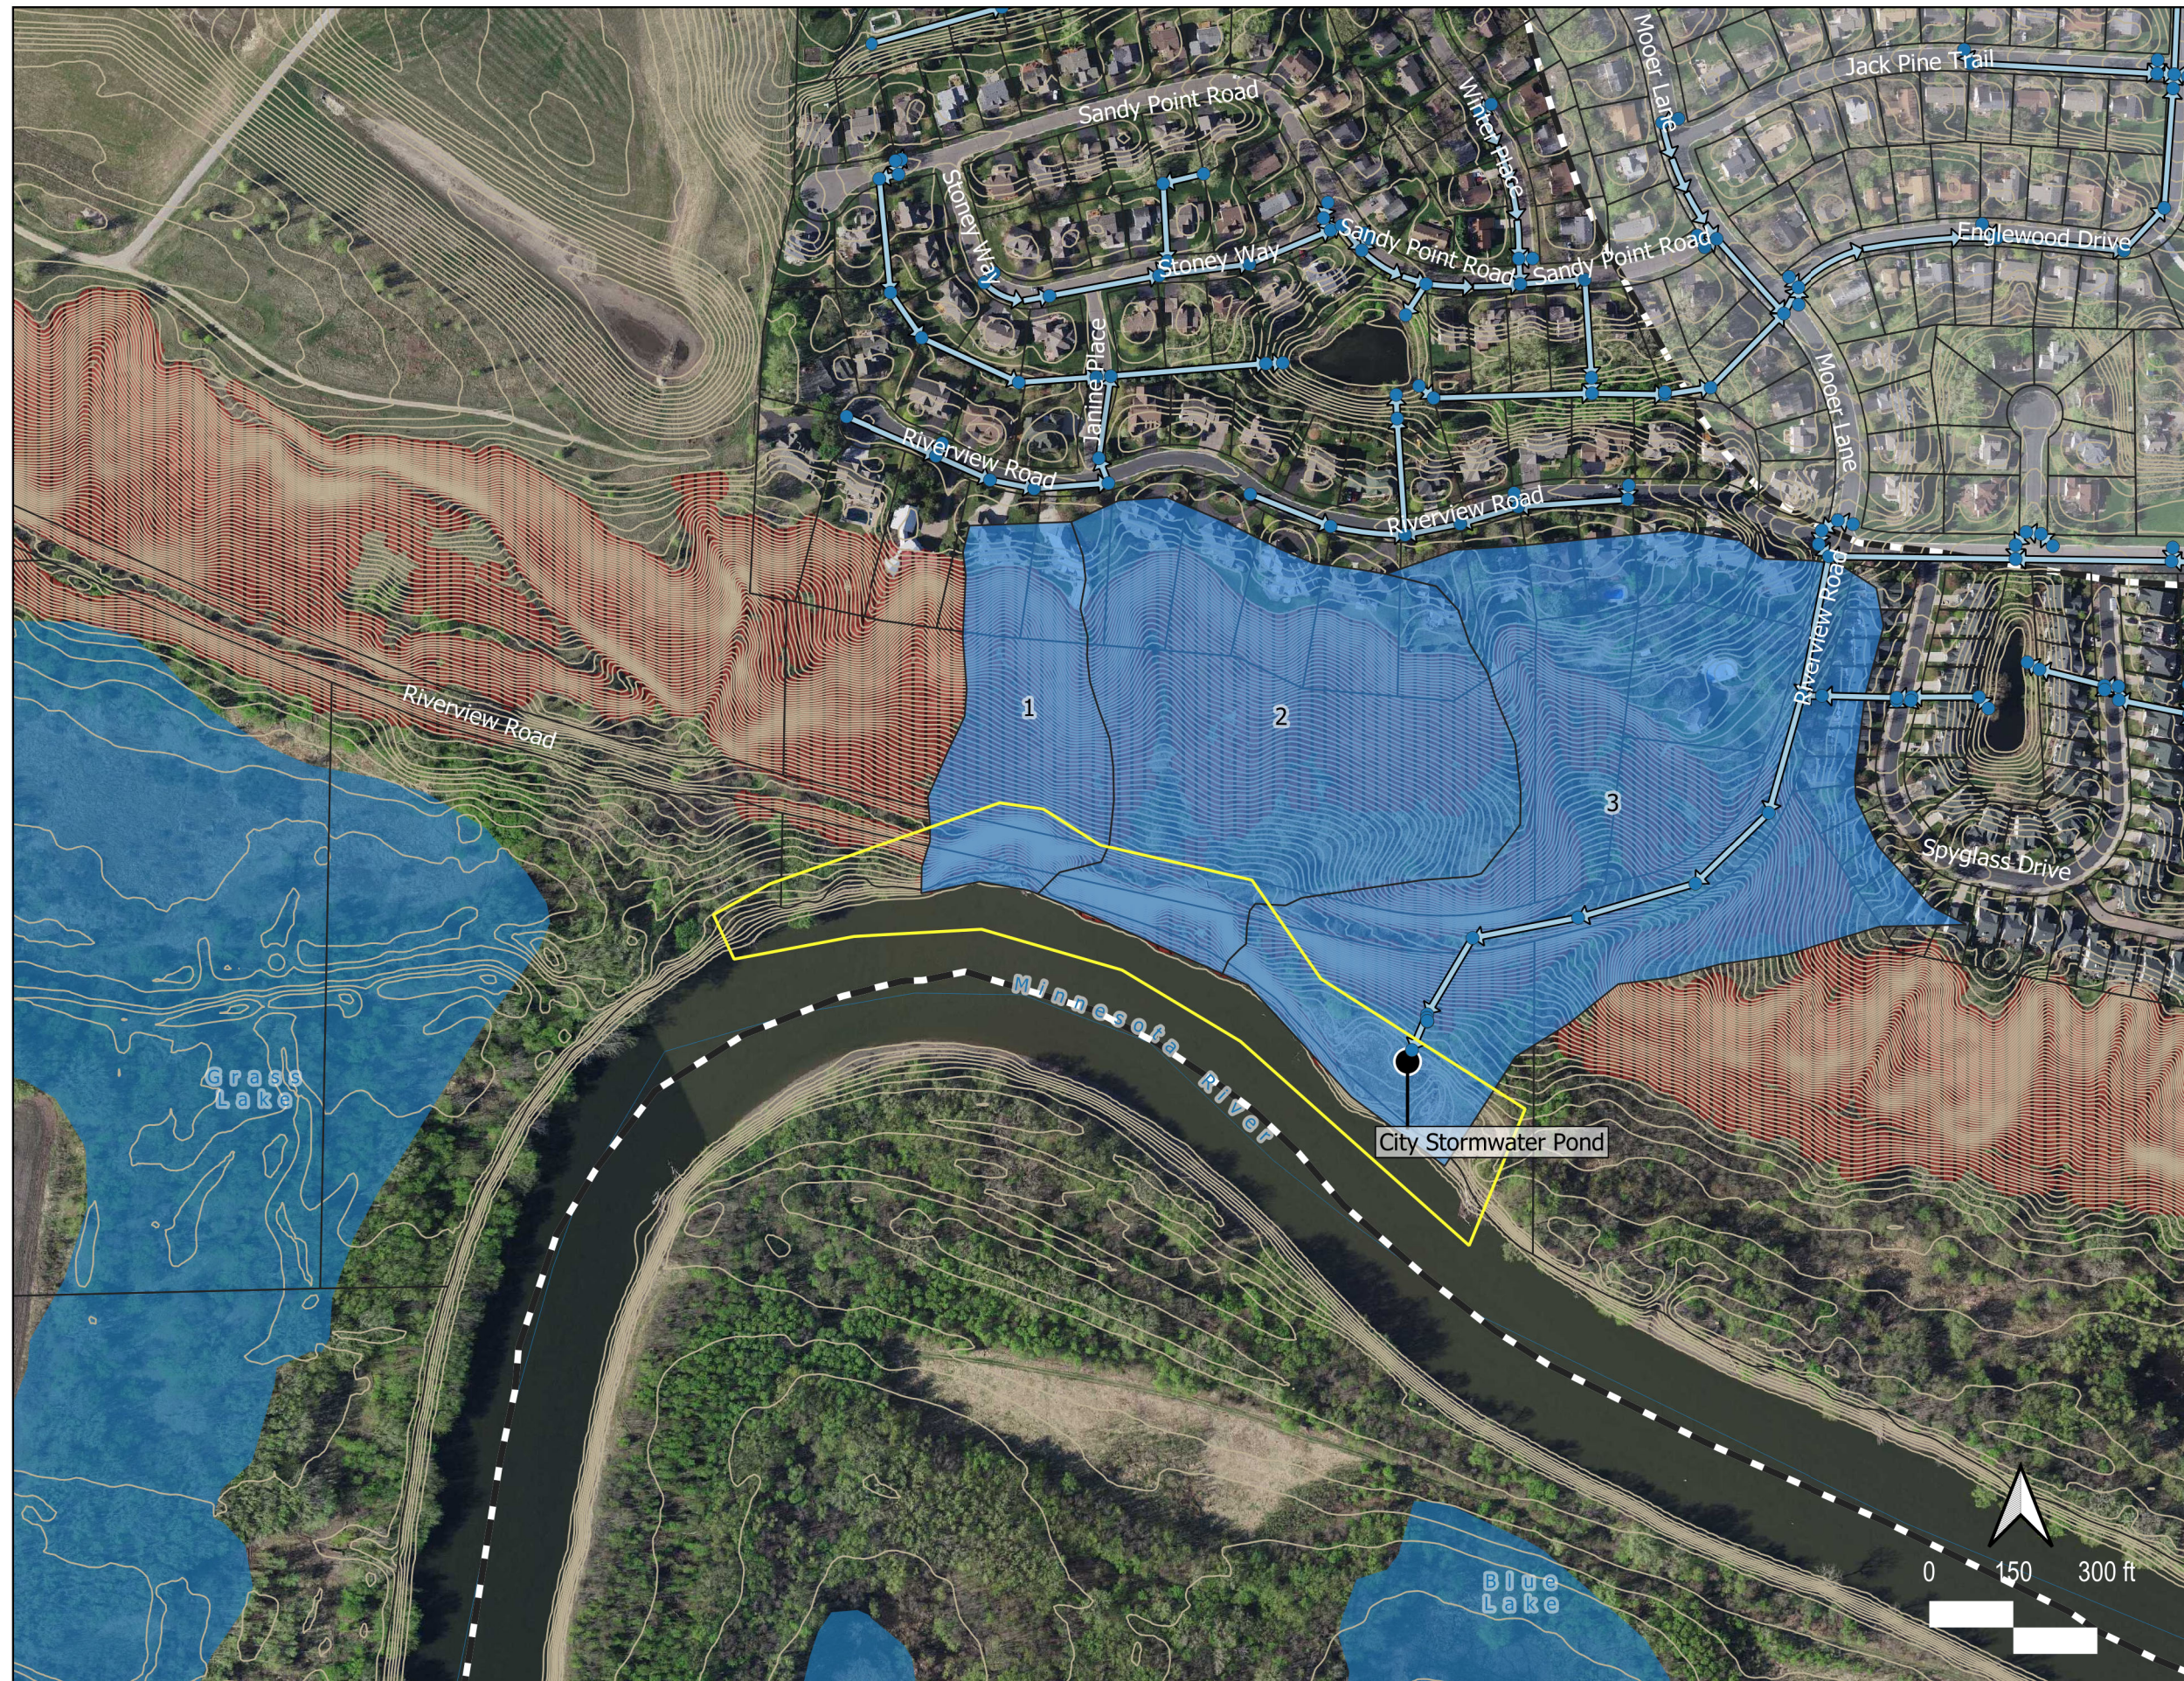
**Figure 6:  
Area 3 Watershed  
Delineations**

Using the City’s storm sewer network and the MnDNR LiDAR data, three sub-catchments were delineated to the locations where gullies flow into the Minnesota River from the Area 3 embankment (**Figure 6**). This delineation confirmed that there are no major storm sewer outfalls into the gullies from Riverview Road. The gully drainage areas appear to be limited to the areas directly connected to the gullies. The sub-catchments are relatively small (3.3–16.2 acres) and predominately open space, with a small amount of single-family residential development at the top of each subcatchment.

It should be noted that this analysis only considers design events typically used for permitting and design of stormwater management features. As discussed in the Hennepin County Historical Landslide Inventory, the soils are susceptible to failure during extreme rainfall events or saturated by excessive rainfall or groundwater. While the design storms indicate the soil can infiltrate large amounts of water, this is only possible when the groundwater table is sufficiently below the ground surface to allow this infiltration to occur. Monitoring groundwater will be especially crucial for future stabilization designs because surface water runoff does not appear to be a main driver of erosion or instability.

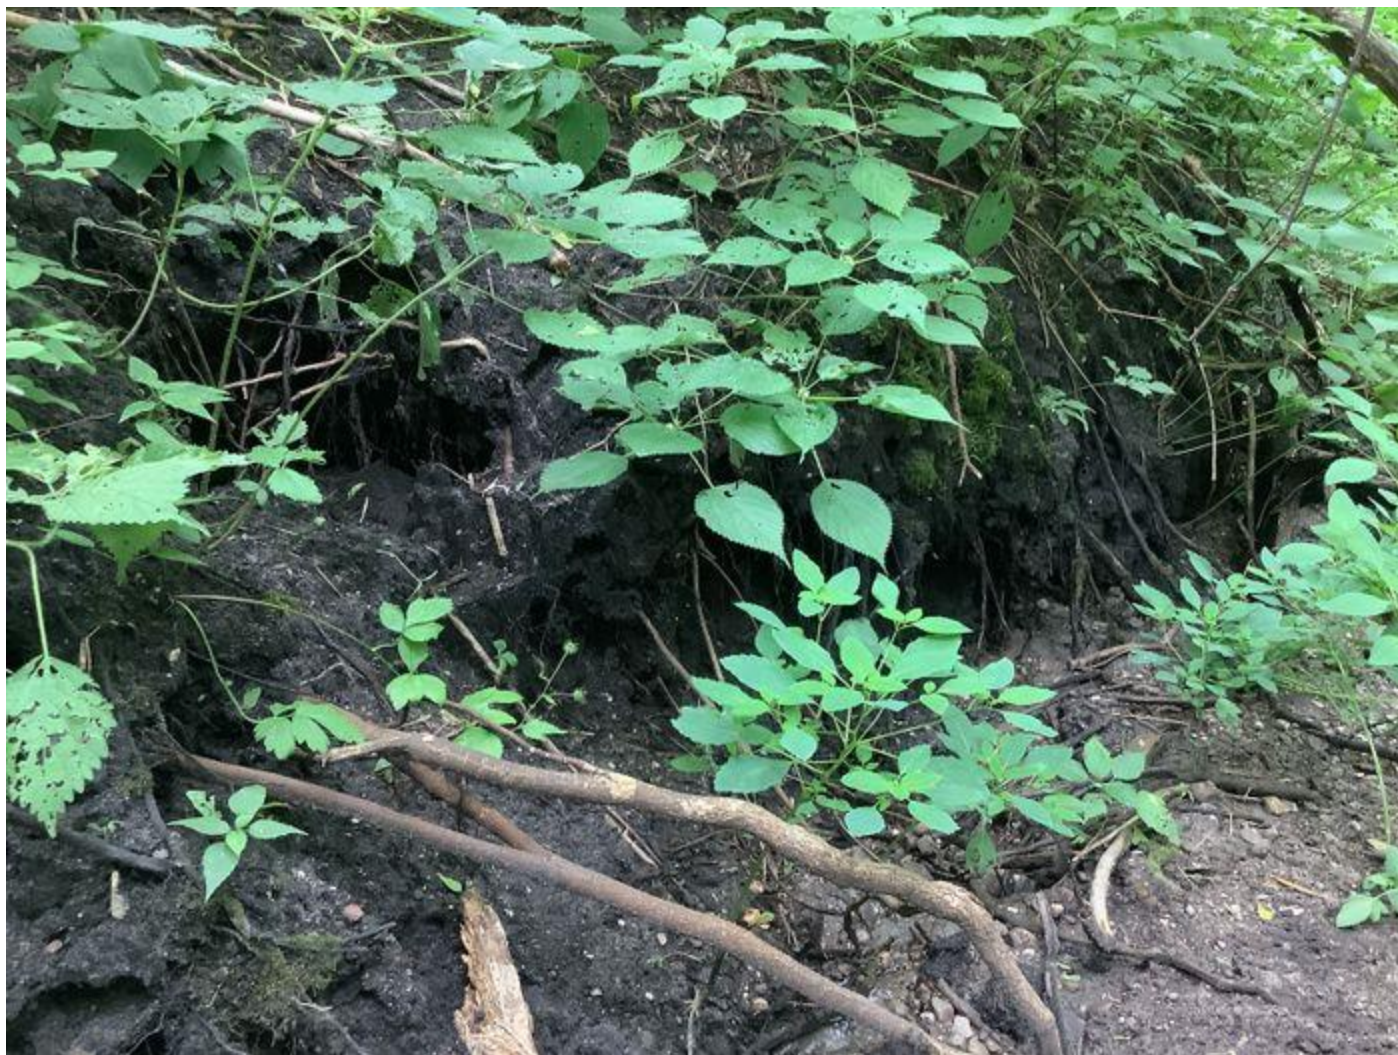
Looking d/s from right bank at a slump and severely overhanging left banks
