# Technical Memorandum

**Date:** October 16, 2020

**Re:** Area 3 Slope Stability Project Update

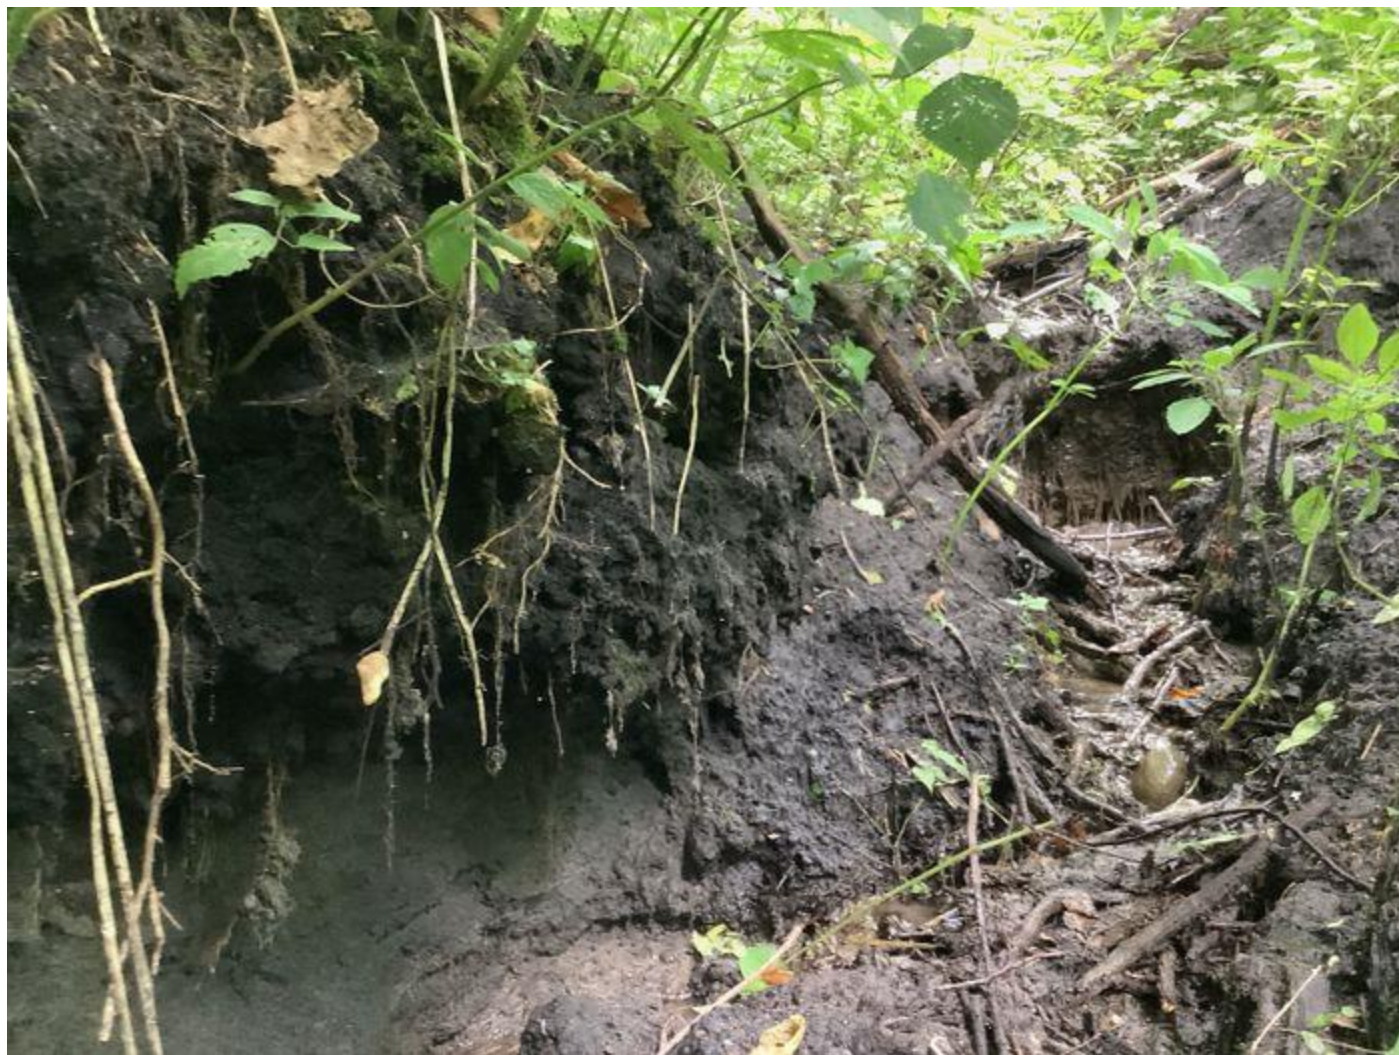
Looking u/s at overhanging right banks (d/s from initial slumping )

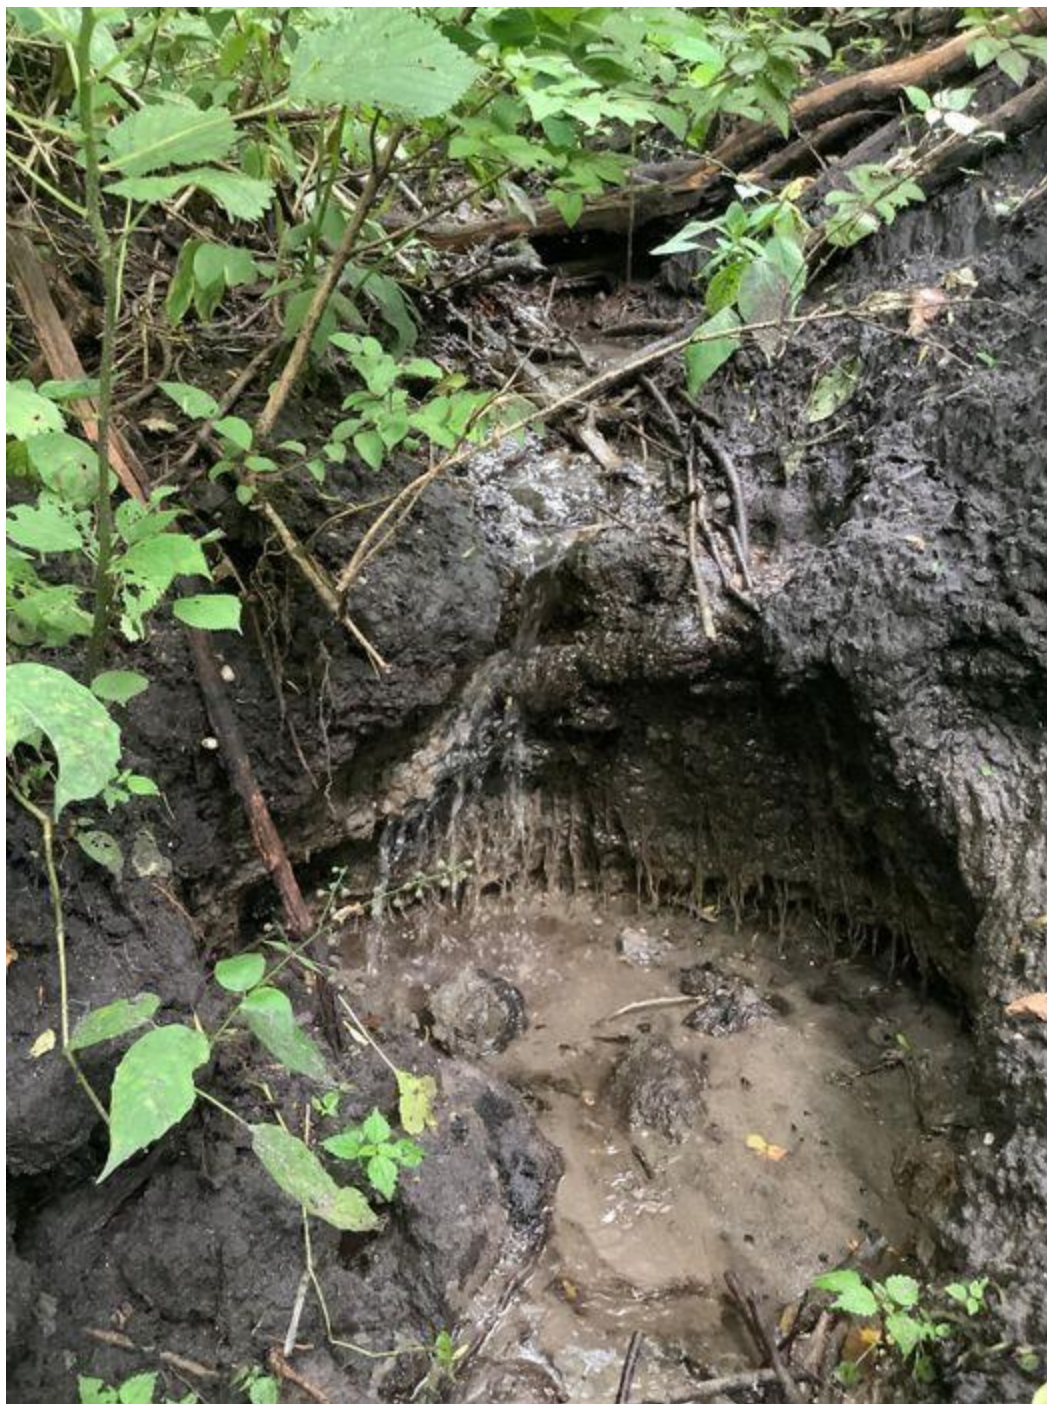
Looking u/s from large knickpoint (d/s from initial slumping )

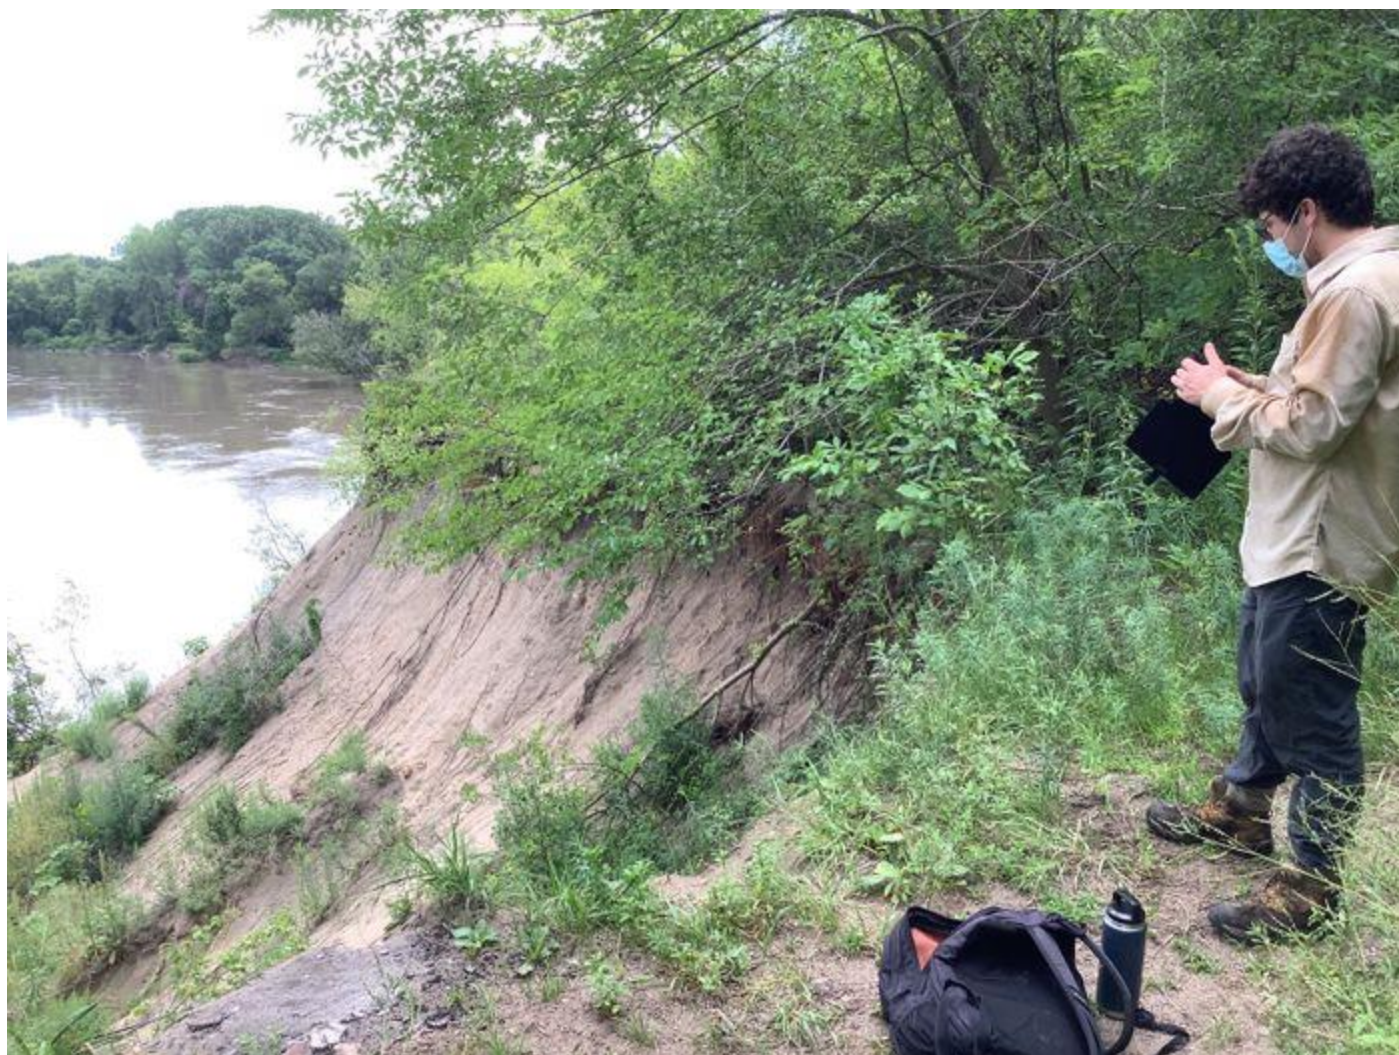
Looking u/s to the headcut area, scale

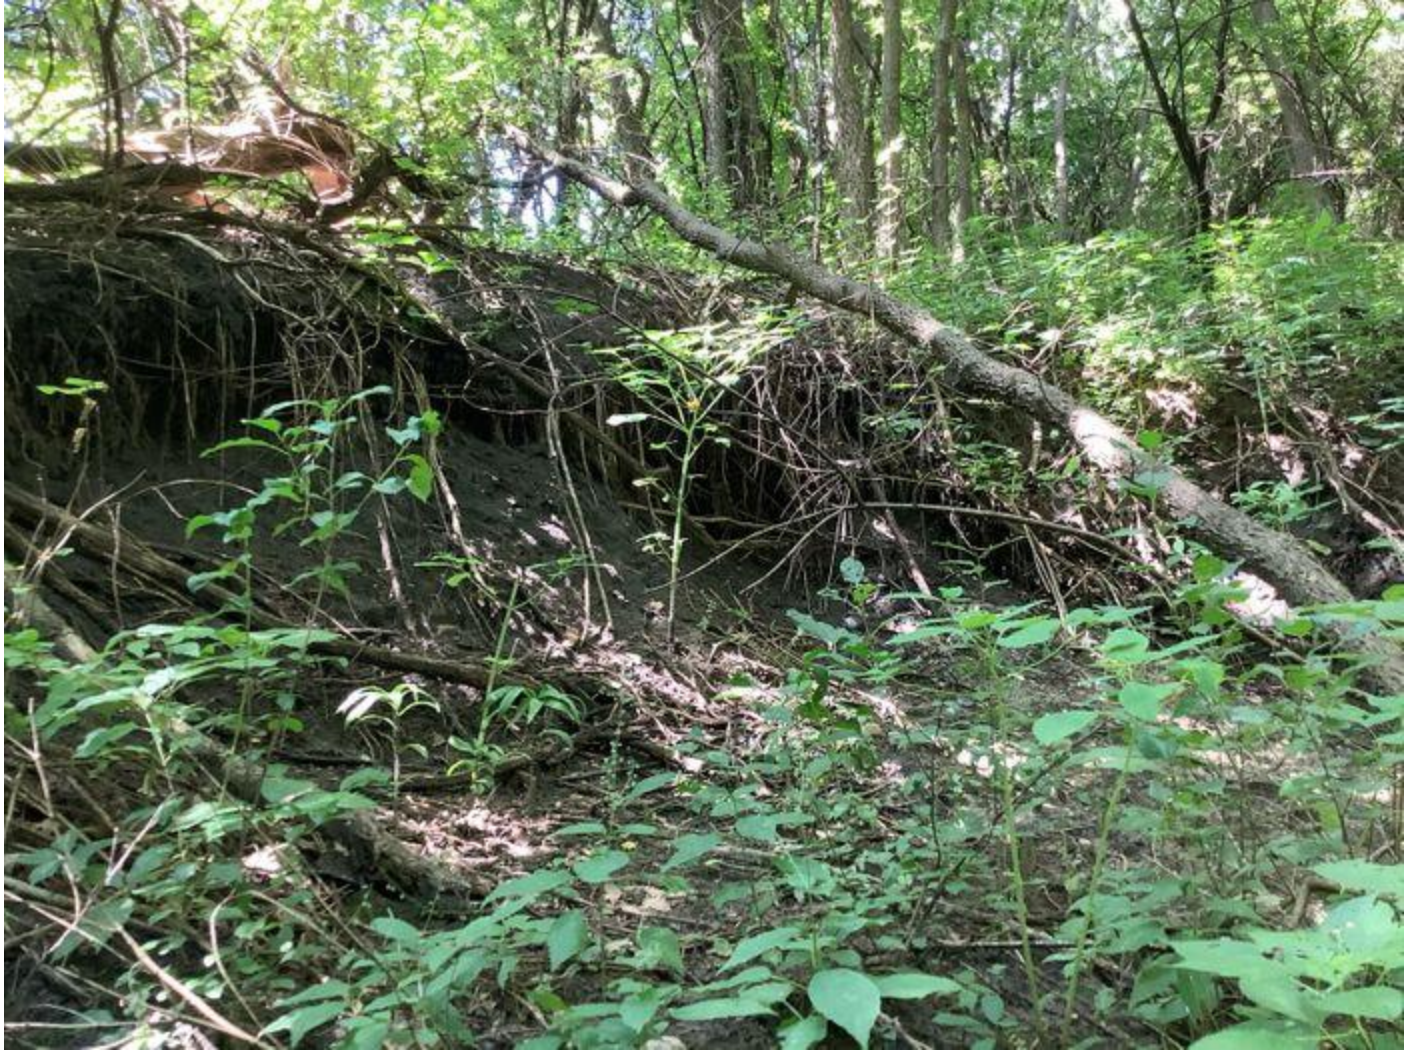
Upstream view from gully bottom looking at overhanging right banks above slump.

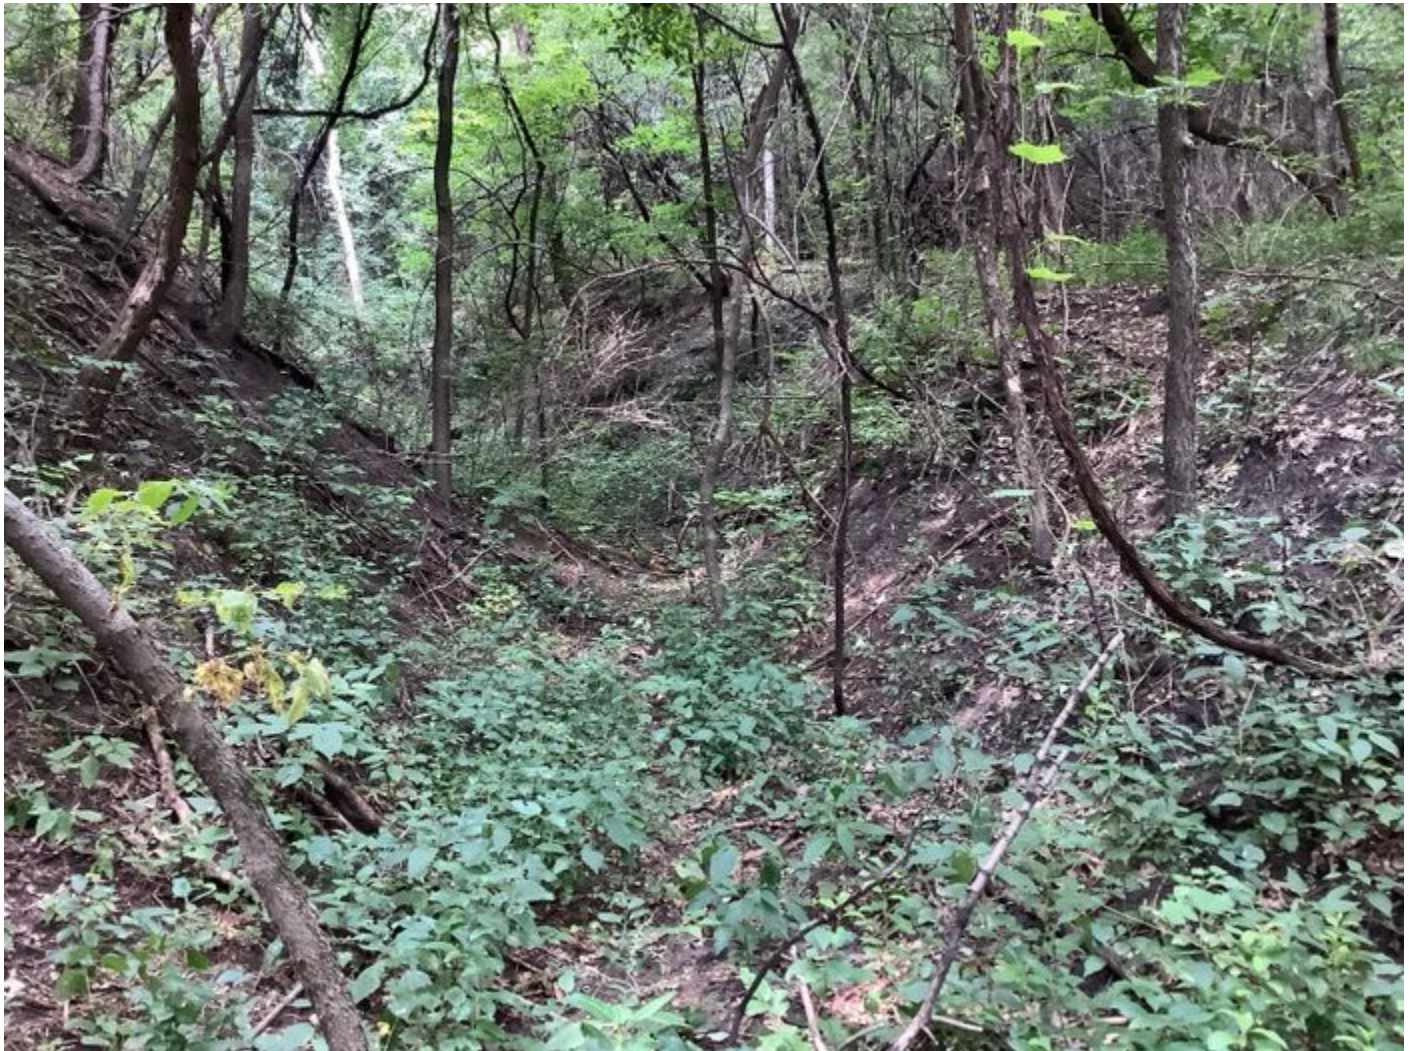
Looking u/s at gully channel from toe. Leaning tree on right bank and bare soil exhibited

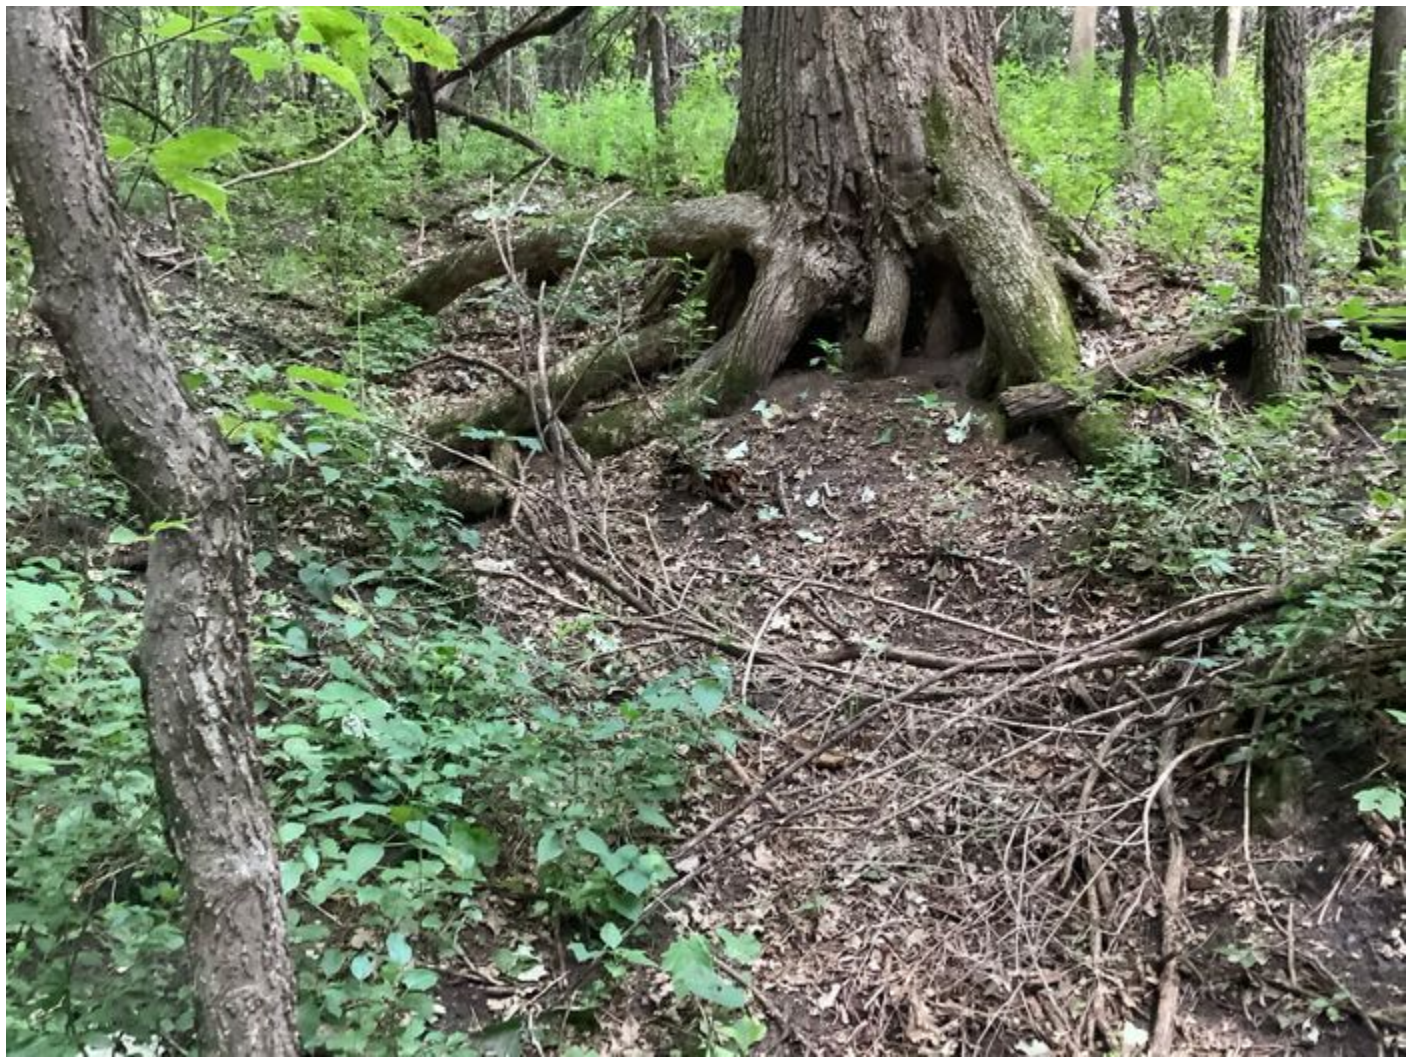
Looking u/s from gully toe towards left bank at exposed tree roots and bare soil

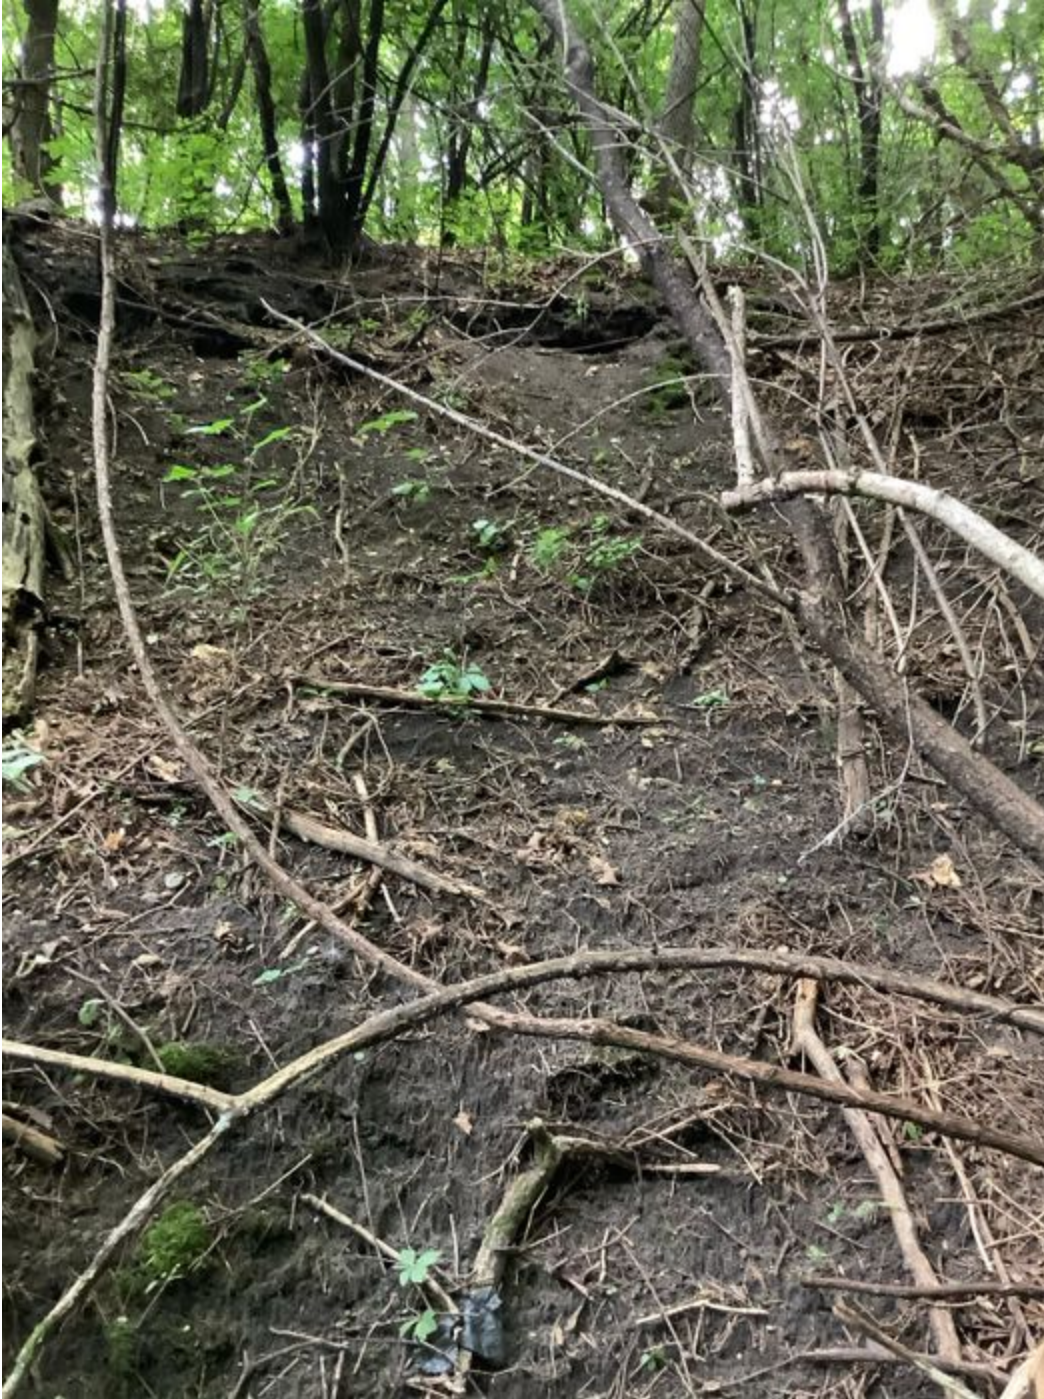
Looking u/s from gully bottom towards the headcut at the steep slopes and bare soil along the right bank

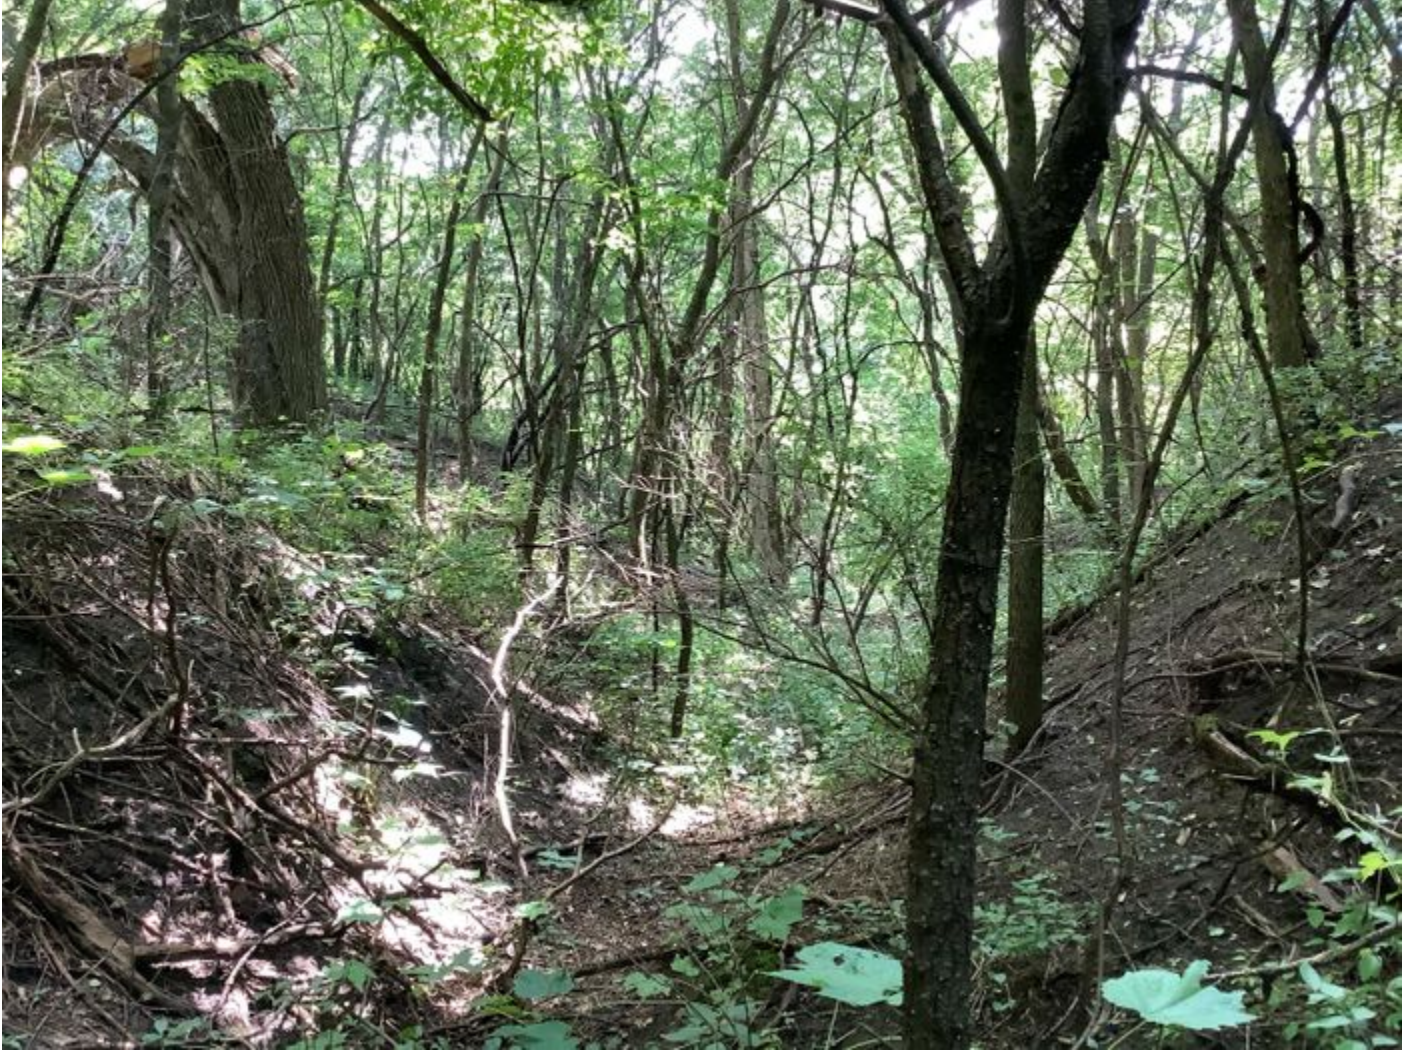
Looking d/s from gully bottom and bare soil and steep banks

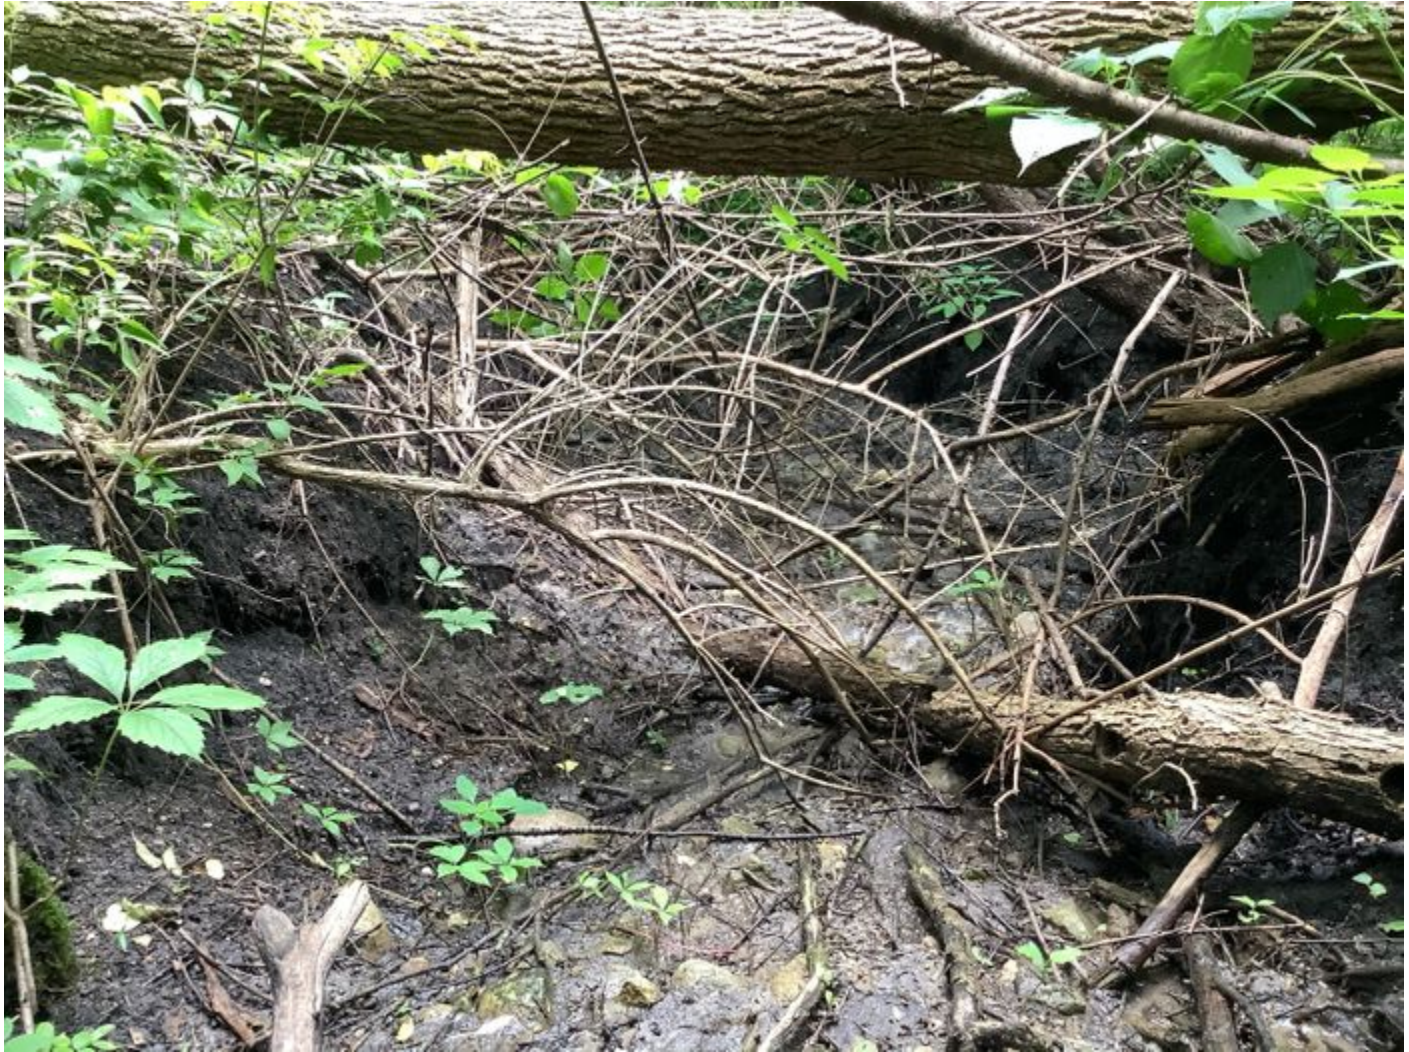
Downstream view from gully bottom looking at incision and tree debris

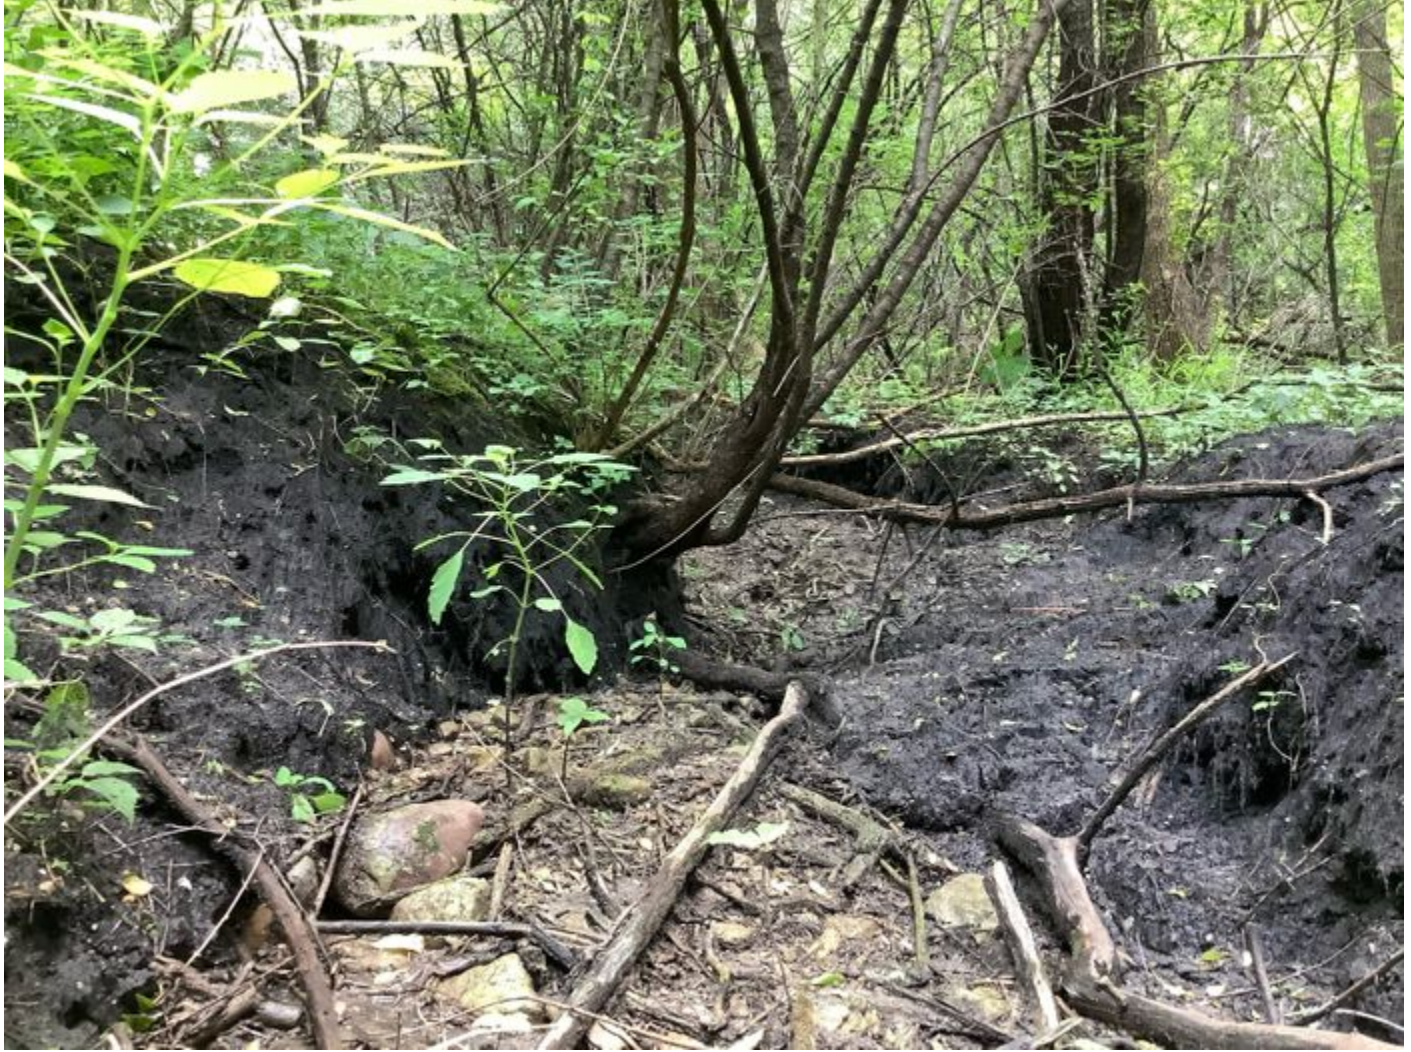
Upstream view from gully bottom looking at overhanging banks on both sides and leaning tree on right bank.

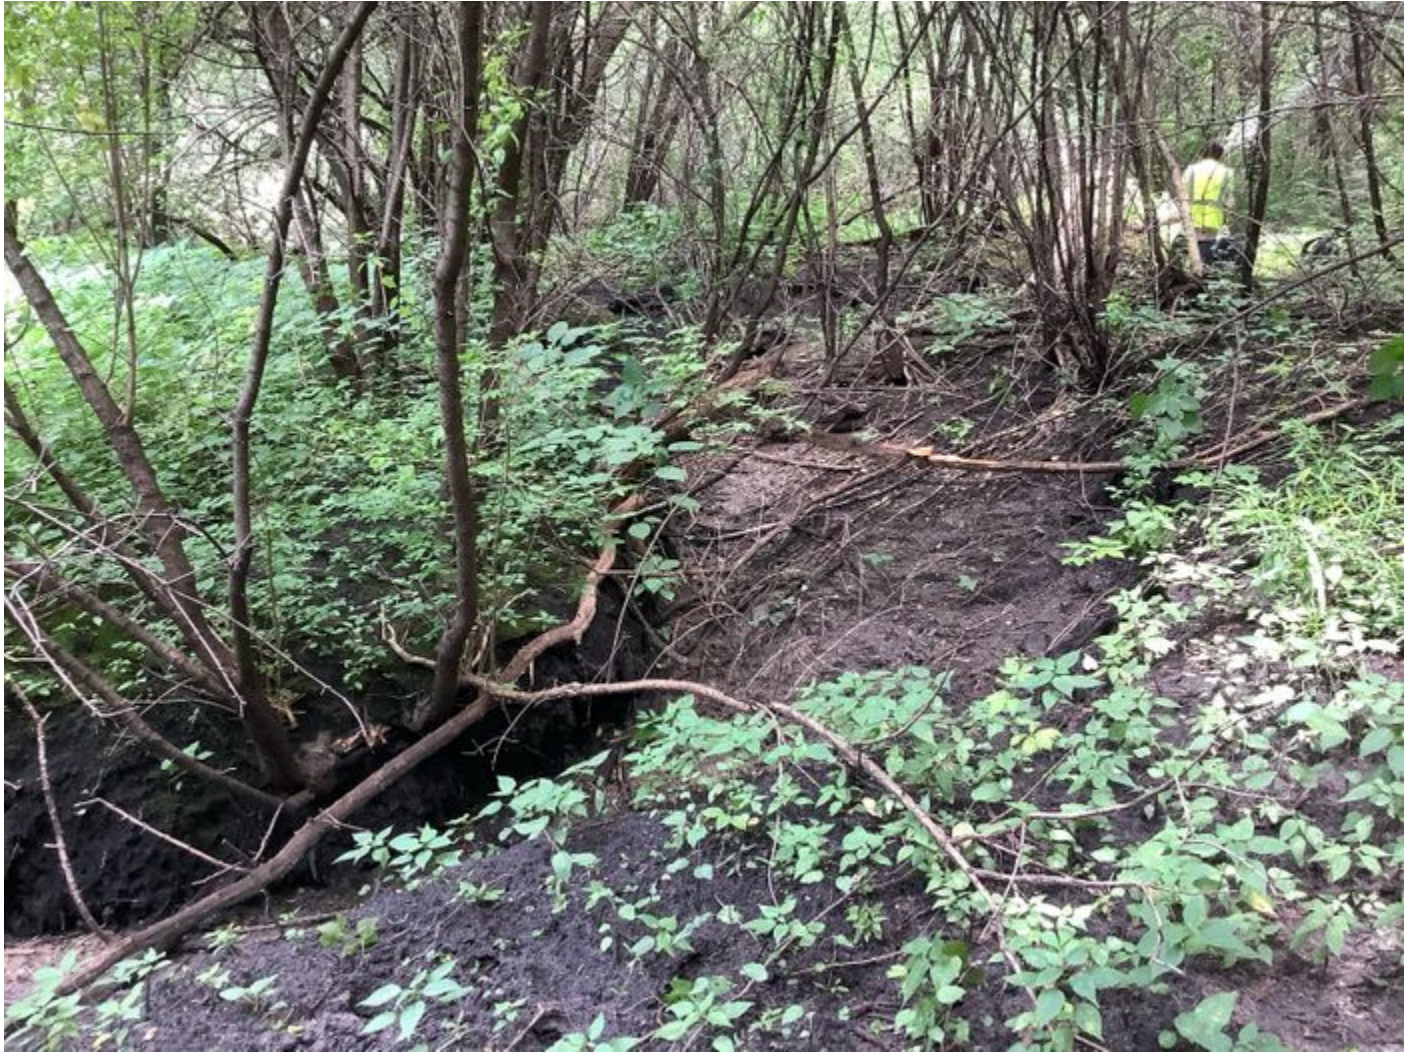
Upstream view from left bank looking at deep incision along right bank with person for scale.

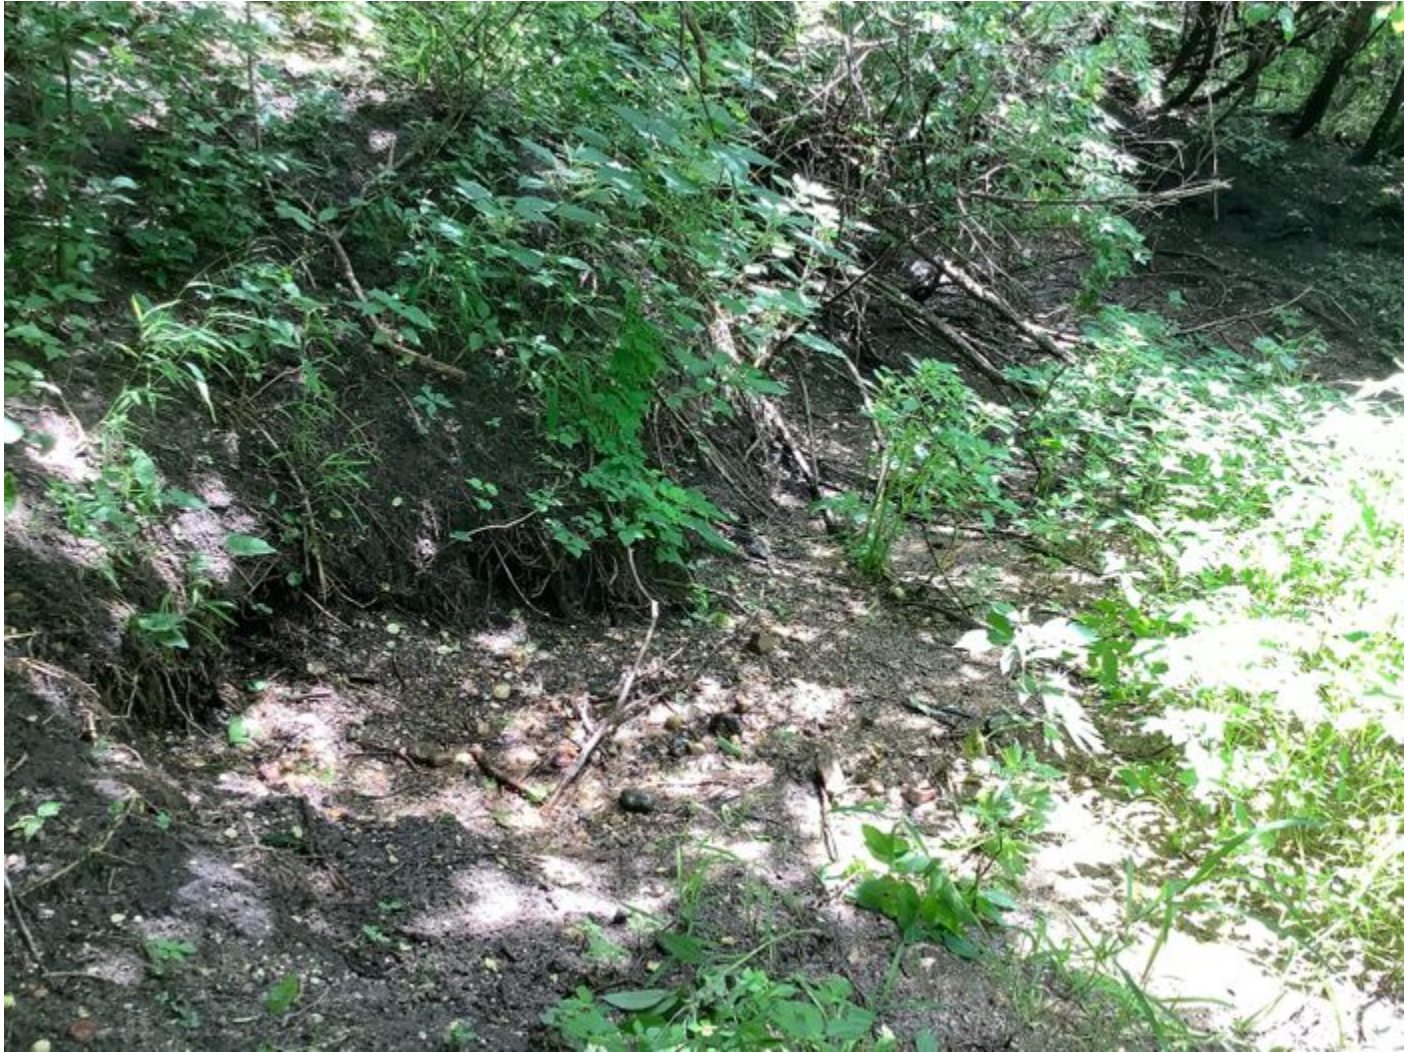
Downstream view from right bank look at headcut, slumping along left bank.

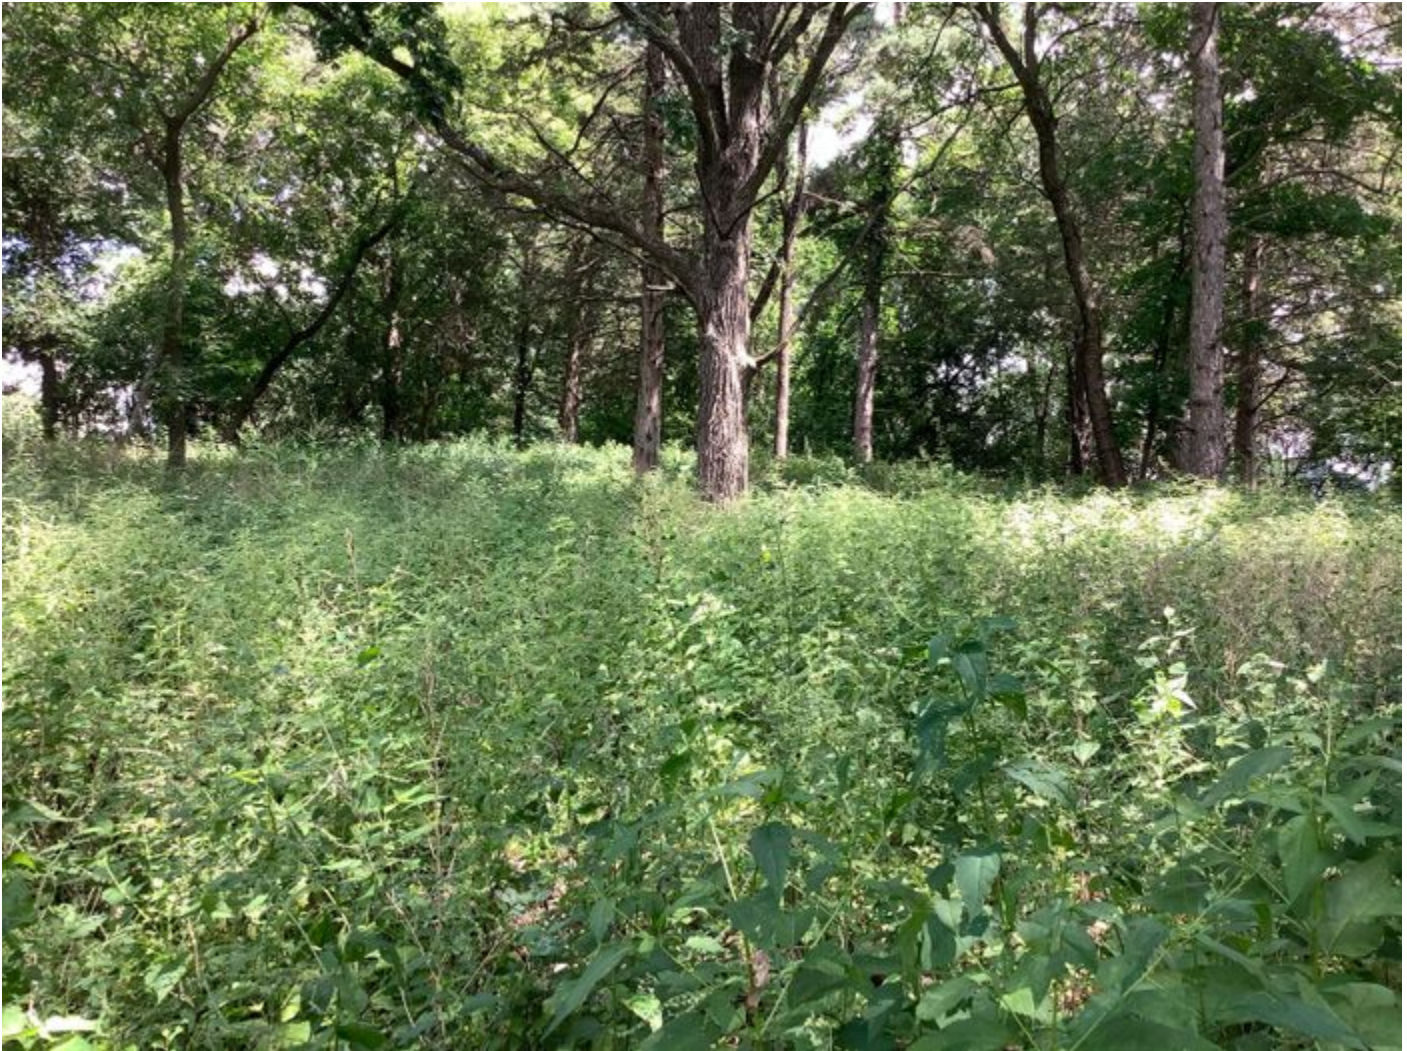
Looking u/s from 2008 waypoint location (site correction listed above). Unsure if this area was also revegetated

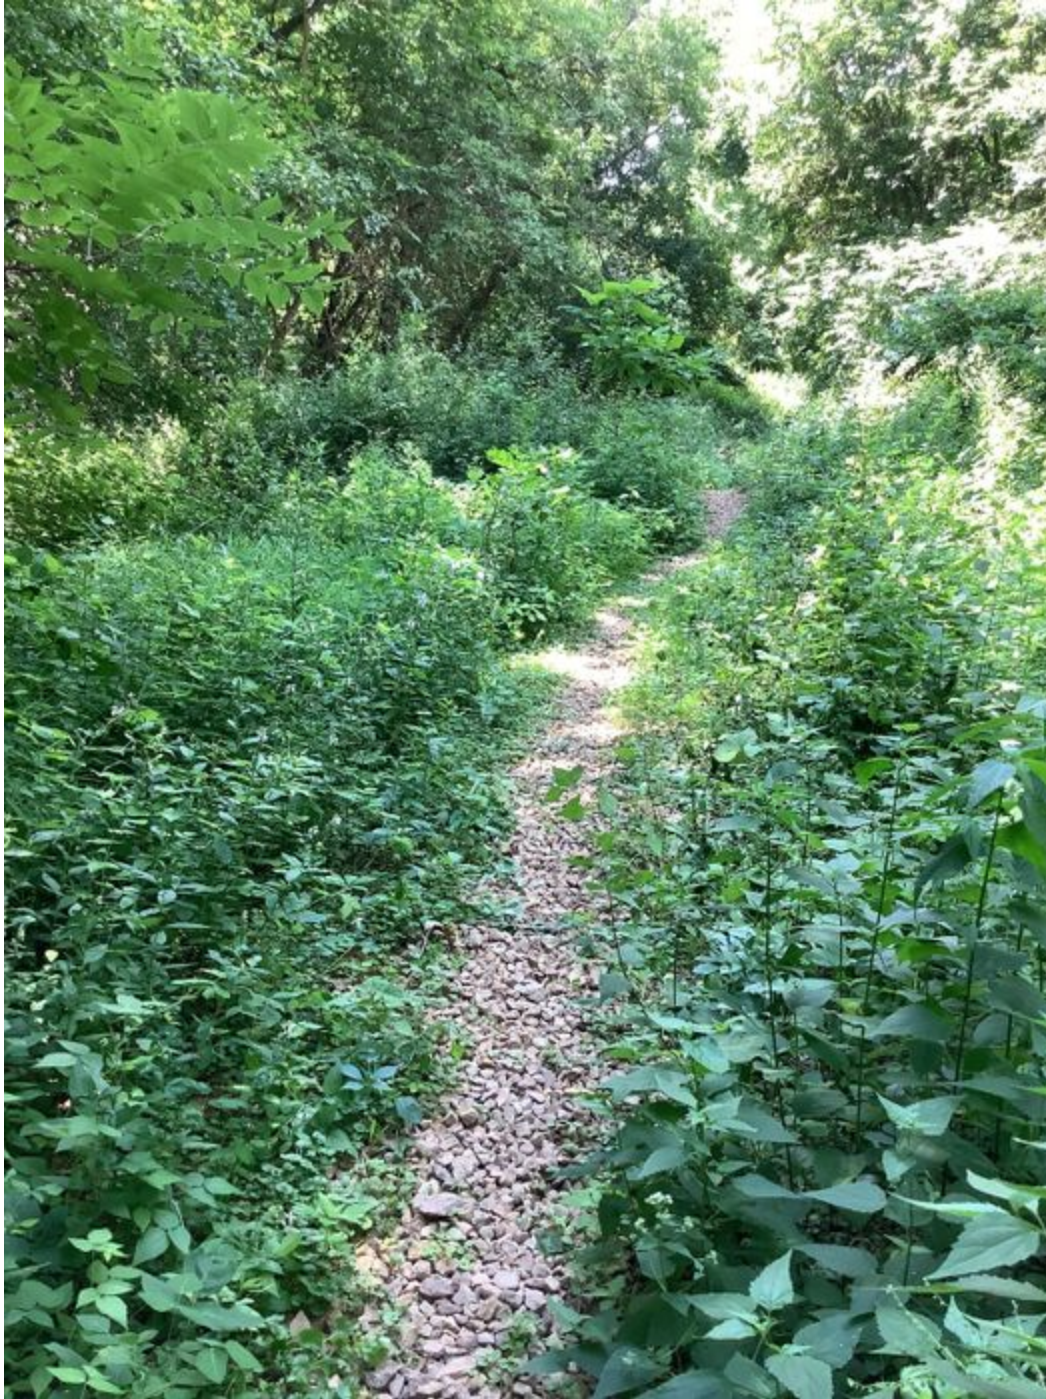
Looking d/s at stable path and heavy vegetation along the sides

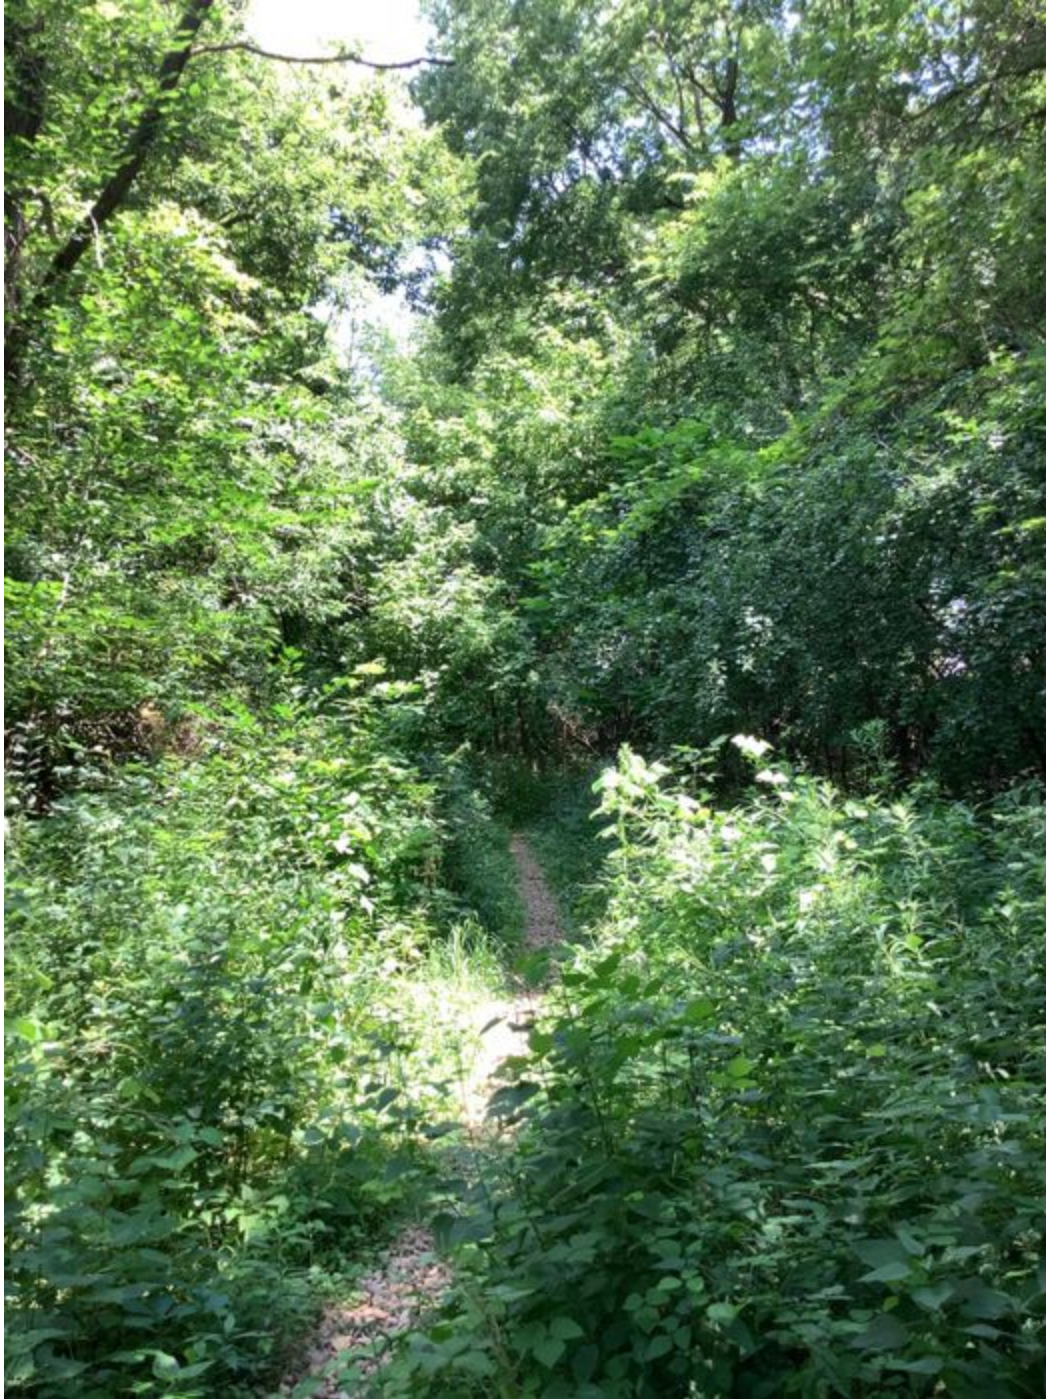
Looking u/s at stabilized path
