# Technical Memorandum

**Date:** October 16, 2020

**Re:** Area 3 Slope Stability Project Update

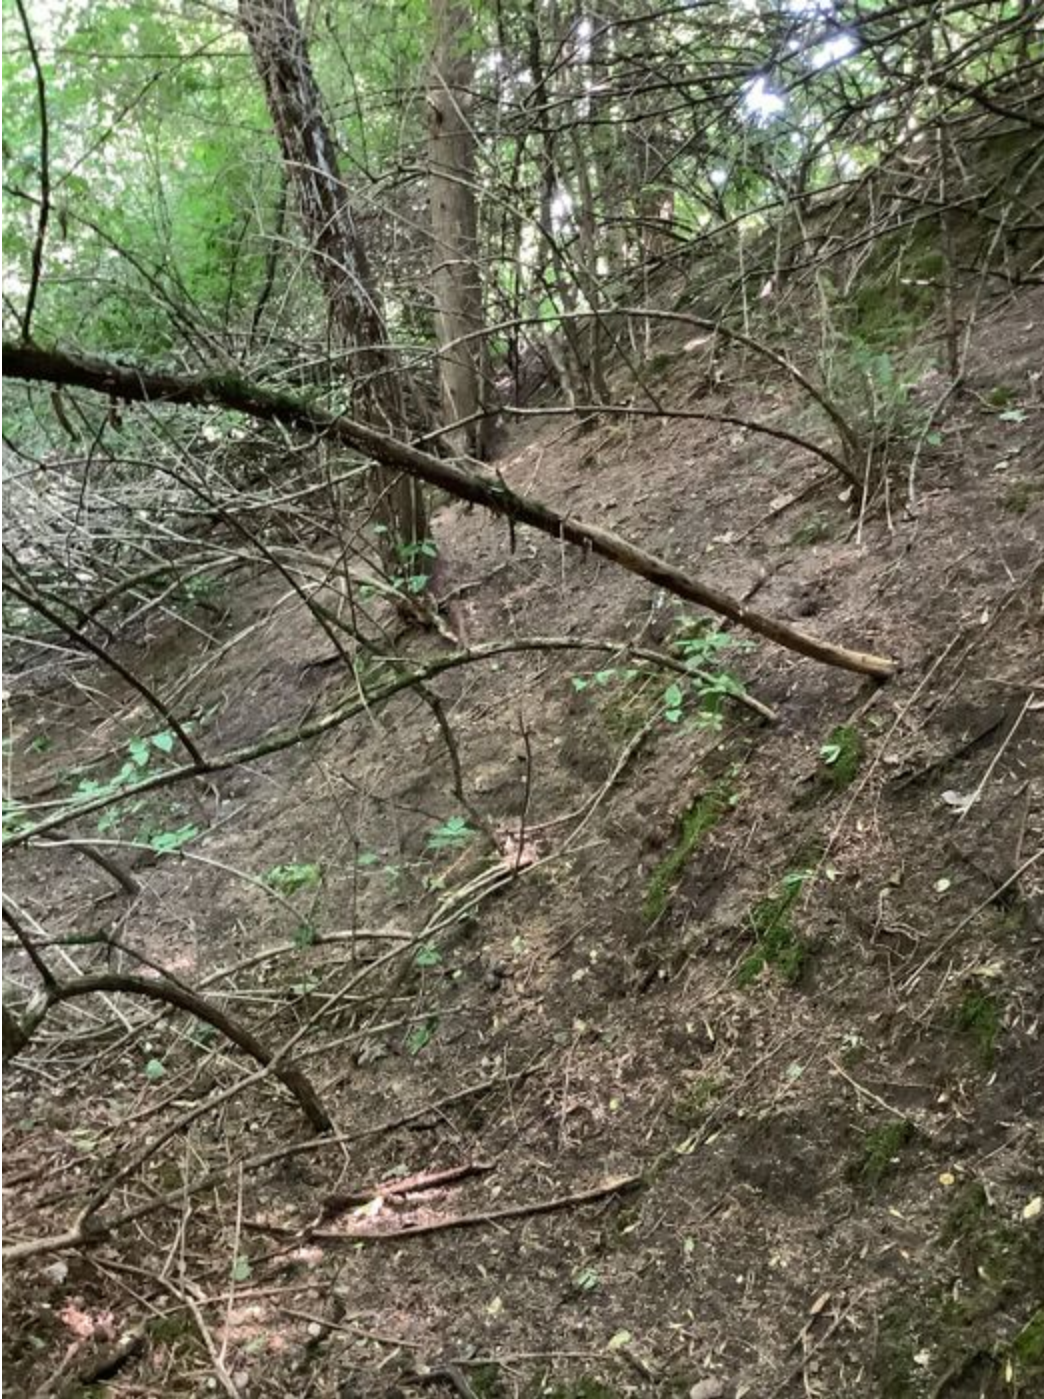
Upstream view from gully bottom looking at bare soil along right bank of channel.

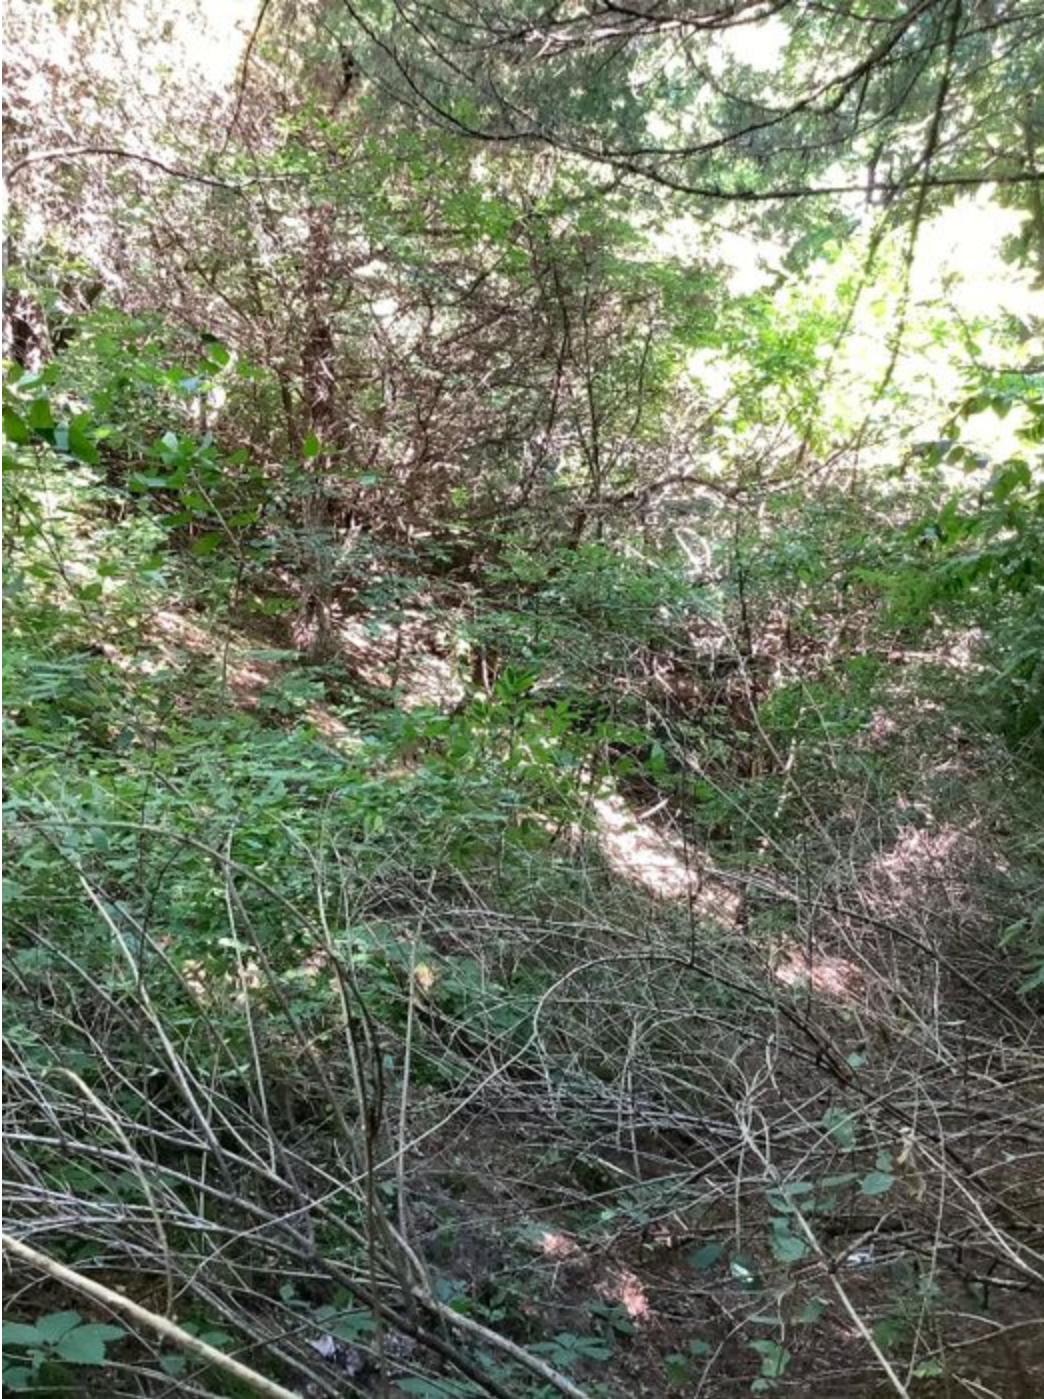
Downstream view of left bank of channel which is mostly obstructed by trees. View of partial vegetation on left bank and steep bank slope. View from gully bottom.

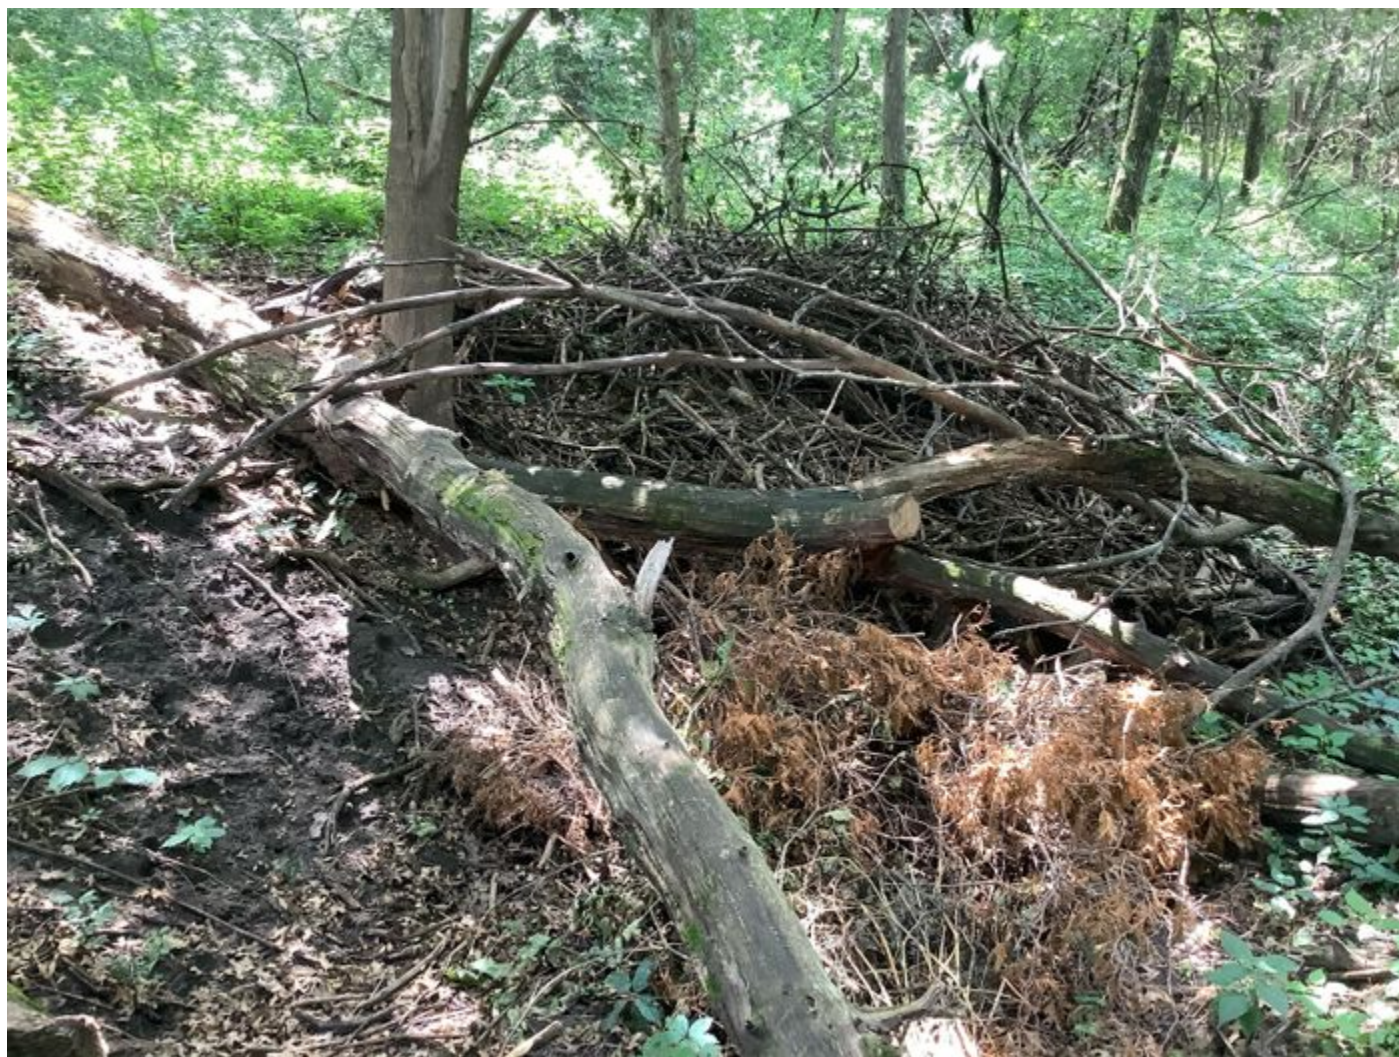
Downstream view from right bank looking at bare soil and tree debris near headcut.

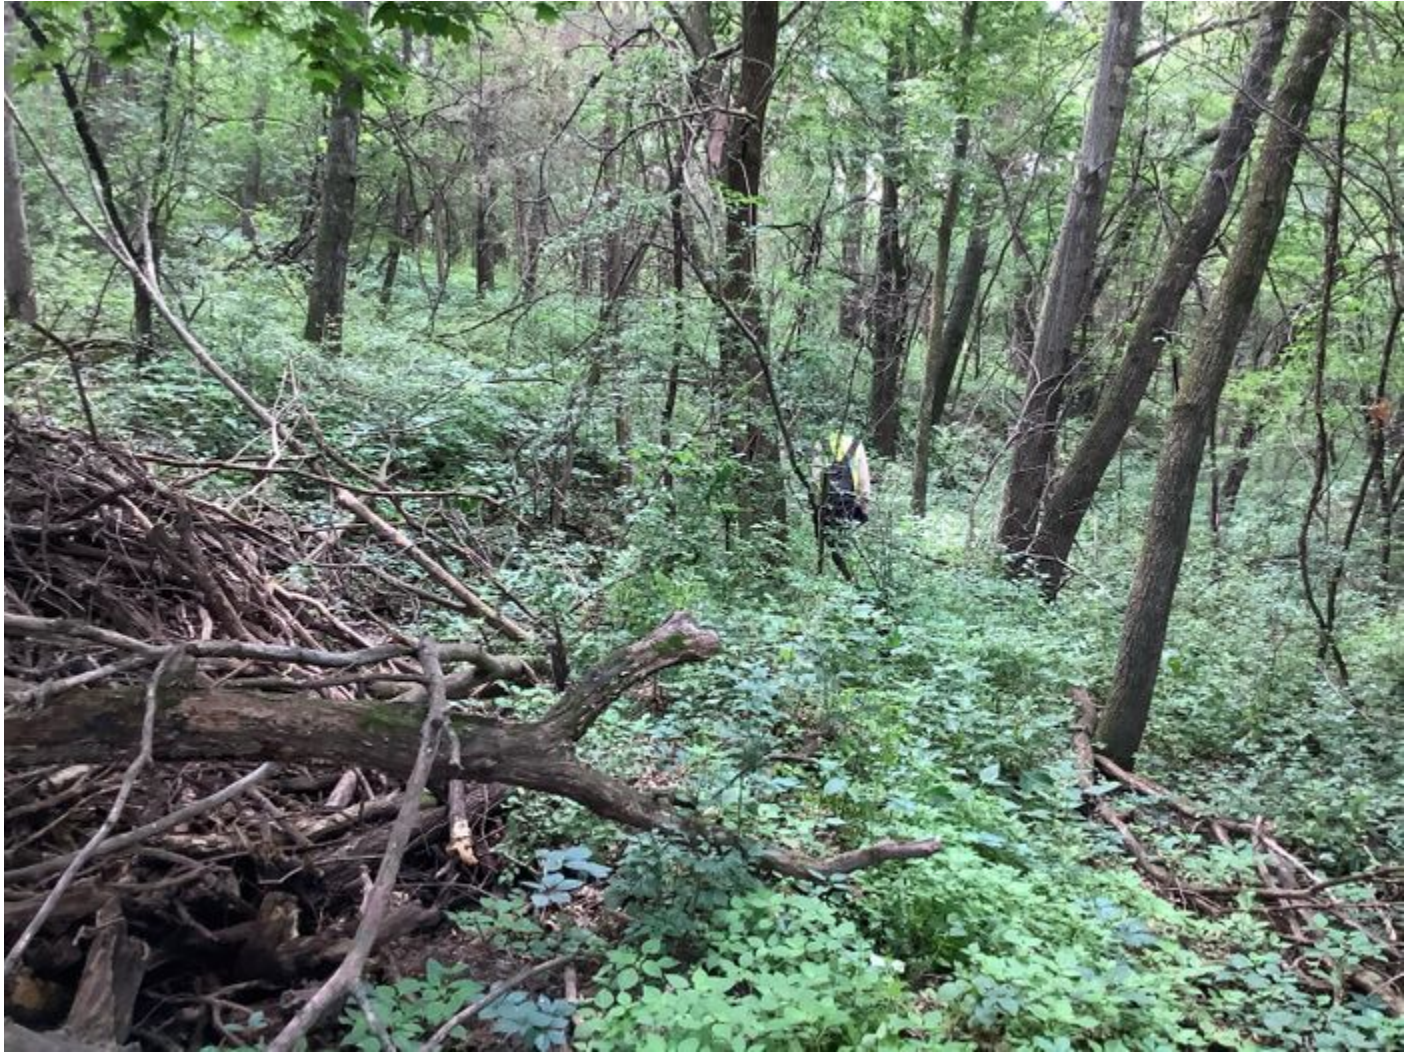
Downstream view from right bank looking at scale and vegetation in the channel.

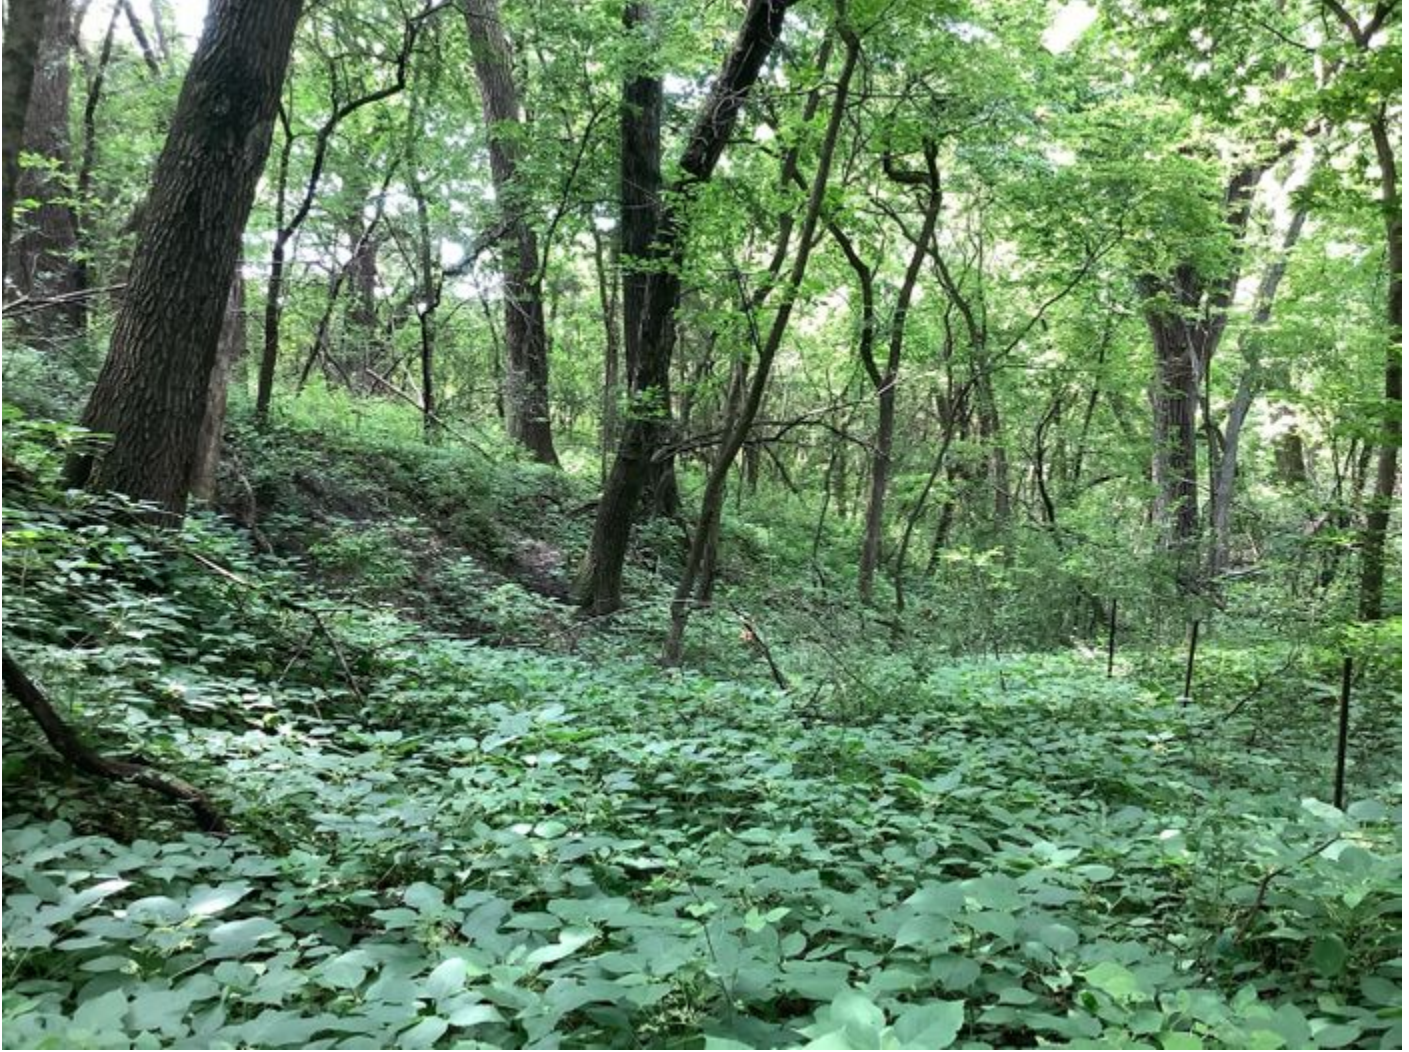
Downstream view from gully bottom looking at channel widening, leaning trees along left bank, and heavy vegetation.
