Technical Memorandum

Re: University of Minnesota Partnership for the Gully Assessment and
Condition Project

ATTACHMENT 2 - ESPM CLASS GULLY DATA SHEETS

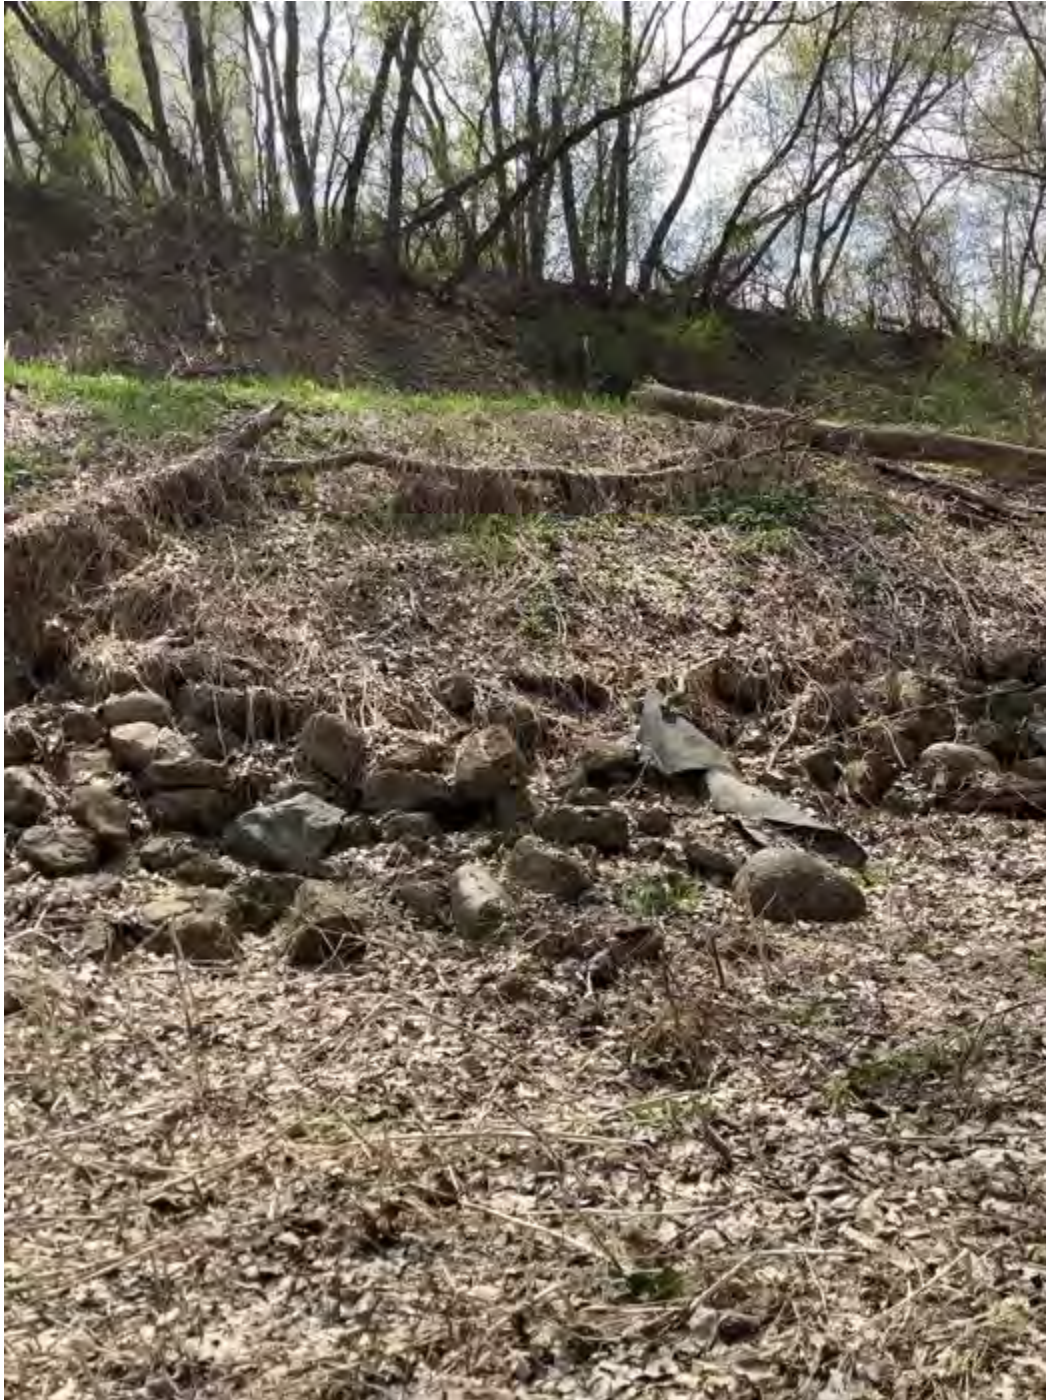
Bank reinforcing stones

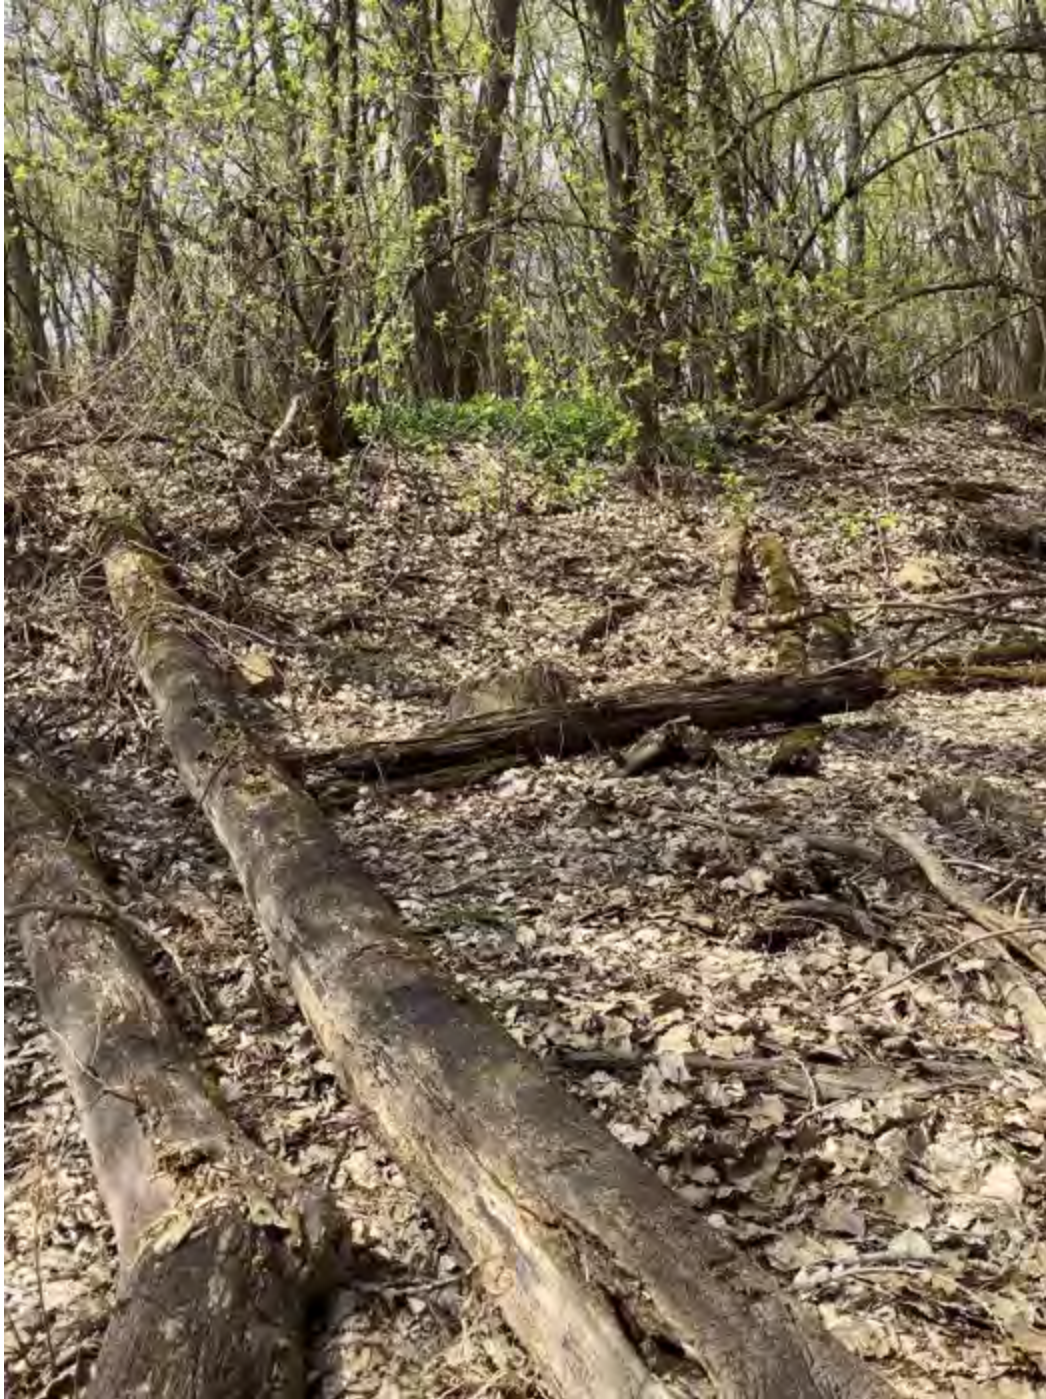
Edge of gully opposite reinforcing edge

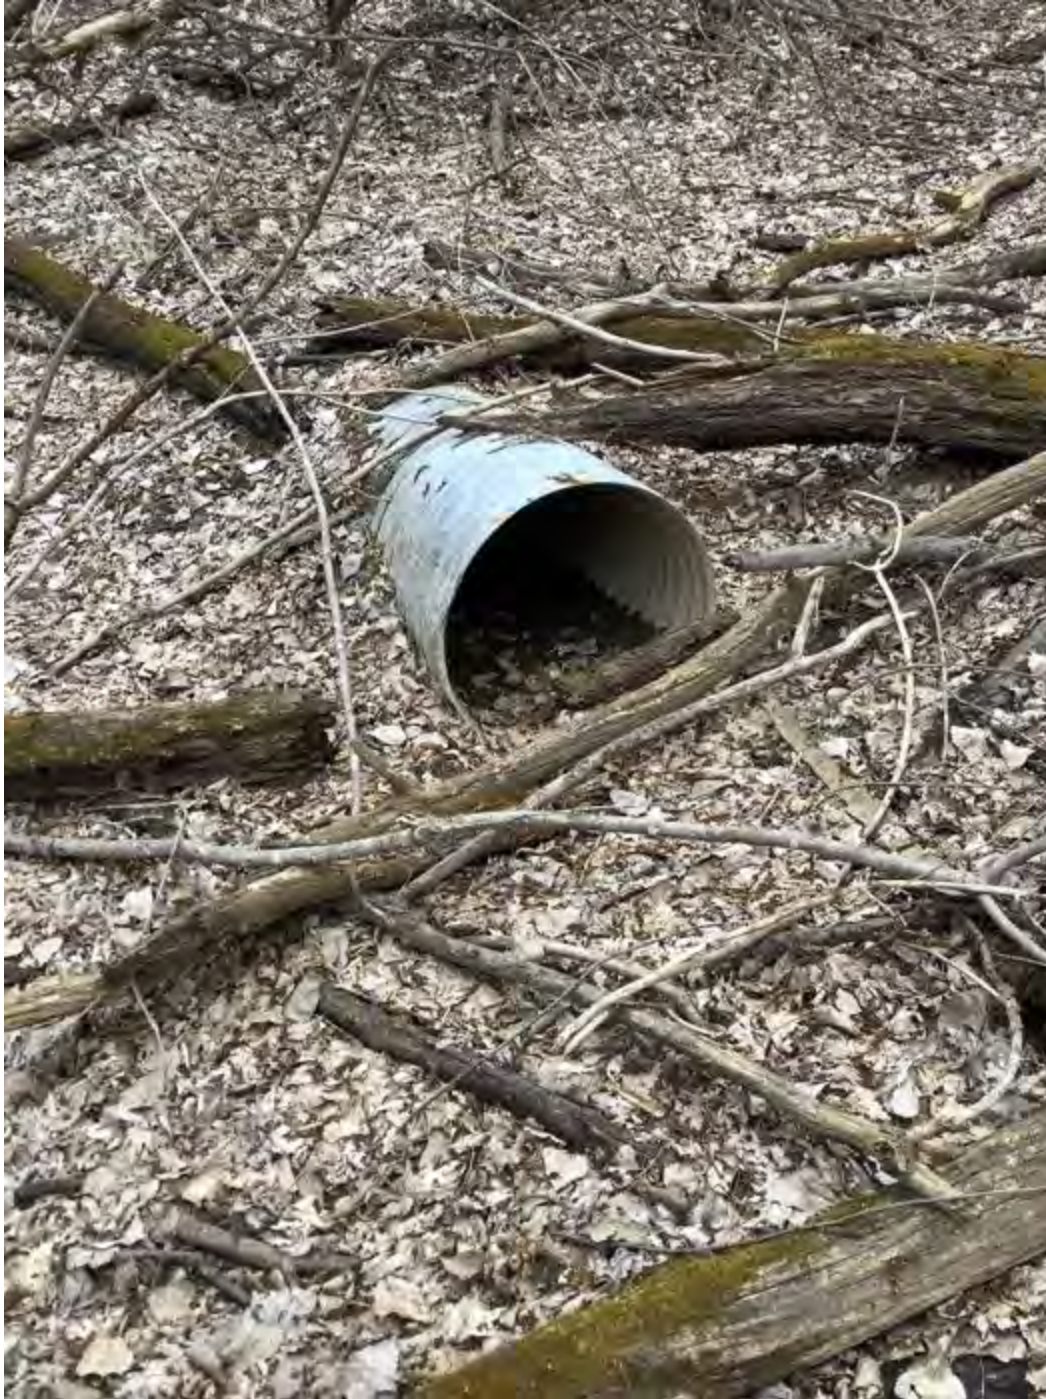
Drainage feature blocked by sticks

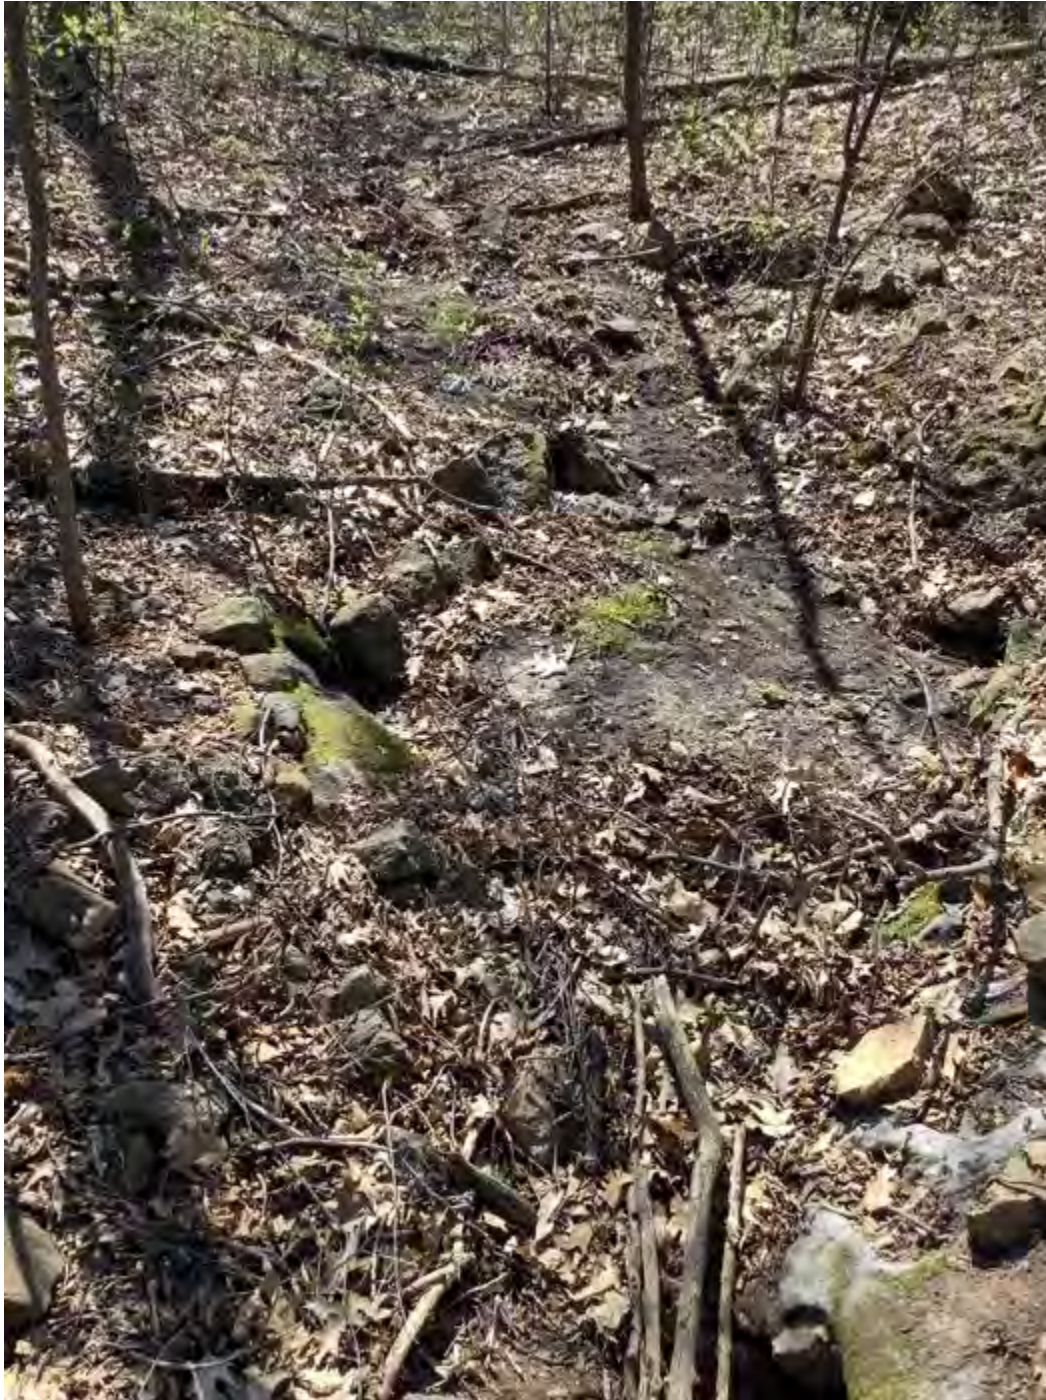
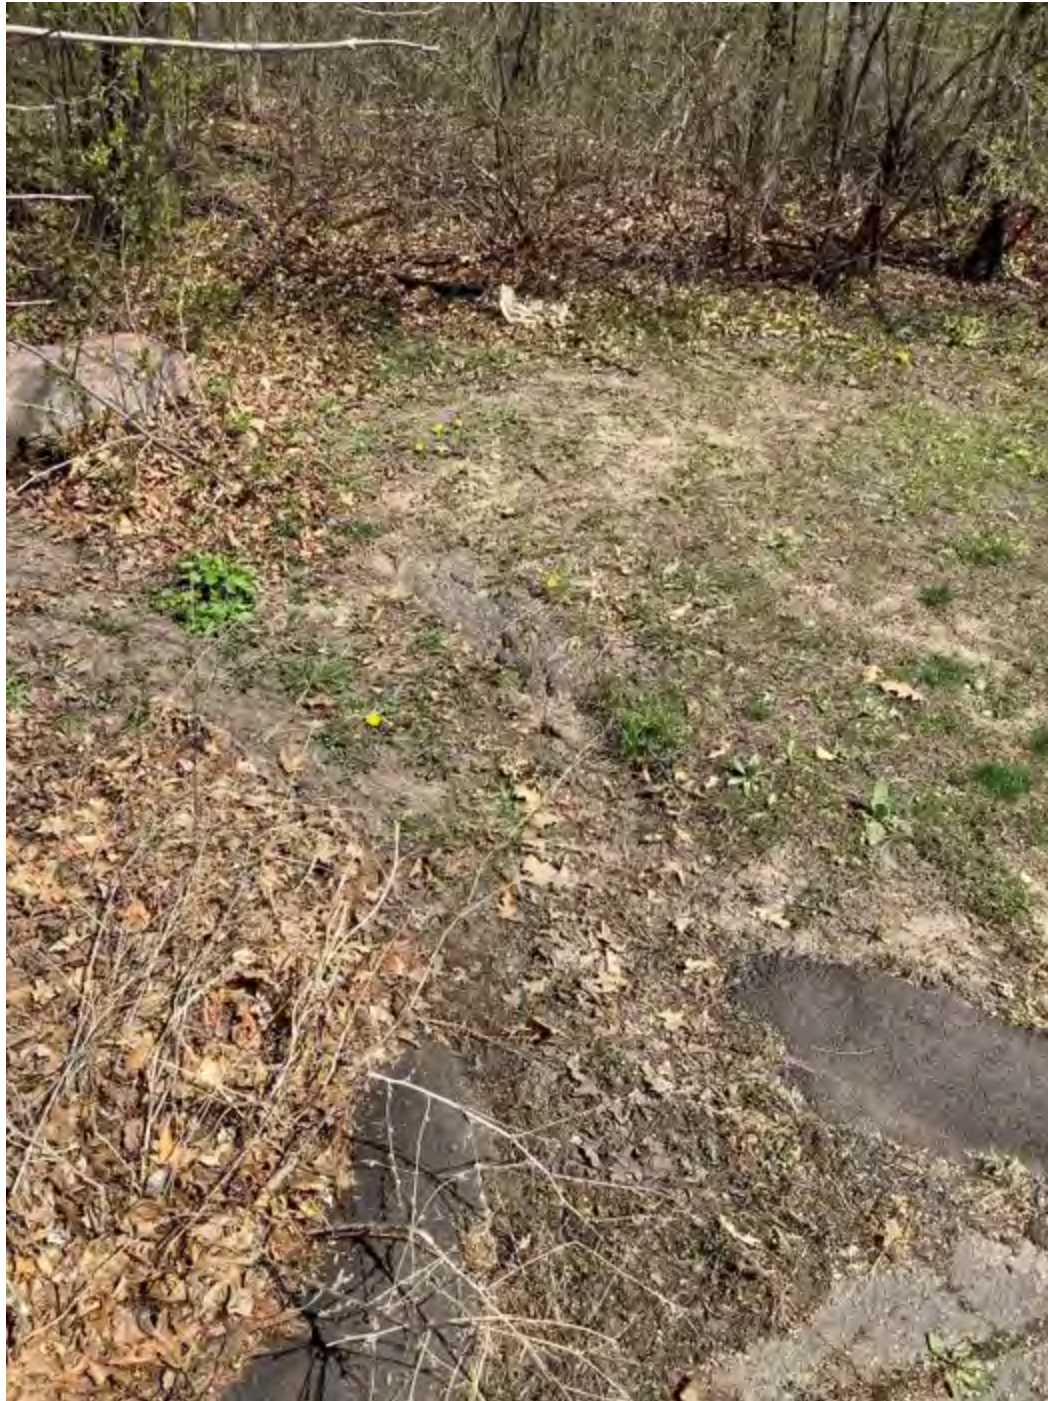
GULLY ID: ESPM Site 6

PREVIOUS WAYPOINT ID: Site 6	
SURVEY DATE: April 22, 2021 12:04 PM	
LOCATION:	
TYPE OF SITE: Gully	
SITE SUMMARY: Sunny Rain in previous 24 hours: Yes: Low Intensity, No Along a Road Long: >100' gully. The problem indicators were: Degradation, Aggradation, Flattened and/or slumping banks (widening), undercut or overhanging banks (lateral scouring), pistol-butted or leaning trees	Gully Head UTM Estimation: 30 ft, Observation Point correction, if applicable: 15T4674994956382 Connections to other points, if applicable:
GULLY INFORMATION	
EROSION POTENTIAL:	High
GULLY DEPTH:	Shallow: <3'
BOTTOM WIDTH:	Narrow/V Ditch, Medium: 1'-5'
TOP WIDTH:	Medium: 5'-10', Narrow: 1'-5'
BANK CONDITION:	Some Vegetation
BOTTOM CONDITION:	Some Vegetation
CHANNEL SLOPE:	Steep
GULLY SHAPE:	U-shaped
GULLY MATERIAL:	Gravel/cobble/ boulders , Sand, Fine-grained cohesive
WATER LEVELS	None, N/A
SEEP	No
APPARENT CAUSES:	Slope, Unstable drainage feature entering system

ADDITIONAL NOTES: Near site 6 Invasive Species? None Type: Burdock, None Debris? Little trash Existing Stabilization? Rip rap or burlap under rocks at top of gully Success: No

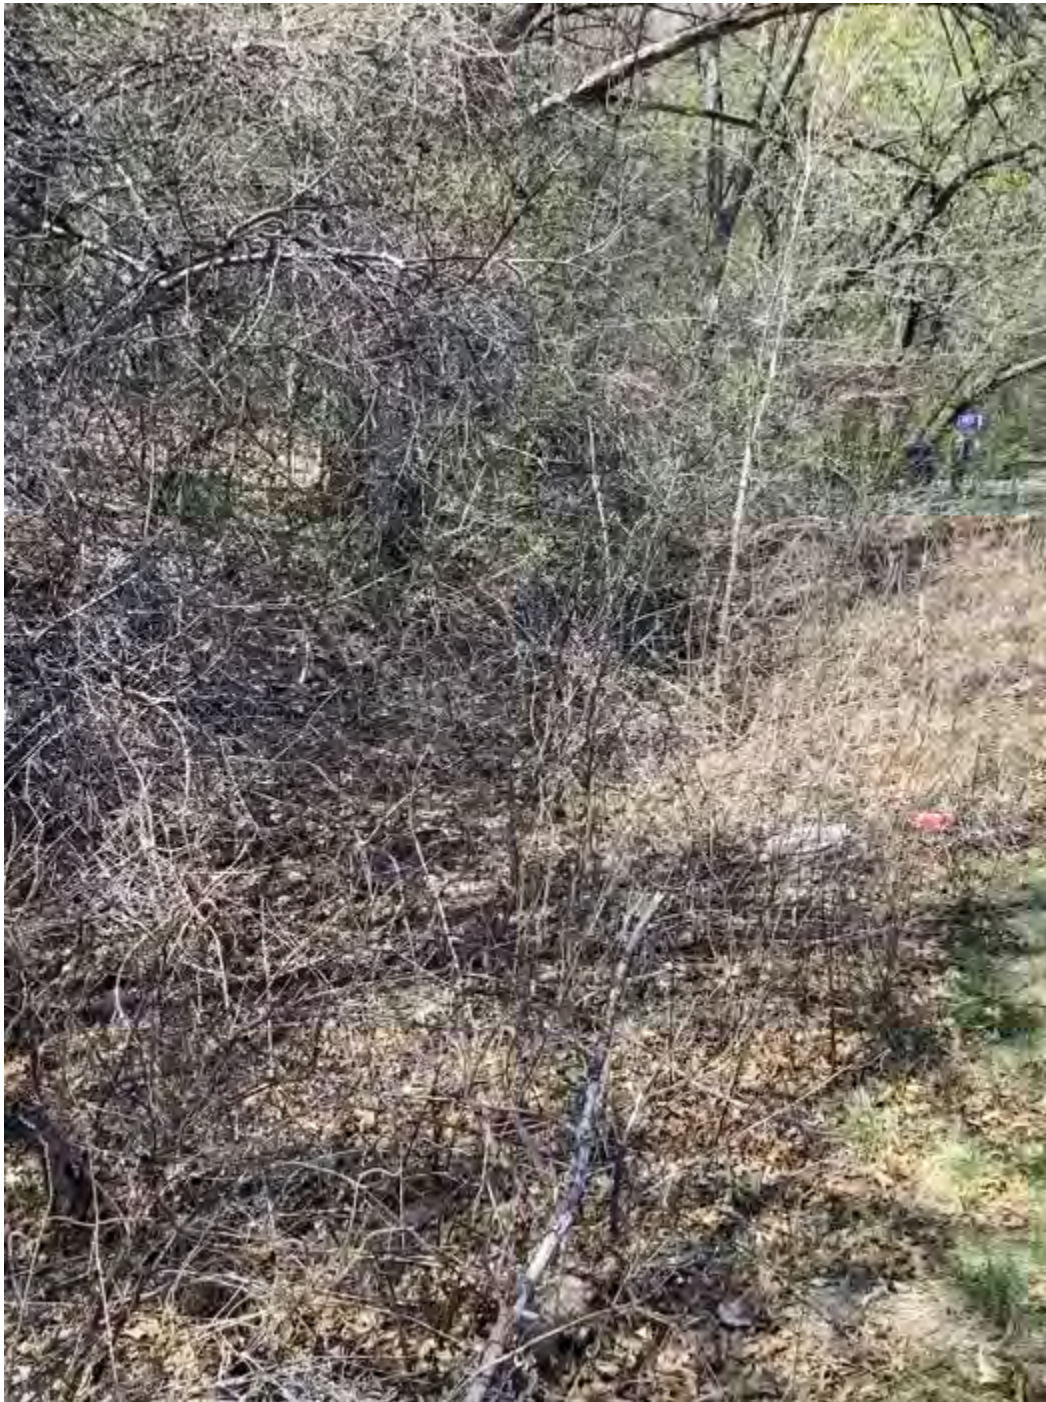
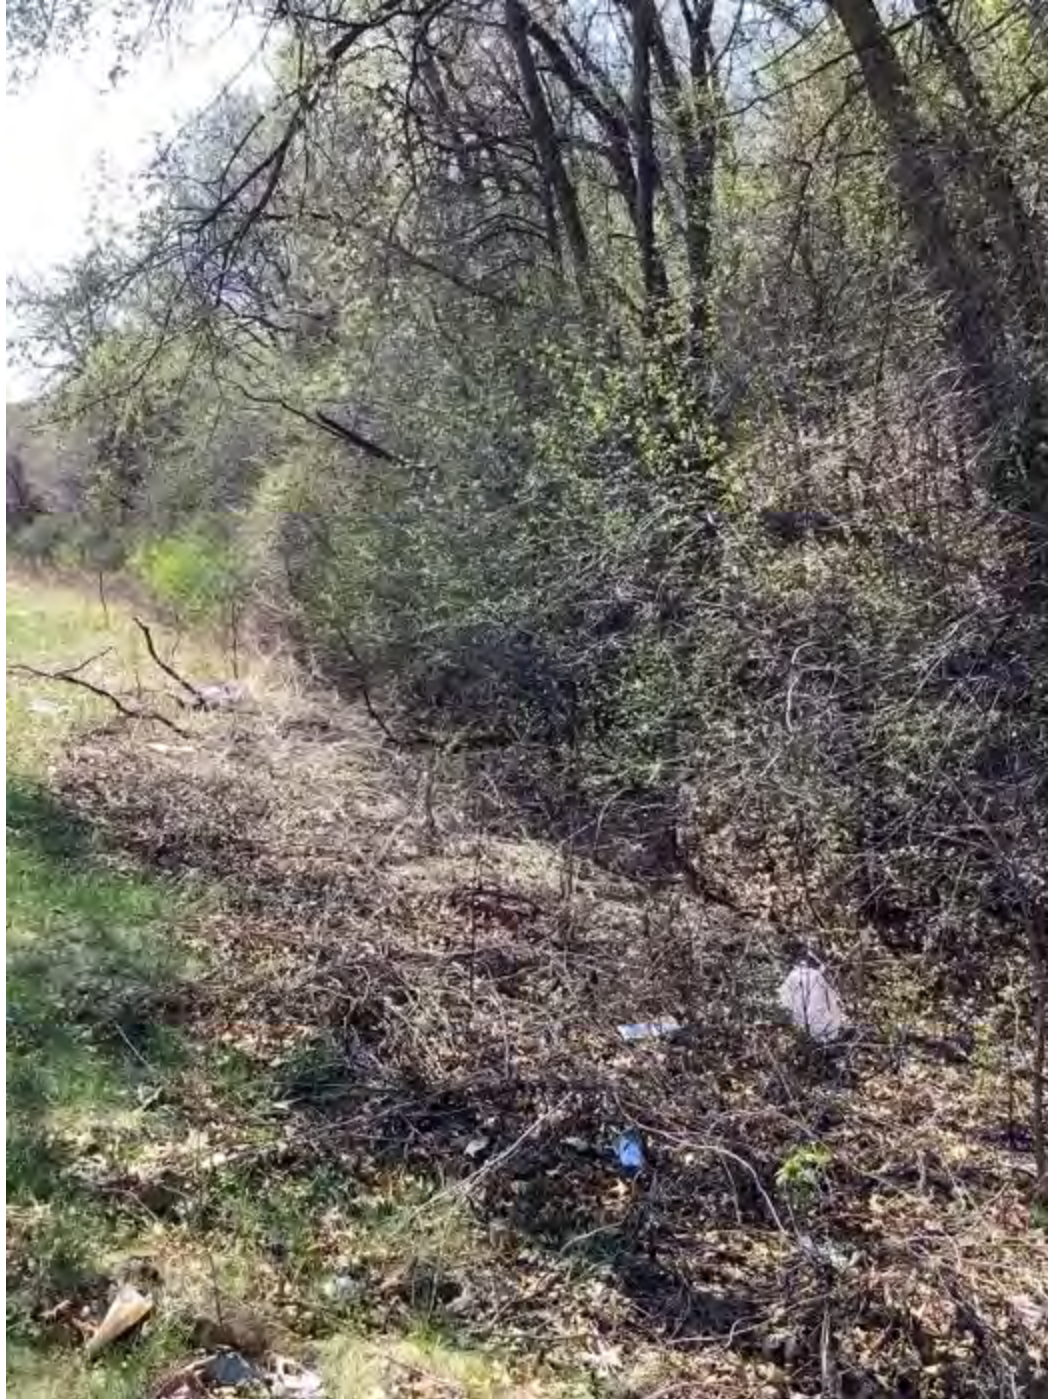
GULLY ID: ESPM Site 7

<p style="text-align: center;">Gully Head UTM Estimation: 5 ft,</p> <p style="text-align: center;">Observation Point correction, if applicable:</p> <p style="text-align: center;">Connections to other points, if applicable:</p>
PREVIOUS WAYPOINT ID: Site 7	
SURVEY DATE: April 22, 2021 12:51 PM	
LOCATION: Shakopee	
TYPE OF SITE: Gully	
SITE SUMMARY: Sunny Rain in previous 24 hours: No Off of Walking Trail Long: >100' gully. The problem indicators were: Degradation, Loss of Bank Vegetation, Flattened and/or slumping banks (widening), pistol-butted or leaning trees	
GULLY INFORMATION	
EROSION POTENTIAL:	Moderate
GULLY DEPTH:	Shallow: <3'
BOTTOM WIDTH:	Medium: 1'-5'
TOP WIDTH:	Medium: 5'-10'
BANK CONDITION:	Some Vegetation
BOTTOM CONDITION:	Some Vegetation
CHANNEL SLOPE:	Steep
GULLY SHAPE:	U-shaped
GULLY MATERIAL:	Fine-grained cohesive
WATER LEVELS	None, N/A
SEEP	No
APPARENT CAUSES:	Slope

ADDITIONAL NOTES: Slight slope drains into storm sewer at end of gully Invasive Species? Type: Debris? Lots of trash Existing Stabilization? None Success: N/A

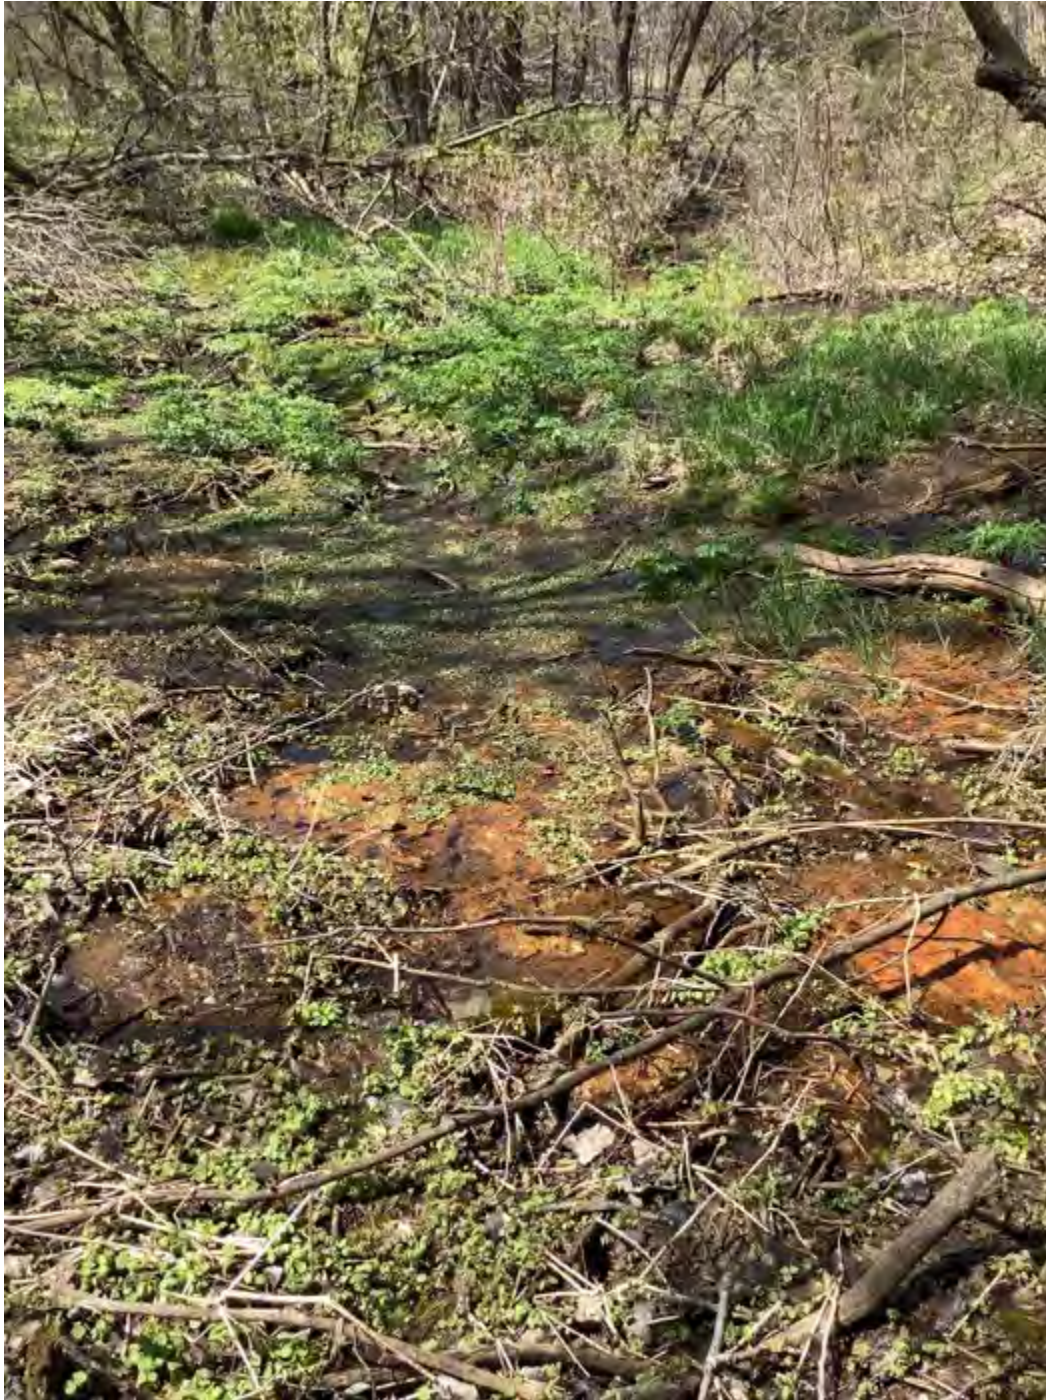
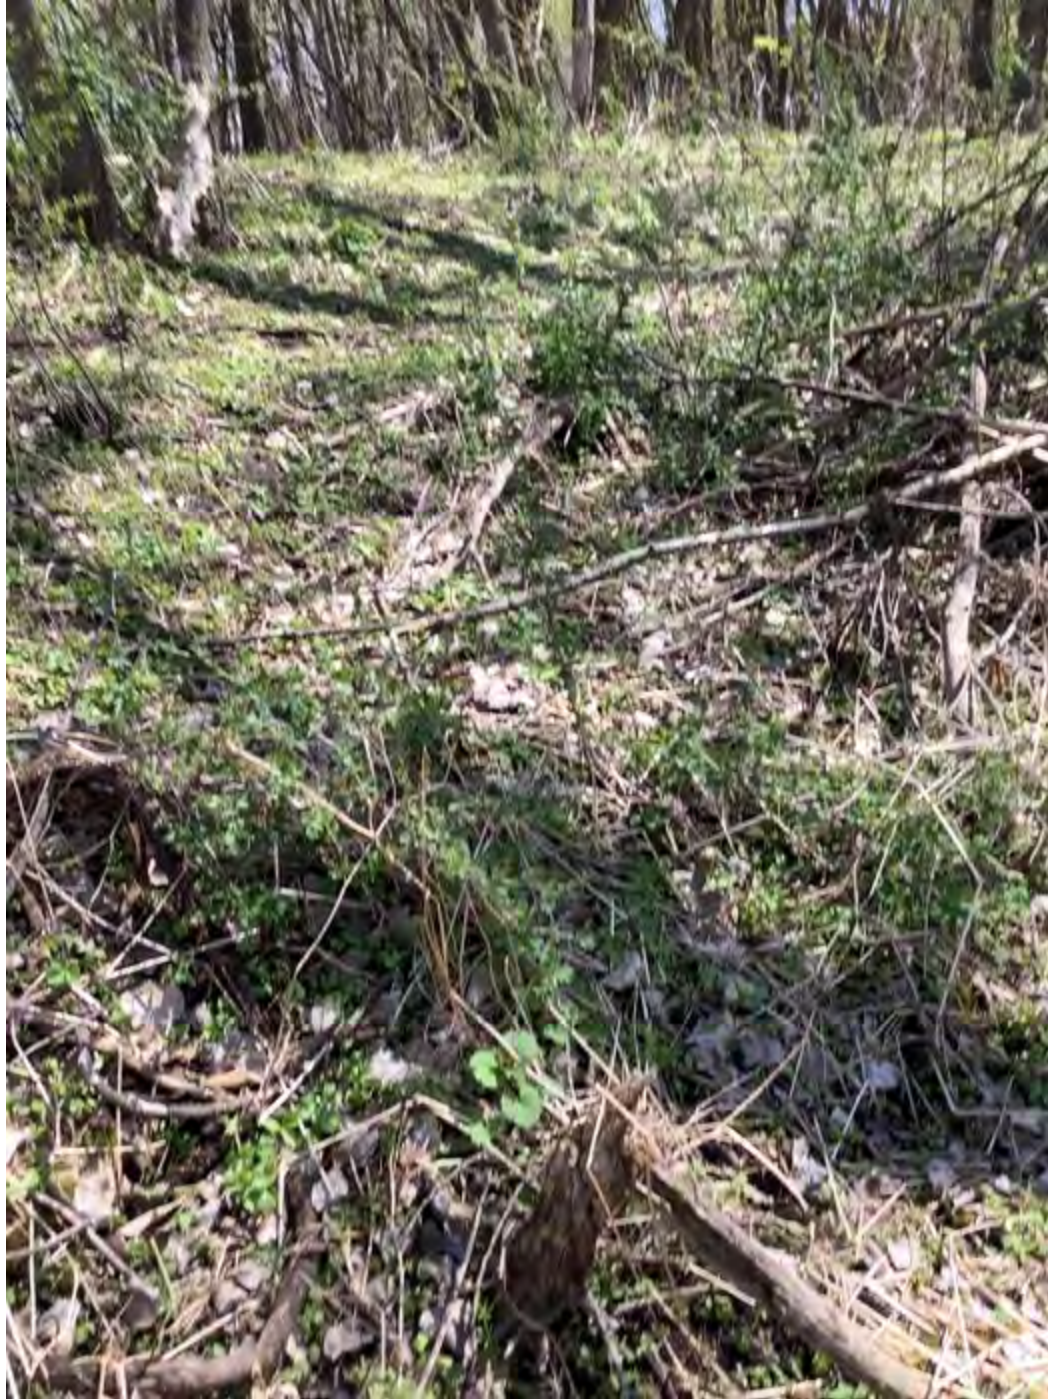
GULLY ID: ESPM Site 9

PREVIOUS WAYPOINT ID: Site 9	
SURVEY DATE: April 22, 2021 1:58 PM	
LOCATION: Savage	
TYPE OF SITE: Gully	
SITE SUMMARY: Sunny Rain in previous 24 hours: No Heavily Forested Medium: 50'-100' gully. The problem indicators were: Degradation, Aggradation, Loss of Bank Vegetation, Vertical and/or bare banks (incision), pistol-butted or leaning trees	
GULLY INFORMATION	
EROSION POTENTIAL:	Moderate
GULLY DEPTH:	Shallow: <3'
BOTTOM WIDTH:	Wide: >5'
TOP WIDTH:	Medium: 5'-10'
BANK CONDITION:	Some Vegetation
BOTTOM CONDITION:	Some Vegetation
CHANNEL SLOPE:	Flat
GULLY SHAPE:	Trapezoid
GULLY MATERIAL:	Fine-grained cohesive
WATER LEVELS	Moderate, Slow
SEEP	Yes
APPARENT CAUSES:	Seep/groundwater, Slope
ADDITIONAL NOTES:	
Invasive Species? None Type: None	
Debris? No trash some debris	
Existing Stabilization? None Success: No, N/A

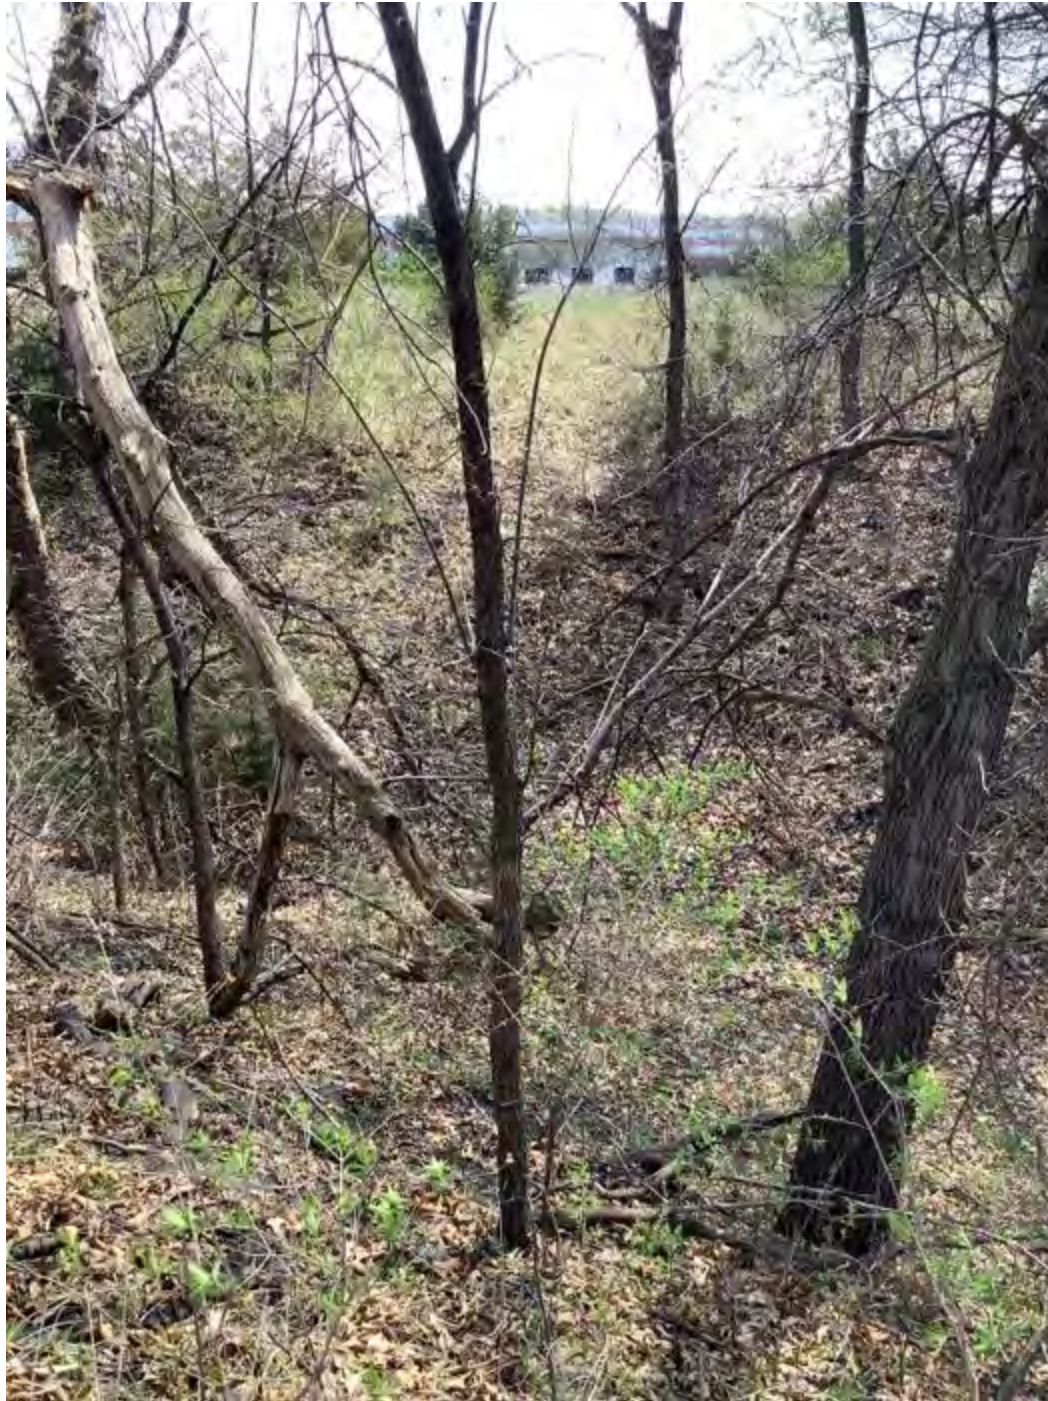
Start of gully

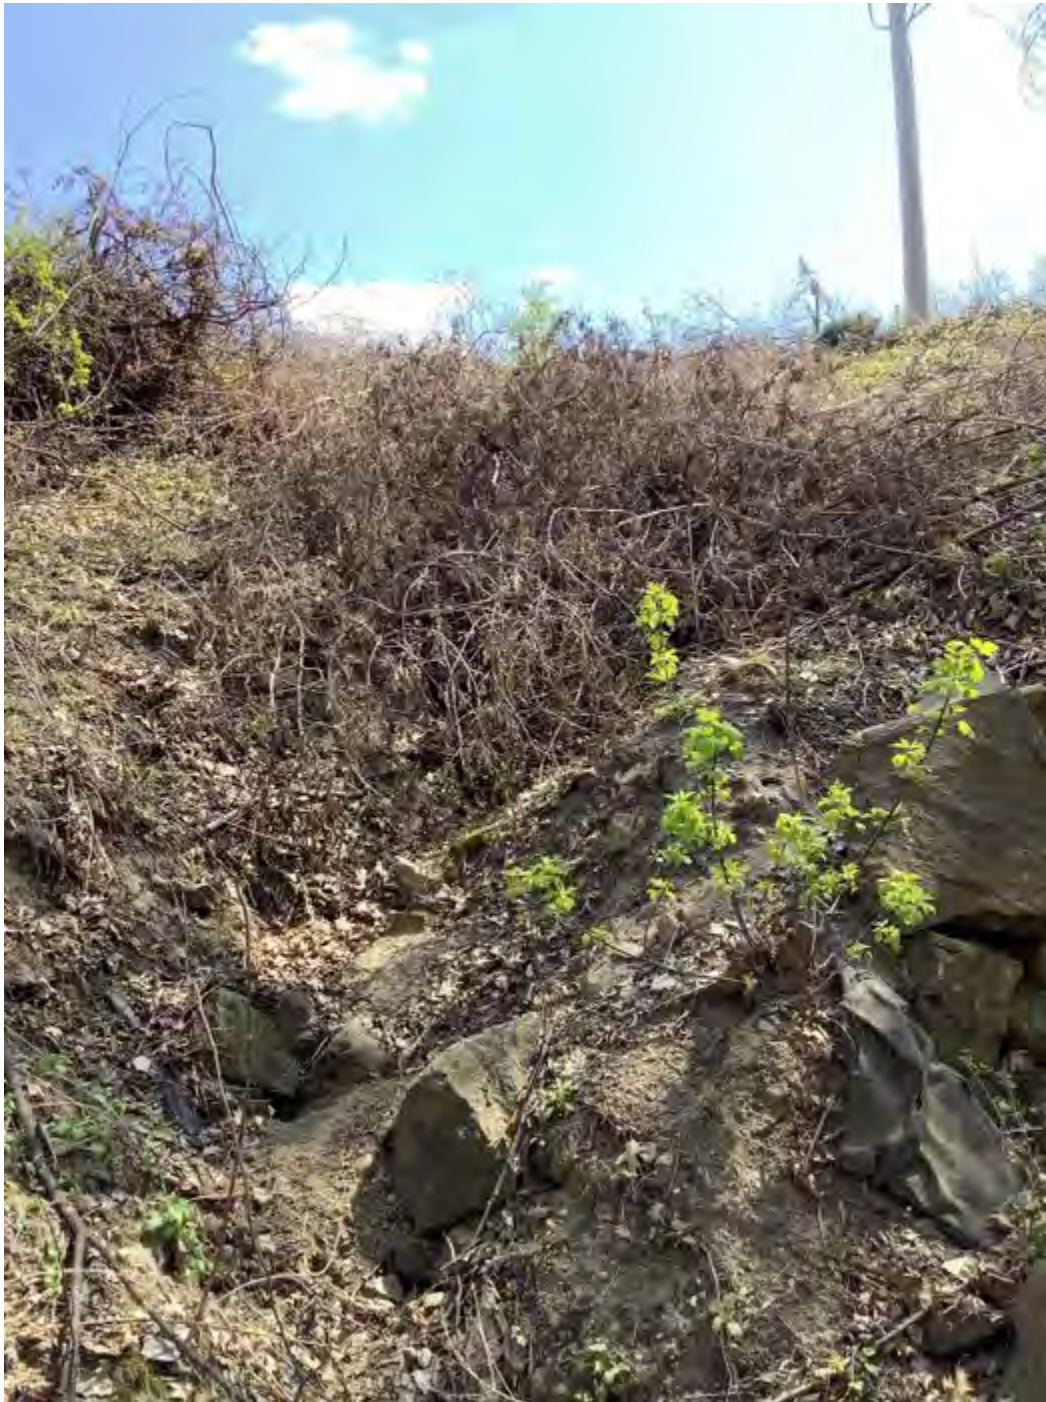
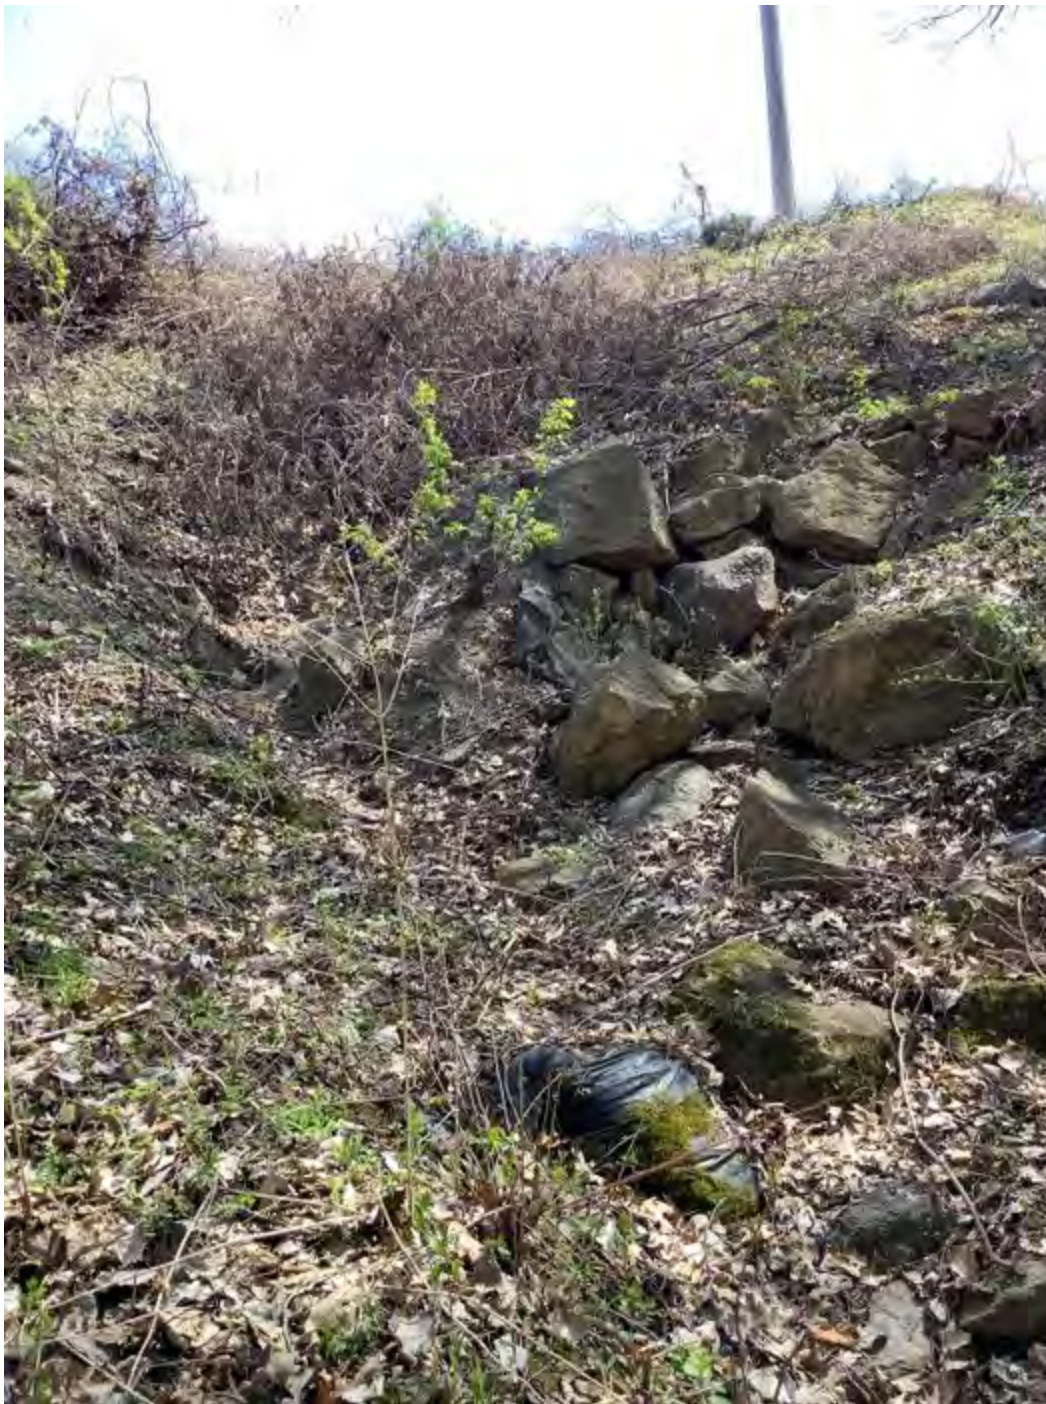
GULLY ID: ESPM Site 11	  <p style="text-align: center;">Gully Head UTM Estimation: 20 feet,</p> <p style="text-align: center;">Observation Point correction, if applicable:</p> <p style="text-align: center;">Connections to other points, if applicable:</p>
PREVIOUS WAYPOINT ID: Site 11	
SURVEY DATE: April 22, 2021 1:29 PM	
LOCATION: Savage	
TYPE OF SITE: Gully	
SITE SUMMARY: Sunny Rain in previous 24 hours: No Along a Road Medium: 50'-100' gully. The problem indicators were: Degradation, Aggradation, Loss of Bank Vegetation, Vertical and/or bare banks (incision), Flattened and/or slumping banks (widening)	
GULLY INFORMATION	
EROSION POTENTIAL:	High
GULLY DEPTH:	Shallow: <3'
BOTTOM WIDTH:	Medium: 1'-5'
TOP WIDTH:	Narrow: 1'-5'
BANK CONDITION:	Some Vegetation
BOTTOM CONDITION:	Bare Soil
CHANNEL SLOPE:	Steep
GULLY SHAPE:	V-shaped
GULLY MATERIAL:	Sand, Fine-grained cohesive
WATER LEVELS	None, N/A
SEEP	No
APPARENT CAUSES:	Slope, Unstable drainage feature entering system , Channel Incision

ADDITIONAL NOTES: Invasive Species? None Type: None Debris? Some debris but no trash Existing Stabilization? None Success: No, N/A

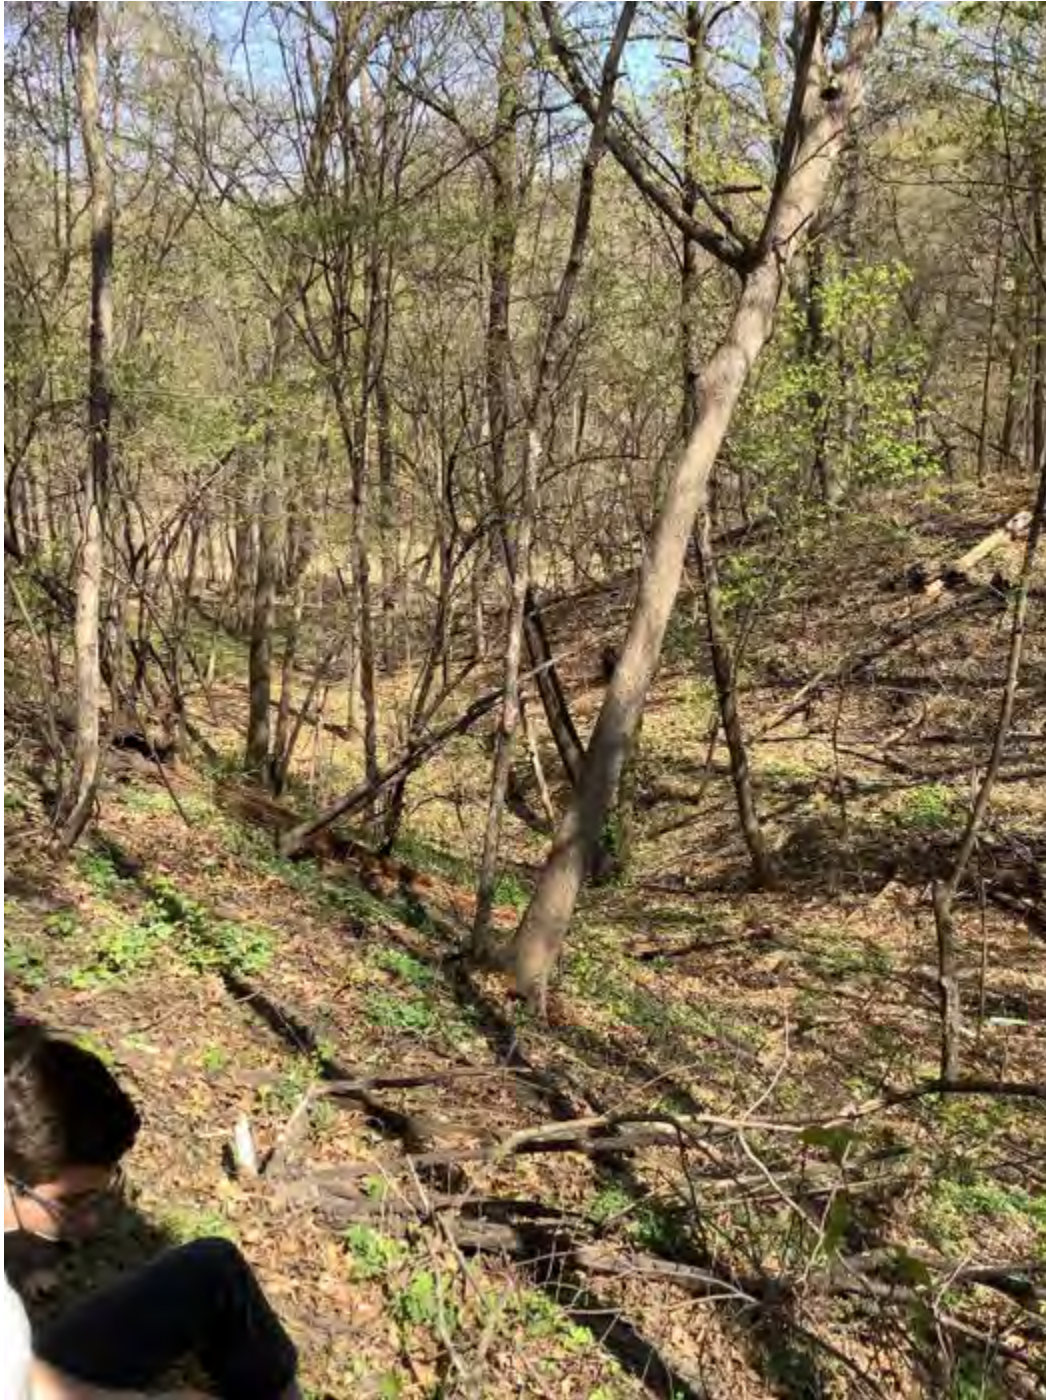
GULLY ID: ESPM Site 13

PREVIOUS WAYPOINT ID: Site 13	
SURVEY DATE: April 22, 2021 2:44 PM	
LOCATION: Savage	
TYPE OF SITE: Gully	
SITE SUMMARY: Sunny Rain in previous 24 hours: No Along a Road Long: >100' gully. The problem indicators were: Degradation, Flattened and/or slumping banks (widening), pistol-butted or leaning trees	
GULLY INFORMATION	
EROSION POTENTIAL:	High
GULLY DEPTH:	Deep: >15'
BOTTOM WIDTH:	Wide: >5'
TOP WIDTH:	Wide: >10', Medium: 5'-10', Narrow: 1'-5'
BANK CONDITION:	Some Vegetation
BOTTOM CONDITION:	Some Vegetation
CHANNEL SLOPE:	Steep
GULLY SHAPE:	V-shaped
GULLY MATERIAL:	Fine-grained cohesive
WATER LEVELS	None, N/A
SEEP	No
APPARENT CAUSES:	Slope, Unstable drainage feature entering system
ADDITIONAL NOTES:	
Invasive Species? Type:	
Debris? Some trash and debris	
Existing Stabilization? None	
Success: N/A

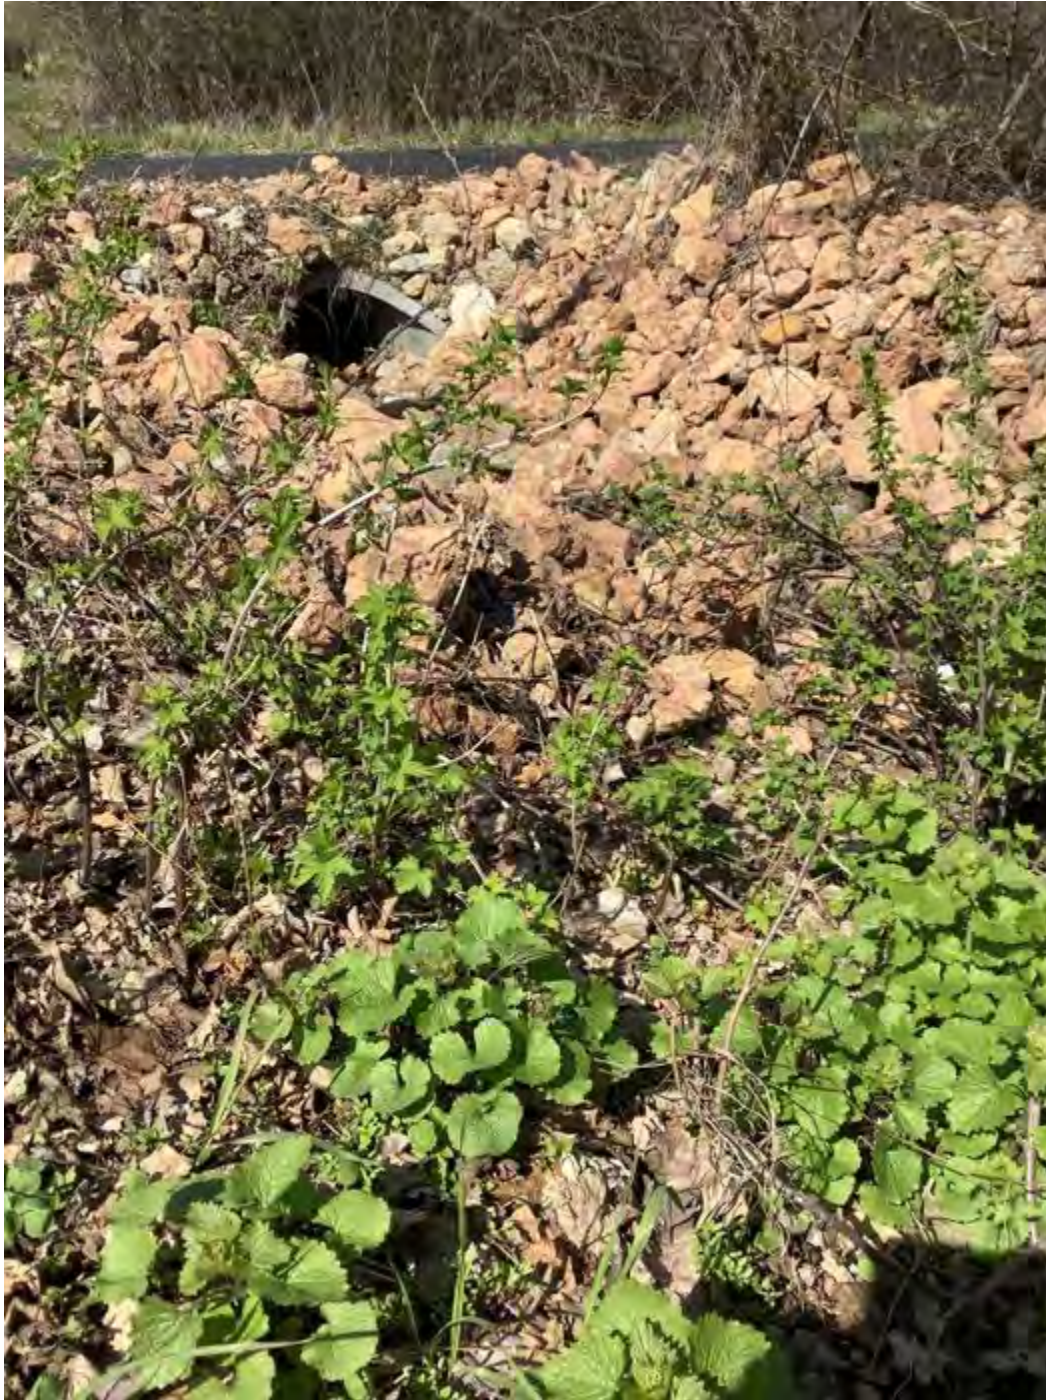
Riprap surrounding outlet feature
