Technical Memorandum

Re: University of Minnesota Partnership for the Gully Assessment and
Condition Project

ATTACHMENT 2 - ESPM CLASS GULLY DATA SHEETS

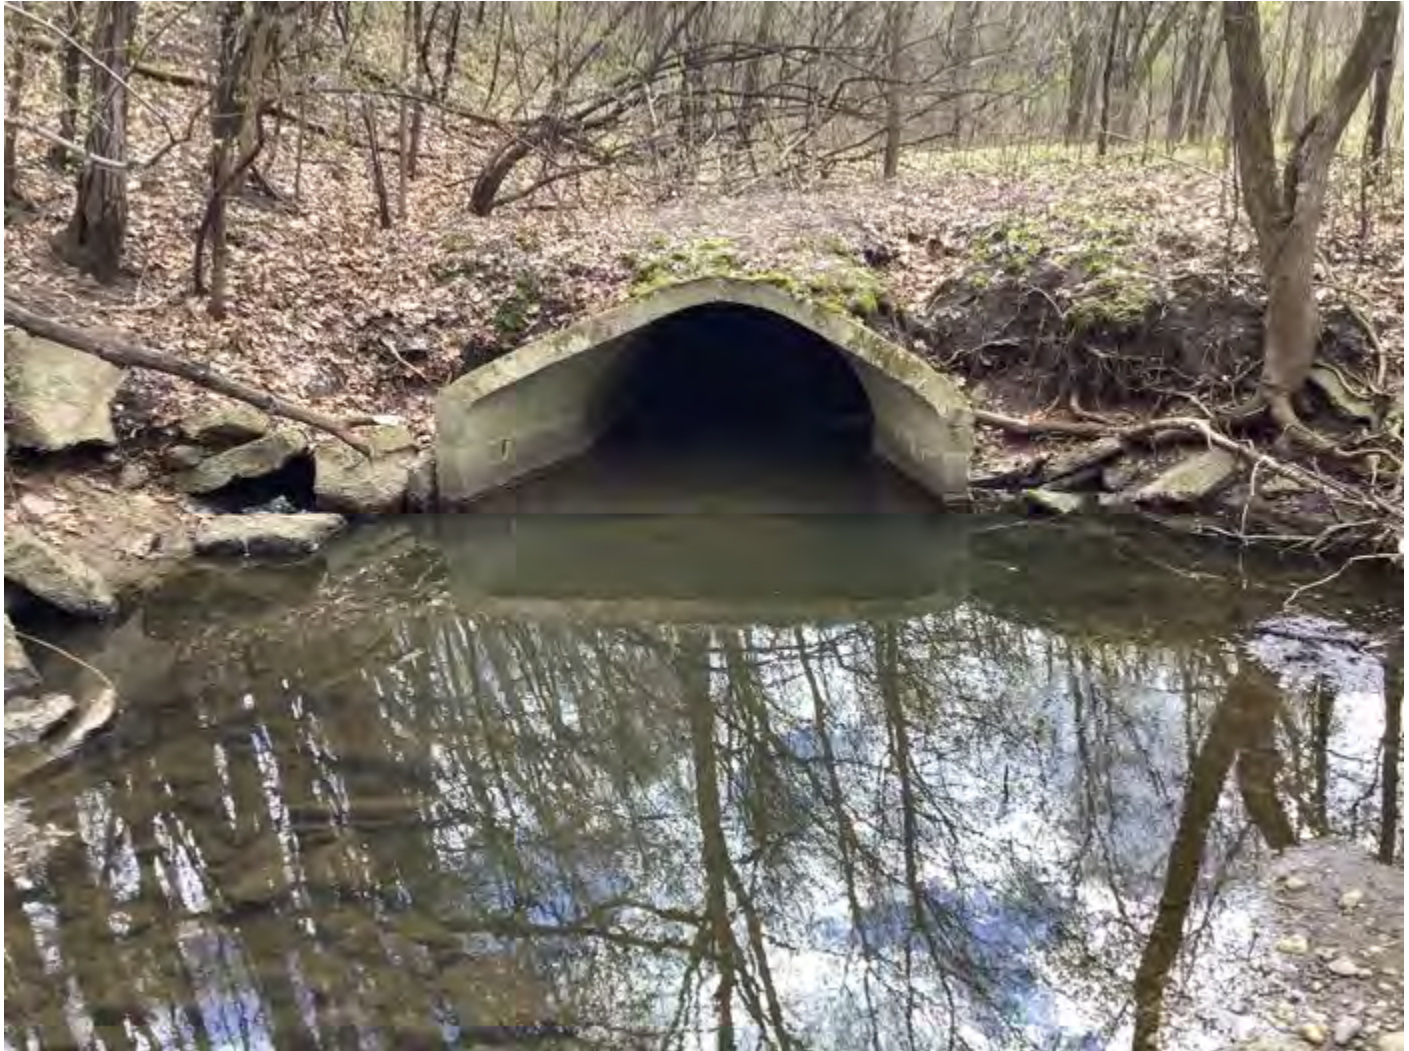
Stormwater outlet

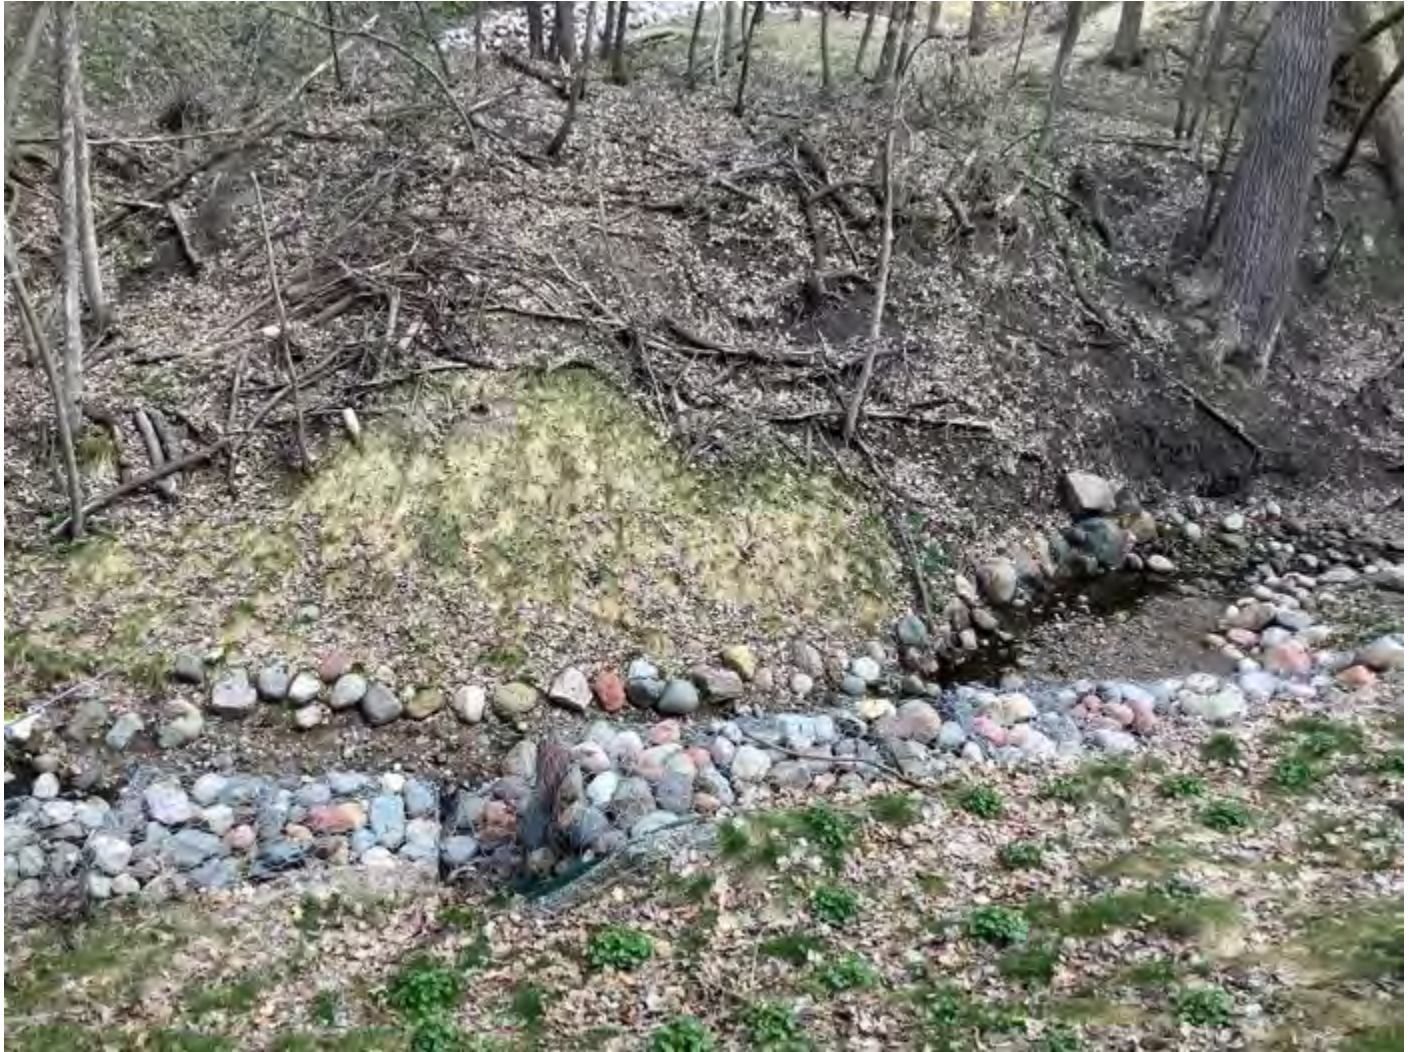
Erosion control structures

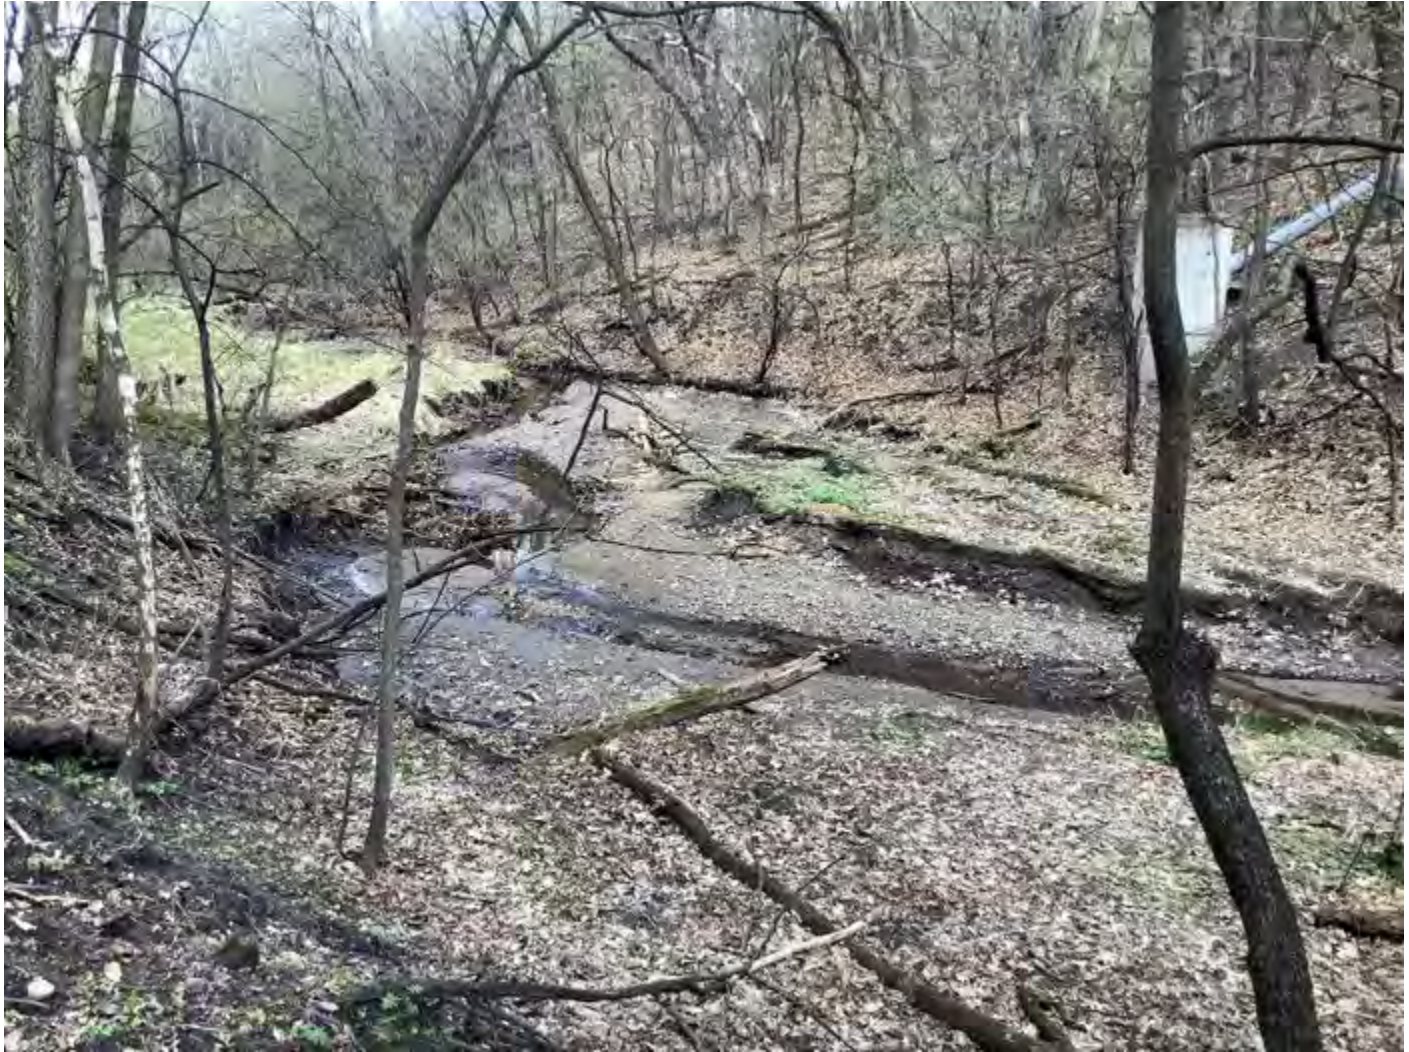
Turns into meandering stream
