TECHNICAL MEMORANDUM

То:	Lower Minnesota River Watershed District				
From:	Inter-Fluve, Inc.				
Date:	May 18, 2021	Project: Area 3 Lower Minnesota River			
Re:	Area 3 Findings and Alternative Review Memorandum

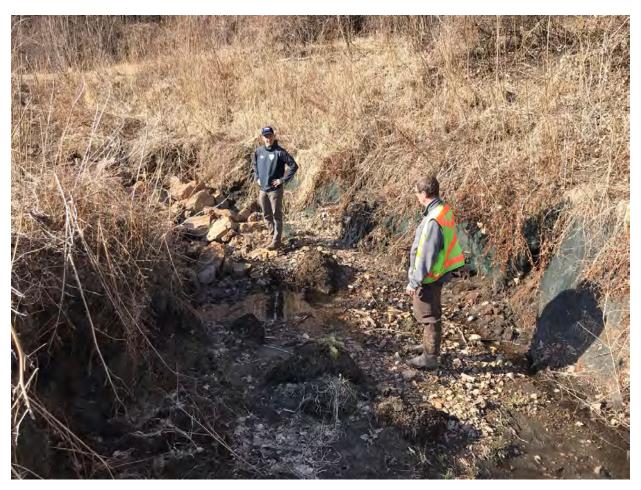
Inter-Fluve conducted an onsite geomorphic site assessment on April 2, 2021 in the late afternoon. At the time of the visit, the water surface elevation was at approximately 703.9 feet NAVD88 and the discharge was approximately 10,650 cubic feet per second (cfs) at the USGS gage station 05330000 Minnesota River near Jordan, MN (USGS NWIS Web Interface). The Minnesota River channel in the project reach is currently between 250 and 350 feet wide. Upstream and downstream of the project site, the both channel banks are actively eroding. At Area 3, the left bank (bluff toe) is erosional, and the right bank is depositional. The floodplain below the valley walls is characterized by a floodplain forest, with some development, agricultural land, and several floodplain lakes. Where the City's non-functional stormwater pond is located downstream of the Area 3 bluff, there is a floodplain bench dominated by reed canary grass and willow shrubs. A stormwater outlet empties into an incised ditch that carved through this floodplain (Figure 3). It appears that this floodplain bench is the former location of the City stormwater pond that has been filled in and is no longer serving any water quality benefit Based on review of historic air photos and past reports, it is clear that several phases of construction and repair have been done to restore or rebuild the pond. We understand that in 2013 a rock toe and bioengineering stabilization project was implemented to fortify the river bank along the length of the pond, however, due to high water, vegetation never established. Inter-Fluve observed the failed treatment in the field and also identified a structure that appeared to be a constructed log structure on the bank adjacent to the pond location (Figure 4).

Figure 3: Photo taken of incised channel carved through former stormwater pond.

1. <u>Pursue decommissioning of the City Stormwater Pond</u>. We understand that the stormwater pond is a part of the City's current MS4 compliance; however, the pond has had continued functional issues, and is currently not retaining any water or providing any water quality benefits. The river is anticipated to move in the direction of the stormwater pond, so stormwater treatment in this location is not a viable long-term solution. Removing the bank and structures in this location and allowing the river

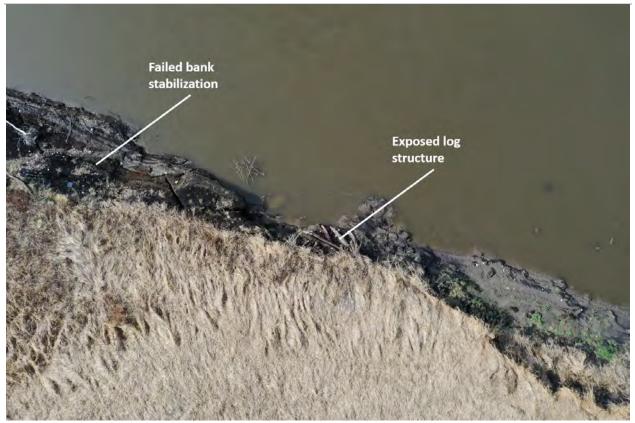
In 2013, a bank toe stabilization effort using rock and bioengineering was implemented around the perimeter of the City stormwater pond to protect the pond. However, a Wenck report indicated that vegetation did not grow due to high water conditions, resulting in failure of the bioengineering techniques (Wenck, 2017.)

Figure 4: Drone image showing exposed log crib structure and failed bank stabilization.

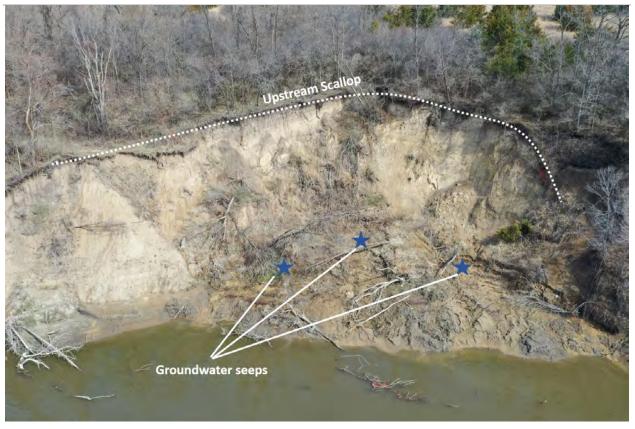
The eroding section of the Area 3 bluff is estimated to be approximately 700 feet long and 60 feet high, with evidence of erosion concentrated in three scallops spaced along the bluff top. The shape of these scallops coincides with the location of groundwater seeps along the bottom half of the eroded bluff (Figure 5). The bluff erosion has impacted approximately 500 feet of the former road/trail surface. The bluff is composed of exposed fine sand with sparse gravels concentrated in the upper ~10 feet of the bluff face. Alluvial material, likely sourced from the eroding bluff with minor flood deposits, is present at the base of the eroding bluff. Only minimal vegetation was observed on the bluff face. Several cliff swallow nests were observed in the upper portion of the eroded bluff. Upslope of the eroding bluff, the slope is largely prairie grasses interspersed with cedar trees.

Figure 5: Drone image of bluff segment showing scallop shape and approximate location of groundwater seeps.

- The shape of the scallops in the upper bluff aligns with the locations of the groundwater seeps expressed in the lower bluff and near the midpoint of the bluff.⁵ This suggests that the seeps may be playing a role in the bluff erosion.

- 2. <u>Continue geotechnical investigations on the upper slope and include assessment and design for addressing groundwater seeps</u>. Investigate how the stormwater ponds and landscape irrigation at the top of the slope may be impacting the seeps (e.g., Are the stormwater ponds lined or have they sealed? Are they functioning as designed?) Design and implement a measure to express seeps at the bottom of the bluff to prevent continued soil wasting from seep erosion allowing vegetation to establish and stabilize the bluff toe.

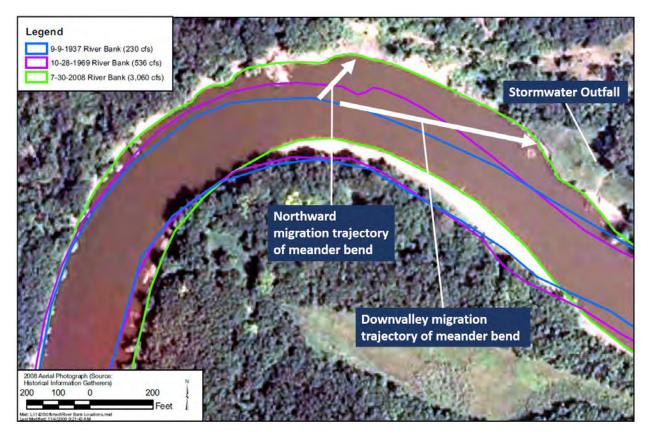
A review of recent aerial photographs from GoogleEarth³ reveals that the two meander bends upstream of Area 3 are shifting down-valley, which is an expected geomorphic trend and aligns with aerial photo analysis. This trend suggests that the trajectory of the Area 3 meander bend is also down valley. However, the presence and location of the stormwater pond stabilization work⁴ is delaying down valley migration, resulting in persistent northward erosion at Area 3. This trend is illustrated below on Figure 6.

Figure 6: Historical Aerial photograph analysis showing bank lines from 1937, 1969, and 2008 (modified from Wenck, 2010)

• Inter-Fluve's onsite observations of bilateral bank erosion and historical air photo analysis indicate that the river segment upstream of the Area 3 bluff is widening. In the Area 3 segment, the inside bend is experiencing deposition, and the outside bend is eroding (or moving north in the direction of the bluff.) The aerial photo analysis (see Figure 5) shows the historic trends of meander bend migration for the project area. The
