<b>Gully ID:</b> 06:10-09:36	<p style="text-align: center;"><b>MAP</b></p>

<b>Date &amp; Time:</b> June 10, 2021 9:36 AM	
<b>Location:</b> Eagan	
<b>Weather:</b> Sunny <b>Storm/Rainfall Event in the Past 24 Hours?</b> No	
<b>GULLY INFORMATION</b>	
<b>Calculated Erosion Potential:</b>	Moderate
<b>Approximate Depth:</b>	3-Medium (3'-15')
<b>Approximate Bottom Width:</b>	1-Wide (>5')
<b>Approximate Gully Length:</b>	5-Long (>100')
<b>Condition of Gully Bottom:</b>	3-Some Vegetation
<b>Condition of Gully Banks:</b>	5-Bare Soil
<b>Gully Bank Angles:</b>	3-Mid-Range (45 to 90 degrees)
<b>Gully Shape:</b>	5-V-Shaped
<b>Gully Material:</b>	Silt/Clay

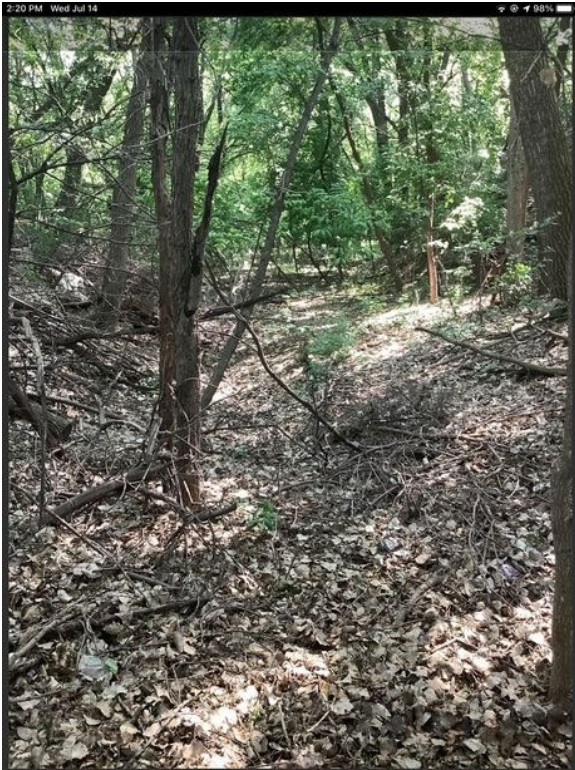
**Photo 1 Image**

Downstream view of gully. Slumping trees on left bank.

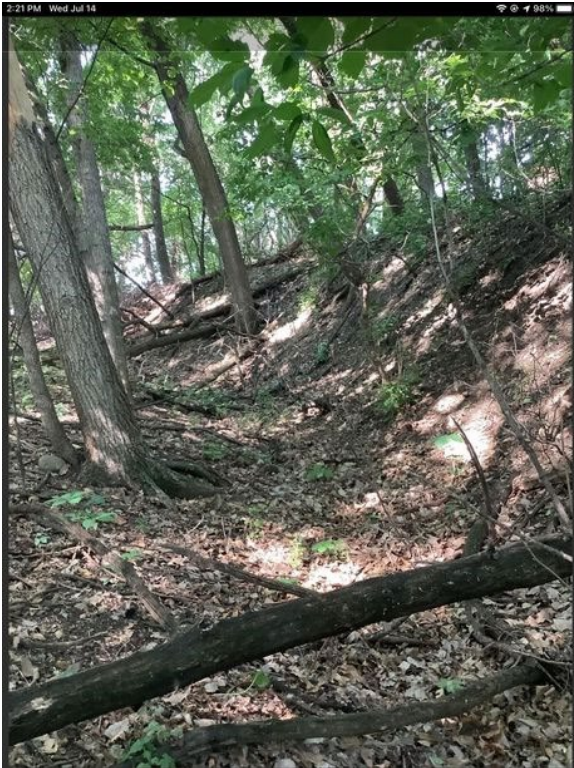
**Photo 3 Image**

Upstream view from near the bottom of the gully.

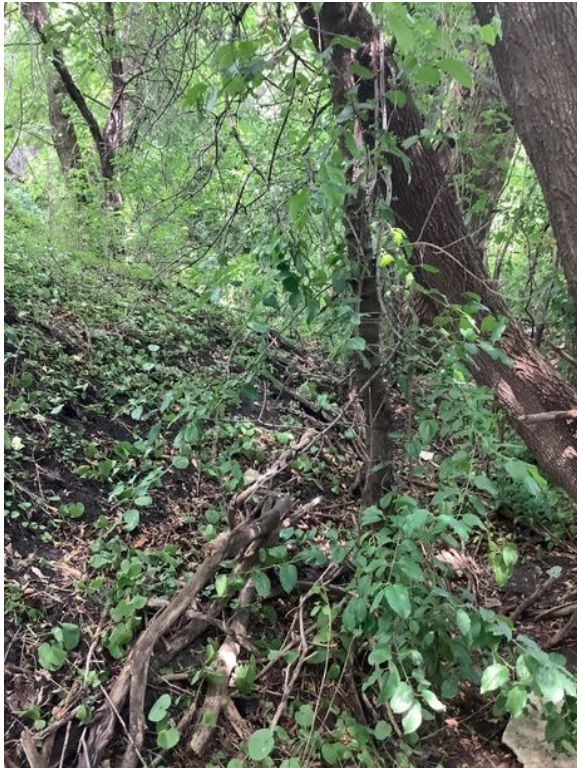
**Photo 1 Image**

Upstream view of left bank.

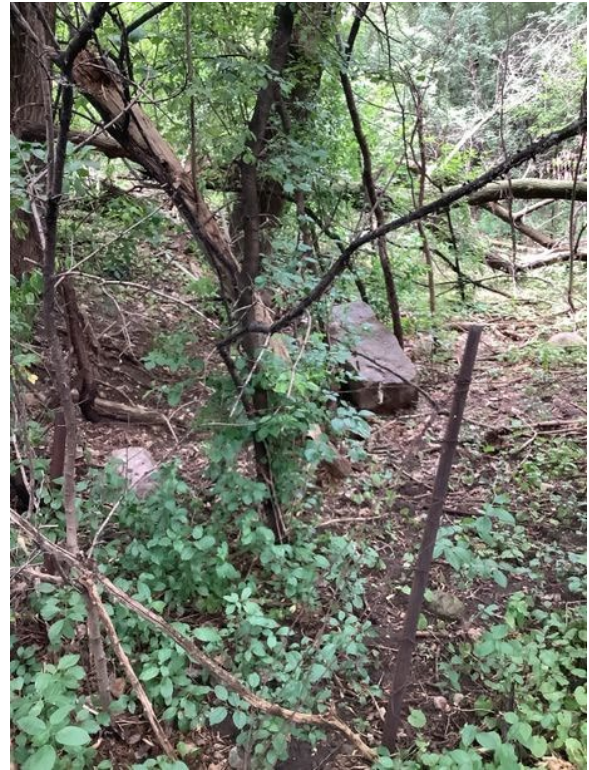
**Photo 4 Image**

Downstream view of left bank. Barbed wire fence is in picture downstream.

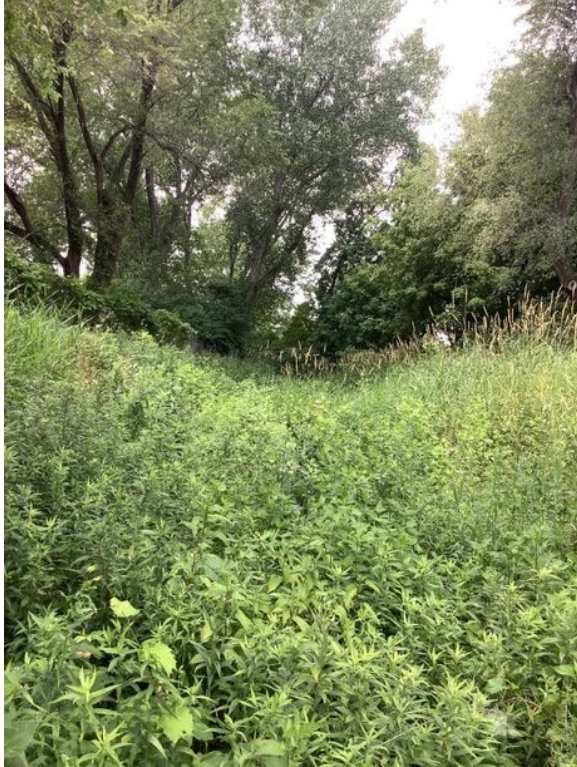
**Photo 1 Image**

Downstream view.

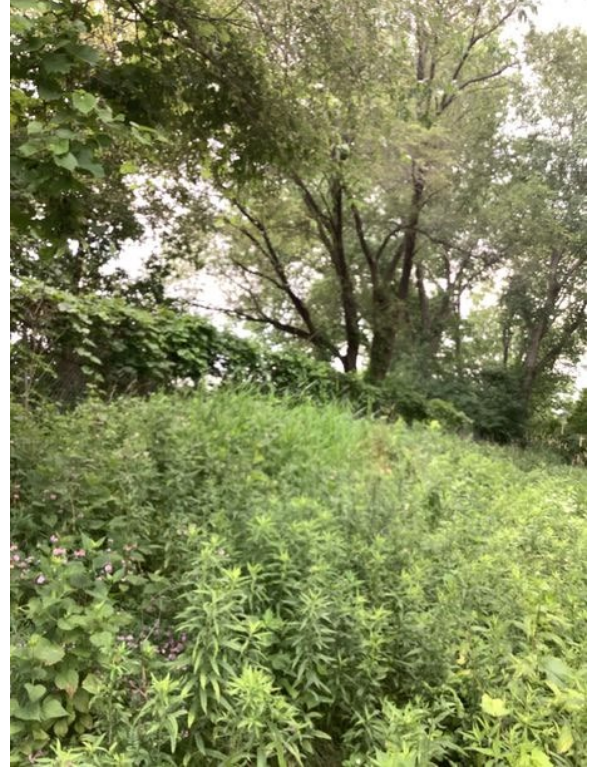
**Photo 2 Image**

Downstream view of left bank.

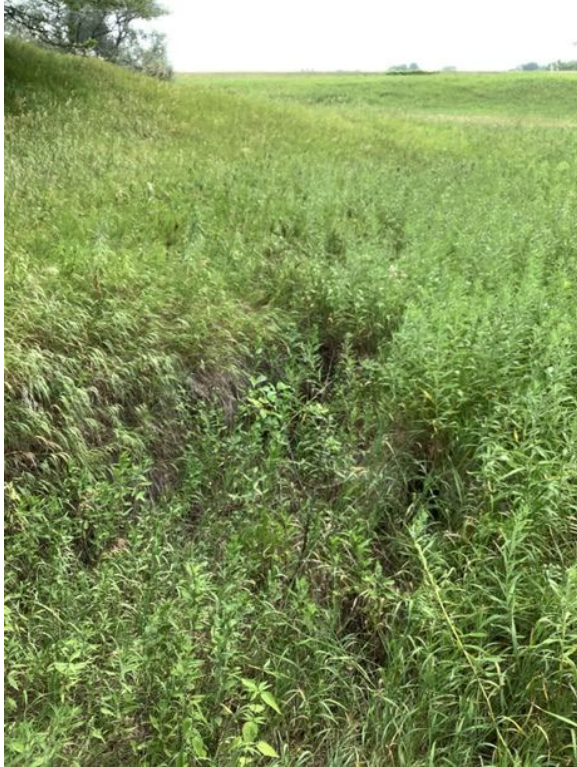
**Photo 1 Image**

Gully top

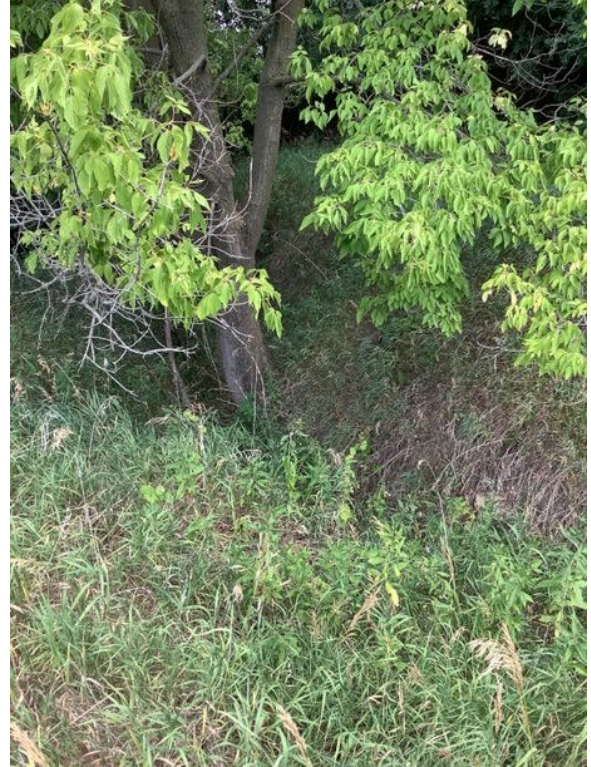
**Photo 2 Image**

Right bank

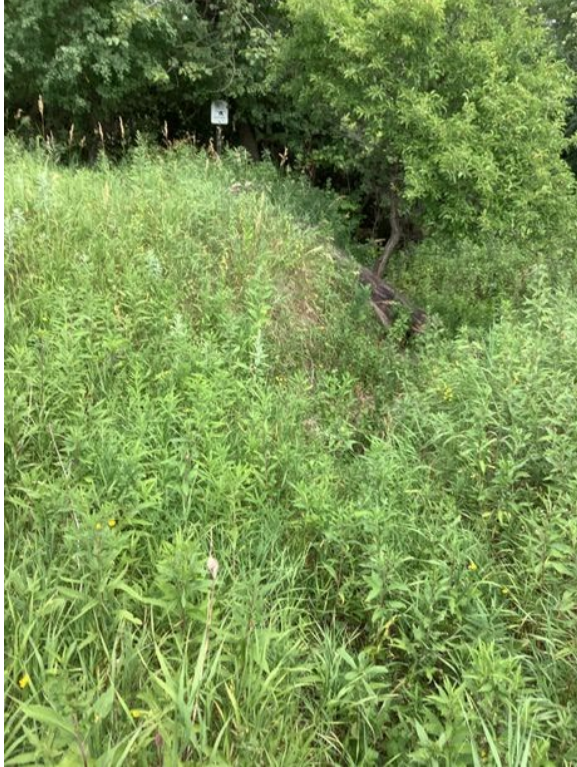
**Photo 1 Image**

Left bank

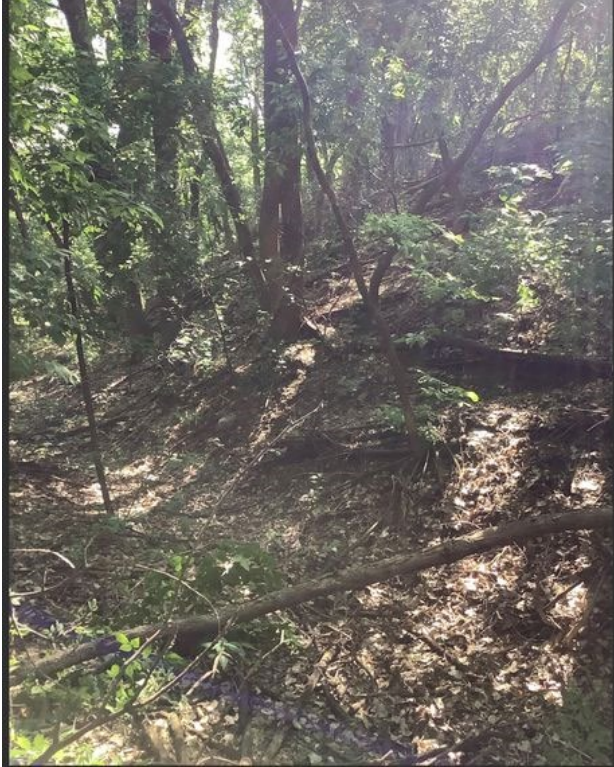
**Photo 1 Image**

Right bank

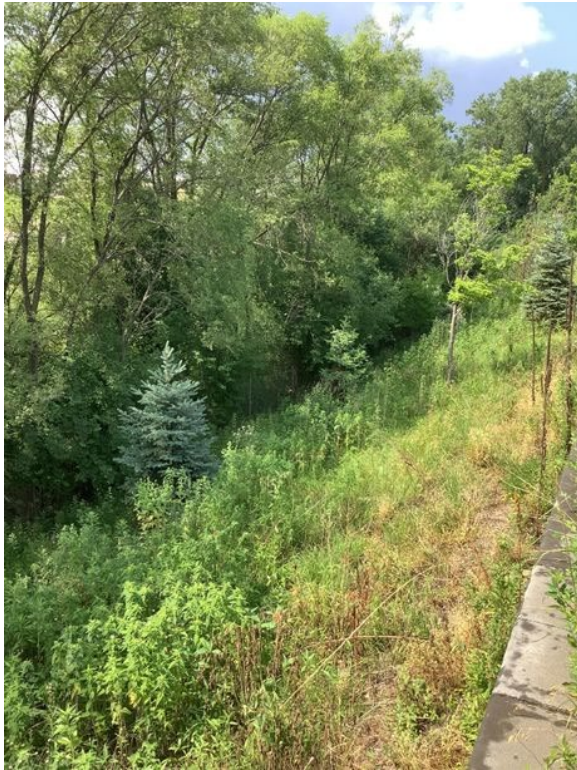
**Photo 1 Image**

Downstream view from right bank

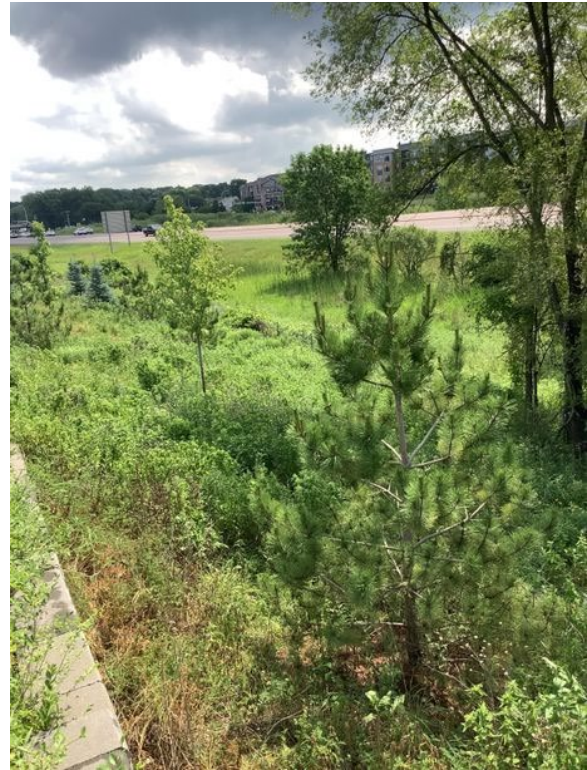
**Photo 2 Image**

Upstream view from right bank

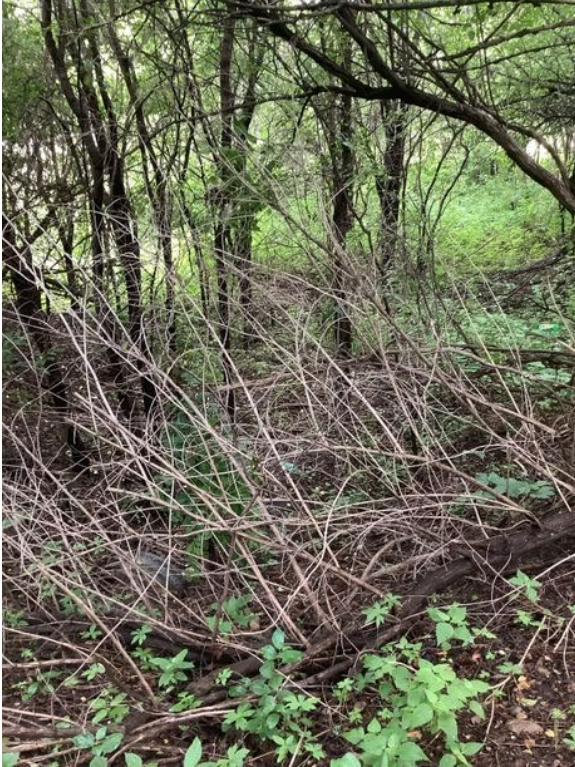
**Photo 1 Image**

Downstream view from right side

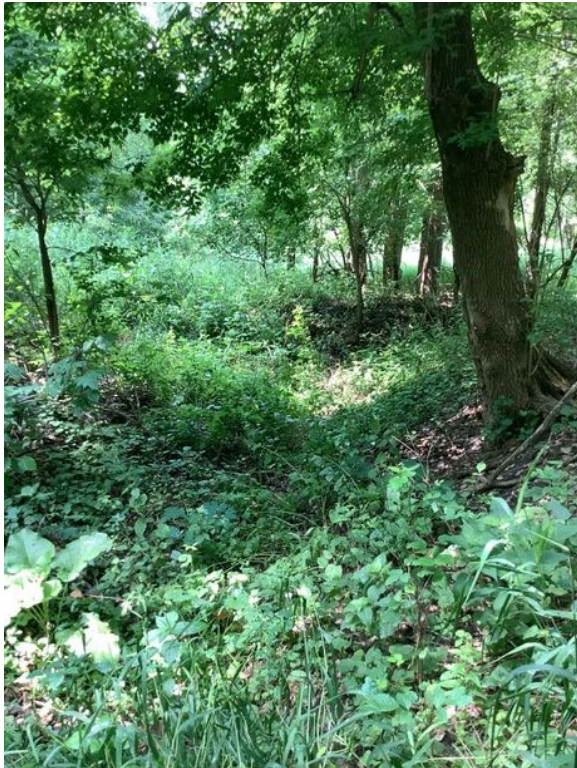
**Photo 1 Image**

Downstream view of gully, it turns right about 20 feet from beginning as seen in this photo.

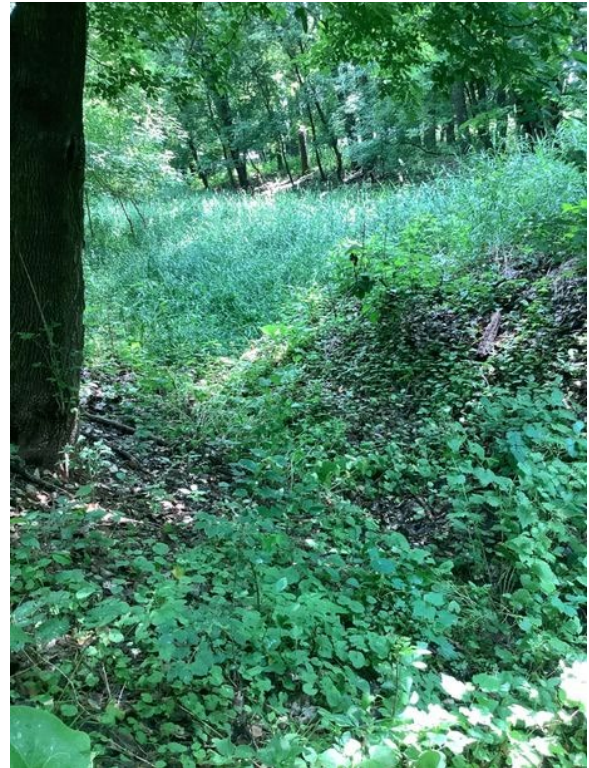
**Photo 2 Image**

Upstream view at turn.

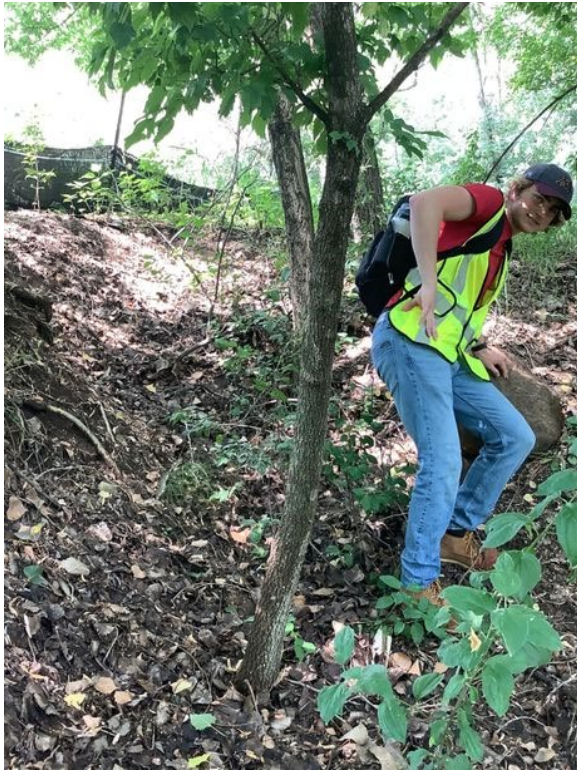
**Photo 1 Image**

Upstream view of small gully.

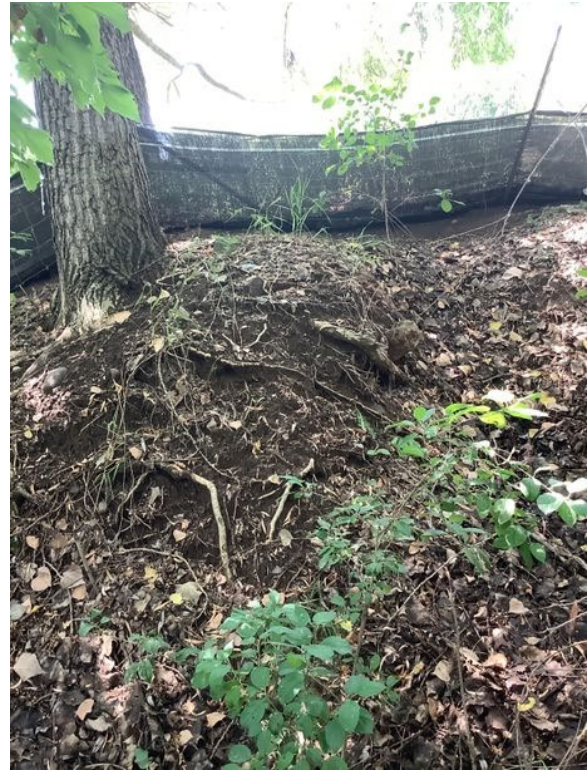
**Photo 2 Image**

Upstream view of left bank were severe degradation is visible.

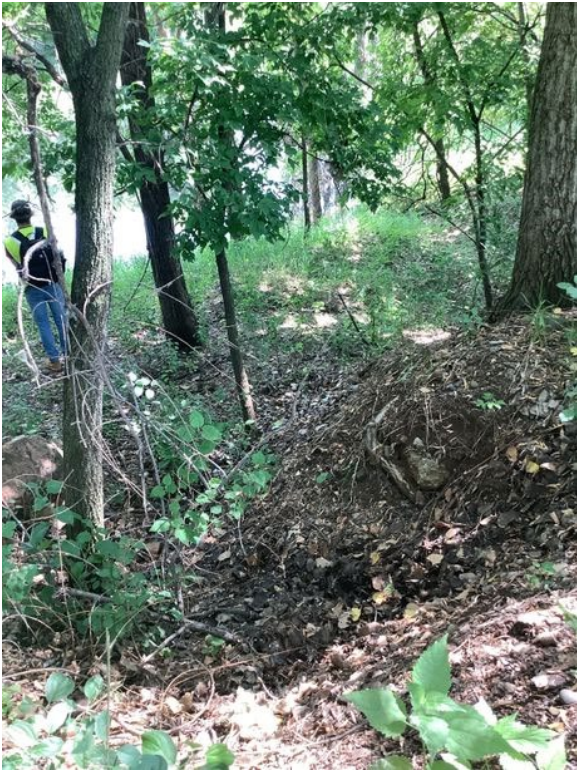
**Photo 3 Image**

Downstream view of gully. Pond can be seen in the background.

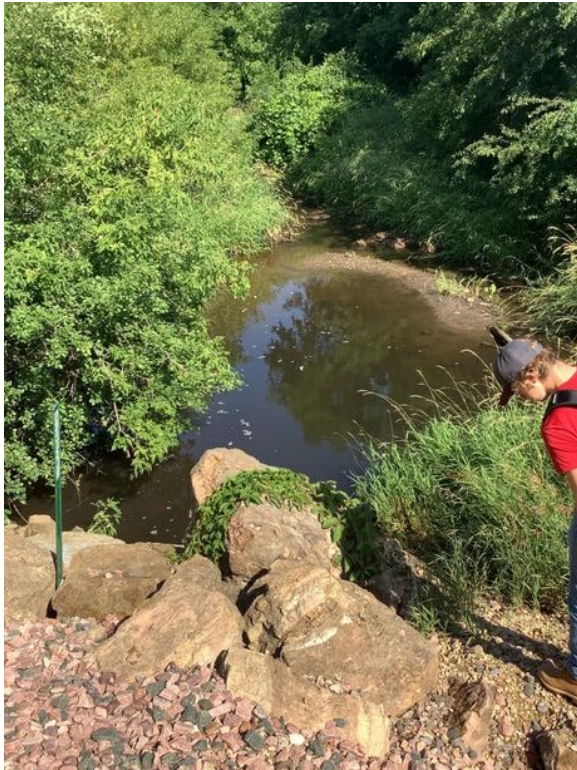
**Photo 1 Image**

Downstream view from railroad tracks of stream. Green post says this is a sewer pipeline.

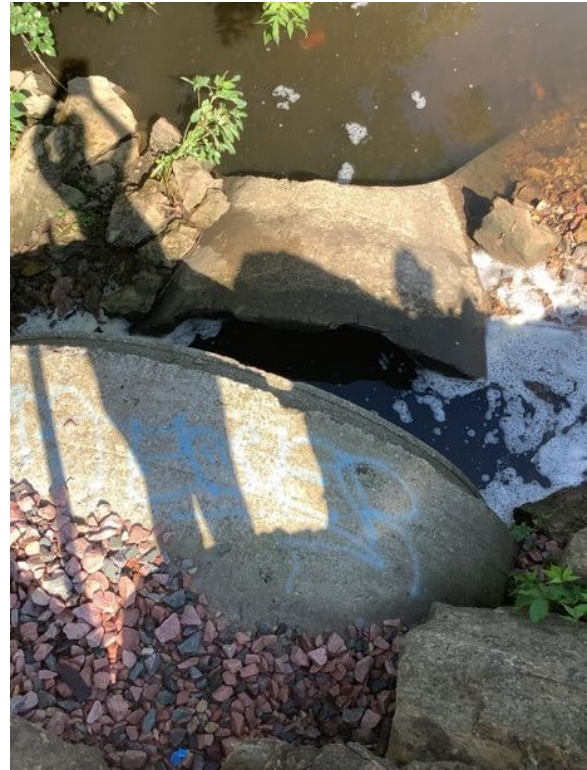
**Photo 2 Image**

Birdseye view of broken pipe which is armored, but not well.

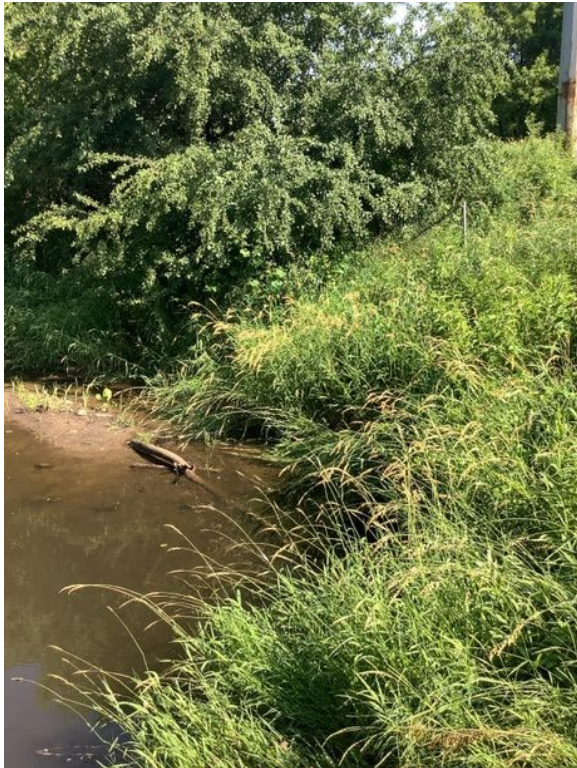
**Photo 3 Image**

Picture of heavily vegetated bank.

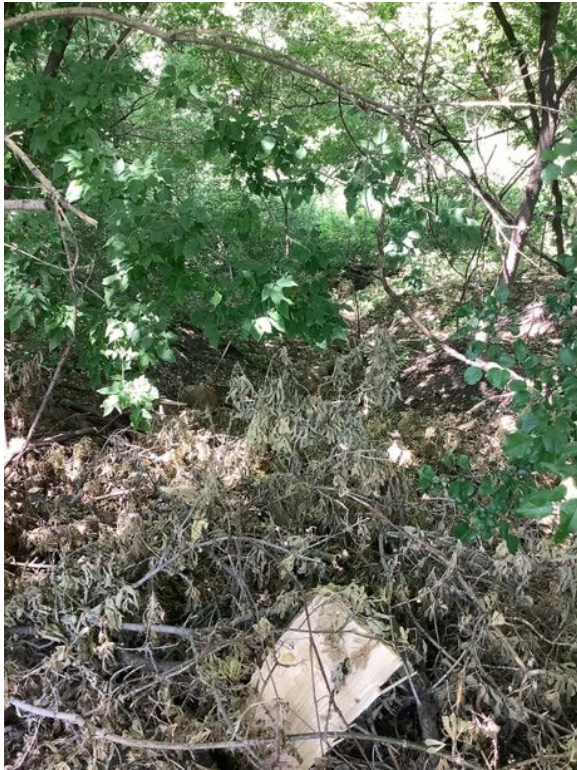
**Photo 1 Image**

Downstream view from the top of gully.

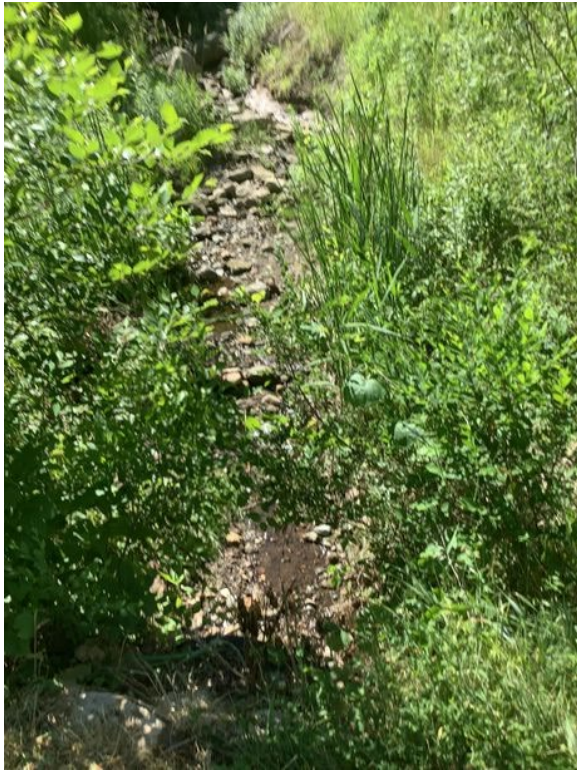
**Photo1**

**Upstream view of south side of trail. Severe degradation is visible on the left bank upstream.**

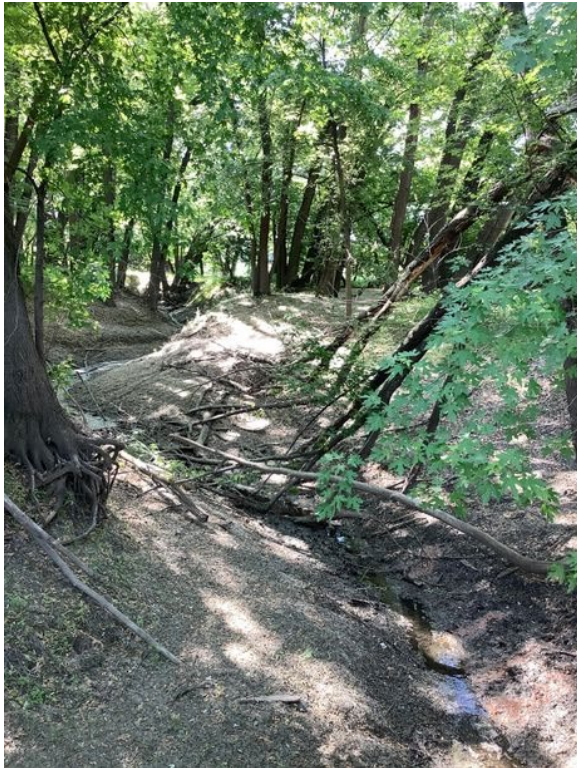
**Photo1**

View upstream from bridge above gully. Can see exposed roots from tree on right bank and some broken branches in the middle of the gully.

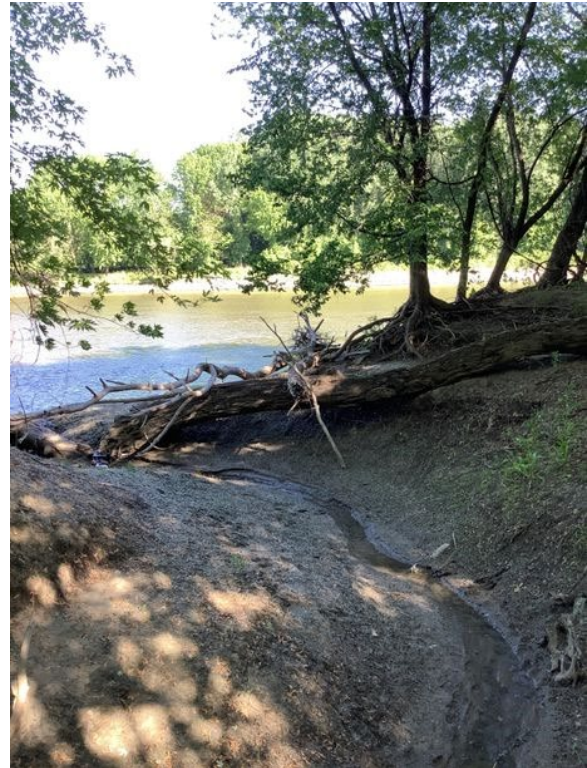
**Photo2**

View of where stream connects to the river, can see moderate degradation on the lower banks right near the stream.
