<b>Gully ID:</b> 07:12-10:13	<p style="text-align: center;"><b>MAP</b></p>  
<b>Date &amp; Time:</b> July 12, 2021 10:13 AM	
<b>Location:</b> Jackson Township	
<b>Weather:</b> Sunny  <b>Storm/Rainfall Event in the Past 24 Hours?</b> No	
<b>GULLY INFORMATION</b>	
<b>Calculated Erosion Potential:</b>	High
<b>Approximate Depth:</b>	5-Deep (>15')
<b>Approximate Bottom Width:</b>	3-Medium (1'-5')
<b>Approximate Gully Length:</b>	5-Long (>100')
<b>Condition of Gully Bottom:</b>	3-Some Vegetation
<b>Condition of Gully Banks:</b>	3-Some Vegetation
<b>Gully Bank Angles:</b>	5-Acute (<45 degrees or undercut)
<b>Gully Shape:</b>	5-V-Shaped
<b>Gully Material:</b>	Silt/Clay

<b>Gully ID:</b> 07:12-10:01	<p style="text-align: center;"><b>MAP</b></p>

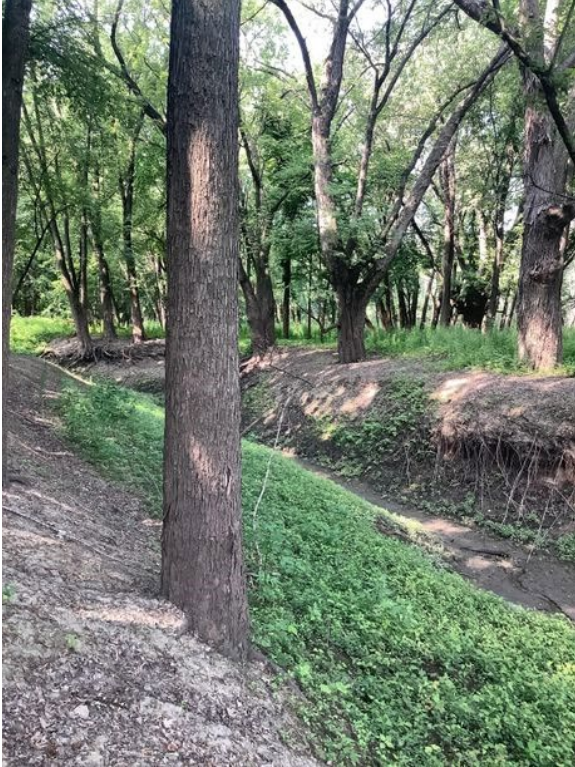
**Photo 1 Image**

Upstream view of gully from right bank.

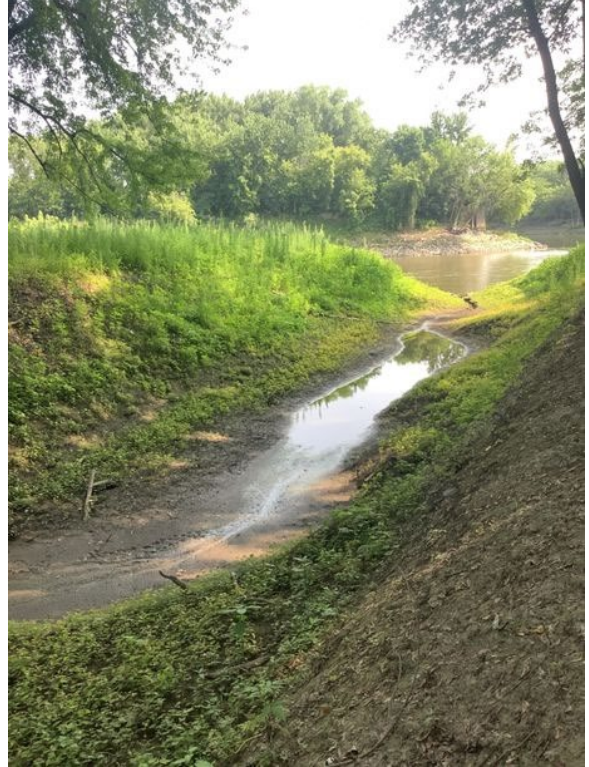
**Photo 2 Image**

Downstream view of gully where it connects to the MN River.

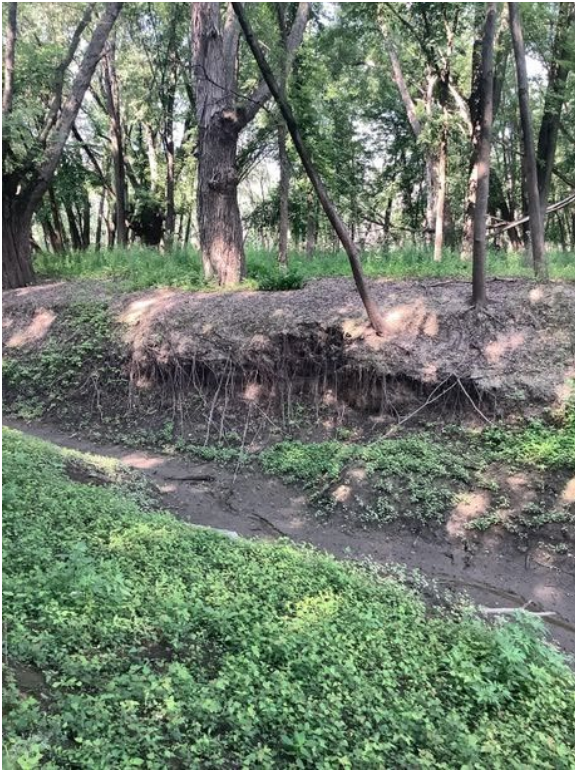
**Photo 3 Image**

View of severe degradation on left bank.

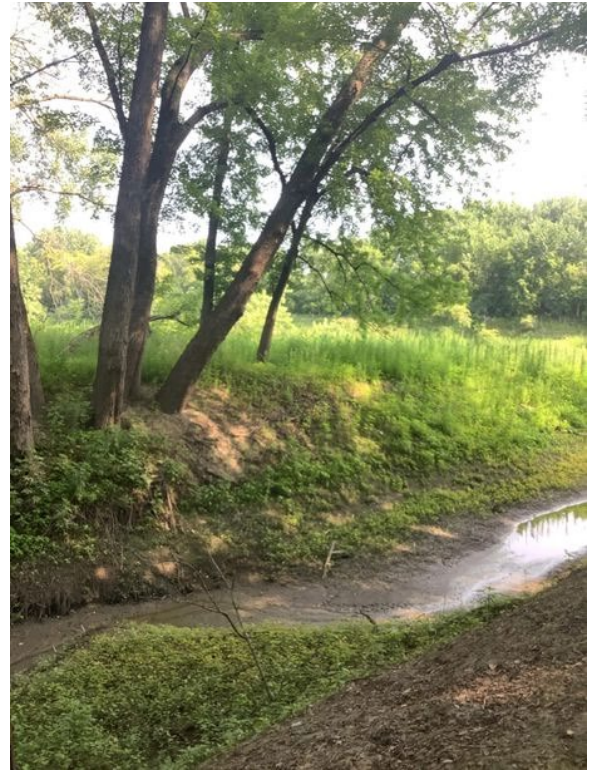
**Photo 4 Image**

View of large leaning trees on left bank.

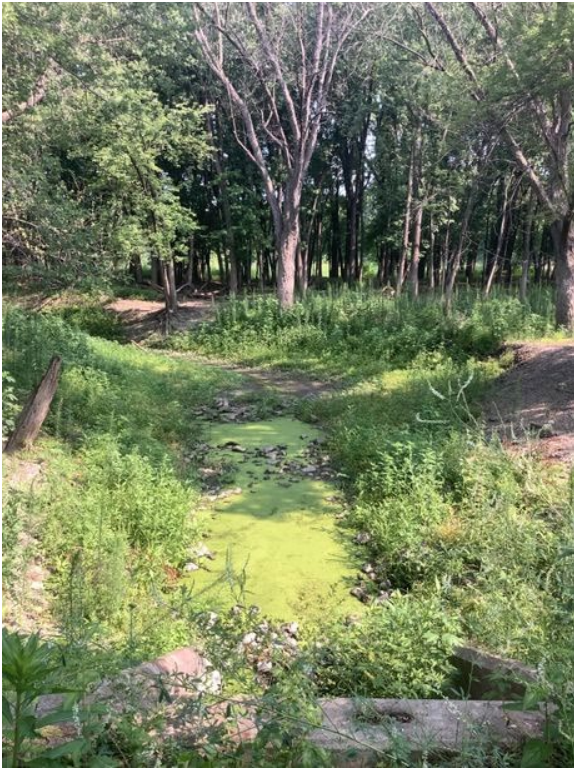
**Photo 1 Image**

Downstream view of area where tree roots have severe degradation

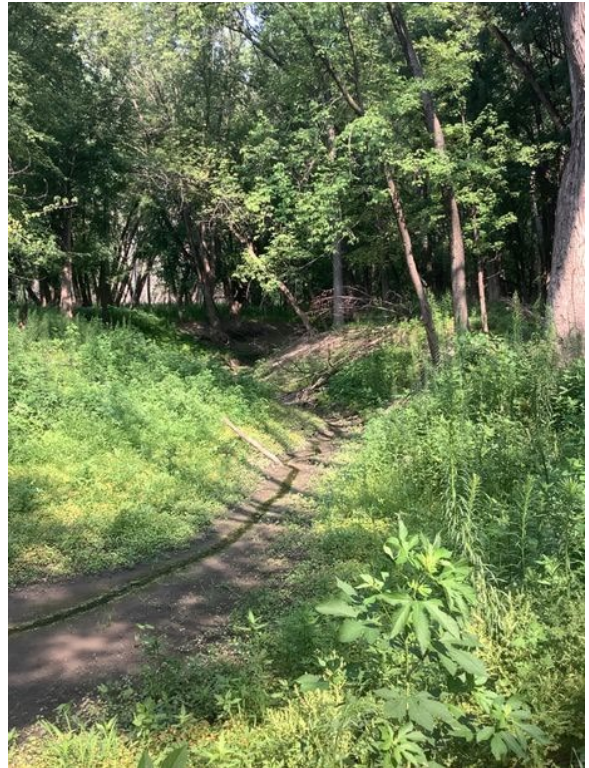
**Photo 2 Image**

Downstream view of right bank which is bare in a large area and has degradation.

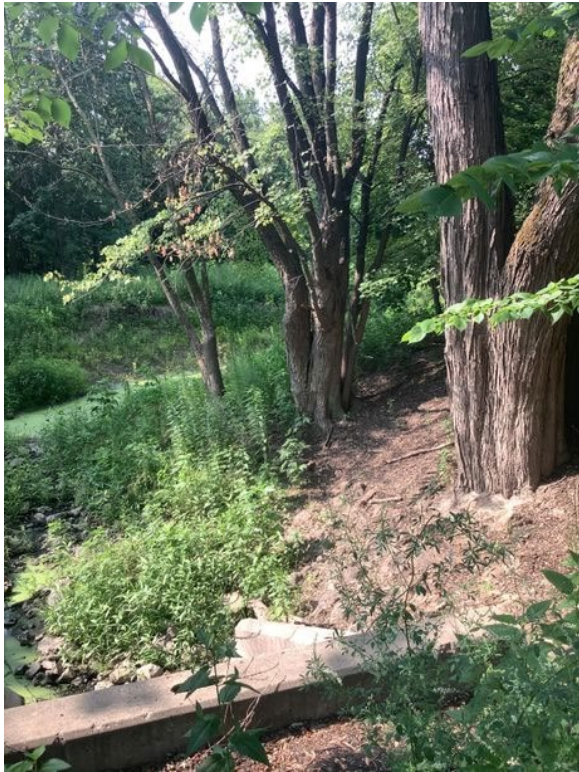
**Photo 3 Image**

Upstream view of left bank with a tree beginning to lean over channel.

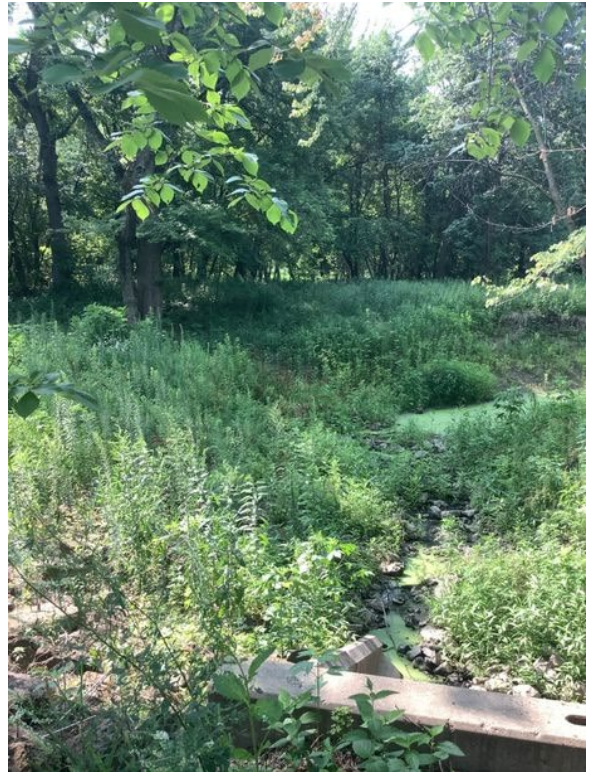
**Photo 4 Image**

Upstream view of heavily vegetated right bank.

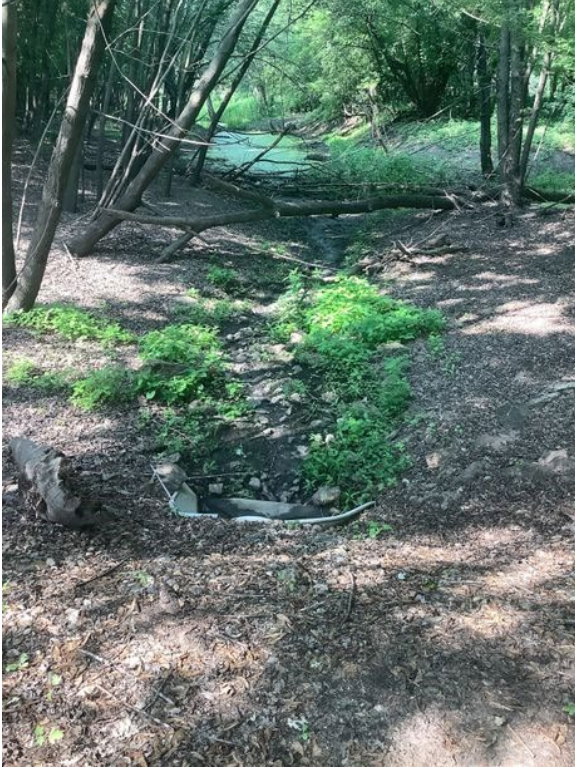
**Photo 1 Image**

Upstream view of gully, you can see where it connects to the wider gully upstream.

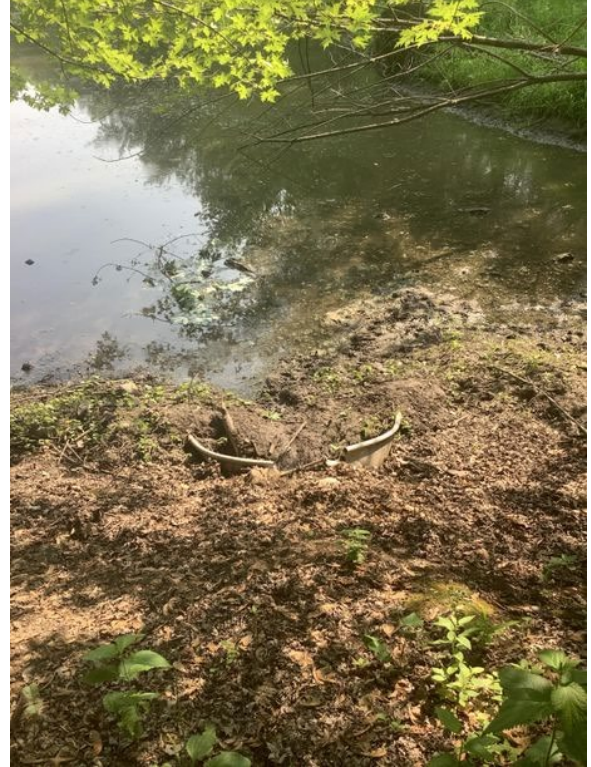
**Photo 2 Image**

Downstream view of the other side of pipe which appears to be covered in dirt.

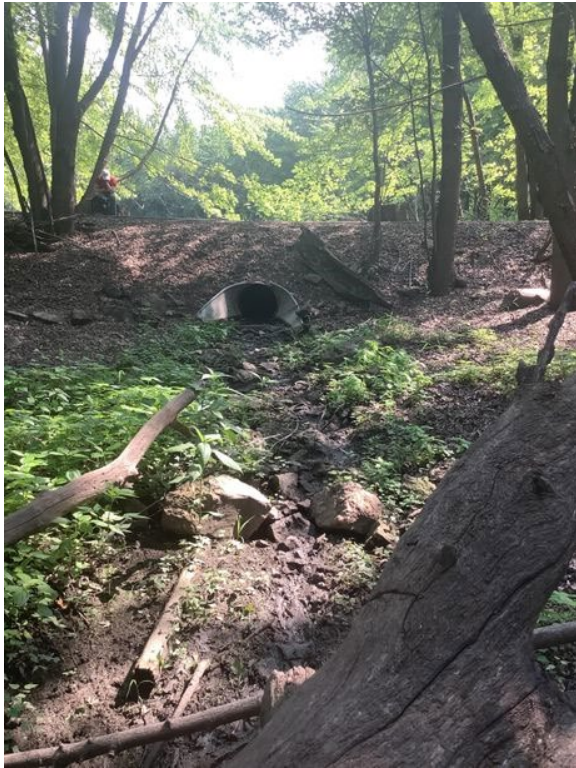
**Photo 3 Image**

Downstream view of pipe from where this small gully begins downstream of the wider gully.

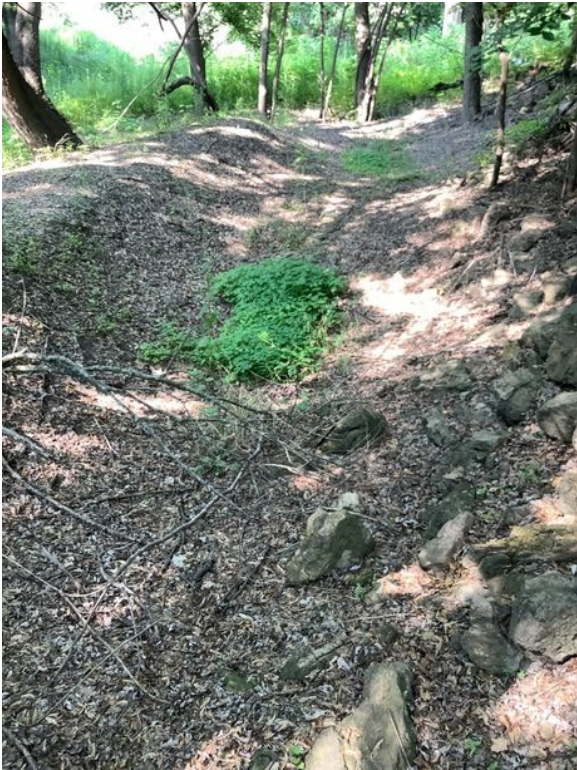
**Photo 3 Image**

Middle and fallen branches

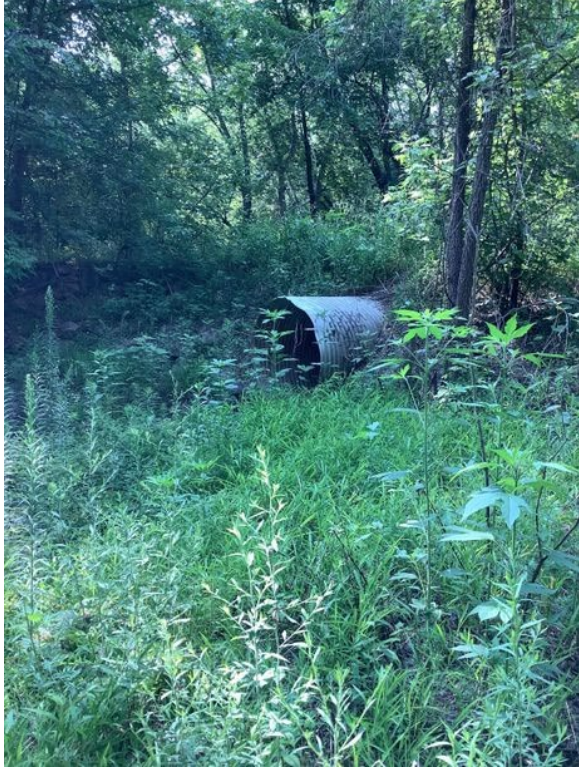
**Photo 1 Image**

Pipe outfall

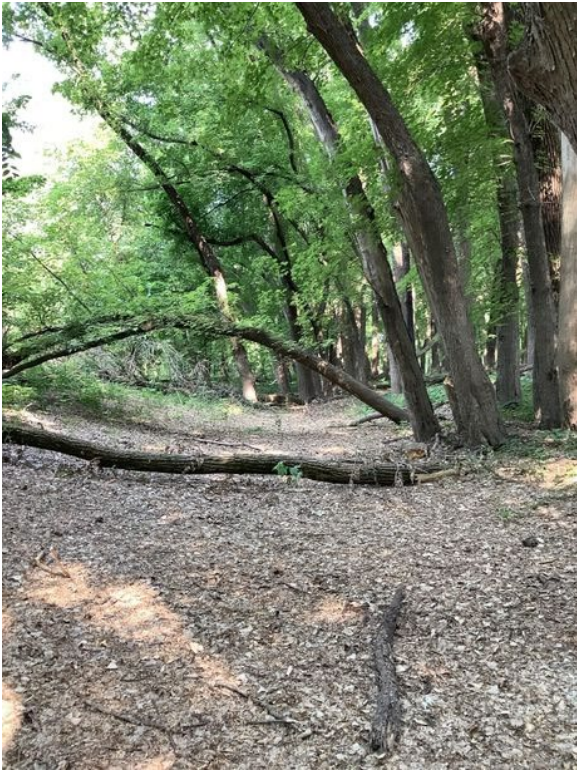
**Photo 3 Image**

Fallen and slumping trees

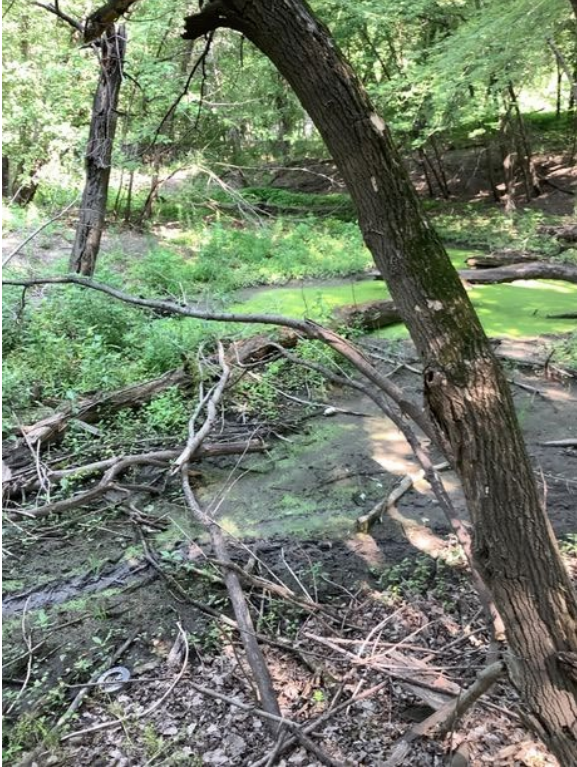
**Photo 3 Image**

Where it meets previous site
