Gully ID: 06:14-11:46	<p style="text-align: center;">MAP</p>

Date & Time: June 14, 2021 11:46	
Location: Mendota Heights	
Weather: Sunny Storm/Rainfall Event in the Past 24 Hours? No	
GULLY INFORMATION	
Calculated Erosion Potential:	High (x - 49)
Approximate Depth:	1-Shallow (<3')
Approximate Bottom Width:	5-Narrow/V-Ditch
Approximate Gully Length:	Medium: 50'-100'
Condition of Gully Bottom:	5-Bare Soil
Condition of Gully Banks:	5-Bare Soil
Gully Bank Angles:	5-Acute (< 90 degrees or undercut)
Gully Shape:	5-V-Shaped
Gully Material:	Silt and/or Clay

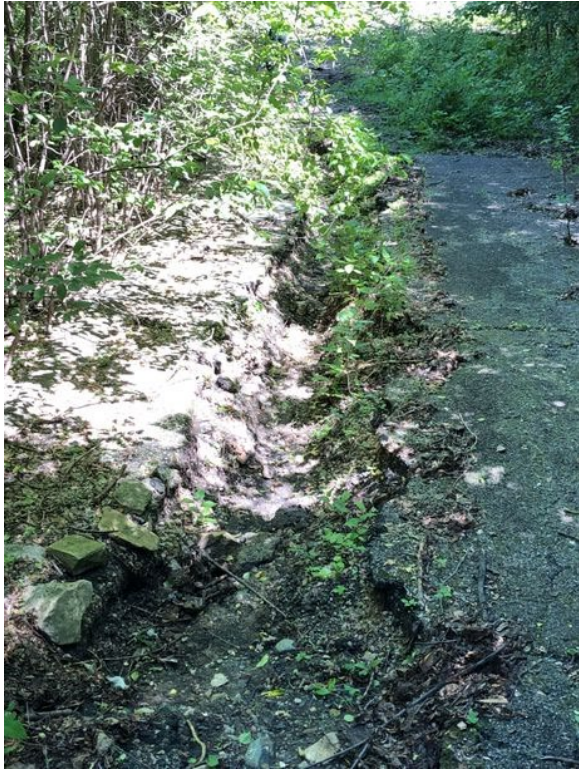
Photo1

Seep:	No	
Stormwater Inputs:	0-Not present	
Fallen Trees:	No	
Degradation:	5-Severe	
Aggradation:	3-Moderate	
Slumping:	1-Low	
Additional Notes:	<p>Classification? High (x - 49)</p> <p>Notes/Comments: Thin gully that looks like it eroded away some of the paved trail. V shaped, with a decently steep channel, high degradation on banks</p>

Downstream view of gully.

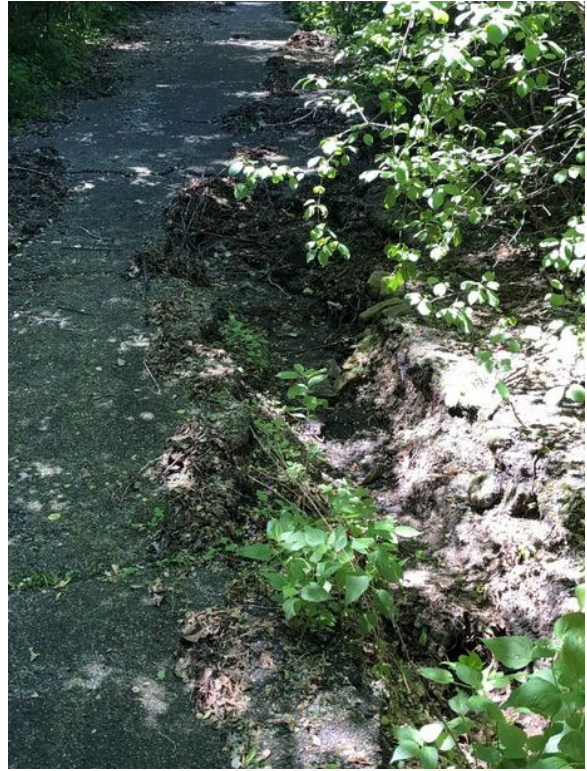
Photo2

Upstream view of gully.

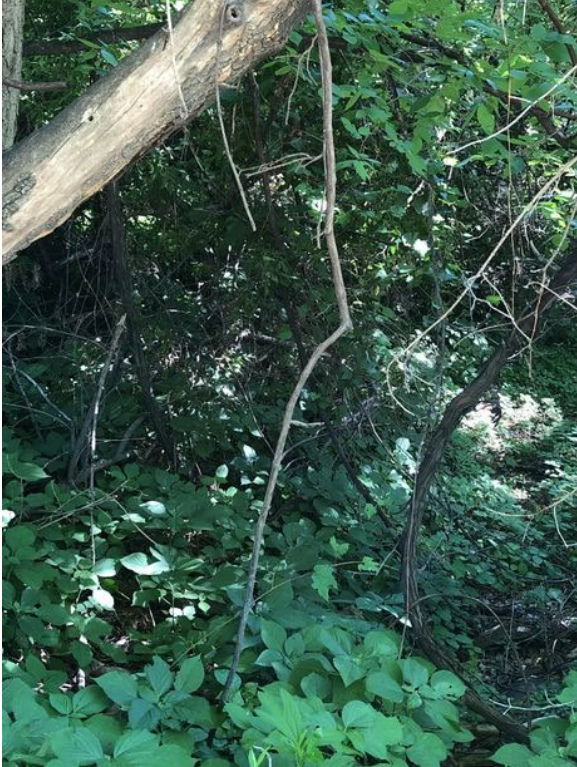
Photo1

Seep:	No	
Stormwater Inputs:	0-Not present	
Fallen Trees:	No	
Degradation:		1-Low
Aggradation:		1-Low
Slumping:		1-Low
Additional Notes:	Classification? Moderate (x - x) Notes/Comments: Gully goes under trail to other side, moderate vegetation on banks and bottom, not much slumping. Some tree branches in bottom, but not any fallen trees

Upstream view of right bank.

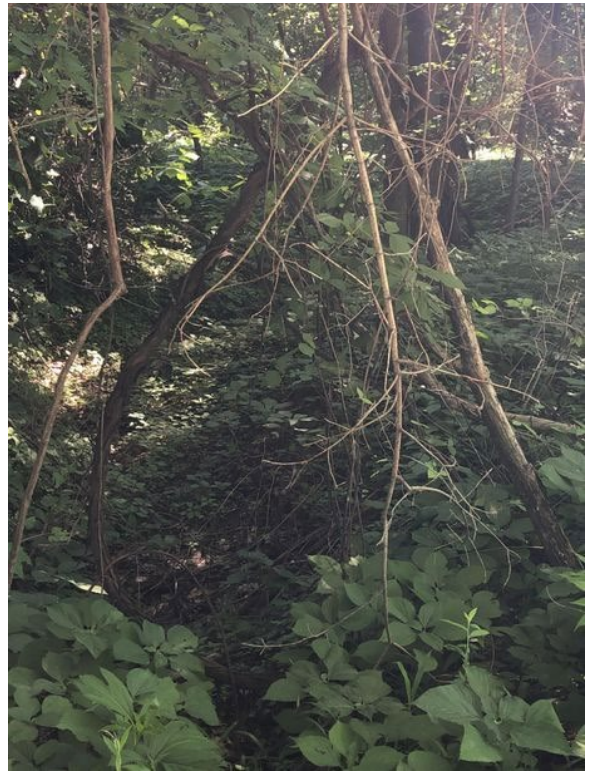
Photo2

Upstream view of left bank.

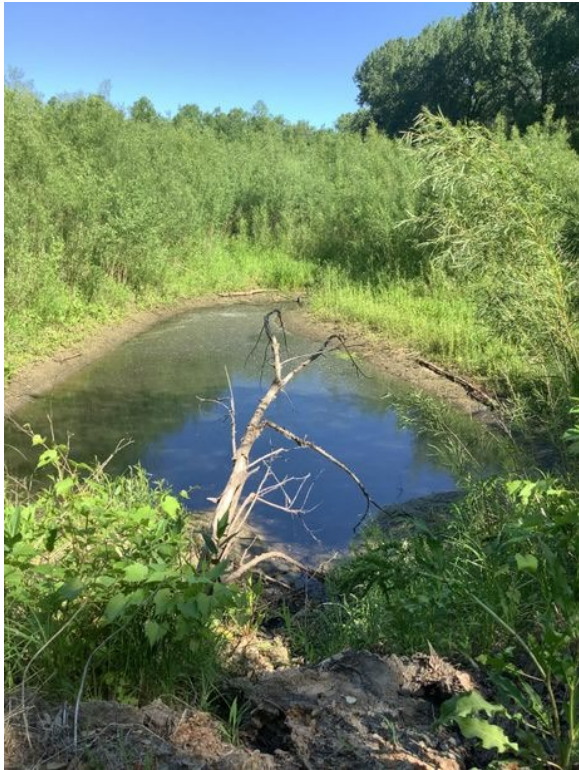
Photo1

Seep:	Yes	
Stormwater Inputs:	0-Not present	
Fallen Trees:	No	
Degradation:		1-Low
Aggradation:		0-No aggradation
Slumping:		1-Low
Additional Notes:	Classification? Low (4 - x) Notes/Comments: Tiny gully leading into pond off of road on Picnic Island. Lots of vegetation on banks and no pipe found as source so we're assuming there is some seepage from the river.

Downstream view from road.

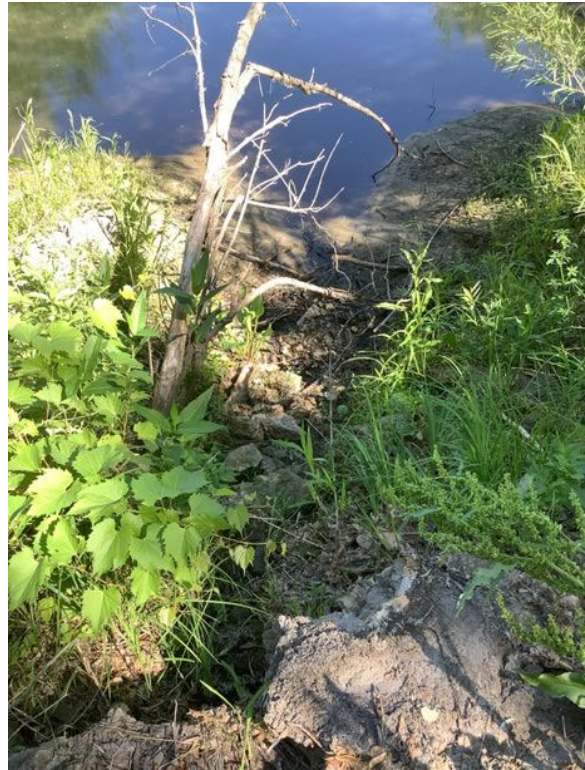
Photo2

Downstream view of erosion and beginning part of the gully.

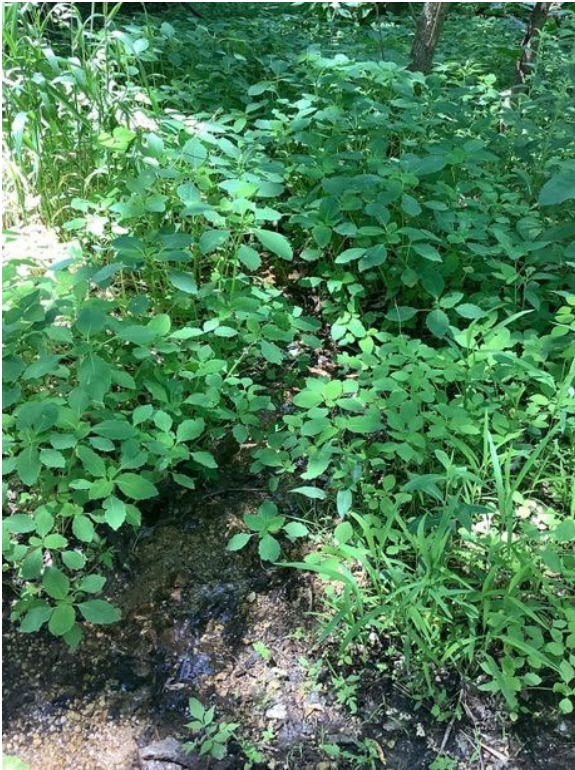
Photo1

Seep:	No	
Stormwater Inputs:	2-Low flow	
Fallen Trees:	No	
Degradation:	3-Moderate	
Aggradation:	1-Low	
Slumping:	0-No slumping	
Additional Notes:	Classification? Moderate (x - x) Notes/Comments: Used to be a pipe here, eroded away the trail, flow of constant water, pebbles and rocks at bottom of gully

Full gully

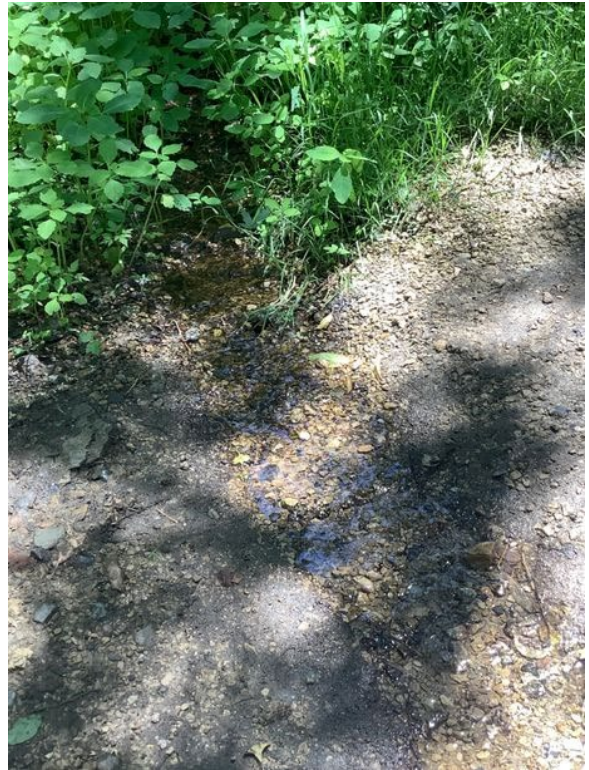
Photo2

Upstream and where it eroded trail

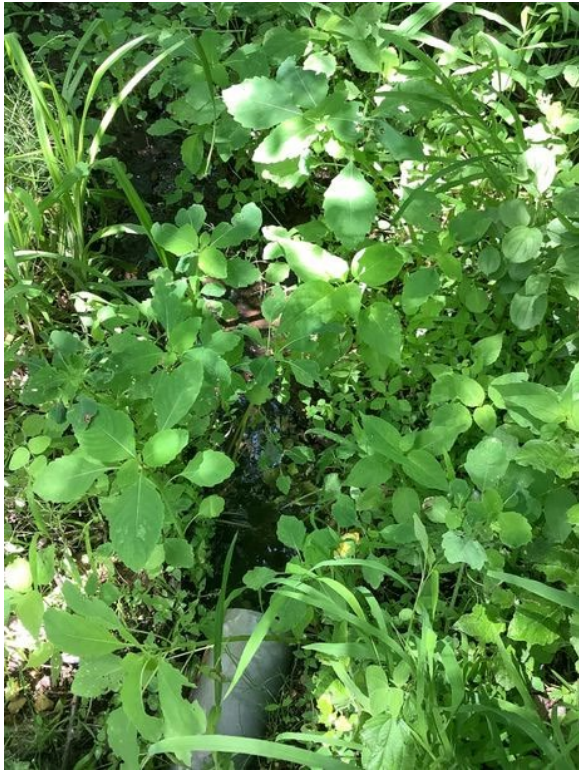
Photo1

Seep:	No	
Stormwater Inputs:	1-Dripping	
Fallen Trees:	No	
Degradation:		3-Moderate
Aggradation:		1-Low
Slumping:		1-Low
Additional Notes:	Classification? Moderate (x - x) Notes/Comments: Pipe going under trail, difficult to see downstream. Not much water flowing through pipe, some rocks on upstream side

Pipe outfall

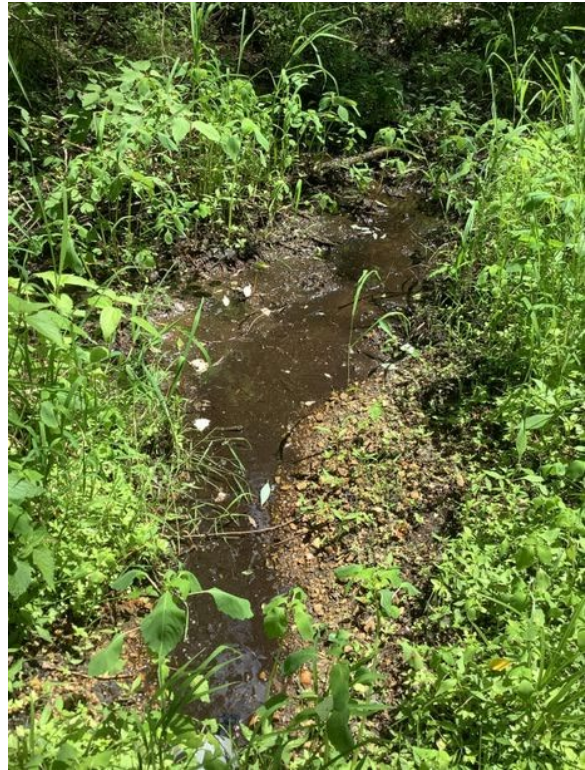
Photo2

Upstream pipe

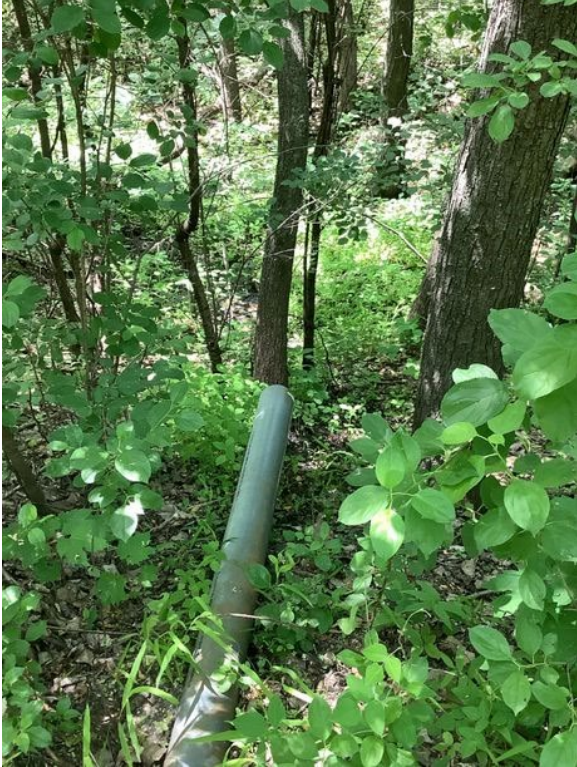
Photo1

Seep:	No	
Stormwater Inputs:	3-Constant high flow	
Fallen Trees:	No	
Degradation:		3-Moderate
Aggradation:		1-Low
Slumping:		0-No slumping
Additional Notes:	Classification? Moderate (x - x) Notes/Comments: Gully has not fully formed, but high constant flow of water coming out of a hanging pipe.

Hanging pipe

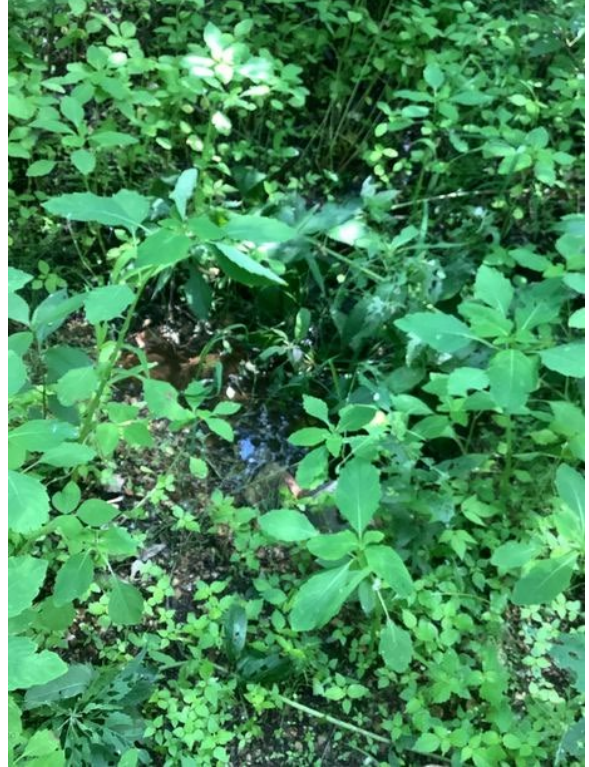
Photo2

Where water is coming from

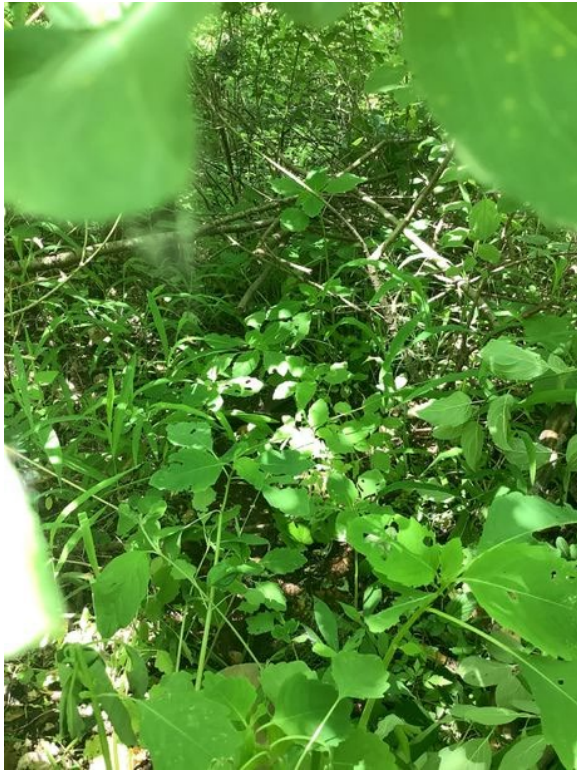
Photo1

Seep:	No	
Stormwater Inputs:	2-Low flow	
Fallen Trees:	No	
Degradation:	3-Moderate	
Aggradation:	0-No aggradation	
Slumping:	1-Low	
Additional Notes:	<p>Classification? Moderate (x - x)</p> <p>Notes/Comments: Pipe running underneath trail behind D St in fort snelling st park. Moderately vegetated but signs of moderate degradation as there is a constant slow moving flow through the pipe.</p>

Downstream view from top of pipe

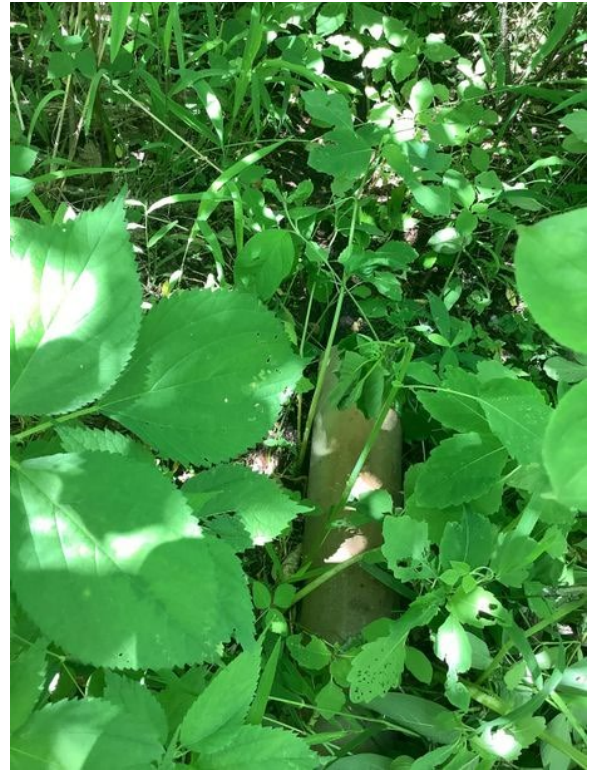
Photo2

Downstream view of exposed pipe.

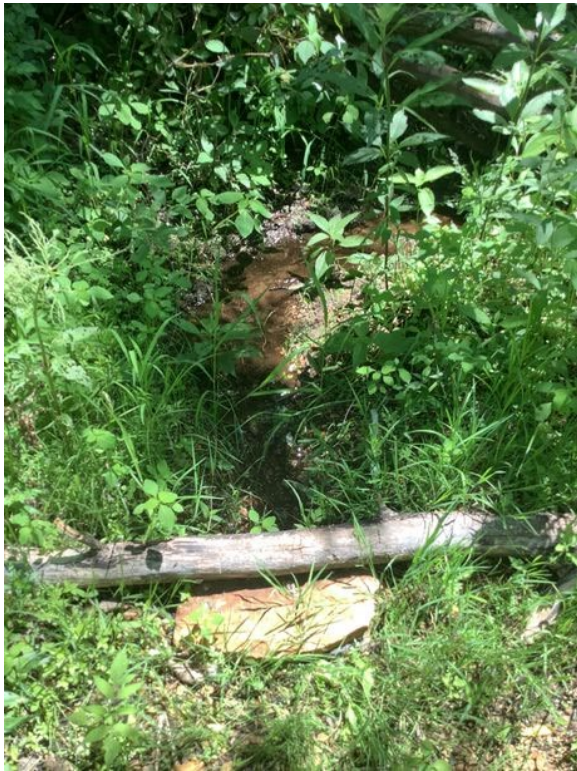
Photo3

Upstream view on other side of trail.

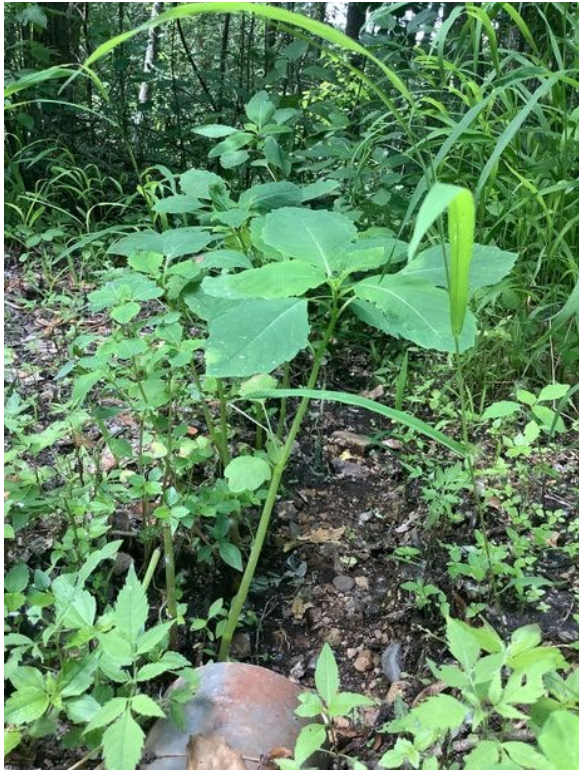
Photo1

Seep:	No	
Stormwater Inputs:	0-Not present	
Fallen Trees:	No	
Degradation:		1-Low
Aggradation:		0-No aggradation
Slumping:		1-Low
Additional Notes:	Classification? Moderate (x - x) Notes/Comments: Gully caused by pipe running under trail in fort snelling state park. No water present in the pipe at the time.

Downstream view from above pipe

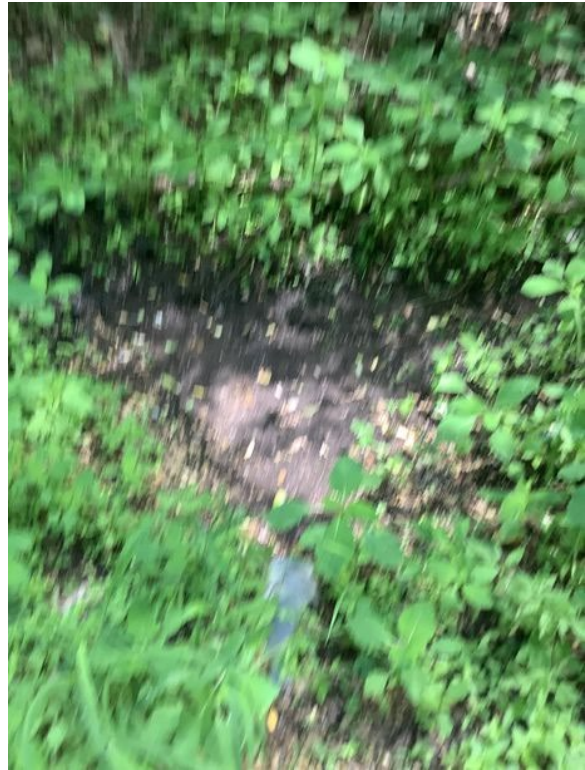
Photo2

Upstream view of pipe on other side of the trail.

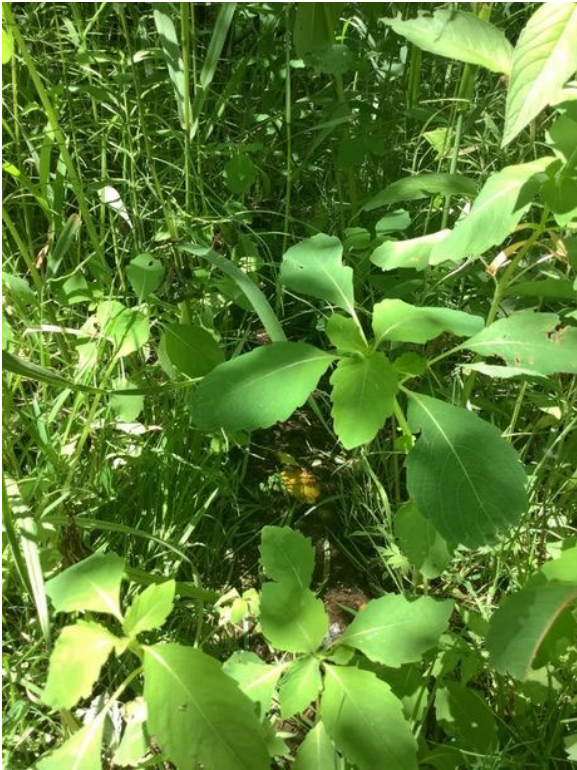
Photo1

Seep:	No	
Stormwater Inputs:	2-Low flow	
Fallen Trees:	No	
Degradation:	5-Severe	
Aggradation:	0-No aggradation	
Slumping:	0-No slumping	
Additional Notes:	<p>Classification? Moderate (x - x)</p> <p>Notes/Comments: Gully caused by pipe that has dislodged and been removed from under the trail to drain water. Water now runs directly through trail and is causing erosion. The pipe is laying next to the right bank of the gully. ses</p>

Downstream view from trail.

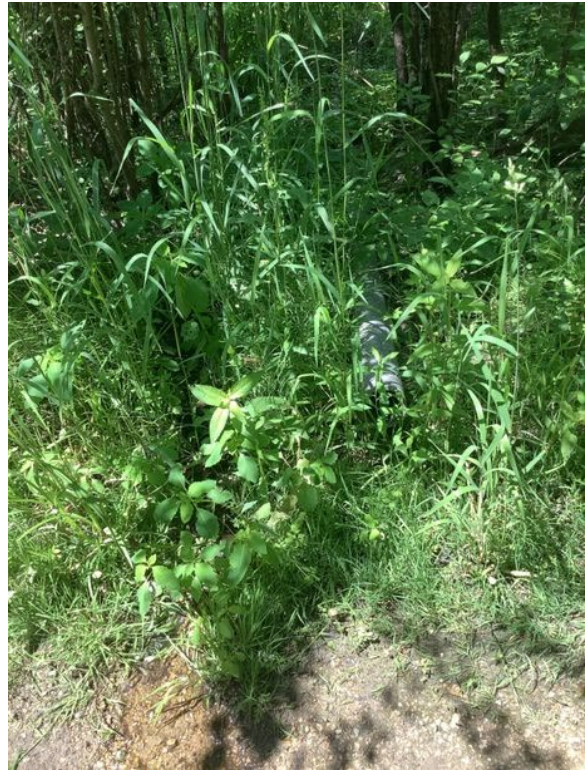
Photo2

Downstream view of dislodged pipe laying to the right bank of the gully.

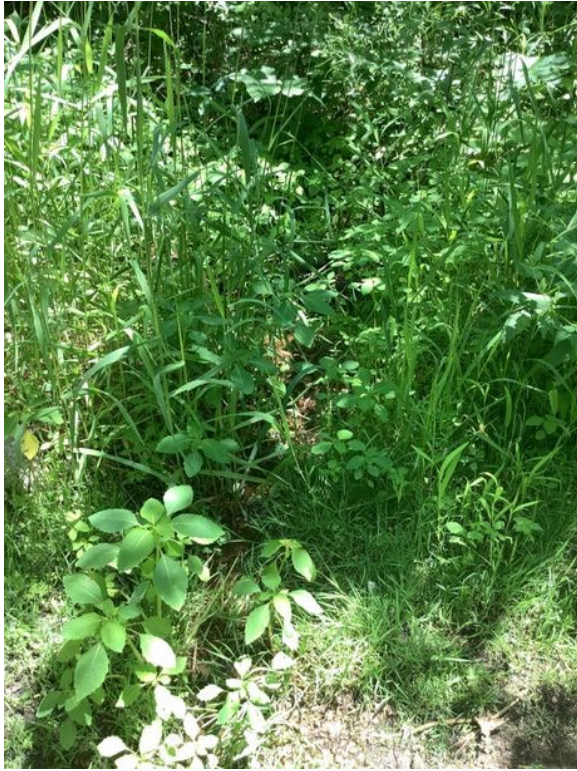
Photo3

Upstream view of gully on other side of trail.

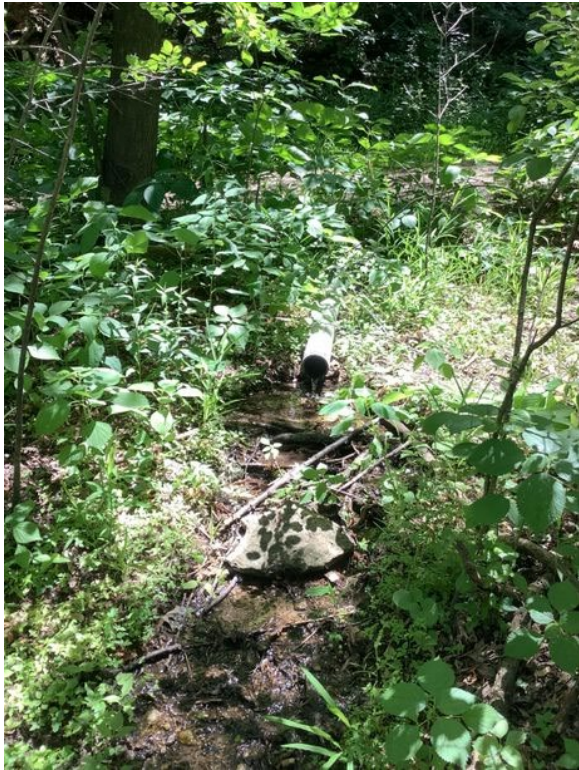
Photo1

Seep:	No	
Stormwater Inputs:	2-Low flow	
Fallen Trees:	No	
Degradation:	3-Moderate	
Aggradation:	1-Low	
Slumping:	1-Low	
Additional Notes:	<p>Classification? Moderate (x - x)</p> <p>Notes/Comments: Hanging pipe outfall releasing constant flow of water into gully. Very shallow, decently long with twists and turns. Pipe looks to be starting to expose itself on trail</p>

Upstream view of pipe and gully.

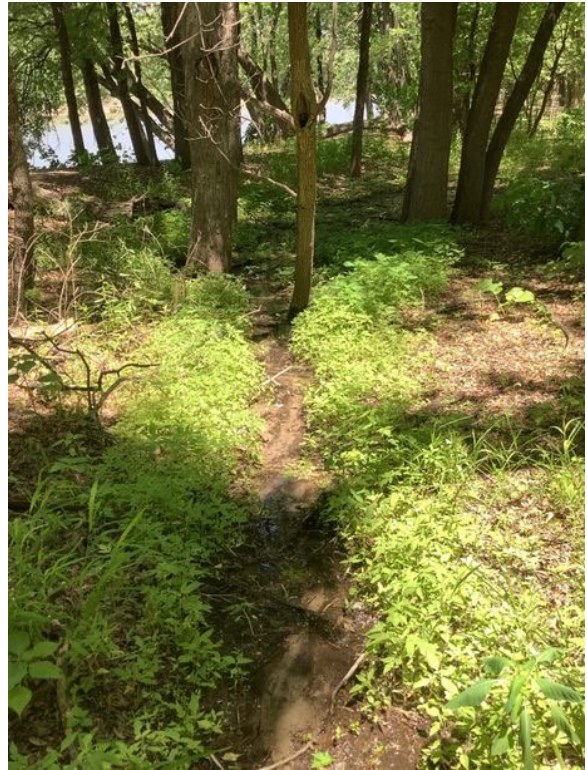
Photo2

Downstream view of full gully.

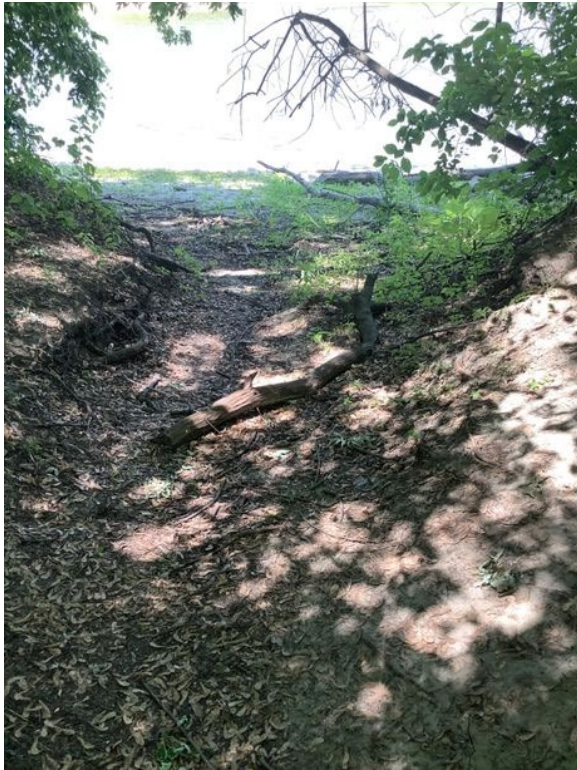
Photo1

Seep:	No	
Stormwater Inputs:	0-Not present	
Fallen Trees:	No	
Degradation:		5-Severe
Aggradation:		0-No aggradation
Slumping:		1-Low
Additional Notes:	<p>Classification? Moderate (x - x)</p> <p>Notes/Comments: Small gully in the south bank of the MN river which has very little vegetation. It doesn't appear that there is an outfall source although there is an old rusty and tangled pipe about 15 feet upstream of it that could have been a previous source.</p>

Downstream view from top of gully.

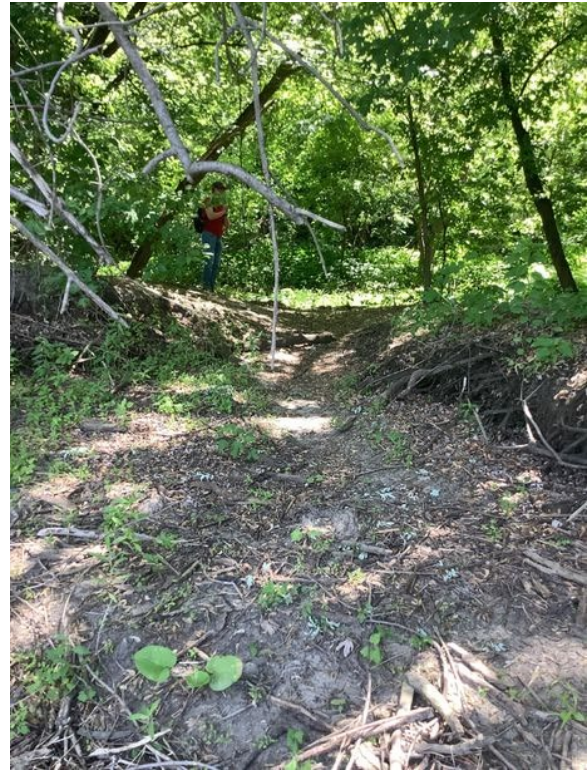
Photo2

Upstream view from the low part of the mn river bank.

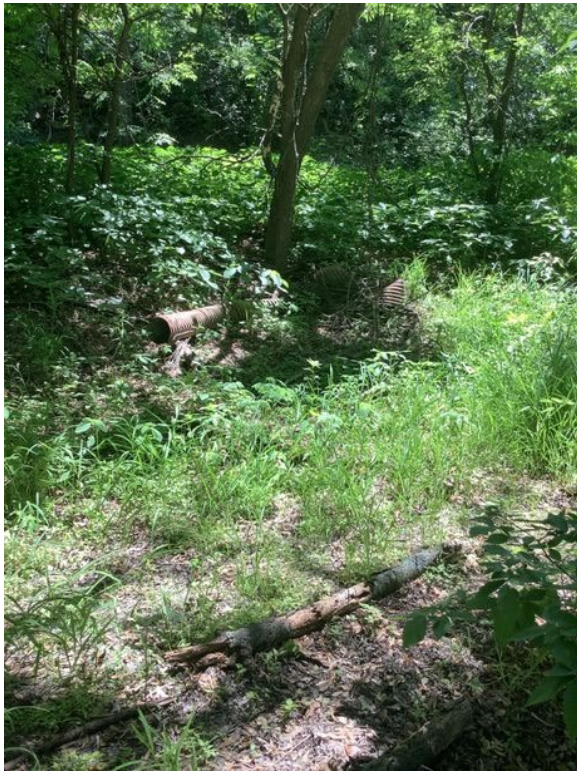
Photo3

View of old pipe.

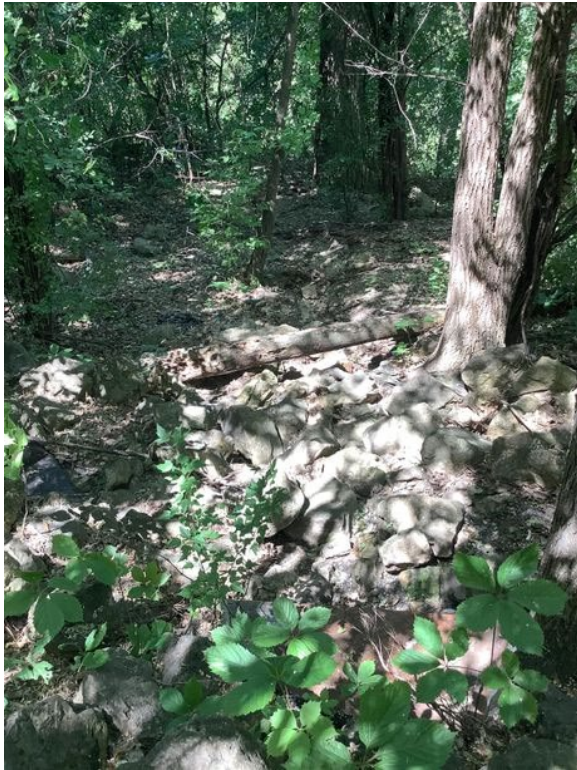
Photo1

Seep:	No
Stormwater Inputs:	1-Dripping
Fallen Trees:	No
Degradation:	3-Moderate
Aggradation:	0-No aggradation
Slumping:	1-Low
Additional Notes:	<p>Classification? Moderate (x - x)</p> <p>Notes/Comments: Gully with two pipe outfalls off trail behind church. Pipes are armored but very little vegetation in the gully. no water was present at the time.</p>

Downstream view from above the pipe on the right side. The second pipe outfall is to the left.

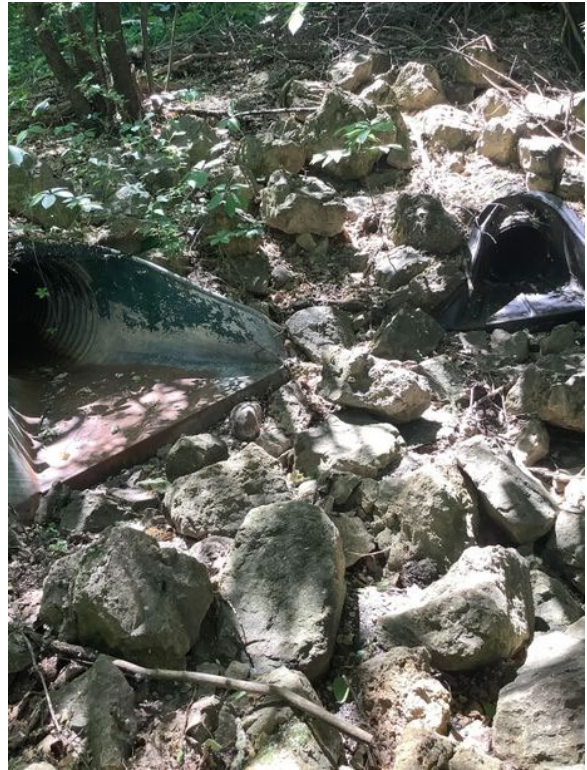
Photo2

Upstream view of pipes.

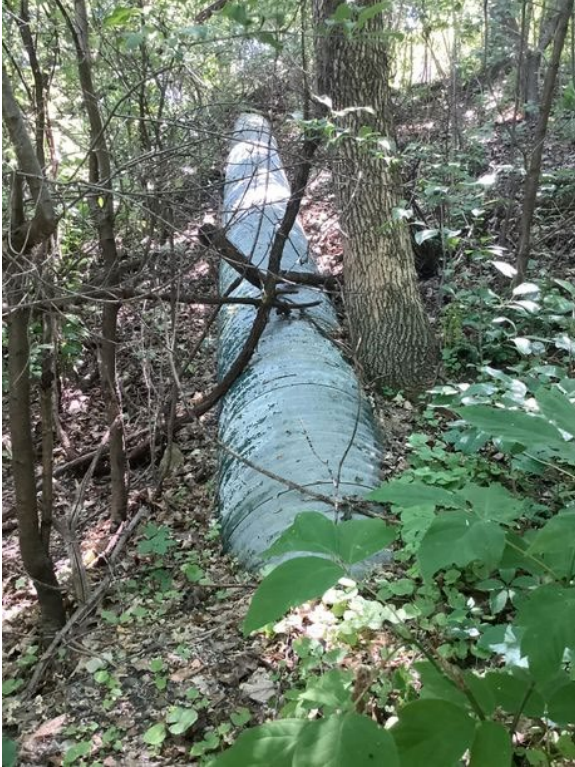
Photo3

Upstream view of exposed pipe on other side of the trail coming down the hill. Area around the pipe is severely eroded. We believe this pipe is connected to the right pipe outfall downstream.

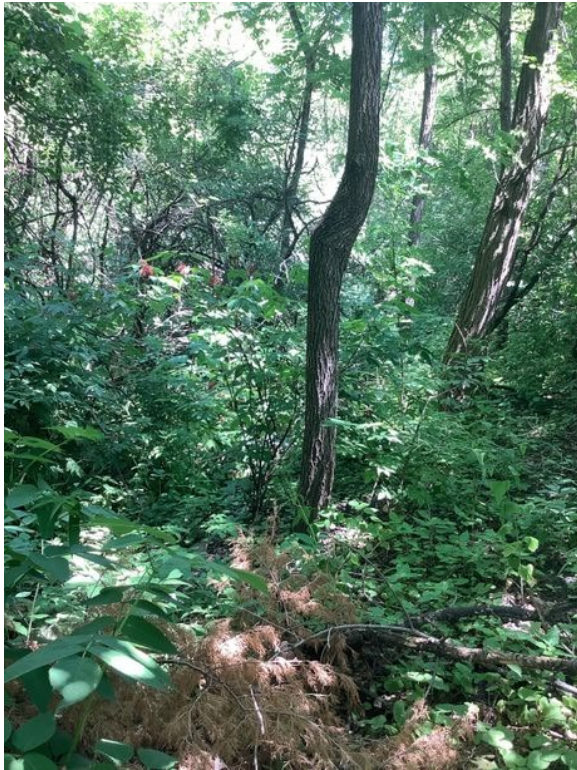
Photo1

Seep:	No
Stormwater Inputs:	0-Not present
Fallen Trees:	Yes
Degradation:	1-Low
Aggradation:	0-No aggradation
Slumping:	3-Moderate
Additional Notes:	<p>Classification? Moderate (x - x)</p> <p>Notes/Comments: Gully accessed off parking lot right off sublet memorial highway. Very heavily vegetated area with no water or potential source we could see.</p>

Downstream view right bank. Pistol shaped tree on right side in the back.

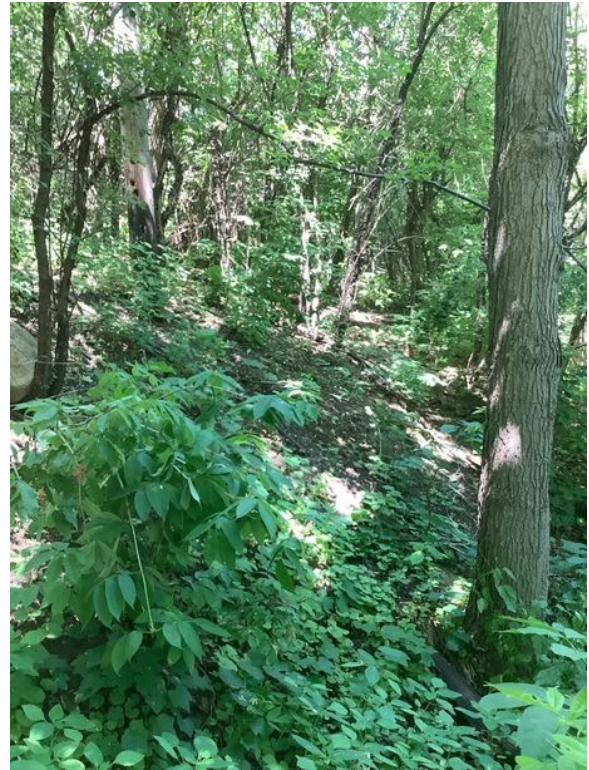
Photo2

Downstream view left bank.

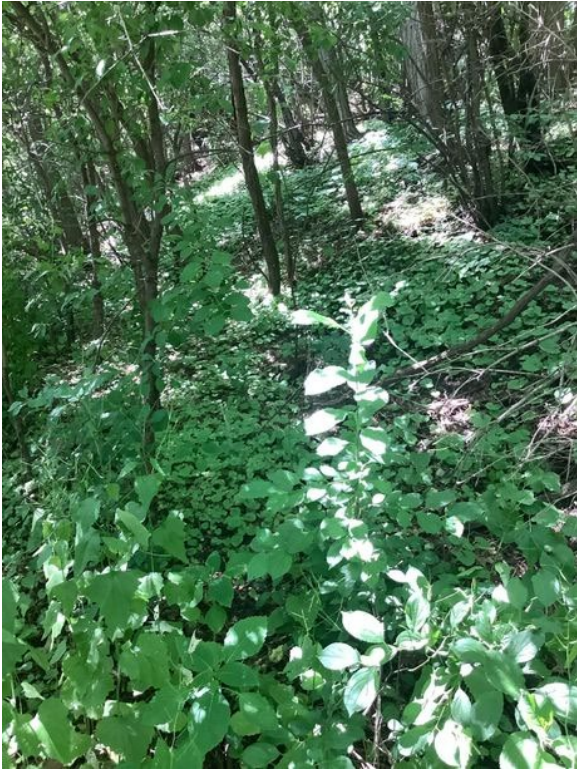
Photo3

Upstream view of beginning of gully.

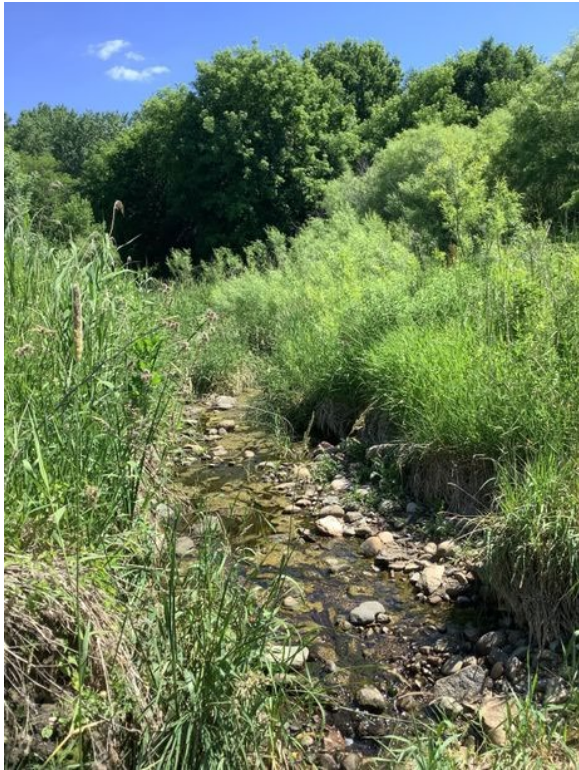
Photo1

Seep:	No	
Stormwater Inputs:	0-Not present	
Fallen Trees:	No	
Degradation:	5-Severe	
Aggradation:	3-Moderate	
Slumping:	1-Low	
Additional Notes:	Classification? Moderate (x - x) Notes/Comments: Long gully with water flowing constantly through it. Grass roots hanging, heavier degradation downstream

Upstream view of full gully.

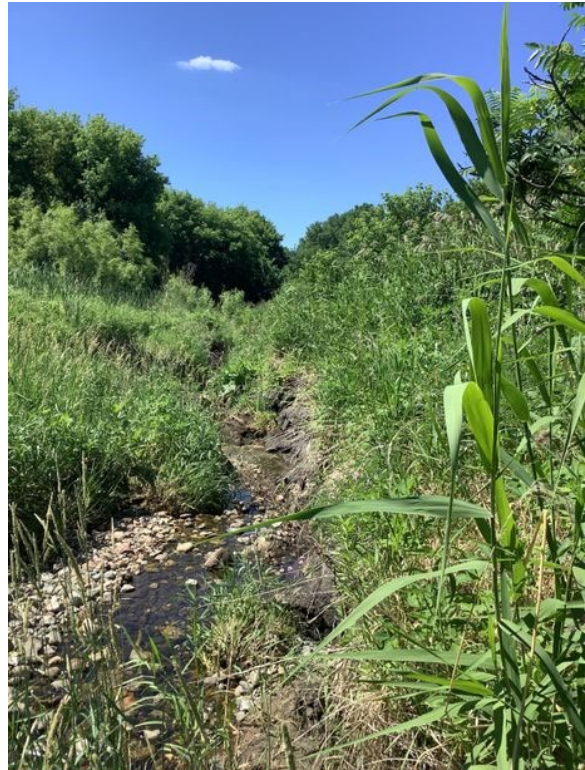
Photo2

Downstream view of full gully.

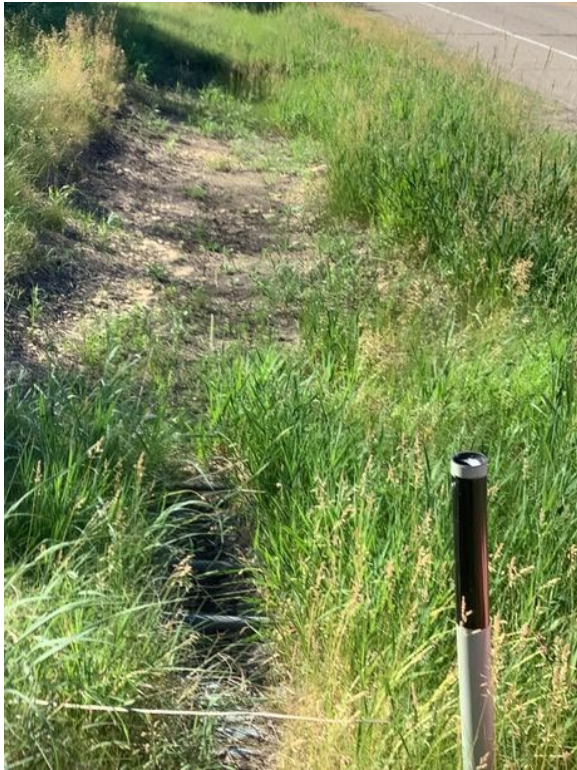
Photo1

Seep:	No	
Stormwater Inputs:	0-Not present	
Fallen Trees:	No	
Degradation:	1-Low	
Aggradation:	1-Low	
Slumping:	0-No slumping	
Additional Notes:	Classification? Low (4 - x) Notes/Comments: No vegetation on bottom, lots on banks, pipe at top of gully, minor degradation

Downstream view of full gully.

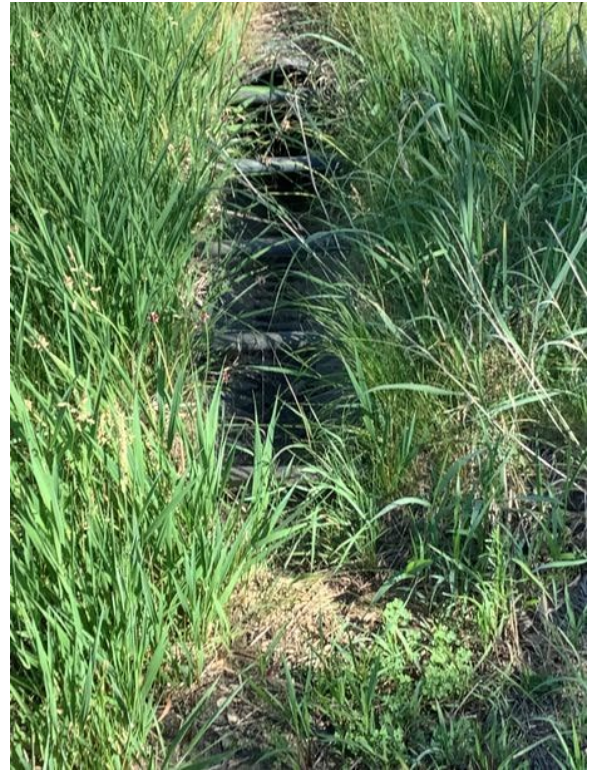
Photo2

Upstream view of pipe.

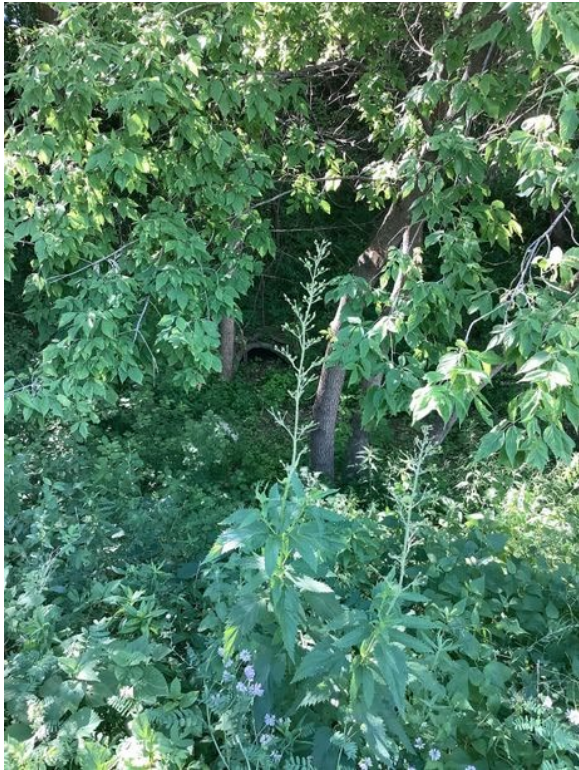
Photo1

Seep:	No	
Stormwater Inputs:	1-Dripping	
Fallen Trees:	No	
Degradation:		1-Low
Aggradation:		0-No aggradation
Slumping:		1-Low
Additional Notes:	Classification? Low (4 - x) Notes/Comments: Gully off Big River regional trail. Gully has pipe outfall that appears to have no water flow present and it looks like the pipe is being filled with sediment.

Upstream view of gully.

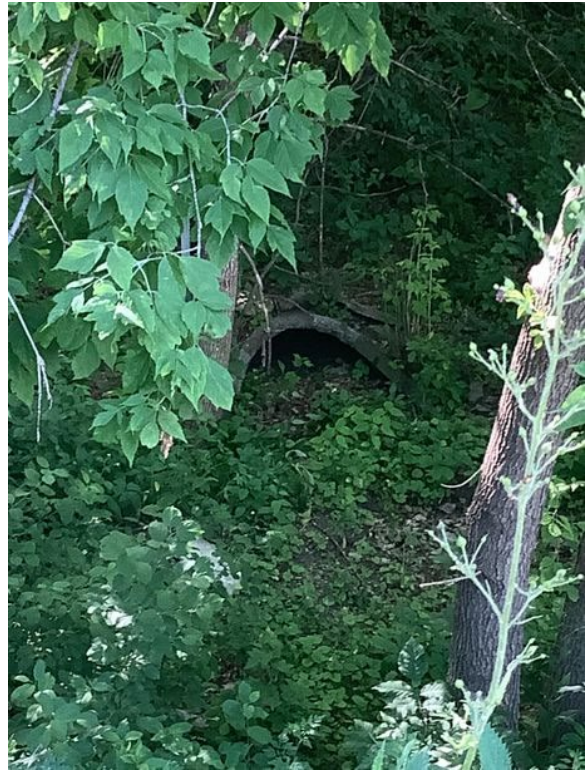
Photo2

Zoomed in upstream view of pipe filling with sediment.

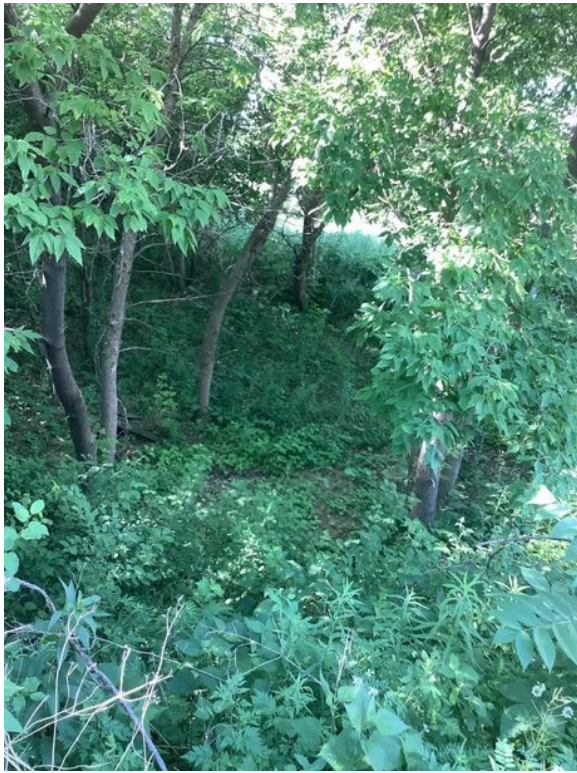
Photo3

Side stream view from right bank area off of trail.

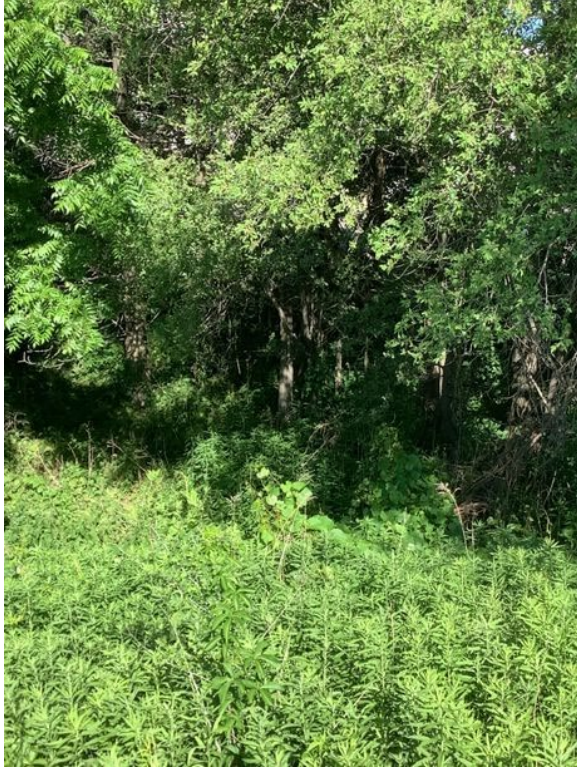
Photo1

Seep:	No	
Stormwater Inputs:	0-Not present	
Fallen Trees:	No	
Degradation:	0-No degradation	
Aggradation:	0-No aggradation	
Slumping:	0-No slumping	
Additional Notes:	Classification? Low (4 - x) Notes/Comments: Lots of vegetation, no slumping, not many signs of degradation

Downstream view of right bank.

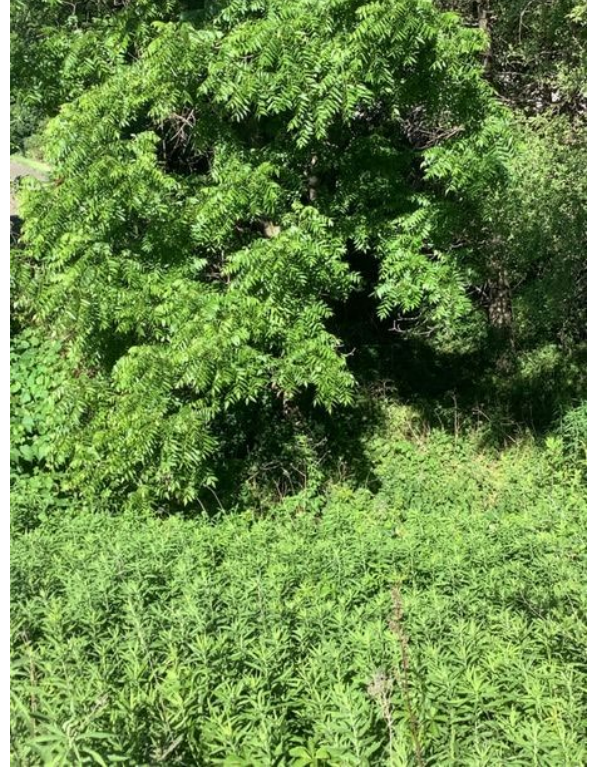
Photo2

Downstream view of left bank.
