Gully ID: 07:19-11:55	MAP

Date & Time: July 19, 2021 11:55 AM	
Location: Savage	
Weather: Sunny Storm/Rainfall Event in the Past 24 Hours? No	
GULLY INFORMATION	
Calculated Erosion Potential:	High
Approximate Depth:	5-Deep (>15')
Approximate Bottom Width:	5-Narrow/V-Ditch
Approximate Gully Length:	5-Long (>100')
Condition of Gully Bottom:	5-Bare Soil
Condition of Gully Banks:	3-Some Vegetation
Gully Bank Angles:	5-Acute (<45 degrees or undercut)
Gully Shape:	5-V-Shaped
Gully Material:	Silt/Clay

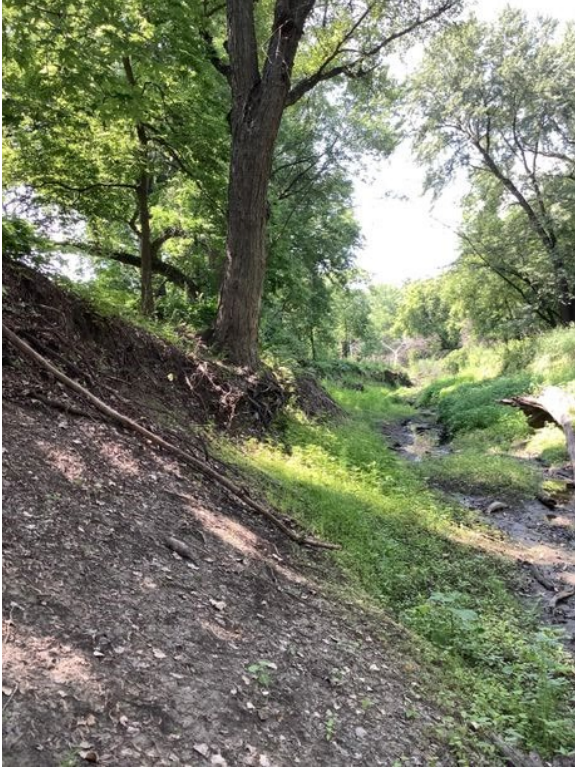
Photo 1 Image

Right bank

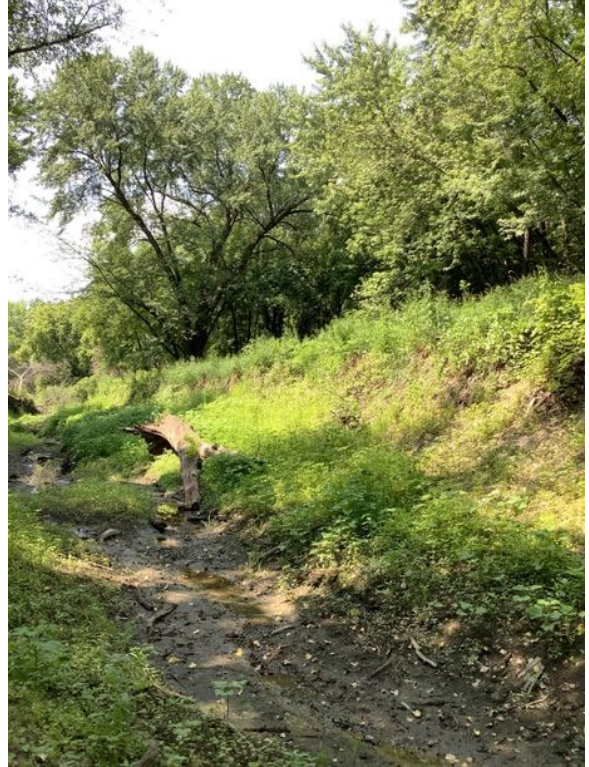
Photo 2 Image

Left bank

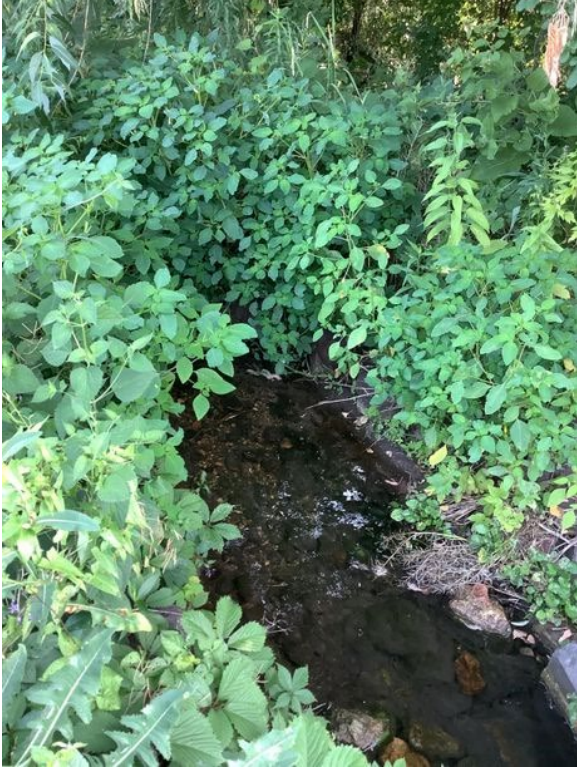
Photo 1 Image

Gully

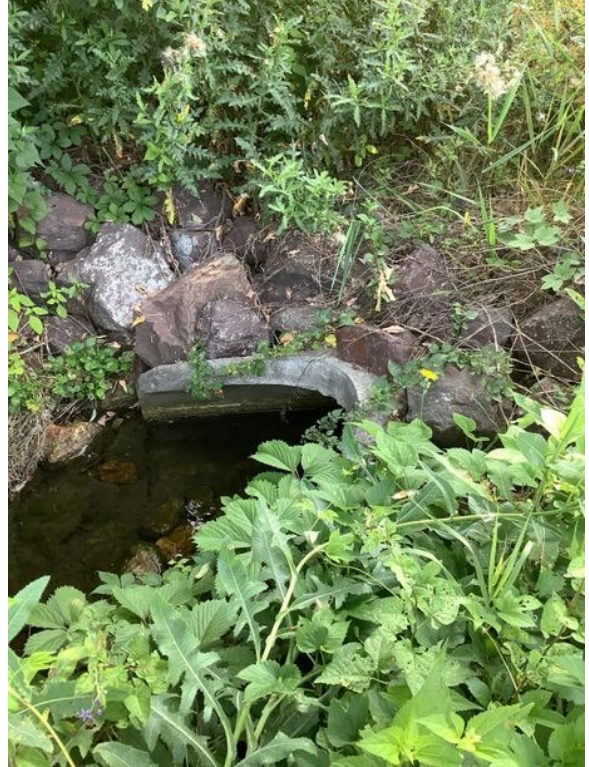
Photo 2 Image

Pipe

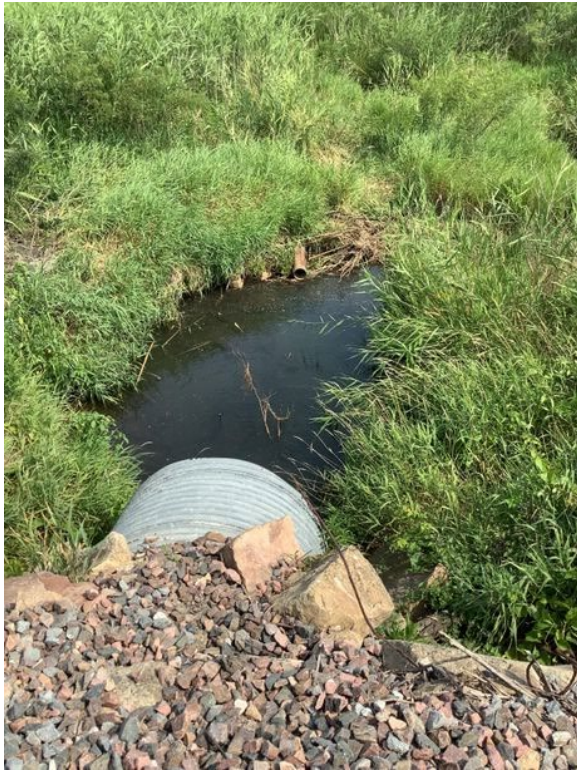
Photo 1 Image

Pipe and bottom

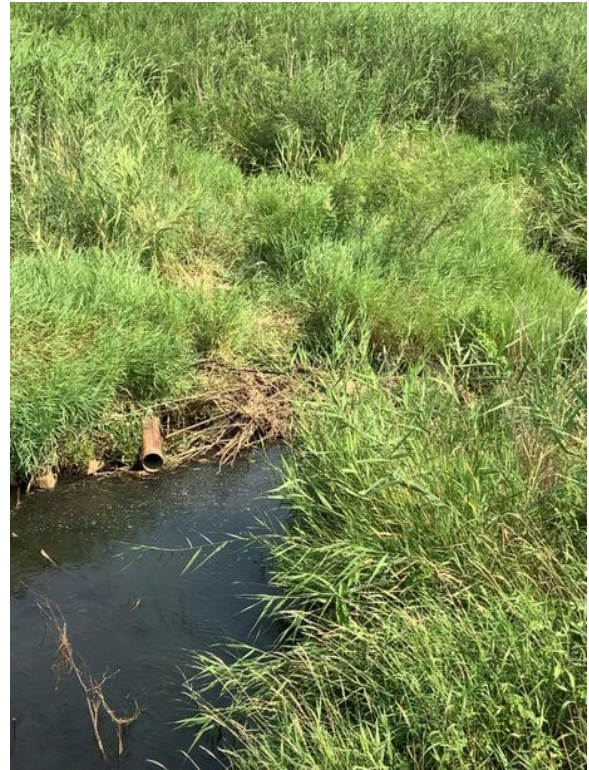
Photo 2 Image

Other pipe

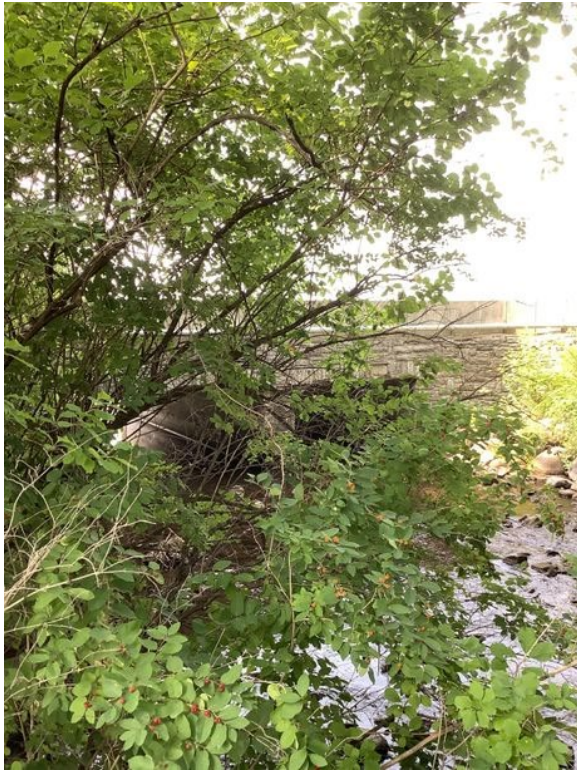
Photo 1 Image

Pipes

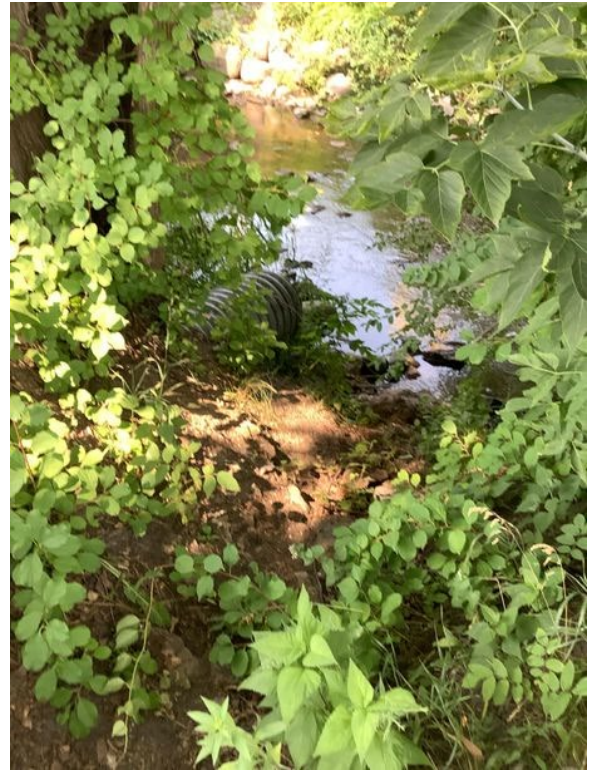
Photo 2 Image

Pipe

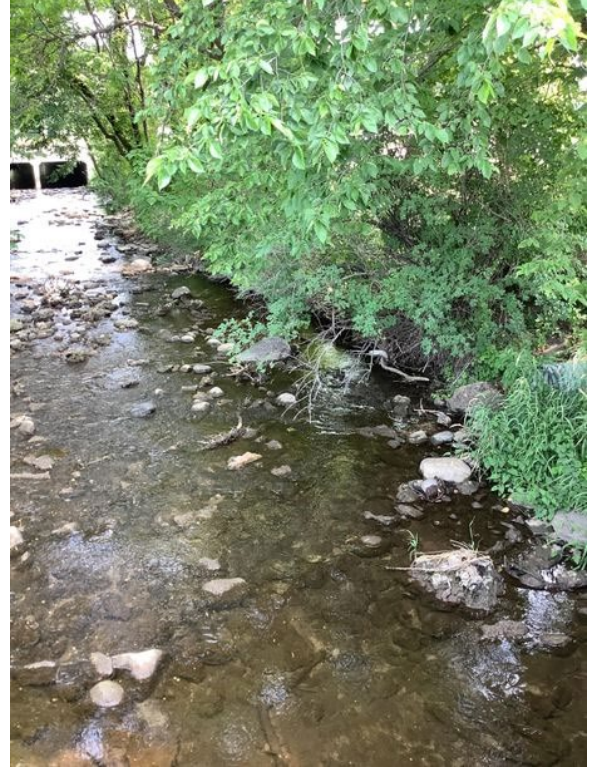
Photo 4 Image

Right bank

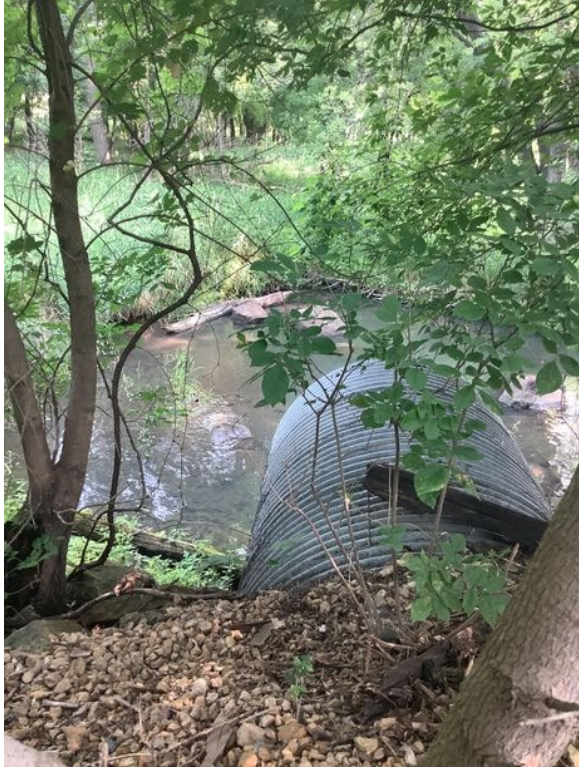
Photo 1 Image

Downstream view of pipe, gully cuts to the right after this area.

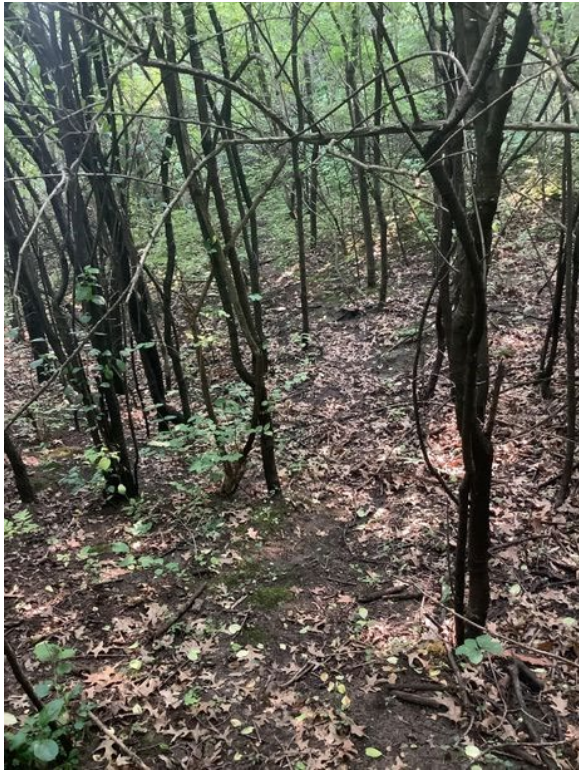
Photo 1 Image

Downstream view of gully.

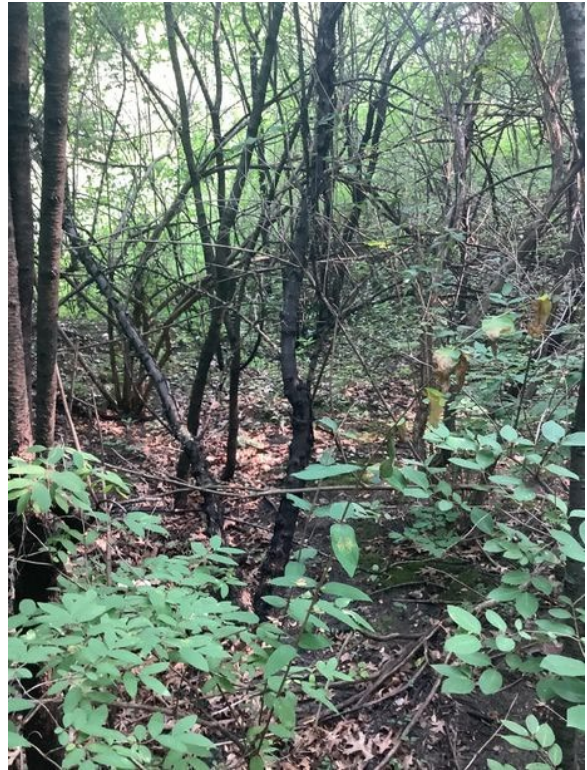
Photo 2 Image

Continuation of downstream where gully flows into grassy area of eagle creek.

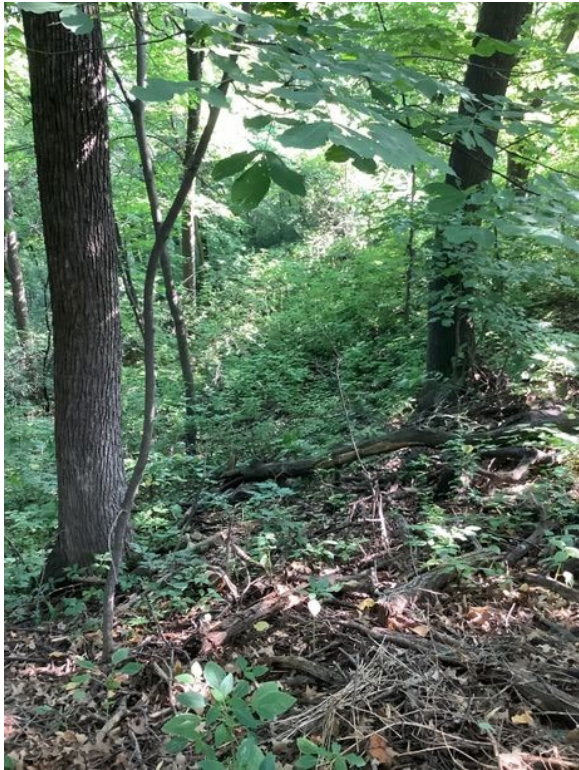
Photo 1 Image

Right bank

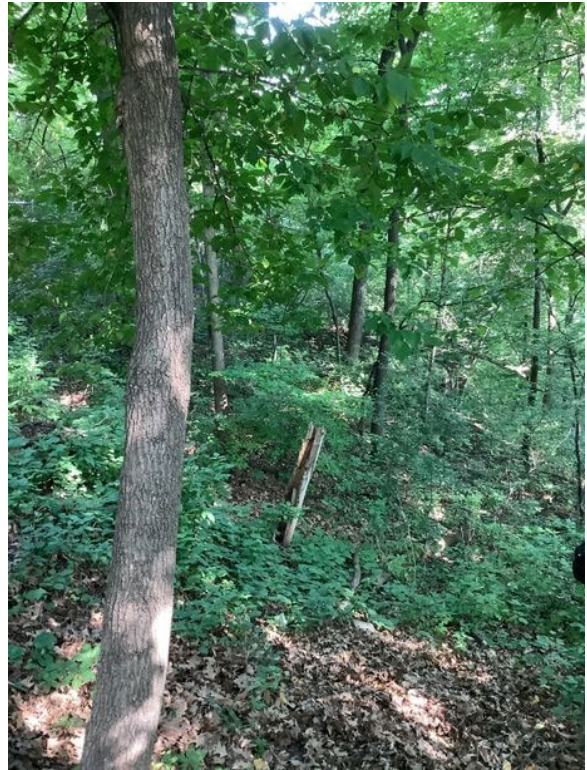
Photo 2 Image

Left bank

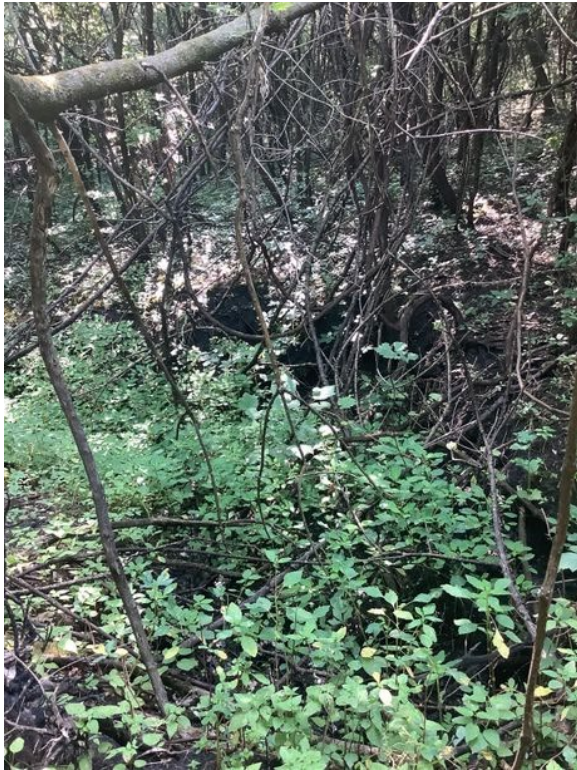
Photo 1 Image

Downstream view of gully where it widens. Lots of fallen branches and trees in the channel. Severe degradation is visible on the right bank.

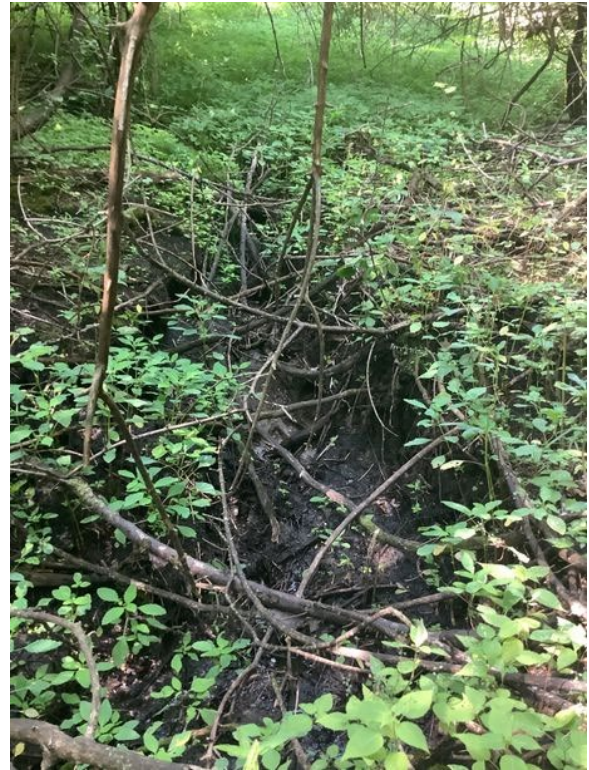
Photo 2 Image

Upstream view of where gully slopes down and becomes more severe.

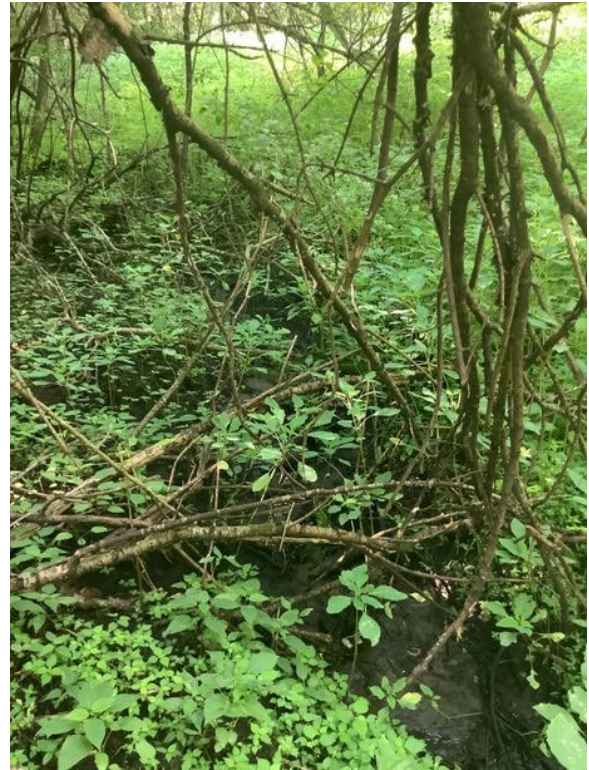
Photo 4 Image

Upstream, view of beginning of gully. The darker and less vegetated area is where the narrow channel lies. Seeps are visible here.

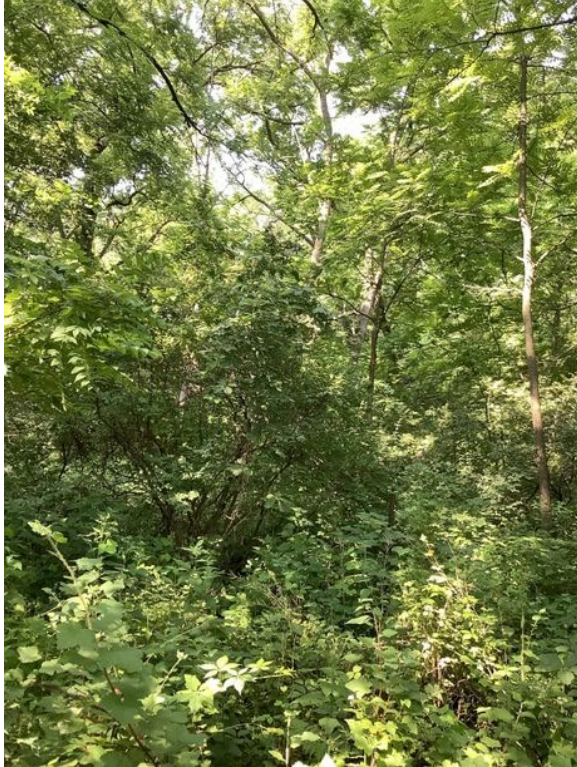
Photo 1 Image

Upstream view of gully from right side.

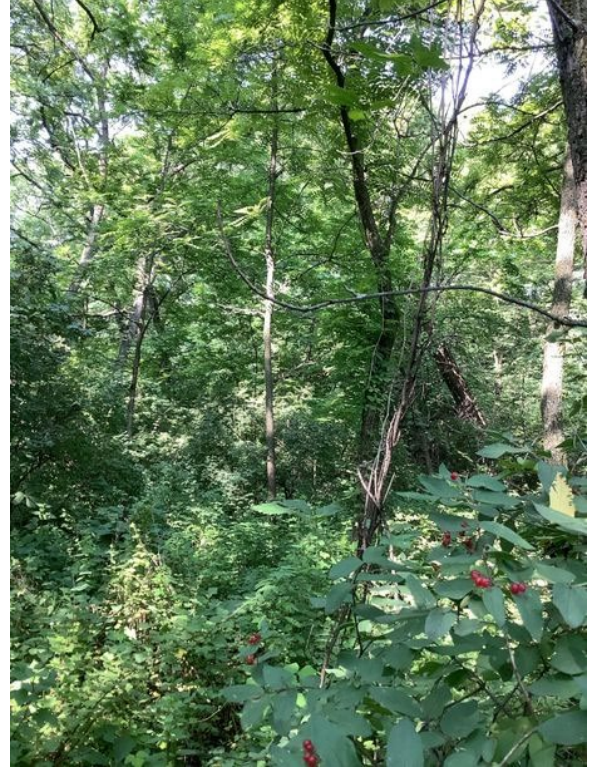
Photo 2 Image

Upstream view showing trees leaning in on both sides.

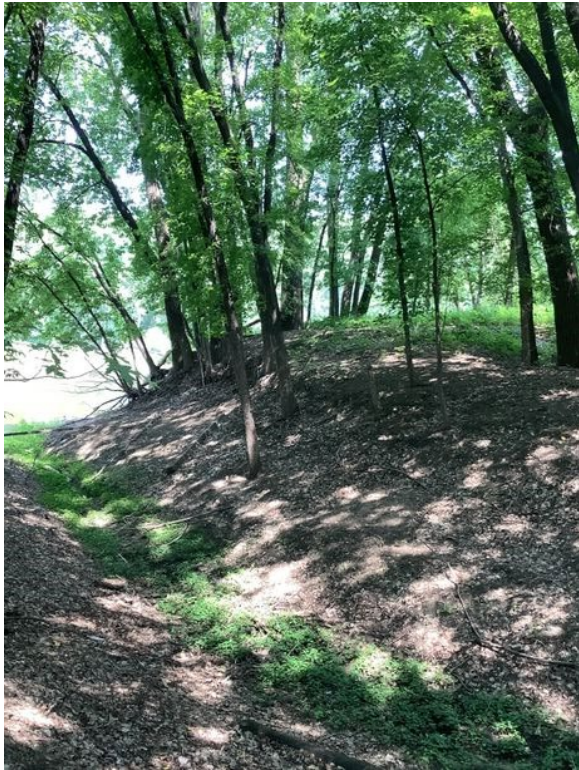
Photo 1 Image

Right bank

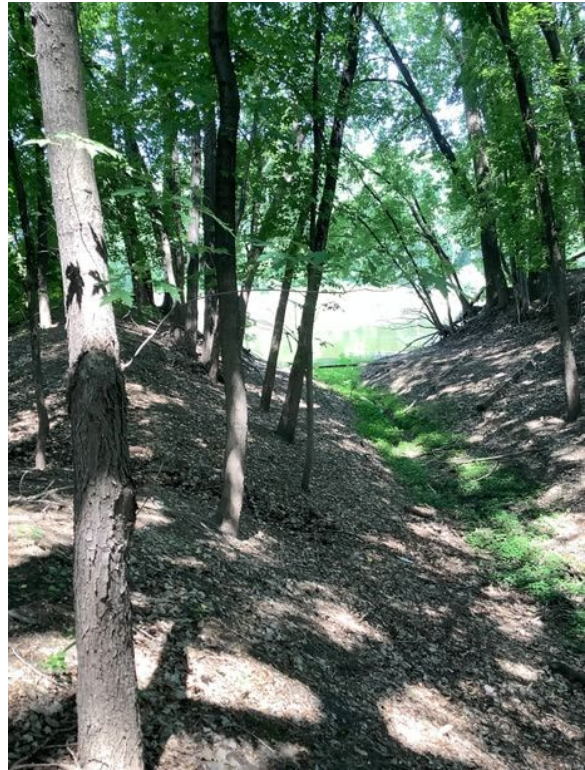
Photo 2 Image

Left bank

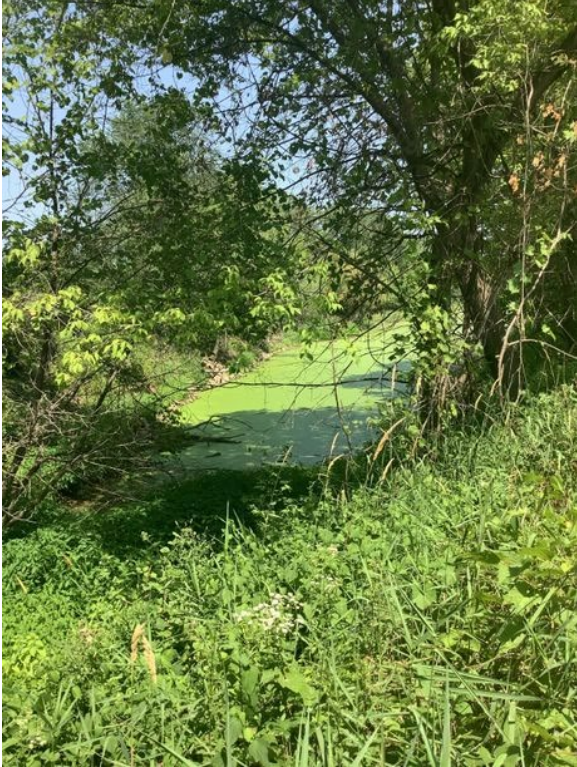
Photo 1 Image

Downstream view of gully.

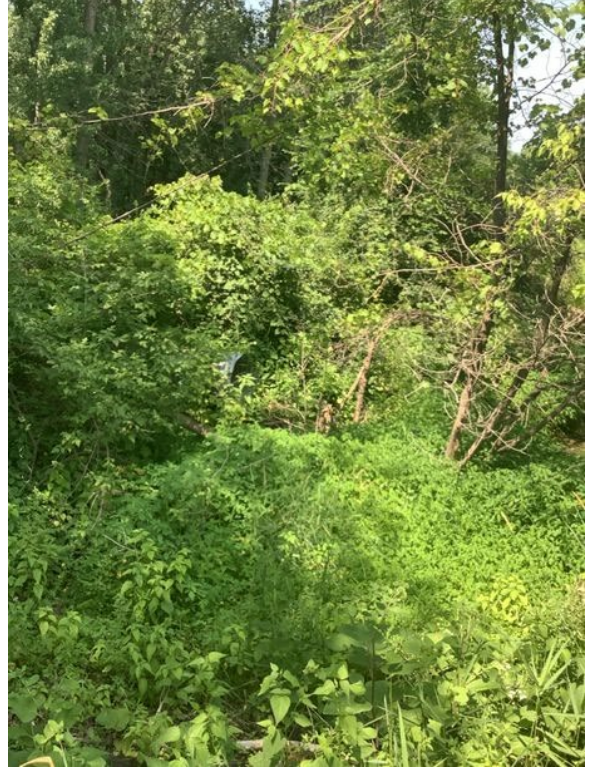
Photo 2 Image

View of pipe outfall on the left bank.

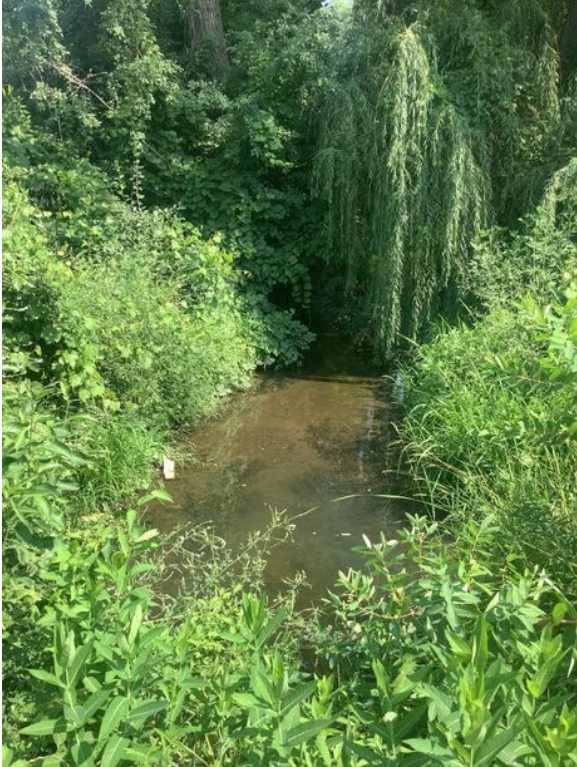
Photo 1 Image

Downstream view of gully from above pipe. Could not get picture of pipe due to heavy vegetation and the pipe being nestled into the bank.

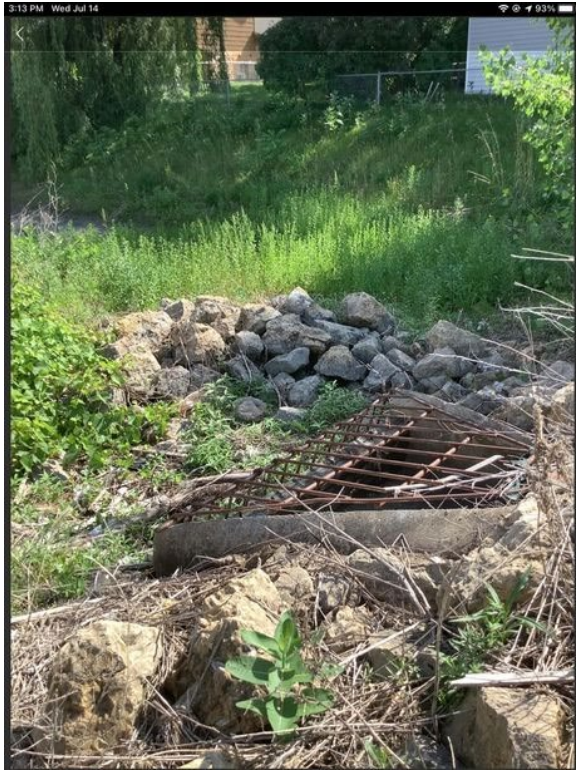
Photo 1 Image

View of downstream from the beginning of the gully at the drain.

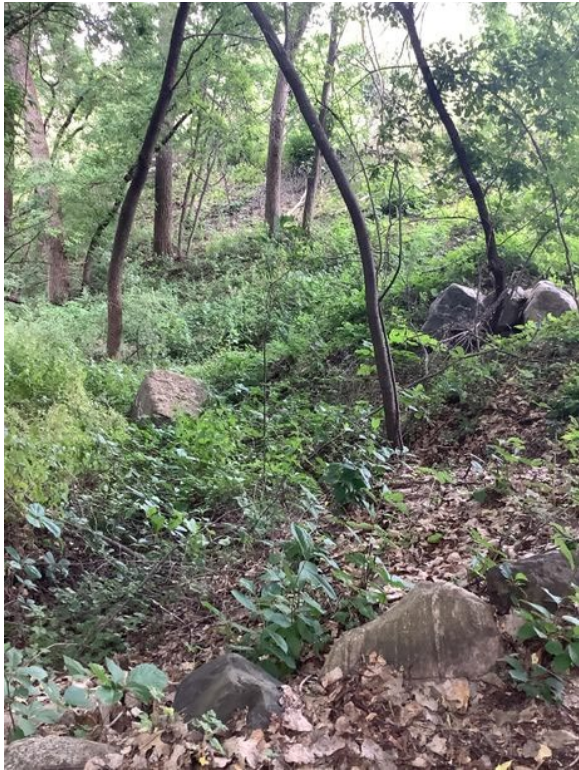
Photo 1 Image

Downstream view from trail.

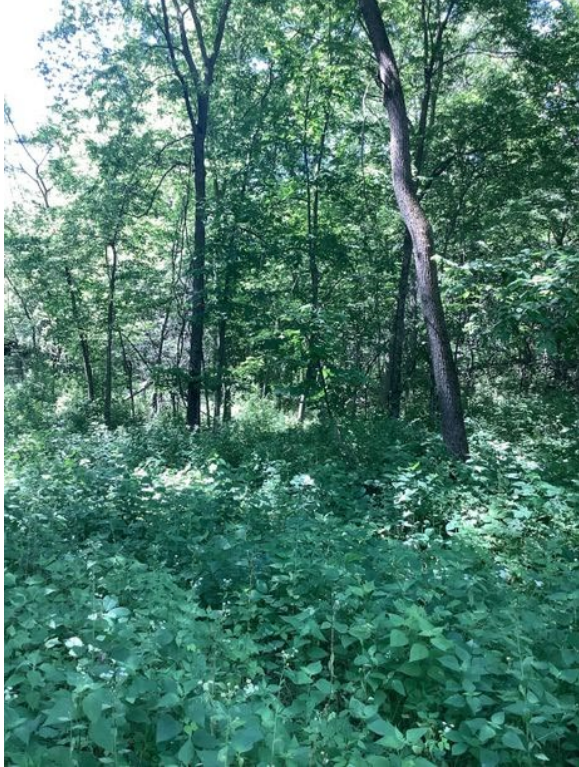
Photo 1 Image

Upstream view of left bank.

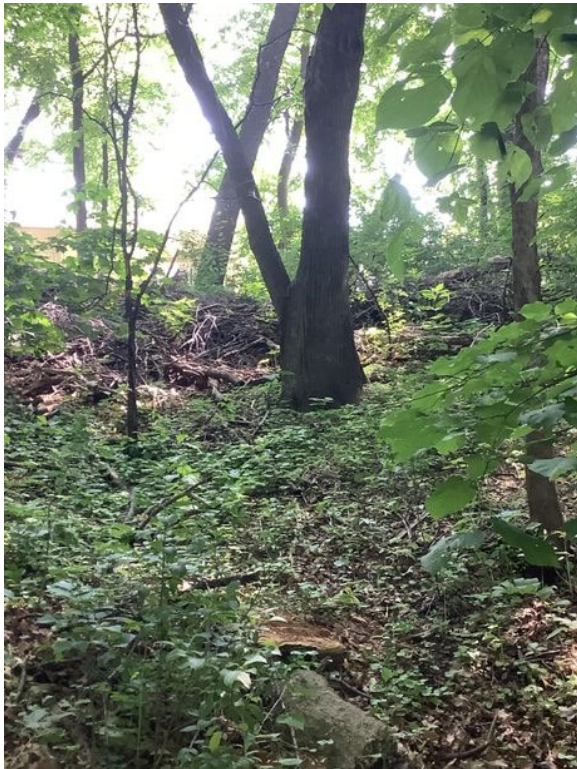
Photo1

Upstream view of left bank.

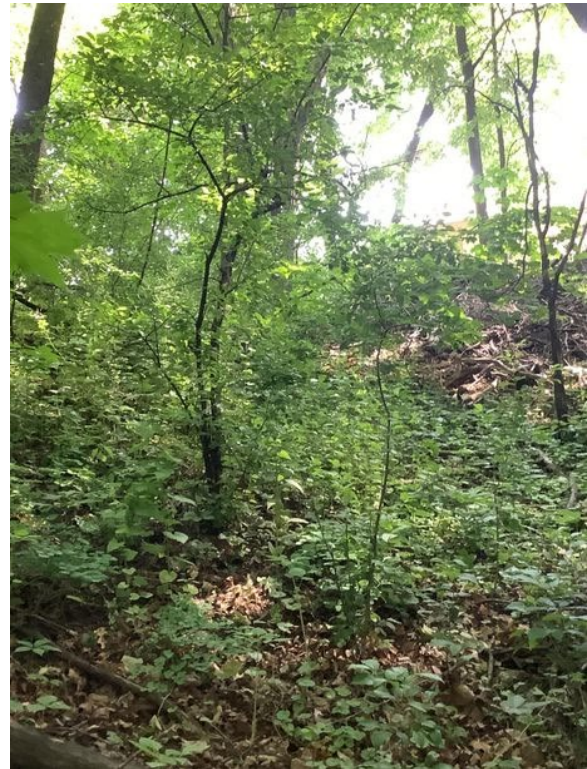
Photo2

Upstream view of right bank.

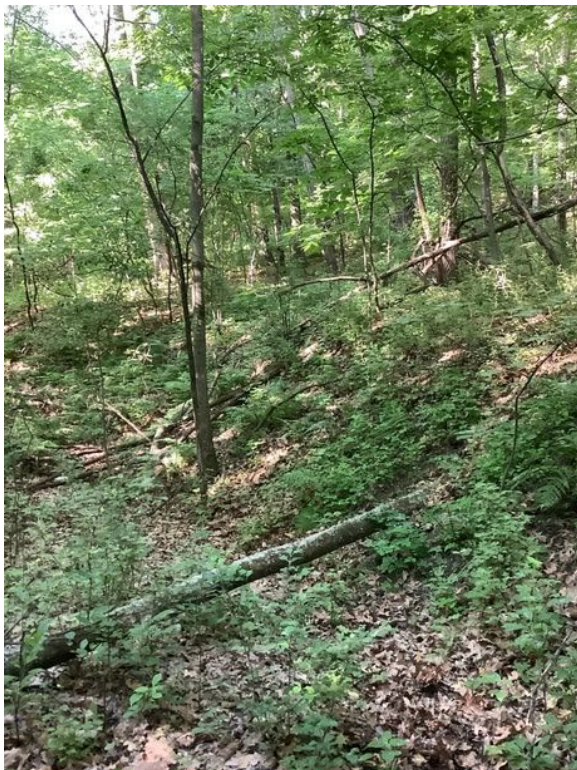
Photo1 Caption Upstream view of left bank.

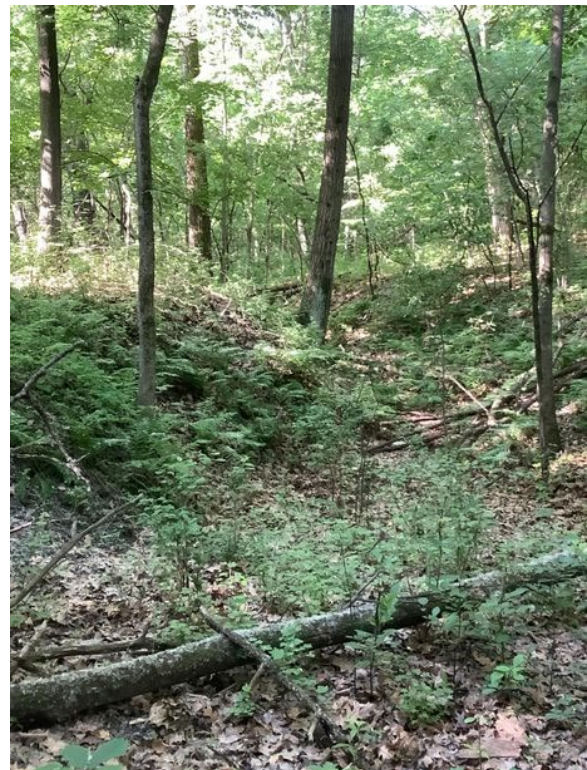
Photo2 Caption Upstream view of right bank.
