LOWER MINNESOTA RIVER WATERSHED DISTRICT

Lower Minnesota River Watershed District Board of Managers Meeting
Wednesday, September 21, 2022

Technical Memorandum

Re: Lower Minnesota River Watershed District Dredge Site Visit Summary

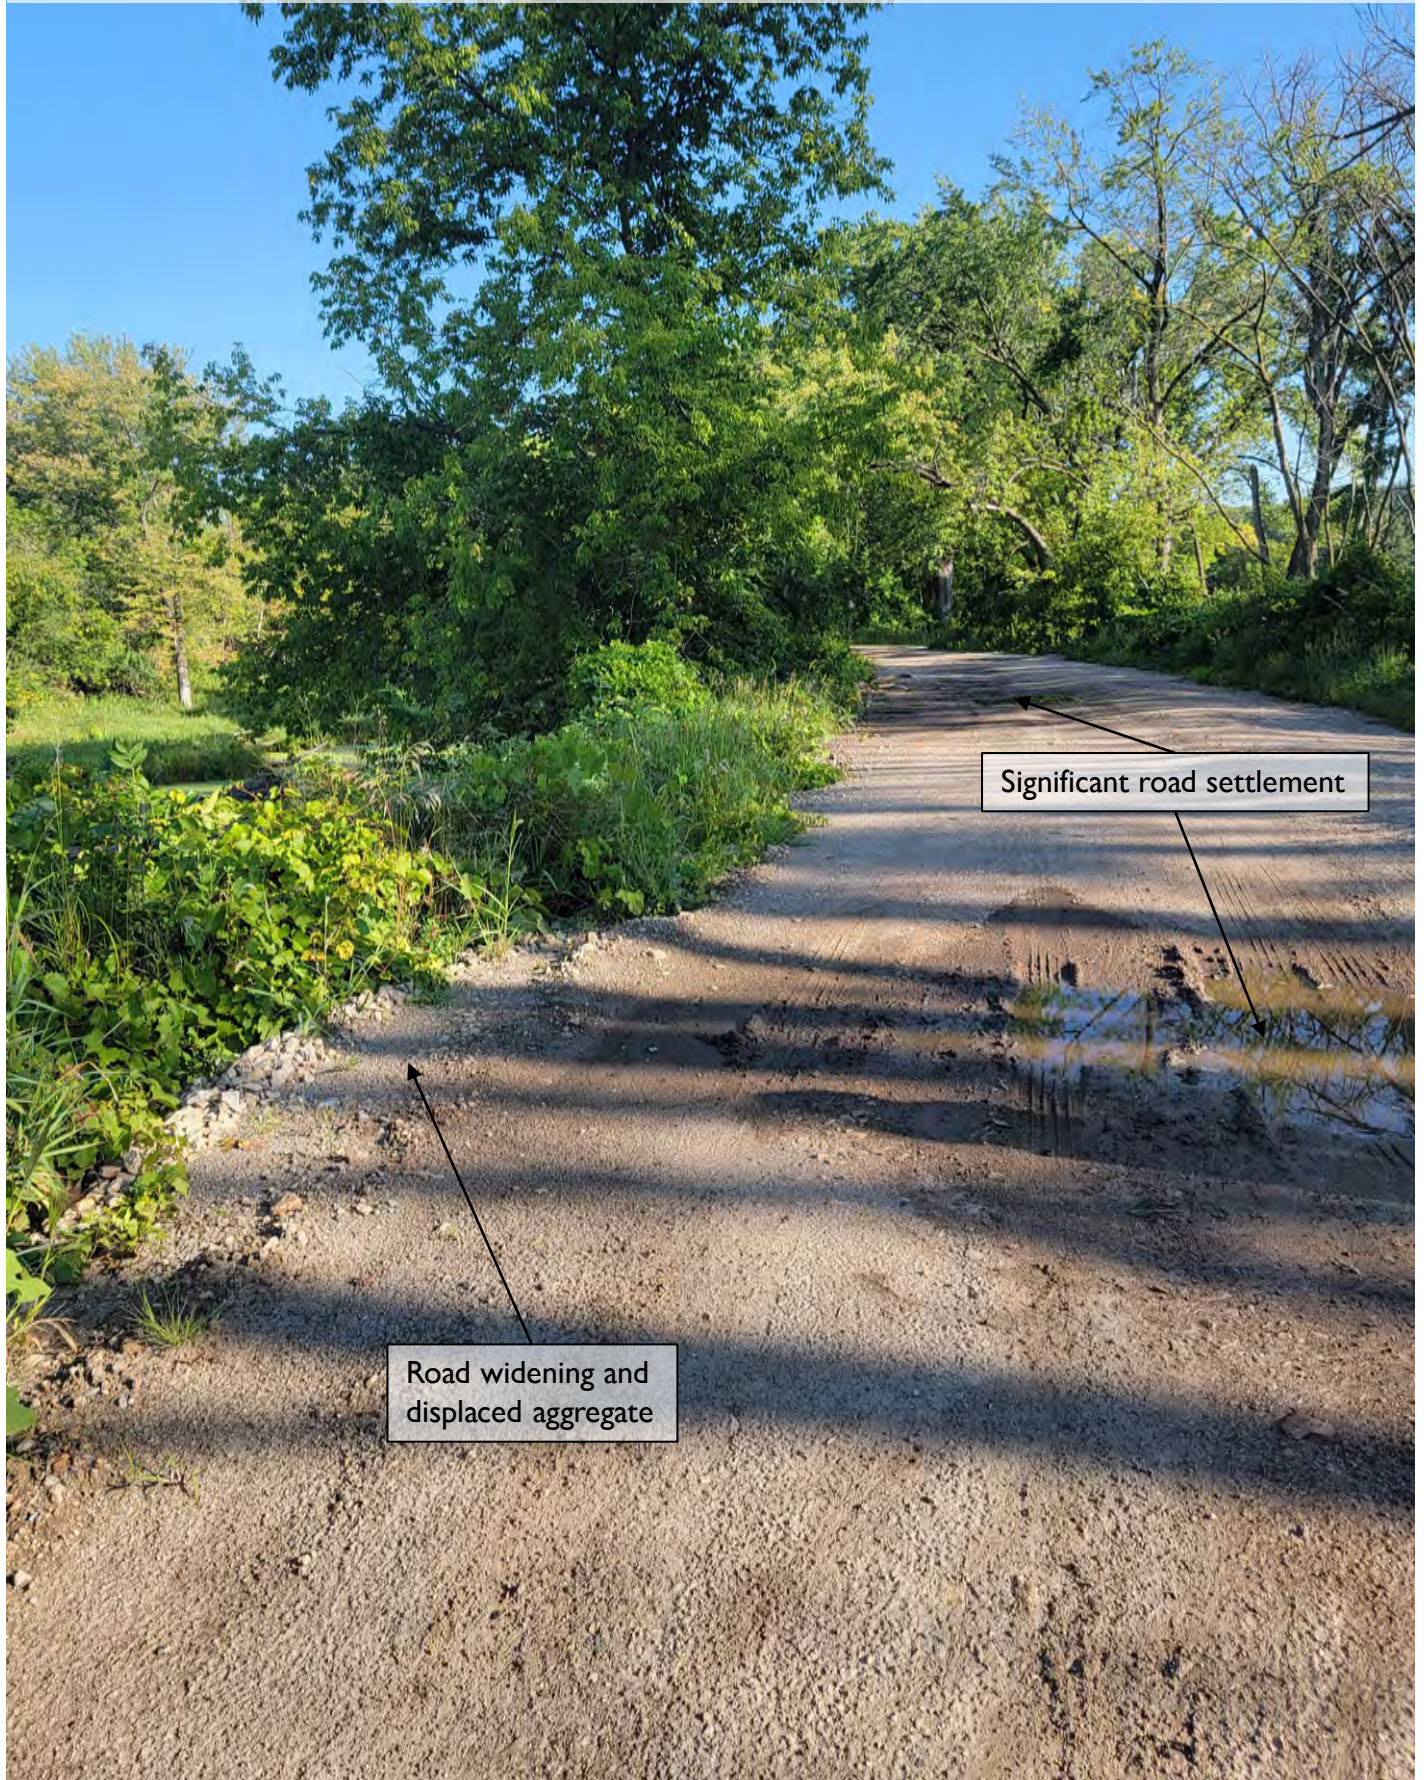
Also consistent with LS Marine's maintenance concerns, there was evidence of road widening due to displaced aggregate (Photos 1C, 2A, 4A, and 5, Attachment 1). The road widening may be intentional turnouts from the 2015–2016 stockpile removal, which would have allowed the trucks hauling sediment offsite to bypass each other on the narrow road. It is also possible that because the road surface is in such poor condition, the aggregate placed by LS Marine is not properly secured in place and gets displaced from heavy truck traffic and rainfall. If this is the case, continuing to place aggregate to fill the ruts and depressions in the roadway does not appear to be a sustainable solution and could adversely affect the neighboring wetlands over time. LS Marine should be consulted to determine if the road widening was intentional or the result of further roadway degradation.

Photo 5. Vernon Avenue road widening and settlement, looking north

Significant road settlement

Road widening and displaced aggregate
