2021 GULLY INVENTORY AND CONDITION ASSESSMENT, VOLUME 2

July 15, 2022

Lower Minnesota River Watershed District
112 E. 5th Street, #102
Chaska, MN 55318

Young Environmental Consulting Group, LLC
6040 Earle Brown Drive, Suite 306
Brooklyn Center, MN 55430

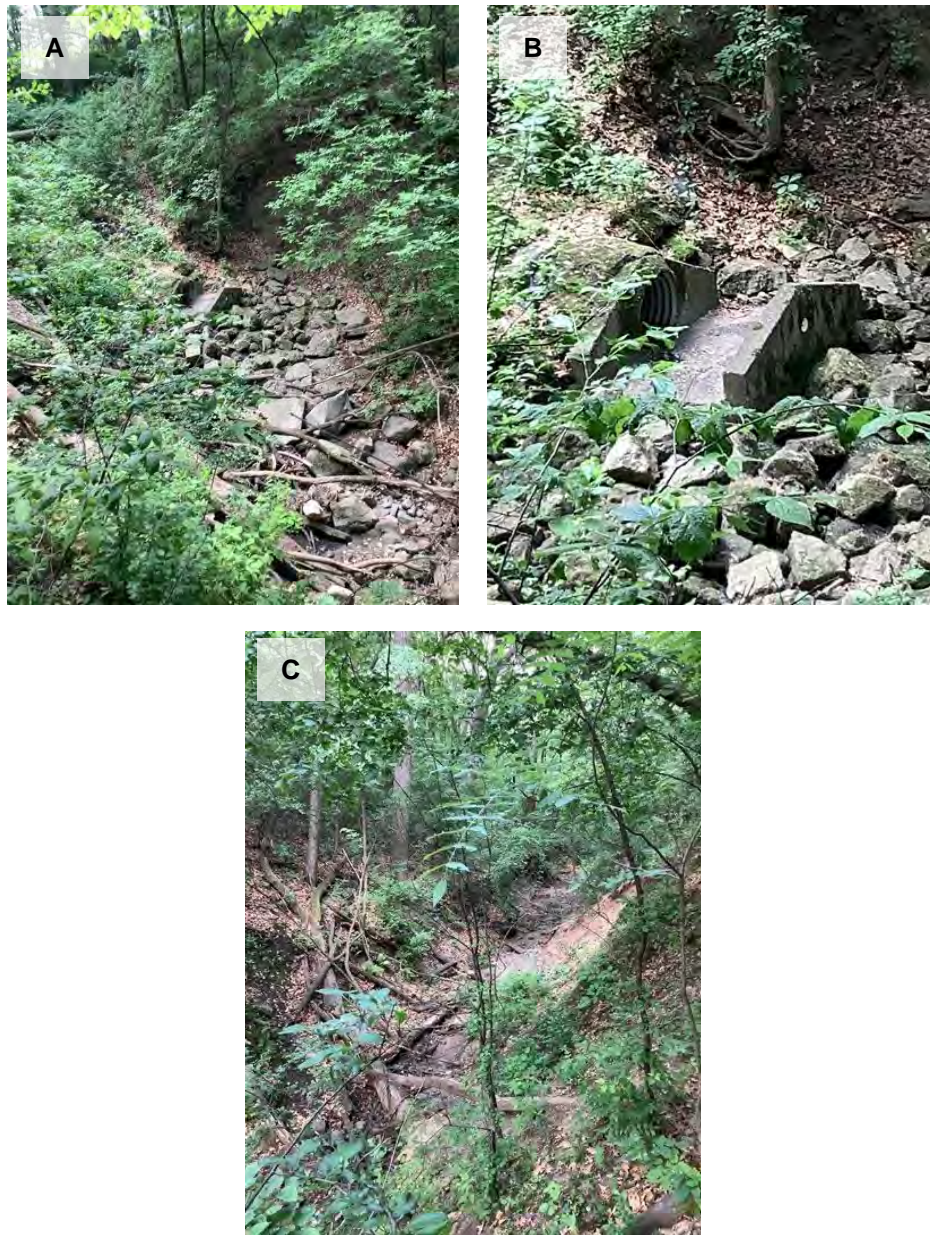
Figure 4: Photos of Gully 06:08-01:06 A) Upstream view of gully, B) Upstream view of pipe, C) Downstream view of gully

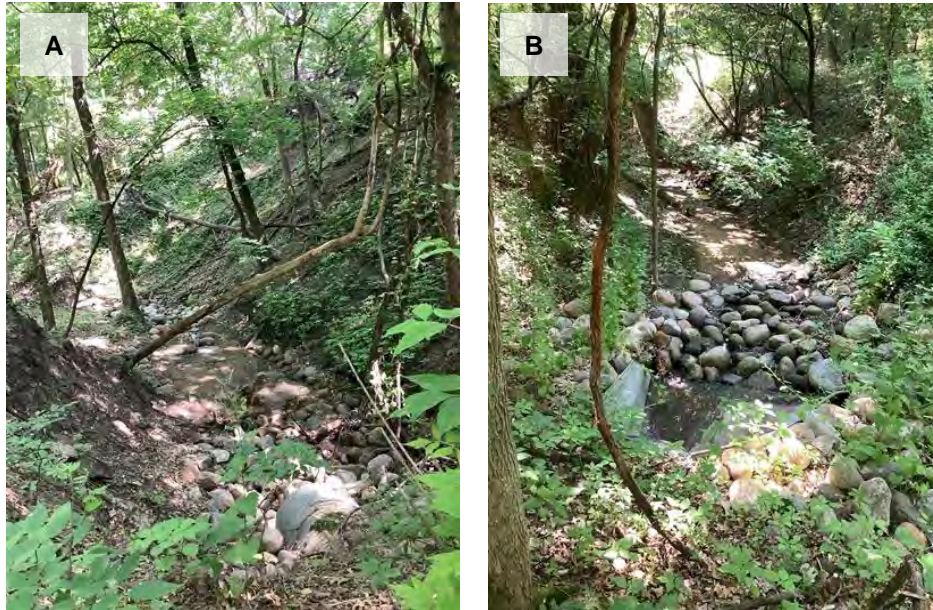
Figure 6: Photos of Gully 06:08-10:51 A) Downstream view of gully, B) View of other side of pipe

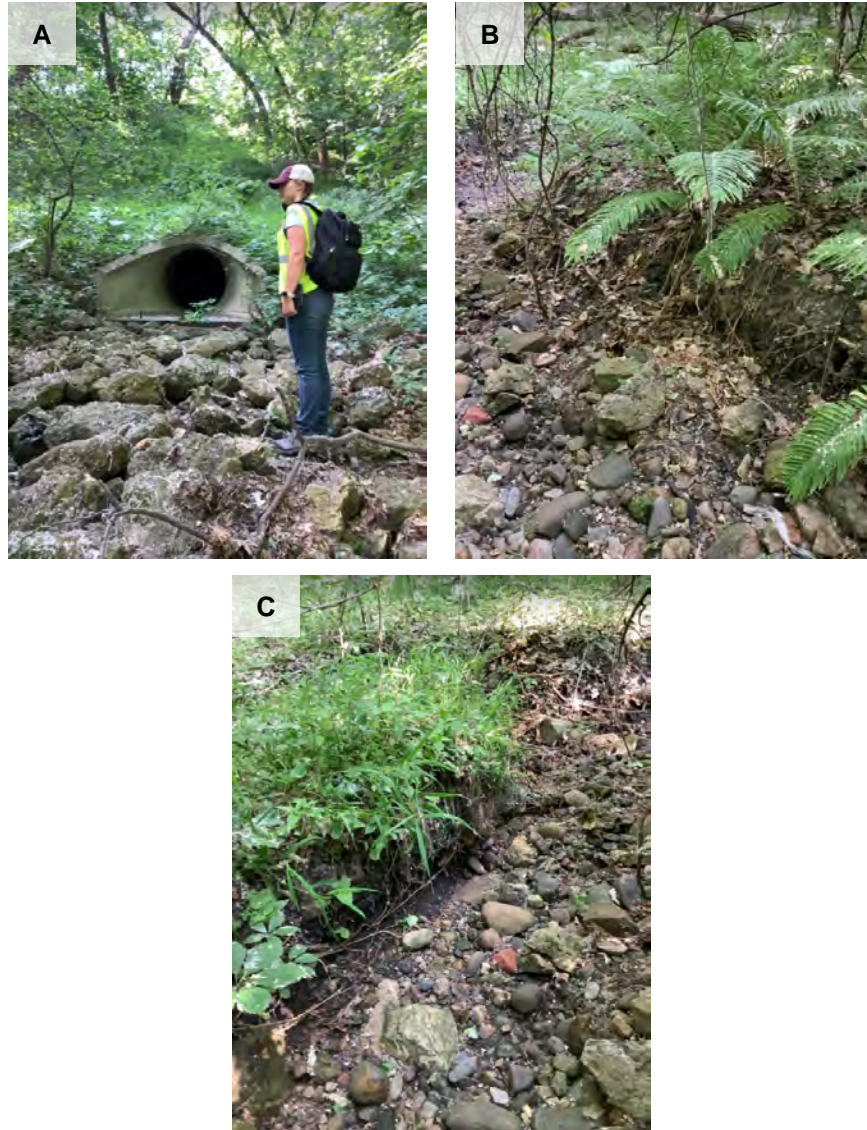
Figure 8: Photos of Gully 06:23-09:48 A). Looking upstream at pipe outfall, B) Looking downstream at right bank, C) Looking downstream at gully channel

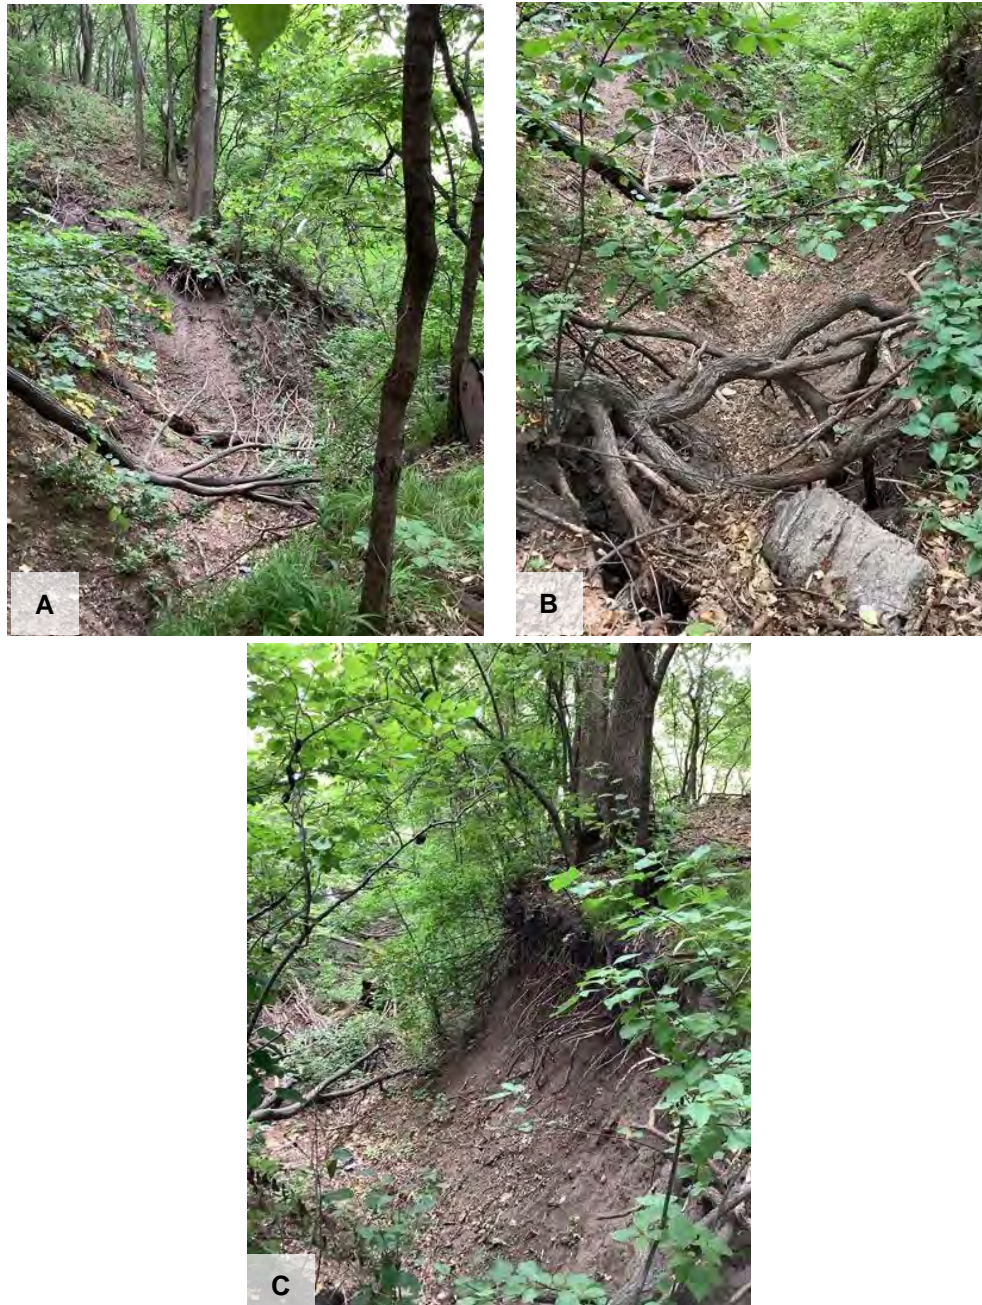
Figure 11: Photos of Gully 07:21-11:43 A) Downstream view of left bank, B) Downstream view of gully middle, C) Downstream view of right bank

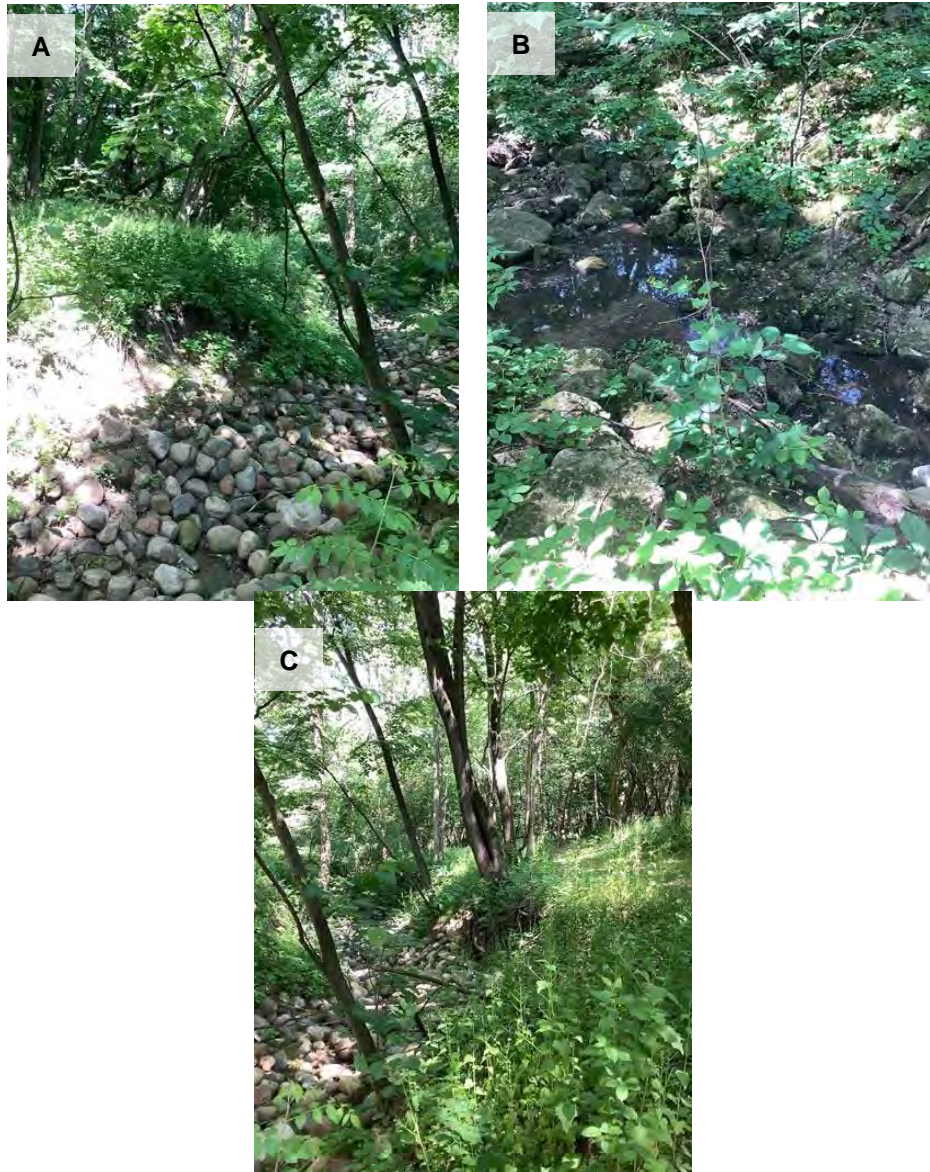
Figure 15: Photos of Gully 06:08-10:45 A) Downstream view of left bank, B) Upstream view of gully, C) Downstream view of right bank

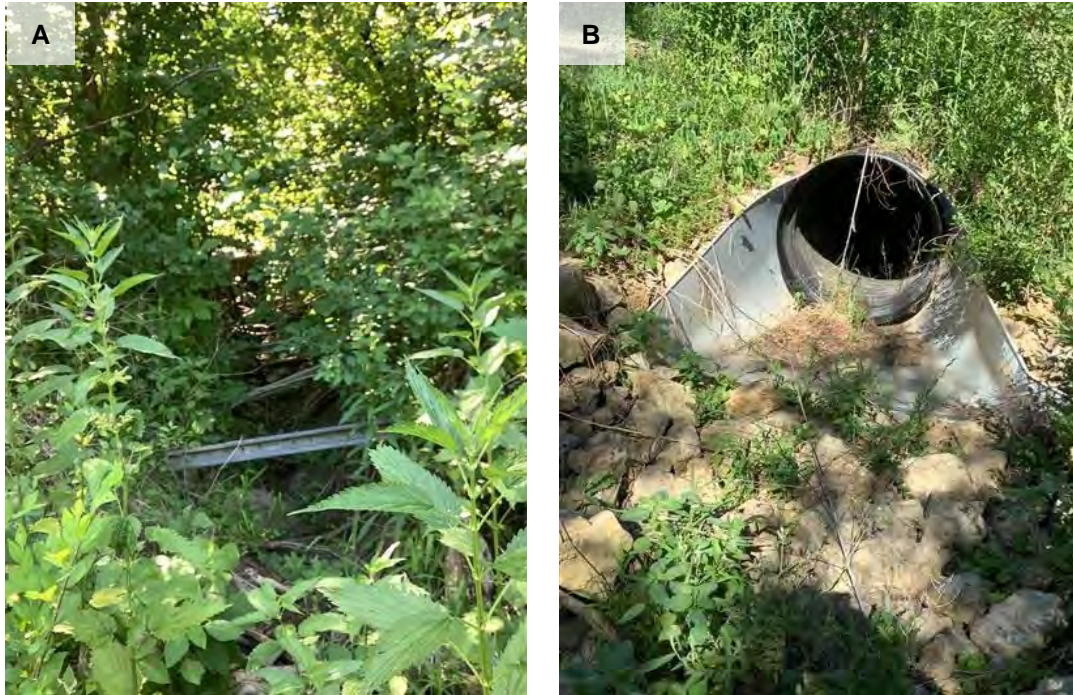
Figure 20. Photos of Gully 06:15-10:06 A) Upstream view of the gully, B) Downstream view of the pipe at the end of the gully

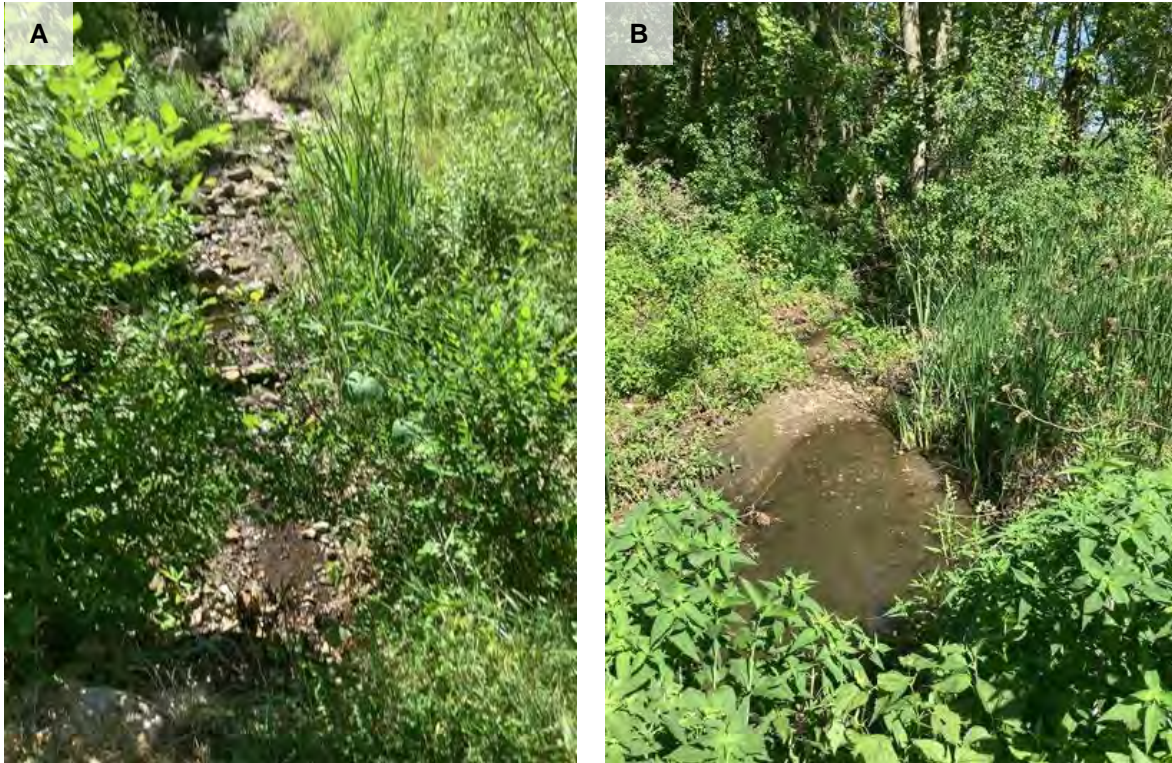
Figure 22. Photos of Gully 06:15-10:13. A) Upstream view of south side of trail. Severe degradation is visible on the left bank upstream. B) Downstream view of north side of trail of gully with stagnant water

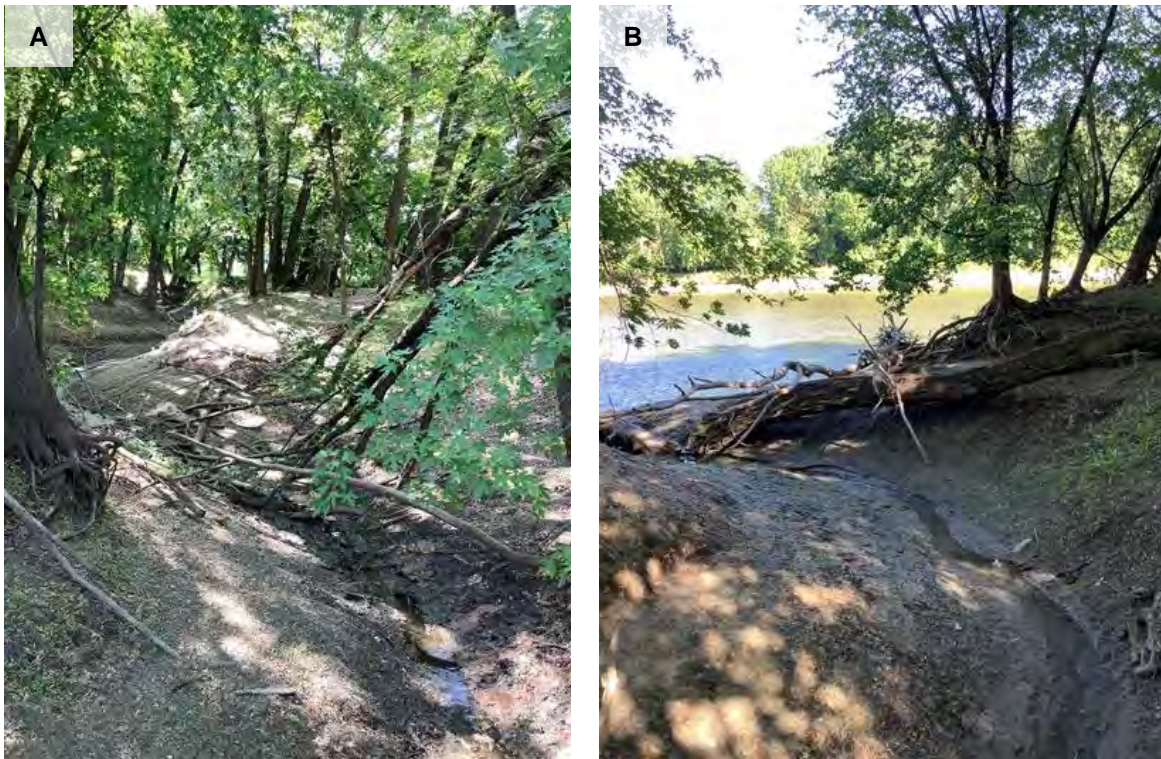
This site was located in Fort Snelling State Park, northeast of the confluence of Kennaley's Creek and the Minnesota River (Figure 23). There was very little vegetation on the banks, and severe degradation was visible downstream, closer to its connecting point with the river (Figure 26). It should be noted that the Minnesota River was exceptionally low throughout most of the summer, and this gully may normally be inundated by higher river flows. However, based on the observations at the time, this gully was given a high erosion potential because of degradation and a lack of vegetation. This site is not located within the HVRA and is in the Tier III impact zone, so the resulting risk for this gully was considered to be medium.

Figure 26. Photos of Gully 06:04-08:59. A) View upstream from the bridge crossing the gully. Exposed roots from trees on the right bank are visible along with some broken branches lying in the middle of the gully. B) View of the gully's confluence with the MN River, where there is visible severe degradation on the lower banks right near the stream.

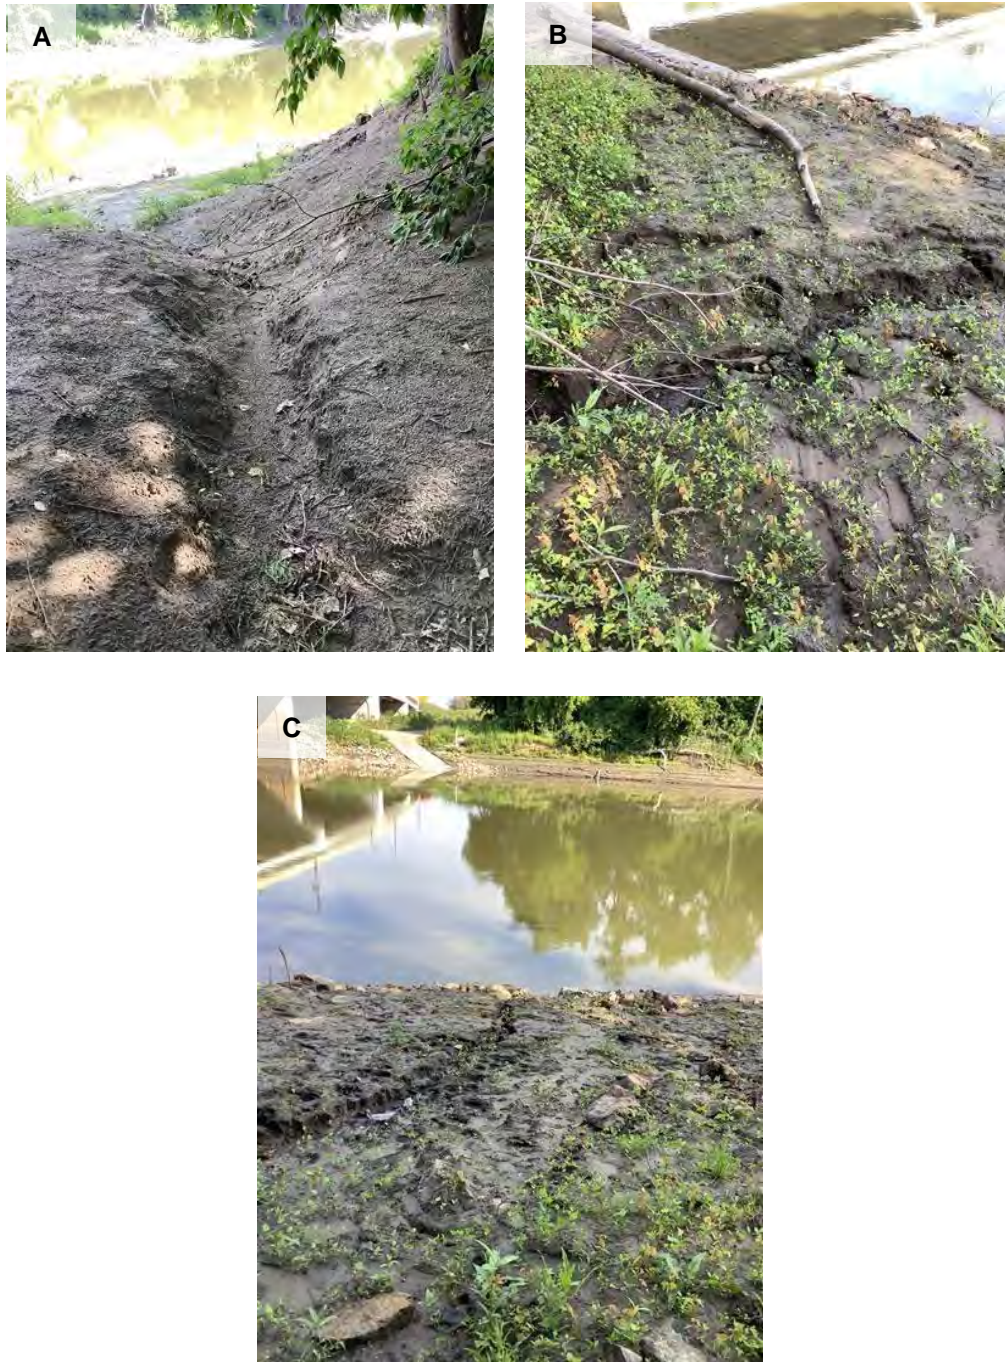
Figure 42: Photos of Gully 07:08-09:17. A) Downstream view of the gully, B) Downstream view showing the severely eroding left bank of the gully, C) Downstream view of the gully's confluence with the Minnesota River

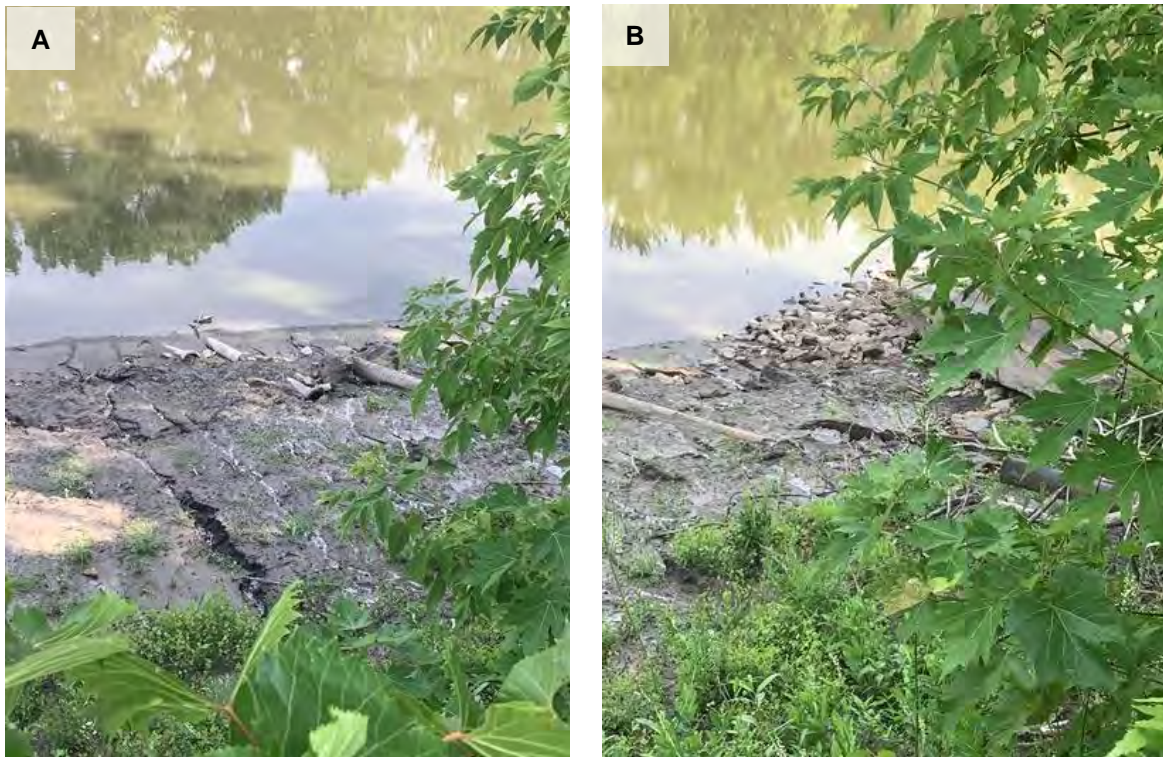
Figure 43: Photos of Gully 07:08–09:29. A) Downstream view of mini gullies and broken pipe. There was a very steep drop-off along with a lot of vegetation, so pictures were difficult to obtain. B) Downstream view of where pipe outfall broke and now drains

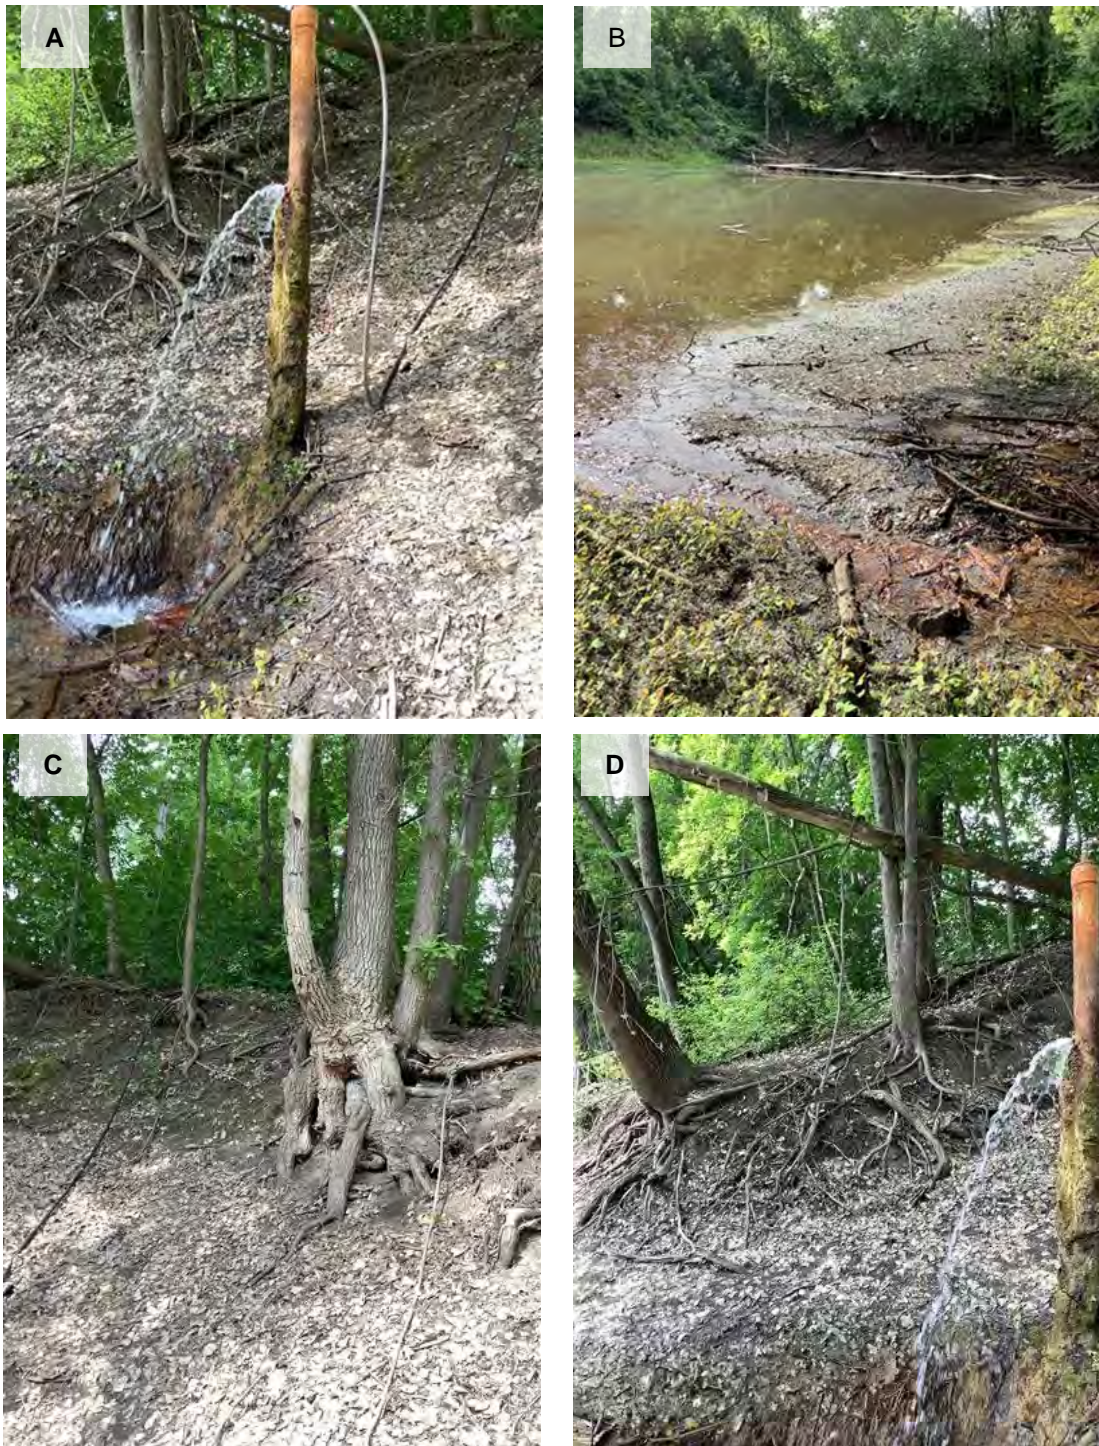
Figure 44: Photos of Gully 07:08-09:58. A) Upstream view of high flow of water exiting pipe, B) Downstream view of water draining into this pond area where the gully flows, C) Upstream view of the left bank, D) Upstream view of the right bank

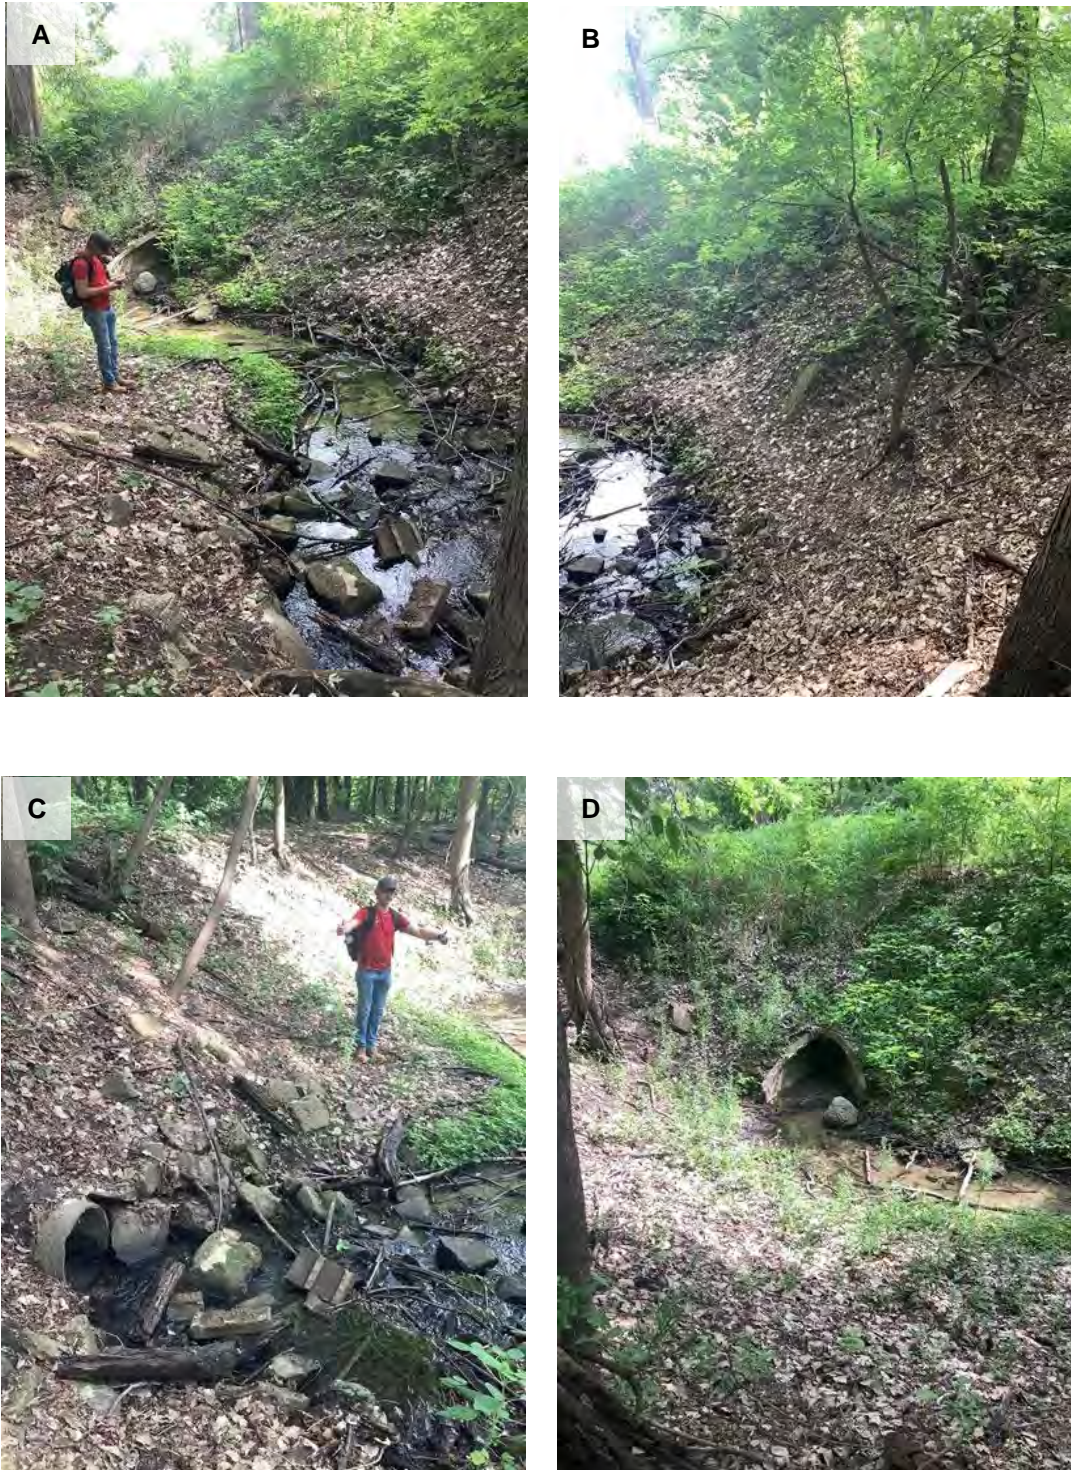
Figure 45: Photos of Gully 07:08–10:03. A) Downstream view of gully; inflow and outflow pipes are visible. B) Downstream view of the right bank, which has worse degradation, C) Downstream view of inflow pipe and left bank, D) Downstream view of outflow pipe

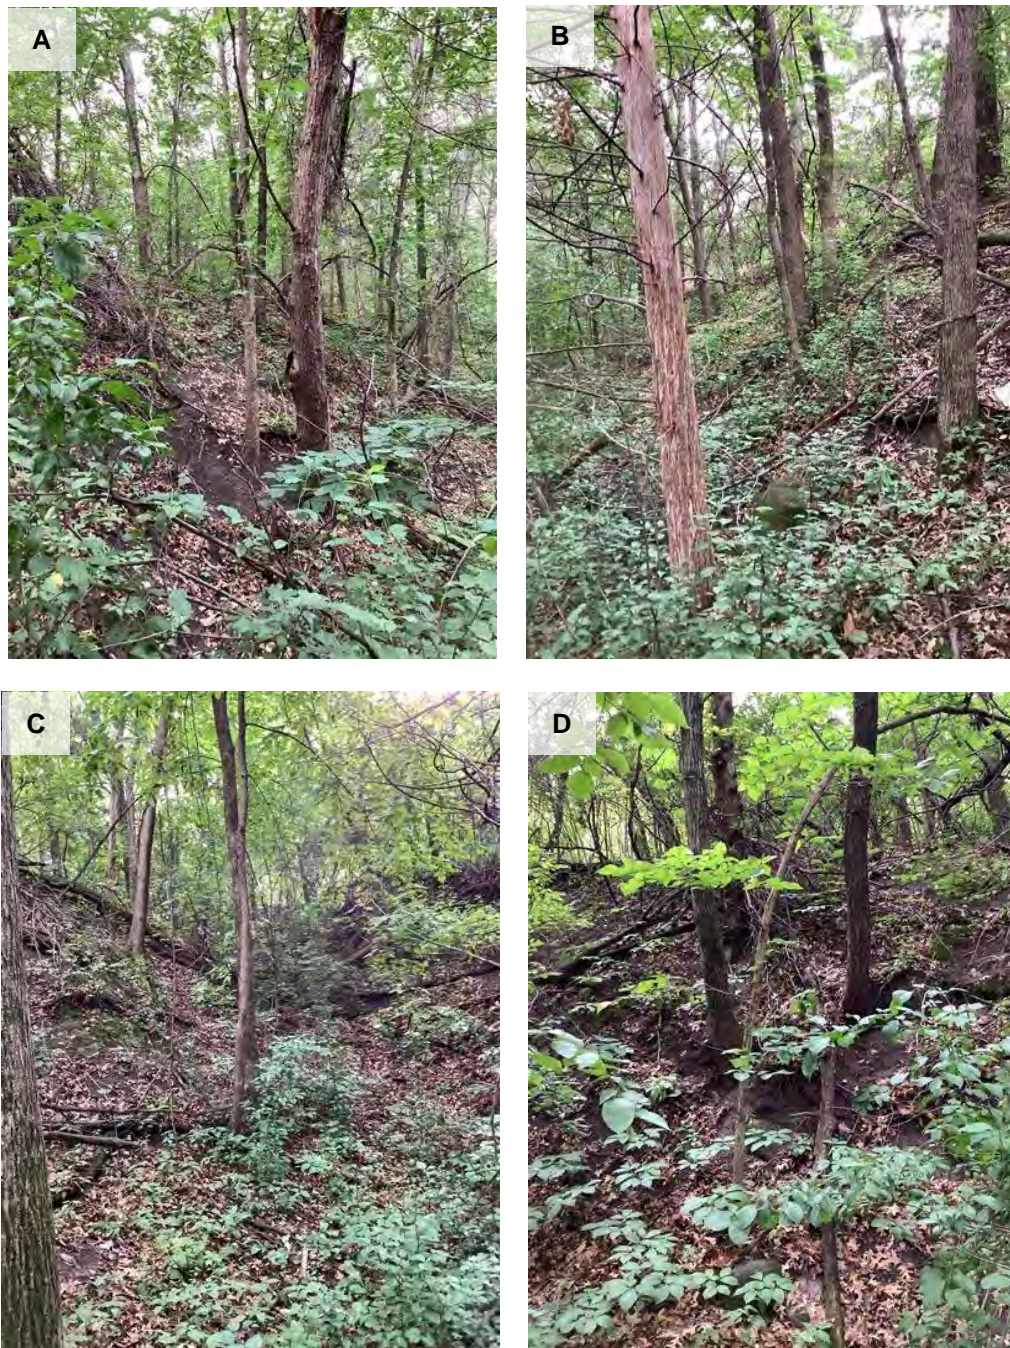
Figure 49: Photos of Gully 07:08–11:17. A) Downstream view of the left bank, B) Downstream view of the right bank, C) Upstream view of the area where the gully is narrower: the tree on the left edge of the photo is where the small gully connects to this larger one. D) Left bank view of degradation, slumping and pistol shaped trees
