LOWER MINNESOTA RIVER
WATERSHED DISTRICT

2023 Gully Inventory and Condition Assessment Project

Final
August 9, 2023

Young Environmental
Consulting Group, LLC

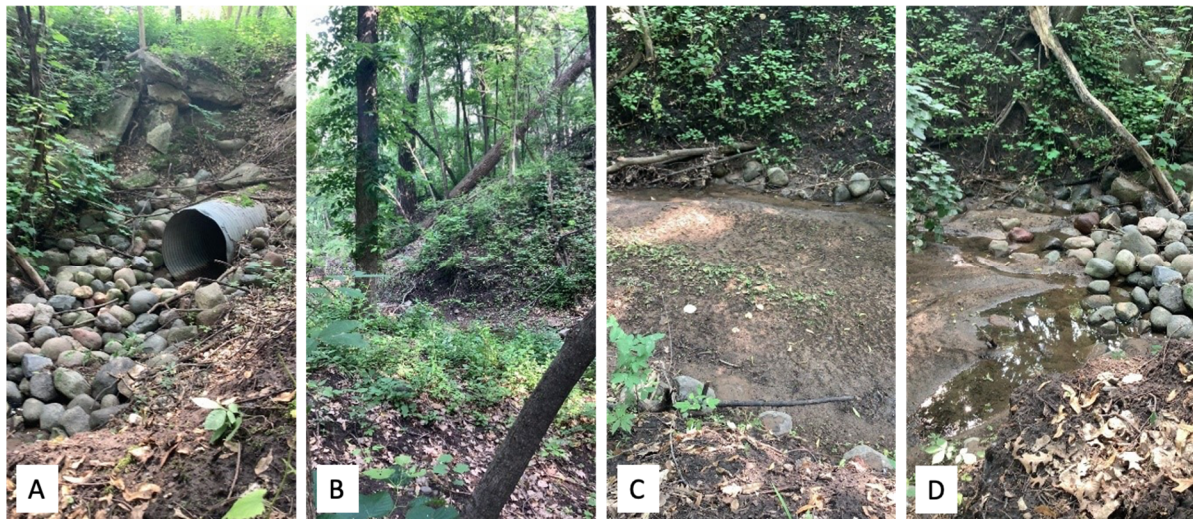
- **Soils:** BVL62 consists of very sandy, non-compact material, which contributes to the overhanging banks and slumping observed.
- **Field Observations:** There is a large pipe outfall located near the headcut of the gully, which is surrounded by existing riprap (Figure 8). This pipe conveys water from BVL14 into BVL62. BVL14 was a much smaller gully on the other side of the pipe and did not receive a high-ranking score. There was also severe accumulation of sediment below the flowing water within BVL62.

- **Ranking Score Breakdown:** This gully has a total erosion score of **47**, which is greater than the 2021 assessment’s score of **32**. This is due to the gully being longer, deeper, and less vegetated than in the last visit. BVL62 is in impact Tier A, meaning it is near high value resource areas in the LMRWD, adding **10** points to the final ranking score. BVL62 specifically impacts Black Dog Fen. It also has 18 sites of active investigation or cleanup within a 1-mile radius, adding **4.5** points to the final ranking score. Gully BVL62 received a total of **61.5** points (Table 6), which is the highest-ranking score given out of all the gullies surveyed.

Figure 8. Photos of gully BVL62. A) Headcut with large pipe outfall and surrounding rip rap. B) Facing North at bank from the side of the headcut. C) Gully bottom condition. D) Image of water pooling at bottom of rip rap

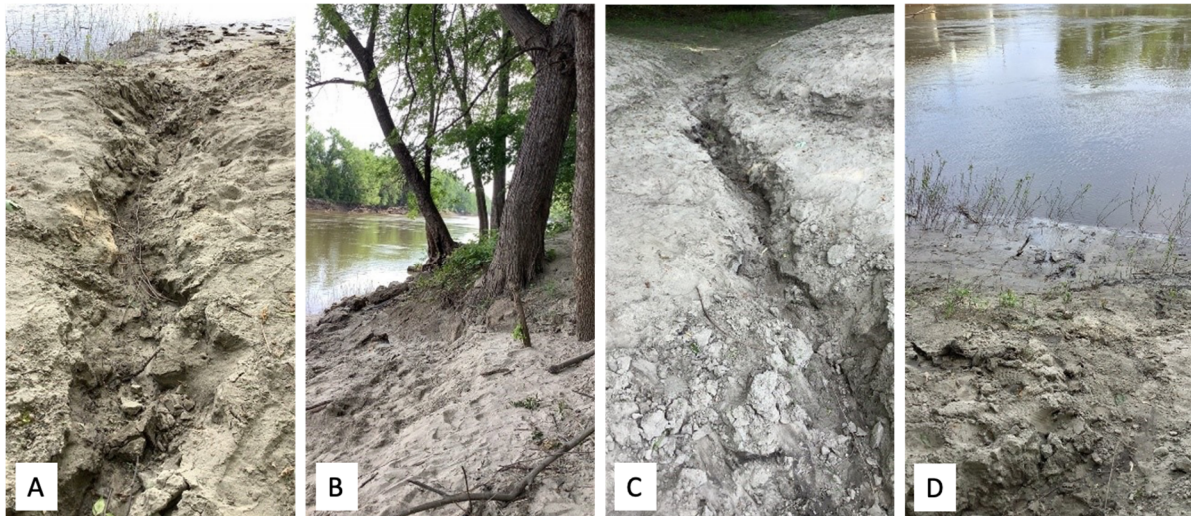
- **Vegetation:** The gully has no vegetation on the bottom or the banks.
- **Soils:** The gully was observed to be very unstable because it is on the banks of the Minnesota River and consists of easily erodible sand (Figure 9).

- **Ranking Score Breakdown:** The calculated erosion score was **42**, which is greater than the previous year's score of **35**. SHK1 is in impact Tier B because it directly discharges sediment to the Minnesota River, which is defined as an impaired water body, adding **7** points to the final ranking score. This gully has 32 active investigation or cleanup sites within a mile radius, adding **8** points and giving it a final score of **57** (Table 7).

Figure 9. Photos of gully SHK1. A) Facing north looking down at gully. B) Facing south looking up at gully. C) Leaning tree along bank adjacent to the gully. D) Water at gully edge in the Minnesota River.

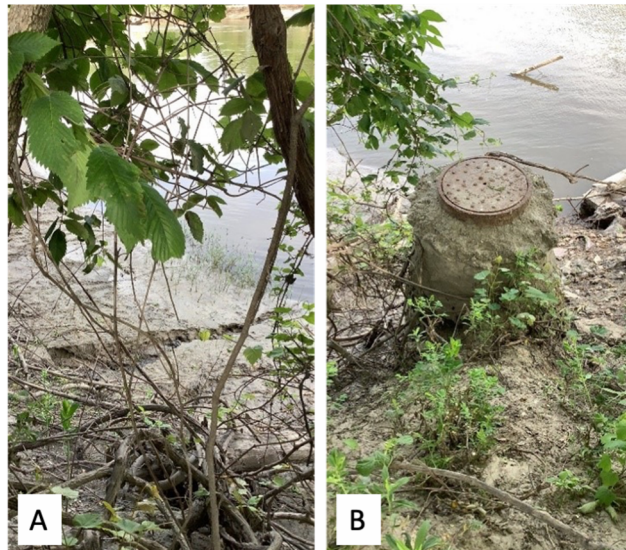
- **Soils:** The gully consists of sand with observed seepage.
- **Field Observations:** While the gully is small, the area has undergone severe erosion as seen in Figure 10 where the top of a manhole and the concrete is fully exposed and apparent sedimentation can be seen at the outlet of the gully.

- **Ranking Score Breakdown:** The erosion potential score is **42**, which is higher than the previous erosion score of **34**. SHK10 falls into impact Tier B because of its proximity to the Minnesota River, which is an impaired waterbody, contributing **7** points to the final score. This gully was found to have 32 active investigation or cleanup sites found within a mile radius adding another **8** points, giving it a final score of **57** (Table 8).

Figure 10. Photos of gully SHK10. A) Facing northwest looking down at gully. B) Image of structure that is surrounded by evident erosion.

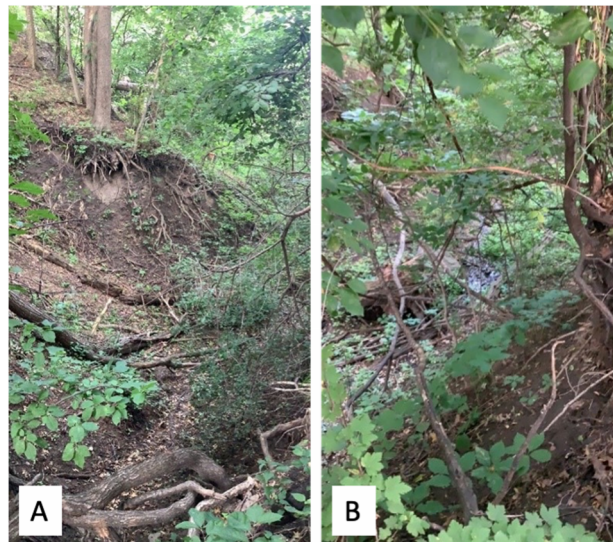
- **Field Observations:** There were areas with overhanging banks and subsequent slumping and flattened banks. There was observed evidence of groundwater upwelling or seepage from the gully bottom, but the water was not flowing, indicating that the gully was actively eroding and unstable.

- **Ranking Score Breakdown:** The gully ultimately has an erosion score of **44**, which is higher than the previous erosion potential score of **39**, due to the gully being longer and less vegetated. BVL3 is in impact Tier A contributing **10** points, as this site is near the location of the high value resource, Black Dog Fen. There are also 30 active investigation or cleanup sites within a 1-mile radius of this gully, which contributed **7.5** points. Gully BVL3 received a total of **61.5** points (Table 9), which is the highest score given from these assessments.

Figure 11. Photos of gully BVL3. A) Facing west by the headcut, viewing overhanging bank B) Seepage at gully bottom

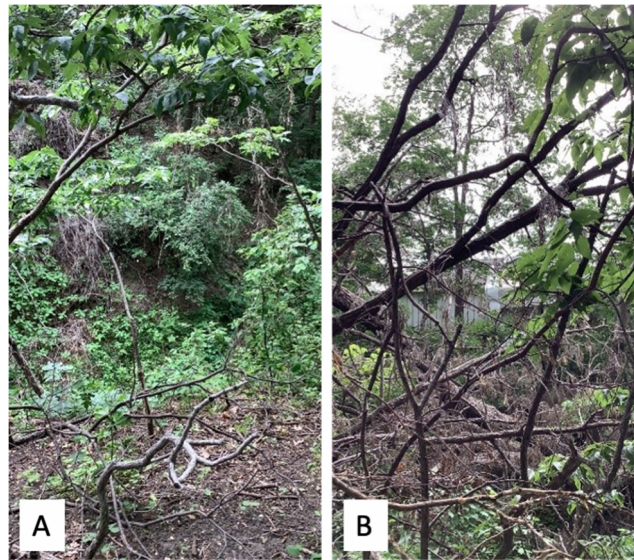
- **Field Observations:** There were undercut areas causing slumping. Many fallen trees were observed in the channel and the gully was very unstable due to its extremely steep slopes (Figure 12).

- **Ranking Score Breakdown:** The final erosion potential score was calculated to be **44**. This gully fell into impact Tier A, due to its proximity to the high value resource Black Dog Fen, contributing **10** points to the final ranking score. Lastly, there were 21 active investigation or cleanup sites within a mile of the gully contributing another **5.25** points. The final score for this gully is **59.25** (Table 10).

Figure 12. Photos of gully BLM68. A) Facing southeast on bank, looking down at the gully. B) Image of large shed near the gully

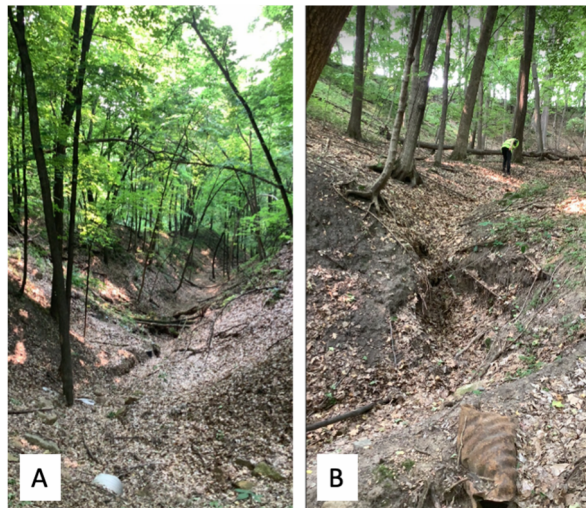
- **Field Observations:** Two drainage pipes were identified near the headcut of the gully which are likely the cause of the gully's continued development.

- **Ranking Score Breakdown:** CVR81 received a final erosion score of **50**, which is tied for the highest erosion potential score of all the gullies surveyed. Previously, CVR81 received an erosion potential score of **43**; however, the gully has become more V-shaped, developed overhanging banks, and had more sediment aggradation, increasing its erosion potential score during the 2023 Project assessment. CVR81 is within impact Tier B, as it affects the impaired waterbody of Spring Creek, accounting for **7** points toward its final score. CVR81 has 6 active investigation and cleanup sites within a mile radius, giving it an additional **1.5** points toward the final score. The final ranked score for this gully is **58.5** (Table 11).

Figure 13. Photos of Gully CVR81. A) Northeast looking down from headcut with view of outlet. B) East looking at new headcut development

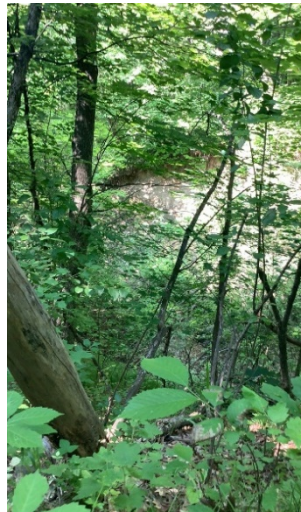
- **Soils:** The gully material was comprised of sand along the banks, making it a greater erosion risk.
- **Field Observations:** There were numerous points where undercuts, overhanging roots, and leaning or fallen trees were observed (Figure 14). There are additional gullies of a lower risk connected to this gully; however, CVR55 seems to be the main contributor to the downstream erosion of nearby gullies.

- **Ranking Score Breakdown:** CVR55 received a previous erosion score of **32** and had a large increase in erosion since the last assessment. Due to its easily erodible material and large size, CVR55 received an initial erosion score of **45**. Seven points were added because the gully is in impact Tier B contributing **7** points, affecting the impaired waterbody Spring Creek, which is of some concern to LMRWD. There were also 3 active investigation or cleanup sites near the gully, adding **0.75 points** to the score. The total score for this gully was **52.75** (Table 12)

Figure 14. Photo of CVR55. Facing west looking downstream of the gully.

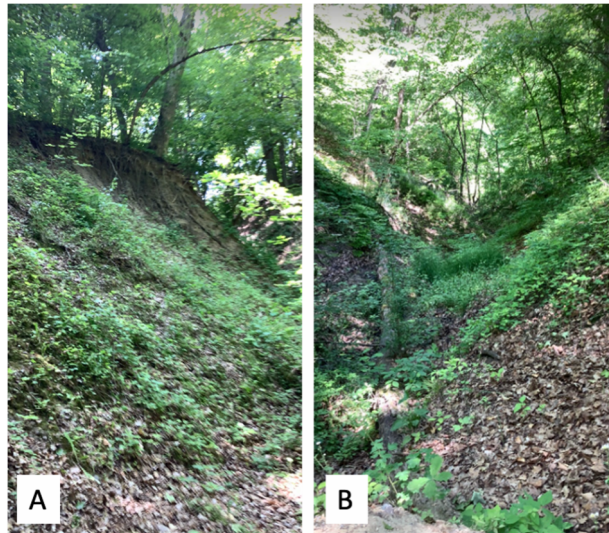
- **Soils:** The gully consisted of fine-grained cohesive material (Figure 16).
- **Field Observations:** CVR56 is connected to many other gullies throughout the area and forms a large system of gullies that run from behind the houses on Red Oak Ridge and Hackberry Court. These gullies would have to be considered for a joint restoration project to reduce the chances of gullies reforming after restoration. Throughout this gully there is clear evidence of seepage leading to running water along the bottom. The gully includes overhang and exhibits signs of severe degradation and active erosion.

- **Ranking Score Breakdown:** The erosion score of the gully was **43**. The previous erosion score for CVR56 was **41**, suggesting that the gully has not changed drastically but has continued to actively erode. The gully is in impact Tier B affecting the impaired waterbody Spring Creek and contributing **7** points towards the ranking score. Lastly, 4 active investigation and cleanup sites were found within a 1-mile radius, contributing 1 point towards the final score of **51** (Table 14).

Figure 16. Photos of gully CVR56. A) Facing west looking towards left bank from inside. B) Facing north looking up gully.

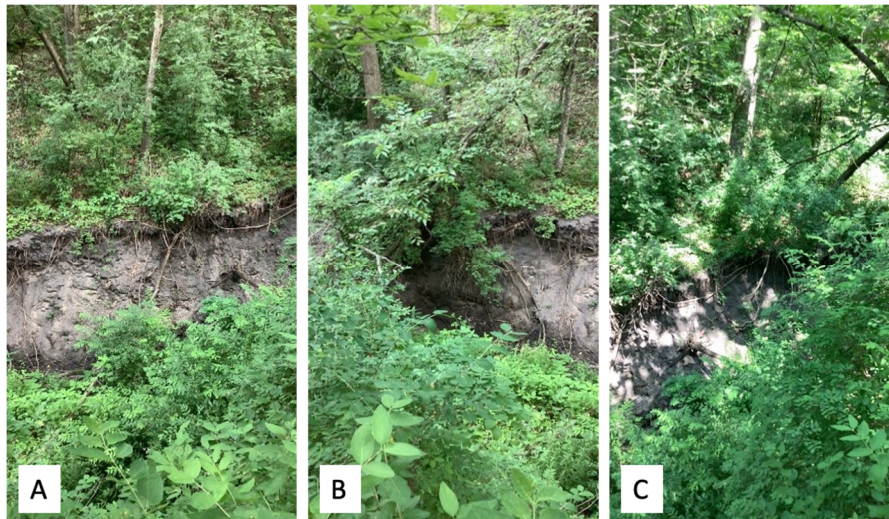
- **Soils:** There is bare soil on the banks and the gully bottom, consisting of mostly sandy material.
- **Field Observations:** There is evidence of overhanging banks and slumping, due to the non-compact soil (Figure 17). There was a drainage feature observed as well as running water at the bottom of the gully, but due to extremely steep slopes, photos of these conditions are not available.

- **Ranking Score Breakdown:** This gully received a potential erosion score of **50**, which is higher than its previous erosion score of **45**. This change in erosion score is due to the change in gully depth and lack of vegetation during the 2023 Project assessment. This gully is located in impact Tier B contributing **7** points, due to its proximity to an impaired waterbody or tributary to a high value resource. BLM78 contained only 1 active investigation or cleanup site within a 1-mile radius, contributing **0.25** points to the ranking score. BLM78 resulted in a final score of **57.25** (Table 15).

Figure 17. Photos of gully BLM78. A) Facing south looking across the gully at bare bank. B) Facing southeast at bare bank. C) Facing southwest at bare bank with leaning trees.

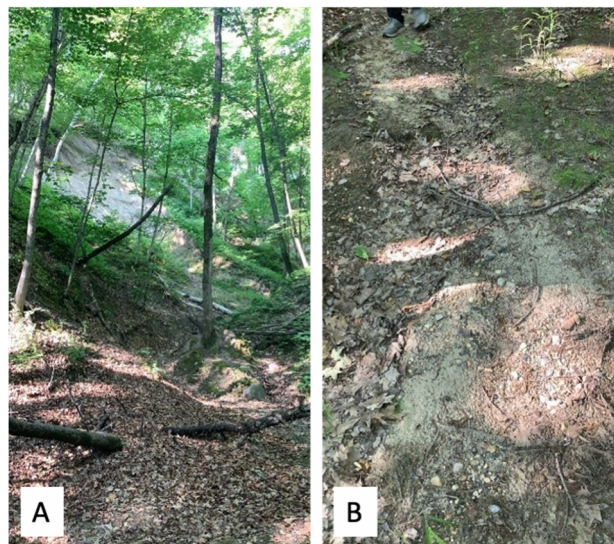
- **Ranking Score Breakdown:** The current erosion score of this gully is **47**. CVR38 had a previous erosion score of **40** and previously had more vegetation on its banks. This increased erosion score indicates that CVR38 is unstable and should be considered for a restoration project. This gully fell within impact Tier B contributing **7** points, which is of some concern to the LMRWD as it is near an impaired waterbody, Spring Creek. There are 6 active investigation or cleanup sites within a 1-mile radius, bringing the total score for CVR38 to **55.5** (Table 16).

Figure 18. Photos of gully CVR38. A) Facing south looking up at headcut. B) Gully bottom material and aggradation.

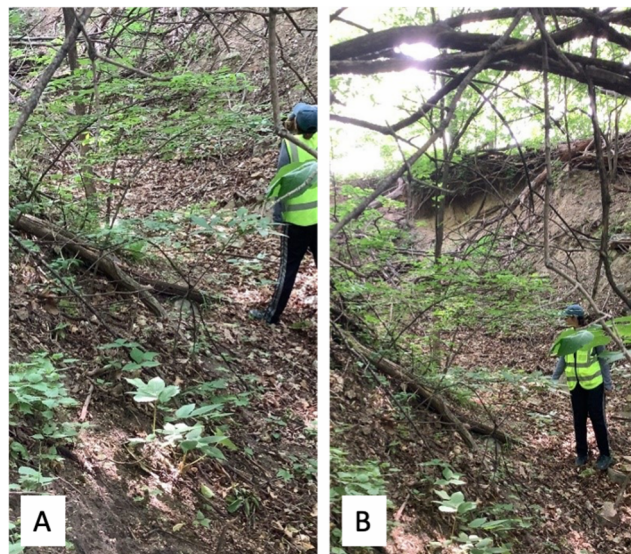
- **Soils:** The gully consists of sandy non-compact material.
- **Field Observations:** The slopes were extremely steep and there were significant overhanging banks, causing many leaning or falling trees within the channel (Figure 19). There was also severe sediment aggradation and degradation observed.

- **Ranking Score Breakdown:** The overall erosion potential score was **43**. In previous assessments, this gully received a score of **39**, but as the gully became deeper, narrower, and less vegetated, the erosion potential score increased. Additionally, the gully material is no longer sand and has eroded away to a fine-grained cohesive material. It was also noted from 2020 that the nearby homeowner had expressed concerns about the gully worsening. CVR76 is in impact Tier B contributing **7** points, due to its proximity to Spring Creek. There are 4 active investigation or cleanup sites within a 1-mile radius of CVR76, which contributed **1** point. This resulted in gully CVR76 receiving a final ranking score of **51** (Table 17).

Figure 19. Photos of gully CVR76. A) Facing east looking up at the gully. B) Facing east looking at headcut.

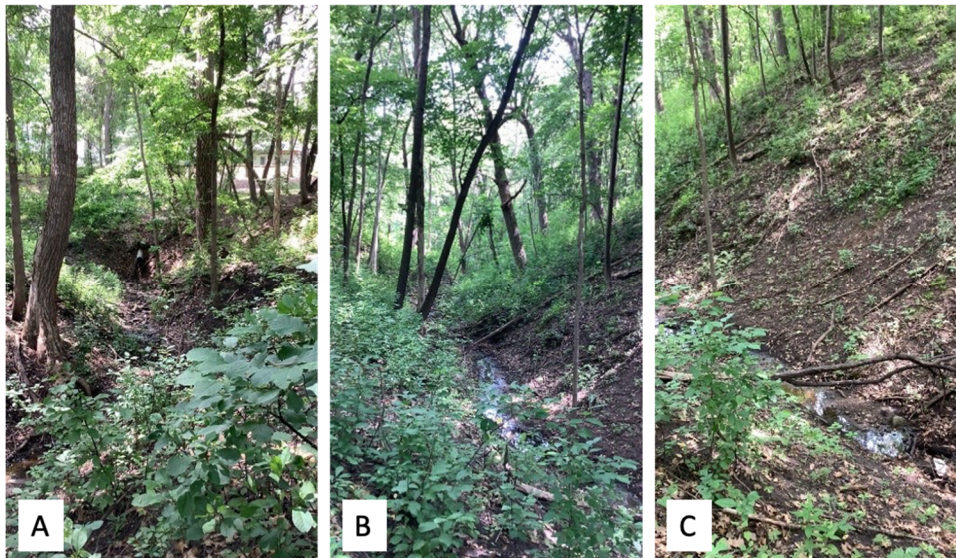
- **Safety:** The home is within 50 feet of the gully, indicating a possible safety concern.
- **Vegetation:** No vegetation was found on the banks or bottom (Figure 20).

- **Soils:** The gully consisted of non-cohesive material that was not compact (Figure 20).
- **Field Observations:** There was a drainage feature observed, causing water to flow within the channel. Additionally, there was evidence of severe aggradation in the bottom of the gully.

- **Ranking Score Breakdown:** BVL15 received an erosion score of **39**. Previously, this gully had an erosion score of **37**, but has become more V-shaped and less vegetated. This gully is in impact Tier A, contributing **10** points for Black Dog Fen and has 15 active investigation or cleanup sites within a 1-mile radius for a total score of **52.75** (Table 18). Since the outfall is likely the cause of this erosion and it is near a residential home, BVL15 is a gully of concern.

Figure 20. Photos of gully BVL15. A) Facing south viewing the drainage feature in the headcut. B) Facing north looking down at the gully from bank. C) Bare bank of gully with water flowing in channel.

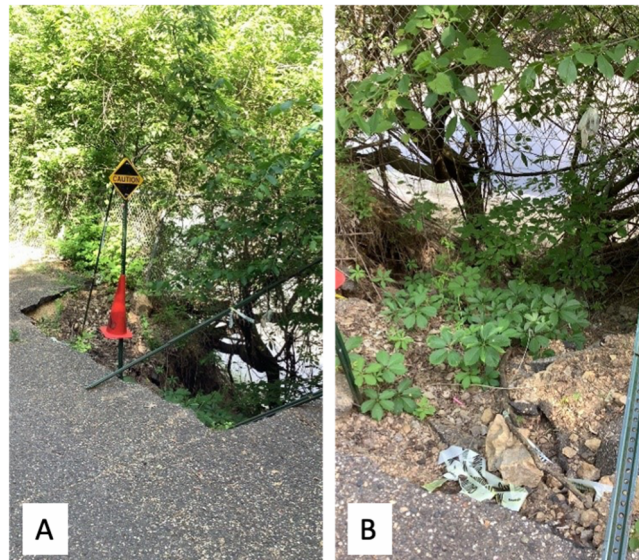
- **Ranking Score Breakdown:** SHK16 was given an erosion potential score of **32**. Previously, this gully had a similar erosion score of **31**. It is within impact Tier B, contributing **7** points, due to its proximity to the Minnesota River and has 14 active investigation or cleanup sites within a 1-mile radius, contributing **3.5** points to the final ranking score. Although the overall score for SHK16 is only **42.5** (Table 19) and it is located on private land, the gully is causing significant damage to infrastructure and poses a safety threat. Thus, SHK16 should be considered for a restoration project.

Figure 21. Photos of SHK16. A) Gully marked with sign as it encroaches on paved trail. B) Looking down at the gully from the headcut.

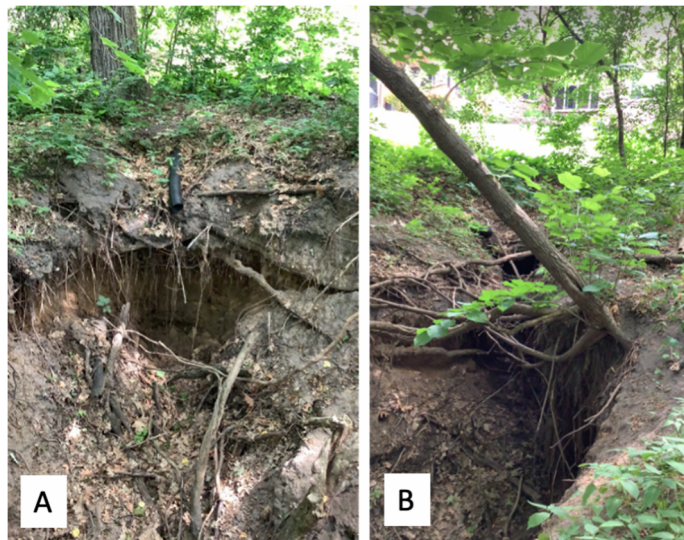
- **Erosion Score Breakdown:** The erosion potential score for this gully is **48**. While the gully is not currently extremely long, it will continue to rapidly grow if no intervention takes place. Many other drainage pipes were observed around the area that could lead to similar issues.

Figure 22. Photos of BLM173. A) Facing north looking at one headcut of the gully. B) Facing northeast looking at another headcut

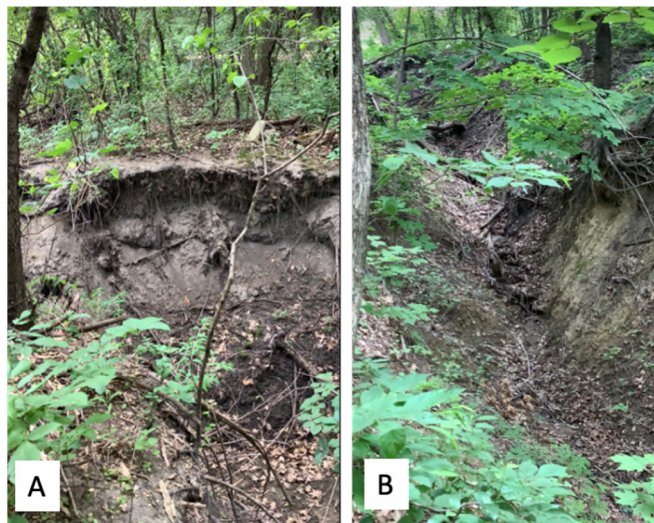
- **Erosion Score Breakdown:** The total erosion score for this gully is **49**.

Figure 23. Photos of CHH11. A) Headcut viewed from gully bottom. B) V-shaped banks viewed from gully bottom.
