Technical Memorandum

Re: 2025 Gully Inventory – Post-Field Assessment Summary

2023 Gully Inventory and Condition Assessment Project

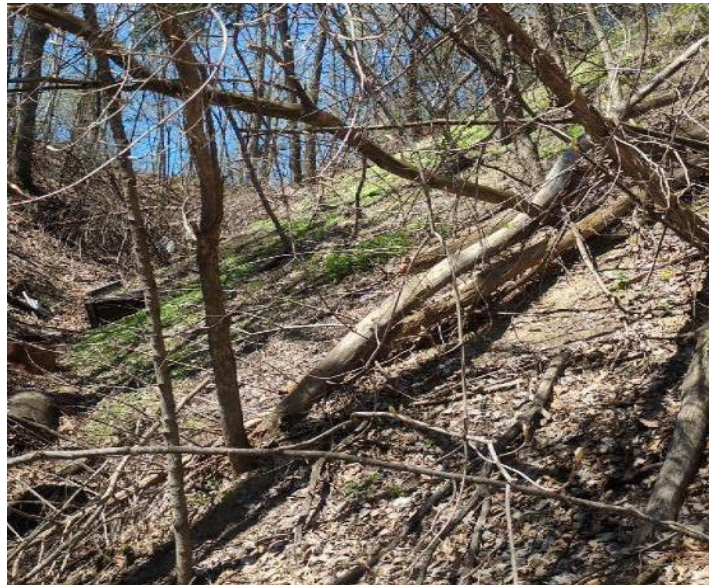
Photo 1. CVR63 Gully Condition

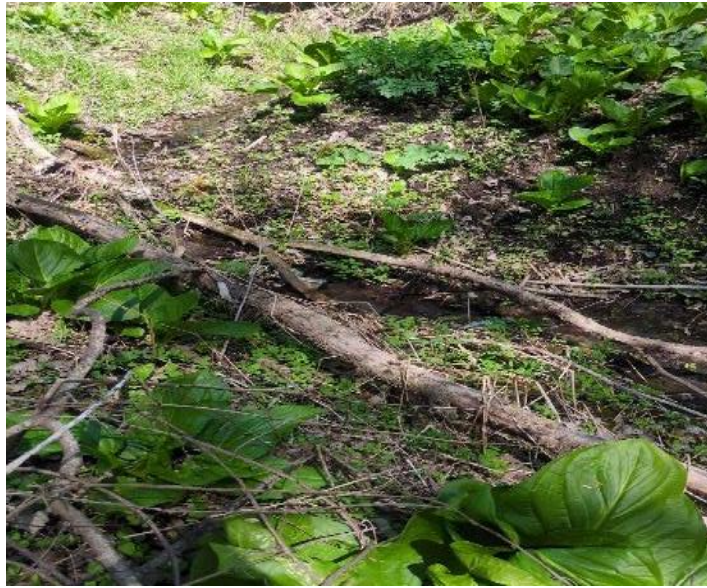
BLM61, 64, and 151 are located to the west of Interstate 35 West (I-35W) near the interstate bridge. To access the gullies, Young Environmental staff accessed residential property. BLM151, shown below, is the largest of these Bloomington gullies and forms a drainage ditch that the other nearby gullies empty into. BLM61 and BLM64, shown on page 6, are both small gullies created by groundwater seepage.

Photo 2. BLM151 Gully Condition

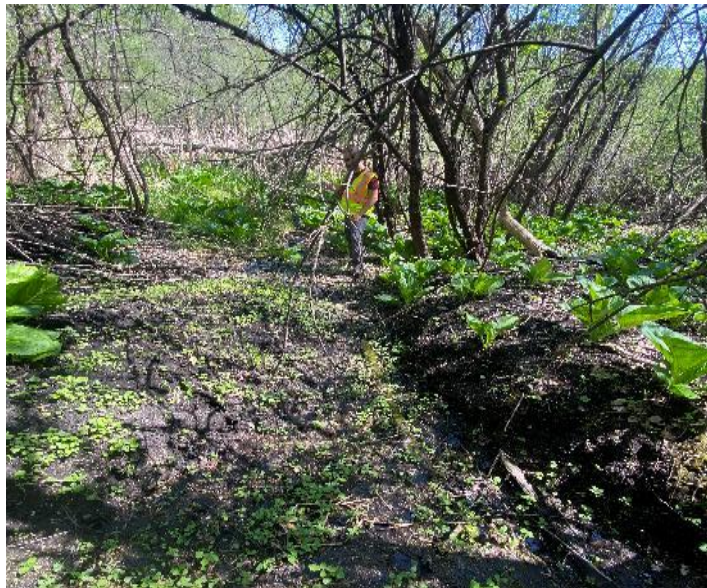
Photo 3. BLM64 Gully Condition

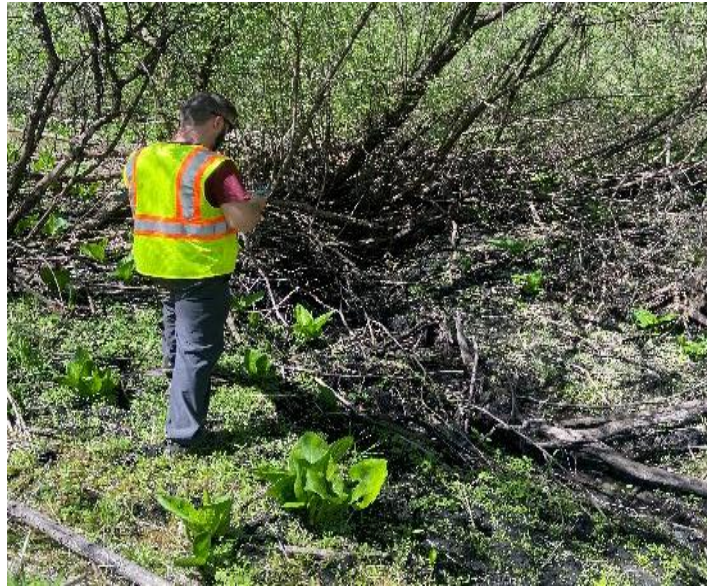
Photo 4. BLM61 Gully Condition

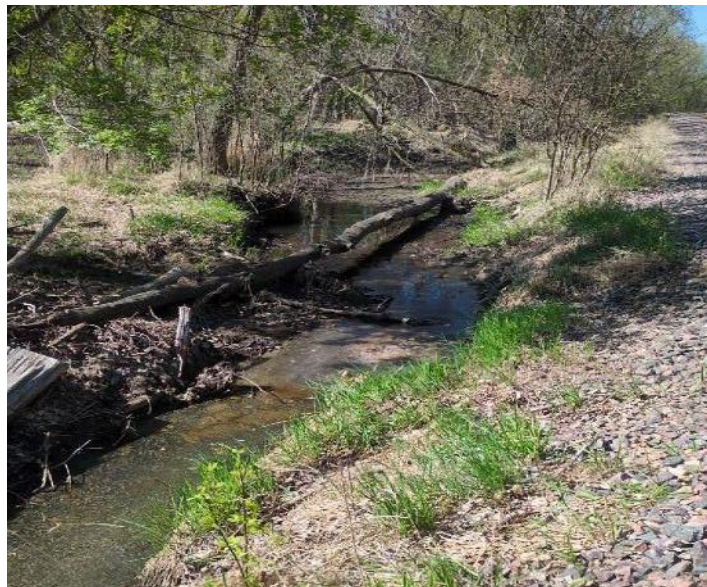
BVL52 and 8 are located adjacent to railroad tracks. The gullies were accessed by walking along the City right-of-way (Hayes Drive), exiting Hayes Drive to the north, following a constructed drainage channel, and through undeveloped, US Fish and Wildlife Service land. The gullies were close in proximity (within 50 feet of one another). BVL52 is a long drainage ditch that runs along the south side of the elevated rail line. BVL8 is a small gully that has developed where a natural drainage network empties into the larger drainage ditch (BVL52).

Photo 5. BVL52 Gully Condition

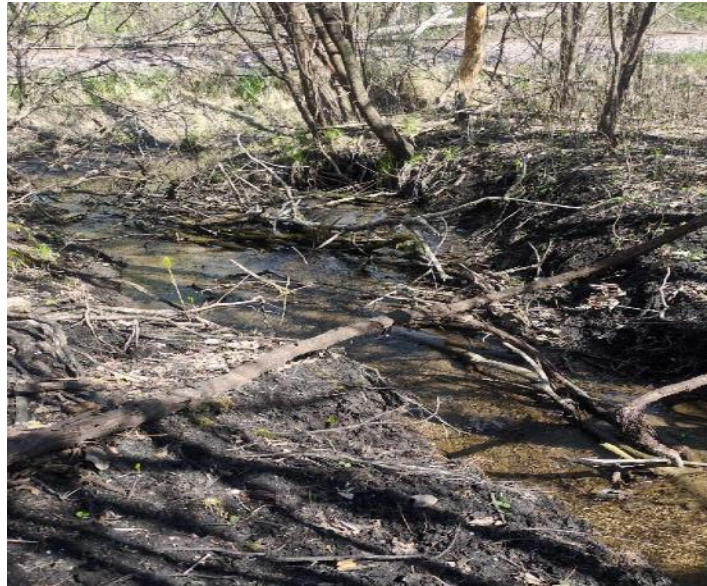
Photo 6. BVL8 Gully Condition

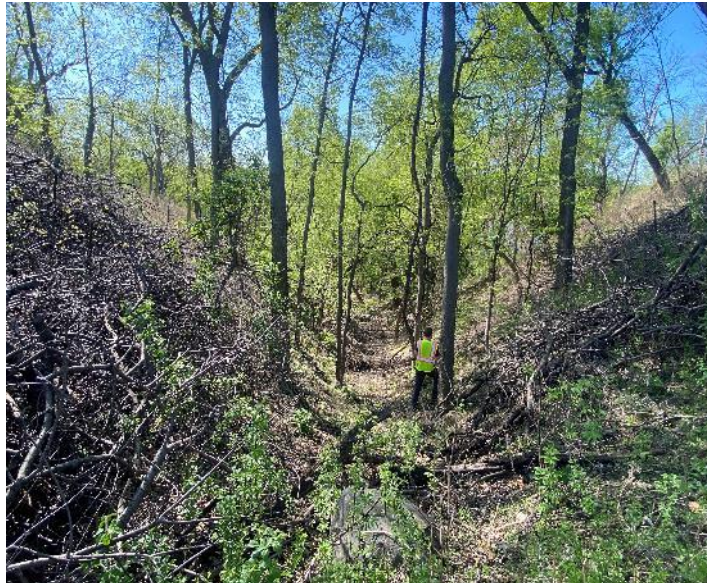
FSN2 is located along a public trail on the south side of Interstate 494 (I-494) near the interstate bridge. Young Environmental accessed the gully from the nearby Minnesota Valley National Wildlife Refuge visitor center and the adjacent walking trail.

Photo 7. FSN2 Gully Condition

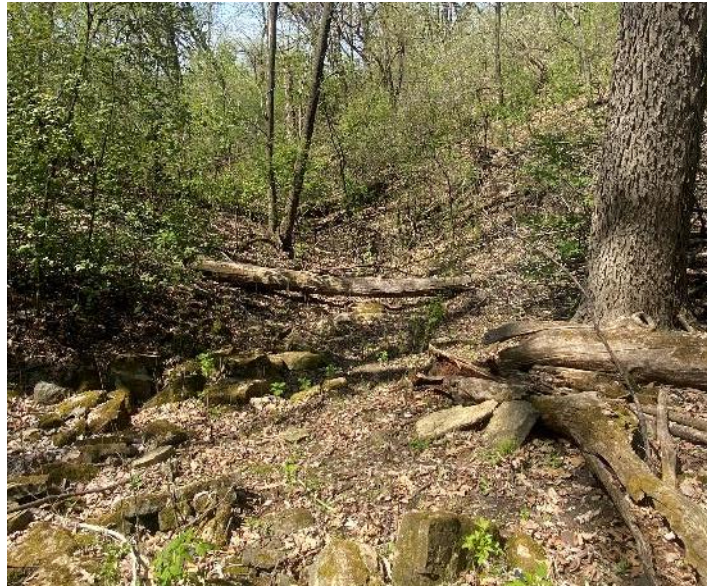
MDH11 and 14 are located near Sibley Memorial Highway along the railroad tracks. Both gullies were accessed by parking at the Big Rivers Regional Trail parking lot and walking along the trail. MDH14 is a short distance from the parking lot, and there appears to be rip rap installed previously to prevent erosion. MDH11, shown on page 9, is further north along the trail, has a wide base, and dense vegetation growing in it.

Photo 8. MDH14 Gully Condition

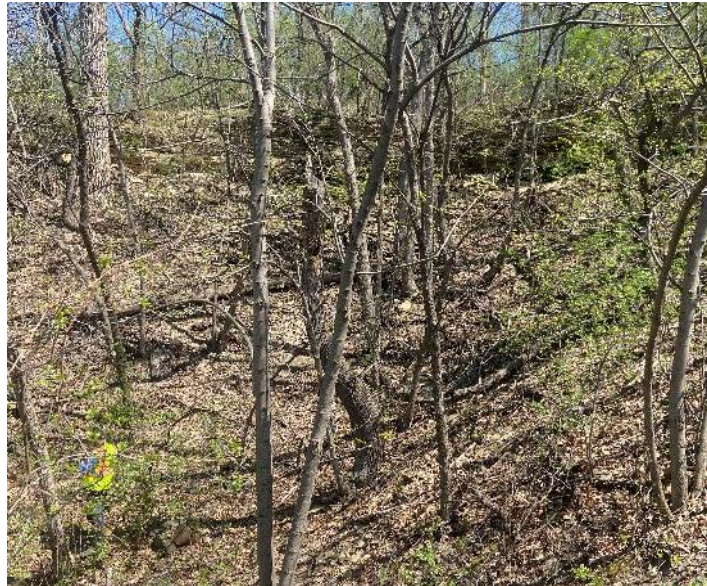
Photo 9. MDH11 Gully Condition

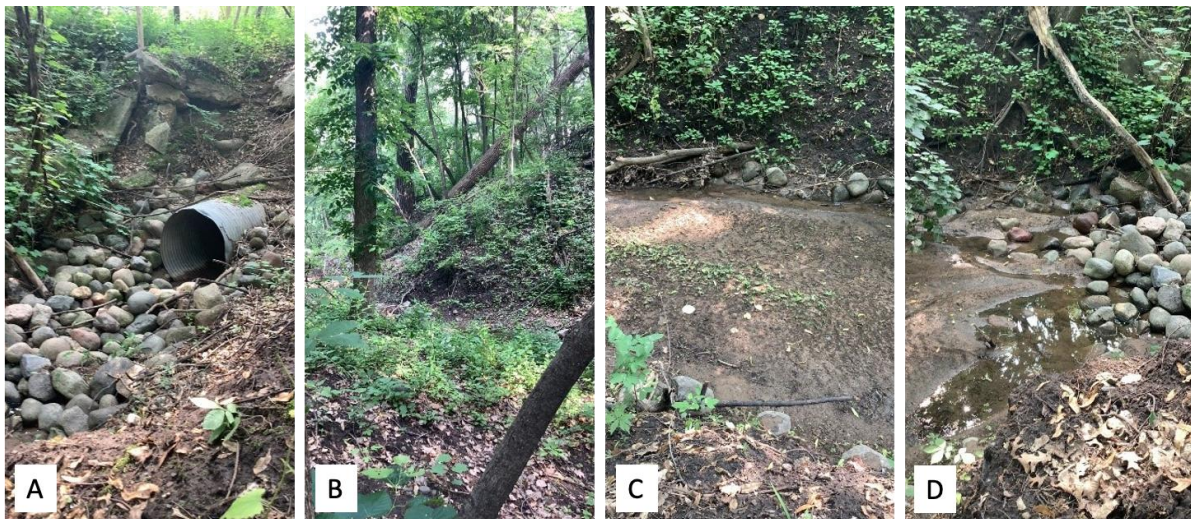
- **Location:** BVL62, located in Burnsville and was easily accessible behind homes on Chatham Ct N (Figure 7).
- **Size:** The gully is over 100 feet long, 15 feet high, and 1-5 feet wide at the bottom.

- **Ranking Score Breakdown:** This gully has a total erosion score of **47**, which is greater than the 2021 assessment’s score of **32**. This is due to the gully being longer, deeper, and less vegetated than in the last visit. BVL62 is in impact Tier A, meaning it is near high value resource areas in the LMRWD, adding **10** points to the final ranking score. BVL62 specifically impacts Black Dog Fen. It also has 18 sites of active investigation or cleanup within a 1-mile radius, adding **4.5** points to the final ranking score. Gully BVL62 received a total of **61.5** points (Table 6), which is the highest-ranking score given out of all the gullies surveyed.

Figure 8. Photos of gully BVL62. A) Headcut with large pipe outfall and surrounding rip rap. B) Facing North at bank from the side of the headcut. C) Gully bottom condition. D) Image of water pooling at bottom of rip rap

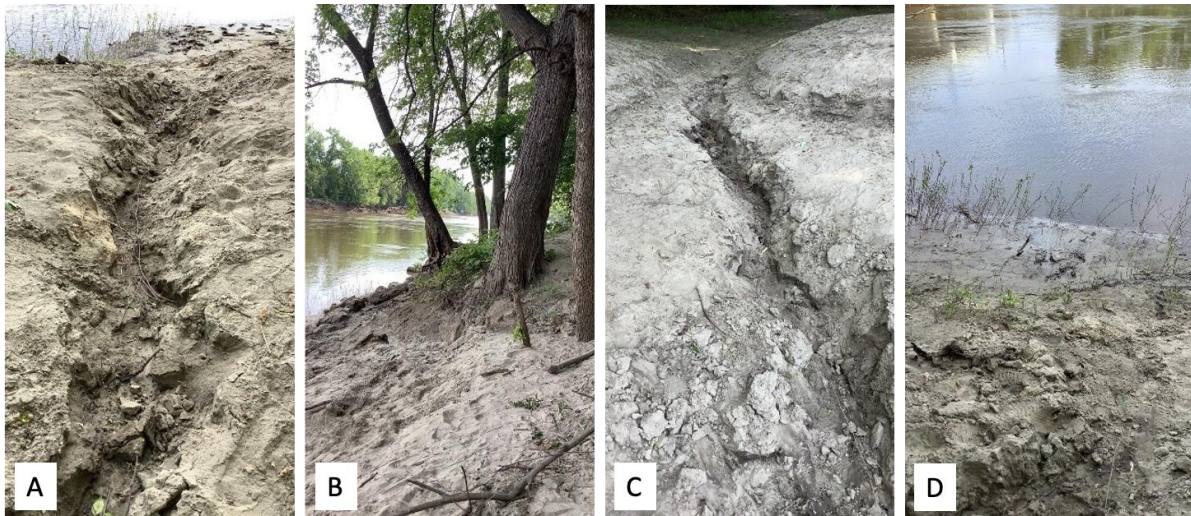
- **Ranking Score Breakdown:** The calculated erosion score was **42**, which is greater than the previous year's score of **35**. SHK1 is in impact Tier B because it directly discharges sediment to the Minnesota River, which is defined as an impaired water body, adding **7** points to the final ranking score. This gully has 32 active investigation or cleanup sites within a mile radius, adding **8** points and giving it a final score of **57** (Table 7).

Figure 9. Photos of gully SHK1. A) Facing north looking down at gully. B) Facing south looking up at gully. C) Leaning tree along bank adjacent to the gully. D) Water at gully edge in the Minnesota River.

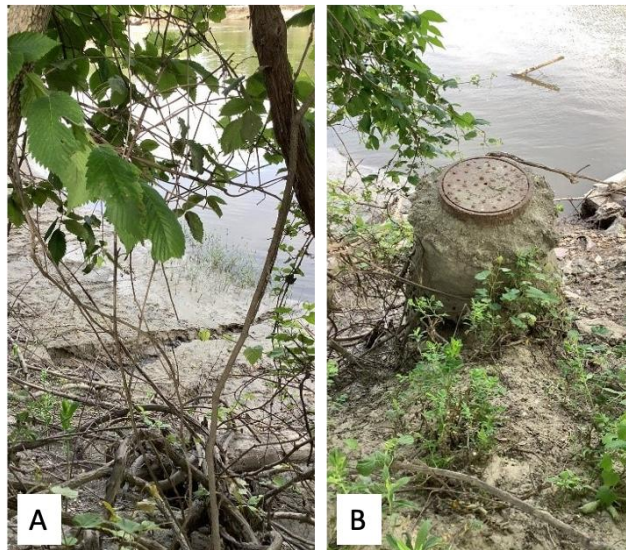
- **Ranking Score Breakdown:** The erosion potential score is **42**, which is higher than the previous erosion score of **34**. SHK10 falls into impact Tier B because of its proximity to the Minnesota River, which is an impaired waterbody, contributing **7** points to the final score. This gully was found to have 32 active investigation or cleanup sites found within a mile radius adding another **8** points, giving it a final score of **57** (Table 8).

Figure 10. Photos of gully SHK10. A) Facing northwest looking down at gully. B) Image of structure that is surrounded by evident erosion.

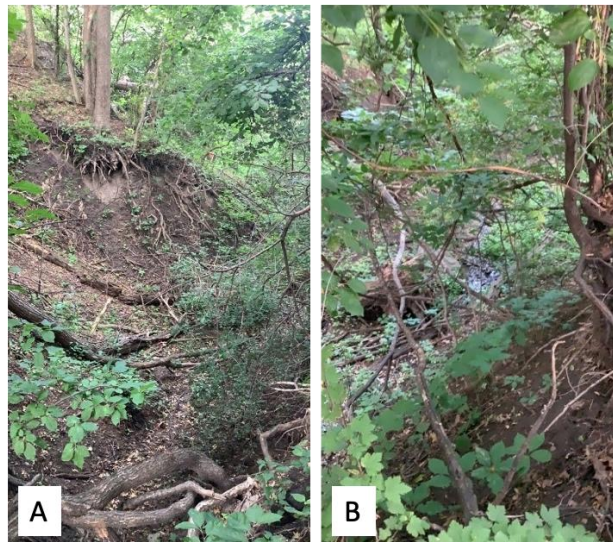
- **Ranking Score Breakdown:** The gully ultimately has an erosion score of **44**, which is higher than the previous erosion potential score of **39**, due to the gully being longer and less vegetated. BVL3 is in impact Tier A contributing **10** points, as this site is near the location of the high value resource, Black Dog Fen. There are also 30 active investigation or cleanup sites within a 1-mile radius of this gully, which contributed **7.5** points. Gully BVL3 received a total of **61.5** points (Table 9), which is the highest score given from these assessments.

Figure 11. Photos of gully BVL3. A) Facing west by the headcut, viewing overhanging bank B) Seepage at gully bottom

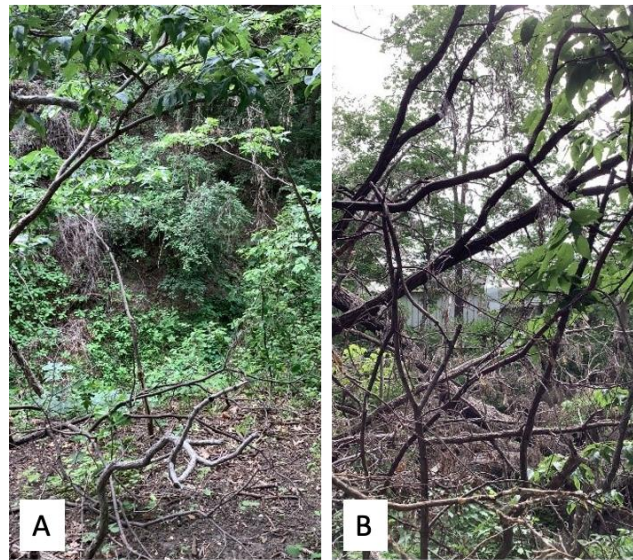
- **Ranking Score Breakdown:** The final erosion potential score was calculated to be **44**. This gully fell into impact Tier A, due to its proximity to the high value resource Black Dog Fen, contributing **10** points to the final ranking score. Lastly, there were 21 active investigation or cleanup sites within a mile of the gully contributing another **5.25** points. The final score for this gully is **59.25** (Table 10).

Figure 12. Photos of gully BLM68. A) Facing southeast on bank, looking down at the gully. B) Image of large shed near the gully

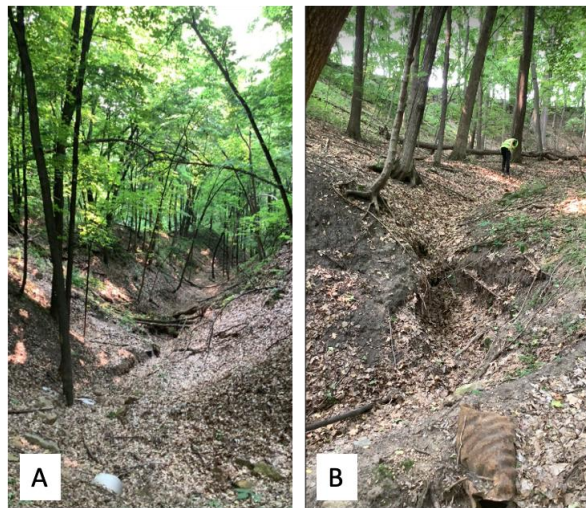
- **Ranking Score Breakdown:** CVR81 received a final erosion score of **50**, which is tied for the highest erosion potential score of all the gullies surveyed. Previously, CVR81 received an erosion potential score of **43**; however, the gully has become more V-shaped, developed overhanging banks, and had more sediment aggradation, increasing its erosion potential score during the 2023 Project assessment. CVR81 is within impact Tier B, as it affects the impaired waterbody of Spring Creek, accounting for **7** points toward its final score. CVR81 has 6 active investigation and cleanup sites within a mile radius, giving it an additional **1.5** points toward the final score. The final ranked score for this gully is **58.5** (Table 11).

Figure 13. Photos of Gully CVR81. A) Northeast looking down from headcut with view of outlet. B) East looking at new headcut development

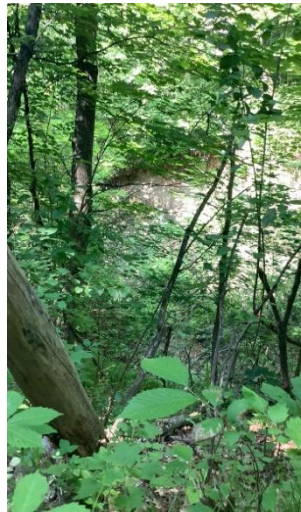
- **Ranking Score Breakdown:** CVR55 received a previous erosion score of **32** and had a large increase in erosion since the last assessment. Due to its easily erodible material and large size, CVR55 received an initial erosion score of **45**. Seven points were added because the gully is in impact Tier B contributing **7** points, affecting the impaired waterbody Spring Creek, which is of some concern to LMRWD. There were also 3 active investigation or cleanup sites near the gully, adding **0.75 points** to the score. The total score for this gully was **52.75** (Table 12)

Figure 14. Photo of CVR55. Facing west looking downstream of the gully.

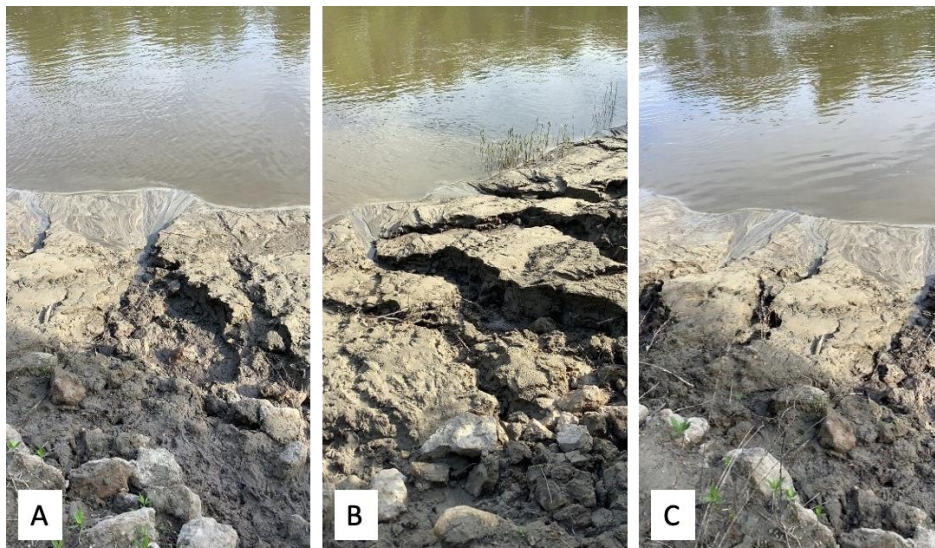
- **Ranking Score Breakdown:** Due to these conditions, this gully received an erosion potential score of **37**. This gully was found to be within impact Tier B and **7** points were awarded to the gully ranking score. Lastly, 14 MPCA active investigation or cleanup sites were found within a 1-mile radius resulting in **8** points added. In total, SHK3 received a ranking score of **52** (Table 13) and was the second highest ranked gully on public property without a safety concern.

Figure 15. Photos of gully SHK3. A) Facing north looking downstream from the headcut. B) Facing northeast looking at the side of the gullies. C) Another view of the gully from the headcut.

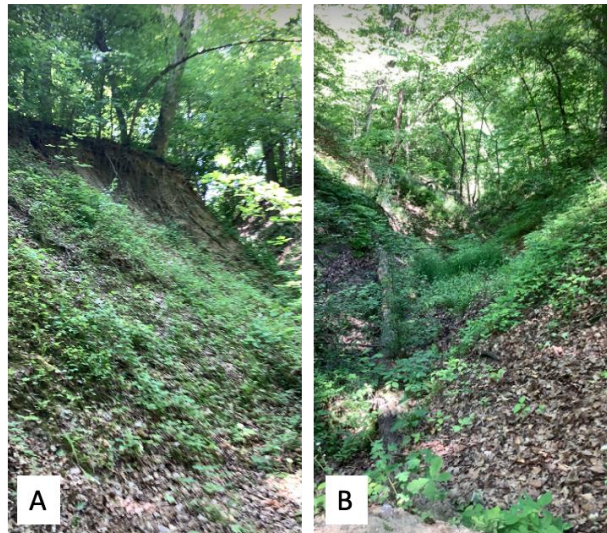
- **Ranking Score Breakdown:** The erosion score of the gully was **43**. The previous erosion score for CVR56 was **41**, suggesting that the gully has not changed drastically but has continued to actively erode. The gully is in impact Tier B affecting the impaired waterbody Spring Creek and contributing **7** points towards the ranking score. Lastly, 4 active investigation and cleanup sites were found within a 1-mile radius, contributing 1 point towards the final score of **51** (Table 14).

Figure 16. Photos of gully CVR56. A) Facing west looking towards left bank from inside. B) Facing north looking up gully.

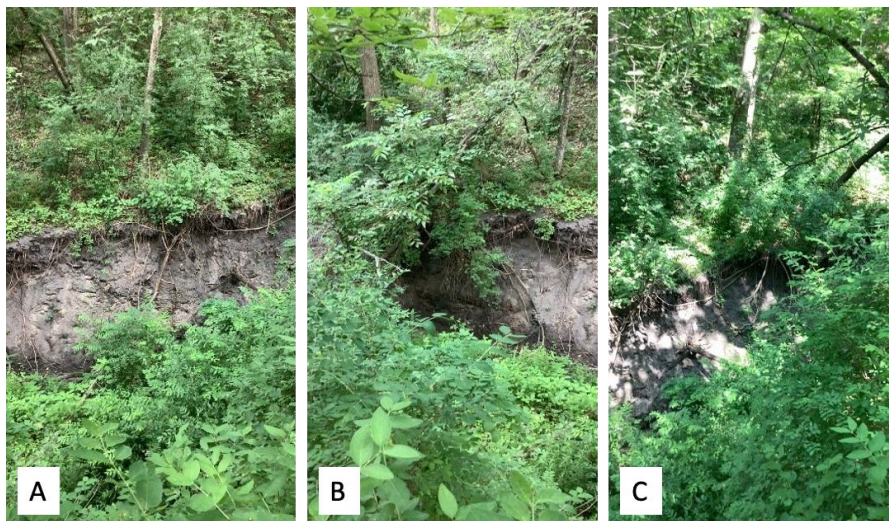
- **Ranking Score Breakdown:** This gully received a potential erosion score of **50**, which is higher than its previous erosion score of **45**. This change in erosion score is due to the change in gully depth and lack of vegetation during the 2023 Project assessment. This gully is located in impact Tier B contributing **7** points, due to its proximity to an impaired waterbody or tributary to a high value resource. BLM78 contained only 1 active investigation or cleanup site within a 1-mile radius, contributing **0.25** points to the ranking score. BLM78 resulted in a final score of **57.25** (Table 15).

Figure 17. Photos of gully BLM78. A) Facing south looking across the gully at bare bank. B) Facing southeast at bare bank. C) Facing southwest at bare bank with leaning trees.

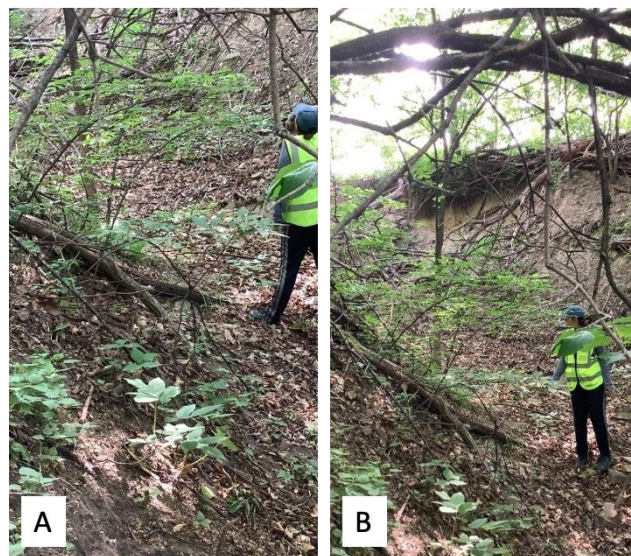
- **Ranking Score Breakdown:** The overall erosion potential score was **43**. In previous assessments, this gully received a score of **39**, but as the gully became deeper, narrower, and less vegetated, the erosion potential score increased. Additionally, the gully material is no longer sand and has eroded away to a fine-grained cohesive material. It was also noted from 2020 that the nearby homeowner had expressed concerns about the gully worsening. CVR76 is in impact Tier B contributing **7** points, due to its proximity to Spring Creek. There are 4 active investigation or cleanup sites within a 1-mile radius of CVR76, which contributed **1** point. This resulted in gully CVR76 receiving a final ranking score of **51** (Table 17).

Figure 19. Photos of gully CVR76. A) Facing east looking up at the gully. B) Facing east looking at headcut.

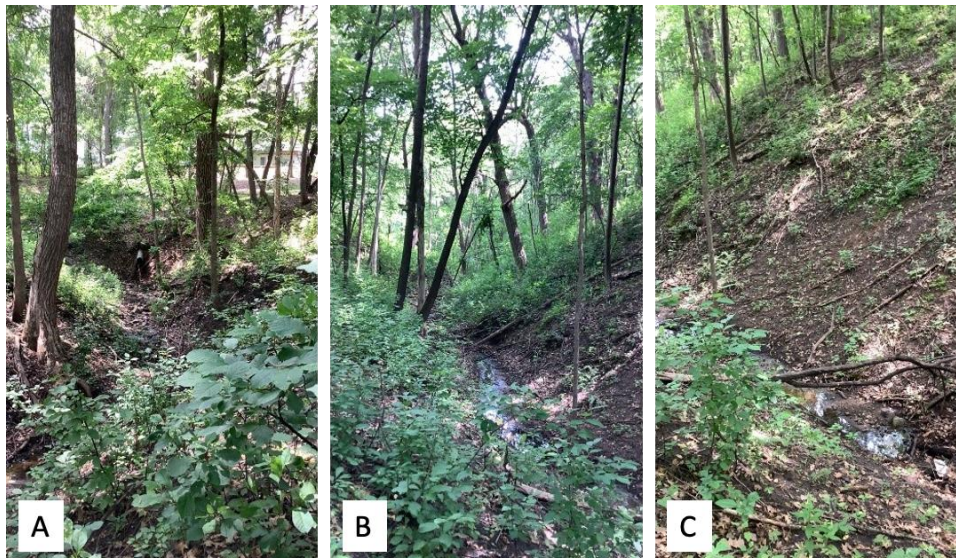
- **Ranking Score Breakdown:** BVL15 received an erosion score of **39**. Previously, this gully had an erosion score of **37**, but has become more V-shaped and less vegetated. This gully is in impact Tier A, contributing **10** points for Black Dog Fen and has 15 active investigation or cleanup sites within a 1-mile radius for a total score of **52.75** (Table 18). Since the outfall is likely the cause of this erosion and it is near a residential home, BVL15 is a gully of concern.

Figure 20. Photos of gully BVL15. A) Facing south viewing the drainage feature in the headcut. B) Facing north looking down at the gully from bank. C) Bare bank of gully with water flowing in channel.

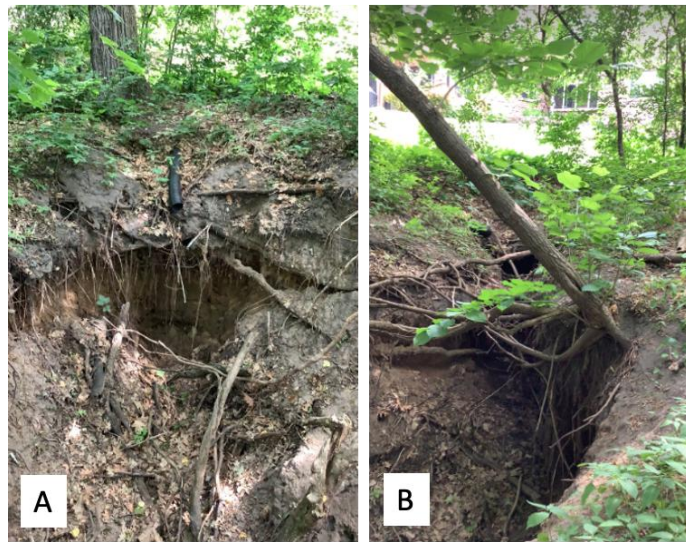
- **Erosion Score Breakdown:** The erosion potential score for this gully is **48**. While the gully is not currently extremely long, it will continue to rapidly grow if no intervention takes place. Many other drainage pipes were observed around the area that could lead to similar issues.

Figure 22. Photos of BLM173. A) Facing north looking at one headcut of the gully. B) Facing northeast looking at another headcut

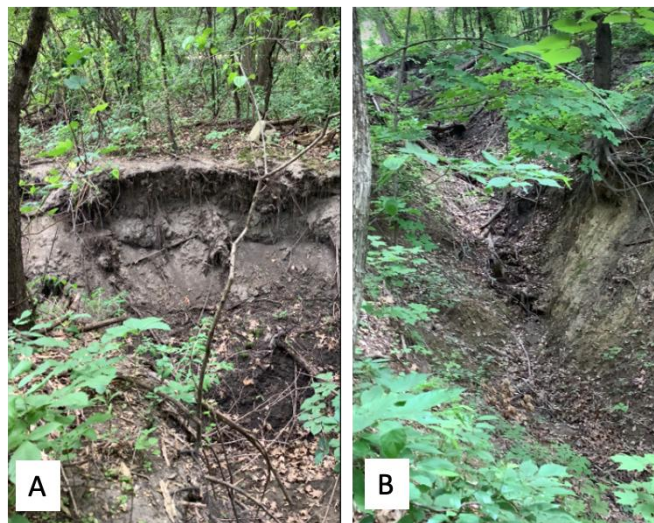
CHH11:

- **Erosion Score Breakdown:** The total erosion score for this gully is 49.

Figure 23. Photos of CHH11. A) Headcut viewed from gully bottom. B) V-shaped banks viewed from gully bottom.
