SITE LOCATION: CSAH 61-Flying Cloud Drive

PURPOSE: Construction Stormwater Site Visit on Behalf of the Lower Minnesota River Watershed District (LMRWD)

DATE & TIME: 4 December 2018, 0830-1030

INSPECTOR: Sarah Duke Middleton, Water Resources Scientist
Young Environmental Consulting Group, LLC

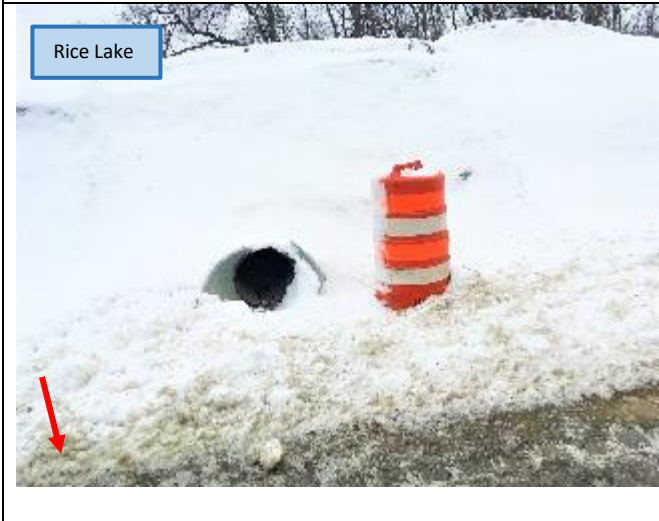
Photo No.: 1

Description: Inlet on top of roadway. Outlet is not visible due to snowpack.

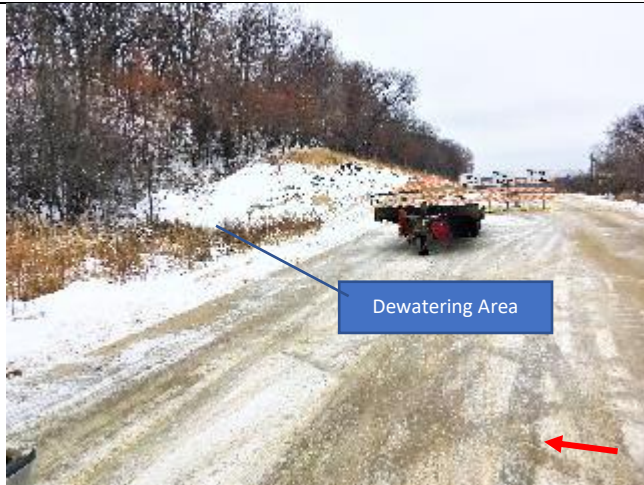
Photo No.: 2

Description: Location of dewatering – originally noted in the November 19th inspection report.

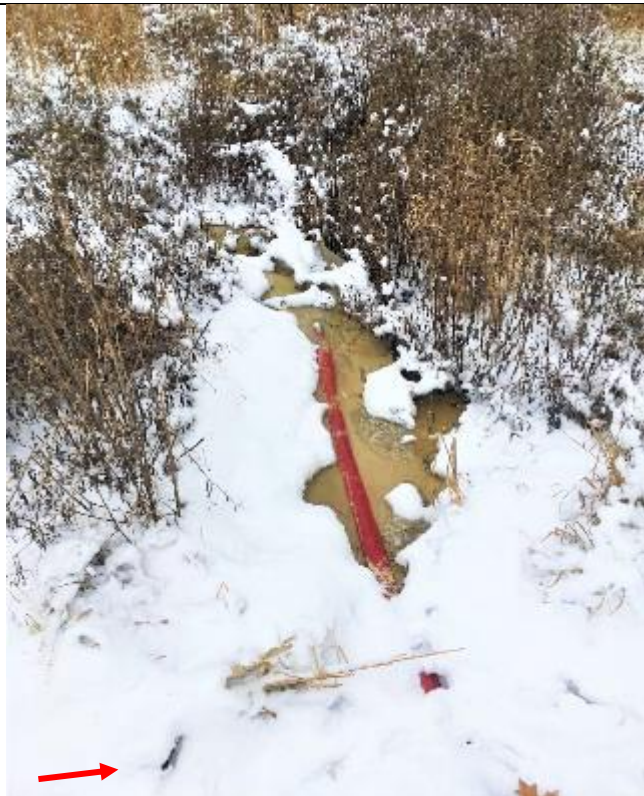
Photo No.: 3

inspection appeared unchanged since my last visit (see photos 2 through 4). The hose still lies on top of a filter bag in the wetland area, with a brown plume in the surrounding water. I was able to confirm that, at the time of my site visit, no water was coming out of the hose.

BMPs Present: Filter bag – unattached to hose

Description: Dewatering setup (first noted in the November 19th inspection report). The site appears unchanged. The hose is lying unattached, on top of the filter bag. The brown plume had not been disturbed in the wetland area.

During this site visit, I confirmed that the hose DOES NOT have water flowing out of it.

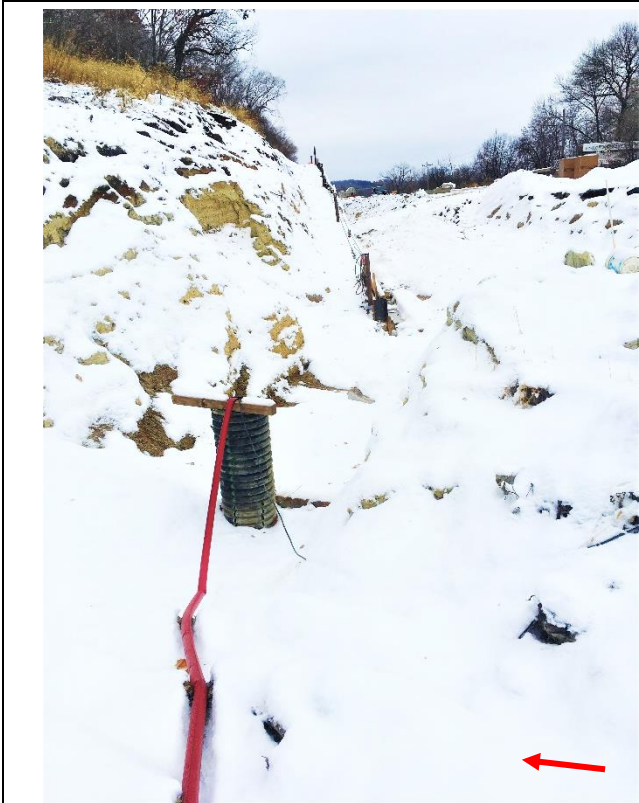
Photo No.: 4

Description: Part of dewatering setup pictured in photos 2 and 3.

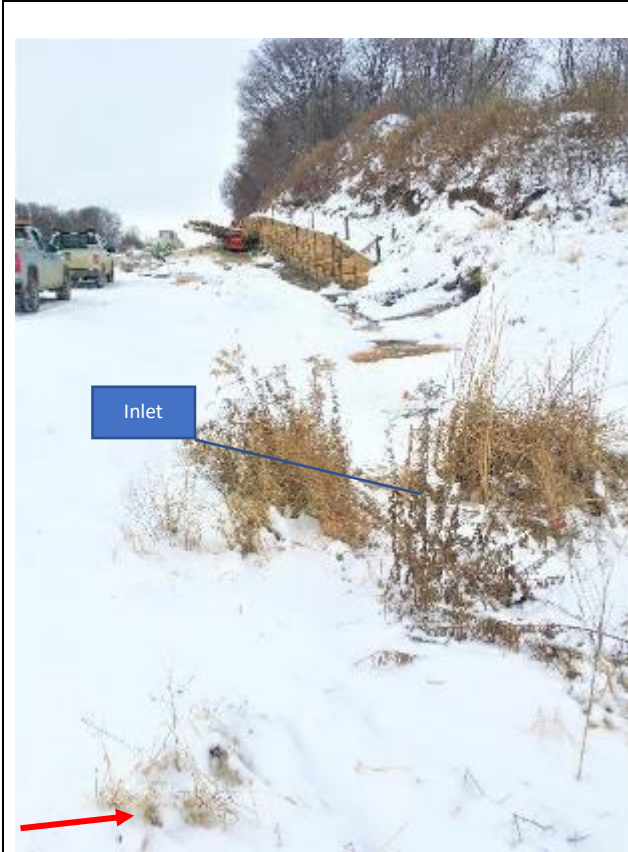
Photo No.: 5

BMPs Present: Possible rock checks

Description: Drainage of ROW on north side of project. Wall drains downslope towards vegetation at forefront of photo. There is an inlet in the vegetation (not visible due to vegetation and snow pack).

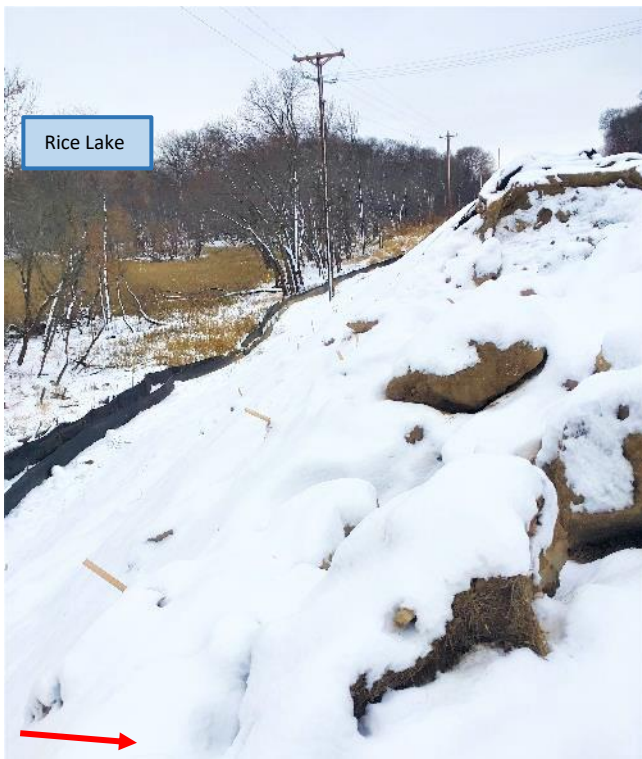
Photo No.: 6

BMPs Present: Two rows of silt fence; fabric

Description: South side of ROW appears unchanged since the November 19th site visit.

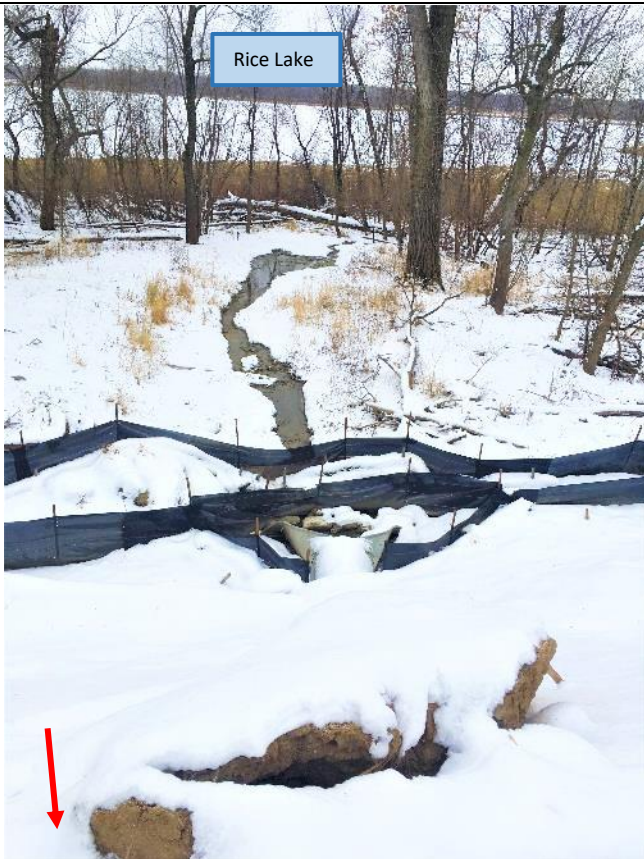
Photo No.: 7

BMPs Present: Multiple rows of silt fencing; sand bags in culvert

Description: Outlet of culvert. BMPs appear largely intact, and surrounding area is stable.

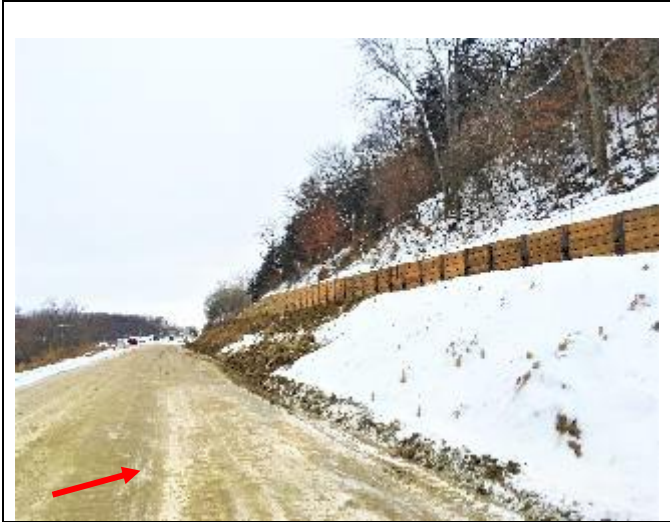
Photo No.: 8

Description: Northern side of ROW.

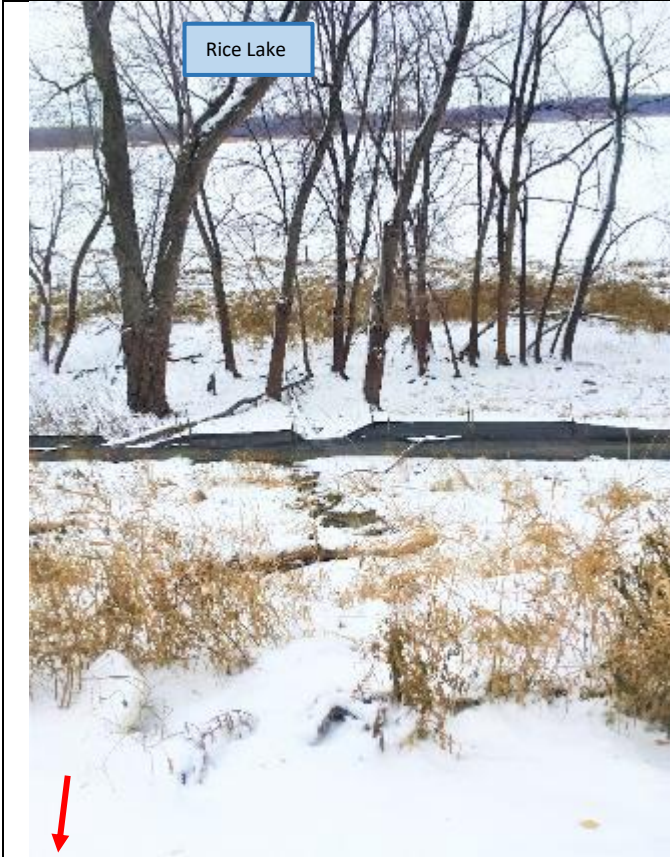
Photo No.: 9

BMPs Present: Two rows of silt fence; vegetation buffer

Description: Outlet of a culvert leading to Rice Lake. Area is frozen and stable.

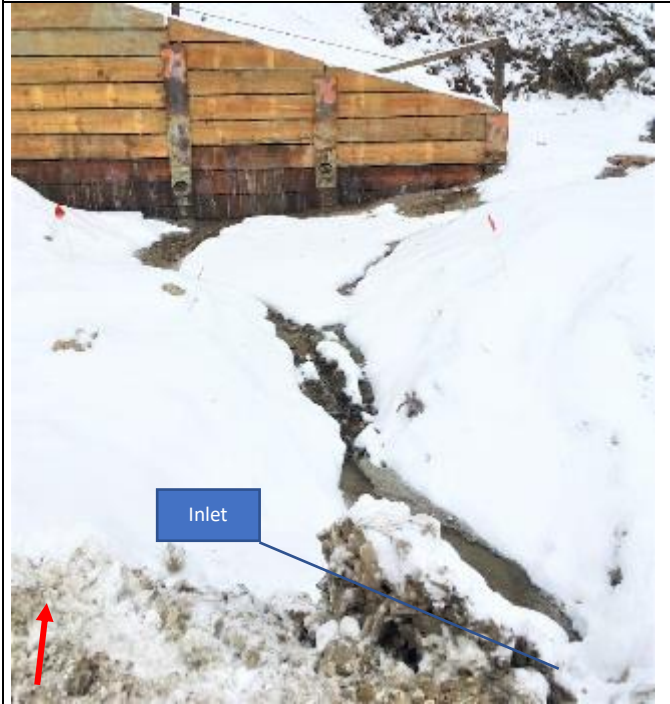
Photo No.: 10

Description: Stormwater runoff flowing from wall and along ROW to half-buried inlet (not visible due to snowpack). Due to current weather and site conditions the runoff is minimal, likely occurring when sun melts the snow.

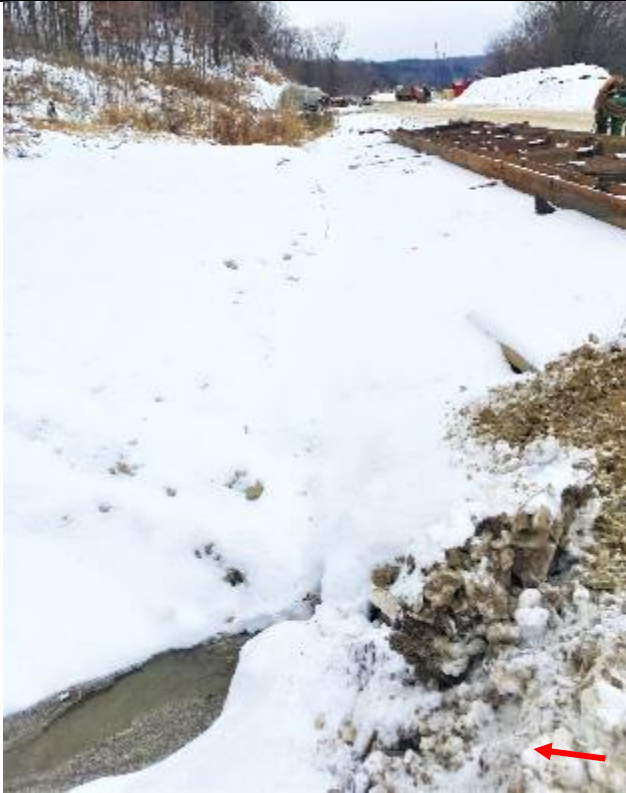
Photo No.: 11

Description: Drainage along northern side of ROW into buried inlet. See photo 10 for an additional view of drainage to this inlet.

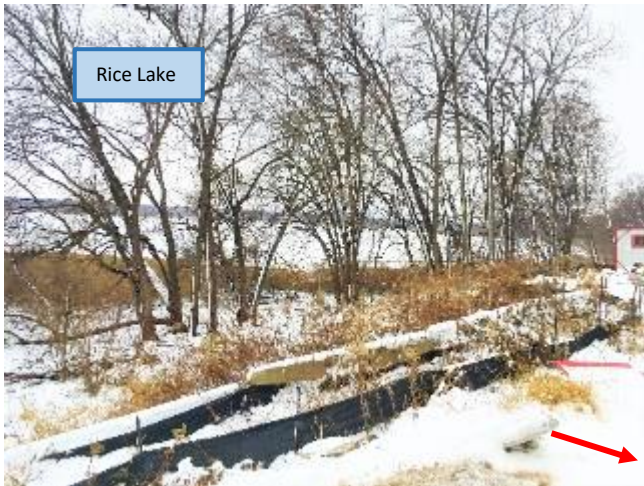
Photo No.: 12

BMPs Present: Silt fence with t-posts; silt fence backed with concrete barriers; vegetation buffer.

Description: South side of ROW stable and snow-covered.

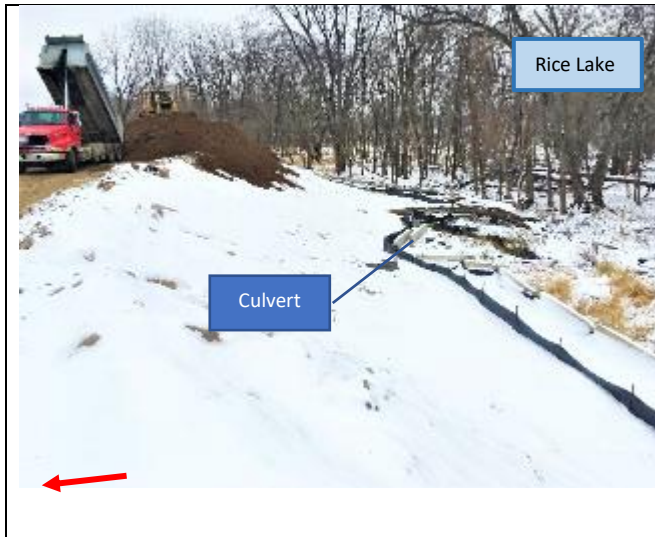
Photo No.: 13

BMPs Present: Silt fence with t-posts; silt fence backed with concrete barriers; possibly biologs

Description: Active construction grading upslope of culvert. Where undisturbed, ROW is stable.

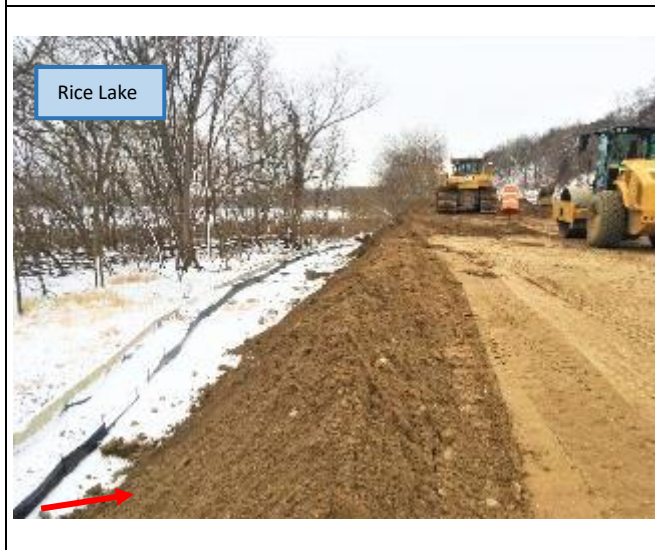
Photo No.: 14

BMPs Present: Silt fence with t-posts; silt fence backed with concrete barriers

Description: East side of construction activity in Photo 13. Grading upslope of BMPs.

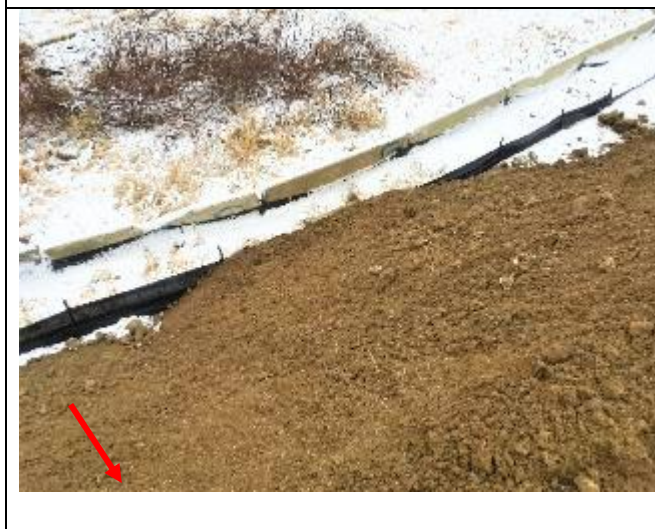
Photo No.: 15

BMPs Present: Silt fence with t-posts; silt fence backed with concrete barriers

Description: Same general area as photo 14. Soil overtopping a section of silt fencing.

- Numerous BMPs appear to have failed. Review site conditions (slope, drainage, etc.), and provide and install appropriate BMPs for site conditions and anticipated seasonal precipitation.
- Culverts draining stormwater: Culverts on the northern side of the road receive drainage from nearby construction activity. Without BMPs in place, sediment-laden stormwater flows directly into the culvert and outputs into Rice Lake or other down-gradient water features. See the following photos for reference: 1, 5, 9-11, 24, and 40-41.
- Actively maintain and install all site BMPs per regulatory requirements, design, and installation specifications.
- Remove construction debris and trash from the site (used oil bottles, fiber, rope, food waste, etc.).

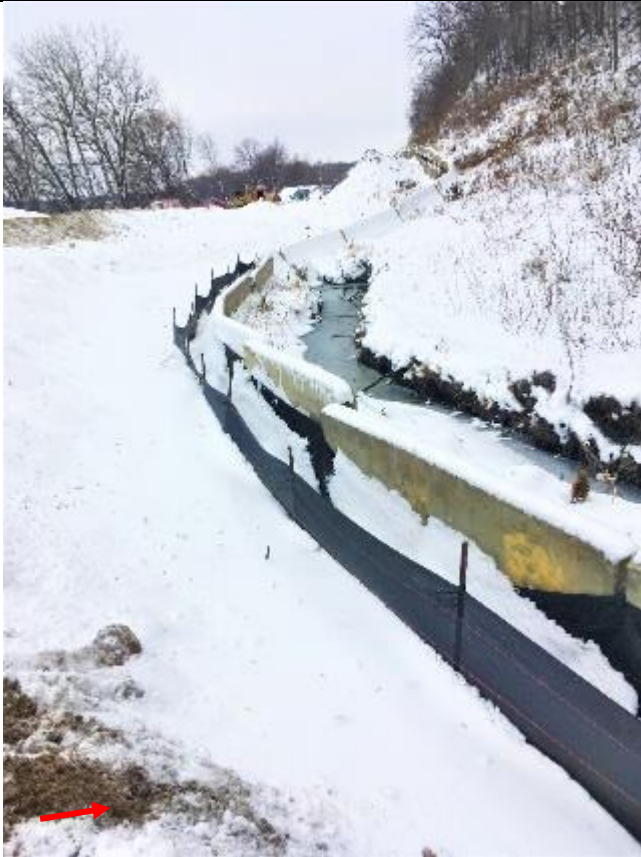
Photo No.: 16

Description: Northern side of ROW conditions.

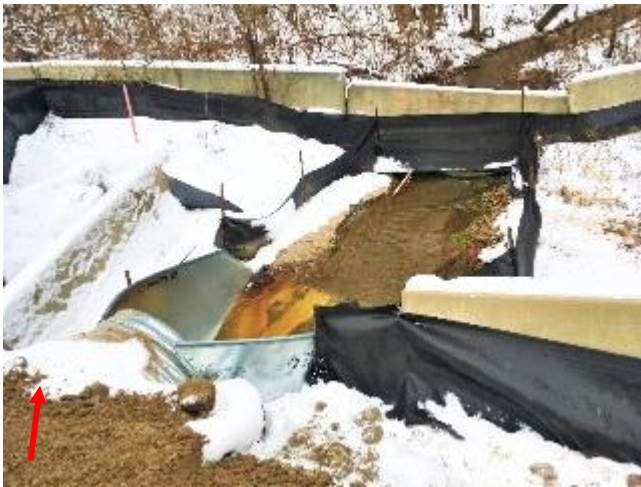
Photo No.: 17

BMPs Present: Silt fence with t-posts; silt fence backed with concrete barriers

Description: (Northern) Culvert inlet for a creek on the north side of the project. Area on either side of the culvert/creek bed is stable. Grading was taking place during the site visit upslope of the culvert.

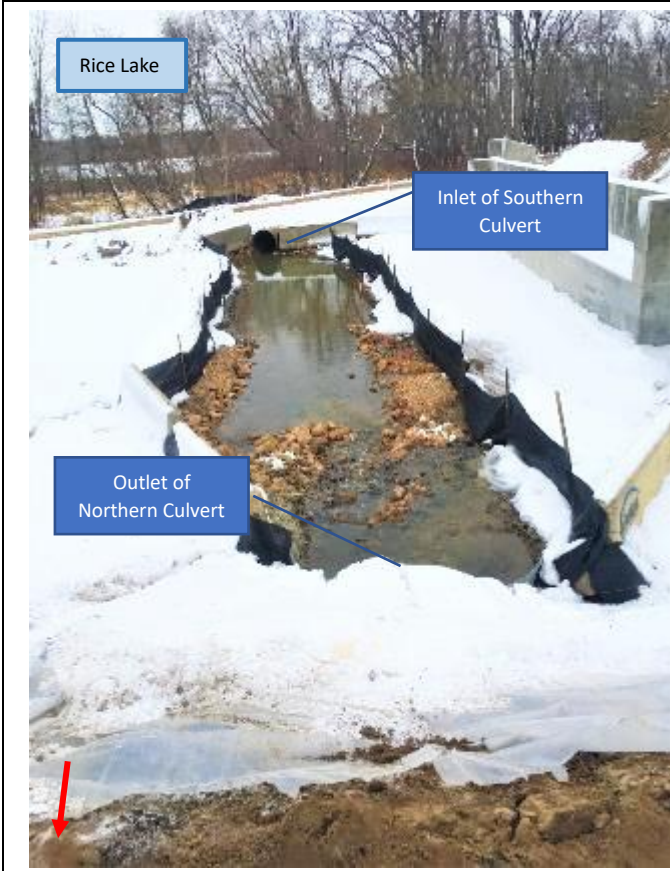
Photo No.: 18

BMPs Present: Plastic sheeting on open soils; riprap; silt fencing

Description: Outlet of Northern Culvert (Photo 17), streambed, and Southern Culvert. Grading was taking place during site visit very close to the Northern culvert (Inlet and outlet).

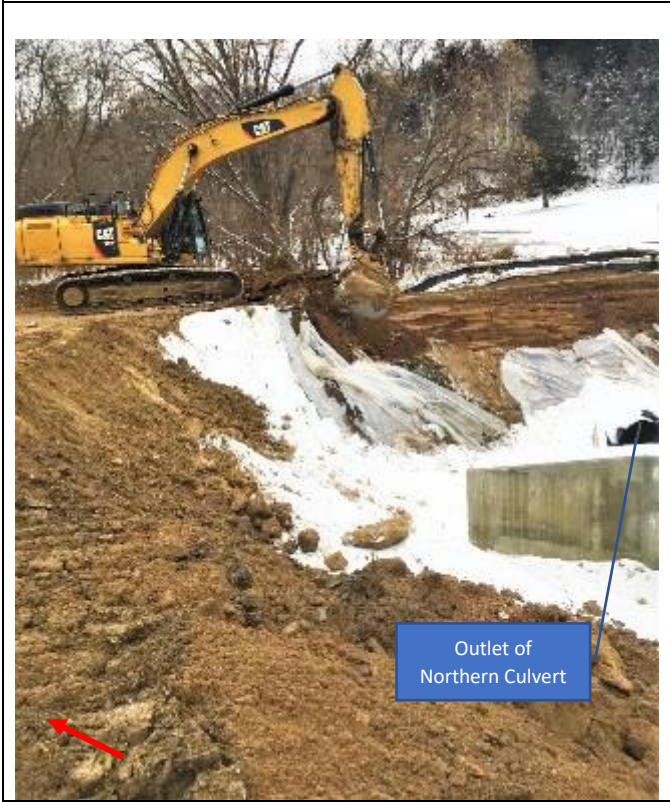
Photo No.: 19

BMPs Present: Sheet of fabric covering open soils.

Description: Active construction taking place near Northern Culvert (photos 17 & 18).

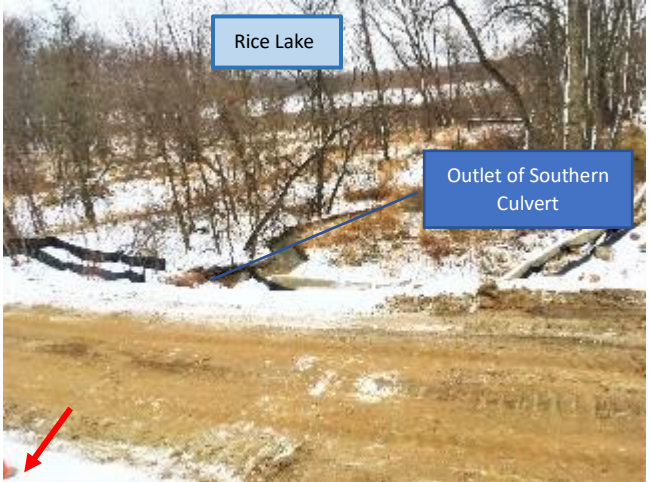
<p><u>Photo No.:</u> 20</p> <p><u>Location:</u> 44°49'04.33"N 93°30'54.44"W</p> <p><u>BMPs Present:</u> Silt fence</p> <p><u>Description:</u> Southern Culvert outlet on southern side of ROW (see Photos 17-18 for Northern Culvert)</p>

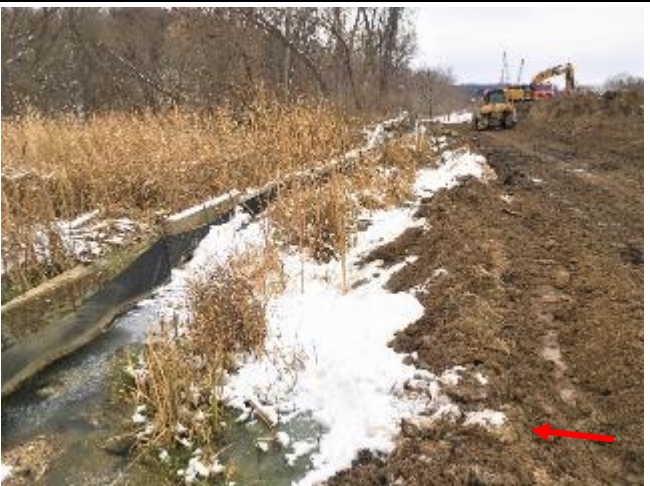
<p><u>Photo No.:</u> 21</p> <p><u>Location:</u> 44°49'05.92"N 93°30'57.71"W</p> <p><u>BMPs Present:</u> Silt fencing with metal t-posts and jersey barriers</p> <p><u>Description:</u> Northern side of ROW and active grading of the site. Soils are very soft and appear slightly lower in elevation than the wetland area (left area of photograph).</p>

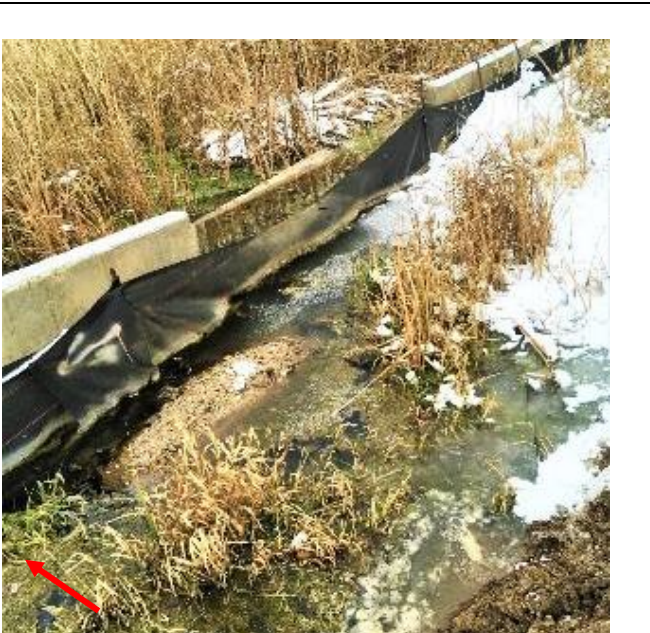
<p><u>Photo No.:</u> 22</p> <p><u>Location:</u> 44°49'05.92"N 93°30'57.71"W</p> <p><u>BMPs Present:</u> Silt fencing with metal t-posts and jersey barriers</p> <p><u>Description:</u> Northern side of ROW near newly graded area (see photo 21). Area appears partially frozen.</p>

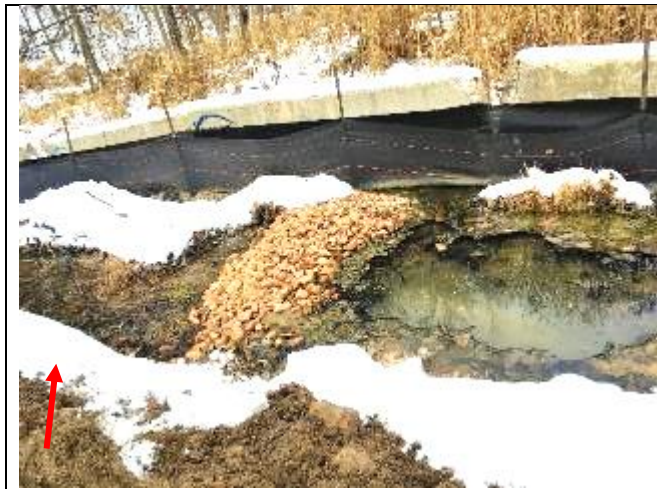
Photo No.: 23

BMPs Present: Silt fencing with metal t-posts and jersey barriers; riprap

Description: Northern side of ROW near newly graded area (see photo 21).

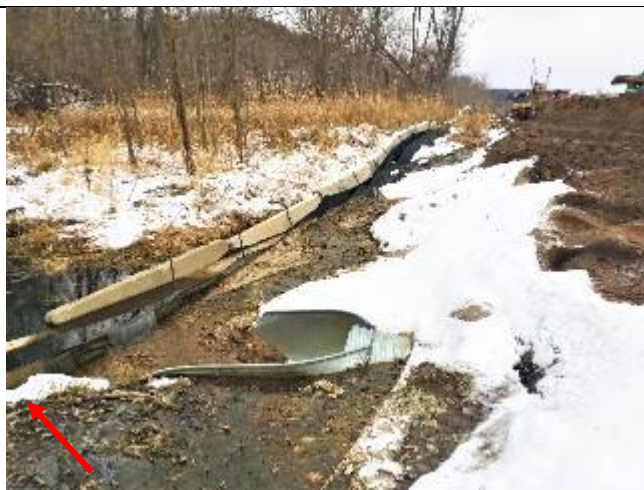
Photo No.: 24

BMPs Present: Silt fencing with metal t-posts and jersey barriers

Description: Culvert along northern side of ROW. Water actively flowing from offsite, over jersey barrier, and into culvert. Photos 16, and 21 through 23 drain to this culvert.

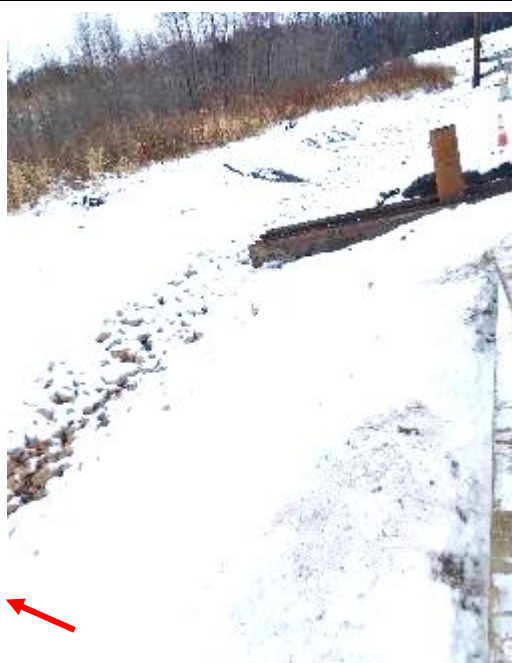
Photo No.: 25

BMPs Present: Rock check

Description: Large rock check spanning 100+ft on the northern side of ROW.

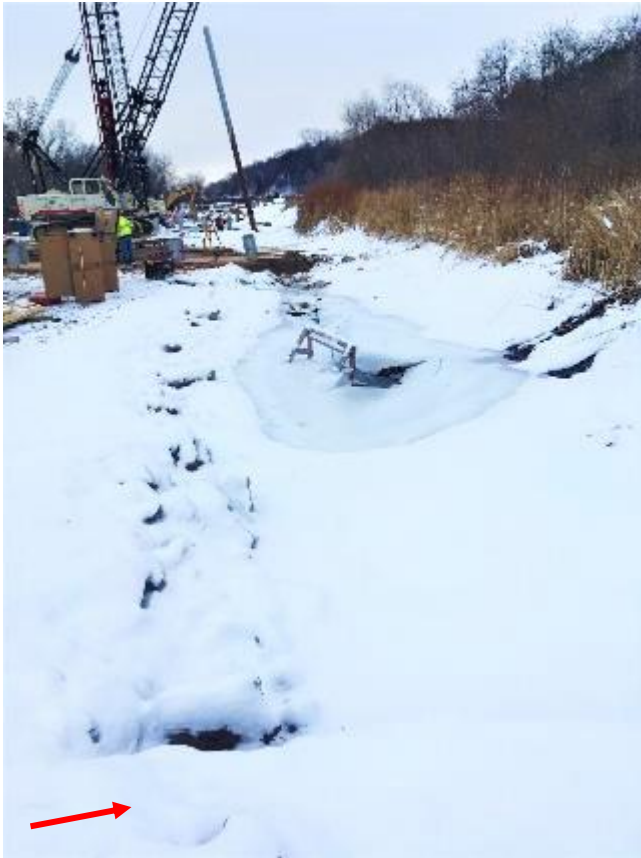
Photo No.: 26

Description: Sawhorse partially in open water, along the northern side of the ROW. Active construction is taking place nearby on wooden mats.

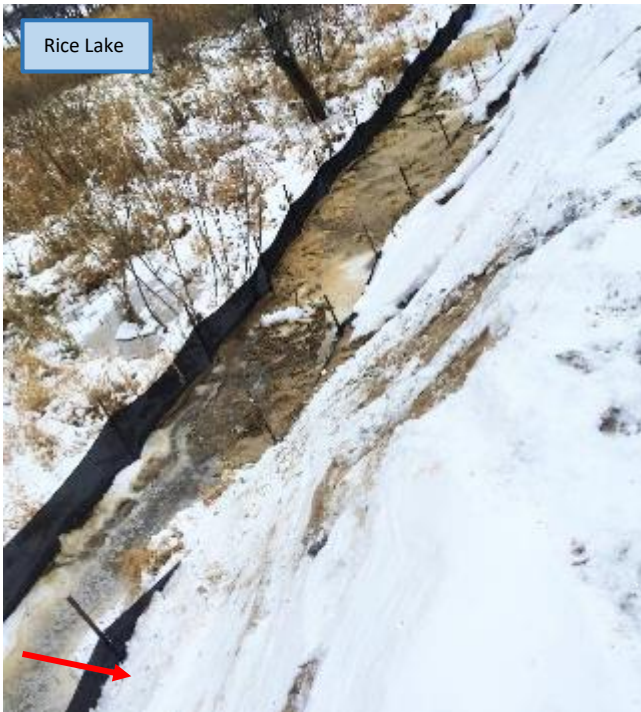
Photo No.: 27

Dewatering is taking place in several areas, predominately in the center of the project (see photos 27 through 30). The dewatering set ups I saw during the site visit had large, brown mud-like substances surrounding the filter/dewatering bag. In one instance, a dewatering bag was not visible (see photo 28). At this site it was unclear if direct discharge was taking place. Two rows of silt fence are directly downslope of these setups, and the discharge has not filtered through these BMPs. The dewatering set up noted in the November 19, 2018,

BMPs Present: Two rows of silt fence

Description: Large deposit of brown substance accumulating in silt fencing. This area is along the southern perimeter of the ROW. This was a dewatering location. During this site visit, several areas along this stretch had dewatering setups (see photos 28 through 30).

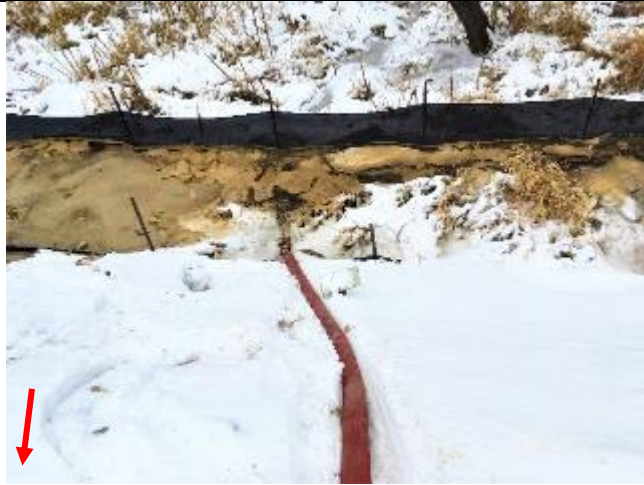
Photo No.: 28

BMPs Present: Two rows of silt fence

Description: Dewatering hose. It is unclear if water is currently coming out of the hose. A filter bag is not visible. Brown sediment has accumulated in the channel between two silt fence rows along the dewatering area (photos 27 through 30).

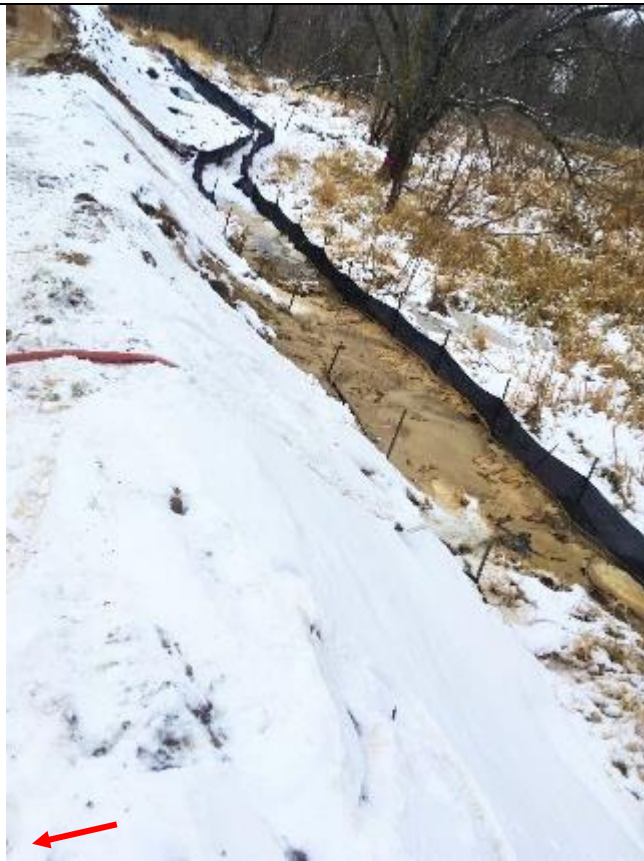
Photo No.: 29

BMPs Present: Two rows of silt fence

Description: Another view of dewatering area on southern side of ROW. At the time of the site visit, the brown sediments did not appear to breach/overwhelm the second silt fence.

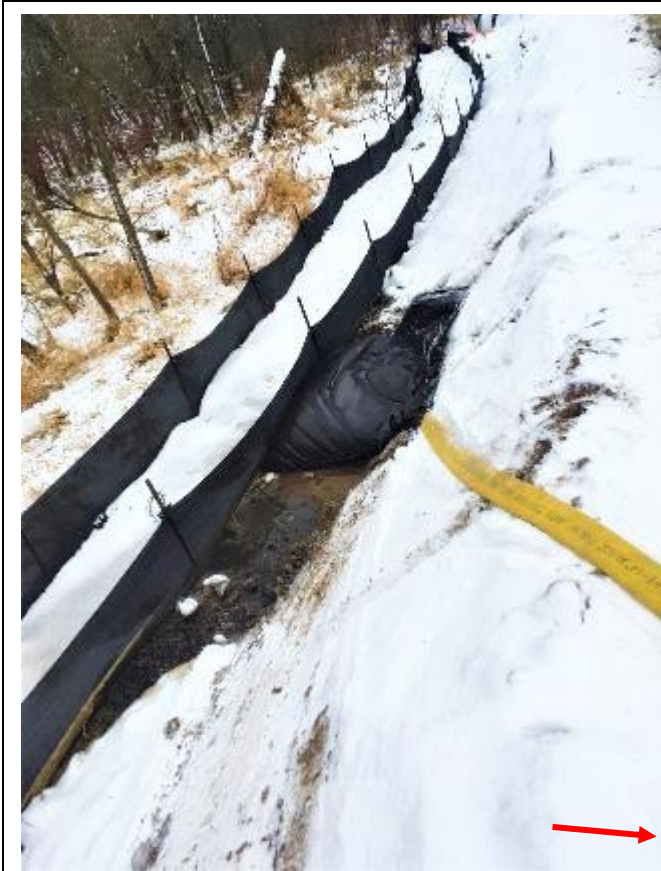
Photo No.: 30

BMPs Present: Two rows of silt fence; filter bag

Description: Dewatering set up on the southern side of the ROW. It is unclear if the dewatering/filter bag has broken and resulted in the accumulation of brown sediments beneath the bag.

At the time of the site visit, the brown sediments were contained by the first row of silt fence.

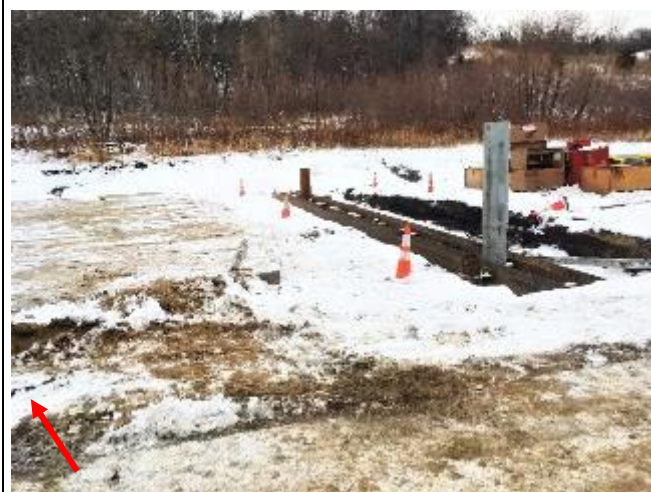
Photo No.: 31

BMPs Present: Wooden mats

Description: ROW conditions

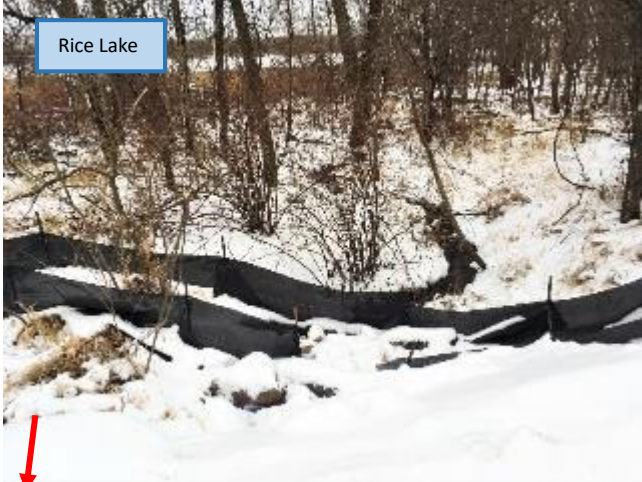
<p><u>Photo No.:</u> 32</p> <p><u>Location:</u> 44°49'07.36"N 93°30'41.53"W</p> <p><u>BMPs Present:</u> Two rows of silt fencing</p> <p><u>Description:</u> Outlet along southern side of ROW. Area is undisturbed and stable.</p>

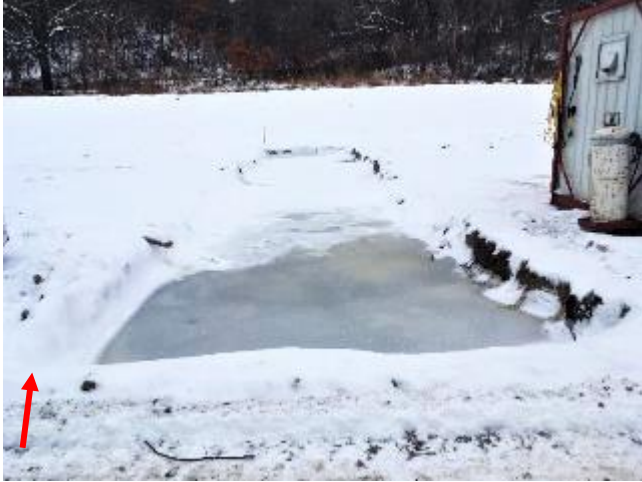
<p><u>Photo No.:</u> 33</p> <p><u>Location:</u> 44°49'06.85"N 93°30'44.79"W</p> <p><u>BMPs Present:</u> None visible</p> <p><u>Description:</u> Ponding area on the northern side of the ROW.</p>

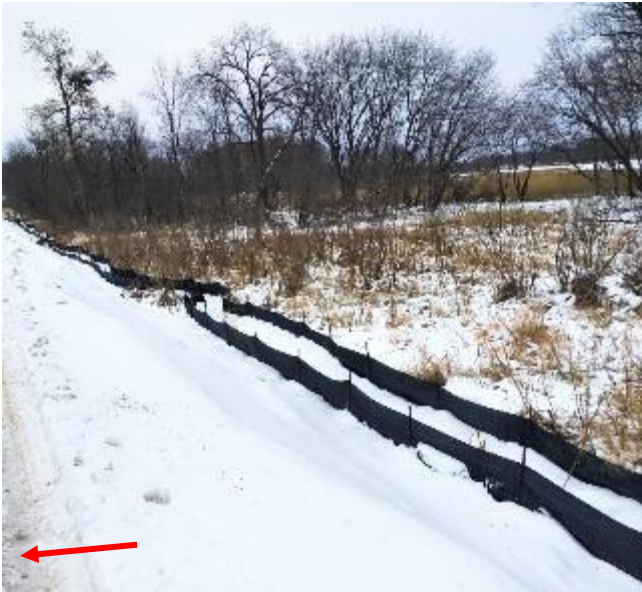
<p><u>Photo No.:</u> 34</p> <p><u>Location:</u> 44°49'06.77"N 93°30'46.28"W</p> <p><u>BMPs Present:</u> Two rows of silt fence</p> <p><u>Description:</u> Southern side of the ROW. Area is stable and undisturbed.</p>

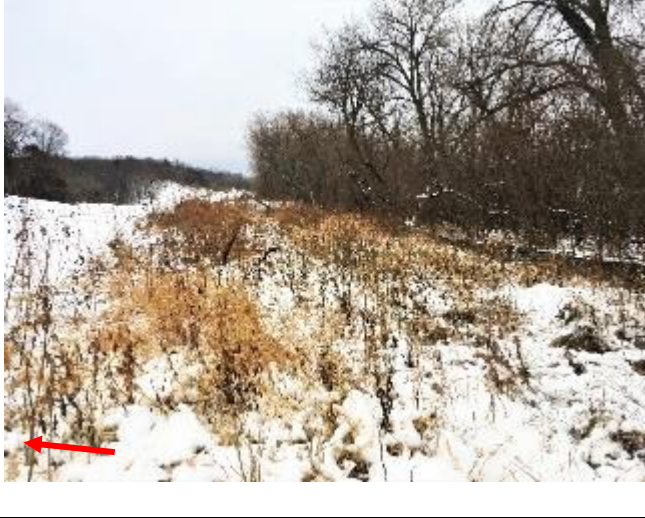
Photo No.: 35
Location: 44°49'10.26"N 93°30'16.34"W
BMPs Present: Vegetative buffer; two rows of silt fencing
Description: Stable and undisturbed ROW (southern side).

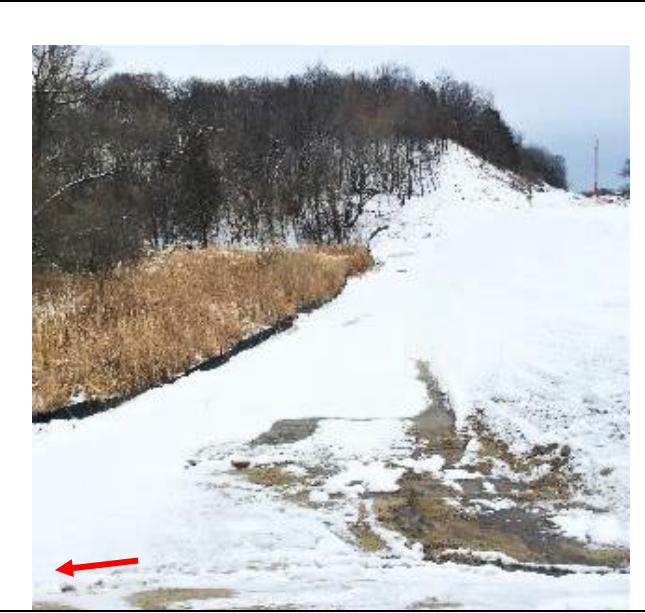
Photo No.: 36
Location: 44°49'11.45"N 93°30'05.27"W
BMPs Present: Two rows of silt fence
Description: ROW conditions on northern side of project.

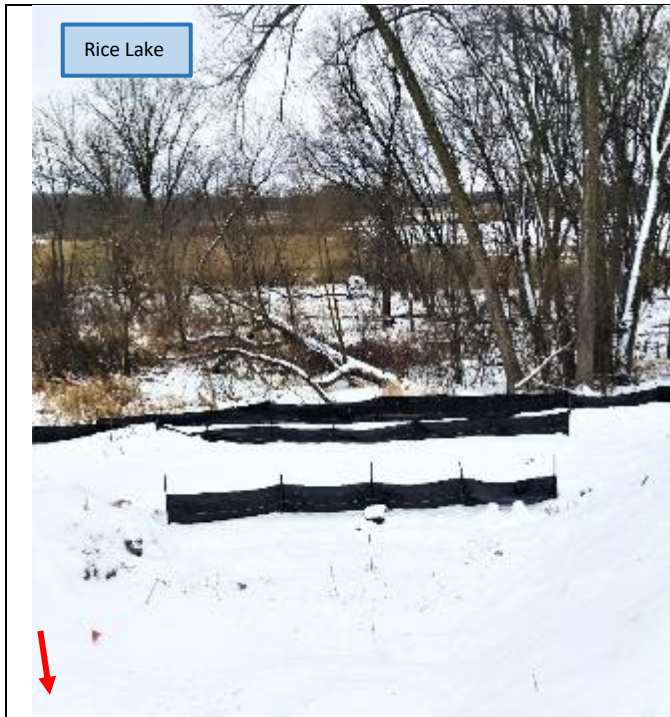
Photo No.: 37

BMPs Present: Three rows of silt fencing

Description: ROW conditions on southern side of project. Ground is stable and undisturbed by construction activities.

Just outside of this photo is a collection of deer carcasses. Appearances suggest they are a result of deer hunting and have been recently deposited on the ROW.

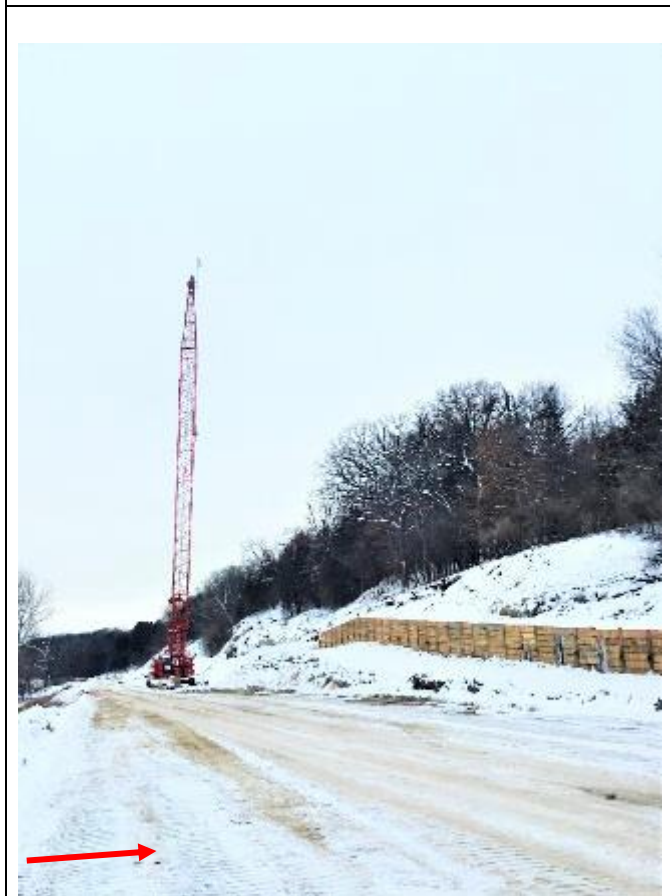
Photo No.: 38

Description: ROW conditions.

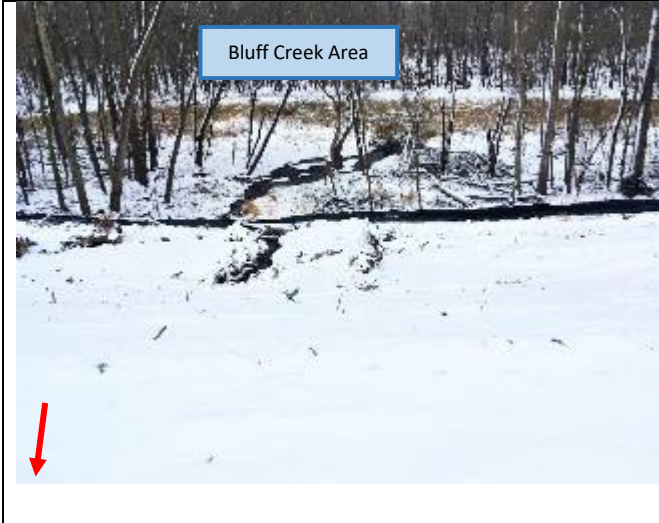
Photo No.: 39

BMPs Present: Two rows of silt fence

Description: Outlet on southern side of ROW. Area is undisturbed and stable.

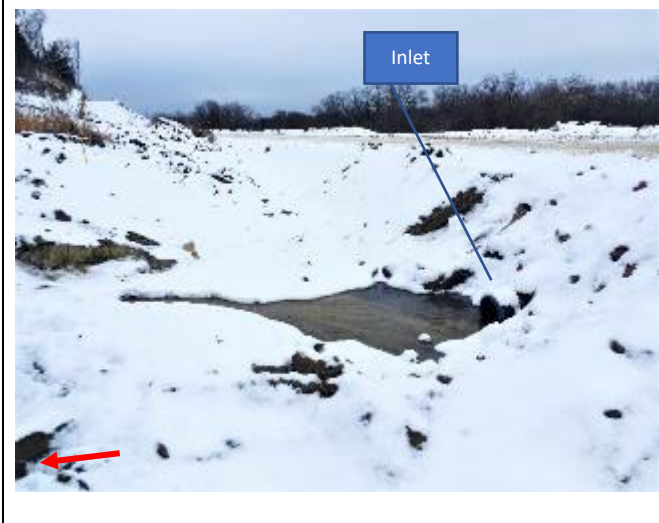
Photo No.: 40

Description: Northern side of ROW inlet.

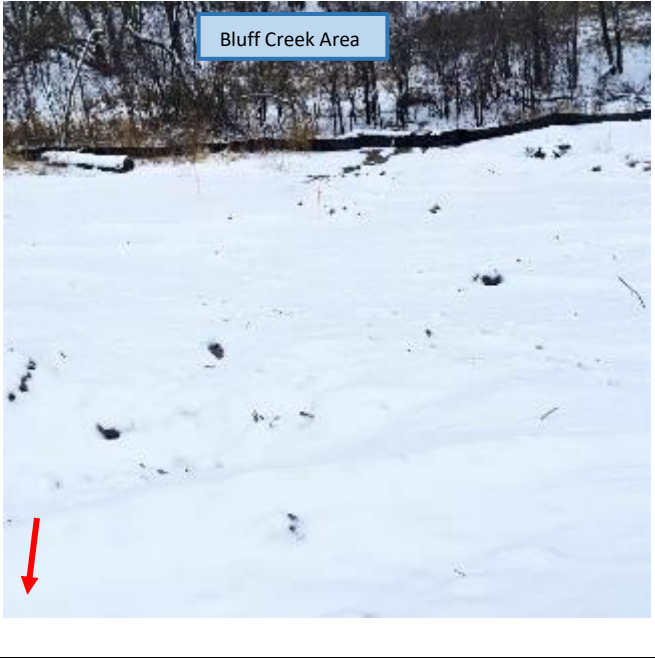
<p>Bluff Creek Area</p>	<p><u>Photo No.:</u> 41</p> <p><u>Location:</u> 44°49'07.26"N 93°29'33.35"W</p> <p><u>BMPs Present:</u> Two rows of silt fence</p> <p><u>Description:</u> Southern outlet, and subsequent flow channel down slope to silt fence. This outlet connected to the inlet in Photo 40.</p> <p>Area is undisturbed and stable.</p>

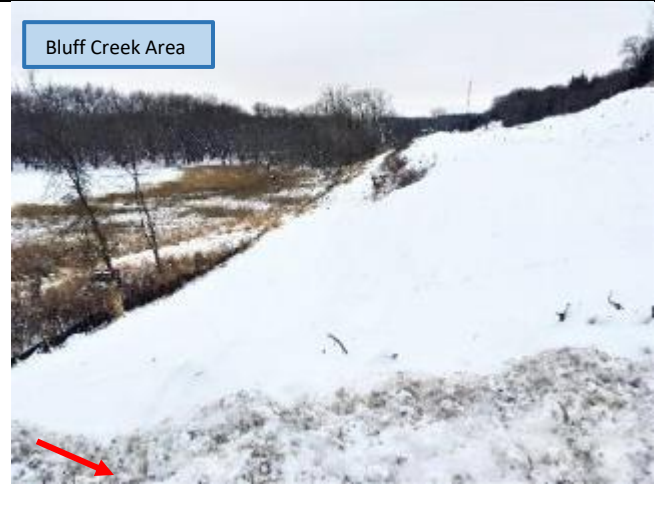
<p>Bluff Creek Area</p>	<p><u>Photo No.:</u> 42</p> <p><u>Location:</u> 44°49'05.38"N 93°29'25.59"W</p> <p><u>BMPs Present:</u> Two rows of silt fencing</p> <p><u>Description:</u> Southern side of ROW.</p>

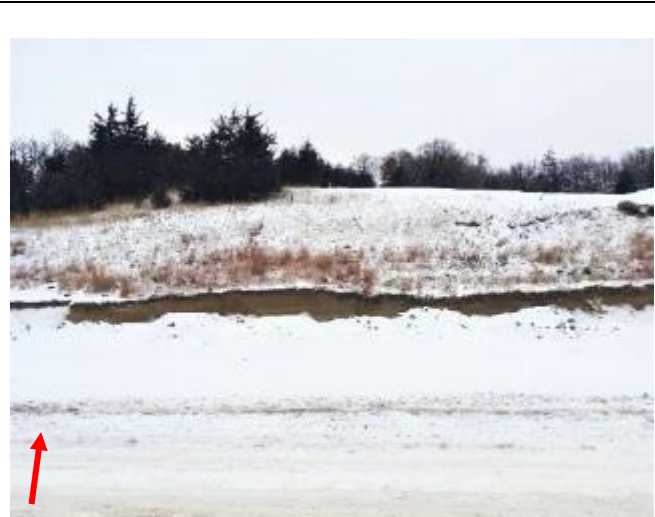
<p><u>Photo No.:</u> 43</p> <p><u>Location:</u> 44°49'06.02"N 93°29'20.83"W</p> <p><u>BMPs Present:</u> None visible</p> <p><u>Description:</u> Northern side of ROW conditions.</p>

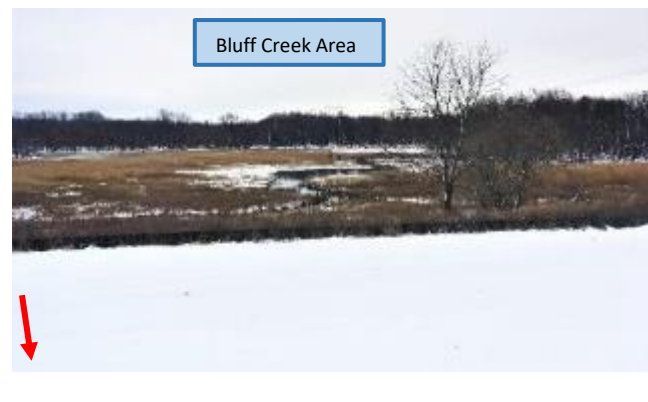
<p><u>Photo No.:</u> 46</p> <p><u>Location:</u> 44°49'05.80"N 93°29'03.39"W</p> <p><u>BMPs Present:</u> Silt fence</p> <p><u>Description:</u> Southern side of ROW is stable and undisturbed.</p>

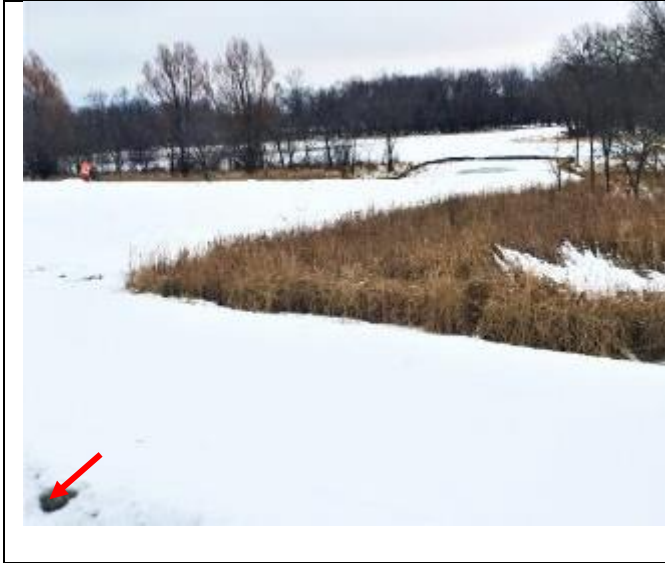
Photo No.: 47

BMPs Present: Silt fence

Description: Southern side of ROW is stable and undisturbed.
