SITE LOCATION: CSAH 61-Flying Cloud Drive

PURPOSE: Construction Stormwater Site Visit on Behalf of the Lower Minnesota River Watershed District (LMRWD)

DATE & TIME: 21 December 2018, 0820-1000

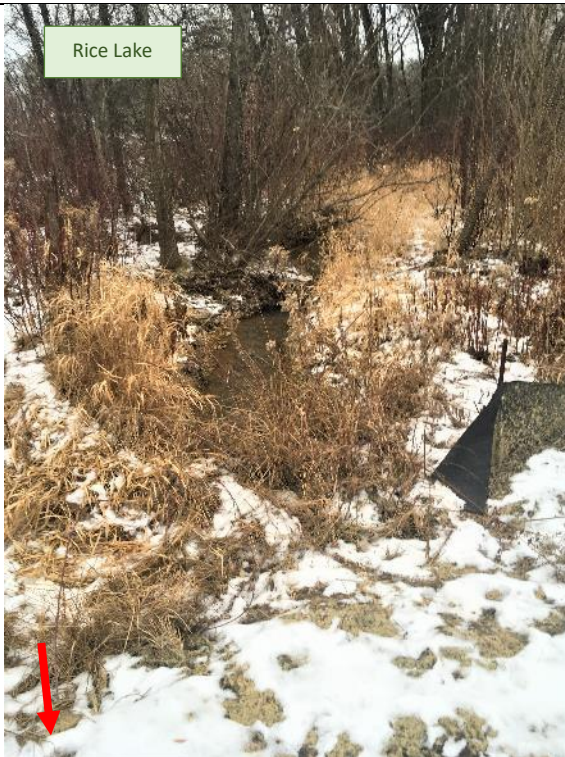
Photo No.: 9

Description: Outlet of small creek (see photo 8 for upstream on north side of ROW). Area is stable and undisturbed.

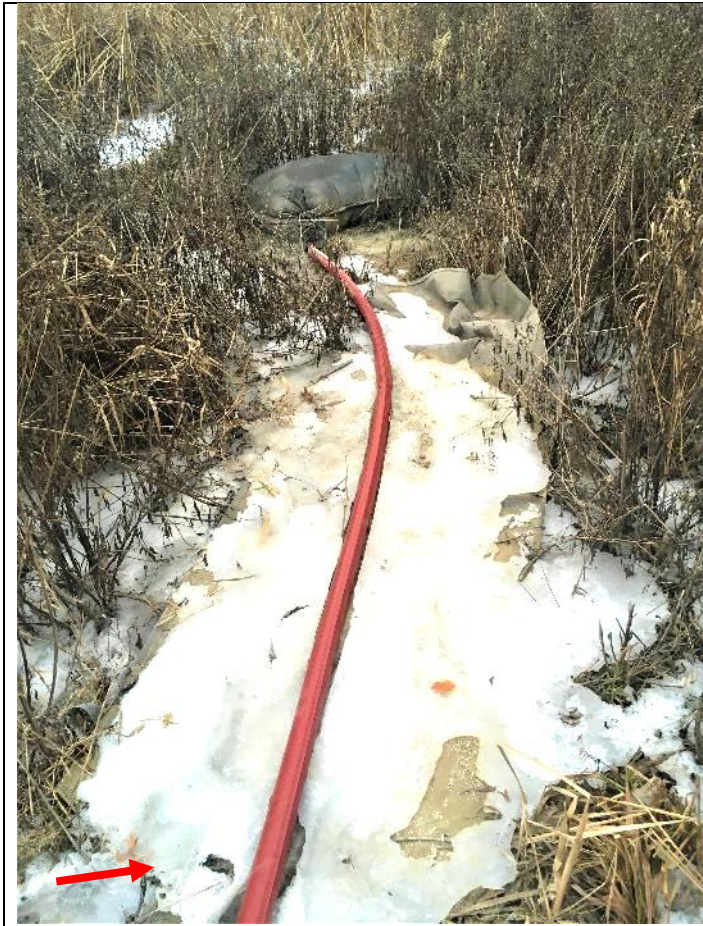
Photo No.: 10

Dewatering is still taking place in several locations. The dewatering setups can be seen in photos 10-12 and 15.

Description: Dewatering taking place on the northern side of the ROW in a wetland area. This area has been used for dewatering activities for several weeks. In the past the bag has not been connected to the hose. During this inspection, the hose is attached to the black filter bag.

An older gray filter bag (referenced in previous inspection reports) is visible beneath the hose and snow.

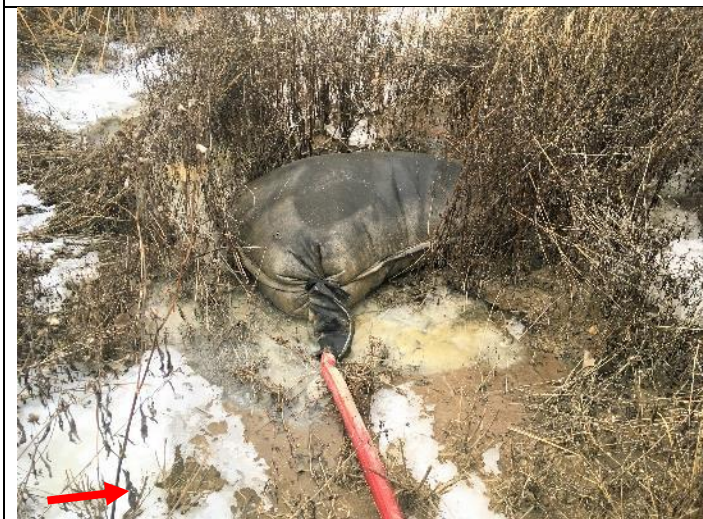
Photo No.: 11

Description: Close-up of the dewatering set up. The gray matter from previous dewatering activities (in early December and November) is visible beneath the new bag.

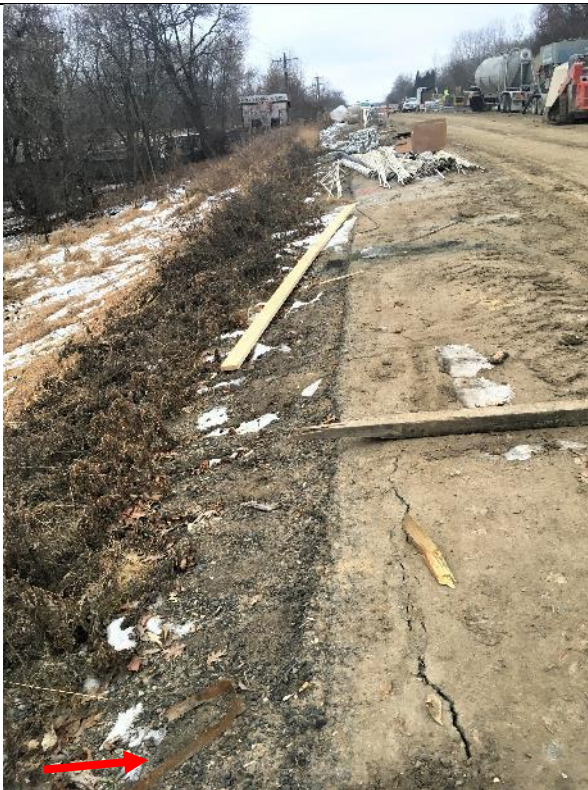
Photo No.: 13

Description: ROW conditions during site visit.

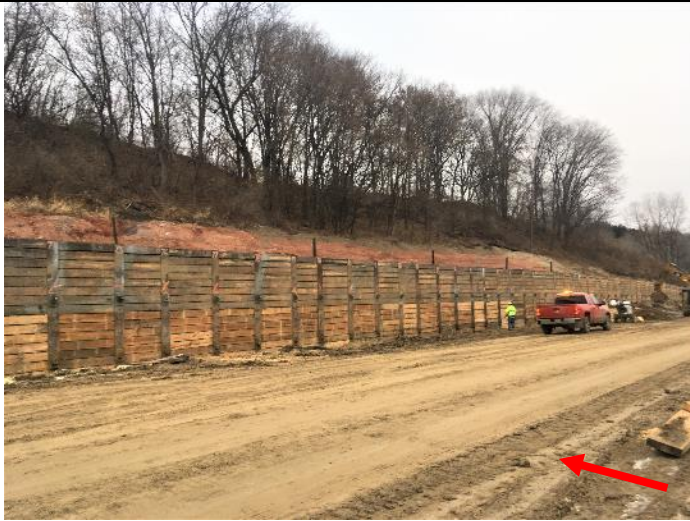
Photo No.: 14

Description: Northern side of ROW conditions.

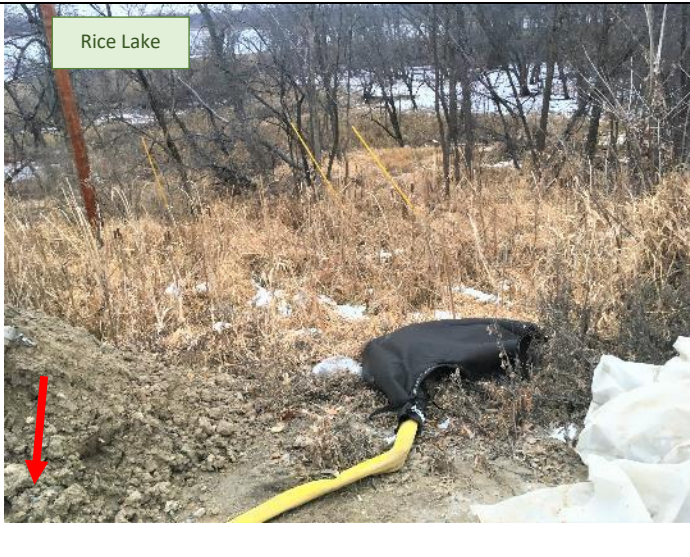
Photo No.: 15

Description: Dewatering setup on the southern side of the ROW. At the time of the site visit, dewatering was not taking place.

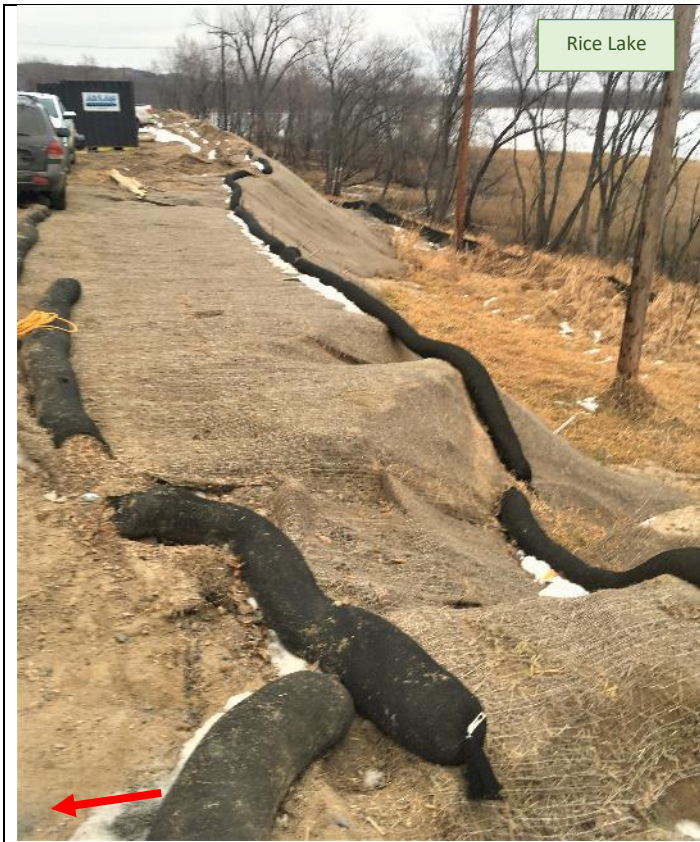
Photo No.: 16

Description: ROW conditions on the southern side of the project. Area is largely unchanged, despite snowmelt in recent days.

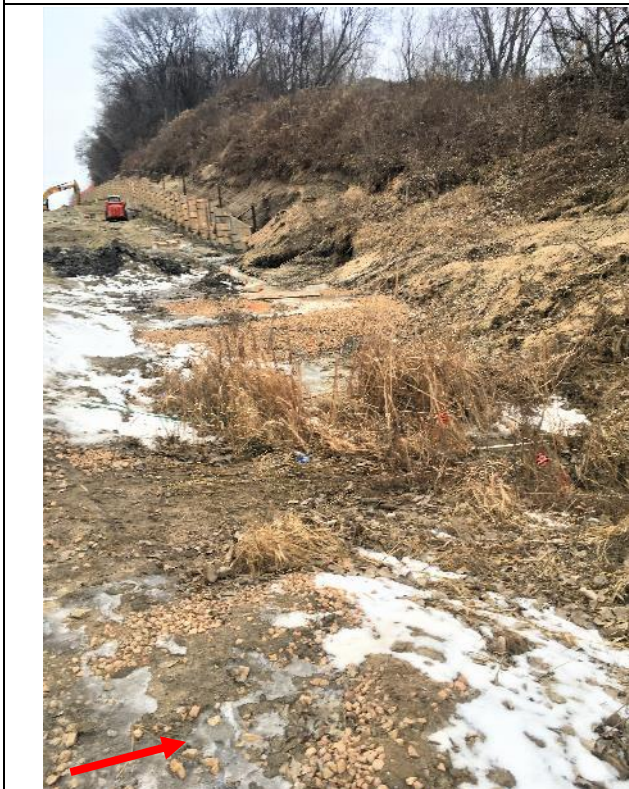
Photo No.: 17

Description: Northern side of ROW conditions. No new washouts were evident in this area.

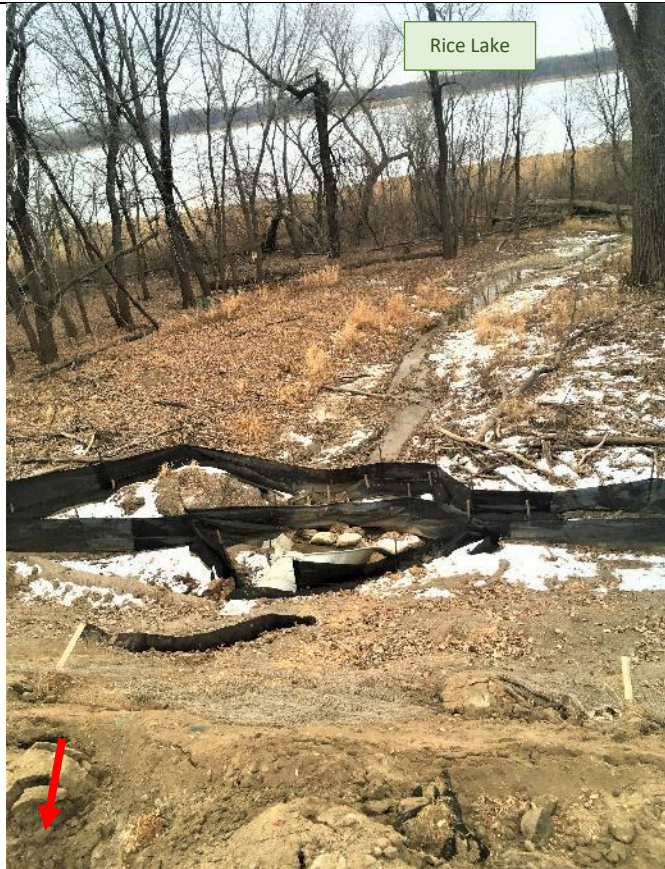
Photo No.: 18

Description: Culvert outlet leading to Rice Lake. Area soils are firm but not frozen. Site conditions appear to be similar to pre-snow conditions earlier in the month.

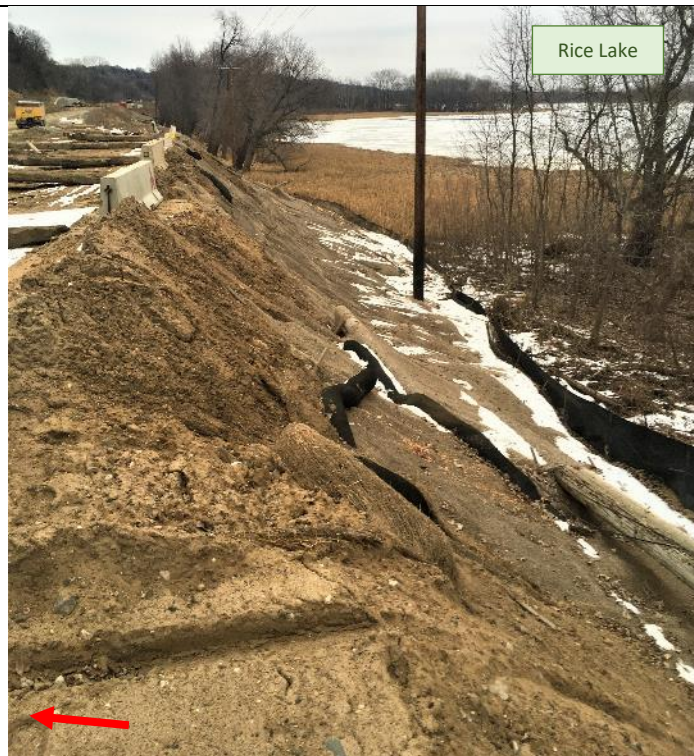
Photo No.: 19

Description: Area upslope of photo 18 culvert outlet.

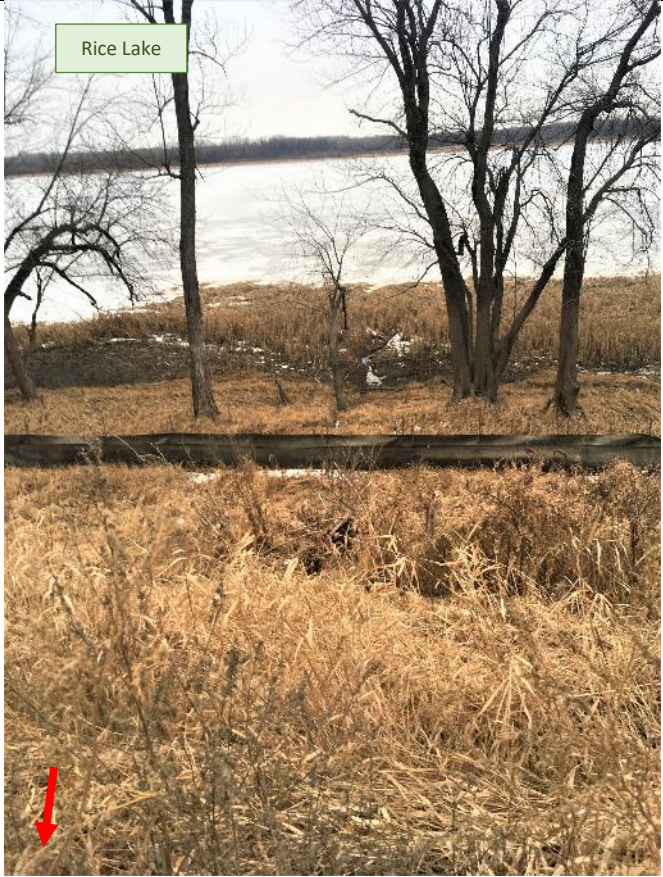
Photo No.: 20

Description: Stable southern side of ROW.

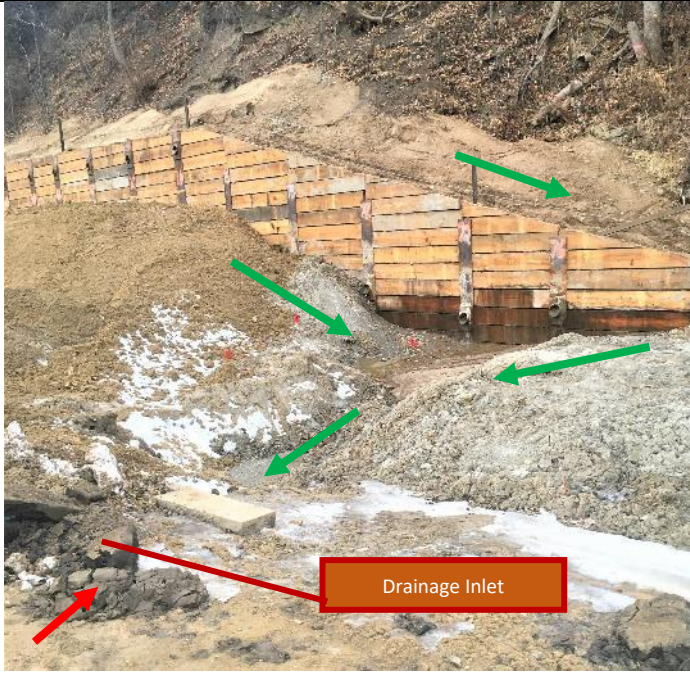
Photo No.: 21

Description: Northern side of the ROW. Green arrows indicate drainage from wall and above slope. See photo 22 to view drainage inlet.

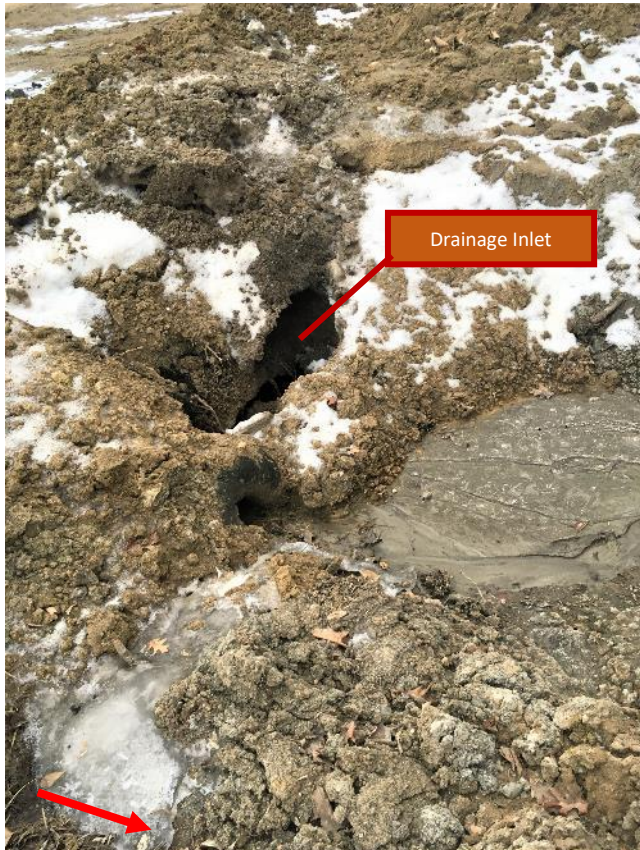
Photo No.: 22

Description: Drainage inlet partially buried by debris. See photo 21 for drainage leading to the inlet.

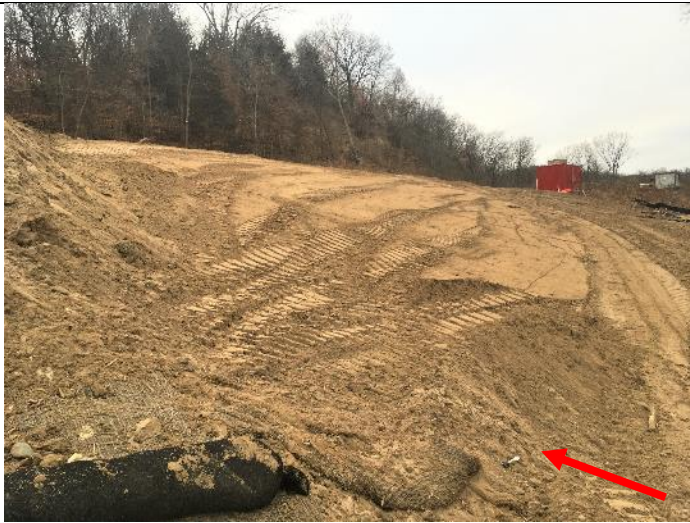
Photo No.: 26

Description: Slope leading to photo 24 area and culvert outlet. This area is several yards east photo 25. Crews have removed the ESC blanket and regraded the area. Soils are very soft, but no erosion was evident during the inspection.

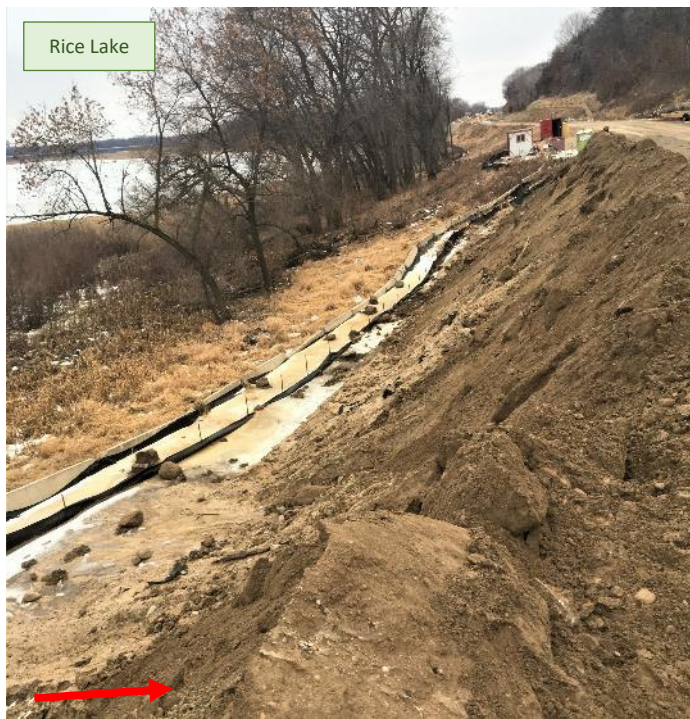
Photo No.: 27

Description: Southern slopes leading to Rice Lake. Silt fencing is intact and filled with snowpack.

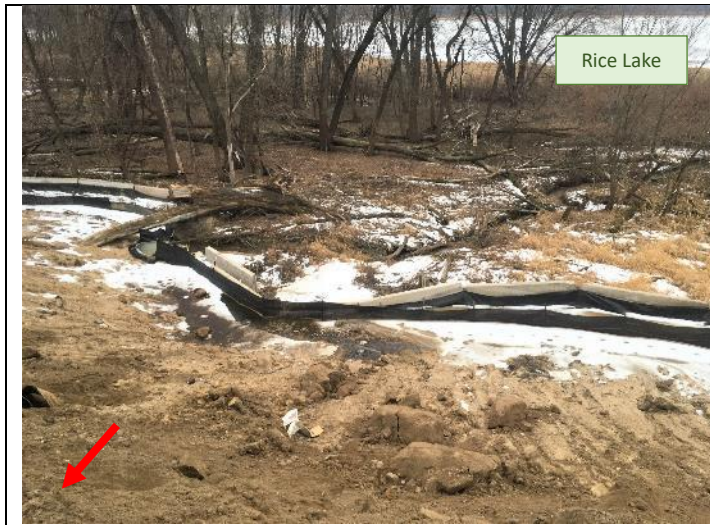
Photo No.: 28

Description: Southern perimeter of the project. Largely unchanged since last site visit, apart from the loss of snowpack.

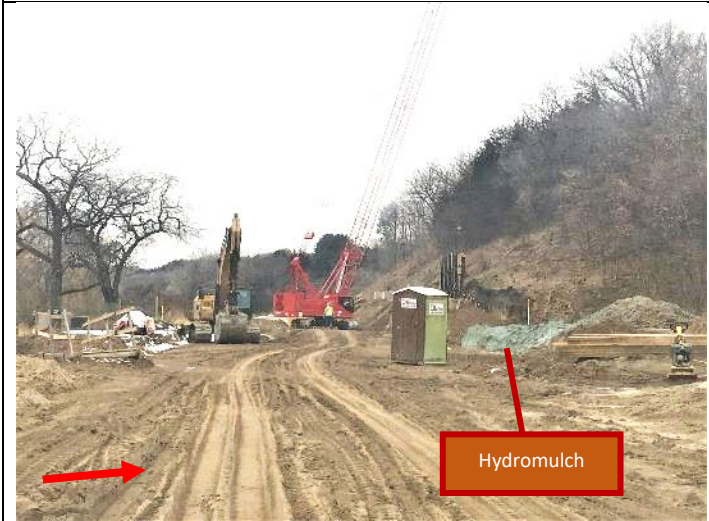
Photo No.: 32

Description: Crews onsite installing walls along the northern side of the ROW. Fresh hydromulch has been spread just outside of the work area.

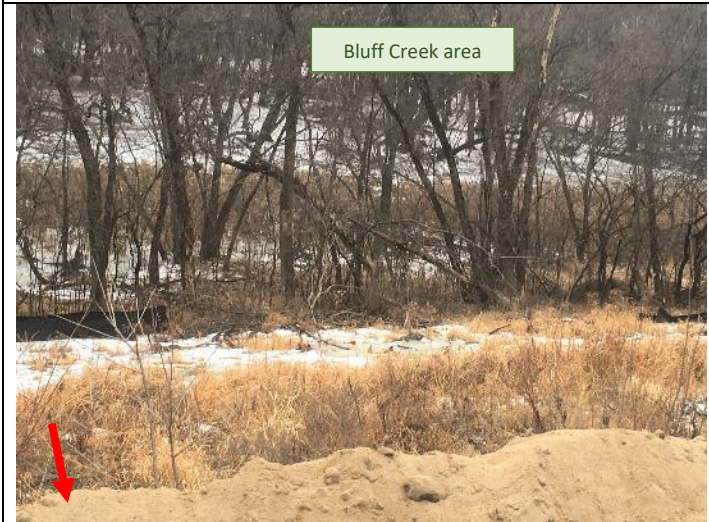
Photo No.: 33

Description: Stable ROW conditions along the southern perimeter of the project.

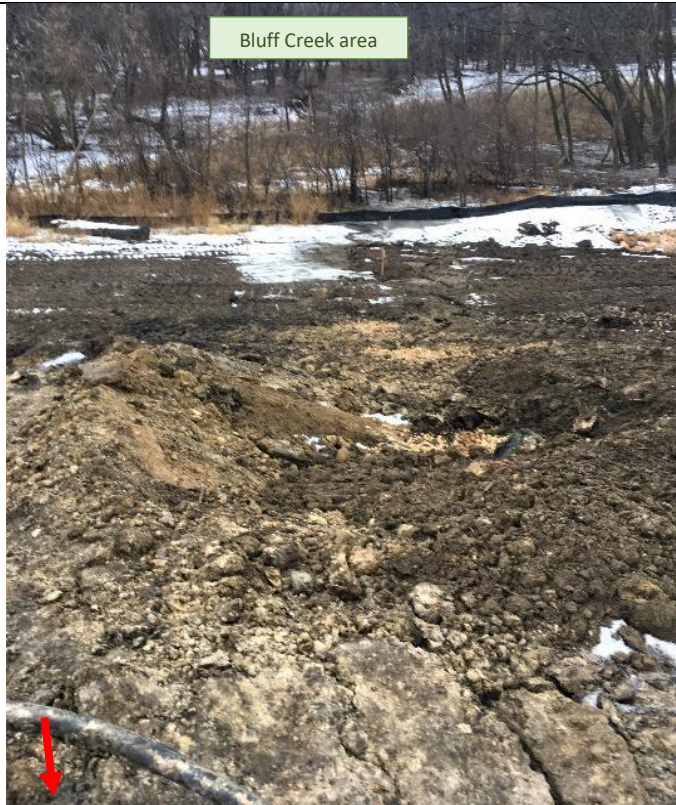
Photo No.: 35

Description: Southern side of the ROW after snowmelt. There is some channeling leading to the silt fence. Water and snow have pooled near the silt fence.
