LOWER MINNESOTA RIVER WATERSHED DISTRICT

Lower Minnesota River Watershed District Board of Managers Meeting

Monday, January 7, 2019

PURPOSE: Construction Stormwater Site Visit on Behalf of the Lower Minnesota River Watershed District (LMRWD)

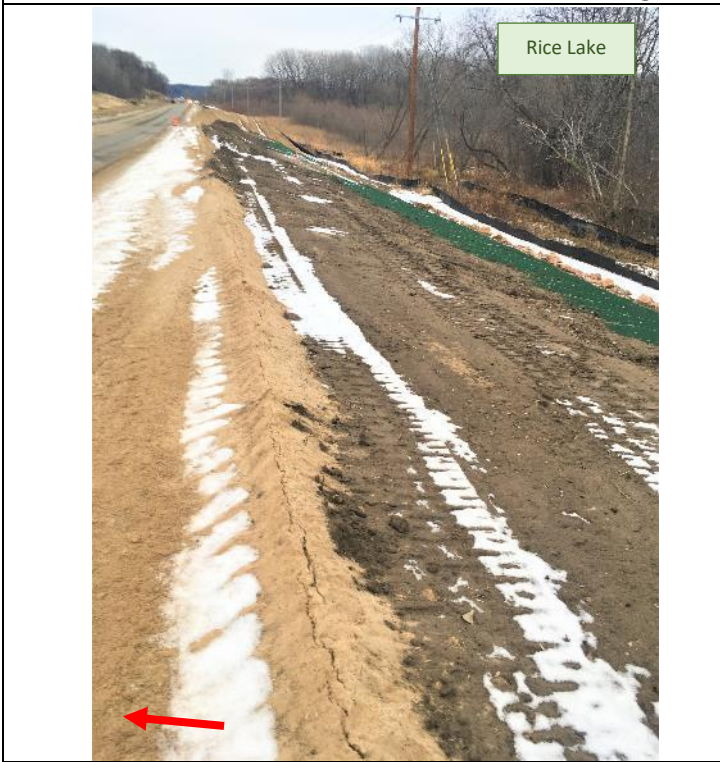
Photo No.: 1

BMPs Present: Green geotextile blanket; two rows of silt fence

Description: ROW conditions after significant snowmelt. This section of the project is stable with no evidence of new erosion.

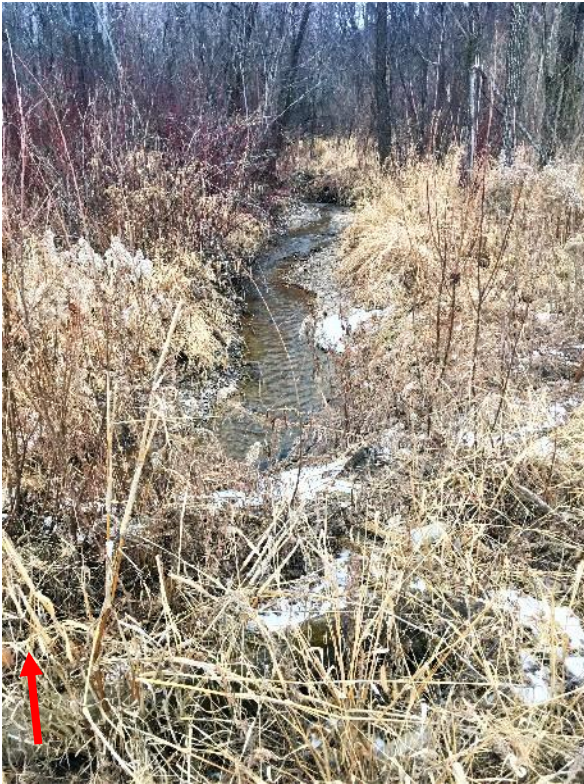
Photo No.: 8

BMPs Present: Vegetation buffer

Description: A stream on the northern side of the ROW. Area is stable.

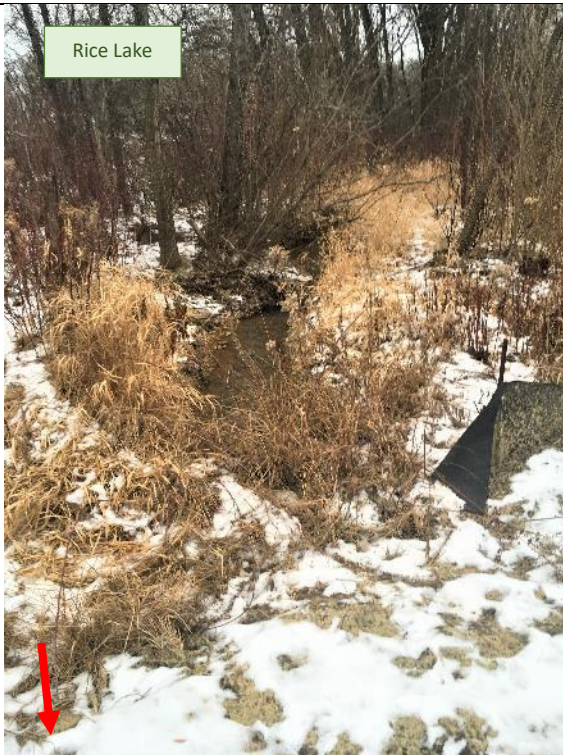
Photo No.: 9

BMPs Present: Silt fence; vegetative buffer

Description: Outlet of small creek (see photo 8 for upstream on north side of ROW). Area is stable and undisturbed.

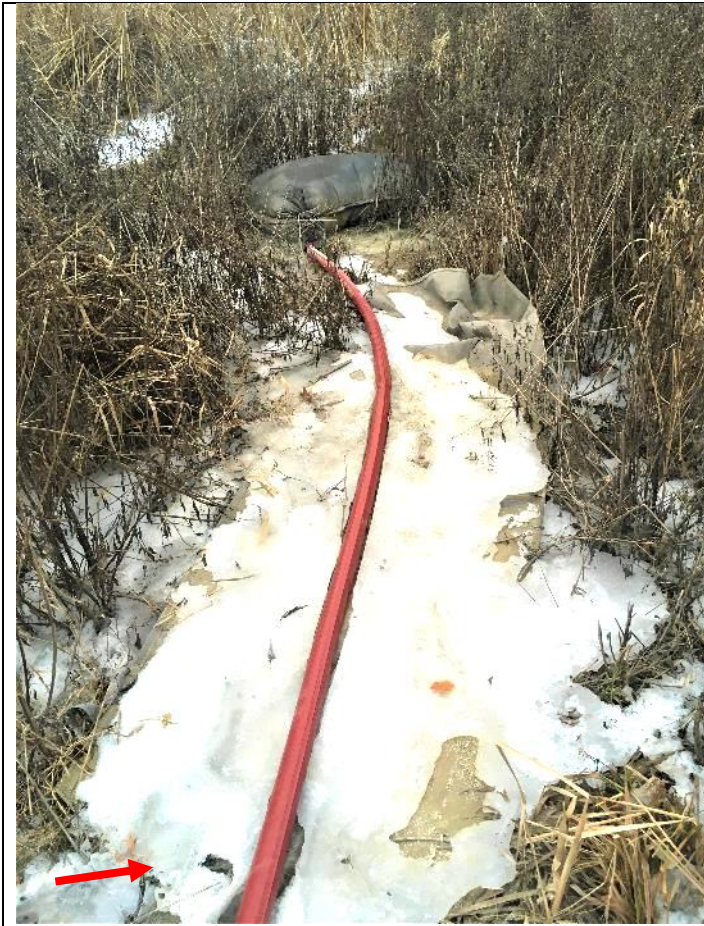
Photo No.: 10

Dewatering is still taking place in several locations. The dewatering setups can be seen in photos 10-12 and 15.

BMPs Present: Dewatering bag

Description: Dewatering taking place on the northern side of the ROW in a wetland area. This area has been used for dewatering activities for several weeks. In the past the bag has not been connected to the hose. During this inspection, the hose is attached to the black filter bag.

An older gray filter bag (referenced in previous inspection reports) is visible beneath the hose and snow.

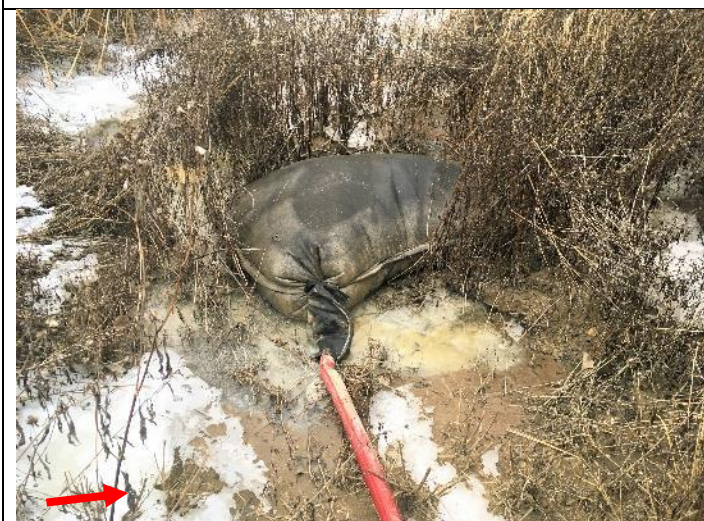
Photo No.: 11

BMPs Present: Dewatering bag

Description: Close-up of the dewatering set up. The gray matter from previous dewatering activities (in early December and November) is visible beneath the new bag.

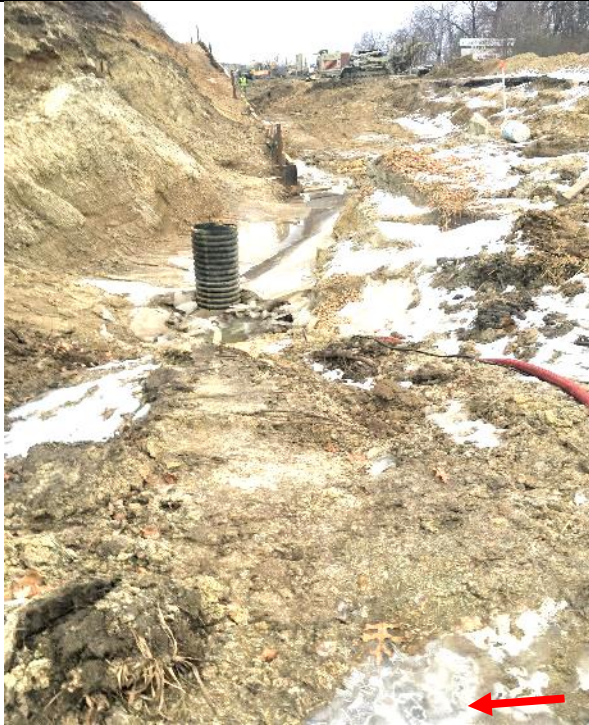
Photo No.: 12

BMPs Present: None visible

Description: Dewatering setup connected to bag and hose in photos 10 and 11.

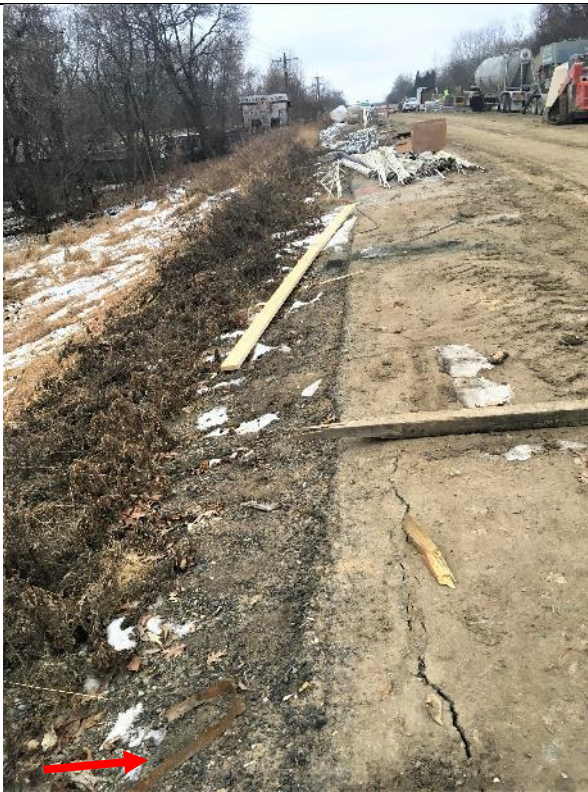
Photo No.: 13

BMPs Present: Vegetative buffer

Description: ROW conditions during site visit.

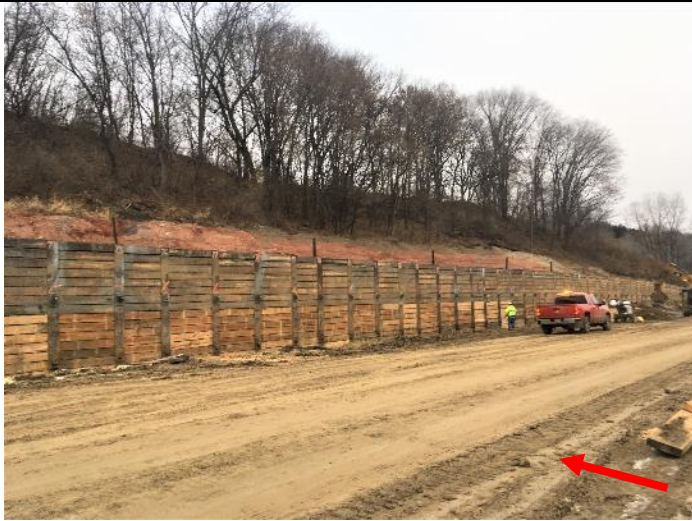
Photo No.: 14
Location: 44°48'55.95"N 93°31'29.65"W
BMPs Present: None visible
Description: Northern side of ROW conditions.

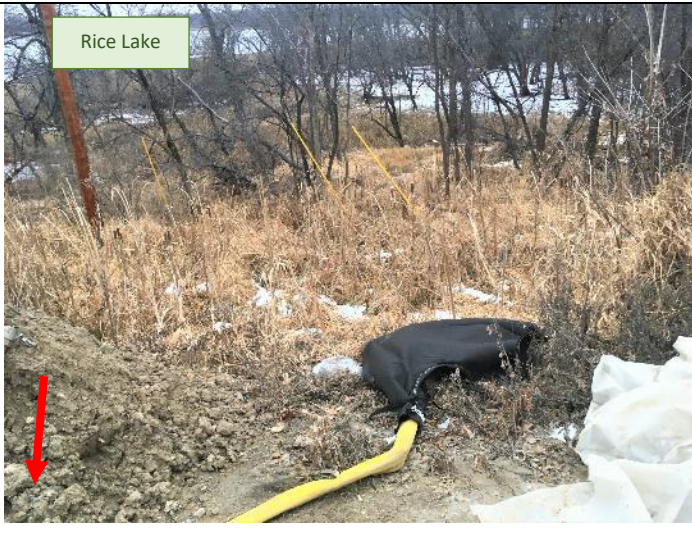
Photo No.: 15
Location: 44°48'56.32"N 93°31'27.26"W
BMPs Present: Vegetative buffer; dewatering bag
Description: Dewatering setup on the southern side of the ROW. At the time of the site visit, dewatering was not taking place.

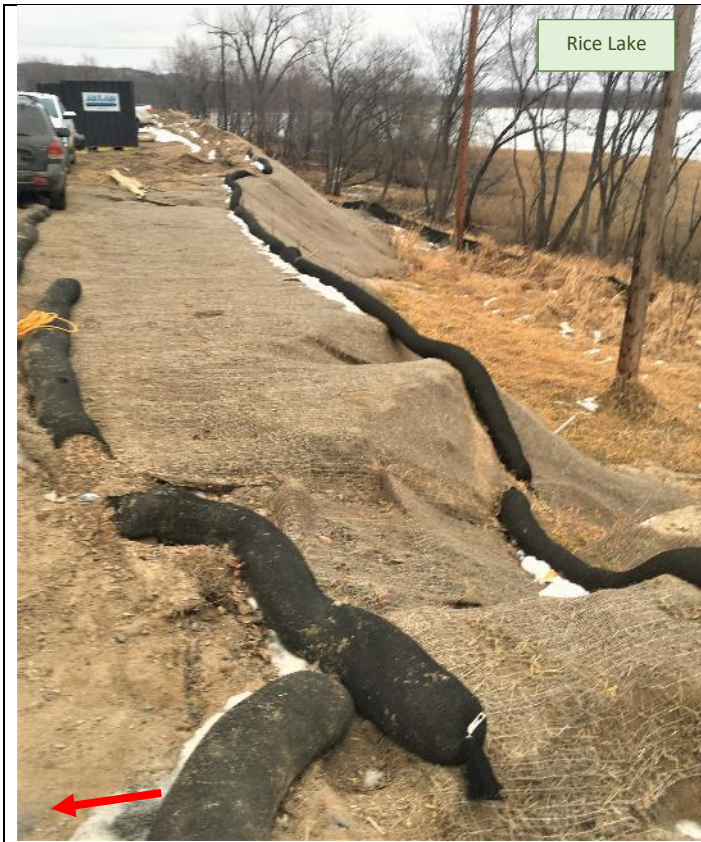
Photo No.: 16

BMPs Present: ESC blanket; biologs; vegetative buffer; two rows of silt fencing.

Description: ROW conditions on the southern side of the project. Area is largely unchanged, despite snowmelt in recent days.

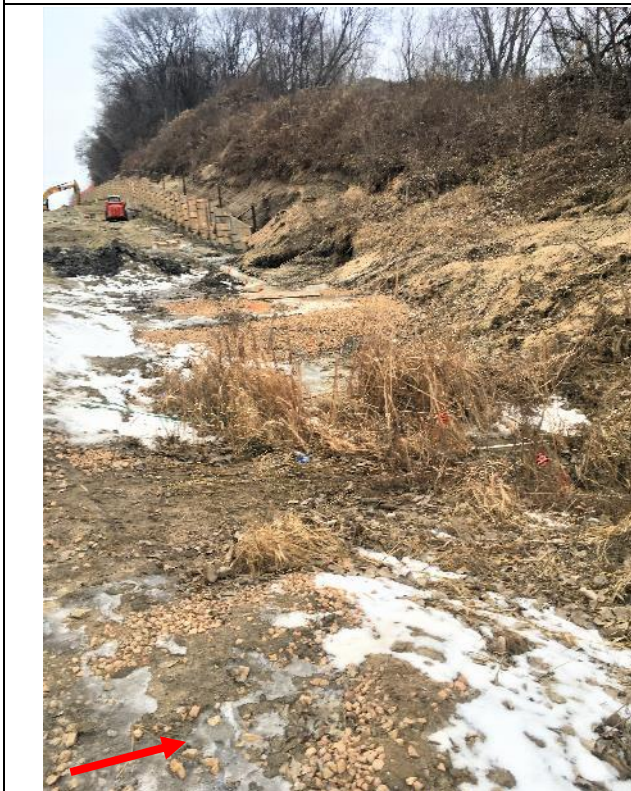
Photo No.: 17

BMPs Present: Rock checks; hydromulch

Description: Northern side of ROW conditions. No new washouts were evident in this area.

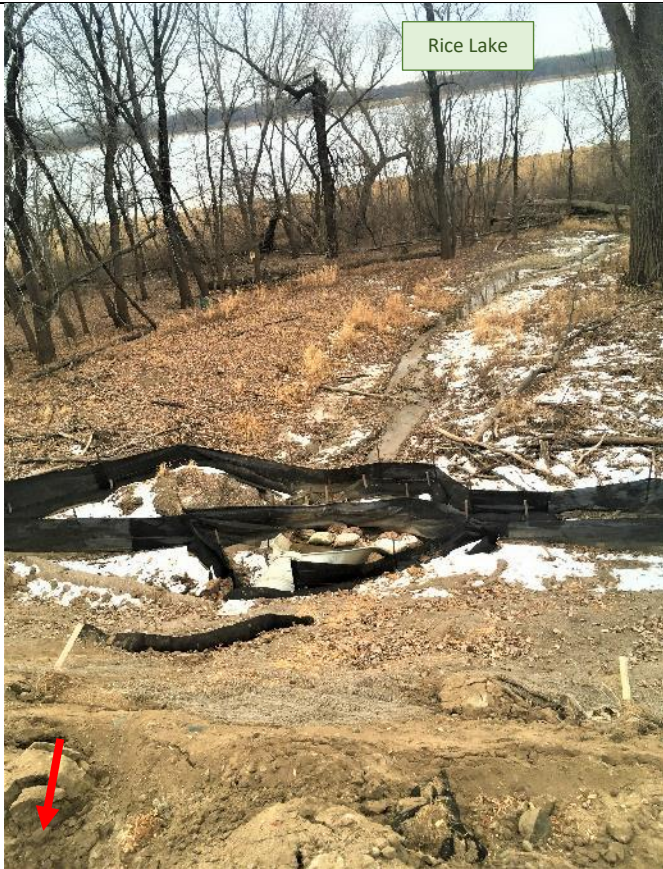
Photo No.: 18

BMPs Present: Some ESC blanket; biologs; several rows of silt fence

Description: Culvert outlet leading to Rice Lake. Area soils are firm but not frozen. Site conditions appear to be similar to pre-snow conditions earlier in the month.

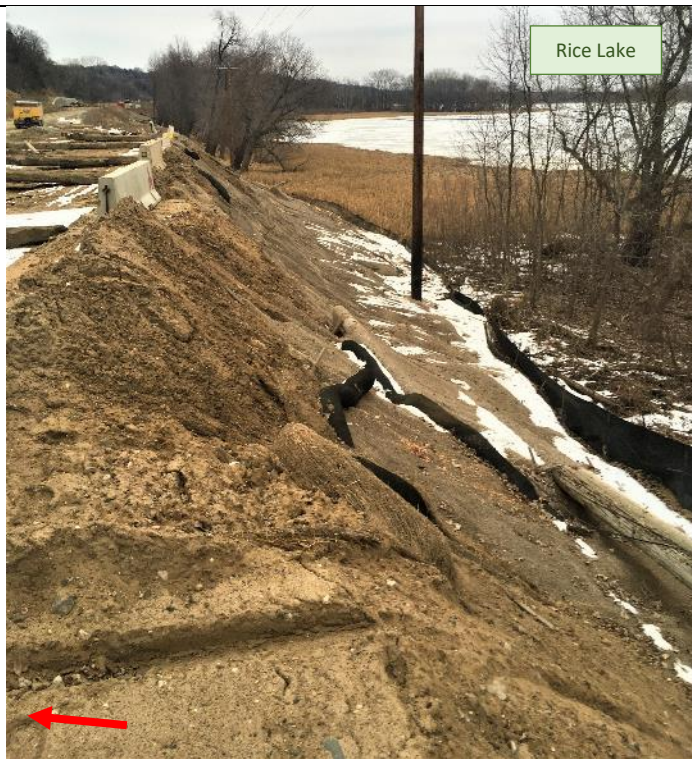
Photo No.: 19

BMPs Present: ESC blanket; biologs; two rows of silt fencing

Description: Area upslope of photo 18 culvert outlet.

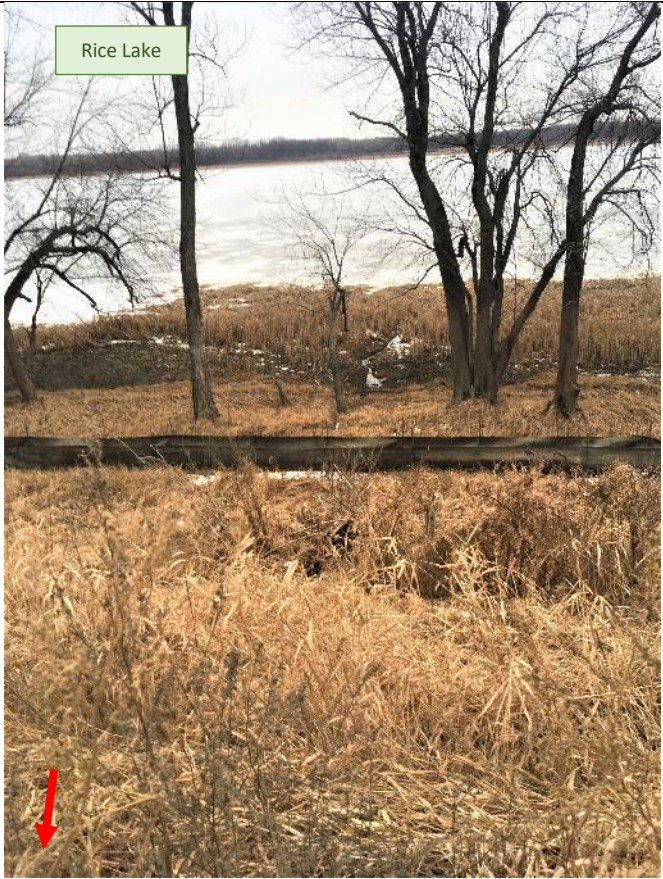
Photo No.: 20

BMPs Present: Two rows of silt fencing; vegetative buffer

Description: Stable southern side of ROW.

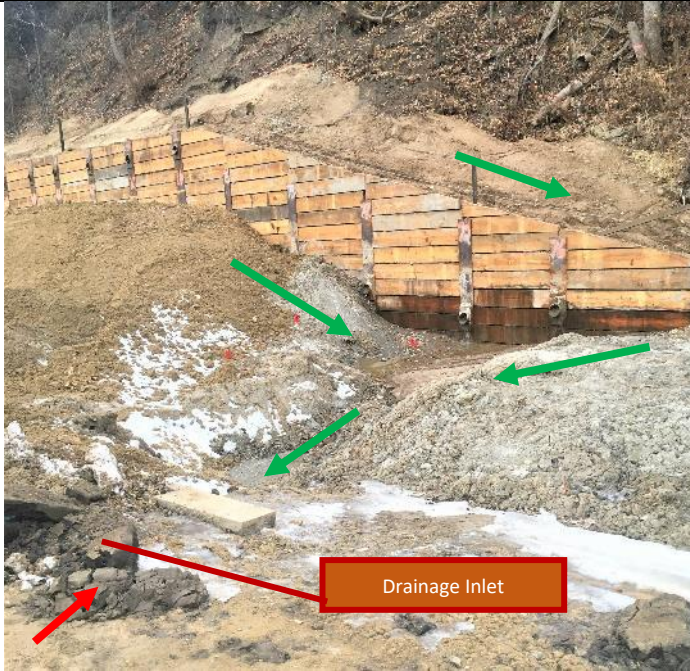
Photo No.: 21

BMPs Present: None visible

Description: Northern side of the ROW. Green arrows indicate drainage from wall and above slope. See photo 22 to view drainage inlet.

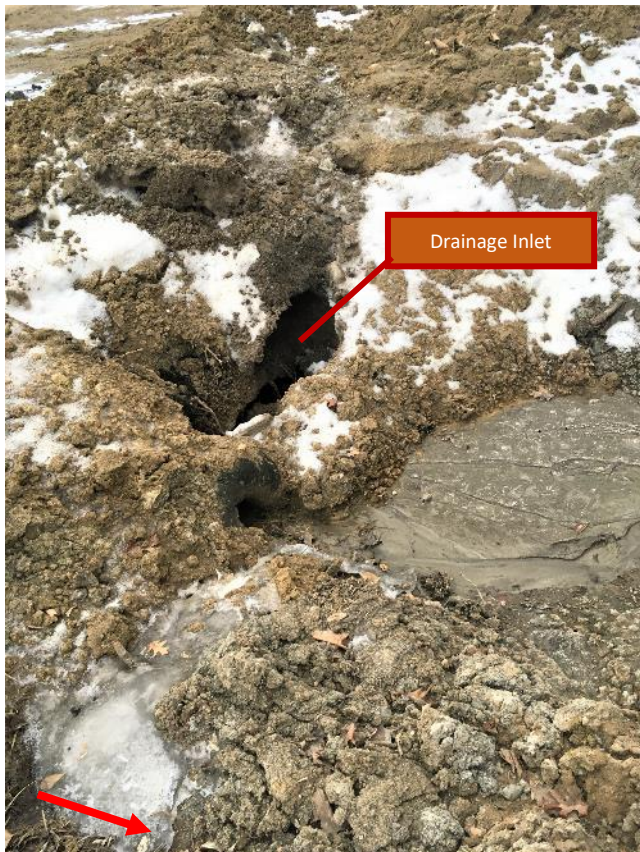
Photo No.: 22

BMPs Present: None visible

Description: Drainage inlet partially buried by debris. See photo 21 for drainage leading to the inlet.

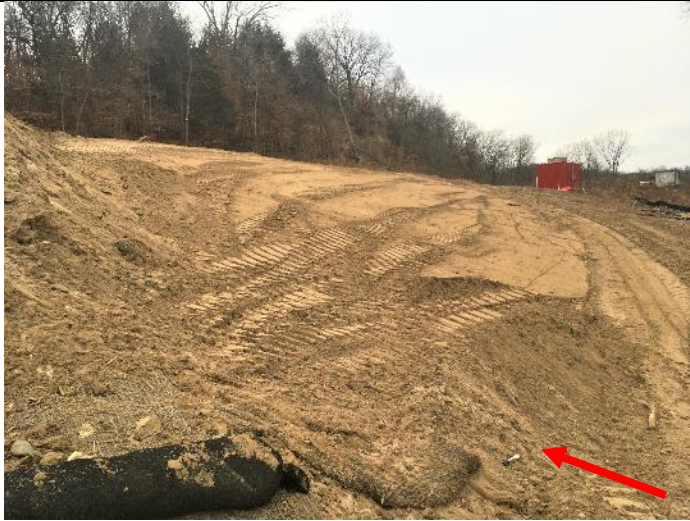
Photo No.: 26

Bare ground conditions allowed for a clear view of grading activities. Since the last inspection, several areas of the project have been graded, including places that previously had extensive erosion. These areas were quite soft, and my boots sank into the soil at least 1-2 inches. See photos 26, 34, and 36 for grading activities.

BMPs Present: Biologs

Description: Slope leading to photo 24 area and culvert outlet. This area is several yards east photo 25. Crews have removed the ESC blanket and regraded the area. Soils are very soft, but no erosion was evident during the inspection.

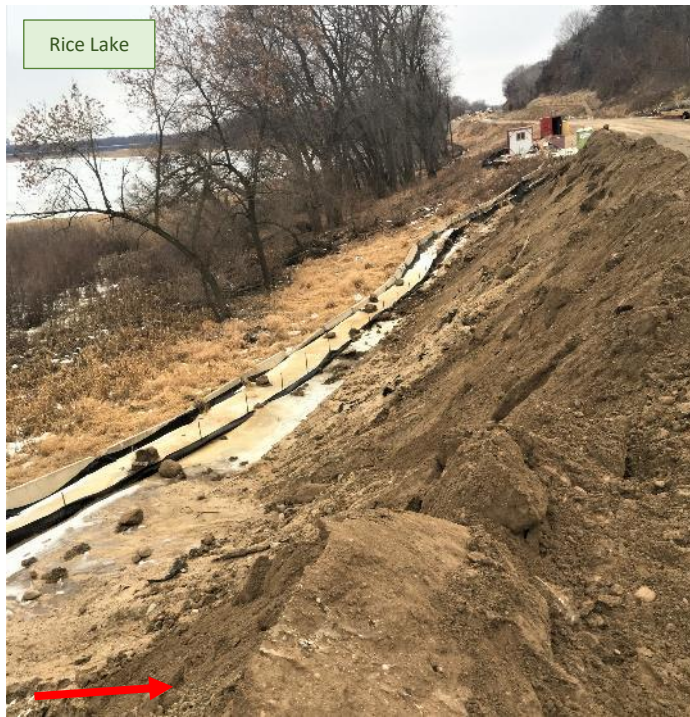
Photo No.: 27

BMPs Present: Silt fencing: two rows, one row backed with jersey barriers

Description: Southern slopes leading to Rice Lake. Silt fencing is intact and filled with snowpack.

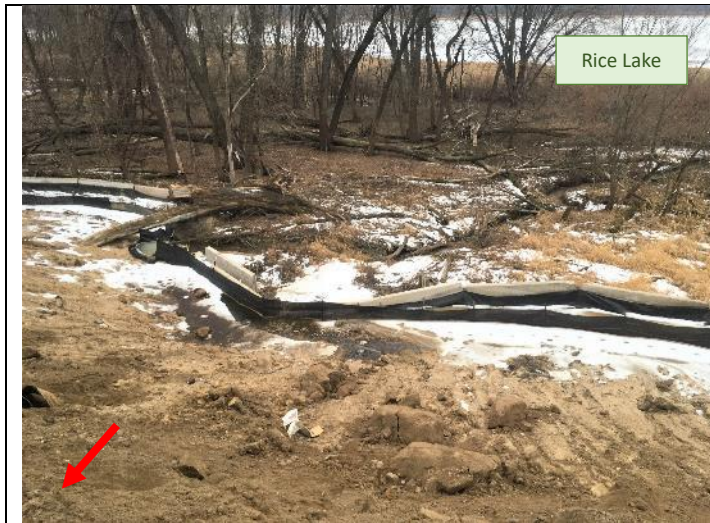
Photo No.: 28

BMPs Present: Silt fencing: two rows, one row backed with jersey barriers

Description: Southern perimeter of the project. Largely unchanged since last site visit, apart from the loss of snowpack.

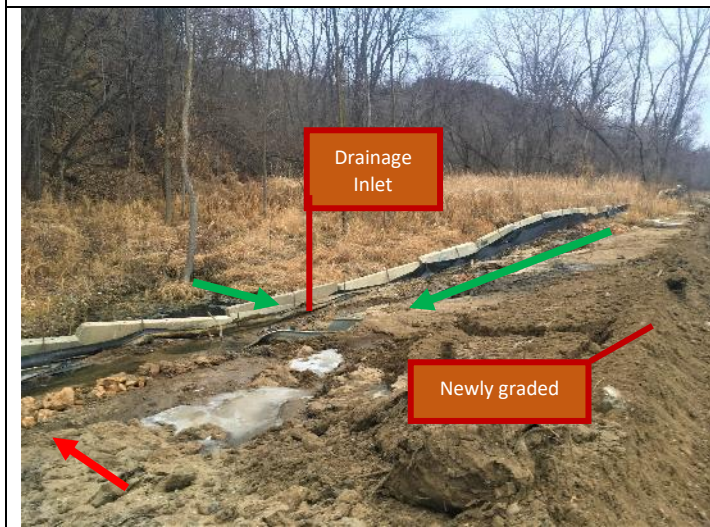
Photo No.: 29

BMPs Present: Silt fencing: two rows, one row backed with jersey barriers

Description: Culvert inlet on the northern side of the ROW. During the last site visit (December 4th), this area was actively being graded. Soils are still soft but are no longer saturated.

During the site visit water was flowing from the wetland area, over the silt fencing, and into the culvert. See the green arrows for path of drainage.

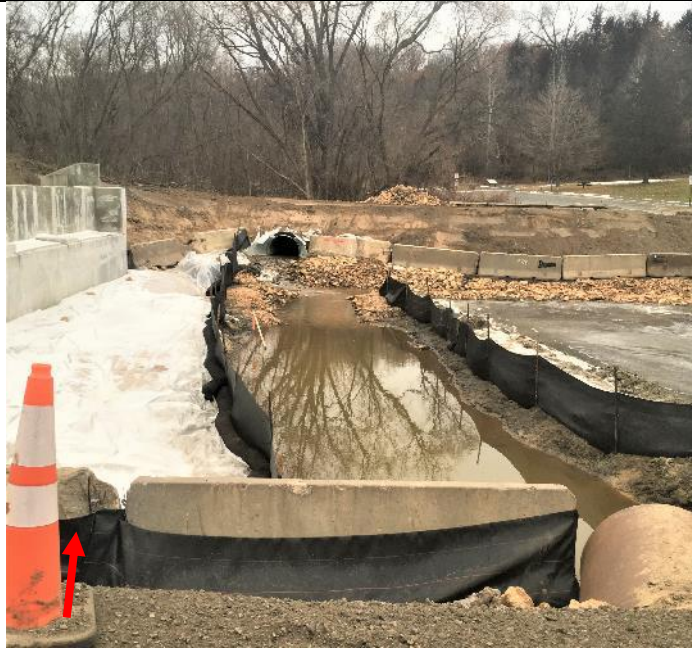
Photo No.: 30

BMPs Present: Silt fencing backed with jersey barriers

Description: Stream channel through running through the project. The area is stable, and no erosion or sedimentation was evident during the inspection.

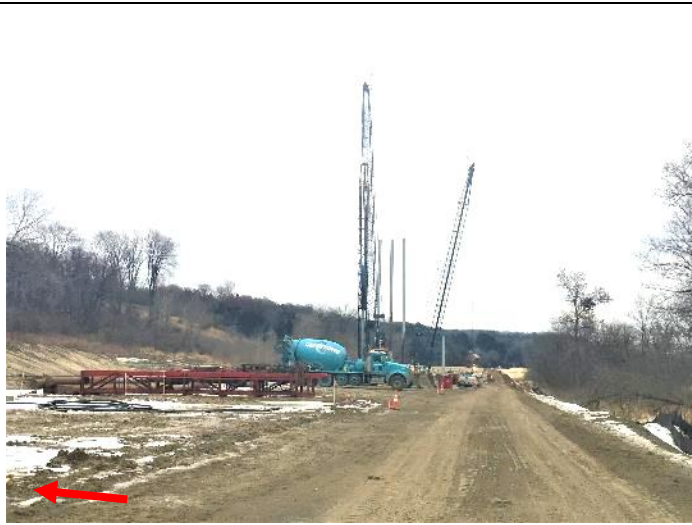
Photo No.: 31

BMPs Present: Two rows of silt fence

Description: Crews pouring concrete on site.

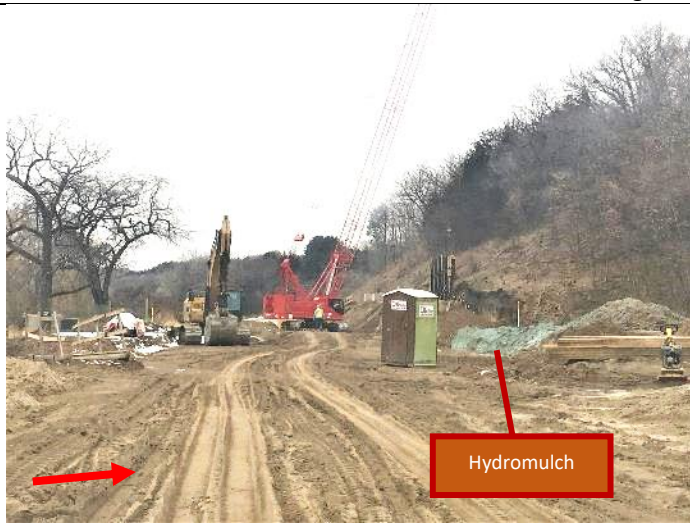
Photo No.: 32

BMPs Present: Hydromulch

Description: Crews onsite installing walls along the northern side of the ROW. Fresh hydromulch has been spread just outside of the work area.

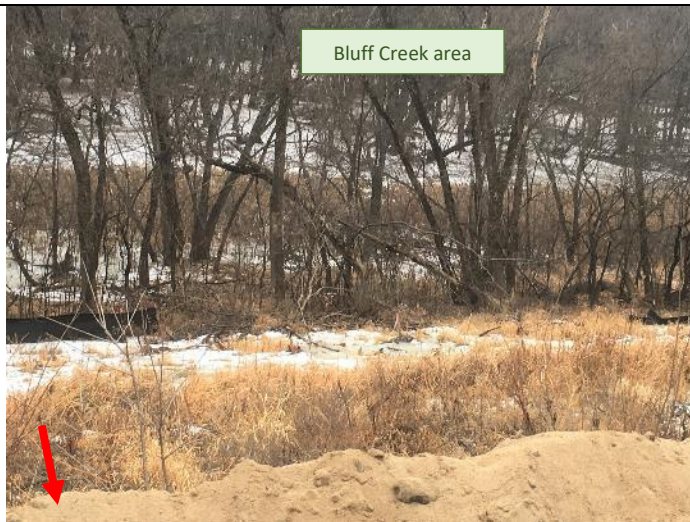
Photo No.: 33

BMPs Present: Silt fencing; vegetative buffer

Description: Stable ROW conditions along the southern perimeter of the project.

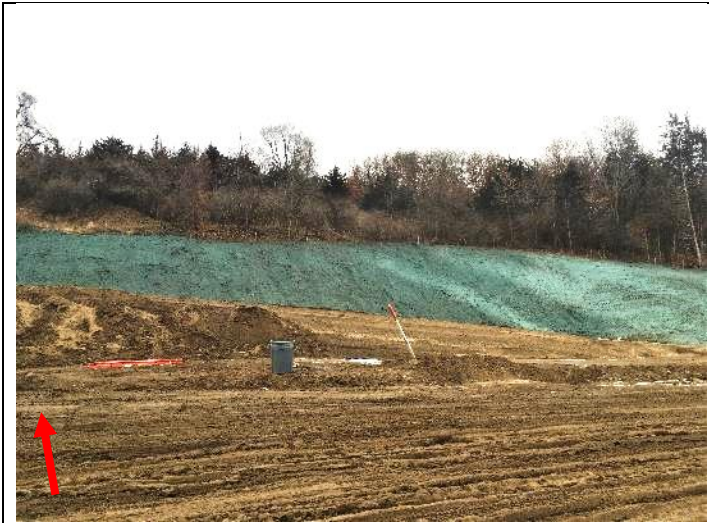
Photo No.: 34

BMPs Present: Hydromulch

Description: The northern side of the ROW after crews sprayed hydromulch on the slopes.

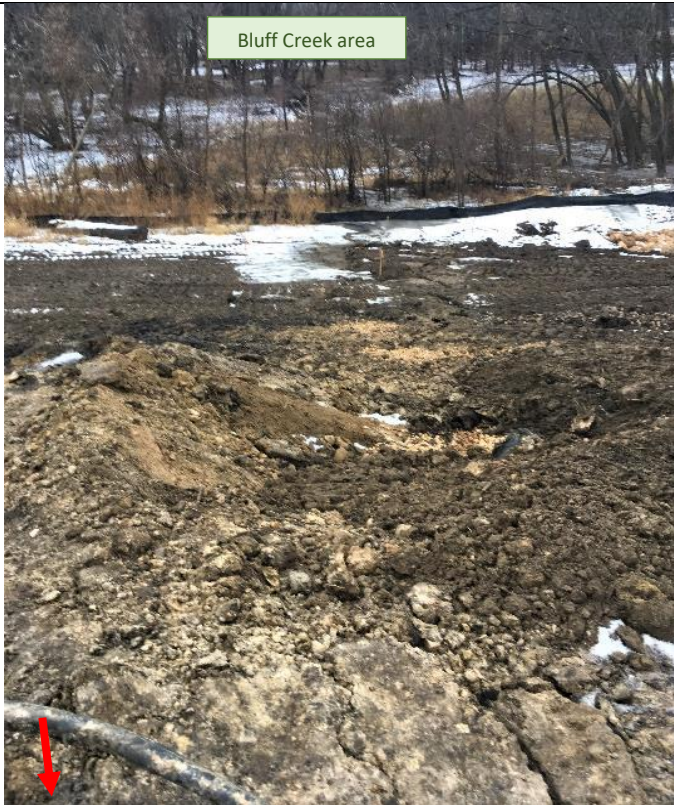
Photo No.: 35

BMPs Present: Silt fencing

Description: Southern side of the ROW after snowmelt. There is some channeling leading to the silt fence. Water and snow have pooled near the silt fence.

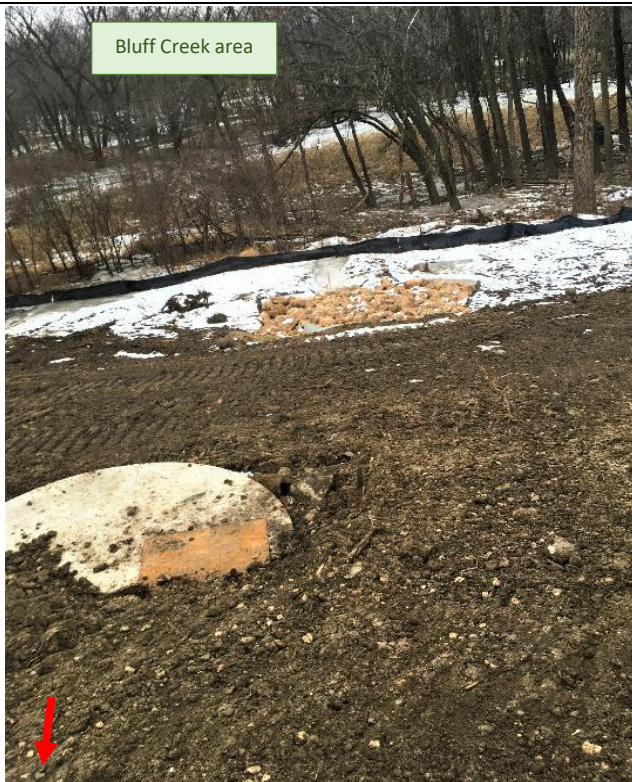
Photo No.: 36

BMPs Present: Silt fence; riprap

Description: Southern side of ROW. The site appears to have been regraded recently, likely in preparation for hydromulch.
