## Memorandum

**To:** Della Schall Young, Principal, Young Environmental Consulting Group, LLC  
Linda Loomis, Administrator, Lower Minnesota River Watershed District  
**From:** Jeff Weiss, PE, Senior Water Resources Engineer  
Adam Howard, PE, Water Resources Engineer  
**Subject:** East Chaska Creek Assessment  
**Date:** January 18, 2019  
**Project:** 23101028.02

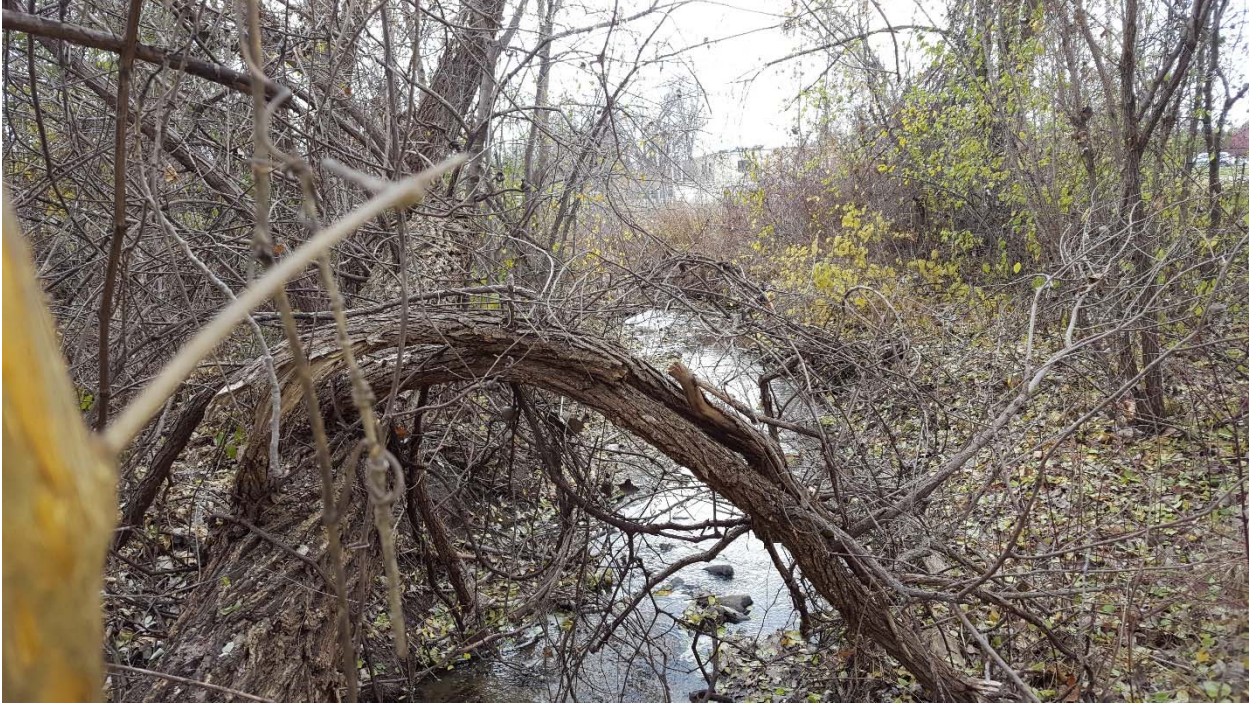
After evaluating photos and field notes, Barr concluded that the maintenance items at M7, M8, M9, and M10 are the lowest priorities, or could be excluded from maintenance activities. Debris is still located at each site and should be removed if it can be done without creating a significant additional disturbance; however, they are minor issues that are not causing significant adverse impacts.

*Photo 5: Site M8 – debris in channel*

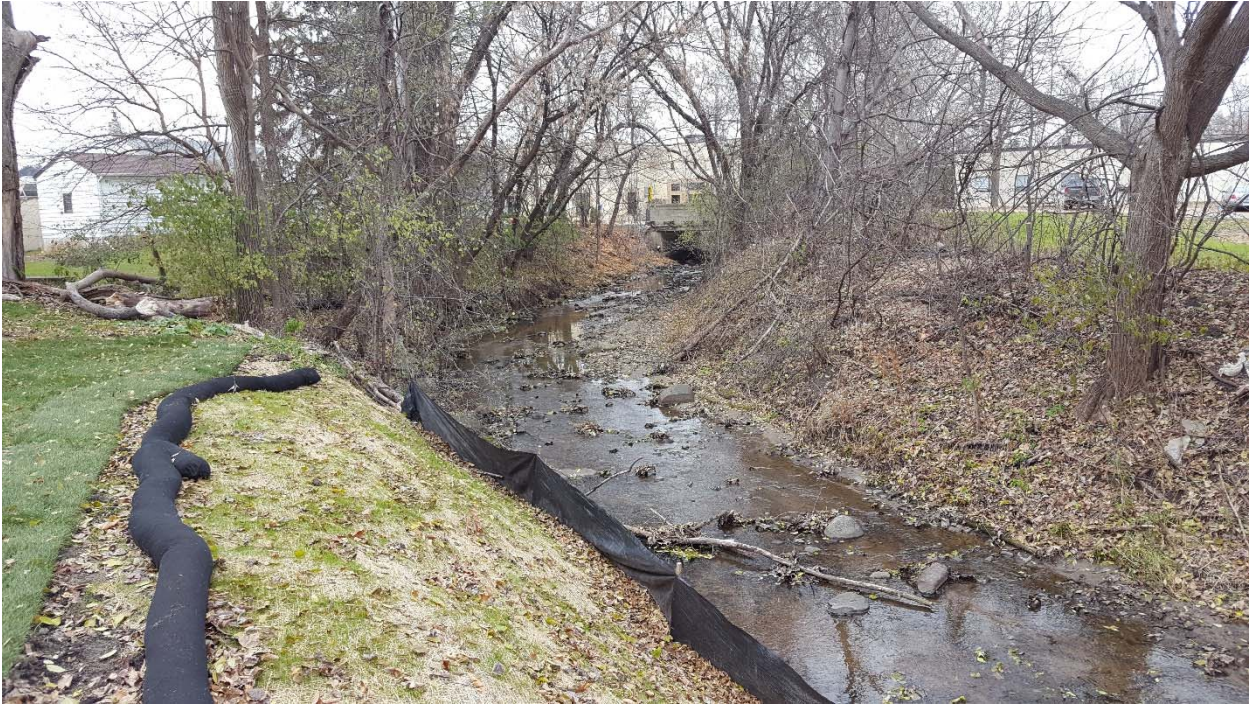
*Photo 6: Site M9 – debris in channel upstream of site repaired by city of Chaska*

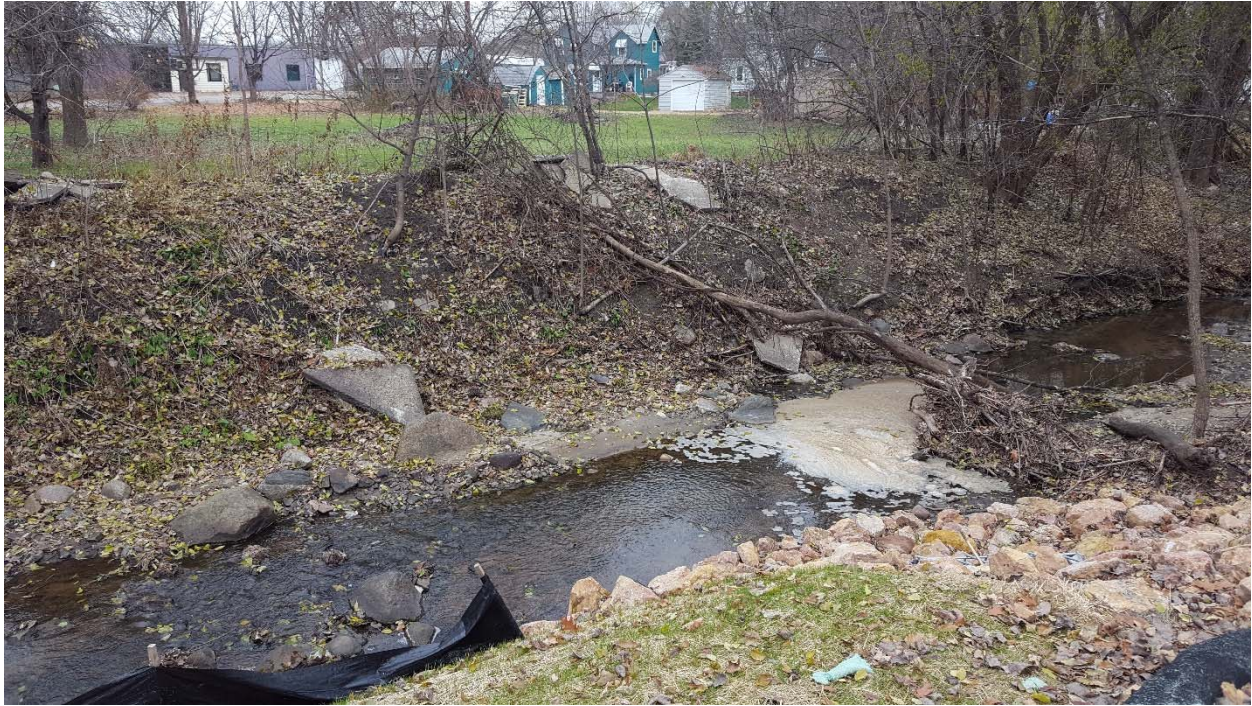
*Photo 7: Site M10 – debris in channel downstream of site repaired by city of Chaska*

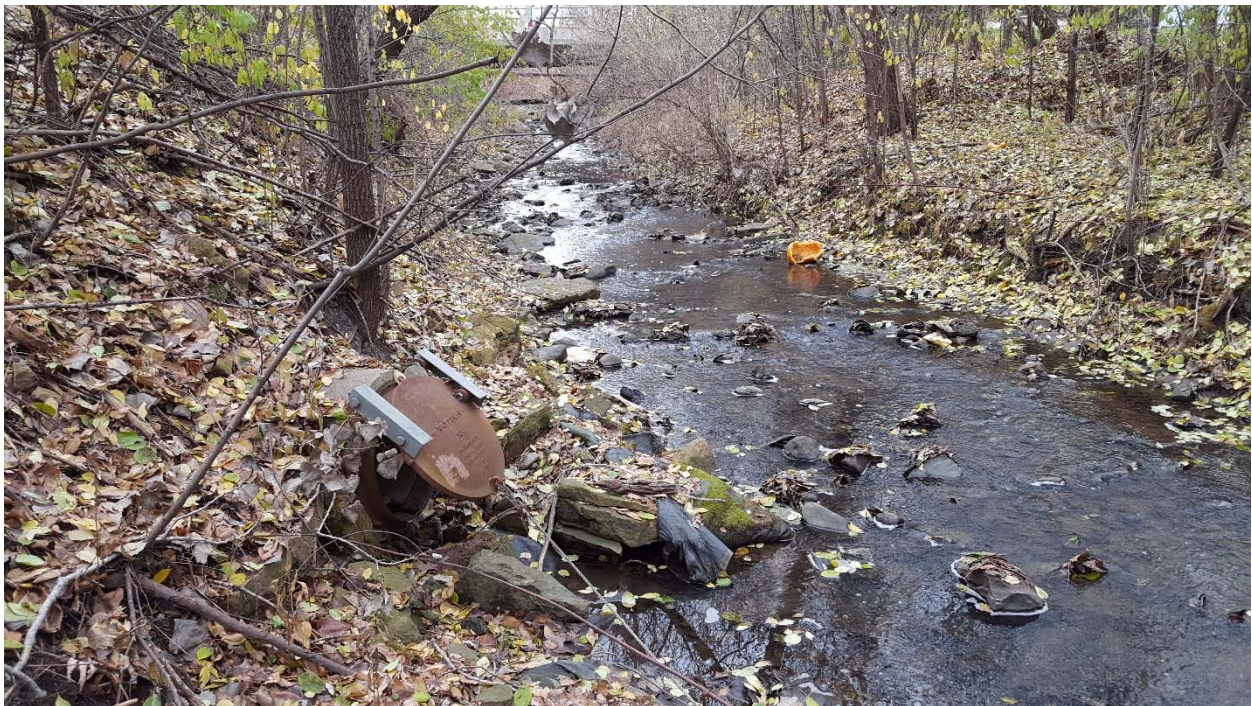
*Photo 8: Site M11 – flap on RCP outlet and minor bank erosion*

M11	Remove flap gate off RCP outlet, repair riprap	No	Complete as planned
M12	Remove debris	No	Complete as planned
M13	Remove debris and remove material pile on left bank, seed	Yes	N/A
M14	Install riprap at end of storm sewer outfalls and cross vane for grade control	No	Added in 2018

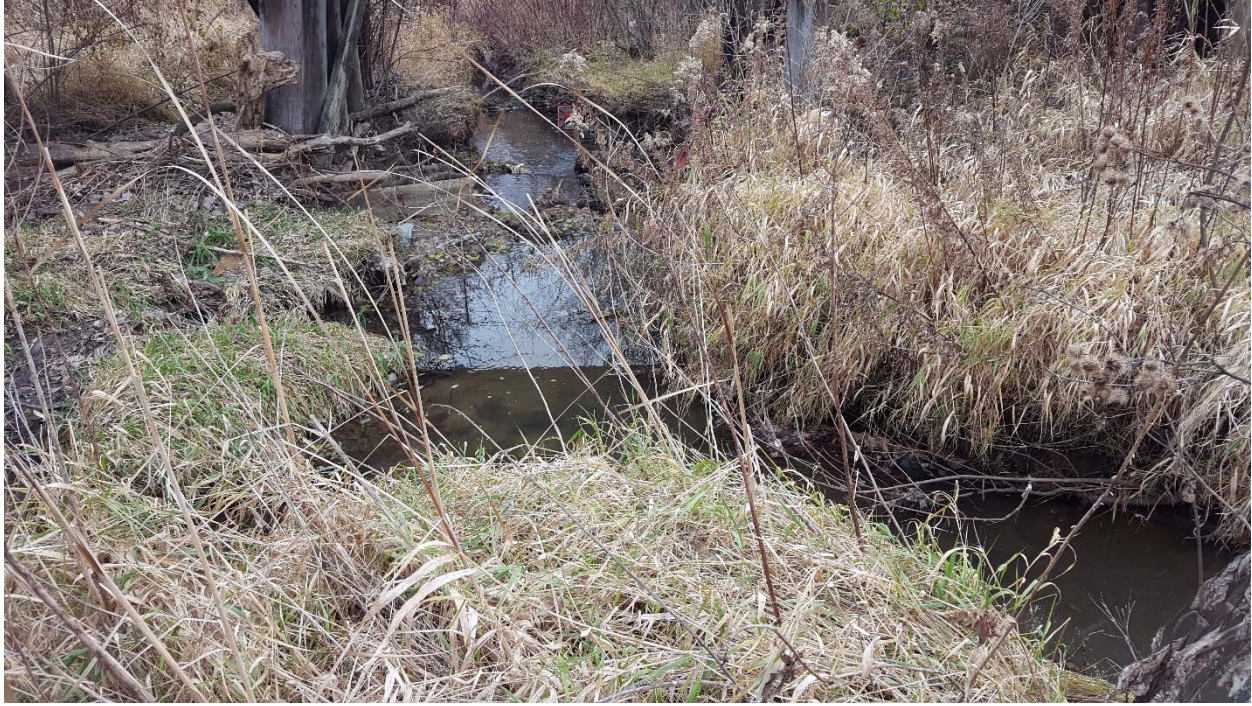
*Photo 11: Site M14 – eroding banks and headcuts near Chaska Boulevard*

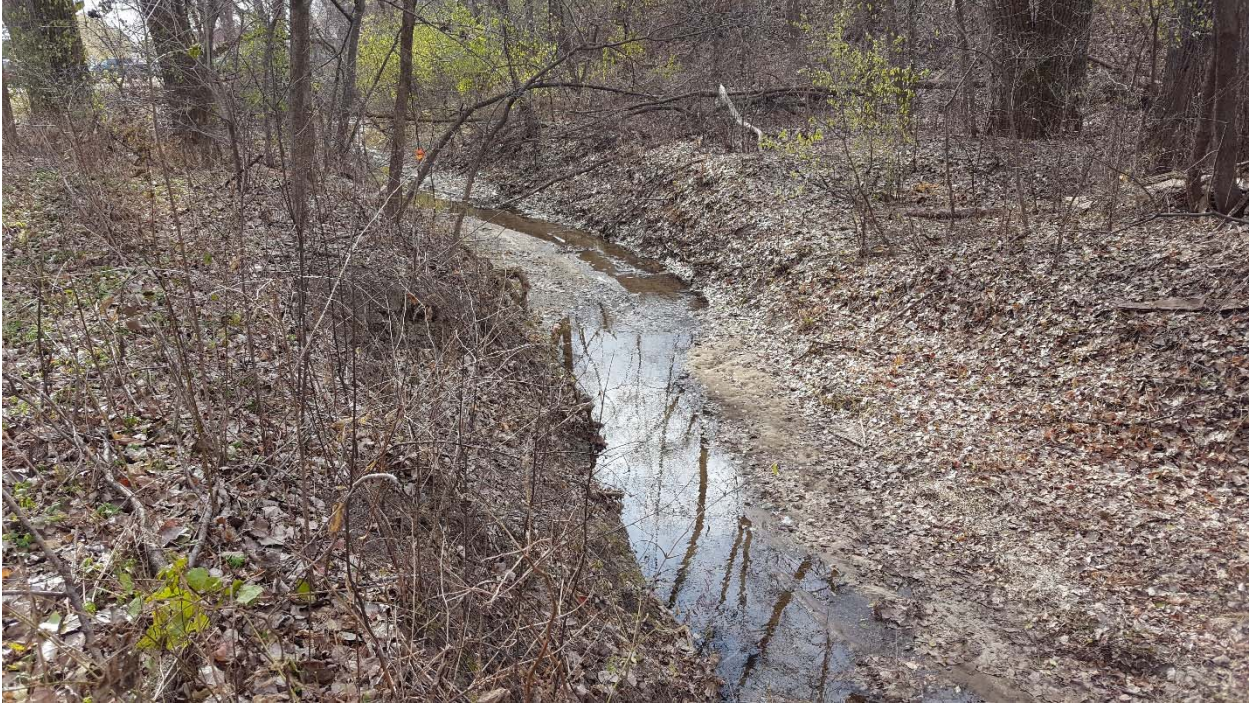
After reviewing the site, Barr concurs that all of the erosion sites should be stabilized, and we concur with the recommendation to remove temporary asphalt repairs. The armoring and toe protection previously recommended would be effective. The previously recommended grade control structure (S2, Figure 2) can be eliminated because headcutting does not appear to be an issue within this reach.

*Photo 13: Channel near site S2*

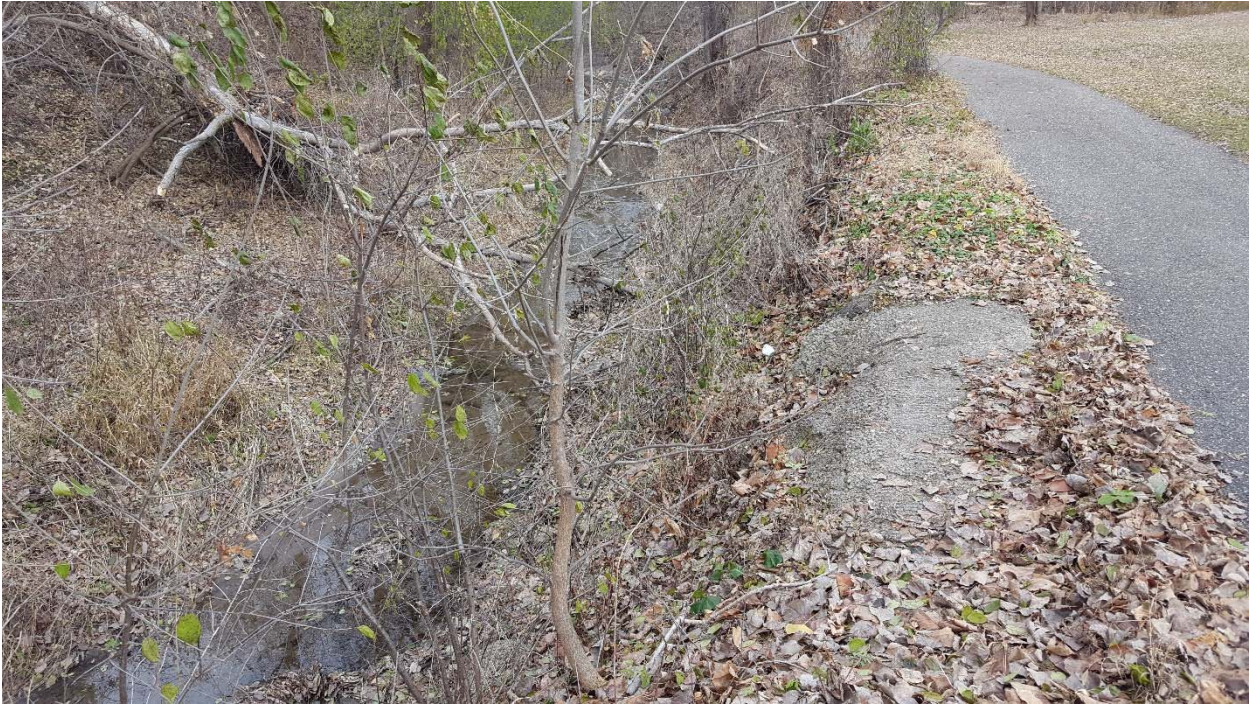
There are multiple eroding banks within this reach (Sites S2 – S6, Figure 2) that threaten the City's paved trail located between the channel and the Lenzen Chevrolet parking lot. The creek appears to be developing point bars and a meandering pattern through this reach that is otherwise relatively straight. Given the man-made origins of the channel, the original channel may have been created too large for the flows it currently experiences in this location, so a smaller, meandering pattern appears to be developing within the larger channel.

*Photo 14: Site S3 – eroding bank between channel and paved trail near Lenzen Chevrolet*

Alternatively, other stabilization measures could be used to achieve the same goals. Toe protection with riprap is still the most effective option in some places; however, rock vanes and root wads would be used in many locations to provide bank protection at a lower cost. The following table provides a comparison of the 2016 recommendations and alternatives considered in this analysis.

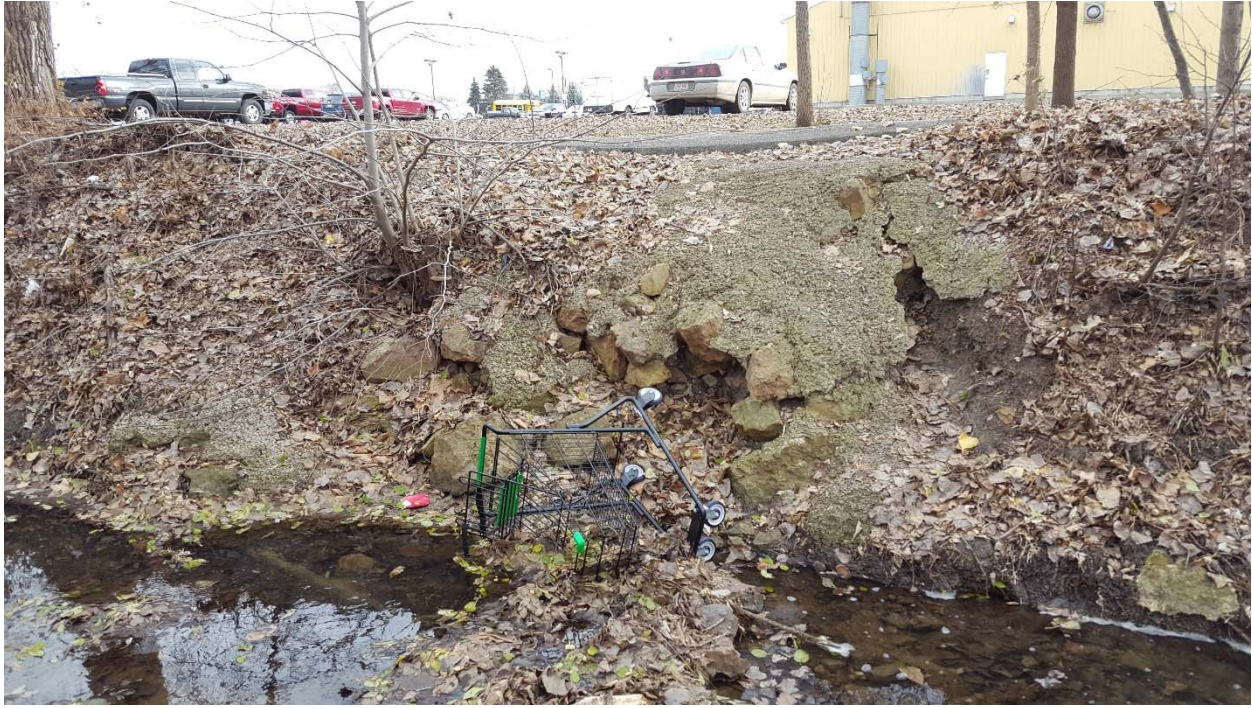
*Photo 15: Site S4 – eroding bank and debris in the channel*

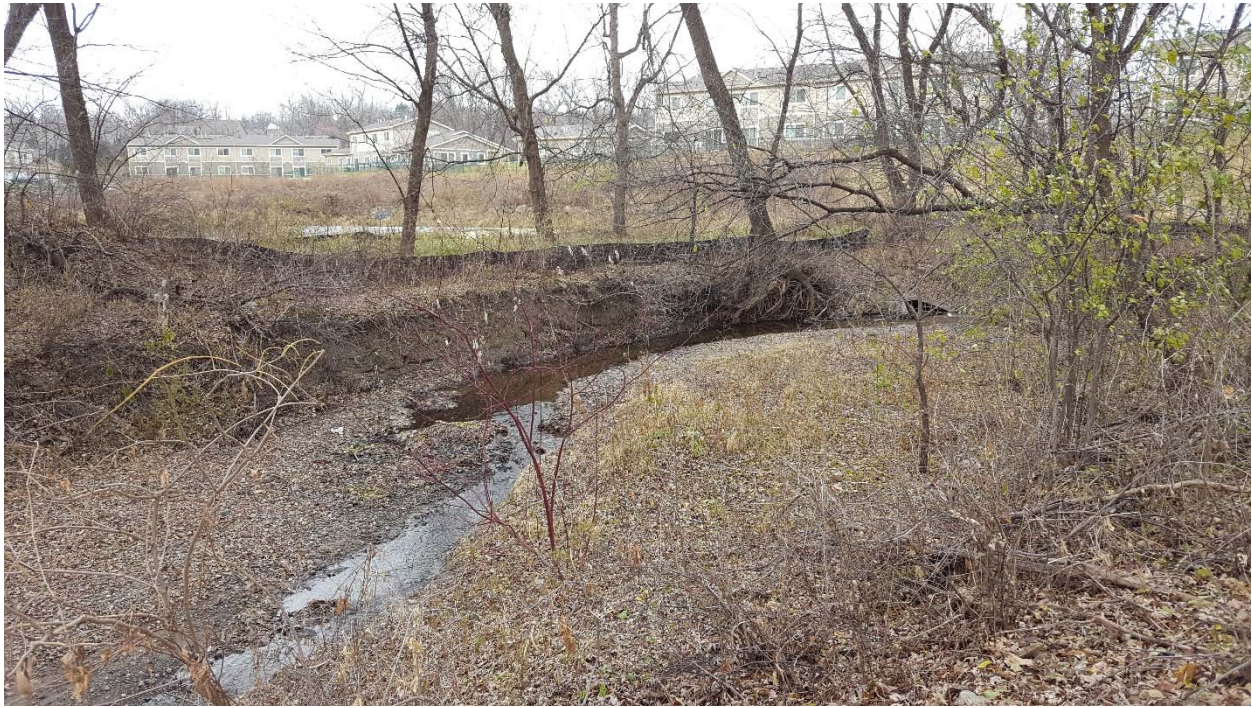
*Photo 16: Site S5 – eroding bank and undercut trees*

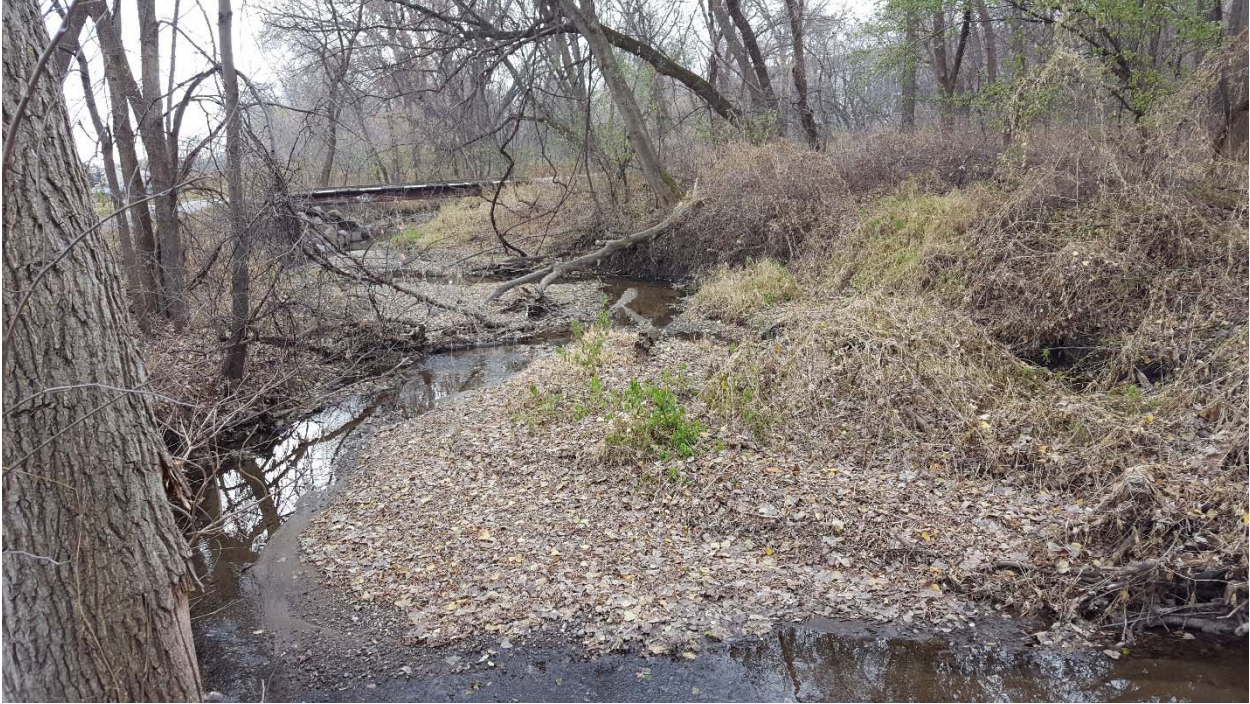
*Photo 17: Site S6 – minor bank erosion downstream on Lenzen Chevrolet*

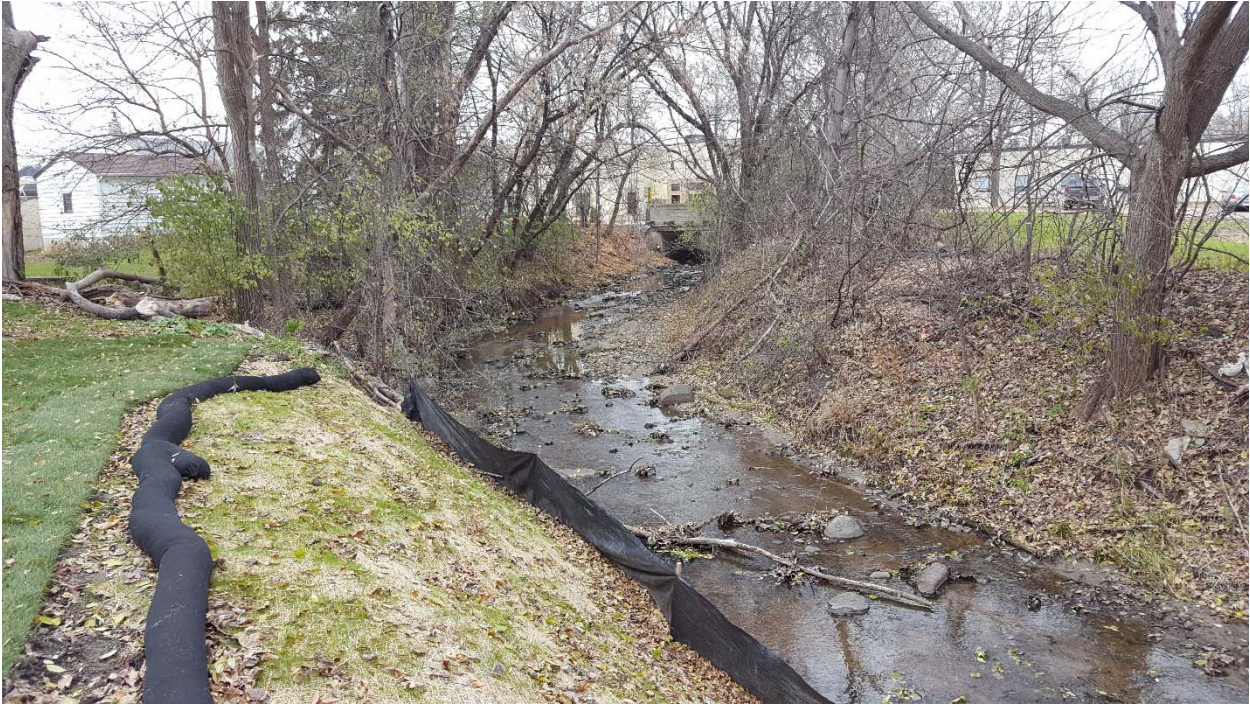
The original recommendation included installing toe protection for approximately 120 feet of the right bank (Figure 3). The 2018 assessment found that the City had recently completed some stabilization work

on this site, including grading and revegetating the bank. As a result, Barr recommends not completing additional stabilization work in this area.

*Photo 18: Site S7 – recent repairs made by city of Chaska*
