6.0 CITY OF CARVER

6.3 Findings

6.5 Carver High-Priority Sites

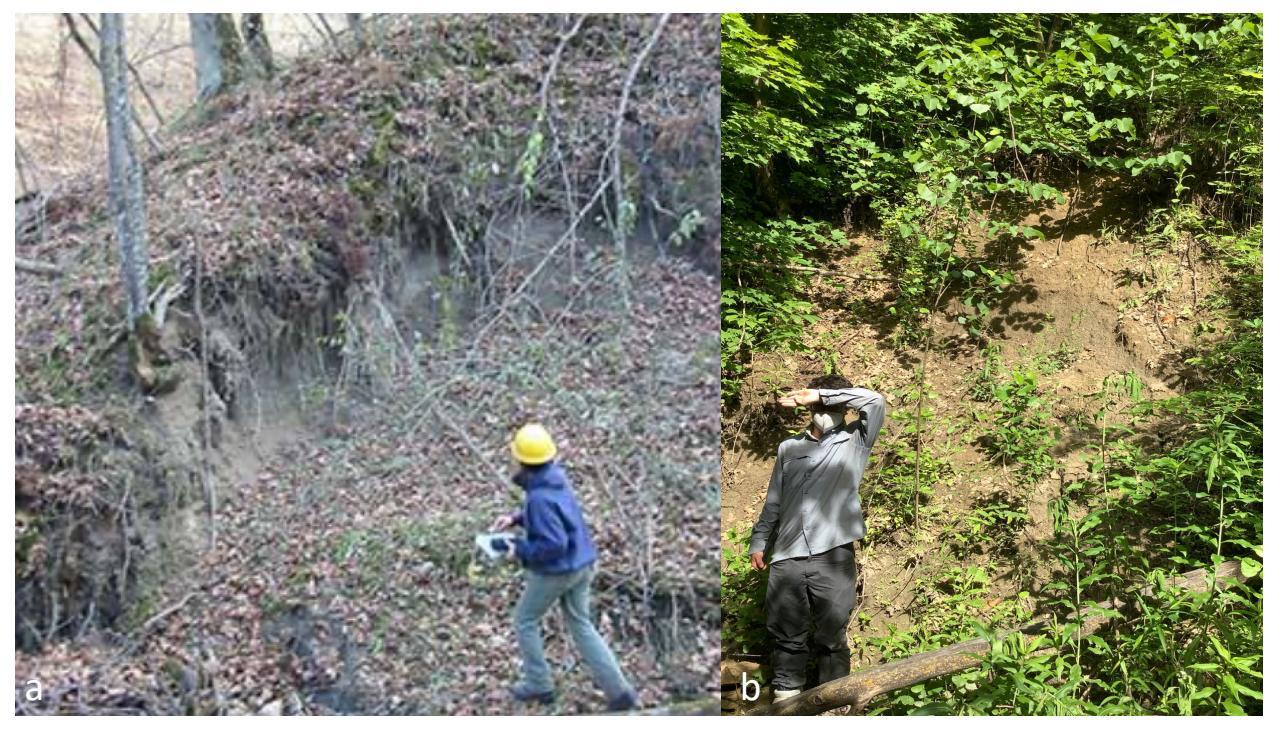
In 2008, the previous study found that the mainstream channel was formed by a culvert, with extensive erosion found throughout the channel. Steady water flow was observed at the time of the visit in 2008, and a spring was observed. This gully system was benchmarked predominantly as having high erosion potential, with the upstream portion rated as moderate based on the information available from the previous study. In 2020, the field team confirmed their findings, with seeps observed throughout the channel. The field team observed that extensive and severe erosion were still apparent in the channel, and that the stream has continued to incise and erode. **Figure 46** shows a side-by-side comparison of conditions observed at L145 during each study. **Figure 46a** highlights the depth and magnitude of channel incision along the stream channel seen in 2008. **Figure 46b** highlights the recent slumping and magnitude of channel incision observed in 2020. **Figure 47a** shows the channel incision that was noted in 2008. **Figure 47b** shows the channel incision observed in 2020, as well as recent slumping along the left bank. The gully system was rated in 2020 as having high erosion potential throughout the reach, giving evidence of its continued evolution to increased severity and providing the rational for its high priority ranking.

Figure 46. Photo 'a' is an image taken in 2008 of L145's banks with person for scale; Photo 'b' is an image taken in 2020 of L145's channel and left bank with a person for scale.

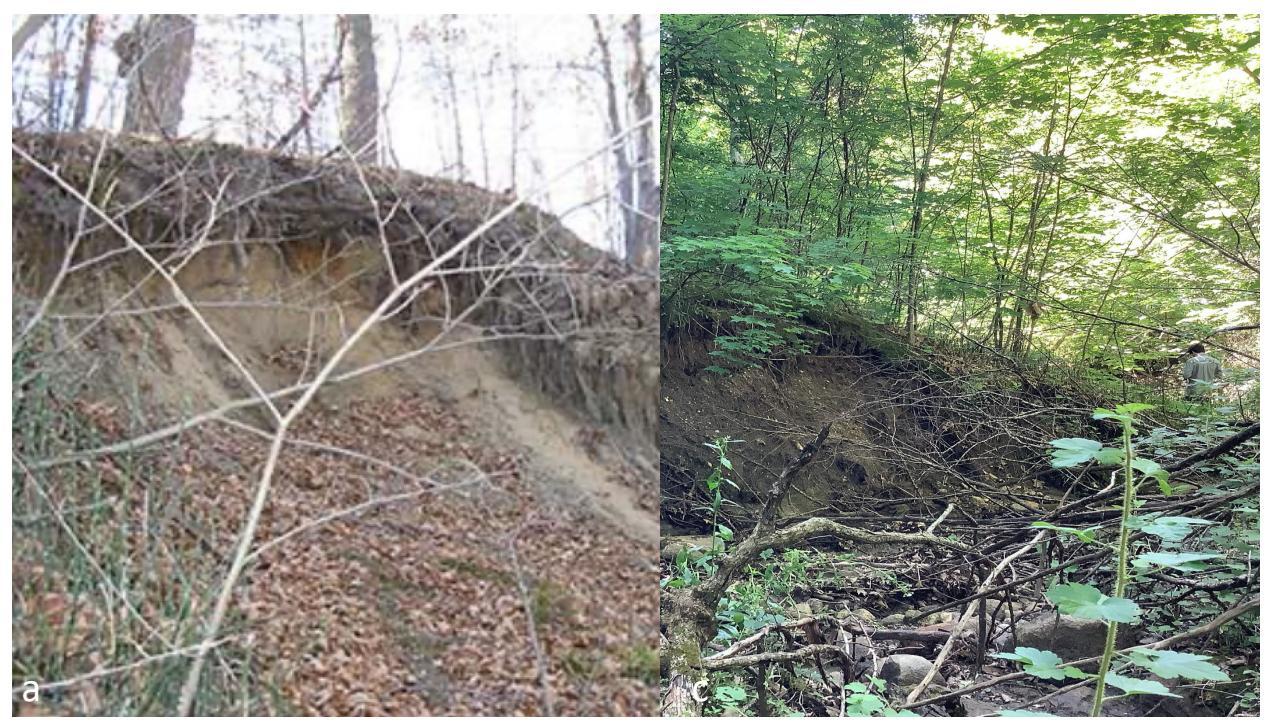
In 2008, the small finger gully system was described as having a head cut with mild erosion near the head cut and spring water in the channel. The system was benchmarked as having a low erosion potential near the head cut and a high erosion potential at the downstream portion of the channel. The team found in 2020 that the gully has progressed to having a more severe erosion potential near the head cut, with steep bank slopes and active signs of erosion and slope movement. The team additionally confirmed the high erosion potential ranking of the downstream portion of the system. The slump was described in 2008 as follows: "bigger gully tip, looks all right." It was benchmarked as having low erosion potential based on the information available to the team. In 2020, it was determined to have a high erosion potential ranking and was observed to be degrading and incising at its toe, a characteristic not noted or described in 2008.

Figure 47. Photo 'a' is an image taken in 2008 of L146's channel with a person for scale; Photo 'b' is an image taken in 2020 of L146's channel and left bank with a person for scale.

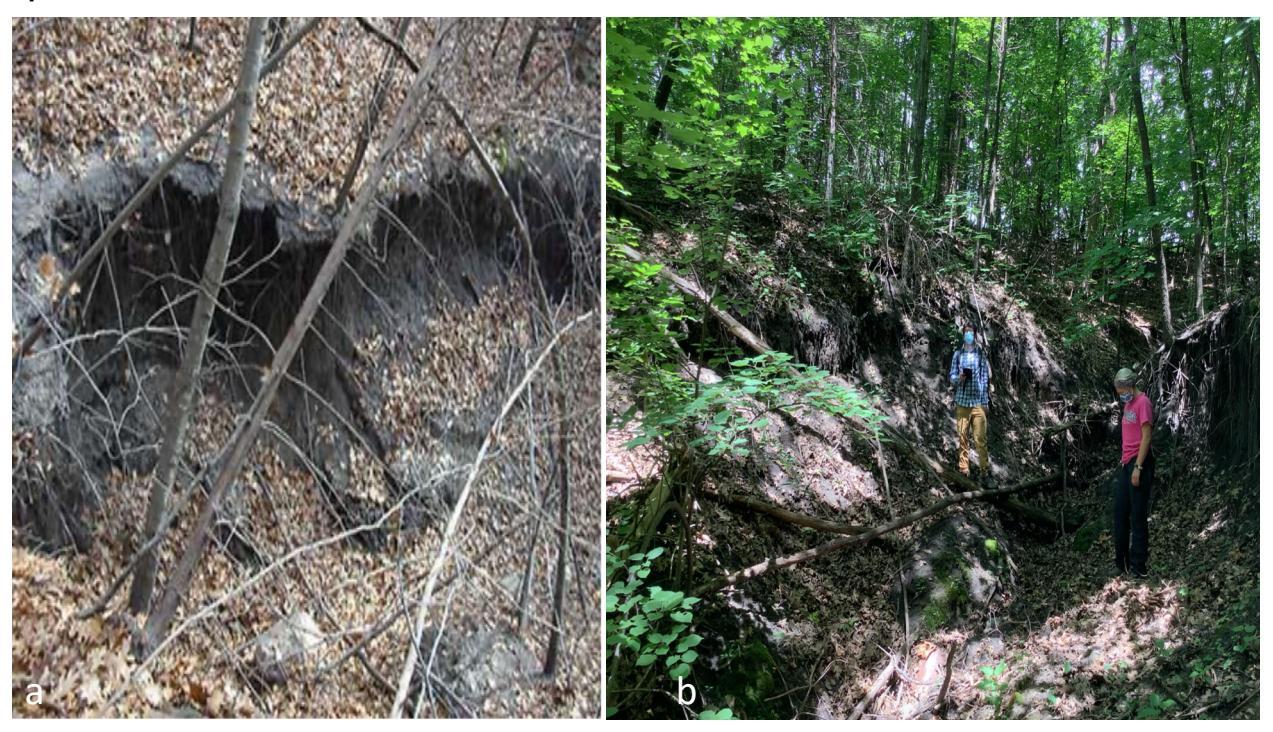
In 2008, L414 was described as the top of the gully, with severe bank erosion and a deeply cut channel. L128 was also described in 2008 as "cut deep with bad erosion." Both sites were rated as having high erosion potential during the desktop analysis. In 2020, the field team confirmed the high erosion potential rankings, finding similar signs of degradation, channel incision, and severe erosion. **Figure 51a** shows an image taken in 2008 of L128's channel, showing slumping and channel incision along the banks of the gully. **Figure 51b** shows an upstream view of L128's channel taken in 2020, showing a large knickpoint and its associated downstream degradation. Slumping was additionally observed in the channel downstream of the knickpoint.

Figure 51. Photo 'a' is an image of L128's channel and banks taken in 2008; Photo 'b' is an upstream view of L128's channel taken in 2020.

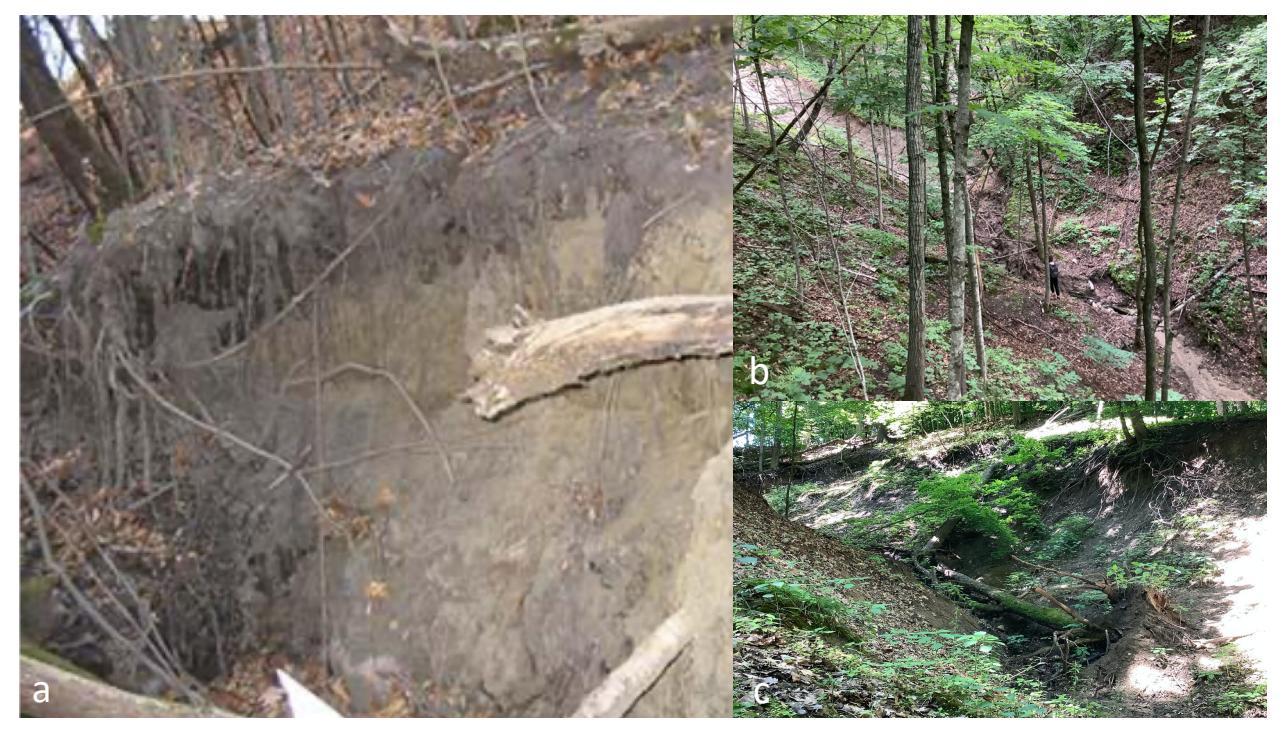
In 2008, the study documented extensive erosion at L420, L150, and L148. **Figure 53a** depicts the channel incision and active erosion seen at L148 during the previous study. At L153, the previous study characterized it as a "fingertip that looks good." The desktop analysis rated L420, L150, and L148 as having high erosion potential and L153 as having moderate erosion potential. The field team confirmed the three high ratings in the field, determining evidence of active erosion and slumping that provided the rational for high erosion potential rankings. **Figure 53b** and **Figure 53c** provide examples of the severe slumping, overhanging banks, and channel incision observed throughout the gully system. L153 was determined to be high erosion in the field, due in part to a second head cut forming off the main channel not previously identified in the 2008 study. Fresh bare soil with exposed roots also provided rationale for the site's high priority ranking.

Figure 53. Photo 'a' is an image of L148's channel and banks taken in 2008; Photo 'b' is an upstream view of L148's channel taken in 2020; and Photo 'c' is an upstream view of L150's channel taken in 2020.

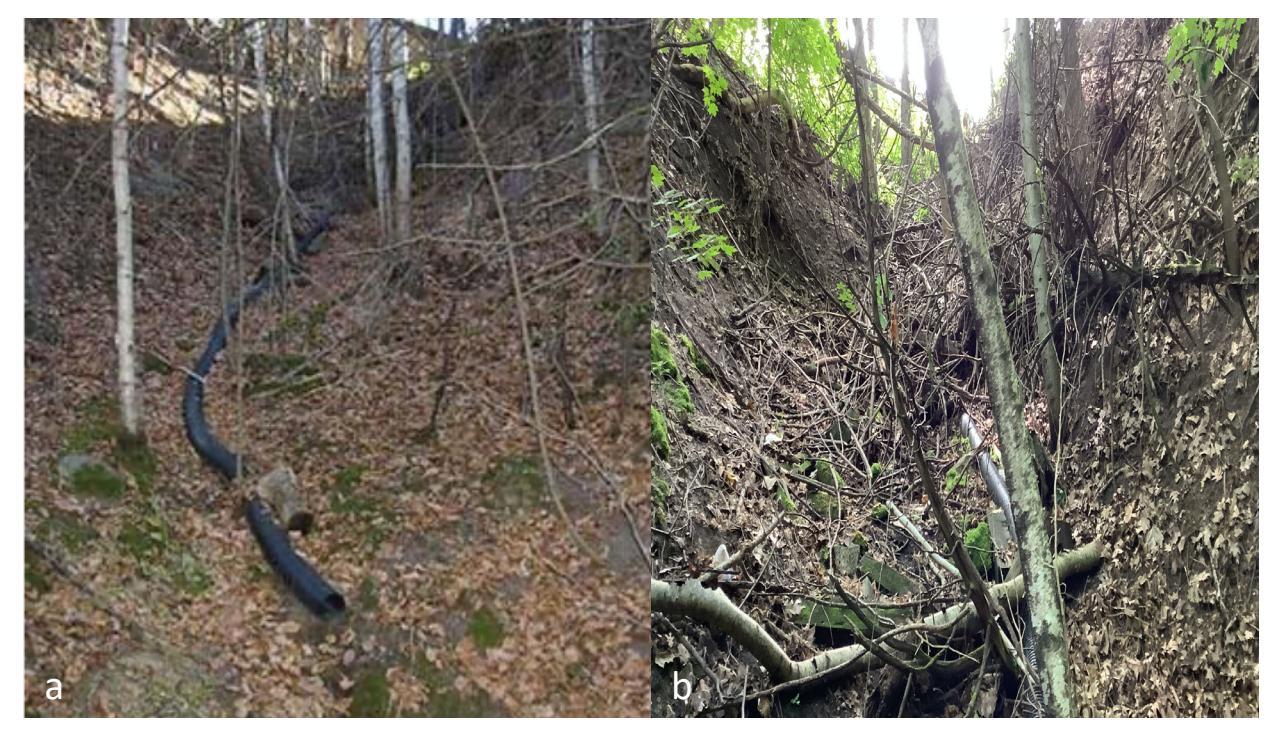
In 2008, L133 was noted as a residential drainage pipe. The site was classified as having moderate erosion potential based on the limited information available during the desktop analysis. The team confirmed the presence of a residential runoff drainage pipe causing the gully and found it has significantly eroded since the previous survey. Figure 55 shows the head cut area of L133. Figure 55a depicts the upstream view of L133's channel looking towards the head cut, showing the increased erosion. In comparison, Figure 55b shows the same upstream view of L133, taken in 2008. The two photos highlight the increased erosion in the gully channel between the two studies. The team rated it as having high erosion potential in 2020. L135 was evaluated as "bank erosion pretty bad" and as having groundwater upwelling occur and then disappear downstream. The gully was ranked as having high erosion potential during the benchmarking process. The team confirmed the high erosion potential ranking in the field, finding it to be a large slump. The team noted that given its large perimeter of undercut banks and completely bare bottom, there is a high potential for erosion from future precipitation events. Figure 56 depicts the comparison of the gully between the 2008 and 2020 study. Figure 56a is an image of the gully taken in 2008, showing similarly incised and overhanging banks. Figure 56b is an upstream view of the incised and overhanging left banks taken in 2020. Sites 999-094 and 999-050 are newly identified points, and as such were not surveyed in 2008 or benchmarked.

Figure 55. Photo 'a' is an upstream view of L133's head cut taken in 2008; Photo 'b' is an upstream view of L133's head cut taken in 2020.

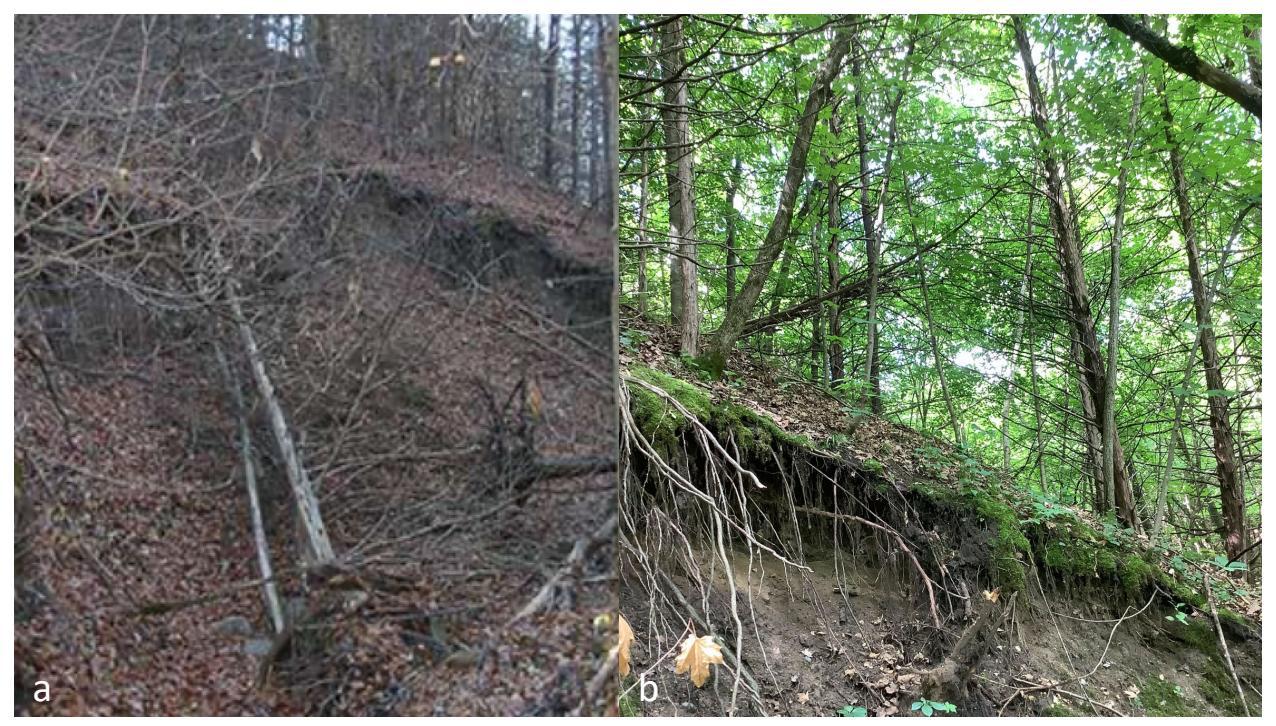
Figure 56. Photo 'a' is an image of L135's channel and banks around the head cut area taken in 2008; Photo 'b' is an upstream view of L135's head cut area and left bank.

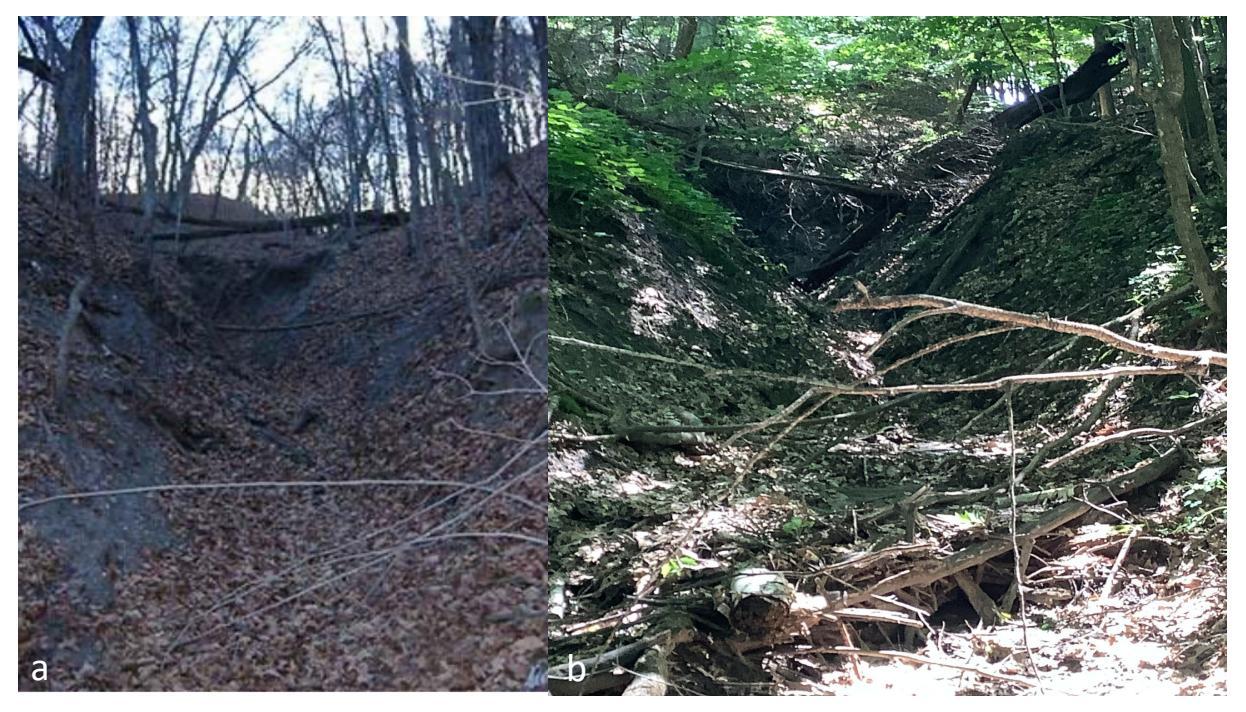
In 2008, L156 was noted as being a small finger gully with "deep cut erosion under trees and all up hillside." The gully was benchmarked as having high erosion potential based on the information provided. The team confirmed this ranking during the 2020 study. The main gully system was described in 2008 as being a finger gully with sizeable erosion throughout. Additionally, it was noted to have deep cut erosion at L157 near the gully toe. The system was ranked as having high erosion potential during the desktop analysis. The ranking was confirmed in the 2020 study, with the whole gully system being ranked as having high erosion potential. The team observed a significant increase in erosion and degradation since 2008, further providing a rationale for its high-priority status. **Figure 58** depicts the increased erosion and degradation that has occurred between the two studies. **Figure 58a** is an upstream view of the main gully system channel taken in 2020, showing the channel incision and erosion near L157. **Figure 58b** is the same upstream view taken in 2020, showing the increased channel incision and erosion that has occurred since the previous study, as well as highlighting the channel shape and incision commonly seen throughout the region.

Figure 58. Photo 'a' is an upstream view of L157's channel taken in 2008; Photo 'b' is an upstream view of L157's channel taken in 2020.

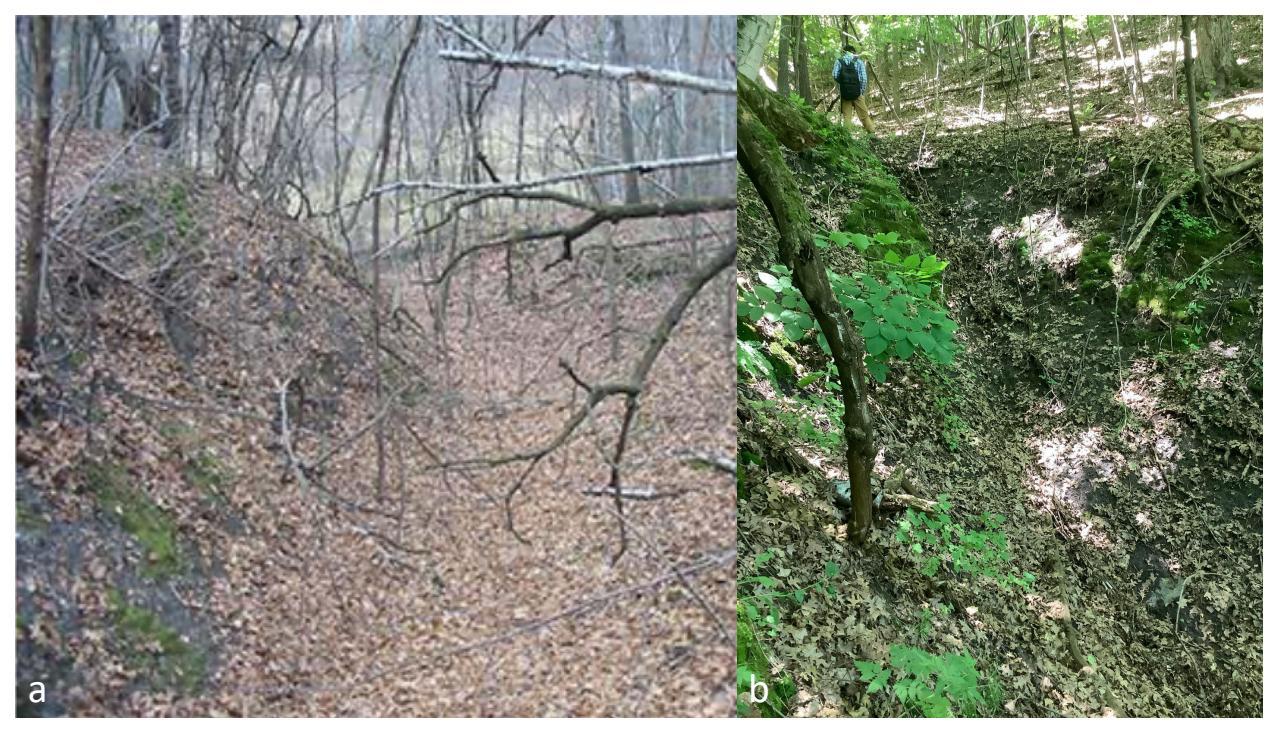
In 2008, L160 was described as "erosion control/tile outlet." It was rated as having moderate erosion potential during the desktop analysis, based on the limited information provided. Contrary to the previous rating, the field team ranked L160 as having a high erosion potential, evident by the significant downstream erosion observed. Site L162 was described as "minimal erosion along the channel" in 2008; and as such, was rated as having a low erosion potential during the desktop analysis. However, the field team found that it had a high erosion potential due to the fact that the banks and head cut were actively eroding and slumping off; but found it was on the lower end of high potential due to the channel's stable appearance. Gully L175 was described in 2008 as "the start of severe erosion in the gully" and was benchmarked as having moderate erosion potential based on the image and available information. In 2020, the field team found evident slumping and the head cut pushing back upstream. Additionally, they noted a finger gully forming on L175's channel. The team in turn rated this gully as having high erosion potential. **Figure 60** shows the gully's evolution between the two studies. **Figure 60a** is an image taken in 2008 of the gully channel and banks, showing incision and erosion in the channel. **Figure 60b** is an upstream view of the gully taken in 2020, showing the slumping, overhanging banks and active erosion seen at the time of the visit.

Figure 60. Photo 'a' is a view of L175's channel and banks taken in 2008; Photo 'b' is an upstream view taken in 2020 of L175's channel and banks.

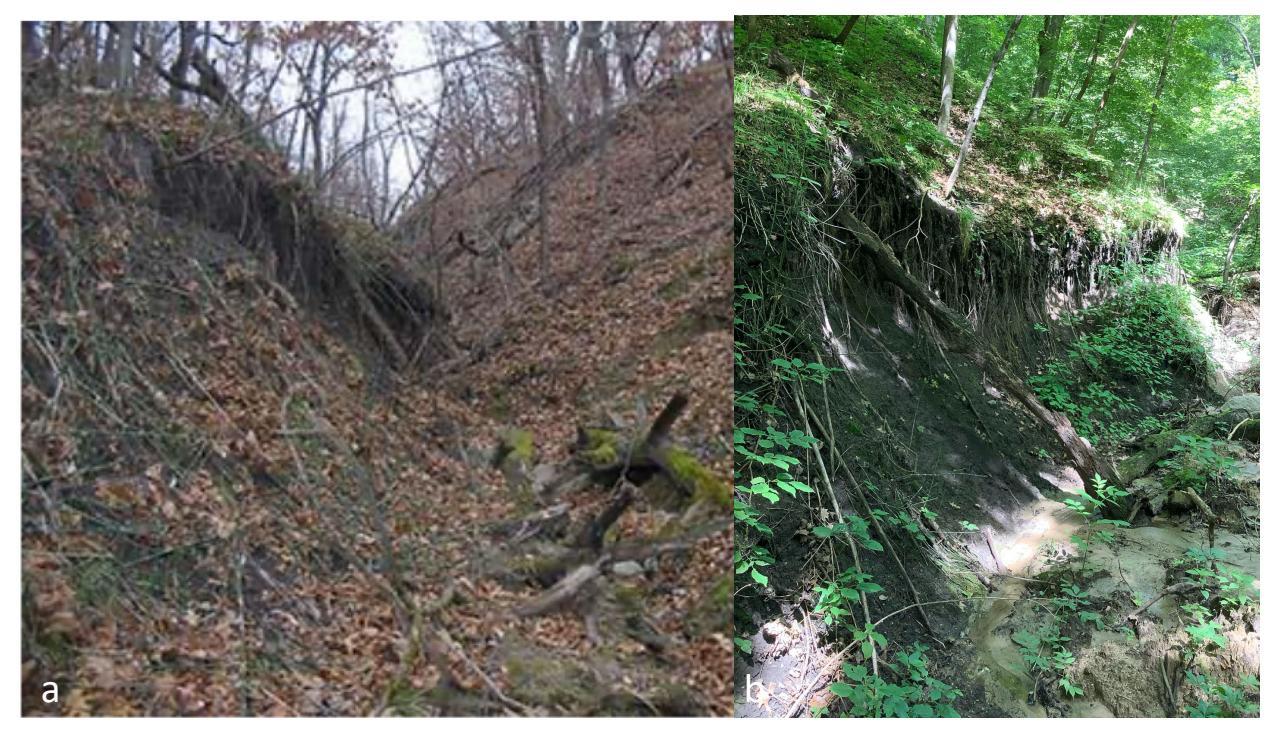
In 2008, the stream channel was evaluated starting at L128, noting it as the beginning of a long channel. Its evaluation ended with L170, which the survey described as the "end of [an] extremely eroded channel." The desktop analysis rated both L128 and L170 as having high erosion potential based on the images and information provided. The team confirmed these ratings in the field during the 2020 study, finding continued evidence of active erosion, slumping, and incision in the channel. **Figure 62** shows the incision and extreme erosion occurring in L170's channel. **Figure 62a** is an upstream view taken in 2008 showing the severe incision and undercut banks along the right bank. **Figure 62b** is another upstream view taken in 2020 showing the continued severe incision and undercut banks along the right bank. L426 was described as a finger gully with strongly eroded banks in 2008 as shown in **Figure 63a** and was ranked as having moderate erosion potential during the desktop analysis. The team visited the site in 2020 and ranked it as having high erosion potential due to the actively eroding head cut and deeply incised channel observed as shown in **Figure 63b**.

Figure 62. Photo 'a' is an upstream view of L170's channel taken in 2008; Photo 'b' is another upstream view of L170's channel taken in 2020.

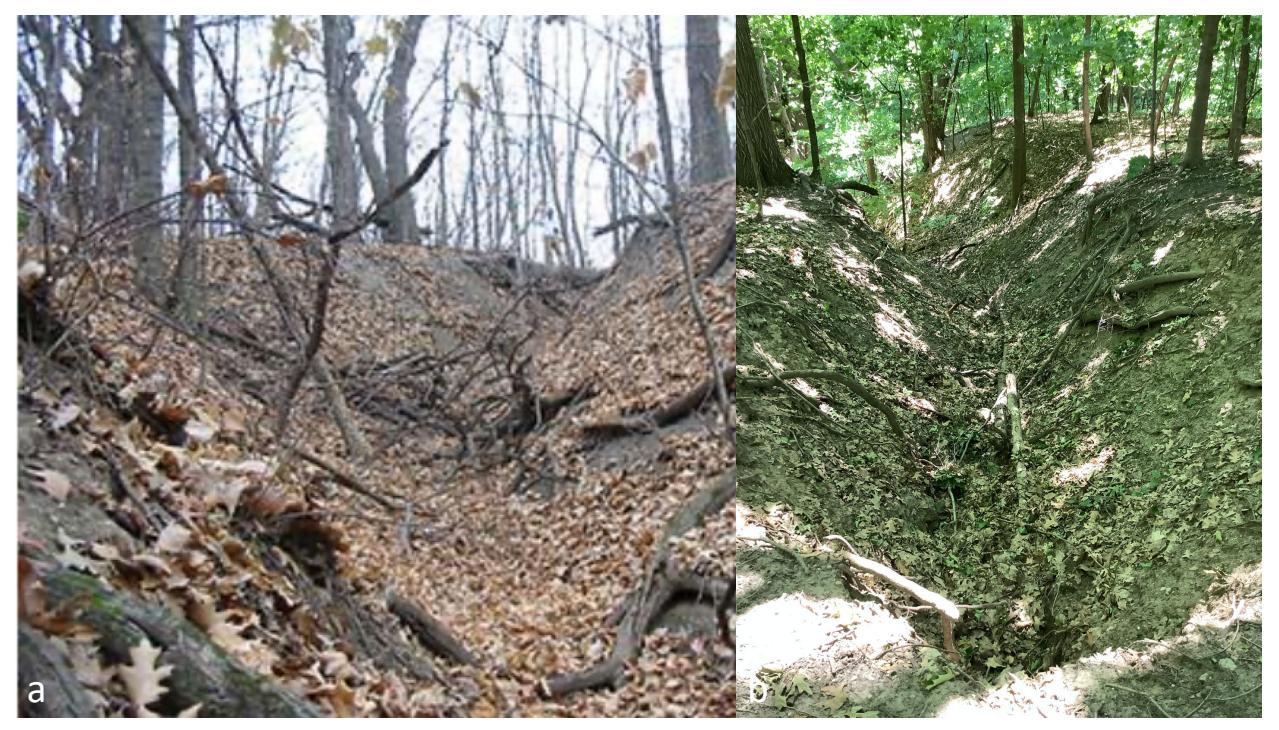
Figure 63. Photo 'a' is an upstream view of L426's channel taken in 2008, Photo 'b' is a downstream view taken in 2020 of L426's channel.

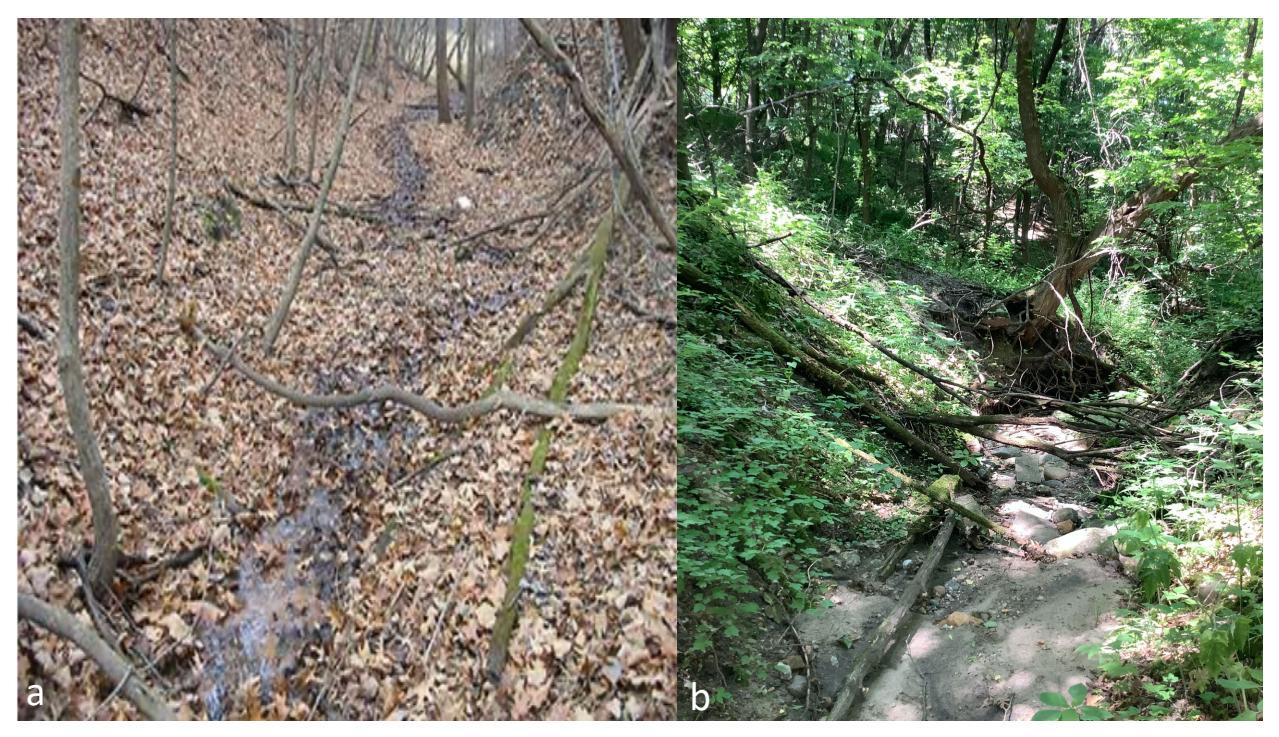
In 2008, L187 was described as a "washout area." During the desktop analysis, it was determined the site had high erosion potential based on the image and information available. The team in 2020 confirmed this high erosion potential ranking in the field, finding evidence of active erosion throughout the channel and significant slumping. Site L186 was evaluated as a spring at the end of a marsh in 2008 and given a low erosion potential ranking during the desktop analysis, based on the limited information available. The field team determined the site had high erosion potential in 2020, finding evidence of slumping and new head cuts forming from the original channel. Groundwater incision in the channel was additionally noted, providing a rationale for its high erosion potential ranking. **Figure 65** shows the evolution of L186. **Figure 65a** is a downstream image of L186's channel taken in 2008, showing minimal channel incision and erosion. **Figure 65b** is a downstream image of L186's channel taken in 2020, showing severe channel incision, undercut and exposed banks, and erosion in channel.

Figure 65. Photo 'a' is a downstream view of L186's channel taken in 2008; Photo 'b' is a downstream view of L186's channel taken in 2020.

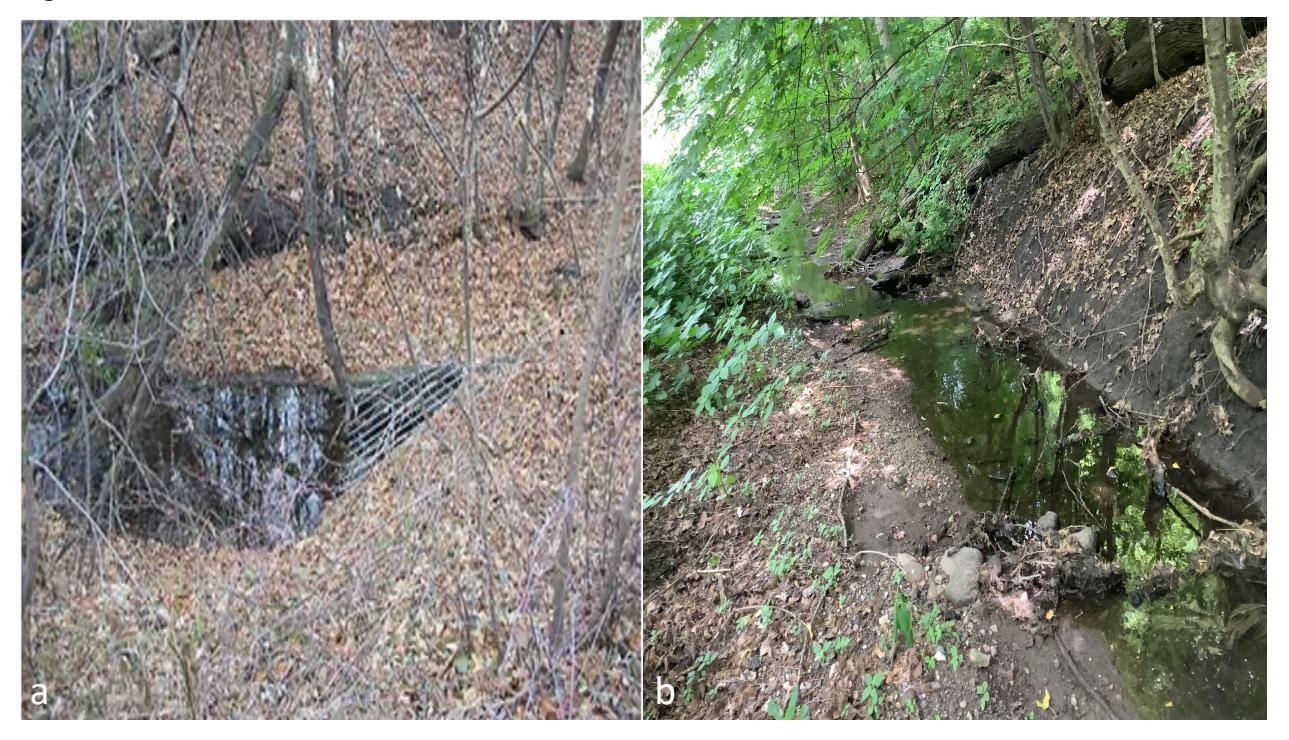
The problem indicators for L178 were loss of bank vegetation, incision, slumping, undercut banks, and leaning trees. The apparent cause of L178 was determined to be channel incision and an unstable drainage feature entering the system. In 2008, L178 was evaluated as a "culvert on side of road." Based on the limited information available, it was determined to be of moderate erosion potential during the 2020 desktop analysis. The field team conversely found it to be of high erosion potential. It was determined as such because it was observed in the field that the right bank was unstable and a large storm coming through the pipe outfall could cause significant erosion and slumping along the bank. **Figure 66** shows a side-by-side comparison of conditions observed at the time of each study. **Figure 66a** shows an image taken in 2008 of the outfall pipe and surrounding channel; the image shows moderate incision and minimal erosion in the downstream channel. **Figure 66b** shows an image of the downstream channel taken in 2020. The image highlights the severe channel incision, active erosion, and unstable right bank.

Figure 66. Photo 'a' is an image taken in 2008 of the culvert forming the head cut of L178 and its downstream channel; Photo 'b' is an image taken in 2020 of L178's downstream channel, showing significant incision of the channel.

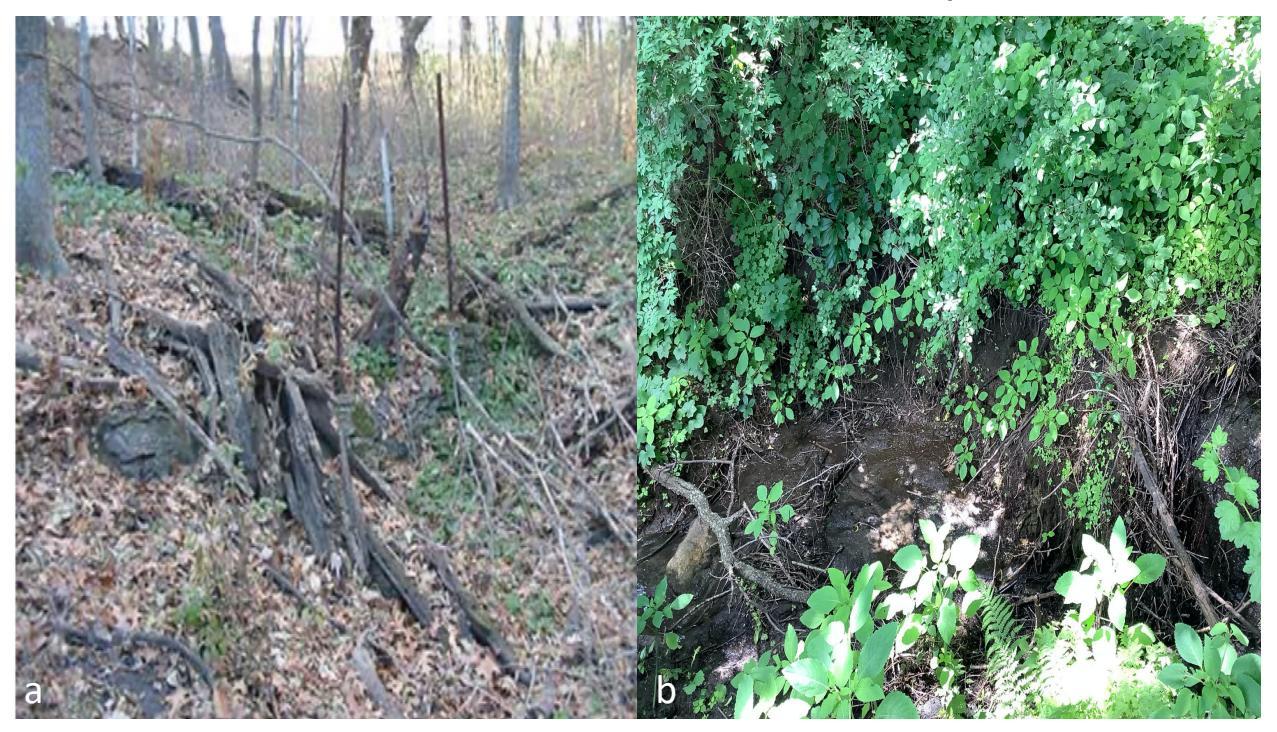
The problem indicators observed at L430 were degradation, loss of bank vegetation, incision, slumping, and overhanging banks. The apparent causes of L430's formation are groundwater, dense canopy, and channel incision. In 2008, the gully was described as an "old foundation" as shown in **Figure 67a**. The 2020 desktop analysis determined this site had high erosion potential, based on the limited information available. In 2020, the team confirmed this ranking in the field. Evidence of significant degradation and incision were observed as shown in **Figure 67b**, providing a rationale for the high erosion potential ranking.

Figure 67. Photo 'a' is an upstream view of L430 highlighting the old foundation inside the channel; Photo 'b' is a downstream view of L430's channel from the knickpoint.
