To: Leslie Stovring City of Eden Prairie

Date: 24 January 2017

Subject: 2016 Minnesota River Erosion Monitoring

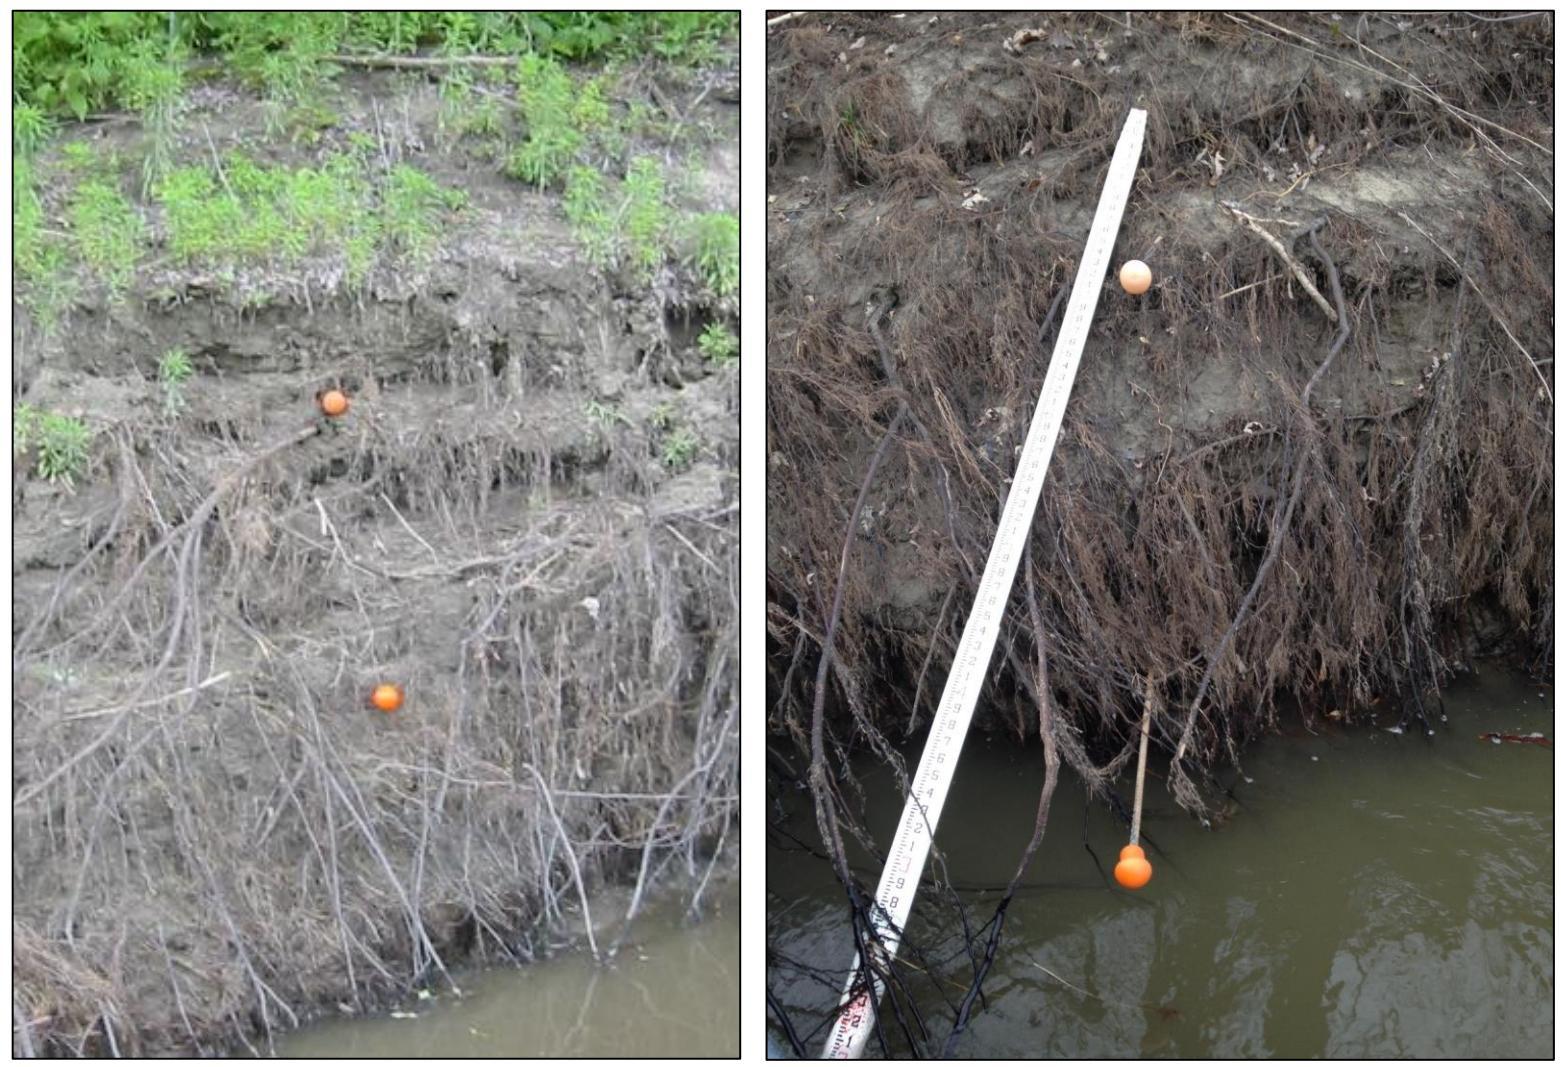
Summary: Approximately 1.8 feet of bank loss between June and November site visits

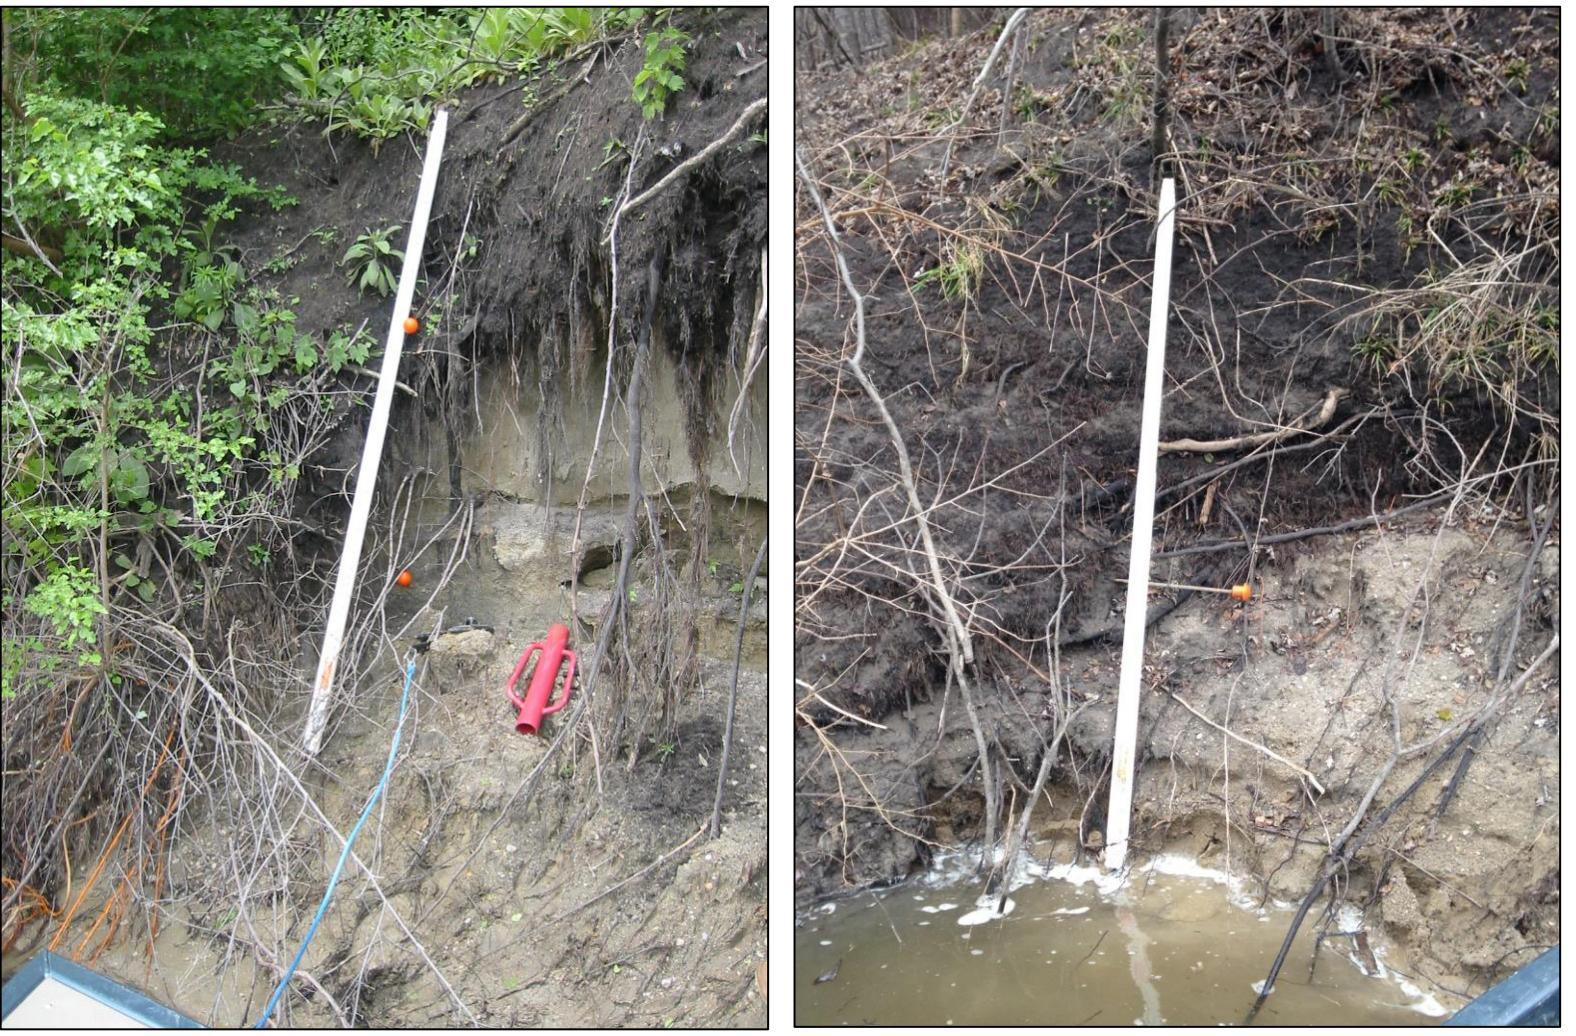
Location #2 lost its lower pin while its upper pin was twisted almost 90 degrees to downstream. It is likely that soil erosion, river velocity and floating debris had a significant impact on this site location. Location #5 appeared to have significant bank failure which resulted in the bank pins being buried and/or displaced. Location #6 was subjected to a large sand deposit that appeared to have buried the lower bank pin.

Summary: Upper pin was gone and lower was bent sideways and experienced approximately 1.4 feet of bank loss between June and November site visits

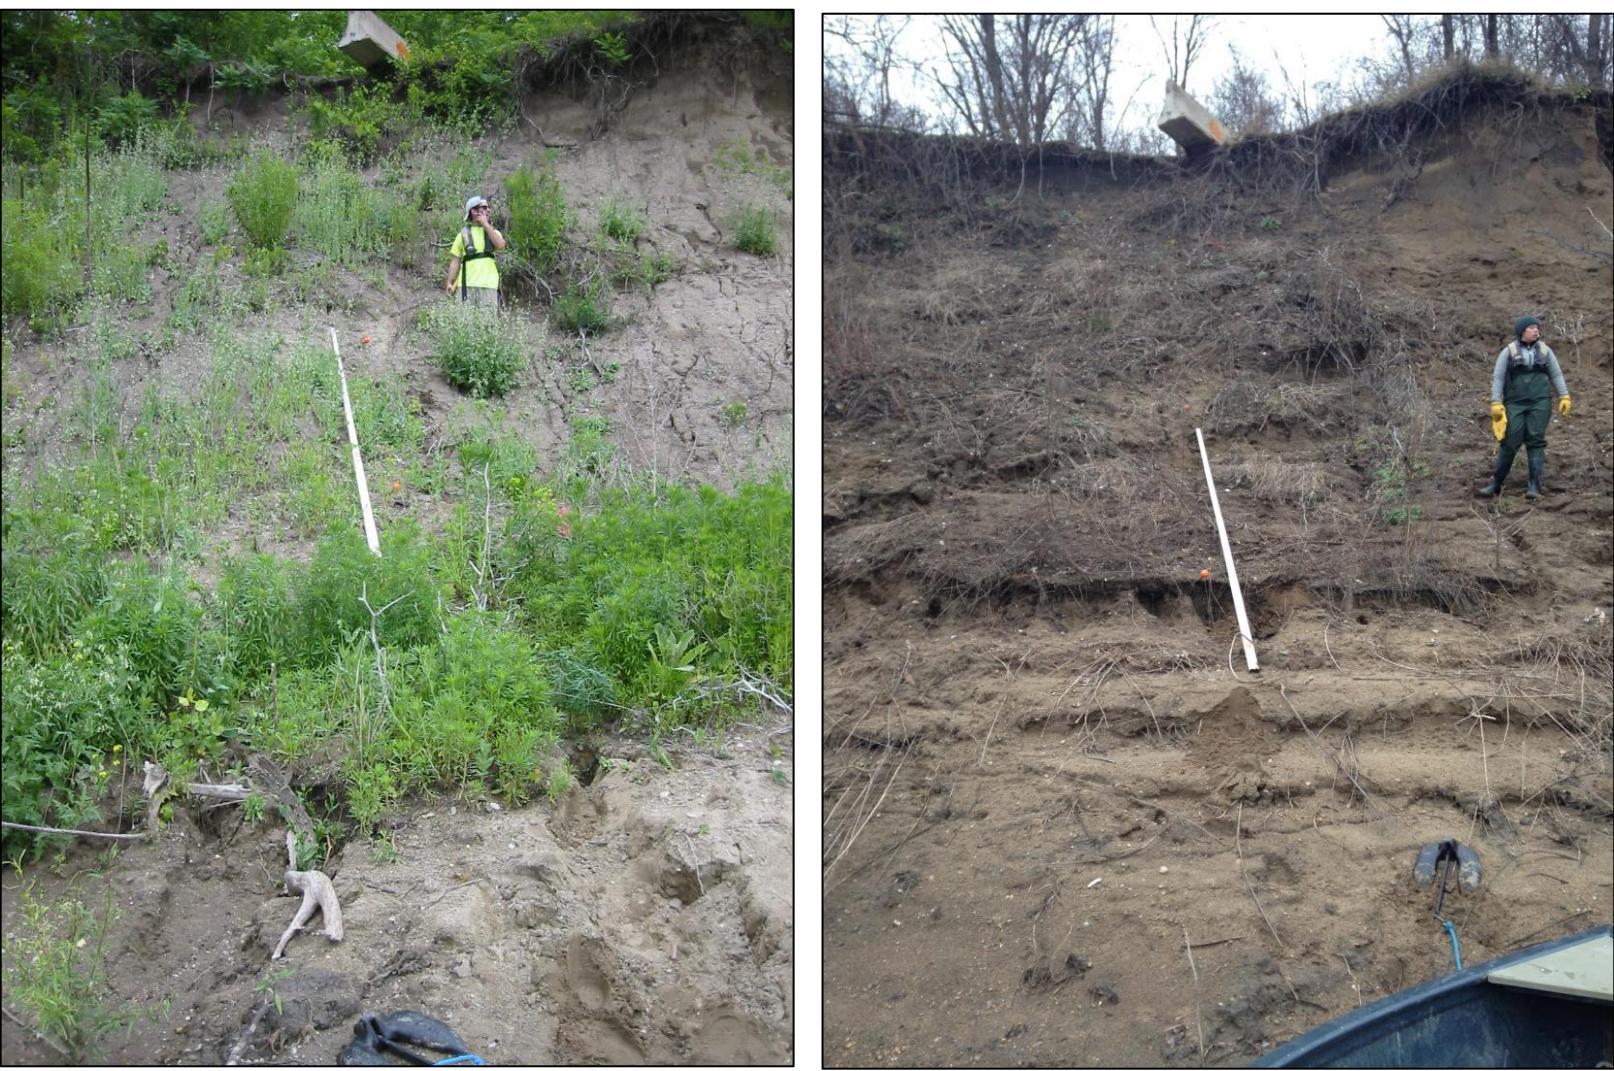
Bank Pins #3

Summary: No changes/bank loss noted between June and November site visits

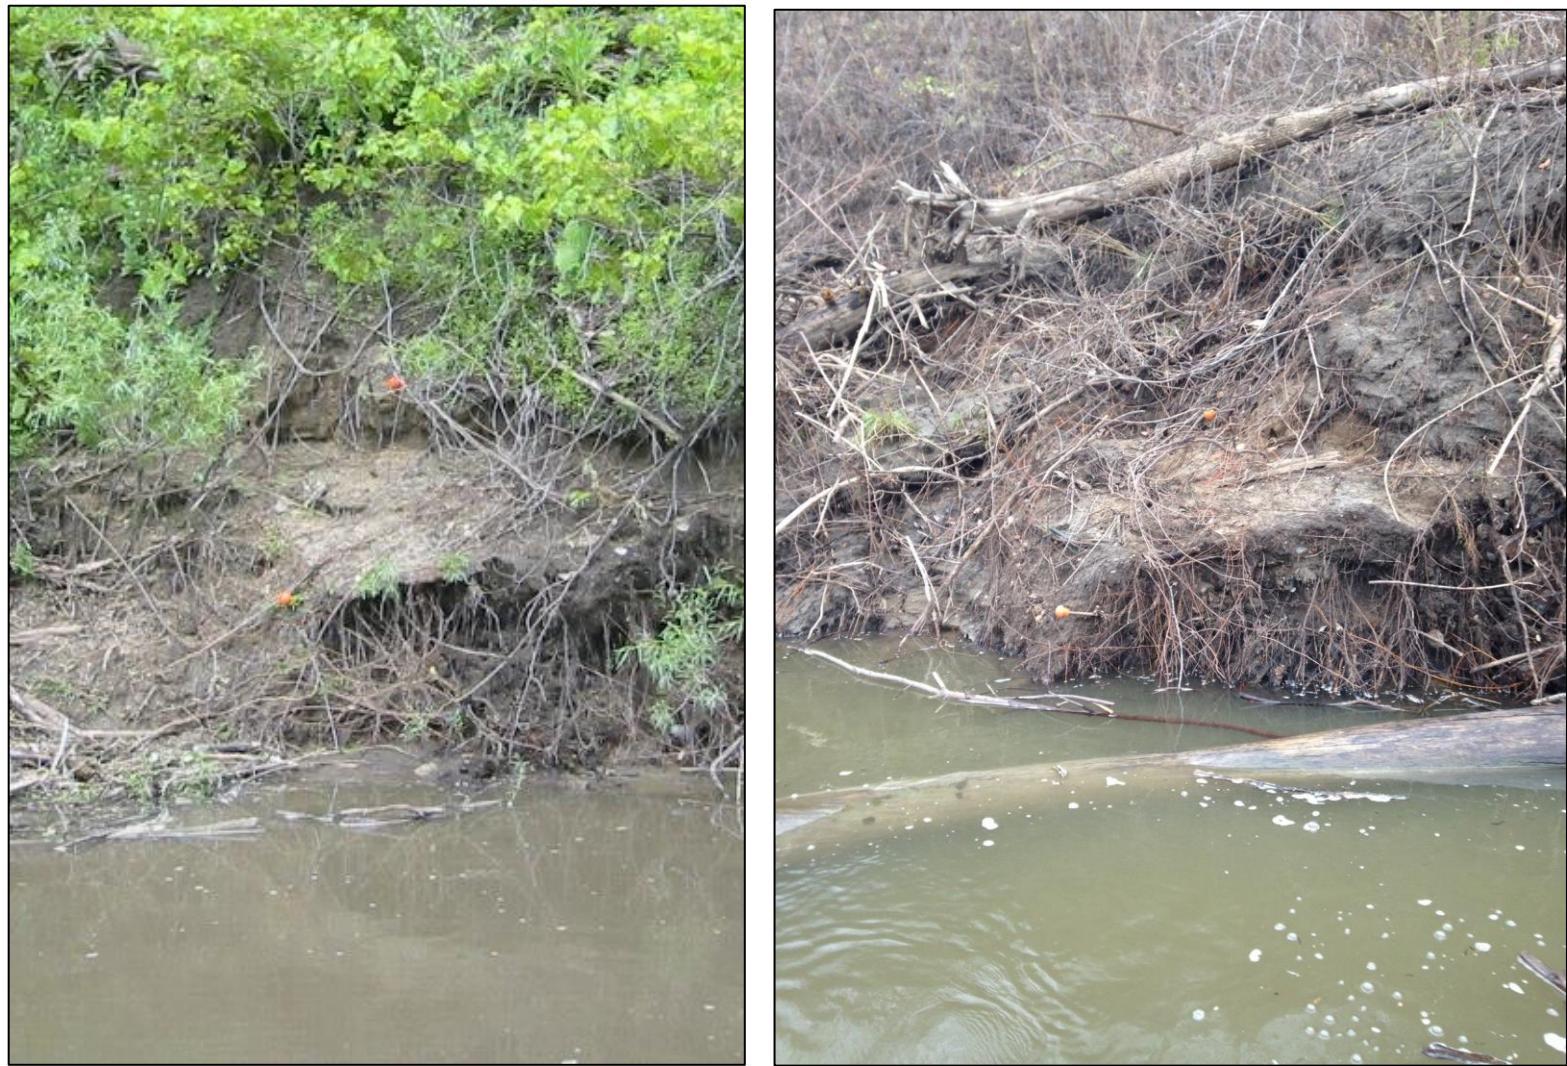
Summary: Approximately 1.5 feet of bank loss between June and November site visits

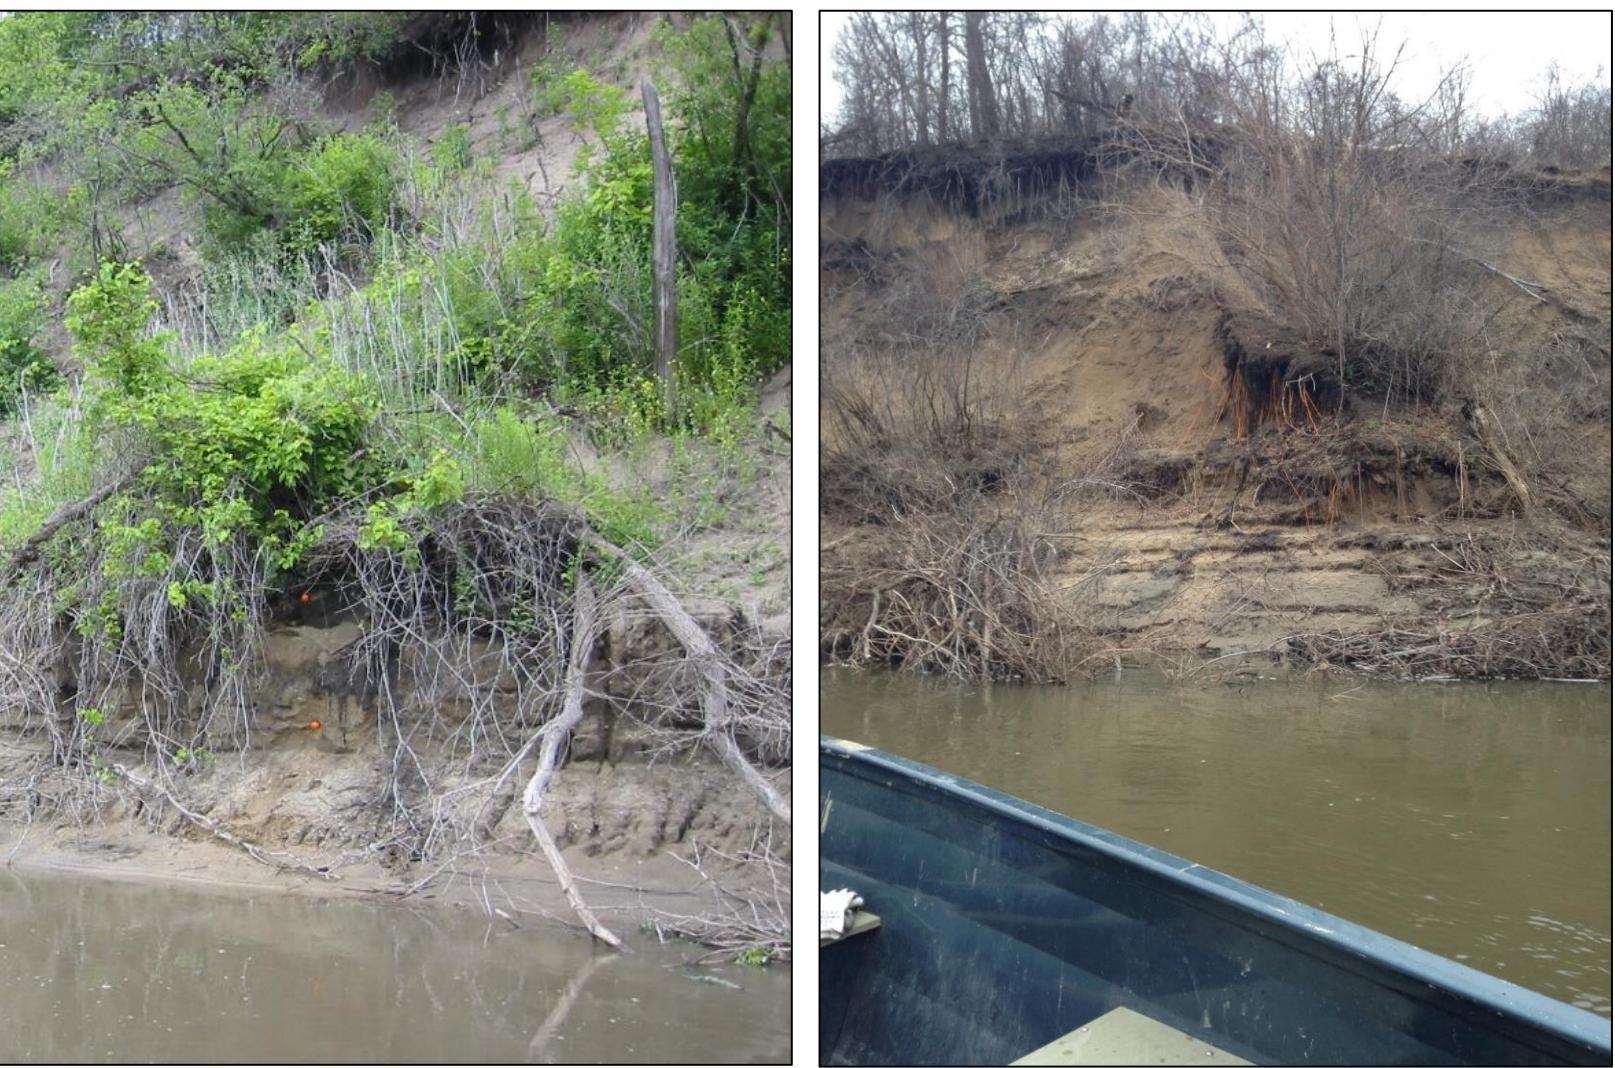
Summary: Site experienced significant erosion as both upper and lower pins were lost between June and November site visits

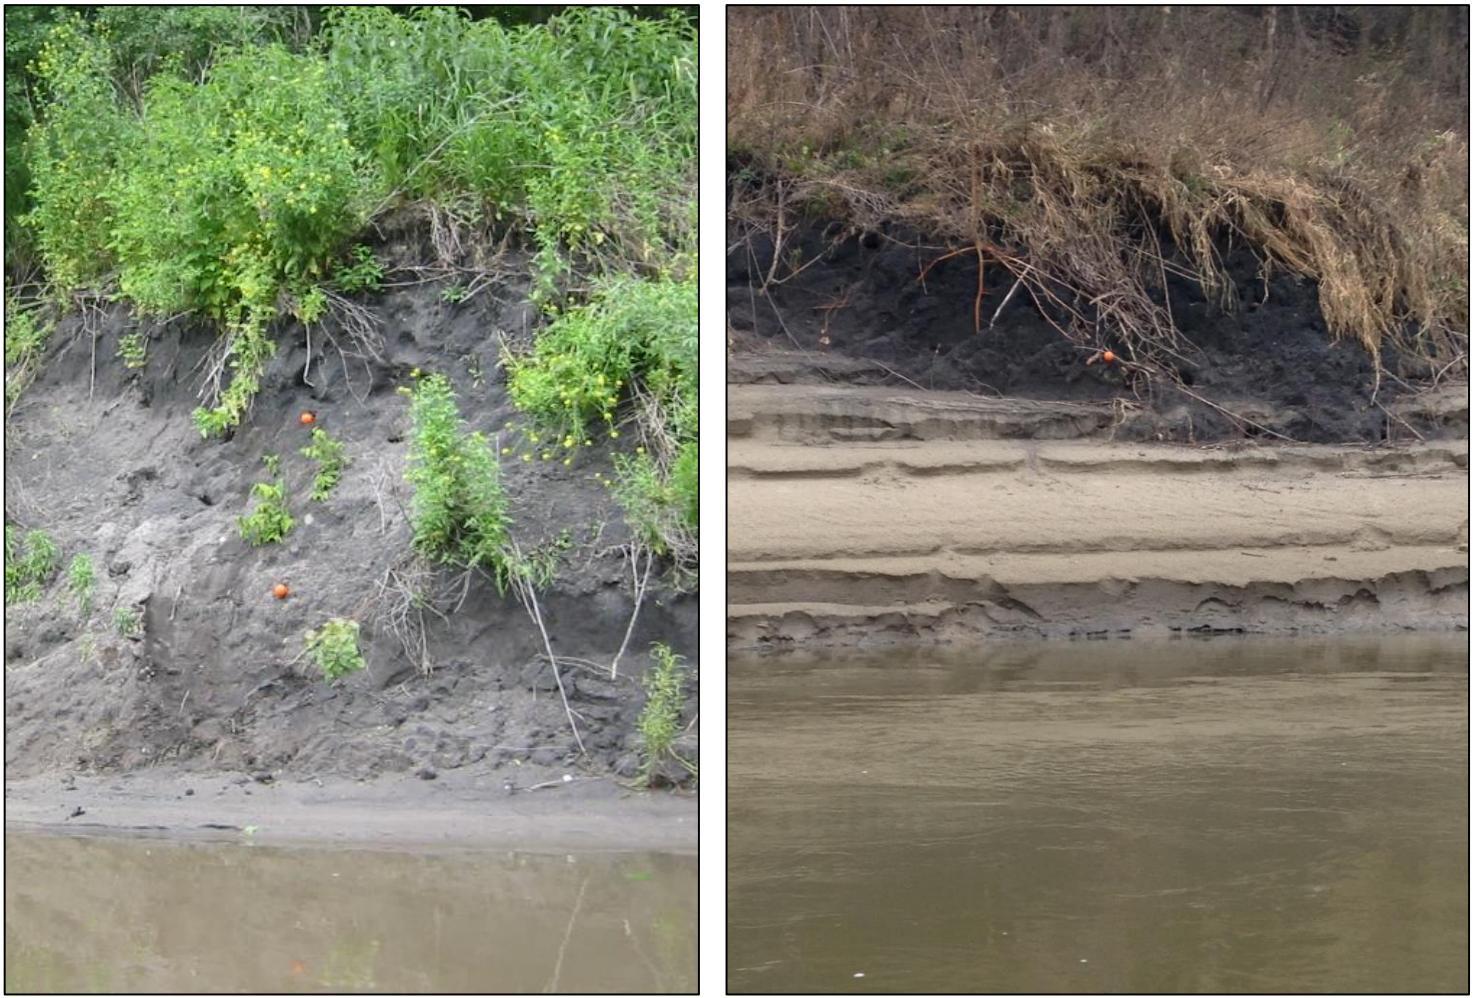
Summary: Upper pin experienced approximately 0.2 feet of bank loss between June and November site visits and lower pin was buried by sand

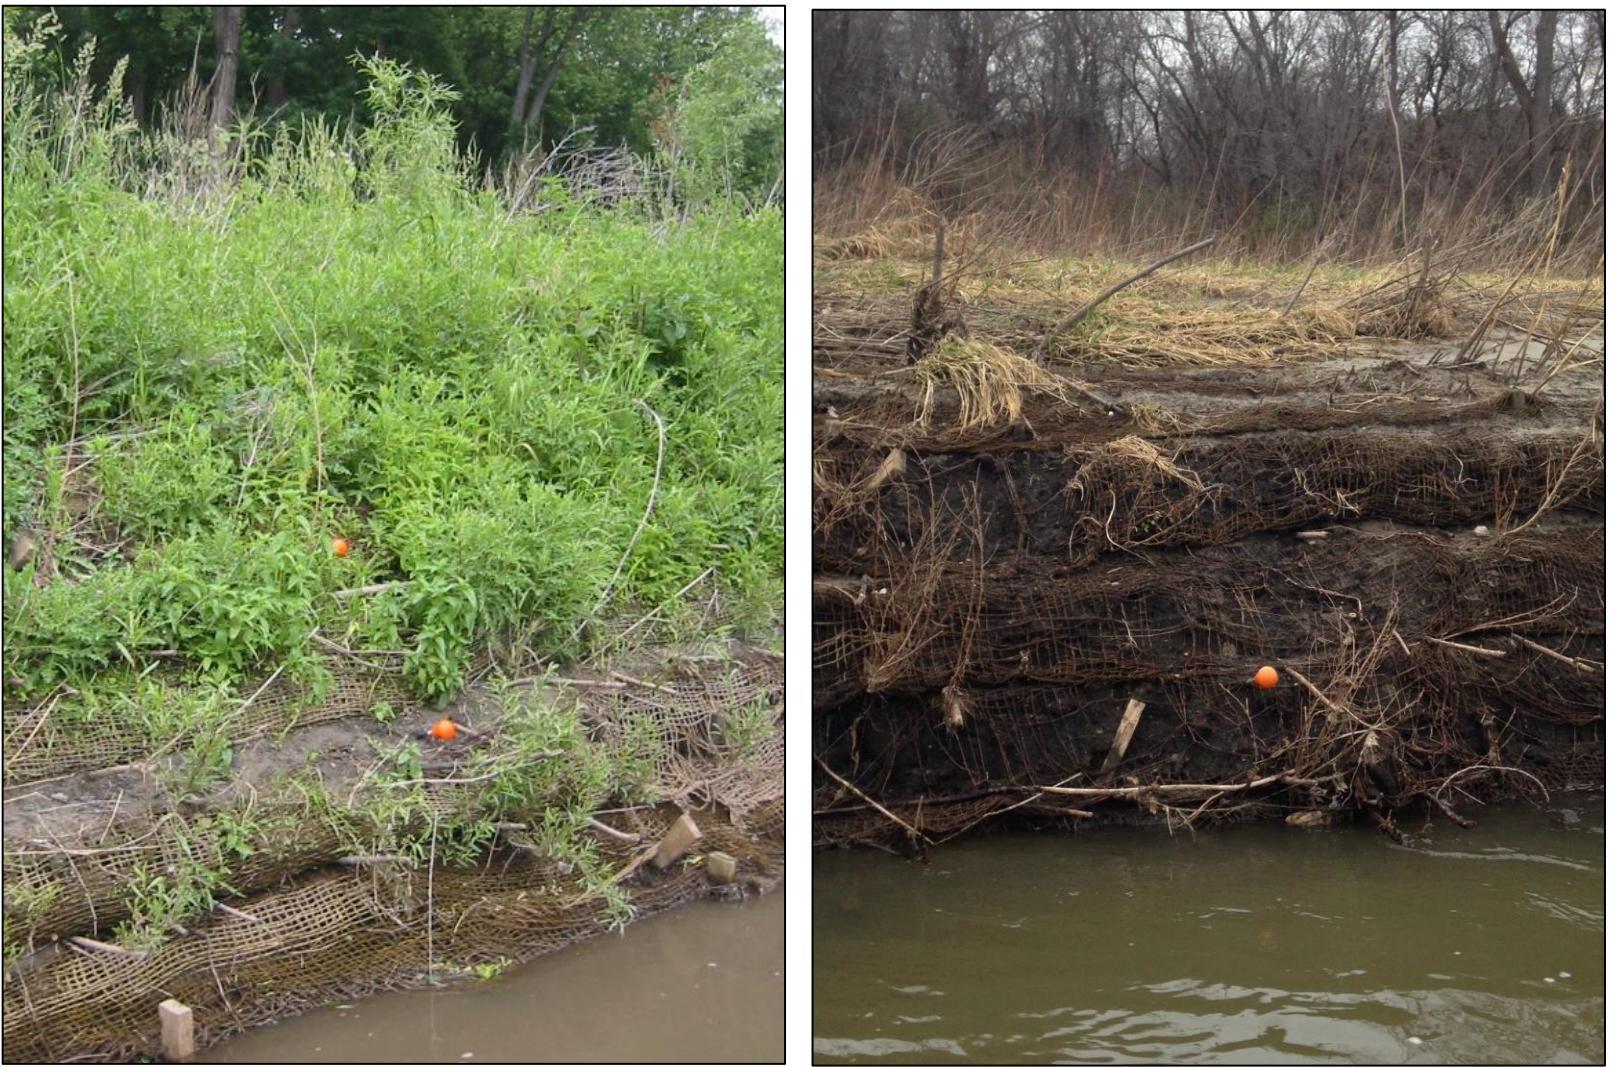
Bank Pins #7

Locations #7, #8, and #9 showed moderate bank erosion in 2016. These locations are located along a previous bank stabilization project that is intended to protect a City stormwater pond (see Figure 2). It should be pointed out that the end caps were missing at Locations #7 and #9 during the November site visit, suggesting a significant amount of force was exerted on the banks at these locations, likely high channel velocities and/or floating debris.

Summary: Approximately 0.3 feet of bank loss between June and November site visits

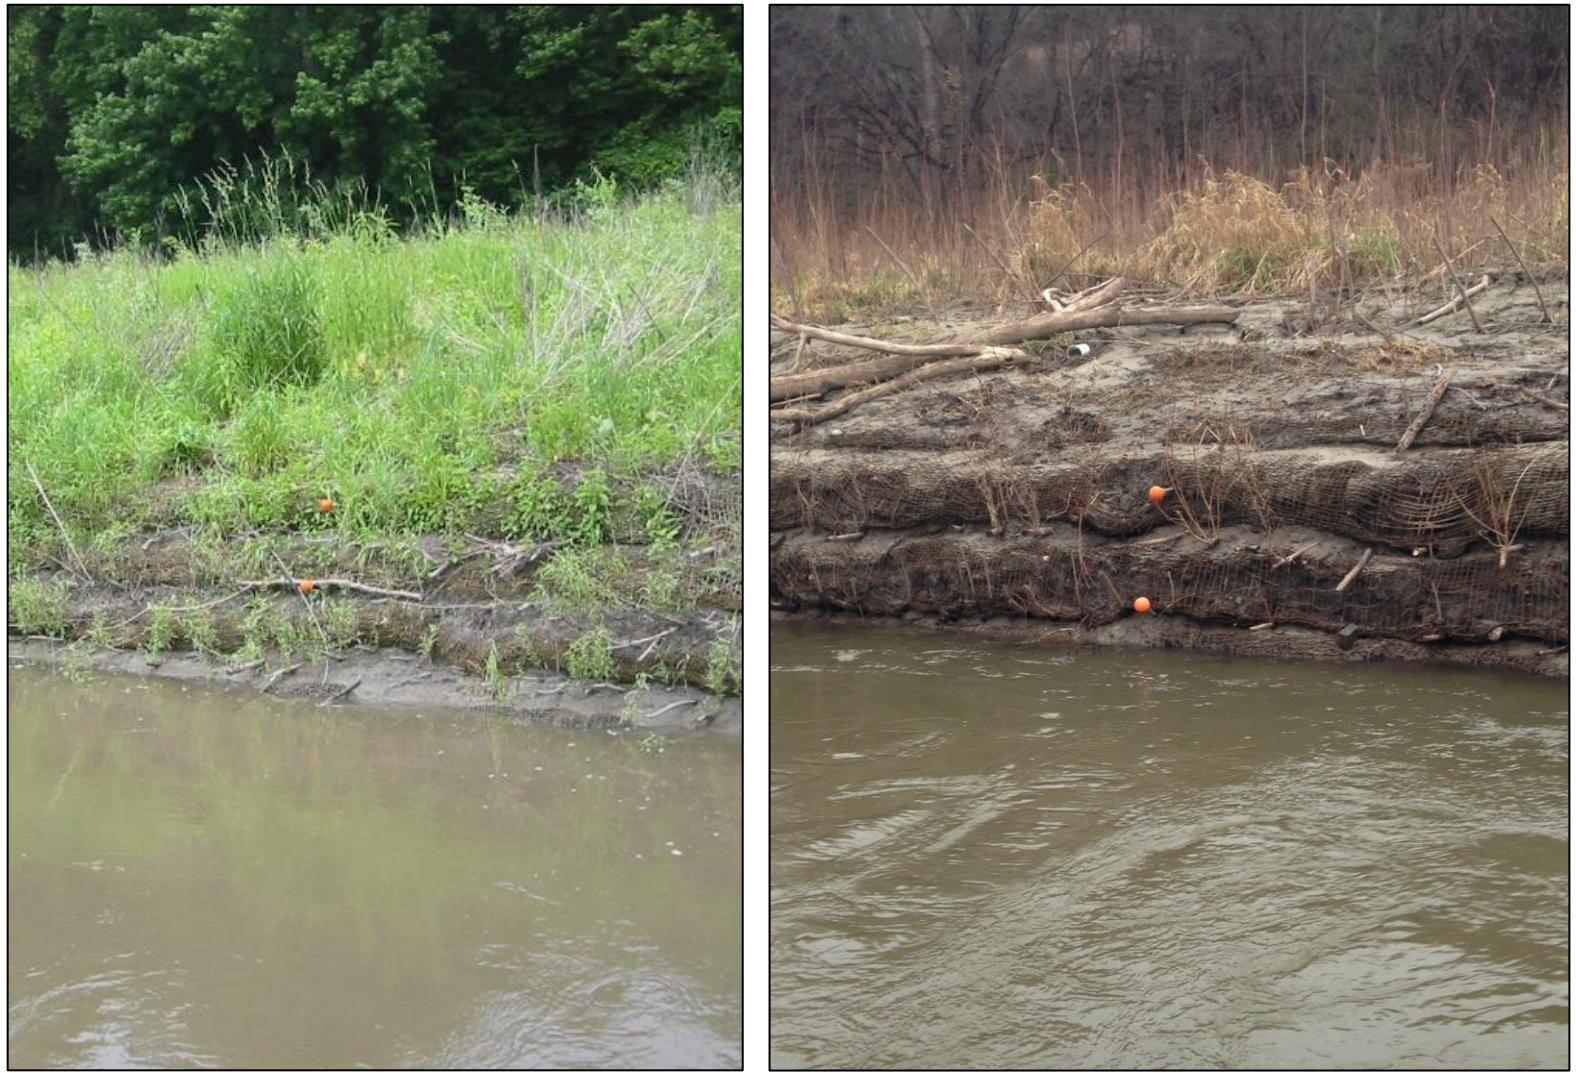
Summary: Approximately 0.1 feet of bank loss between June and November site visits

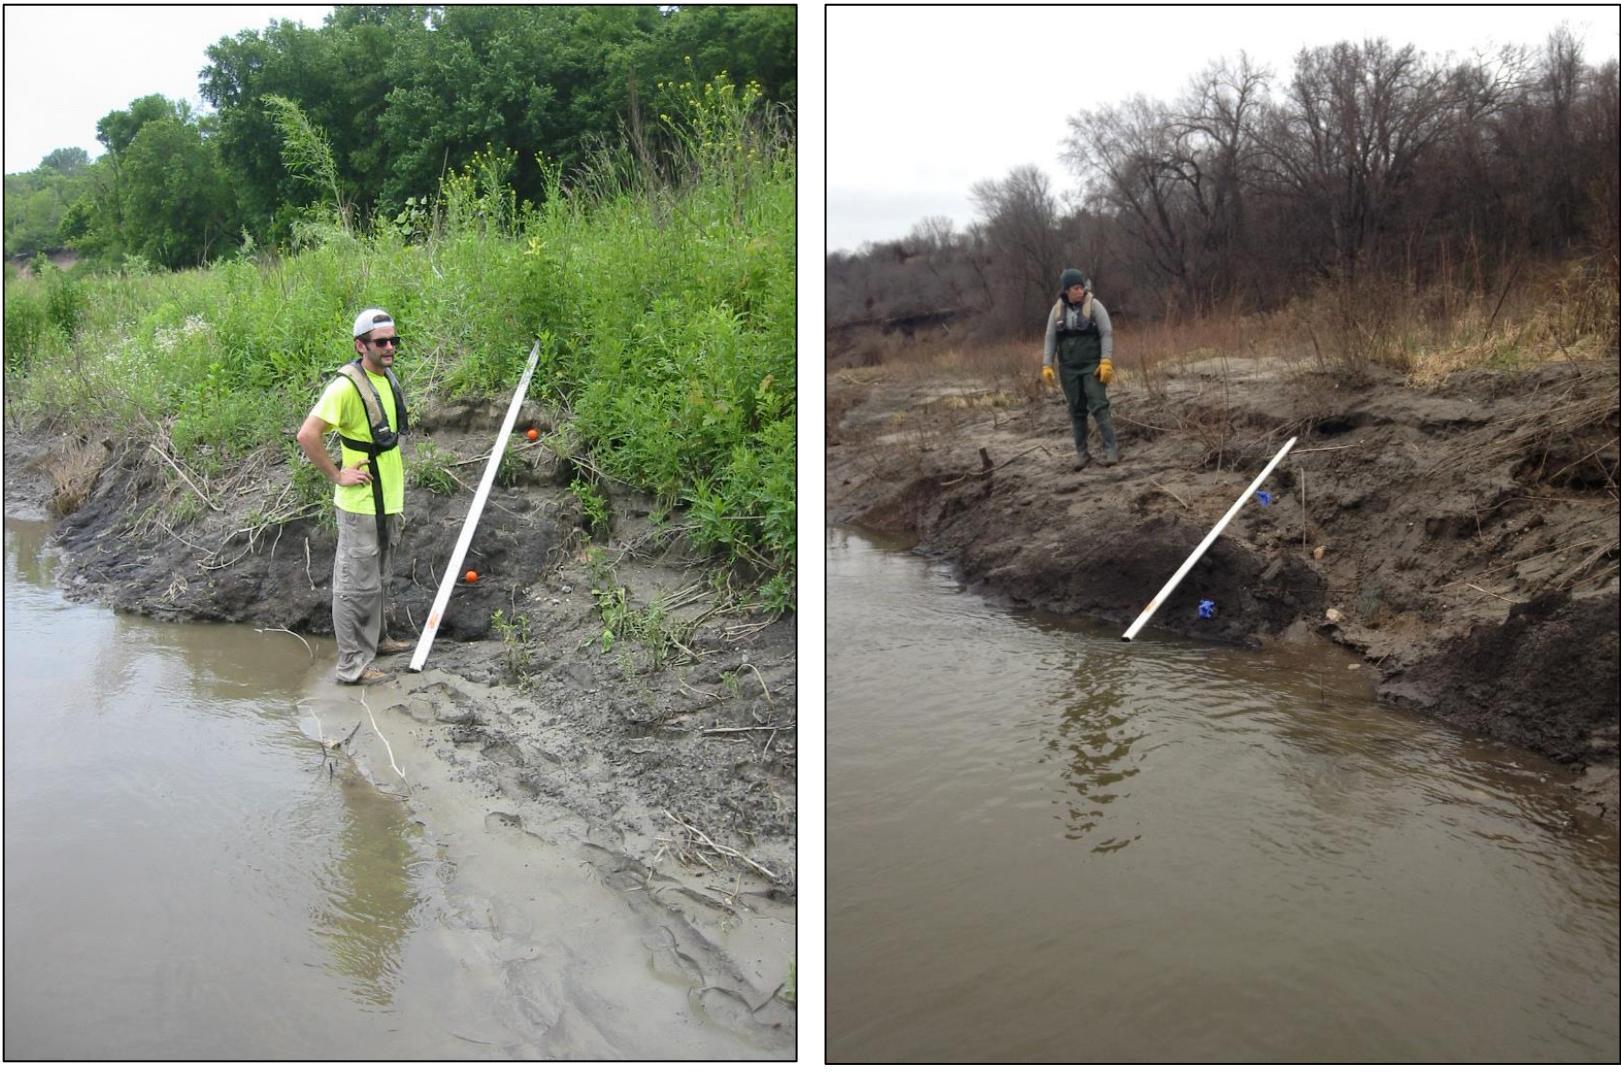
Summary: Approximately 0.8 feet of bank loss between June and November site visits

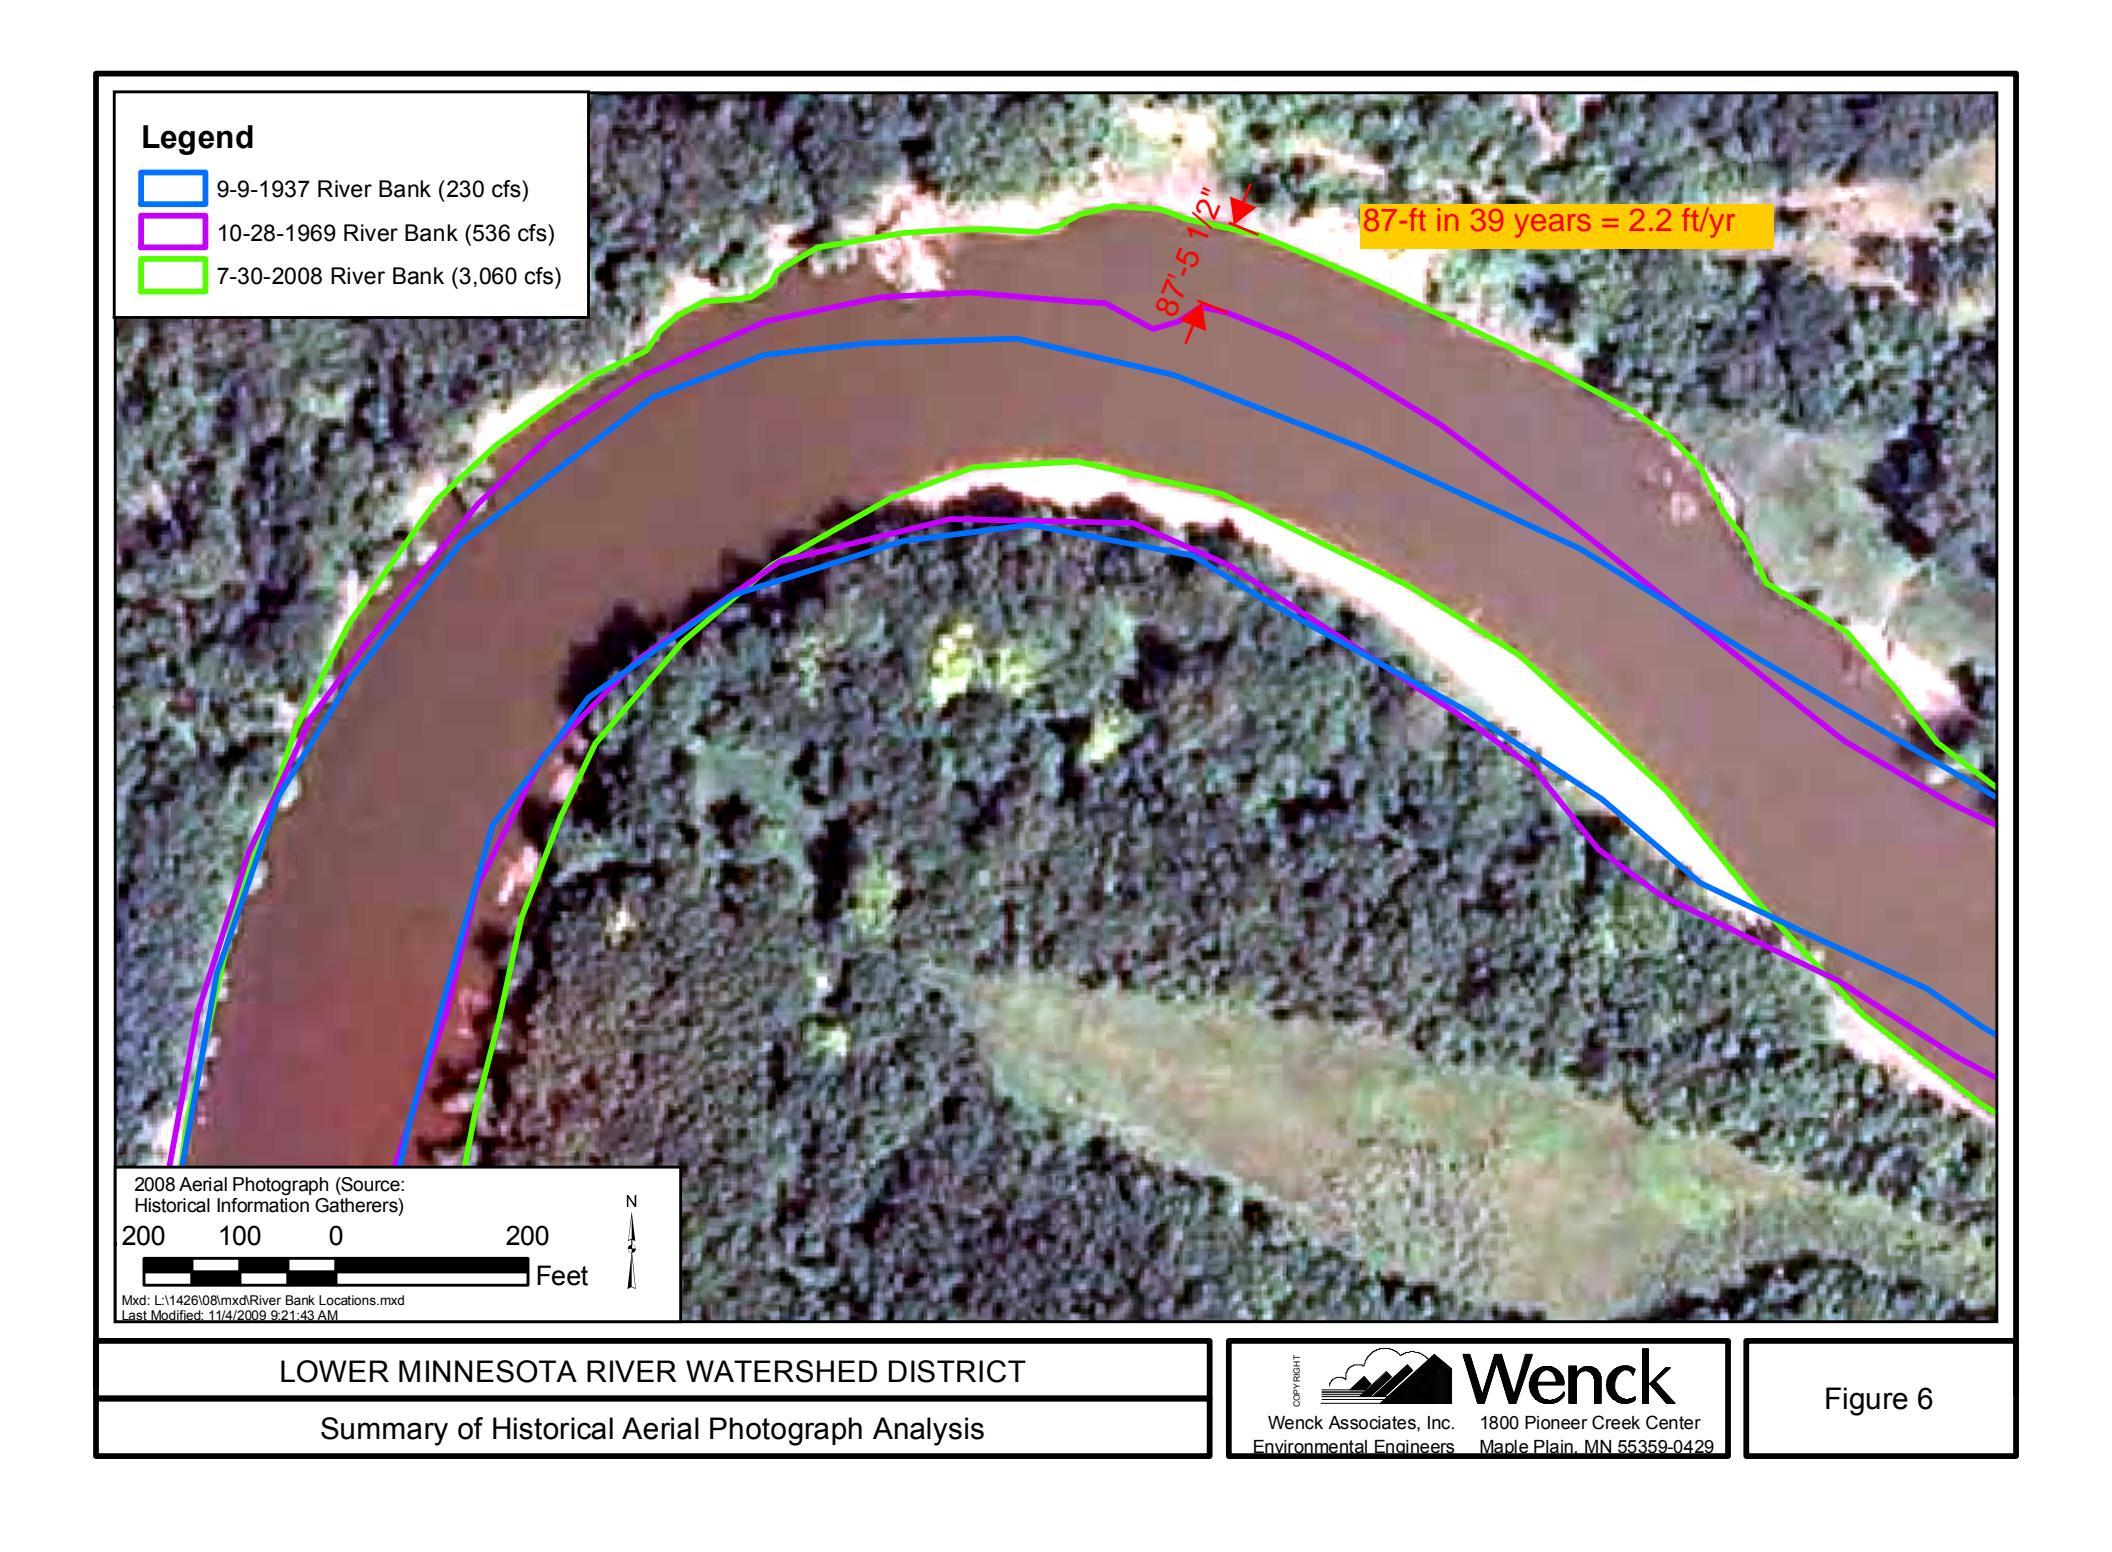
Attachement B: Historic Aerial Photograph Analysis

The average bank erosion rate in 2016 is approximately 2 ft/yr in the unprotected areas upstream of the City stormwater pond (Sites #1 through #6). Figure 6 (See Attachment B) from a Lower Minnesota River Watershed District report titled Summary of Historical Aerial Photograph Analysis from 1937 to 2008 further confirms the average bank loss of approximately 2.2 ft/yr. Near the City stormwater pond (locations #7, #8, #9) the rate of erosion was approximately 0.5 feet per year in 2016, however photographs for bank pins #7, #8 and #9 show that the coir fabric along the banks is deteriorating, soil is falling through the openings and vegetation is dead and/or never established. In addition the City pond is on an outside bend and clearly within the meander belt indicating the channel according to river geomorphological tendencies will migrate into the pond. Therefore, because the closest edge of the city storm water pond is located approximately 80 feet to 100 feet from the 2016 river bank there is a need to further reinforce the Minnesota River bank in this vicinity to protect the pond.
