LOWER MINNESOTA RIVER WATERSHED DISTRICT

Executive Summary for Action

**East Chaska Creek Restoration Project
Project No. 86550**

February 2016

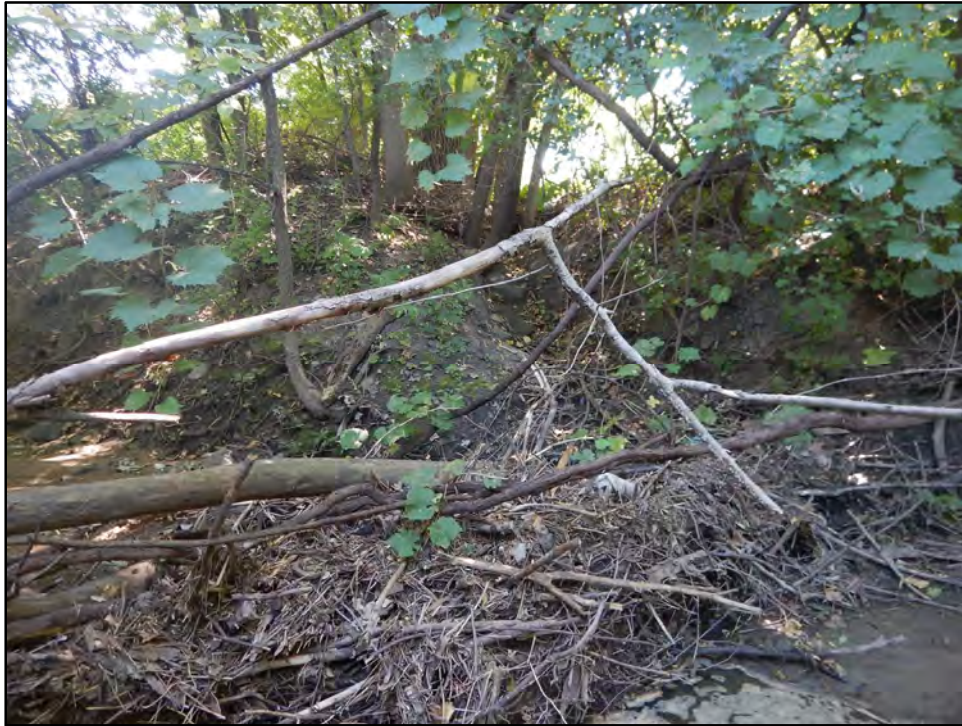
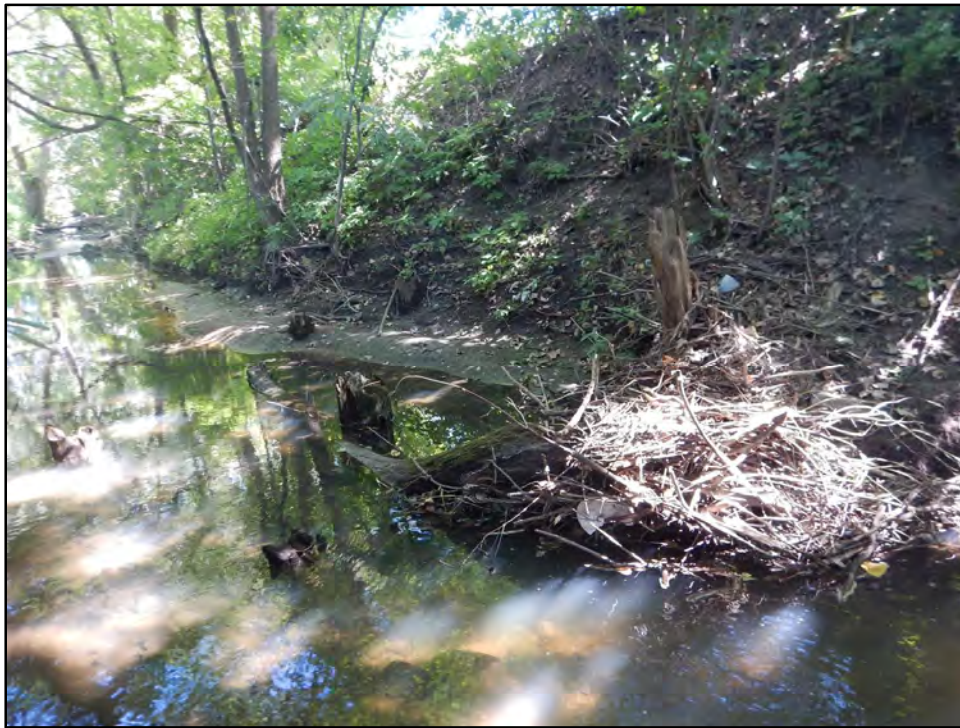
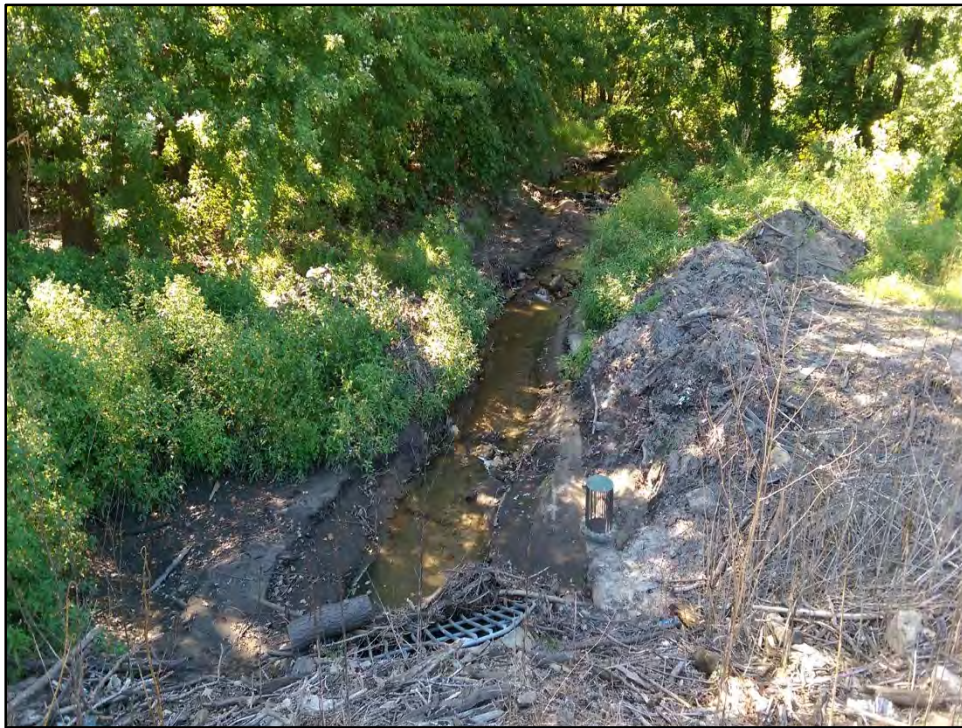
Photograph A-3: View south of debris.

Photograph A-4: View south of debris.

Photograph A-5: View south of debris.

Photograph A-7: View north of debris.

Photograph A-8: View south of debris.

Photograph A-9: View south of debris.

Photograph A-10: View east of debris.

Photograph A-11: View east of debris.

Photograph A-13: View east of debris.

Photograph A-14: View east of debris at RCP.

Photograph A-15: View west of debris and RCP.

- Removal of debris to maintain the channel capacity and to prevent larger debris jams at road crossings.
- Point repair of stormwater outfalls with riprap to prevent future erosion and to protect outfalls.
- Removal of consolidated sediment at most downstream area near the levee and reseeded of the area to stabilize the lower end of the stream.

These maintenance activities should be done as soon as possible to prevent more costly future improvement caused by lack of maintenance. The lower end of the Creek should be checked routinely for signs of sedimentation upstream of the 84-inch RCP through the levee. Following any flood fighting activities, the sediment and debris removed from the creek should be hauled away from the site and the overbanks reseeded.

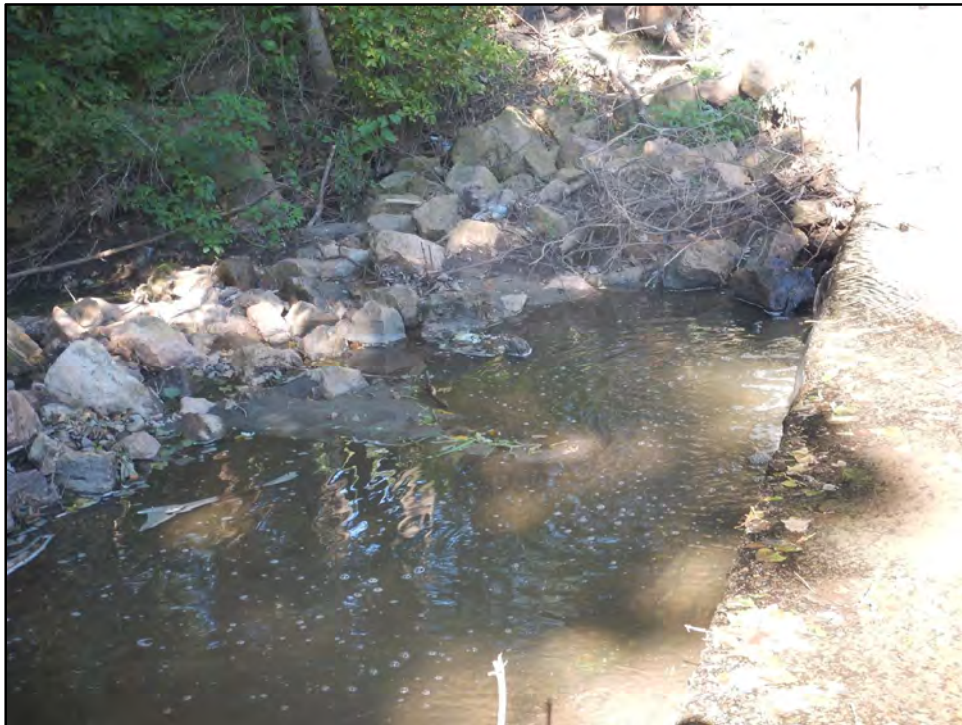
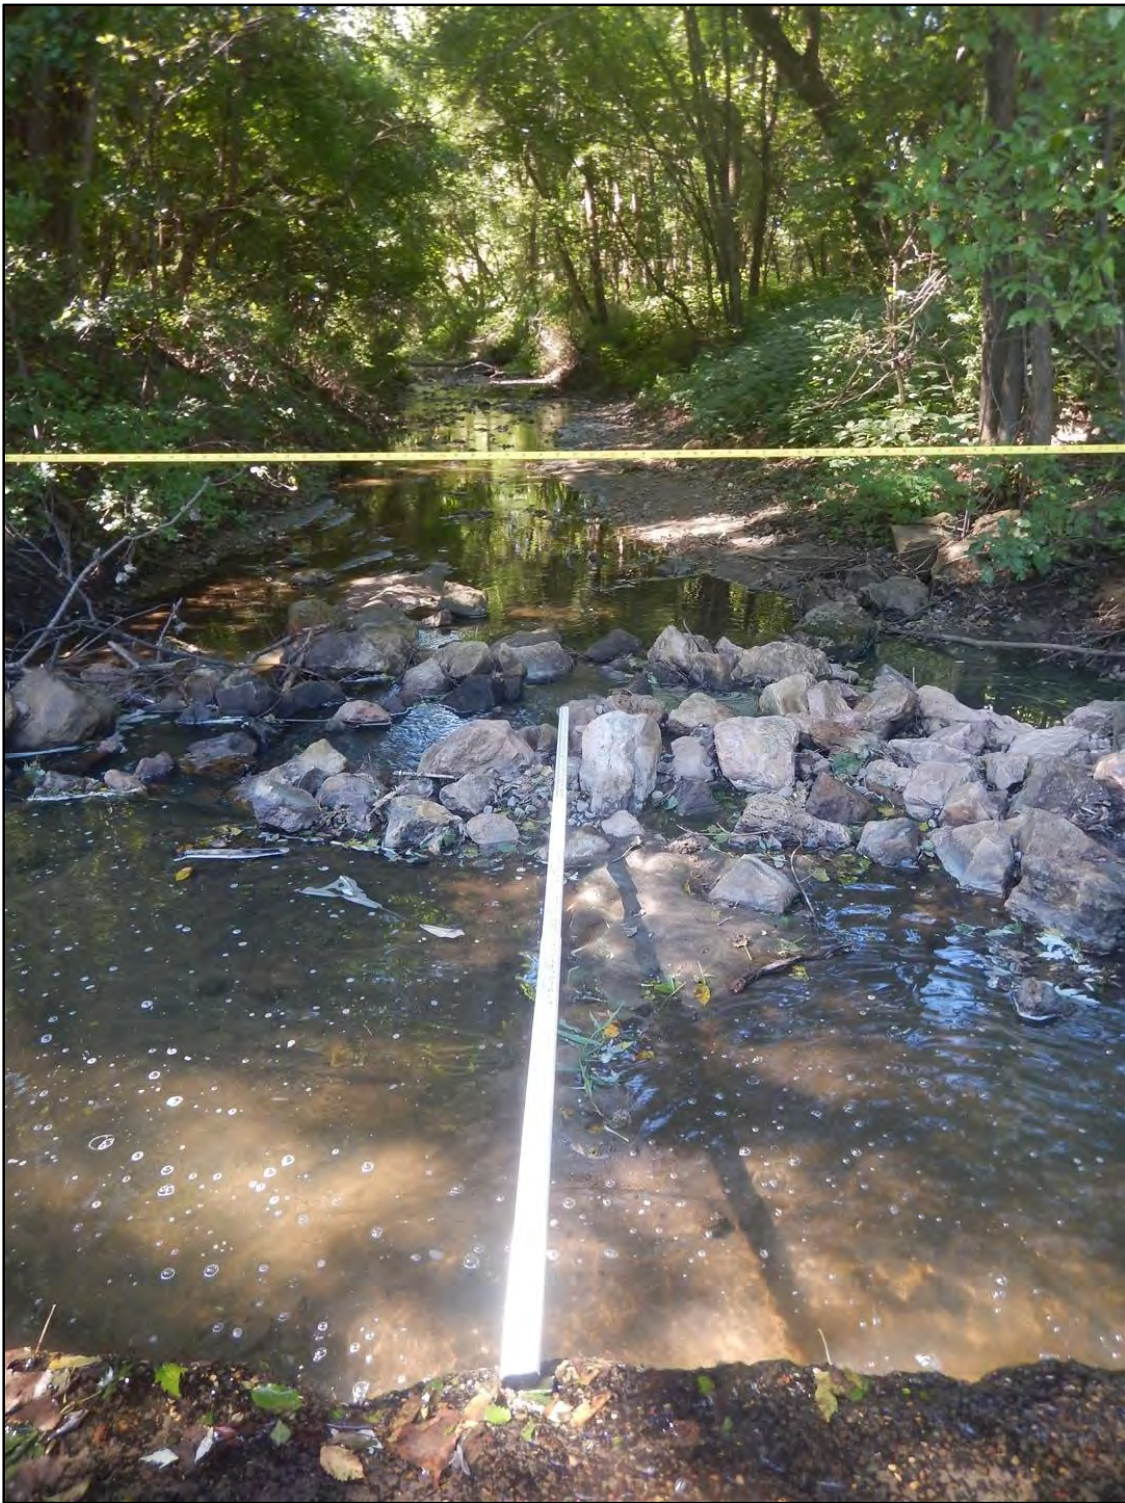
This recommended creek improvement consists of repairing the scour hole downstream of Crosstown Boulevard Bridge; the scour hole has been caused by the creek downcutting to this point (Appendix A, Figure 5). The scour hole is approximately 30 feet wide, 10 feet long, and 3 feet deep (Photographs B1 – B9). Repair would consist of salvaging existing riprap, re-grading the channel downstream of the structure apron, and re-installing filter fabric and riprap.

Photograph B-1: View northwest of scour hole.

Photograph B-3: View southeast of bridge crossing and scour hole.

Photograph B-4: View southwest of scour hole.

Photograph B-5: View northwest of scour hole.

Photograph B-6: View southwest of bridge crossing and scour hole.

Photograph B-7: View southwest of debris and scour hole.

Photograph B-8: View north of bridge crossing and scour hole.

Task	Description	Units	Quantity	Unit Price	Total
1.0	Repair scour hole				
1.1	Salvage existing riprap	CY	30	\$20	\$600
1.2	Backfill and grade granular material	CY	105	\$50	\$5,250

1.3	Install filter fabric	SY	350	\$8	\$2,800
1.4	Replace salvaged riprap	CY	30	\$20	\$600
1.5	Install additional riprap (MnDOT Class IV Riprap)	CY	50	\$110	\$5,500
TASK TOTAL					\$14,750

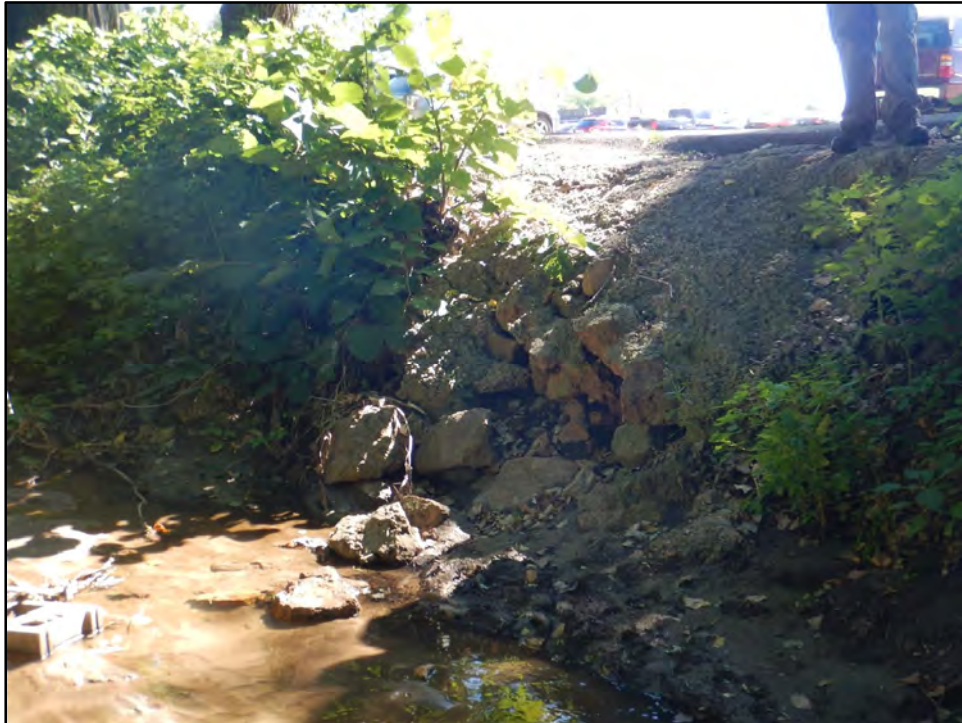
This project consists of repairing bank erosion which threatens the City's paved trail as well as two large cottonwood trees behind Lenzen Chevrolet (Appendix A, Figure 5). The channel through this reach is approximately 6 to 7 feet deep. Two temporary asphalt repairs have been implemented in this location, but the repairs have subsequently failed (Photographs B10 – B14). A grade control structure would also be installed to prevent potential channel downcutting upstream to Crosstown Boulevard. Repairs would consist of removal of temporary asphalt repairs, complete bank hard armoring for approximately 320 linear feet along the left bank, toe protection for approximately 340 linear feet on the left and right banks, and a grade control structure.

Photograph B-10: View east of bank erosion.

Photograph B-11: View south of eroded bank.

Photograph B-12: View south of eroded bank.

Photograph B-13: View north of eroded bank.

Photograph B-14: View south of eroded bank.

Photograph B-15: View south of eroded bank.

2.0	Install bank armoring, toe protection and grade control structure				
2.1	Remove asphalt bank repairs	SF	140	\$6	\$840
2.2	Install filter fabric	SY	250	\$8	\$2,000
