# Engineer's Report for Lower Riley Creek Stabilization Project

*RPBCWD Reach E, Site D3, and LMRWD Reach*

*Eden Prairie, MN*

Prepared for  
Riley Purgatory Bluff Creek Watershed District and  
Lower Minnesota River Watershed District

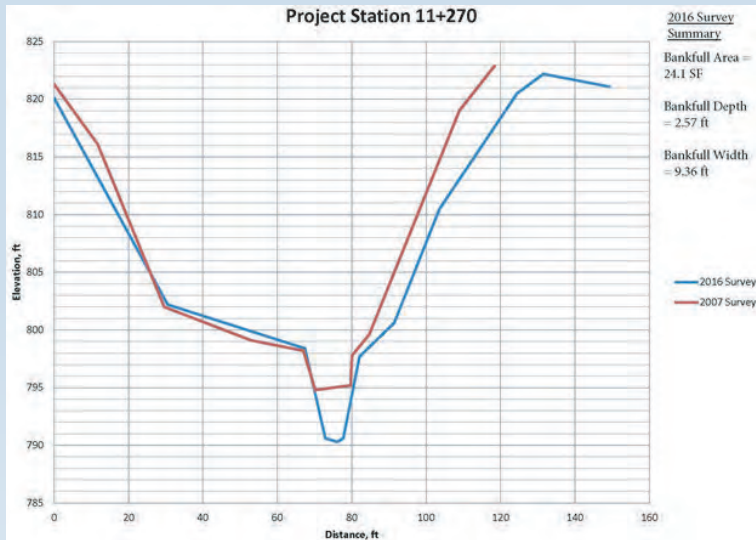
### CROSS SECTION COMPARISON

Site D3 is experiencing significant bank erosion that is likely contributing sediment loads to Riley Creek. A comparison of surveyed cross sections shows that the channel has degraded since the 2007 survey as it is currently both deeper and wider. The cause of the initial instability within this reach is likely the gradual increase in runoff volume and increased peak runoff rates generated by a developing watershed.

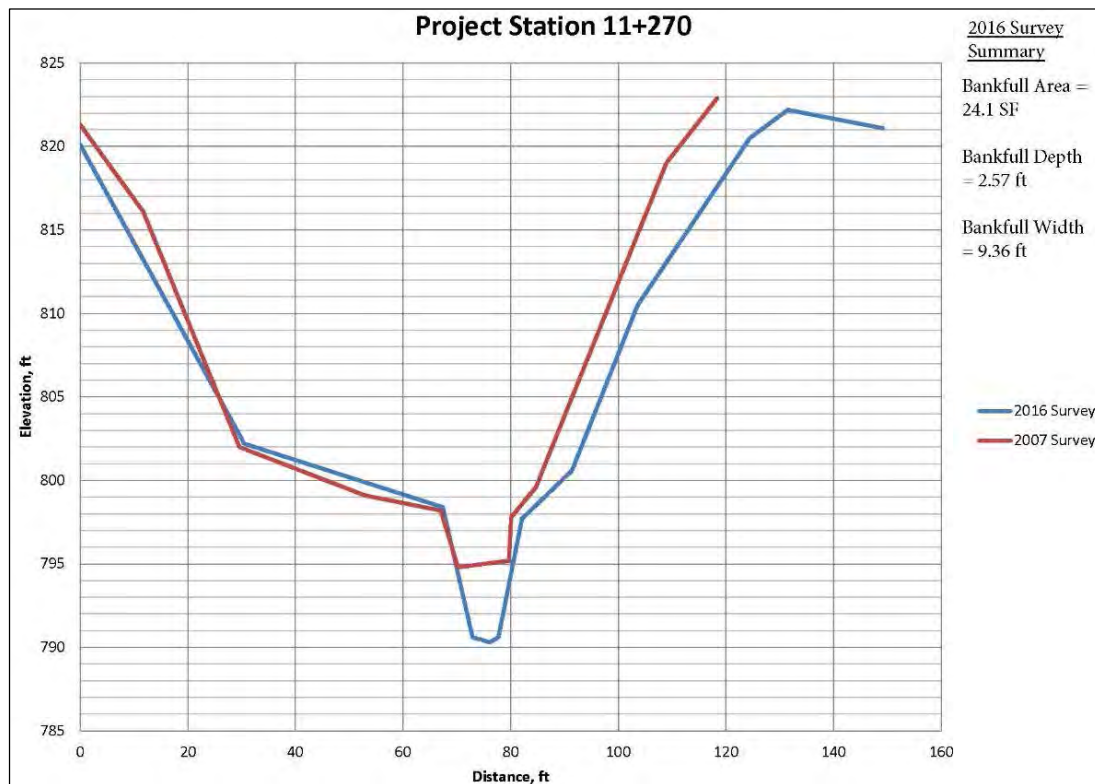
**Figure 2-2 Reach E Cross Section Comparison Example**

Stream survey data was collected in 2016 and compared to similar data collected in 2007 to verify the stream geomorphic changes during this time period. The 2007 survey was conducted during the winter months and included limited data in the upstream portions of the reach below the ice. However, the points available below the ice clearly show that the channel bed has lowered in the upper portions of the reach (approximately the upper 2,500 feet of the reach) while remaining fairly unchanged in the lower section. This survey data correlates with field observations of active erosion and head cutting in the upper section of the study reach. A comparison of cross sections (Figure 2-2) also shows that the channel has lowered since the 2007 survey as it is currently both deeper and wider. Detailed figures showing surveyed locations, longitudinal profile comparison, and all cross section comparisons are included in Appendix E.

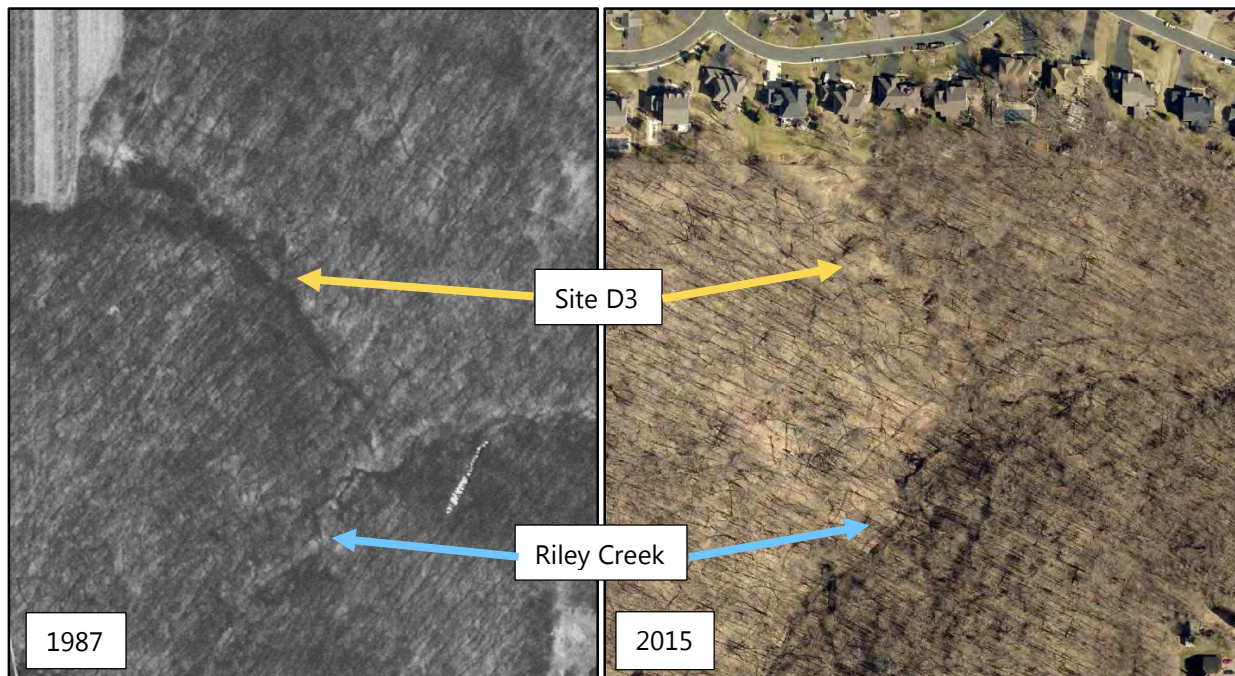
Figure 2-3 Aerial images of Site D3 from 1987 and 2015 (from figures in Appendix F)

At Site D3, the original cause of erosion appears to be concentrated runoff into the ravine from agricultural fields, as shown in Figure 2-3. It appears that the top of the ravine was partially filled and some erosion protection was installed when the current development was built. The adjacent parkland and the back half of seven residential lots along Laforet Drive and Acorn Ridge drain toward the ravine, and the runoff is captured by two berms located near the top of the ravine. A small storm sewer system captures stormwater collected behind the berms and discharges the runoff into the ravine. It is assumed that the current development reduced the drainage area to the ravine and the runoff rates and volume to the ravine have likely been further reduced by the berms installed to intercept runoff at the top of the ravine. However, erosion has continued, as evidenced by undermining of the riprap installed at the storm sewer outlet. The storm sewer outlet is still located high enough within the ravine that the discharge causes erosion of the ravine bed. High velocities from the culvert (12 to 13 feet per second) combined with the steep channel slope of the ravine (11 percent slope) to cause continual erosion downstream of the culvert outfall. The invert of the ravine is actively eroding, creating scarps and adding sediment load to Riley Creek.

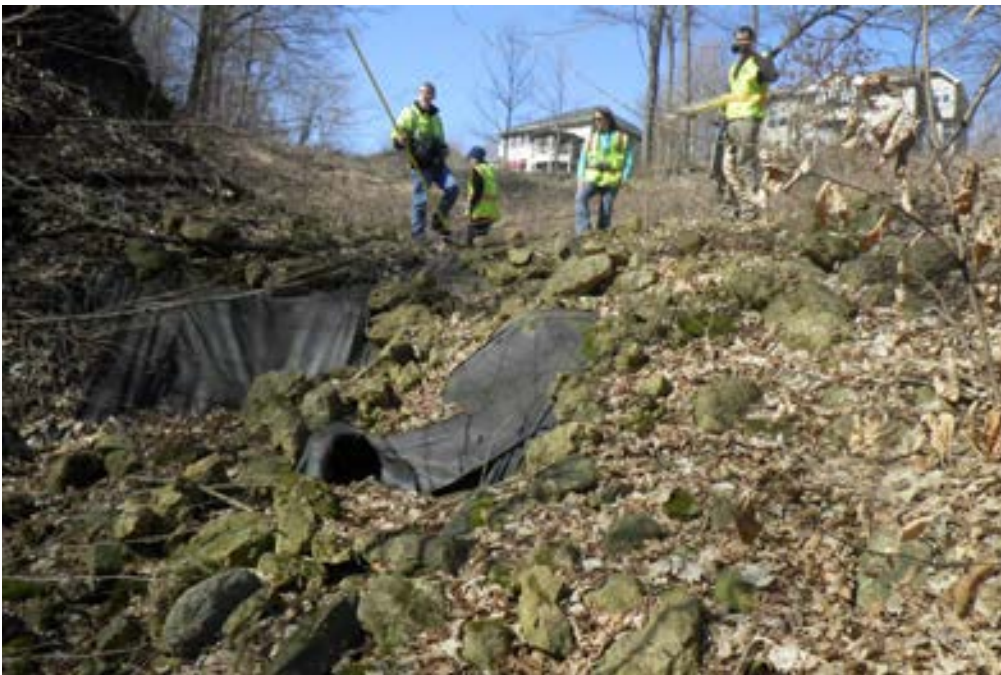
**Photo 2.** *Site D3.* Failing riprap downstream of storm sewer outfall (photo is looking upstream)

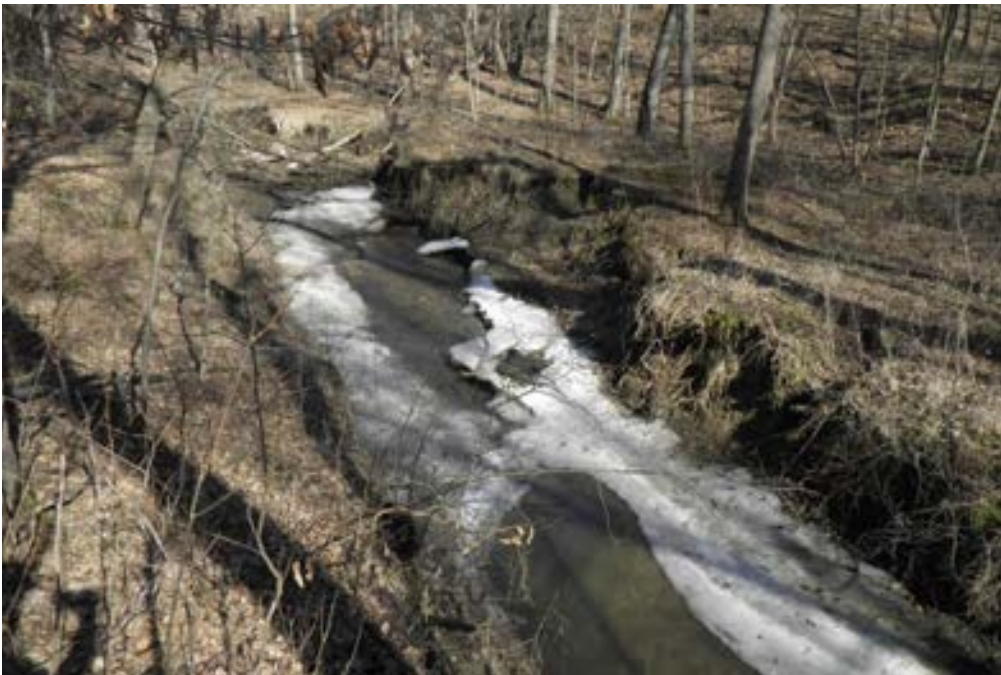
**Photo 14.** *Reach E3.* Channel degradation and bank erosion (looking downstream)

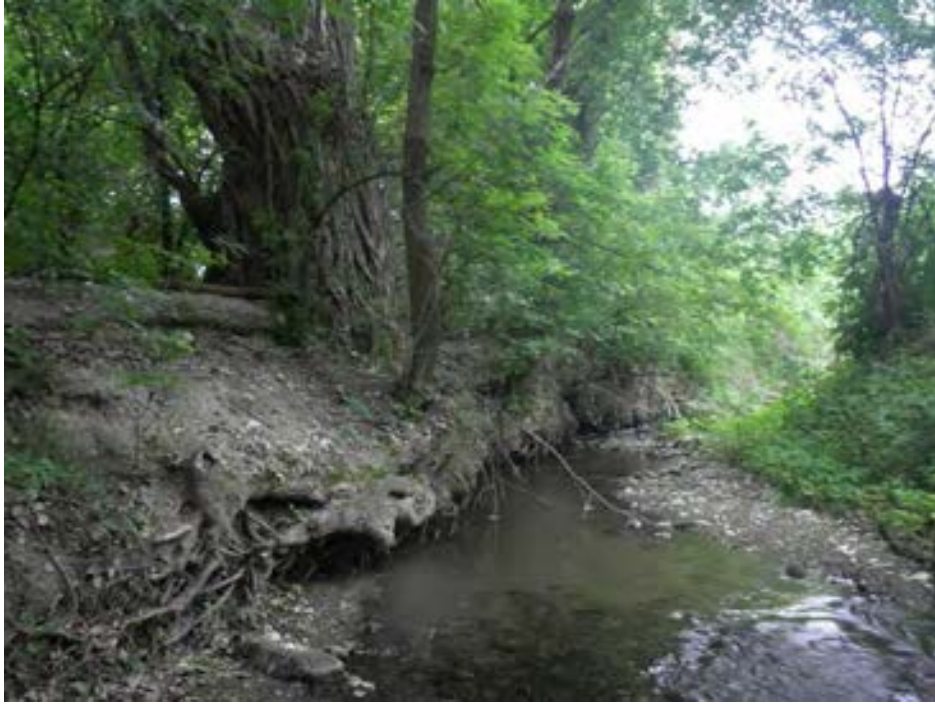
**Photo 25.** *LMRWD Reach.* Undercutting bank (looking upstream)

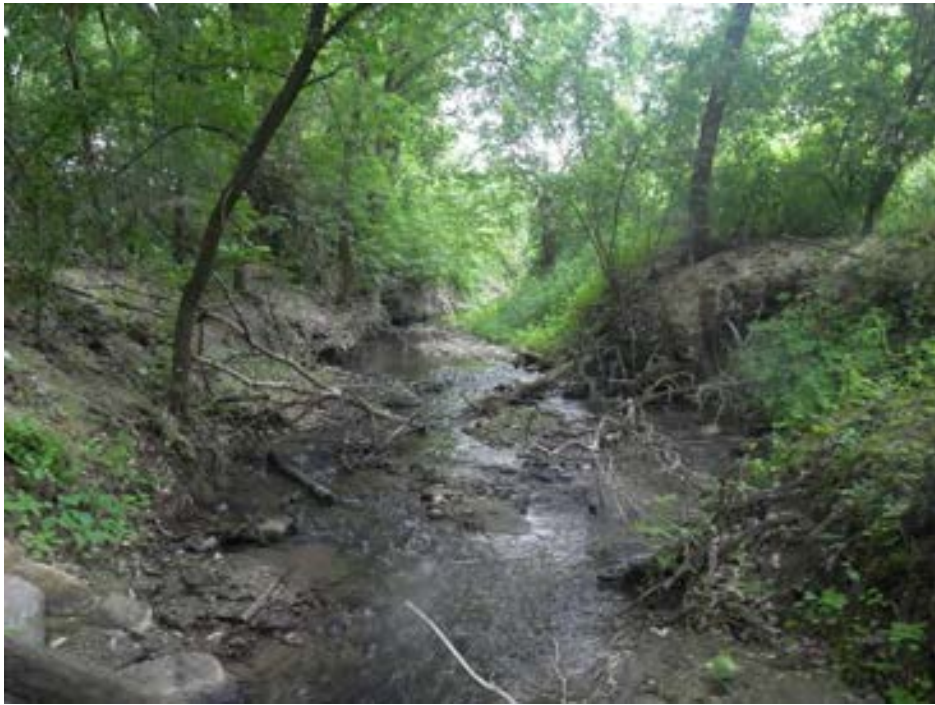
**Photo 26.** *LMRWD Reach.* Channel degradation and bank erosion (looking upstream). A scarp can be seen on the right side of the picture

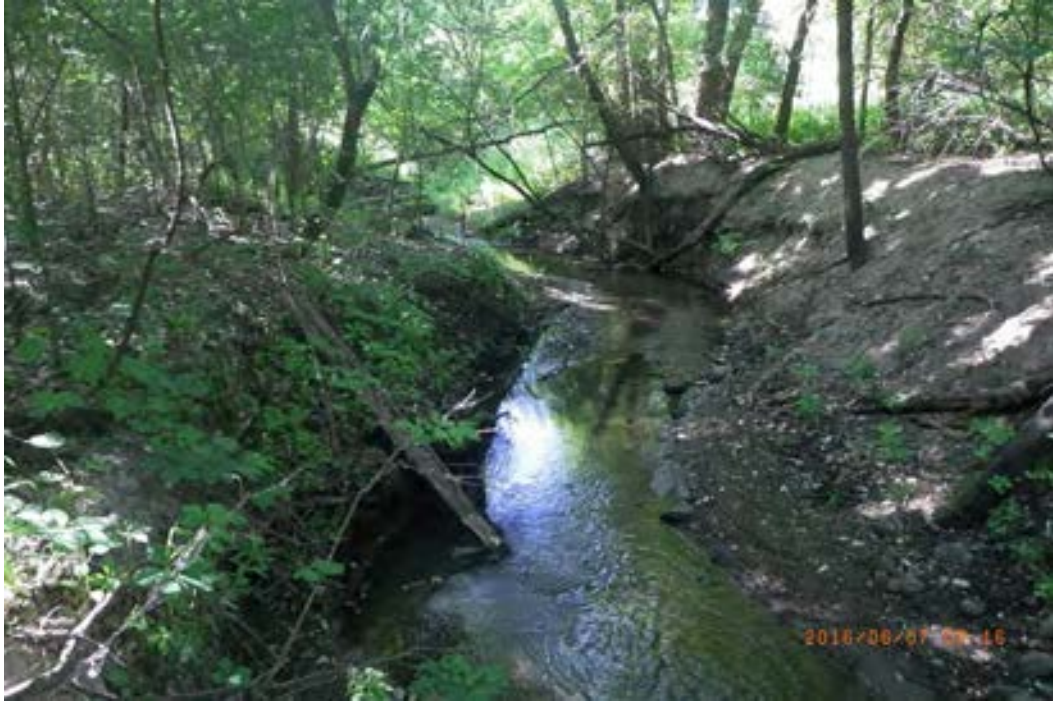
**Photo 27.** *LMRWD Reach.* Channel degradation and bank erosion (looking downstream)

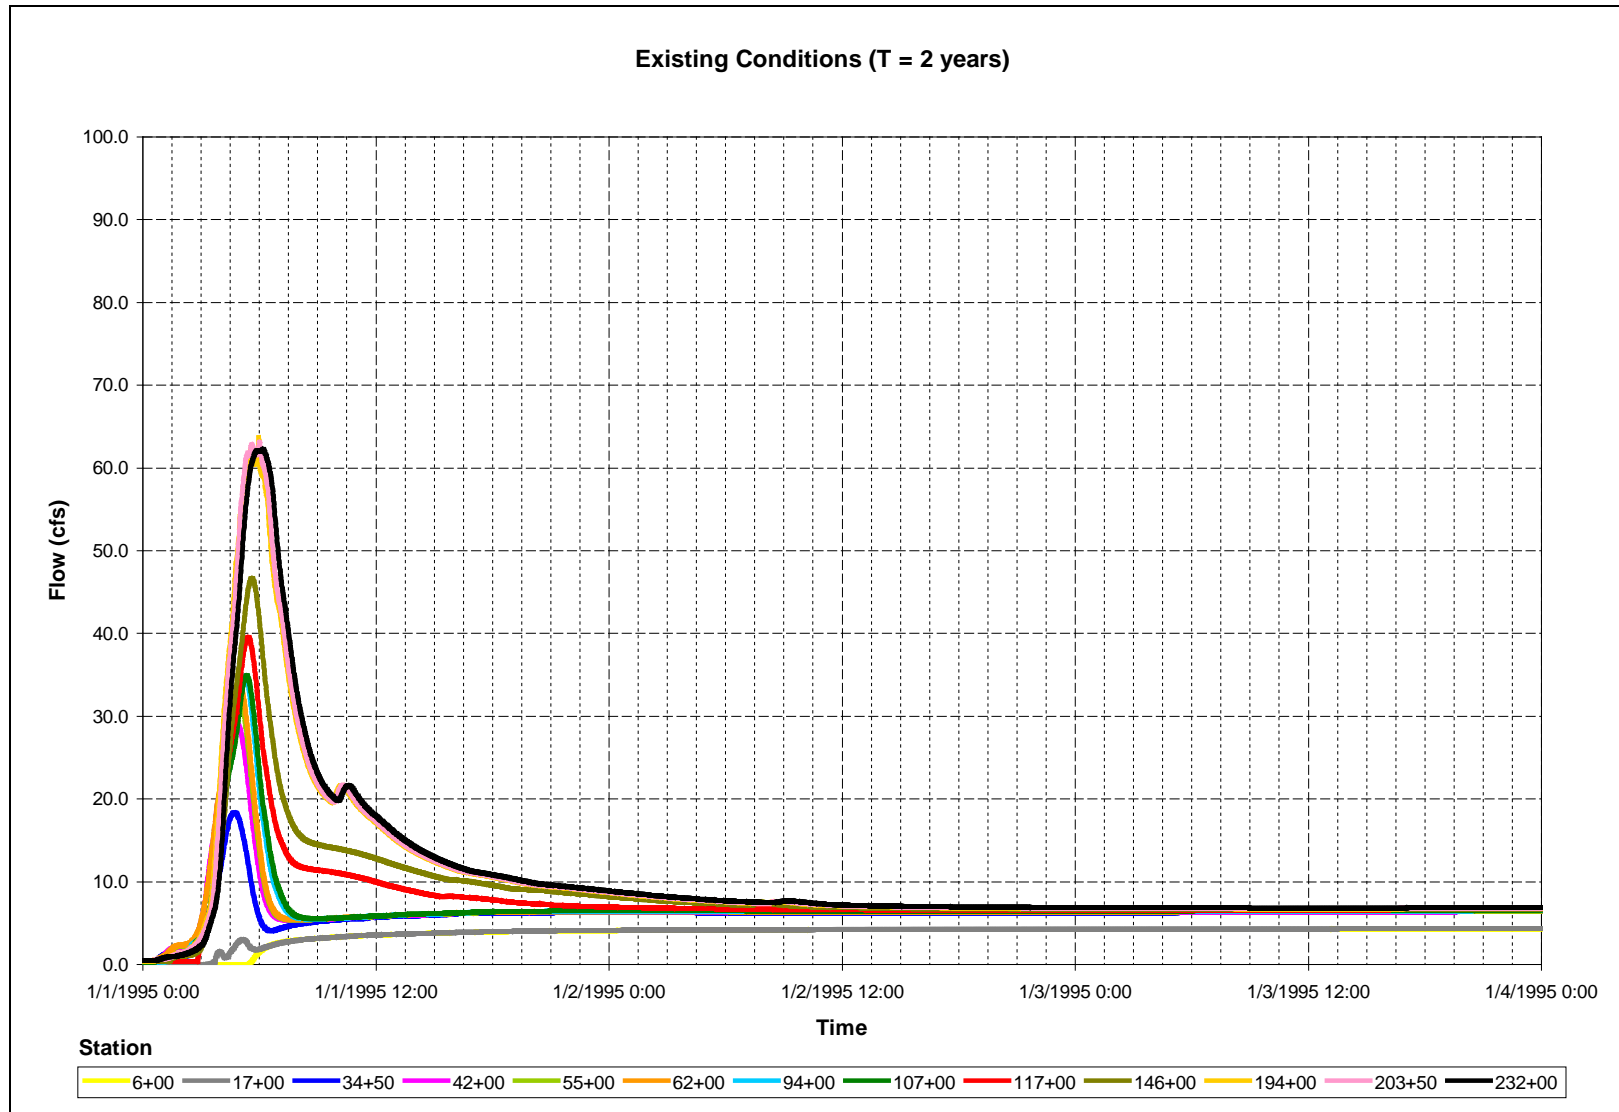
Figure 17. Modeled Flood Hydrograph, Existing Conditions, 2-Year Event

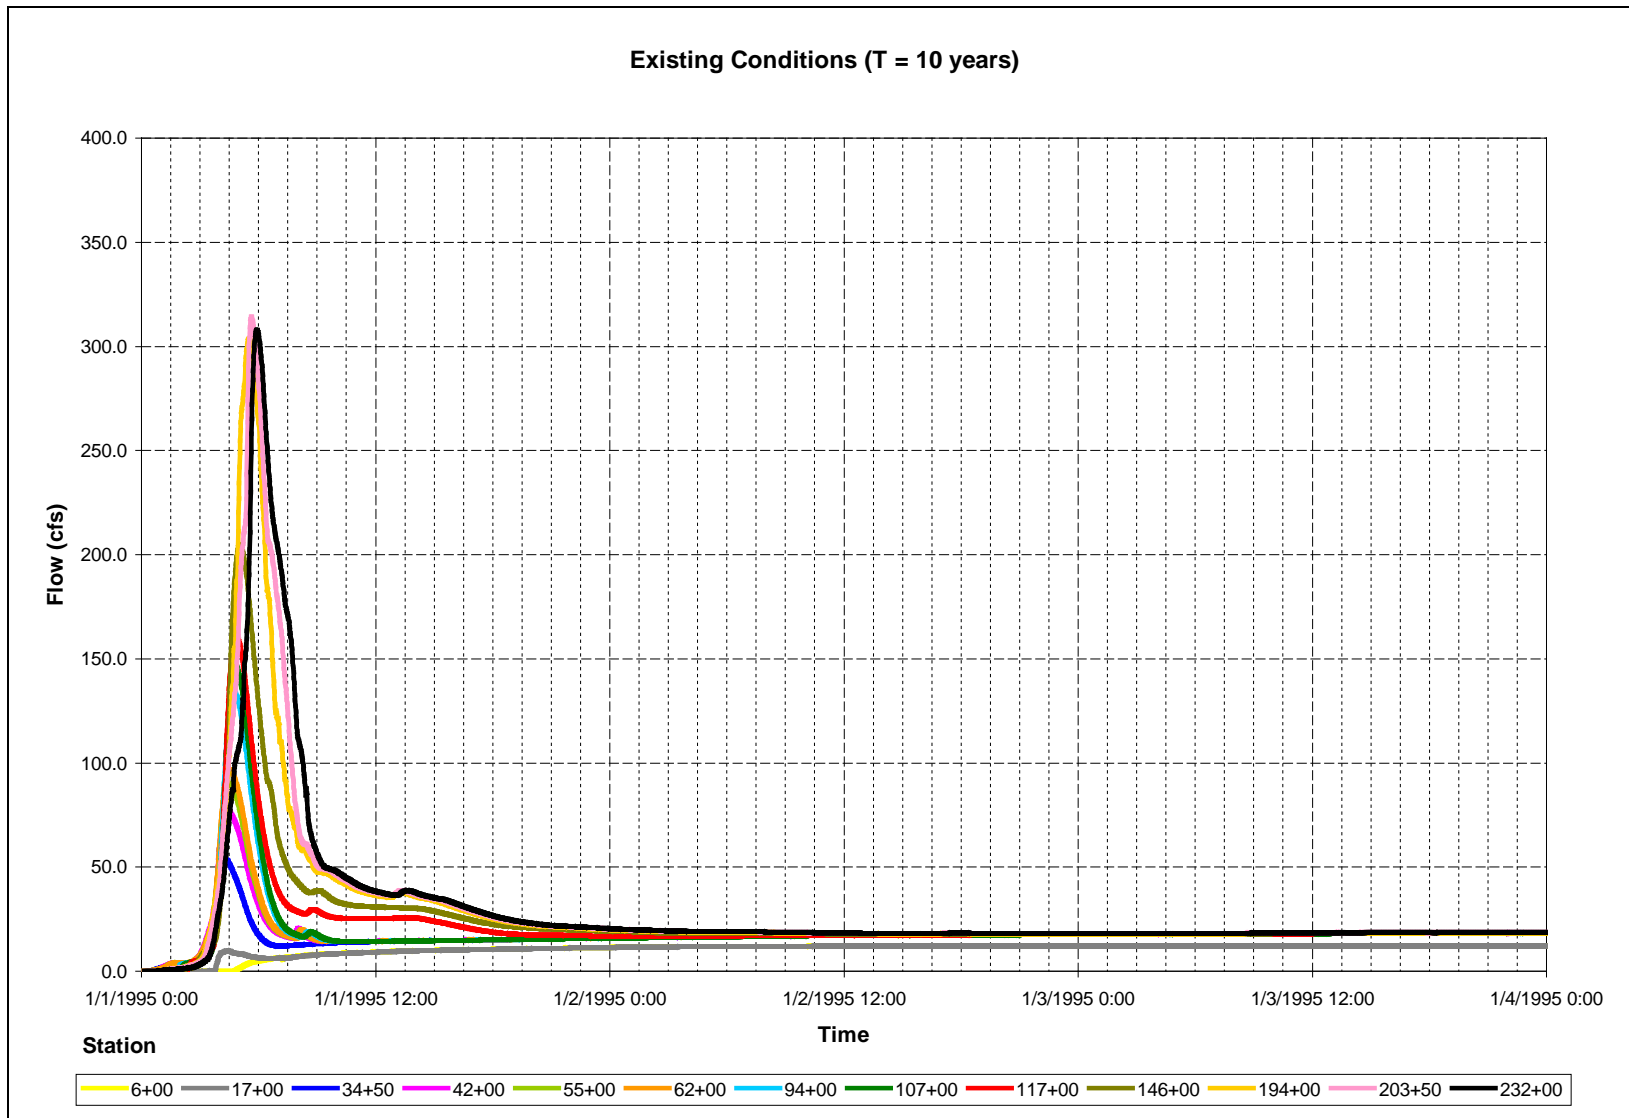
**Figure 18. Modeled Flood Hydrograph, Existing Conditions, 10-Year Event**

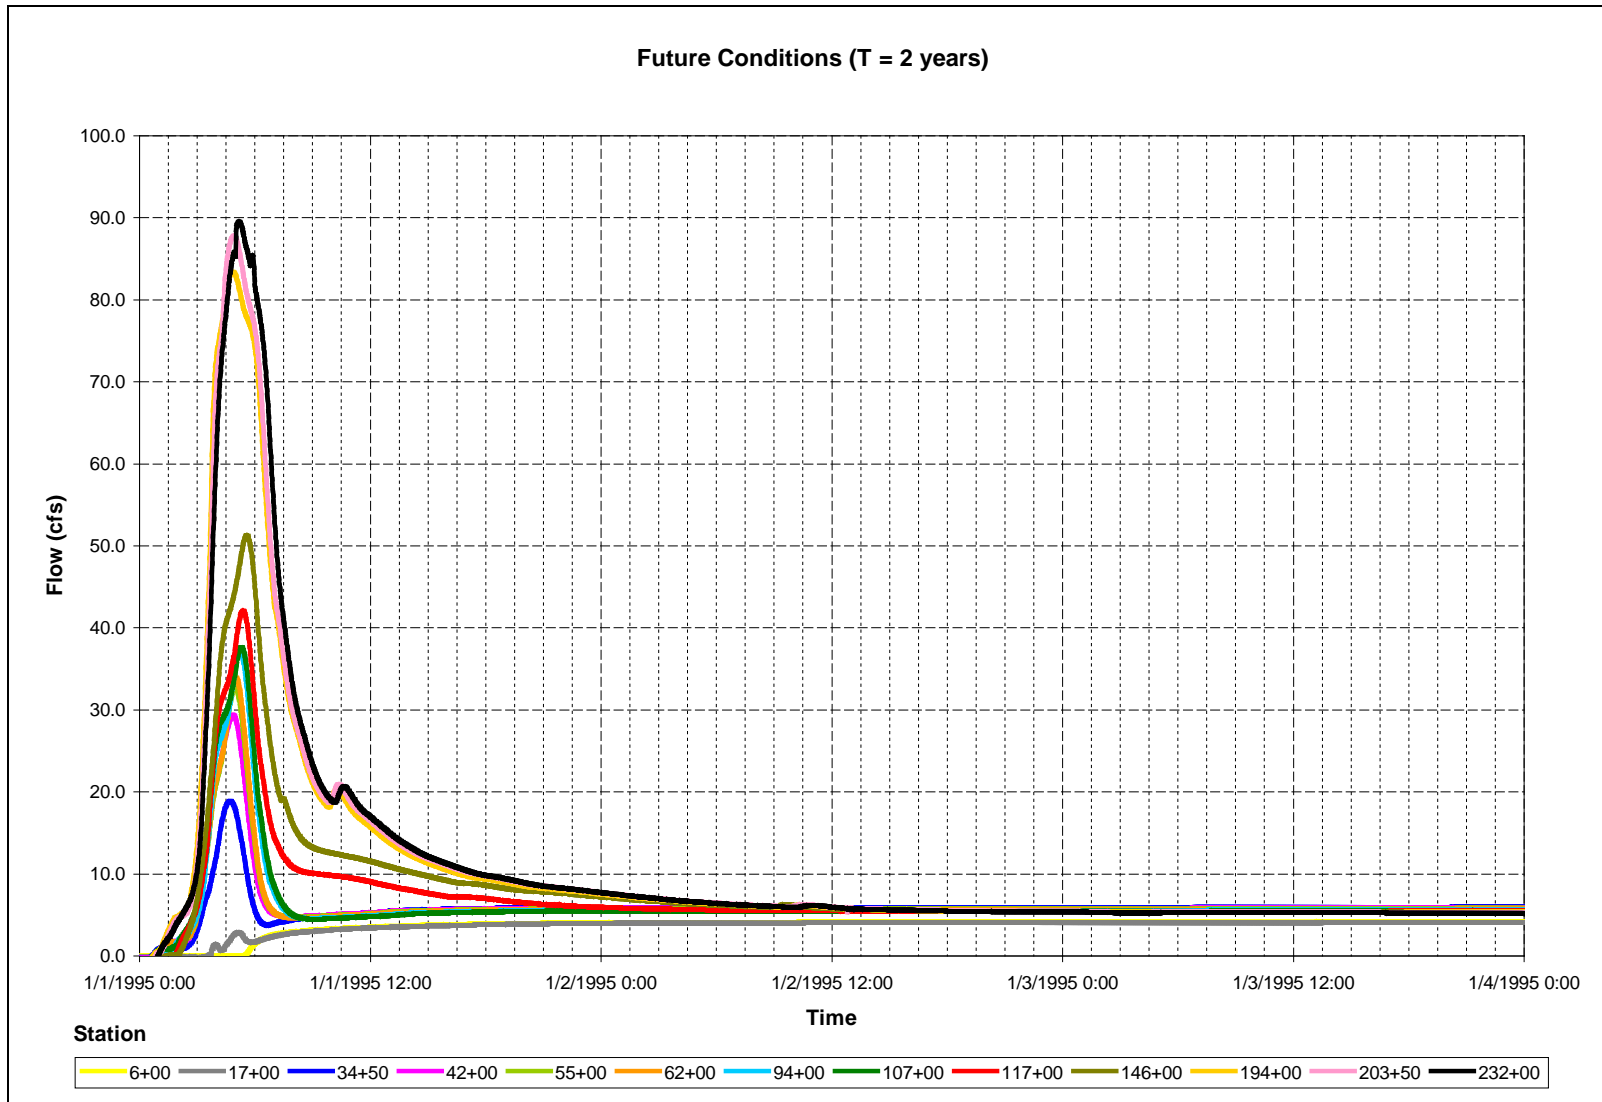
Figure 19. Modeled Flood Hydrograph, Future Conditions, 2-Year Event

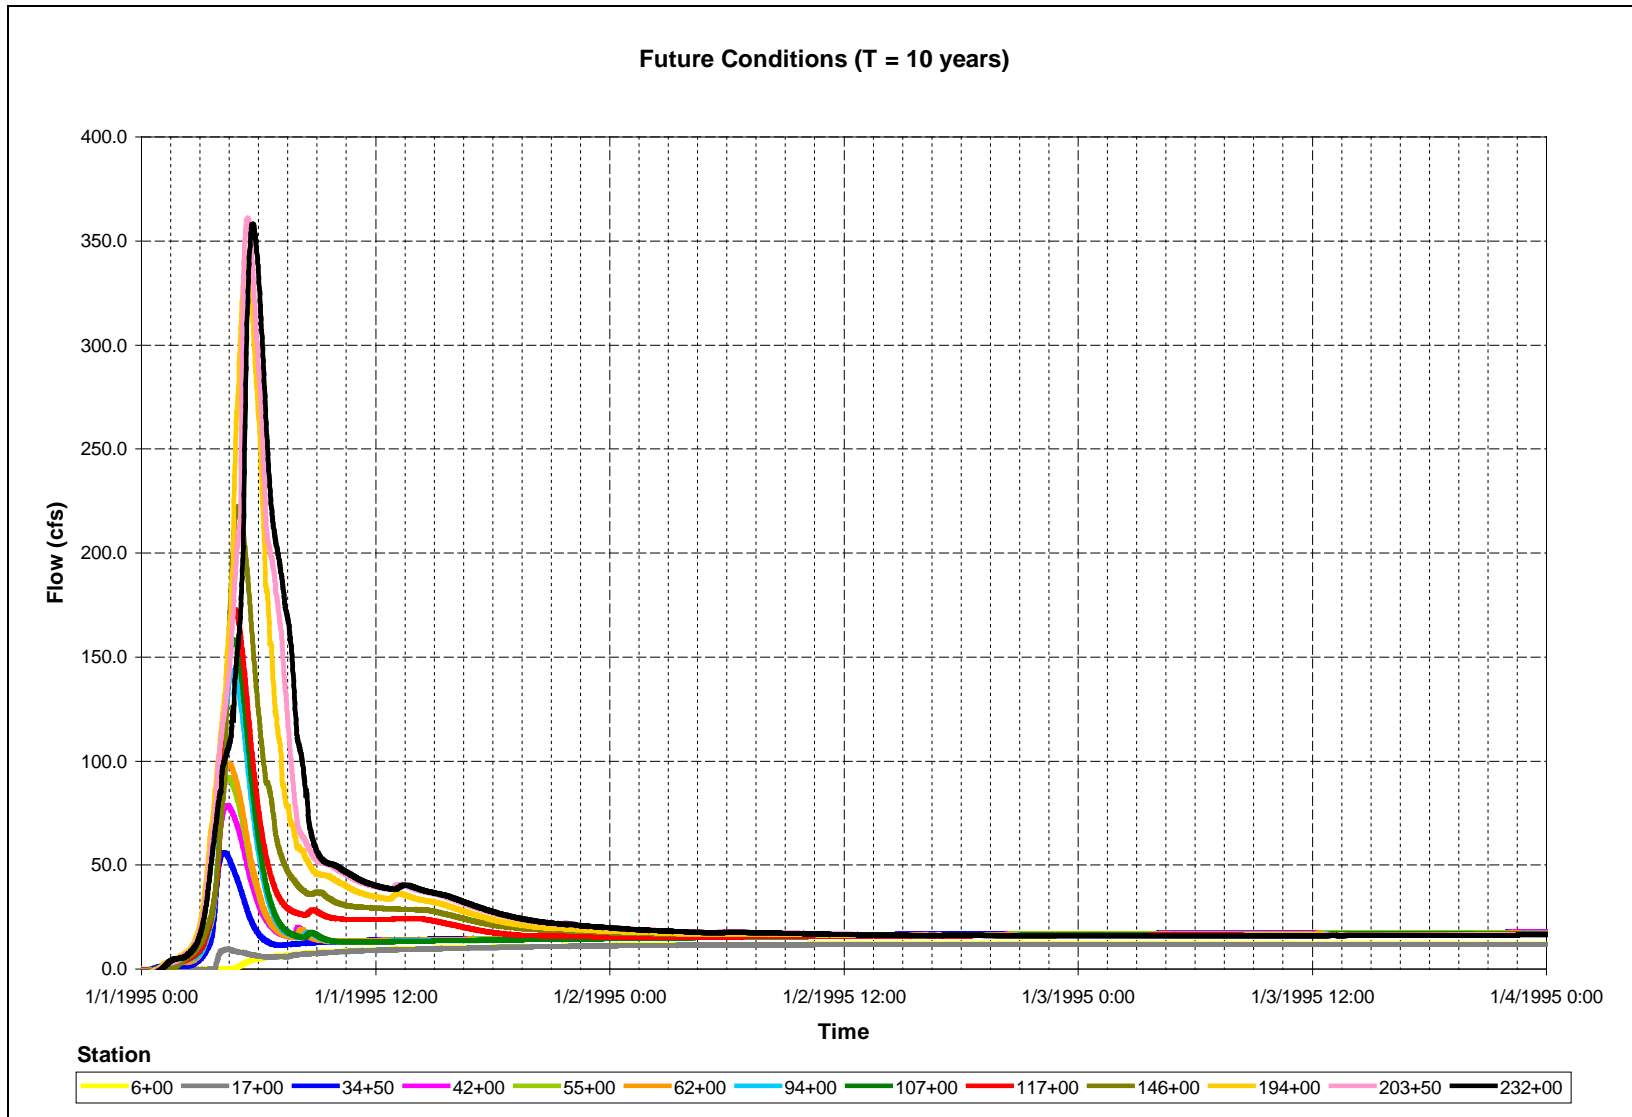
**Figure 20. Modeled Flood Hydrograph, Future Conditions, 10-Year Event**

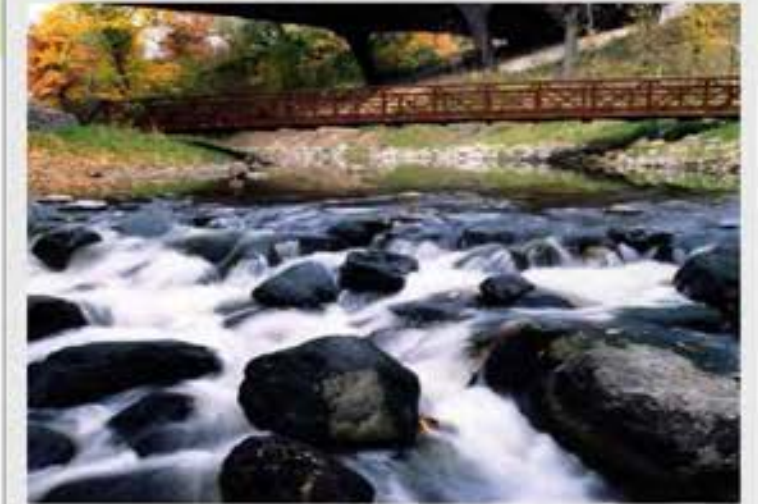
Following the 1987 "super storm," a rapids was constructed on Nine Mile Creek downstream of the 106th Street Bridge. The rapids was one of several grade-control structures that were installed on a three-mile stretch of creek in the lower valley. The proposal allowed the stream to continue its course while taking measures to protect areas where water flow was eroding valley walls. Protection measures included applying porous deflector dikes, burying sheetpile walls parallel to the creek to prevent undercutting of slopes, installing weirs (rock or capped sheetpile) to limit stream-bed degradation, and improving storm-sewer outlets.

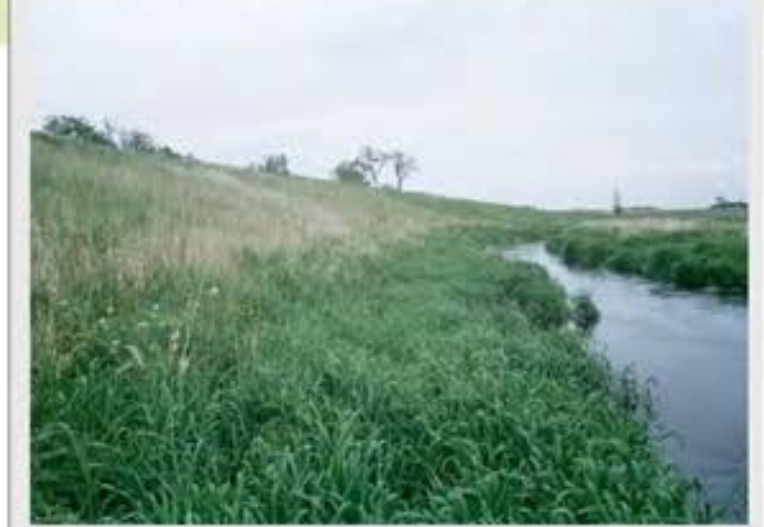
Here is an example of a stabilization project designed for a 1,000-foot long, 20-foot high streambank that was severely eroded. The channel was directed away from the bank toe by installing six rock vanes. The bank was planted with native vegetation and protected with erosion control blanket, while the terrace above the bank was graded to redirect surface runoff to a less vulnerable area. The restored streambank withstood significant flooding during 2001, and has become nicely vegetated (see picture above).
