ASSUMPTION CREEK HYDROLOGIC & HYDRAULIC STUDY

August 30, 2022

FINAL

Young Environmental Consulting Group, LLC
6040 Earle Brown Drive, Suite 306
Brooklyn Center, MN 55430

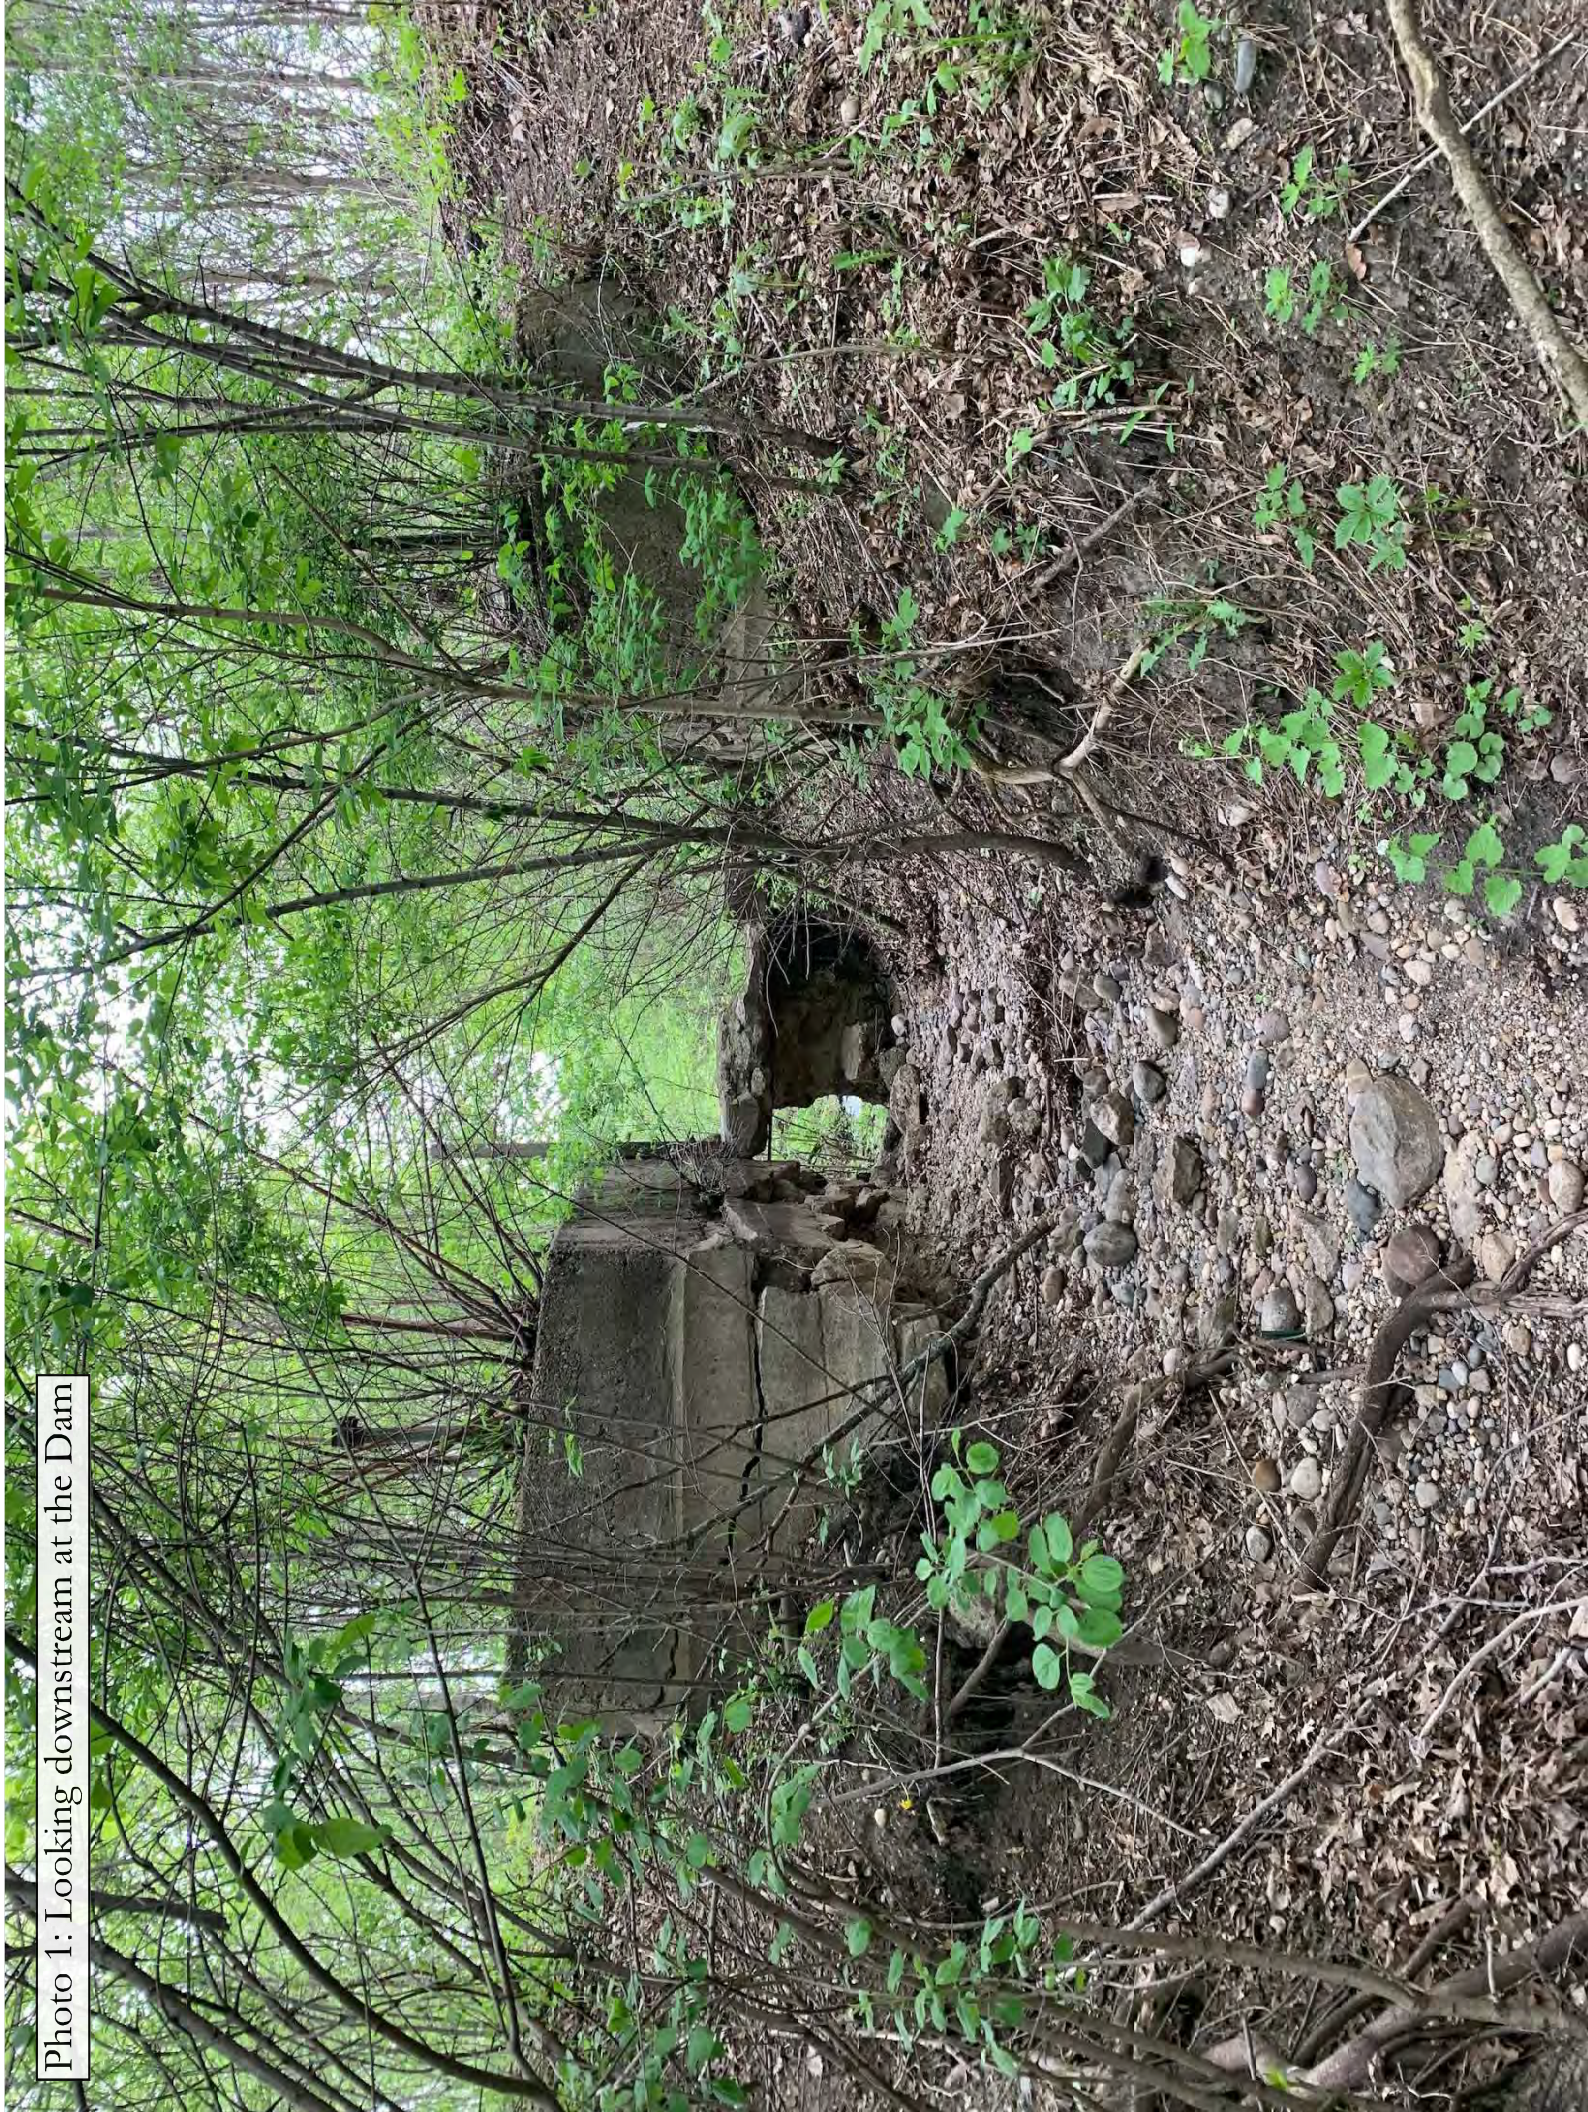
Photo 1: Looking downstream at the Dam

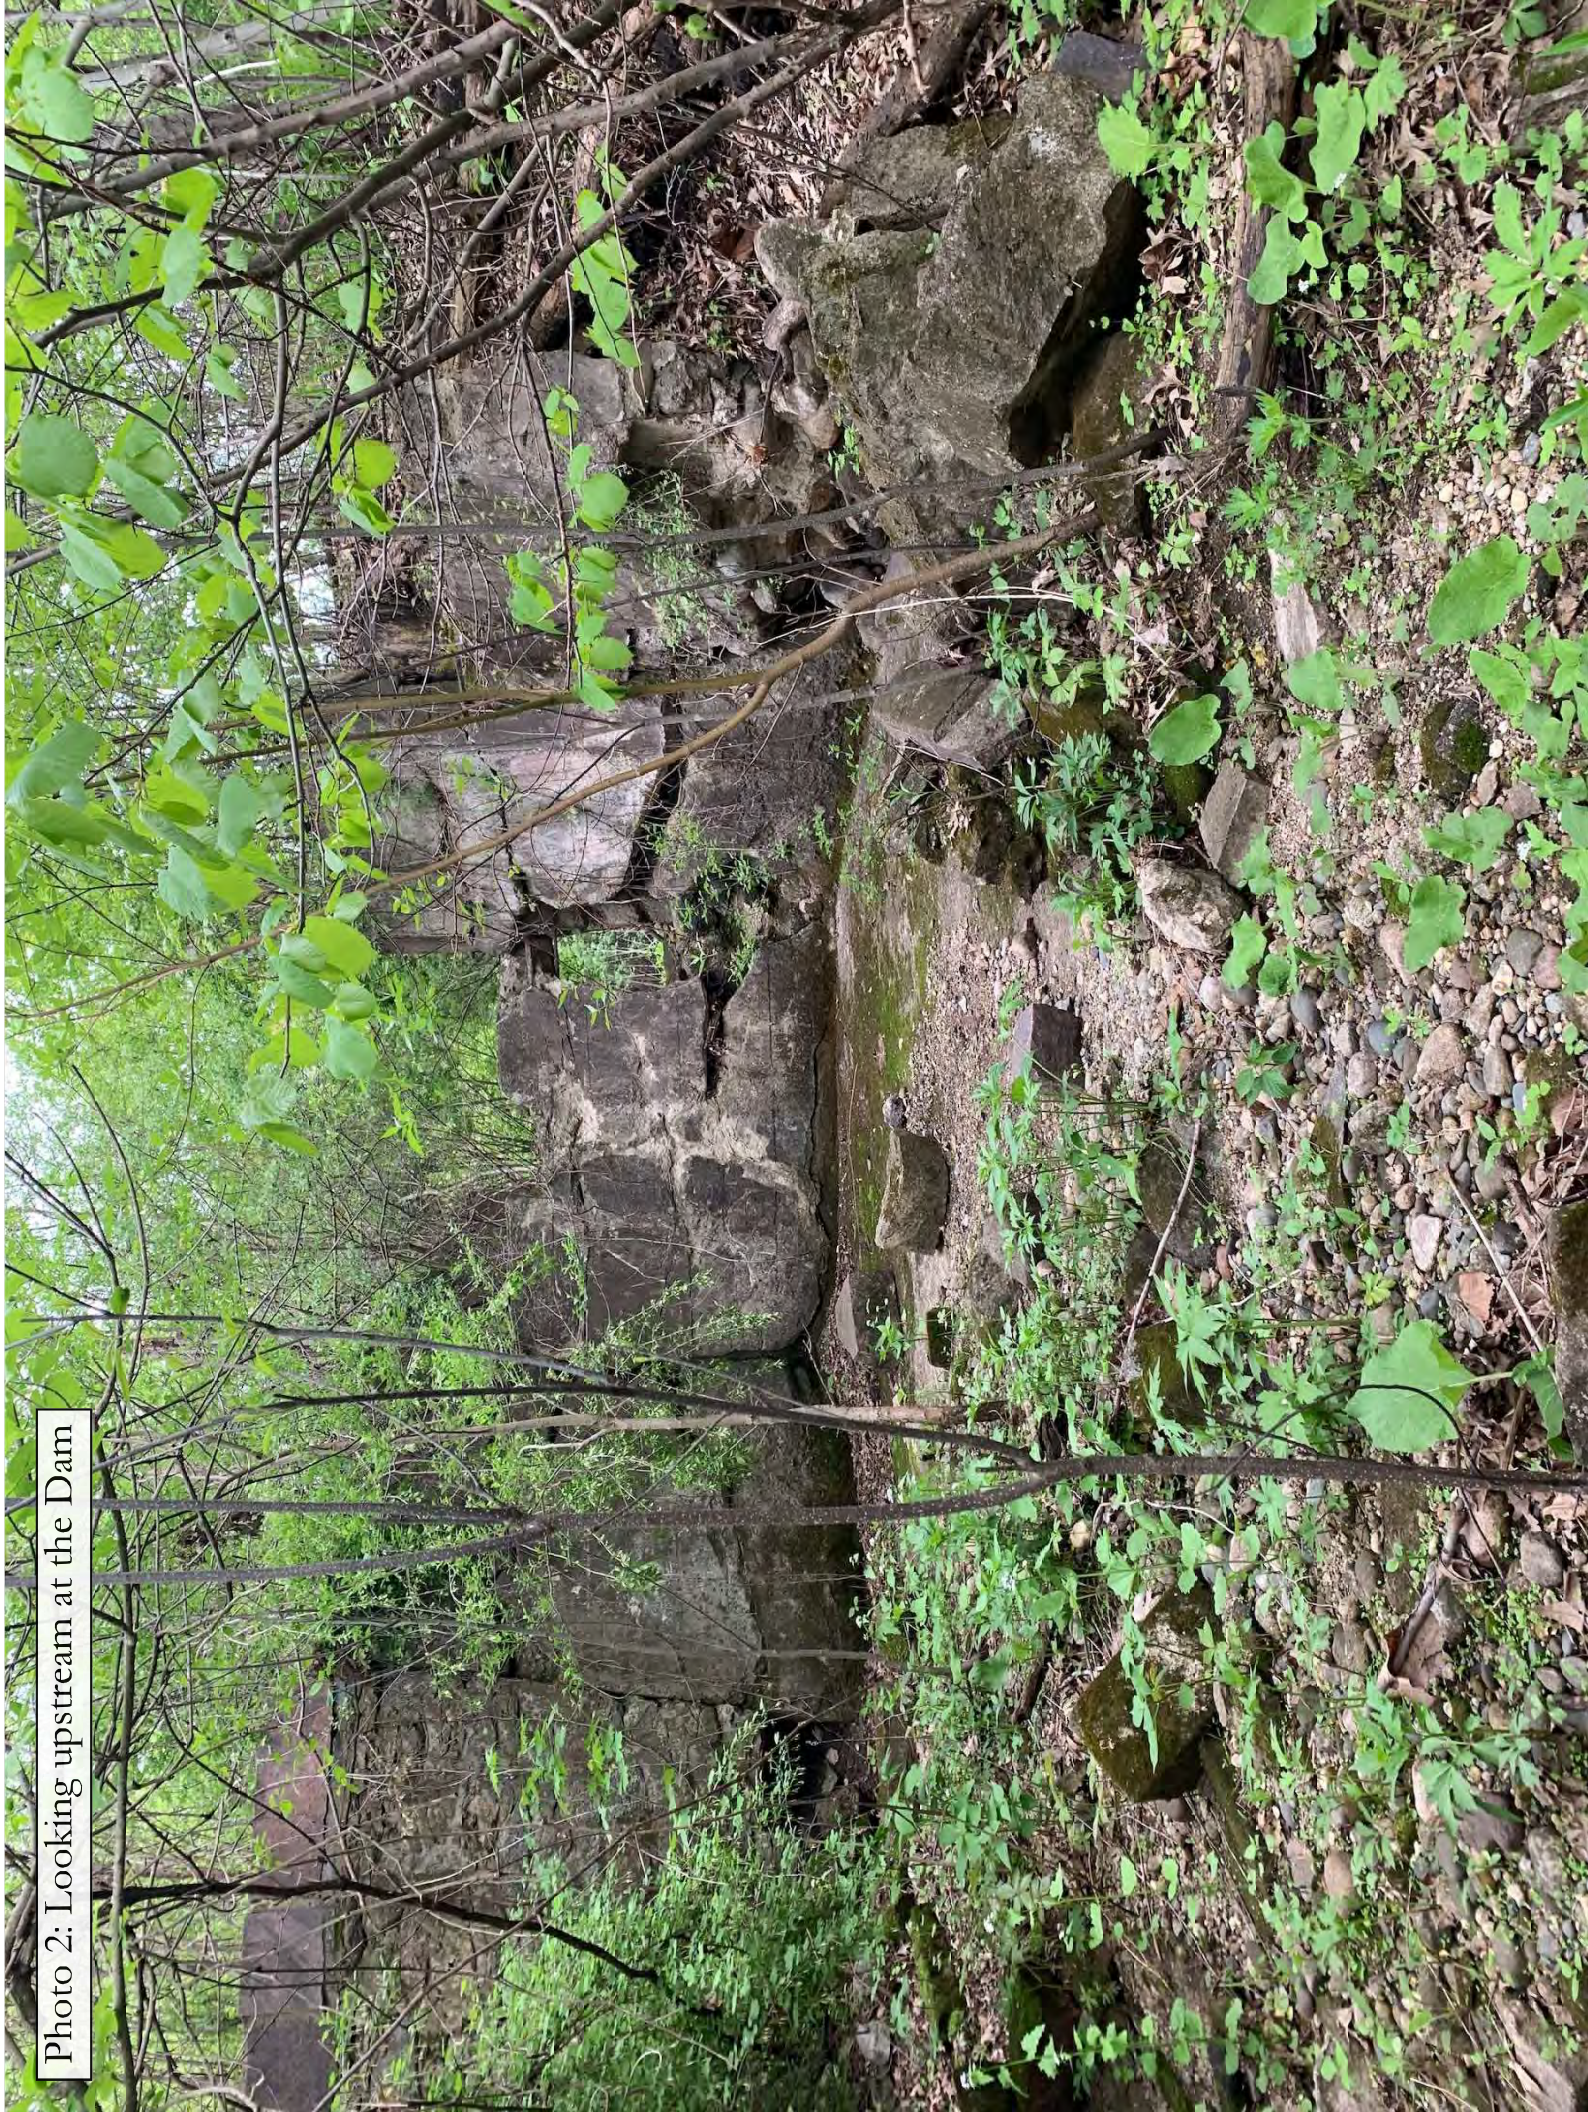
Photo 2: Looking upstream at the Dam

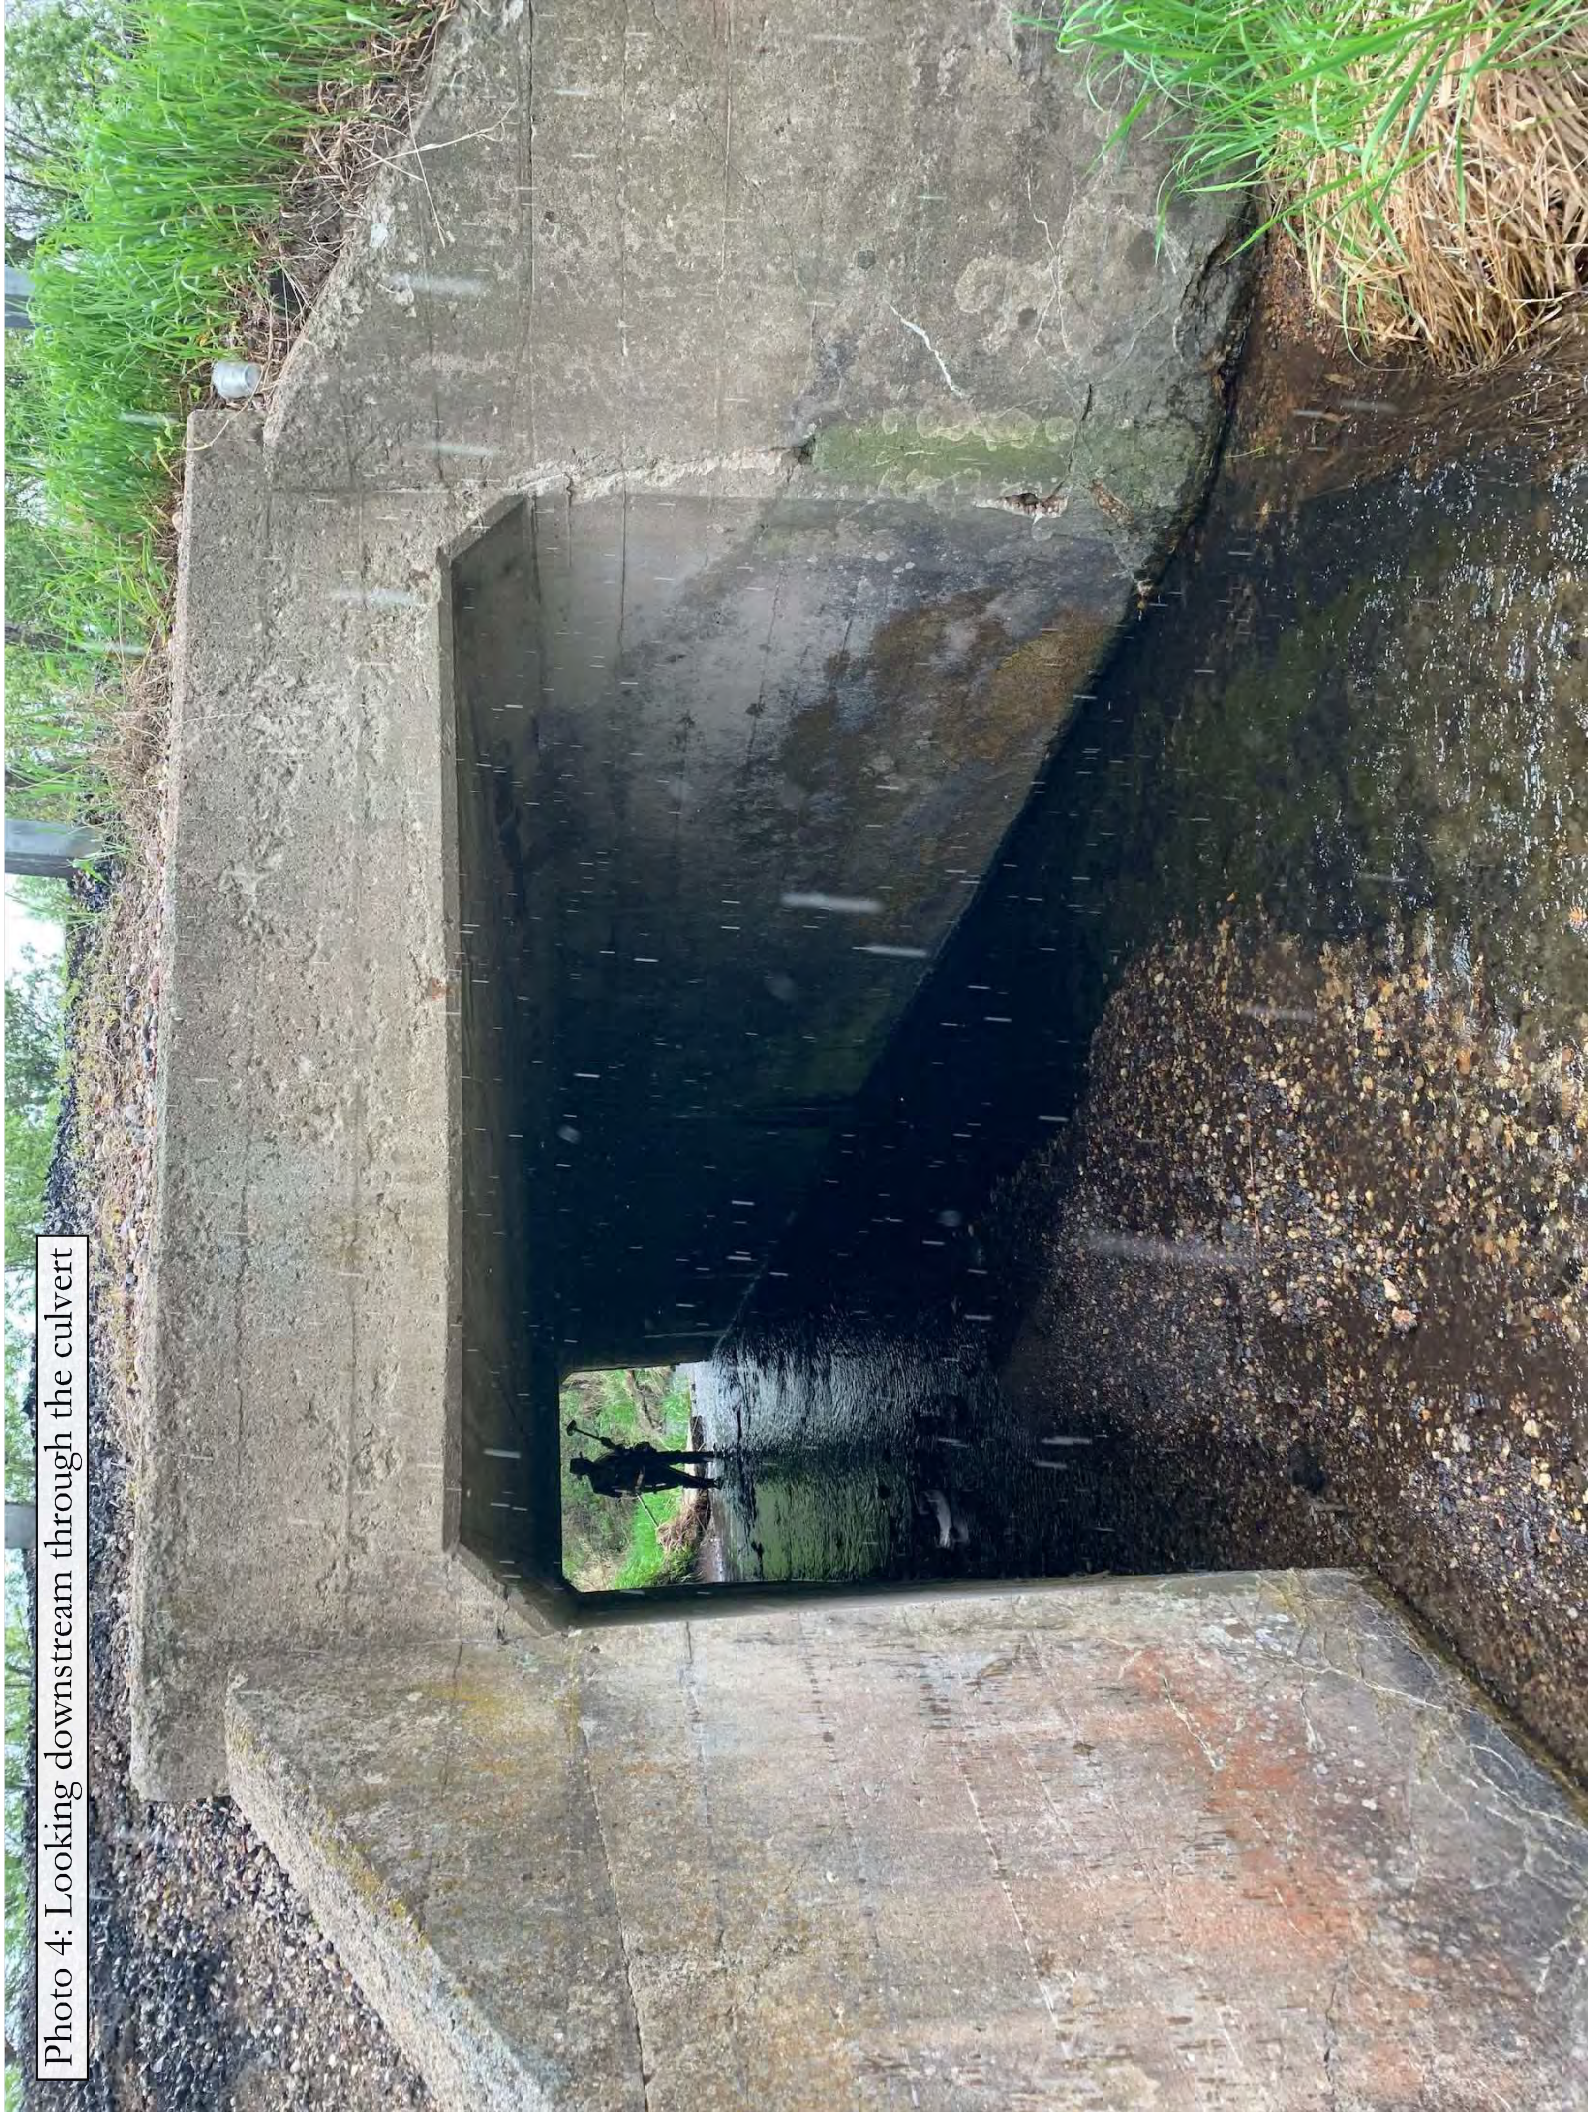
Photo 4: Looking downstream through the culvert

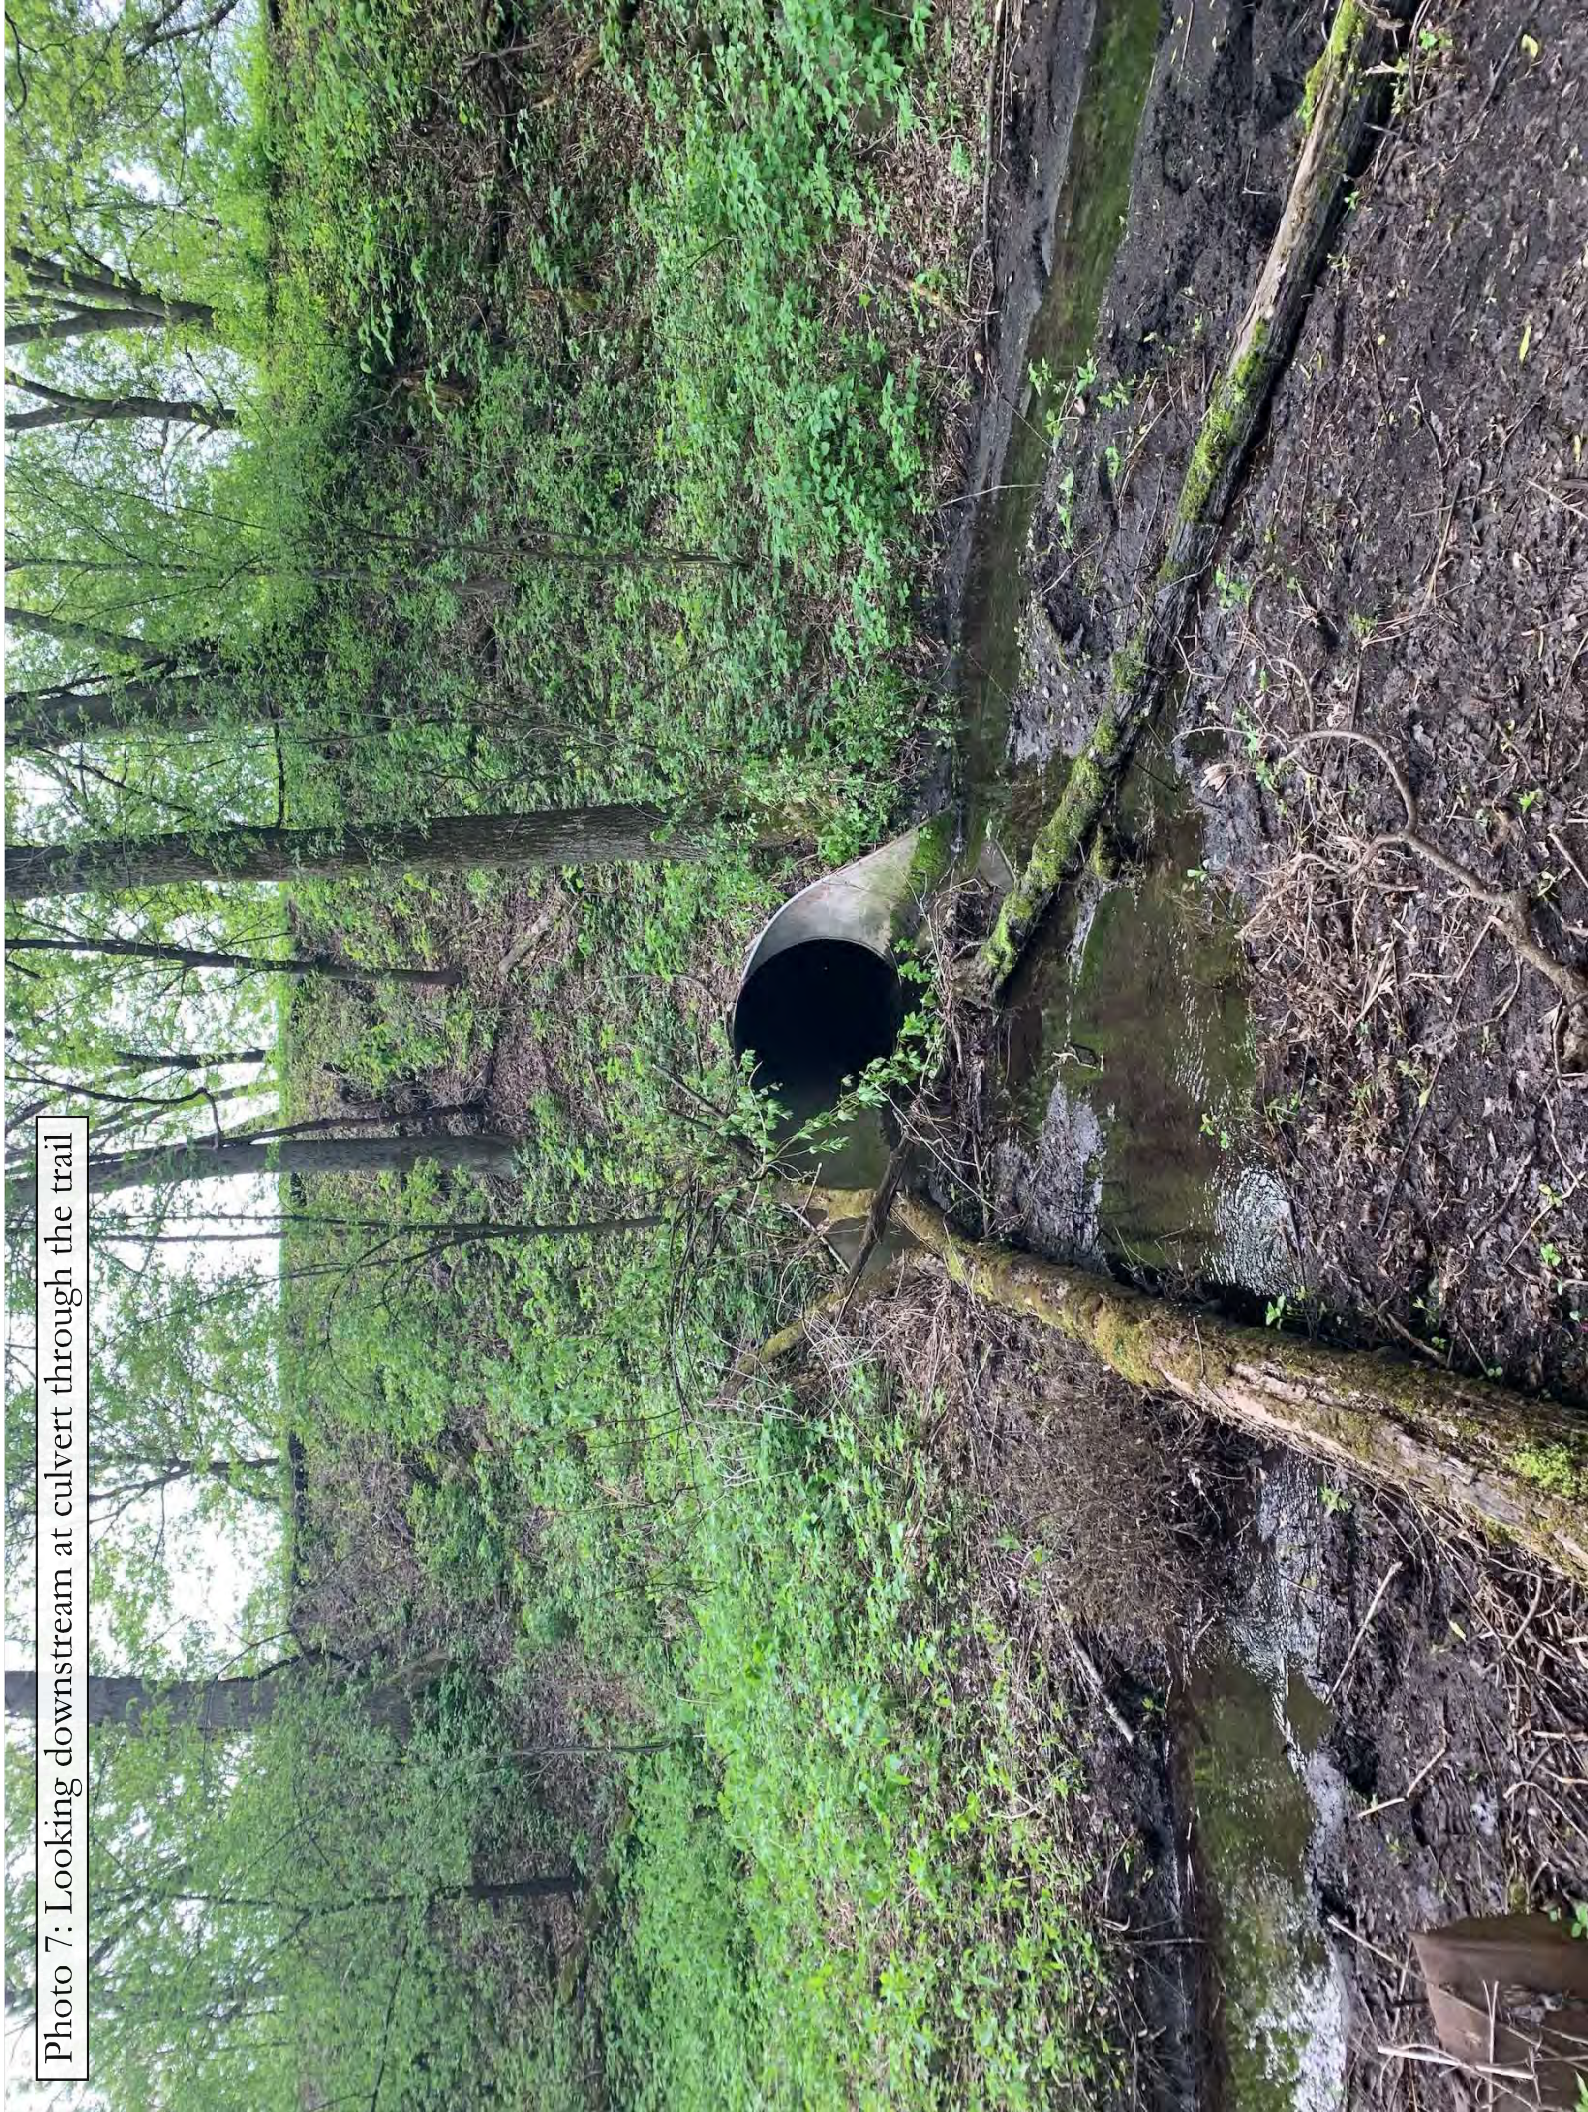
Photo 7: Looking downstream at culvert through the trail

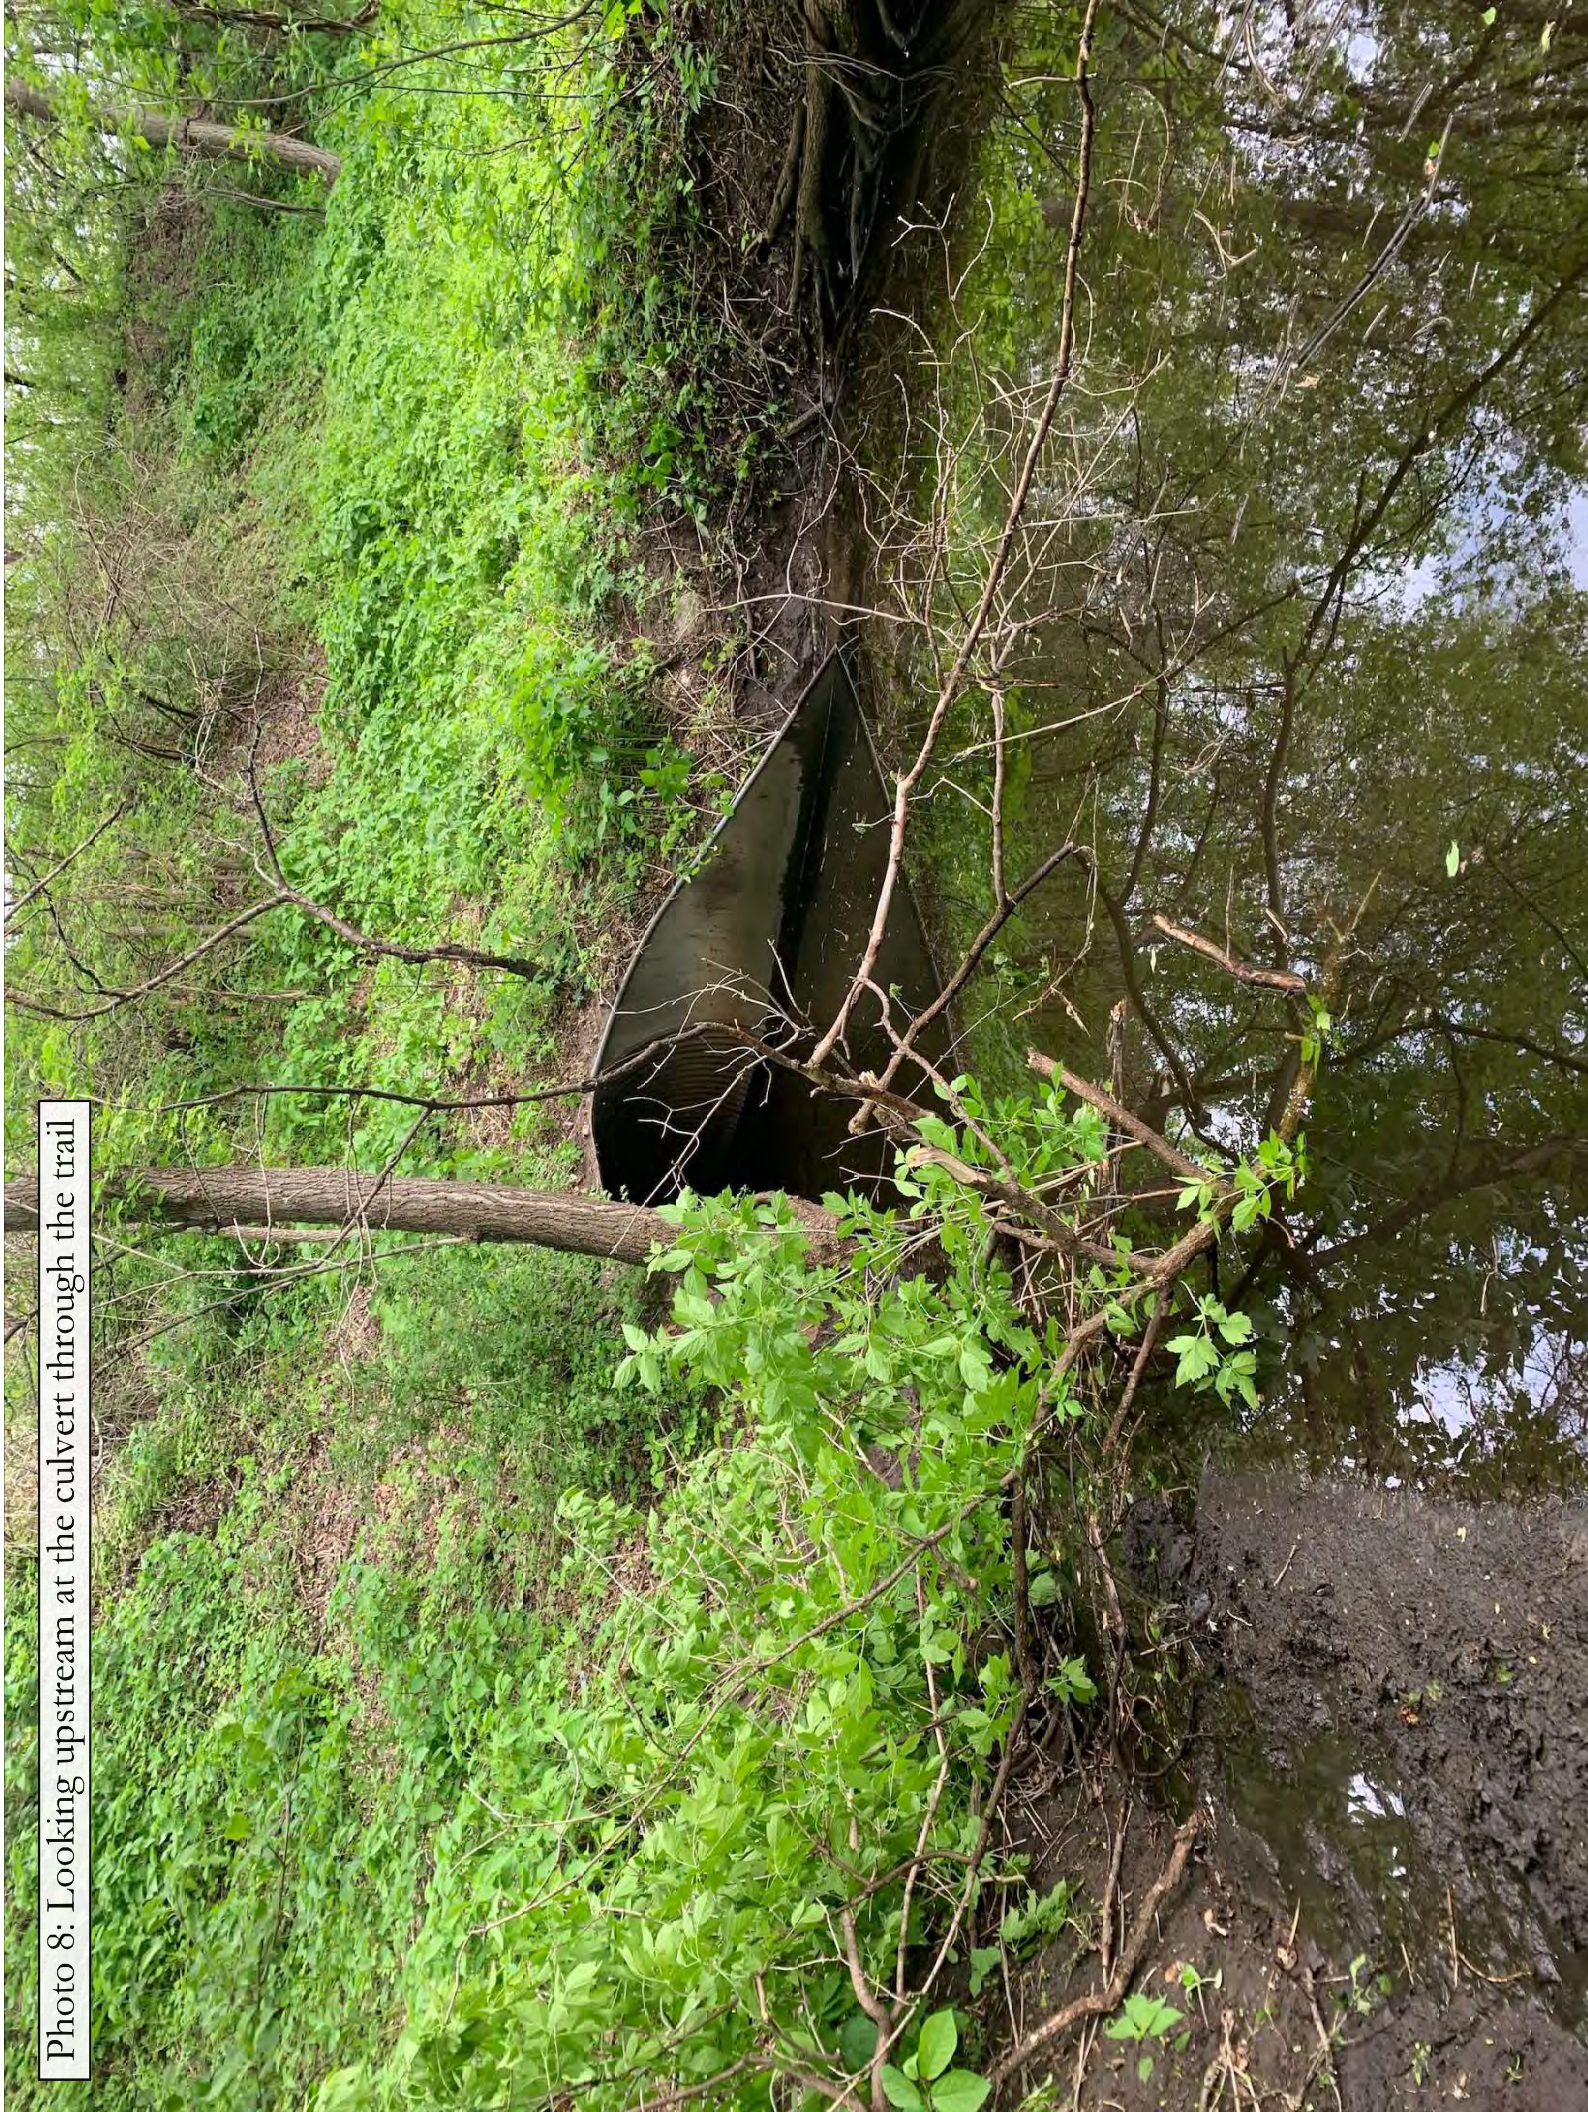
Photo 8: Looking upstream at the culvert through the trail

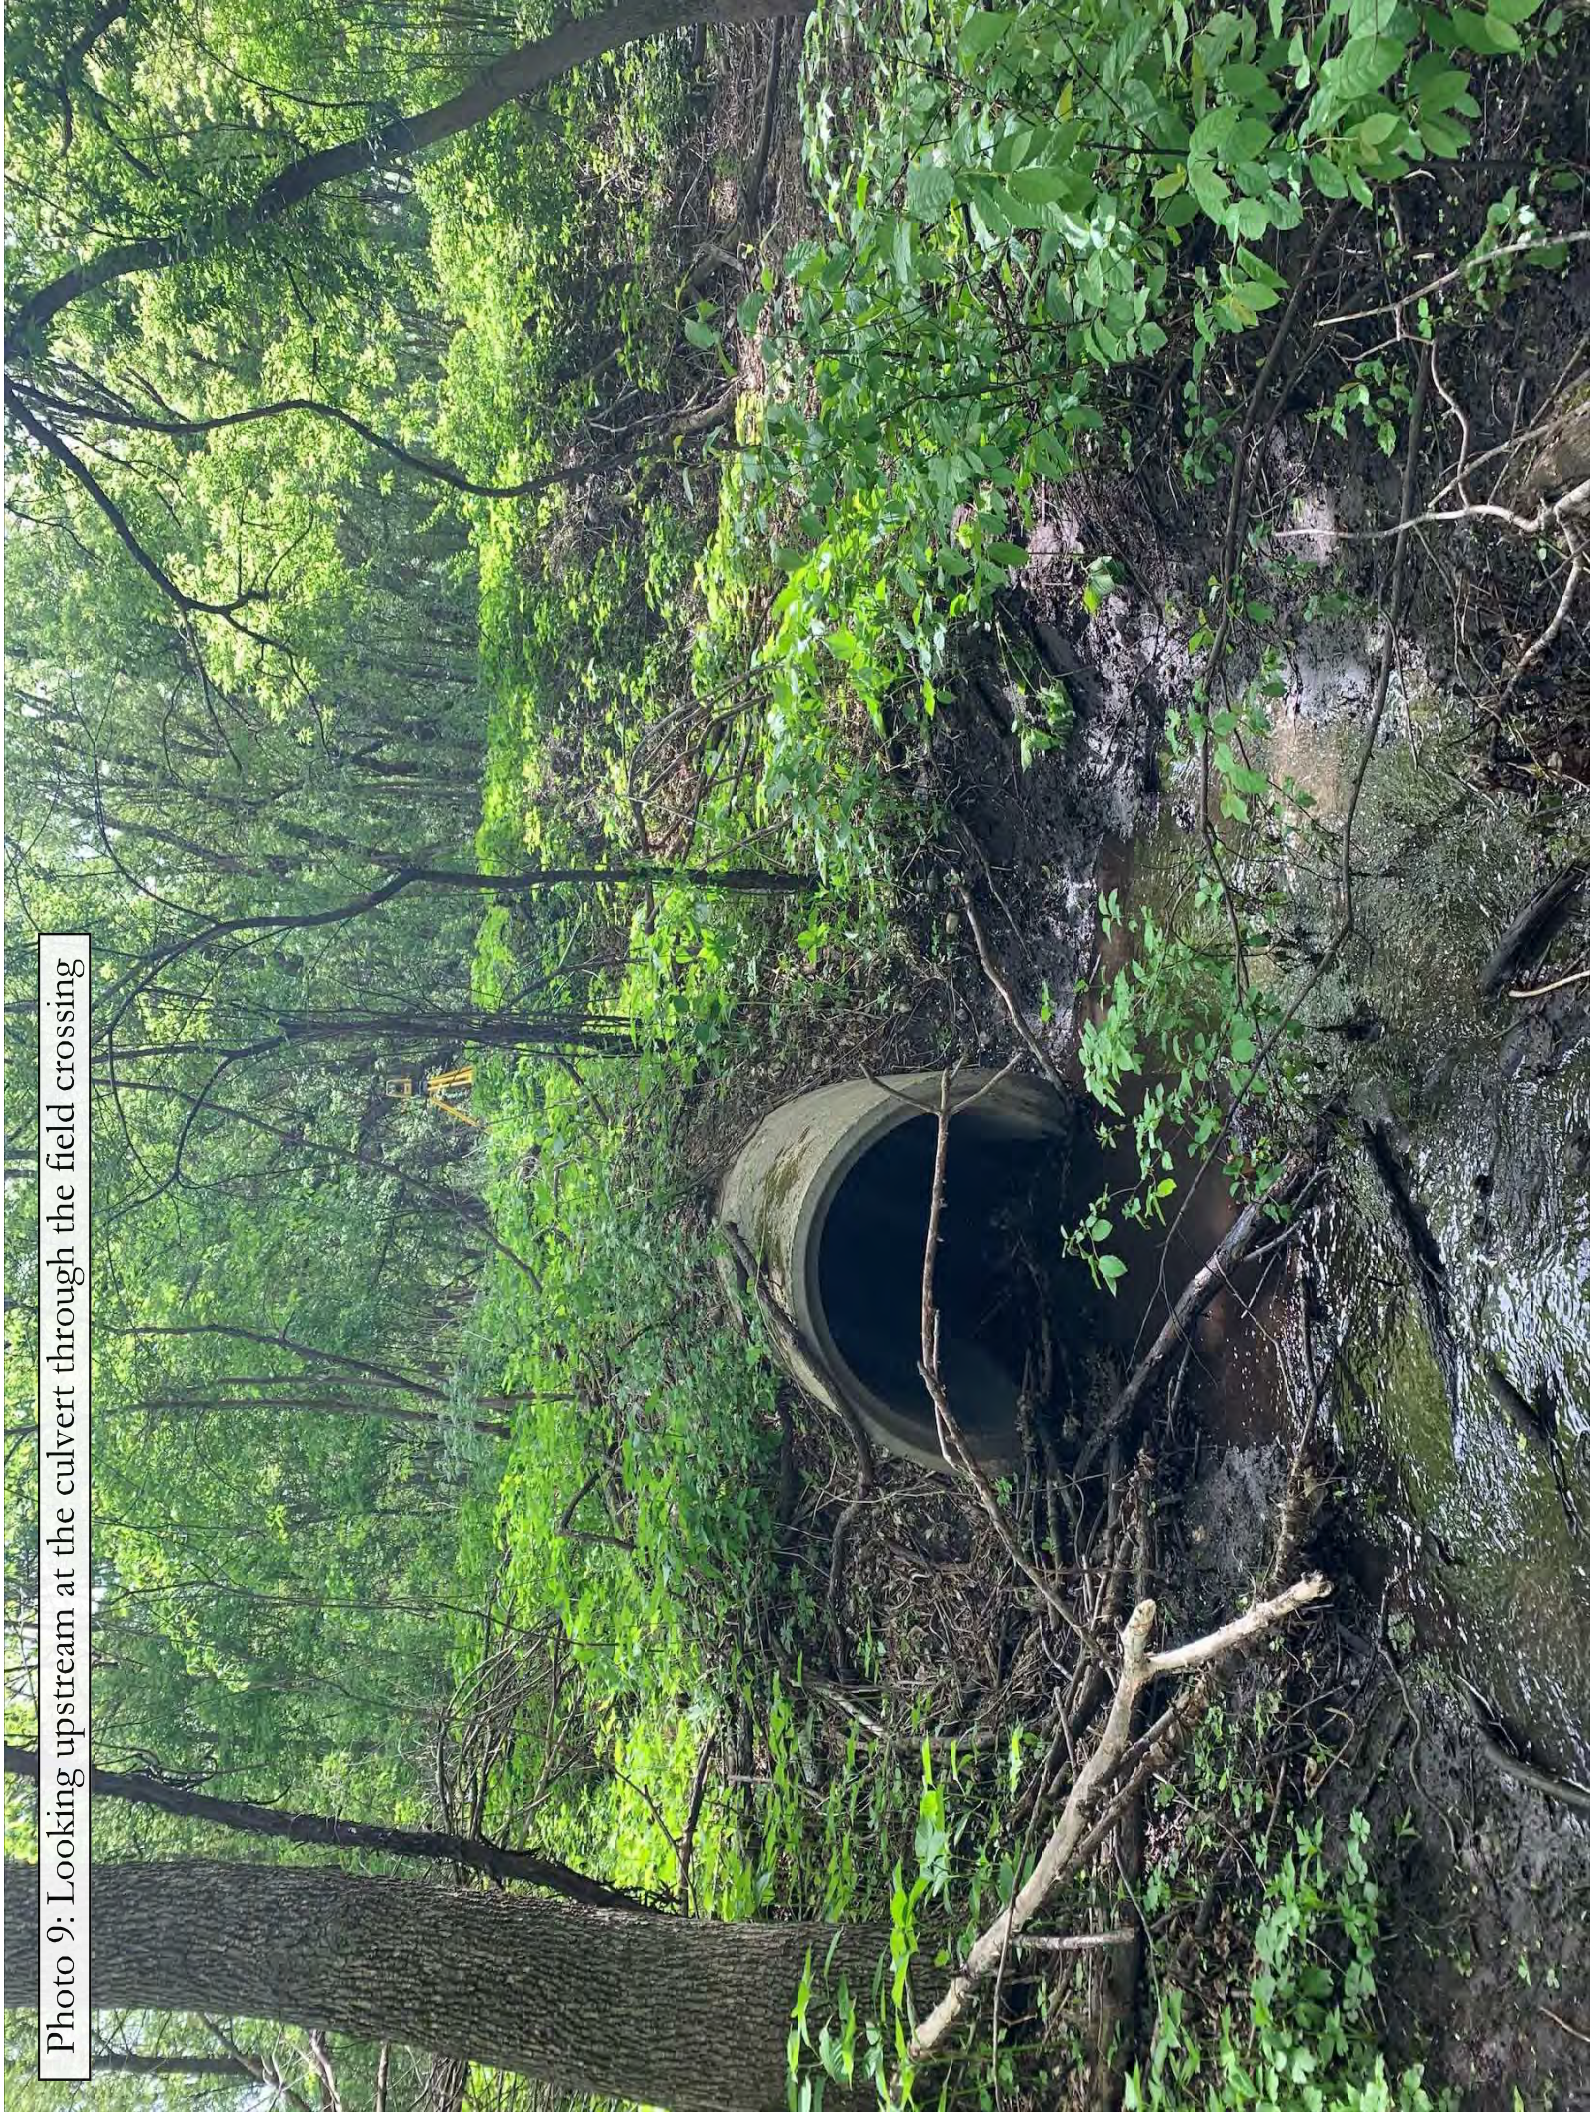
Photo 9: Looking upstream at the culvert through the field crossing
