LOWER MINNESOTA RIVER WATERSHED DISTRICT

July 2019 Administrator report
From: Linda Loomis, Administrator
To: LMRWD Board of Managers

Memorandum

SUBJECT: Stormwater Visit Summary
June 26, 2019, 5:13 a.m.–6:12 a.m.
CSAH 61 – Flying Cloud Drive
Owner – Hennepin County and Contractor – Ames Construction

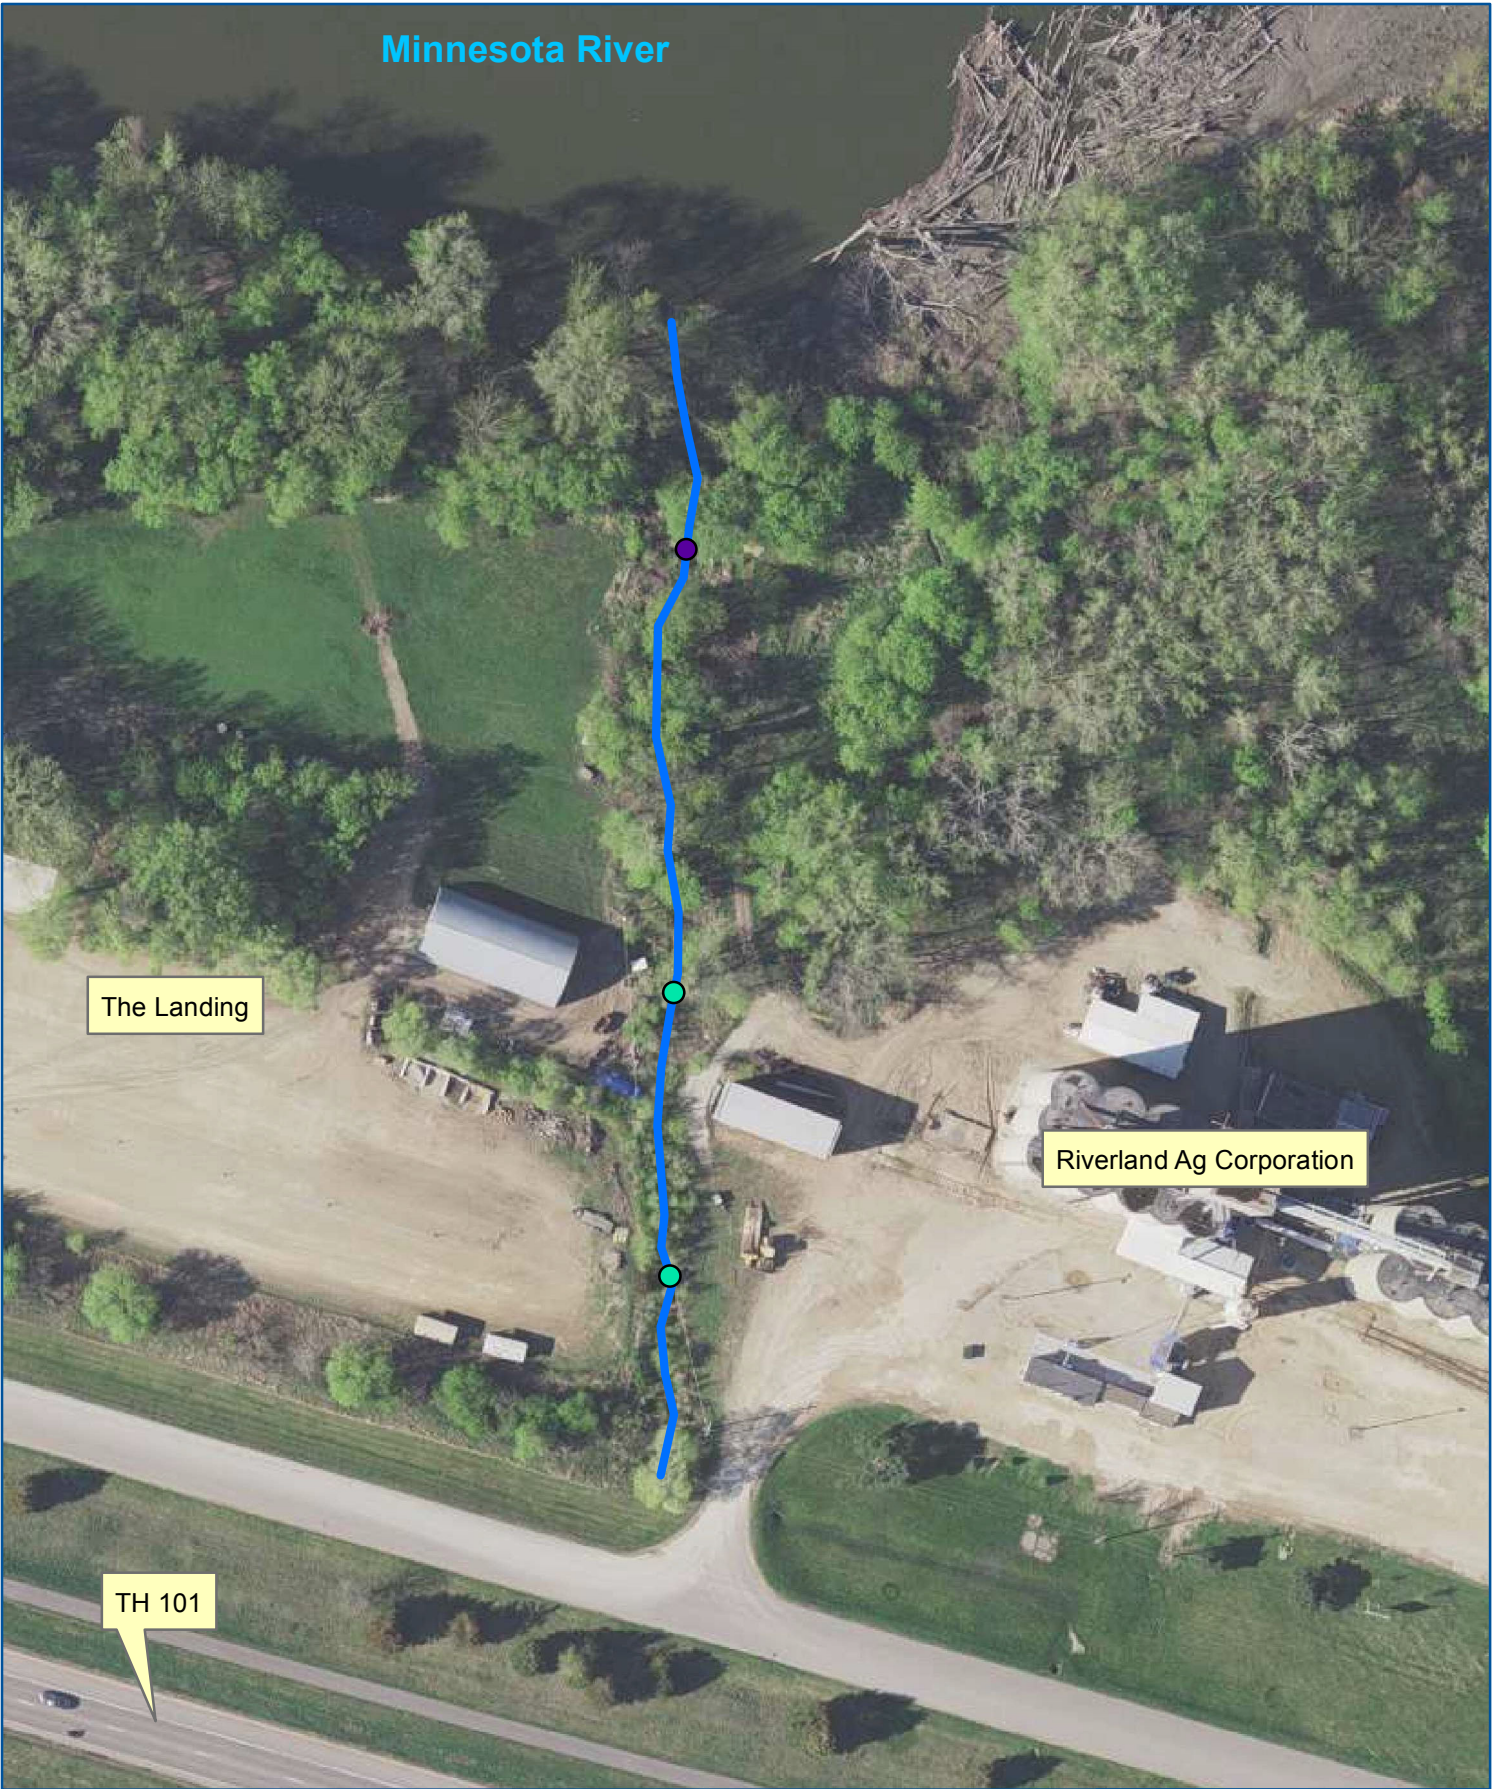
EXISTING CONDITIONS
TH 101 Ravine Assessment
Lower Minnesota River
Watershed District

The ravine is located on the east end of the parking lot for The Landing, which is an historical heritage park run by the Three Rivers Park District. The land on the east side of the ravine is owned by Riverland Ag Corporation.

The ravine is narrow and well-vegetated. Buckthorn is growing on the banks in the upper half of the ravine, and in more than one location it was observed growing within the main channel. At the upstream end, the ravine is relatively shallow, with the bottom of the channel being approximately three feet deep relative to the adjacent overbank areas. The width of the channel at the bottom varies, but it was approximately one to two feet wide in most locations. The bottom of the channel was primarily gravel.

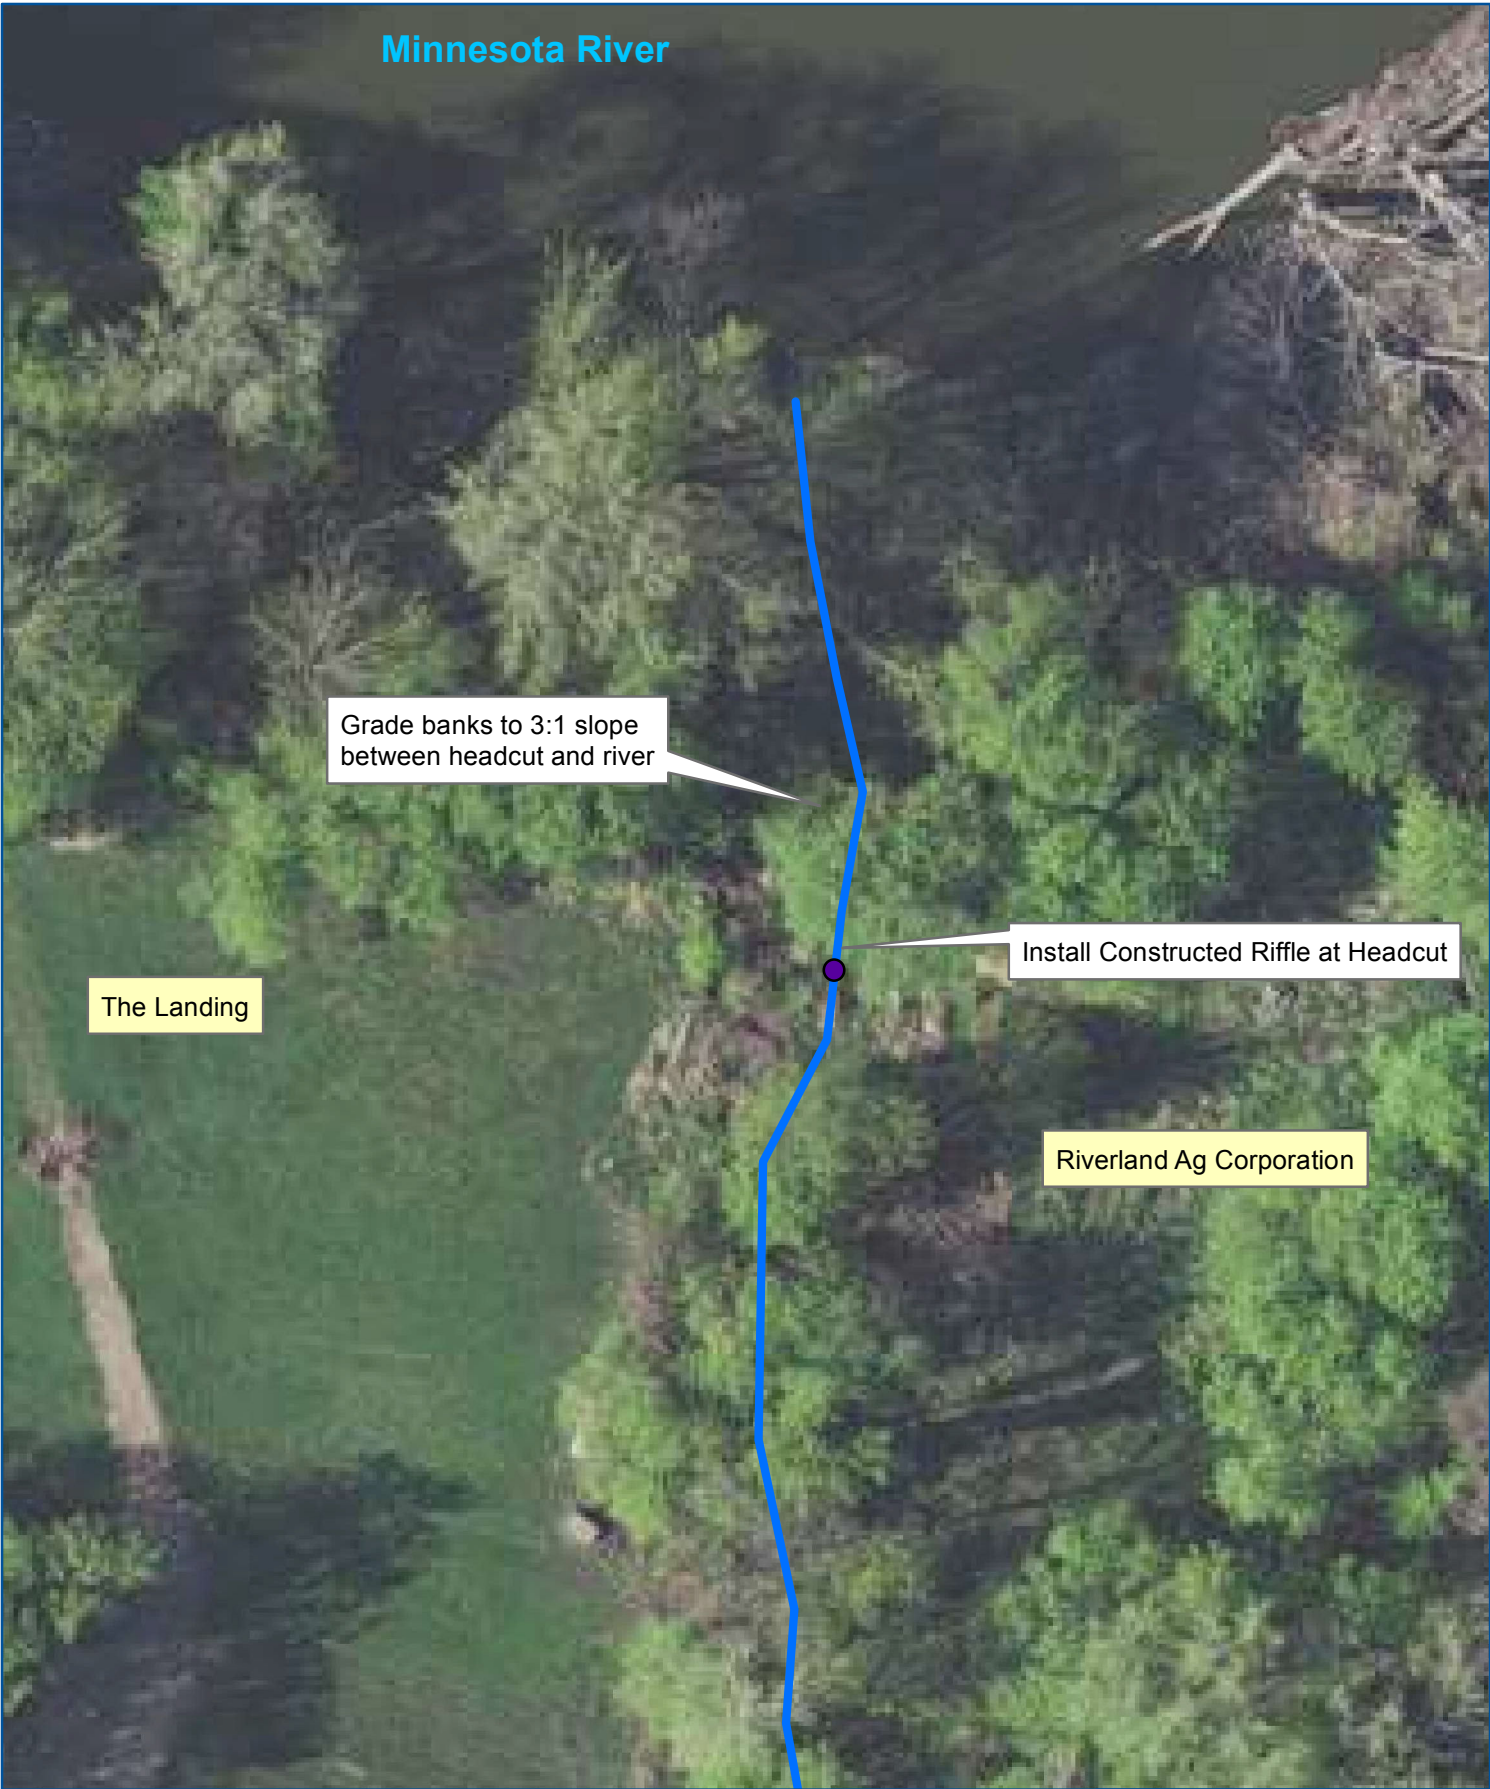
FIGURE 2

Grade banks to 3:1 slope between headcut and river

We recommend stabilizing the existing erosion area to prevent erosion from migrating upstream. We recommend using a constructed riffle to stabilize the head cut itself. The banks between the headcut and the river should be graded to a 2:1 slope and revegetated.

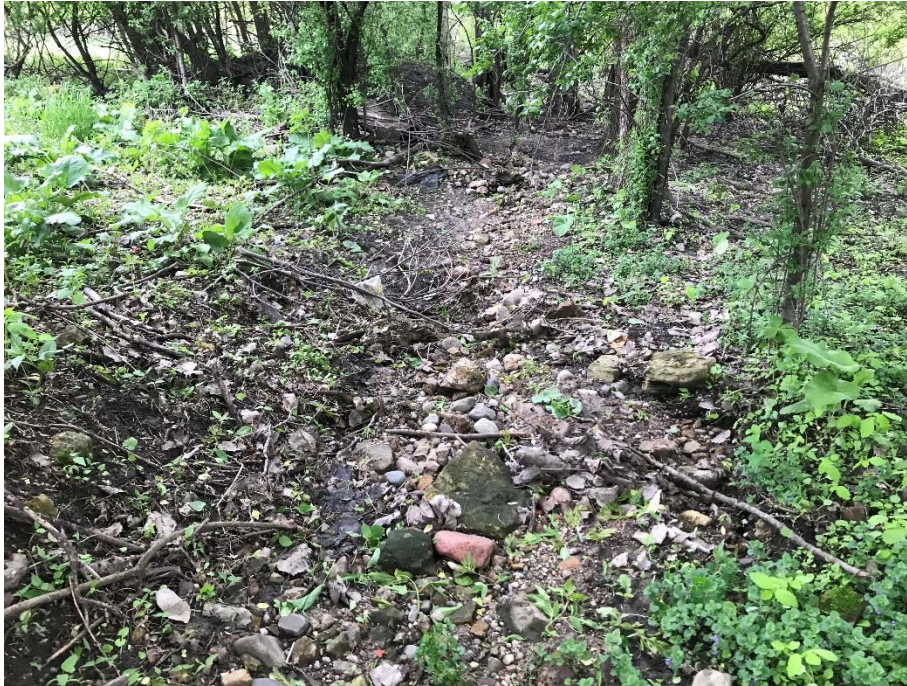
Towards the bottom half of the ravine, the gradient appears to change and become less steep. The channel become wider and shows evidence of braiding. The vegetation also changed and buckthorn was no longer the dominant species on the banks.

Photo 1. Looking downstream in the lower half of the ravine

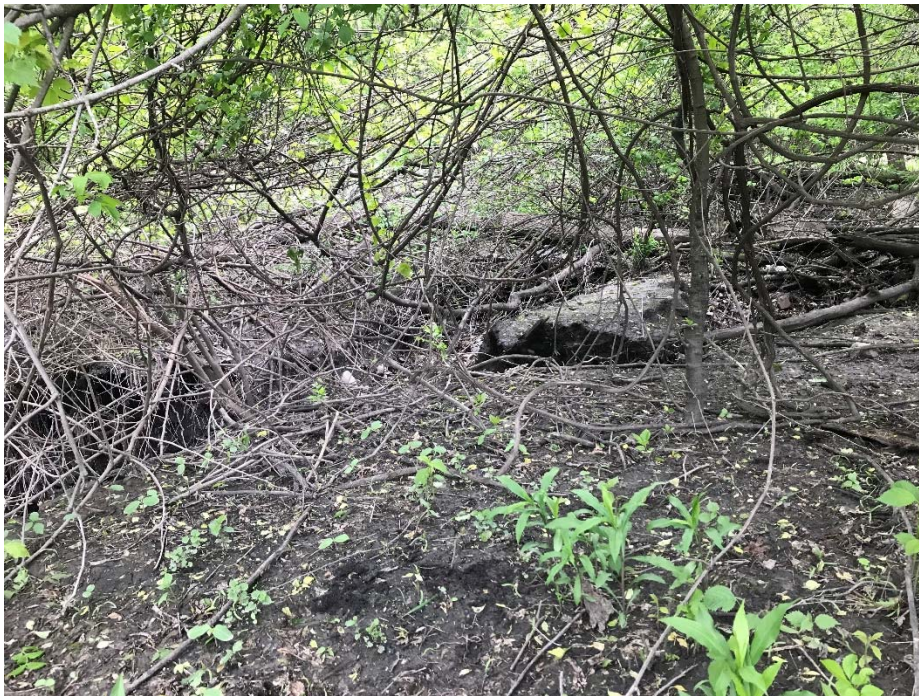
A headcut and spring were observed approximately 100 feet upstream of the banks of the Minnesota River. At the time of the site visit, the Minnesota River was at flood stage, and the edge of the river was approximately 30 feet away from the headcut. A spring was observed bubbling out of the ravine bed at the location of the headcut. The ravine bed dropped approximately three to four feet at the headcut and spring, and the banks downstream of this location were near vertical. The flow rates was not estimated, but it was a relatively small trickle of flow from the spring. The water downstream of the spring was approximately three to four inches wide and approximately one inch deep.

The only notable erosion within the ravine was observed at the headcut and spring. The erosion present was likely caused by a combination of the spring and intermittent flows within the ravine. Springs naturally saturate the ground immediately around them and the saturated soil is easily mobilized by flowing water. Springs often naturally create a channel away from the spring, so some of the erosion that has occurred between the spring and the main channel of the river is likely caused by natural processes.

The creation of the spring's channel to the river also creates a headcut in the ravine. A headcut is a feature in a channel that indicates that the channel bed is dropping in elevation. Downstream of headcuts, the channel becomes deeper and contains more flow, which also contains erosive pressures within the channel. Erosion at the headcut causes the headcut to migrate upstream.

Photo 2. Headcut area

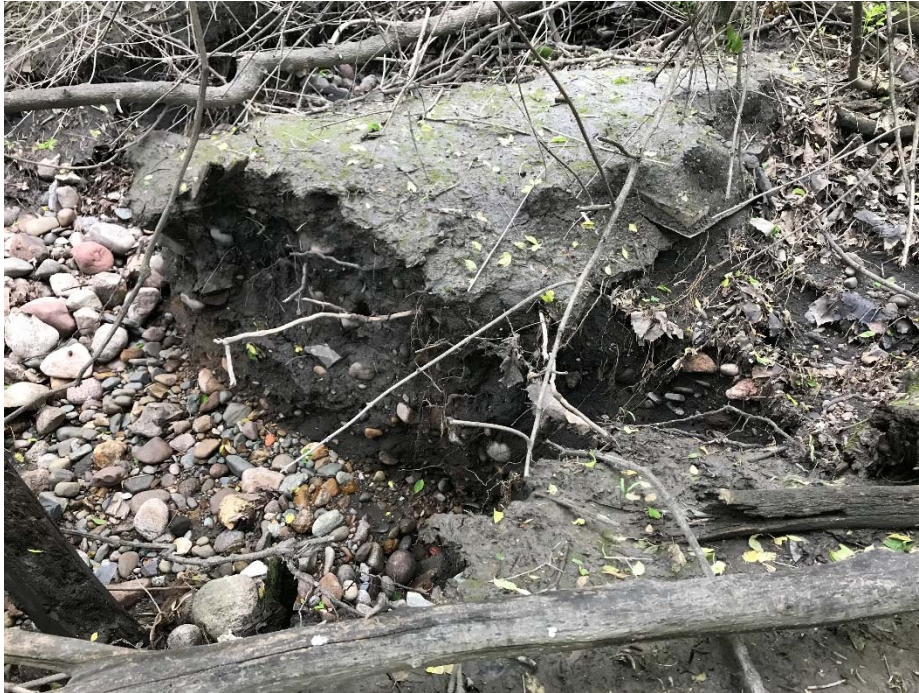
Since this spring is located within a drainageway, the intermittent flows in the ravine have likely helped the headcut migrate upstream; however since ongoing monitoring of this ravine has not been completed, it is not possible to accurately determine how much the headcut has migrated in recent years.

Photo 3. Zoom in of headcut. Headcut has migrated upstream of the spring; however brush was too thick for a clear picture of the spring.

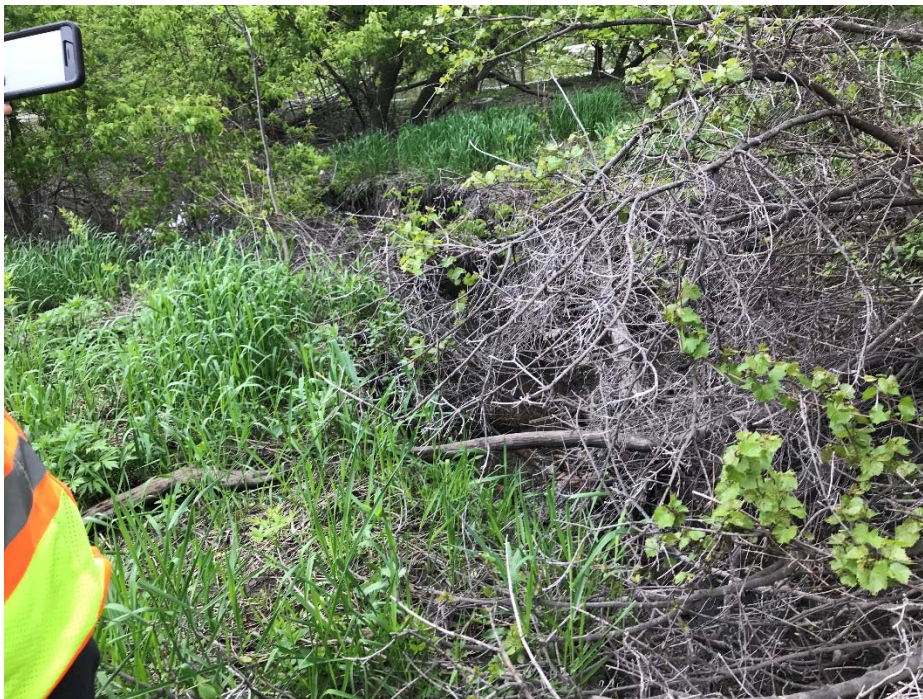
Photo 4. Eroding banks downstream of the spring
