Trout Stream Geomorphology Assessment

In the Lower Minnesota River Watershed District

Prepared for
Young Environmental Consulting Group

October 2019

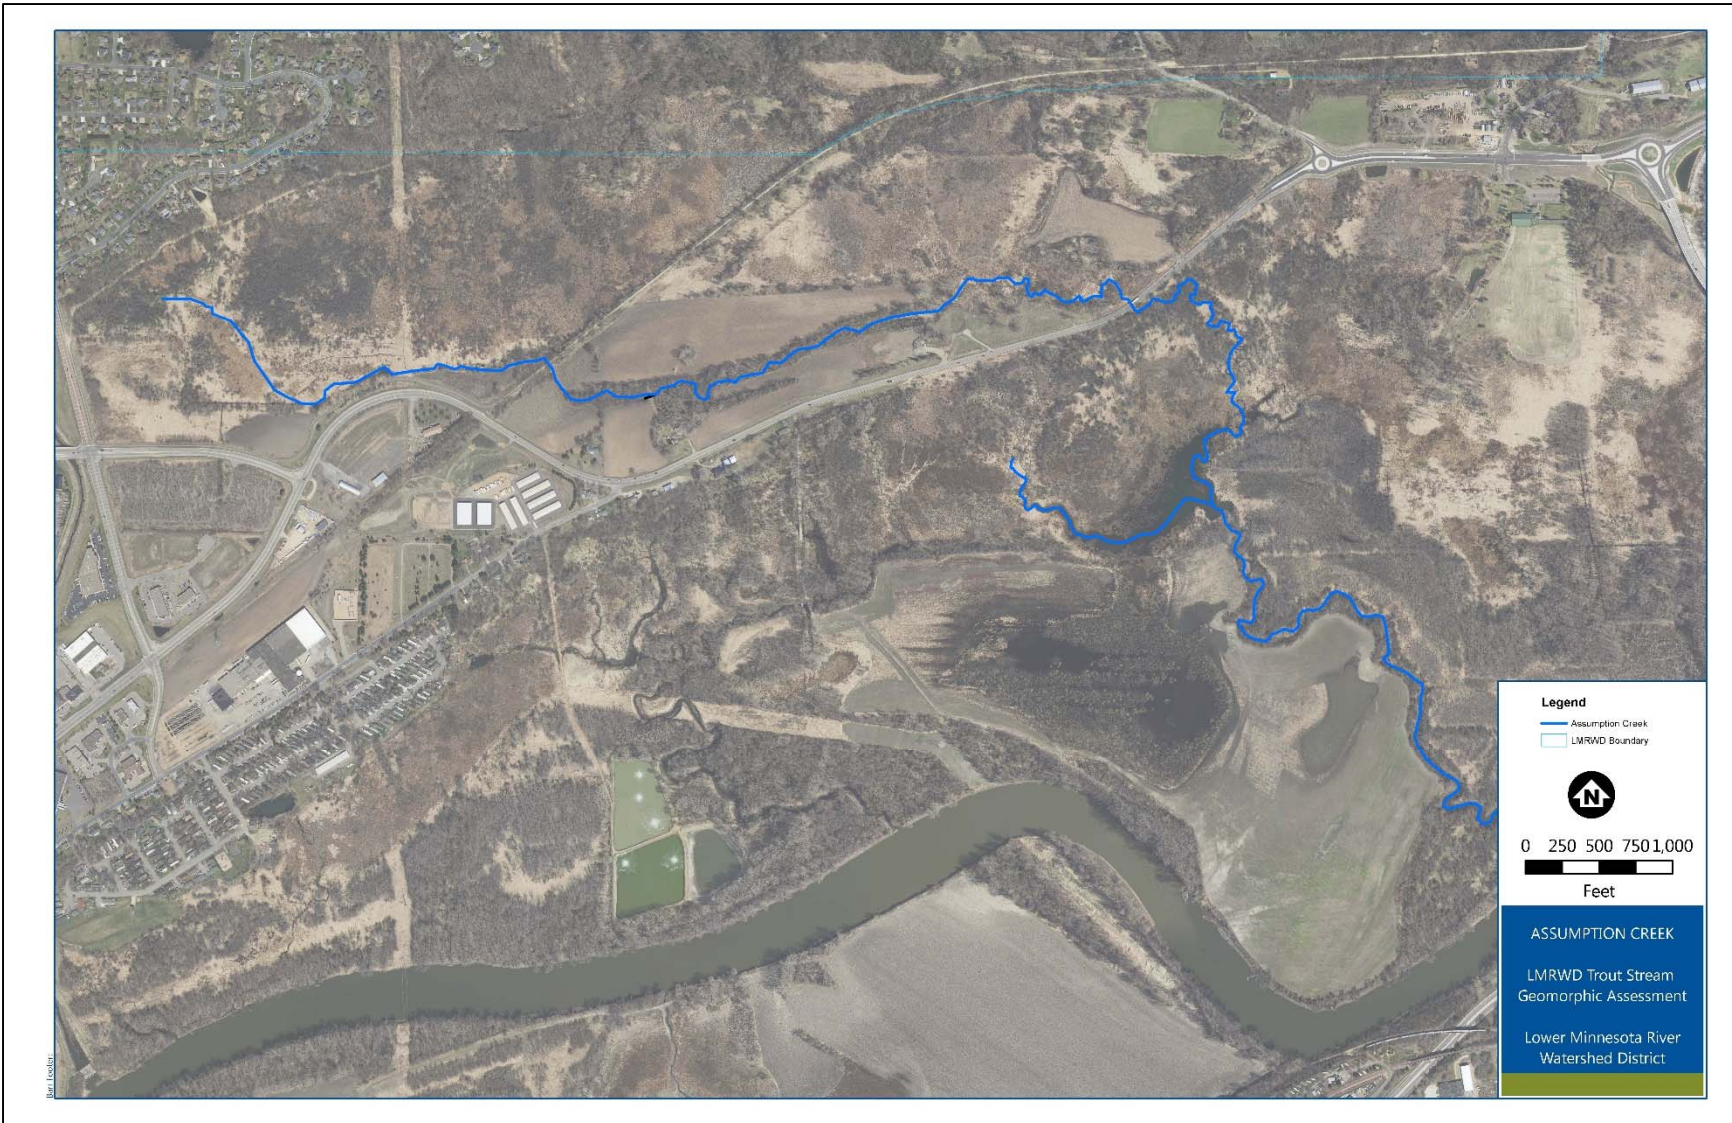
Figure 4-1 Assumption Creek

Assumption Creek (Figure 4-1) has one main branch, and one small tributary between Flying Cloud Drive and the Minnesota River. The creek was divided into a west reach and east reach upstream of Flying Cloud Drive. It was not possible to assess the creek downstream of Flying Cloud Drive due to high water.

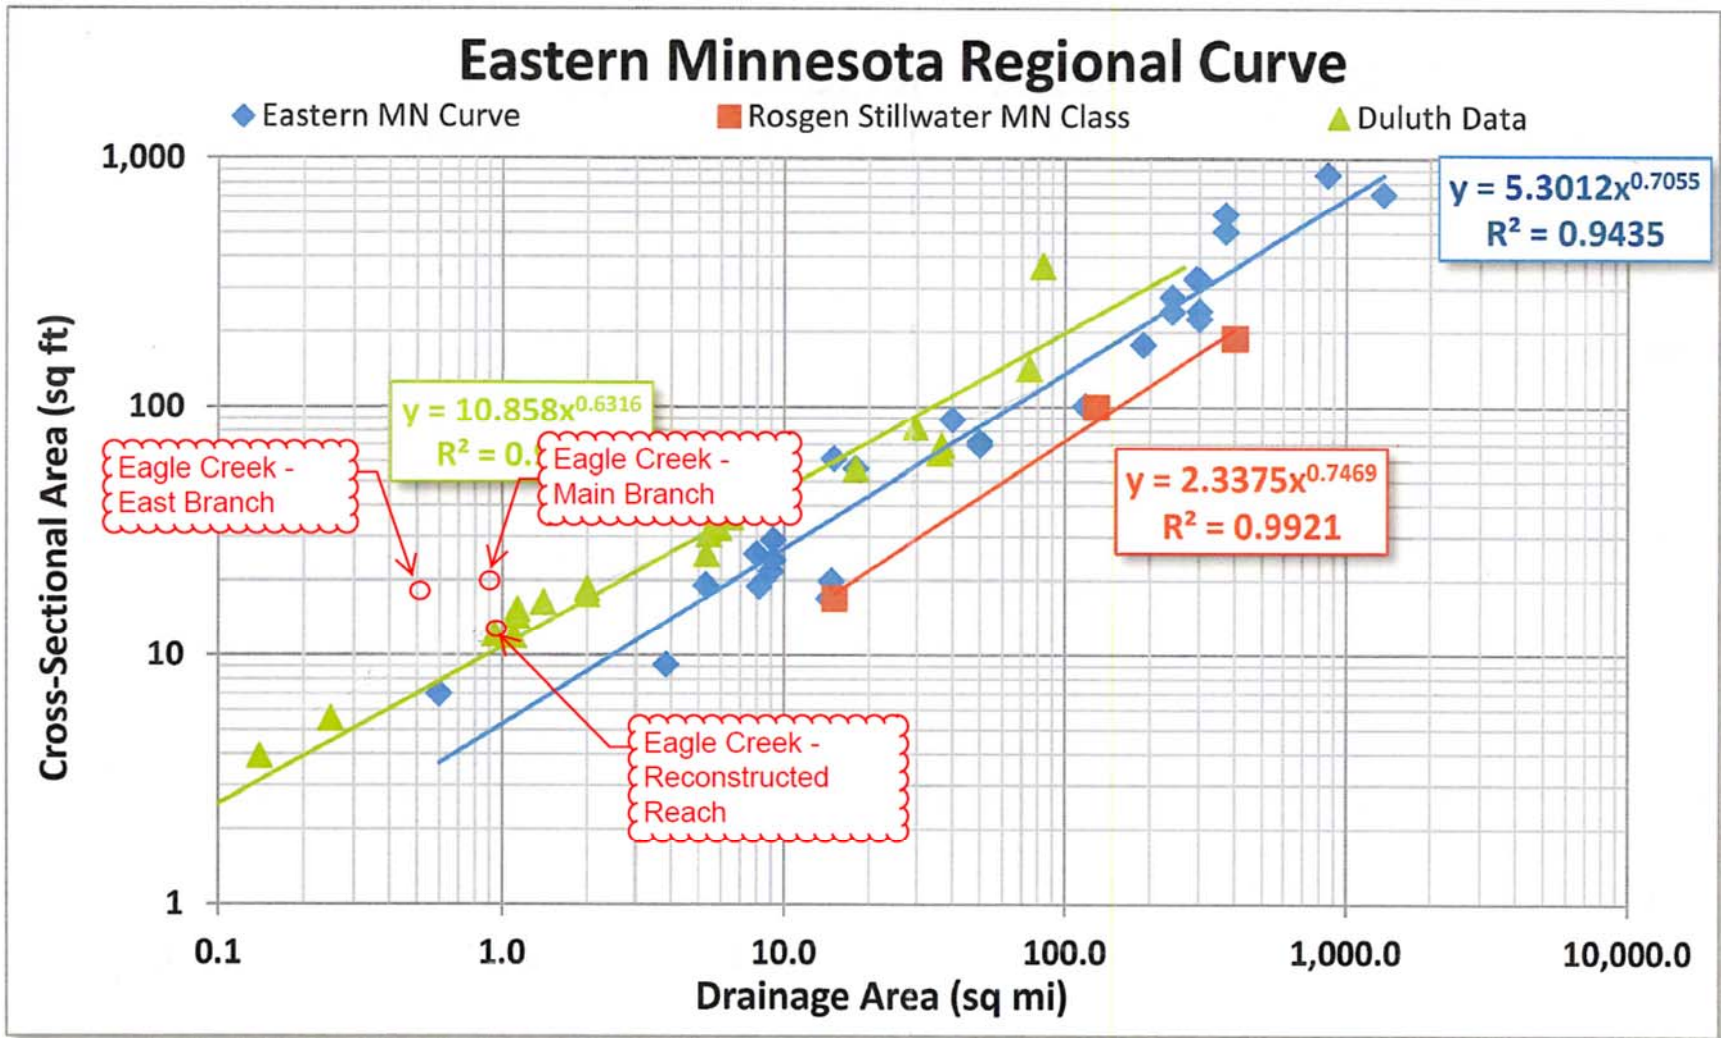
Figure 5-2 Eagle Creek dimensions plotted on MN DNR regional curve

The reconstructed reach on the main stem of Eagle Creek was completed in 2013, and the smaller cross sectional area for that reach compared to the others is very notable. The design was completed with the Minnesota Department of Natural Resources (DNR) to improve trout habitat. The cross section area was sized carefully account for current hydrology. Using Figure 5-2, it appears that the cross section area for the reconstructed reach is similar to other values on the regression lines; however, the cross sectional areas for the other two reaches are larger than would be expected. If the channel is too large, it may lack necessary sediment carrying capacity, which can contribute to the other items identified in the Interns' Report, notably mid-channel bars and wide, shallow cross sections. It can also contribute to the creation of braided, Type D streams, identified in one cross sections.

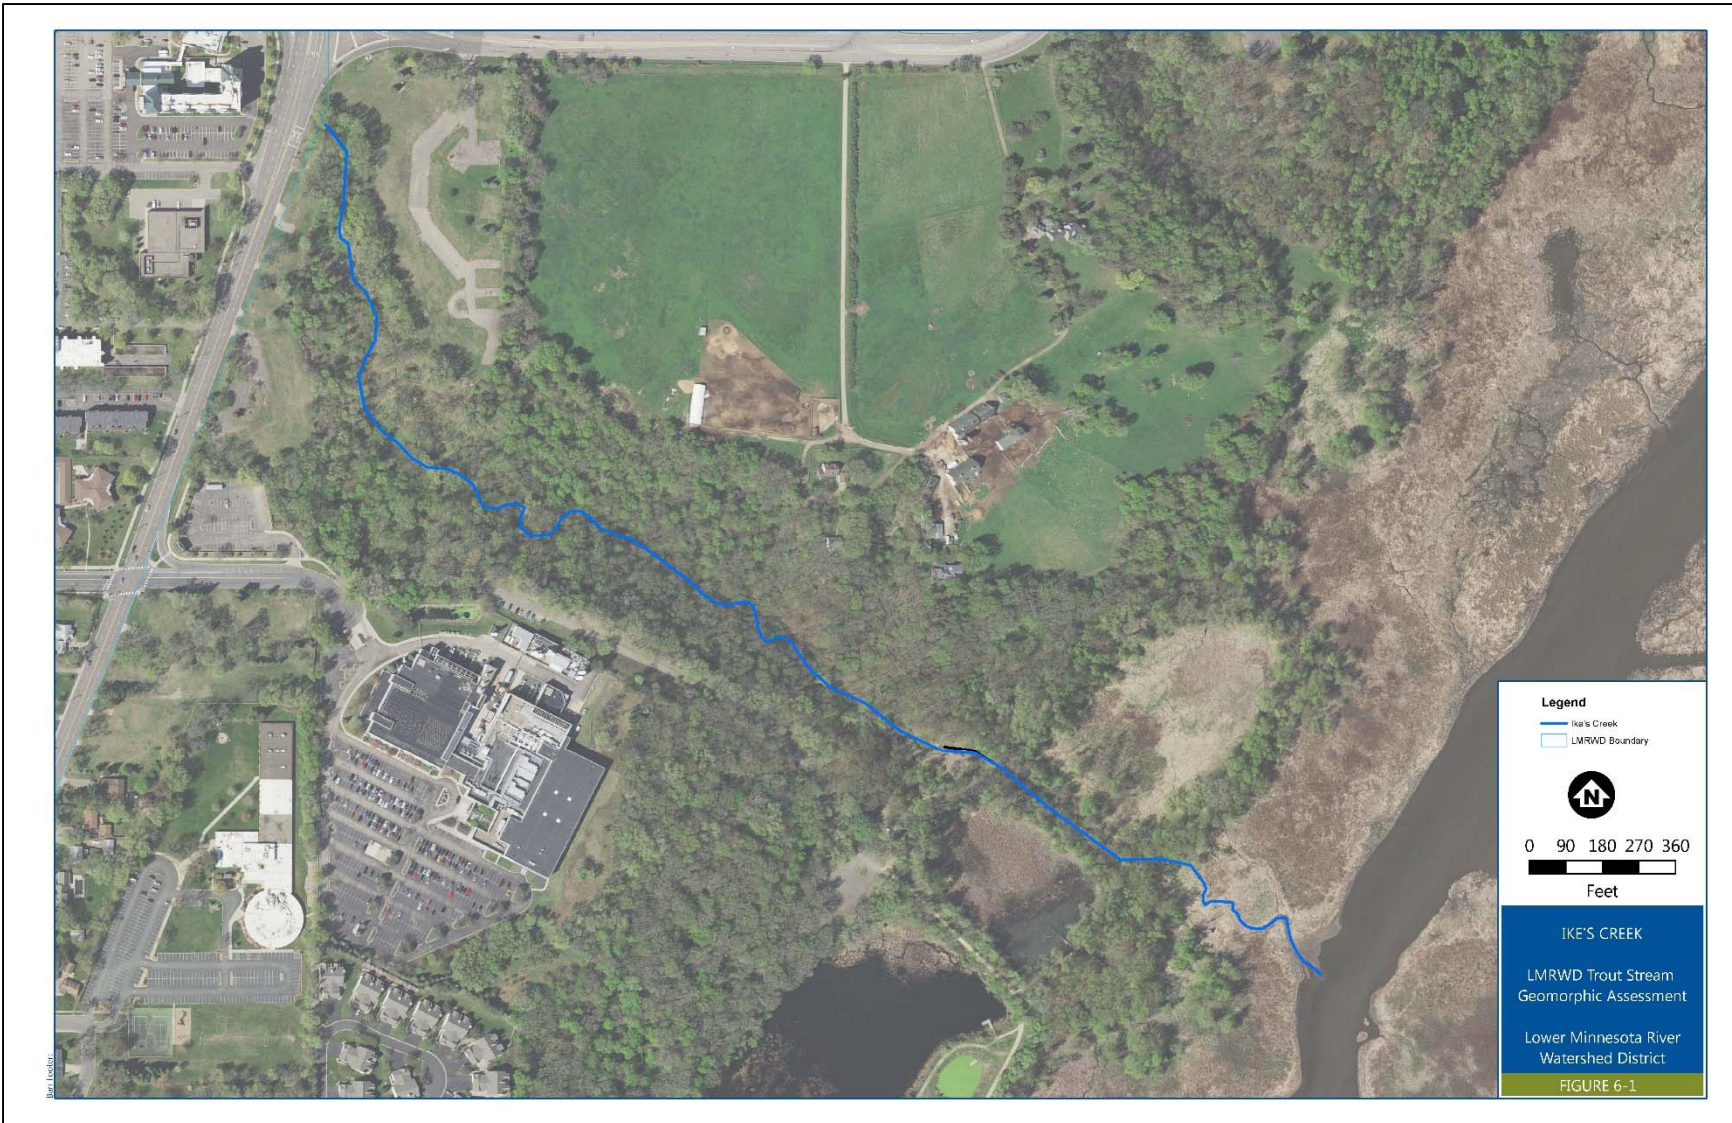
Figure 6-1 Ike's Creek

Ike's Creek (Figure 6-1) has one main branch. Other potential tributaries have been identified by others; however, the field reconnaissance for this study did not find any tributaries.
