LOWER MINNESOTA RIVER WATERSHED DISTRICT

Lower Minnesota River Watershed District Board of Managers Meeting
Wednesday, May 20, 2020

Re: Area 3 Site Visit Meeting Summary

Re: Eden Prairie Area 3 and the Minnesota River—Meeting summary and recommendations

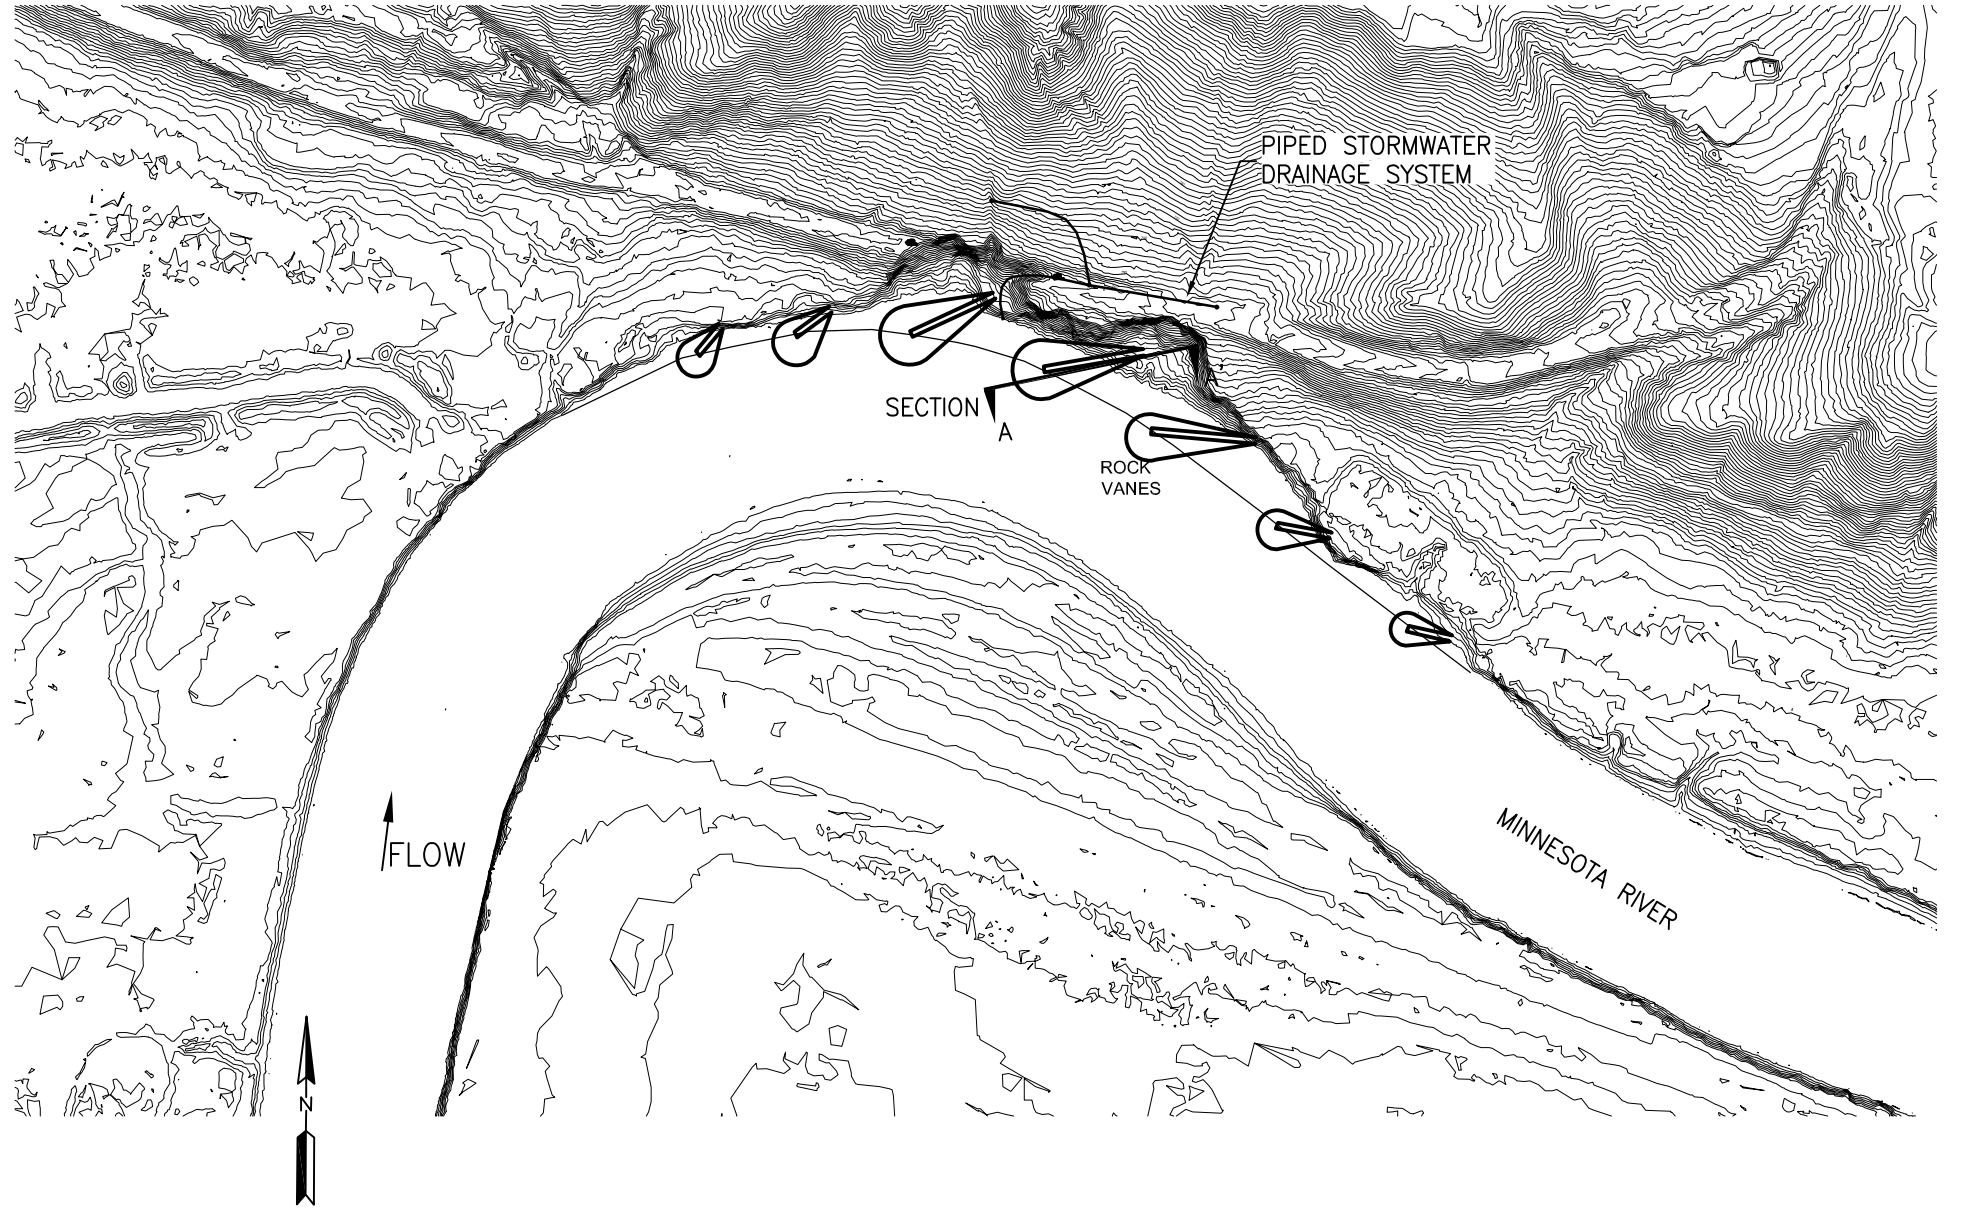
FIGURE 15

Rock Vane Plan

5. Design and construct the Minnesota River rock vane bank stabilization alternative recommended in 2010 by the Wenck team (See enclosed Rock Vane Plan and Section). As presented, the alternative had a PCE of \$1.1 million. To convert this estimate to 2020 dollars, we applied the Engineering News-Record cost index for Minneapolis, which advances the PCE to \$1.4 million³. Engineering design and regulatory costs were not included in the Wenck team's PCE. However, those costs are estimated to be 10–15 percent of the PCE. This project represents a potential partnership with the City, area legislators, the US Army Corps of Engineers, and the river transport-based industry concerned with navigability of the Minnesota River. (Note: The LMRWD has no property or infrastructure in the project area.)

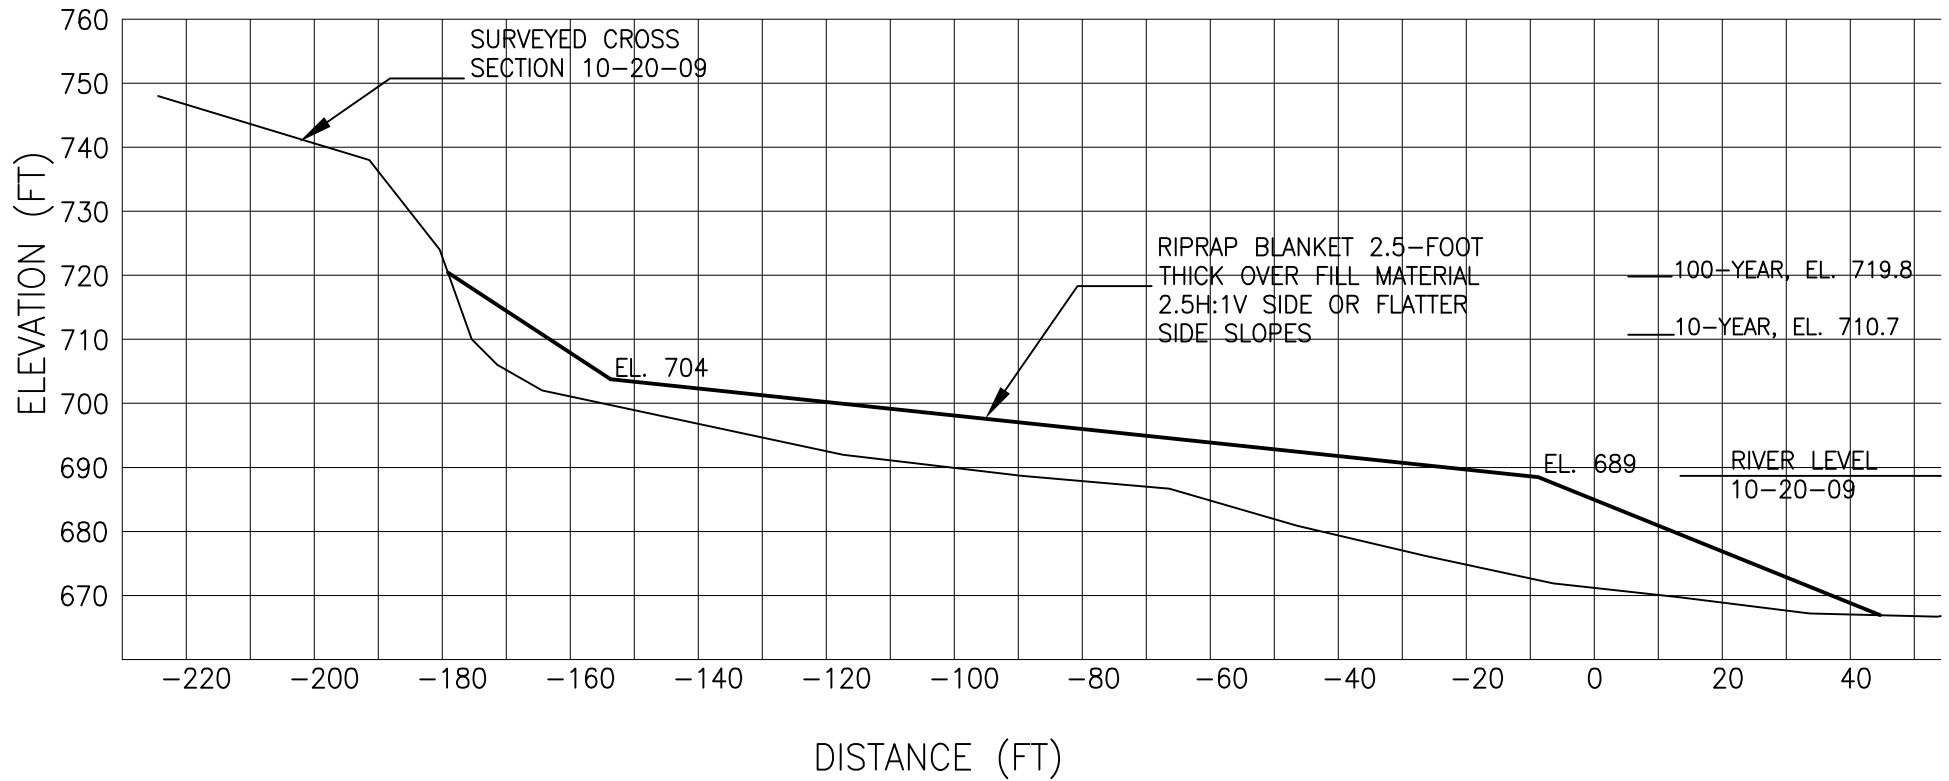
FIGURE 16

Rock Vane Section A-A'

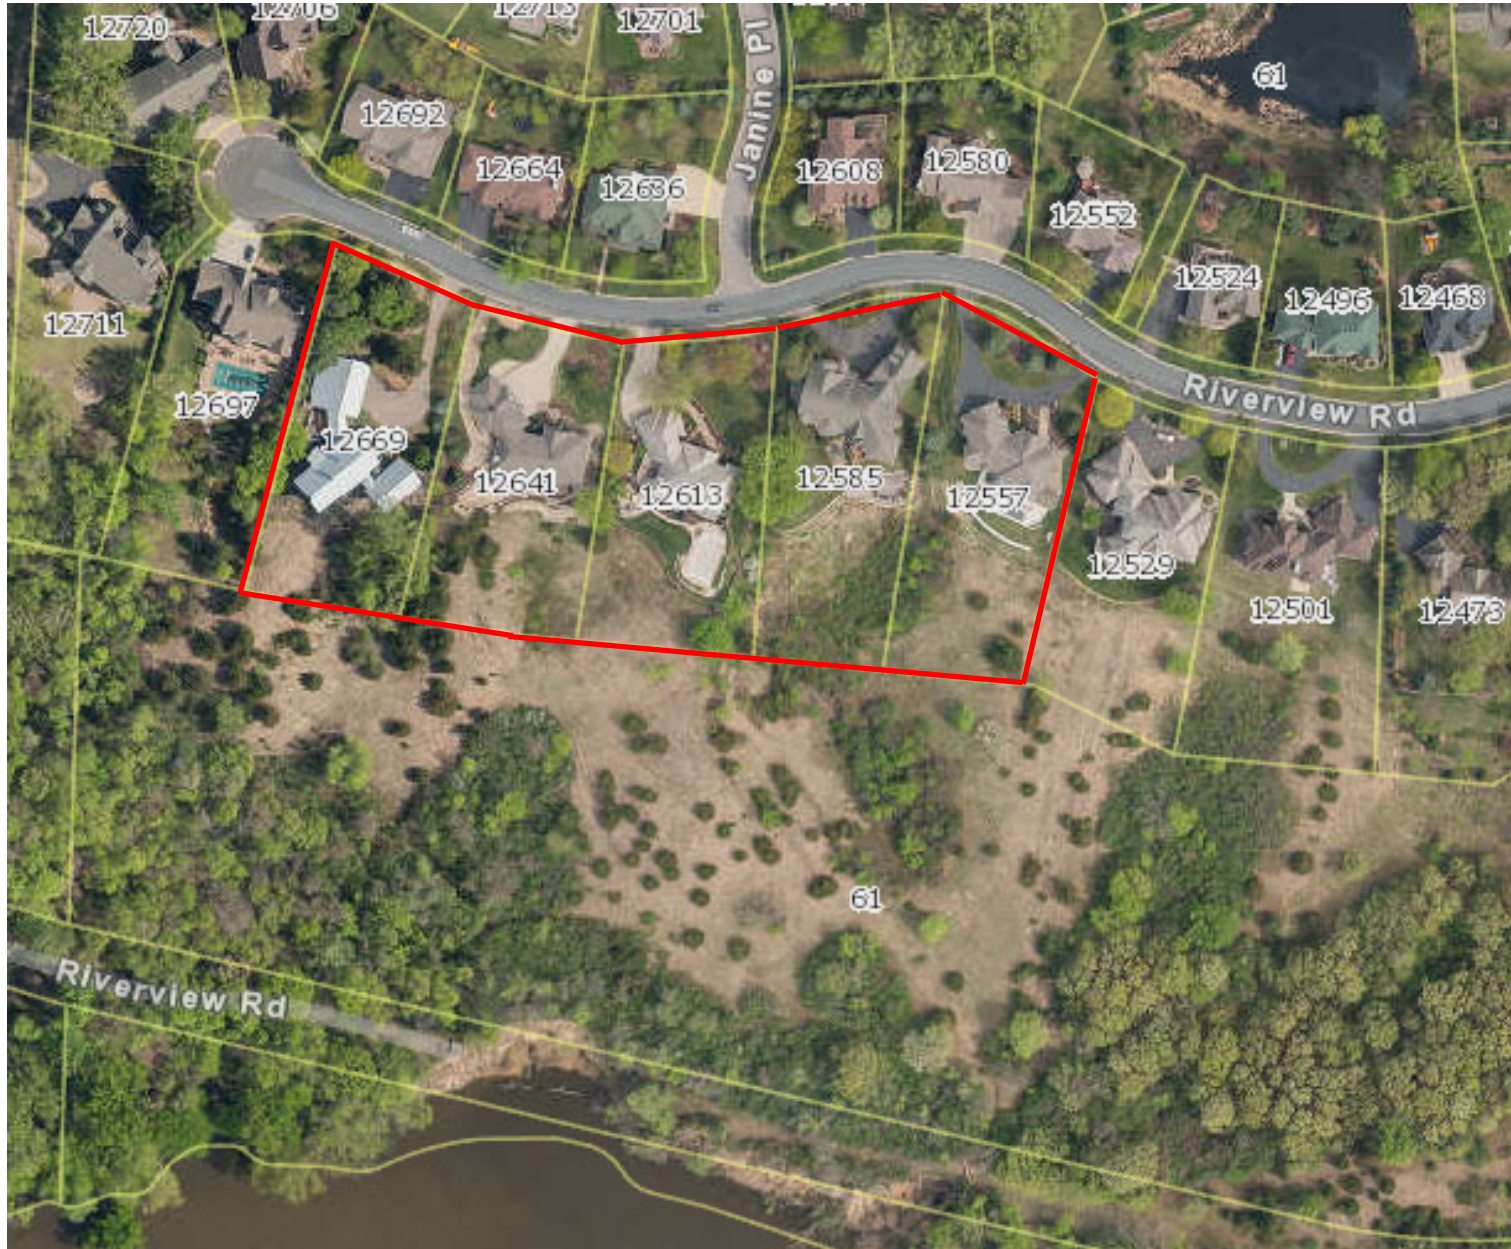
MAY 7, 2020 SITE VISIT

The owner of 12613 Riverview Road was outside and allowed access to the bluff on her property. She has lived there since 2003 and said that the rate of erosion on the bluff near the property has accelerated in recent years. She said that she reached out to LMRWD, the City, and the US Army Corps of Engineers (USACE) several times to discuss the neighborhood concerns, especially the need to install retaining walls to protect their residences. The backyards of 12557, 12585, 12613, 12641, and 12669 Riverview Road all were observed to have relatively new retaining walls located near the residences (see attached landowners map and photos).

The inclinometers could not be found during the visit, but no signs of active landslides or mass wasting processes were observed in the field. The active erosion seemed to be contained to the existing gullies and runoff from private property.

12585 Riverview Rd

12557 Riverview Rd

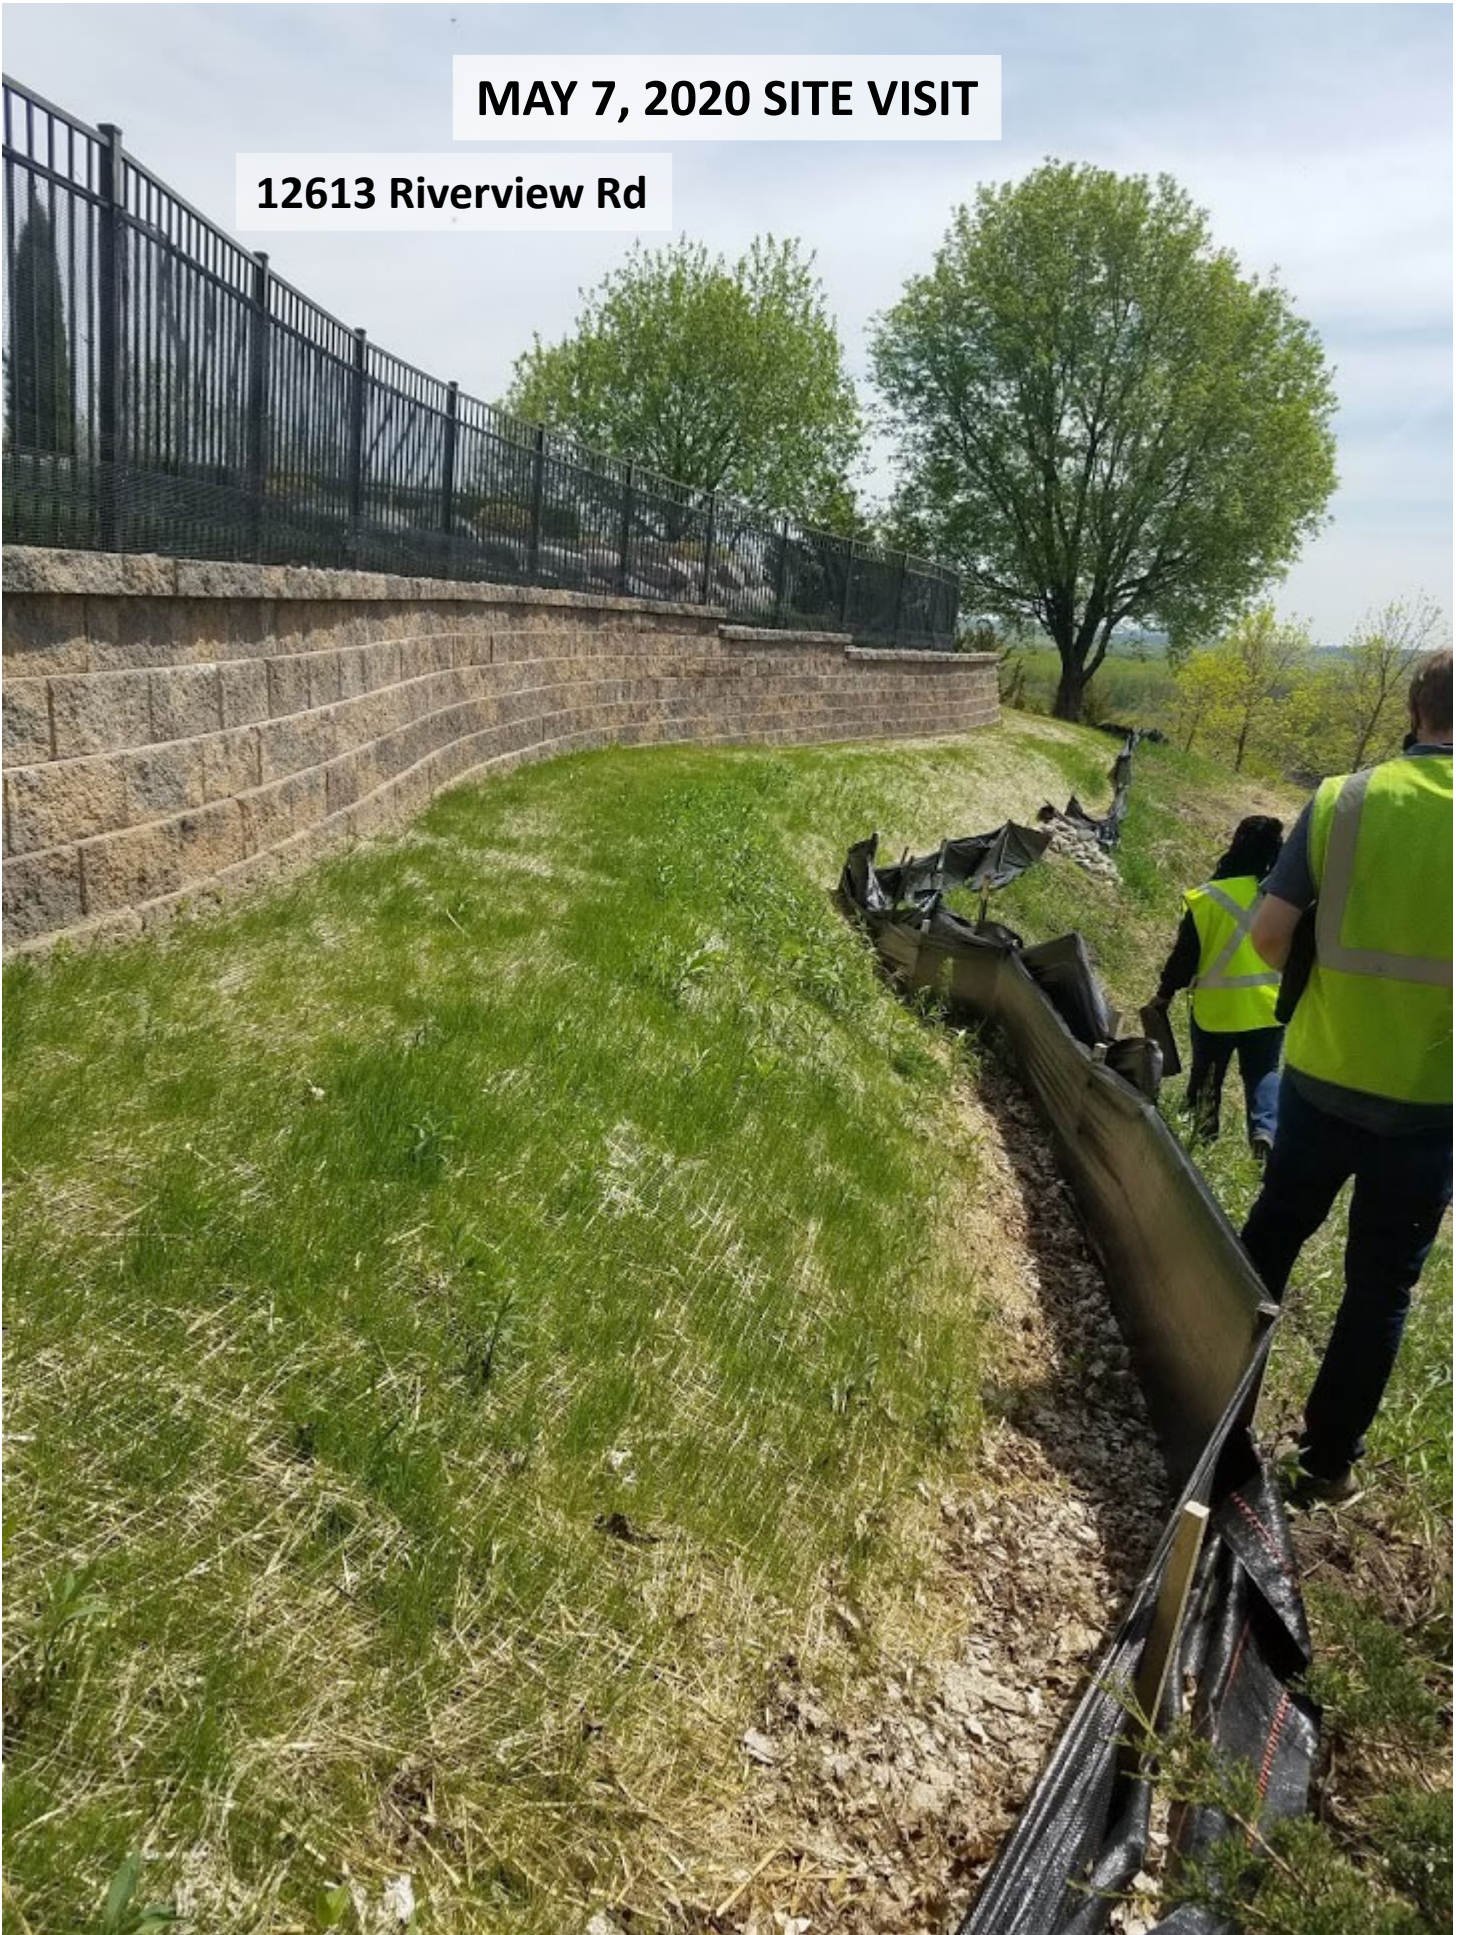
The homeowner confirmed that the soils around her property were extremely sandy, as evidenced by active bank erosion in nearby gullies. The gullies contained numerous

brush clippings and vegetation, placed in the gully at the advice of USACE staff several years ago.

A photograph showing a gully with a tree and a river in the background. The gully is filled with dry, tangled brush and some green grass. A tree with yellow-green leaves stands in the middle ground. In the background, a river flows through a lush green landscape under a clear sky.

**Active gully erosion
at 12613 Riverview
Rd and homeowner
preventative
measures**

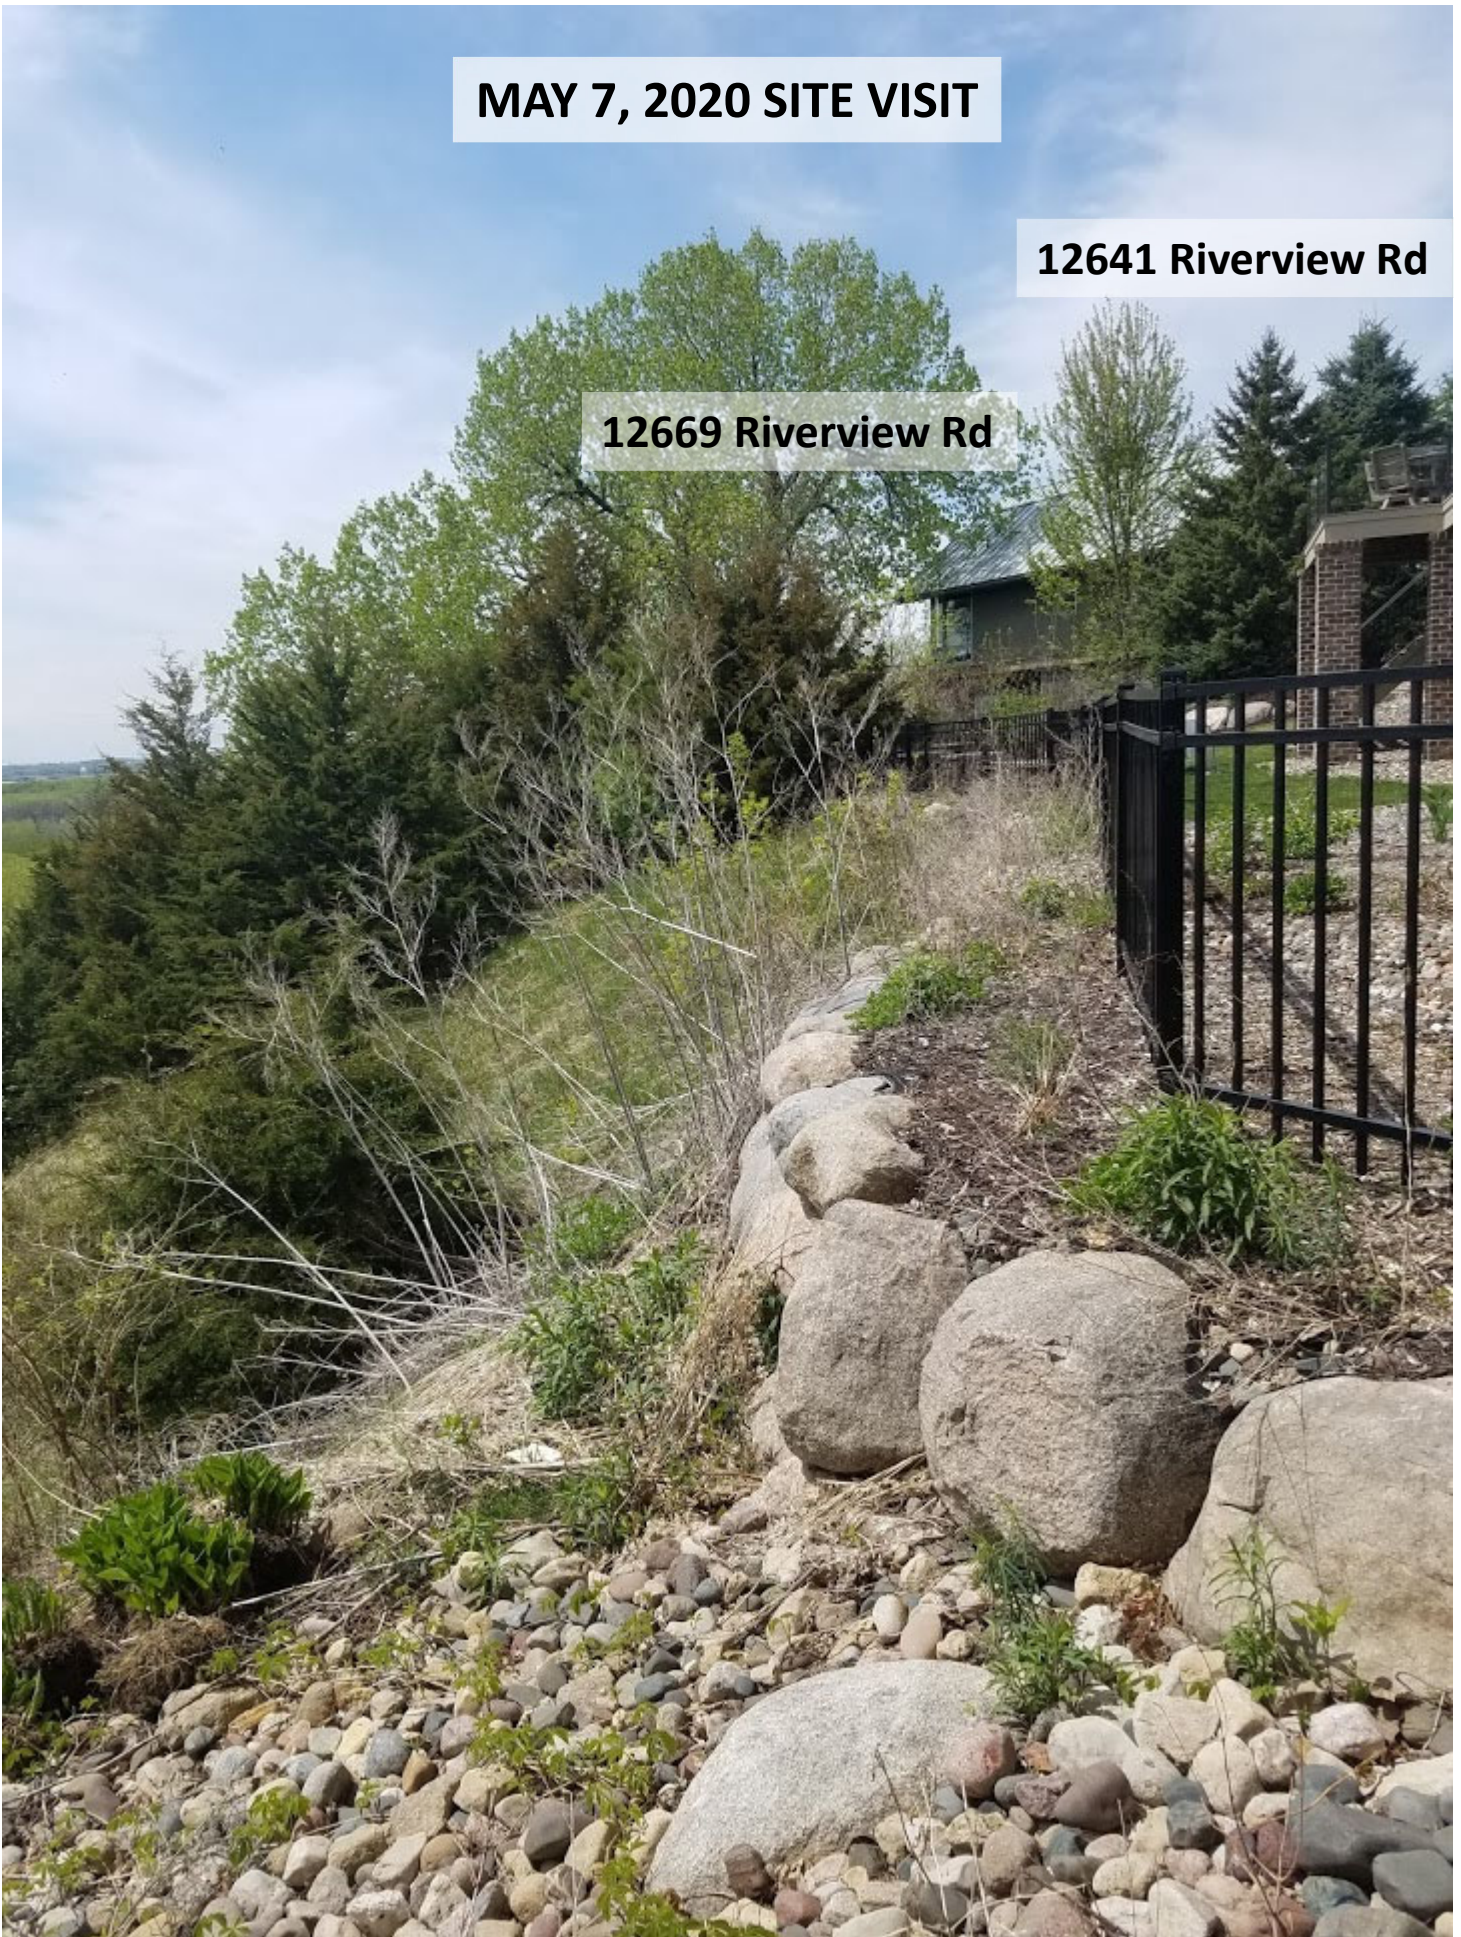
12641 Riverview Rd

12669 Riverview Rd
