# Fens Sustainability Gaps Analysis for Carver, Dakota, and Scott Counties, Minnesota

LOWER MINNESOTA RIVER  
WATERSHED DISTRICT

FINAL REPORT  
May 3, 2020

Young Environmental Consulting Group, LLC

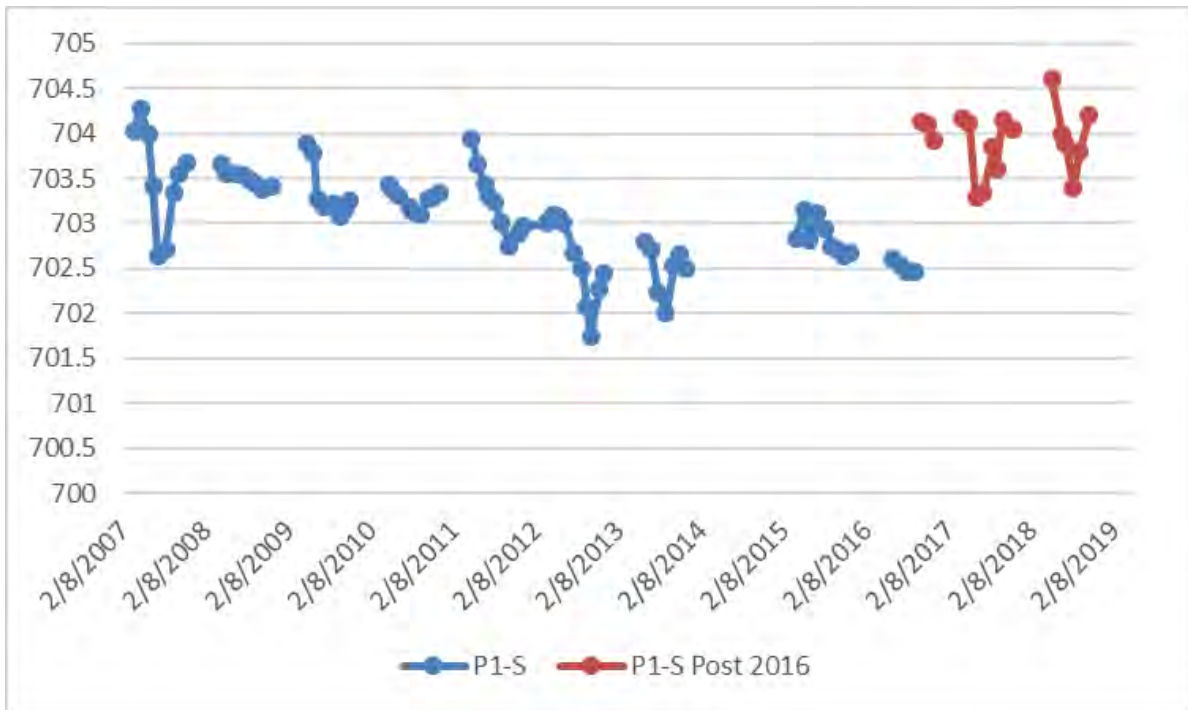
**Graph 4-1. Gun Club Lake North Fen Well P1-S (277776) Groundwater Levels**

Note that the apparent downward trend in **Graphs 4-1** and **4-2**, may actually be the wells sinking over time. The water levels recover when the elevations are resurveyed in 2016.

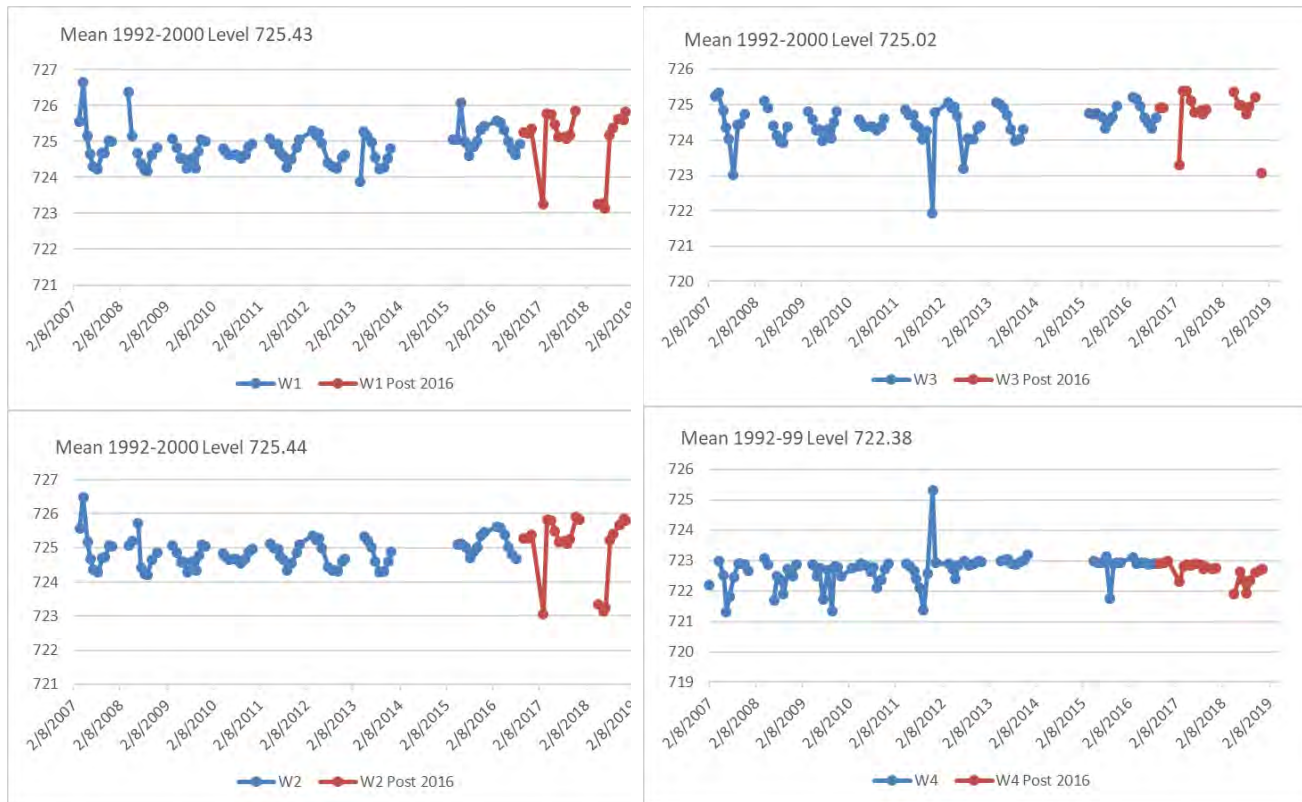
**Graph 4-5. Groundwater Levels in Gun Club Lake South Wells Designated “W” (From left to right, top to bottom: 482157, 482154, 591979, 591980)**

Note that the wells were resurveyed in 2016, which is shown in red.

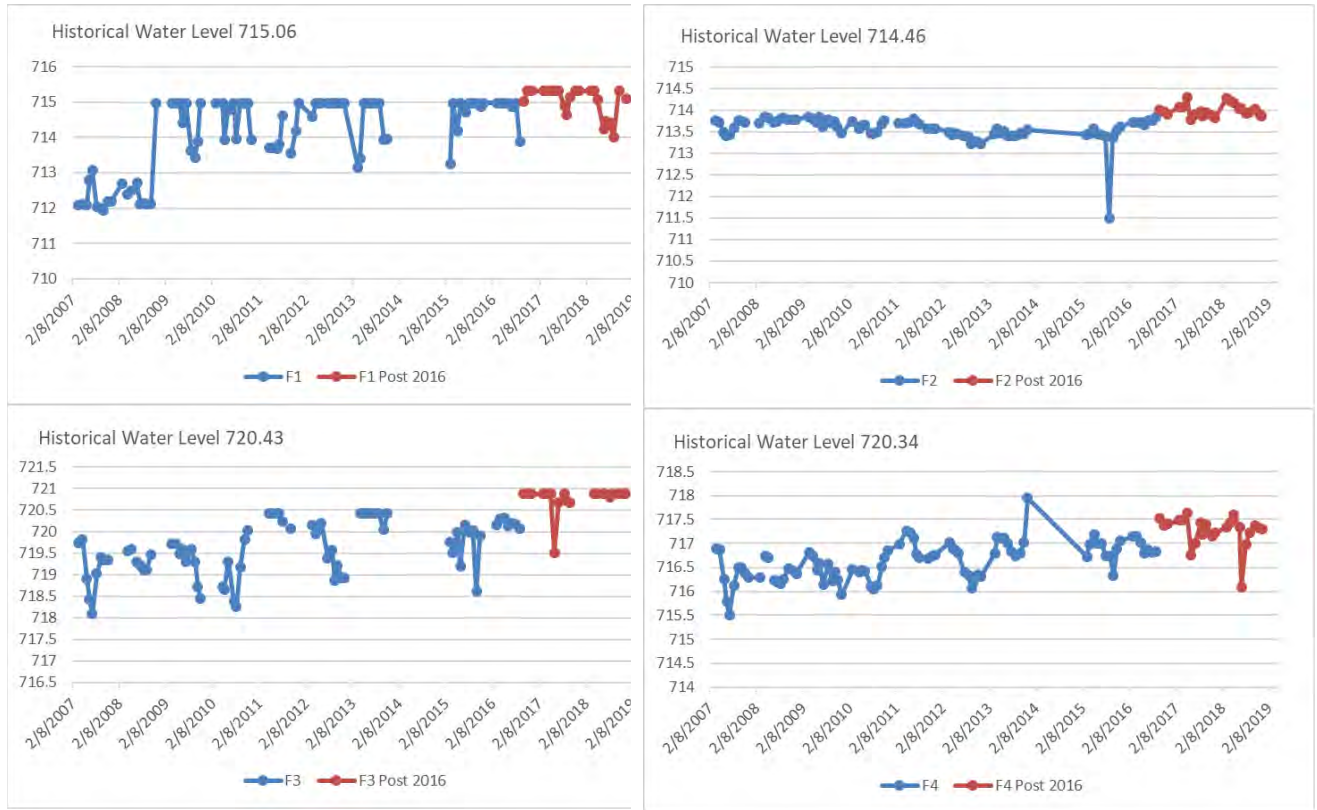
**Graph 4-6. Groundwater Levels in Nicols Meadow Fen Wells F1–F4 (Left to right, top to bottom: 452922, 452924, 452923, and 452925)**

Note that the wells were resurveyed in 2016, which is shown in red.

Nicols Meadow Fen groundwater hydrology was examined again in 2014 as part of an effort to understand the effects of installation and operation of a new lift station for the Seneca wastewater treatment plant operated by the Metropolitan Waste Control Commission. Dewatering for the construction was permitted starting December 3, 2015, and ending on or before April 1, 2016. This period was chosen to ensure that the peat was protected from desiccation and degradation during dewatering by keeping it frozen during the winter months. The hydrographs shown in **Graph 4-6** did not show effects from that drawdown.

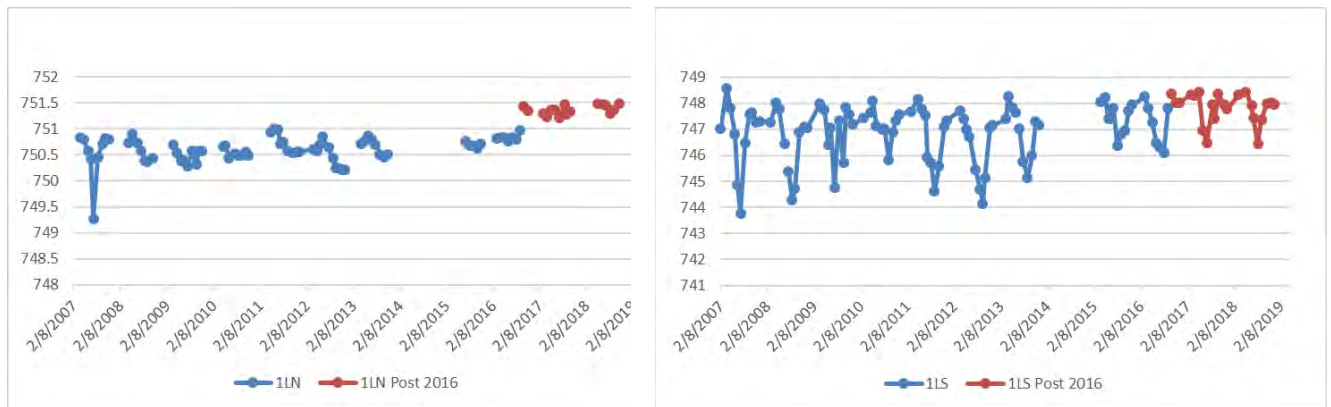
**Graph 4-7. Groundwater Levels in Nicols Meadow Fen Wells 1LN and 1LS (526701 and 522299)**

Note that the wells were resurveyed in 2016, which is shown in red.

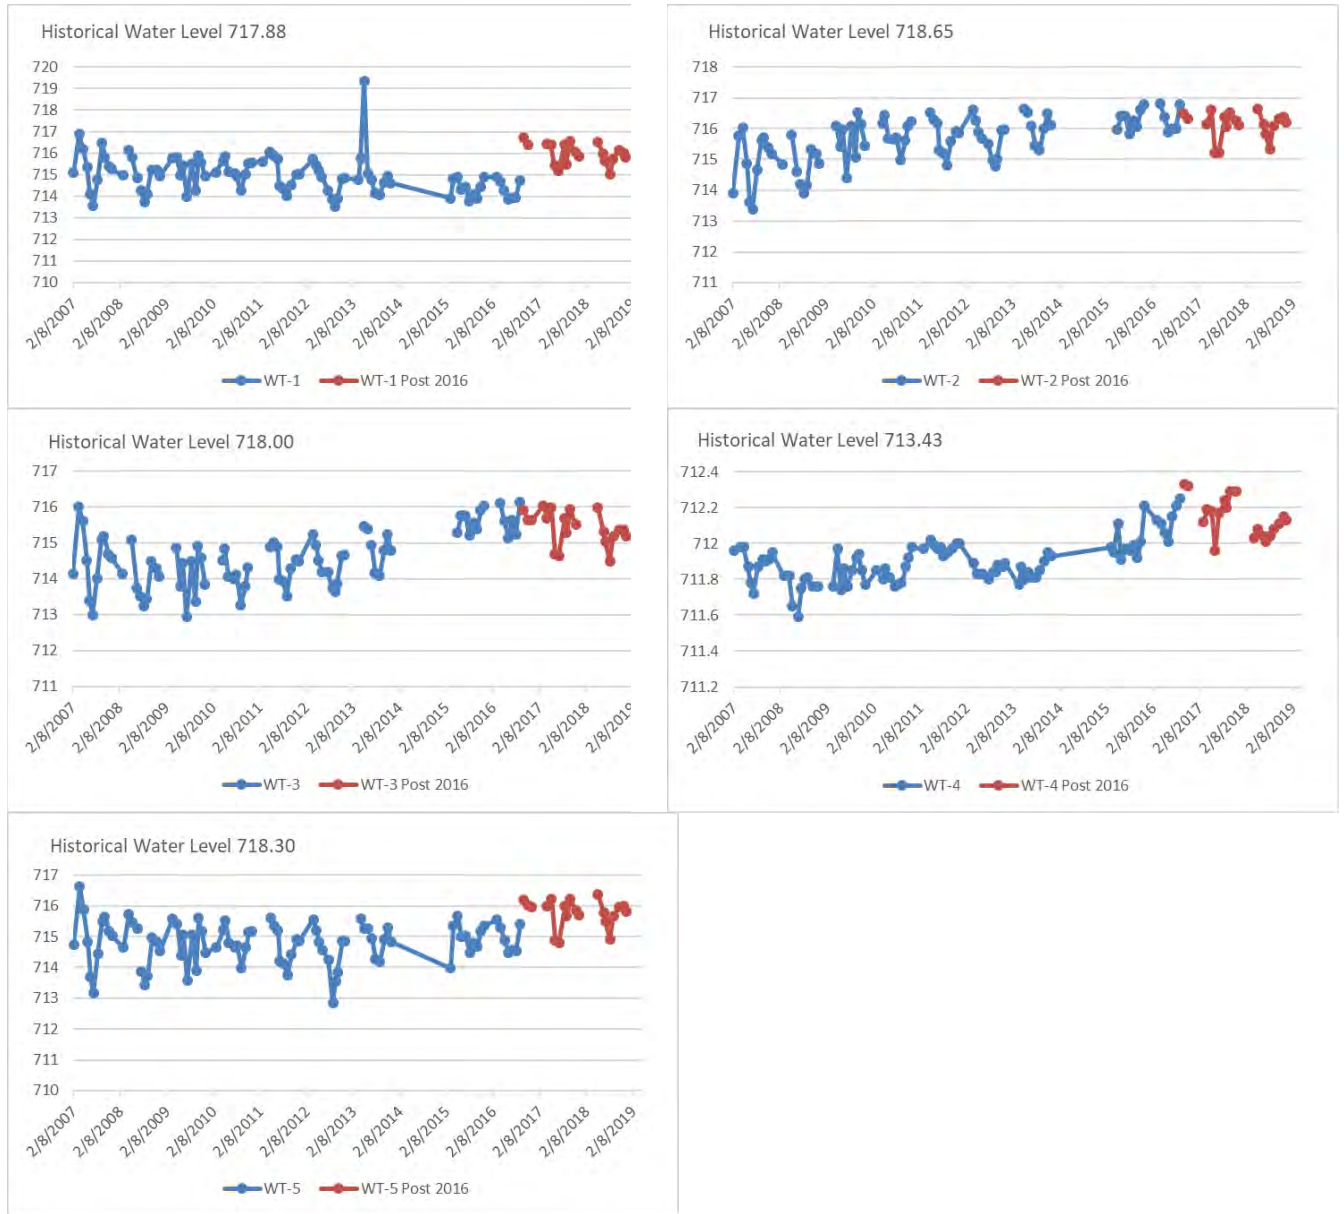
**Graph 4-8. Groundwater Levels in Nicols Meadow Fen Wells WT1–WT4 (Left to right, top to bottom: 540952, 277773, 277771, 277772, and 277770)**

Note that the wells were resurveyed in 2016, which is shown in red.

A series of wells were installed near the water table of Nicols Meadow Fen, named WT-1 through WT-5 (540952, 277773, 277771, 277772, and 277770), and have been monitored since 2008. Water level records from three of these wells show similar patterns of variability over time. Water levels in well WT-4 (277772) are lower and much less variable than the other wells, suggesting that they are influenced by different hydrologic conditions.
