East Chaska Stream Stabilization Project

LOWER MINNESOTA RIVER
WATERSHED DISTRICT

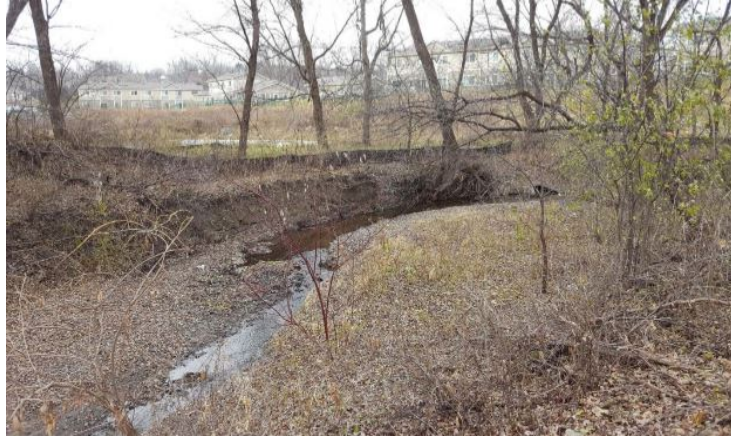
The above photo highlights some of the current bank erosion occurring in East Chaska Creek.

East Chaska Creek is a source of sediment entering the Minnesota River as a result of ongoing streambank erosion.

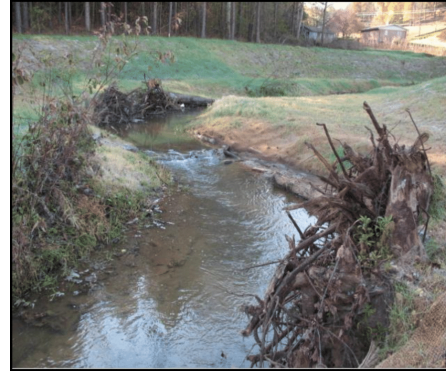
Root Wads

Provide toe support for bank revegetation, collect sediment and debris, enhance bank structure

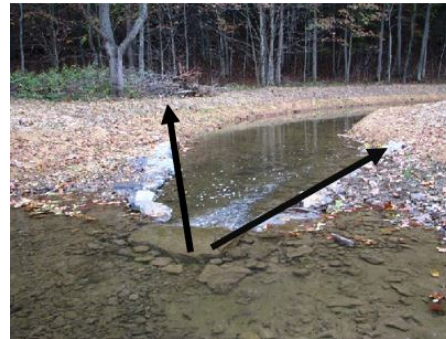
Rock Cross Vanes

Direct the stream's energy toward the center of the channel relieving pressure on the banks, establish grade control, reduce bank erosion,

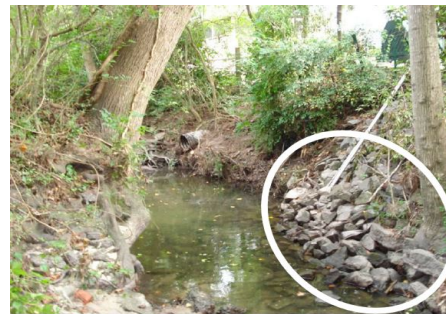
Riprap Toe Protection

Rock riprap placed along the streambank to dissipate energy, protecting the slopes from erosion
