Minnesota River Bank and Bluff Stabilization Eden Prairie, Minnesota

A Report Prepared for
The Lower Minnesota River Watershed District

Prepared by
Wenck Associates, Inc.

February 10, 2010

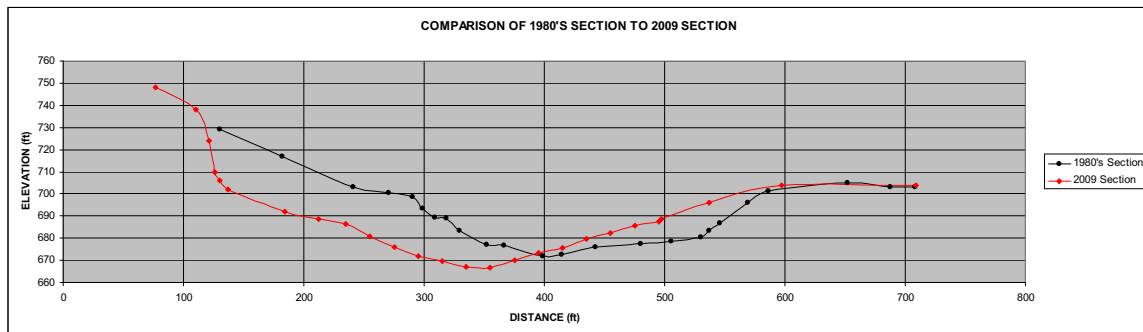
Figure 5. Comparison of Cross Section in 1980s and 2009.

Figure 5 below illustrates the change in the cross section at the site (Section 4) between the time the Flood Insurance Study (FIS) was completed in the 1980s until now. The river has clearly moved significantly to the left bank (north). Further evidence of the shift north and east is demonstrated by the historical aerial photograph review described below.

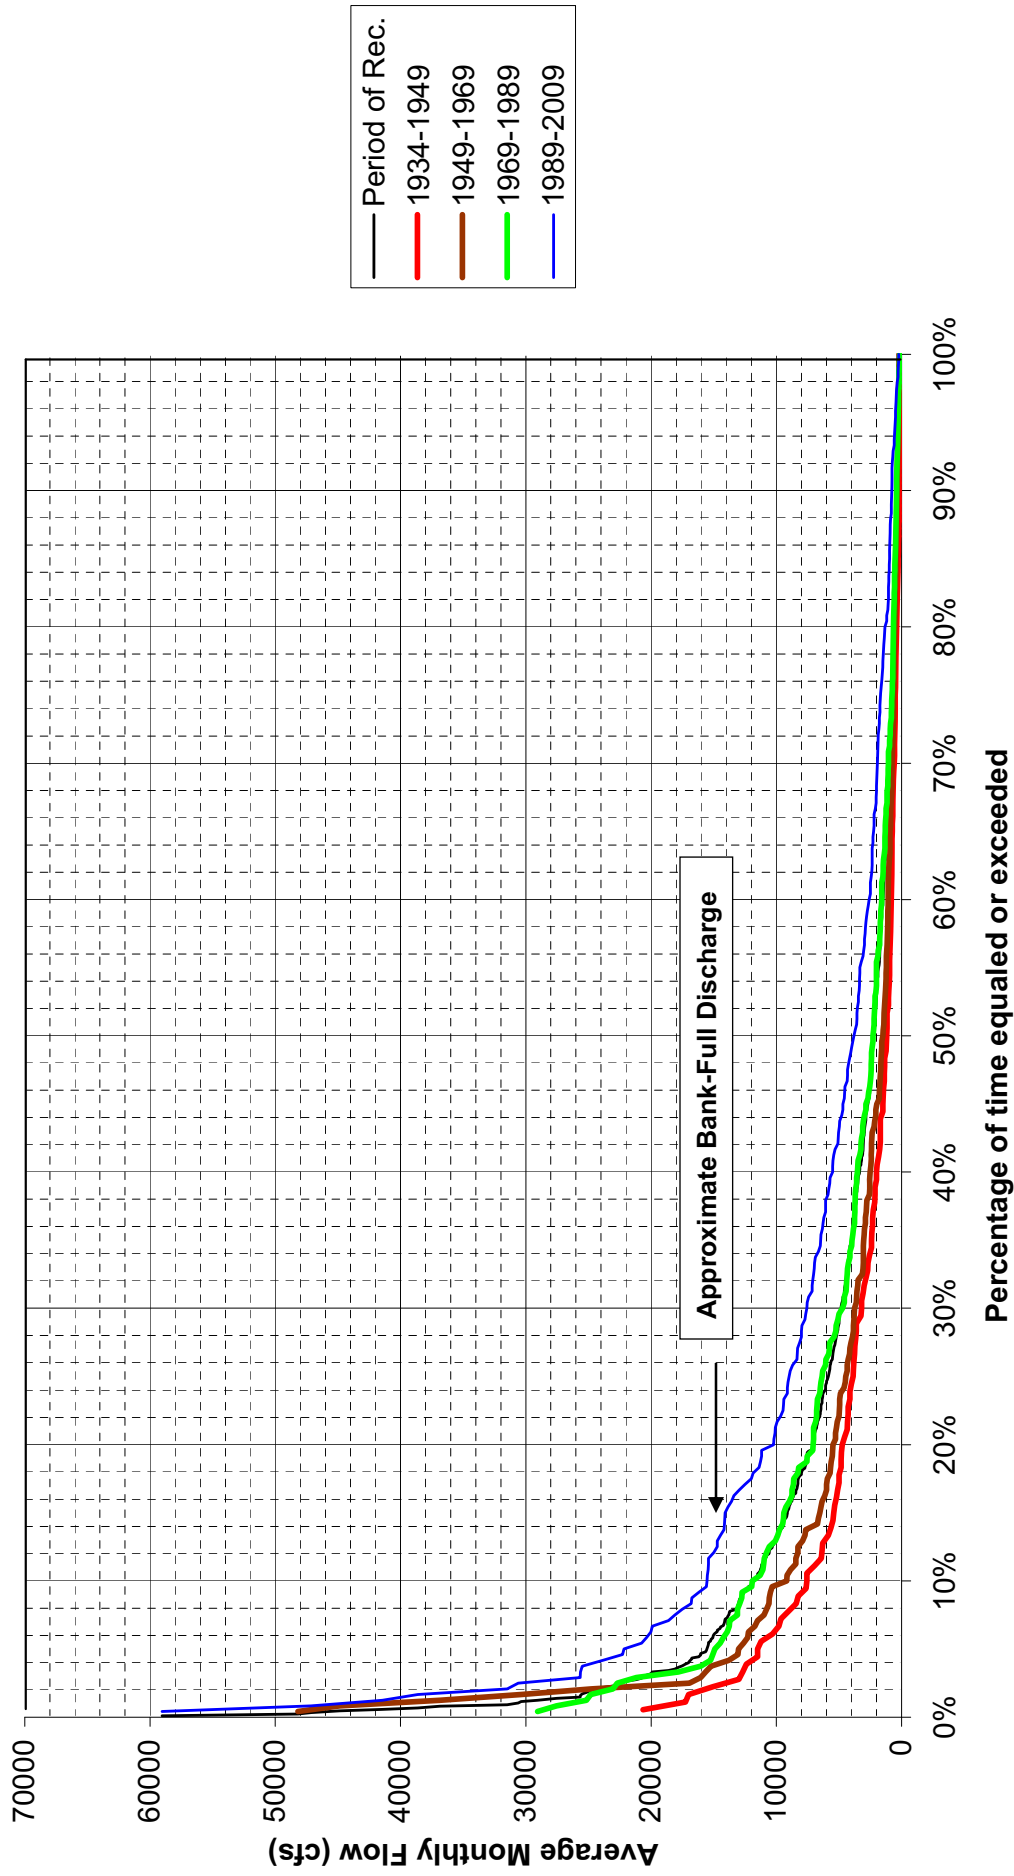
FLOW DURATION CURVES Minnesota River at Jordan

Figure 8 illustrates that the time the river remains at the bank-full discharge of approximately 17,000 cfs has significantly changed in the past 20 years. Presentations at the 2009 Annual Water Resources Conference in St. Paul support the change in river flow rates and attribute the deviation to climate change and drainage changes (added

drain tiles) in the watershed. Novotny and Stefan (2007) also provide research in concurrence with this premise.

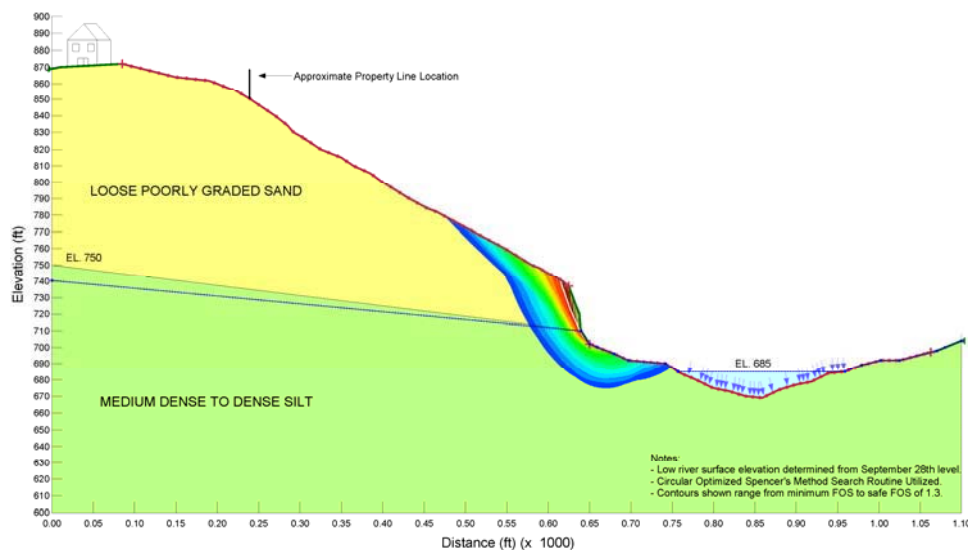
Figure 10. Site Stratigraphy and Stability

The subsurface profile developed for the stability analysis model of the bluff consists of very loose to loose poorly graded sand extending from the top of the slope down to elevation 730. The sand is underlain by medium dense to dense silt which extends to the limits of the borings. See Figure 10. The soil parameters utilized in the analysis were based upon general classifications determined from SPT blow counts. Refer to the slope stability plates in the appendix for soil parameters used.

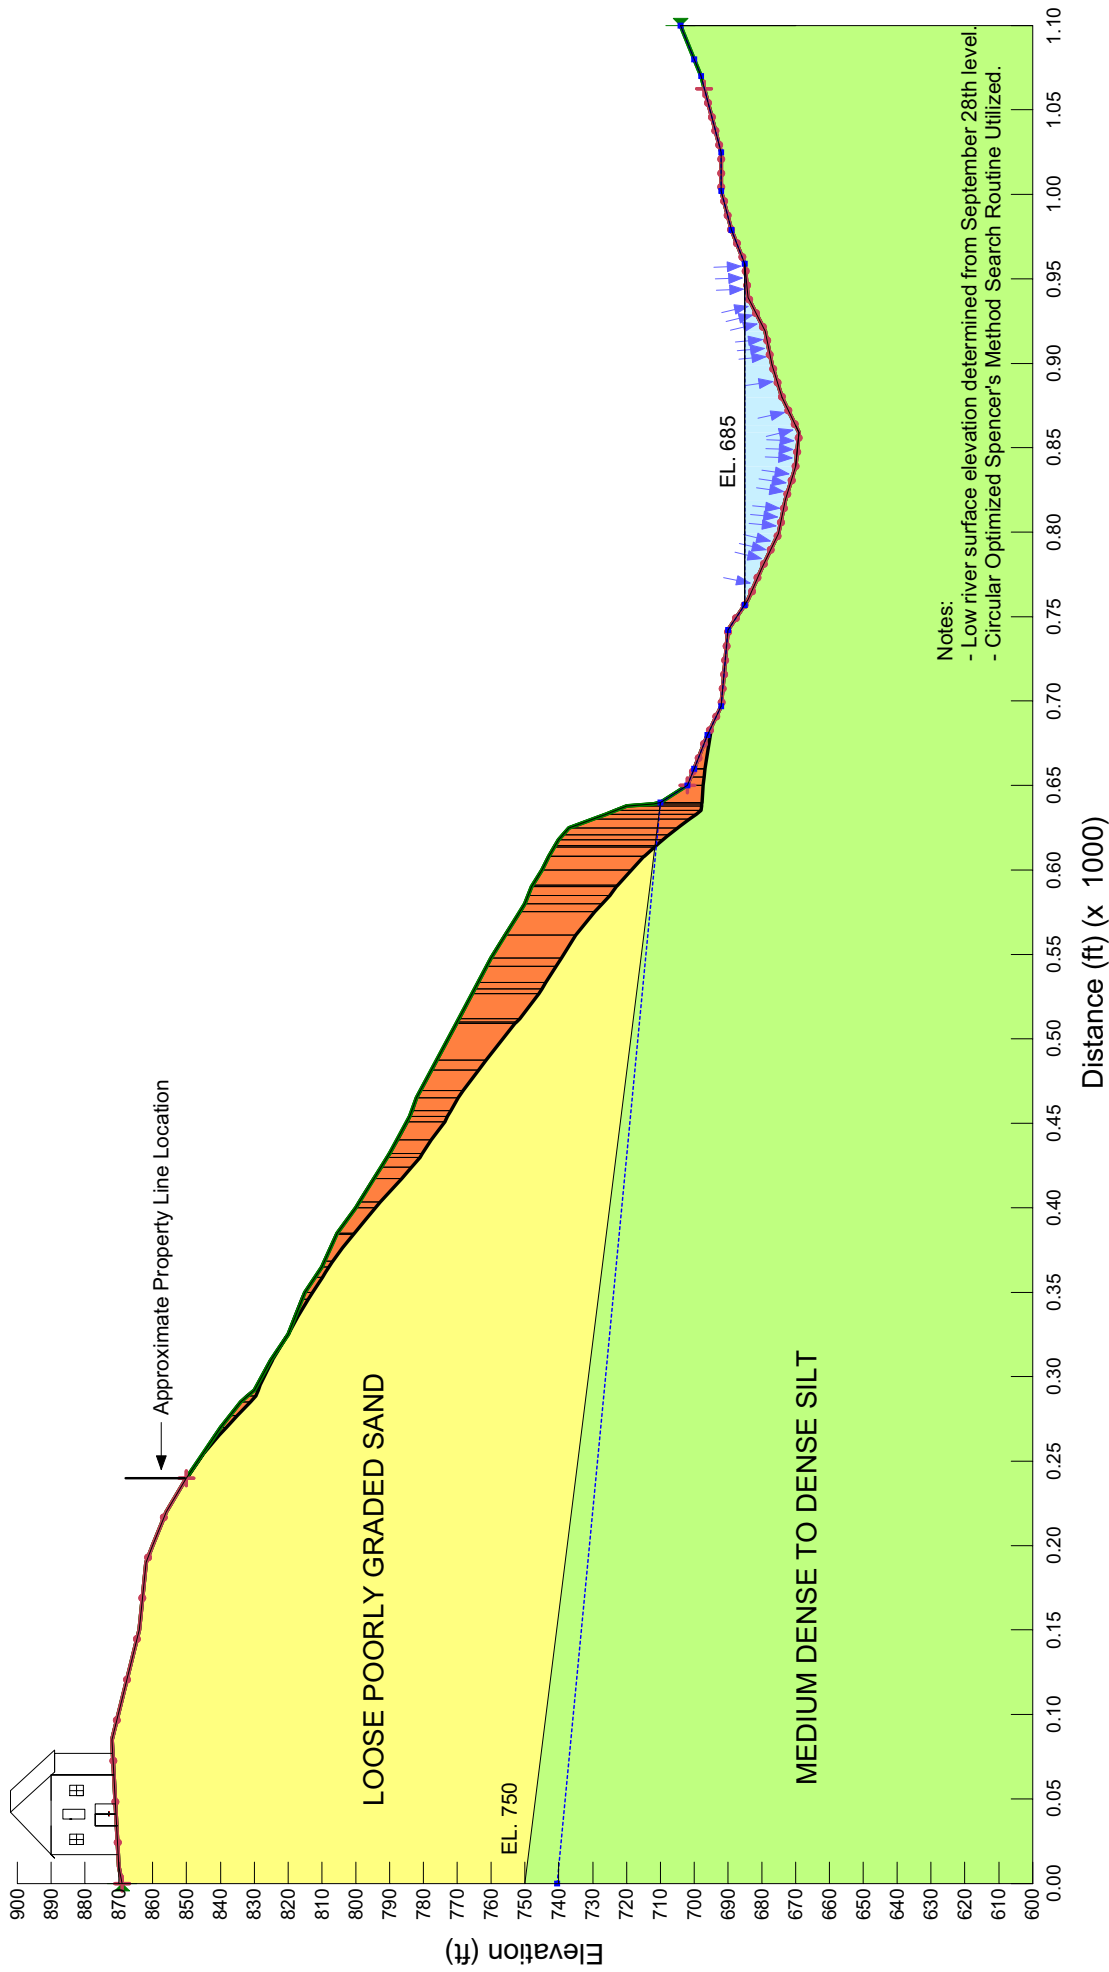
Lower Minnesota River Bank Stability
 PLATE 1: Low Water Analysis (Wide)
 File Name: LMR_Stability_Circular_House_Search(P1).gsz
 Computed: LDK Date: 2/9/2010
 Checked: JRJ Date: 2/9/2010

Notes:
 - Low river surface elevation determined from September 28th level.
 - Circular Optimized Spencer's Method Search Routine Utilized.

Name: SP Model: Mohr-Coulomb Unit Weight: 115 pcf Cohesion: 0 psf Phi: 28° Phi-B: 0° Piezometric Line: 1
 Name: Silt Model: Mohr-Coulomb Unit Weight: 115 pcf Cohesion: 200 psf Phi: 32° Phi-B: 0° Piezometric Line: 1

An initial, “sunny day” analysis was completed for the entire slope spanning a horizontal distance of approximately 1100 feet and a vertical height of approximately 200 feet. A low-water river surface elevation of 685 was conservatively assumed based on September 2009 low water levels. The model and results for this analysis are shown as Plate 1 in the appendix. The objective of this analysis was to evaluate the risk of potential slope failures adversely affecting the safety of the homes and/or their property along the Minnesota River bluff, in the vicinity of the eroded bluff. This analysis returned a minimum factor of safety of 1.31 which exceeds the acceptable minimum value of 1.3. It should be noted that this was for a failure surface with an exit point located at the approximate riverward property line of the nearest property. Factors of safety will be higher than 1.4 for failure surfaces exiting the ground closer to the homes and their backyards. These higher factors of safety indicate that the risk of a failure impacting the homes or their backyards is very small.

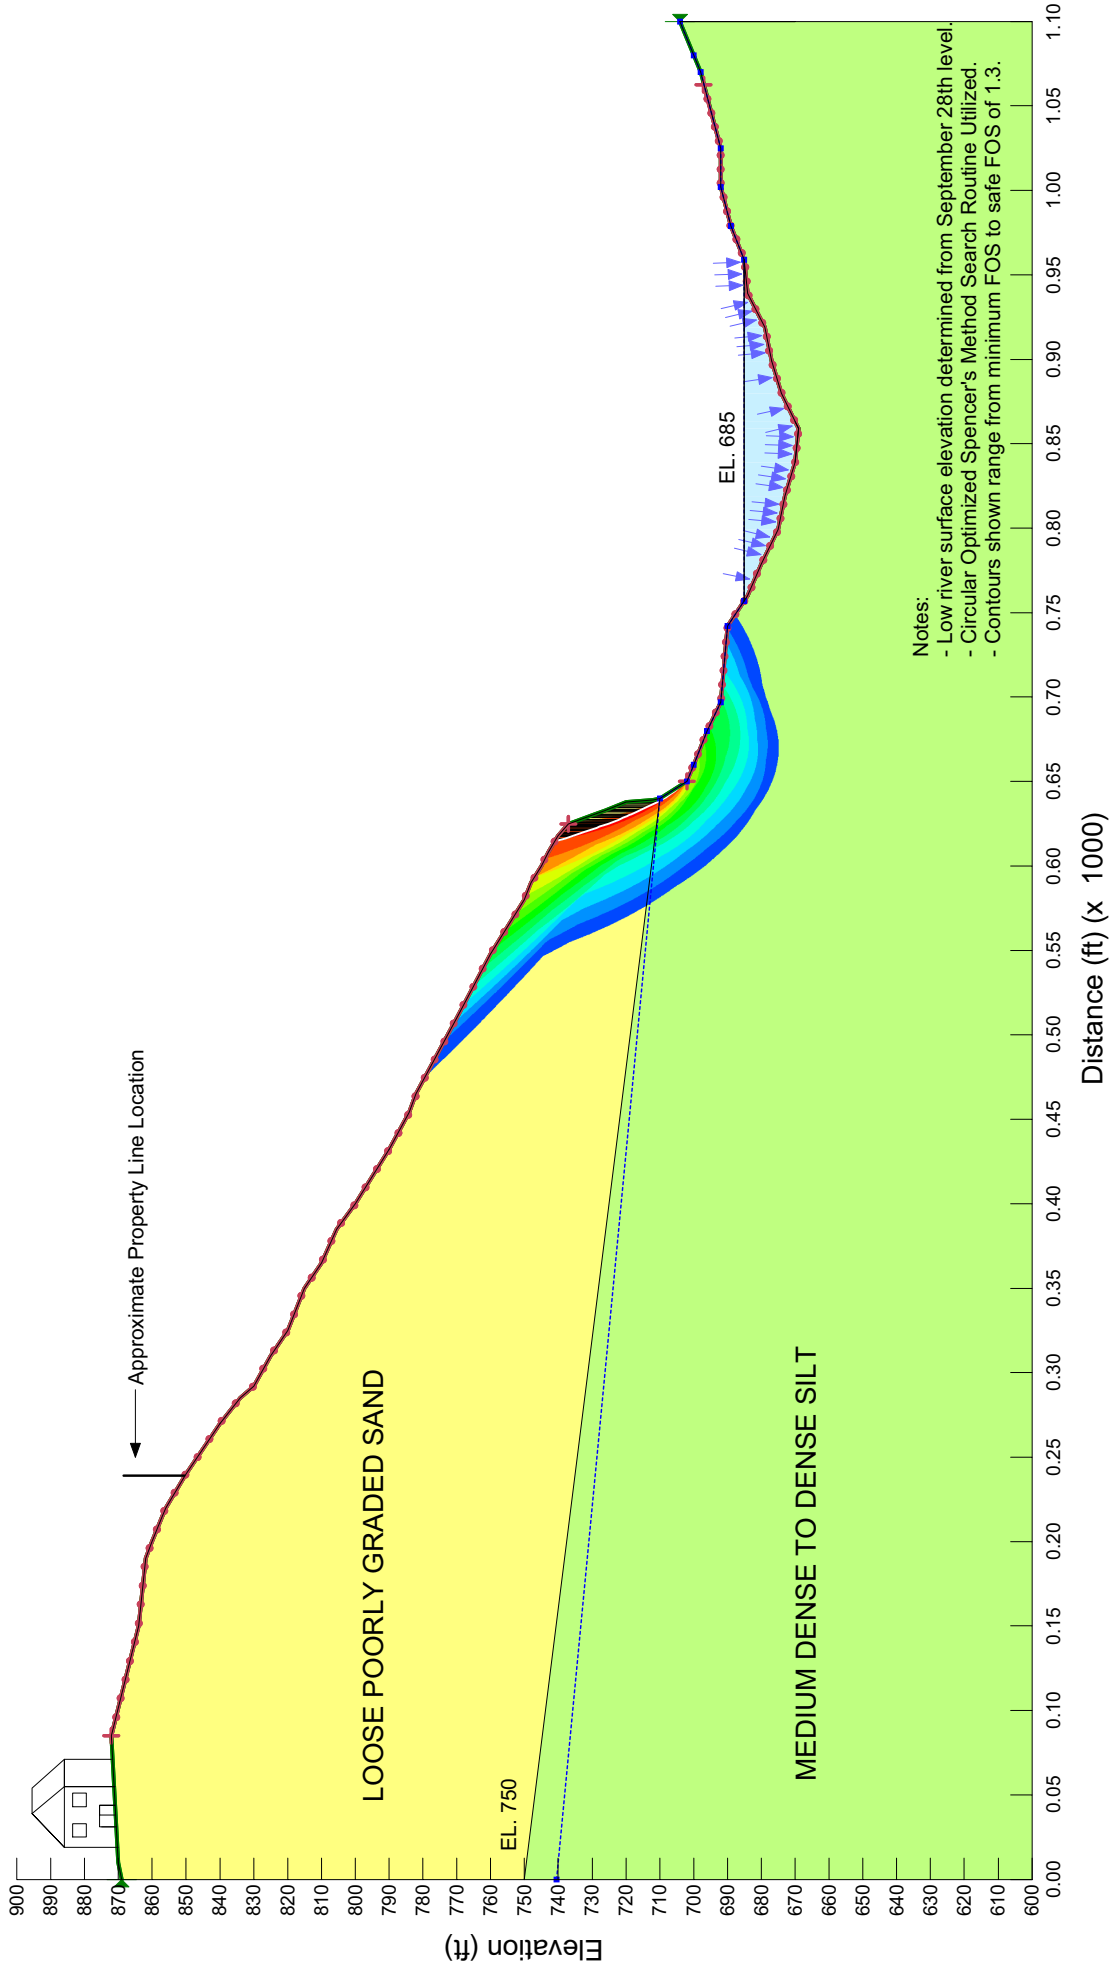
File Name: LMR_Stability_Circular_Bluff(P2).gsz
 Computed: LDK Date: 1/13/2010
 Checked: JRJ Date: 1/13/2010

Name: SP Model: Mohr-Coulomb Unit Weight: 115 pcf Cohesion: 0 psf Phi: 28° Phi-B: 0° Piezometric Line: 1
 Name: Silt Model: Mohr-Coulomb Unit Weight: 115 pcf Cohesion: 200 psf Phi: 32° Phi-B: 0° Piezometric Line: 1

Minimum Factor of Safety = 0.26

Next, the eroded, steep face of the bluff was isolated in the stability model. Stability analysis of the steep eroded slope produced a factor of safety of 0.61 which indicates the steep face of the bluff is unstable in its current shape, and will likely experience failures and sloughing until a stable slope is achieved. Alternatively, the steep face of the bluff could be graded flat to achieve a stable condition. The model and results of this analysis are shown as Plate 2 in the appendix. It should be noted that these failures are in the immediate vicinity of the near vertical bluff face and do not pose a risk to the homes or their property. It can be seen from the slip surface safety map of this analysis that minimum required factors of safety are achieved well before any surfaces approach the homes or their property.

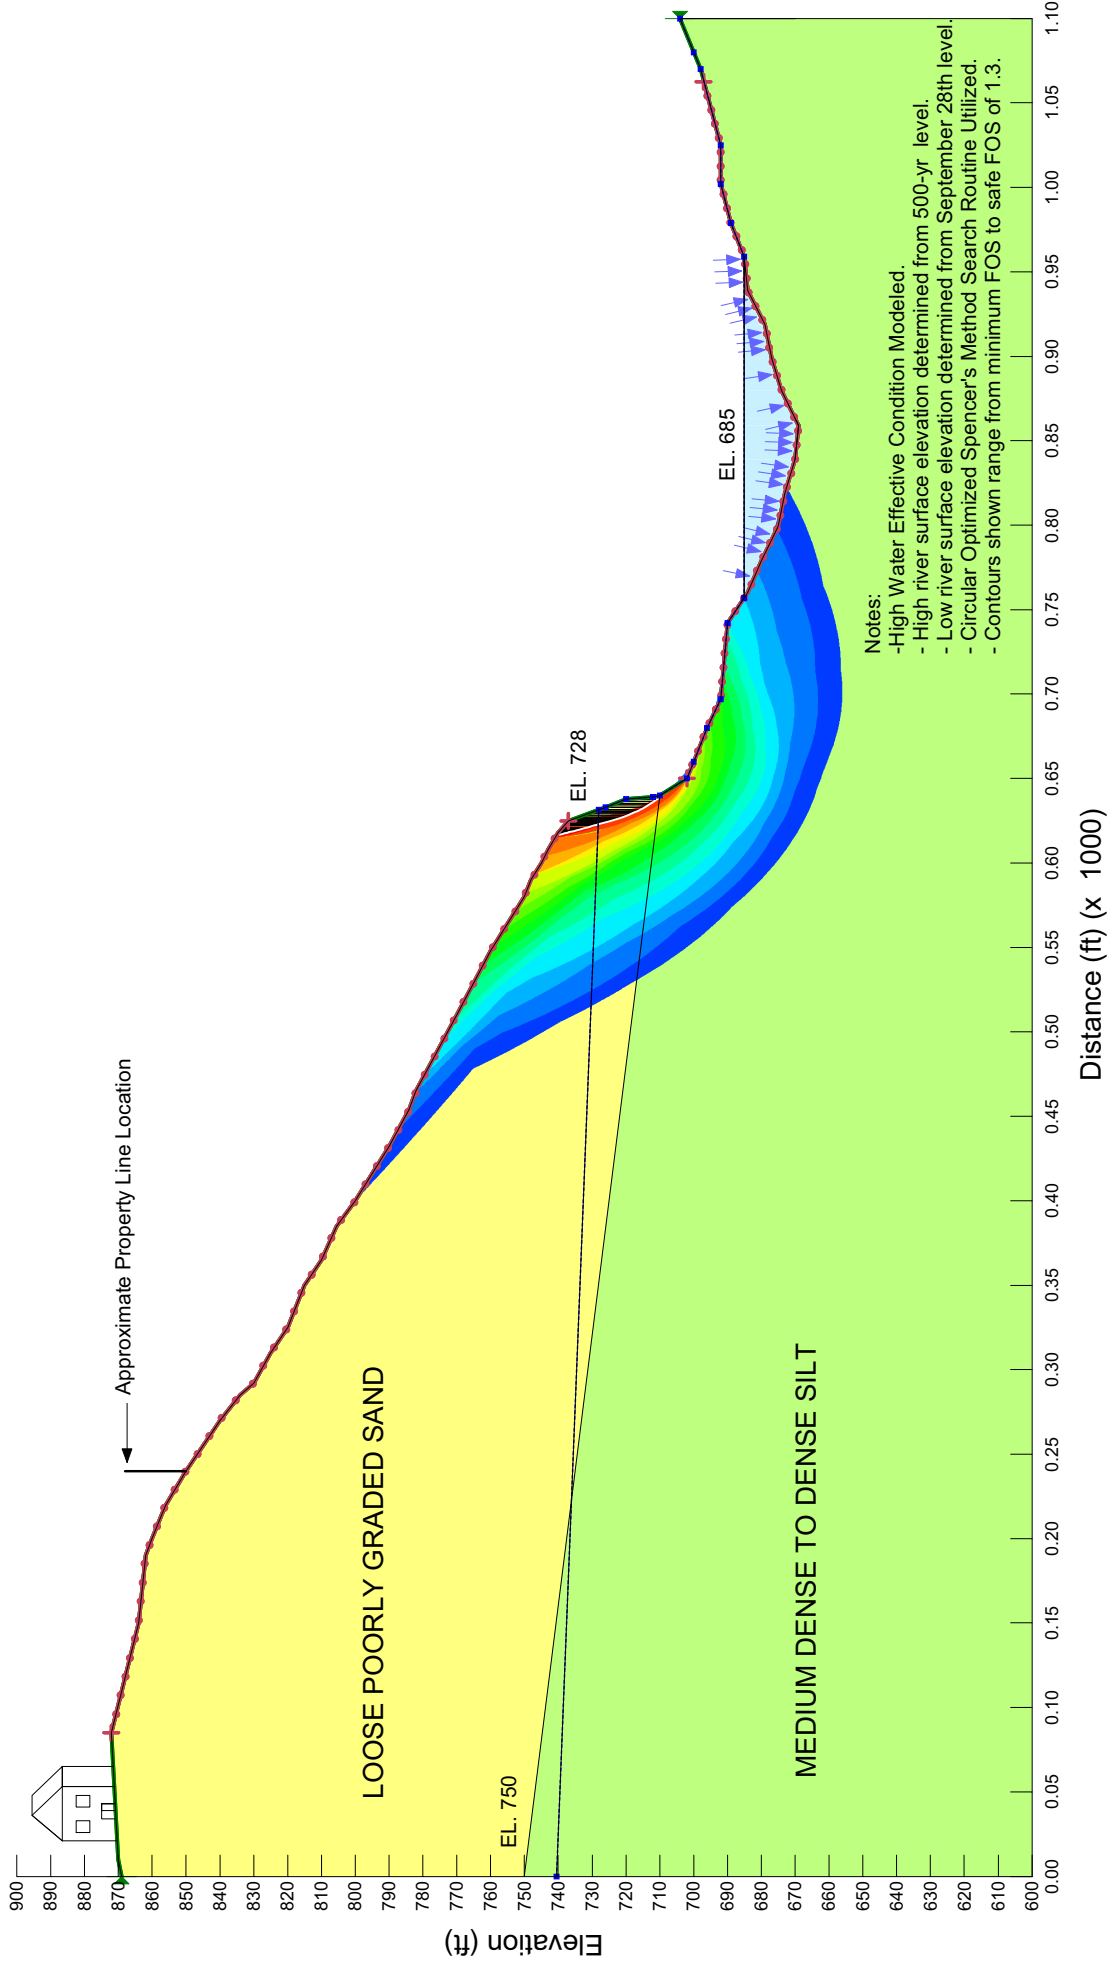
Lower Minnesota River Bank Stability
 PLATE 3a: Drawdown Analysis (FS=1.3)
 File Name: LMR_Stability_Circular_Bluff_Drawdown(P3a).gsz
 Computed: LDK Date: 2/9/2010
 Checked: JRJ Date: 2/9/2010

Name: SP Model: Mohr-Coulomb Unit Weight: 115 pcf Cohesion: 0 psf Phi: 28° Phi-B: 0° Piezometric Line: 1
 Name: Silt Model: Mohr-Coulomb Unit Weight: 115 pcf Cohesion: 200 psf Phi: 32° Phi-B: 0° Piezometric Line: 1

A third condition analyzed represents the bluff following a major flood event. Eye witnesses indicate that the past bluff failures have typically occurred following significant flood events. During prolonged flood conditions, high water levels will exist both with the river and the bluff soils. The water in the river exerts a stabilizing force on the bluff. When the river drops after the flood, the soils within the bluff will remain saturated for awhile until they can drain. The saturated soils add weight to the bluff, increasing the forces tending to destabilize the bluff. This loading condition is typically called the rapid drawdown case. In the drawdown model, the high water level was assumed at elevation 728 (500-yr flood elevation). The water in the river was then drawn down to elevation 685 and the stability of the bluff under drawdown conditions was evaluated. The model and results of this analysis are provided as Plates 3a and 3b in the appendix. The failure surface safety map provided on Plate 3a shows failure surfaces with factors of safety ranging from the minimum factor of safety to a factor of safety of 1.3. This plate shows that the failure surfaces extend higher up the bluff, further into the river and are slightly deeper than the non-flood analysis results. However, even with the larger and deeper failure surfaces, required minimum stability factors of safety are
