LOWER MINNESOTA RIVER WATERSHED DISTRICT

Lower Minnesota River Watershed District Board of Managers Meeting
Wednesday, May 19, 2021

Re: Area 3 Minnesota Riverbank Stabilization Project Update

Re: East Chaska Creek Restoration—Construction Update

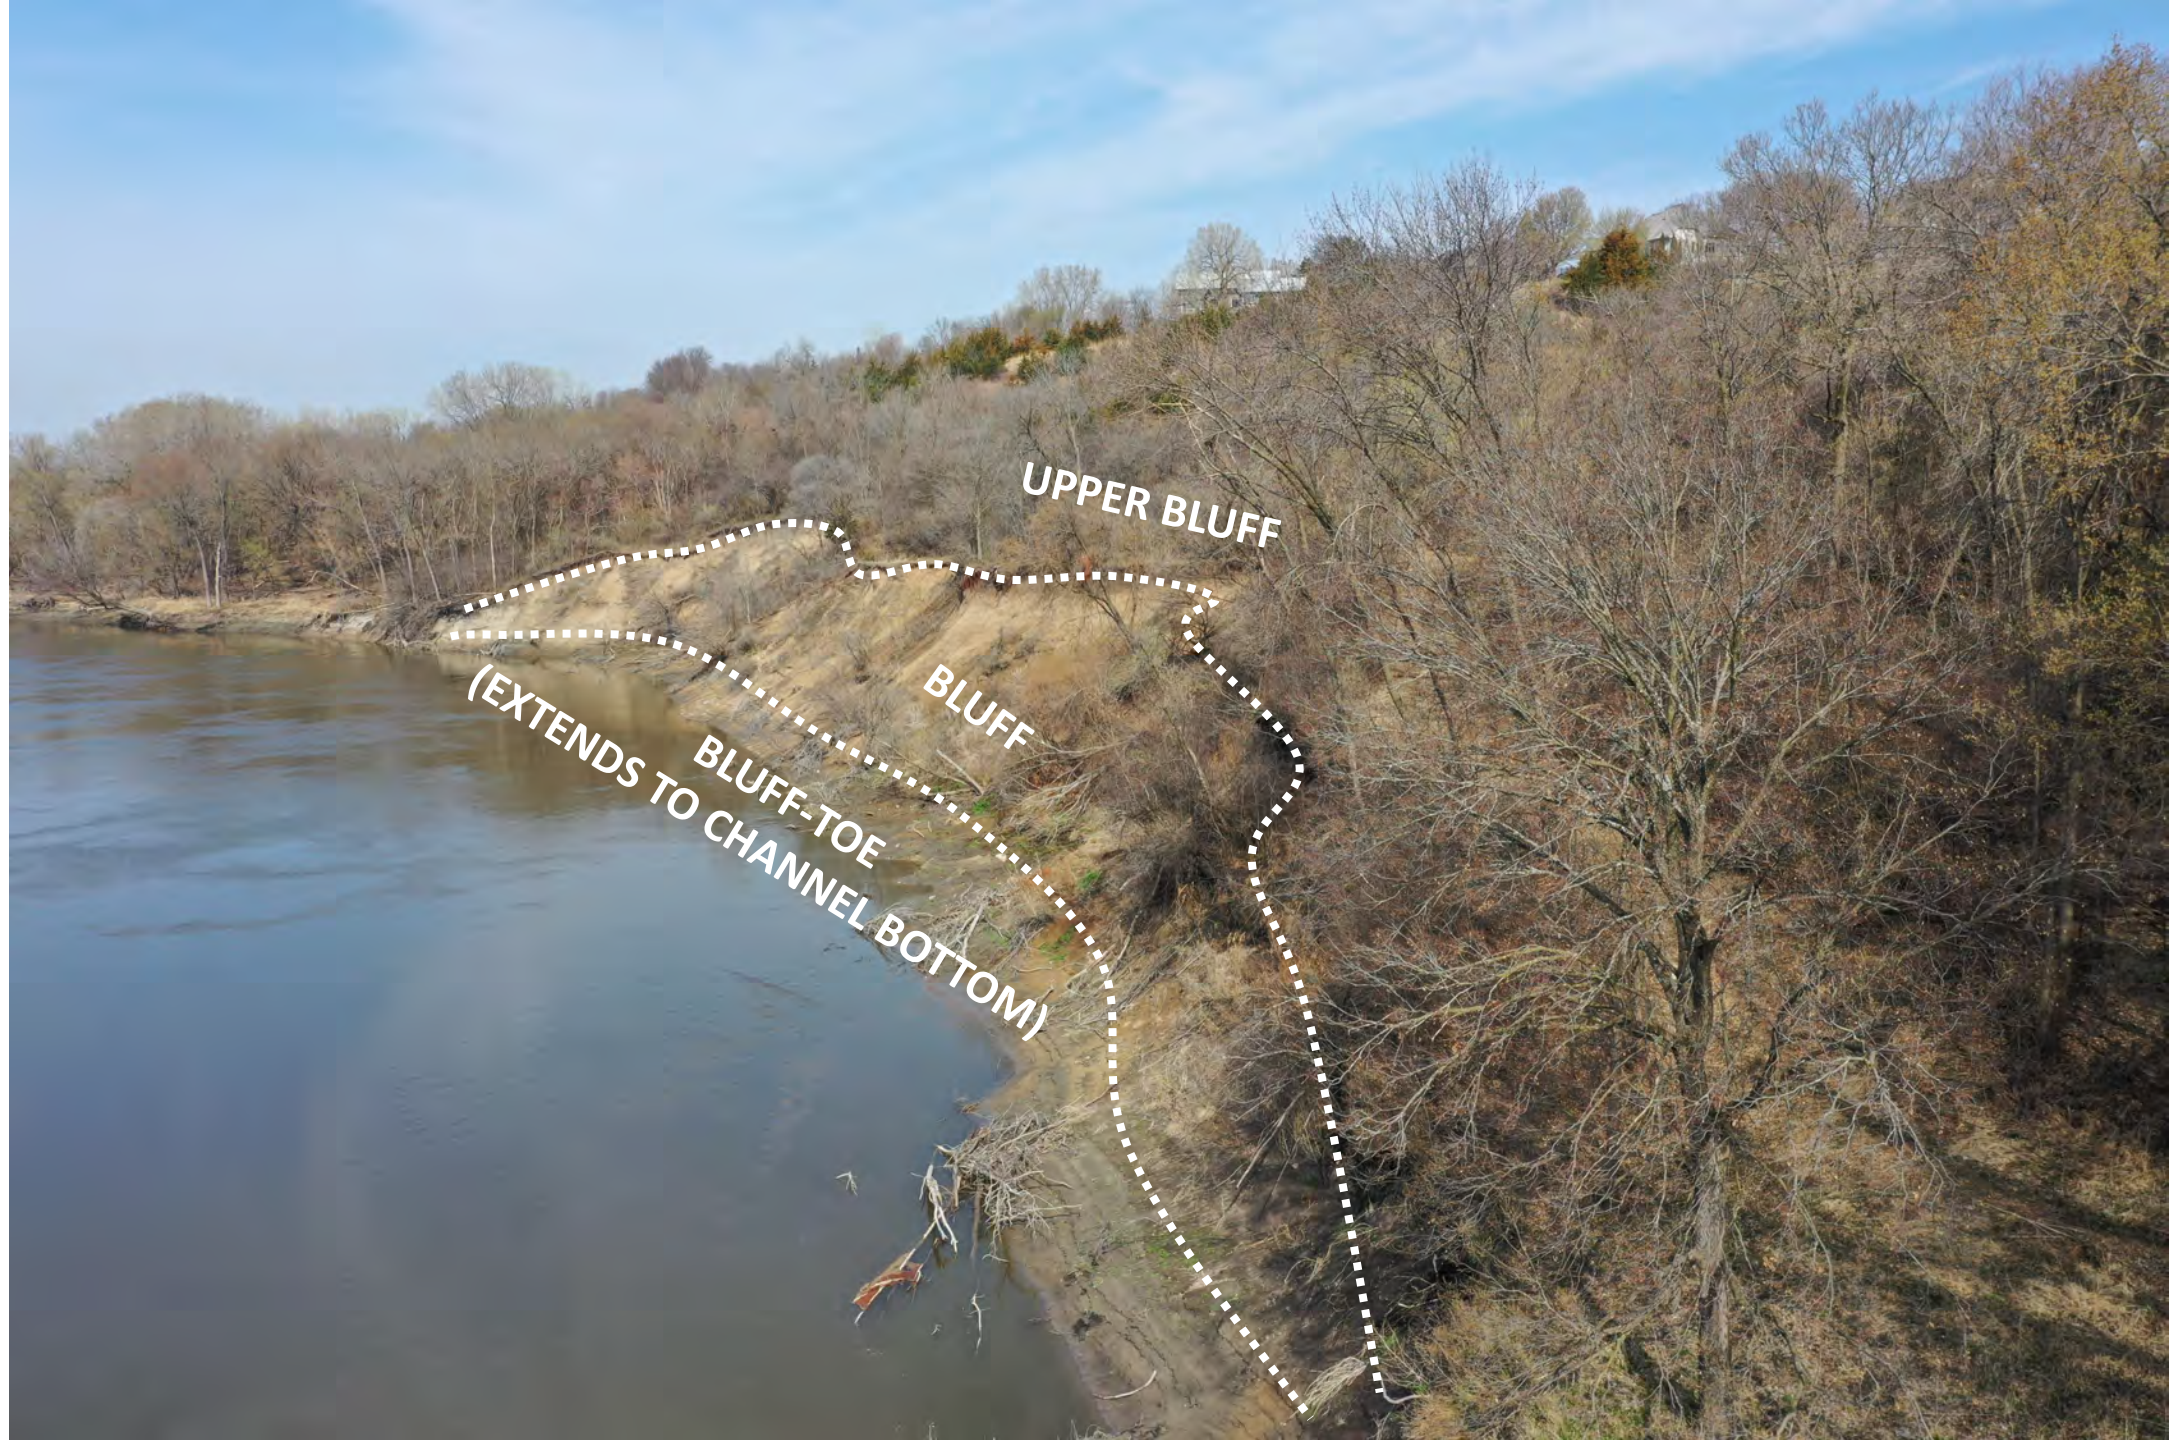
UPPER BLUFF

BLUFF

BLUFF-TOE
(EXTENDS TO CHANNEL BOTTOM)

Upstream Scallop

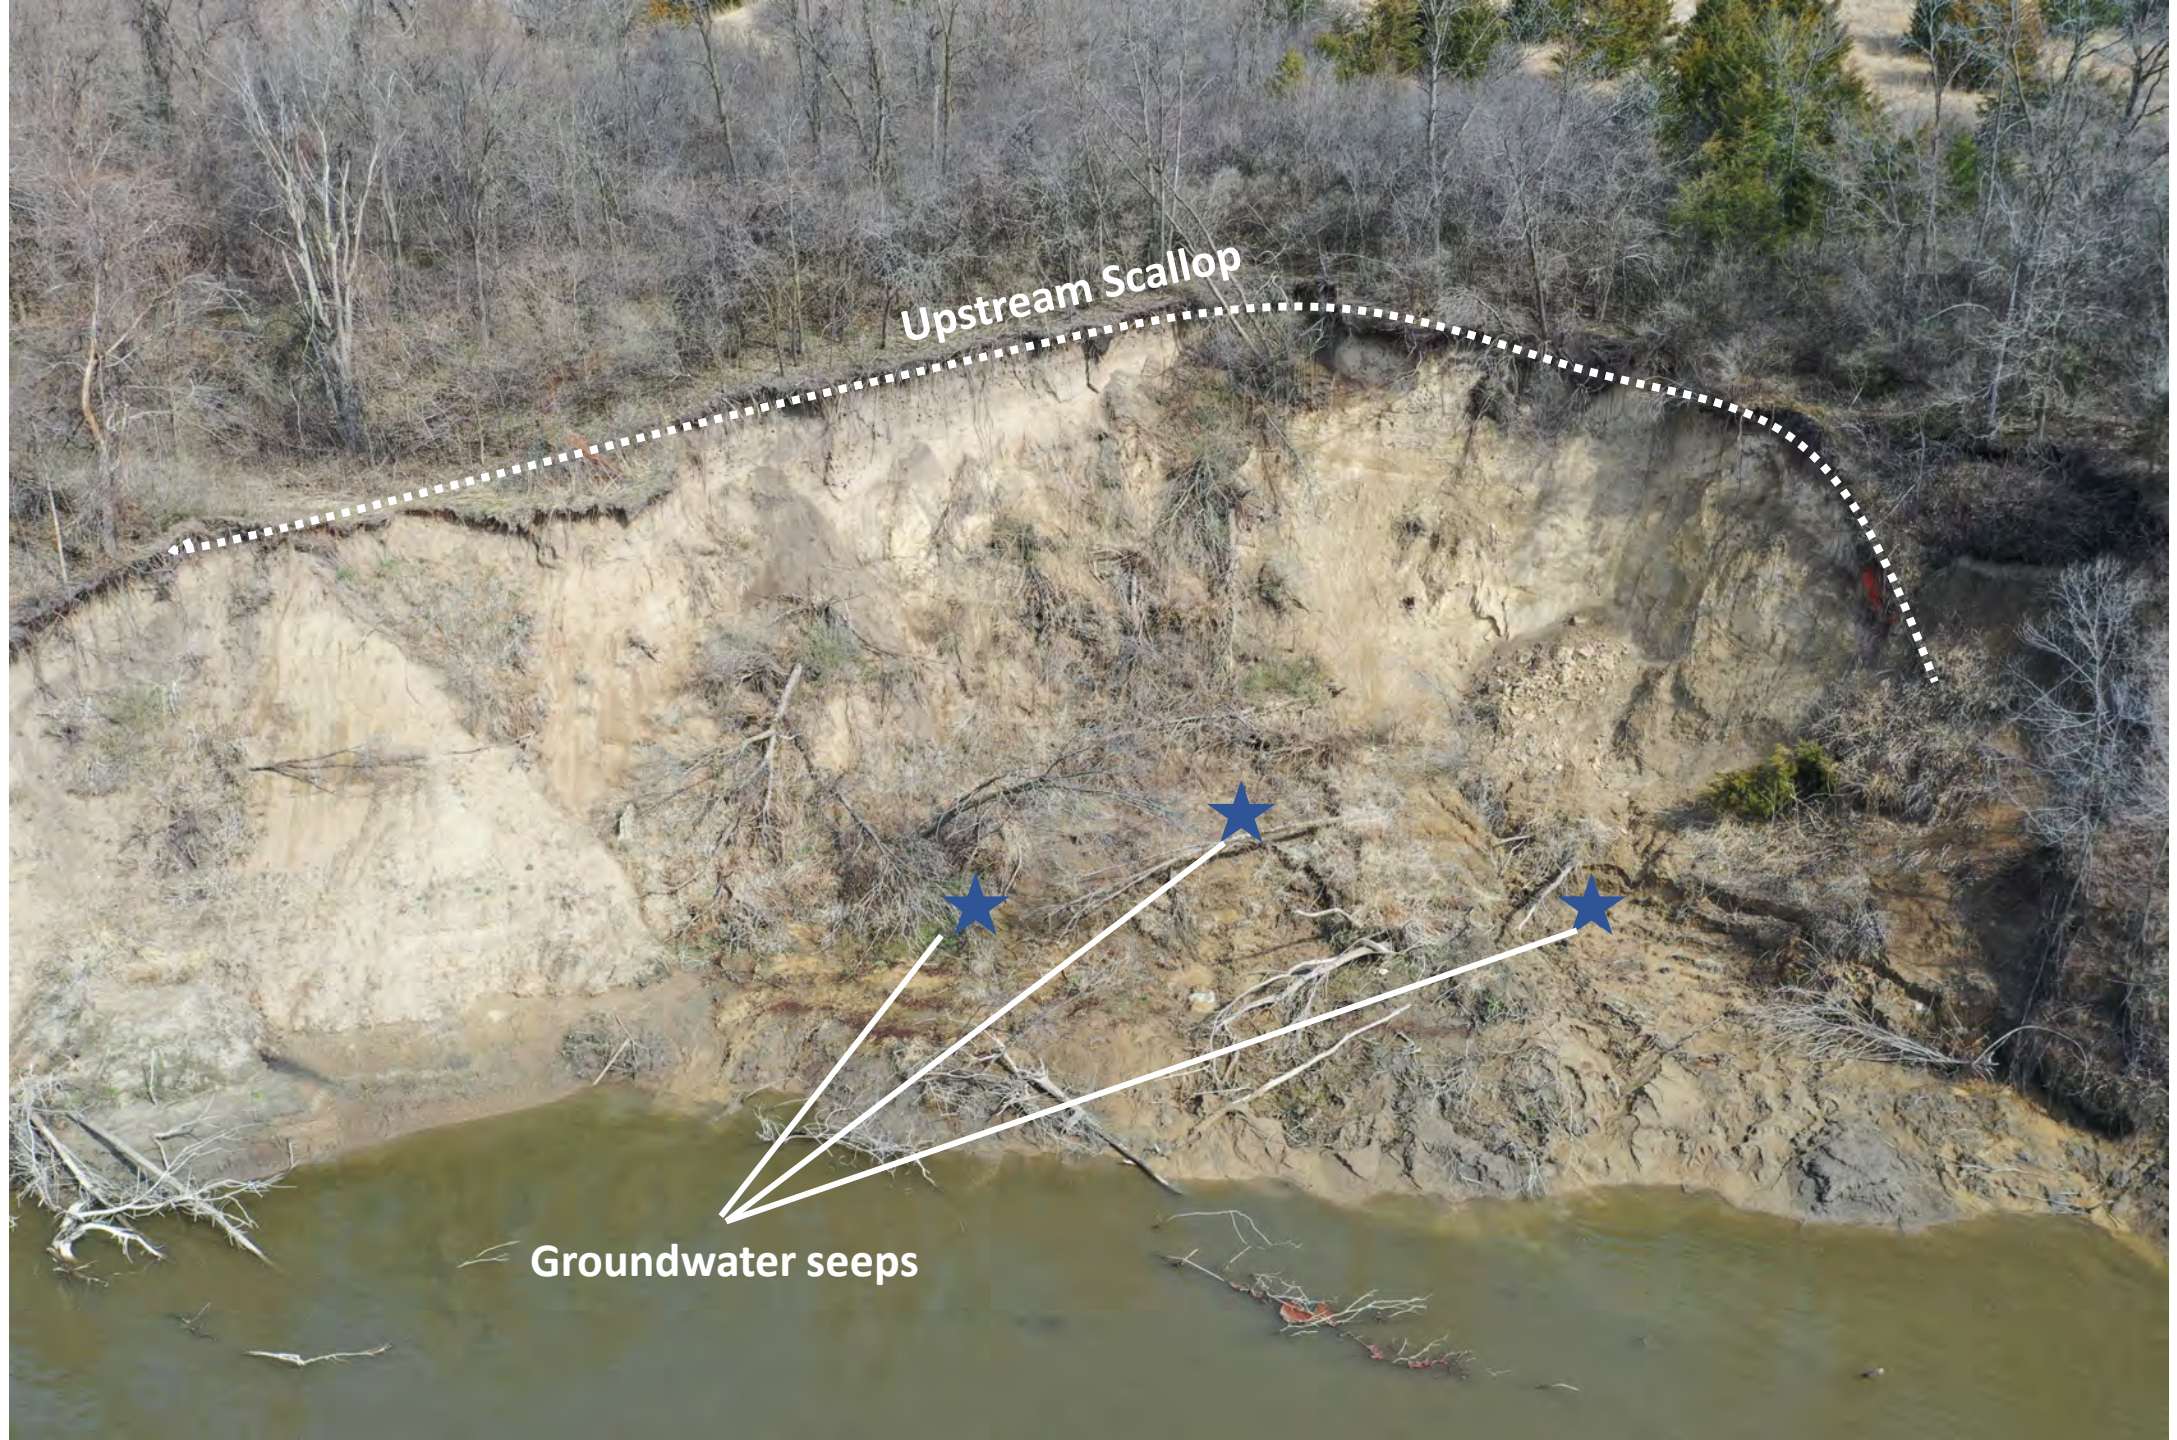
- Natural progression of the river meander is contributing to erosion.
- Several groundwater seeps are present at the base of the slope and have the potential to saturate the soils and weaken the integrity of the bluff, causing erosion.
- Land development on top of the bluff can cause increased runoff from rooftops and sump pump discharges in addition to creating infiltration opportunities from features such as pools and stormwater basins. Inter-Fluve has posited that the increased infiltration on top of the bluff could have increased groundwater pressure and increased the flow at the existing seeps, further destabilizing the riverbank.
- Previous bank stabilization attempts by the City of Eden Prairie to protect the stormwater pond in the floodplain are exacerbating the erosion at Area 3 by

Upstream Scallop

Groundwater seeps

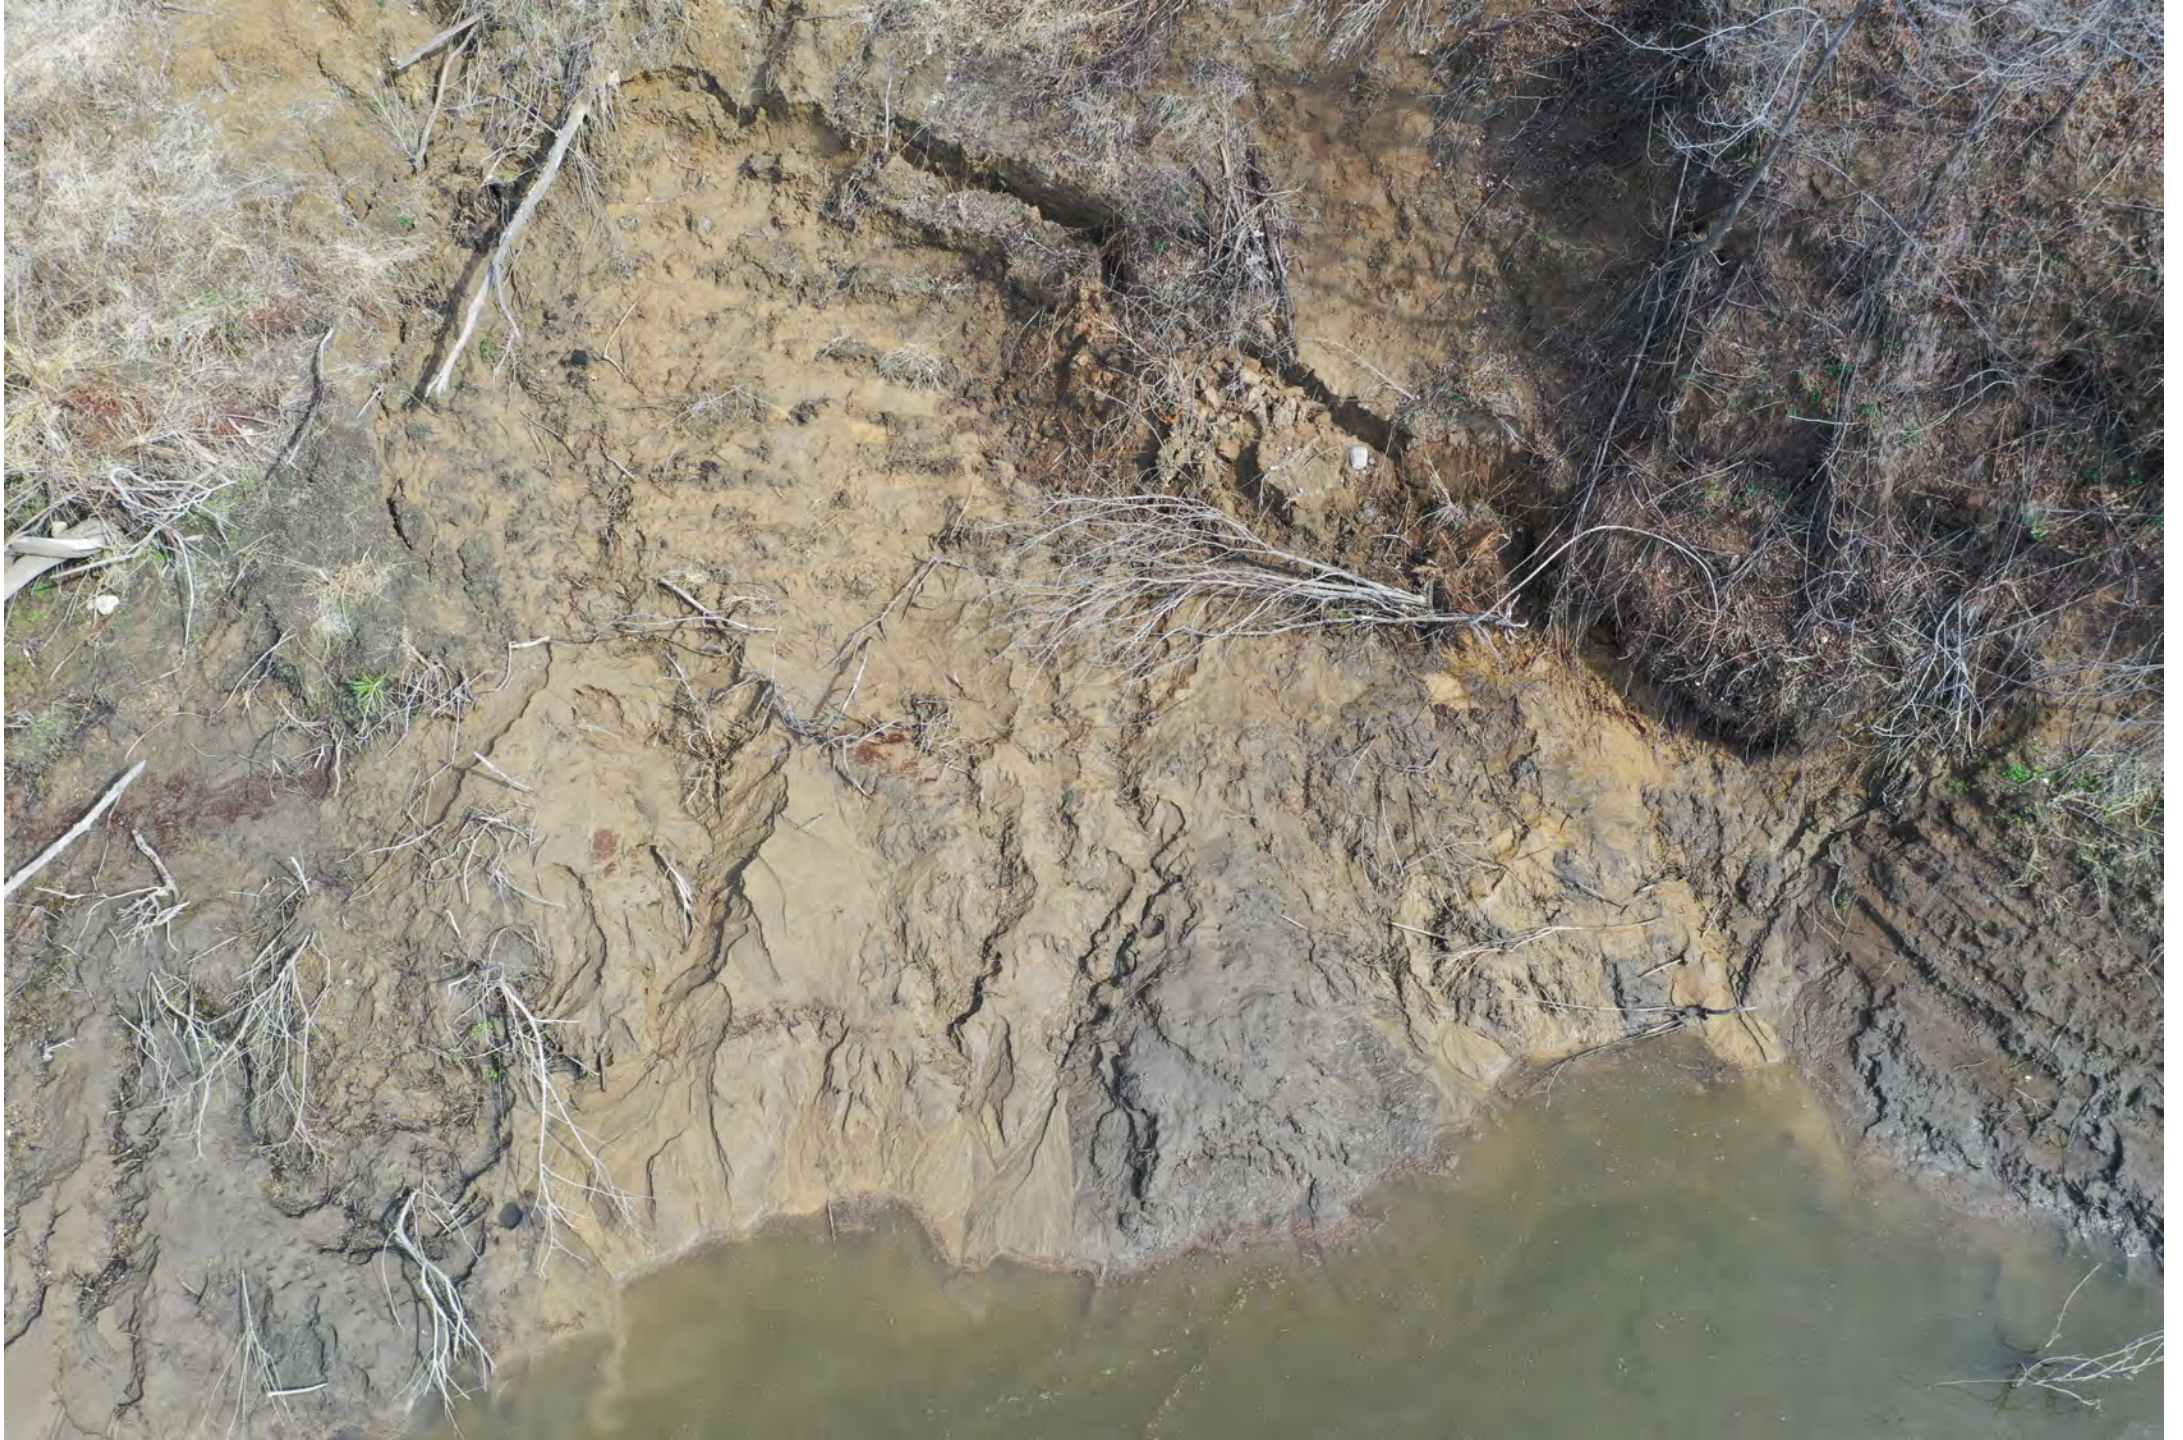
An aerial photograph showing a grassy bank on the left side of a body of water. A channel, labeled 'Incised Channel', runs parallel to the water's edge. To the right of this channel, a stormwater outfall, labeled 'Stormwater Outfall', is visible, consisting of a series of rocks and a metal grate. The grass is dry and yellowish-brown. The water is a murky, brownish-green color.

Stormwater
Outfall

Incised Channel

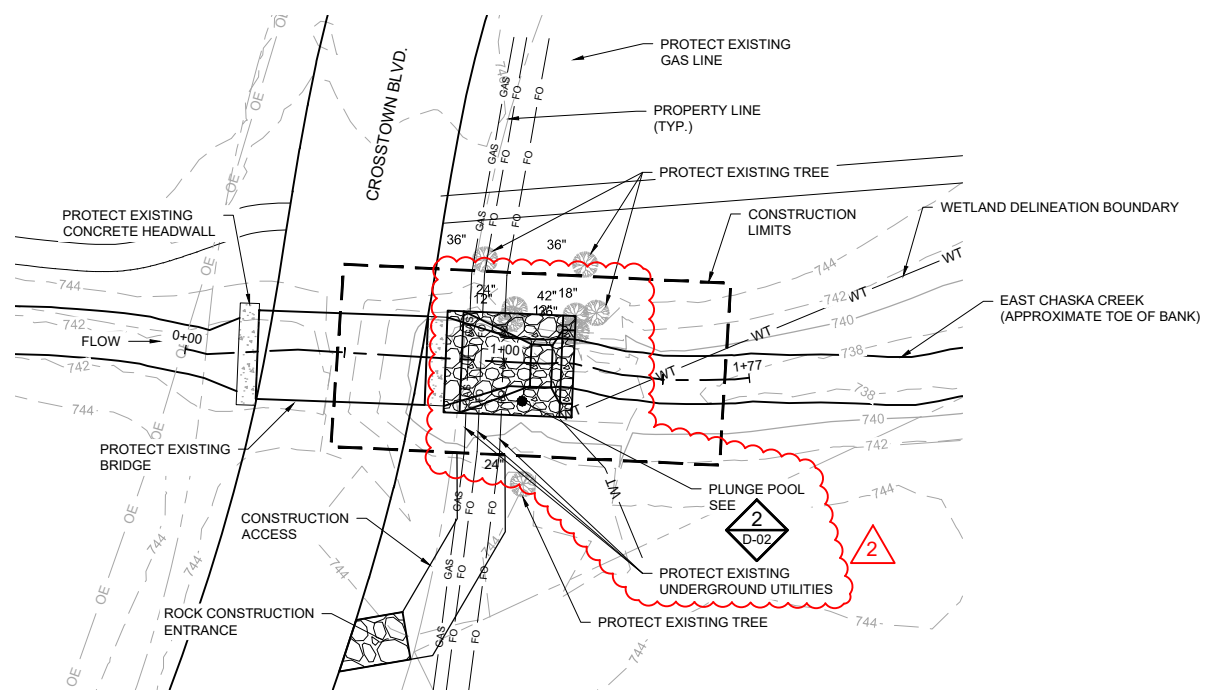
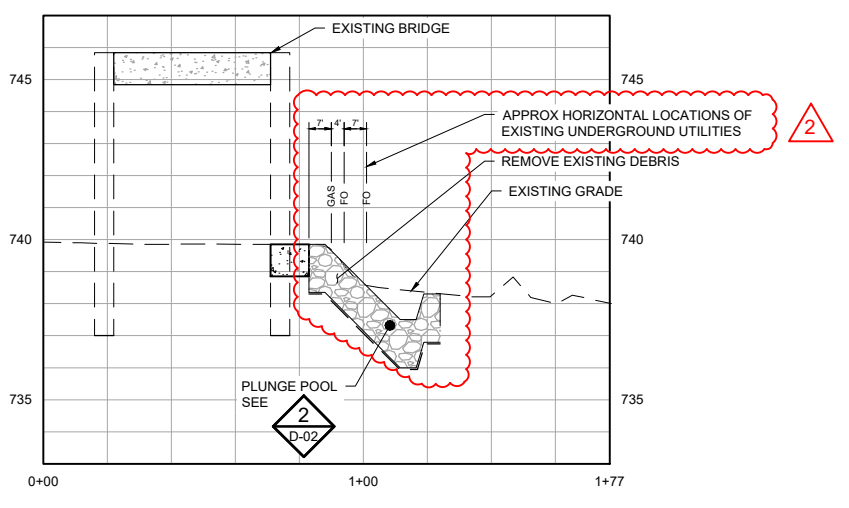
1 PLAN: STREAM RESTORATION (AREA 1)

2 PROFILE: STREAM RESTORATION (AREA 1)

Young Environmental met with Barr on May 12, 2021 to discuss the proposed field fit and whether altering the design would present any issues with the permits. Barr has developed a solution that continues to meet the permit obligations while also protecting the existing utilities (Attachment 2). Further coordination is expected to continue this week, and staff will be prepared to provide an update to the managers as needed.
