LOWER MINNESOTA RIVER WATERSHED DISTRICT

Item 6. B. - Burnsville Ravine Stabilization Cost Share

Re: Burnsville 2021 Slope Project—Funding Request Review

Gully ID: 07:21-01:33	MAP	
Date & Time: July 21, 2021 1:33 PM

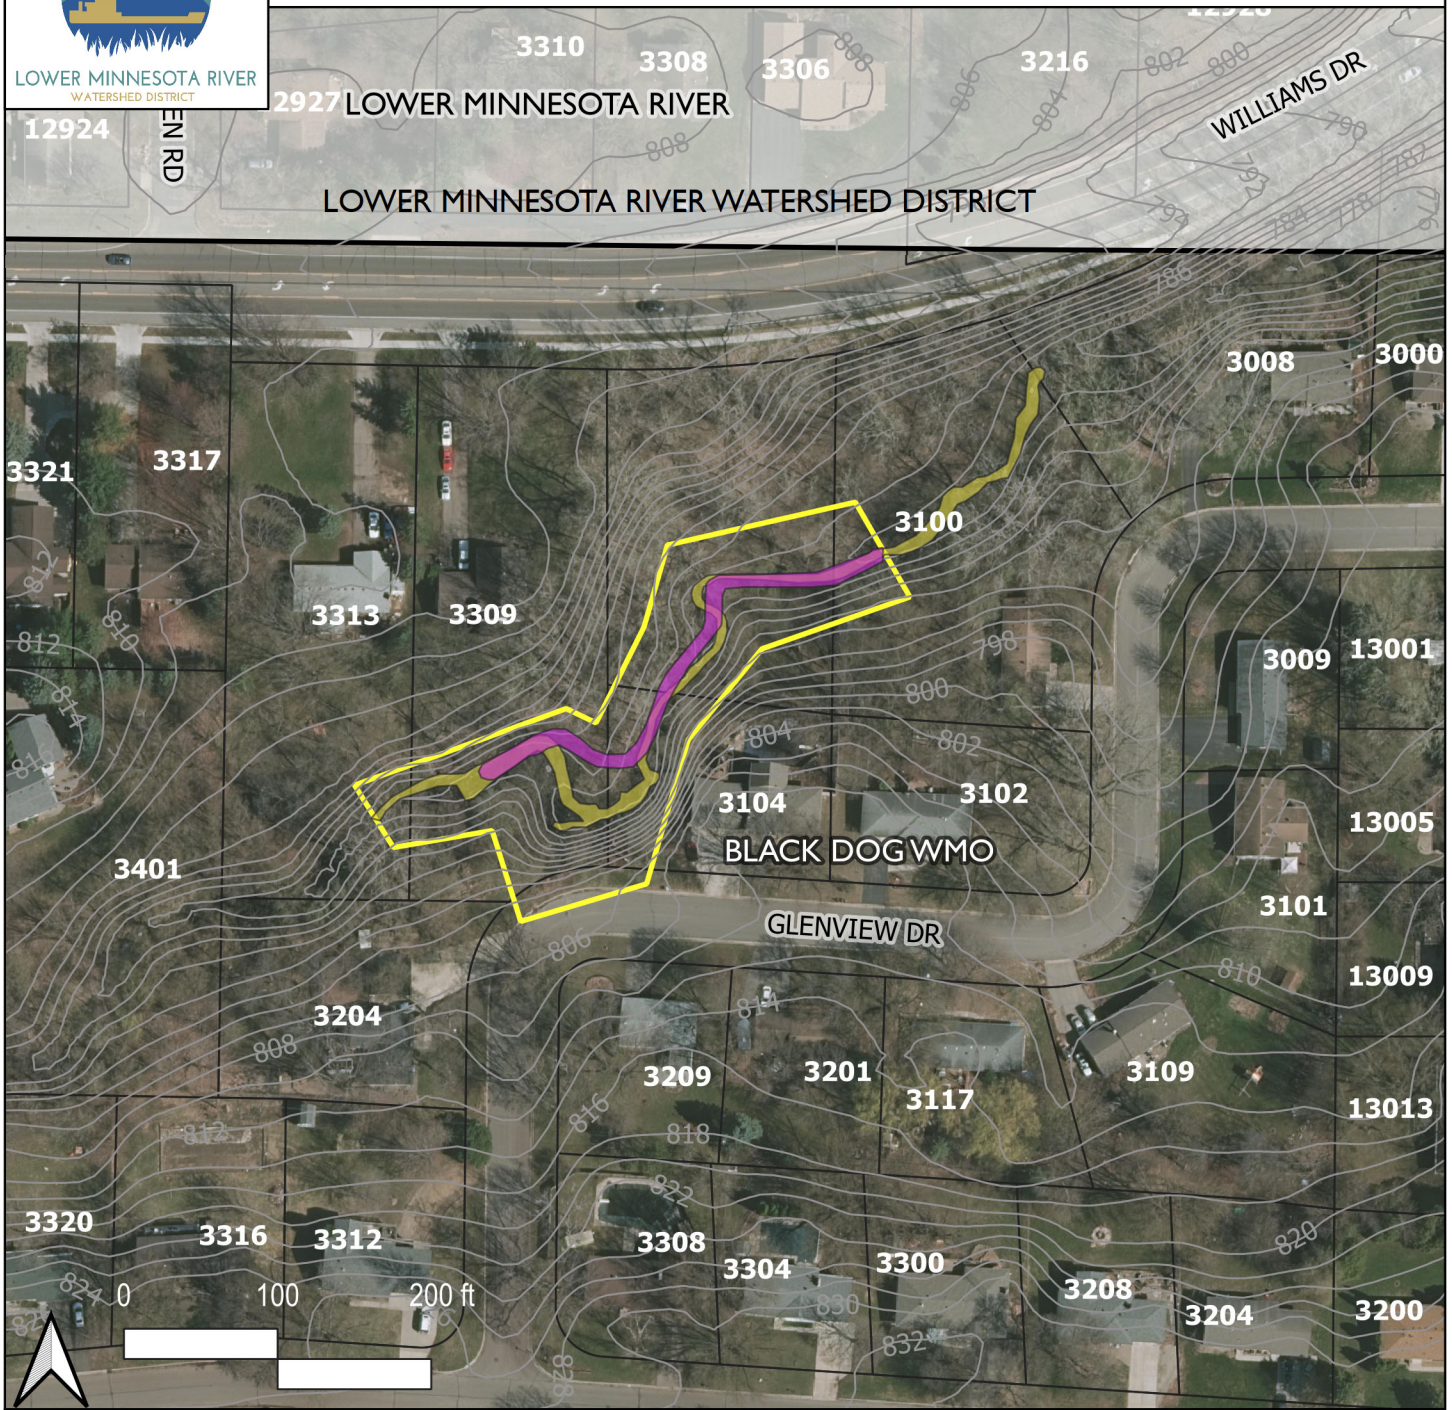
Figure I: 2021 Bursville Slope Project Location

- Approximate Project Extents
- Project Location
- Existing Stream Alignment
- Proposed Stream Alignment
- LMRWD Boundary
- Parcel Boundaries
- LiDAR Contours

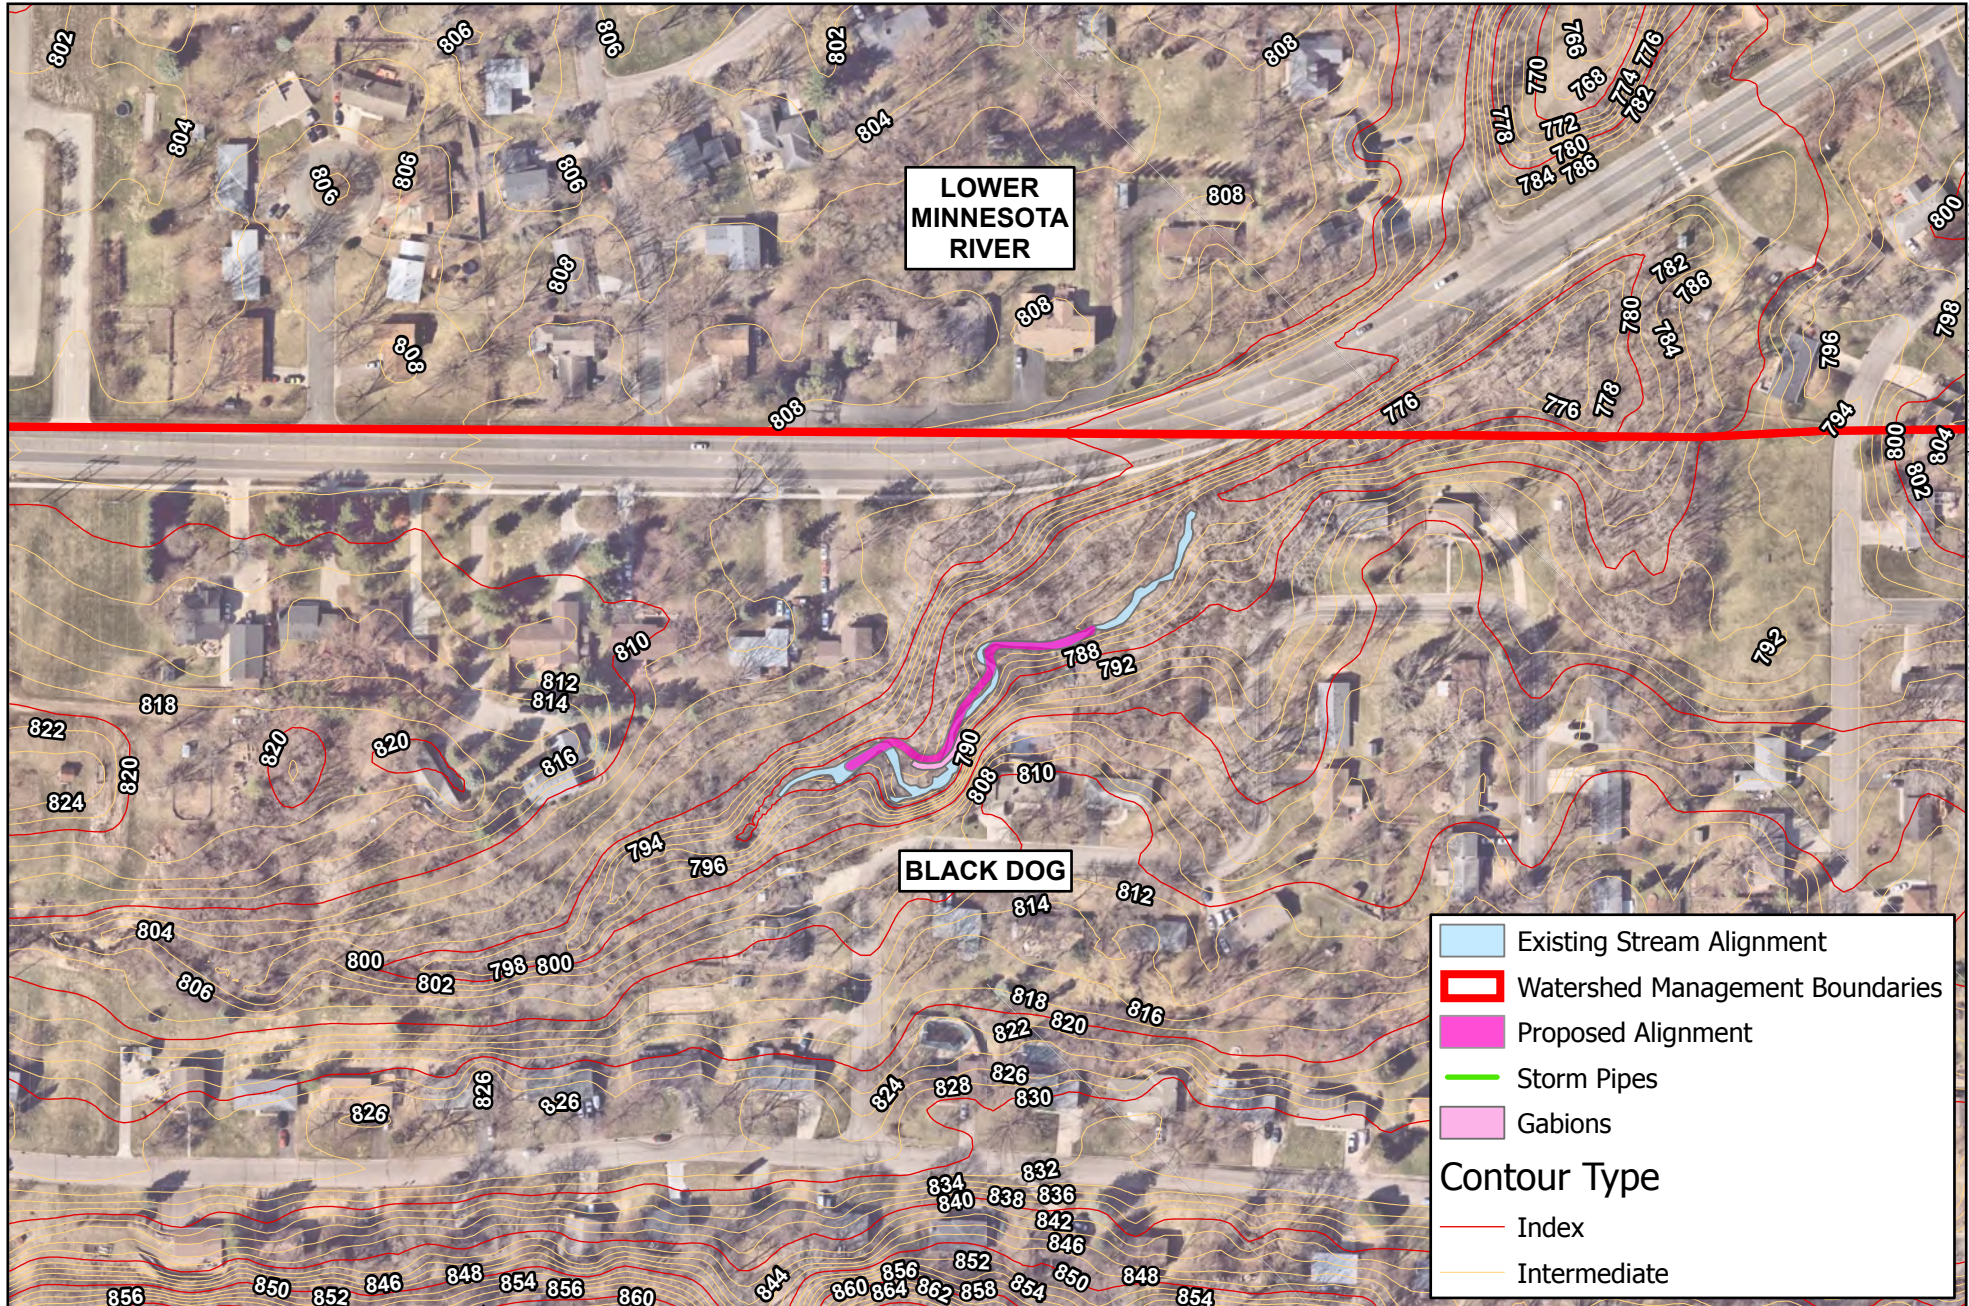
Figure 1 - Streambank Alignments
 Burnsville 2021 Slope Stability Project
 City of Burnsville

The proposed project will change the alignment to remove large scale erosion areas, and the banks will be stabilized with hard armoring and bioengineering. Gabion retaining walls will also be used along the southern side adjacent to the roadway and home to result in more gradual slopes. Grading and turf reinforcement mats will be installed along the banks to reduce erosion and stabilize the bank slopes. Removal of sloughed material will be done with the location of the new alignment. See **Figure 1** for project location and proposed improvements.

The proposed improvements will help reduce erosion, benefit downstream water quality, and increase the stability of the creek and streambanks. The City of Burnsville is planning on construction in the fall of 2021. The 60% construction cost estimate is approximately \$400,000. The proposed project will alter the channel alignment, include bioengineering and rock armoring, install gabion walls, grading side slopes, and installation of geofabrics.

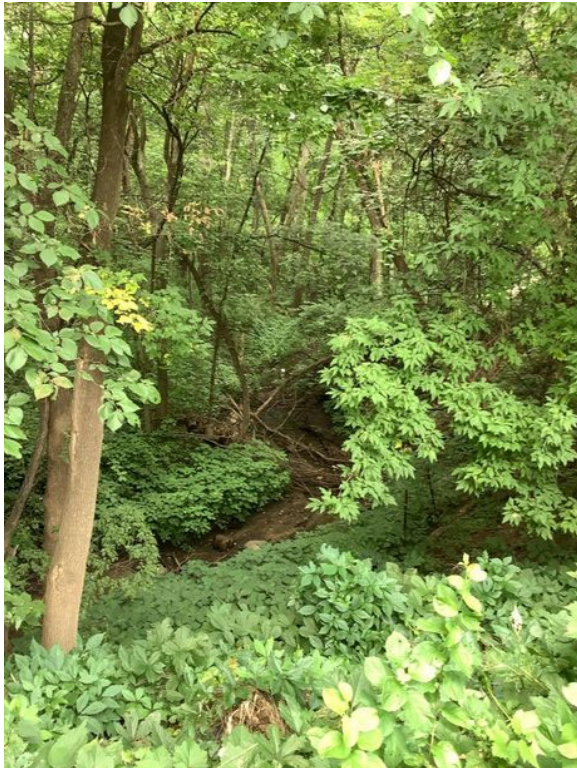
Photo 1 Image

Location: Burnsville		
Weather: Cloudy Storm/Rainfall Event in the Past 24 Hours? No		
GULLY INFORMATION		
Calculated Erosion Potential:	High	
Approximate Depth:	5-Deep (>15')	
Approximate Bottom Width:	3-Medium (1'-5')	
Approximate Gully Length:	5-Long (>100')	
Condition of Gully Bottom:	5-Bare Soil	
Condition of Gully Banks:	1-Heavy Vegetation	
Gully Bank Angles:	3-Mid-Range (45 to 90 degrees)	
Gully Shape:	5-V-Shaped	
Gully Material:	Silt/Clay	
Seep:	0-No	
Stormwater Runoff:	0-No	
Stormwater Inputs:		
Fallen Trees:	1-Yes	
Degradation:	3-Moderate

Aggradation:	1-Low
Slumping:	1-Yes
Additional Notes:	<p>Classification? High</p> <p>Presence of Water? Yes</p> <p>Quantity of Water? Puddles/Stagnant</p> <p>Notes/Comments: Large gully outside district, bottom has puddles of water that look like they may be slowly flowing, many fallen trees in gully, could not get down right bank due to safety so pictures may be rough</p>

Downstream

Gully

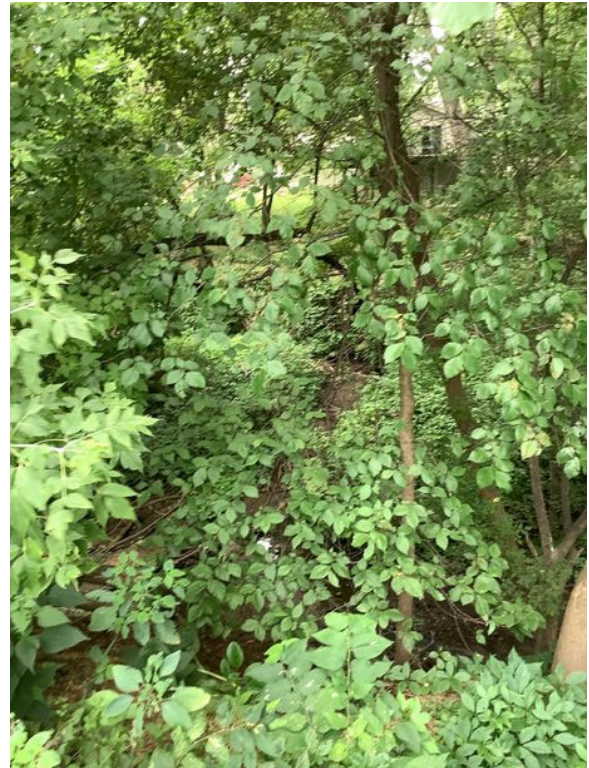
Photo 2 Image

Upstream

Gully
