LOWER MINNESOTA RIVER WATERSHED DISTRICT

Executive Summary for Action

Item 5. C. – Appletree Condominium Cost Share Application

Title: Erosion Control & Maintenance Project

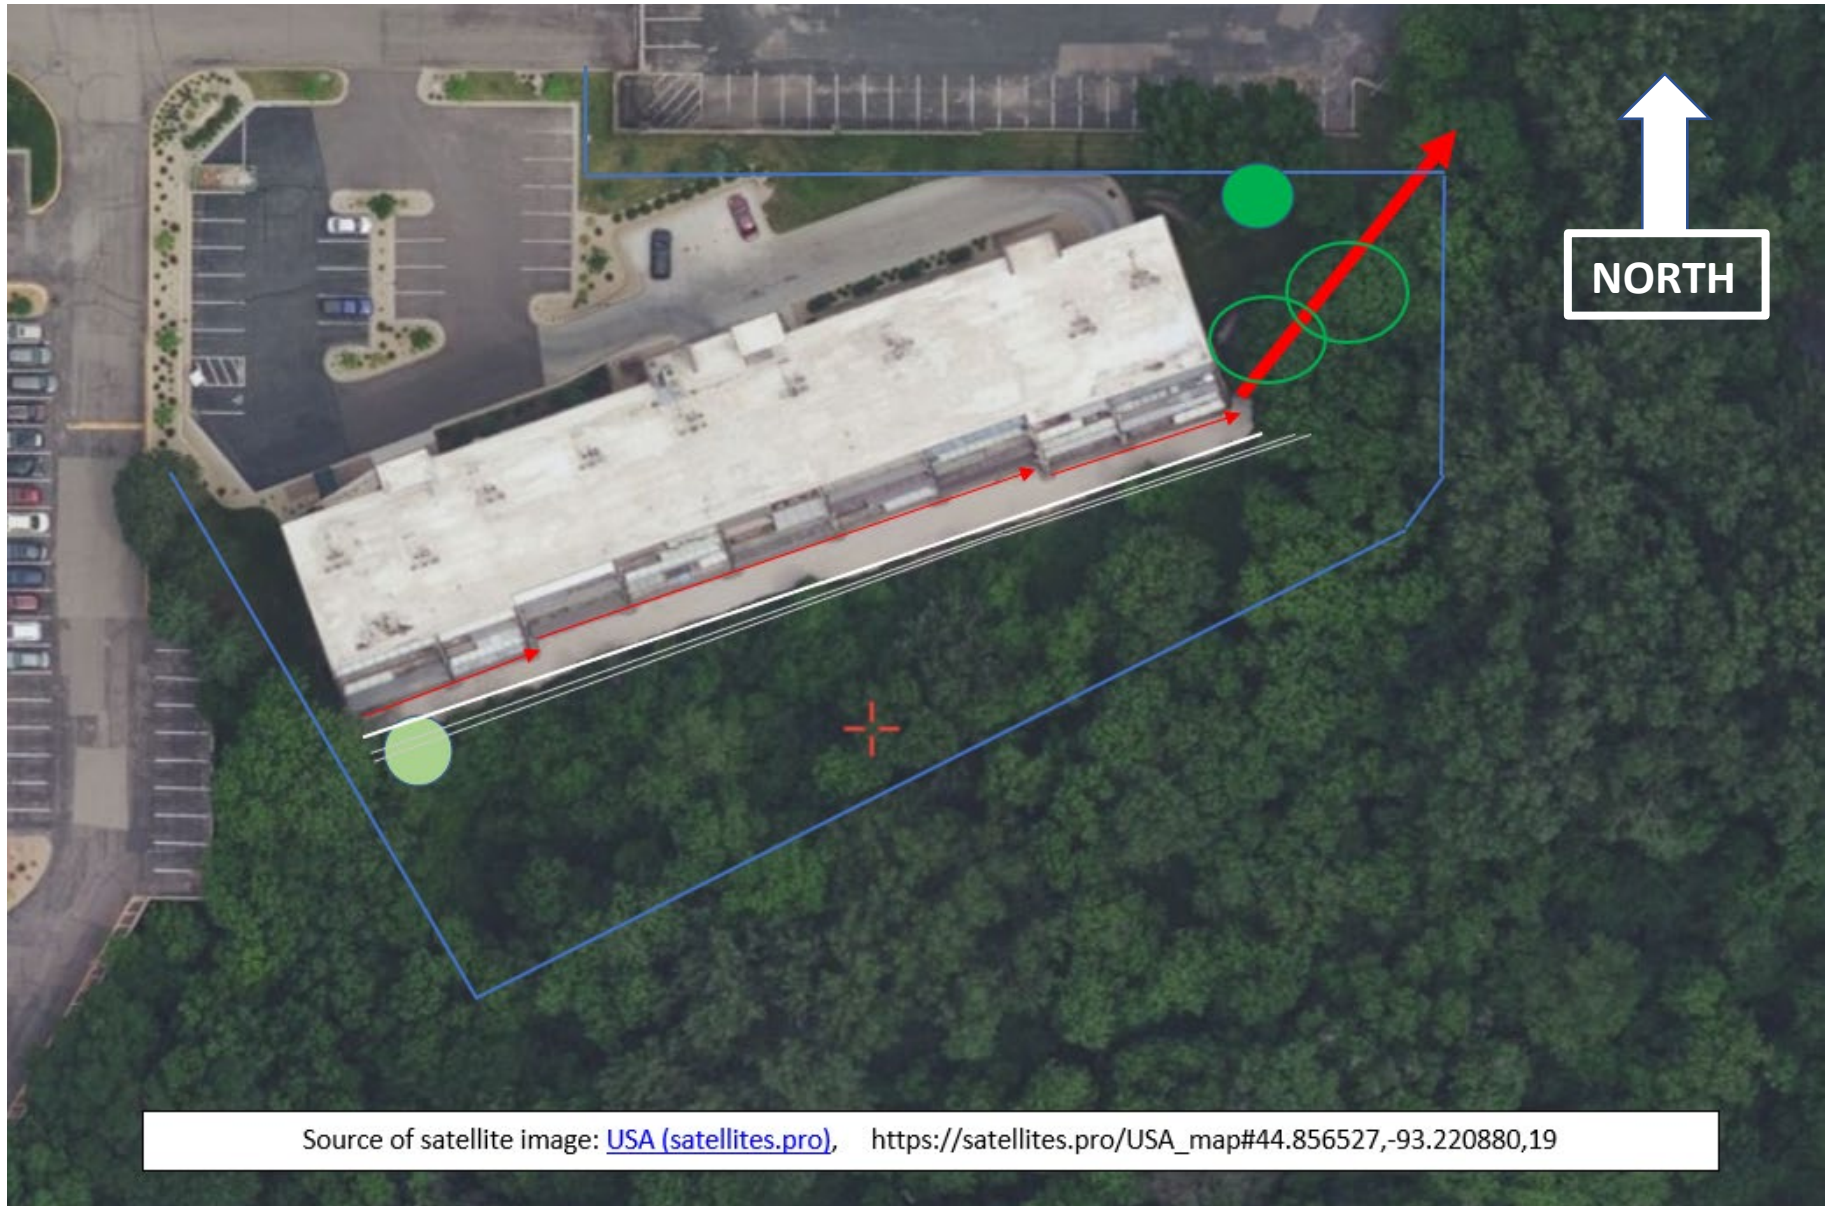
Current Conditions - Diagram

An aerial photograph with annotations, as well as a legend are provided to help explain current conditions at the 8121 34th Ave S, Bloomington, MN 55425 project site (See "Current Conditions Diagram" and "Legend"). Existing gravel area, drain tile, top of the embankment, double silt fence, approximate property lines, and trees to be trimmed are highlighted on the photo and in the legend. Gravel, drain tile, and silt fence were installed in spring 2020 as part of a separate building repair project. All proposed erosion control work will be done on the south and east sides of the building. Future work, on the west side of the building, as a separate project, is anticipated after a 146-unit apartment building is completed, located at 8131 34th Ave S., which is immediately to the west of the project site.

Draintile buried along entire southside of building with river rock at the surface. Extends 2 feet to 3 feet out from the south side of the building, approx 310 feet along length of the building. **Must not be removed.**

Drain extends underground from east side of building approx 130' to the edge of bluff. **Must not be damaged.**

13 inch diameter boxelder tree. (located 11 ft E of west edge of bldg & 12 ft from top of the embankment & 7 ft down from 2nd silt fence). To be trimmed or if determined in coordination with City Forester, removed.

Approximate property lines. (Bldg is approx. 307 feet long. South property line is approx. 90-110 ft from SW corner of the bldg. & approx. 45-55 ft from SE corner of the bldg.)

Gravel area is in light tan color, it extends 12 ft to 16 ft from building to top of embankment (extending 10 ft to 14 ft from edge of river rock to top of embankment).

The top of the embankment is shown as a white line.

Double silt fence is shown in a double grey line & has been placed anywhere from 1 foot to 5 feet down the embankment from the crest. **(Both silt fences to remain until new Mesic Prairie Native seed is 80% established.)**

Two Maple trees on East side of building. Require trimming.

One Green Ash on East side of building, to be determined if needing trimming or removal.
