LOWER MINNESOTA RIVER WATERSHED DISTRICT

Technical Memorandum

Re: Lower Minnesota River Watershed District (LMRWD) 2020–2022
Permitted Projects Inspections

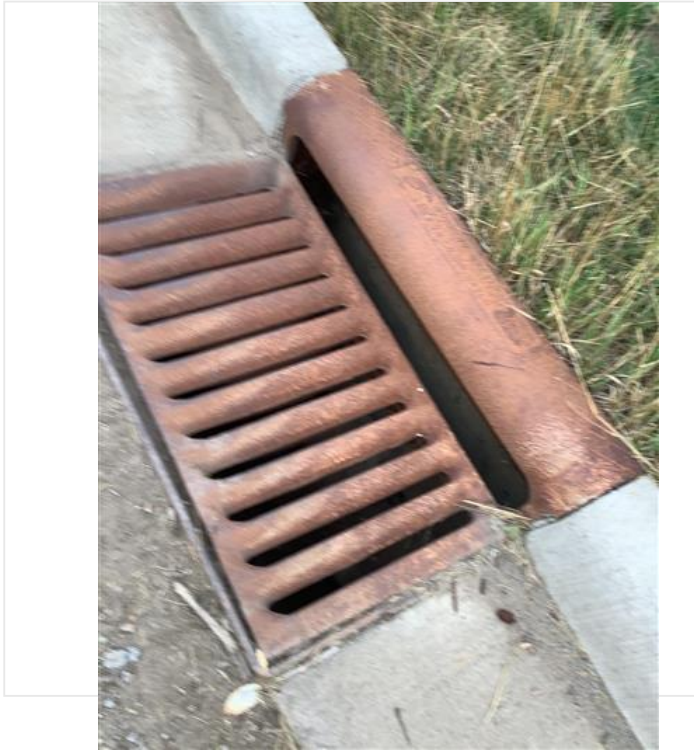
If "No," upload images of the temporary erosion control BMPs differing from the sediment control plan or stormwater management plan:
