# **Engineer's Report for Lower Riley Creek Stabilization Project**

***RPBCWD Reach E, Site D3, and LMRWD Reach***

***Eden Prairie, MN***

Prepared for  
Riley Purgatory Bluff Creek Watershed District and  
Lower Minnesota River Watershed District

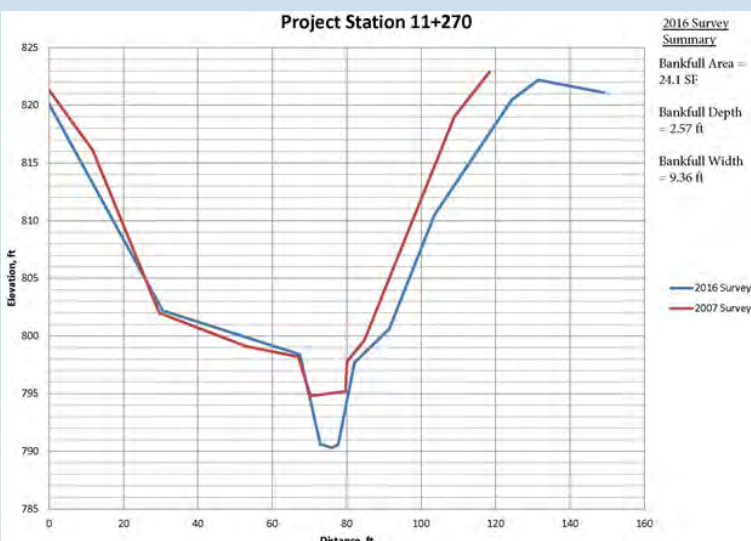
## CROSS SECTION COMPARISON

Site D3 is experiencing significant bank erosion that is likely contributing sediment loads to Riley Creek. A comparison of surveyed cross sections shows that the channel has degraded since the 2007 survey as it is currently both deeper and wider. The cause of the initial instability within this reach is likely the gradual increase in runoff volume and increased peak runoff rates generated by a developing watershed.

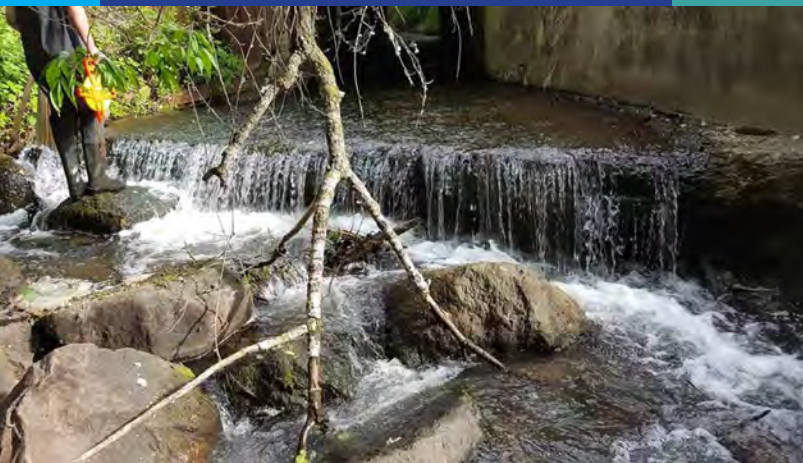
Scouring on the downstream side of Flying Cloud Drive is representative of active erosion in Riley Creek

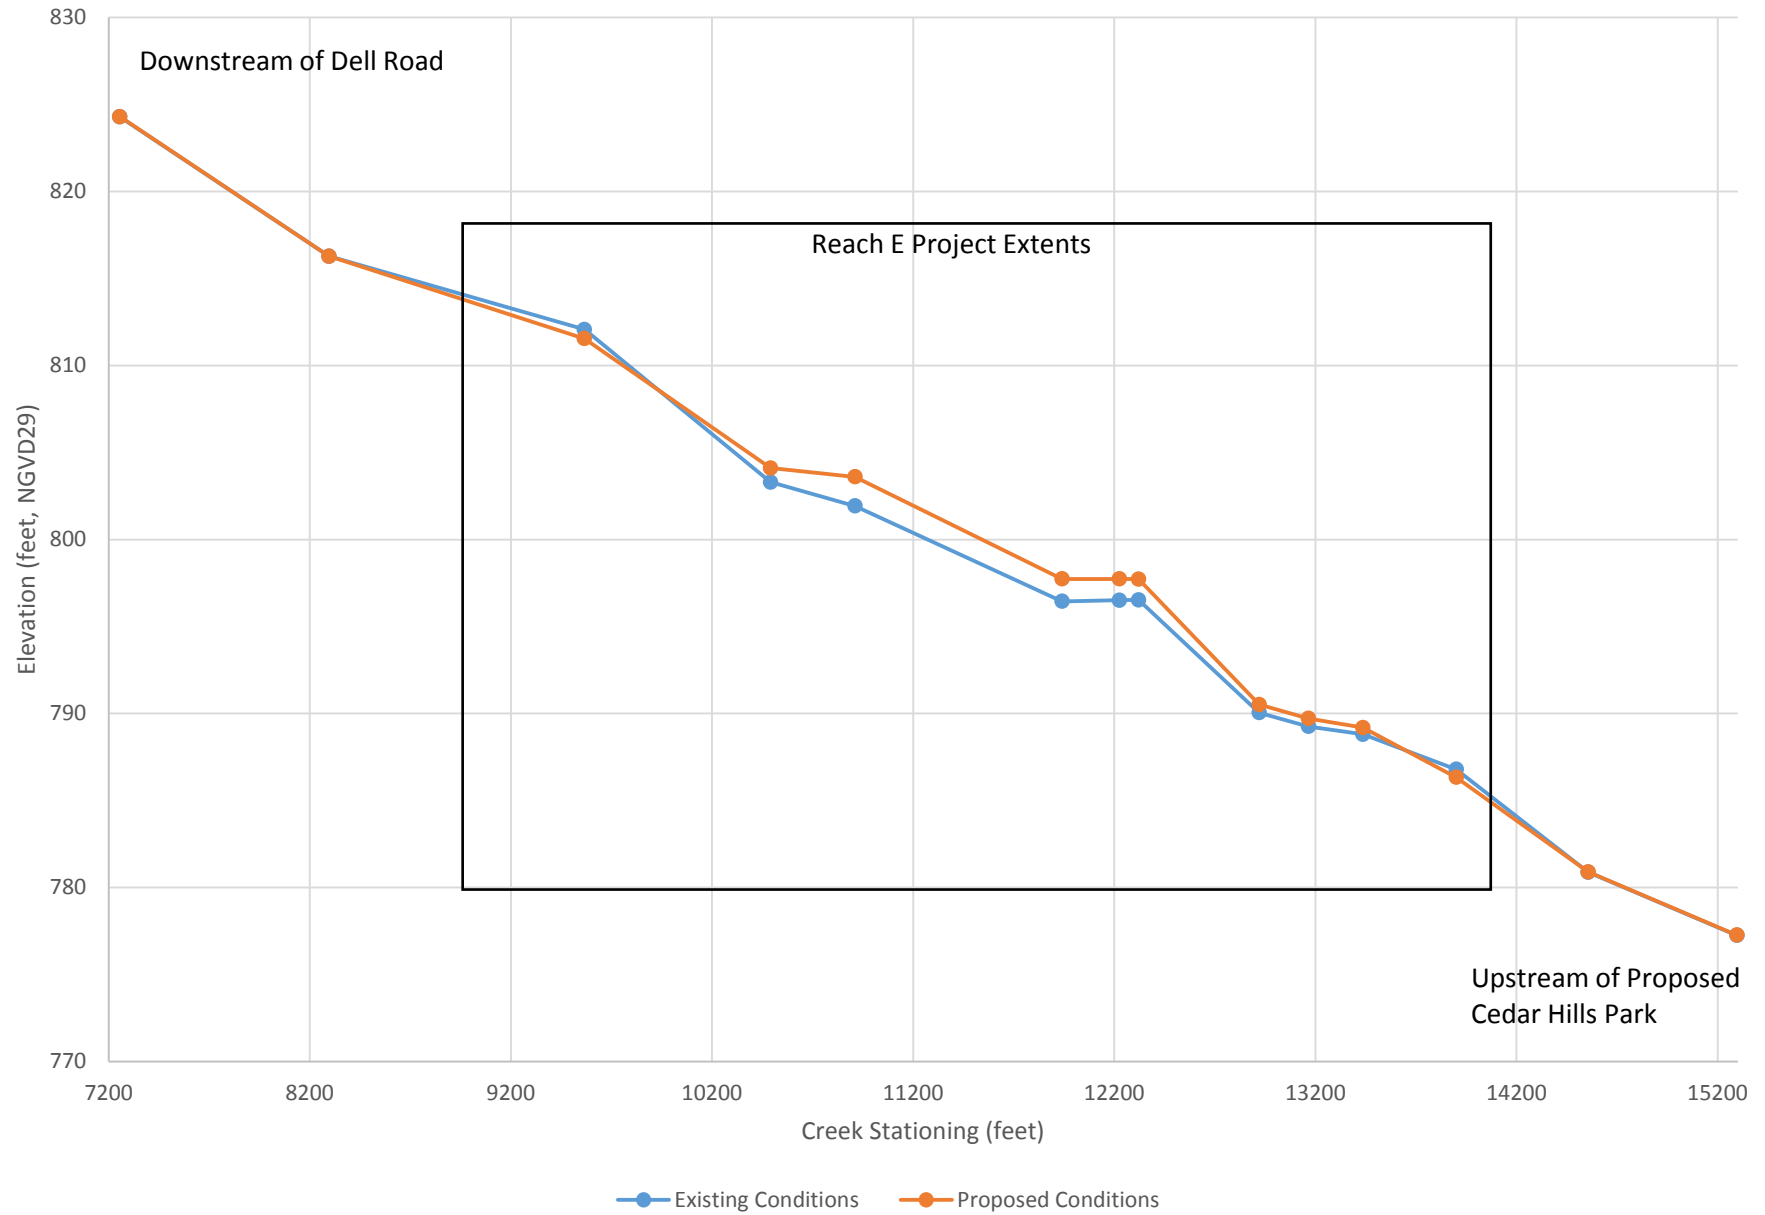
Riley Creek 100-year, 24-hour Design Event Water Surface Elevations

Figure 6-1 shows the existing and projected water surface elevation for the 100-yr design storm based on the District's Hydrology and Hydraulics (H&H) model. The proposed condition simulates raising the bed of the stream by 3-feet without any additional floodplain mitigation, similar to the rock riffle alternatives proposed. The maximum rise within the reach is 1.7 feet and the proposed profile matches the existing profile near the upstream end of the project reach. Based on this preliminary modeling, the rock riffle alternatives could be permitted through the State and FEMA. RPBCWD Rules B and G require no net rise, maintenance of the hydraulic capacity, and compensatory storage within the floodplain for any fill within the channel.
